# Collapsing Structures and Public Mismanagement

Wolfgang Seibel

Collapsing Structures  
and Public  
Mismanagement

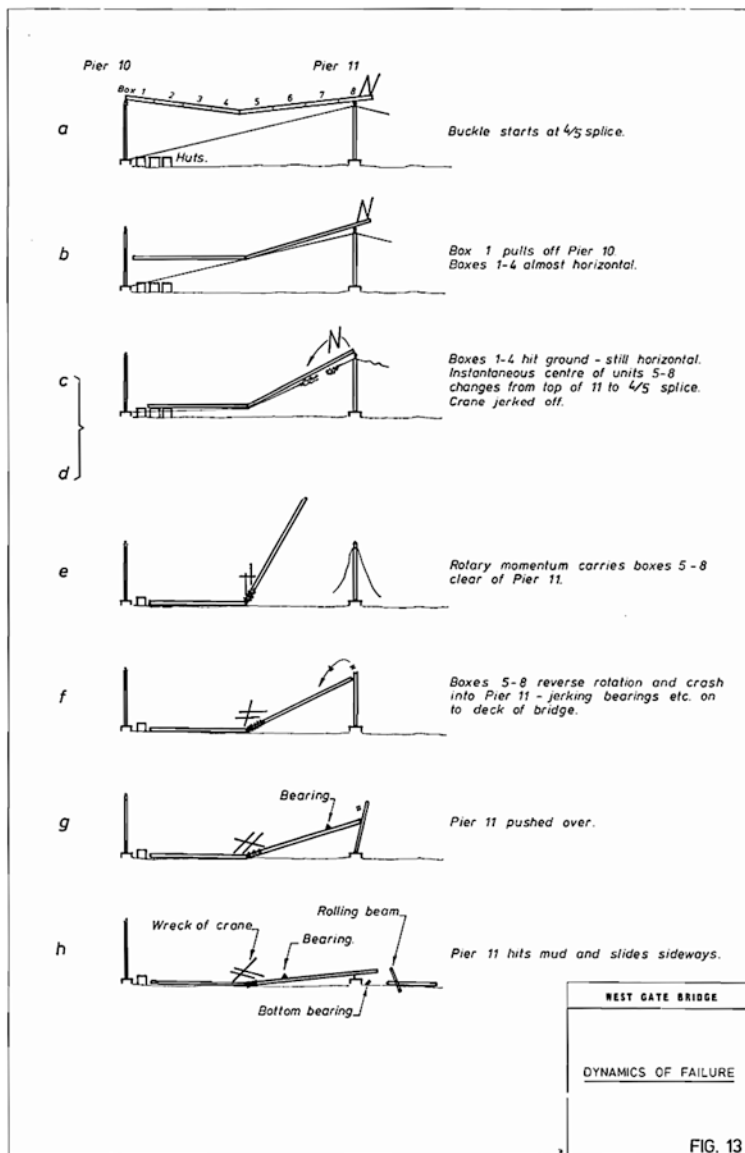
stress and resulting buckling was of immediate and crucial importance for the overall stability and safety of the bridge, a fact that was tragically corroborated by the collapse of 15 October 1970.

Illustration 2.2 “Dynamics of Failure”. (Source: Royal Commission, Appendix, p. 134)

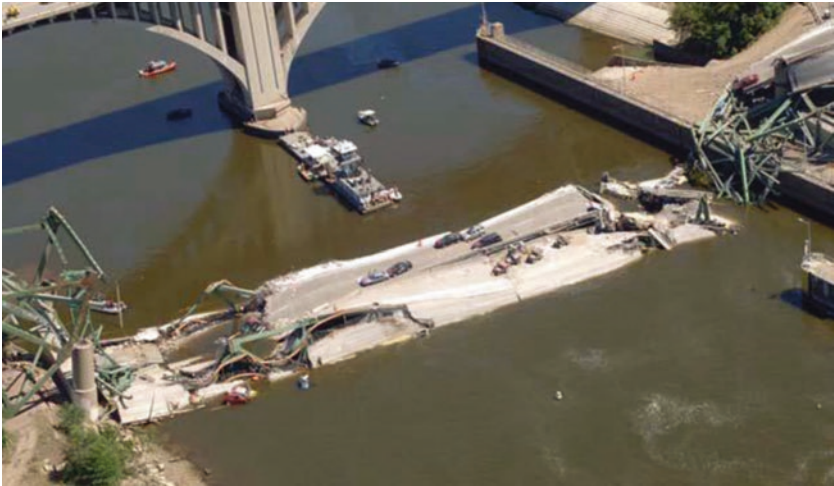
**Illustration 3.1** Collapsed I-35W Bridge center section. (Source: NTSB Report, p. 19)

Subsequently, construction equipment and aggregates such as sand and gravel were positioned in the closed inside southbound lanes. These works were completed by about 2:30 PM. At about 6:05 PM, the bridge center span separated from the rest of the bridge and fell into the river.

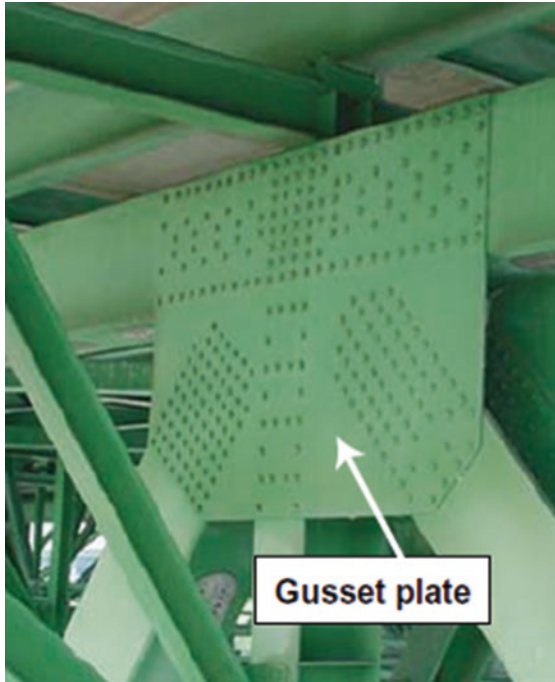
The middle part of the bridge where the failure of 1 August 2007 occurred consisted of welded built-up steel beams forming truss-structured girders whose individual components are referred to as “members”. The steel beams and truss members were riveted and bolted together. The nodes of supporting steel spans, steel beams and truss members were connected by riveted gusset plates. As the NTSB found out, the collapse of the Mississippi River Bridge was triggered by the concurrent failure of the gusset plates at the two nodes at position U10.<sup>3</sup> The failure, according to the NTSB, was due to “a combination of (1) substantial increases in the weight of the bridge, which resulted from previous bridge modifications, and (2) the traffic and concentrated construction loads on the bridge on the day of the collapse”.<sup>4</sup> The bridge’s load capacity was inadequate relative to an undetected design error pertaining to insufficient robustness of the gusset plates. The fact that the error had remained undetected was,

**Illustration 3.2** I-35W Bridge, main truss member with node and gusset plate. (Source: NTSB Report, p. ix)

according to the findings of the NTSB, due to the fact that it had been a “generally accepted practice among Federal and State transportation officials of giving inadequate attention to gusset plates during inspections for conditions of distortion, such as bowing, and of excluding gusset plates in load rating analyses” (Illustration 3.2).<sup>5</sup>

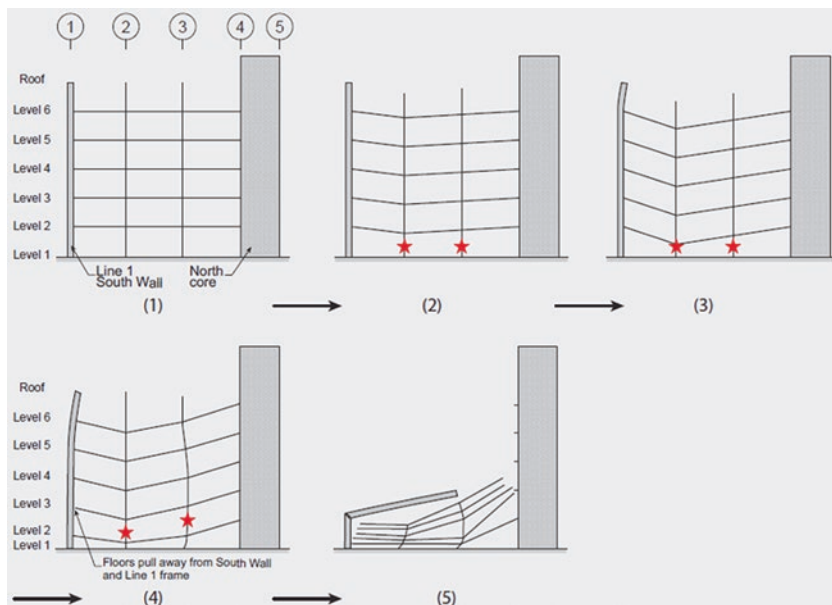
**Illustration 4.2** Most likely collapse scenario of the CTV Building with disconnecting floors/diaphragms. (Source: Royal Commission Vol. 6, p. 236 (originally: C. Hyland C. A. Smith, CTV building collapse investigation for Department of Building and Housing: 25 January 2012. Wellington, New Zealand: Department of Building and Housing))

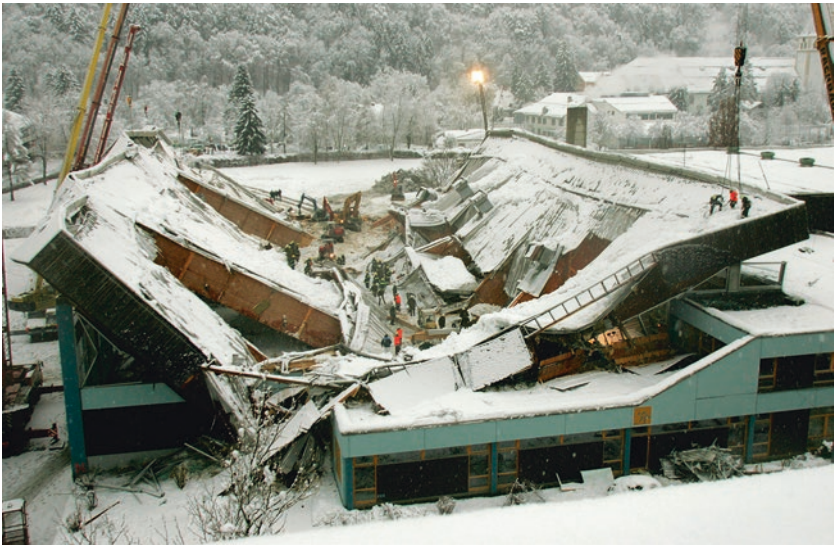
**Illustration 5.1** Bad Reichenhall Ice Skating Rink after the collapse of 2 January 2006 (Deutsche Presseagentur / Picture Alliance, media no. 38145505, license 212103591)
