# Sherborne Old Castle, Dorset

archaeological investigations 1930–90

**Peter White and Alan Cook**

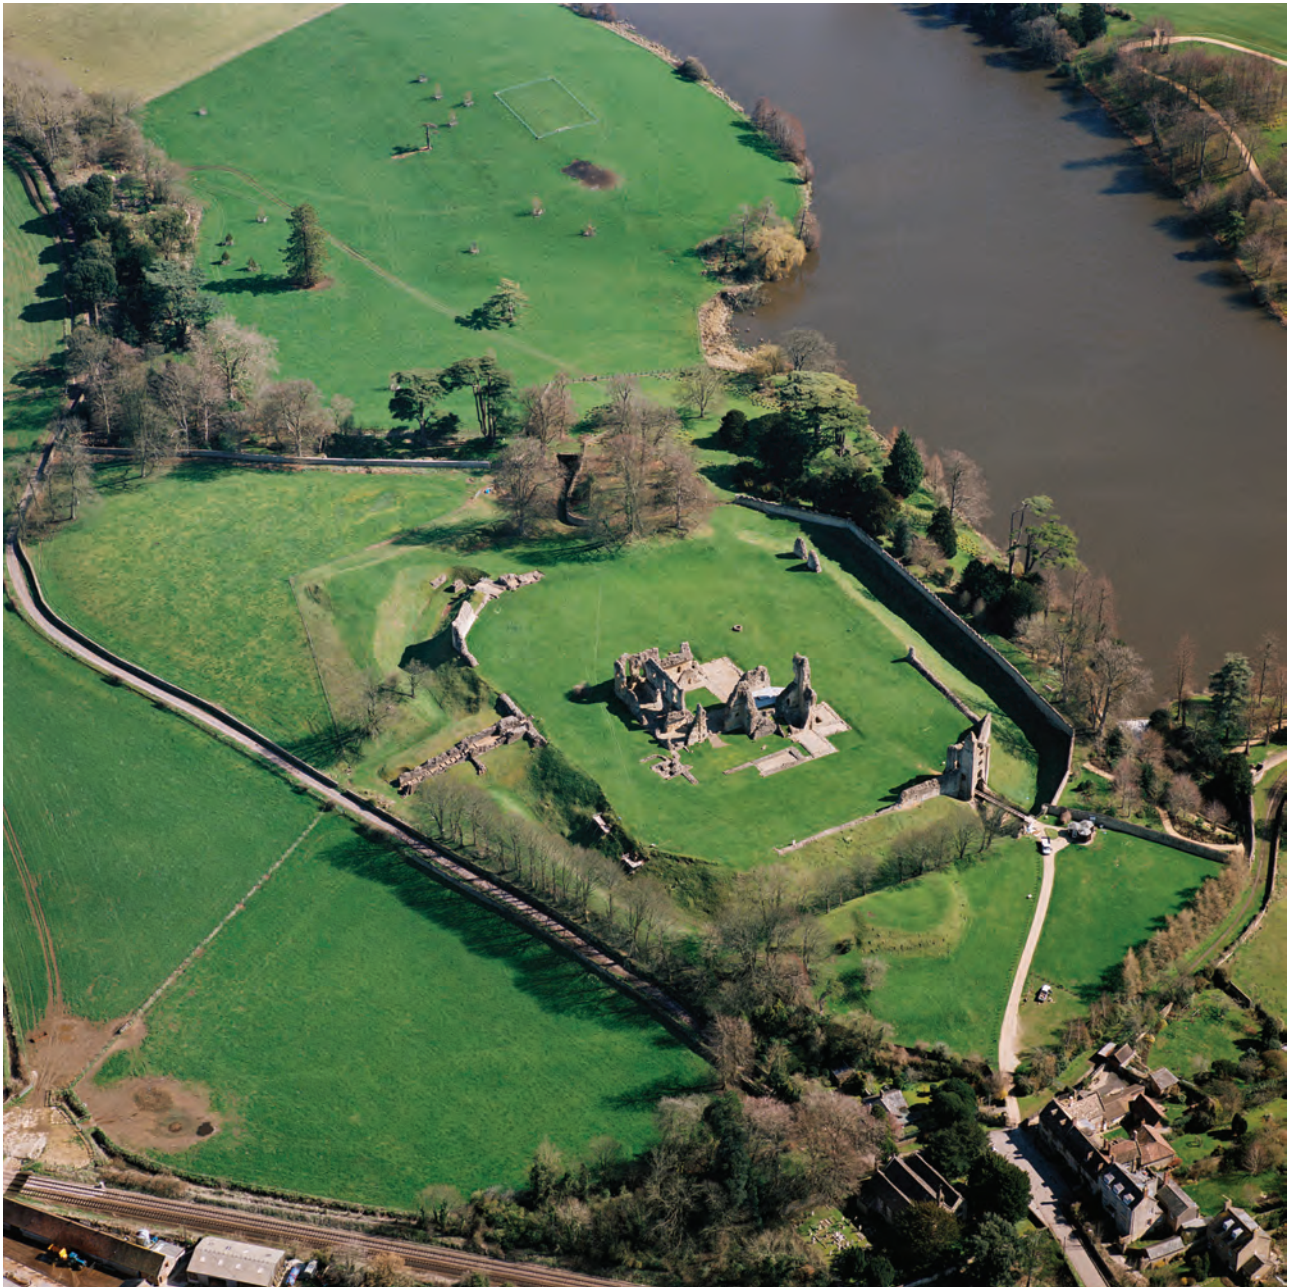
**Fig 3** Aerial view of the castle from the north west. *Photograph: NMR 23441.12*

There are fragmentary remains of the original curtain wall, but of the four mural towers placed symmetrically across the angles of the bailey at either end of its eastern and western sides only the two with gateways, to the south west and north east, survive above ground (figs 3 and 4). The four towers projected both externally and internally beyond the abutting flanks of the curtain wall. Only the south-west tower survives to its full height, including part of its parapet and a chimney stack above its western corner. It is the most complete structure, probably largely due to the improvement of the domestic accommodation on its upper floors by Raleigh for his steward. It seems to have formed the principal entrance to the bailey throughout, and elements of the original gate-passage survive at ground level. The entry was approached across the outer ditch by a double-span stone-arched bridge, for which the abutments survive within the ditch below the modern timber bridge. The exposed remains of the north-east tower show that it also formed a gatehouse with a passage, approached by a bridge similar in design to that at the south west.

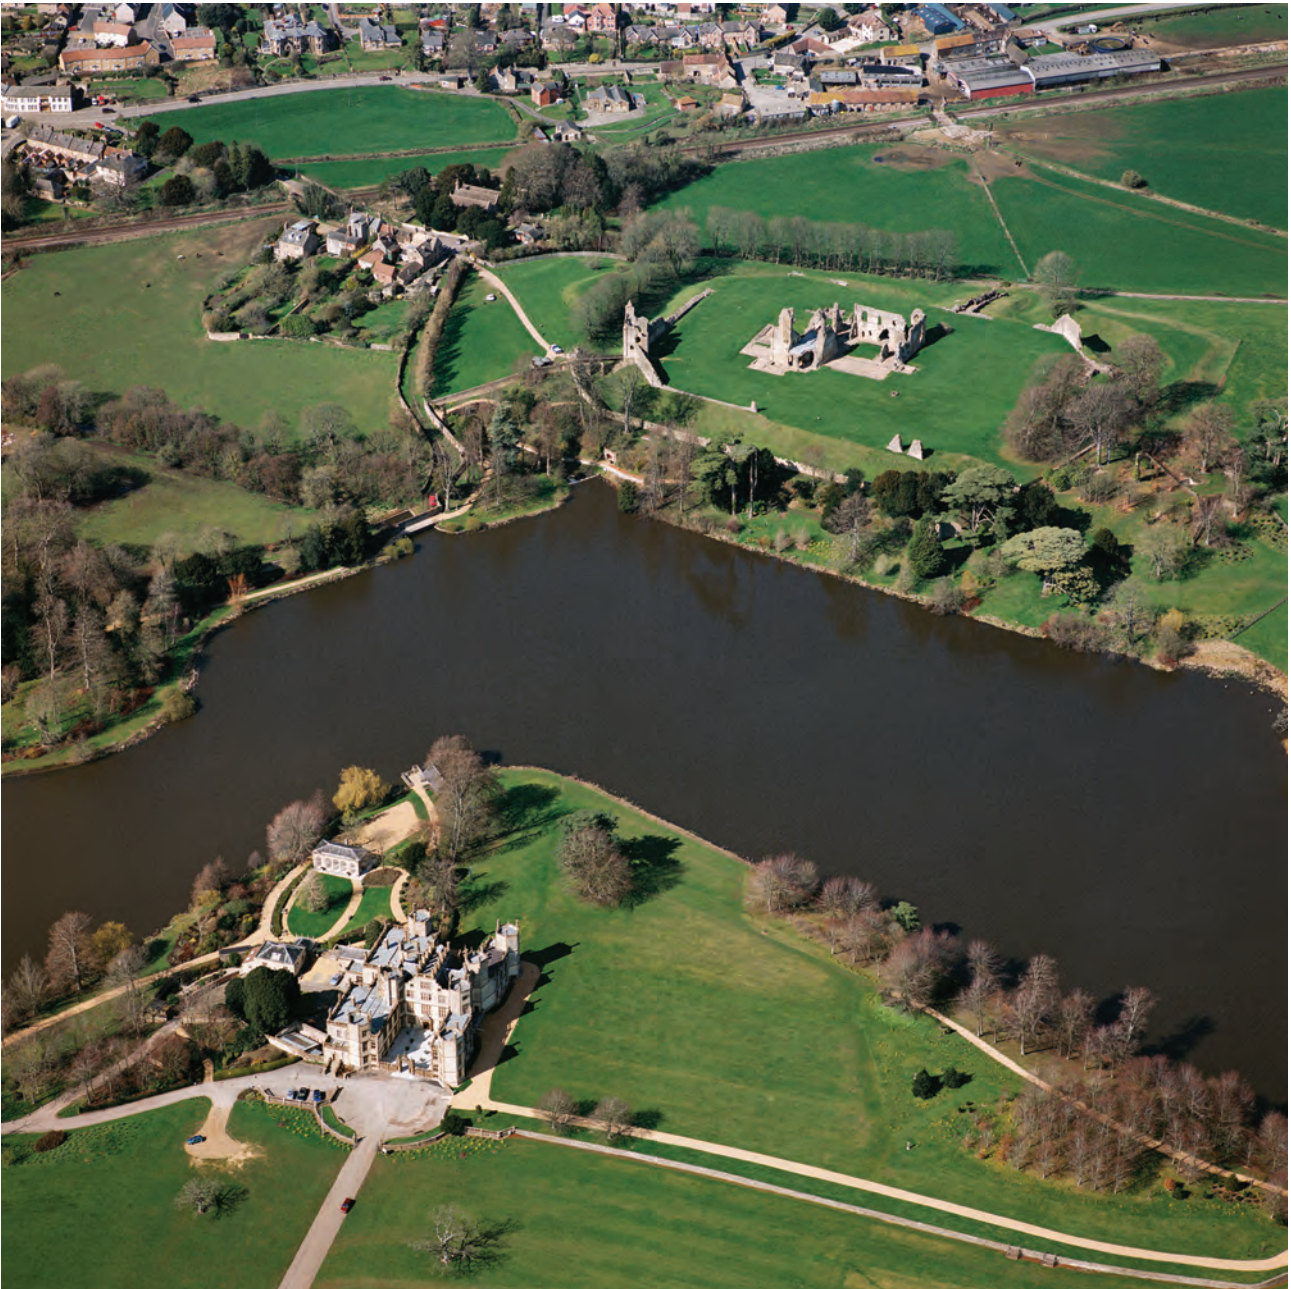
**Fig 4** Aerial view from the south, showing Sherborne Castle (Lodge) and the eighteenth-century lake. *Photograph: NMR 23441.08*

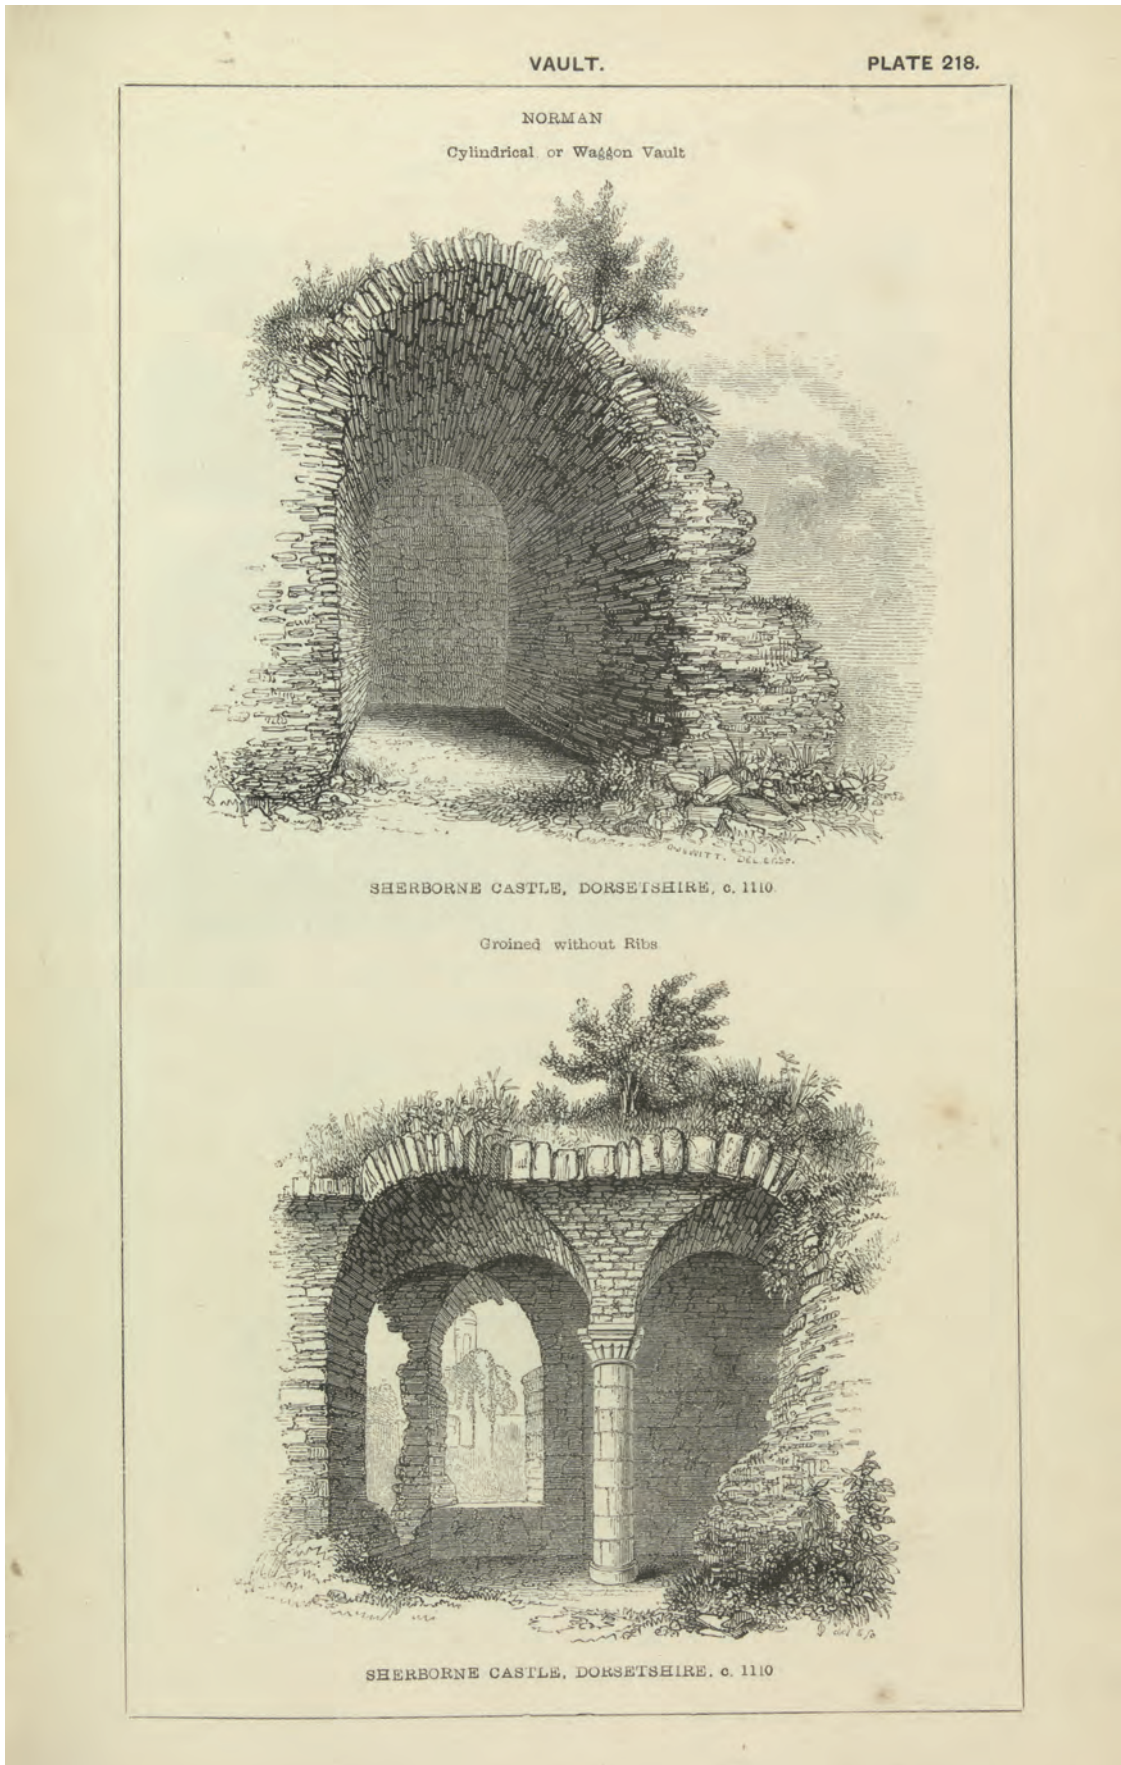
**Fig 20** Architectural details from the *Glossary of Terms used in Architecture* published by J H Parker, in 1845, showing (above) a view of one of the barrel vaults within the undercroft; and (below) a view looking into the southern end of the undercroft of the great tower showing the twelfth-century column reused to support the vault. *Engravings*: Parker 1845, II, pl 218

removal from a higher level within the tower (see fig 20).

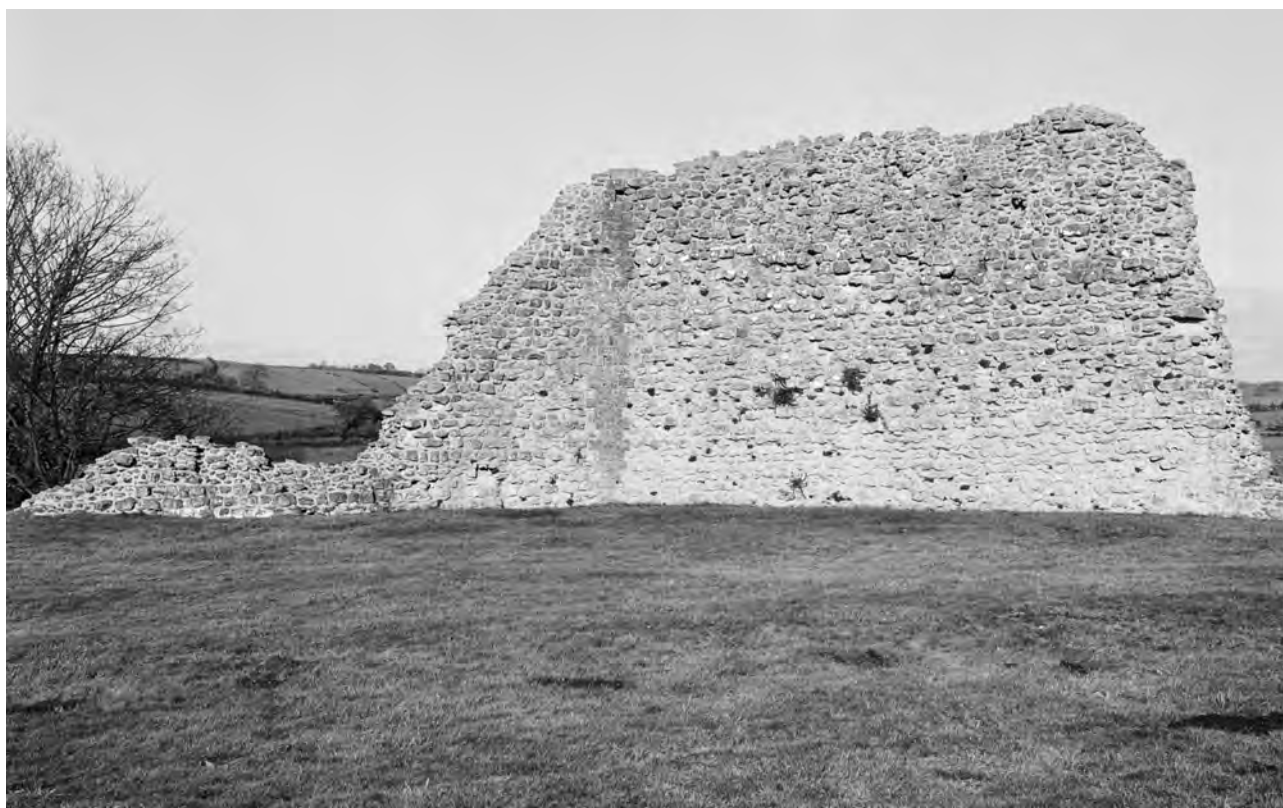
**Fig 34** The remains of the curtain wall at the north-east corner seen from within the bailey, showing the Ham Hill ashlar quoining in the angle of the wall junction. *Photograph:* NMR EH/B925739

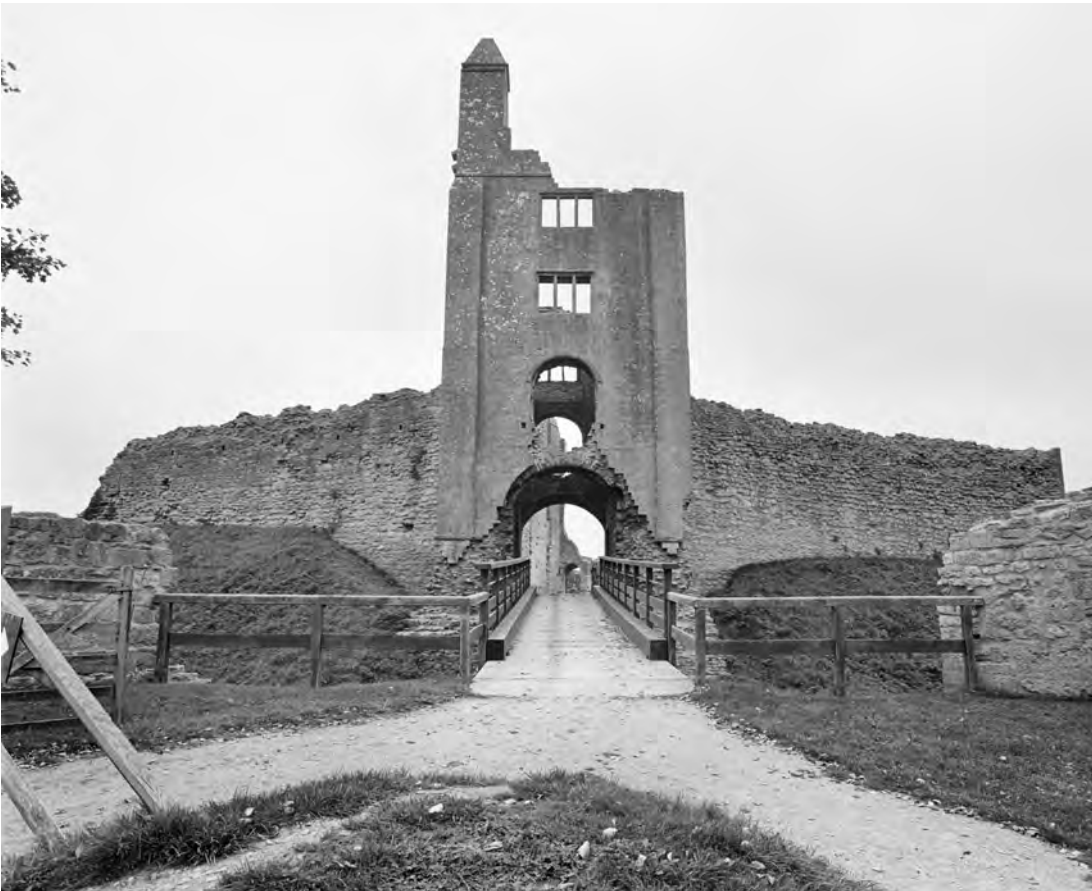
**Fig 35** The south-west gatehouse tower and the flanking lengths of the curtain wall seen from the approach to the modern bridge over the outer ditch. *Photograph: NMR EH/B925718*

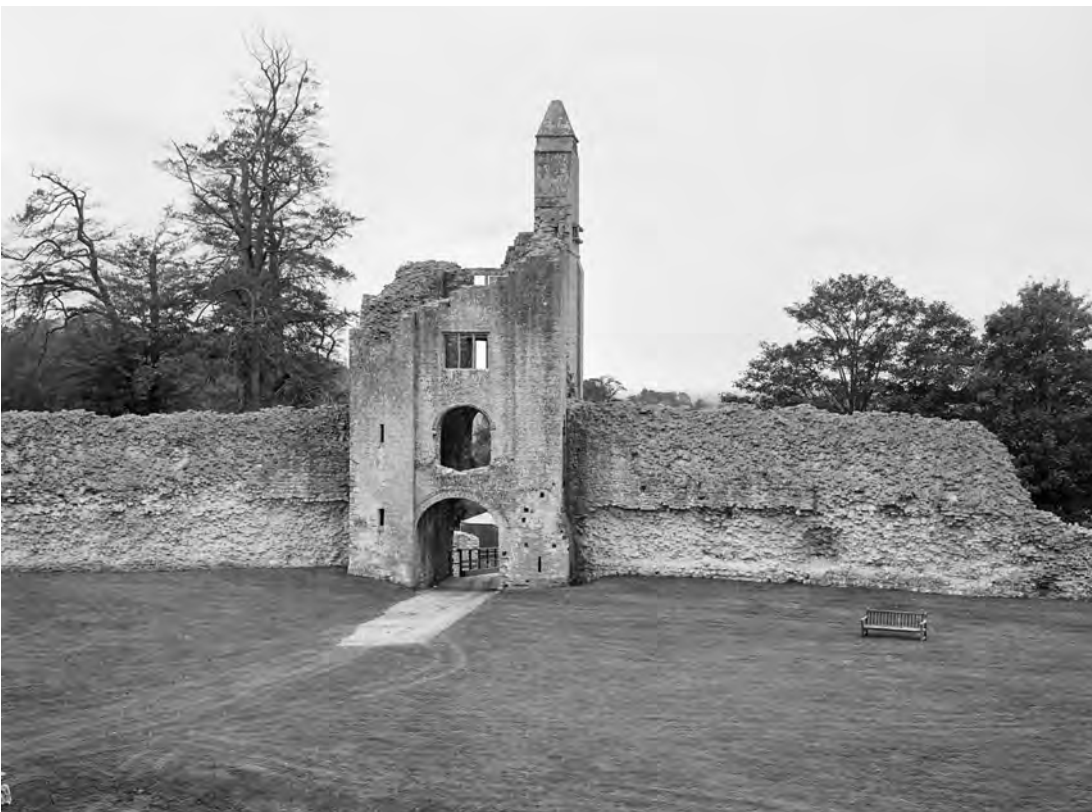
**Fig 36** The south-west gatehouse tower and the flanking lengths of the curtain wall seen from inside the bailey. *Photograph: NMR EH/B925711*

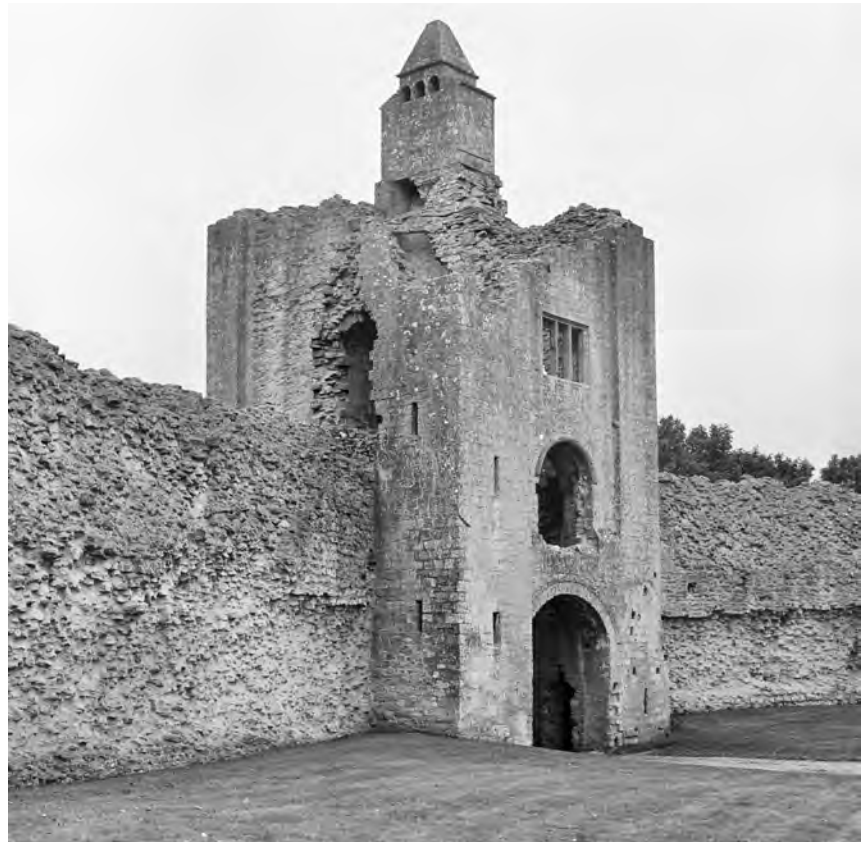
**Fig 37** The south-west gatehouse tower seen from the east within the bailey. *Photograph:* NMR EH/B925721

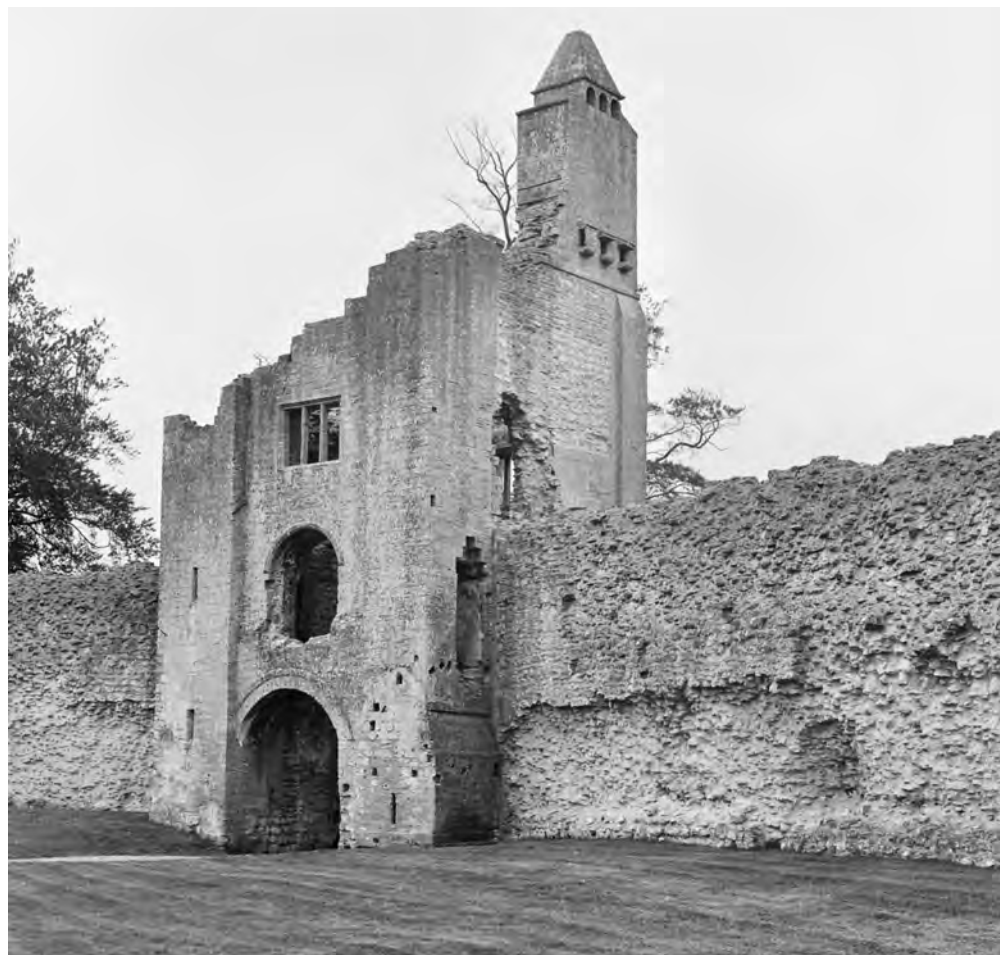
**Fig 38** The south-west gatehouse tower seen from the north within the bailey. *Photograph:* NMR EH/B925720

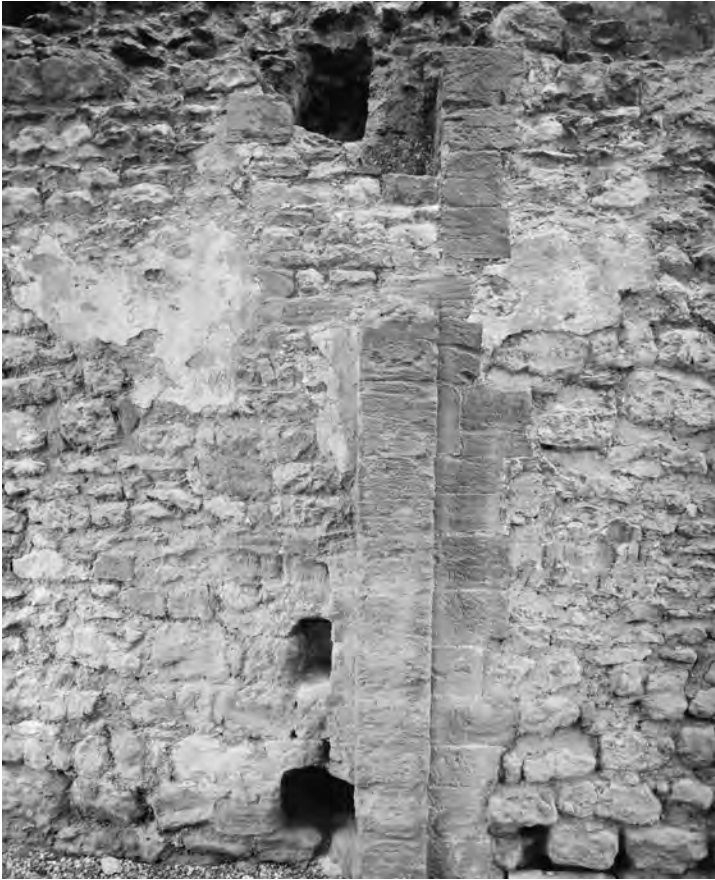
**Fig 39** The south-west gatehouse tower: a detail of the ashlar jamb at the centre of the south-east side of the passageway through the tower. *Photograph:* NMR EH/925733

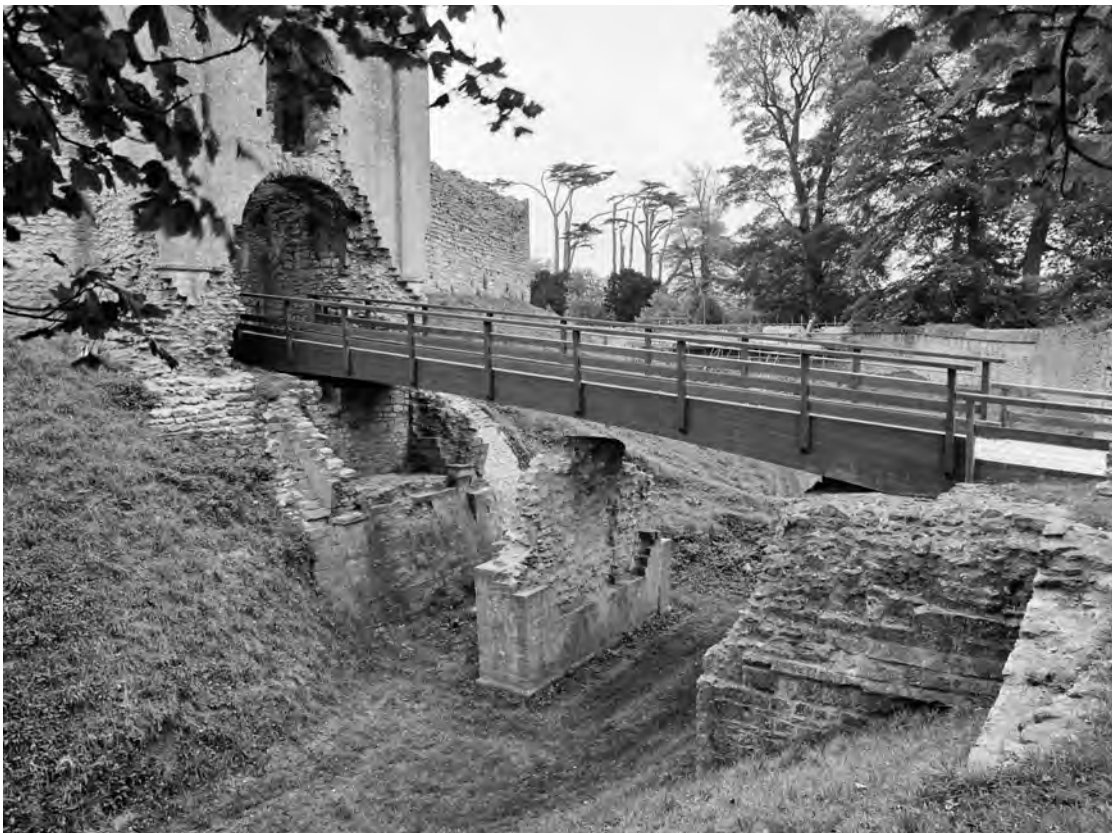
**Fig 40** The south-west bridge: the remains of the twelfth-century bridge within the outer ditch seen from the west showing the central pier and the outer and inner abutments below the modern bridge. *Photograph:* NMR EH/B925719

On the outer front of the tower the arched entrance to the passageway through the first storey has lost the ashlar facings to its jambs and arch, but, at the springing level of the arch, the remains of sockets on each side may indicate the later insertion of a beam. These and two other sockets cut into the ashlar face of the wall immediately above the arch were possibly formed to hold the mechanism to raise a drawbridge, probably installed in Phase II (1140–99), at the entrance to the tower. The counterweight for this bridge was presumably housed in the large pit formed in the inner revetment wall of the bridge (fig 40).

The complete excavation of the causeway supervised by Dr Gill Hey was undertaken in 1978–9.<sup>193</sup> After the plan of the causeway was recorded, the fill between its flanking revetments was excavated in stages. Ultimately, this work exposed all the remains of the original bridge and the evidence of later alterations to its structure. The faces of both bridge revetments and the central pier indicated that originally both bays were spanned by three diaphragm arches, with an arch to either side and a wider arch in the centre of each bay. As there was no indication of any joint or other change of build between the masonry of the bridge's inner abutment wall and the base of the gatehouse tower immediately above the revetment, it is assumed that the bridge and the tower were part of a single integrated programme of construction in Phase I (1122–39: figs 40, 47 and 48).

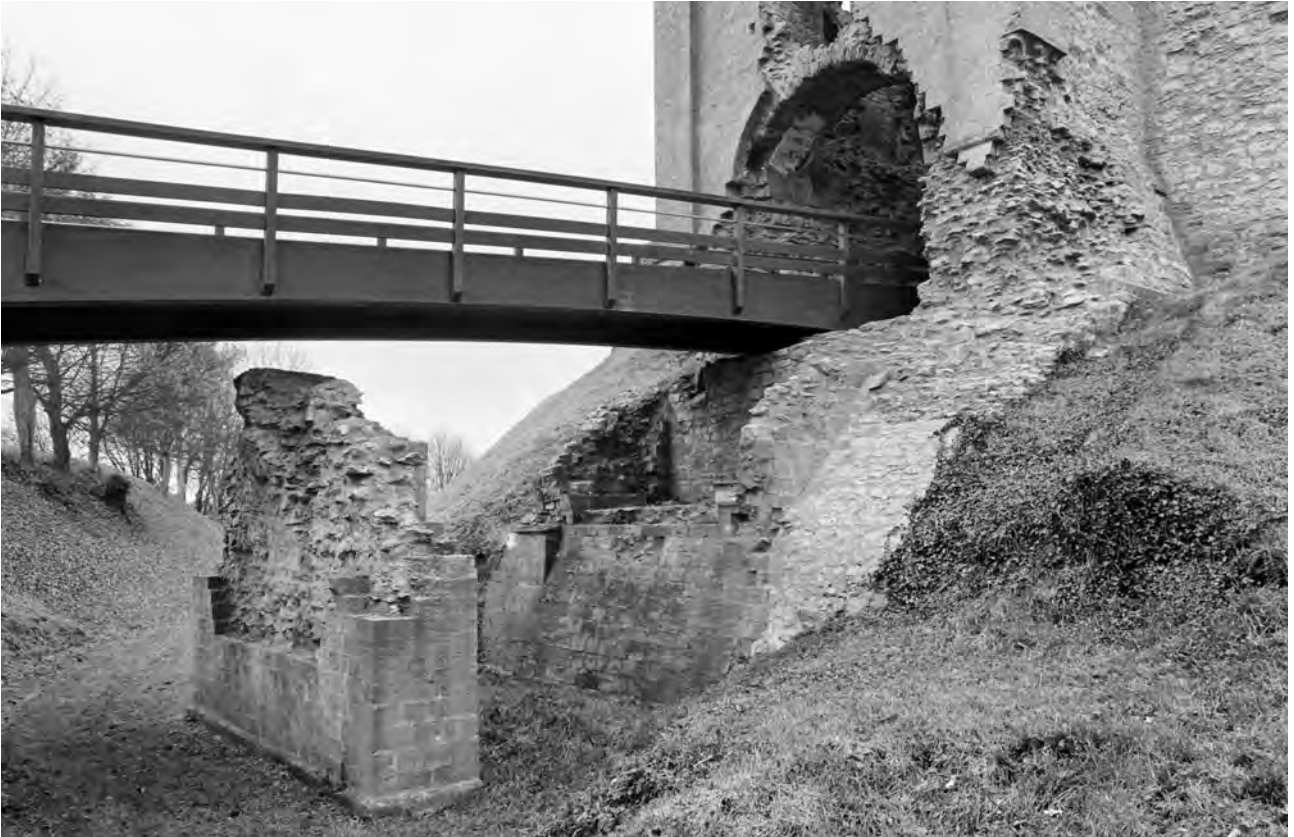
**Fig 47** The south-west bridge: the central pier of the original bridge and the batter of the inner abutment, altered later to incorporate a drawbridge pit. *Photograph: NMR EH/B925724*

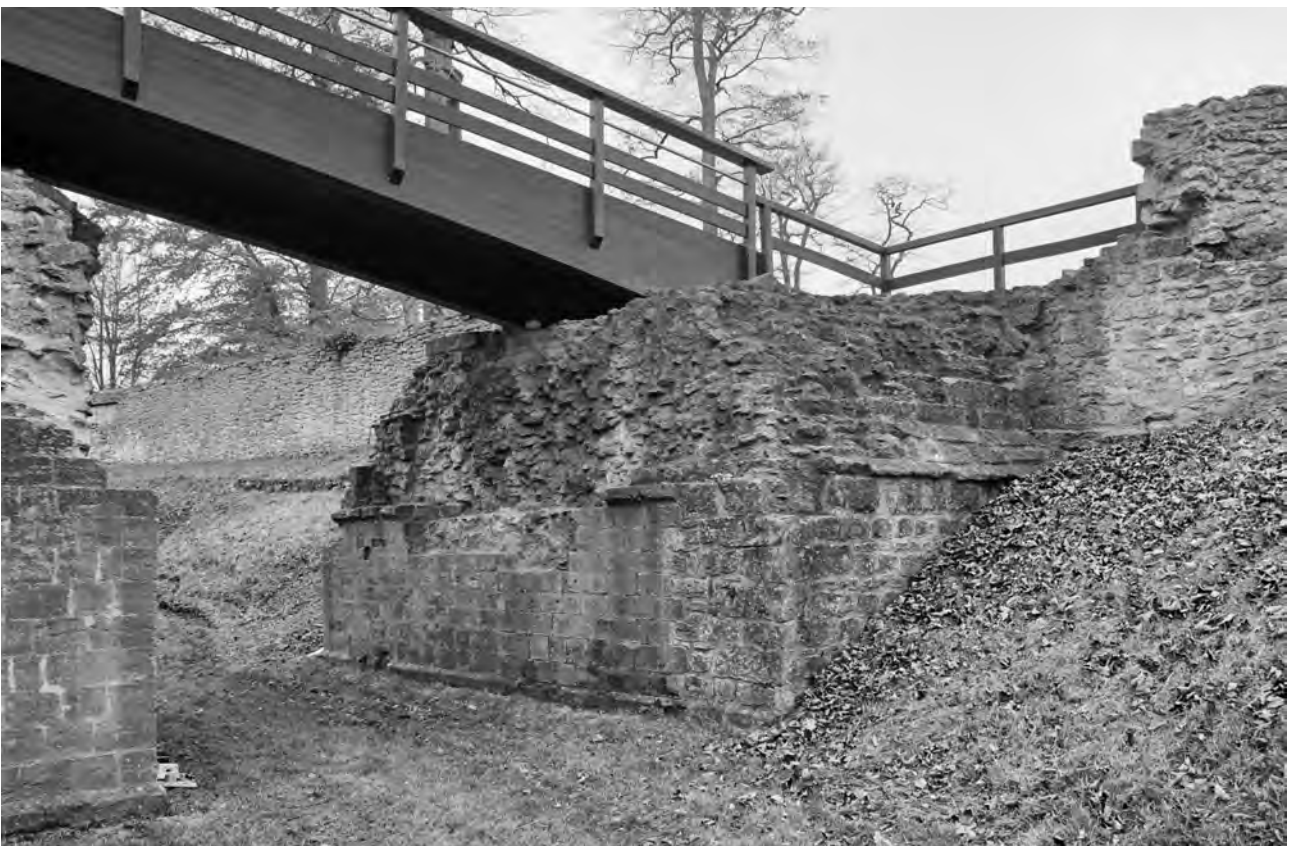
**Fig 48** The south-west bridge: the outer abutment to the original bridge with added revetments at each end. *Photograph: NMR EH/B925735*

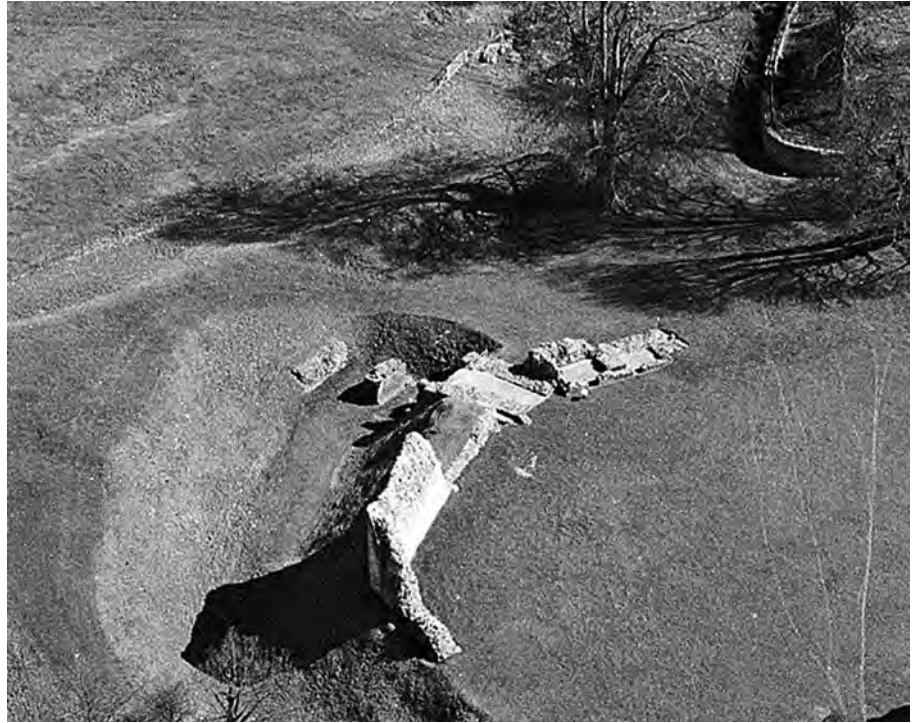
**Fig 50** The north-east gatehouse tower: the remains of the tower and bridge from the air. *Photograph:* detail of NMR 23441.12

The remains of the tower, the adjoining structures and the bridge were fully exposed in 1972–3 to record the archaeological contexts (figs 50 and 51).<sup>197</sup> Examination of

Bean exposed a series of buildings of rubble construction added against the curtain wall (see figs 49 and 50).

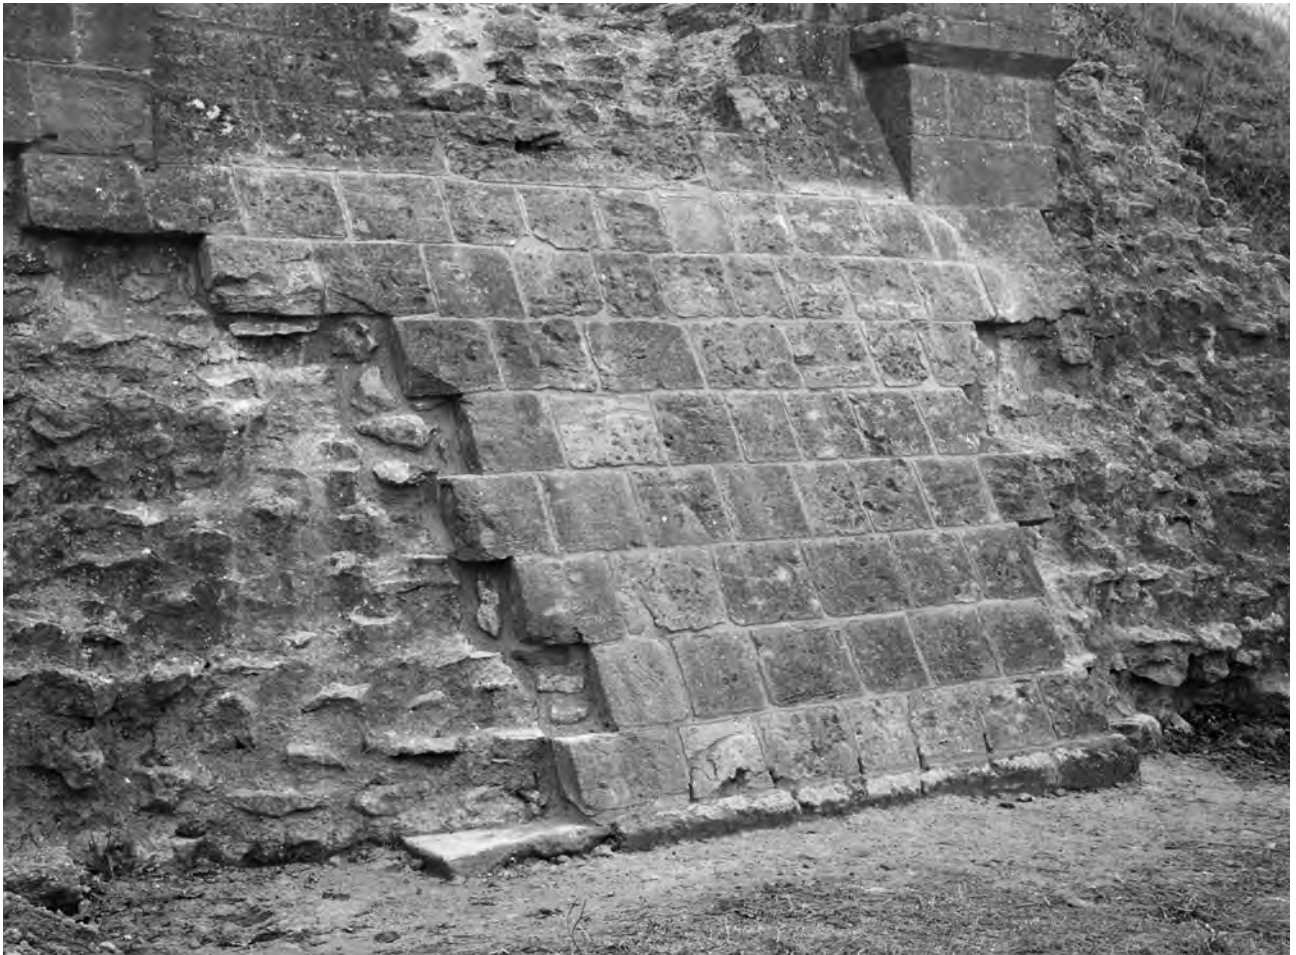
**Fig 51** The north-east bridge: a detail of the ashlar-faced batter to the inner abutment of the bridge. *Photograph:* NMR EH/B905617

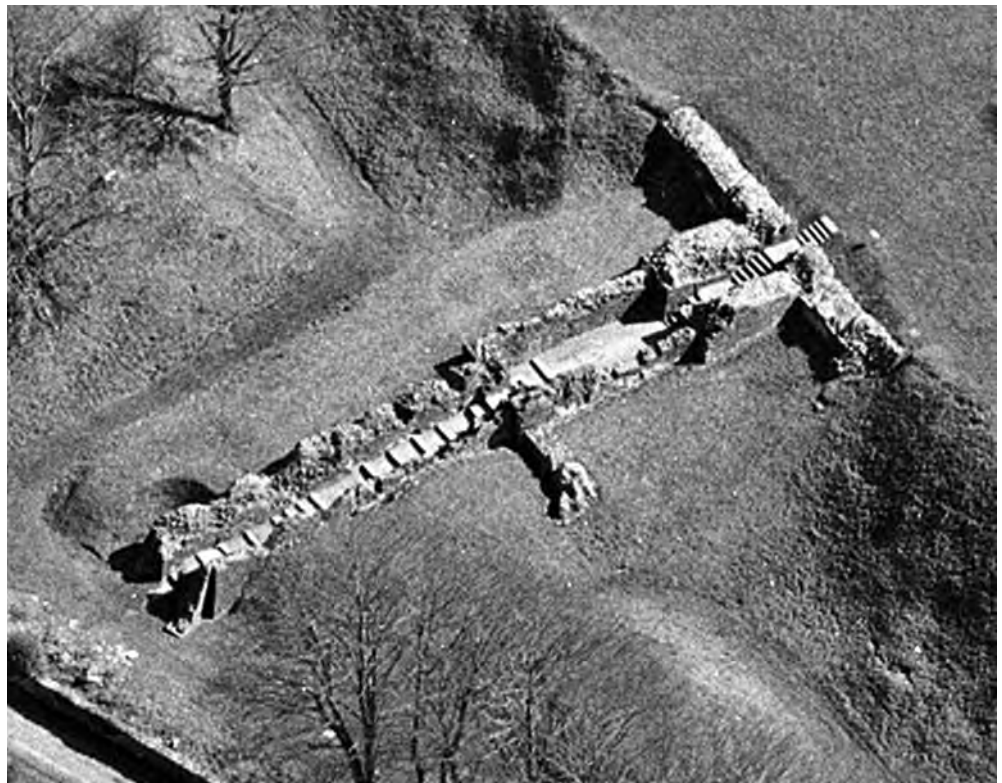
**Fig 55** The north gate: the  
remains after excavation,  
looking south, from the air.  
*Photograph: detail of fig 50*

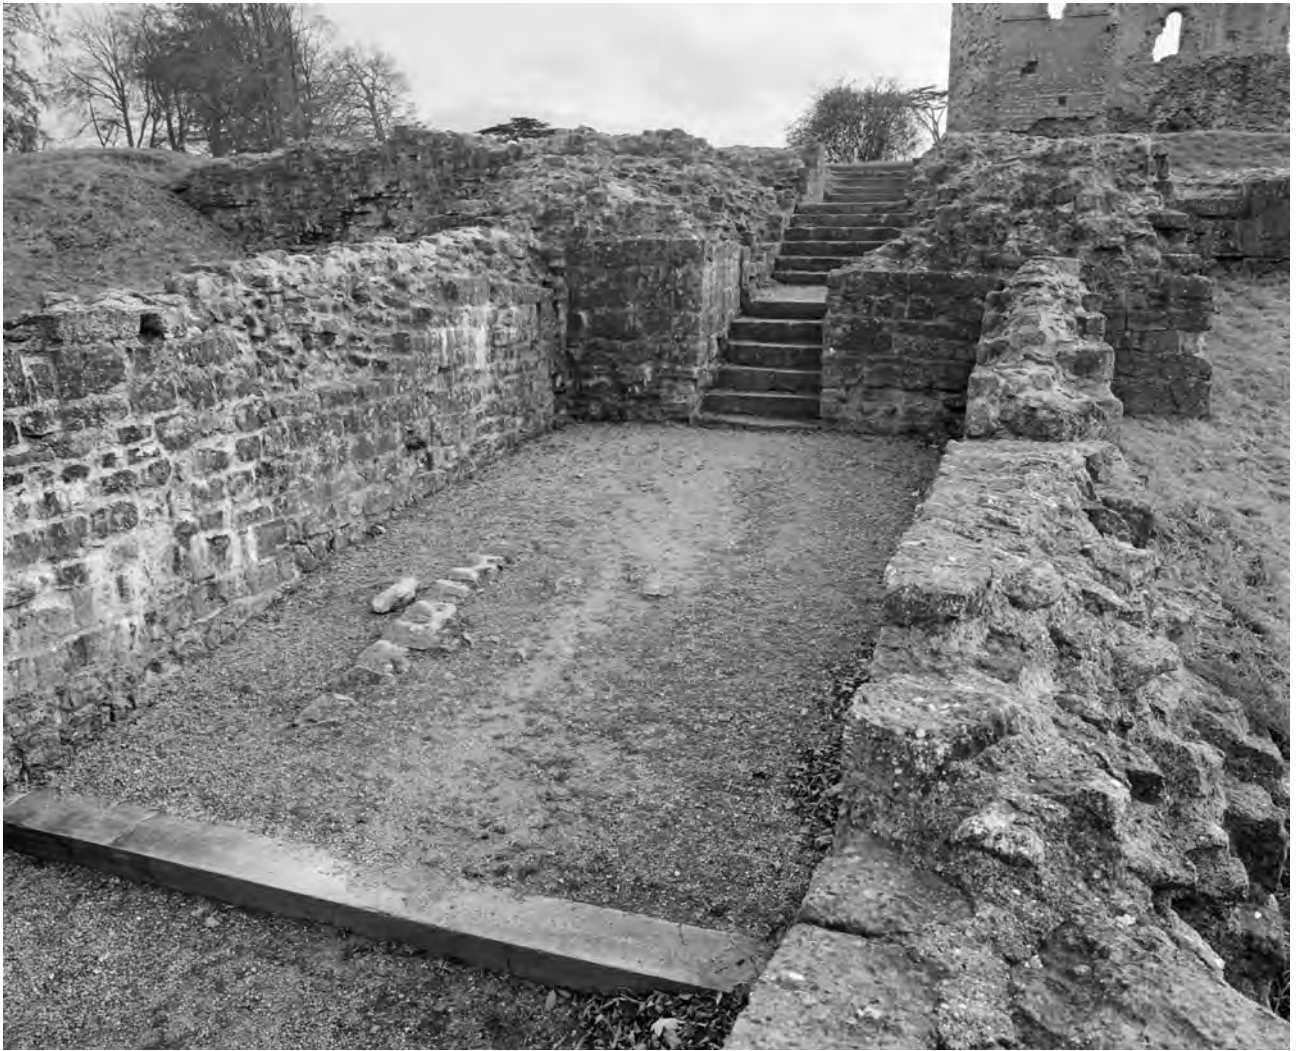
**Fig 56** The north gate: the remains of the walled causeway leading to the stairs within the later gatehouse tower abutting to the curtain wall.  
*Photograph: NMR EH/B925755*

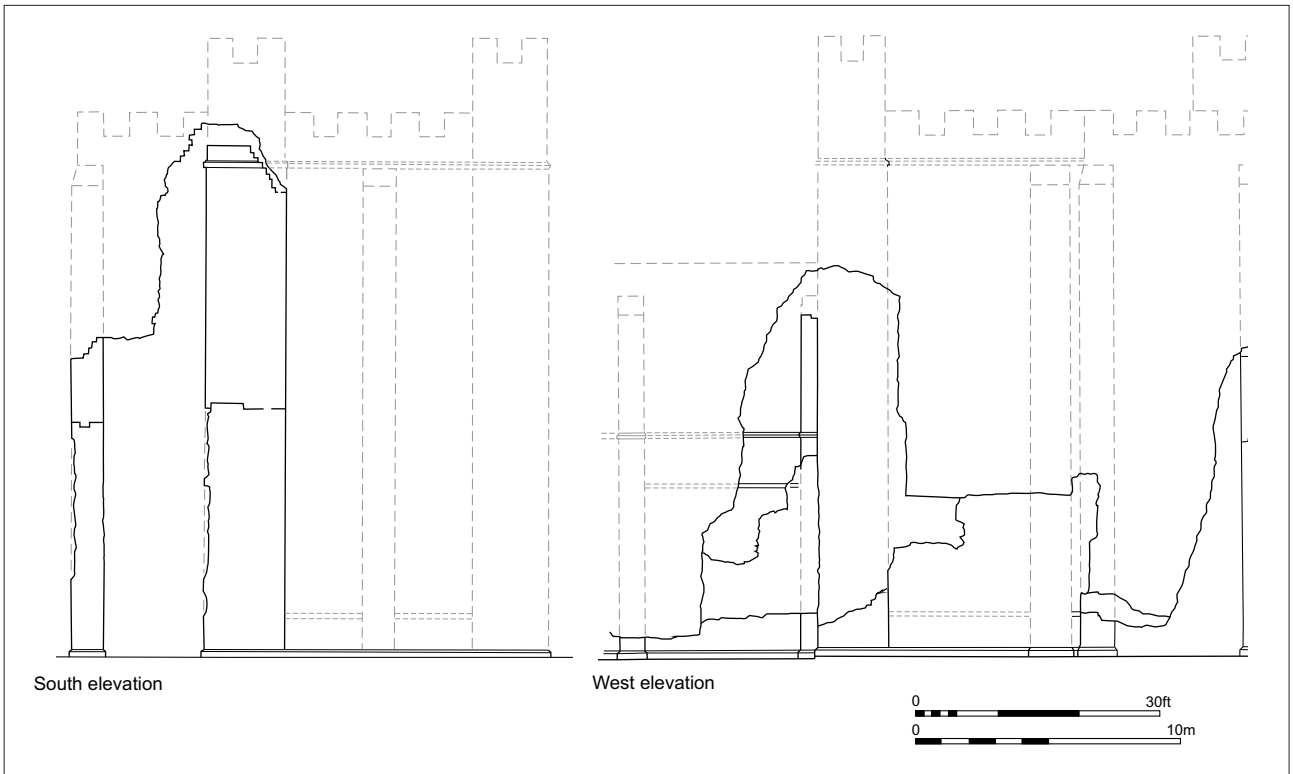
Fig 59 The central building complex: reconstructed south and west elevations of the great tower in Phase I

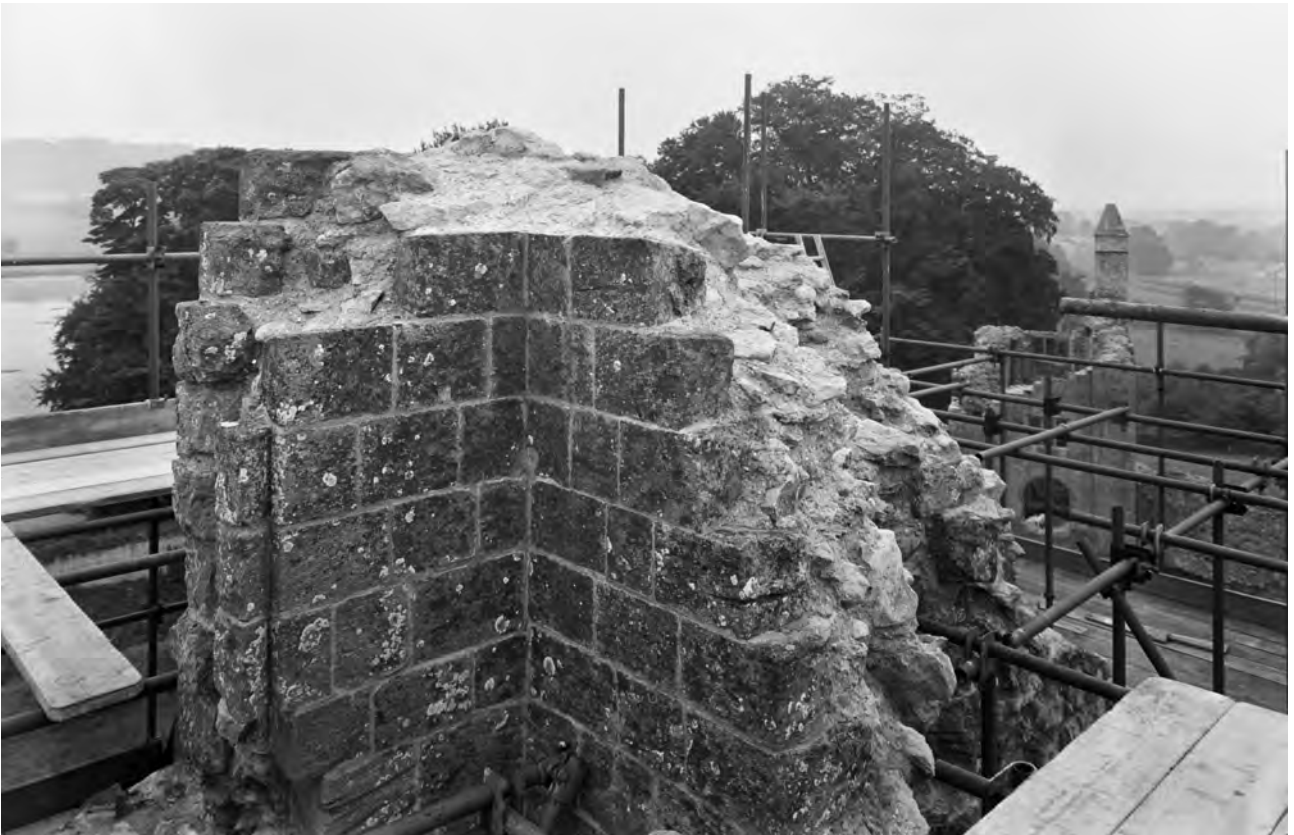
**Fig 63** The great tower: the south-west internal corner at roof level showing the base of the parapet turret and, to the left, the remains of the west jamb with the nook shaft of the former doorway leading to the stairs within the turret, after consolidation in 1969. *Photograph: NMR MPBW A8058/6*

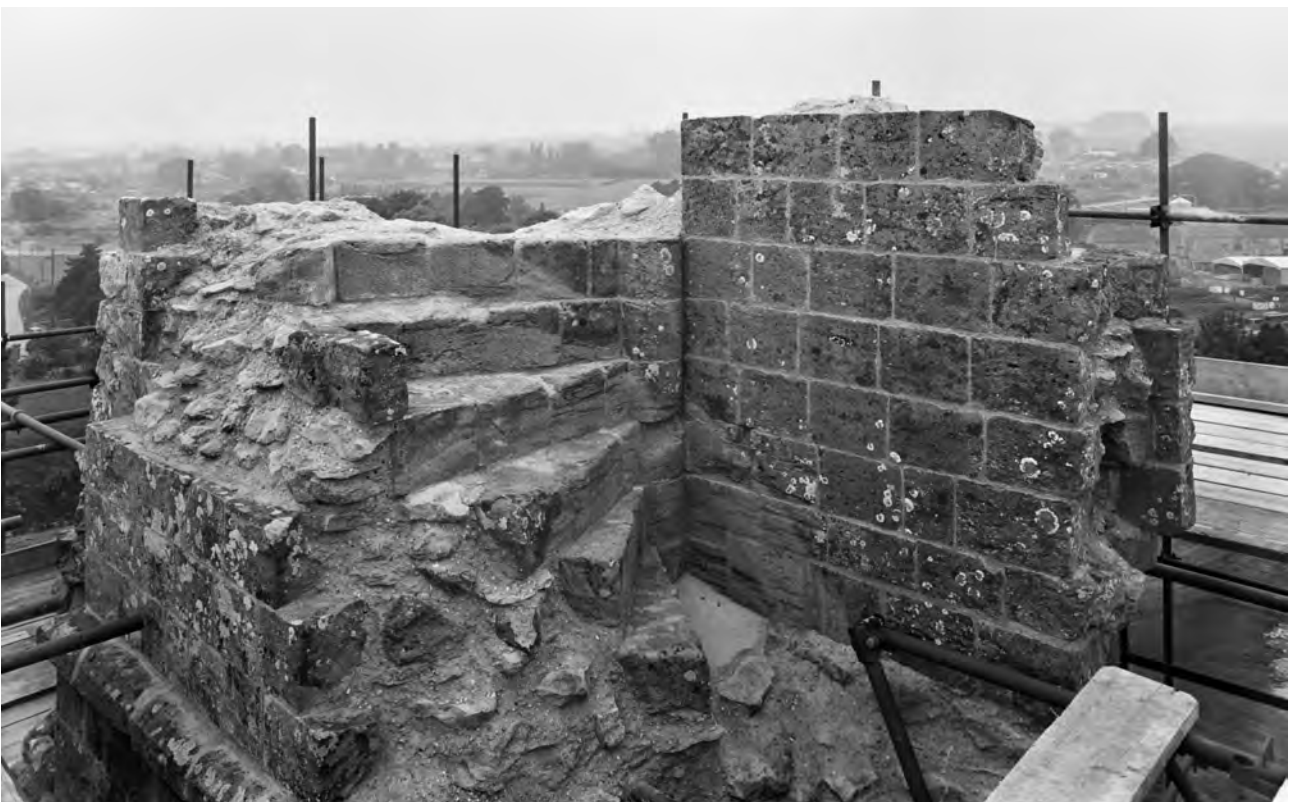
**Fig 64** The great tower: the remains of the stairs that rose within the turret above the south-west corner, after consolidation in 1969. *Photograph: NMR MPBW A8058/4*
