# Sherborne Old Castle, Dorset

archaeological investigations 1930–90

**Peter White and Alan Cook**

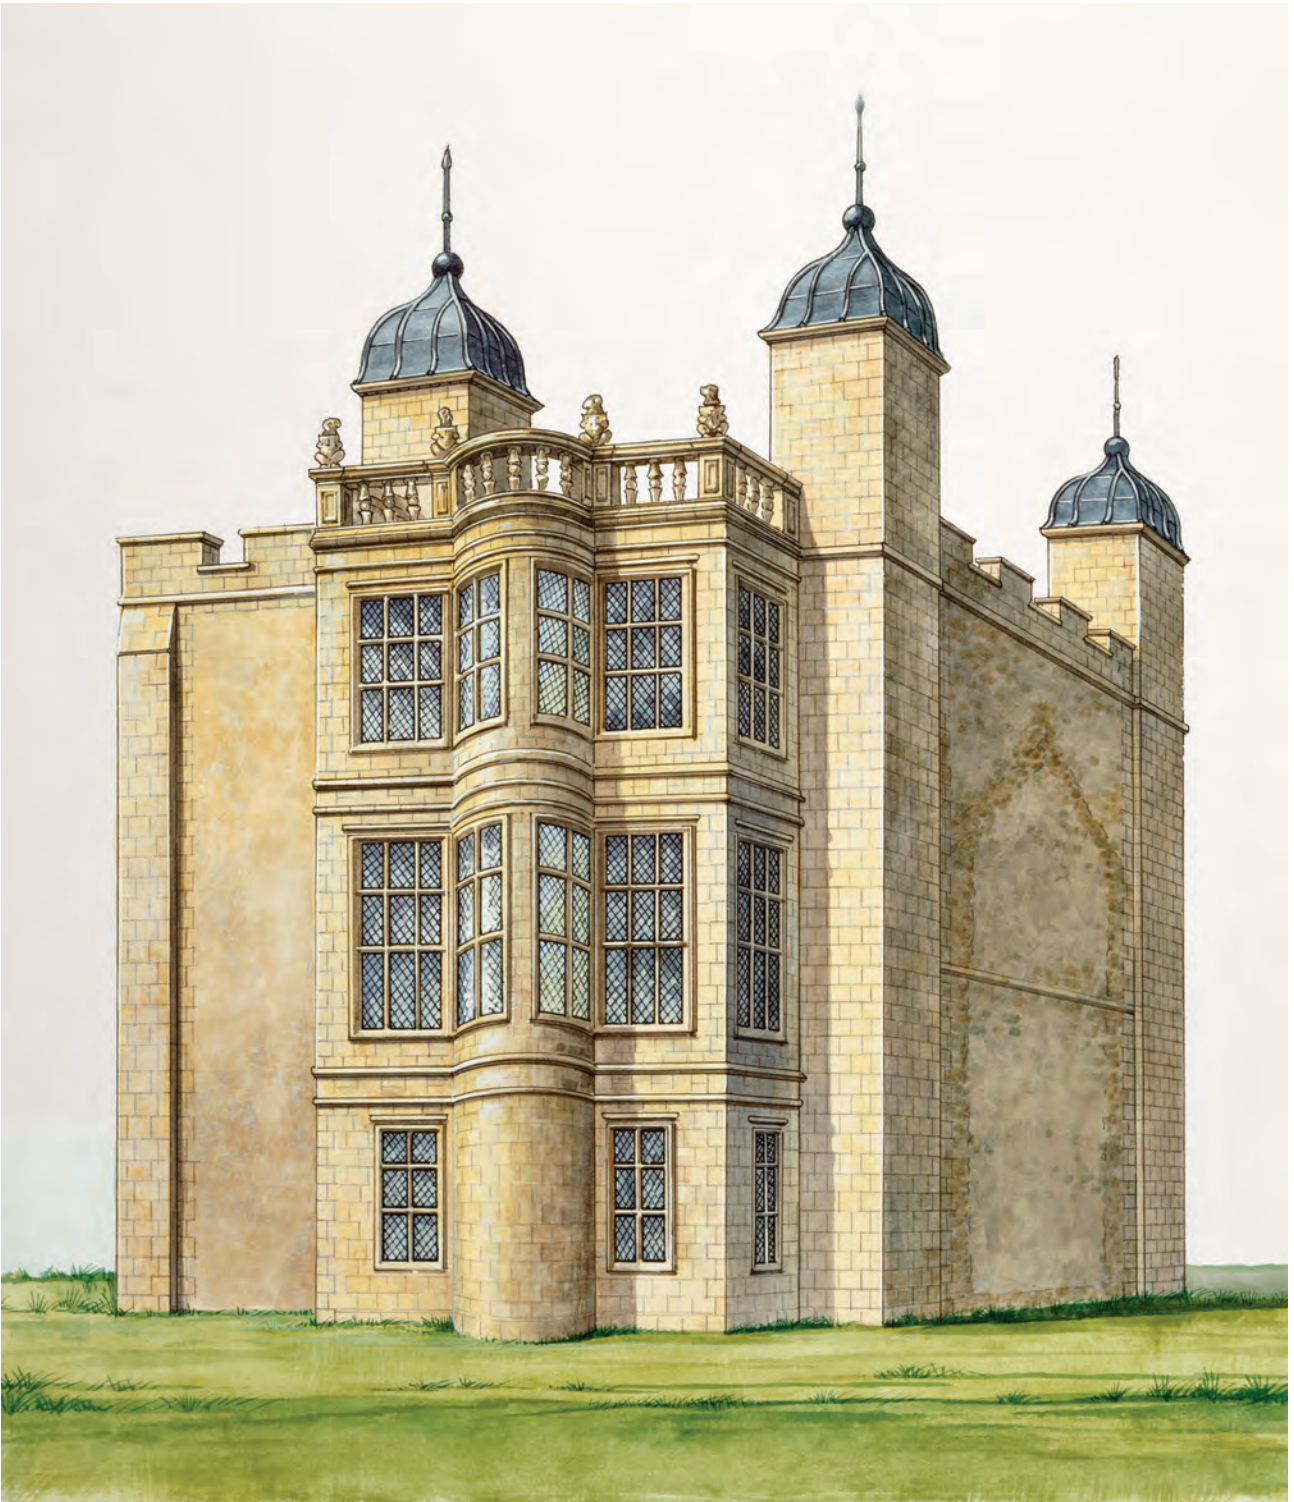
**Fig 65** The great tower: reconstruction drawing by Philip Corke of the south elevation, showing Raleigh's alterations. *Photograph:* NMR J960259 1997 print 7

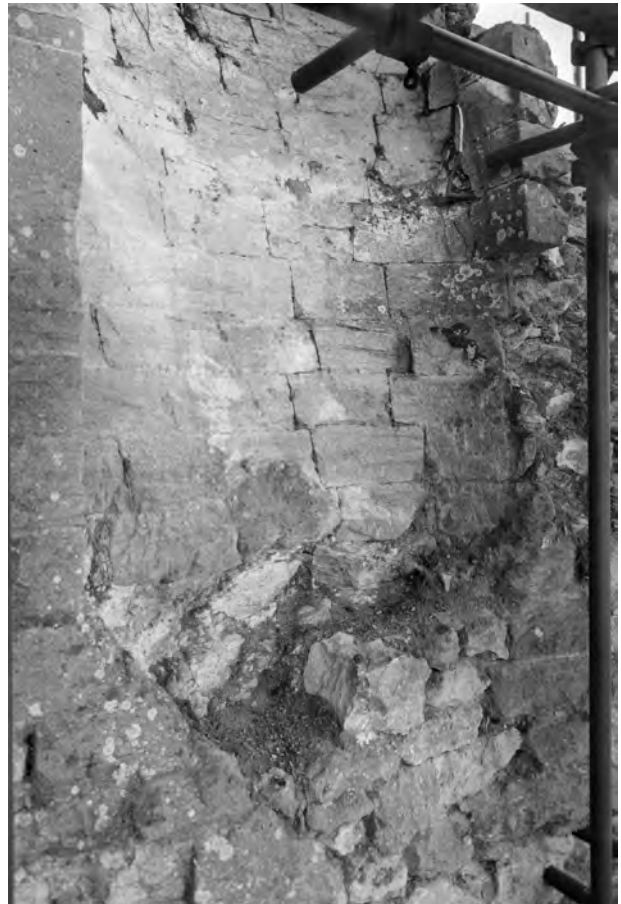
**Fig 66** The small tower: detail of the curved ashlar back of the fireplace in the south wall of the chamber at the upper level. *Photograph: NMR MPBW A7378/9*

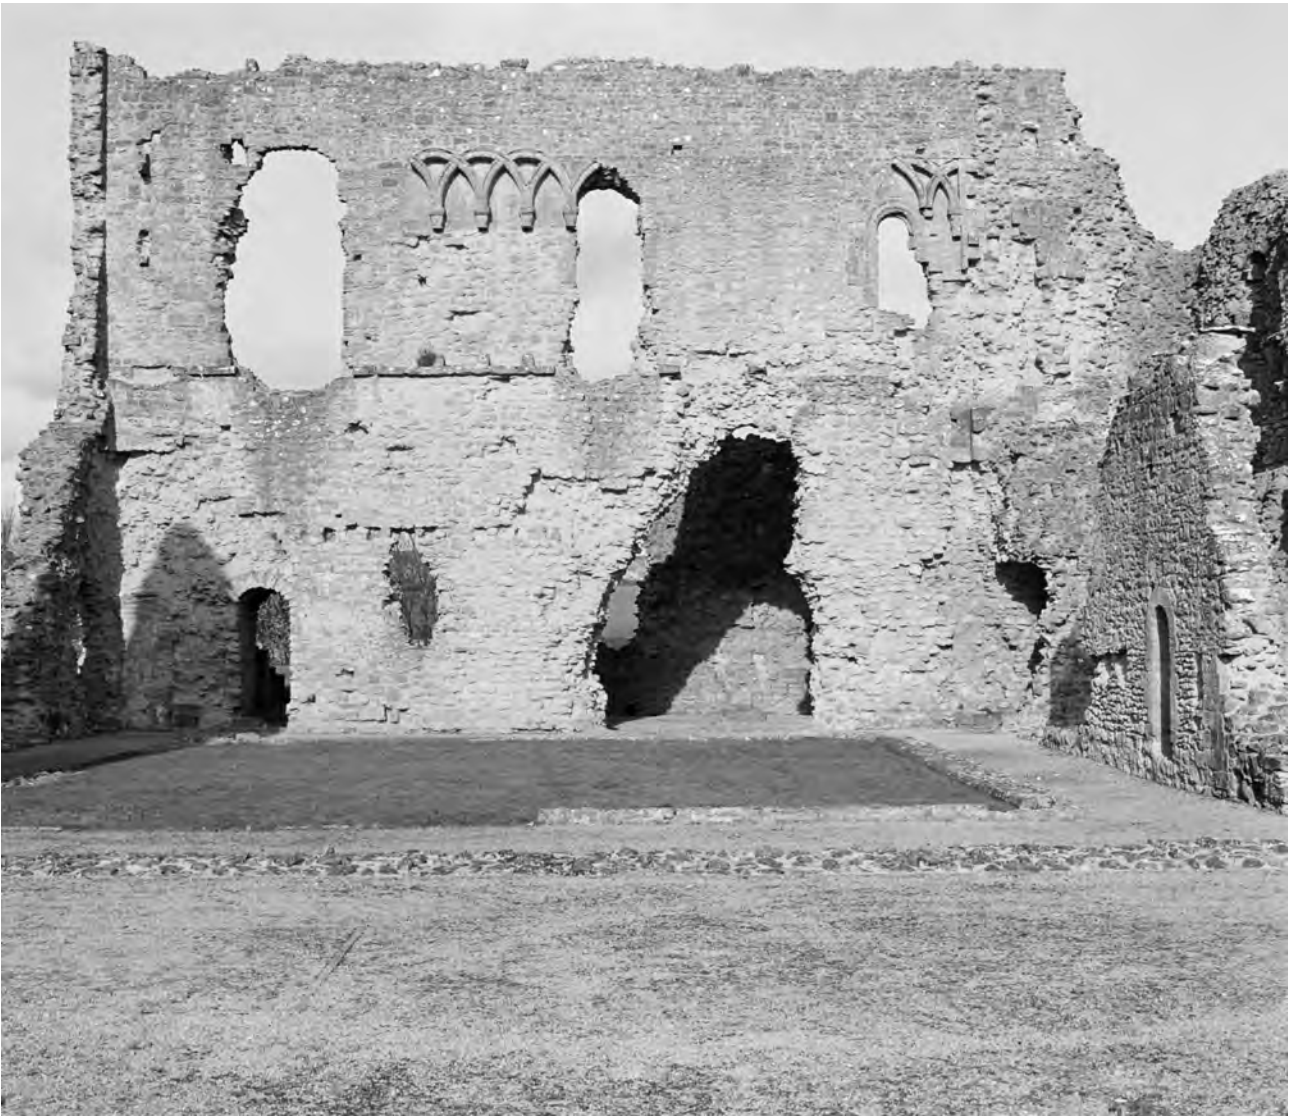
**Fig 67** Central complex, north range: the south wall from the inner court. *Photograph: NMR EH/B 925751*

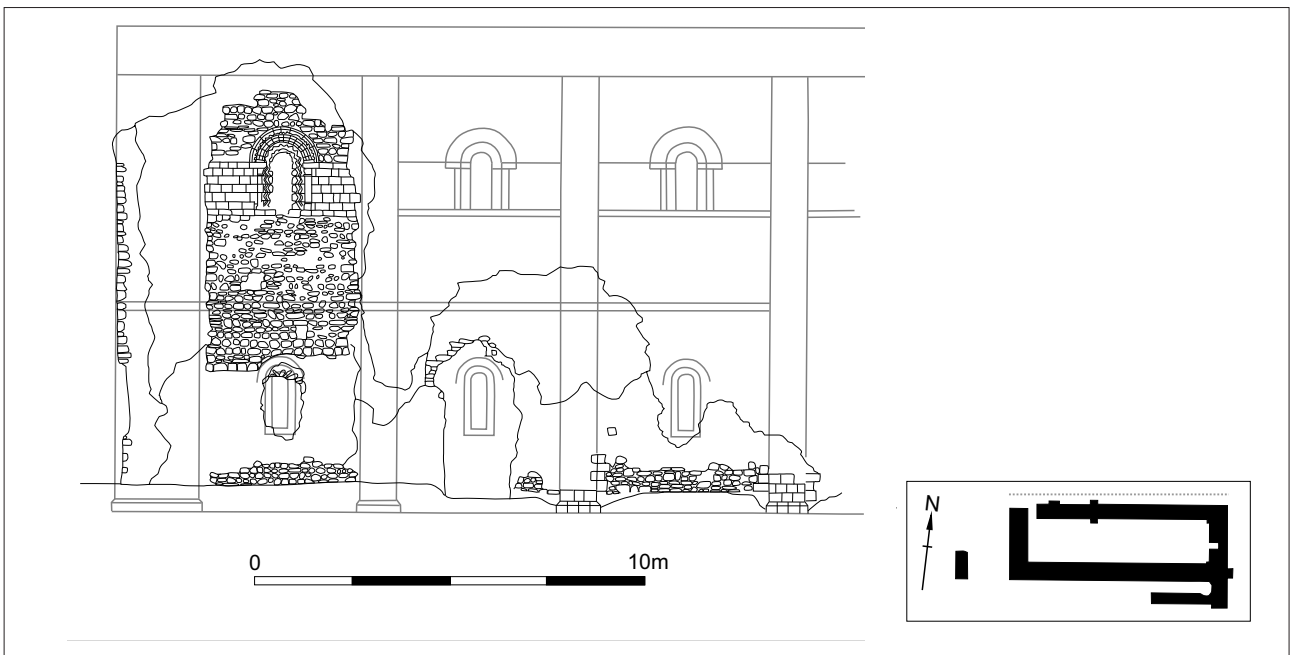
Fig 69 Reconstructed external elevation of the north wall of the north range, c 1135

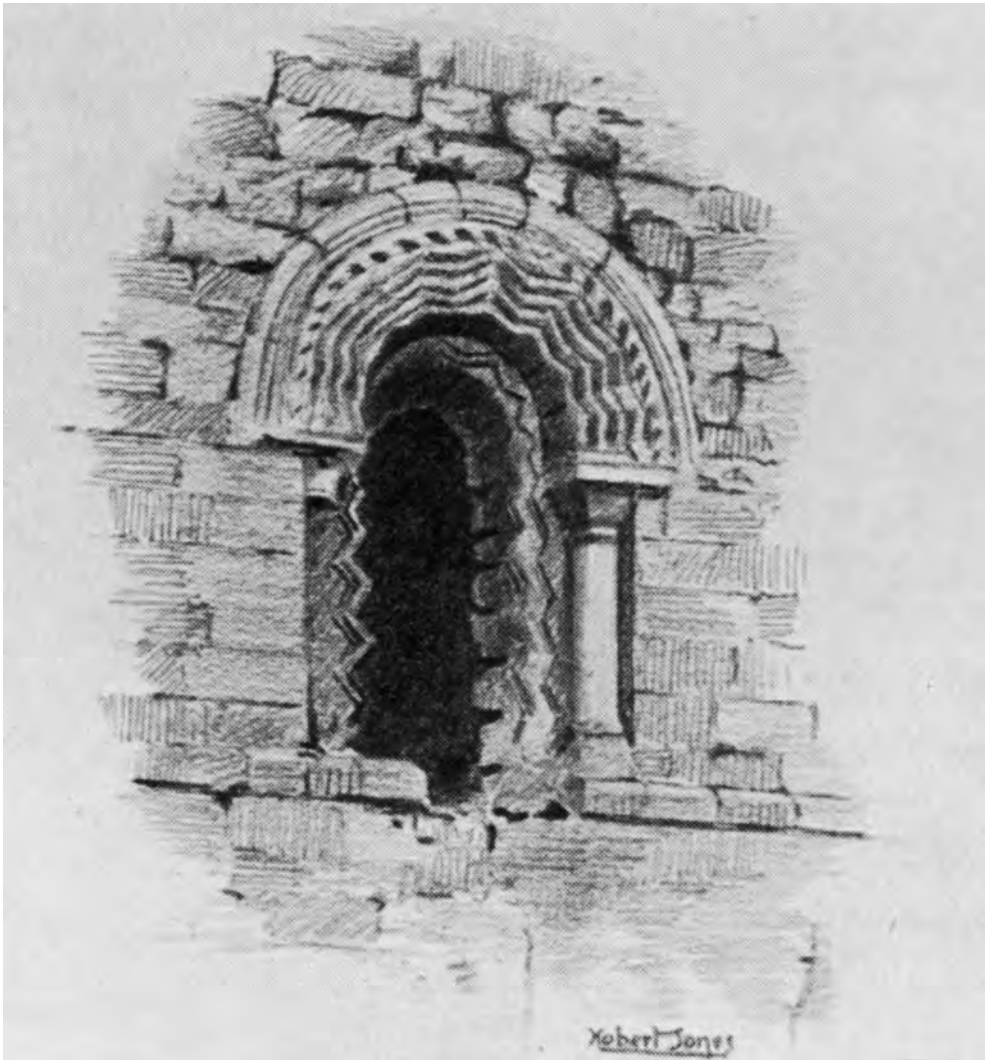
**Fig 70** Central complex, north range: twelfth-century window, upper-floor north wall, exterior. *Drawing: by the Revd H W Jones, from Fowler 1951*

The three-bay chamber occupying bays 2 to 4 of the upper storey of the range preserves evidence of its original architectural treatment (fig 73). On its southern, eastern and northern walls the wall piers defined each bay and within each bay appear to have framed a dado of blind arcading with intersecting, semicircular arches supported on slender, detached colonnettes. The colonnettes had moulded bases, set on a continuous single-course chamfered-offset ashlar plinth, and scalloped capitals; within each bay, the arcading was capped by a string course. The tympana to the intersecting arches were of ashlar. Two of these tympana, and the lower part of a third, survive in the south wall face, while others are indicated by robbed sockets. The capital of a colonnette survives in the north-eastern corner of the chamber. The quality of the architectural embellishment applied to the chamber is also shown by the continuous chevron mouldings in the outer jambs of its surviving north window.

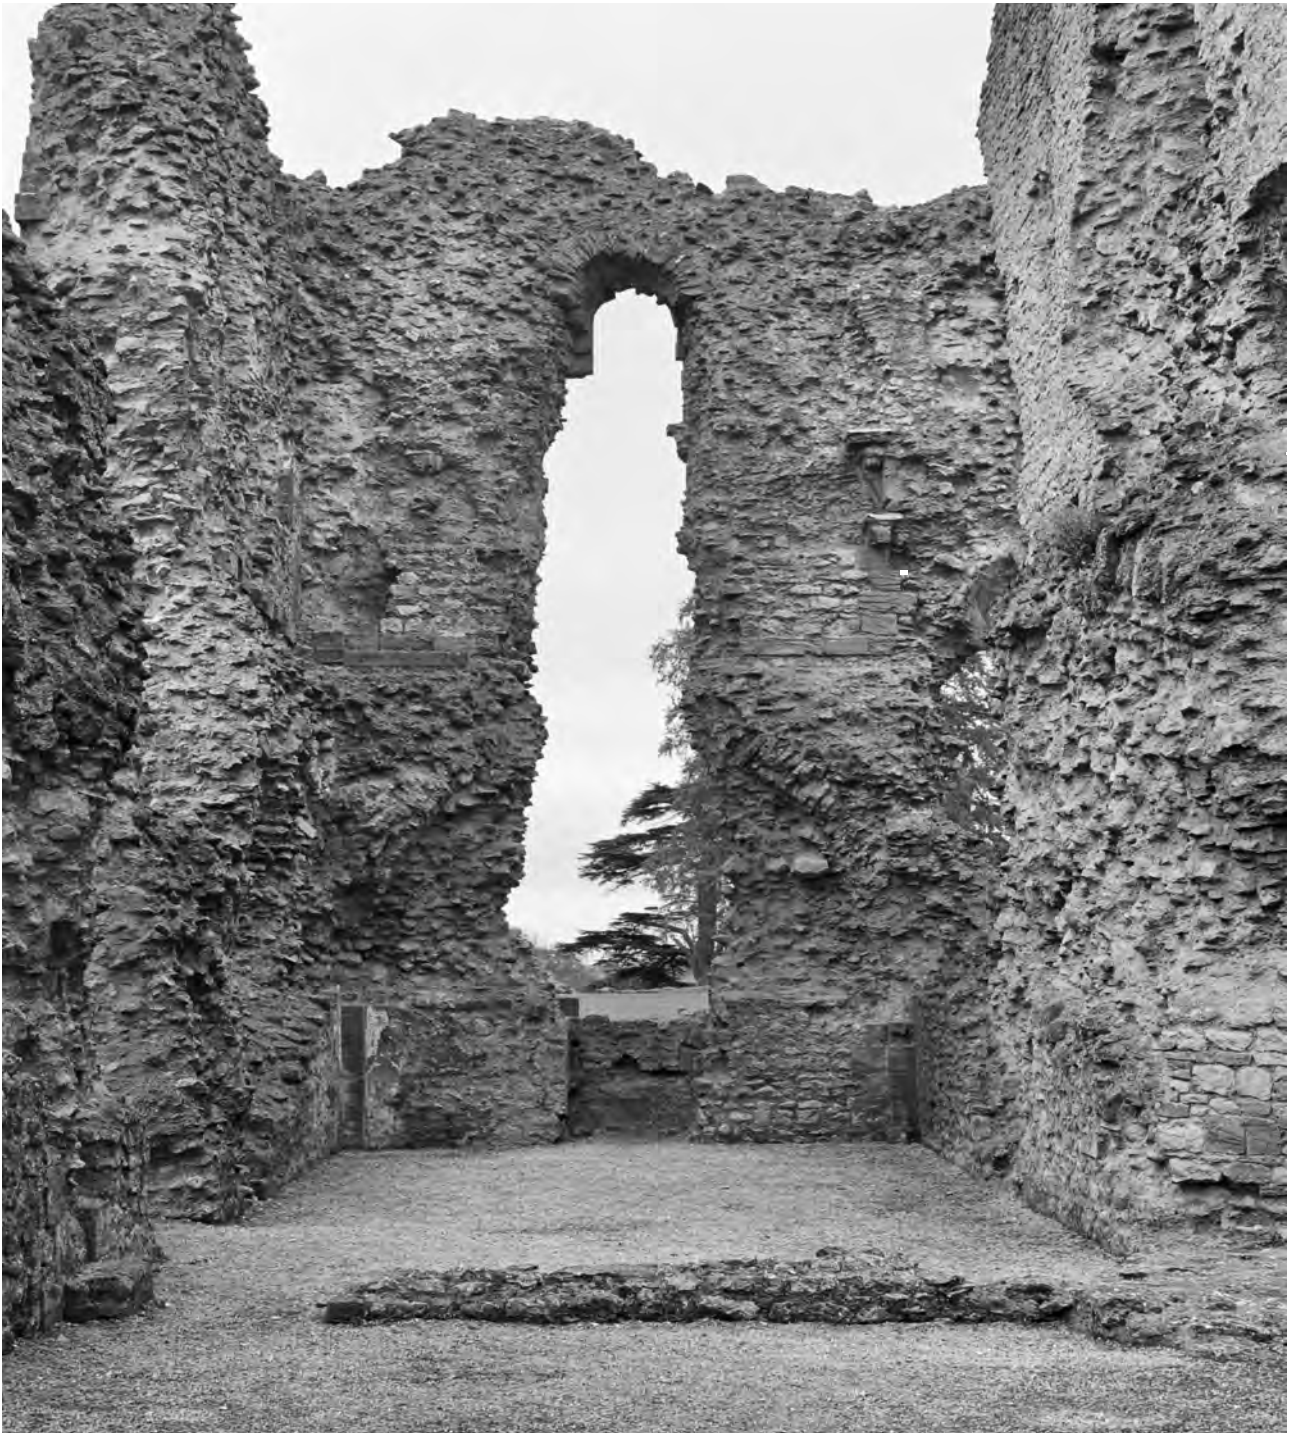
**Fig 72** Central complex, north range: the interior looking east. *Photograph:* NMR EH/B 925751

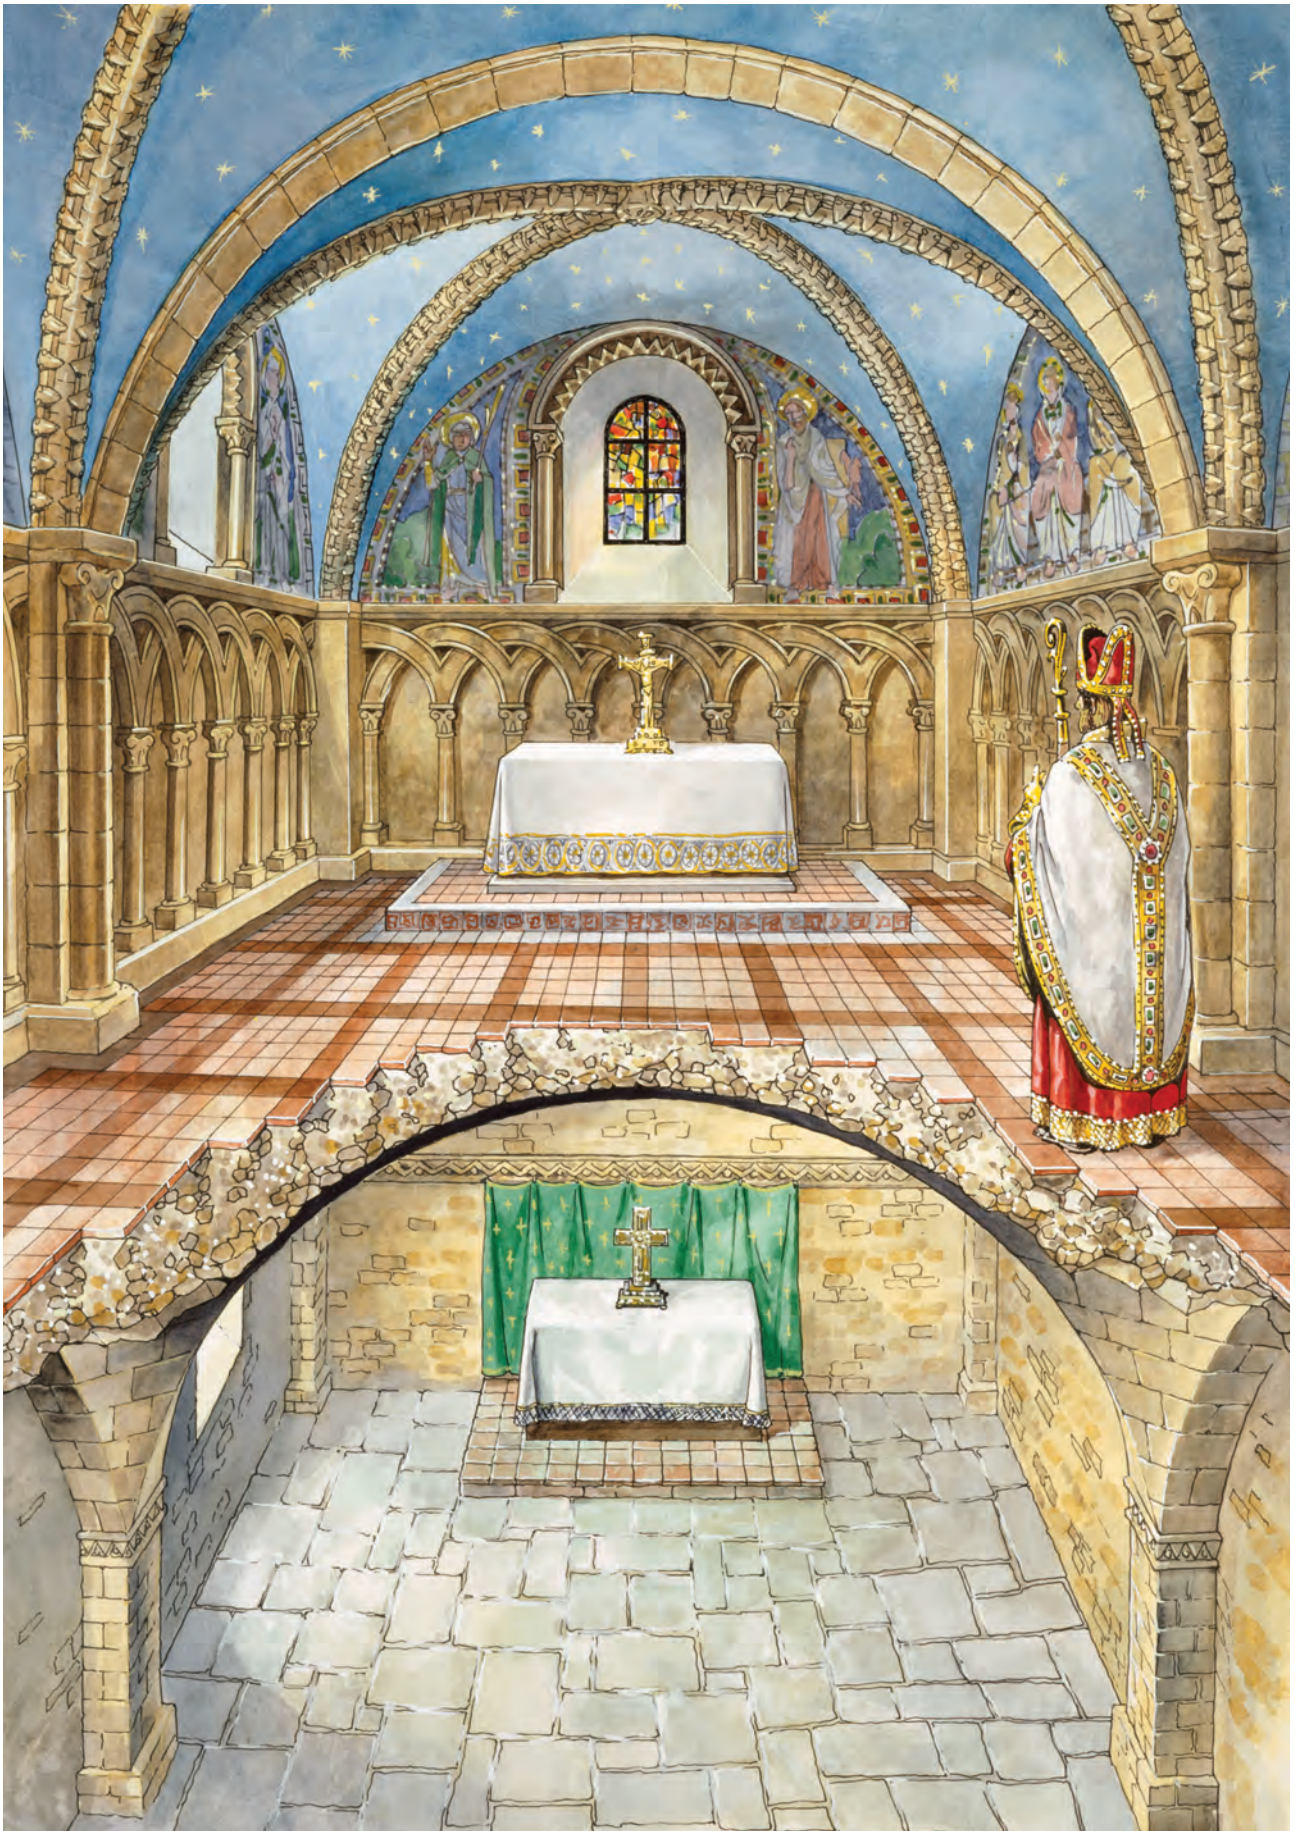
Fig 73 Central complex, north range: reconstruction drawing by Philip Corke of the interior looking east. *Photograph: NMR J960262 1997 print 9*

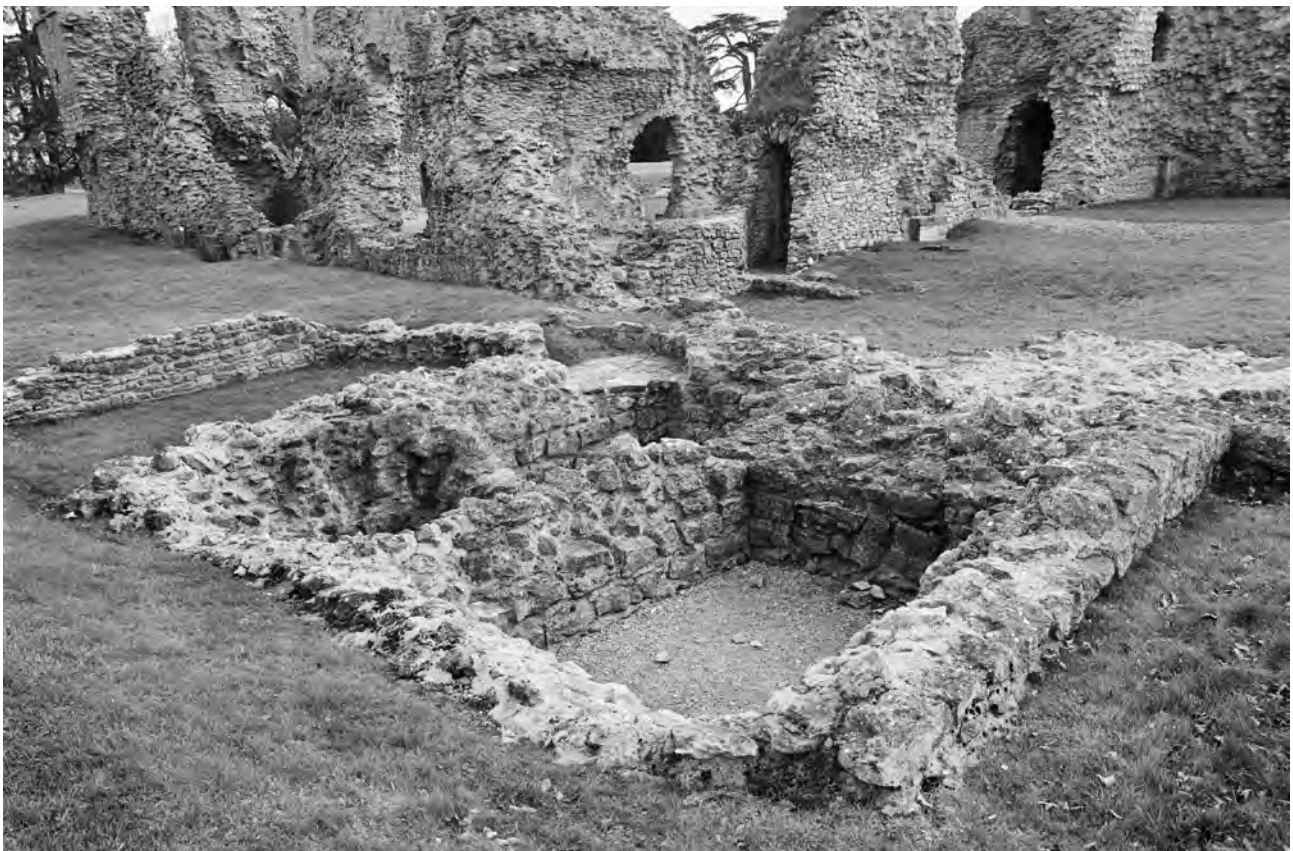
**Fig 74** Central complex, west courtyard: the excavated remains of the latrine tower projecting from the northern end of the court, seen from the north west.  
*Photograph: NMR EH/B925745*

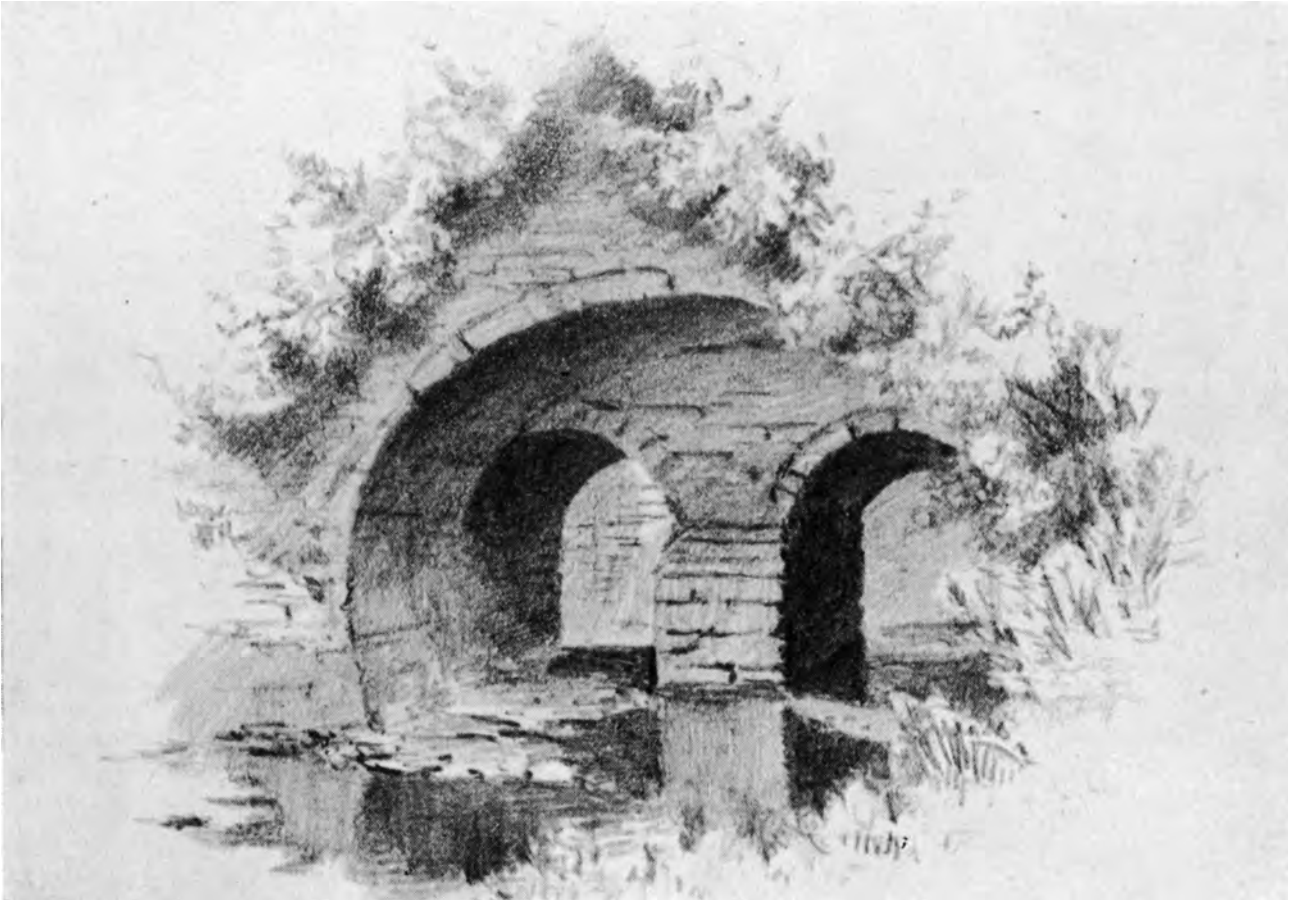
**Fig 81** Denny Bridge: *Drawing*: by the Revd H W Jones from Fowler 1951

traffic on an important highway to a single safe controllable crossing point. Its size and construction compares with the masonry bridges into the castle bailey:

the carriageway is about the same width as the gate passage through the south-west tower. The bridge is likely to have been part of Bishop Roger's overall plan.

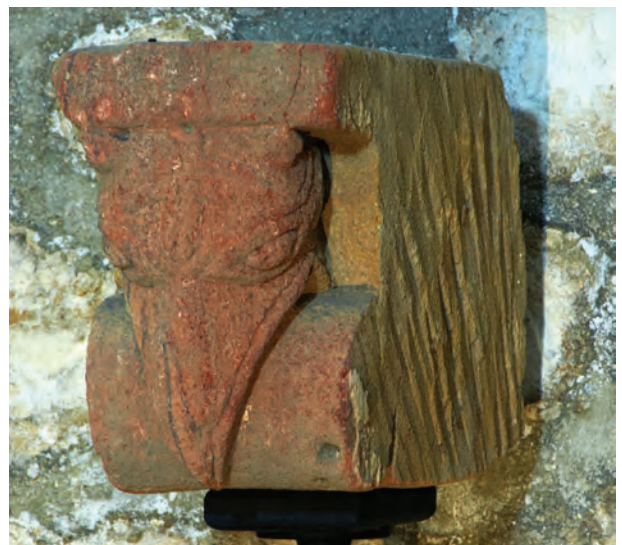
**Fig 85** Beakhead, cat no. 2. *Photograph: Sherborne Castle Estates*

Arches, windows and, almost certainly, door openings were also embellished, as is indicated by a beakhead voussoir from an arch of square order (cat no. 2; fig 85), another with a geometric variant in the form of a moulded 'blade' (cat no. 3a) and yet another from a wall arcade decorated with long leaves as a foliate variant of the form (cat nos 7a–c). Richly modelled and deeply cut chevron ornament is also represented both *in situ* in the north range windows and among the loose stones, where four decorated chevron voussoirs (cat nos 19a–d) have extrados

## 2 Single bird-head beakhead voussoir (fig 85)

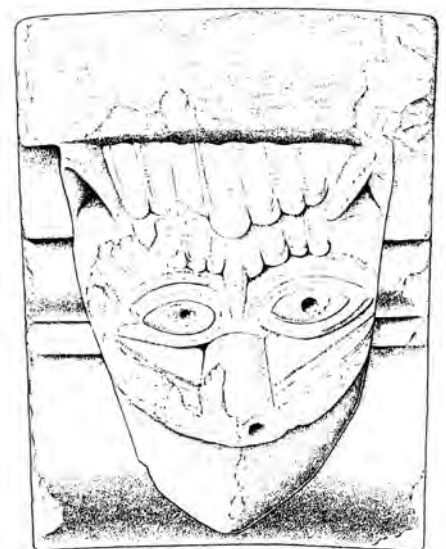
Fig 87 Beakhead, cat no. 1b. Drawing: EH site file

Roger Stalley's publication of the double beakhead voussoirs from Sherborne Castle brought to public notice one of the most precocious architectural ornaments of English Romanesque art. To date only two voussoirs have been recovered in more or less complete condition (cat nos 1a–b; figs 86 and 87), each measuring approximately 450mm (18in) wide and 240mm (9in) deep and taking the form of a triple-roll moulding with fillets, flanked on each side by a beakhead whose undercut beak arches across the voussoir to touch the central roll moulding with the tip of its beak at a point back from the centre of the central roll. Seven voussoirs, or part voussoirs, of the same form and dimension, but without beakheads (cat. nos 1m, 8a–f), point either to two designs – one with beakhead and one without – or to the alternation of decorated and plain voussoirs as a means of spacing the beakheads. Either way,

- b Animal-head beakhead voussoir (91235) (fig 87)  
The sides of the voussoir have diagonal tooling. One side has a series of gouges; the other side has a deep, square hole carved into it. Traces of mortar remain.  
Height 240mm, length 445mm, top width 185mm, bottom width 175mm

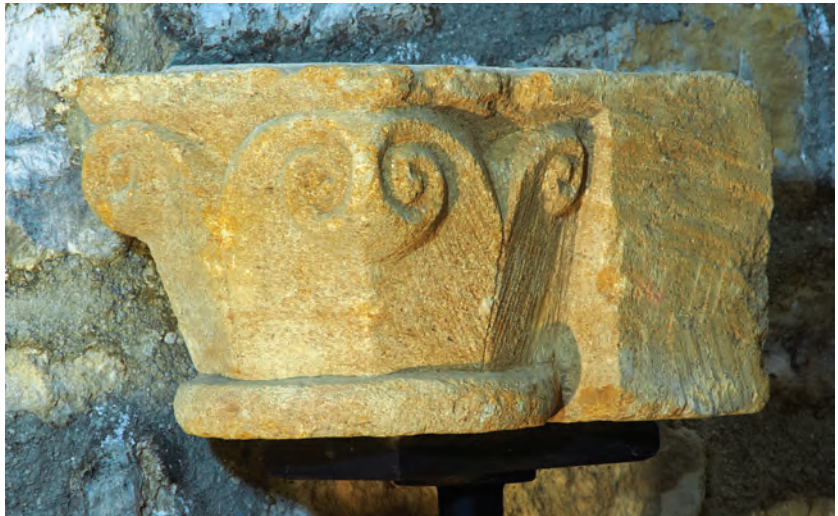
**Fig 89** Capital, scalloped, cat no. 30b.  
*Photograph:* Sherborne Castle Estates

With the exception of the two figurative capitals, to which reference has already been made, the capitals at Sherborne are of standard twelfth-century type, being either of scallop (cat nos 30a–e, 30g) or volute form (cat no. 31; fig 88) and with few added embellishments in the form of beading (cat no. 30a) or incised lines (cat no. 30b; fig 89). There is also a fragment of a cushion capital with part of the octagonal shaft that supported it (cat no. 32) and

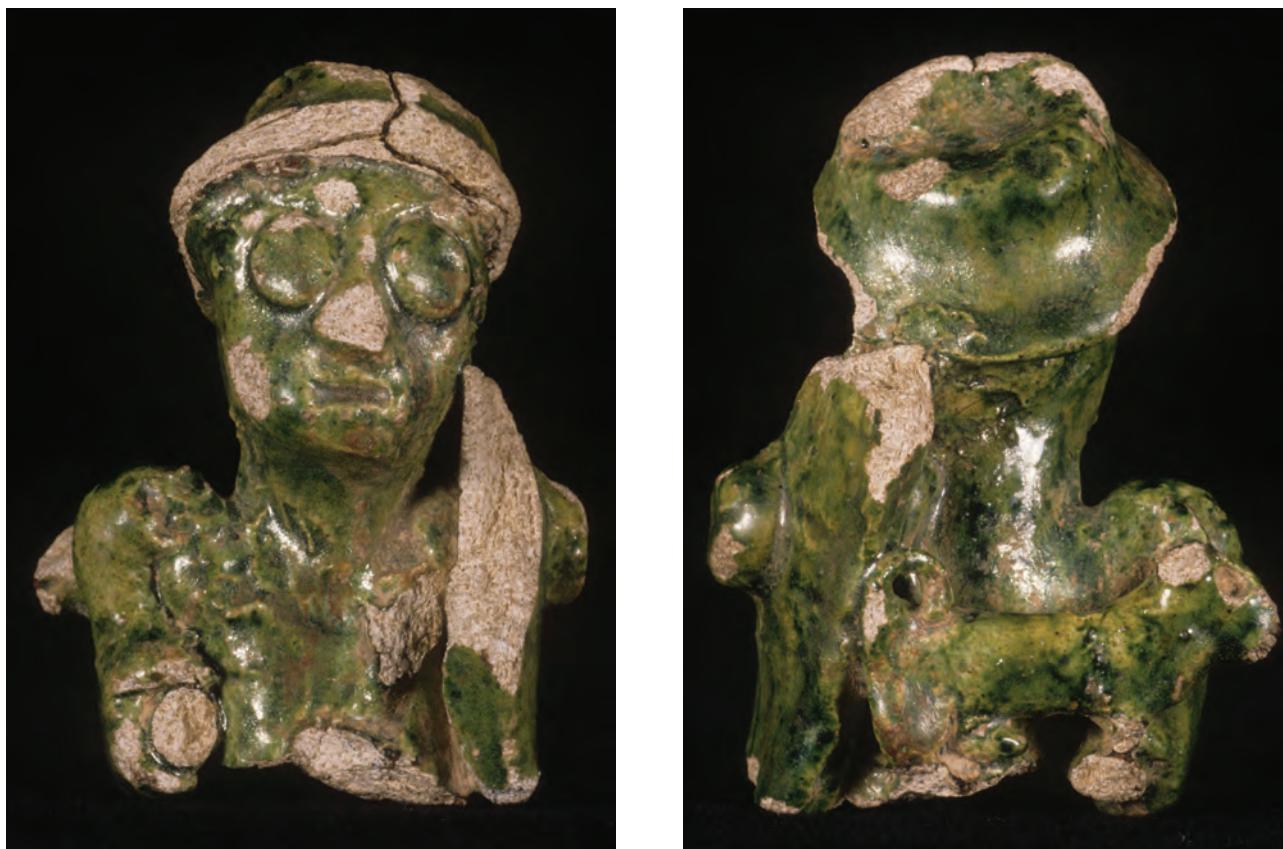
**Fig 98** Part of a small knight figurine in south Dorset whiteware (fabric Q423), probably late thirteenth century, and possibly from an aquamanile or from an anthropomorphic roof finial (shown here at about twice the actual size)

One very unusual piece merits a more detailed discussion (fig 93: 17; fig 98). This is part of a small figurine, consisting of the head and upper torso of a male figure, helmeted and carrying a shield in his left arm and what appear to be the remains of a lance under his right arm. On his back is a small dog with its front paws on the lance and back paws on an unknown support, perhaps a saddle cantle. The treatment of the eyes is particularly distinctive; these are formed from applied pads, giving a somewhat 'bug-eyed' appearance to the face. The overall glaze is mottled mid- to dark green.
