ST PETER'S

Barton-upon-Humber, Lincolnshire

A Parish Church and its Community

HISTORY, ARCHAEOLOGY AND ARCHITECTURE

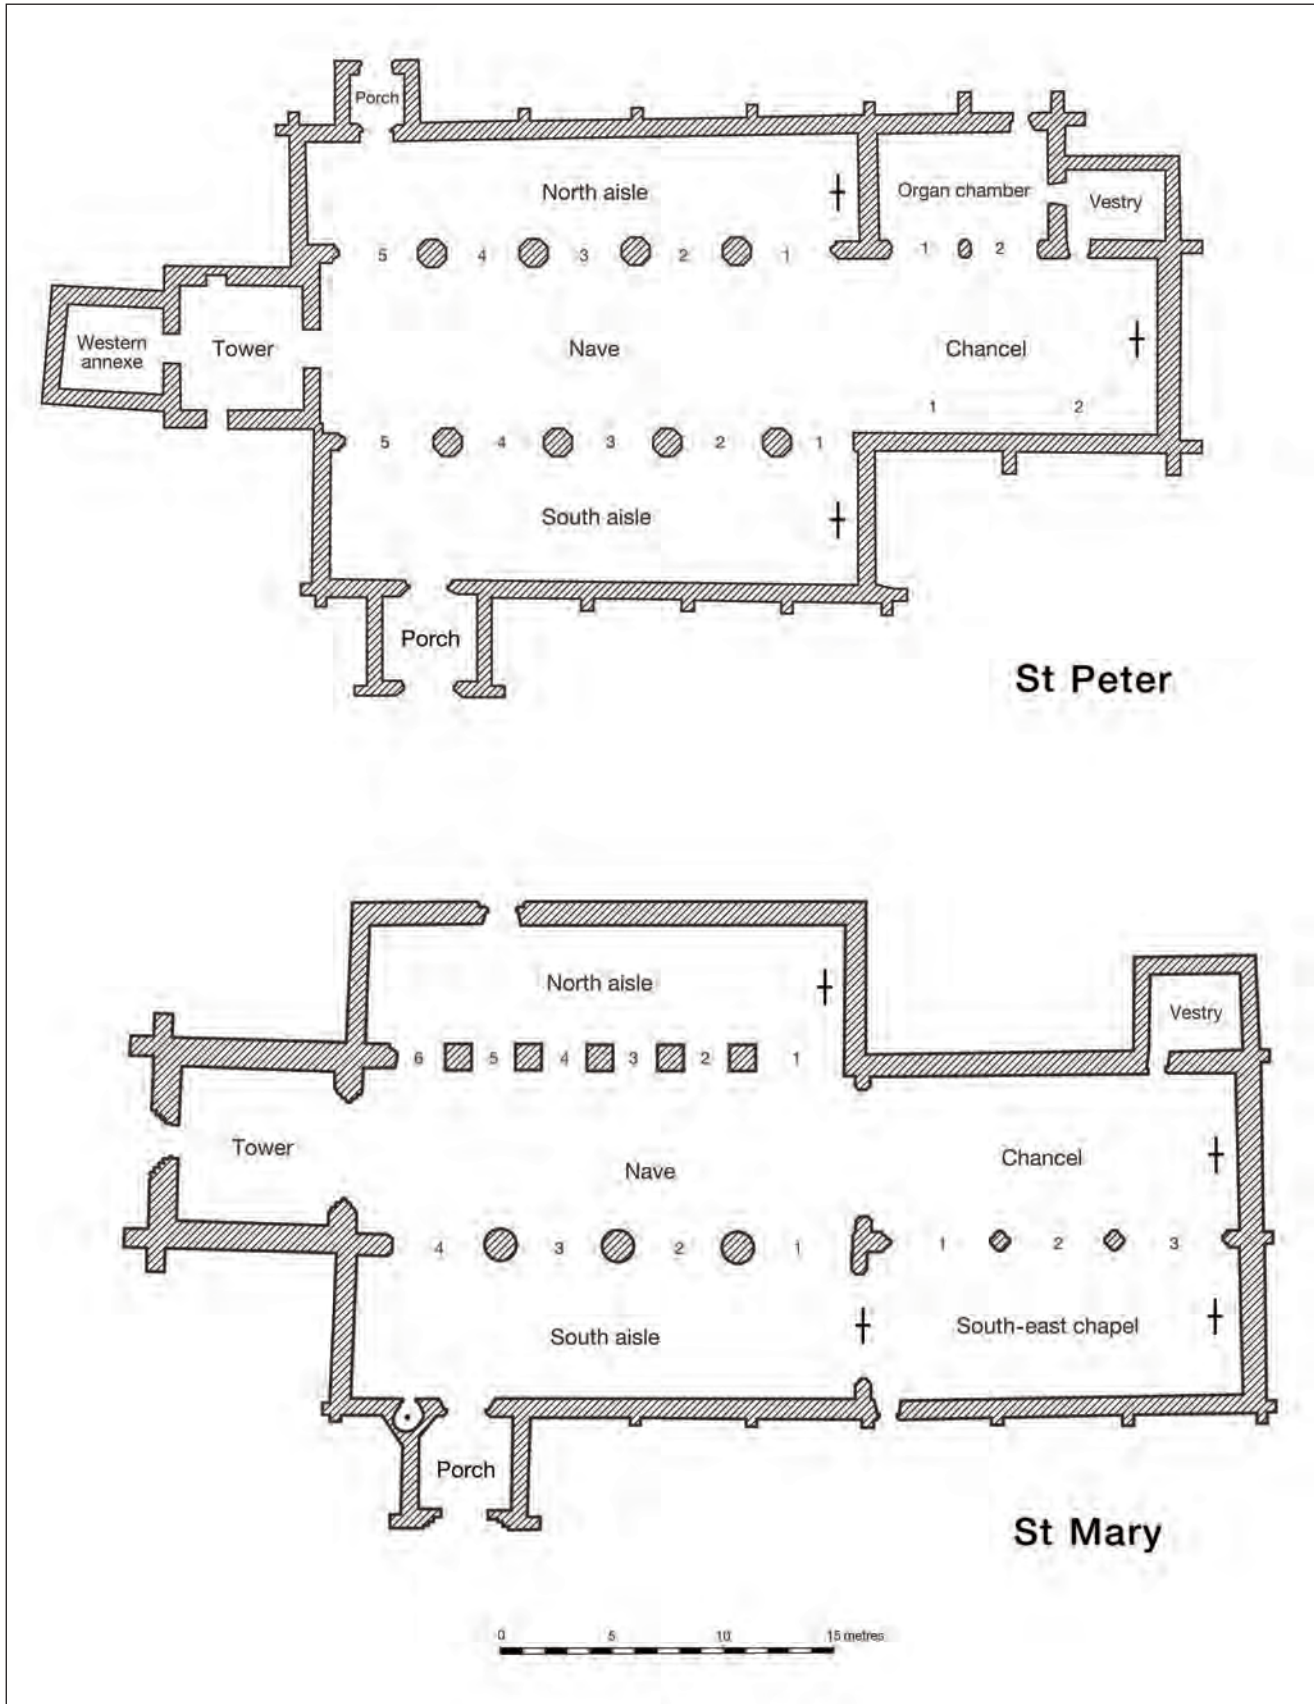
Fig. 7: Comparative floor plans of St Peter's and St Mary's churches in their fully developed form. The nomenclature and bay-numbering system adopted in this report is indicated. Drawing: Simon Hayfield

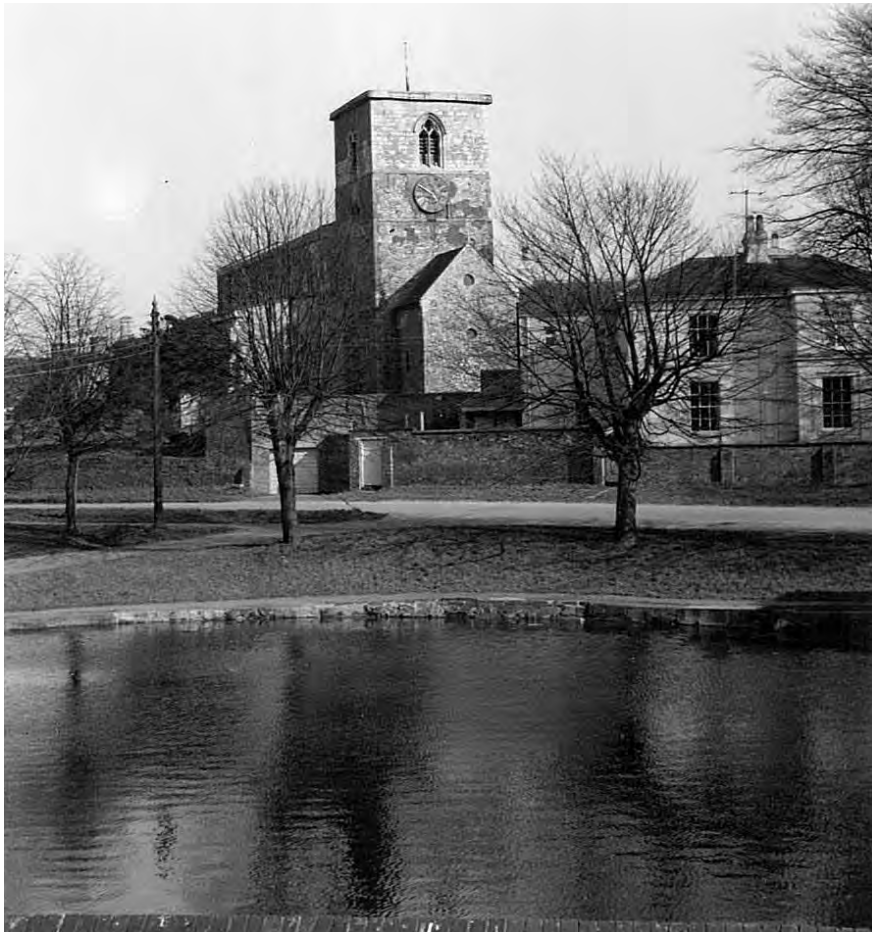
Fig. 9: St Peter's church. Tower and western annexe from the west, 1965. View from St Mary's churchyard, with the Beck in the foreground and the vicarage to the right. For the same view in 1823, see Pl. 9, and in 2006, see Pl. 4. Photo: David Lee Photography

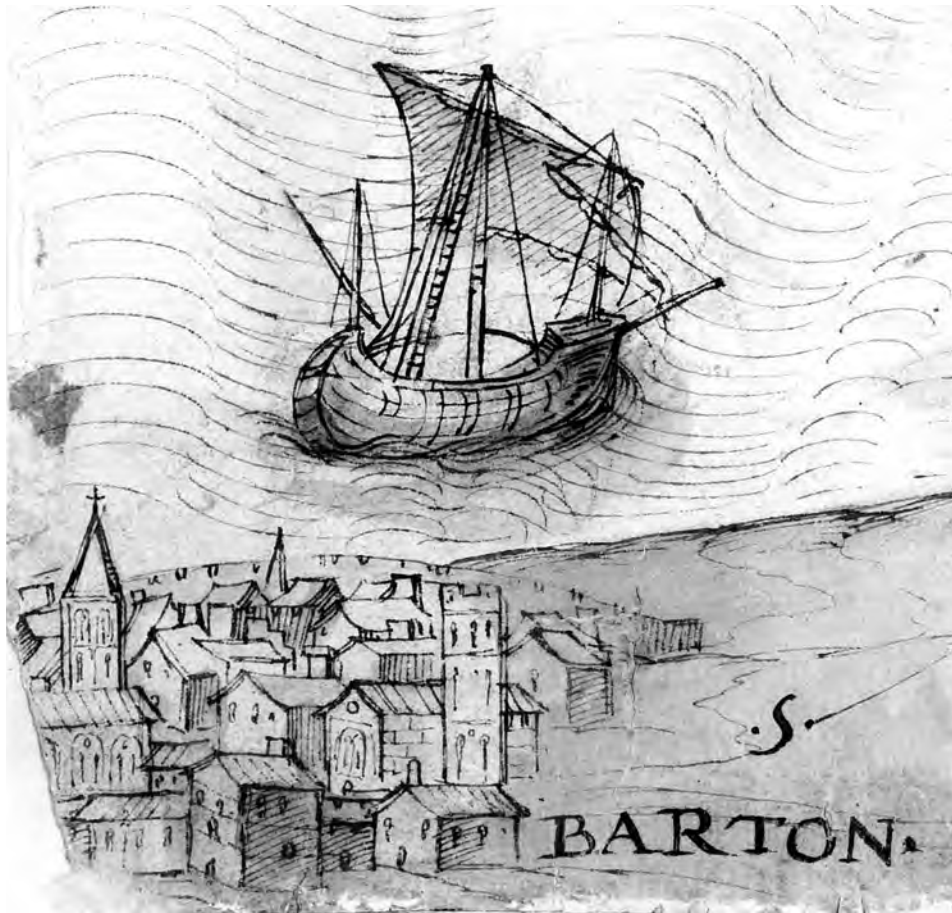
Fig. 16: *Bird's-eye view of Barton, c. 1538–39, showing St Mary's church (left), St Peter's church and a Tudor riverside fortification, above which rises a possible signalling mast. Photo: British Library. Cotton Ms Aug. I.i, f. 83*

Barton has not been well served by cartographers. The earliest representations of the town appear incidentally on two Tudor military engineers' plans (plans) of Hull and its environs (de Boer 1973).⁵⁸ Both are largely schematic and one is in very poor condition. The earlier map, which probably dates from 1538–39, gives a bird's-eye view of the fortifications at Hull in considerable detail; it also includes the eastern part of Barton (Fig. 16).⁵⁹ A ship is shown approaching the town. Unfortunately, the edges of the map have been trimmed, with some loss of detail, and a small piece has been torn from the lower left-hand corner.⁶⁰ The mouth of Barton Haven is just glimpsed on the extreme edge.

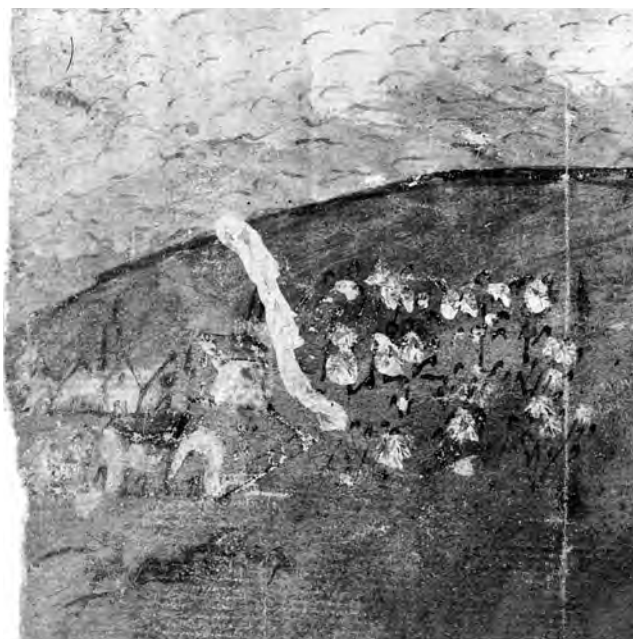
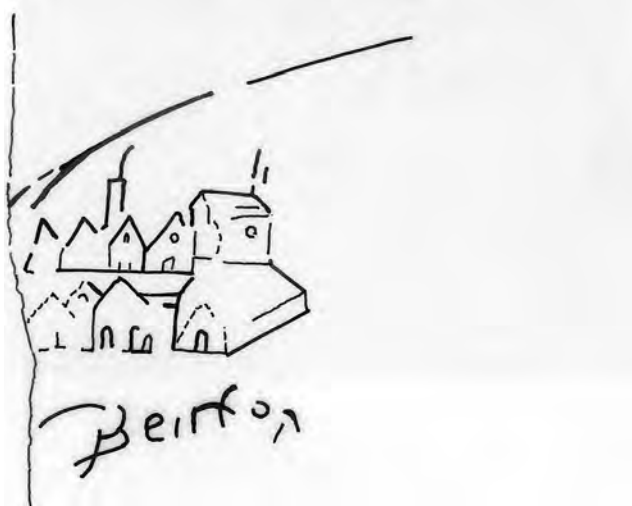
Fig. 17: Plan of Barton, *c.* 1540–41, showing buildings in rudimentary form, including the two church towers. Photo: British Library. Cotton Ms Aug. I.i. f. 86

The second map, which dates from 1541–42, is much cruder and depicts the entire Humber mouth.⁶⁴ Consequently, the scale is much smaller, and little attention is paid to the detail of buildings. Again Barton is included and labelled. The view seems to include two churches with towers, and a series of gable-ends which could be interpreted as aisles and other parts of the churches, but are more likely to represent buildings on a street frontage (Fig. 17). A wood

is shown immediately east of the town. The canopies of the trees are dappled with white paint, and a thick, crude line in the same paint separates the town from the wood.⁶⁵ This plan is very schematic and no conclusions can safely be drawn from what is depicted.⁶⁶

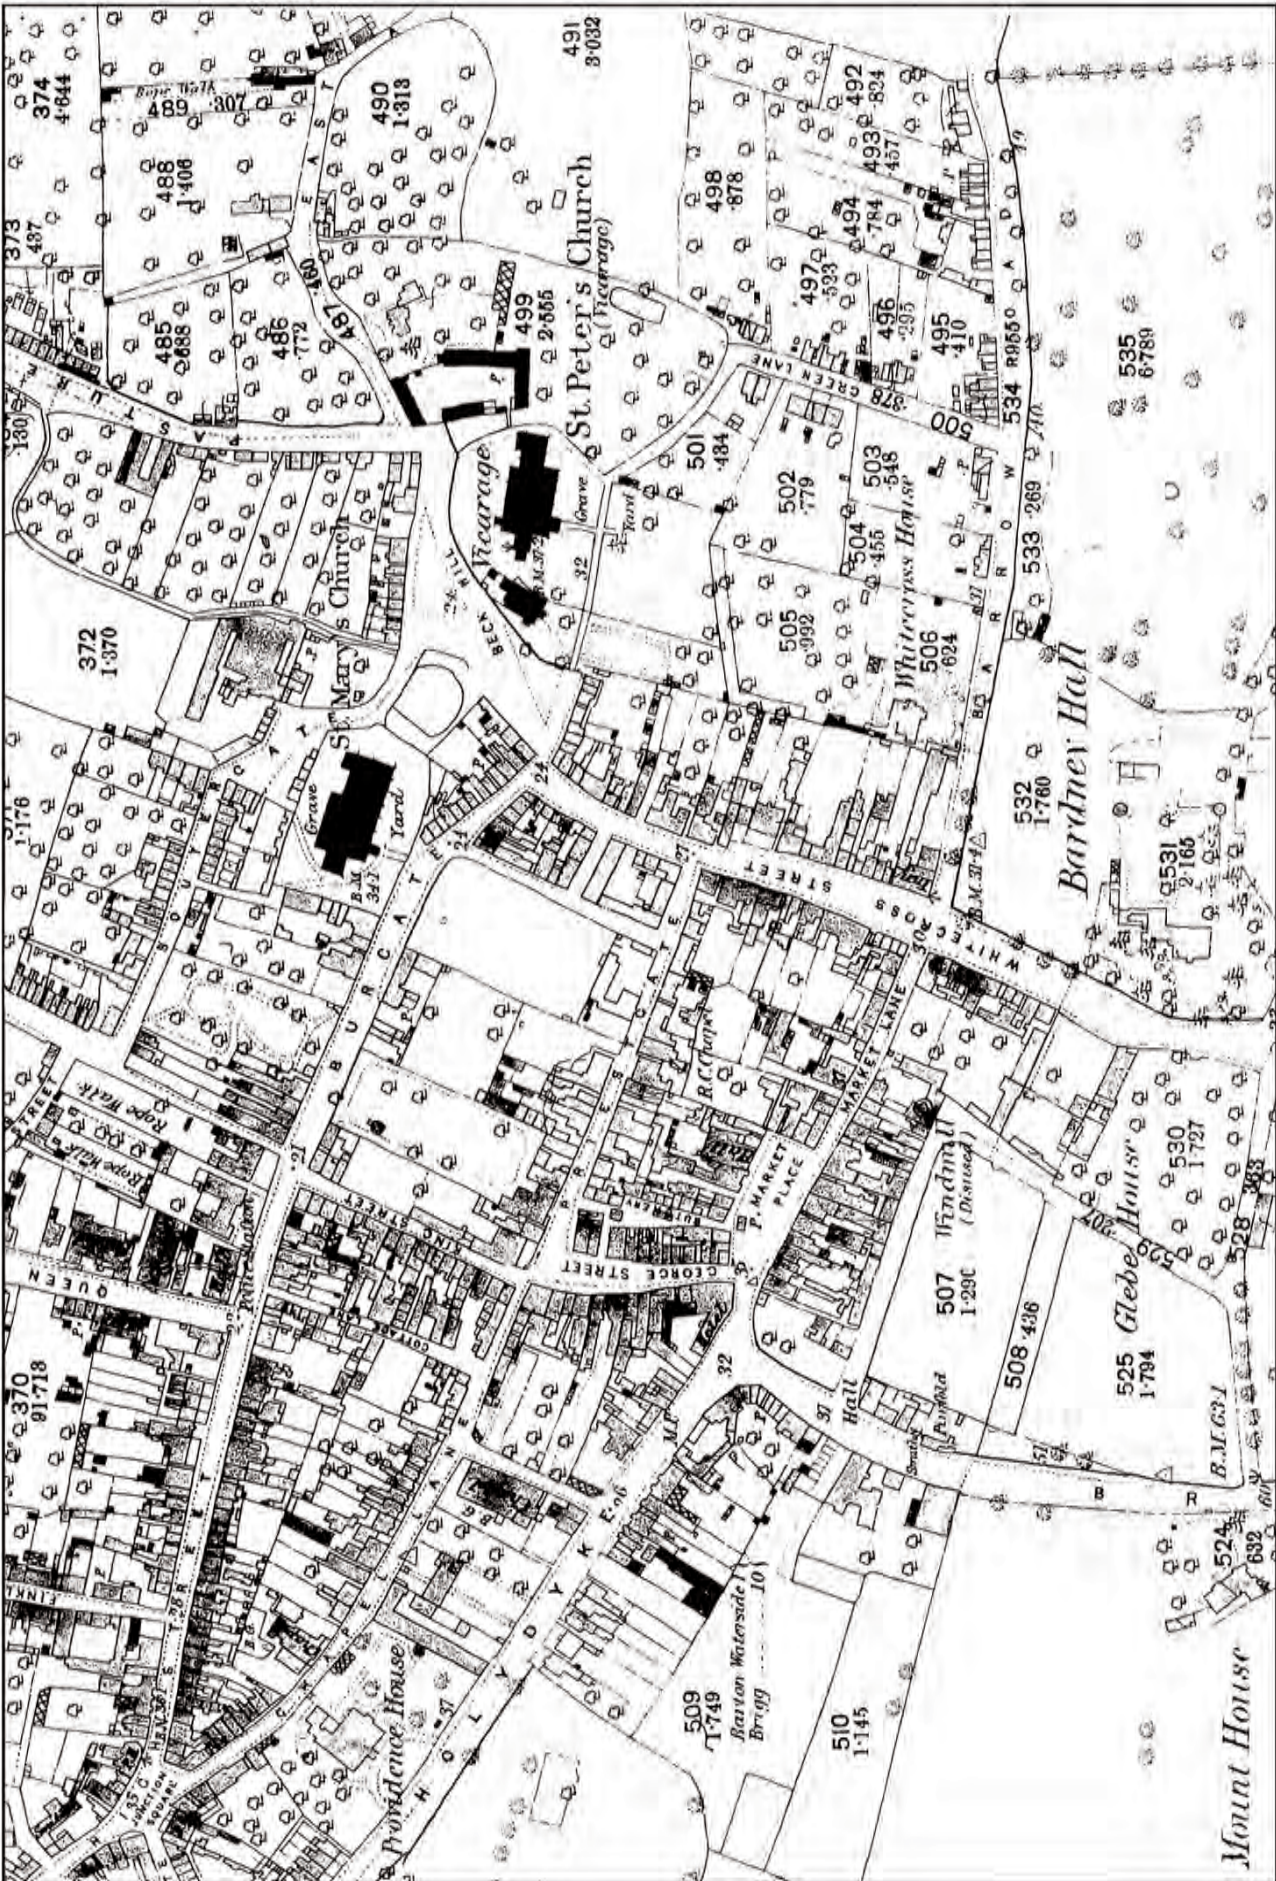
Fig. 20: Ordnance Survey 1:2,500 town plan of Barton, first edition, 1886. The churches, vicarage and Tyrethitt Hall have been emphasized

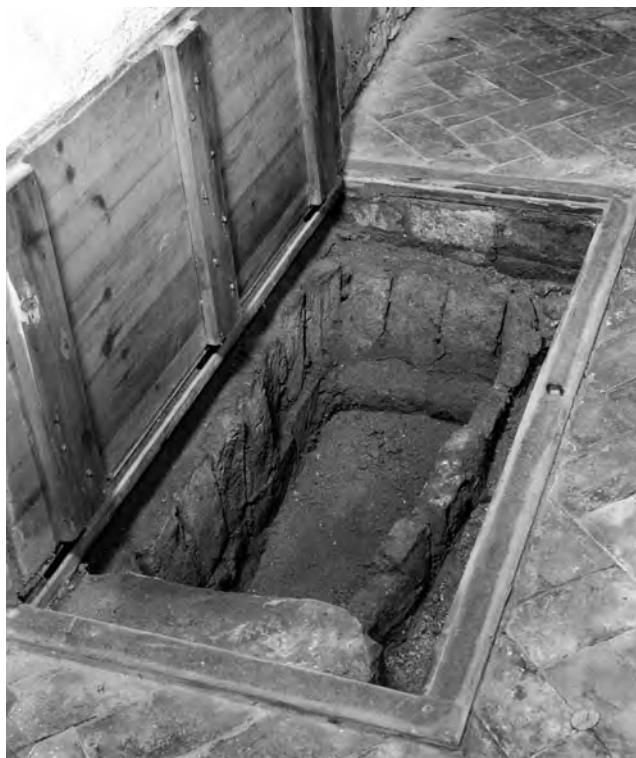
Fig. 21: St Peter's church: trap-door set into the floor of the tower in 1913, to display a sixteenth-century bell-metal furnace discovered during excavations by W.E. Varah. View north-east. Photo: David Lee Photography

Further small-scale excavations were carried out in 1912–13, 1945 and 1951–54, revealing ambiguous structural evidence and a bell-metal furnace (Fig. 21), but they failed to shed fresh light on the architectural history of the early building. Meanwhile, various scholars published their views on the form and date of the late

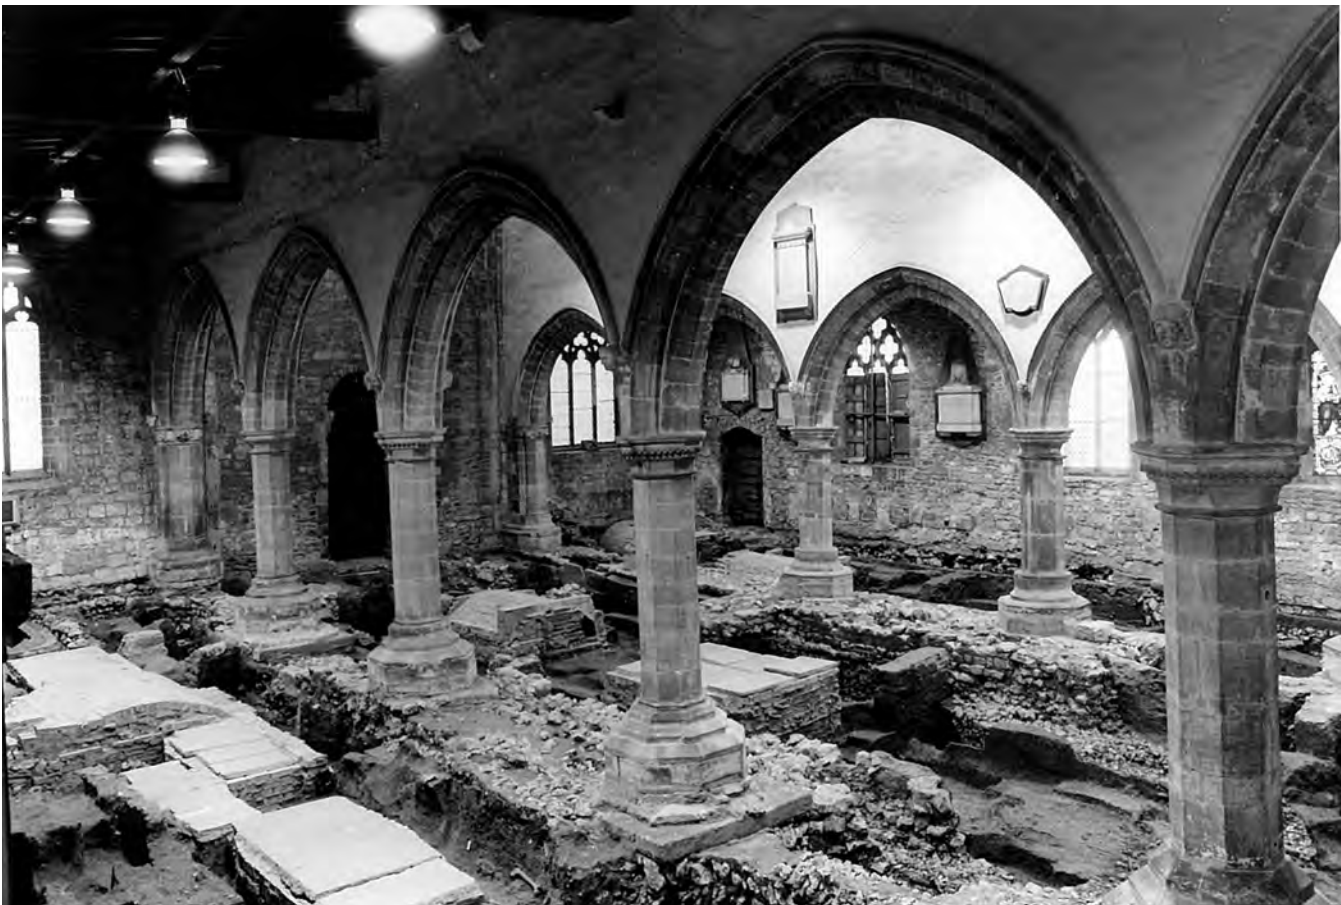
Fig. 23: St Peter's church: excavation in the nave and aisles, 1980. View north-west, from the east end of the south aisle. Photo: Warwick Rodwell

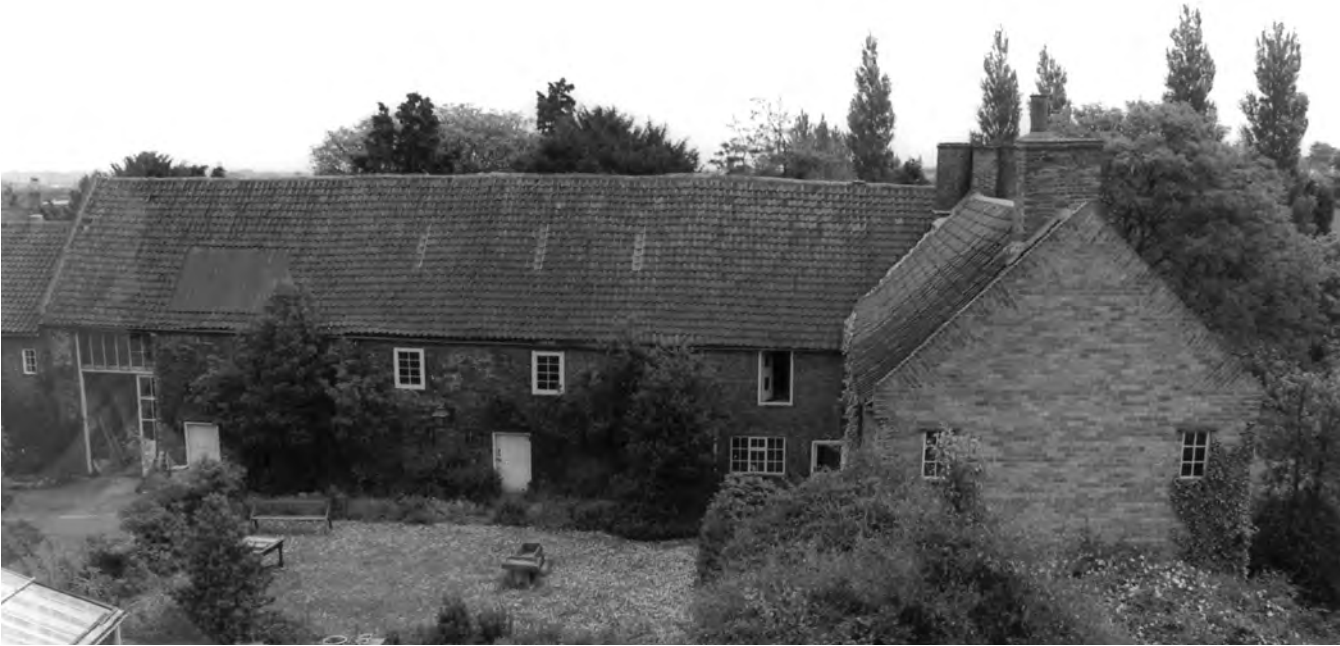
Fig. 32: Tyrwhitt Hall, Barton. View east into the courtyard, towards the brick-encased medieval hall; the south range is on the right. Photo: Warwick Rodwell

The south range once comprised eight bays (now reduced to seven) and its fabric incorporates medieval chalk rubble masonry and timber framing, although much refurbished and clad in brick at later periods. Some of the rubble walling stands to first-floor level, where it carries a timber-framed superstructure. An excavation in 1984 alongside the south wall revealed foundations of medieval buttresses and a lateral chimney stack to the central room in this range. There are now two inserted brick chimney stacks: the eastern one has diagonally set shafts. Prior to its remodelling, probably in the late seventeenth century, as a range of reception rooms with chambers above, this wing may have comprised a two-storied Tudor hall.

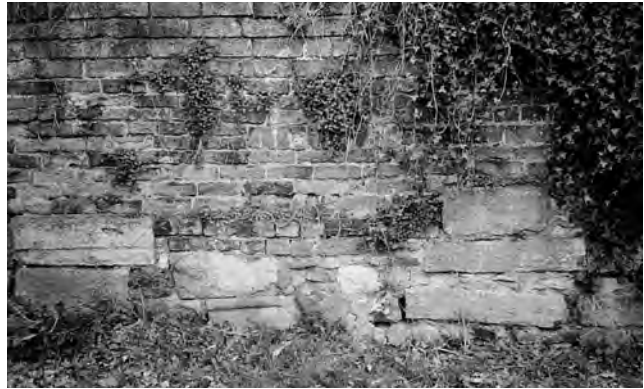
Fig. 42: St Mary's: eastern churchyard wall (c), adjoining the Beck, showing reused moulded stones and flat limestone slabs. Photo: Warwick Rodwell

prepared for this purpose, or were salvaged from a previous use, is unknown. Reused materials are certainly present in the later work, including flat slabs (medieval grave-covers?) and mouldings (Fig. 42). The stone wall stood at least 2 m high before the brick capping was installed in the nineteenth century and, as noted above, was probably in the region of 3 m. Additionally, it must have been founded on a solid base, rather than on unstable silt around the rim of the Beck, otherwise the lateral pressure exerted by the raised churchyard would have overturned the wall bodily. It was probably in the late seventeenth century that the process of replacing decayed masonry with brick began, and may be related to several references in the churchwardens' accounts (particularly in the 1690s) to hauling quantities of bricks to the churchyard (p. 126). In 1862 the whole wall was heightened – or the upper courses were removed and rebuilt – and given a bevelled capping.

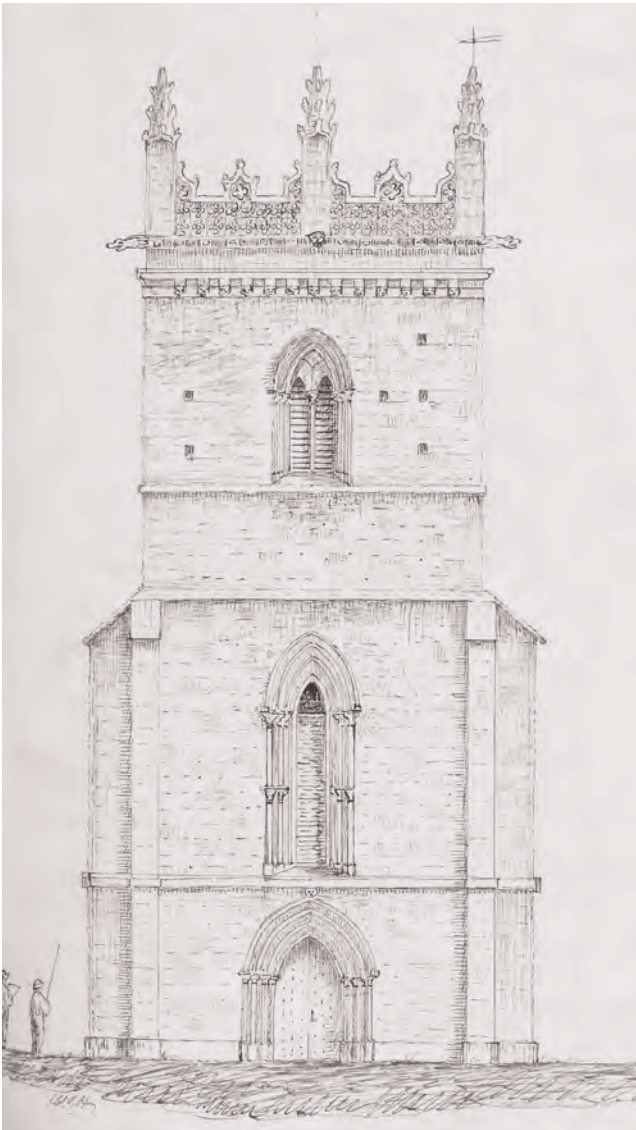
Fig. 45: St Mary's: west elevation of the tower by W.S. Hesleden, 1833. The figure on the left (partly obscured by the binding) represents Hesleden himself, taking notes, and the other figure holding a measuring rod would have been his assistant, possibly his son. Bodleian Library, University of Oxford: Ms Top. Lincs. b.1, f. 211

drawing.⁴⁰ Interestingly, the preliminary drawing shows the pinnacles surmounted by vanes, but the final version does not. However, it is enlivened with two male figures: one (Hesleden) holds a plan, the other a measuring-rod (Fig. 45).

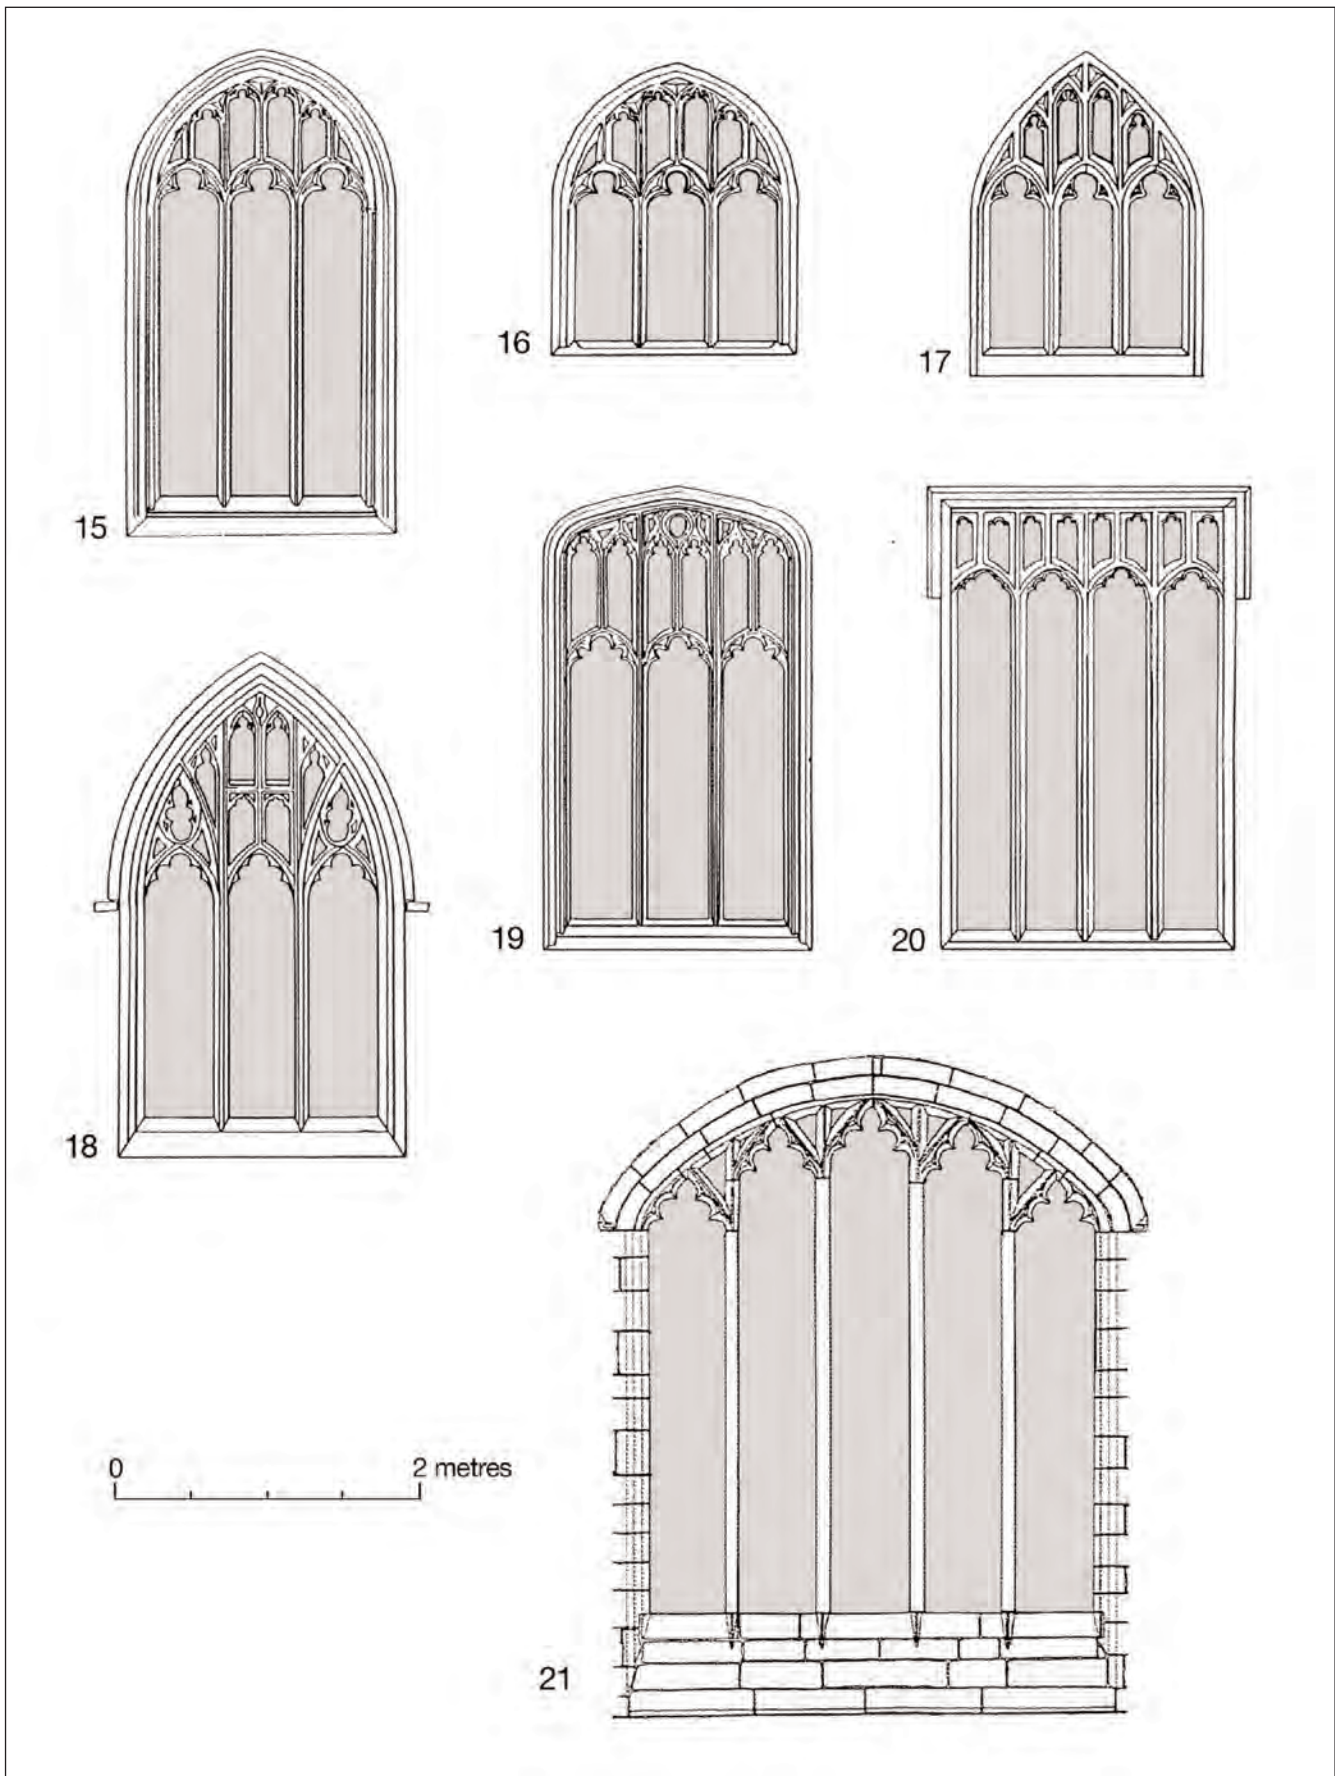
Fig. 50: Typology of the medieval windows in St Peter's and St Mary's churches. 15 St P., south aisle, west wall; 16 St P., clerestory; 17 St M., clerestory; 18 St M., north aisle, west wall; 19 St P., south aisle, east wall; 20 St M., north aisle; 21 St P., chancel, east wall. Scale 1:50. After Bryant 2003 (except 21)

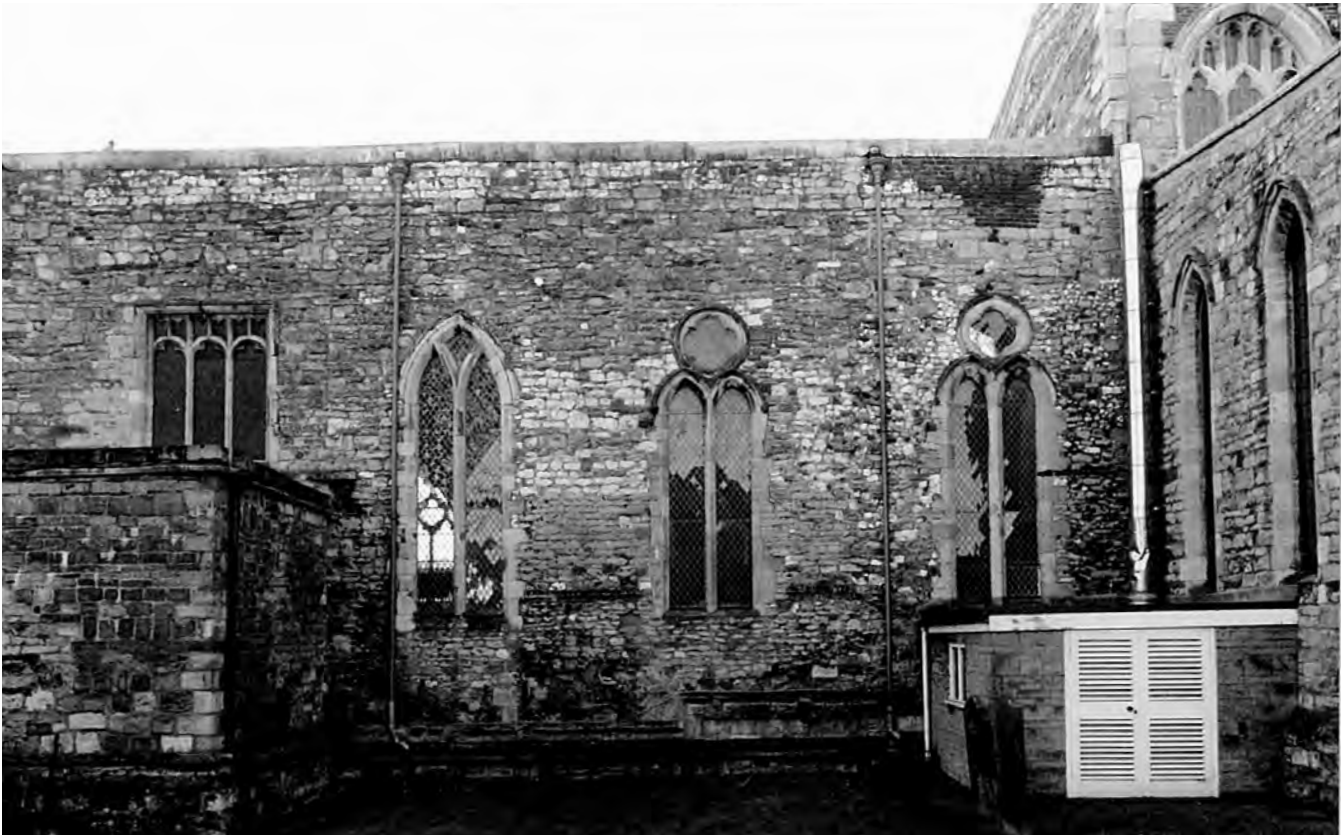
Fig. 51: St Mary's: north elevation of the chancel, showing also the vestry (left) and boiler-house (right). Photo: Warwick Rodwell

Externally, there is a marked difference on the north side between the masonry of bays 1–3, and that of the easternmost bay and the vestry; this indicates two periods of construction (Fig. 51). The east elevation is united by a moulded plinth and a string-course at window sill level; the masonry is predominantly squared limestone rubble laid to neat courses. The north and west sides of the vestry are less well finished and lack the string-course (Fig. 54). The masonry of bays 1–3 is much less regular and contains a greater mixture of rubble, with clear banding present, representing the arrival on site of different loads of stone. Thus, up to sill level the rubble is mixed, there is then a band of flattish pieces of limestone, followed by a band which is primarily chalk. This wall also contains the remnants of a string-course which is a little above sill level and the mid-thirteenth-century windows have clearly been cut through it. Internally, traces of former (Norman?) windows can be detected in the wallplaster above the present window heads in bays 1 and 2. The primary masonry of the north wall is similar to that in the same location at Barrow church.

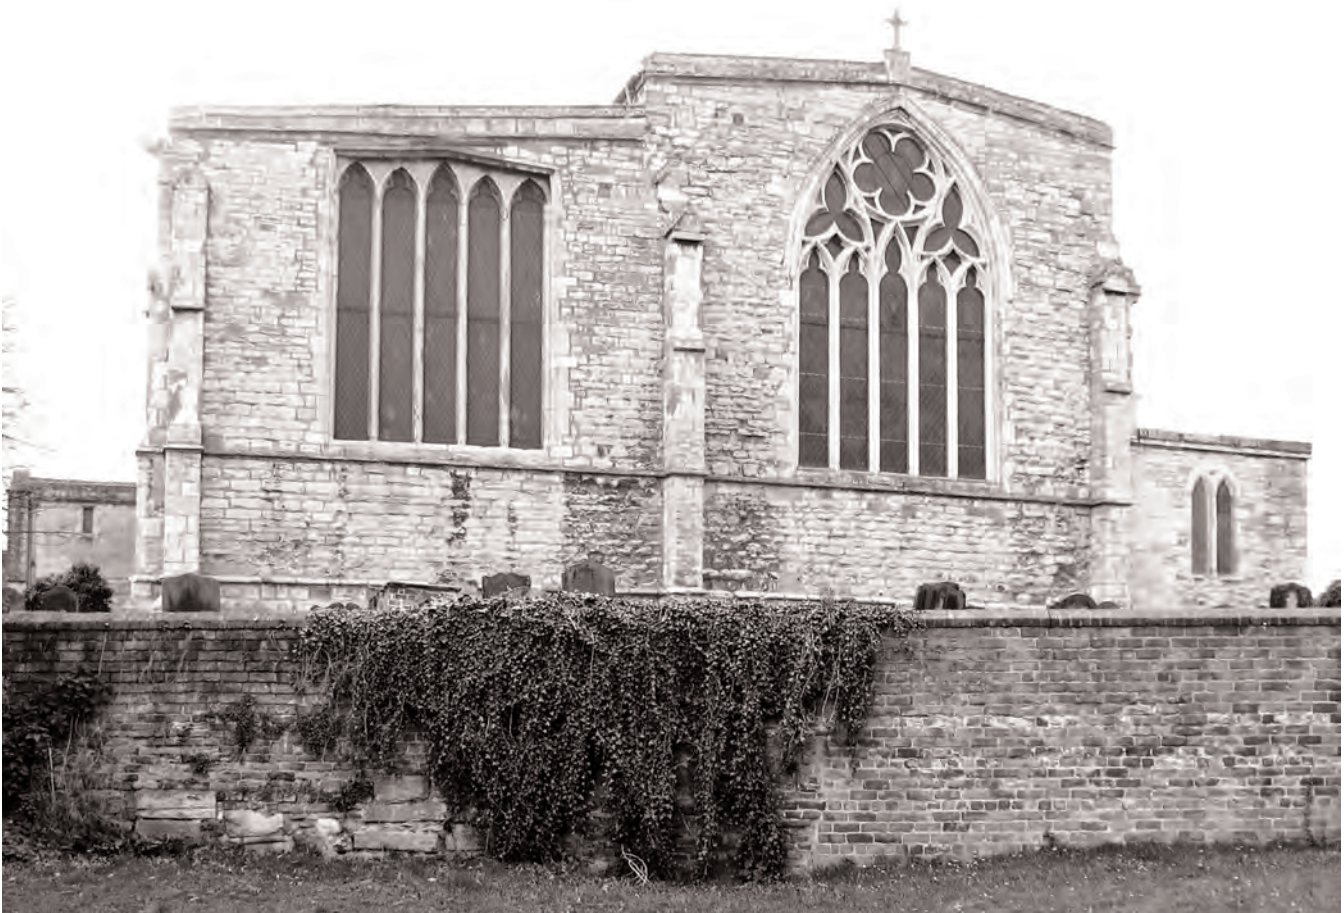
Fig. 53: St Mary's: east elevation of the chancel, south aisle and vestry, 2005. Photo: Warwick Rodwell

Loft described the gargoyle at the south-east angle of the church as 'a most capital Gothic figure of stone projecting 3 ft from the wall: it is a man with his face looking horizontally, his arms raised & his hands closed at the back of his head'. This feature, which is now heavily weathered, is glimpsed in Figure 53.

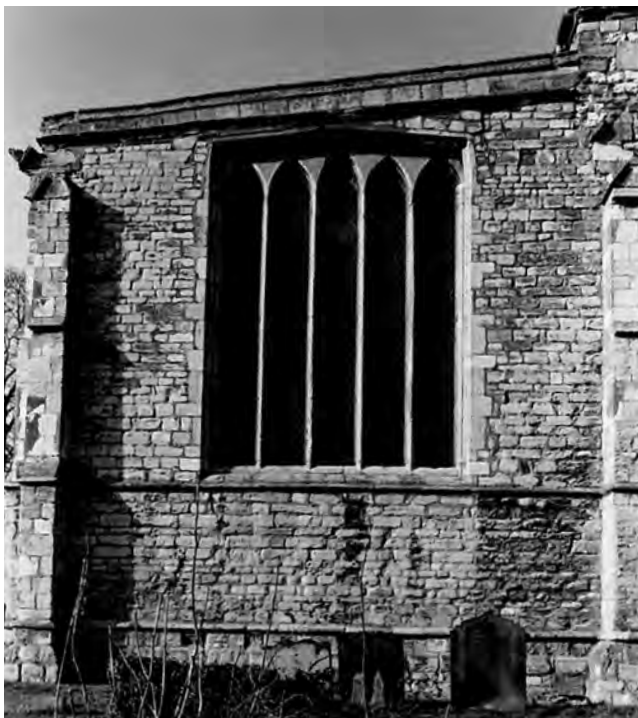
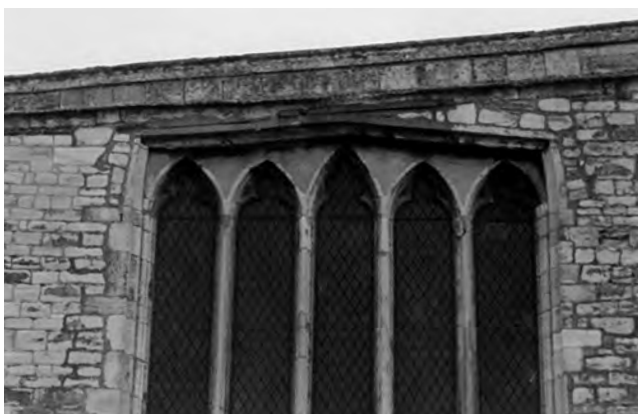
Fig. 56: *St Mary's: south chancel aisle. Upper, east end, with its truncated window. Lower, detail of the window tracery and substitute cambered head. Photos: Warwick Rodwell*

The five-light east window was once much taller and more elaborate (Fig. 56). It has been truncated at the apex of the main lights and all the traceries have gone: it now has a cambered head externally and a timber lintel internally. The springing of the two-centred head

survives outside, together with the scars where the hood-moulding and label-stops have been removed. The springing of the head can also be seen inside, together with the lower ends of the hollow-moulded hood and the two human heads that formed its label-stops (Fig. 117, sculpture nos. 9 and 10). They are *en suite* with the stops on the chancel arcade. The reveals are unmoulded. The main lights have trefoil heads, with the exception of the central one which stands slightly taller and has an elongated cinquefoiled head, similar to the windows in the south nave aisle.⁵⁷ This suggests that the tracery of the east window was Geometrical and was not contemporaneous with the fourteenth-century aisle: almost certainly, this was a repositioned window, fitted with a pair of label-stops to match those on the new arcade. The window is likely to have originated in the east end of the late thirteenth-century south nave aisle and to have contained one or more foiled circles in the tracery.

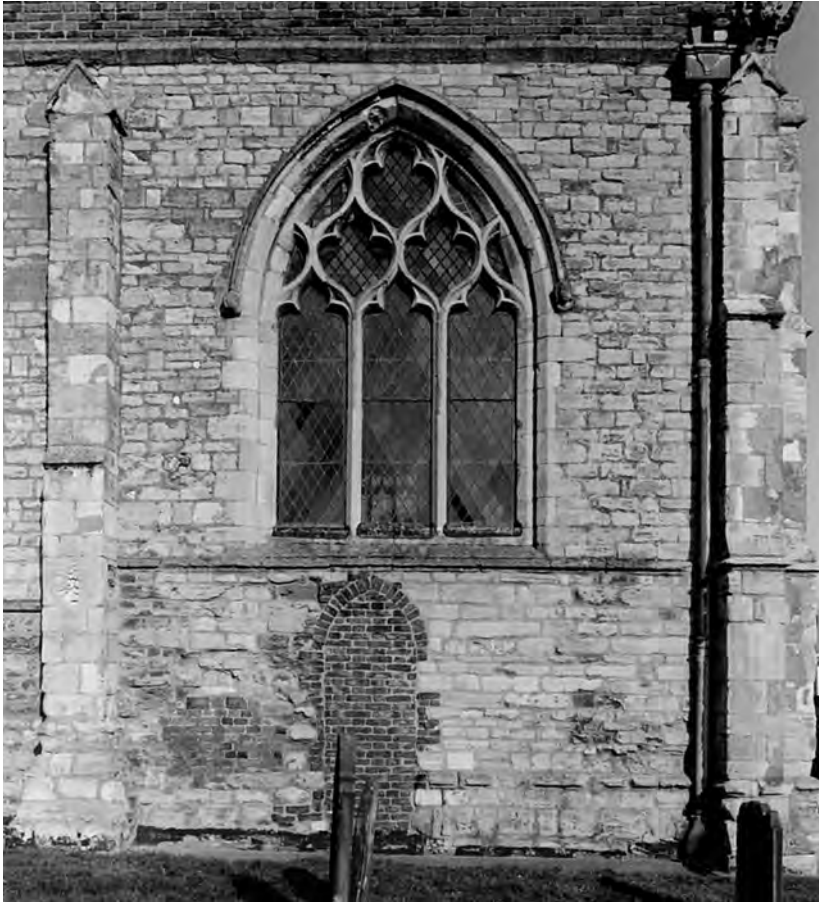
Fig. 58: St Mary's: south chancel aisle. Reticulated window tracery and blocked post-medieval doorway in bay 3. Photo: Warwick Rodwell

The three-light reticulated window with a two-centred head in the south wall of bay 3 is almost identical to those in the north aisle of St Peter's: only the cusping is slightly different (Figs. 49, 9 and 11 and 58). The rear-arch is chamfered, the splays plain. The window is contemporary with the triple sedilia in the wall below (Fig. 59).⁵⁹ The openings are pointed and have continuous chamfered arrises. The divisions between the seats were originally mullion-like and freestanding (*cf.* sedilia in the south nave aisle), but the lateral openings have been infilled with brick. There is a hood-moulding of crude, angular section (not hollowed), cut on the same blocks as the voussoirs of the arch; this is similar to the hood over the vestry doorway in St Peter's (p. 456). The associated piscina originally had a broad, trefoil-shaped head with a continuous plain chamfer (cut from a single block), but the cusping has been hacked away to form a square-topped cupboard. The basin has gone and a plain stone slab substituted as a sill. The piscina and sedilia are thirteenth century in style and were probably once in the south wall of the chancel, being repositioned when the aisle was added.

Probably in the eighteenth century, the masonry in and beneath the central sedilium was broken out to create a small pointed doorway; this was the external entrance to the schoolroom that, from an unrecorded date, occupied the easternmost bay of the aisle (Fig. 58). A fireplace was installed in the south-east corner of the room, and a chimney erected on top of the angle buttresses. The doorway was infilled, probably in 1883, and the fireplace later removed.

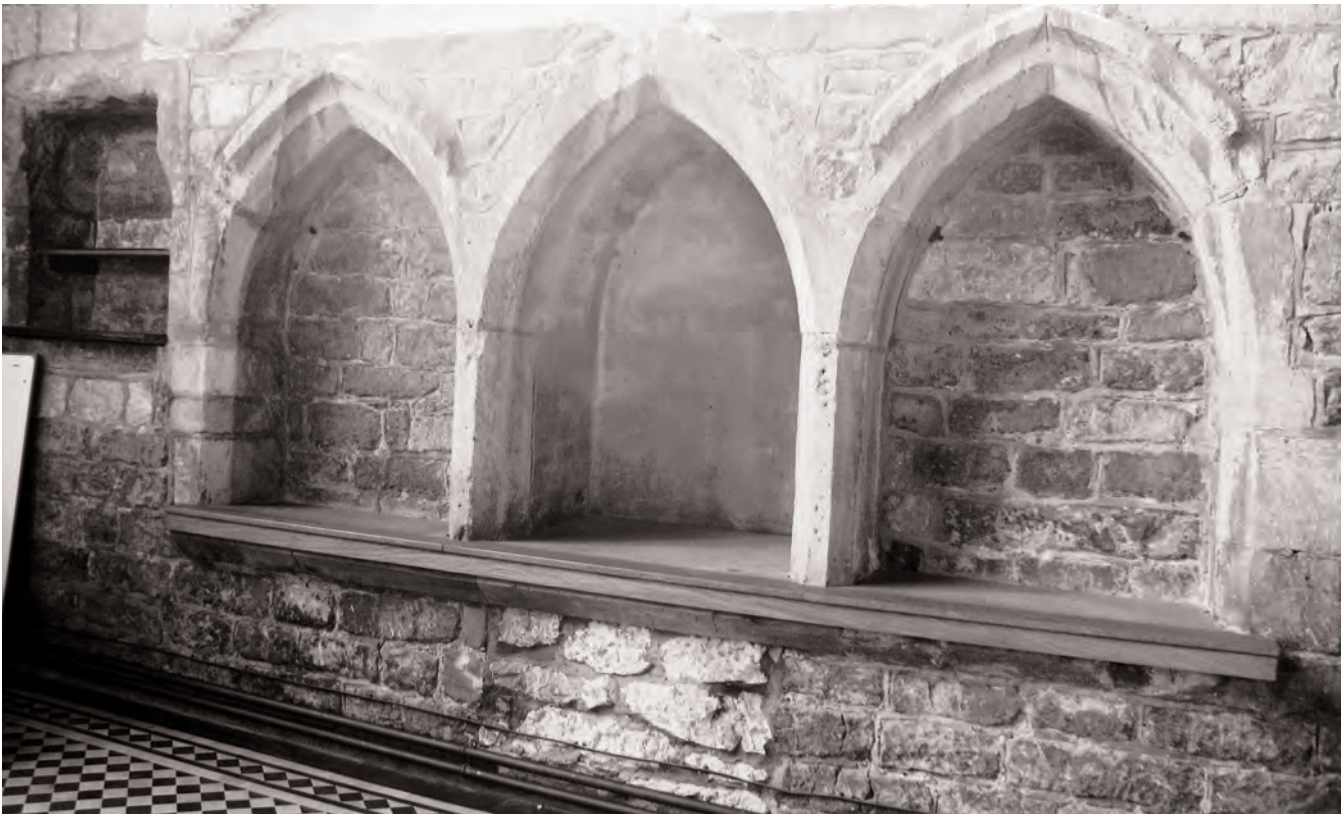
Fig. 59: St Mary's: south chancel aisle. Piscina and sedilia in south wall, the central seat restored after being converted into a doorway. Photo: Warwick Rodwell

The writer continued by describing two of the sedilia in the south wall of the chancel aisle (the third had been opened up to form a doorway; Figs. 58 and 59). The piscina with the 'very perfect' drain must be a reference to that in the north aisle, with the 'recess' being the aumbry in the same wall.

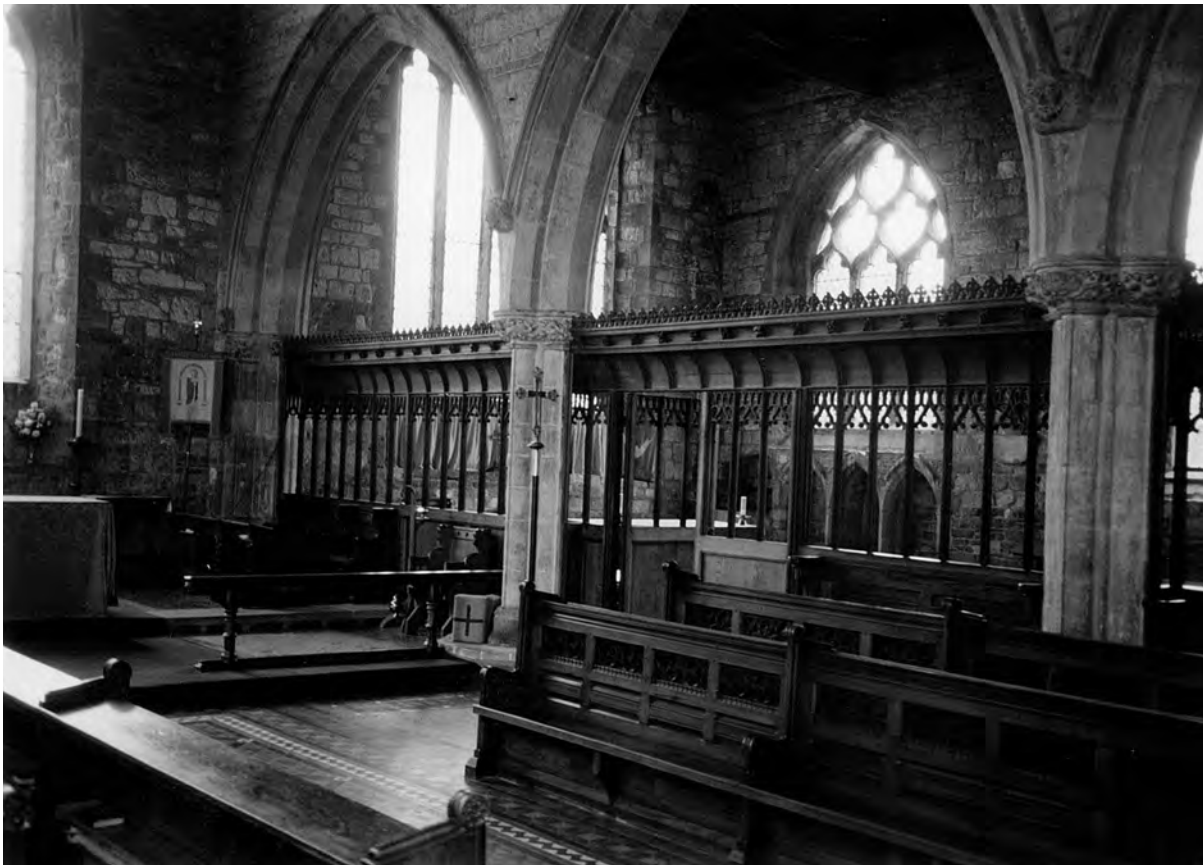
Fig. 61: St Mary's: chancel arcade. View south-east of bays 2 and 3. Photo: Warwick Rodwell

Chancel arcade (Figs. 61–62)

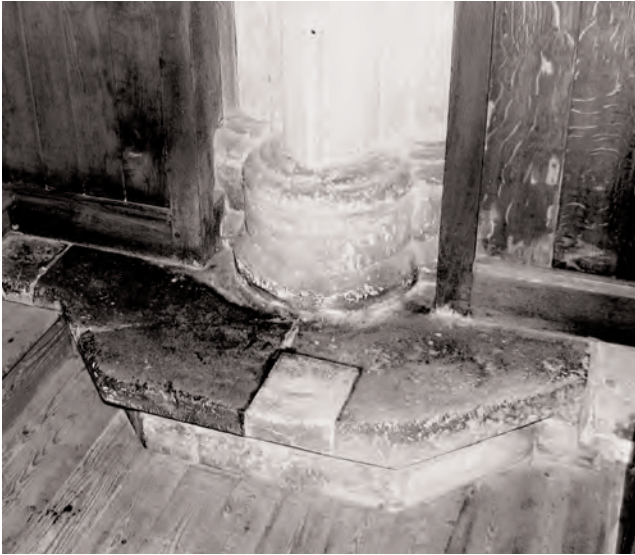
Fig. 63: St Mary's: chancel arcade. Stone bench angled around the base of the pier between bays 1 and 2, as seen from the aisle. Photo: Warwick Rodwell
