ST PETER'S

Barton-upon-Humber, Lincolnshire

A Parish Church and its Community

HISTORY, ARCHAEOLOGY AND ARCHITECTURE

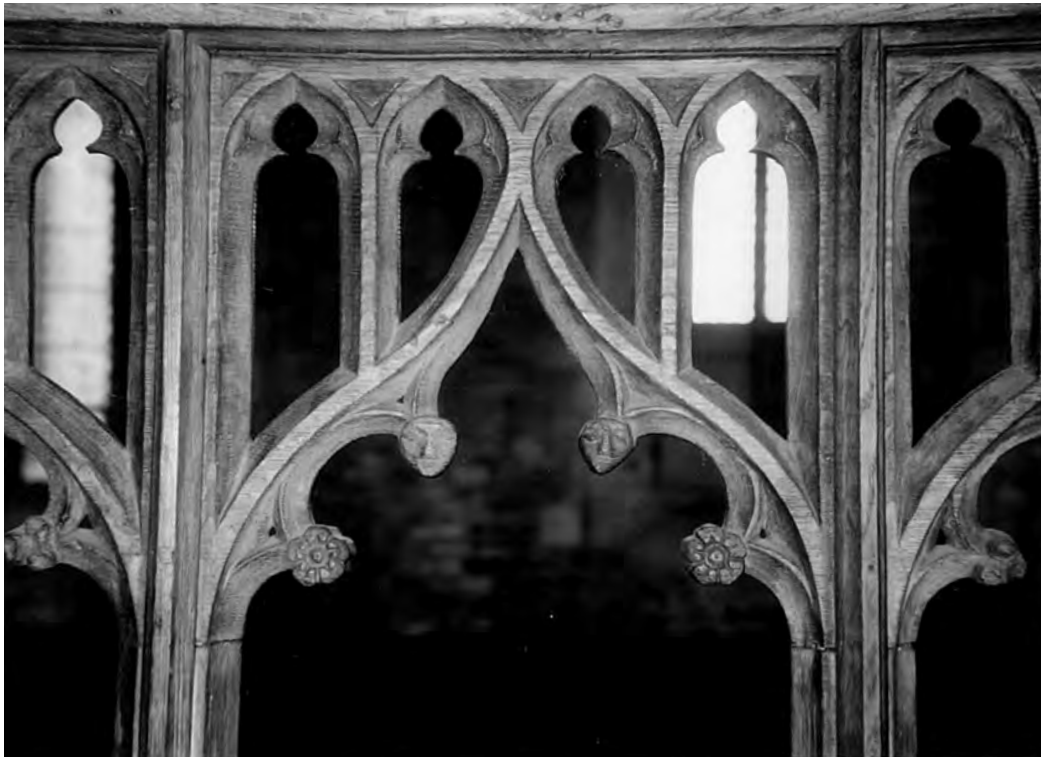
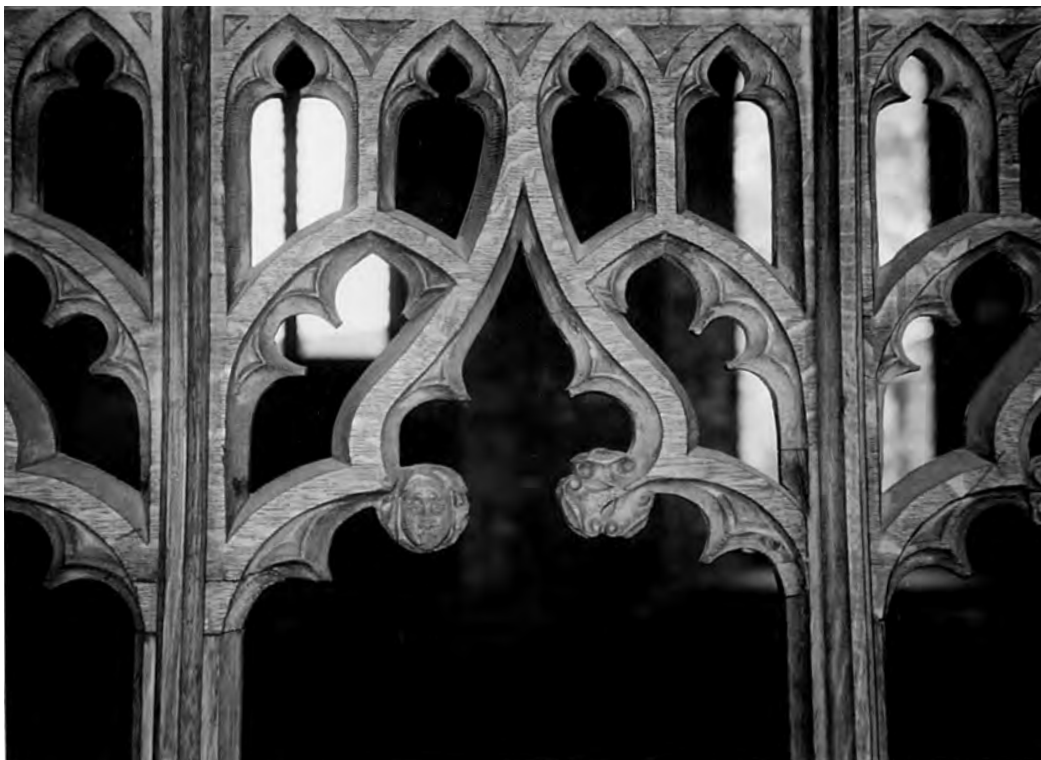
Fig. 64: St Mary's: chancel arcade. Details of the traceried heads of the timber screens. Upper, bay 1. Lower, bay 2. Photos: Warwick Rodwell

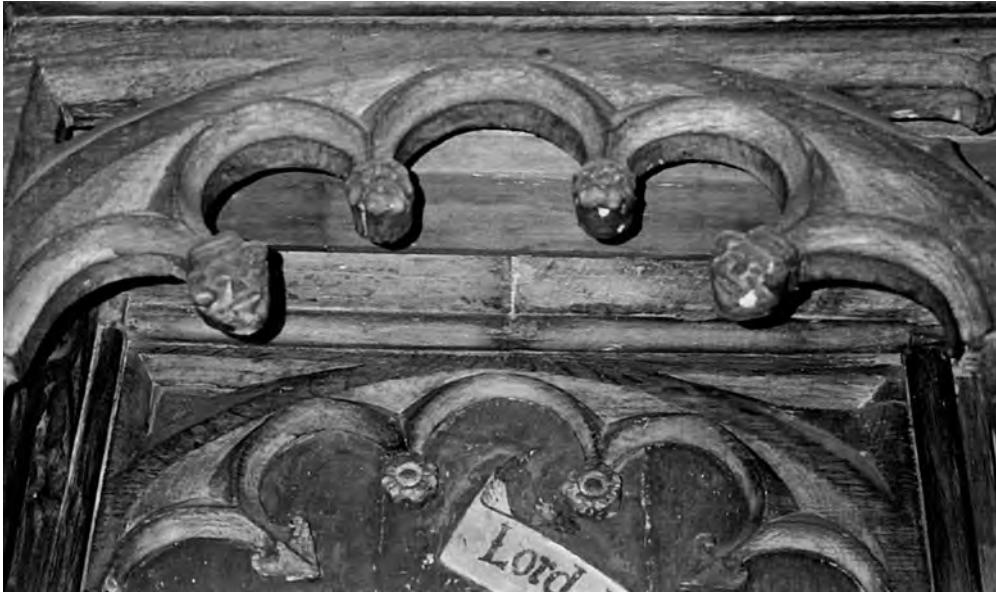
Fig. 65: *St Mary, Astley (Warks.): collegiate stalls. Cusp-bosses in the form of human heads, rosettes and arrow-heads. Photo: Warwick Rodwell*

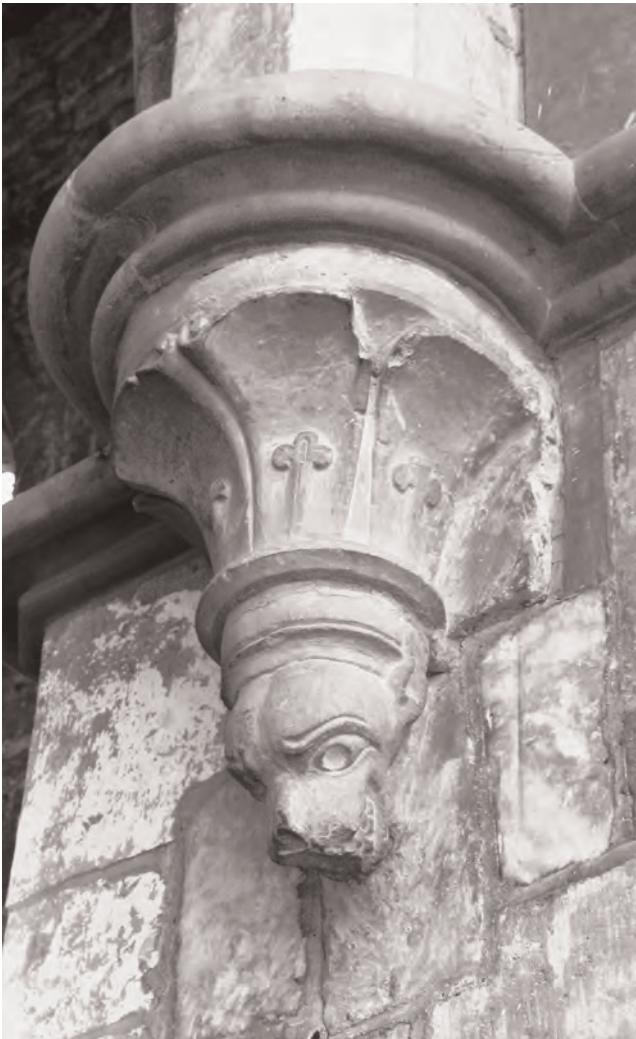
Fig. 66: *St Mary's: south nave arcade. Waterleaf corbel and beast-head on the west respond. Photo: Warwick Rodwell*

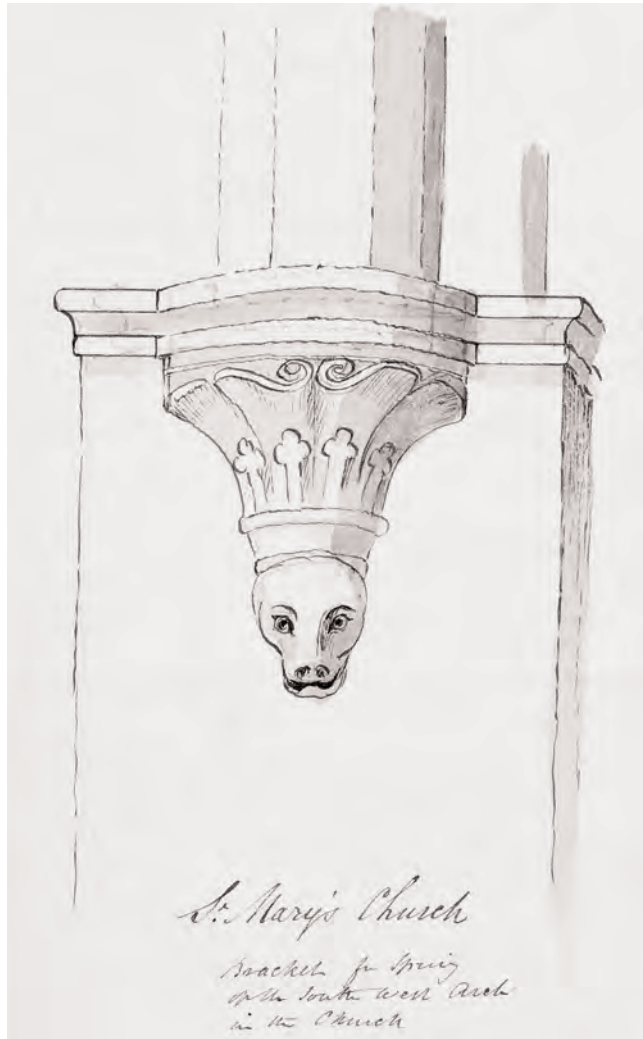
Fig. 67: *St Mary's: south nave arcade. Waterleaf corbel and beast-head, drawn by W.S. Hesleden, c. 1833. Bodleian Library, University of Oxford: Ms Top. Lincs. b.1, f. 214.*

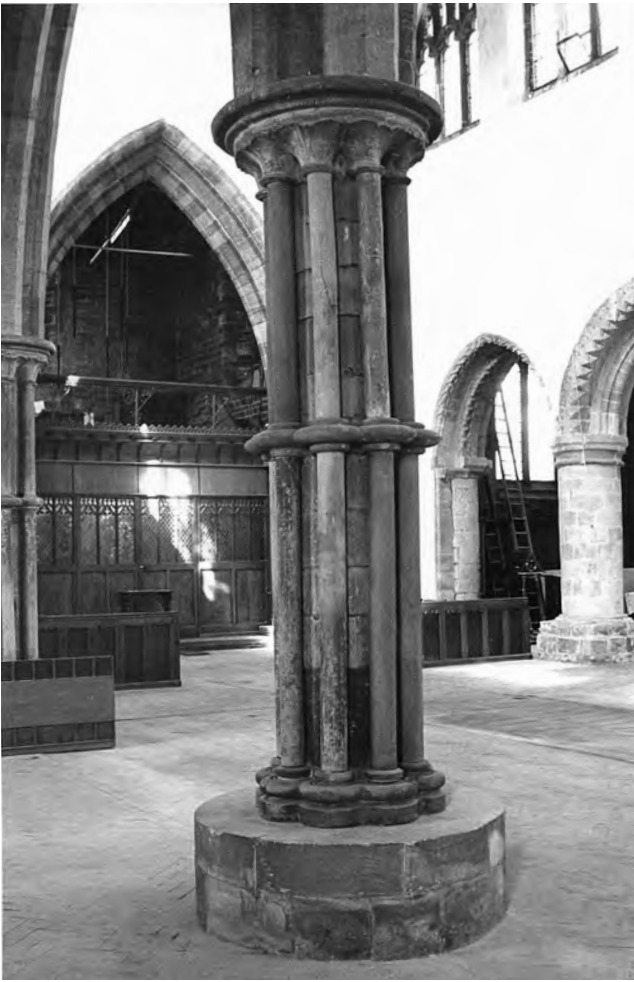
Fig. 68: St Mary's: south nave arcade, 1984. Clustered pier with basal seat in bay 2/3; view from the south-east. This pier was rebuilt in 1892. Photo: Geoffrey Bryant

The three piers are all similar, comprising an octagonal core with eight detached circular shafts with rings at mid-height (Fig. 68). The capitals are decorated with waterleaf and the circular, cavetto-moulded abacus

The pier of bay 2/3 was completely dismantled and rebuilt in 1892 (Fig. 71) because it had leaned southwards: the cause of this movement is not recorded, but it was very likely induced by an underlying archaeological feature. Set one above the other (300 mm apart), in the upper section of the north-east shaft of the pier in bay 1/2, is a pair of wrought iron pins with round shanks and large, flat heads; the shanks are horizontal (Fig. 72).⁶⁵ The shaft was drilled and the pins set horizontally in lead. The caulking is so neatly executed as to indicate the likelihood that the fixings were inserted before the shaft was mounted in the pier: that being so, the pins must date from the late twelfth century. It has been suggested that these were the fixings for an hour-glass (or sand-glass), a preaching aid which became popular in the reign of Elizabeth I (Moor 1892, 26; Cox 1923, 184–8). The suggestion was doubtless prompted by the fact that 'one sand glass 8d.' is recorded in the accounts for 1662.⁶⁶ However, the two substantial and very rigid fixings are not only medieval but also unsuited for such an insubstantial item.

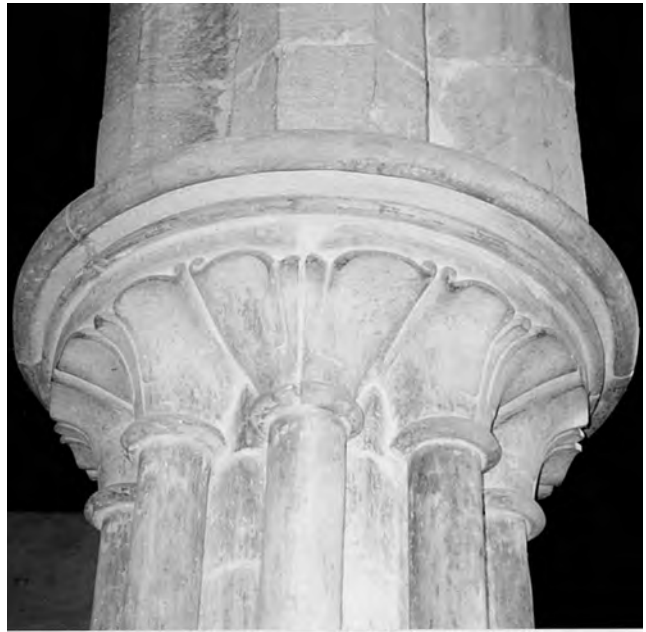
Fig. 69: St Mary's: south nave arcade. Waterleaf capital on the pier of bay 1/2; view from the east. Photo: Warwick Rodwell

is separate (Fig. 69); the bases are water-holding with a quirk, and stand on plain circular plinths which served also as seats (Fig. 70). The latter comprise a series of wedge-shaped segments, some of which are chalk. Lead was used for jointing the shafts.⁶⁴ and the masonry is a mixture of cream limestone and Lower Magnesian Limestone. A good deal of dark red paint

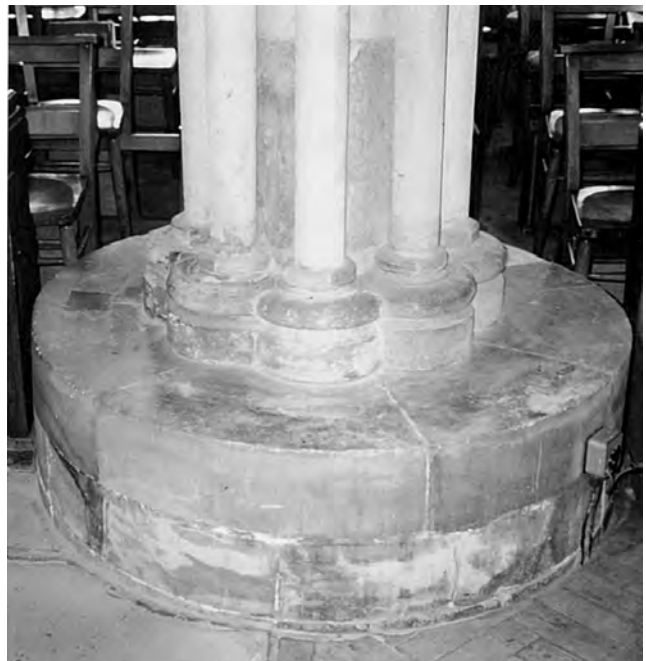
Fig. 70: St Mary's: south nave arcade. Base of the pier in bay 1/2, with circular bench around; view from the east. Photo: Warwick Rodwell

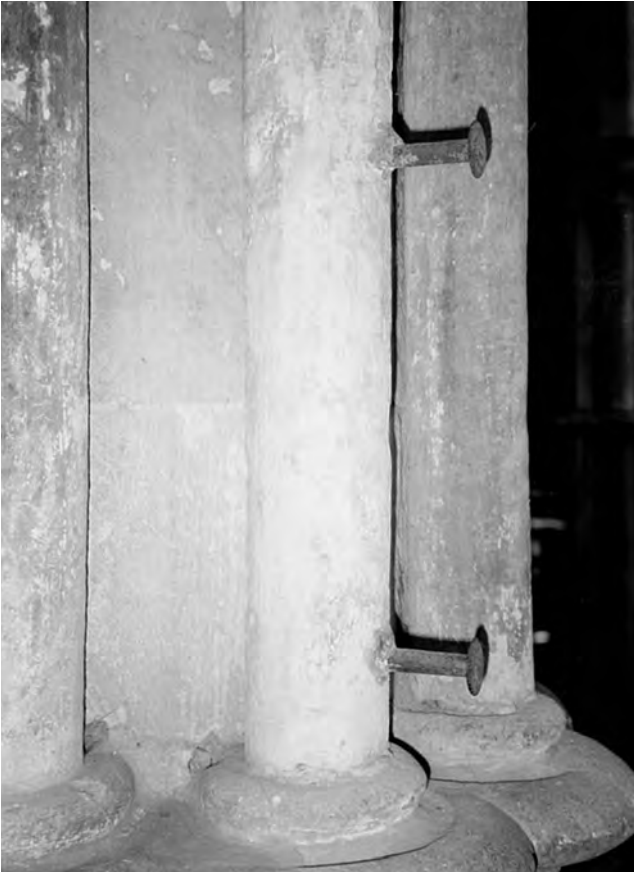
Fig. 72: St Mary's: south nave arcade. Two iron pins set in lead in one of the shafts of the pier between bays 1 and 2. The pins were probably for securing the rope that operated the medieval rood veil. Photo: Warwick Rodwell

a large sheet which was raised by ropes and pulleys, although in practical terms little is known about these. If the pins were for the operation of a rood veil, which would have hung just in front of the chancel arch, then it certainly implies that by the late twelfth century St Mary's was already provided with a chancel. The latter is the more likely, particularly in view of the aisle arrangements on the south.

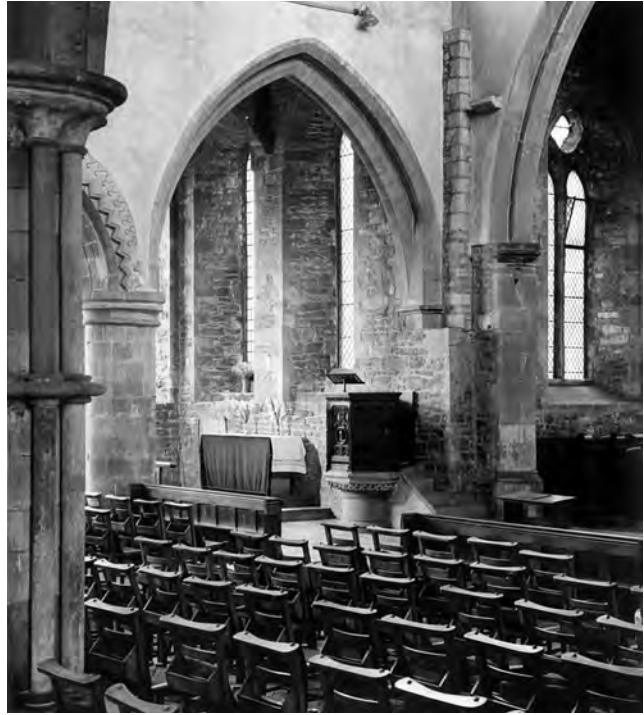
Fig. 73: St Mary's: nave. View north-east across the nave, showing bay 1 of the north arcade, and the chapel beyond, c. 1965. Photo: David Lee Photography

This has generated a great deal of antiquarian interest on account of the irregularities in its construction.⁶⁷ It comprises six unequal bays, and a short nib at the west end. Bay 1 is the widest and highest, with an early thirteenth-century two-centred and stilted arch of two chamfered orders and no label-moulding. There is no respond on the east, and the arch simply springs from a short length of string-course (not original) set into the rubble masonry of the north aisle wall (Fig. 73).

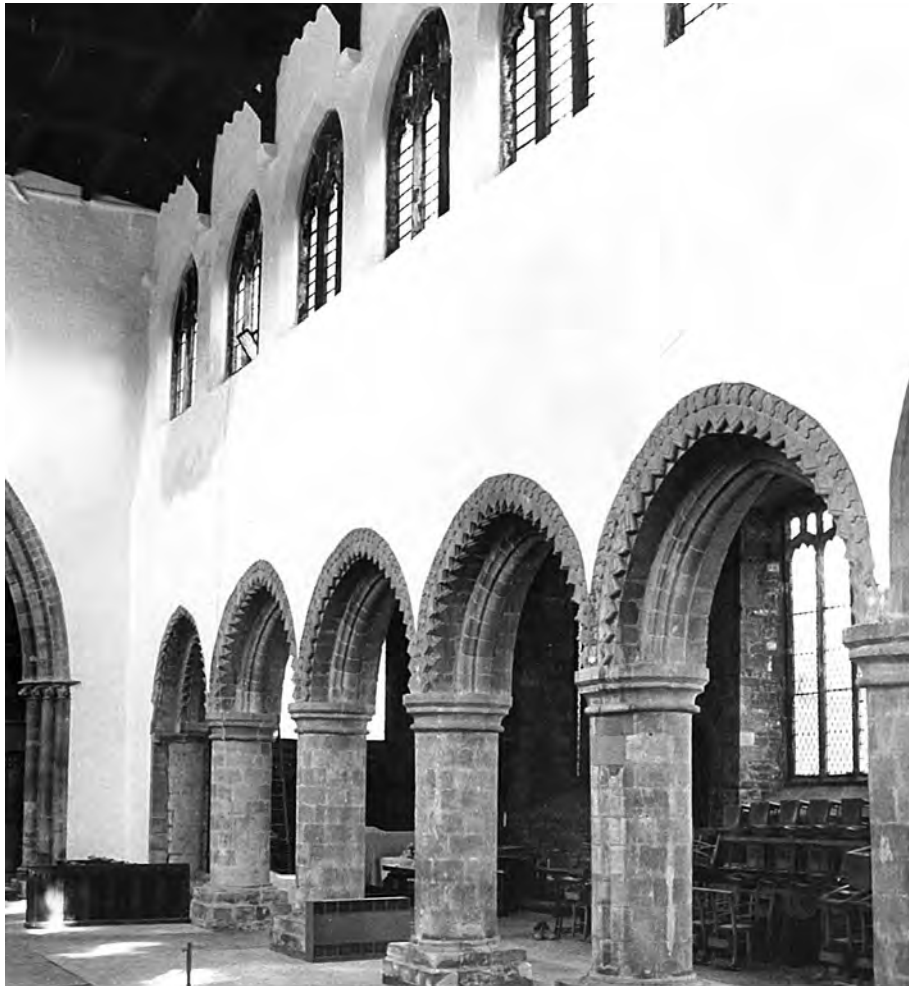
Fig. 74: St Mary's: north arcade and clerestory. View north-west, 1984. Photo: Geoffrey Bryant

The nave is tall and crowned by an elegant clerestory of eight bays; this was a late addition and its north and south walls are slightly thinner than those of the arcades below (Figs. 38, 52 and 74; Pl. 14). Consequently, there is a clearly evidenced 'shoulder' in the wallplaster just above the top of the south arcade, and at a similar level on the north (where the arcade is not as tall). A good deal of medieval wallplaster survives above the arches on all four sides of the nave, and when contractors scrubbed the walls prior to redecoration in 1984, extensive traces of polychromy were observed.⁶¹ Nothing is now visible.

The arcade is carried on five circular piers, with a corresponding half-pier forming the respond at the west end: this is all late Romanesque work (Fig. 74). The shafts are made of medium-sized ashlar of several different stone types, and much dark red paint survives on them, which is almost certainly medieval.⁶⁸ The capitals have hollow mouldings and separate basally chamfered abaci (Fig. 75; *cf.* the north arcade in St Peter's). Both the capitals and the abaci are constructed segmentally. The moulded bases are square and mounted on chamfered plinths of various heights: bay 1/2 stands the highest. Each base is composed of about six separate blocks, mostly limestone. However, pier 5/6 differs from the previous four in several respects: the presence of sandstone in the shaft;⁶⁹ the

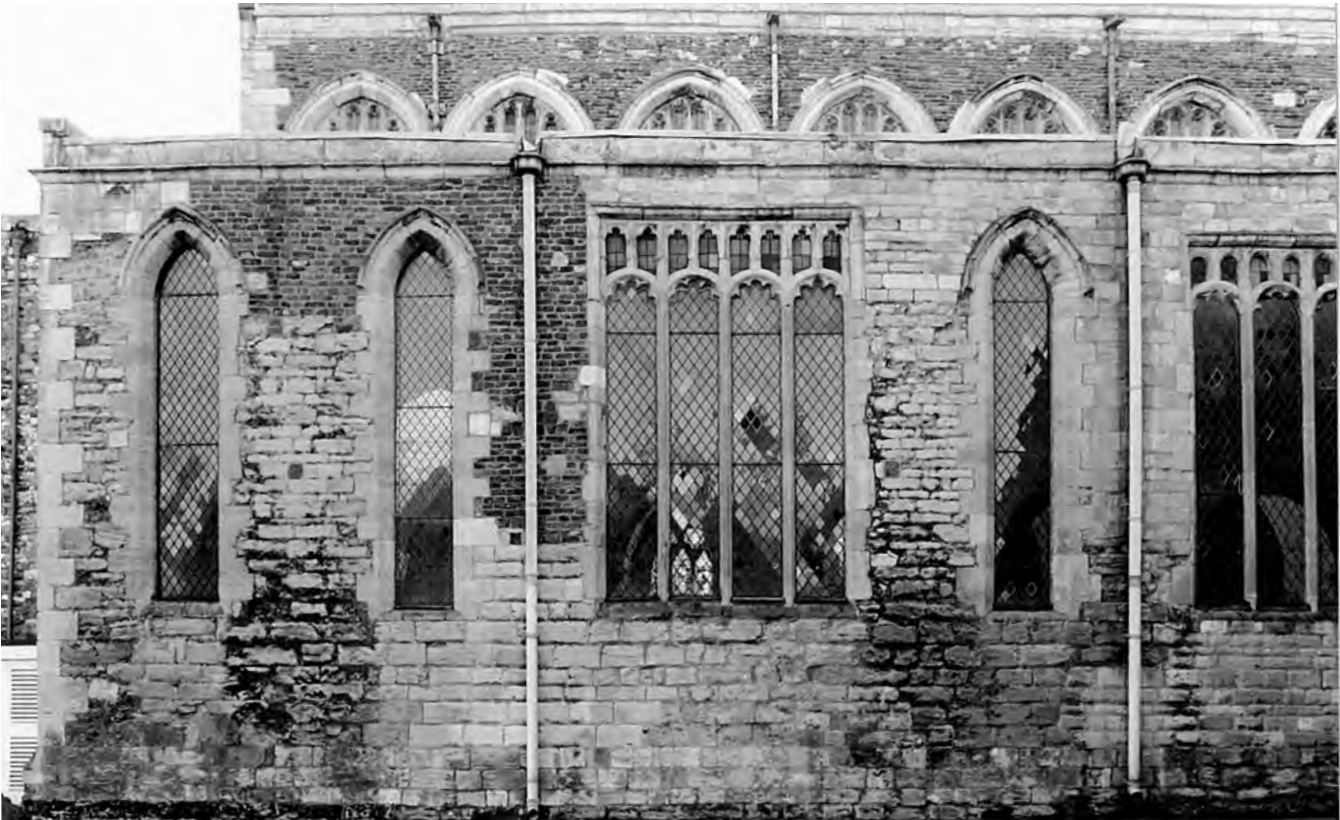
Fig. 78: St Mary's: north aisle. Exterior, bays 1 to 3. Photo: Warwick Rodwell

The north wall contains a mixture of windows, three of which are primary (bays 1, 3 and 6), and it is likely that two more have been destroyed by later openings (bays 2 and 4) (Fig. 78). These are plain, tall lancets with hood-mouldings and externally chamfered apertures. Internally, the heads are shouldered, matching the windows in the east wall. Another tall lancet was

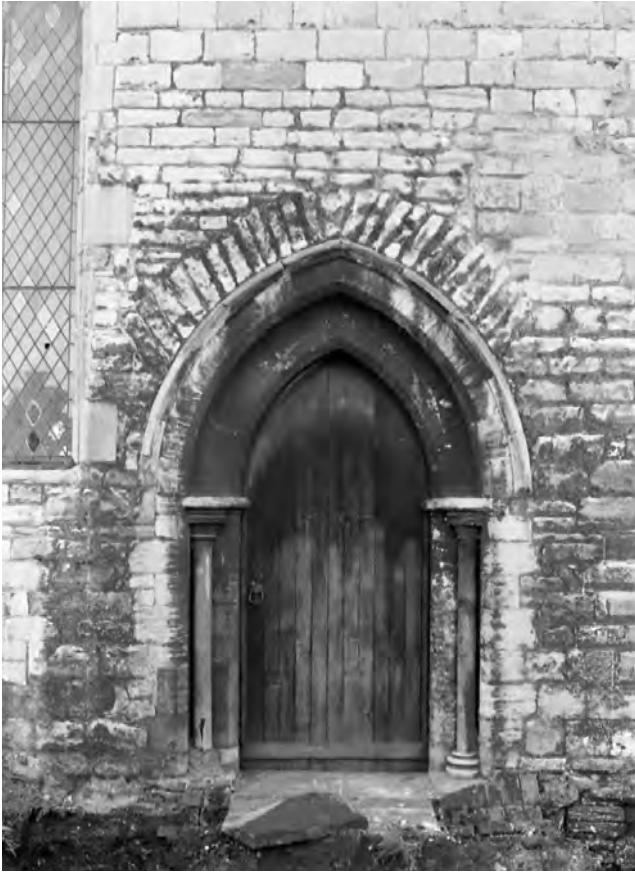
Fig. 81: St Mary's: north doorway, 1980. Photo: Warwick Rodwell

The north doorway (bay 5) has a rather plain, two-centred head of two modestly chamfered orders and a hood-moulding (Fig. 81). The arch has an outer ring of roughly cut voussoirs. The opening is flanked by detached shafts (secured with lead dowels), with plain bell capitals and renewed bases; the abaci are separate from the capitals and do not support anything. This odd arrangement gives the impression that there ought to be a moulding between the two chamfered orders, but there clearly never was one. Although original, the shafted reveals were not designed to carry such a basic arch. The rear-arch is unadorned, has a pointed head and the splays are ashlar-dressed; there is an outer ring of roughly cut voussoirs; infilled draw-bar sockets are visible in the reveals. The doorway was blocked and obscured by pews until 1891.

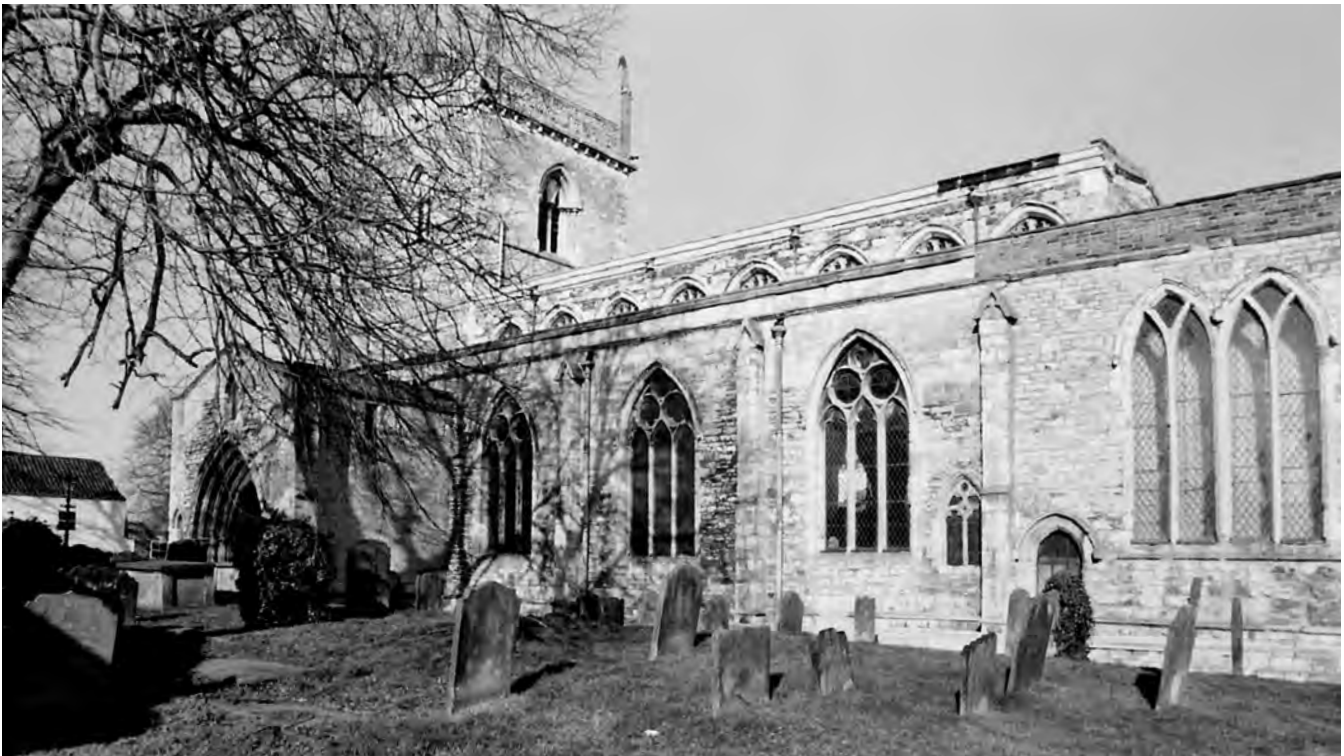
Fig. 82: St Mary's: south nave aisle and porch, and bay 1 of the chancel aisle. View from the south-east. Photo: Warwick Rodwell

At the east end of the wall, a small two-light window with a pointed head and curvilinear tracery was inserted in the early fourteenth century (Figs. 49, 14, 82 and 89). The traceried head appears to be cut from a single block of stone, the rear-arch is crudely chamfered and the soffit is formed in brick.

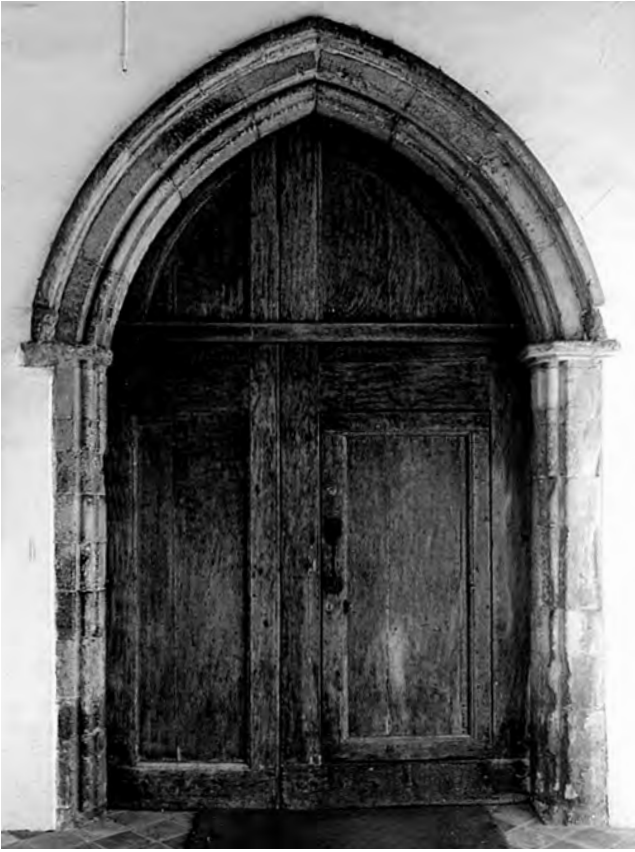
Fig. 83: St Mary's: south doorway. Photo: Warwick Rodwell

The doorway is in bay 4 and is remarkably plain: it has a two-centred arch and moulded jambs of the same profile (Fig. 83). The moulding comprises a roll with a deep hollow to either flank. The imposts are unusually thin and flat, and are also moulded;⁷⁶ there are no capitals or bases (Fig. 84). The hood-moulding does not have complementary stops, but two pieces of stone have been roughly built-in at the ends: that on the east is a shapeless lump of limestone which does not appear ever to have been carved. In contrast, on the west, a reused head has been incorporated: it has an elongated face with a flattened nose, almond-shaped eyes, a high

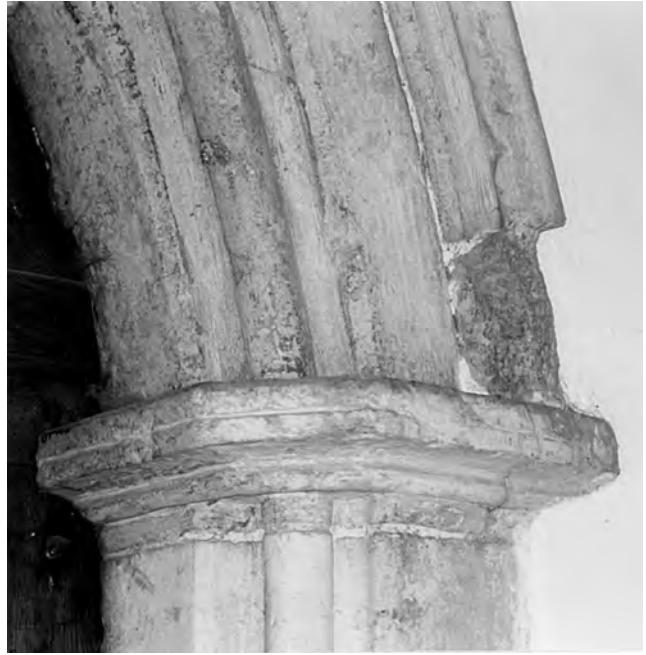
Fig. 84: St Mary's: eastern impost of the south doorway. A shapeless piece of stone occupies the place of the missing label-stop. Photo: Warwick Rodwell

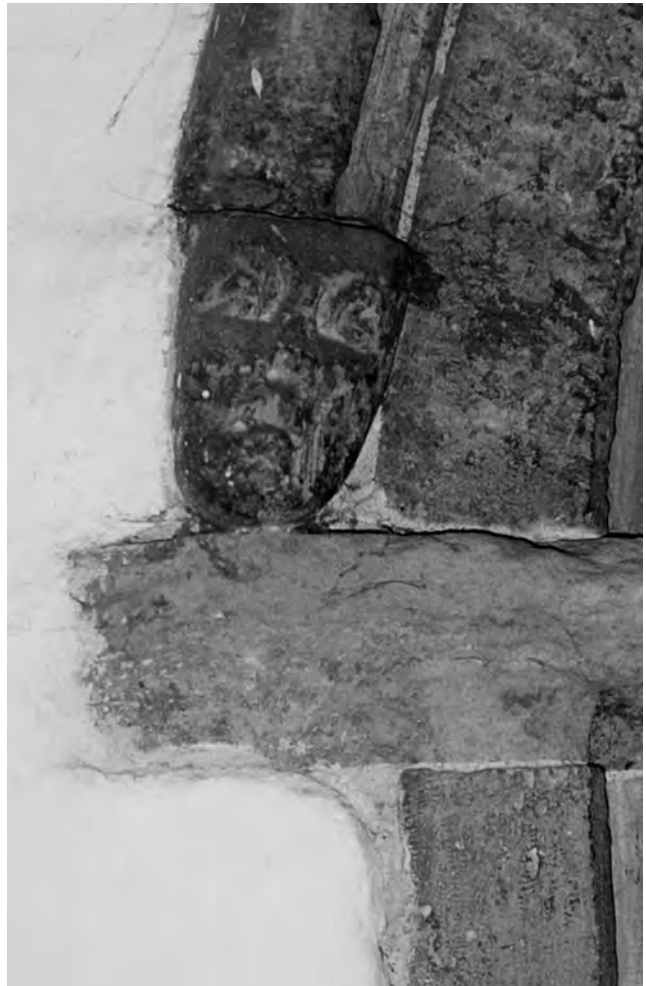
Fig. 85: St Mary's: decayed western impost of the south doorway, with a reused Romanesque head as the label-stop (sculpture no. 18). Photo: Warwick Rodwell

brow and a small mouth (sculpture no. 18; Fig. 85). The face is clean-shaven and has no hair descending on to the forehead. The head is Romanesque in style and has clearly been broken from a sculpture, perhaps another label moulding or a small corbel: it has merely been set here in a bed of mortar.

18. Male head reused as west label-stop (Fig. 85).

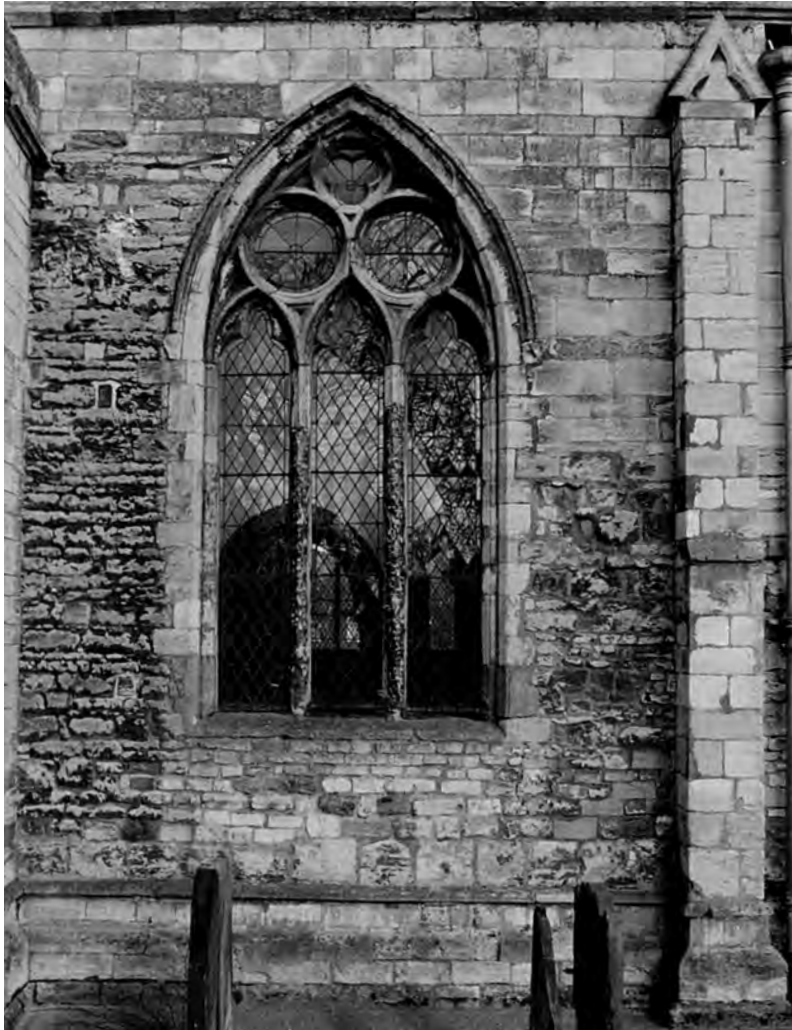
Fig. 86: *St Mary's: south nave aisle. Unrestored window in bay 3. Photo: Warwick Rodwell*

The windows in bays 1–3, and in the west wall, are each of three lights under a pointed head (Fig. 86). The rear-arches of these windows are dressed with limestone ashlar and have chamfered arrises; the splays are of rubble. The central light in each is cinquefoiled, the others trefoiled. The tracery lights comprise three

circles: a small one at the top containing a trefoil, and two larger ones which are uncusped, except in the case of bay 2. There, the larger circles are cinquefoiled, although the originality of this detail is dubious.⁷⁷ Similar windows with uncusped circles in the traceries are found in other Lincolnshire churches (*e.g.* Sutterton, south transept; see also the transept at Castor, Cambs). The south wall of the chancel at Barrow had a two-light version of the Barton windows, with a small trefoiled circle in the apex; it is evidently from the same workshop (Fig. 87). At Winterton there is another two-light example which is entirely devoid of cusping (Fig. 88). The tracery design at St Mary's is remarkably close to that on the back of the Coronation Chair at Westminster Abbey, commissioned by Edward I in 1297 (RCHME 1924, pl. 23).

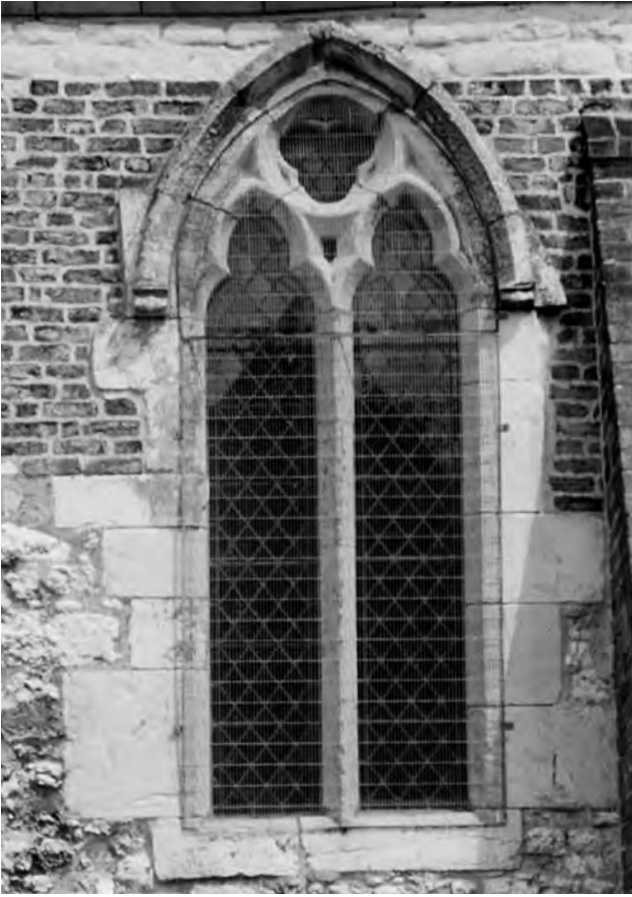
Fig. 87: *Holy Trinity, Barrow-upon-Humber (Lincs.): south wall of chancel. A two-light version of the window seen in Fig. 86. Photo: Warwick Rodwell*

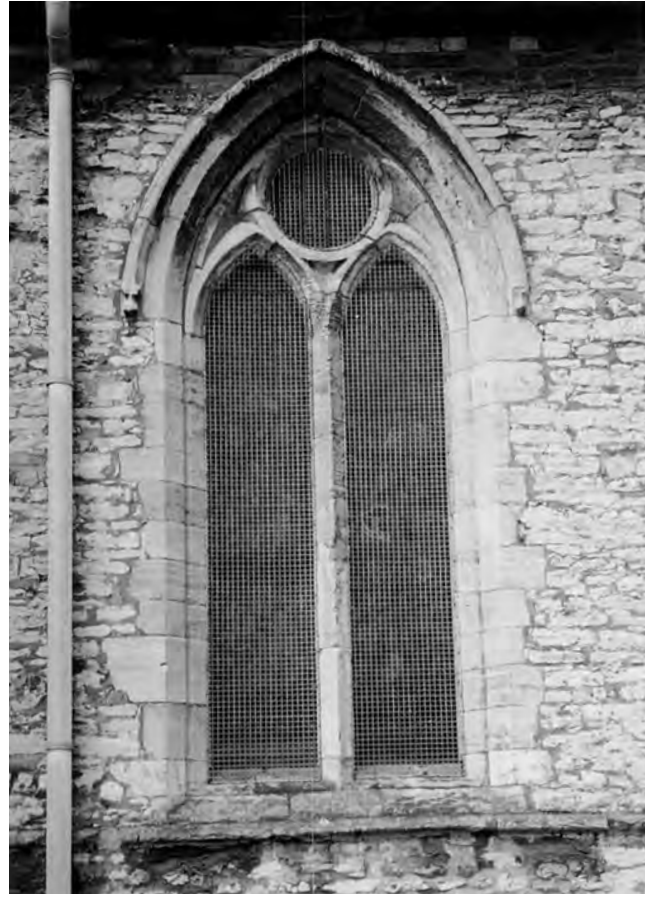
Fig. 88: *All Saints, Winterton (Lincs.): south wall of chancel. A two-light window with tracery circle, all uncusped. Photo: Warwick Rodwell*

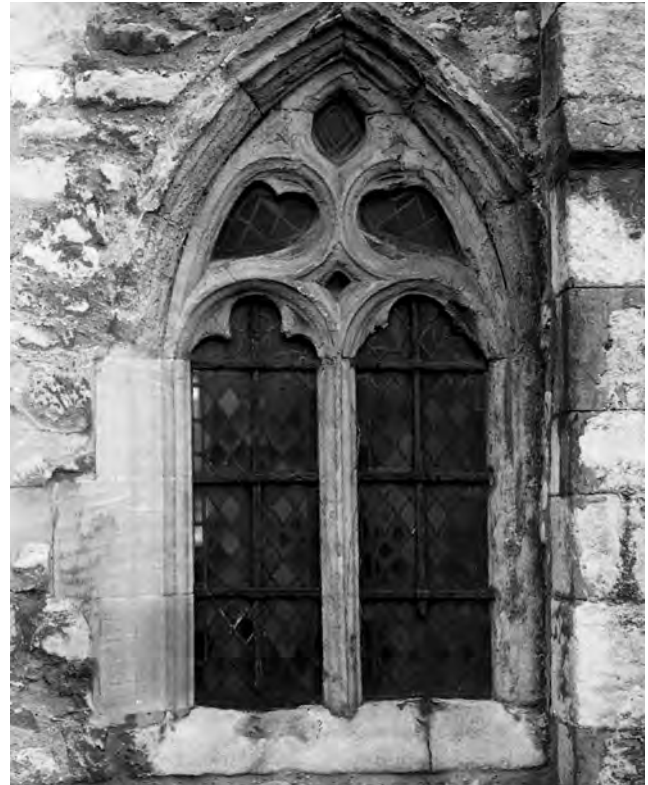
Fig. 89: *St Mary's: south nave aisle. 'Low-side window' in bay 1. Photo: Warwick Rodwell*

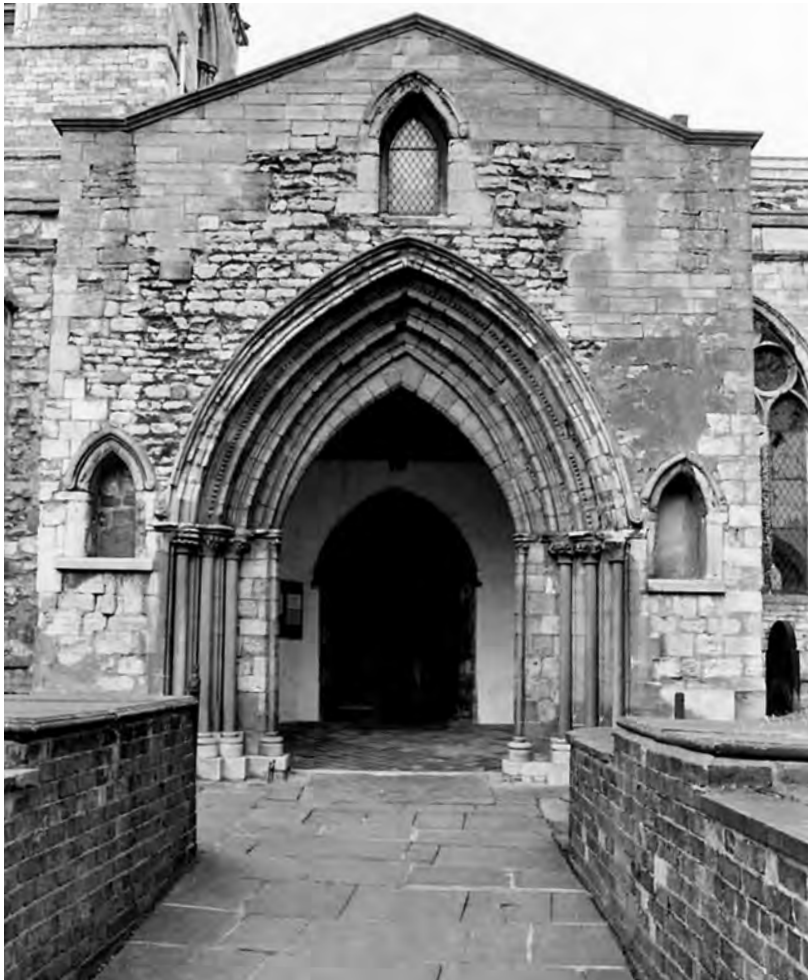
Fig. 91: St Mary's: south porch and entrance from Burgate. The brick walls form a revetment to the elevated churchyard. Photo: Warwick Rodwell

Externally, to either side of the opening is a flat-backed niche with a lancet head and hood-moulding, all made from small blocks of stone; the sills are modern slabs (Figs. 91 and 93). These niches are of uncertain age and even function: they could have been fabricated from the heads of small lancet windows taken from the earlier aisle. A third, generally similar, feature in the wall above the entrance is now a window, lighting the upper chamber, but it too was potentially once a niche.⁸² The remains of one label-stop survive. If these were niches, they presumably all once held

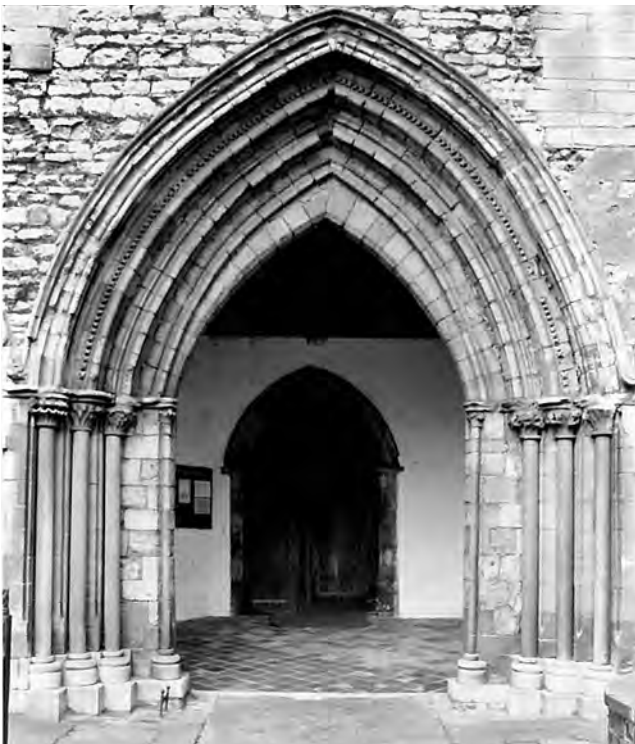
Fig. 92: St Mary's: outer entrance to the south porch. Note also the large threshold slab (no. 20). Photo: Warwick Rodwell

St Peter's south aisle incorporated a small porch, and we may suspect that one was subsequently added to St Mary's (*cf.* the elaborate doorway reused in the later porch; Fig. 92). Then, *c.* 1270–80, followed the widening of the south aisles of both churches: St Peter's

dogtooth ornament (Fig. 92). The plain chamfered innermost order is not concentric with the others, but the whole arrangement is nevertheless contemporaneous. The responds of the innermost order have small engaged angle-shafts which are flanked by three detached shafts, all with stiff-leaf capitals and separate abaci (Fig. 93). The stiff-leaf work was highly accomplished and deeply undercut, seemingly to Lincoln cathedral standards, but is now sadly decayed (Figs. 94 and 95). The arch has a hood-moulding and the terminal on the west displays the remains of a large stiff-leaf; the eastern stop is modern.

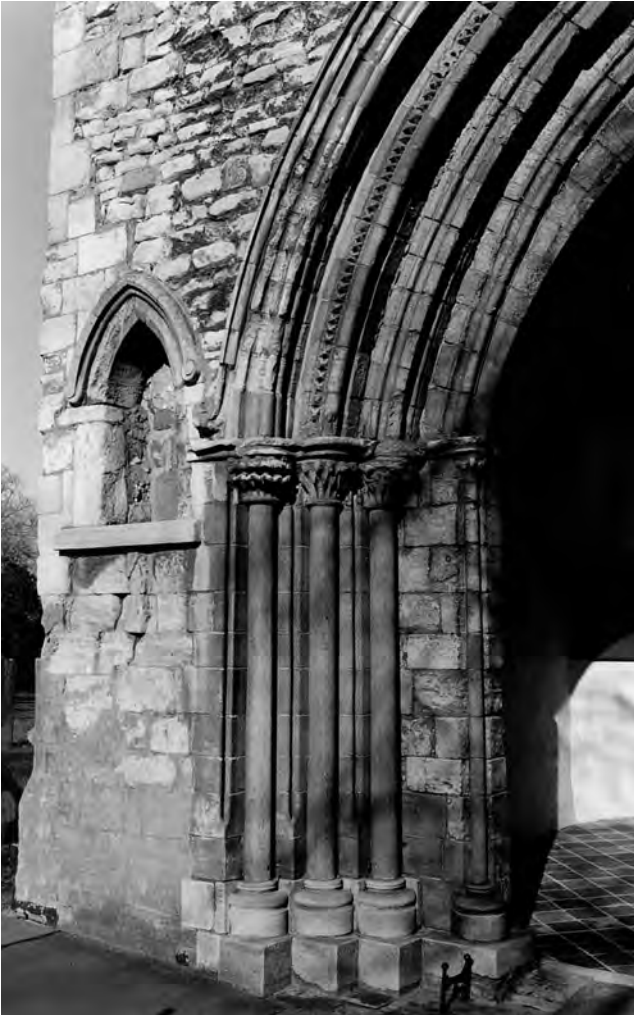
Fig. 93: St Mary's: south porch. West respond of outer entrance, with adjacent niche. Photo: Warwick Rodwell

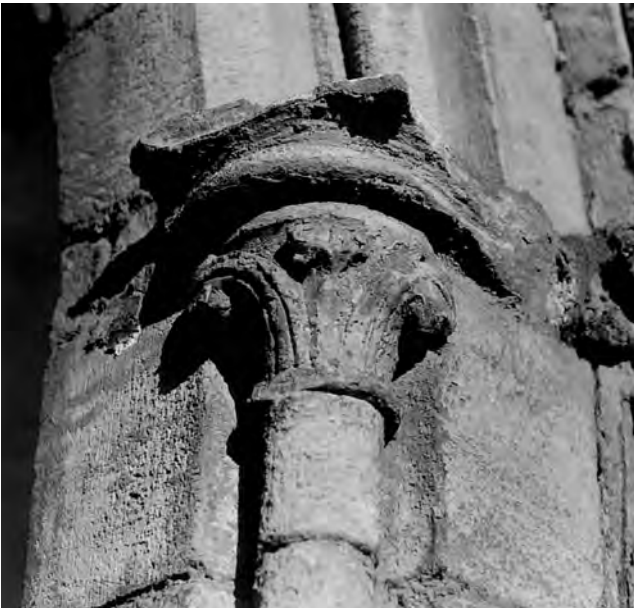
Fig. 94: St Mary's: south porch. Decayed stiff-leaf capital and abacus on the east respond of the innermost order of the arch. Photo: Warwick Rodwell

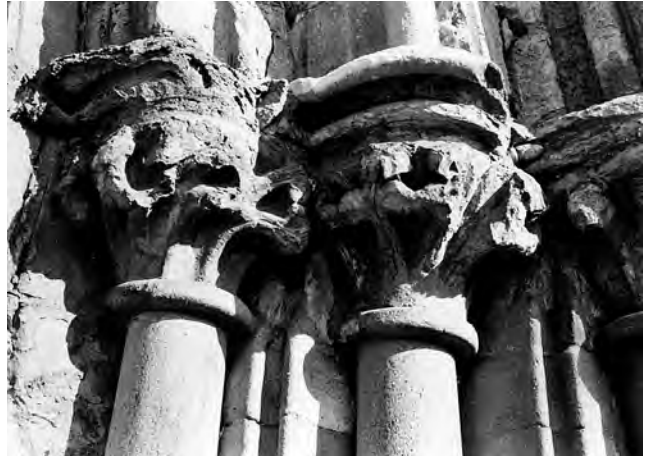
Fig. 95: St Mary's: south porch. Decayed stiff-leaf capitals and abaci on the outer order of the east respond of the arch. Photo: Warwick Rodwell

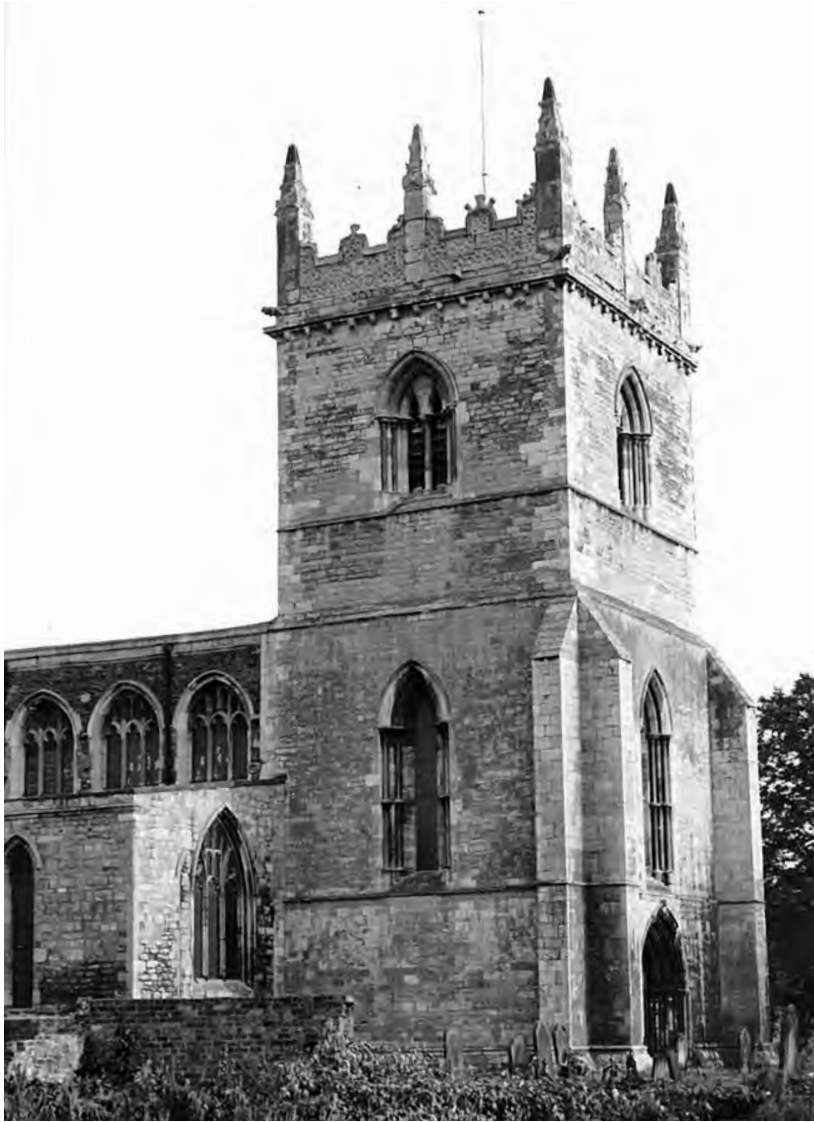
Fig. 97: St Mary's: the tower from the north-west in the 1960s, before the church hall was erected. In the foreground is the site of the Chantry House, now built upon. Photo: David Lee Photography

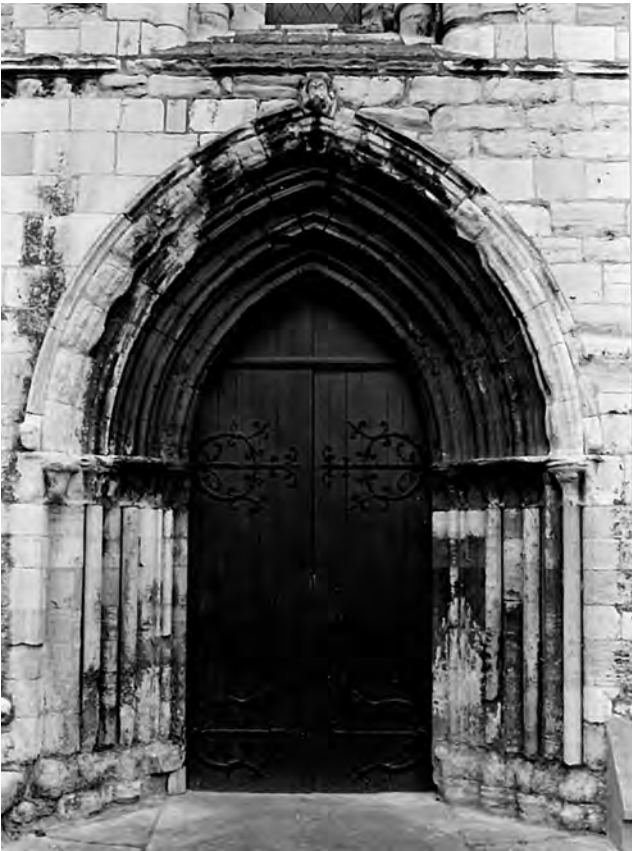
Fig. 98: St Mary's: tower, west doorway. Note the small head-sculpture incorporated in the apex of the arch (sculpture no. 19). Photo: Warwick Rodwell

The ground stage stands on a substantial moulded plinth and has clasping buttresses on the western angles (Fig. 41); they have no set-backs. In the west face is a fine doorway with a well-moulded arch of four orders with fillets (Fig. 98). The responds have four linked stiff-leaf capitals: the innermost order comprises an attached triplet roll, which is flanked by three detached shafts and capitals, all now heavily eroded. The abaci are integral with the capitals, and the entire set on each side appears to be carved on a single block; the shafts are secured with poured lead. All detail to the bases of the responds has been lost. The hood-moulding terminates with a pair of head-stops, now weathered beyond recognition, and also has a third original head fitted at the apex of the arch; this is male, boldly projecting, and integral with the moulding (sculpture no. 19). The arch and capitals are of yellow Magnesian Limestone, while the hood-moulding, reveals and bases are in white limestone. Internally, the doorway has plain, squarely-cut reveals and an unmoulded, pointed arch composed of two rings of ashlar voussoirs; there is a draw-bar socket.

19. Male head set centrally in the external hood-moulding (Fig. 98).

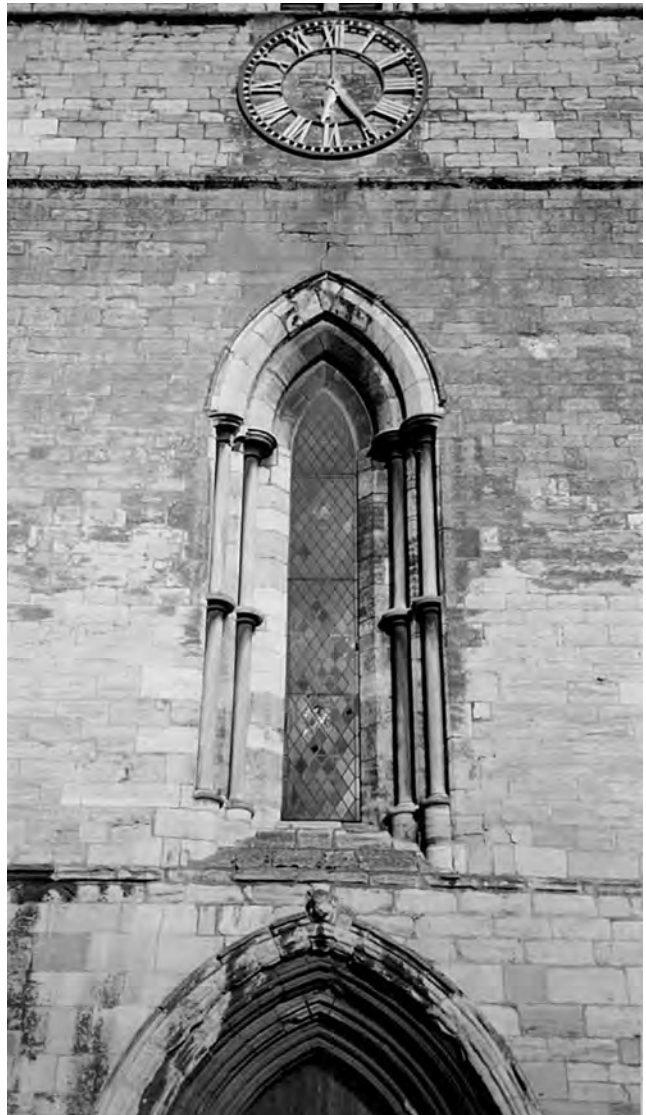
Fig. 99: St Mary's: tower. West window and clock dial formerly on St Peter's tower. Photo: Warwick Rodwell
