ST PETER'S

Barton-upon-Humber, Lincolnshire

A Parish Church and its Community

HISTORY, ARCHAEOLOGY AND ARCHITECTURE

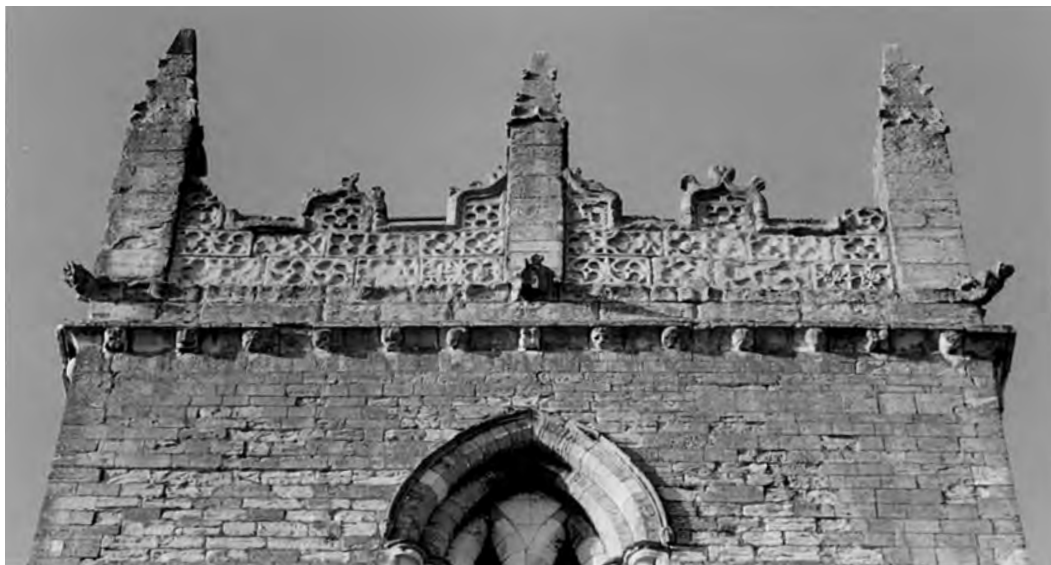
Fig. 100: St Mary's: tower. Corbel-table and decorated parapet on the south side. Photo: Warwick Rodwell

The upper stage is crowned by a corbel-table with thirteen heads on each face of the tower. The original roof – which almost certainly took the form of a timber and lead spire – would have rested directly on the eaves-course, without a parapet (Fig. 100). Internally,

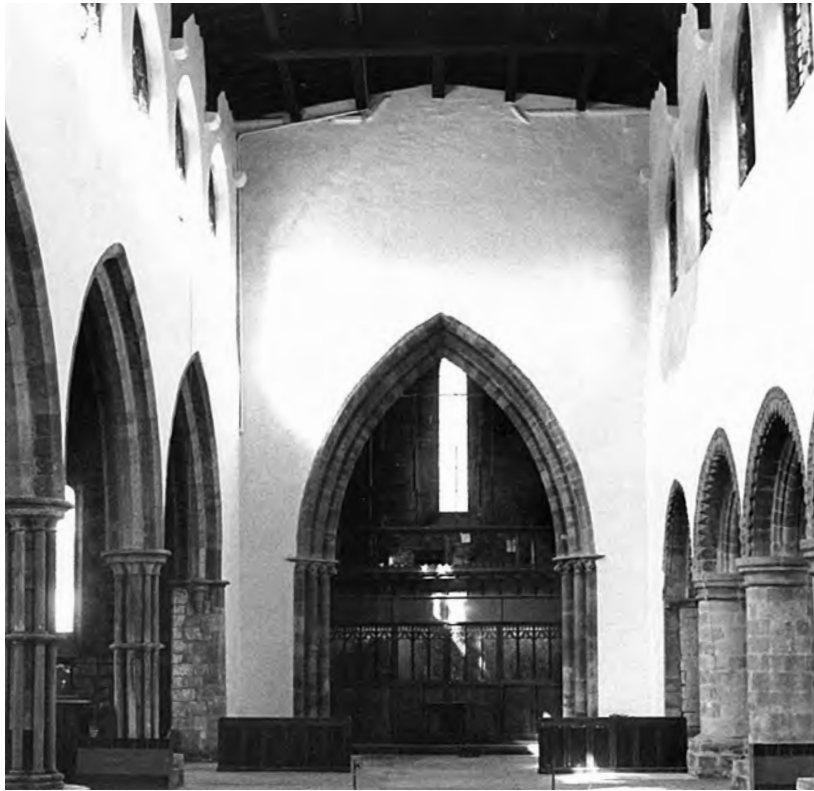
Fig. 101: St Mary's: tower arch with inserted gallery and screen, 1984. The wall above carries the scars of the steeply pitched roof of the early medieval nave. Photo: Geoffrey Bryant

There was formerly another bay of screenwork, on a north–south axis, dividing the nave aisle from the chancel aisle (Varah 1965, 13). This is now repositioned under the tower arch (pp. 112–13; Fig. 101).

On the east face of the tower, above the nave, a projecting stone weathering is preserved, which related to the steeply pitched, pre-Tudor roof. The weathering re-emerges inside the church just below the present roof, but stops abruptly: it was probably hacked away when a ceiling was erected in the nave in the eighteenth century (Fig. 101).⁹⁰

A large, steeply pointed arch communicates between the basement of the tower and the nave (Fig. 101). It is of three plain chamfered orders, with no label-moulding; concentric with it is an outer ring of large, rectangular stones laid voussoir-fashion. Each respond comprises a cluster of five attached shafts with quirks between; the central shaft has a broad fillet, which indicates a date not before the mid-century. Each block bears a mason's mark on the fillet. The capitals carry very bold stiff-leaf foliage and have integral abaci (Fig. 102), and the waterholding bases stand on a plain square plinth.⁹²

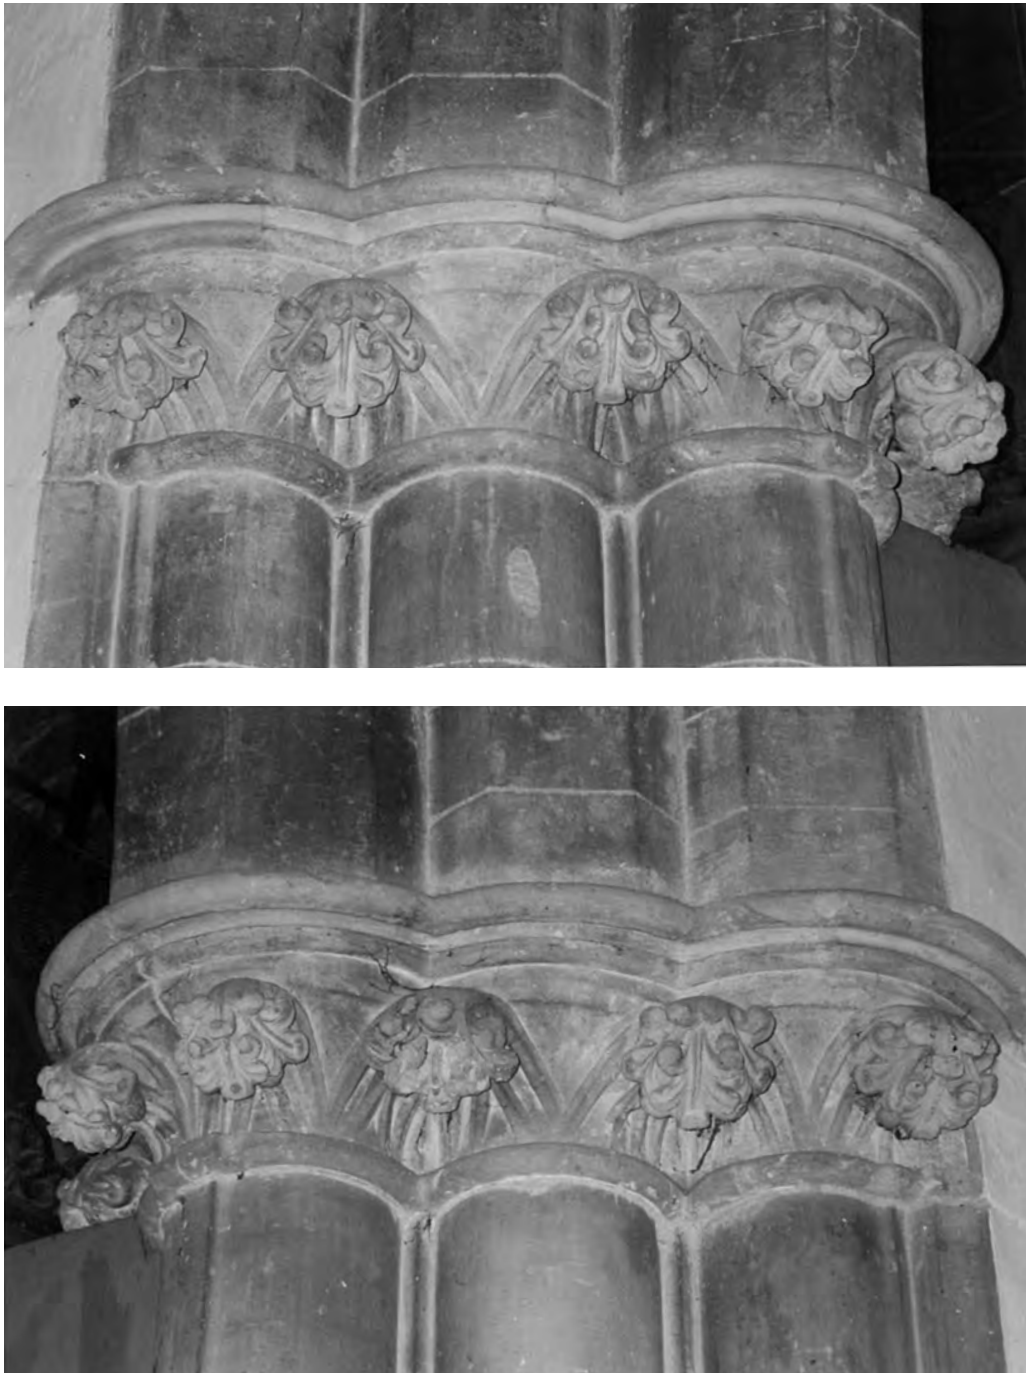
Fig. 102: St Mary's: tower arch responds. Stiff-leaf capitals. Upper, south; lower, north. Photos: Warwick Rodwell

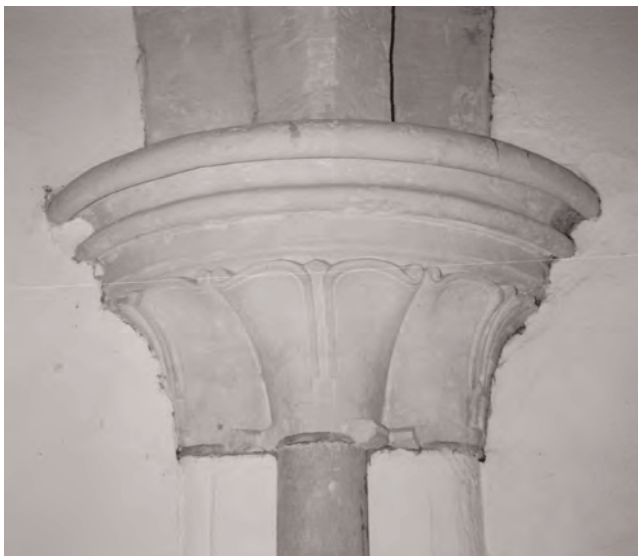
Fig. 103: SS Peter and Paul, Reepham (Lincs.): south arcade (blocked). Waterleaf capital and octagonal clustered shaft. Photo: Warwick Rodwell

A close analogue for the St Mary's waterleaf occurs on one of the capitals of the blocked south arcade at Reepham, which is only 5 km east of Lincoln (Fig. 103). The work is of similarly high quality, but there the octagonal piers have attached shafts. The capitals at Barton could be by the same sculptor, but the pier design represents a further stage in the development. However, there are other Transitional churches in the vicinity of Lincoln which have detached shafts around an angular core, such as Waddington (Sharpe 1871, pl. 23). Bryant has therefore questioned the design source for the St Mary's arcade and, by implication, the primacy of Lincoln in the development of the multi-shafted pier.¹⁰¹ Also at Reepham is a related springer-corbelle with lotus leaves (Fig. 104).

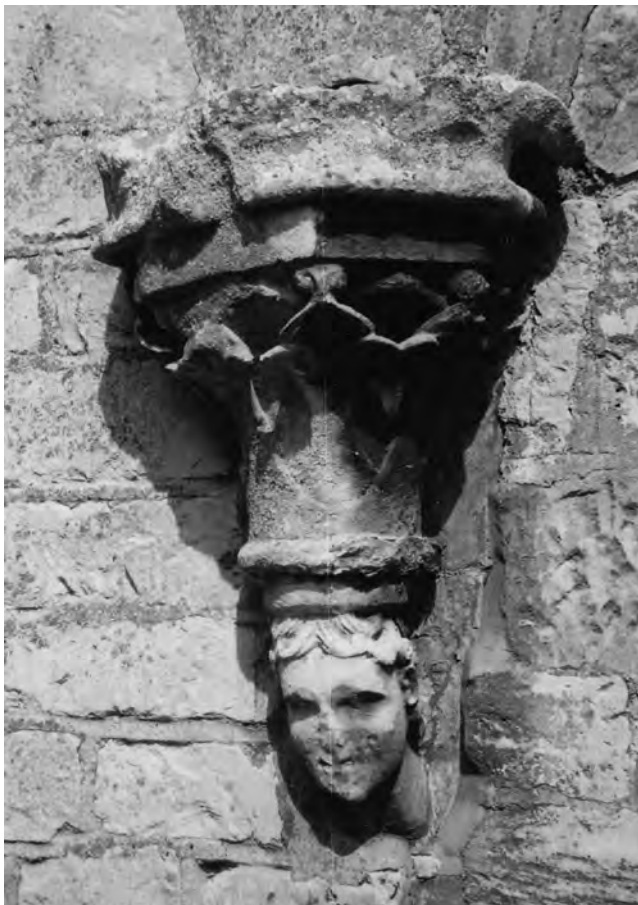
Fig. 104: SS Peter and Paul, Reepham (Lincs.): south arcade. Springer corbel with lotus leaves and separate abacus. Now external (aisle demolished). Photo: Warwick Rodwell

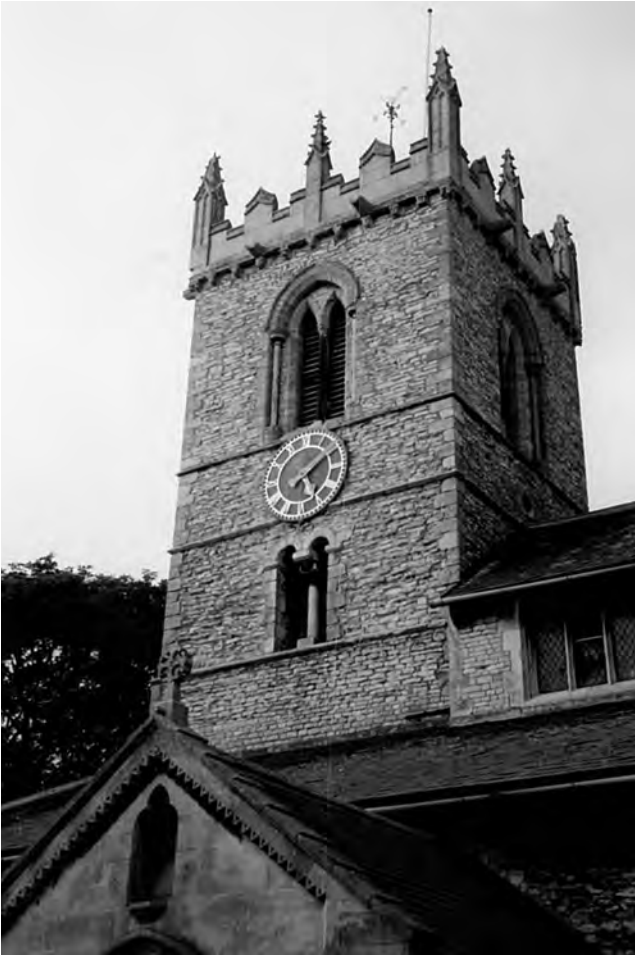
Fig. 106: *All Saints, Winterton (Lincs.): west tower. Upper stages, from the south-east. Photo: Warwick Rodwell*

at Thornton Curtis, which may be the work of the same masons (Fig. 105). Thornton has two-light belfry openings, separated by octagonal shafts, and flanked by circular shafts with plain capitals and shaft-rings; the tower is topped by a corbel-table (as is the chancel too). There is no west door, but the lancet window with its flanking shafts is a reduced version of those in the ground stage at Barton. The added upper belfry on the tower at Winterton is another product of the same workshop (Fig. 106).

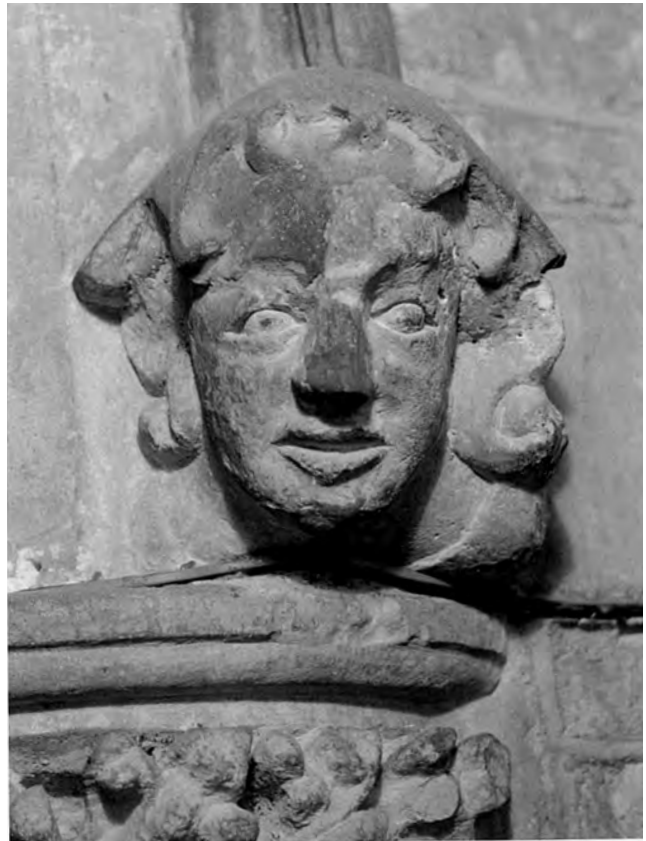
Fig. 109: St Mary's: chancel arcade. Label-stop no. 1. Photo: Warwick Rodwell

1. Young man with long curly hair and no beard. Angled into the chancel (Fig. 109). Head and brow much repaired with Roman cement.
2. Bearded man (Fig. 110).
3. Bearded man (Fig. 111).
4. Young man with a beard and long, curly hair. The beard has suffered damage (Fig. 112).

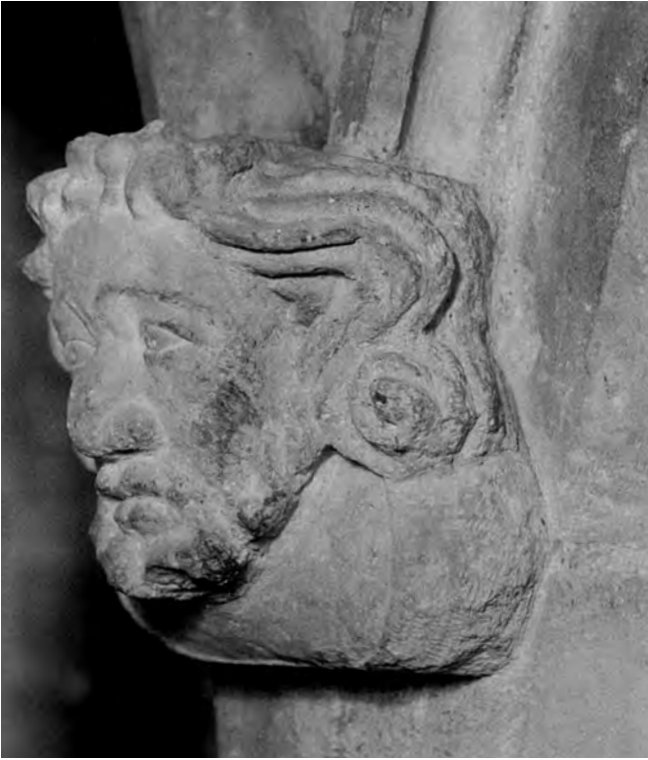
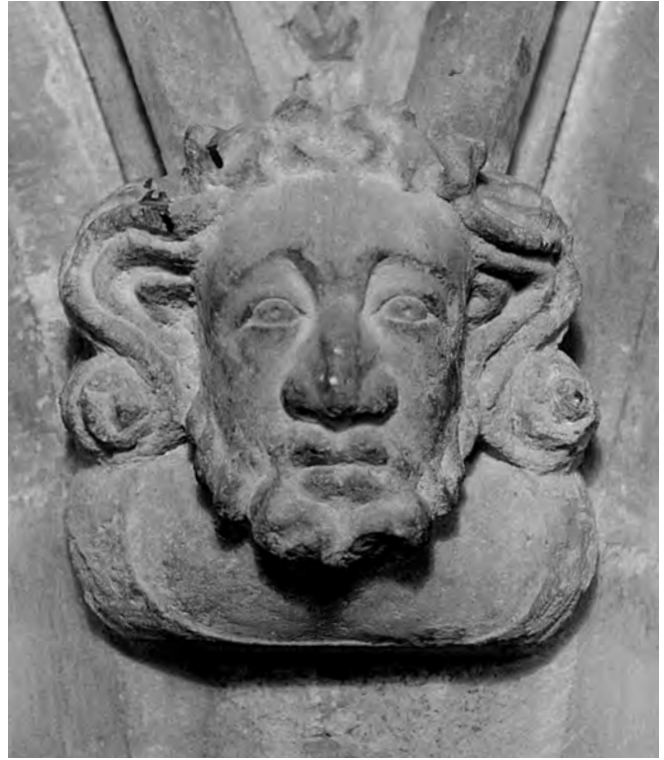
Fig. 110: St Mary's: chancel arcade. Label-stop no. 2. Photos: Warwick Rodwell

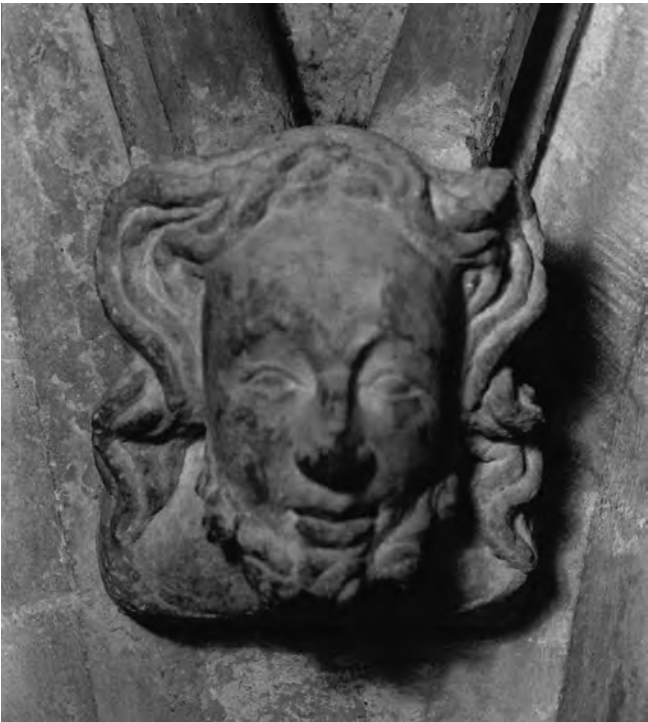
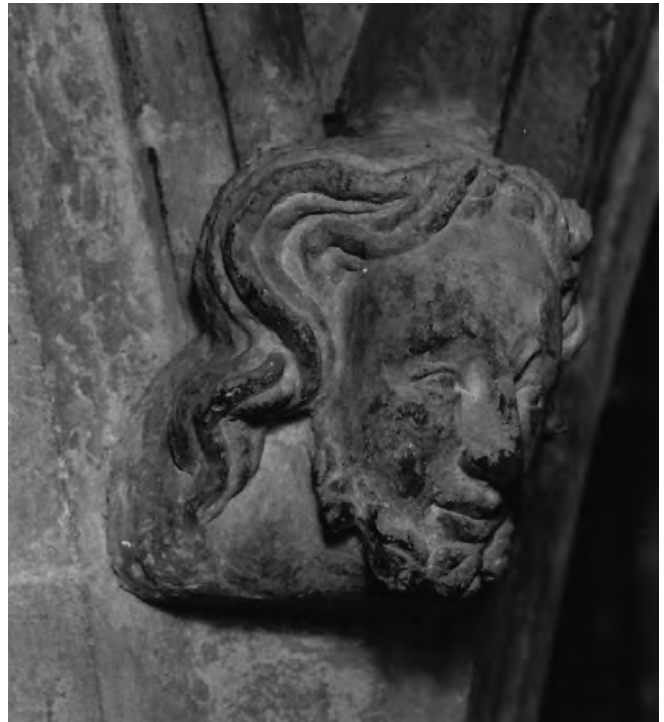
Fig. 111: St Mary's: chancel arcade. Label-stop no. 3. Photos: Warwick Rodwell

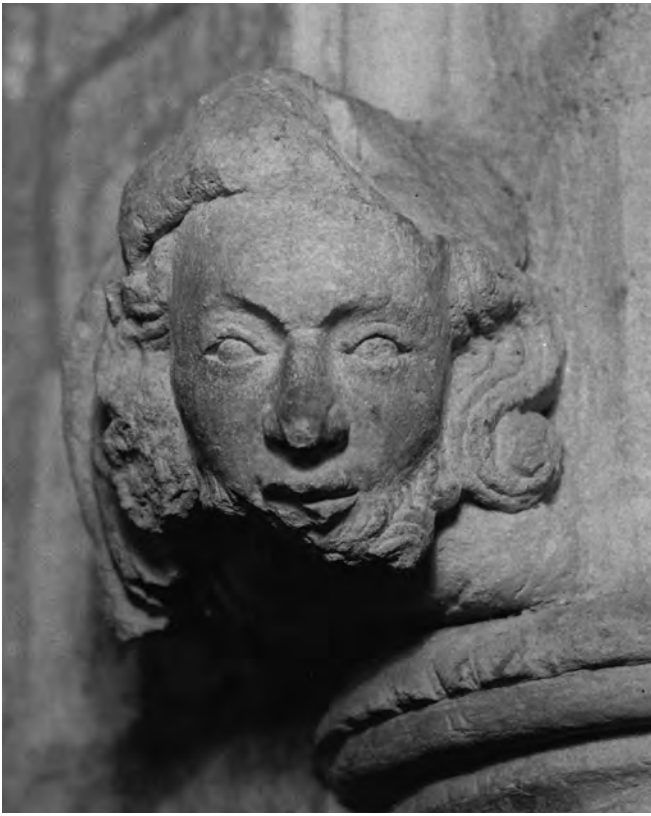
Fig. 112: St Mary's: chancel arcade. Label-stop no. 4. Photos: Warwick Rodwell

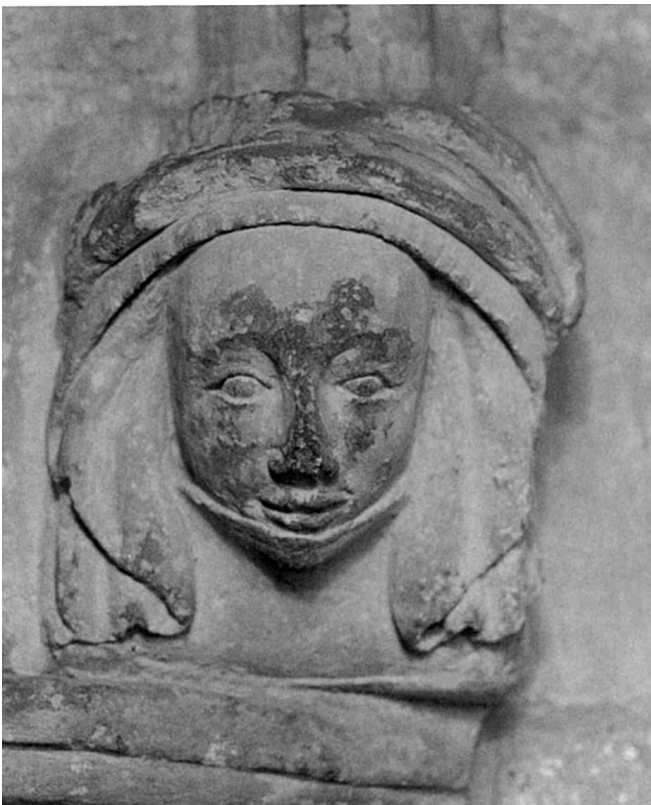
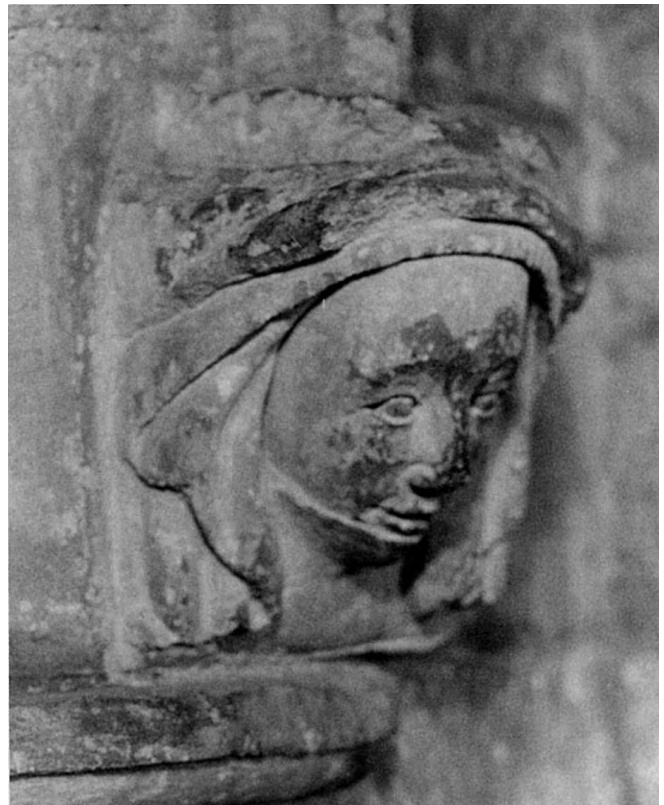
Fig. 113: St Mary's: chancel arcade. Label-stop no. 5. Photos: Warwick Rodwell

5. Lady wearing a wimple (Fig. 113).
6. Crowned lady wearing a veil (Fig. 114).
7. Crowned and bearded man (Fig. 115).
8. Grotesque head with open mouth and pointed ears. Angled into the chapel (Fig. 116).

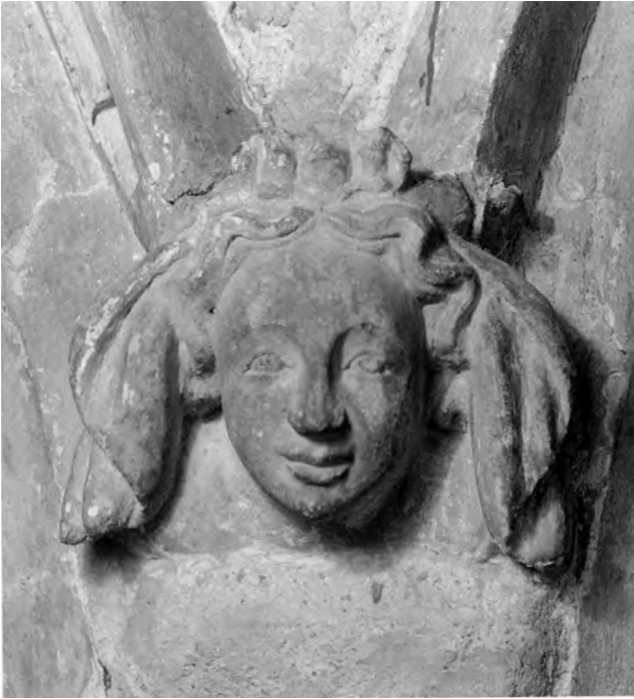
Fig. 114: St Mary's: chancel arcade. Label-stop no. 6.
Photo: Warwick Rodwell

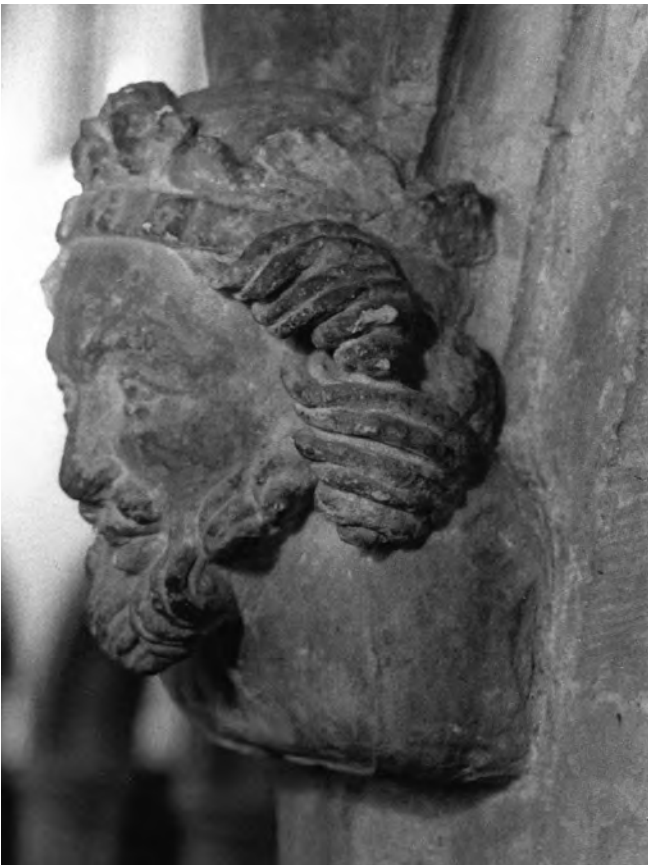
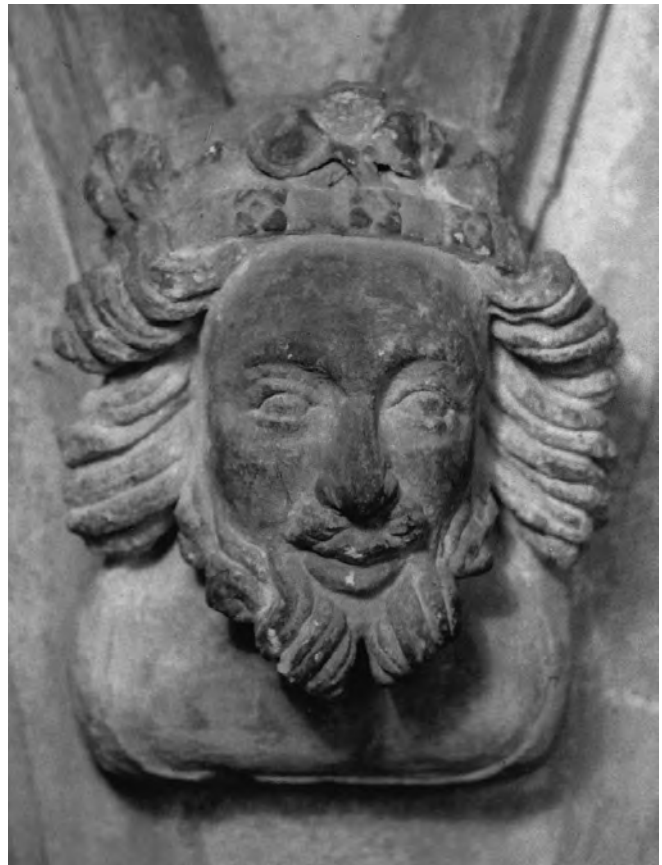
Fig. 115: St Mary's: chancel arcade. Label-stop no. 7. Photos: Warwick Rodwell

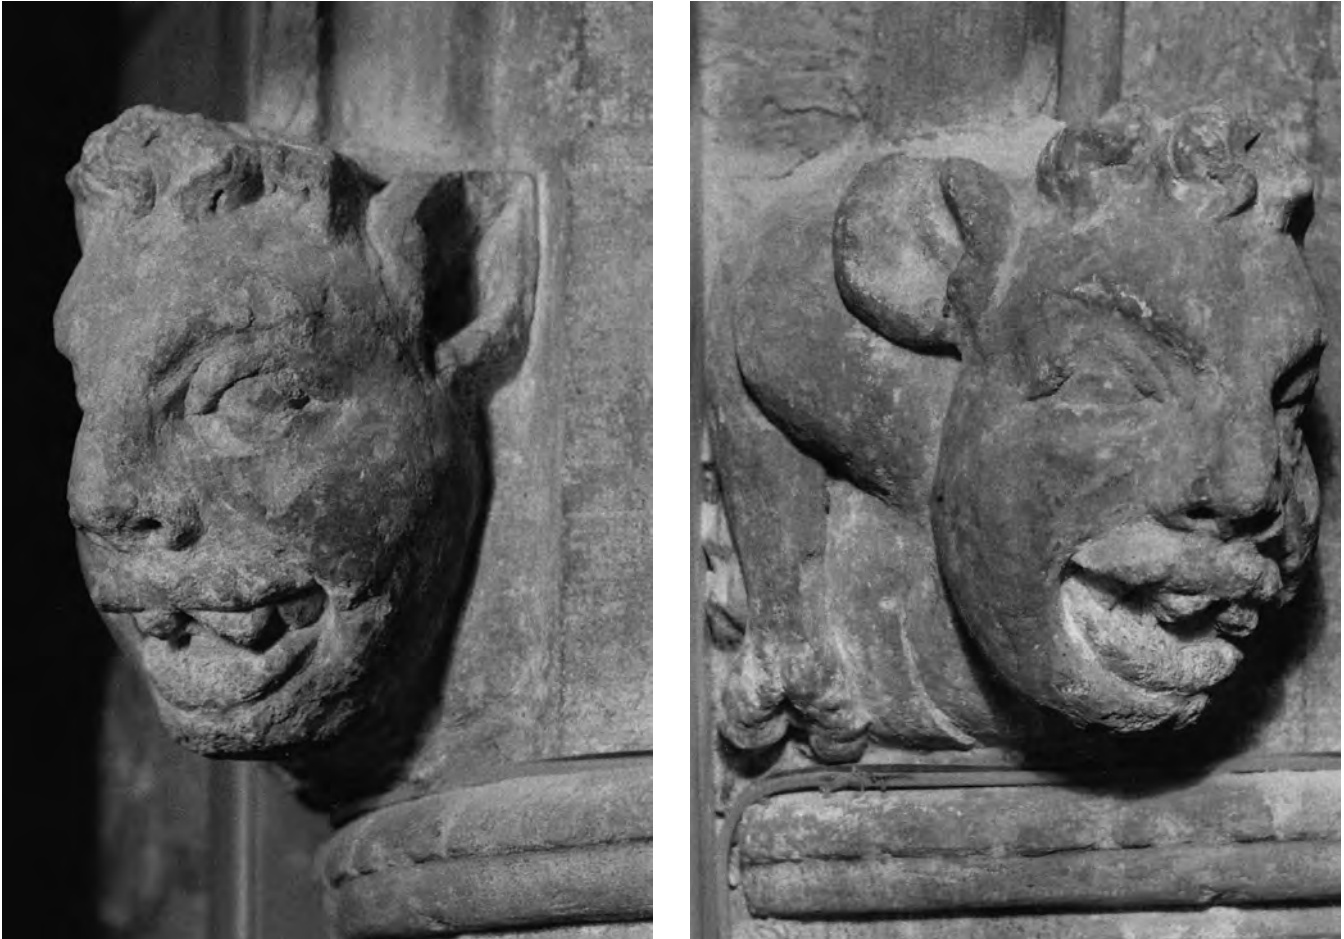
Fig. 116: St Mary's: chancel arcade. Label-stop no. 8. Photos: Warwick Rodwell

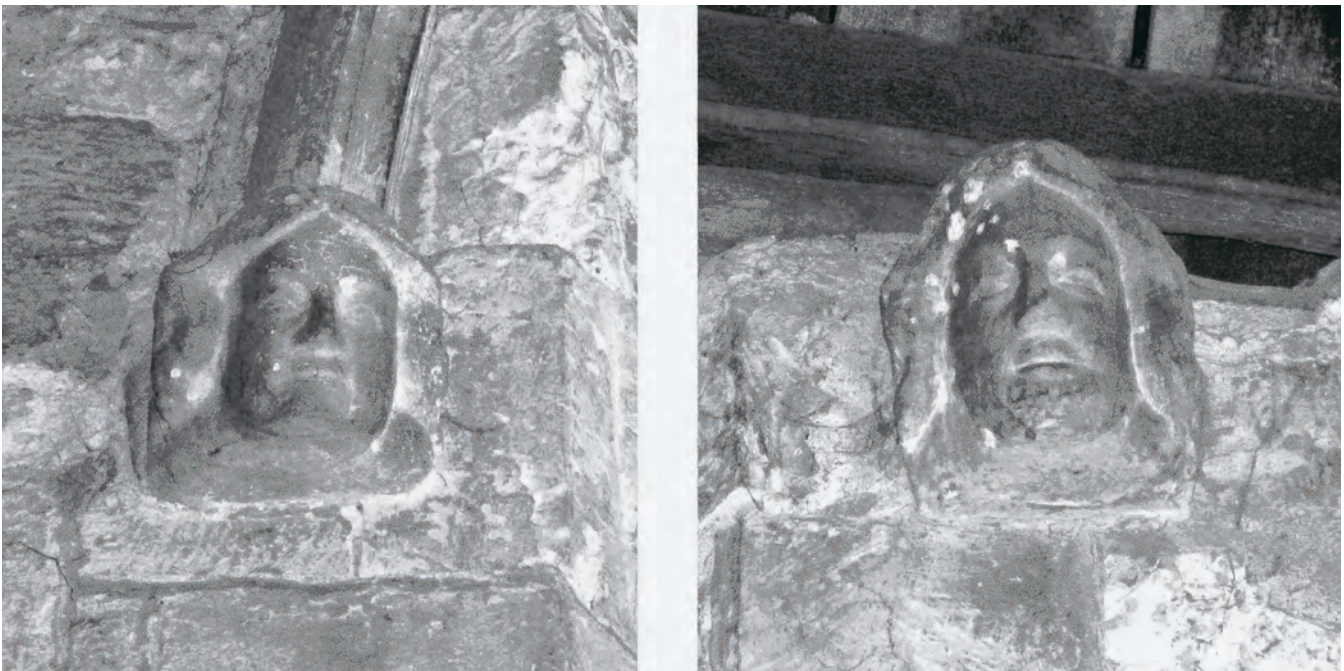
Fig. 117: St Mary's: south chancel aisle. Internal label-stops on the east window. Left, northern (label-stop no. 9). Right, southern (label-stop no. 10). Photos: Warwick Rodwell

9. Lady with flowing hair (Fig. 117, left).
10. Lady with flowing hair (Fig. 117, right).

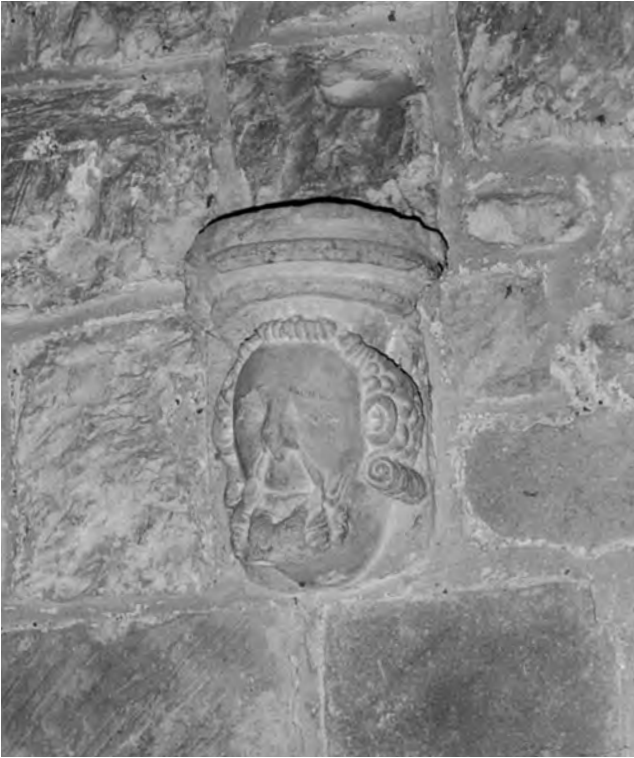
Fig. 118: St Mary's: chancel. Small corbel-head on the north wall (sculpture no. 11). Photo: Warwick Rodwell

11. Small corbel. Man with furrowed brow (Fig. 118).

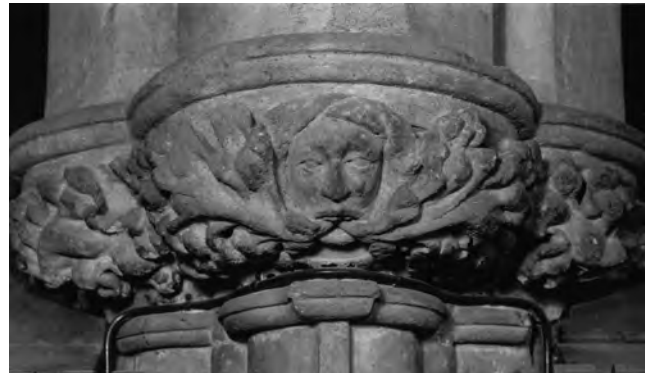
Fig. 120: St Mary's: chancel arcade. Capital bay 1/2 (sculpture no. 15). Upper, north face. Lower, south face. Photos: Warwick Rodwell

14. West respond. Knobbly foliage (Fig. 119).
15. Capital to pier, bay 1/2. Knobbly foliage and four human/grotesque heads (Fig. 120).
16. Capital to pier, bay 2/3. Knobbly foliage and two human/grotesque heads (Fig. 121).
17. East respond. Knobbly foliage (Fig. 122).

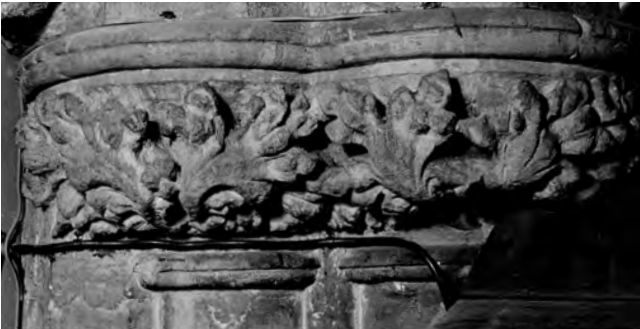
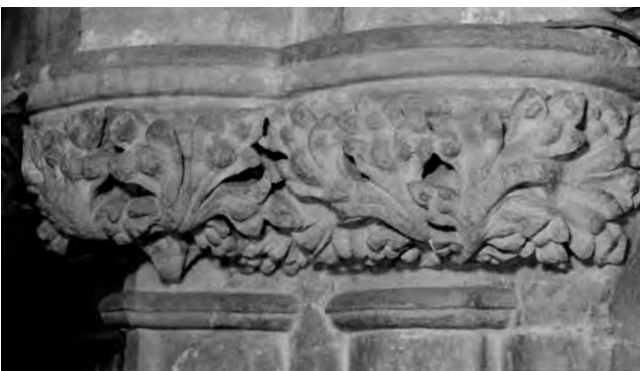
Fig. 119: St Mary's: chancel arcade. West respond (sculpture no. 14). Upper, south-east view. Lower, north-east view. Photos: Warwick Rodwell

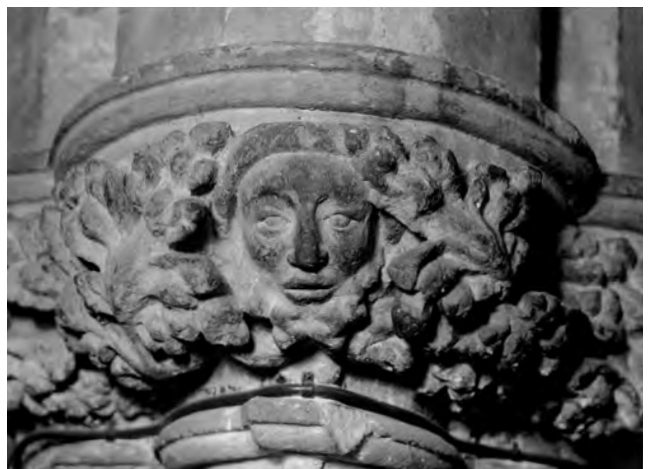
Fig. 121: St Mary's: chancel arcade. Capital bay 2/3 (sculpture no. 16). Upper, south-west view. Lower, south face. Photos: Warwick Rodwell

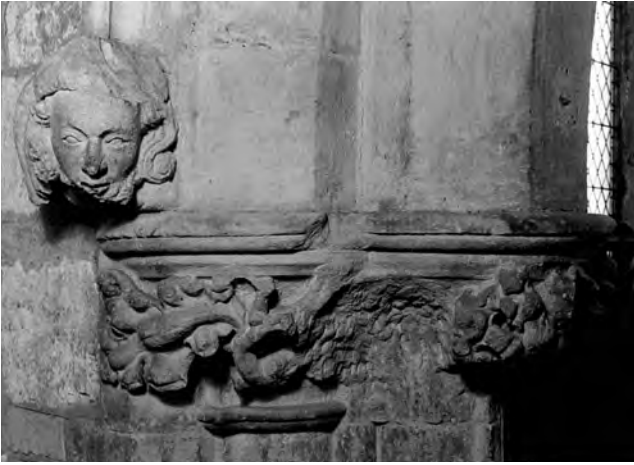
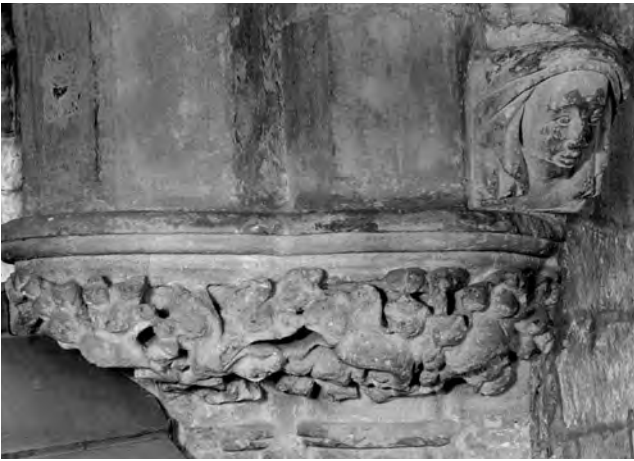
Fig. 122: *St Mary's: chancel arcade. East respond (sculpture no. 17; label-stops nos. 4 and 5). Upper, north-west view. Lower, south-west view. Photos: Warwick Rodwell*

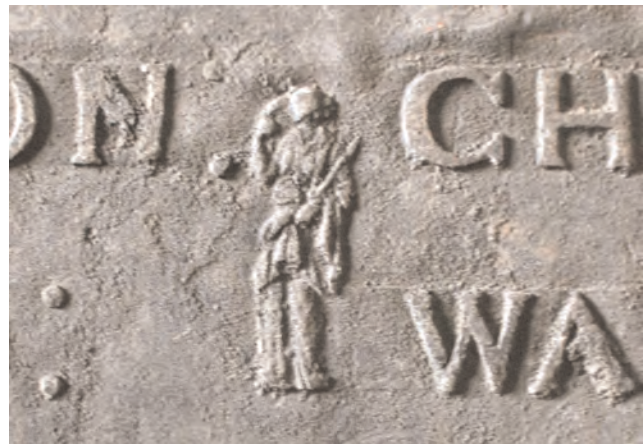
Fig. 124: St Mary's: roof lead. Detail of the moulded neo-classical figure on the plumber's plaque, probably *Diana lucifera*. Photo: Warwick Rodwell

An unusual embellishment was the inclusion of a small neo-classical figure, standing beside the names of the churchwardens (Fig. 124). The figure is female, draped and holding either a sceptre or a torch; the latter is more likely. With her right hand she appears to be holding her veil back. These attributes point to the goddess *Diana lucifera*.¹⁴⁰ The choice of the allusion is particularly apt since widow Handley was carrying on her late husband's plumbing business (chapter 13, note 93). A neo-classical figure also features on a lead downpipe at St Peter's (p. 504; Fig. 585).

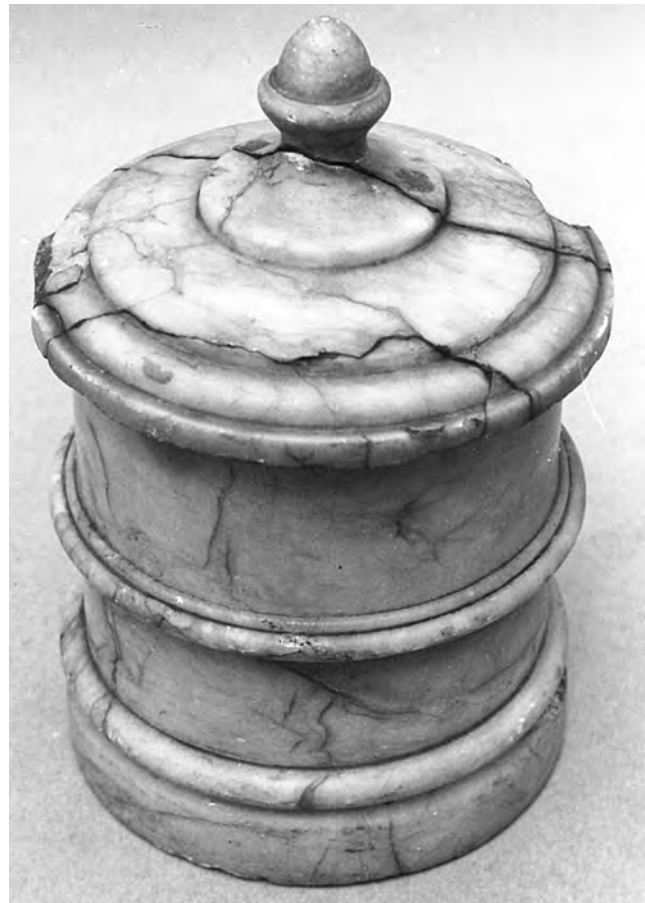
Fig. 126: St Mary's: lathe-turned alabaster jar and cover found under the floor of the church in 1892. It was identified at the time as the receptacle for a heart burial. Diameter 11 cm. Photo: Warwick Rodwell

cylindrical jar and cover, 110 mm in diameter, made of English alabaster (Fig. 126). Both elements are moulded, lathe-turned, and given a polished finish externally; the cover has an acorn-shaped knob.¹⁸² The interior of the jar is quite crudely finished, with pronounced turning lines. Affixed to the side is a small silver plaque recording the discovery, and stating that the function of the vessel was to contain a heart-burial. The jar is of a type made in the eighteenth century for the storage of pipe tobacco, and the astragal moulding around its centre, as well as the acorn knob, point to a date after c. 1780 (Myer 1930). It is difficult to imagine why in the Victorian era, when tobacco jars were commonplace, this one should have been identified so confidently as a heart receptacle. It is certainly not impossible that the vessel was used for this purpose, and perhaps a shrivelled item of organic material was found inside it, giving credence to the claim (Bradford 1933).¹⁸³

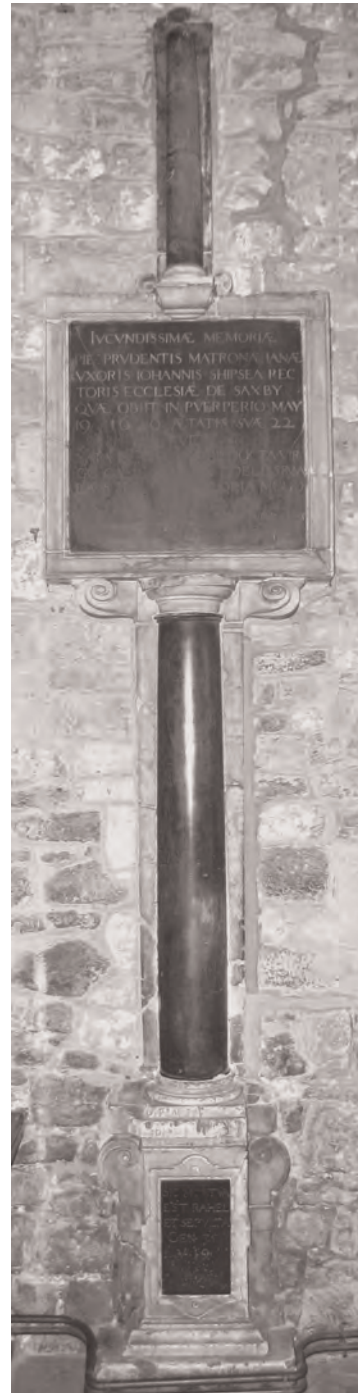
Fig. 129: St Mary's: chancel. Pilaster monument against the north wall, to Jane Shipsea (d. 1626; M.60). Photo: Warwick Rodwell

M.60 Figs. 129–130. An interesting pilaster-monument against the north wall of the chancel commemorates Jane Shipsea (d. 1626); it appears in the watercolour of c. 1820, when it was further to the west (Pl. 13). The monument, which was repositioned in 1883–84, when the present choir stalls were erected,²⁰² is constructed mainly of English alabaster; the two inset panels bearing inscriptions appear to be of Belgian marble; the main Doric column may be an English carboniferous limestone (it has the appearance of Blue Lias), as is the upper column. The latter has lost its finial, which was an angel holding a trumpet.²⁰³ The column carries an incised scroll bearing the words: COLVMNA RESVR=GENDI FIDES. Holles described it as 'a pillar of Touch ... wreathed in golden letters (Cole 1911, 78).²⁰⁴ The inscription panels read:

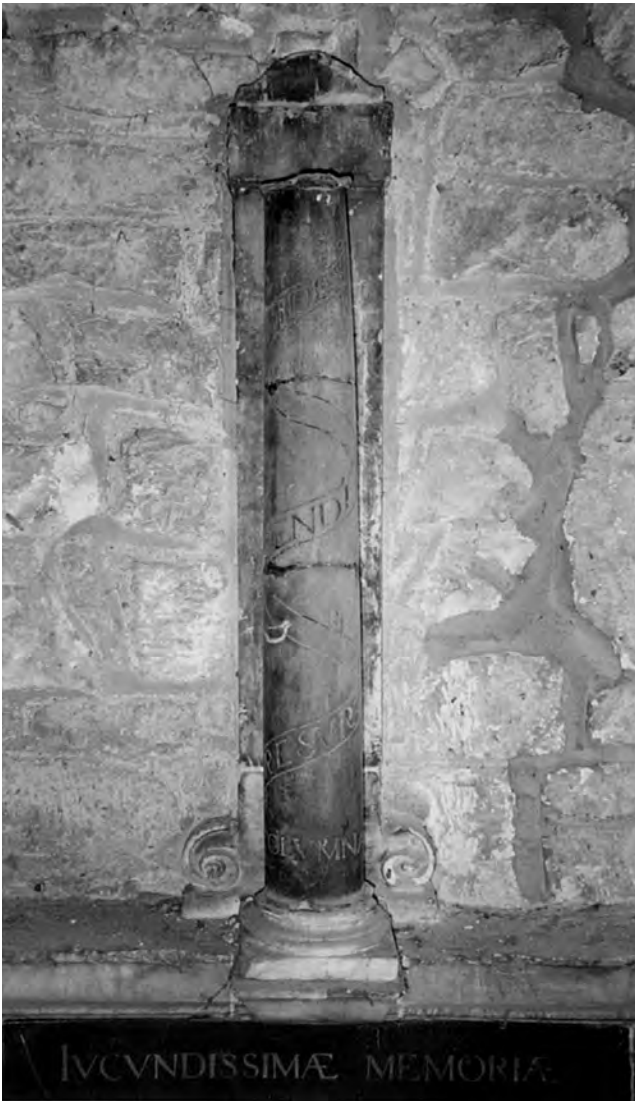
Fig. 130: St Mary's: chancel. Shipsea monument (M.60). Detail of the inscribed upper column. Photo: Warwick Rodwell

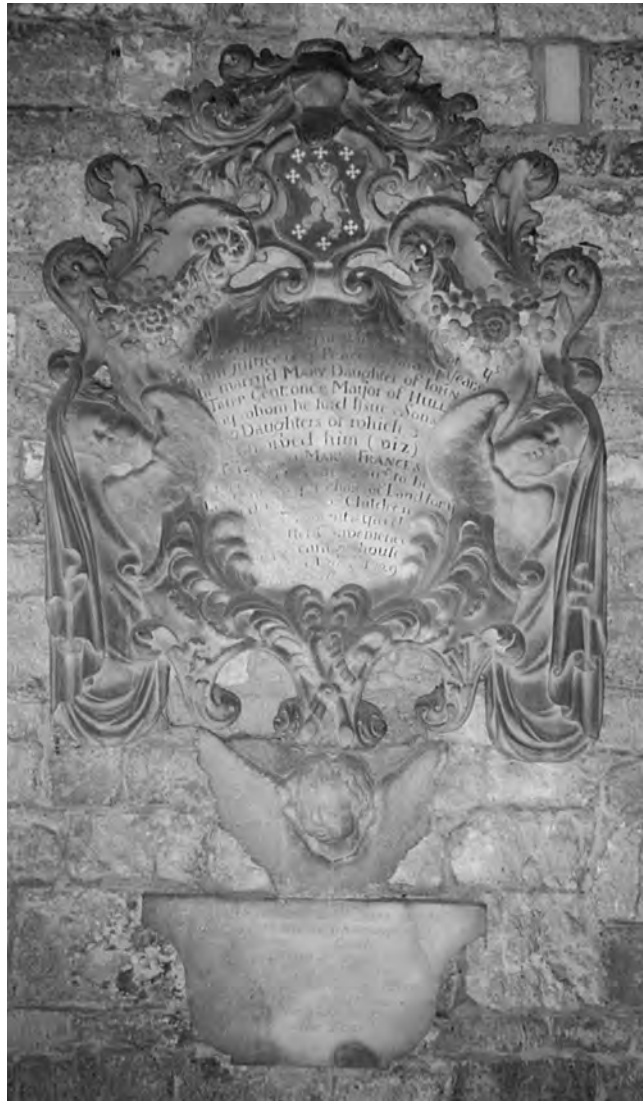
Fig. 131: St Mary's: chancel aisle. Cartouche monument to William Long (d. 1729; M.61). Photo: Warwick Rodwell

M.61 Fig. 131 . An elaborate Baroque cartouche of Carrara marble on the south wall of the chancel aisle (between bays 2 and 3) commemorates William Long (d. 1729). It too has been resited, since the inscription indicates that it was once attached to, or placed above, one of the arcade piers. The inscription reads:

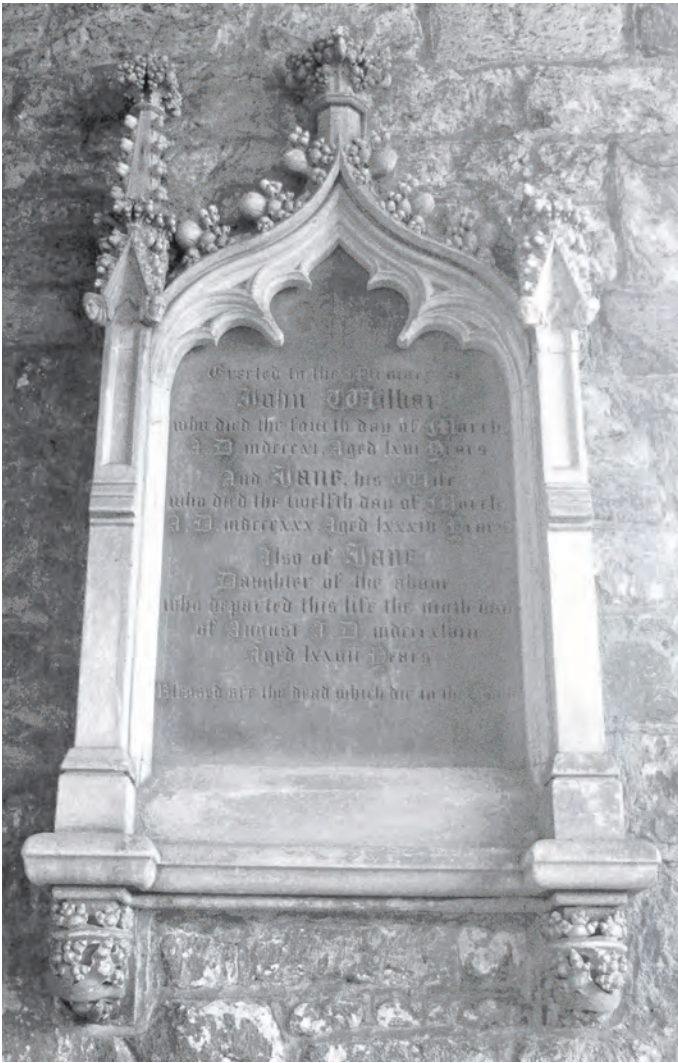
Fig. 132: St Mary's: nave aisle, wall monuments. A (left), Gothick tabernacle (1811; M.63); B (right), Classical (1834; M.62). Photos: Warwick Rodwell

M.63 Fig. 132A. A damaged gothick tabernacle monument on the west wall of the south aisle, carved in fine cream limestone, commemorates John Wilbar (d. 1811), his wife Jane (d. 1830) and daughter Jane (d. 1848).²⁰⁵

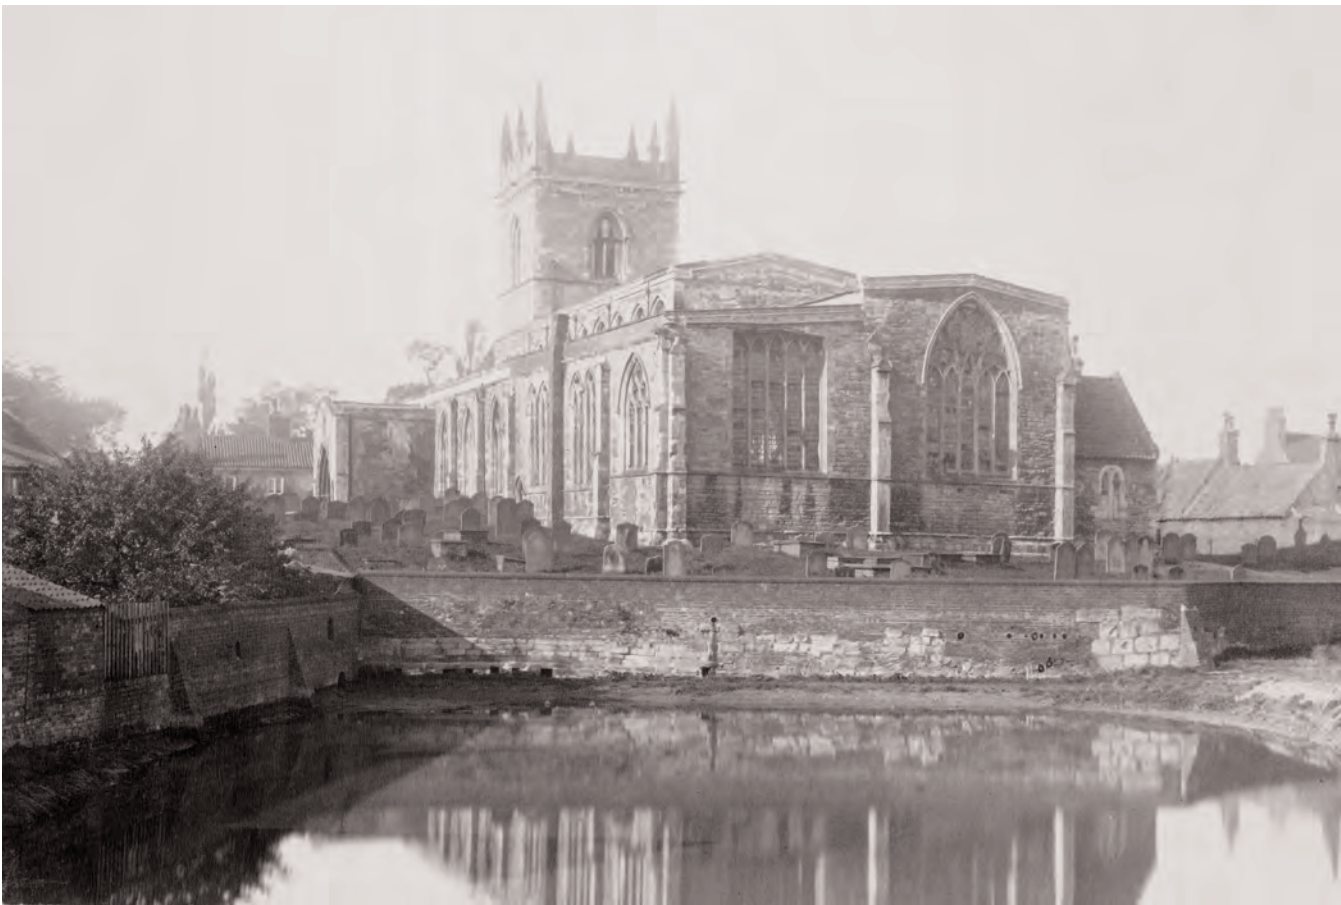
Fig. 140: St Mary's church from the east with the Beck in the foreground, c. 1880. The remnants of the limestone ashlar revetting wall to the churchyard are clearly visible. Photo: English Heritage, NMR
