ST PETER'S

Barton-upon-Humber, Lincolnshire

A Parish Church and its Community

HISTORY, ARCHAEOLOGY AND ARCHITECTURE

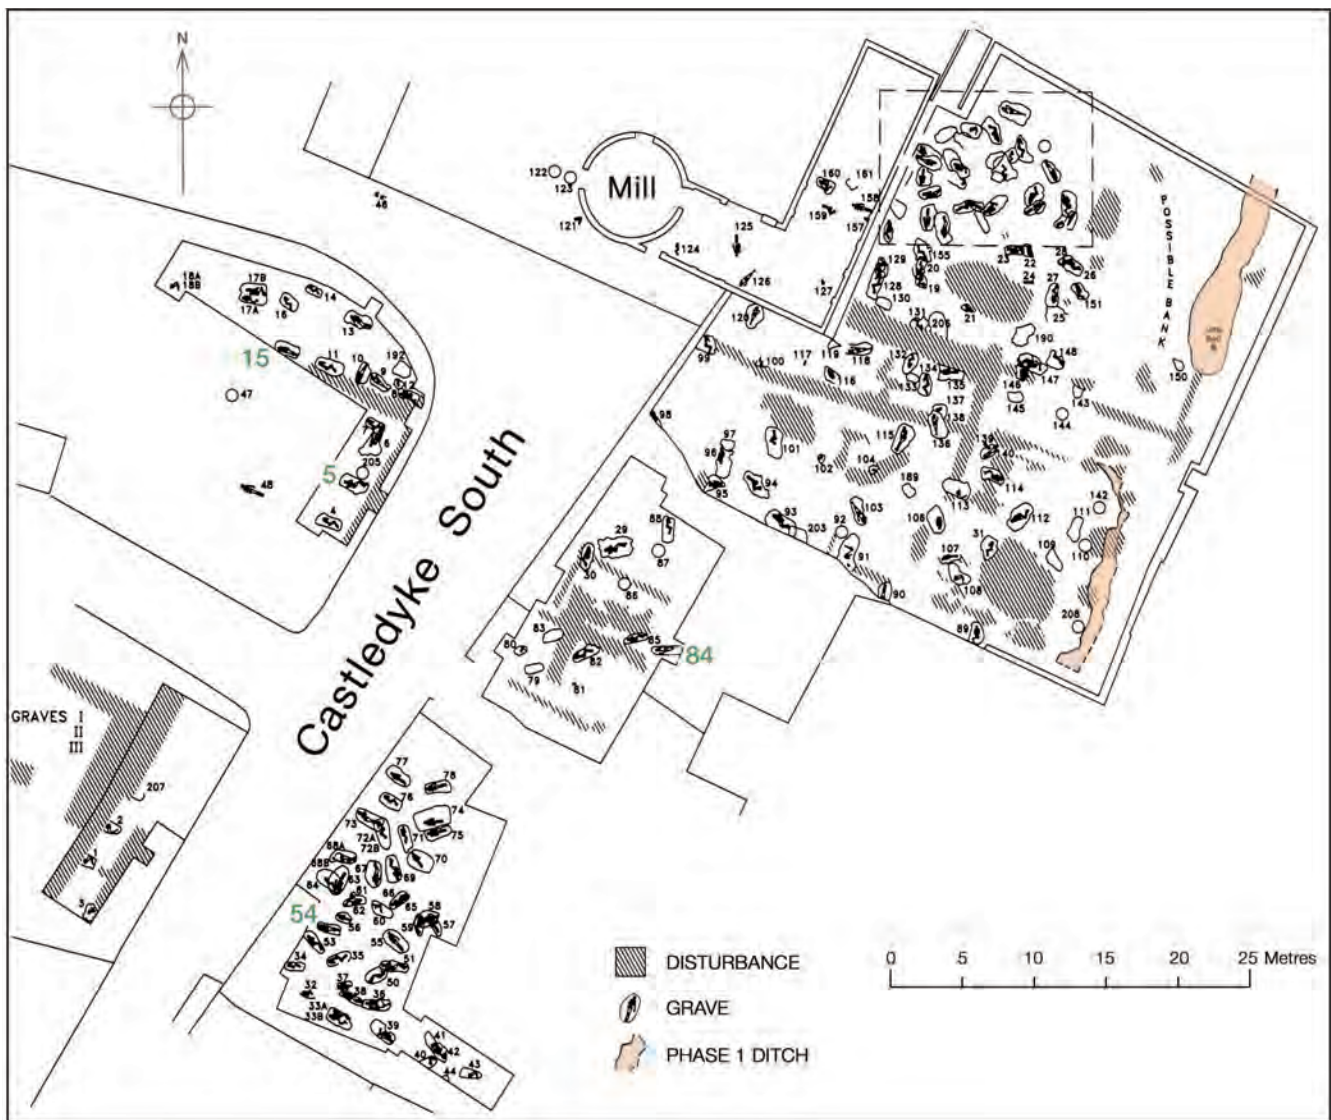
Fig. 146: Castledyke South. Excavation plan of the Anglo-Saxon cemetery. The ditch of the prehistoric earthwork (shown in pink) appears to form the eastern boundary of the cemetery. The four graves with radiocarbon dates are indicated in green (graves 5, 15, 54 and 84). After Drinkall and Foreman 1998

west side of Whitecross Street, only 250 m south-west of St Peter's church. Excavated sporadically between 1939 and 1990, several areas of this cemetery have been sampled and altogether have yielded in excess of 227 burials (Fig. 146; Drinkall and Foreman 1998). These represent an unknown fraction of the total, but it seems likely that at least four hundred interments took place here between the late fifth and the early eighth centuries, and that they were potentially contained within the eastern part of the large prehistoric enclosure mentioned above (p. 149). Disused earthworks seem often to have been chosen for Anglo-Saxon burial grounds (Williams 1997, fig. 6). One urned cremation was also recovered from the enclosure ditch; this is unlikely to have been a singleton, and therefore a phase of cremation burial may yet be discovered.

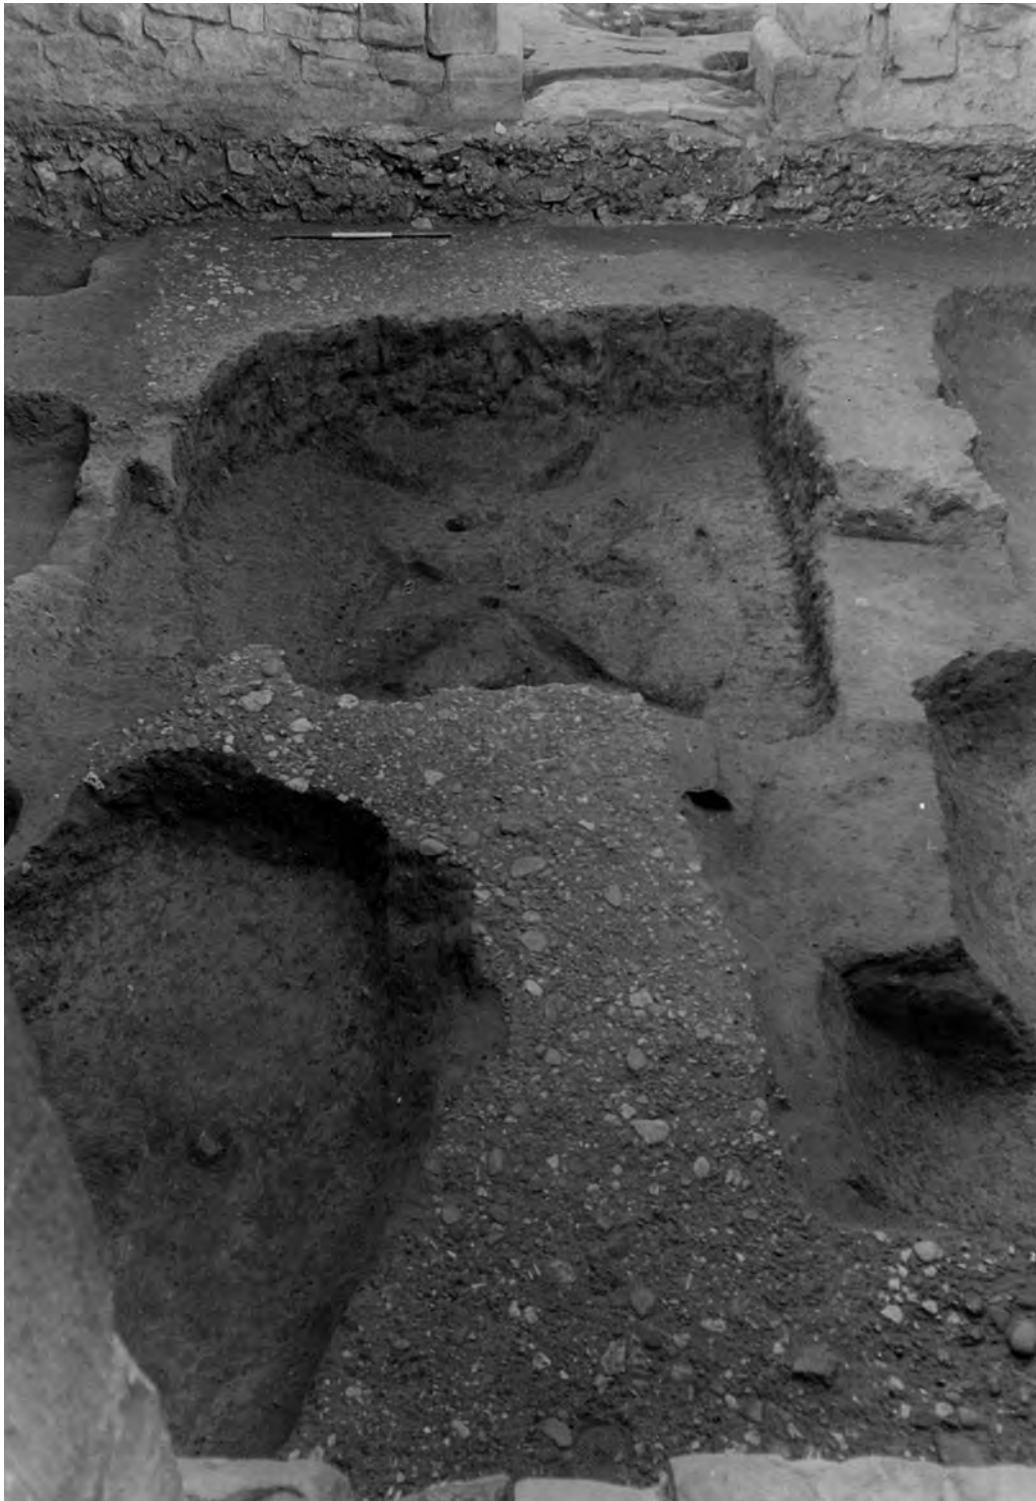
Fig. 148: Band of gravel metalling (F747) running east–west in Area 2, interrupted by the post-medieval bell-pit in the centre. The other features are exhumed late Saxon graves. View east, inside the tower. Scale of 75 cm. Photo: Warwick Rodwell

- iii) A band of metallating (F747/804), only one pebble in thickness and pressed into the surface of the underlying boulder clay, was encountered under the church tower and western annexe (Areas 2 and 3). This floor appears to be a continuation of that recorded under the nave (F1633); it was cut away on all sides by later features (Fig. 148). Finds from the surface comprised animal teeth, sherds of early Saxon pottery, and a small horseshoe.³⁶ The metallating became more diffuse as it progressed westwards, and it was not encountered outside the church in Areas 8 and 9, but the intensity of later burial here was so great that no early layers survived over the boulder clay.
- iv) Excavation outside the church revealed further traces of floors and vestigial structures. Just to the north of the aisle (in Area 12) was a layer of charcoal-rich loam containing small fragments of fired

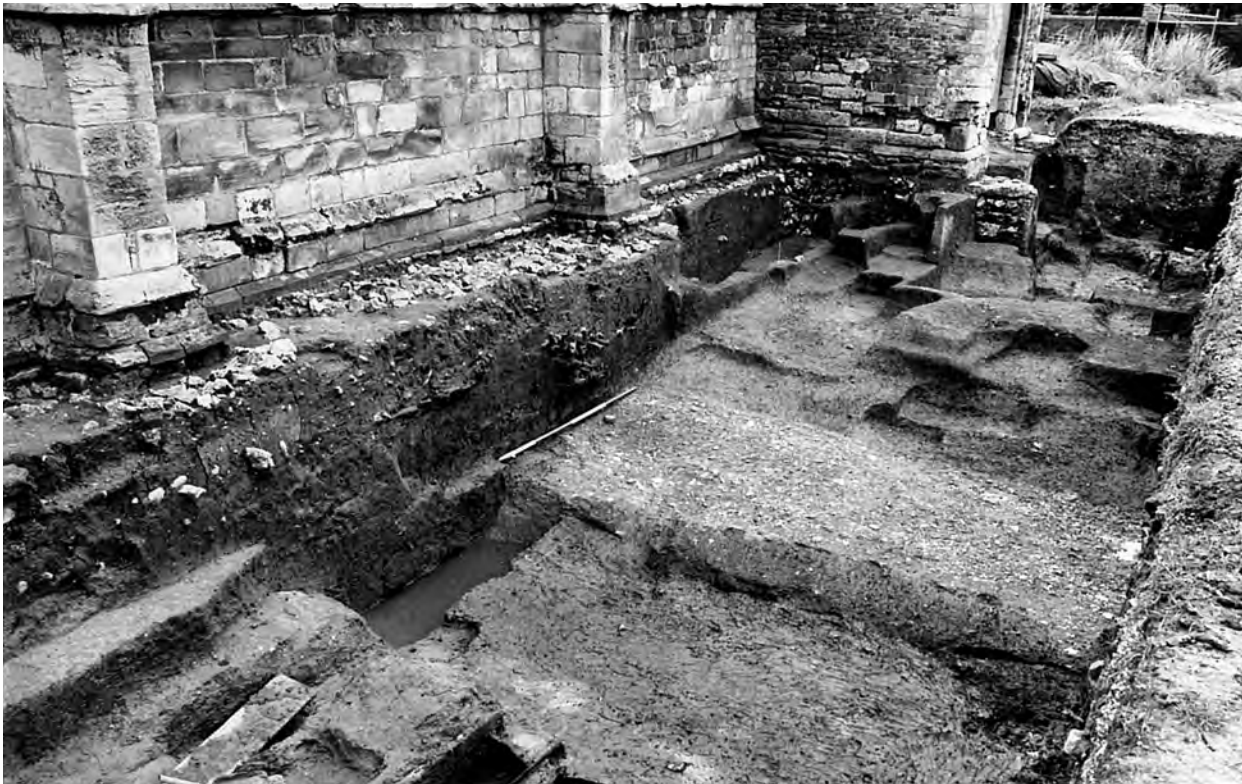
Fig. 149: Band of gravel metalling (F5057) running north–south in Area 11. Upper, view south–west. Lower, detail looking south. Scale of 2 m. Photo: Warwick Rodwell

- v) A little further west, in Area 11, a clearly defined band of metalling (F5057) was preserved, 2 m wide, running north–south across the full width of the excavation (Fig. 149). It comprised a thin, very compact layer of rounded pebbles and small pieces of chalk and flint, laid in a flat-bottomed

hollow or terrace that had been cut into the natural clay. Superficially, this feature had the appearance of being a path, but once again the smooth, level and polished surface of the metalling argues strongly against such an interpretation. Indeed, the western edge of the metalling was so sharply defined that there must have been a delimiting feature, such as a turf or timber wall. The eastern edge was more diffuse and it seems likely that the surface once continued further in this direction, but had been scoured away by later activity. The most plausible interpretation is that we have part of the western edge of a large, gravel-floored building which was slightly terraced into the knoll that forms this site. The metalling recorded within the north aisle (above, Area 5) was part of the same structure. Small pieces of animal bone and teeth were again the principal finds on the surface.

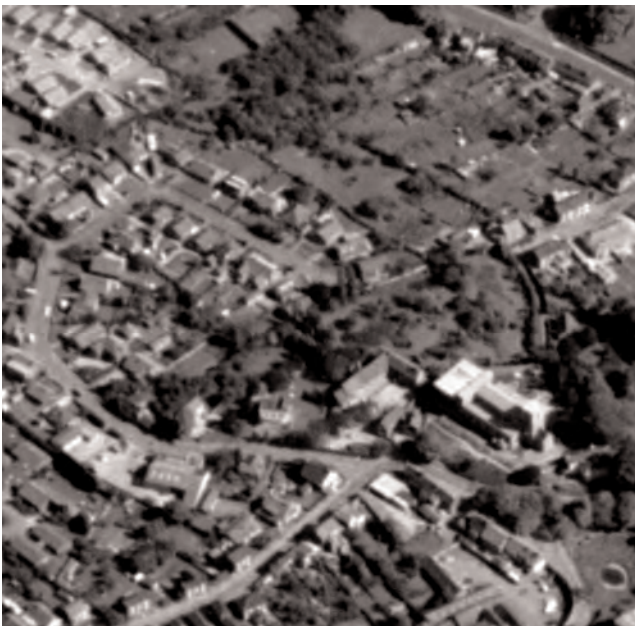
Fig. 150: Aerial view, looking south-east, of the sub-circular enclosure, as defined by features in the modern landscape in 1985. St Peter's church is middle right and Tyrwhitt Hall is the L-shaped building to its left. Photo: David Lee Photography

The sub-circular enclosure surrounding Tyrwhitt Hall has already been described (pp. 29–30; Figs. 150, 151 and 152). Although not a massive fortification, it seems likely that the earthwork was constructed to enclose and give limited protection to a settlement nucleus of middle Saxon date, which was in turn successor to Romano-British and early Anglo-Saxon

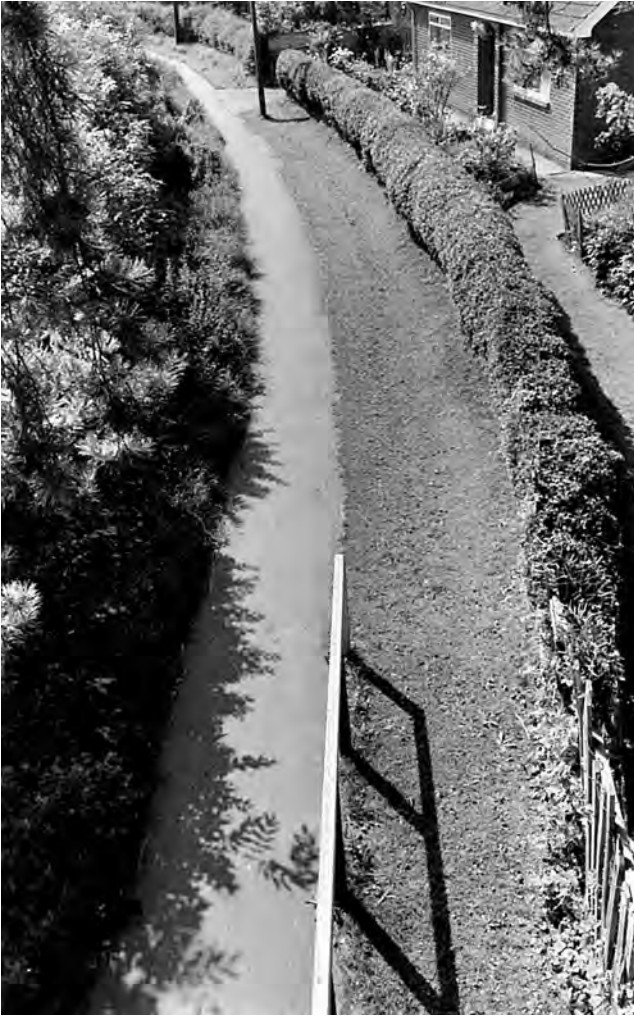
Fig. 152: View eastwards along the sunken footpath leading from the south-east entrance to St Peter's churchyard. Formerly known as Church Lane, this is the only preserved part of the sub-circular enclosure. Photo: Warwick Rodwell

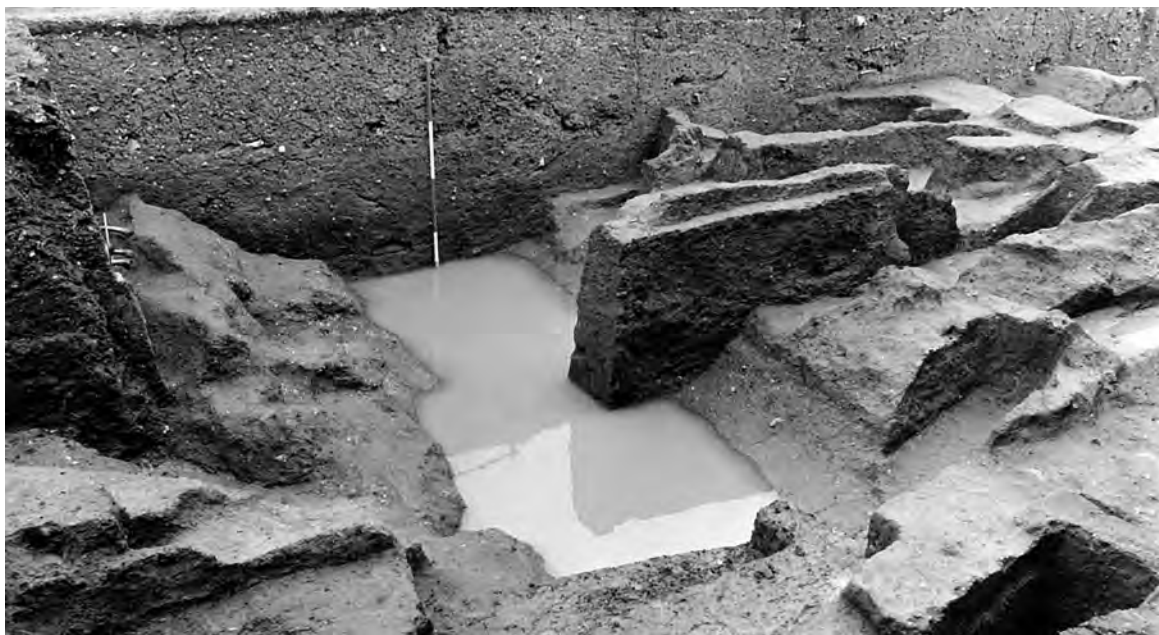
Fig. 153: Section through the ditch of the sub-circular enclosure in Area 12 (F1751). View north-east. Scale of 2 m. Photo: Warwick Rodwell

habitation. Partial sections through the ditch (F1751) were excavated under the church, and a three-metre length was emptied outside to the north (Area 12; Figs. 153, 154 and 155). Although severely truncated by later features, and distorted by recutting, these sections demonstrated that the ditch was originally *c.* 4.8 m (16 ft) wide by 2.4 m (8 ft) deep, with a gently rounded profile. The filling showed that the bank had been internal, and vestigial remains of this were found on the east side of the ditch. The width and profile of the bank could not be ascertained, and no evidence for a primary entrance was encountered. The ditch had, however, been recut several times and a possible butt-end was noted in one of the later fillings (under the centre of the church). There were two principal fillings: the lower comprised grey silt (F3572) and the upper black peaty material (F3573). Organic remains were prolific in these waterlogged deposits.

The lower deposits within the large spring-fed ditch of the sub-circular enclosure were constantly waterlogged; they also served as a conduit through which surplus water could percolate into intercutting and adjacent ditches (F1751, Fig. 153). Furthermore, the earliest graves in this part of the cemetery served to extend the area of waterlogging, by providing soft channels between the wet ditch fills and adjacent deposits that would otherwise have been relatively dry. Within the resulting delta, the degree of waterlogging was consistent in the lowest archaeological levels, permitting the preservation of complete coffins and grave-lining timbers, but at higher levels where the deposits were partially or seasonally waterlogged, the decay of organic materials was only slightly less rapid than elsewhere in the cemetery. Even within the fully waterlogged burials, no textiles, hair or soft tissue survived.

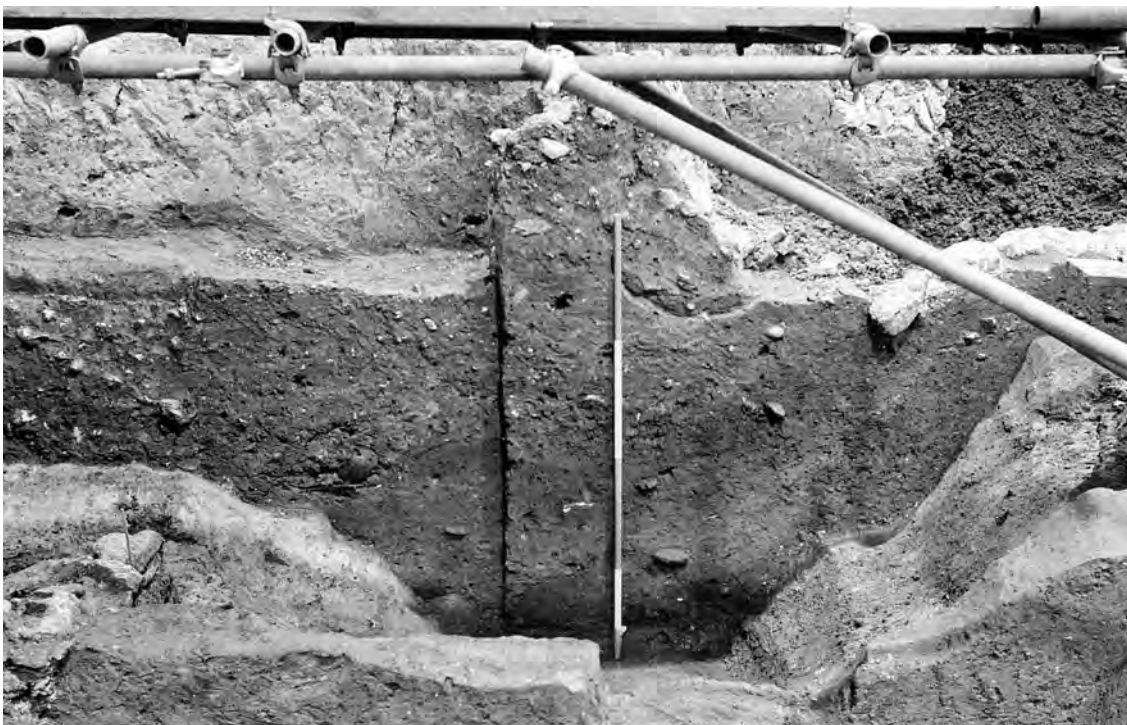
Fig. 155: Section of ditch F1751 in Area 5. View south. Scale of 2 m. Photo: Warwick Rodwell

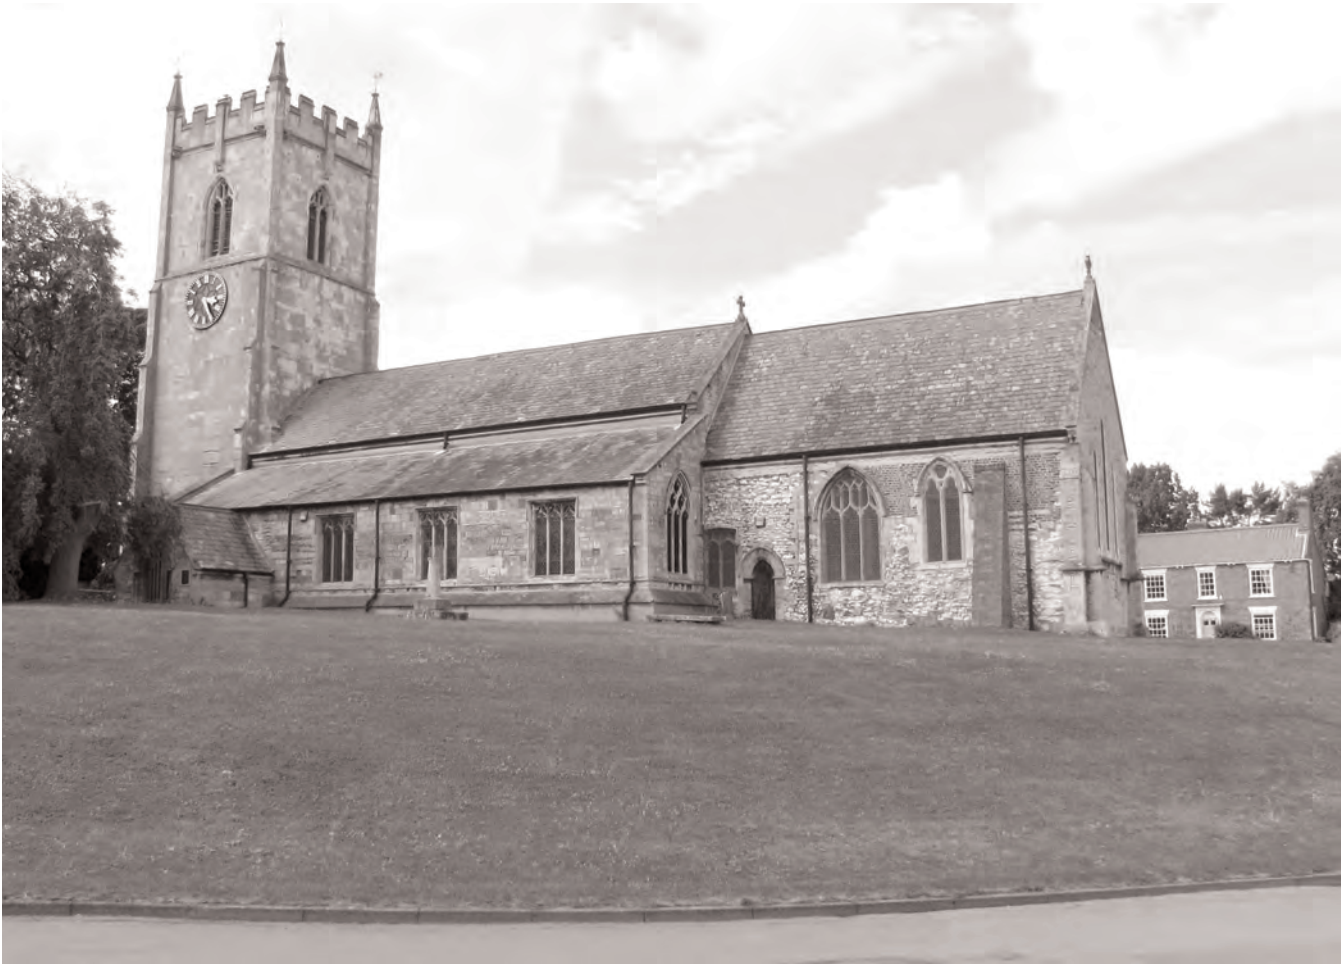
Fig. 159: Holy Trinity, Barrow-upon-Humber. View from the south-east. Photo: Warwick Rodwell

The centre of Barrow is dominated by the parish church of Holy Trinity, the visible fabric of which is Norman and later (Fig. 159; p. 167; Bryant 1988): there is no hint of Anglo-Saxon work. The site, however, generates interest, being a well-defined eminence with the ground falling away on the east, north and south. Running into Barrow from the west is the straight road from Barton, which heads directly for the church site (although development has interrupted the line just before it reaches the church): the tower rises dramatically on the skyline. In part, this road dates from the period of enclosure, although one cannot but wonder whether its alignment could be of earlier origin. The history of the church site is likely to be pivotal in understanding the development of Barrow. Other roads focus on the promontory too: High Street

Holy Trinity church has been neglected by scholars, and a detailed appraisal of its history and architecture is long overdue.⁵⁷ Today, the building comprises an aisled nave and a rectangular chancel; there is a substantial west tower and a south porch (Figs. 159 and 160).⁵⁸ The church is significantly smaller than those at Barton, the nave being 16 m long (St Mary's is 22 m, and St Peter's was originally nearly 24 m). There is no clerestory. The chancel is of the same width as the nave and appears to have been built in the early thirteenth century, succeeding an earlier and narrower structure: similarities with Barton St Mary's are apparent.

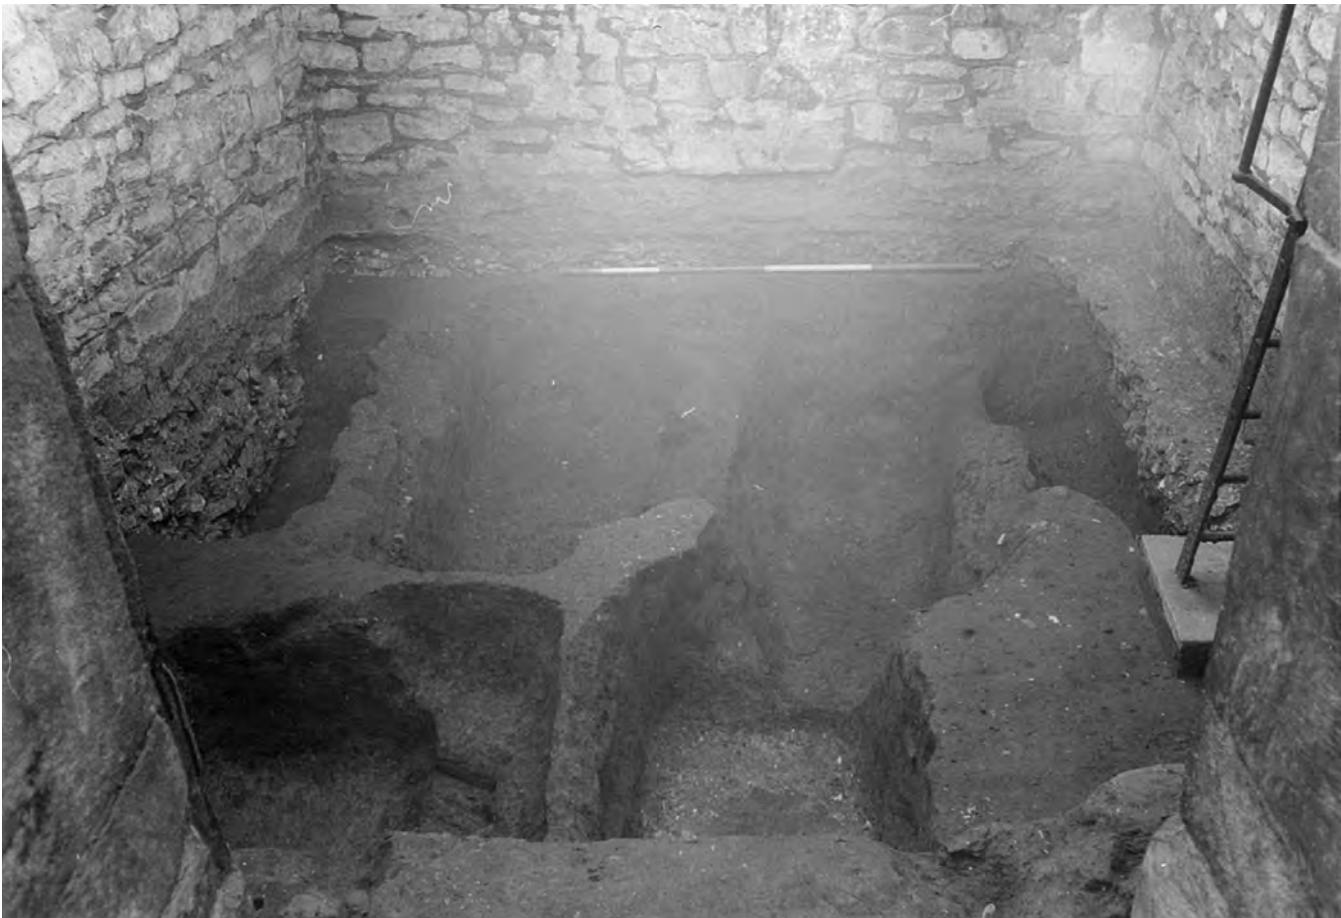
Fig. 165: Exhumed pre-church graves excavated within the western annexe. View west. Scale of 2 m. Photo: Warwick Rodwell

The discrete exhumation cuts suggest that at the time these were relatively recent interments, whose positions were accurately indicated by grave-markers or earthen mounds. Moreover, the identities of the individuals being exhumed are likely to have been preserved in current memory. Several graves on the site of the intended chancel were also neatly exhumed, together with one just outside its north-east angle (F1630). Once emptied of coffins and skeletal remains, the graves were firmly packed with clay and, in a subsequent operation, the foundation trenches were dug through this backfilling (pp. 279–81). The outlines of the original graves had mostly been masked by the activities of the exhumers, who had significantly enlarged the cuts. In some cases, however, the true plan of the grave was preserved in the bottom of the pit: F797, beneath the baptistery, is a good example.

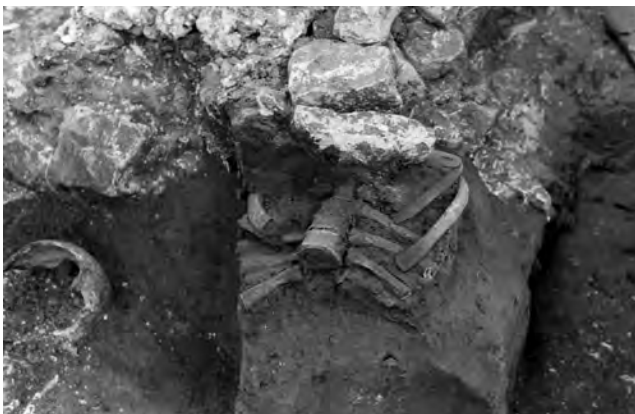
Fig. 166: Remains of the torso of a pre-church burial (F1364), the lower part cut away by the chancel foundations (the skull was removed by a later disturbance in the foreground). View west. Photo: Warwick Rodwell

By contrast, occupants of the earlier, less ordered, cemetery phase are likely to have been forgotten, and their remains not sought prior to construction work. This was especially evidenced on the site of the Anglo-Saxon chancel, where two graves (F1364 and F1400) were disturbed during the excavation of the foundation trench for the east wall: the skeletons were intercepted by the line of the trench and were simply sliced through, leaving parts *in situ* (Fig. 166). A child's burial (F716) on the site of the tower was also overlooked, but this did not impinge on the line of the foundation trenches and thus remained undisturbed. Hardly anything is known about the practice of systematic exhumation prior to building work, and it is clear that this rarely occurred: for discussion, see pp. 346–8.

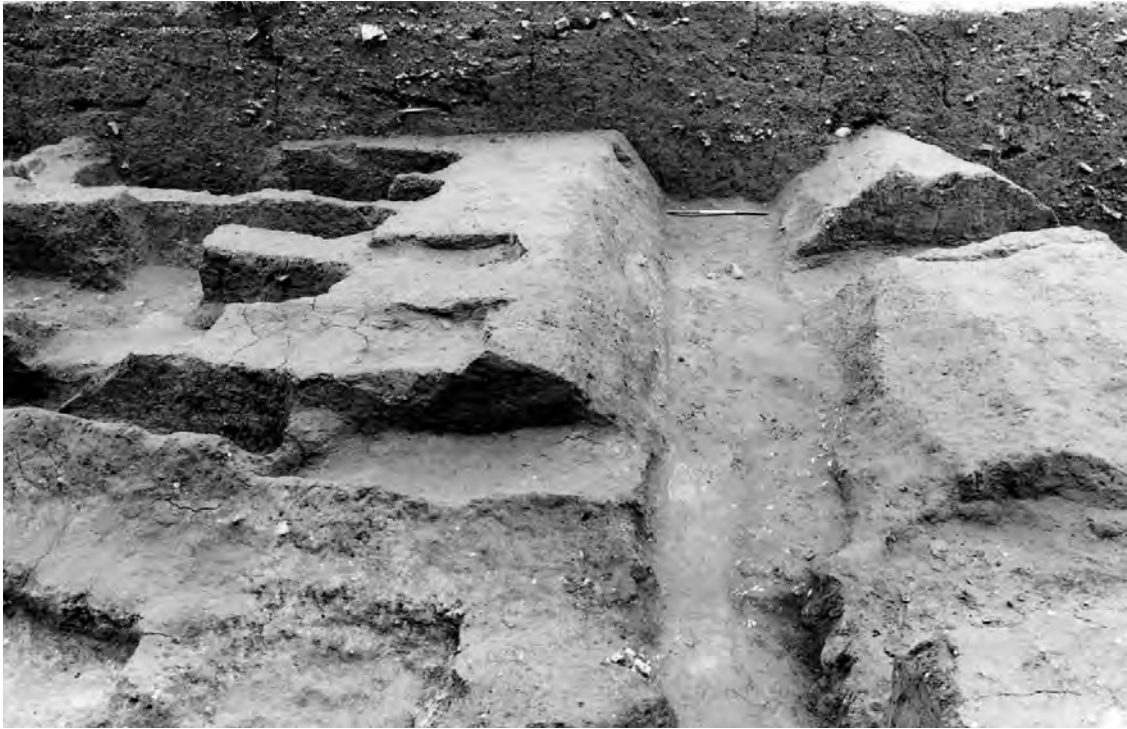
Fig. 168: Eastern boundary ditch of the late Saxon churchyard (F5384). View north. Scale of 75 cm. Photo: Warwick Rodwell

flanked on its western side by a bank and hedge. Although none of the burials in the easternmost row has been scientifically dated, it is probable that they were the first to be made in the churchyard extension. Not only did these six graves lie at right-angles to the new boundary, but they also shared an alignment with the earliest dated burial in the extension (F5475; winter 1103/04), suggesting that they were part of the primary ordering of the extended cemetery.⁷

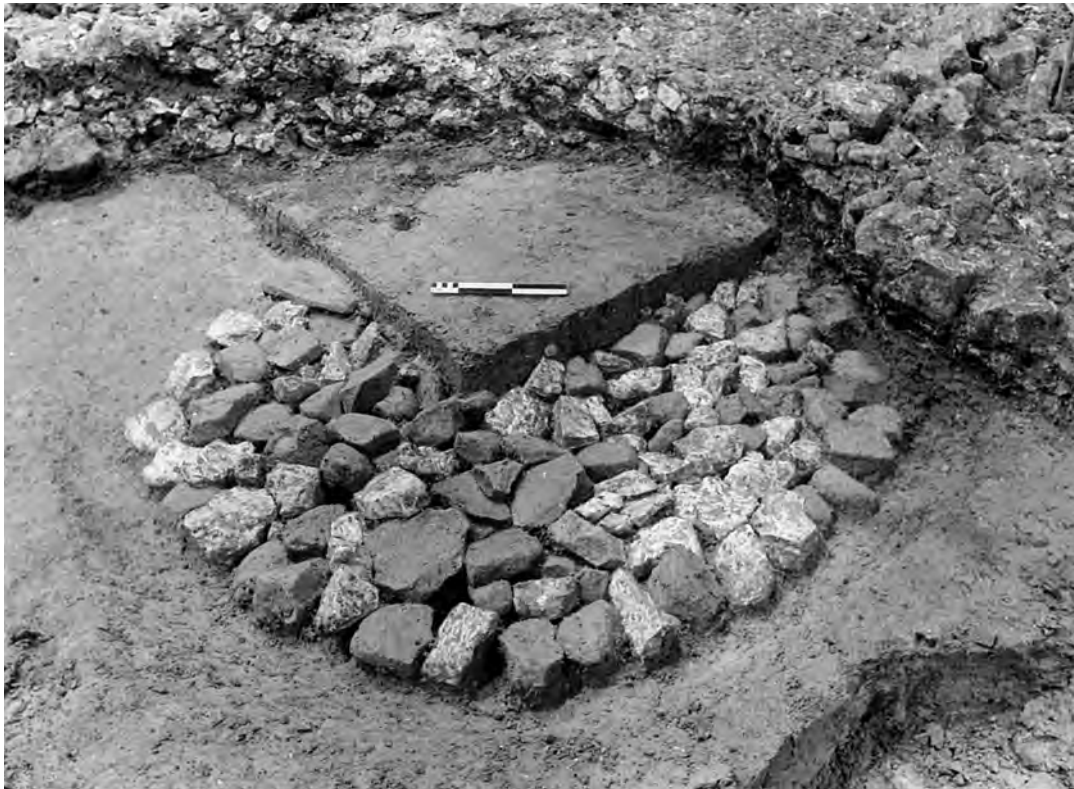
Fig. 170: Stone foundation of kiln (F1727). View south-east. Scale of 25 cm. Photo: Warwick Rodwell

Sealed beneath, and partly destroyed by, the foundation of the apse of the Saxo-Norman church was a kiln or oven (F1727) which had been constructed in a sub-circular pit (F1757). The kiln chamber, which was circular and composed of fired clay, went through four phases (Pl. 38; Fig. 169). The initial structure had an internal diameter of 1.05 m, and had been formed on a carefully prepared base of cobbles and small pieces of limestone (Fig. 170). At the time of the first reconstruction the kiln was enlarged to have an internal diameter of 1.2 m (4 ft). The flue faced north-east, and the stokepit (F1725) contained nothing but fine black ash and some charcoal. Several small postholes in the base of the pit, close to the edge, were evidently associated.

In the absence of any slag or other readily identifiable residues, it was initially concluded that the feature was an oven that performed a function such as baking bread, which would leave no diagnostic evidence. However, the structure is too large for a domestic oven and its situation in the corner of a sizeable stokepit rather implies its association with an industrial process that involved considerable time and labour. It is commensurate with a pottery kiln, but the lack of wasters must cast doubt on such an interpretation. That said, the extent to which later activity had removed the contemporary ground surface from around the pit, and all but a tiny amount of stratification within it, the absence of ceramic evidence cannot be considered definitive.

This argument is reinforced by the fact that very few fragments from the superstructure of the kiln were recovered either: the site must have been cleared and the debris carted away.

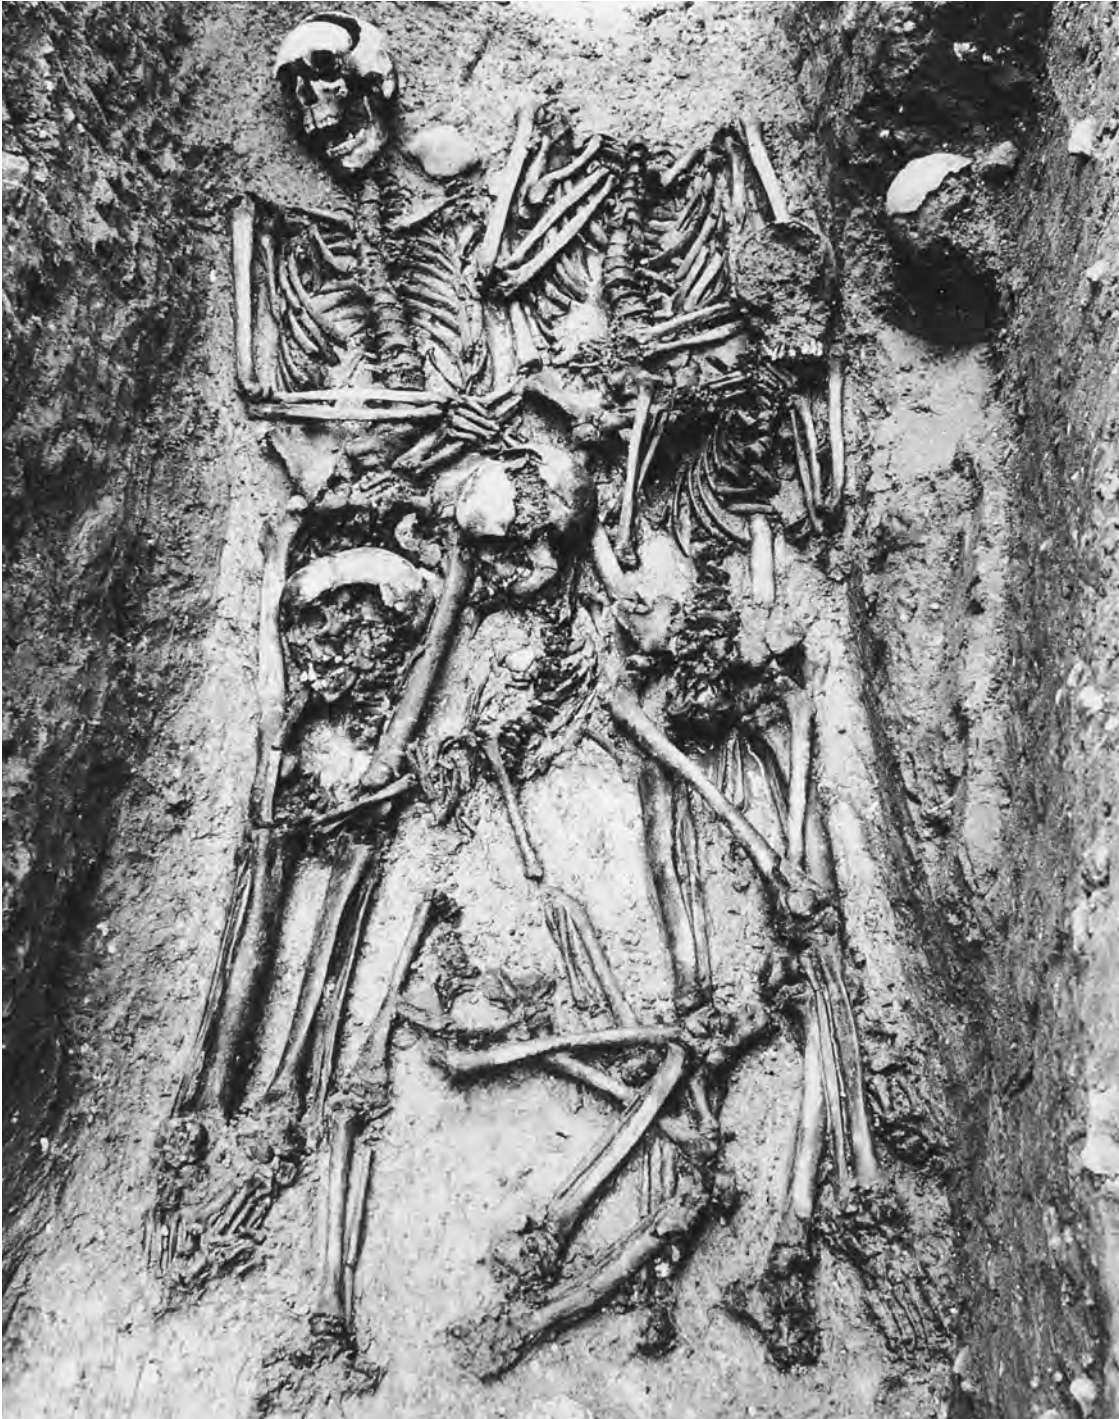
Fig. 172: Late Saxon grave containing two adult males and three adolescents with their limbs inter-twined (F5032). Photo: Warwick Rodwell

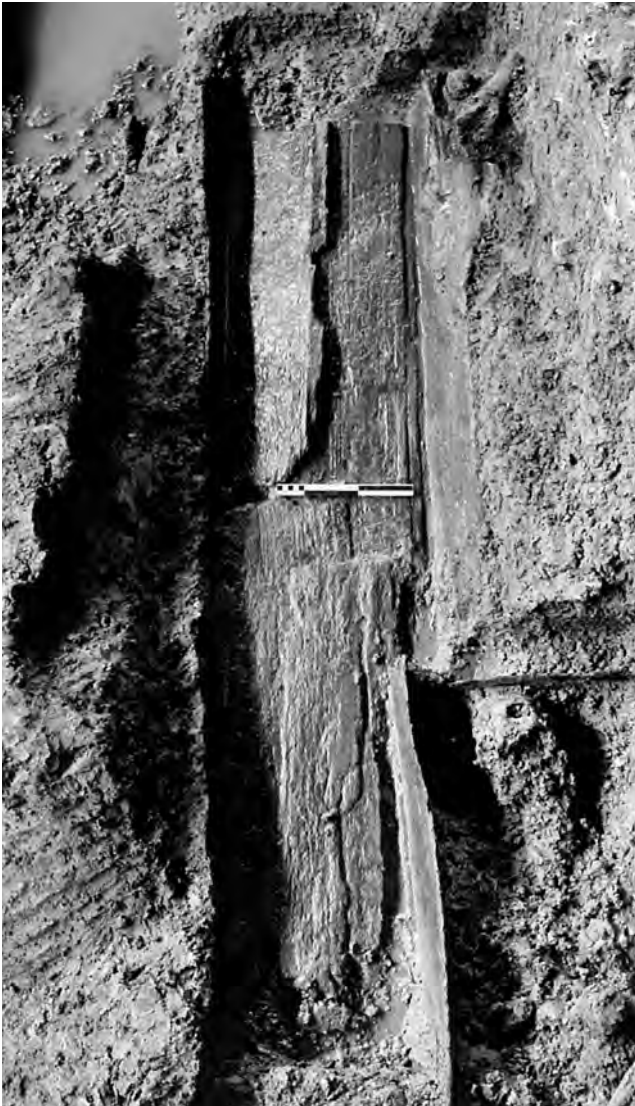
Fig. 173: Loose planks forming the base and sides of grave F3547. View west. Scale of 25 cm. Photo: Warwick Rodwell

two long planks had been stood on edge against the sides of the grave and four short pieces of board laid in the bottom to form a makeshift base (Fig. 173). These had not been cut to fit, and were partly overlapped. Both ends of the grave were destroyed, but they too were presumably lined with loose pieces of timber, wedged between the two sides. Traces of a cover-board were also noted, but this projected above the water-table and had consequently decayed.

through one end; these were not associated with pegged construction. The base-boards had suffered from beetle infestation, possibly indicating that they too were reused timber (but for a cautionary note, see below, p. 223).

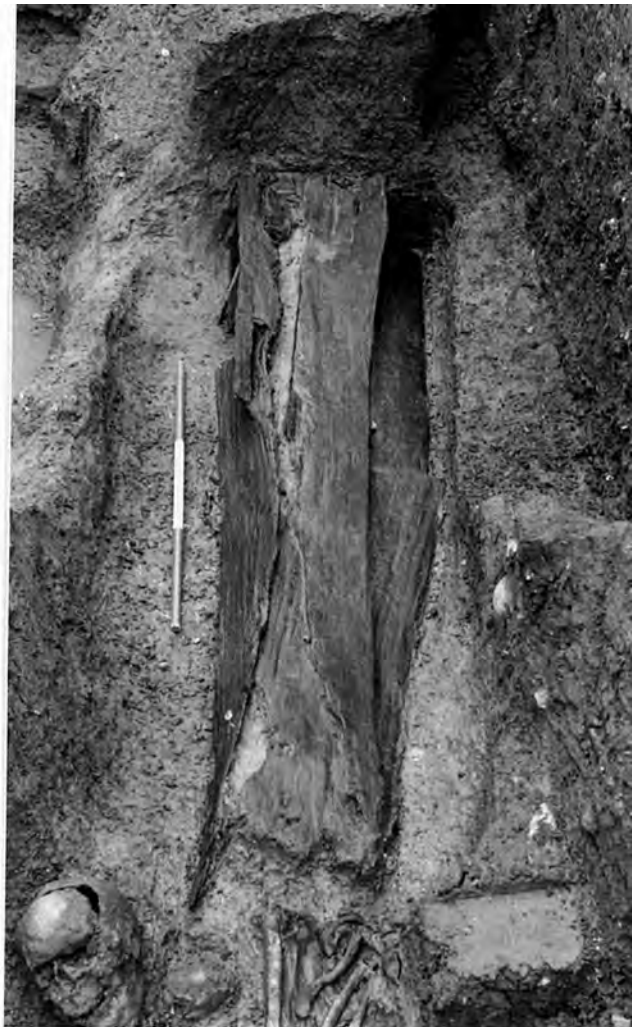
Fig. 174: Planks laid over an uncoffined burial (F5002). The corpse beneath was encapsulated in liquid mud. View west. Scale of 75 cm. Photo: Warwick Rodwell

burials, was encountered on numerous occasions, and its function was presumably to contain disease (p. 194). Several boards had been laid over the body before the grave was backfilled (Fig. 174). At least one plank had had a previous use, since there was a rectangular cut-out in it. There was also a short piece of board wedged across the west end of the grave: its dimensions and the presence of three nail-holes (but no nails) along one edge suggest that it had been, or was intended to be, the end-board of a jointed coffin. One of the covering timbers from this grave gave a tree-ring date of 1049–85, from which a posterior density estimate of 1047–75 (95% probability) was calculated.

Another mud burial was found in Area 11 (F5002), where loose boards had been used to cover the corpse, but there was no coffin (Fig. 174). An adjacent, earlier coffin formed one end of the grave and a piece of board was placed upright at the other end.

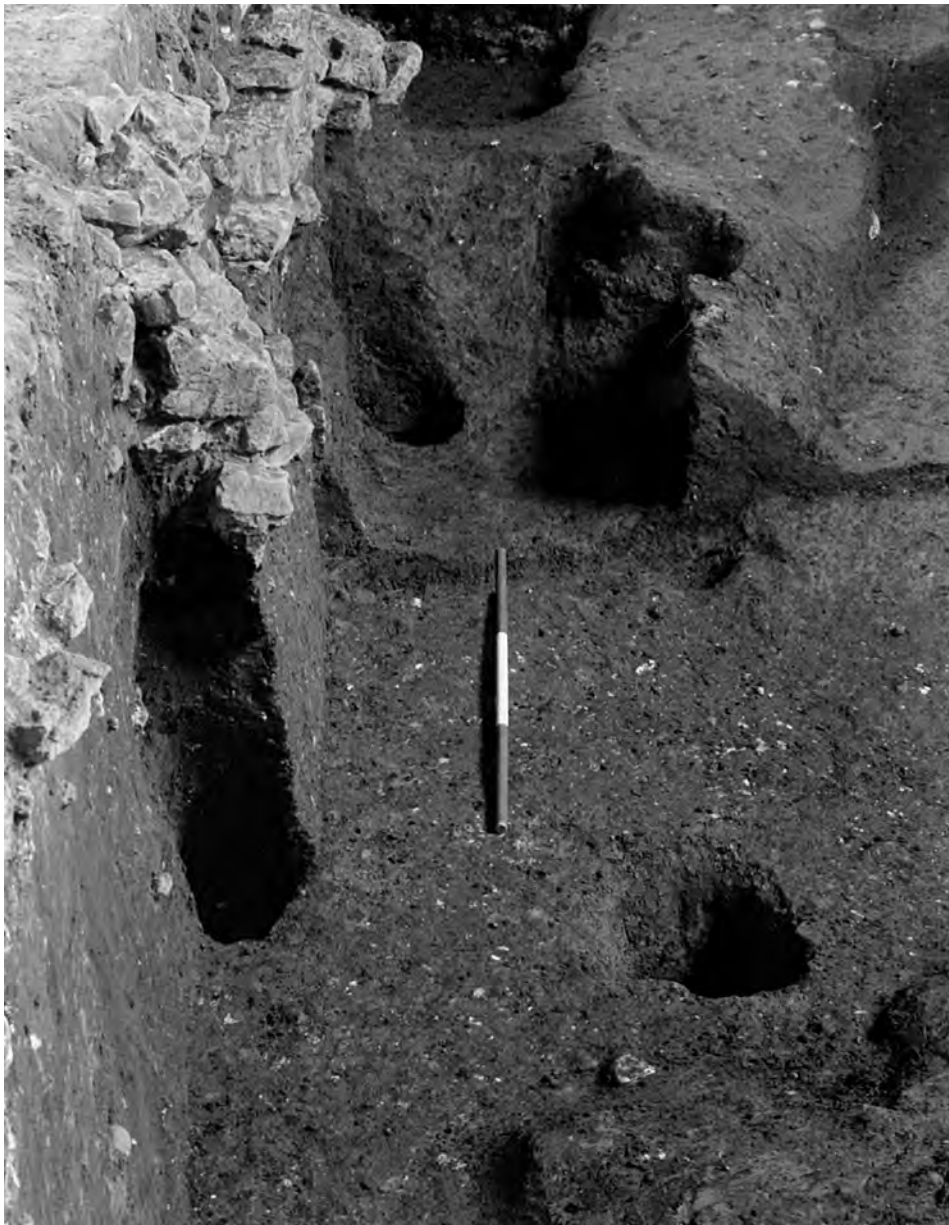
Fig. 178: Exhumed grave F1680, marked at the corners by four postholes. The backfilling was covered by a layer of rough limestone rubble, F384 (left, in section). View west. Scale of 75 cm. Photo: Warwick Rodwell

almost certainly been coffined, but was subsequently exhumed, leaving only the grave-pit with its squarely cut edges (F1680), the modest size of which suggests that the occupant was an older child or sub-adult. The corners of the grave had been marked by four timber posts, for which pits had been excavated (Fig. 178). The length was 1.7 m, to the centres of the posts, and the width *c.* 0.8 m at the east end, by *c.* 0.7 m at the west end. No other feature of this kind was encountered in the cemetery, and the singular treatment accorded to the burial points to a timber canopy or shrine structure having been erected over the grave.

After exhumation – and presumably translation of the corporeal remains to a new location – the grave-pit was backfilled with soil, the upstanding timber structure was removed, and a raft of chalk rubble laid down (F388). The rubble, being set in a matrix of sand, was

presumably intended to be more than just a surface marker for the grave, but was perhaps the foundation for a small cross or other monument. The fact that an exhumed grave was marked by a cenotaph underscores the importance of the original interment. The burial and its successor monument must have been associated with the Anglo-Saxon church, or possibly even preceded it. The site was obliterated in the late eleventh century, the masonry raft being partly cut away when the foundations of the Saxo-Norman church were laid.

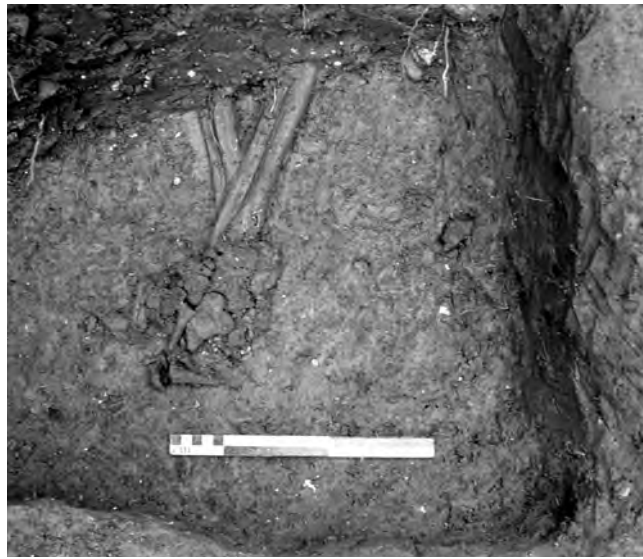
Fig. 179: Grave F7634. Skeleton with crossed ankles. Scale of 25 cm. Photo: Warwick Rodwell

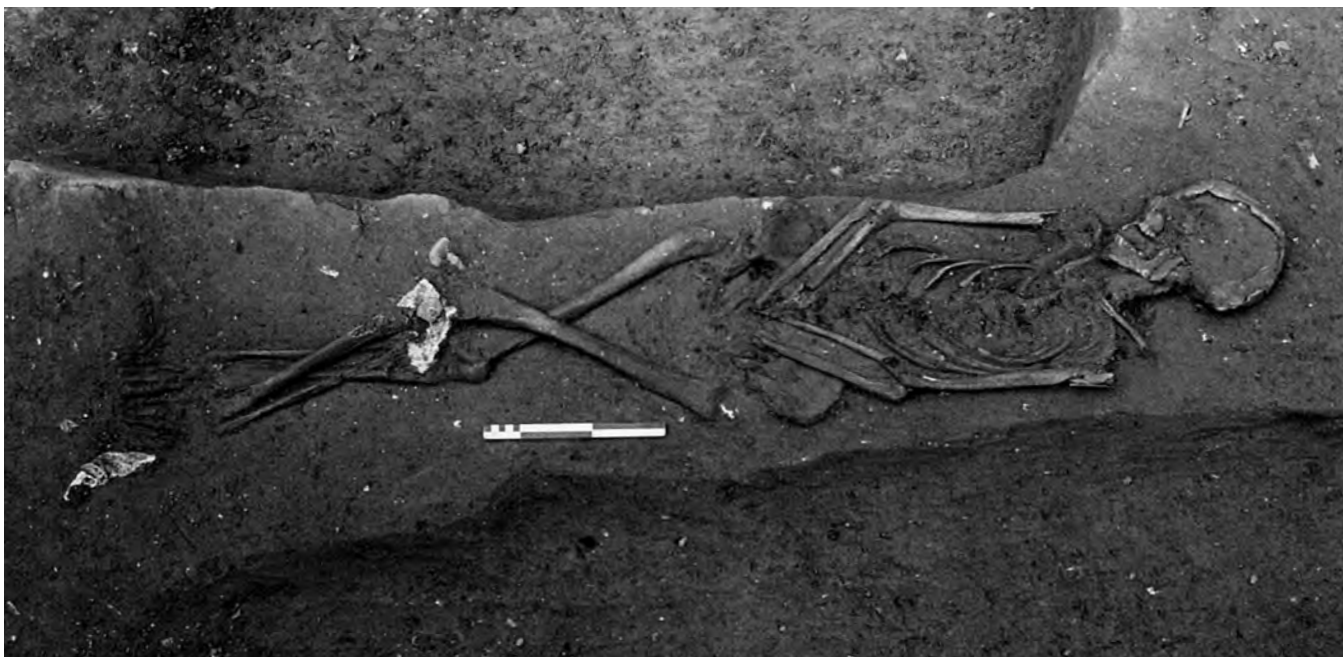
Fig. 180: Grave F3933. Skeleton with double-crossed legs. Scale of 25 cm. Photo: Warwick Rodwell

compactness of the torso and the lack of disturbance of the bones points to the likelihood that the corpse was bound in a shroud (Fig. 180). The upper and lower legs, however, were double-crossed, the left over the right. This would have been physically impossible to achieve with an articulated corpse: the limbs could only have assumed the posture seen here after the decay of the ligaments. Furthermore, it implies that there was a void around the corpse when it decayed.
