ST PETER'S

Barton-upon-Humber, Lincolnshire

A Parish Church and its Community

HISTORY, ARCHAEOLOGY AND ARCHITECTURE

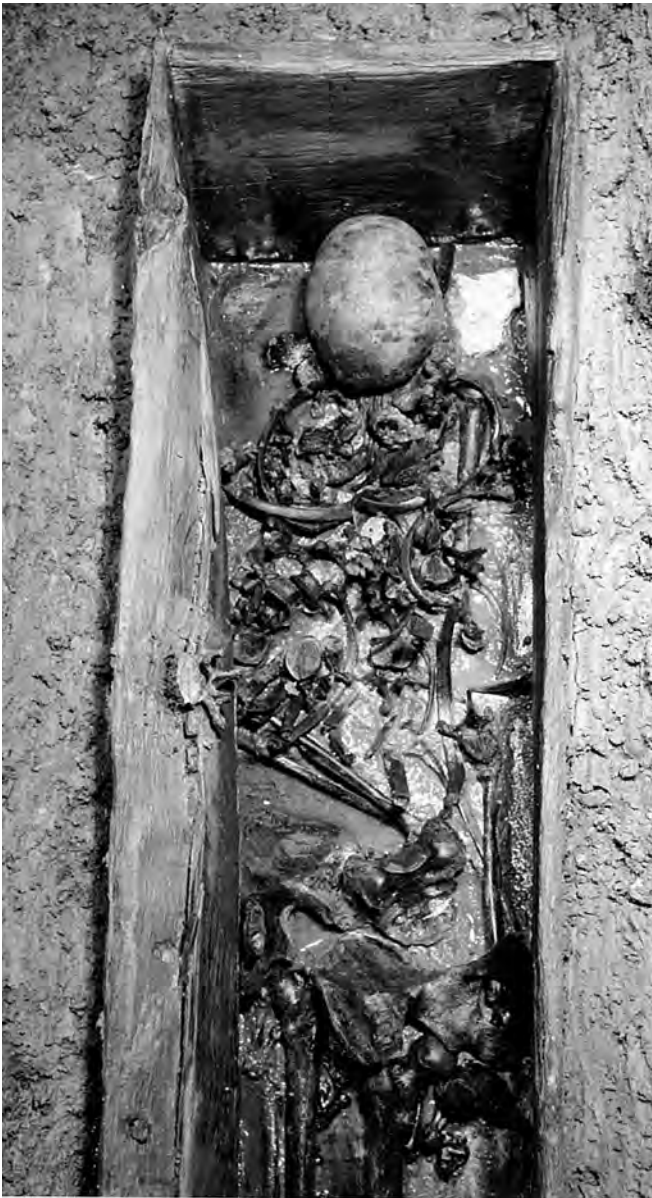
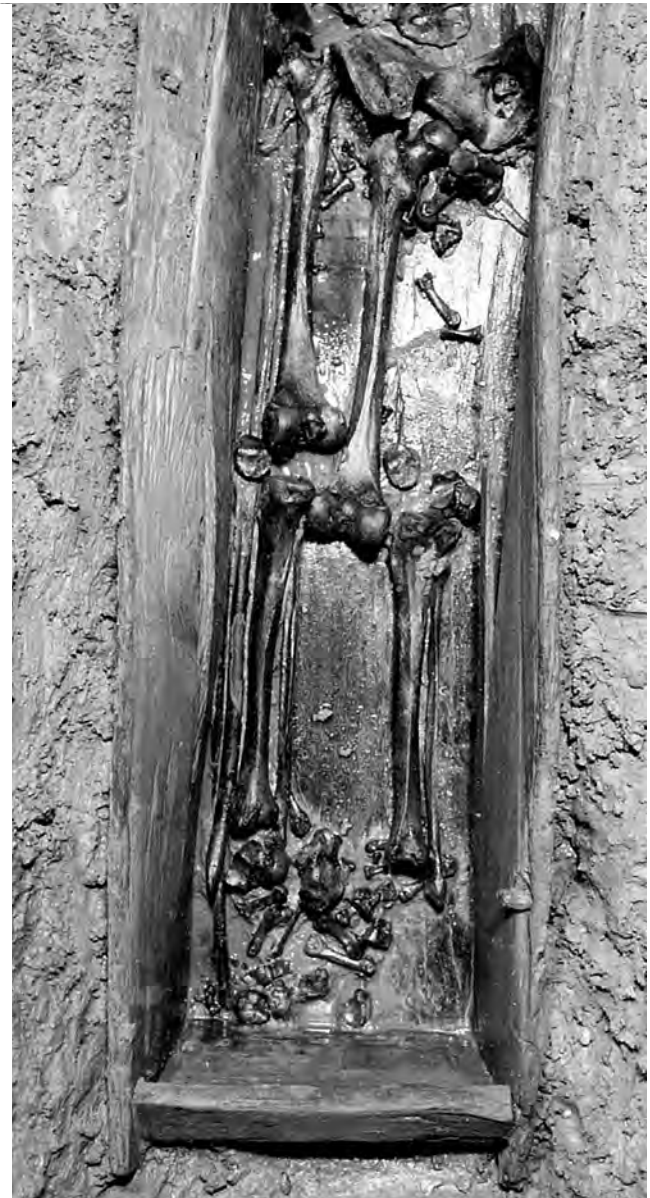
Fig. 181: Coffin, grave F1790 (upper and lower parts of grave). Skeleton with rotated leg bones and dispersed vertebrae and rib cage. Note the single vertebra perched on top of the distorted upper part of the left-hand (south) side, trapped by the lid as the coffin became compressed. Photo: Warwick Rodwell

It was not uncommon to find considerable displacement of bones within the torso, particularly the rib-cage, as though the body had 'exploded' during decomposition (*e.g.* F3968). There were also instances where not only the ribs but also the vertebrae were found in complete disarray (*e.g.* F1790); this could only have occurred after full decomposition, when there were no longer ligaments tying the vertebrae together. The possibility that ground-water alone was responsible for moving bones was considered and rejected for three reasons. First, some of the graves exhibiting 'bone tumble' lay in areas where waterlogging is unlikely. Second, variations in the local water-table would have occurred slowly, so that seepage into

did float to the top of a water-filled coffin. In one instance a single vertebra had become trapped in the joint between the lid and side of a coffin, as the former bowed and collapsed under the weight of the overlying soil. It is difficult to see how a vertebra could have risen to such a level other than by floating in water. In F1753 vertebrae were scattered all over the west end of the coffin, seemingly having settled at random when the water level subsided (or when the bone became fully waterlogged and sank; Fig. 183). The low bone-density of vertebrae, especially of the centrum, gives them greater buoyancy in water than other bones: their movement through this means is thus feasible.

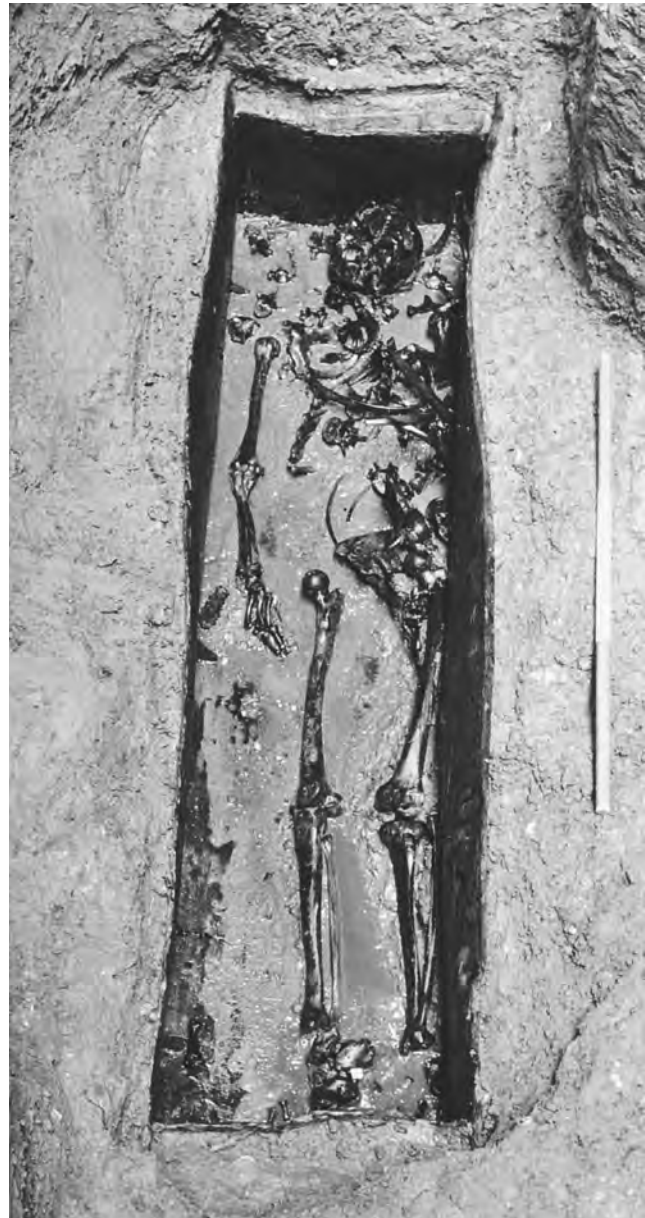
Fig. 182: Coffin, grave F1753. Skeleton with one rotated leg and dispersed vertebrae and rib cage. View west. Scale of 75 cm. Photo: Warwick Rodwell

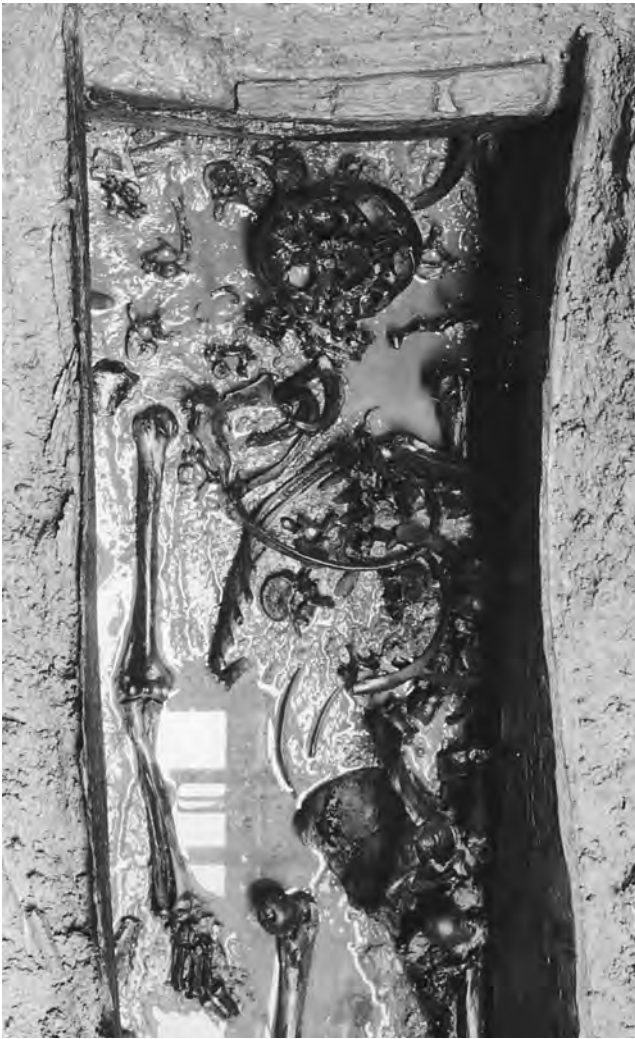
Fig. 183: Coffin, grave F1753. Detail of the dispersed rib cage. Photo: Warwick Rodwell

More intriguing are those instances where a complete arm or leg, or part of one, was found to have rotated axially through 90 or 180 degrees during decomposition, while remaining more-or-less in its original position. Again, this could only occur in a void, as was demonstrated by finding examples inside some of the well-preserved timber coffins of Phase E. A particularly dramatic example occurred in coffin F1790, where the left tibia and both femora had rotated through 180 degrees, while the right tibia had rotated through 90 degrees (Fig. 181). In coffin F1753 the body was hard against the north side: consequently, the bones of the left leg were unable to move during decomposition, but those of the right leg were not constrained and had axially rotated by more than 90 degrees (Fig. 182). Although the rib-cage had completely dispersed, both the left and right arms lay exactly as they were when burial took place (Fig. 183).

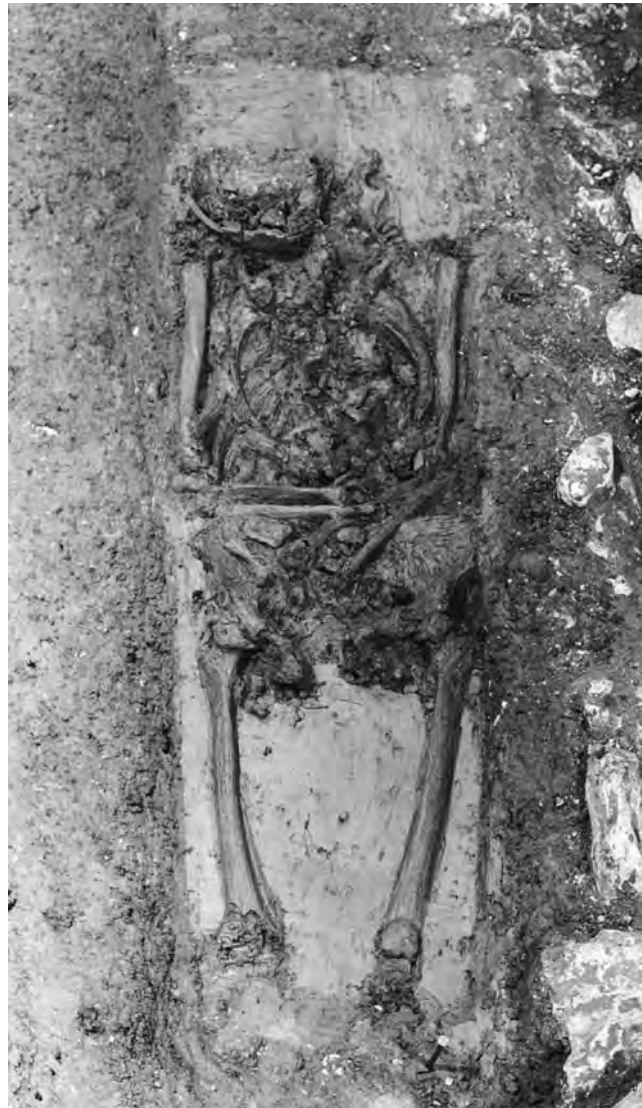
Fig. 184: Grave F4019. Mud burial, excavated to reveal the outline of the coffin, not the grave-cut. The legs have been truncated by a later feature. View west. Photo: Warwick Rodwell

Six mud burials were encountered beneath the nave and south aisle of the present church, giving rise to the recognition of this distinctive class of interment (F4019, F4040, F4064, F4067, F4100 and F4152) (Pl. 113; Fig. 184). Two of the mud burials were included in the scientific dating programme: F4019 gave a posterior density estimate of *cal. AD 1035–1145* (81% probability; UB-4662) and F4040 a posterior density estimate of *cal. AD 1015–1050* (40% probability), or *cal. AD 1085–1125* (30% probability), or *cal. AD 1135–1160* (25% probability; UB-4663). These dates confirm, first, that the mud burials are assignable to Phase E and, second, that they are not consequent upon a single event, but were deposited over the course of a century or so.

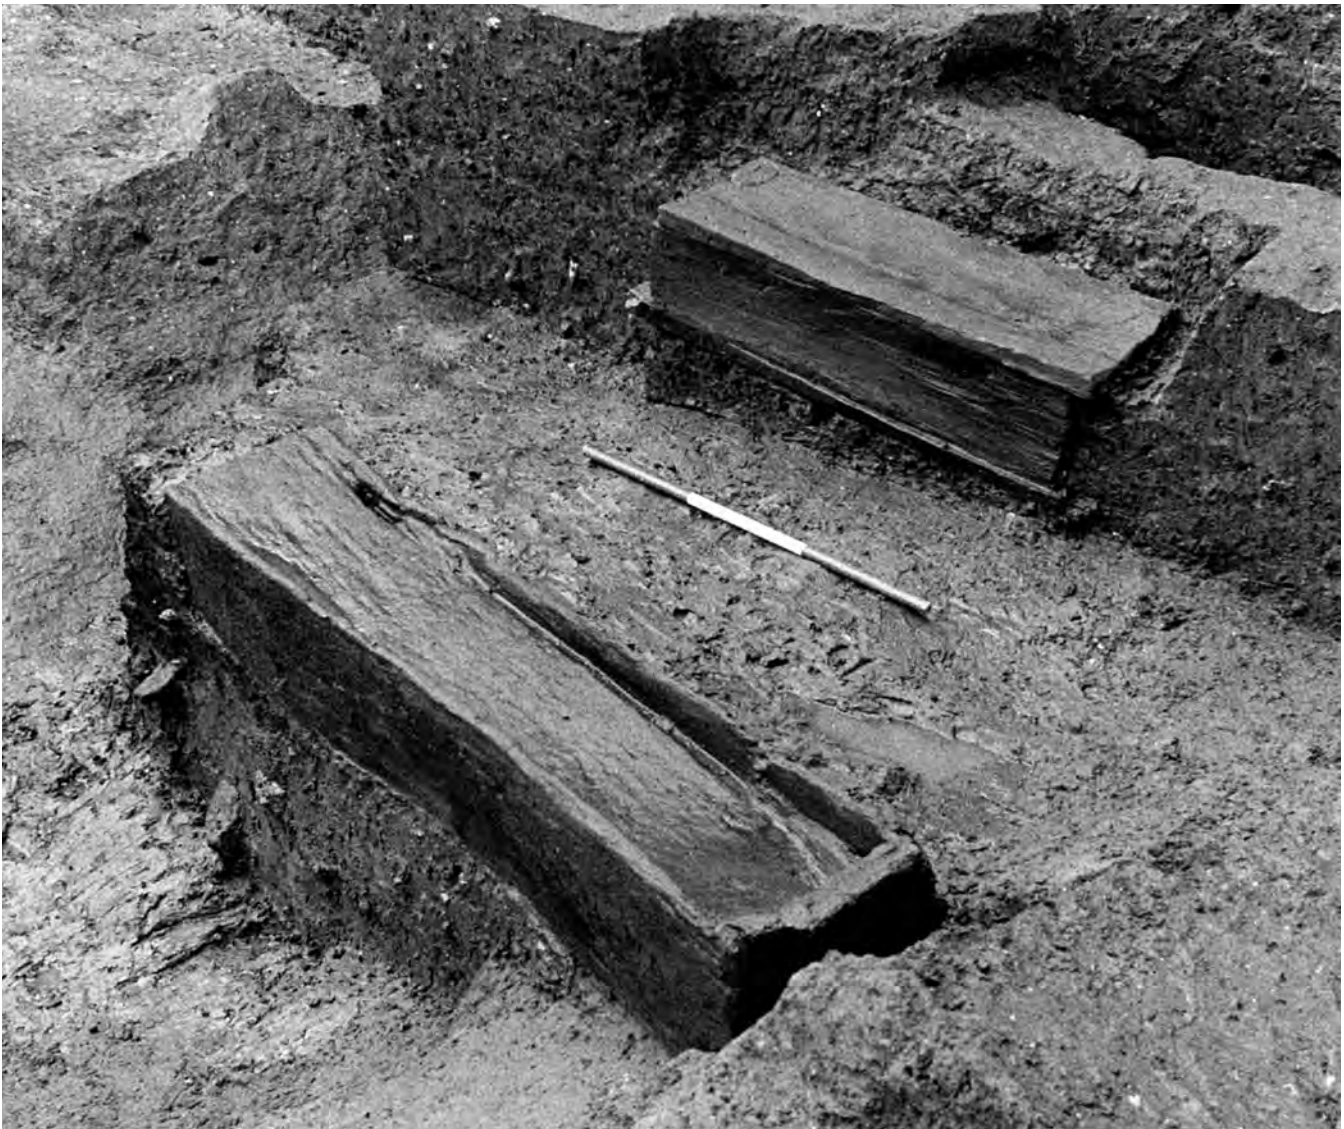
Fig. 185: Preserved timber coffins in the backfilled middle Saxon enclosure ditch (F1751), Area 12. Left, Grave F5475 (oak coffin); right, Grave F5474 (pine coffin). View south-east. Scale of 75 cm. Photo: Warwick Rodwell

In 1981–83 a large body of data – unparalleled elsewhere in Britain at the time – was recovered concerning the construction of timber coffins, many of which were subsequently dated by dendrochronology (Figs. 185 and 186). A representative selection of the material is discussed here. With the sole exception of a child's coffin, made entirely of pine, the identifiable timber was all locally grown oak (Tyers 2001a).

This small, parallel-sided coffin was constructed for the interment of a very young baby (Pl. 39; Figs. 185 and 217–221). Made of pine boards from a single trunk (30–35 cm diam.), it was complete and remarkably well preserved; some of the boards had been tangentially split, others radially. There were clear adze and axe marks on the surfaces and lines of axe-cutting across the ends of the boards. Tool signatures indicate the use of a broad, straight-edged axe with a blade at least 16 cm wide, and an adze with a blade width of 5.6 cm. Curiously, three different finishing tools had been used on this small coffin.

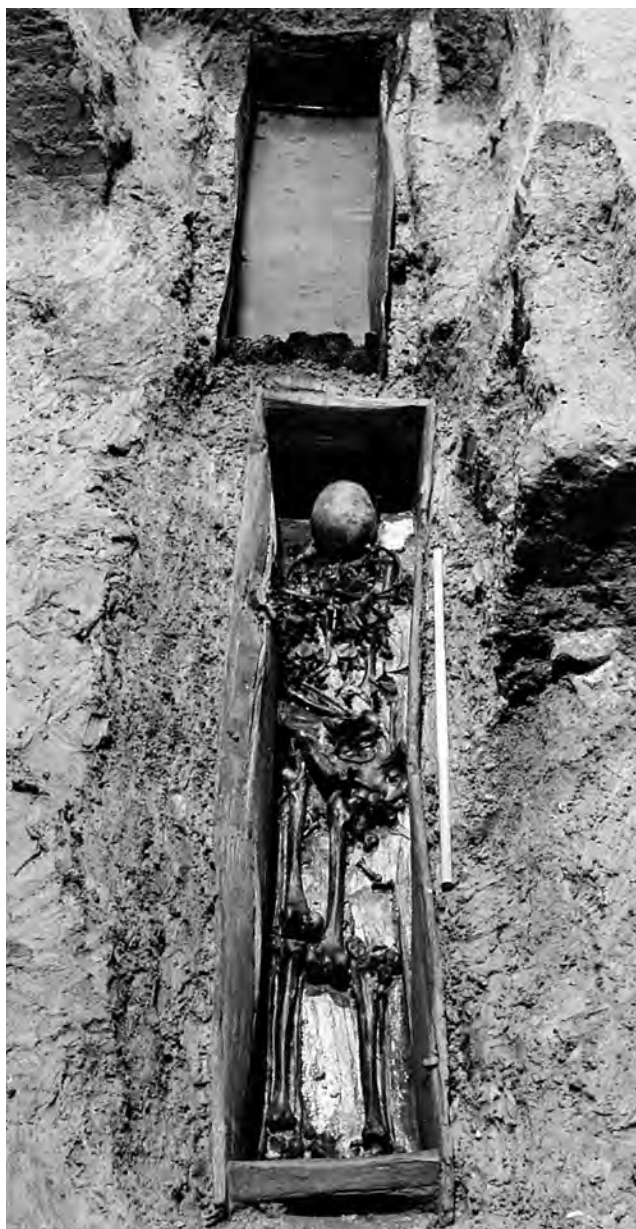
Fig. 186: Two oak coffins under excavation: F1790 with the skeleton in situ, and F1753 after removal of the contents. View west. Scale of 75 cm. Photo: Warwick Rodwell

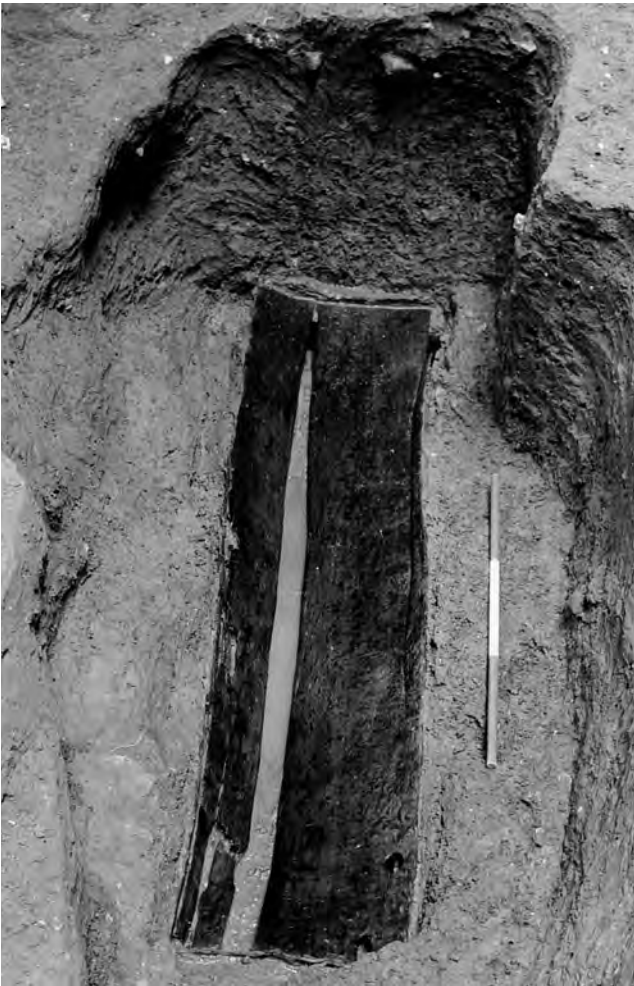
Fig. 187: Coffin, grave F1753, as found with compressed and split lid. View west. Scale of 75 cm. Photo: Warwick Rodwell

An exceptionally well-preserved coffin, intact and undisturbed; the lid was, however, split and distorted by the weight of soil above and exhibited more decay than the remainder of the coffin (Fig. 187). This was made from seven riven oak boards, the surfaces of which still retained clear marks of working with an adze and a broad axe (straight blade 21+ cm long), as well as the joiner's scribed setting-out lines (Fig. 188). The base-board was 1.87 m long, 0.48 m wide at the head (west) end, tapering to 0.40 m at the foot end; it was 28 mm thick. The wider end was gently curved in plan, a feature not reflected in the lid (Figs. 189 and 190).

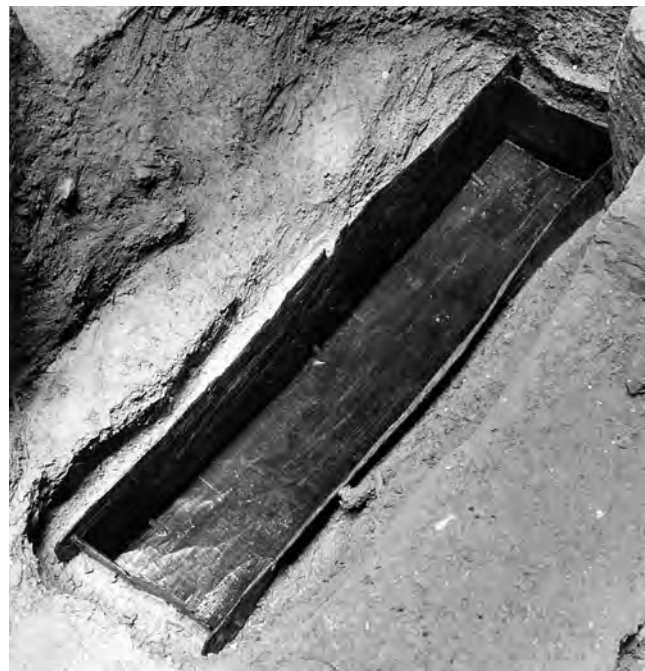
Fig. 188: Coffin, grave F1753, after excavation and removal of the skeleton. View south-west. Photo: Warwick Rodwell

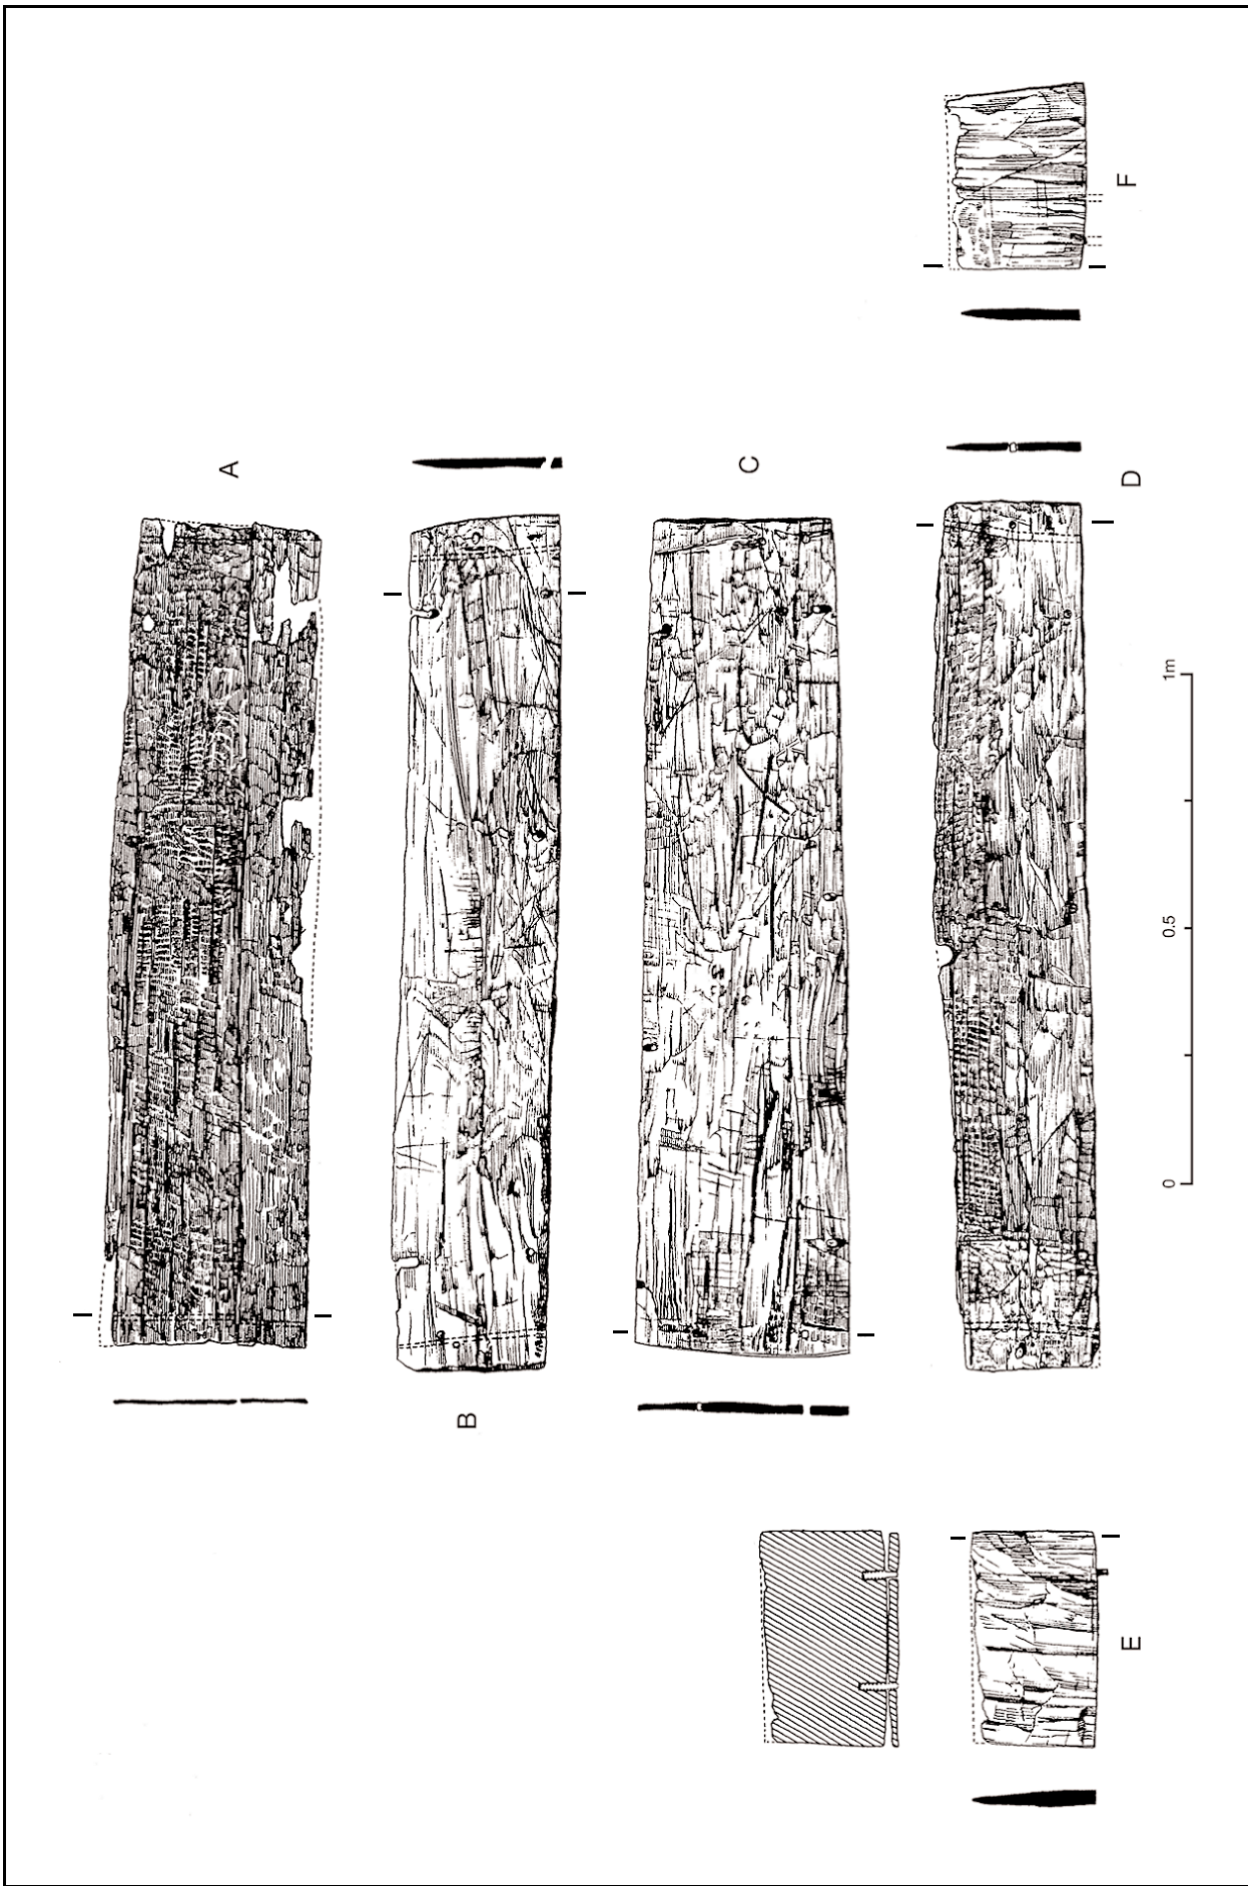
Fig. 189: Coffin, grave F1753. (A) lid; (B) north side (exterior); (C) base (interior); (D) south side (exterior); (E) west end (elevation and vertical section); (F) east end. Scale 1:15. Drawing: Judith Dobie

Both end-boards had their grain running vertically and were mounted on the base, being inset slightly from the extremities; two pegs secured each end to the base-board.⁴⁴ The side planks, 0.34 m in height, were placed outside the base and end-boards, and each was anchored to the base with three skewed pegs (Fig. 191). There was no form of jointing between the sides and the coffin-ends, the whole being tied together, and the ends maintained in an upright position, by long

dowels passing laterally through the coffin, about two-thirds of the way up the sides. There were three of these tying-dowels: two at the narrow end and one at the broad end. In the case of the former, one dowel was set immediately inside and the other outside the end-board, thus preventing it from tilting in either direction (Figs. 192 and 193). The single tying-dowel at the wider end was placed outside the end-board, the only direction in which it needed to be restrained (this board could not have tilted inwards owing to the tapered plan of the coffin).

Finally, the lid was placed on the coffin, and was fixed with four skewed pegs, two on each long side. The lid was slightly wider than the coffin, and oversailed the ends by 30–50 mm; unlike the base, it was made from two planks,⁴⁵ the longitudinal joint being butted and presumably glued. Curiously, no evidence for edge-dowelling could be seen. Instead, the lid appears to have been strengthened simply by gluing battens to the underside. There may have been two or three, but only one batten (50 × 20 mm in cross-section) had survived at the west end of the coffin: it lay outside the end-board and must have been attached to the oversailing part of the lid: no nails, dowels or pegs were involved.⁴⁶ Two holes in the north-east corner of the lid seem not to be the result of decay, and may represent reuse of the plank. Also, the wider plank showed no sign of beetle infestation, but the narrower one had flight-holes of a size commensurate with death-watch beetle; these were in the timber before it was planked (Fig. 194).

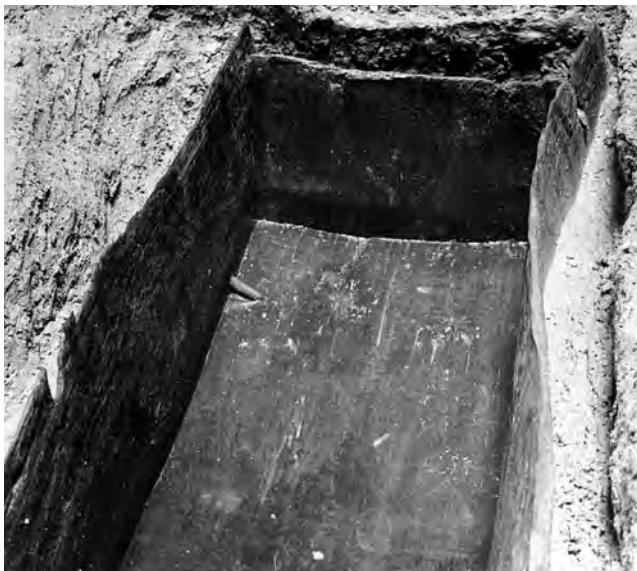
Fig. 191: Coffin, grave F1753. Internal view of the west end, showing a skewed peg attaching the side to the base. Photo: Warwick Rodwell

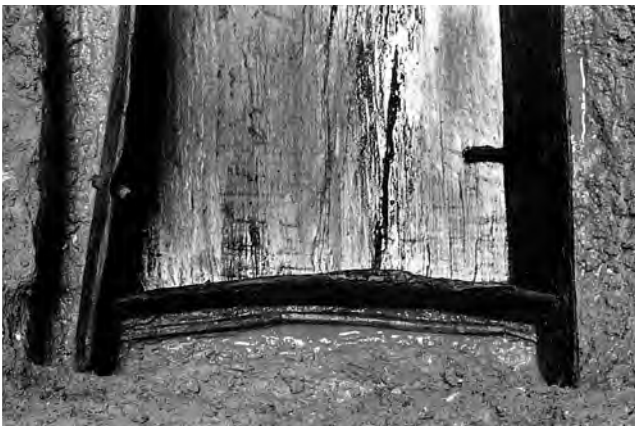
Fig. 192: Coffin, grave F1753. Vertical view of the west end, showing the external tying-dowel in situ. Photo: Warwick Rodwell

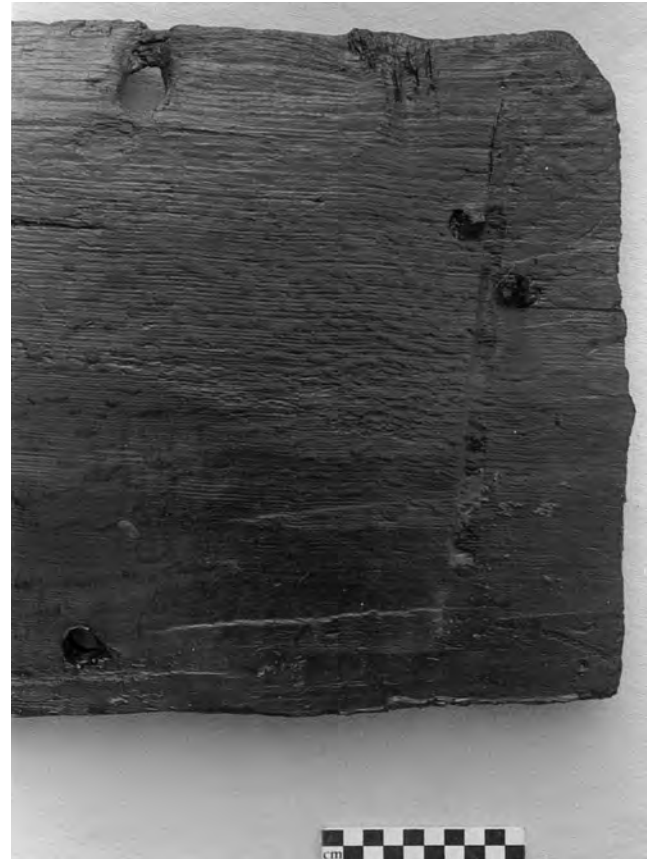
Fig. 193: Coffin, grave F1753. Internal view of the north side plank, showing the compression scar where the east end abutted, the stumps of the dowels that held it upright, and two of the skewed peg-holes where the side was attached to the base and lid, respectively. Photo: Warwick Rodwell

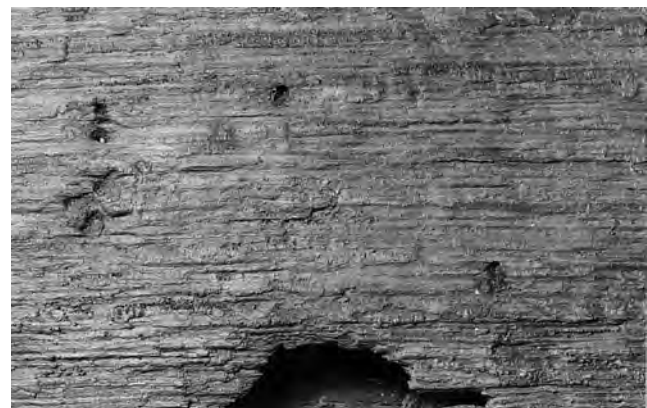
Fig. 194: Coffin, grave F1753. Detail of the lid, showing wood-beetle infestation in the timber before it was used to make the coffin. Photo: Warwick Rodwell

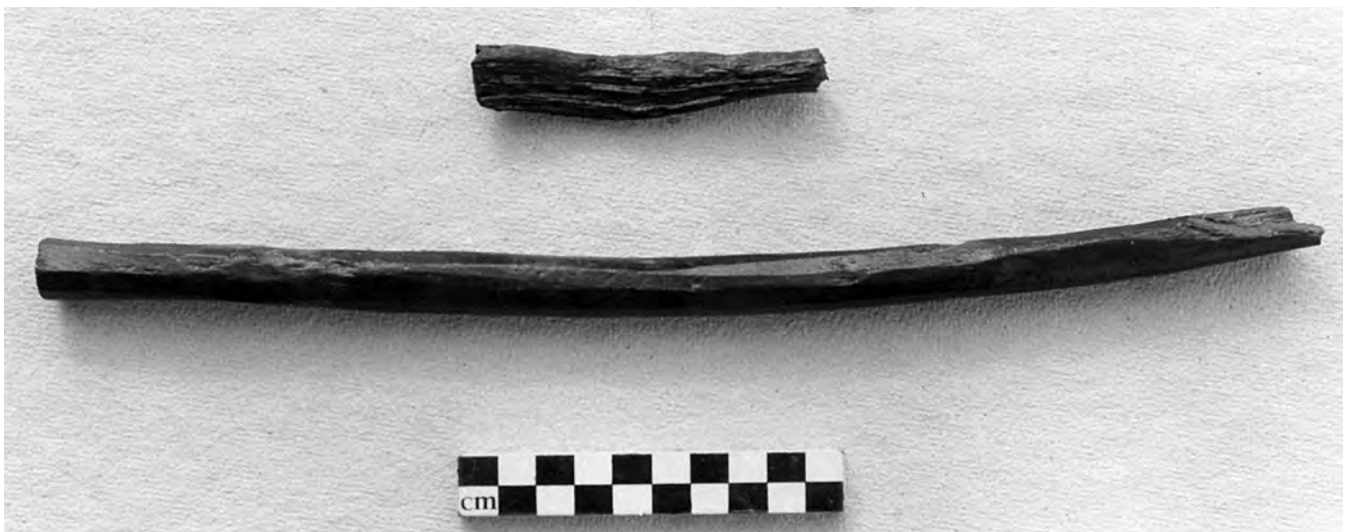
Fig. 196: Coffin, grave F1753. Examples of a peg and a tying-dowel used in the construction. Photo: Warwick Rodwell

The 'standard' features of construction noted at Barton involved fitting the long sides to the outer edges of the base-board, and positioning the end-boards on top of the latter, clamped between the sides. The ends were invariably inset a little, to allow tying-dowels to be fitted, but these survived only in the best-preserved coffins (Figs. 195–6). Curiously, there was no evidence for the sides being physically secured to the end-boards,

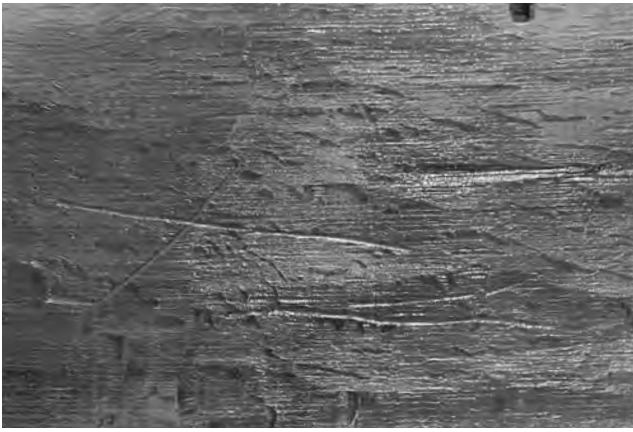
Fig. 197: Coffin, grave F1753. Detail of the base-board showing the incised graffiti. Photo and drawing: Warwick Rodwell

pegs were employed to hold the lid in place. This modest fixing would have allowed it to be removed, or reattached, simply and quickly. The combination of an easily removable lid and the provision of supports for the skull might suggest that corpses were displayed to mourners, either before or during deposition in the grave. The inclusion of coppice-rods inside coffins may also have been relevant in this context. The graffito ('XII') inside the base of F1753 is the sole instance of a marking that must have been made by the carpenter during construction (Fig. 197).

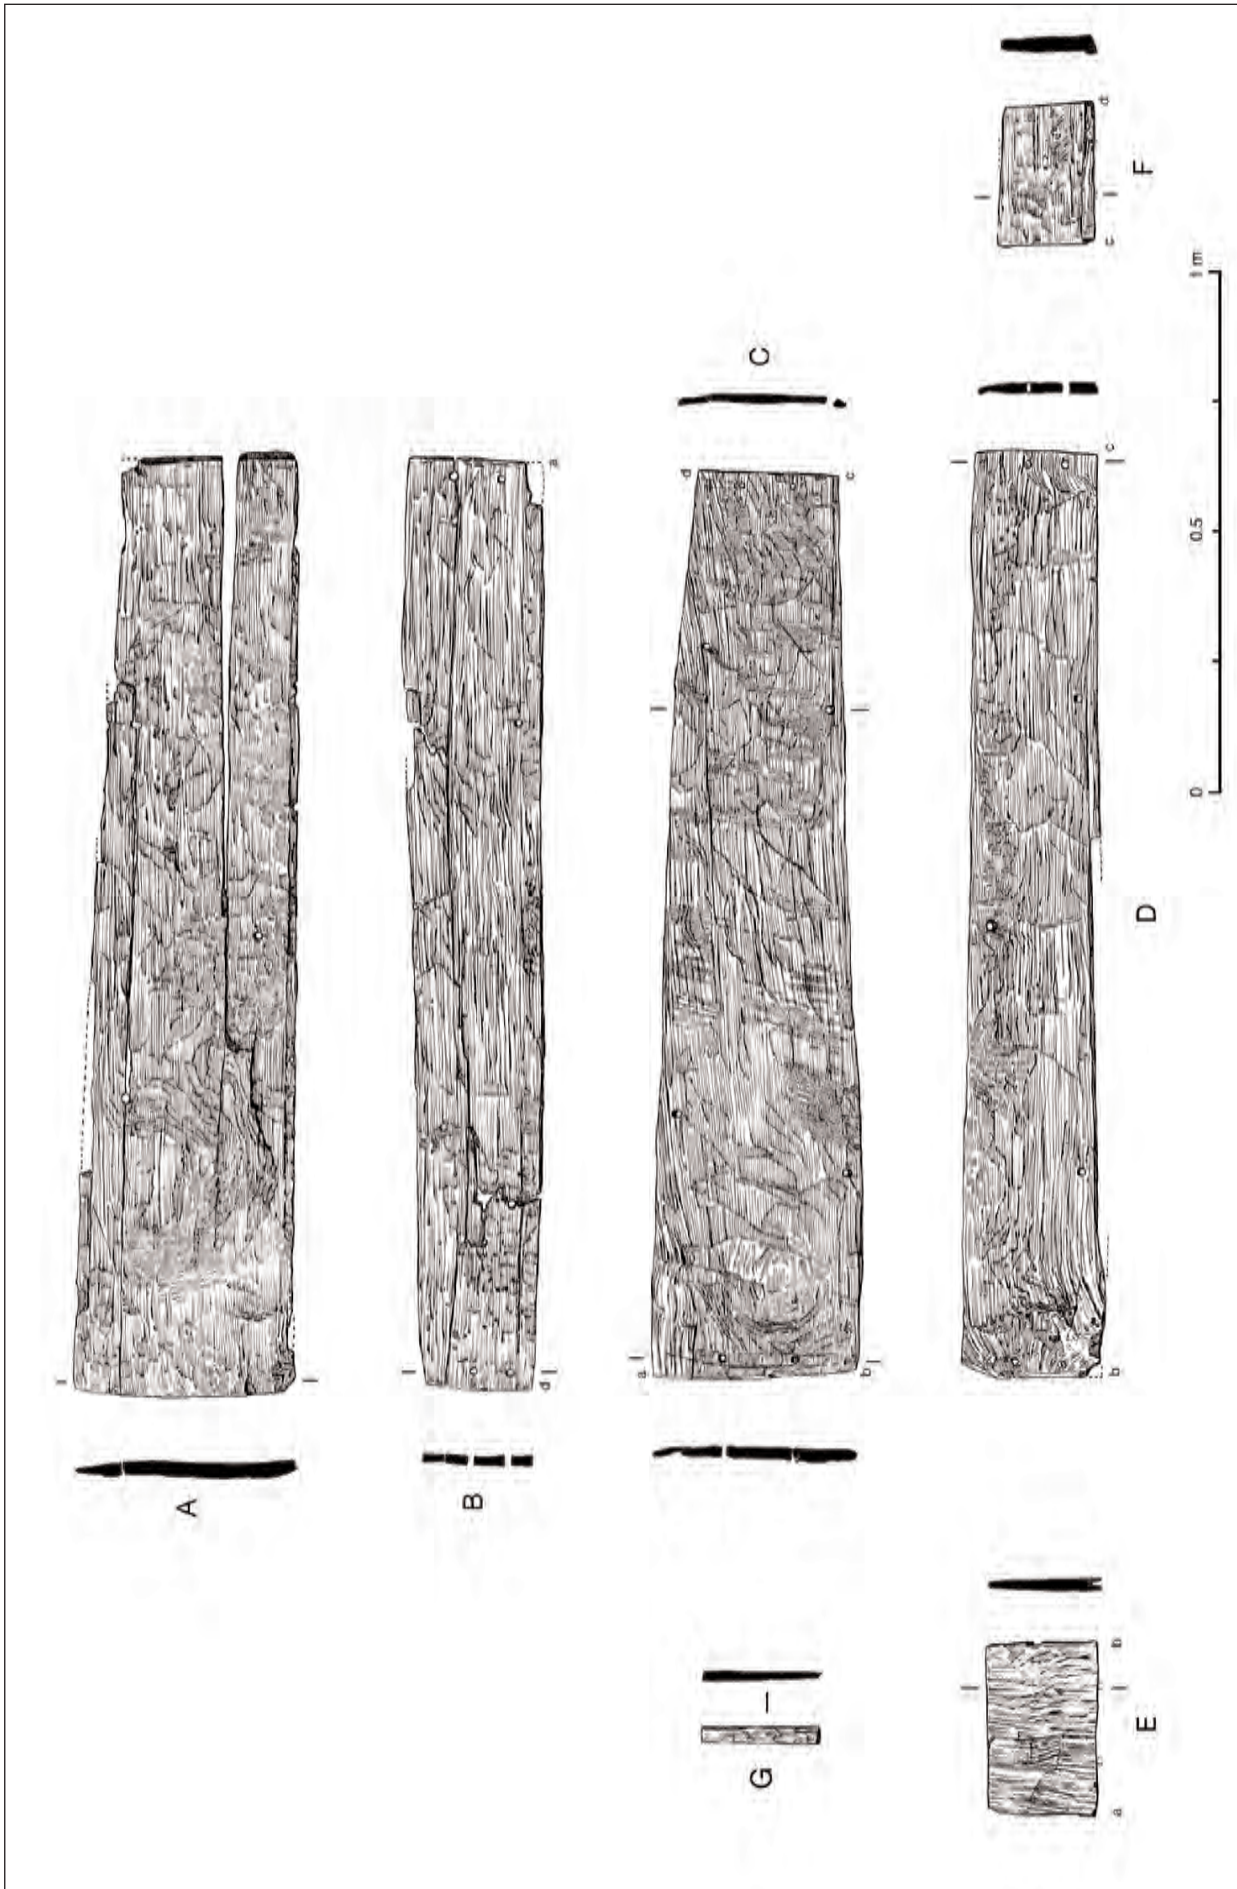
Fig. 200: Coffin, grave F3868. (A) lid; (B) north side (exterior); (C) south side (exterior); (D) west end; (E) east end; (F) east end; (G) wedge from south-west corner. Scale 1:15. Drawing: Judith Dobie

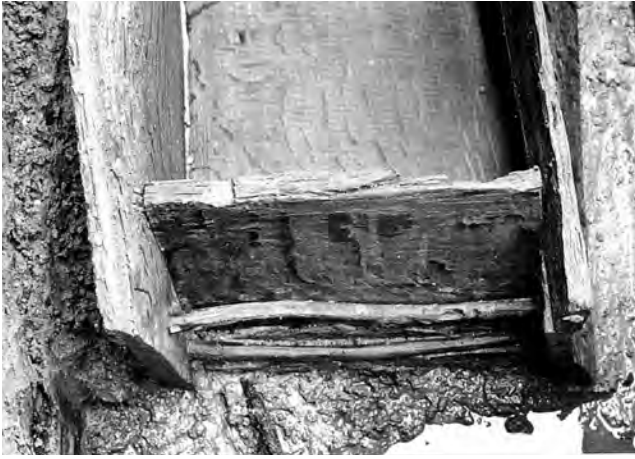
Fig. 201: Coffin, grave F3868. Detail of the east end, showing the twin tying-dowels. Photo: Warwick Rodwell

A large, well-preserved coffin: the base-board, curved at the broad end, measured 1.96 m long by 0.45 m wide, tapering to 0.31 m (Fig. 200). Unusually, the west end-board had vertical grain and the east had horizontal. The construction was similar to F3508, with two external tying-dowels at each end (Fig. 201). The lid was secured with three skewed pegs. The south side had the upper west corner cut off at an obtuse angle, which was probably a residual felling-cut rather than a deliberate feature.

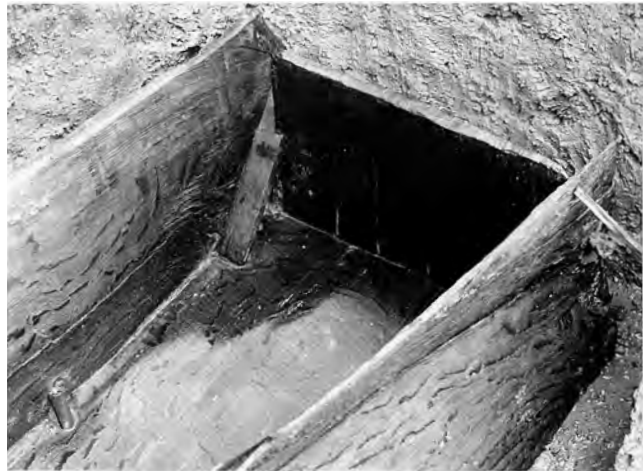
Fig. 202: Coffin, grave F3868. Detail of the west end, showing the wedge passing through an angled slot in the edge of the board. Photo: Warwick Rodwell

Two other anomalies merit mention. First, the east end-board carried an unnecessary shallow rebate across its full width, indicating reuse. Second, the west end-board had a small rectangular cut-out in the middle of its southern edge. This was effectively a slot, made using a chisel angled at 45 degrees to the plane of the board. Inserted into this skewed slot was an oak wedge 25 cm long, which pressed against the south side of the coffin (Fig. 202). Practically, all it could do would be to open up a slight gap between the west end-board and the south side; but that was certainly not desirable, since the two components were held together by tying-dowels. The slot and the long wedge were unquestionably deliberate features of this coffin's construction, but their function remains an enigma.

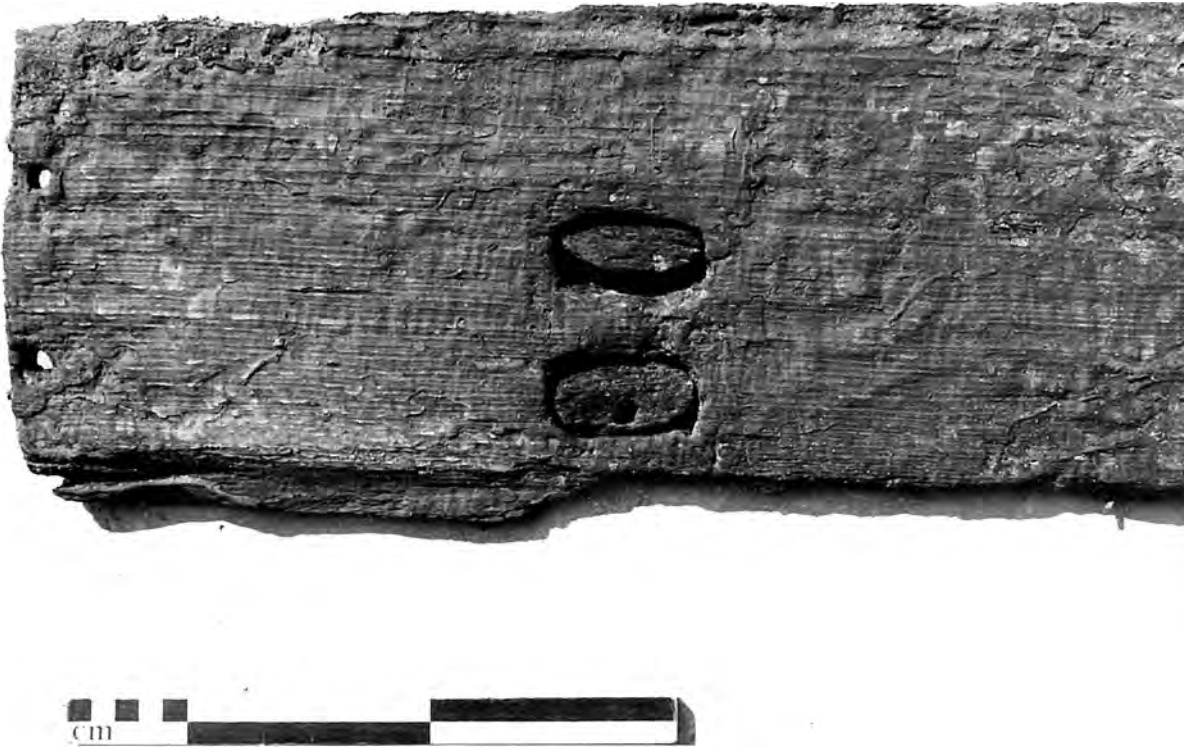
Fig. 203: Coffin, grave F3946. Detail of part of the base board, showing peg-holes for the attachment of the east end and a pair of infilled mortices from the timber's previous use as a bench top. Photo: Warwick Rodwell

The identification of one of the reused boards in coffin F3946 as potentially from the seat of a Norman bench is of particular interest. Likewise, the board from coffin F5045 with numerous holes drilled through it seems to have had two previous uses, probably both as pieces of furniture. First, it was almost certainly the top of a bench with slightly splayed legs, and secondly it may have been the side of a small box-bed, similar to that found in the Oseburg boat burial (Speake 1989). If the suggested identifications are correct, then these are some of the earliest fragments of English furniture to have survived.⁵²

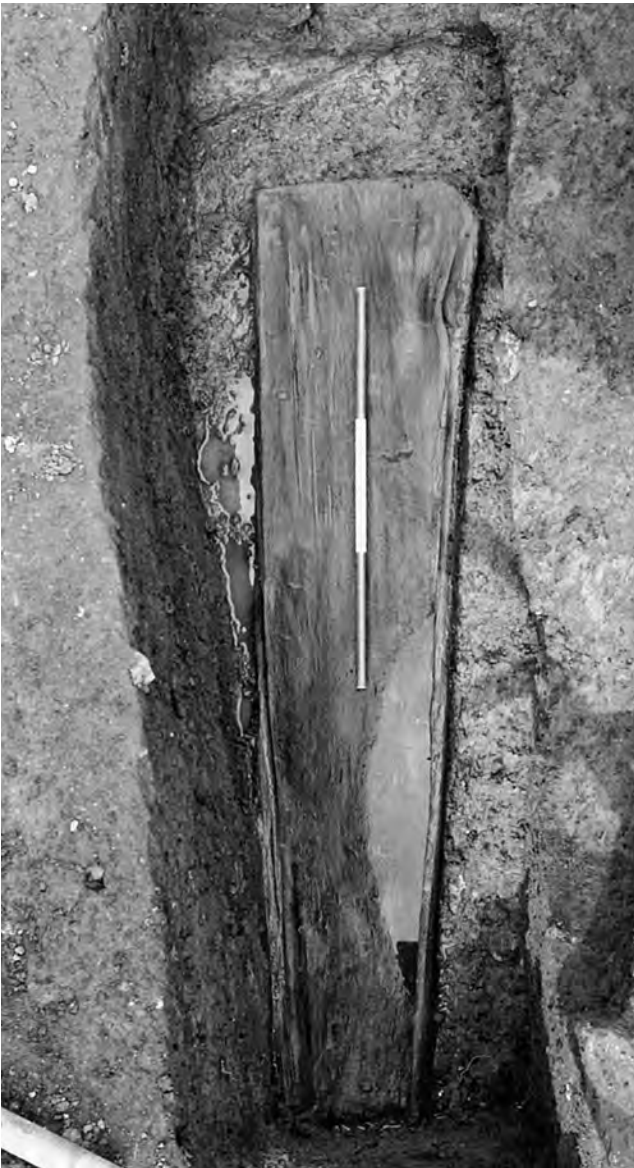
Fig. 204: Coffin, grave F3968, as found, with the lid intact. West is at the top. Scale of 75 cm. Photo: Warwick Rodwell

A well-preserved example, directly underlying coffins F3939 and F3946 (Figs. 204–207 and 209). The planks used for the base and sides were exceptionally thick (up to 45 mm); the north-west corner of the base had been cut off at 45 degrees, using an axe (*cf.* F3868) (Fig. 208). The sides were attached to the base by three horizontal pegs in each, providing the only instance of this form of construction. On the exterior of the south board were

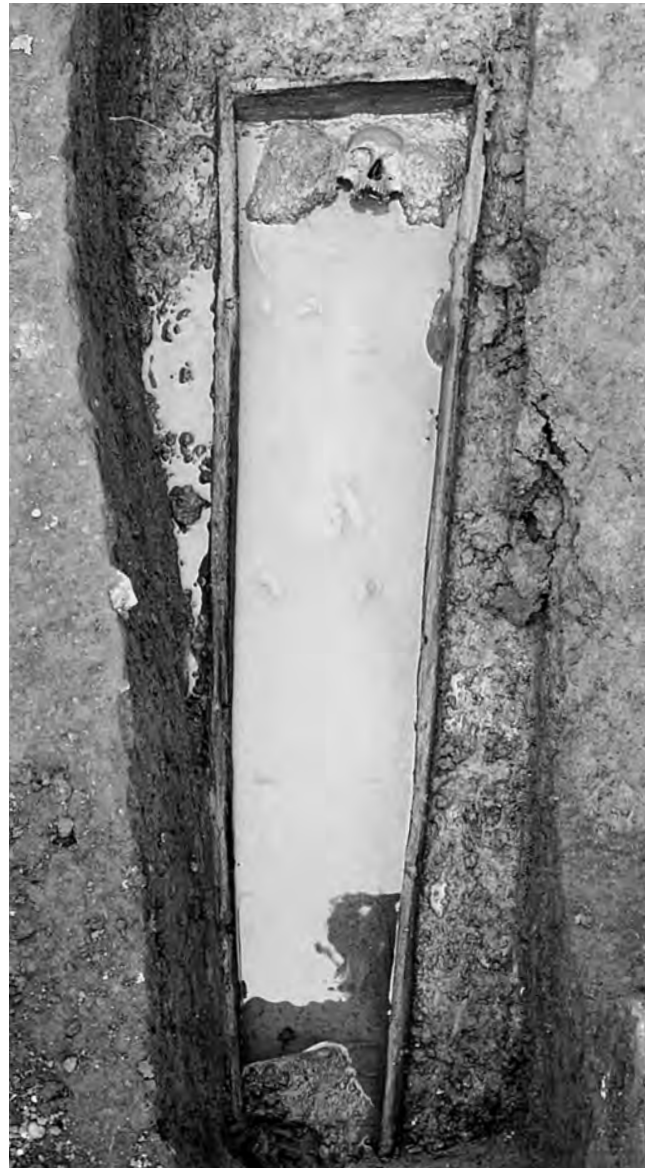
Fig. 205: Coffin, grave F3968. Waterlogged contents, as seen after removal of the lid. Note the mud 'pillow'. Photo: Warwick Rodwell

Of exceptional interest was burial F3968, which was interred just within the eastern boundary of the Anglo-Saxon churchyard. It contained a timber coffin which was intact and tree-ring dated to ?1079; inside it were two pillow-stones (one chalk, the other flint) over which was laid what appeared to be a rectangular pillow stuffed with grass or straw (Figs. 206 and 207). The pillow presumably had an outer casing of cloth, although nothing of this survived: there was just a bed

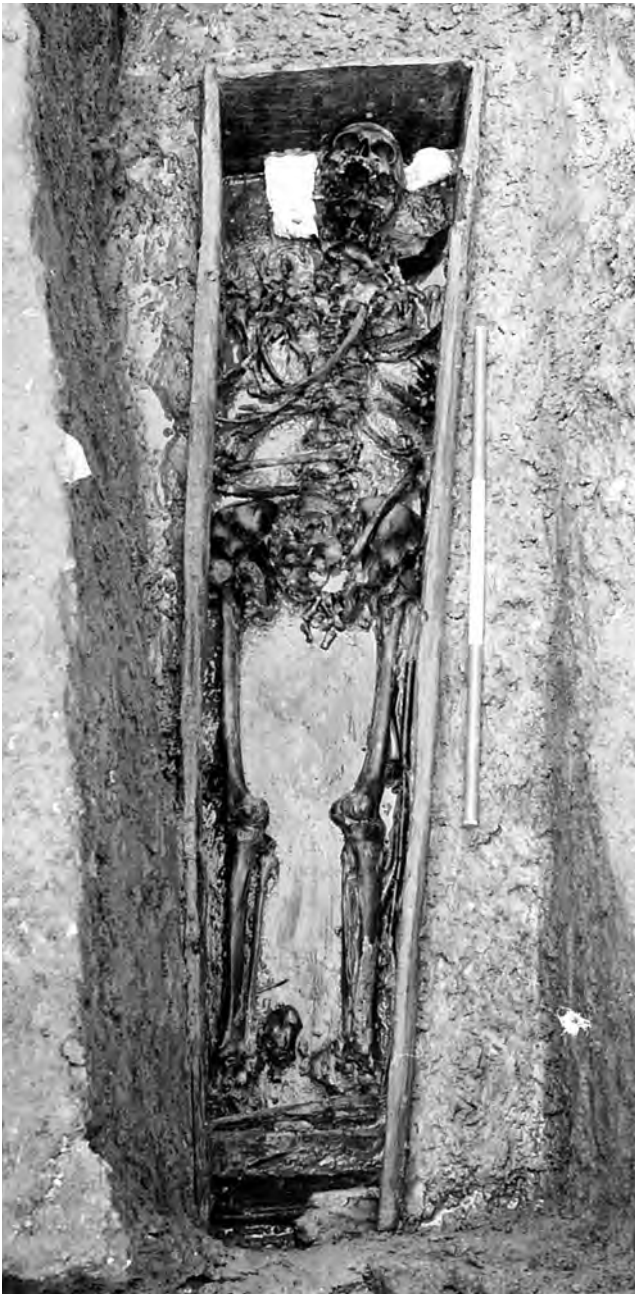
Fig. 206: Coffin, grave F3968. The skeleton fully exposed, with coppice-rods beside the sinister leg. Note also the chalk-block ear-muffs. Scale of 75 cm. Photo: Warwick Rodwell

- F3868 (sk. 1784 and 1785: adult female and young child). Two rods beside the left leg of the adult.
- F3869 (sk. 1819: adult male). One rod lay axially over the body from head to foot (Fig. 230).
- F3968 (sk. 1863: adult male). Three rods beside the left leg.
- F3980 (sk. 1867: adult female). One rod lay on the floor of the coffin against the north (left) side.
- F5044 (sk. 1925: adult male). Three rods: one on the north side by the left leg, two together on the south side.
- F5045 (sk. 1926: adult male). Two rods, one by the left leg and the other by the right.
- F5402 (sk. 2471: adult male). One rod beside the right leg.
- F5475 (sk. 2624: adult female). One rod beside the right leg.
