ST PETER'S

Barton-upon-Humber, Lincolnshire

A Parish Church and its Community

HISTORY, ARCHAEOLOGY AND ARCHITECTURE

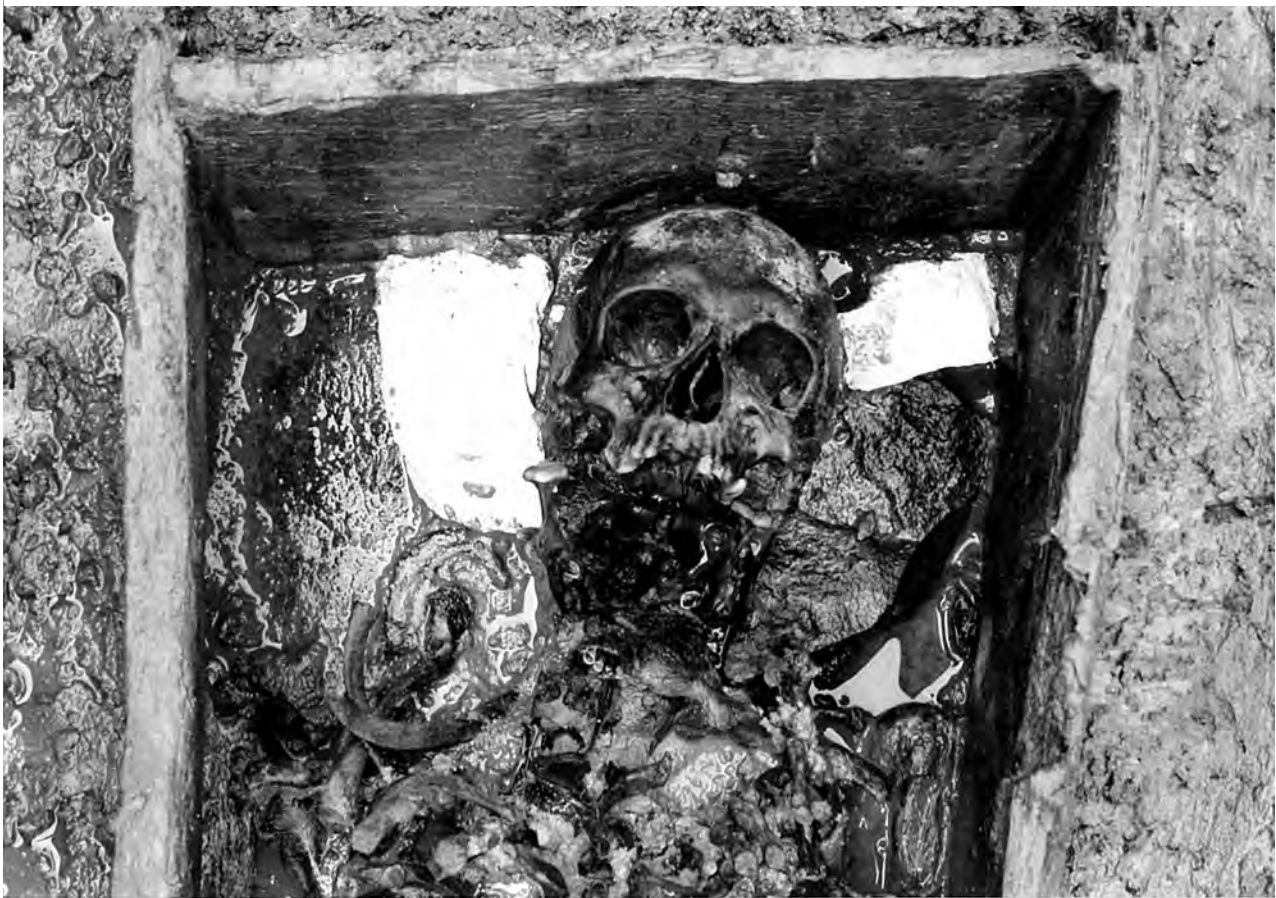
Fig. 207: Coffin, grave F3968. (upper) The skull resting on a pillow; (lower) The chalk blocks which supported the pillow. Photos: Warwick Rodwell

Of exceptional interest was burial F3968, which was interred just within the eastern boundary of the Anglo-Saxon churchyard. It contained a timber coffin which was intact and tree-ring dated to ?1079; inside it were two pillow-stones (one chalk, the other flint) over which was laid what appeared to be a rectangular pillow stuffed with grass or straw (Figs. 206 and 207). The pillow presumably had an outer casing of cloth, although nothing of this survived: there was just a bed

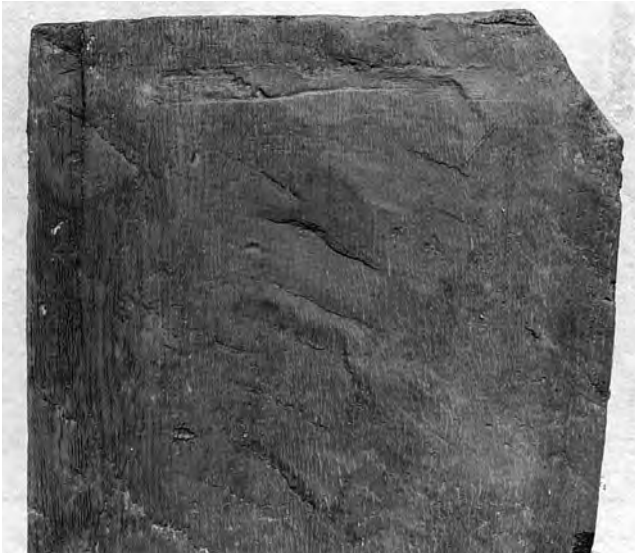
Fig. 208: Coffin, grave F3968. Detail of the base-board, showing adze marks and cut-off corner. Photo: Warwick Rodwell

A well-preserved example, directly underlying coffins F3939 and F3946 (Figs. 204–207 and 209). The planks used for the base and sides were exceptionally thick (up to 45 mm); the north-west corner of the base had been cut off at 45 degrees, using an axe (*cf.* F3868) (Fig. 208). The sides were attached to the base by three horizontal pegs in each, providing the only instance of this form of construction. On the exterior of the south board were

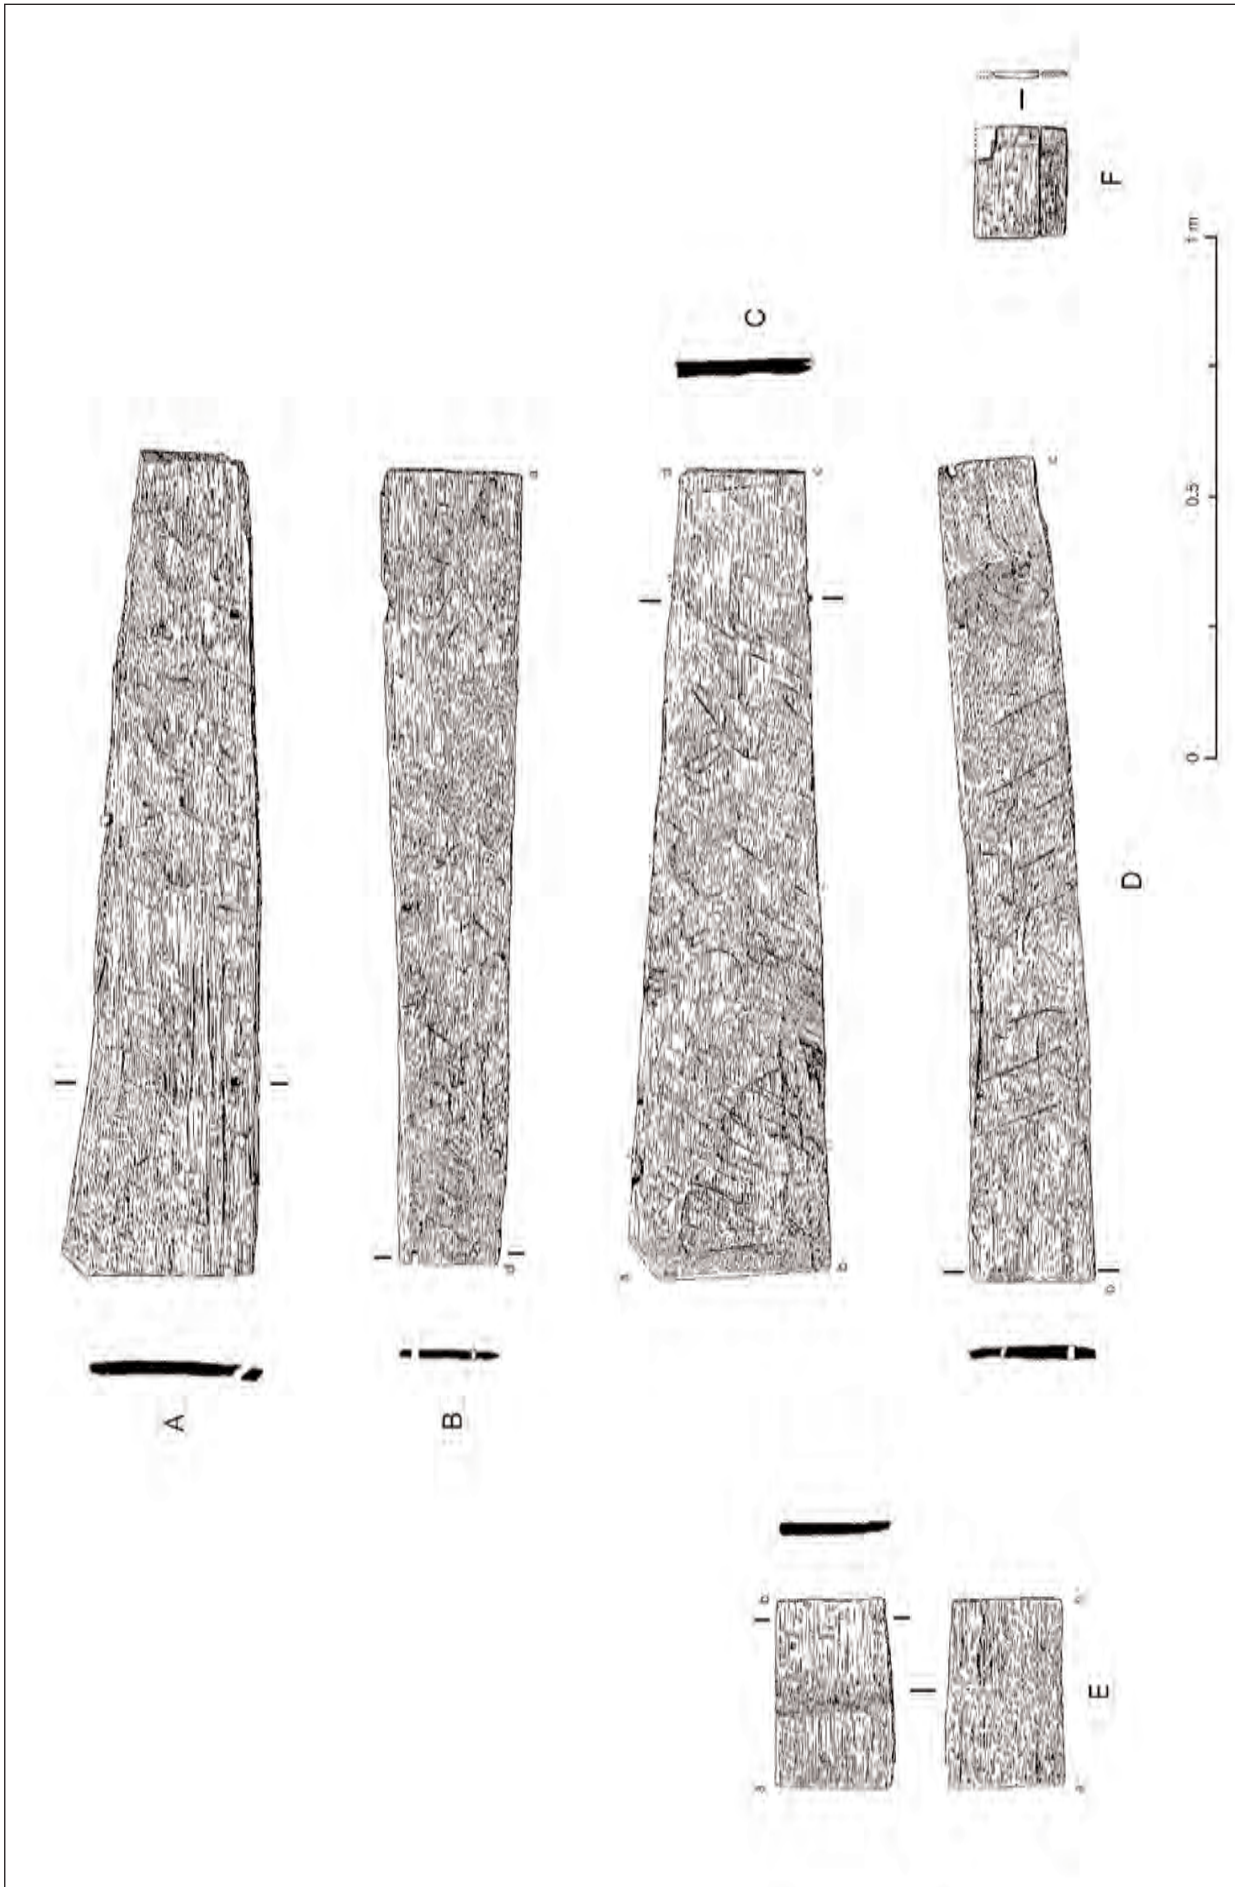
Fig. 209: Coffin, grave F3968. (A) lid (exterior); (B) north side (exterior); (C) base (interior); (D) south side (exterior); (E) west end (internal and external views); (F) east end. Scale 1:15. Drawing: Judith Dobie

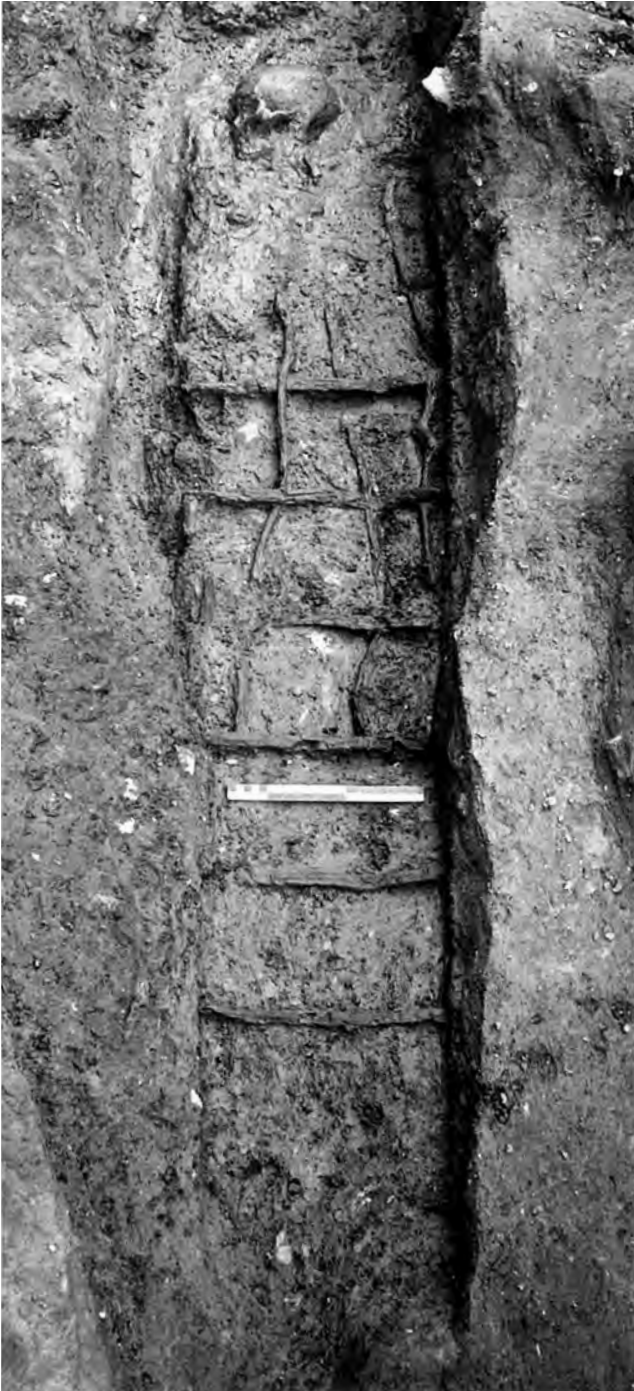
Fig. 210: Coffin, grave F3974. Vestigial remains of the batten and wickerwork base, after removal of the skeleton (the visible skull belongs to an underlying burial). View west. Scale of 25 cm. Photo: Warwick Rodwell

rectangular-section battens or slats, the ends of which were tenoned into the side-boards. The battens formed a ladder-like framework, through which withes were woven longitudinally (Figs. 210 and 211). The coffin thus had a battened and wickerwork base, instead of a plank. There were presumably east and west end-boards, set between the sides and tying-dowels at the top, but all of this had disappeared. Traces of decayed wood overlying the skeleton may have belonged to the lid, or they could have been from the base of another coffined burial which was superimposed on this one.

The vestigial remains of a coffin at Barton with a wickerwork base (F3974) were tantalizing, perhaps pointing to a desire for economy in the use of large planks (Fig. 210). The possibility that the remains in this grave belonged to a bier or bed were considered, but rejected largely on the grounds that the tapered plan and dimensions point firmly to a coffin. Idiosyncratic, *ad absurdum*, was the coffin which had six tying-dowels supporting a base-board which was too narrow (F5045; Fig. 223). These examples serve to remind us of the extraordinary diversity in coffin construction that must have obtained in St Peter's cemetery.

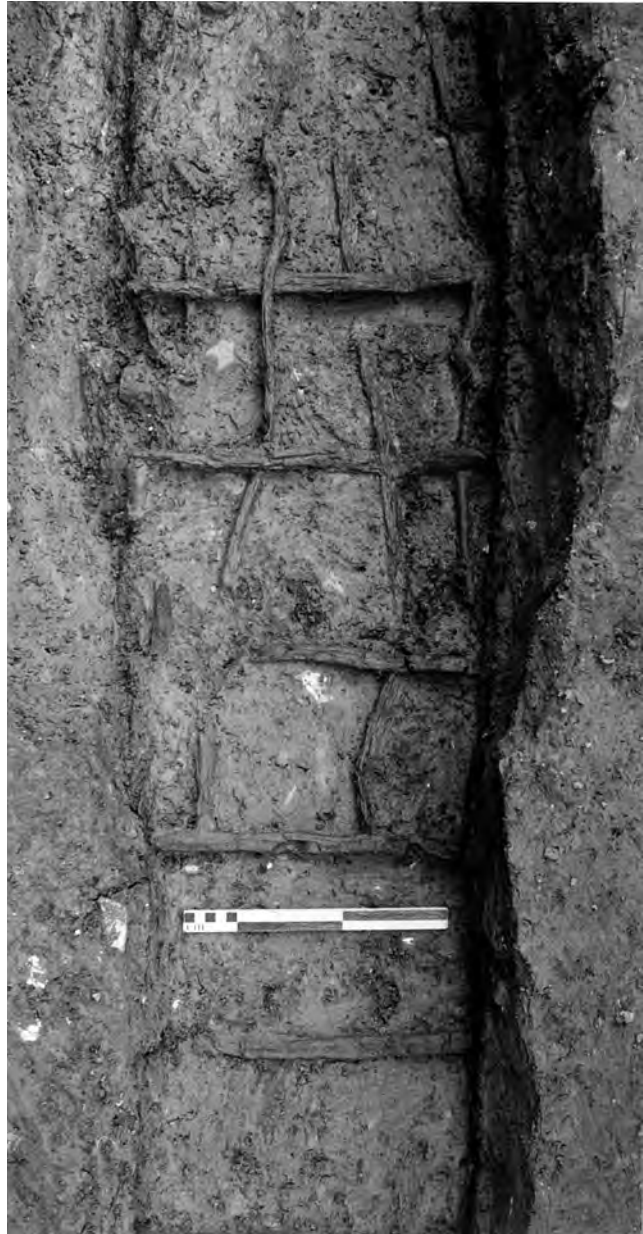
Fig. 211: Coffin, grave F3974. Detail of the batten and wickerwork base. Scale of 25 cm. Photo: Warwick Rodwell

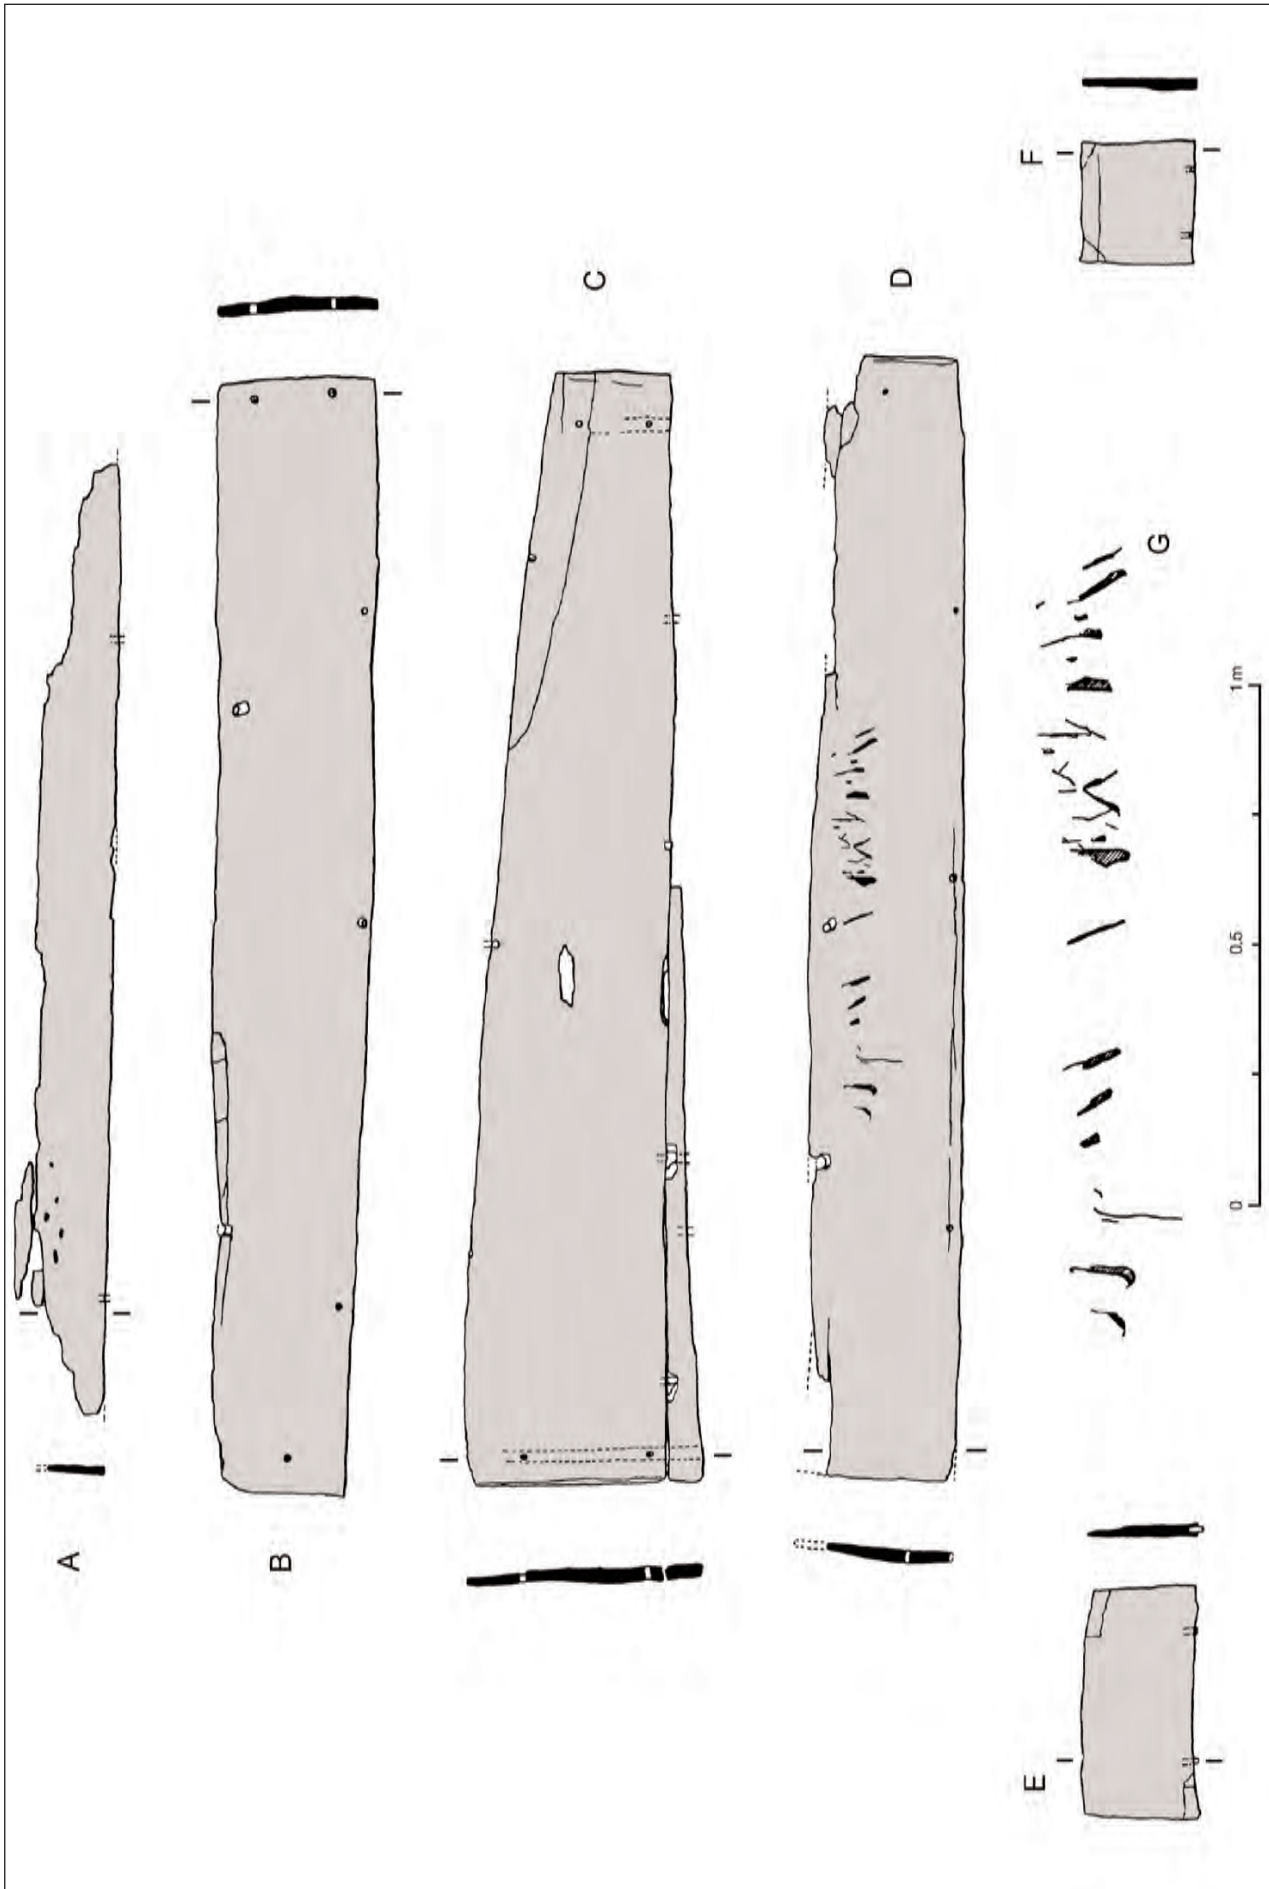
Fig. 213: Coffin, grave F5044, outline drawing. (A) lid; (B) north side (exterior); (C) base (exterior); (D) south side (exterior); (E) south side (interior); (F) east end; (G) inscription(?) on south side. Scale 1:15, except inscription, 1:7.5. Drawing: Judith Dobie

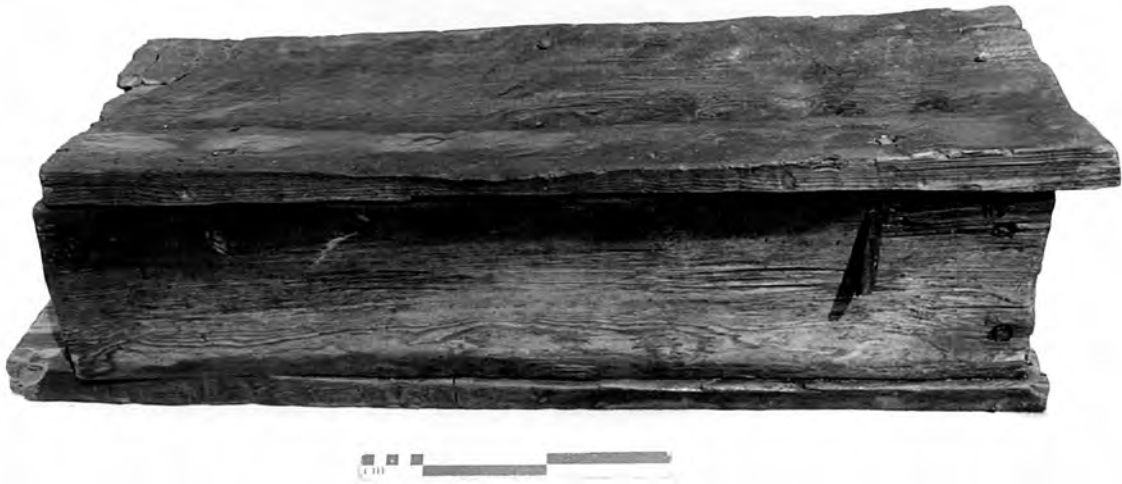
Fig. 218: Coffin, grave F5474. North side of the coffin. Photo: Warwick Rodwell

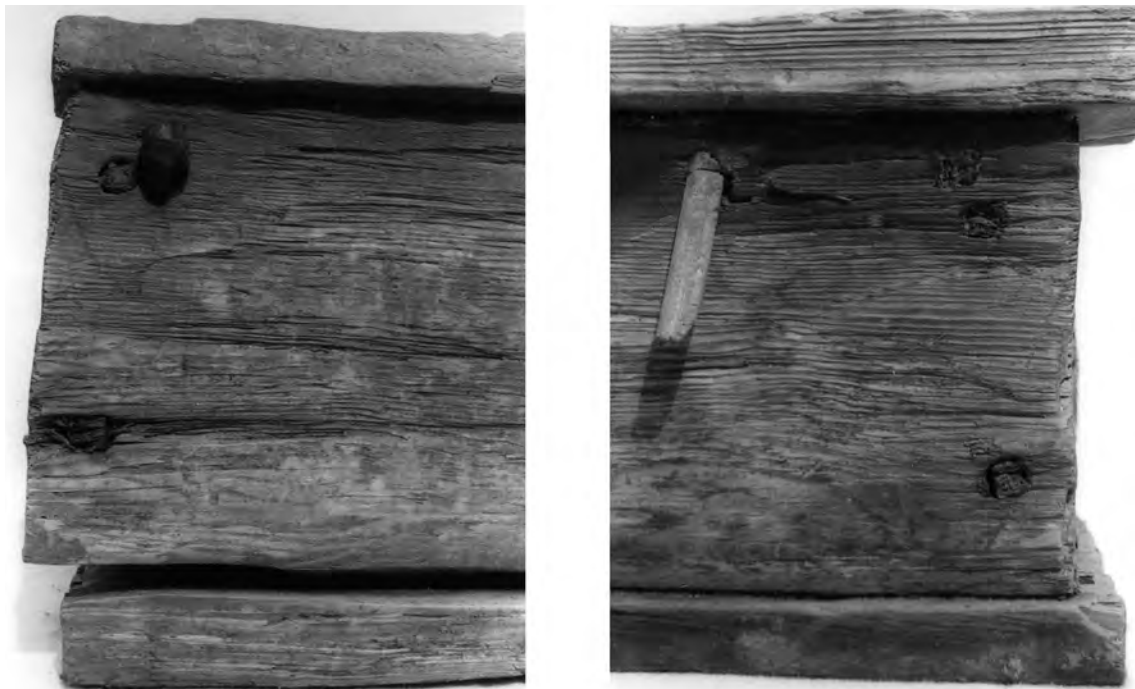
Fig. 219: Coffin, grave F5474. Details of pegging. A South side, west corner; B North side, west corner. Photo: Warwick Rodwell

face of the board. The ends were split and wedged. The lid was fixed with three pegs which were only slightly skewed from the vertical (*i.e.* not inserted at *c.* 45 degrees, like those in the oak coffins). One, on the north side, was 100 mm long and protruded through the side of the coffin, but was not trimmed off flush (Fig. 219B).

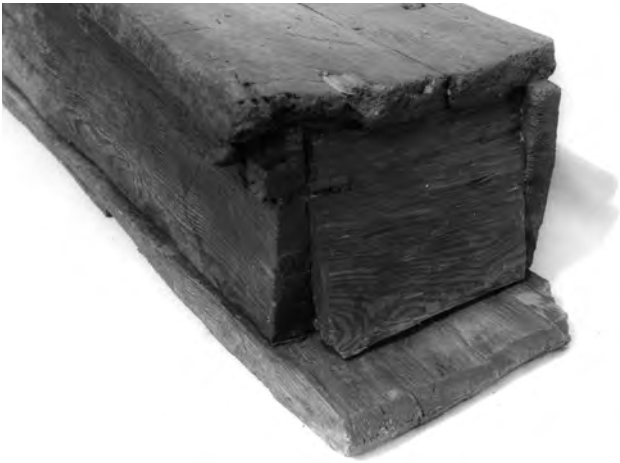
Fig. 220: Coffin, grave F5474. The coffin from the south-east, showing the tilted east end board. Photo: Warwick Rodwell

A mishap evidently occurred, potentially during the burial ritual. The coffin must have been picked up by the lid (perhaps to lower it into the grave), and pegs in the base pulled out of the west end, but those on the east seem to have held. Thus the bottom dropped open at the west end, while the east end-board swivelled on the two pegs that anchored it to the sides (Fig. 220). The carcase of the coffin was hastily pushed back down on to the base, but because the east end had tilted out of upright, this displaced the carcase westwards. The

two vertical pegs did not re-engage with the holes in the west end-board, which simply sat down on the base. Consequently, when the coffin was excavated, it was found with the east end skewed, and the basal pegs at the west end performing no function, but simply projecting into the internal void.

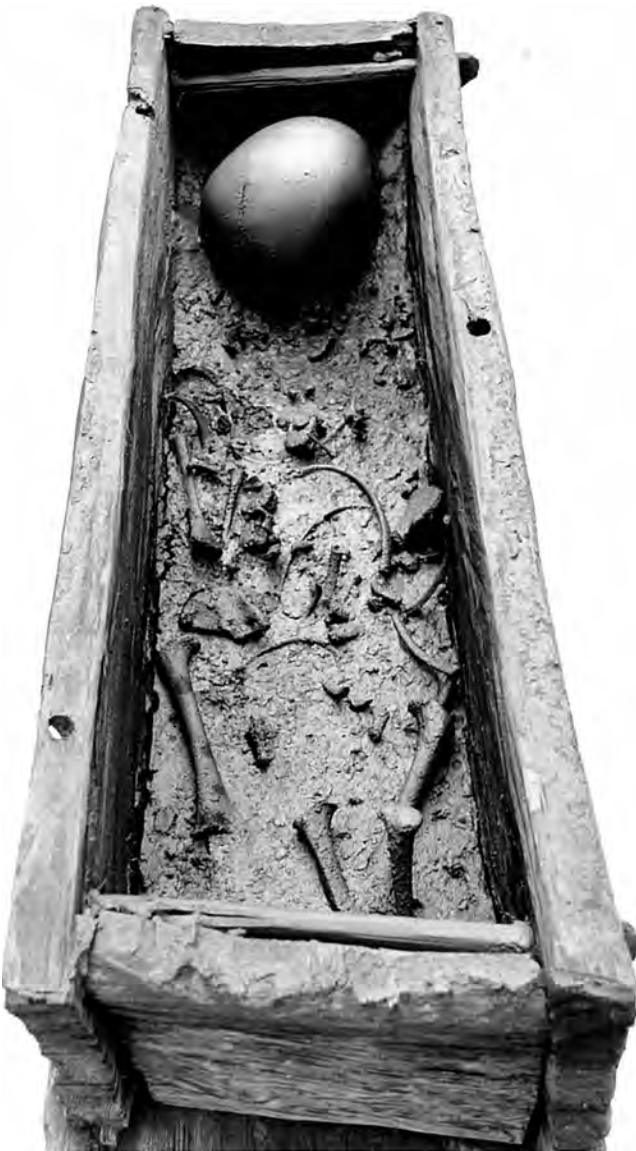
Fig. 221: Coffin, grave F5474. View of the interior from the west, after removing the lid. Unusually, the skull was found at the east end. Photo: Warwick Rodwell

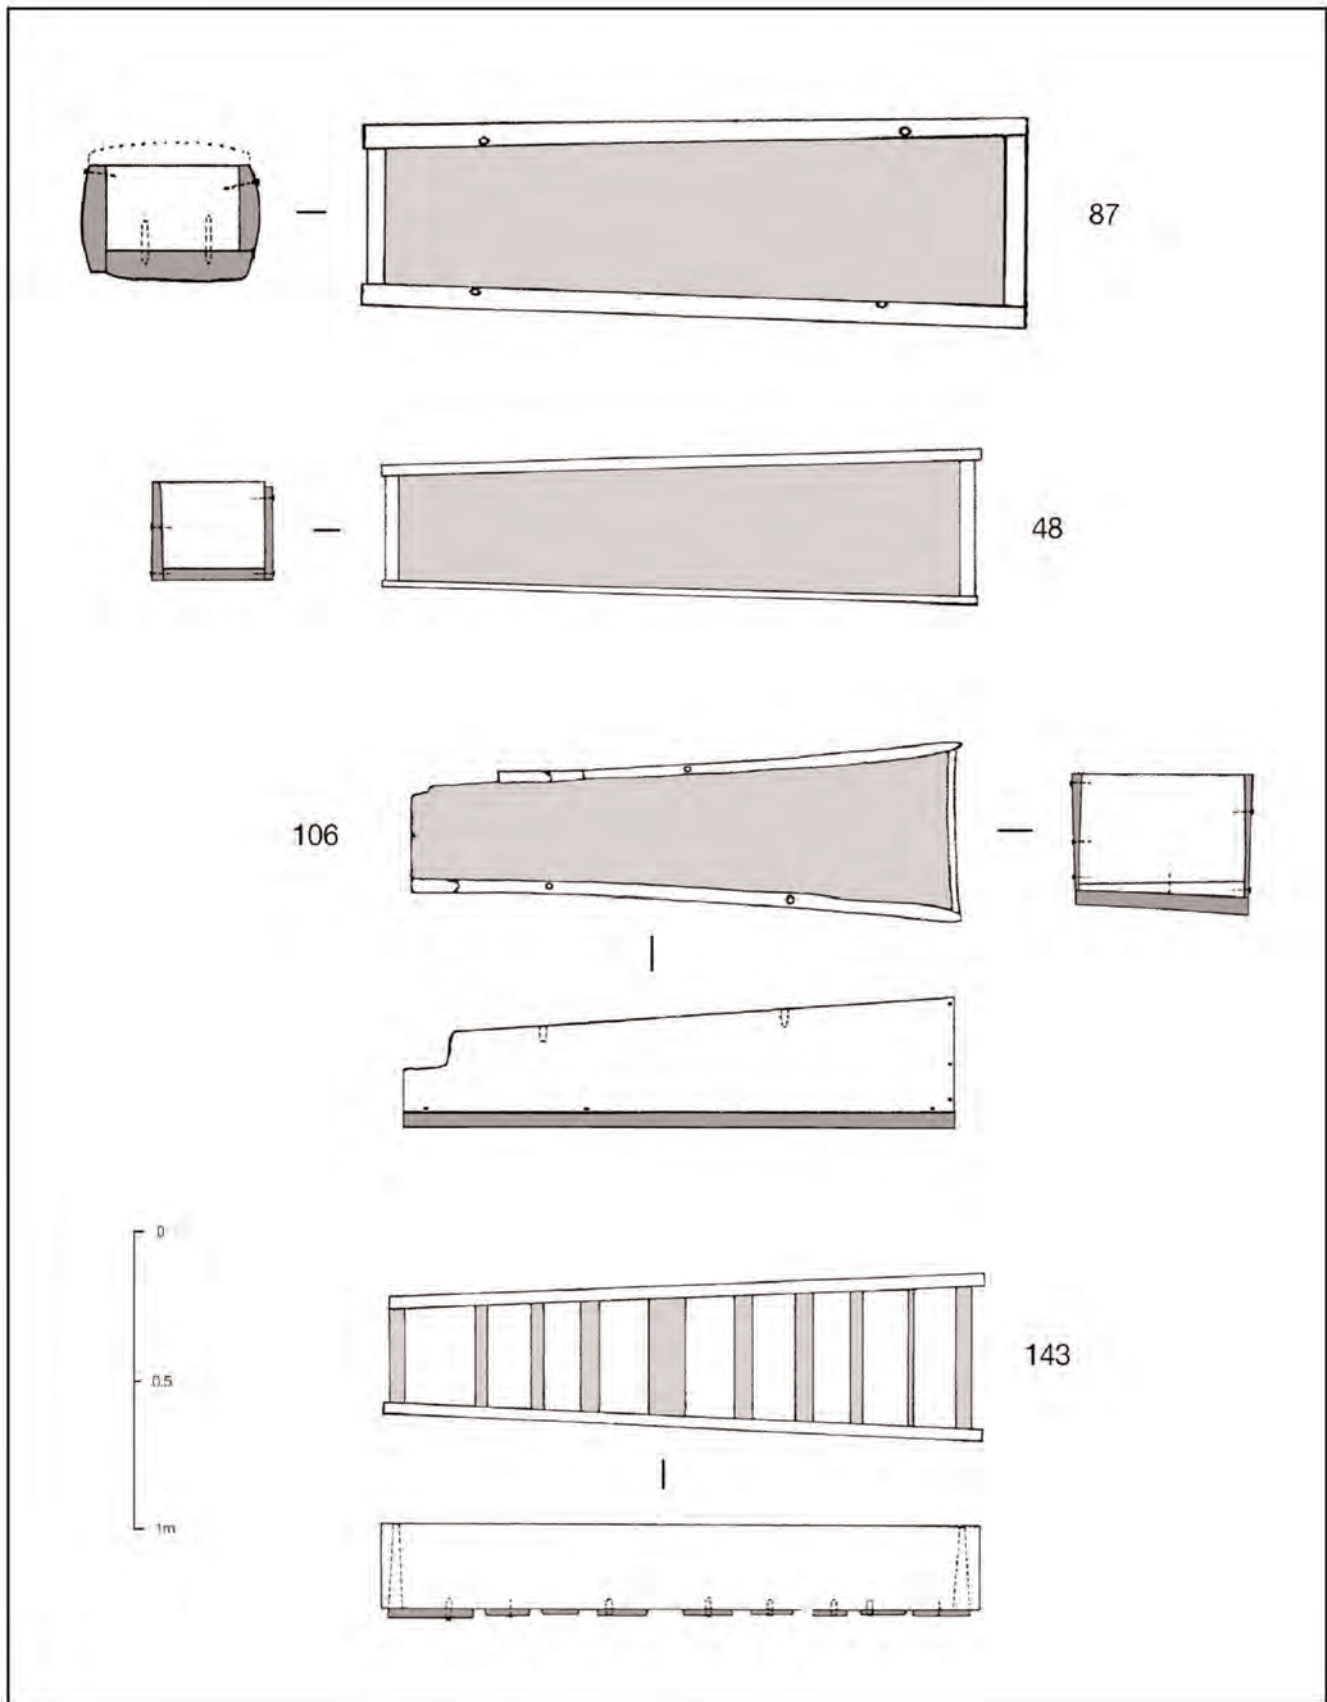
Fig. 224: Lund, Sweden. Details of coffin construction, graves 48, 87, 106 and 143. Scale 1:25. After Blomqvist and Mårtensson 1963

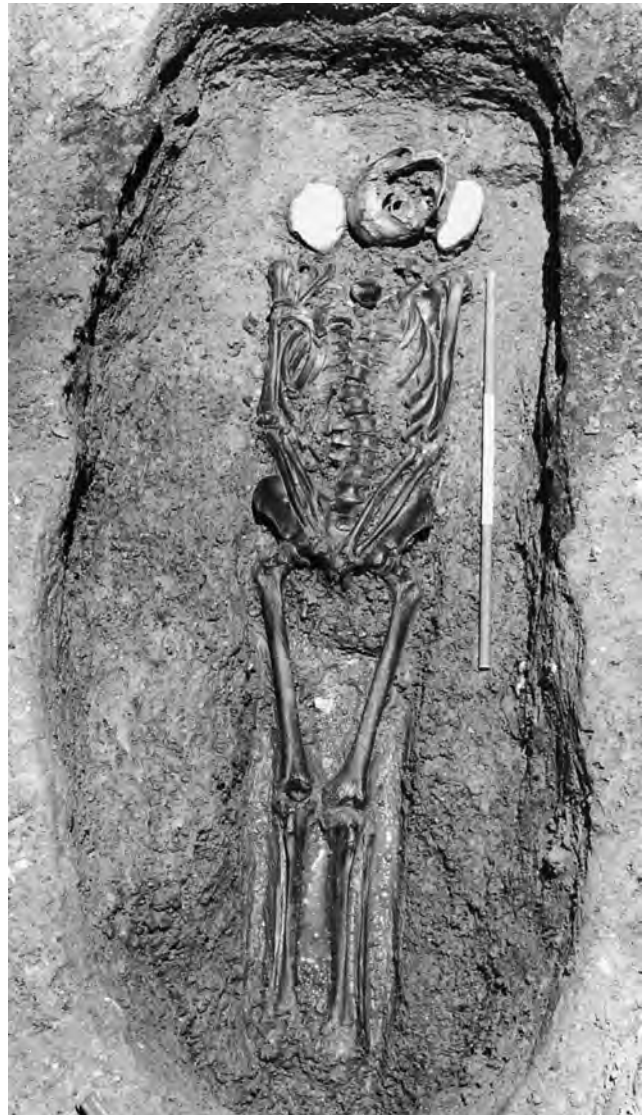
Fig. 225: A large, squarely cut grave (F1621) containing vestigial remains of a timber coffin which was a close fit for the corpse. The skull was supported by two flint nodules. View west. Scale of 75cm. Photo: Warwick Rodwell

Head-supporting stones were recorded in fifty-four of the excavated graves, nearly all of which were certainly coffined. While the evidence for a coffin was slight in five of these burials, grave size and shape provide convincing indications (*e.g.* F1621; Fig. 225). There were only two examples (F7311 and F7405) of stones used to prop the skull in definitely uncoffined burials (although even these may have had timber covers). Two arrangements were noted: 'pillow-stones' (one or more stones placed under or behind the skull to support it) and 'ear-muffs' (a pair of stones flanking the skull to prevent the head from rolling to one side). The materials used for these supports were very varied and clearly not specially selected: they included flint, chalk, sandstone and other erratics, quern fragments and domestic objects of fired clay (*e.g.* loomweights).

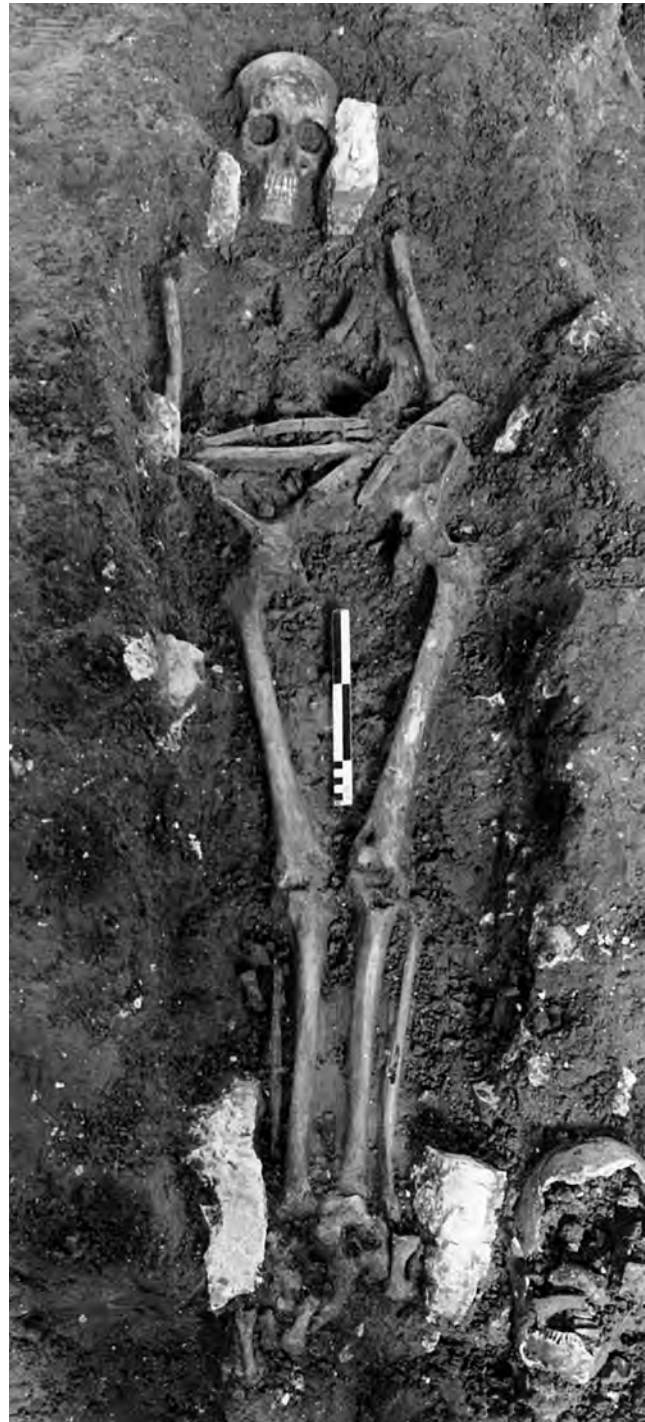
Fig. 227: Grave F1464. A coffined burial with chalk blocks supporting the skull and feet. View west. Scale of 25 cm. Photo: Warwick Rodwell

side, and two smaller pieces (one of limestone, the other a fragment of gritstone quern) cradling the top of the head. There were no instances of additional stones laid over the face, as at Raunds (*cf.* Boddington 1996, figs. 46–9 and 54). A single instance of stones at the feet was recorded in a coffined burial: grave F1464 had two flat pieces of chalk serving as ear-muffs, and two more as ankle-props (Fig. 227). Another piece of chalk beside the dexter thigh was probably fortuitous.

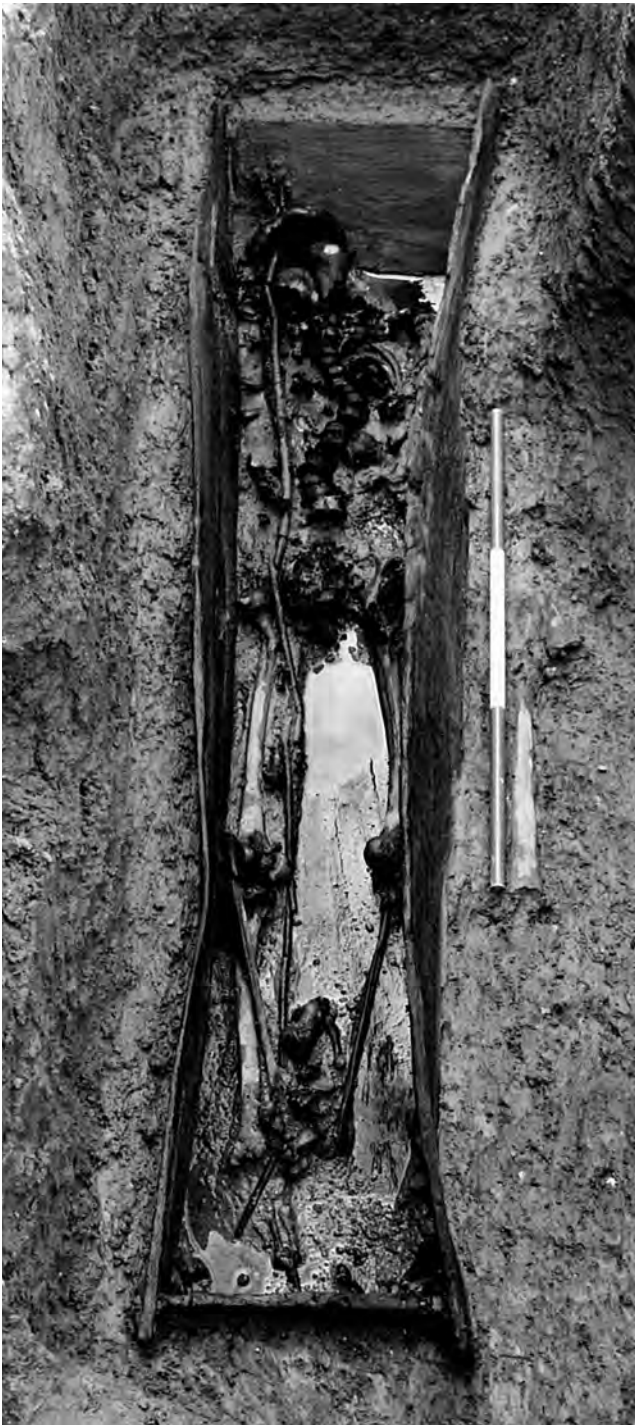
Fig. 230: Grave F3869. A single rod laid on top of the corpse, but collapsed and broken into numerous pieces. It extended for the full length of the coffin. View west. Scale of 75 cm. Photo: Warwick Rodwell

- F3868 (sk. 1784 and 1785: adult female and young child). Two rods beside the left leg of the adult.
- F3869 (sk. 1819: adult male). One rod lay axially over the body from head to foot (Fig. 230).
- F3968 (sk. 1863: adult male). Three rods beside the left leg.
- F3980 (sk. 1867: adult female). One rod lay on the floor of the coffin against the north (left) side.
- F5044 (sk. 1925: adult male). Three rods: one on the north side by the left leg, two together on the south side.
- F5045 (sk. 1926: adult male). Two rods, one by the left leg and the other by the right.
- F5402 (sk. 2471: adult male). One rod beside the right leg.
- F5475 (sk. 2624: adult female). One rod beside the right leg.

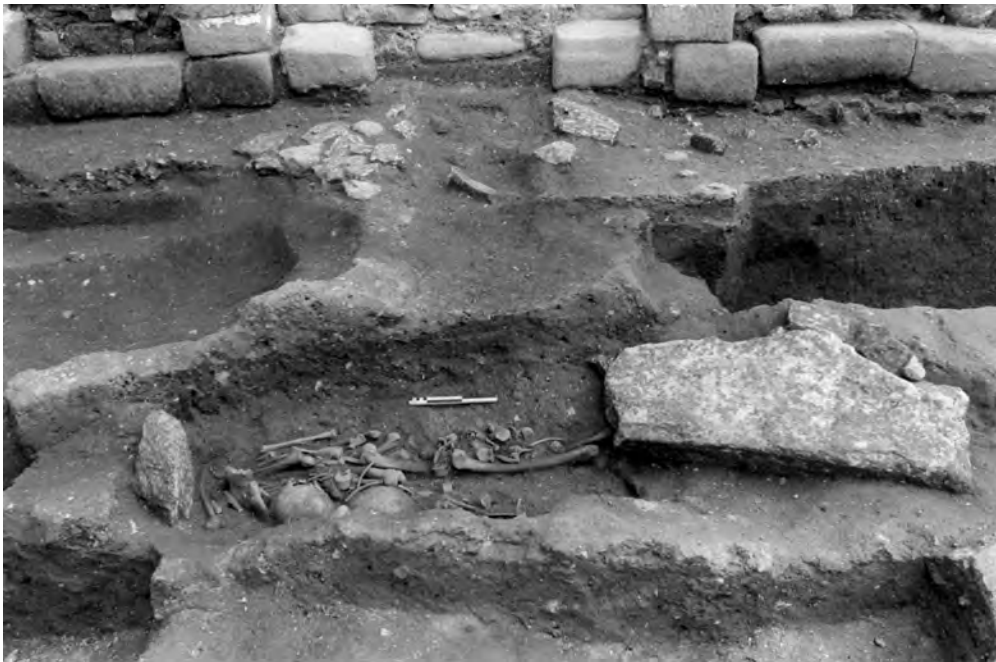
Fig. 233: Grave F7263. As found, with the charnel deposit in the upper filling, and the broken and partly displaced grave-cover. View south, showing also the hollow path leading to the (blocked) north door of the tower. Scale of 25 cm. Photo: Warwick Rodwell

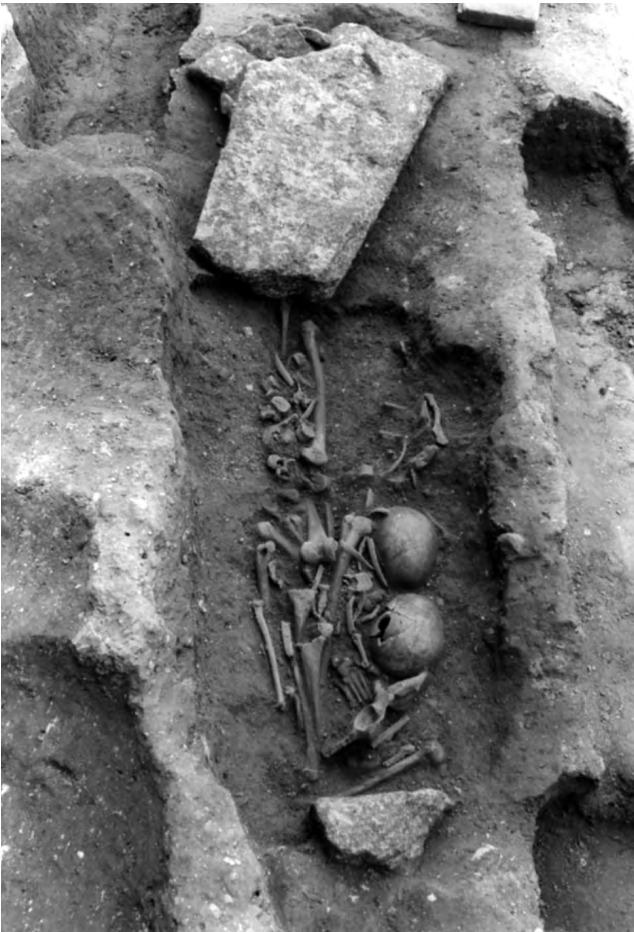
Fig. 234: Grave F7263. Detail of the charnel deposit and fragments of limestone grave-cover. View west. Photo: Warwick Rodwell

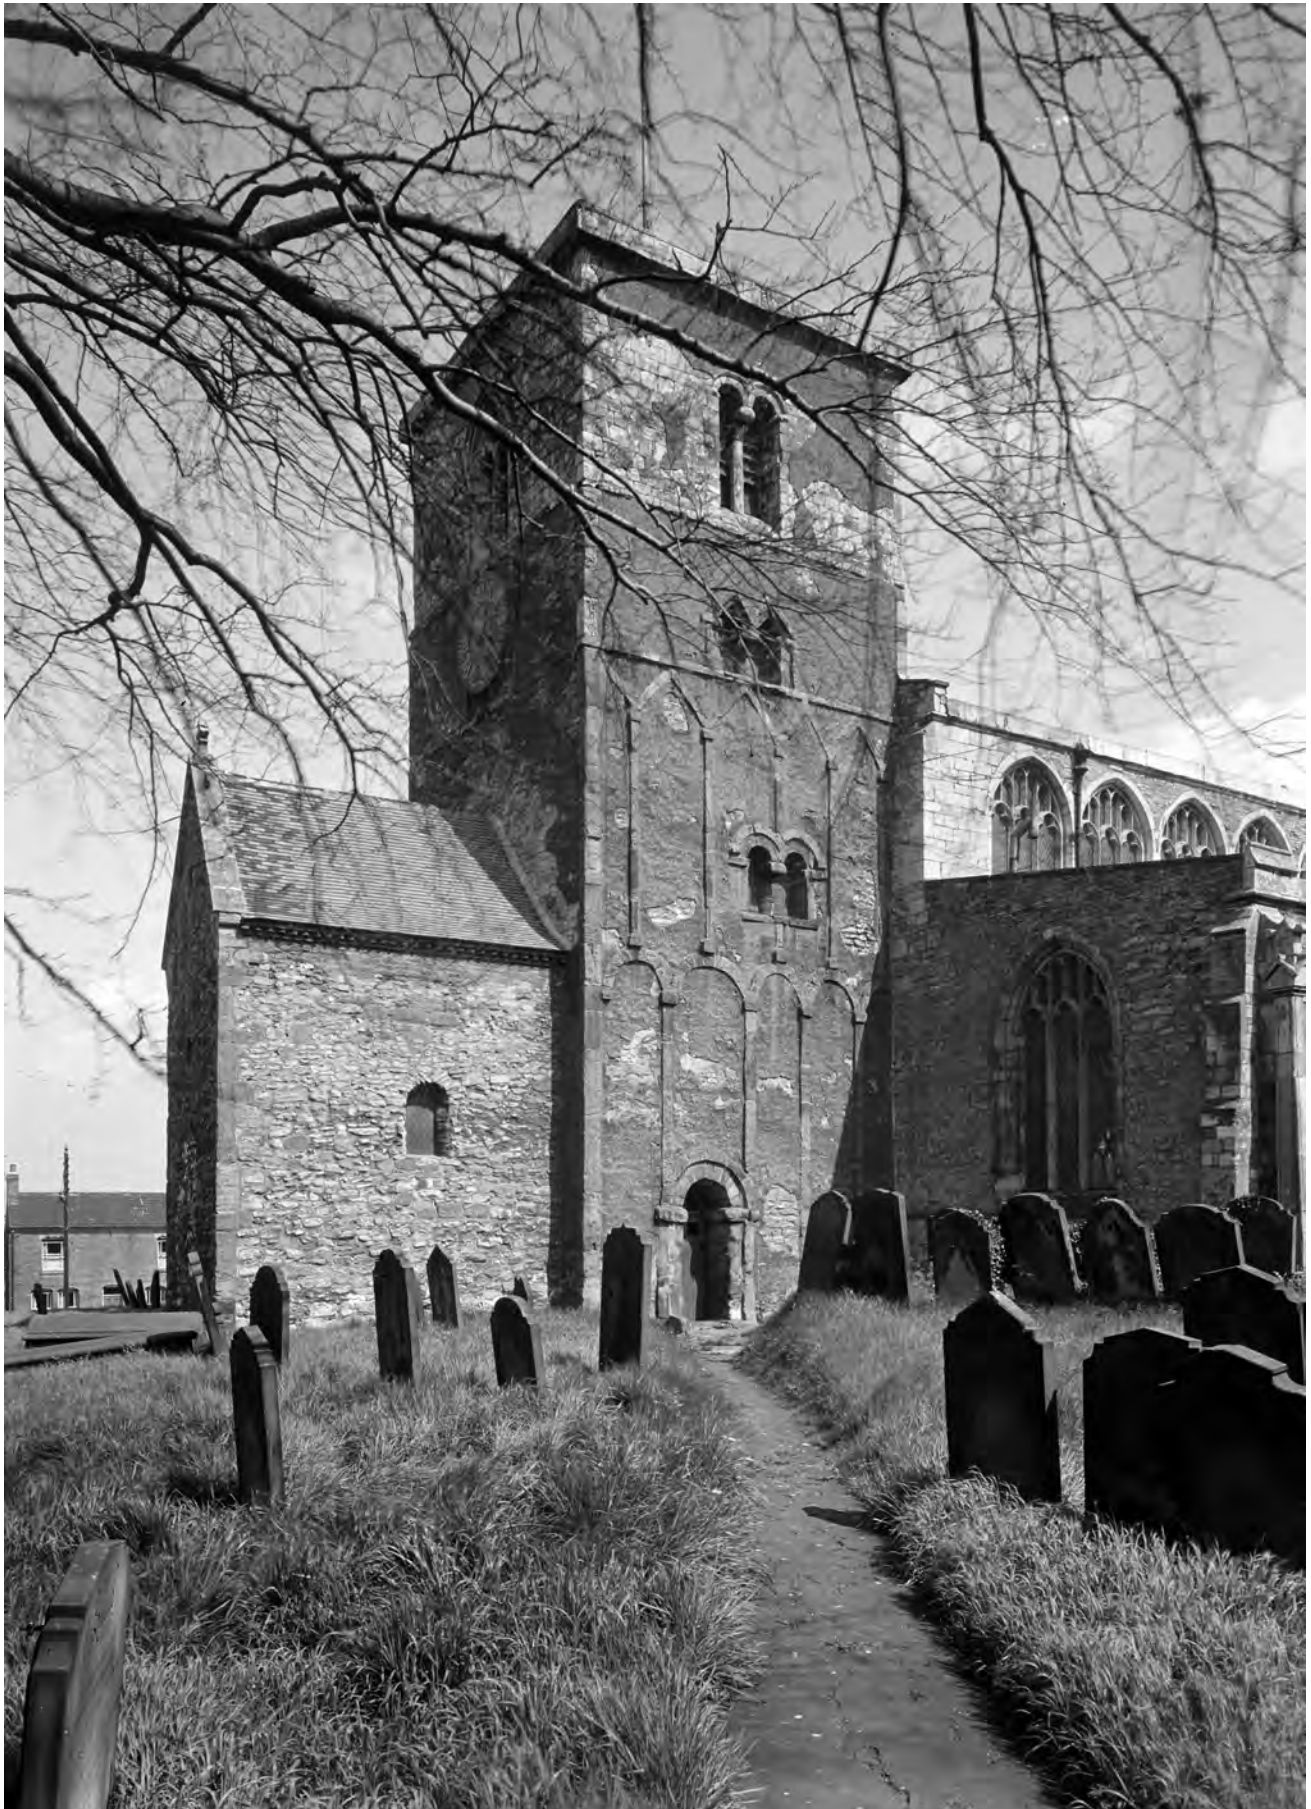
Fig. 239: St Peter's tower and annexe from the south-west, 1953. This shows the church prior to re-rendering in 1965 and graveyard clearance in 1966. Photo: English Heritage, NMR

To the west, the tower is abutted by the lower and narrower annexe, which has a steeply pitched roof covered with red clay tiles (Fig. 239). The annexe is squarish in plan, but slightly skewed in its abutment to the tower; it is gabled on the west and is entirely cement rendered apart from its gritstone-dressed quoins, gable copings and red brick eaves-courses. The annexe is lit by round-headed windows in the north and south walls, and two *oculi* in the west wall, none of which have stone dressings. The scar of a blocked, round-headed opening for a doorway is outlined in the rendering of the west wall.

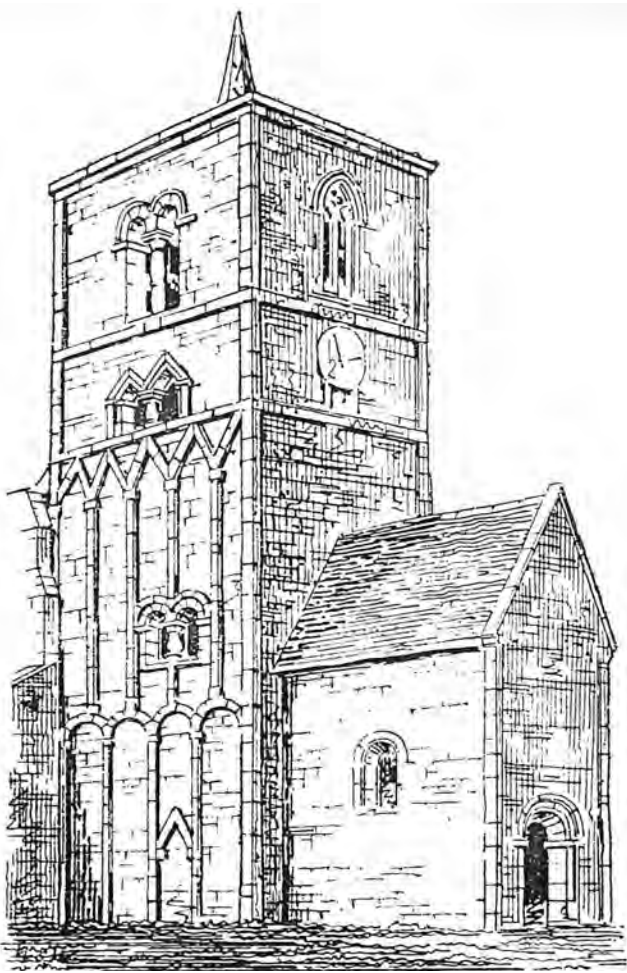
Fig. 251: Tower and western annexe. View from the north-west, showing the intruded west doorway and a *flèche* for which there is no other evidence. Drawn for Sir George Gilbert Scott in the 1860s. Scott 1879

visit sometime in the period 1859–69, when he sketched the western annexe (Fig. 251).

in the annexe, which subsequently resulted in its dismantling and the infilling of the opening, in 1869–70. Although short-lived, the alteration was recorded in a drawing by Sir George Gilbert Scott, and subsequently published in 1879 (Scott 1879, 54) (Fig. 251). The doorway was to cause great confusion in the architectural record for a century to come. Even as early as 1867, the modified annexe was accepted as 'a building, forming a kind of porch or galilee, also of rude and early character ... [with] rude round-headed doorways to the Tower and at the west side' (Glynne 1898, 201–2).
