ST PETER'S

Barton-upon-Humber, Lincolnshire

A Parish Church and its Community

HISTORY, ARCHAEOLOGY AND ARCHITECTURE

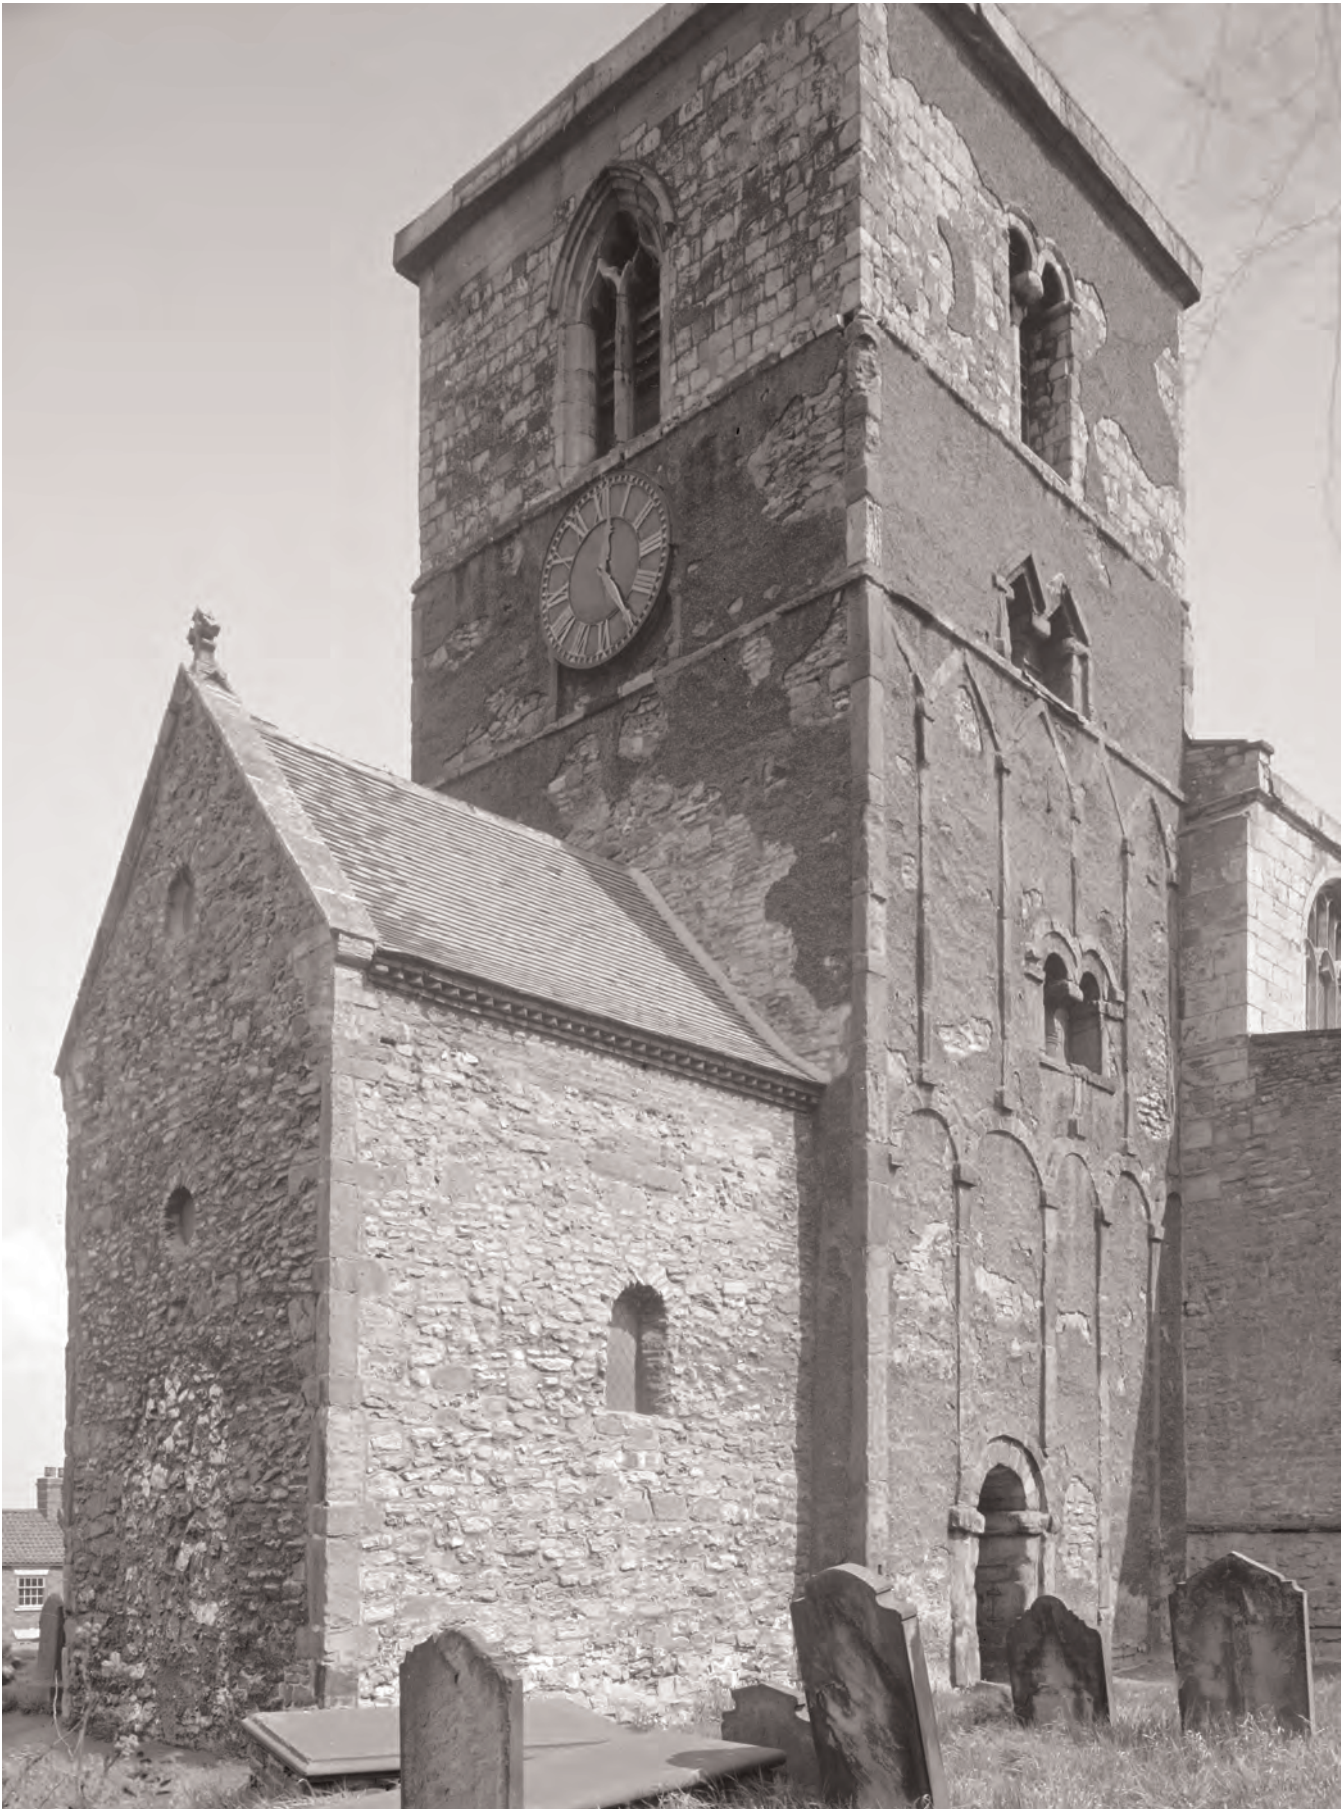
Fig. 255: Tower and western annexe, 1953. By this time the rendering had been stripped from the annexe, revealing the infilled doorway in the west wall. Photo: English Heritage, NMR

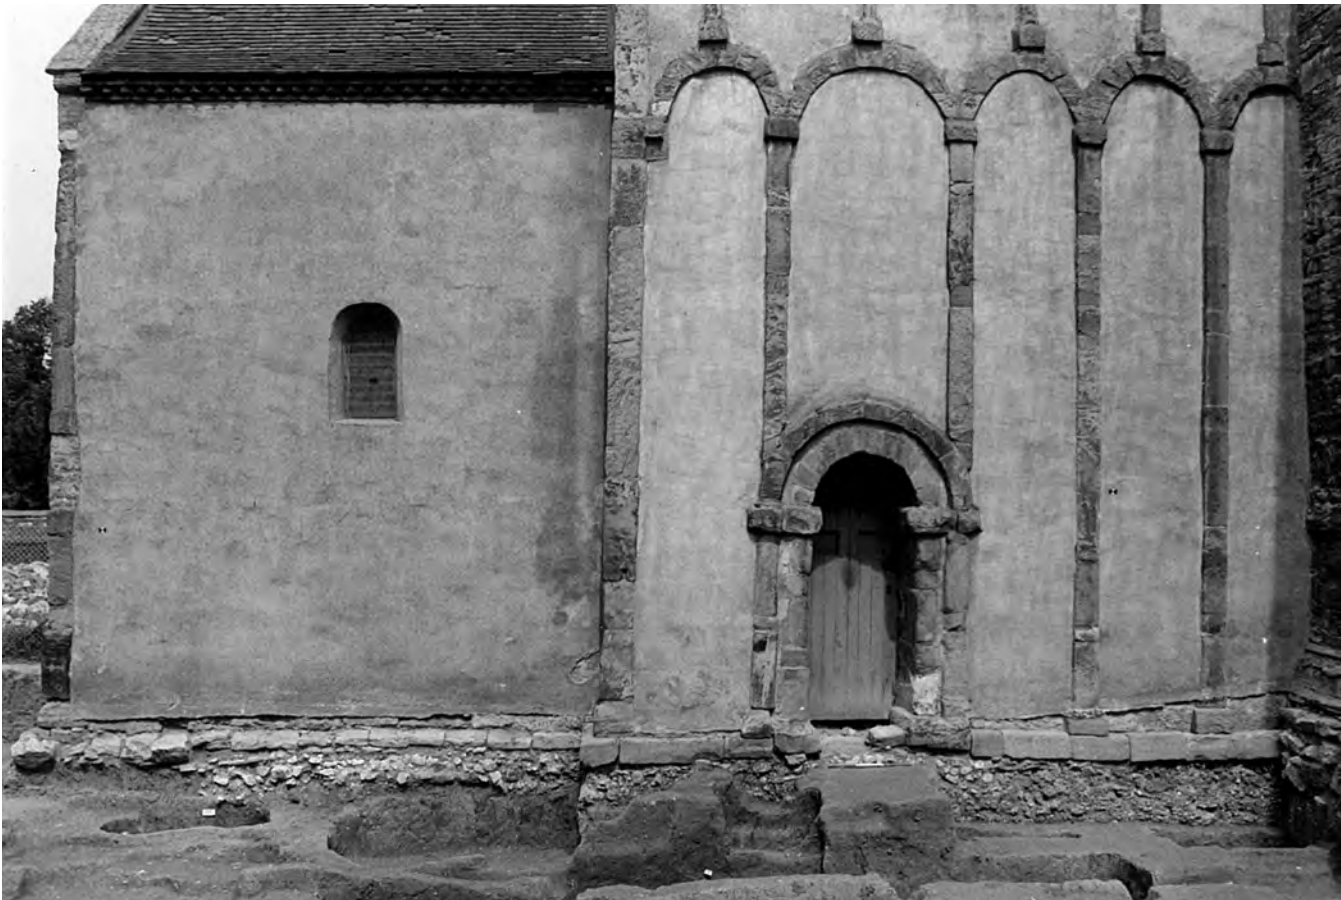
Fig. 260: Tower (Stage 1A) and annexe from the south, after excavation, 1981. Photo: Warwick Rodwell

Externally, the tower measures 7.2 m (23½ ft) square in plan, and the walls rise from a ground-level plinth comprising large blocks of gritstone of varying lengths (Fig. 260). The plinth is square-edged, unmoulded and projects by 5–10 cm beyond the wall face. It is interrupted by the doorways and does not continue across the east and west faces, returning only far enough to meet the abutments of the chancel and baptistery, both of which had their own plinths.

The first register (Stage 1A) comprises five bays of tall, narrow arcading with semicircular heads (Fig. 260). The pitch approximates to 1.2 m (4 ft), except in the case of the second bay from the west, where, on both the north and south, it has been expanded to 1.7 m (5½ ft) to accommodate a doorway, and the arch has been commensurately flattened and stretched to fit. Although varying in size, the voussoirs of the arches have been individually shaped, and many are non-radially jointed; between adjacent bays are special voussoirs, acting as double springer-blocks (Fig. 261). The voussoirs are so eroded that many now give the impression of being bevelled on the upper face, which was not originally the case. In each arch the central keystone is larger than the other voussoirs, but does not project beyond them. Being protected from above,

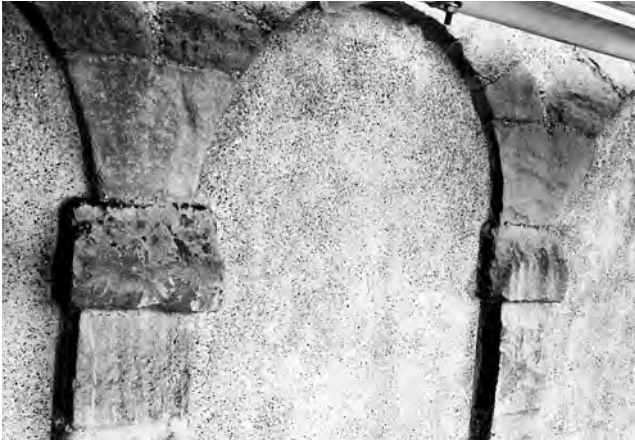
Fig. 261: Tower: Stage 1A, north. Wall-arcading, showing trapezoidal double-springers supported by the plain rectangular capitals of the pilasters. Photo: Warwick Rodwell

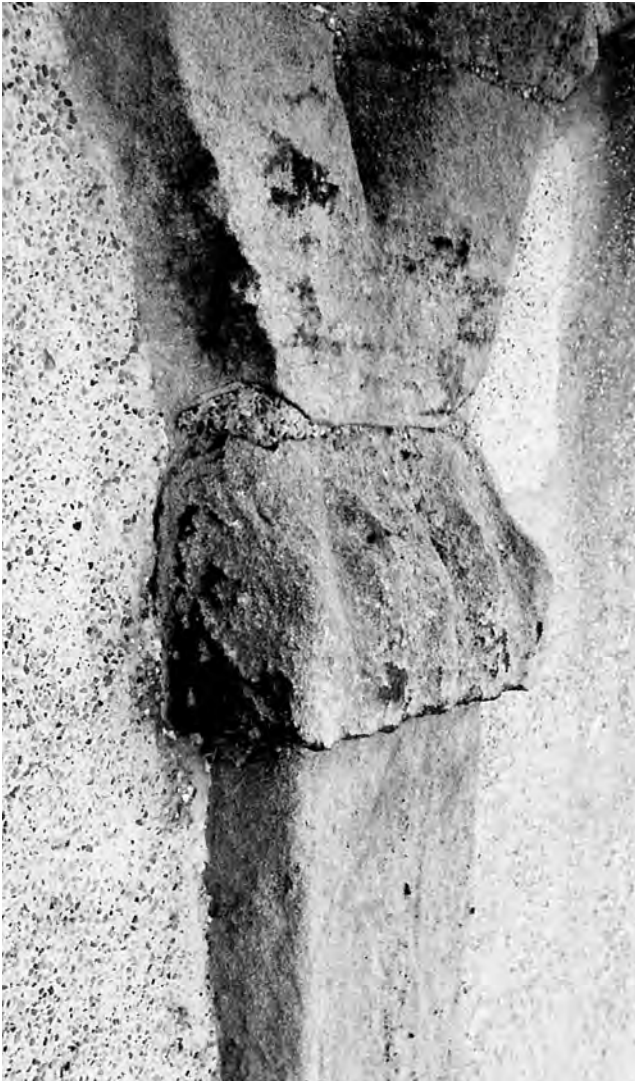
Fig. 262: Tower: Stage 1A, south. Plain rectangular capital, now heavily eroded and giving a false impression of being decoratively fluted. This capital supports the only example of a double-springer at this level which was specially shaped to seat the lowest voussoirs of the adjoining arches. Photo: Warwick Rodwell

The springers rest on plain rectangular capitals which are only slightly wider than the pilaster-strips that support them. Many of the capitals give the appearance of having bevelled upper angles, or fluting on the vertical faces (Fig. 262). Again, these 'decorative' effects are entirely fortuitous, being the result of weathering and variations of hardness within the 'grain' of the gritstone. The effects can be of dramatic appearance and are present throughout the tower. By and large, tall vertical stones were edge-bedded, and many of these have developed pseudo-fluting (*cf.* Potter 2005). By contrast, blocks that have their longer dimension in the horizontal plane were face-bedded and weathering has given them false bevels and semblances of other linear mouldings.

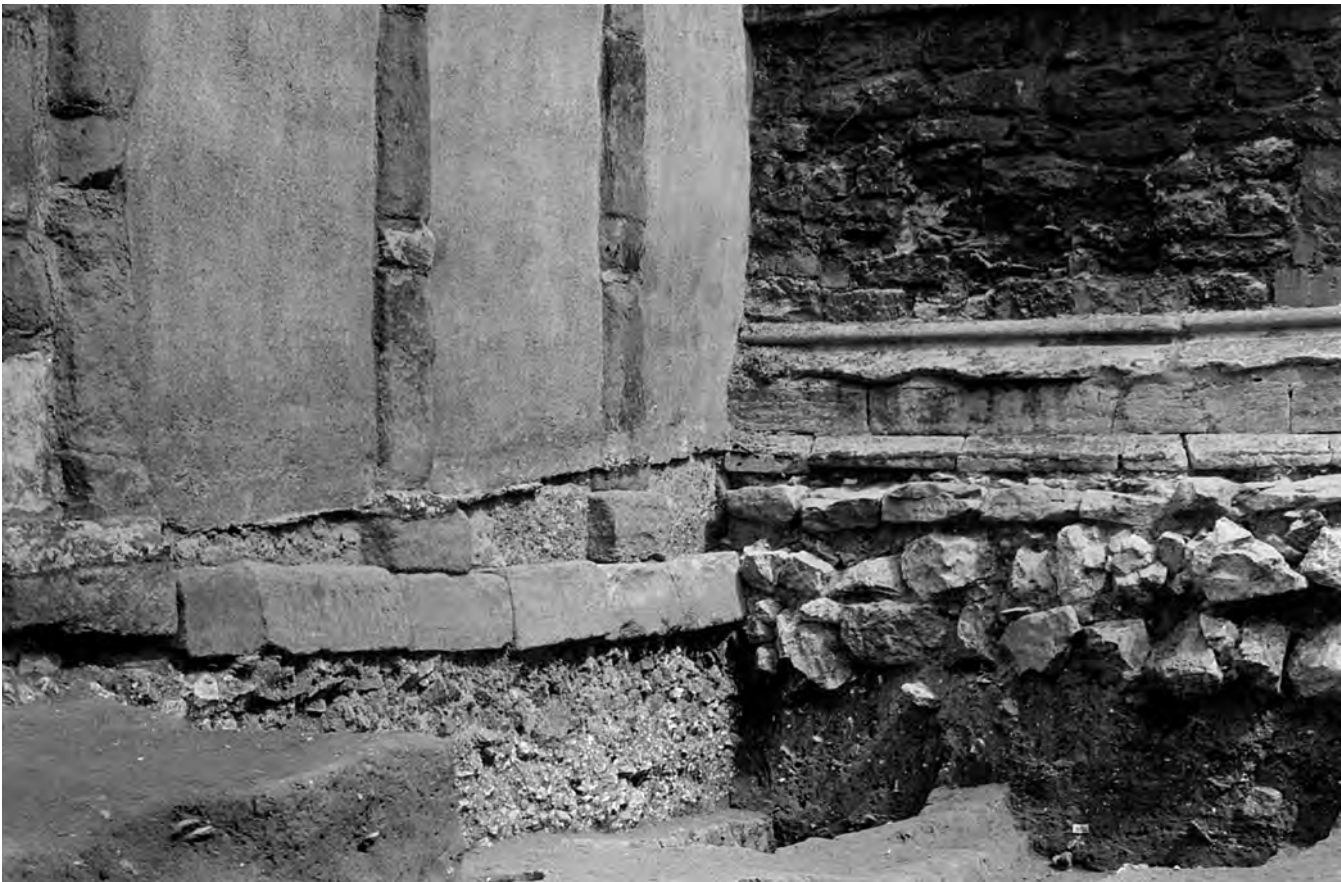
Fig. 264: Tower: plinth and base-blocks of the pilasters, exposed by excavation. These had been buried by the rising churchyard level by the late thirteenth century, when the south aisle (right) was built. Photo: Warwick Rodwell

At the western ends of the arcades, the arches spring from plain impost or brackets which are integral with the quoins of the tower; these specially shaped blocks represent a higher level of sophistication in masoncraft than is present at some of the other points of junction (Fig. 263). The eastern terminations of the arcades are doubtless similar, but are concealed by the abutment of the medieval aisles. The pilaster-strips are of regular long-and-short construction, and each has a plain rectangular base-block similar to the capital, resting on the ground-level plinth (Fig. 264).

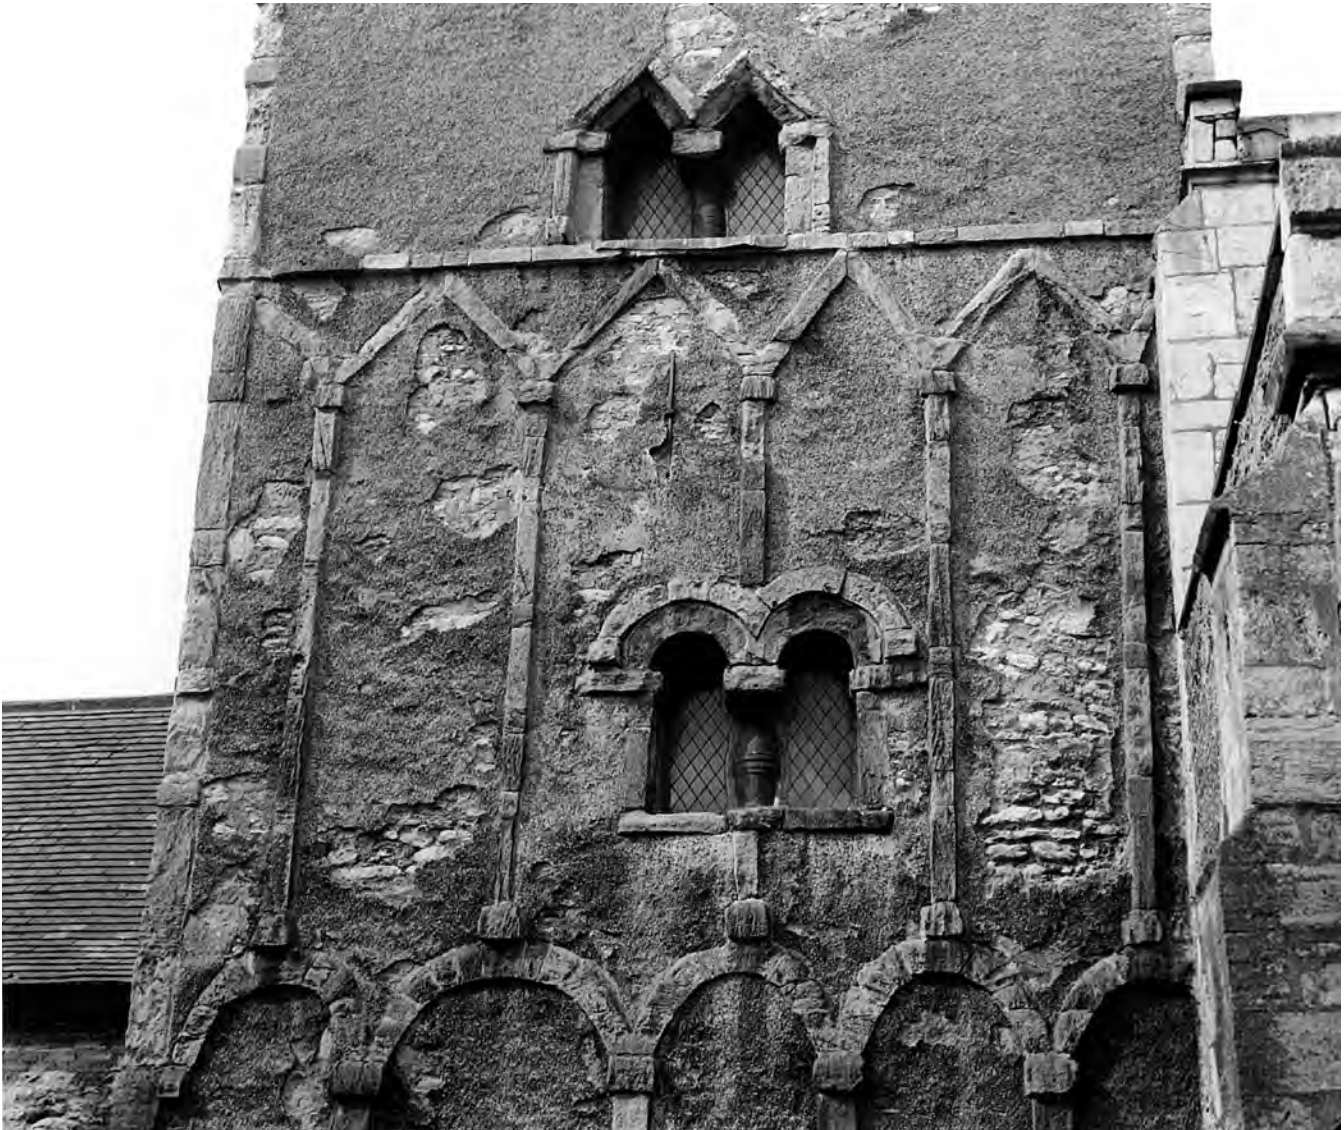
Fig. 265: Tower: Stage 1B, 1965. Triangular-headed arcading and remains of the rendering of c. 1870 on the south side. Photo: David Lee Photography

The second register (Stage 1B) consists of four complete and two half-bays of narrow arcading with triangular heads, all formed in stripwork (Fig. 265). The irregular pitch was determined by the lower arcade, the divisions of the upper bays rising from the keystones of the arches below. Once again, the pilaster-strips comprise fairly regular long-and-short work, with projecting capitals and bases consisting of blocks of more-or-less square form. The base-blocks in particular are now heavily weathered, and some give the impression of being moulded. Nevertheless, there is little doubt that both the capitals and the bases were originally plain cubical blocks of stone, albeit that some faces were out of square. Each capital supports a trapezoidal springer which not only provides a seating for the canted slabs but is also an integral component of the triangular-head.

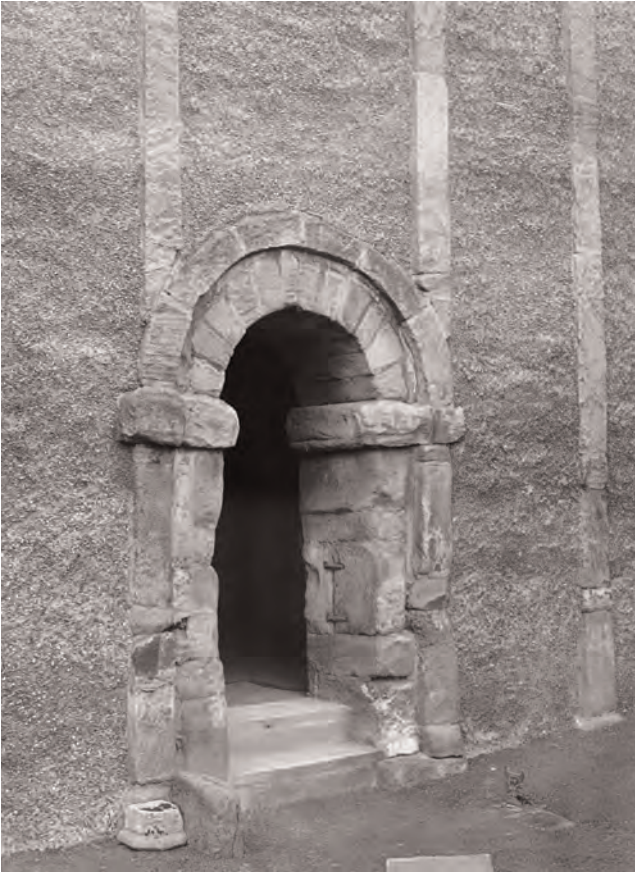
Fig. 266: Tower: south doorway, c. 1900. Taken before internal floor level was lowered and the steps removed. This also shows the pebbledash rendering that was applied c. 1870. Photo: English Heritage, NMR

South doorway (Figs. 259, 5, 266 and 267)

The round-headed doorway is set in the second of the five bays of external arcading. The opening is 1.05 m (3½ ft) wide and passes through the full thickness of the south wall without rebate or splay. The jambs are lined with gritstone blocks, alternating between deep and shallow courses, thus giving an external appearance of long-and-short work.⁴⁷ The jambs are founded on base-blocks that project both forwards and laterally (5 cm) into the opening, and are also raised slightly above the general plinth level. Surmounting the jambs are heavy impost blocks, again projecting forwards and laterally, and the lower arris bears a moulding (Fig. 268, nos. 3 and 4). The semicircular arch is composed of twelve unmodelled voussoirs. Outlining the doorway is a plain, square-section label, the ends of which are seated on small blocks projecting from the flanking stripwork of the wall arcading. The label interrupts the stripwork, thereby imparting greater *gravitas* to the doorway.

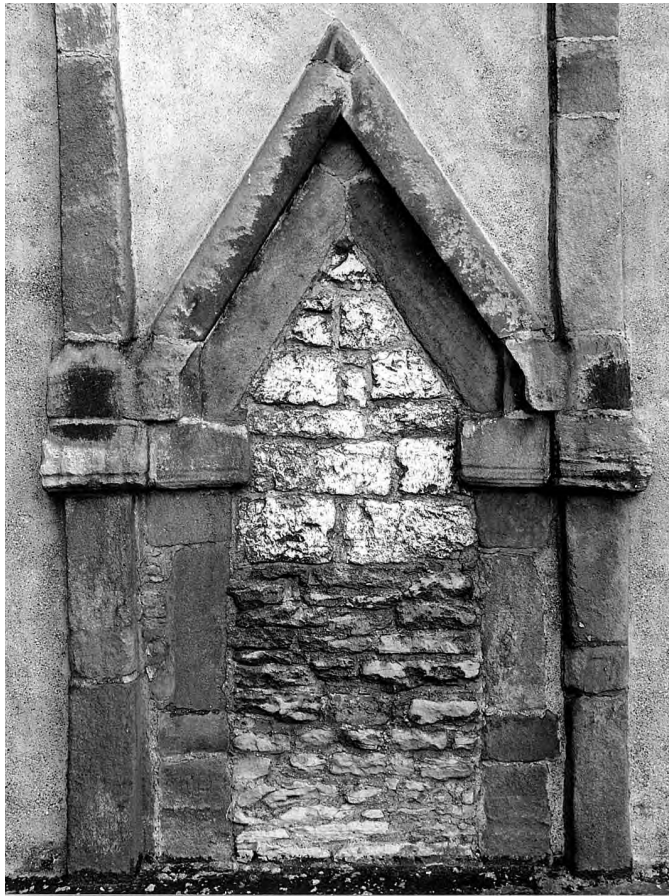
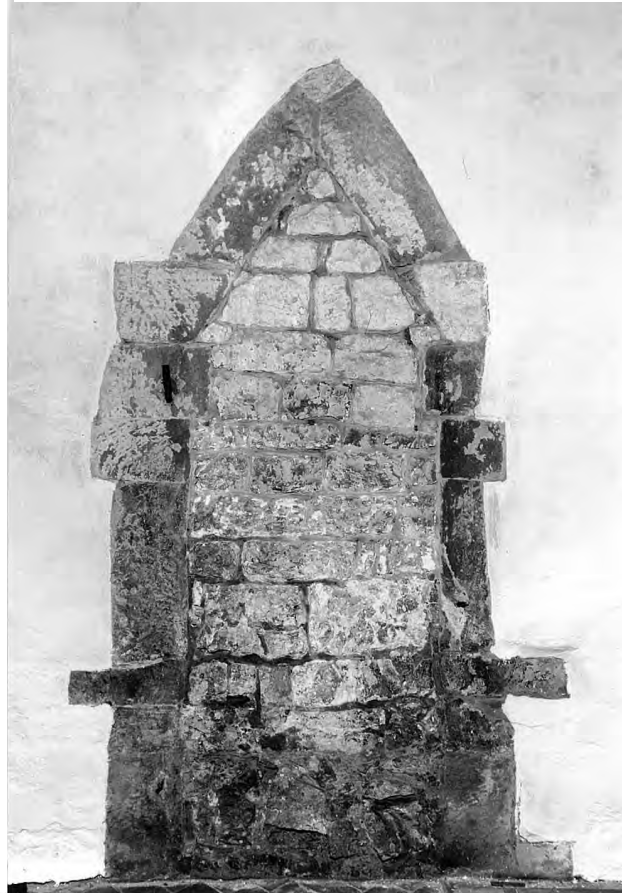
A (left) and B (below)

Fig. 269: Tower: Stage 1A, north doorway, 1972. A, external, and B, internal views at the same scale and vertically registered, illustrating the difference between ground and floor levels. Photos: English Heritage, NMR

North doorway (Figs. 259, 7, 269, A, and 270)

Directly opposite the south doorway is another of slightly smaller size, with a triangular head. Up to impost level the construction is identical, but the width is only 92 cm (3 ft). However, instead of carrying a ring of voussoirs, the moulded imposts support a pair of canted slabs forming a steeply pointed head to the opening (Fig. 271, A). The mouldings are similar to those on the south doorway (Fig. 268, nos. 1 and 2). Also, the imposts are extended laterally by additional blocks that break through, and bond with, the vertical lines of the decorative stripwork. Furthermore, the triangular head is flanked by an outer order of stripwork (the equivalent of a label), which projects further and is seated on corbel-like blocks that are integrated with the vertical stripwork (Pl. 23; Fig. 271, B). The north doorway displays the most sophisticated masoncraft in the tower, a fact doubtless observed by Buckler in the 1820s, when he made careful drawings to illustrate its construction (Fig. 245).

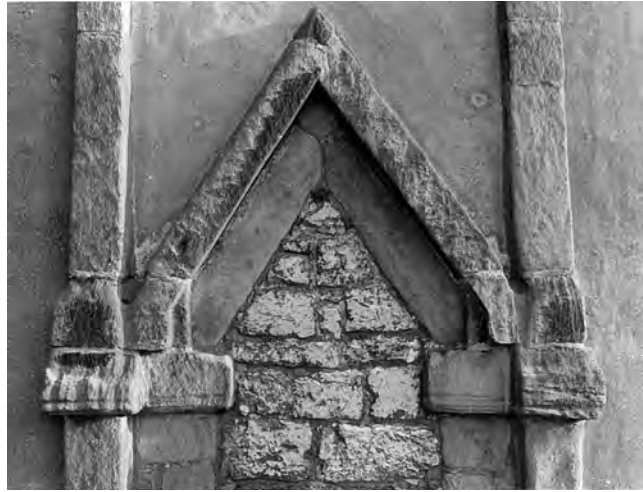
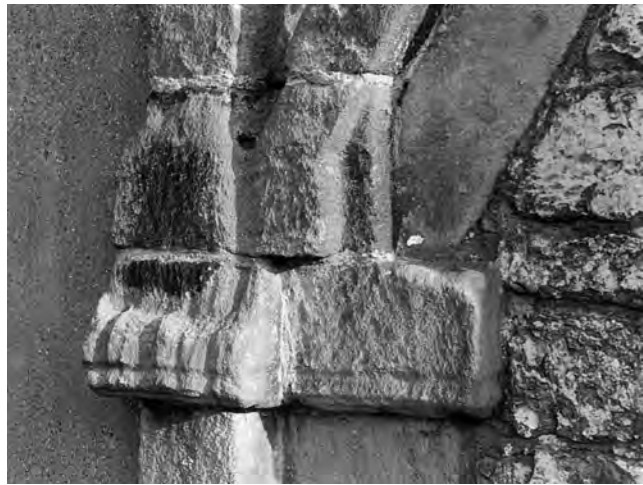
Fig. 271: Tower: north doorway. A (upper), the triangular head. B (lower), construction detail of the eastern impost. Photos: Warwick Rodwell

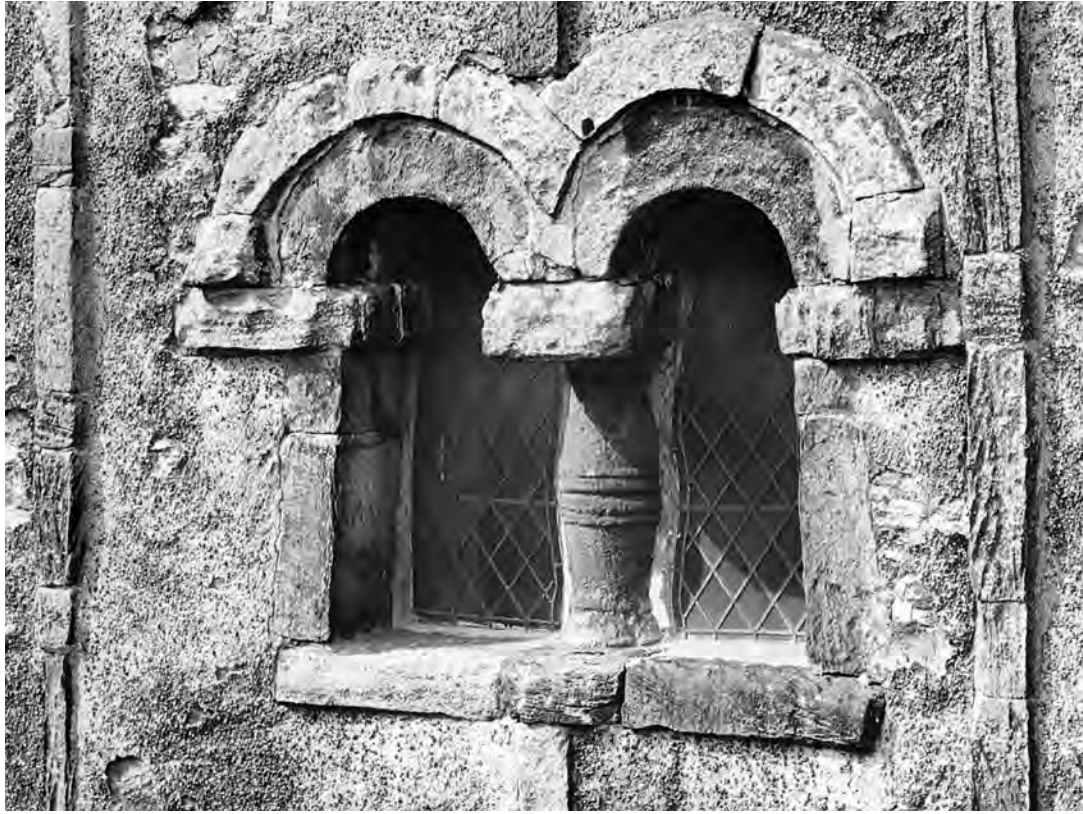
Fig. 272: Tower: Stage 1B. South gallery window, 1965. Photo: David Lee Photography

North and south windows (Fig. 272)

There are no windows in Stage 1A, but Stage 1B is lit by round-arched double openings on the north and south: they are positioned a little to the east of centre. It will be argued that they lit a gallery (pp. 268–9). The sills and jambs are square-edged, and the paired openings separated only by a gritstone baluster which stands in the middle of the wall and supports a flat slab (through-stone) carrying the two unmodelled arches.⁴⁸ The imposts and through-stones are all basally chamfered, but have a plain arris on the upper angle. The baluster, which is moulded in imitation of lathe-turning, is aligned with the third pilaster of the stripwork arcade, the window openings thus piercing the third and fourth bays. Since the bays themselves are of unequal width, the window positions are disconcertingly asymmetrical within the tower elevations. Similarly, the level at which the windows are set bears no relation to the architectural frame: they simply float in such a manner as to give the impression to the casual observer

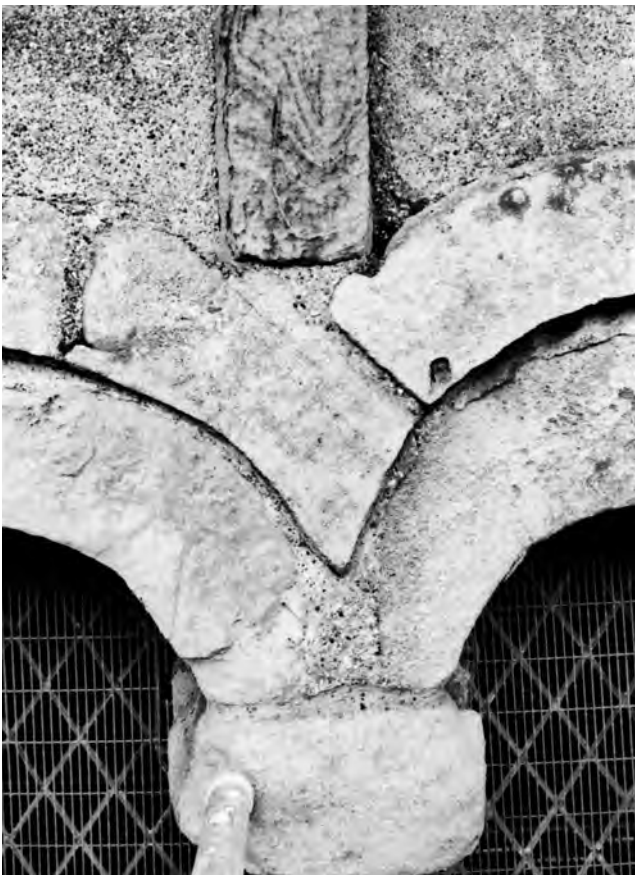
Fig. 273: Tower: Stage 1B, south. Function of the interrupted pilaster-strip with the head of the gallery window. Photo: Warwick Rodwell

that they could be secondary insertions. The windows are, however, unquestionably primary. The junction between the window head and the interrupted pilaster is remarkably clumsy. Instead of cutting a three-way springer-block for the arches and pilaster seating, as the medieval mason would have done, the mouldings are simply stacked one upon another (Fig. 273).

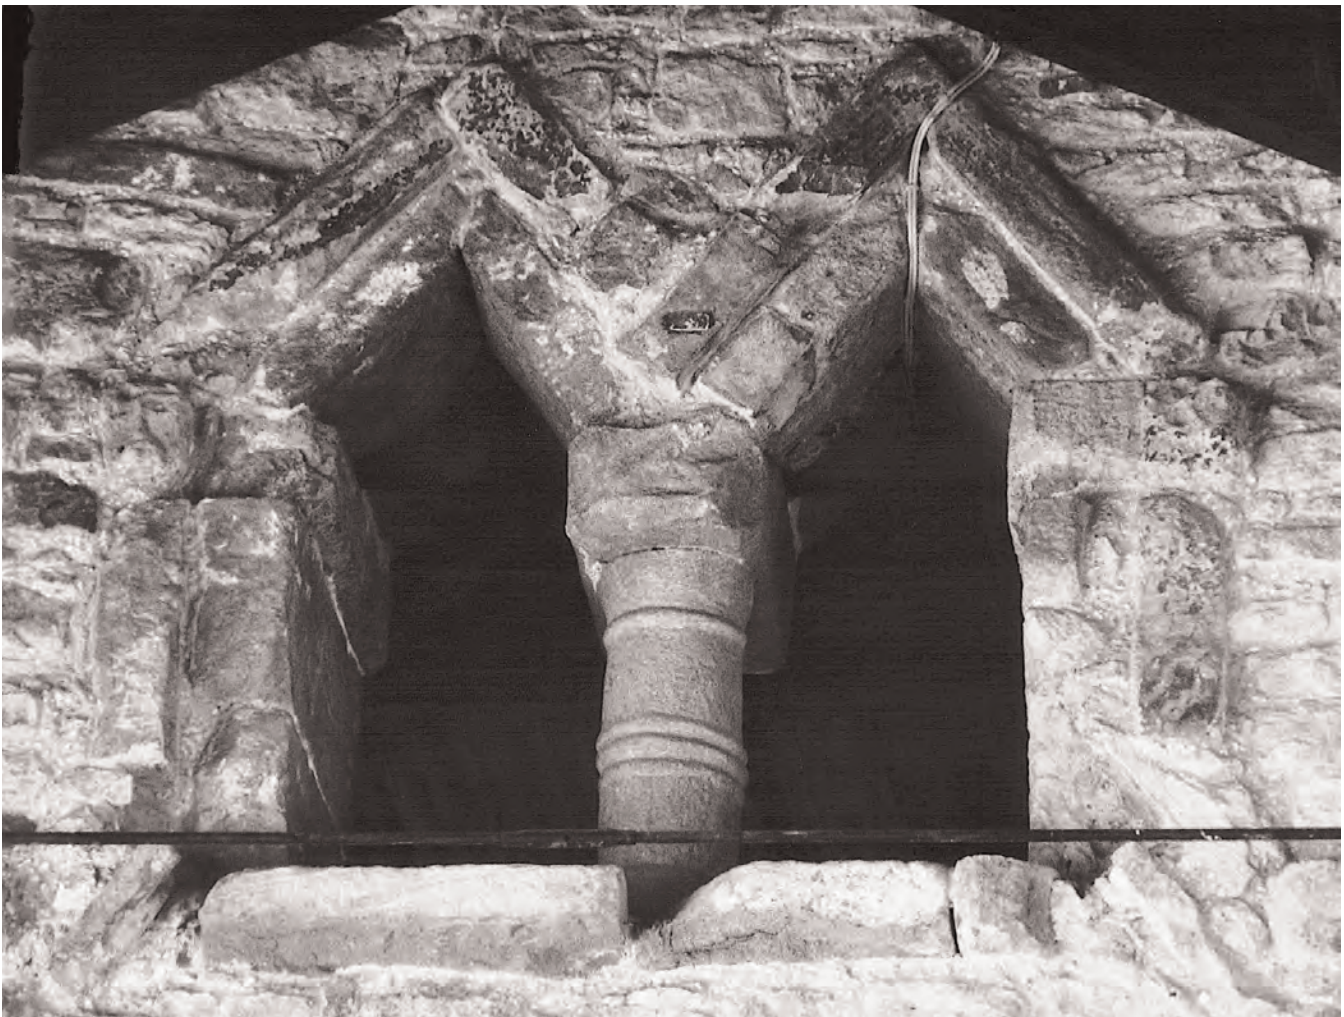
Fig. 276: Tower: Stage 2. East double belfry-opening, seen from within the medieval nave. Note the remains of the headstops, particularly on the left. See also Fig. 377. Photo: Derek Craig. © Corpus of Anglo-Saxon Stone Sculpture

East belfry opening (Figs. 276 and 289)

The impost blocks both carry the eroded remains of carved human heads (Fig. 377). It is certain that no similar elaboration existed on the impost blocks of the other belfry openings, and it seems likely that these were the only examples of external sculpture on the Period 2 tower.

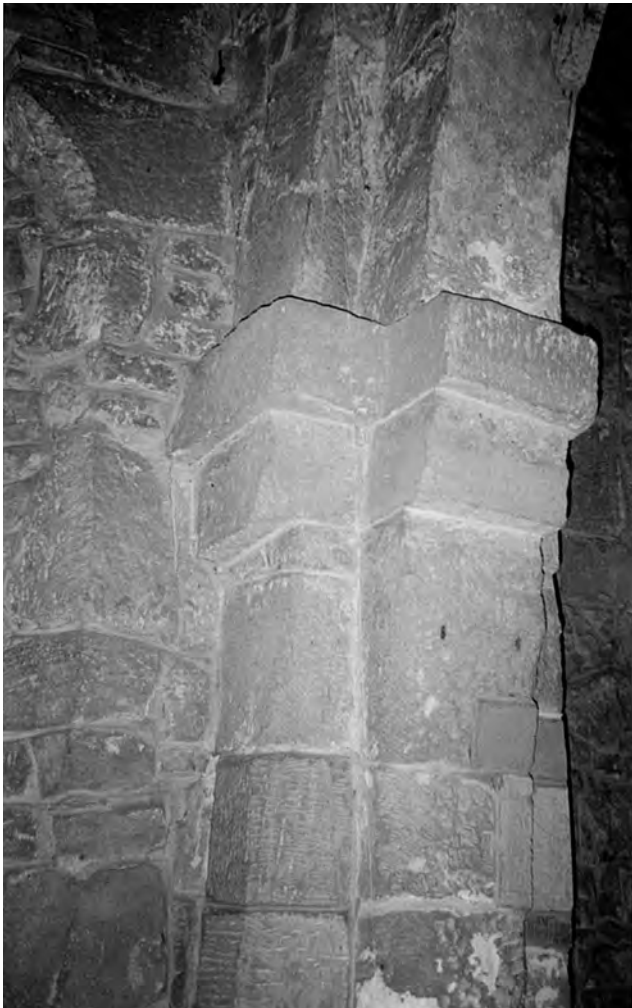
Fig. 280: *St John the Baptist, Kirk Hammerton (W. Yorks.). South respond of the chancel arch, showing the monolithic double impost of gritstone. Photo: Warwick Rodwell*

The east wall is dominated by the largest and most elaborate arch in the church. It is tall, round-headed and monumental in stature: the arch passes squarely through the wall without any splay or rebate. Large blocks of gritstone line the aperture, which is 1.68 m (5½ ft) wide, and 3.6 m (12 ft) high, to the springing-line. There is a projecting base-course, and a double impost which is unmoulded: the latter comprises two stepped courses of squared gritstone. The two-tiered imposts of the chancel arch at Kirk Hammerton (W. Yorks.) are identical, although slightly smaller in scale; there, each impost is cut from a single block of gritstone (Fig. 280). Similar imposts appear in other Anglo-Saxon buildings and on the Deerhurst Virgin panel (Fig. 384).

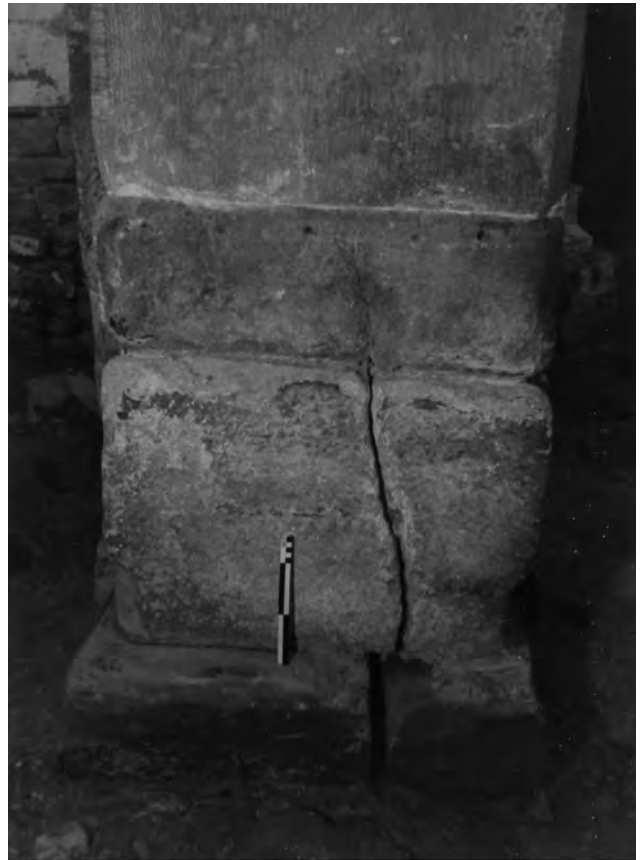
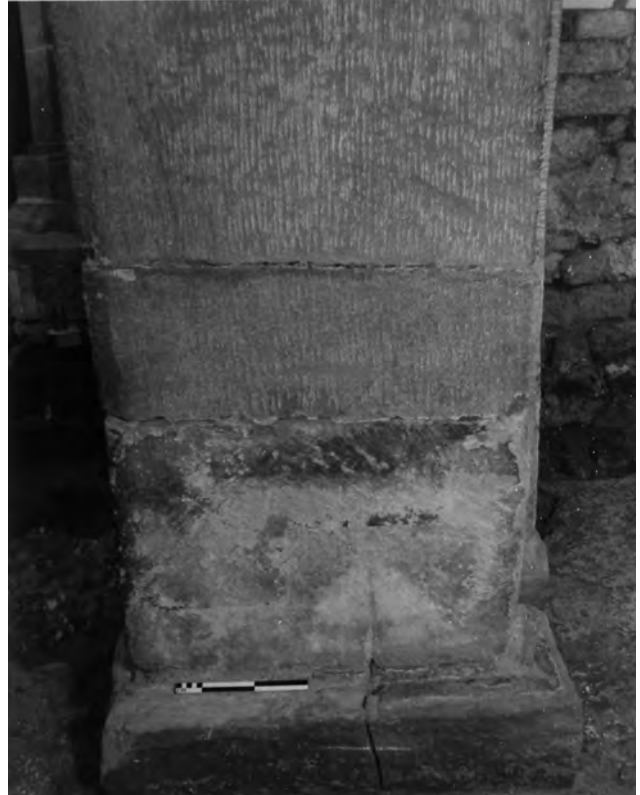
Fig. 281: *Tower: Stage 1A, eastern arch. A, north, and B, south responds and bases, showing settlement fractures and Victorian redressing of the masonry (vertical clawing). Scale of 25 cm. Photos: Warwick Rodwell*

The pattern was repeated in the chancel, although there were fewer pre-church graves present, and in two instances the original burials had not been exhumed, with the consequence that the skeletons were severed by the foundation trench for the east wall (F1364 and F1400). Considerable ground settlement has taken place since the tower was constructed, as evidenced by the fractured and undulating nature of the plinth (Figs. 260 and 270) and the splitting of some of the large blocks lining the reveals of the major openings (Fig. 281).

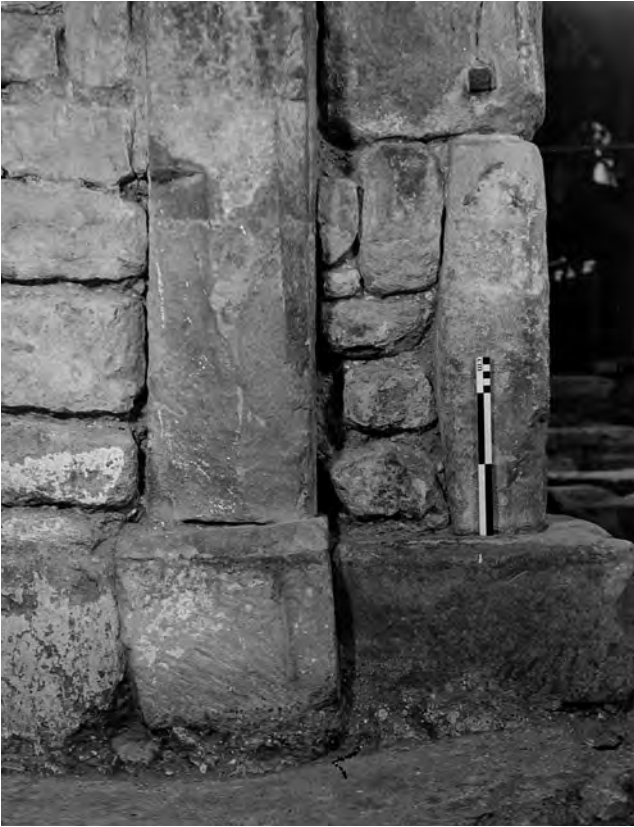
Fig. 282: Tower: Stage 1A. Detail of the base of the north-flanking pilaster-strip of the eastern arch. Note the original bolster finish on the base-block and survival of a band of primary wallplaster above floor level. Scale of 25 cm. Photo: Warwick Rodwell

The bases and impostes project both into the reveals and forward of the wall-face on the west; they do not project on the east, where all the components of the arch are flush with the rubble wall-face. The bases are somewhat worn, and might originally have had chamfered arrises, although this is very unlikely. The crude, diminutive chamfers on the jambs and impostes were all added in the nineteenth century (p. 522). Both responds are fractured at the bottom as a result of stress induced through foundation settlement (Fig. 281). The arch itself is formed of medium-sized voussoirs, many of which are non-radial, especially the lower stones on either side. The whole of the opening is outlined on the west by a square-edged pilaster-strip which has its own base-blocks and stepped impostes, all structurally linked to those of the arch itself (Figs. 282 and 283).

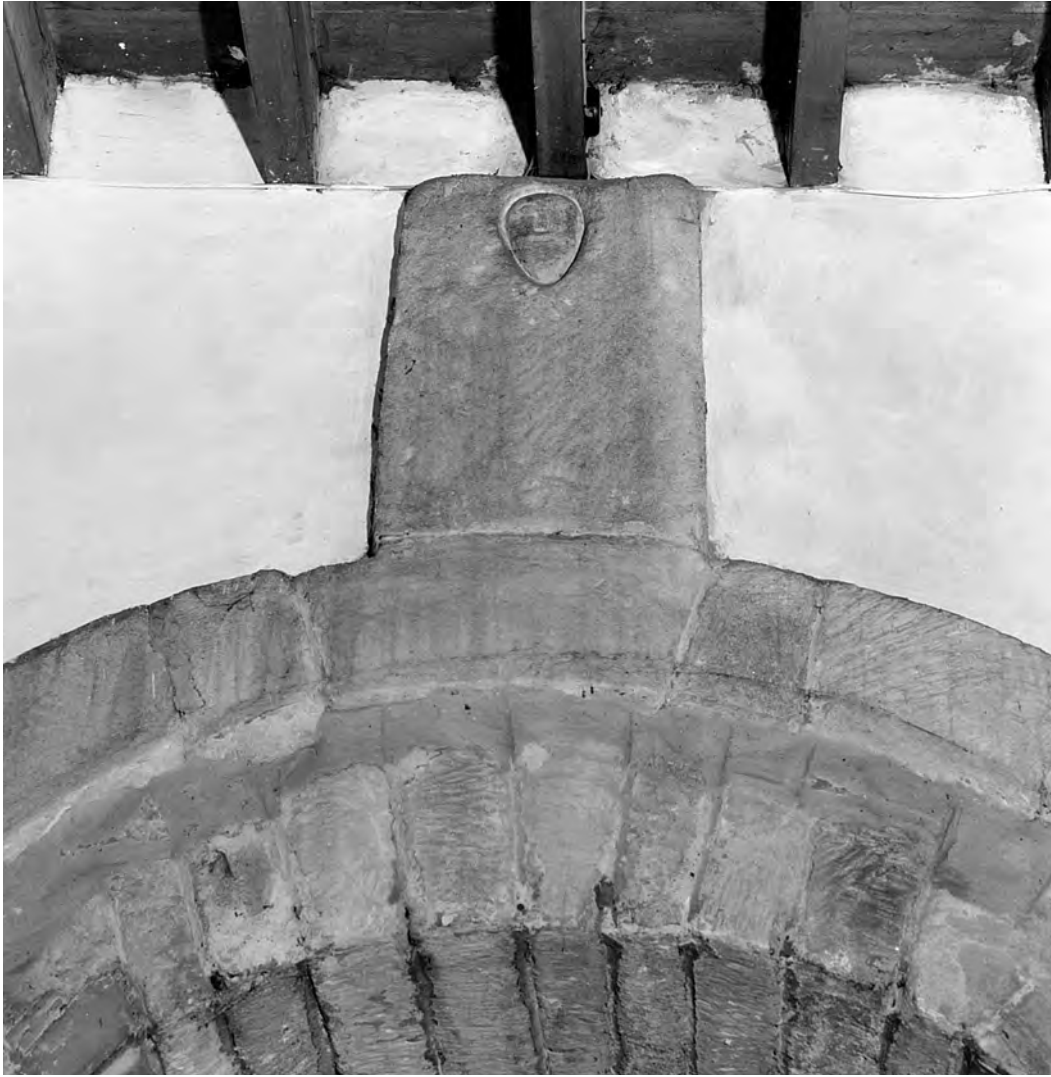
Fig. 284: Tower: Stage 1A. Sculptured panel above the eastern arch, 1972. Photo: English Heritage, NMR

Resting centrally on the pilaster-strip, or label, outlining the arch is a rectangular block of gritstone, 46 cm wide by 70 cm high (18 × 27½ ins), having the appearance of a false keystone (Fig. 284). The block projects from the wall-face to the same extent as the pilaster-strip (c. 5 cm), and the joint between them is tight. Their surfaces are thus fully contiguous, and the panel has no frame or edge-moulding. Towards the upper edge of the block is a *bas-relief* carving of a small

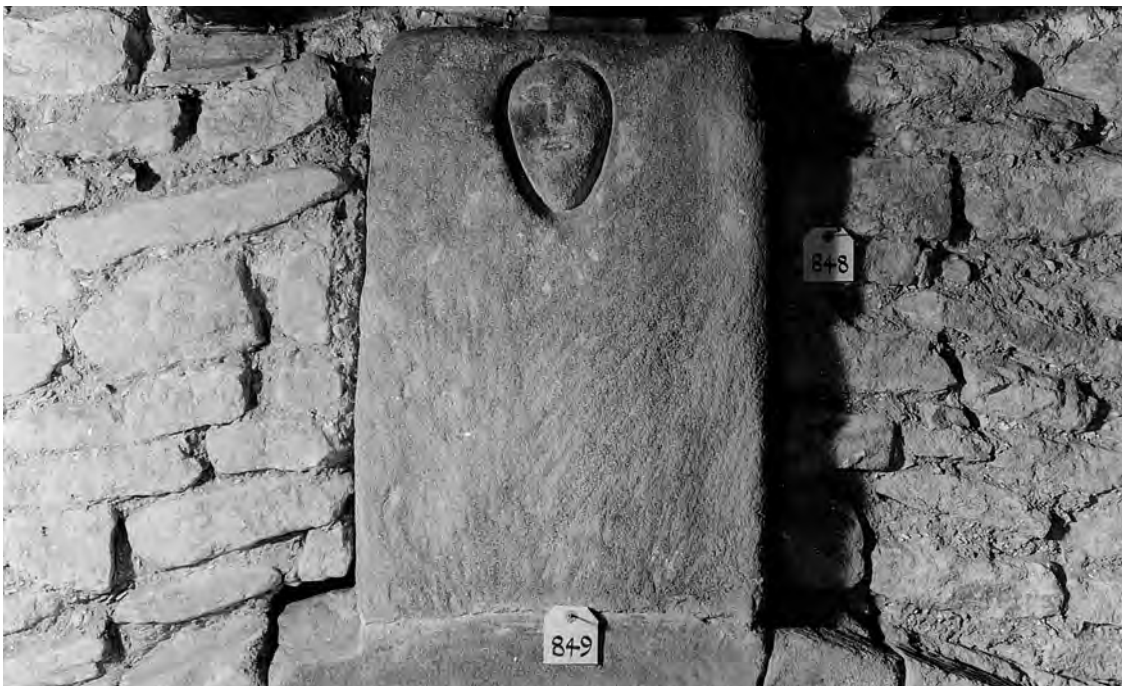
Fig. 285: Tower: Stage 1A. Detail of the sculptured face on the panel above the eastern arch, 1980. Photo: Warwick Rodwell

human head, frontally presented. It is of elemental form, and the lightly incised features consist of almond-shaped eyes (the sinister one damaged), a squarish nose, and a short straight mouth. The 'chin' is depicted as being very pointed and out of proportion to the rest of the features: there can be little doubt that it is not just the chin but also a pointed beard which is represented only by its outline (Fig. 285). The remainder of the stone panel is blank, with no hint of any other sculpted detail having been hacked off. Examination of the stone shows that the original tooling (now faint) is present, and leaves no doubt that the sculptured element is as complete today as it ever was.

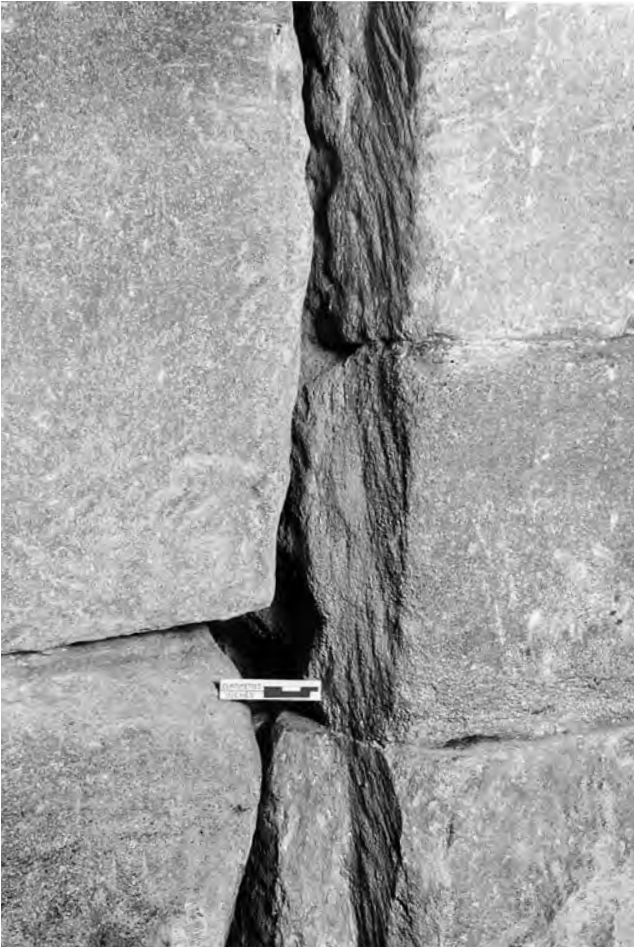
Fig. 286: Tower: Stage 1A. Southern flank of the eastern arch. On the left is seen the west face of two of the blocks lining the reveal, and on the right is the projecting strip-work. Note the in situ bolster dressing on the northern arris of the pilaster-strip. The short scale bridging the gap shows centimetres and inches (below). Photo: Warwick Rodwell

above the plinth. The joint was found to contain small limestone chips, pieces of chalk and mortar. The first (lowest) block of the pilaster was only 20 cm in thickness (of which 5 cm stood proud of the wall face); the second was 34+ cm; the third 30+ cm; and the fourth 20 cm. The northern edge of the fourth stone was very smooth and had clearly been subject to wear in its previous use, as a step or stylobate. The edges of the other blocks were roughly hewn. The dressing *in situ* of the vertical edges of the pilaster, using a bolster, was clearly revealed (Fig. 286).

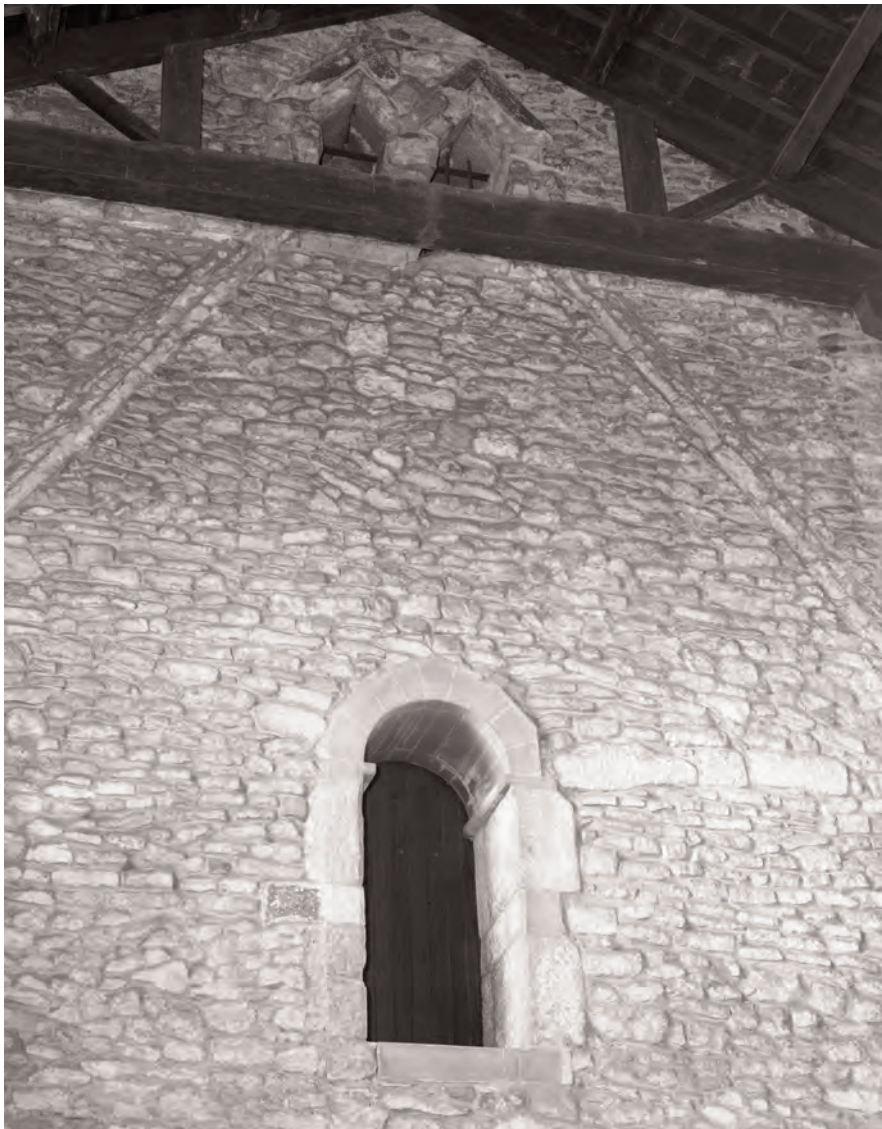
Fig. 289: Tower: Stage 1B. High-level doorway in the east wall (east face), 1972. The voussoirs and impost of the arch date from 1858. Photo: English Heritage, NMR

The east wall of the gallery stage is pierced at its centre-point by a small round-headed opening, the threshold of which was at floor level, but has since been cut away. The aperture is 90 cm wide and lined with grit-stone blocks, alternately laid upright and flat, so that in elevation the west side of the arch appears to have jambs of long-and-short work. There are no mouldings

or projections on either wall face, but the base-blocks project into the opening. The original height of the arch, to its springing point, was *c.* 1.6 m (5¼ ft), where imposts probably also projected into the opening, but these have been lost. The present thin imposts and neat voussoir arch were entirely fabricated in 1858 (p. 522), replacing the original semicircular head which was of rubble, like that which survives in the west doorway of Stage 1B. The threshold was also replaced with a stone kerb flush with the east face of the arch.
