ST PETER'S

Barton-upon-Humber, Lincolnshire

A Parish Church and its Community

HISTORY, ARCHAEOLOGY AND ARCHITECTURE

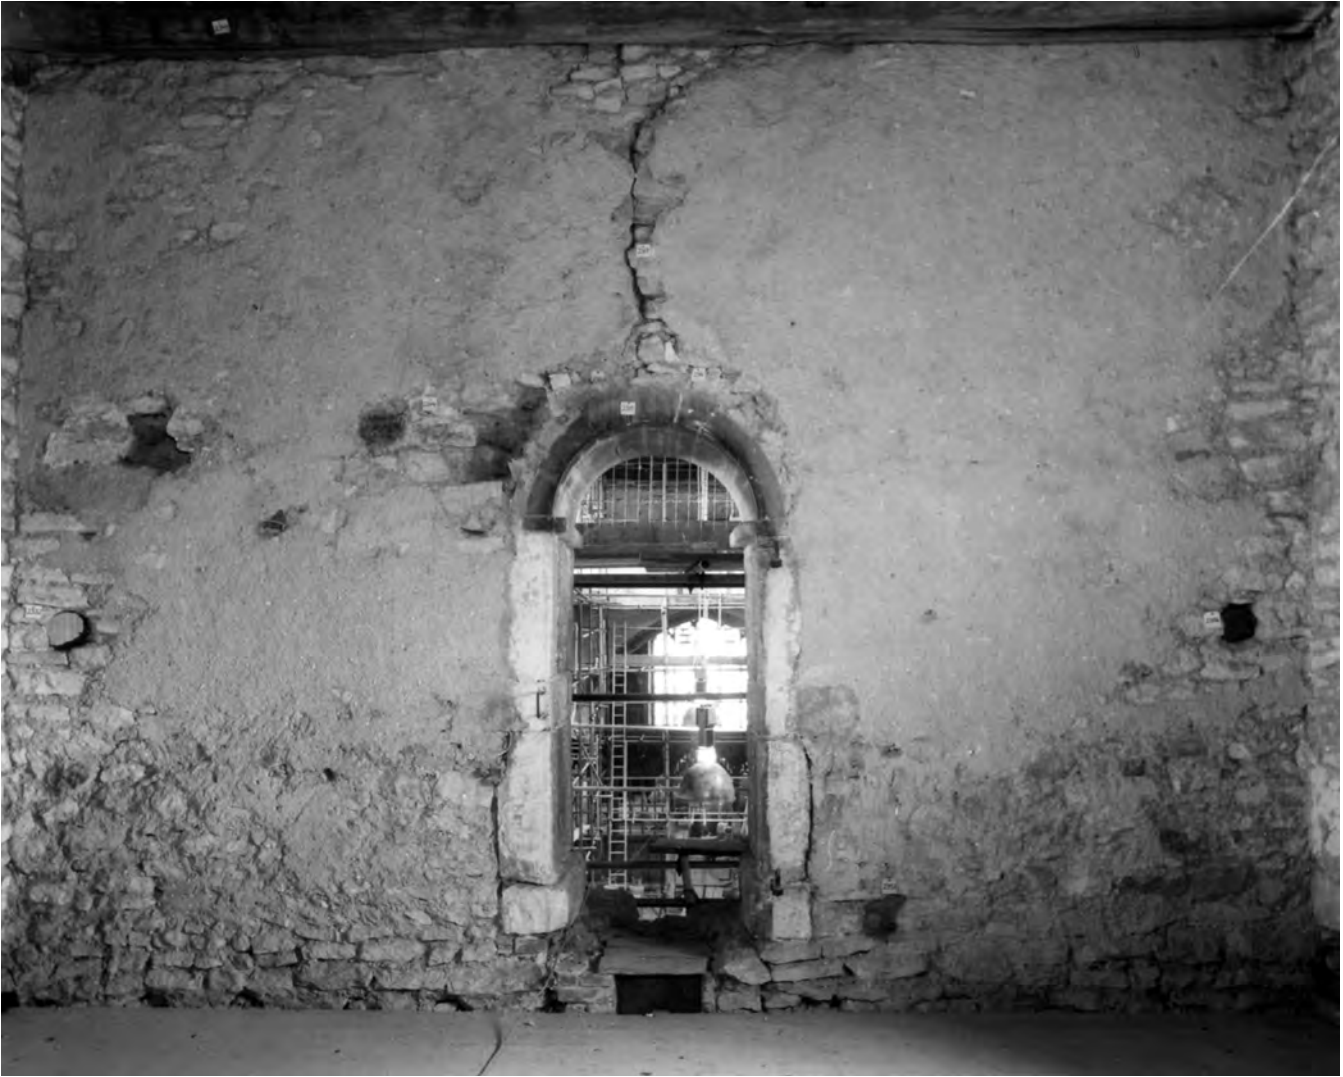
Fig. 290: Tower: Stage 1B, interior. High-level doorway in the east wall (west face), and surviving Anglo-Saxon wall-plaster, 1983. The darker stones comprising the arch date from 1858. Photo: English Heritage Photo Library

The interior was lime-plastered, with a smooth finish. Very little remains on the north and south walls, but substantial areas survive on the east and west (Fig. 290); this is doubtless on account of the protection afforded to those walls from penetrating dampness by the abutment of the chancel and baptistery, respectively. No evidence of early decoration could be found. Partial replastering had taken place in 1926: this was

The east wall of the gallery stage is pierced at its centre-point by a small round-headed opening, the threshold of which was at floor level, but has since been cut away. The aperture is 90 cm wide and lined with grit-stone blocks, alternately laid upright and flat, so that in elevation the west side of the arch appears to have jambs of long-and-short work. There are no mouldings

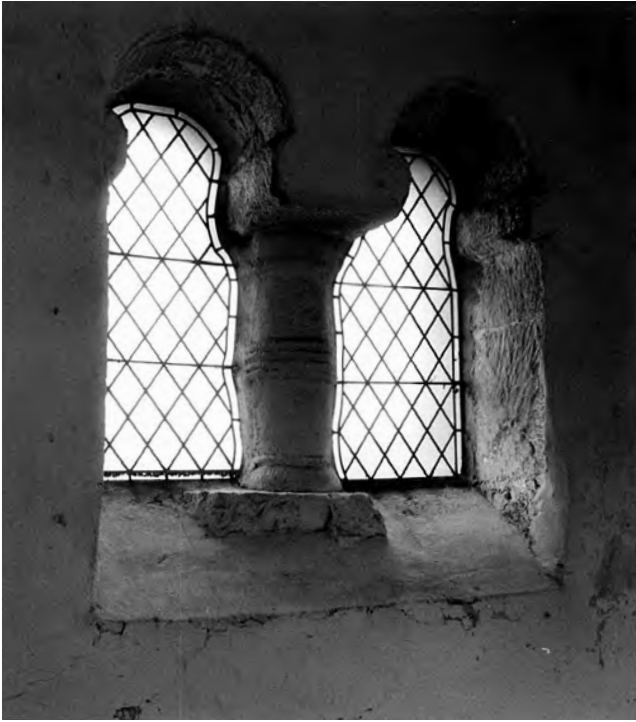
Fig. 291: Tower, Stage 1B. North gallery window, with secondary bevelling of the sill. Photo: Warwick Rodwell

The round-arched double openings in the north and south walls were not embellished internally, but were square-edged all round and overlapped by wallplaster. The arched heads were again cut from slabs of gritstone, and while there was good reason for concentricity in the outer openings (which were fitted with label-mouldings), no purpose was served by similarly creating a curved extrados to the heads of the inner openings. It might therefore be argued that these window heads were all cut from Roman column drums, 90 cm (3 ft) in diameter (Fig. 274). However, the presence of a pair of opposing 'flats' on the circumference of each head suggests another alternative: these could all be reused Roman window heads. Many examples may be seen in the Roman forts and Anglo-Saxon churches of Northumbria of monolithic window heads fashioned from rectangular slabs with semicircular cut-outs. They are present, for example, at Chesters Roman fort⁵⁴ and the churches of Jarrow and Bywell (Figs. 292 and 293). Thus the Barton window heads might be of Roman origin, subsequently trimmed down to give them a curved extrados.

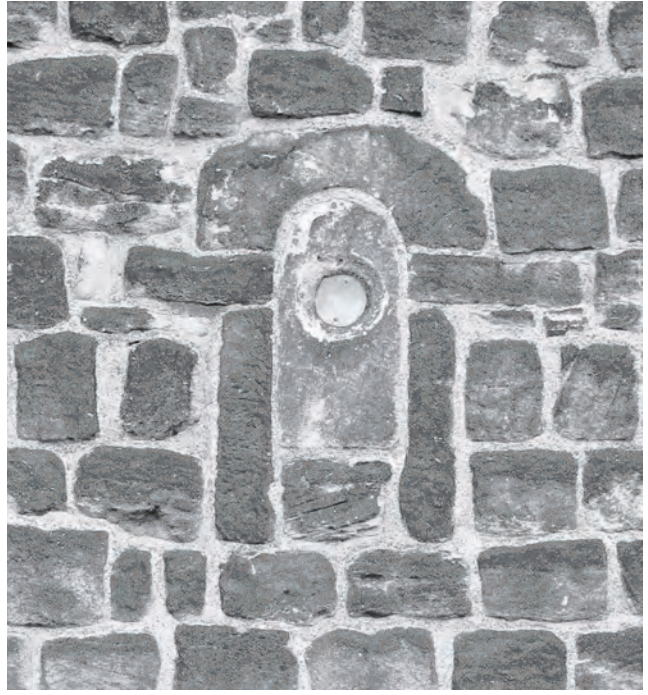
Fig. 292: St Paul, Jarrow (Durham). Monolithic window head formed from a block of Roman masonry. Photo: Warwick Rodwell

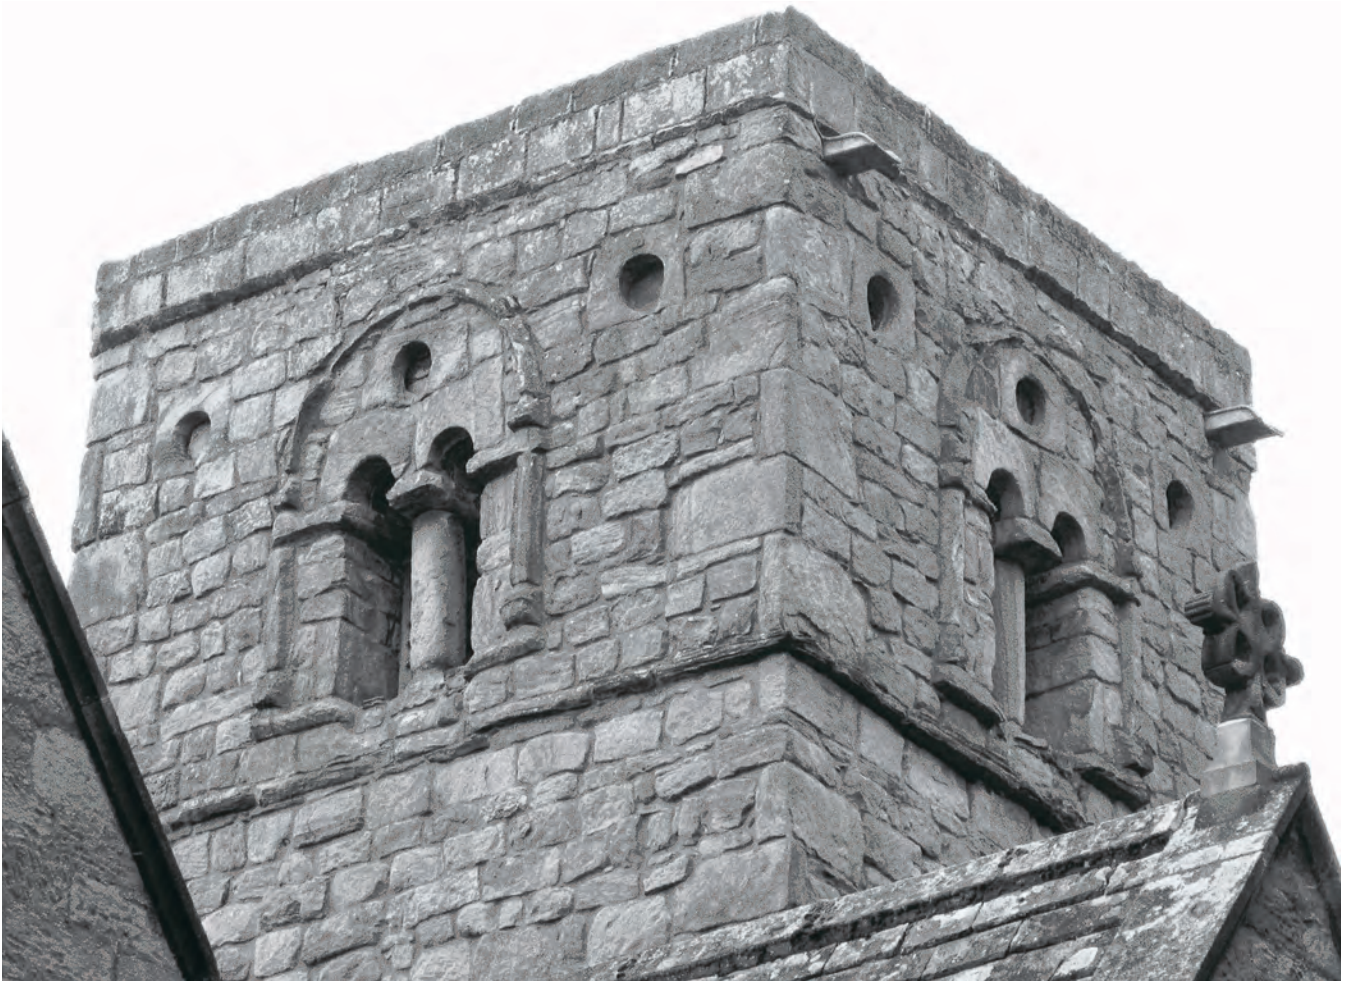
Fig. 293: St Andrew, Bywell (Northumb.). Semicircular heads of the double belfry openings formed from rectangular blocks of Roman masonry, possibly reused window heads. Photo: Warwick Rodwell

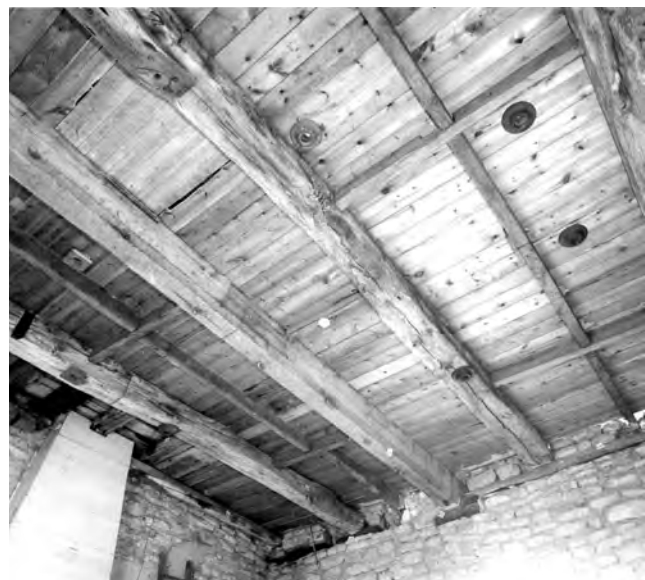
Fig. 295: Tower: floor between Stages 1B and 2. The joists are medieval and later, but the thin spreader-plate in the north wall (right), upon which their ends rest, is primary Anglo-Saxon. Also partly visible on the west side is the casing of the clock pendulum (1852). View north-west, 1983. Photo: English Heritage

A second internal floor marked the division between Stages 1 and 2. As with the gallery below, the floor comprised a series of joists running north-south, although in this case there were seven, rather than six. Again, the ends of the joists rested on spreader-plates that were built into the north and south walls. Decayed sections of the northern plate remained (Fig. 295), but the southern one had entirely disappeared. Although a post-medieval floor occupied the same position, remains of all the pockets carrying the original joists were recorded. Well-defined impressions of some joist-ends were preserved in the core-mortar. The dimensions of the joists were slightly smaller than those of the gallery.

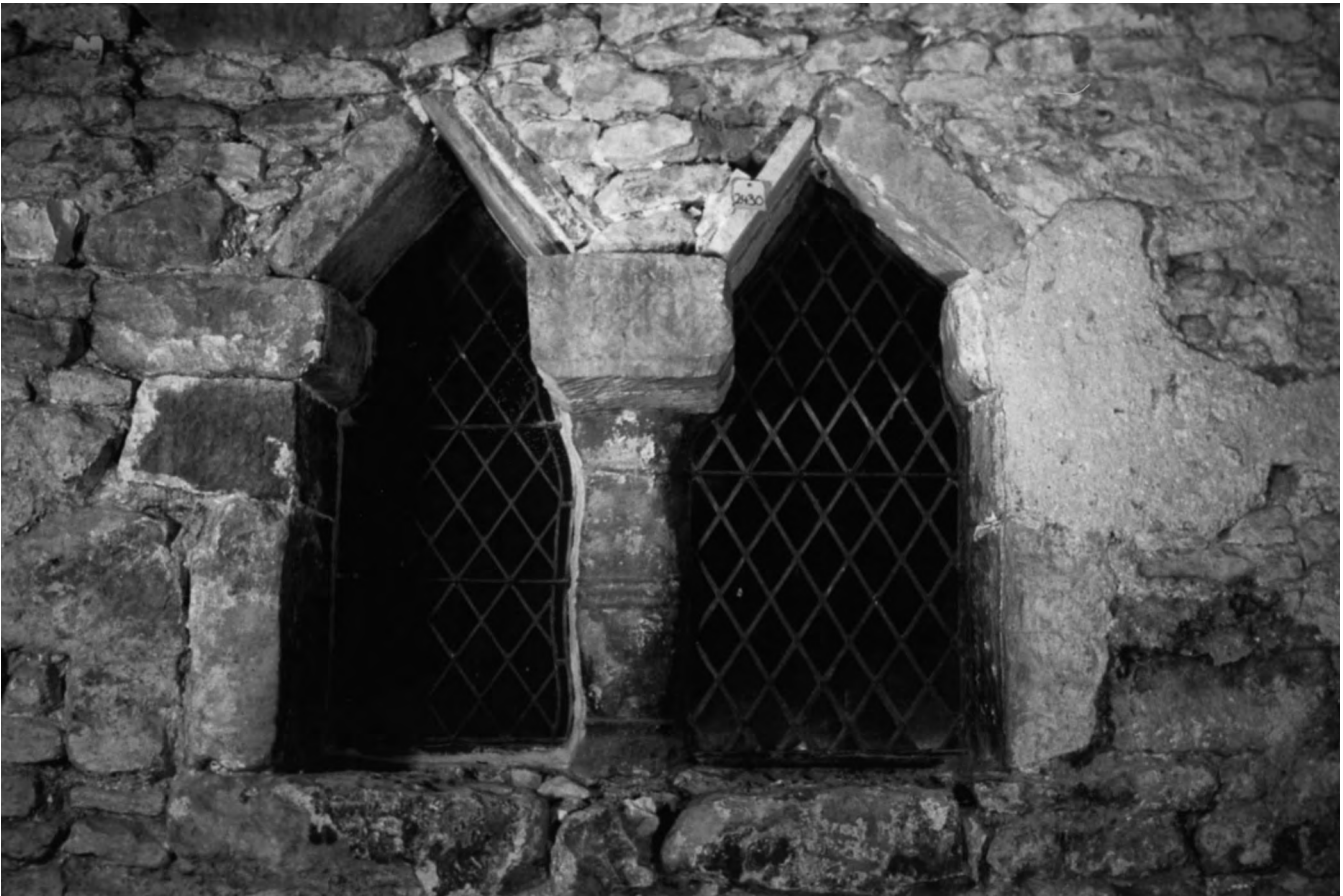
Fig. 297: Tower: Stage 2. South belfry opening with original wallplaster overlapping the right-hand reveal, 1983. Note the nineteenth-century slabs of Yorkstone, replacing original timbers on the two inner slopes of the gabled heads. Photo: Warwick Rodwell

The triangular-headed double belfry-openings are preserved in all four walls, although those on the west remain blocked with medieval masonry. As with the double windows in Stage 1B, the internal reveals are featureless, being formed from stones of various sizes and types, which were intended to be concealed by wallplaster. In part, the original plaster survives on the south opening, overlapping its western jamb (Fig. 297). The sills are all flat and made from a mixture of squared stone and rubble, again plastered. The mid-wall shafts rest on large blocks of gritstone. For the most part, the triangular heads consist of pairs of flat slabs of gritstone, laid on a tilt and touching one another at the apex (Figs. 298 and 299).

In the case of the southern and western openings, however, baulks of timber were employed as substitutes for stone in the two elements rising off the central through-stone. None of the four timbers survives, and when the southern opening was unblocked in 1852 thin slabs of Yorkstone were inserted, more-or-less in the original timber pockets (Figs. 297 and 300). At the same time, the doubtless seriously decayed remains of the timbers were removed from the western belfry opening and the voids infilled with stone rubble. Inspection of the mortar core revealed that there had

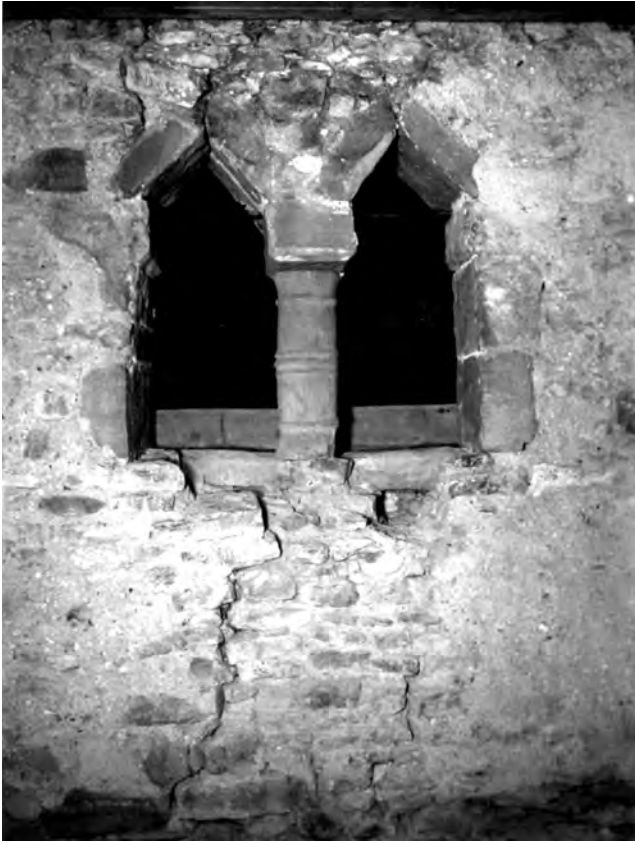
Fig. 299: Tower: Stage 2, interior. East belfry opening, 1983. Note also the cracks in the masonry above and below. Photo: Warwick Rodwell

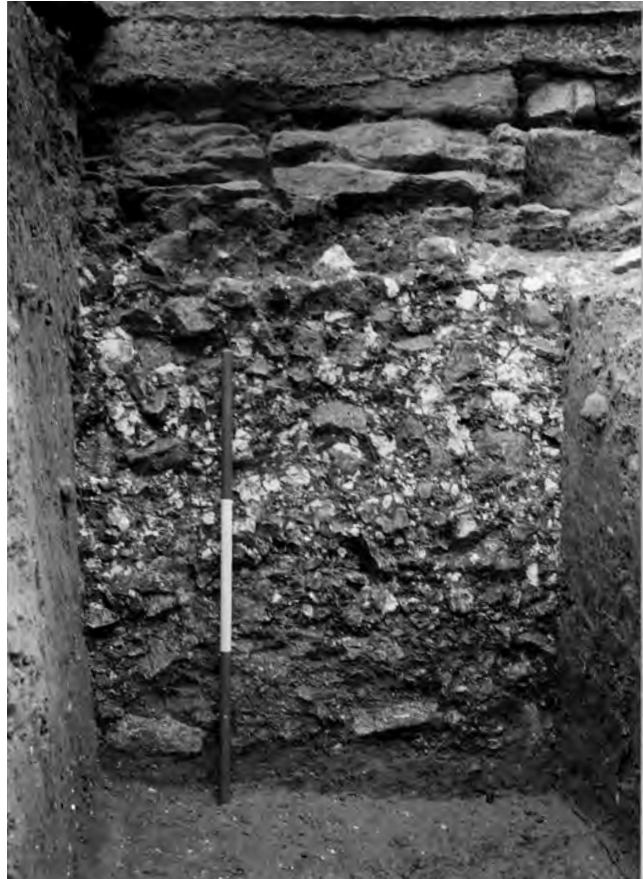
Fig. 303: Western annexe. External face of the rubble foundation on the west side, with the severely fractured limestone plinth course above. Scale of 75 cm. Photo: Warwick Rodwell

Excavation revealed that the foundations for the three-celled church were constructed in a single operation. The square foundation for the tower was continuous on all sides, without interruptions where openings were anticipated in the superstructure. The trench was dug into the clay subsoil to a depth of 95 cm (3 ft), but its width varied somewhat, owing to the instability of the ground in places: localized collapses of the sides had occurred before the foundation filling was inserted. The intended trench width seems to have been of the same order as the depth. The filling comprised small chalk fragments embedded in yellow sandy mortar. No evidence of layering was detectable within the fill (Fig. 303).

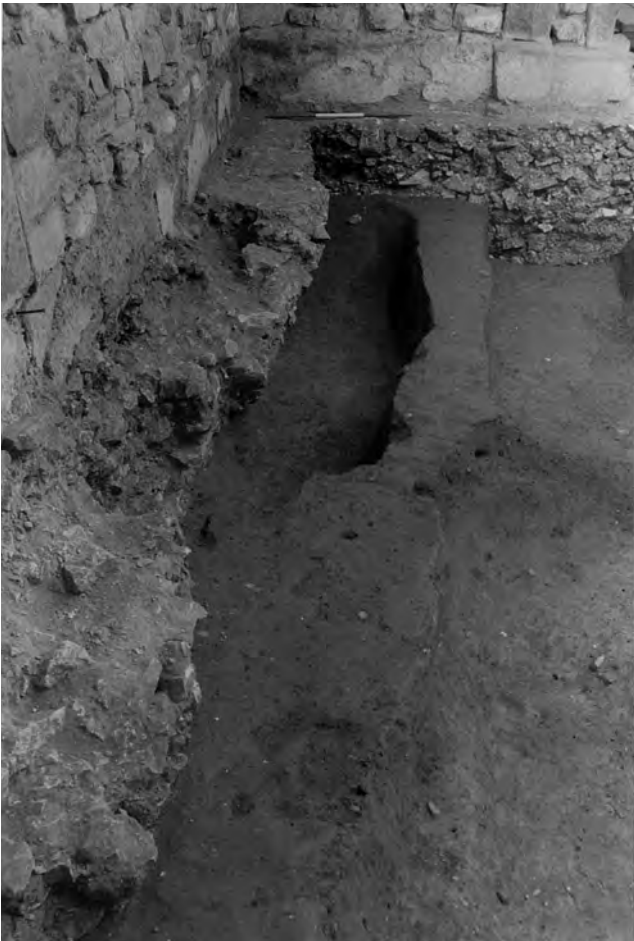
Fig. 304: Tower: interior. Irregular outline of the foundation on the north side (left), resulting from the slumping of the unstable fillings of exhumed graves. View east. Scale of 75 cm. Photo: Warwick Rodwell

In part, the trenches were dug through the uncompacted fillings of graves which then slumped, giving rise to characteristic bulges in the sides of the foundation (Figs. 256 and 304). This is well illustrated in the north and south foundations of the tower.⁵⁷ The evidence is consistent with excavation having taken place in wet weather. However, the graves beneath the tower and baptistery were found, with a single exception (F716), not to contain skeletal remains, indicating that

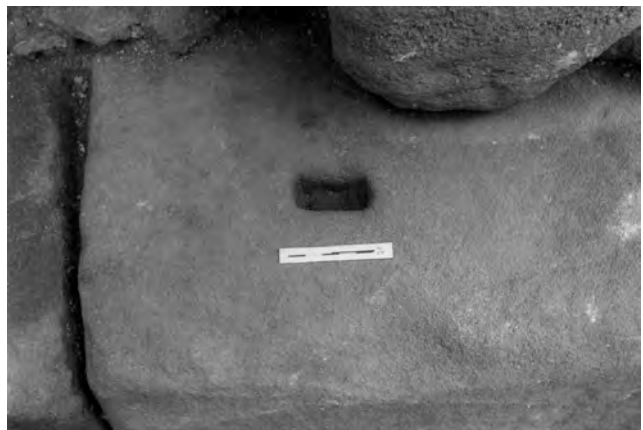
Fig. 305: Tower: details of the plinth at the north-west corner. A, gritstone plinth and fractured base-block of the quoin. B, a small mortice in one of the plinth blocks on the north. Photos: Warwick Rodwell

The walls are 80 cm (2¾ ft) thick and rise vertically without batter or offsets on either the outer or inner faces, apart from the external ground-level plinth. This comprises a series of large gritstone blocks resting on the foundation, forming an offset 10–12 cm in width. The blocks vary in length and thickness, and one has a small mortice in the upper face, relating to its previous use (Fig. 305, B). The plinths were interrupted on the east and

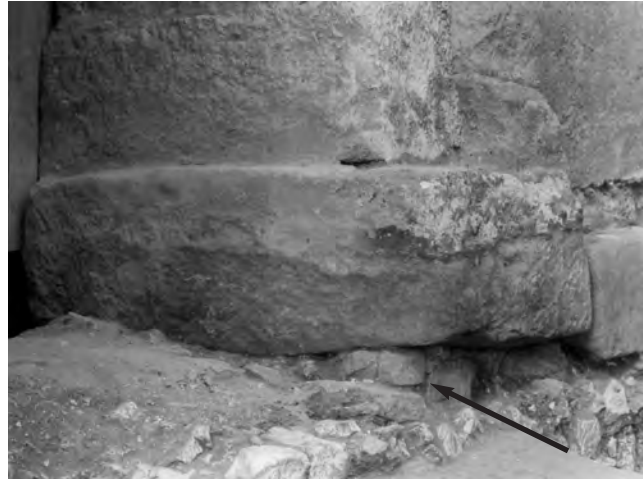
Fig. 306: Tower: south doorway, eastern jamb. Detail of the gritstone base, with masons' waste used as packing material for levelling the block. Photo: Warwick Rodwell

Re-dressing of the Roman gritstone took place on site, the soil around the primary church containing masons' waste (virtually all redeposited in later graves). Chips and small fragments were commonly used as wedges and packing material when levelling the plinth blocks for the tower (much evidence survived on the north side), installing the base-blocks for openings (e.g. the south doorway; Fig. 306), and setting up large

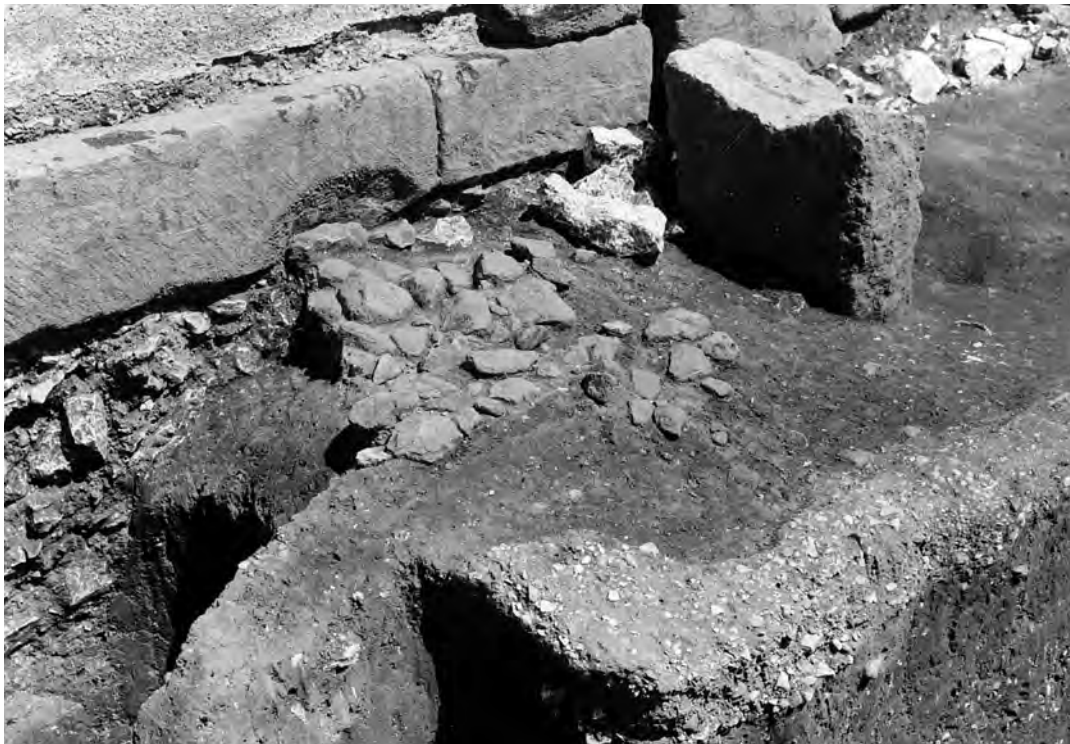
Fig. 307: Tower. Patch of masons' waste resulting from dressing gritstone, lying on the contemporary ground surface outside the south doorway. Photo: Warwick Rodwell

jamb-stones. Very few traces survived of the contemporary ground surface from which the church was built, and thus there were effectively no Anglo-Saxon construction levels present. However, a small area of pre-church ground surface, preserved alongside the south wall of the tower, was strewn with small chips of grit-stone, almost certainly being the detritus arising from the masons' final *in situ* dressing of the blocks forming the stripwork (F3101) (Fig. 307). Along the north side of the tower, vestigial remains of a spread of construction mortar (F7303) were found on the surface of the subsoil, and at the north-west corner, traces of a shallow construction trench for setting the plinth blocks were recorded (F7300). Effectively, the builders' horizon for the tower and baptistery had not survived.

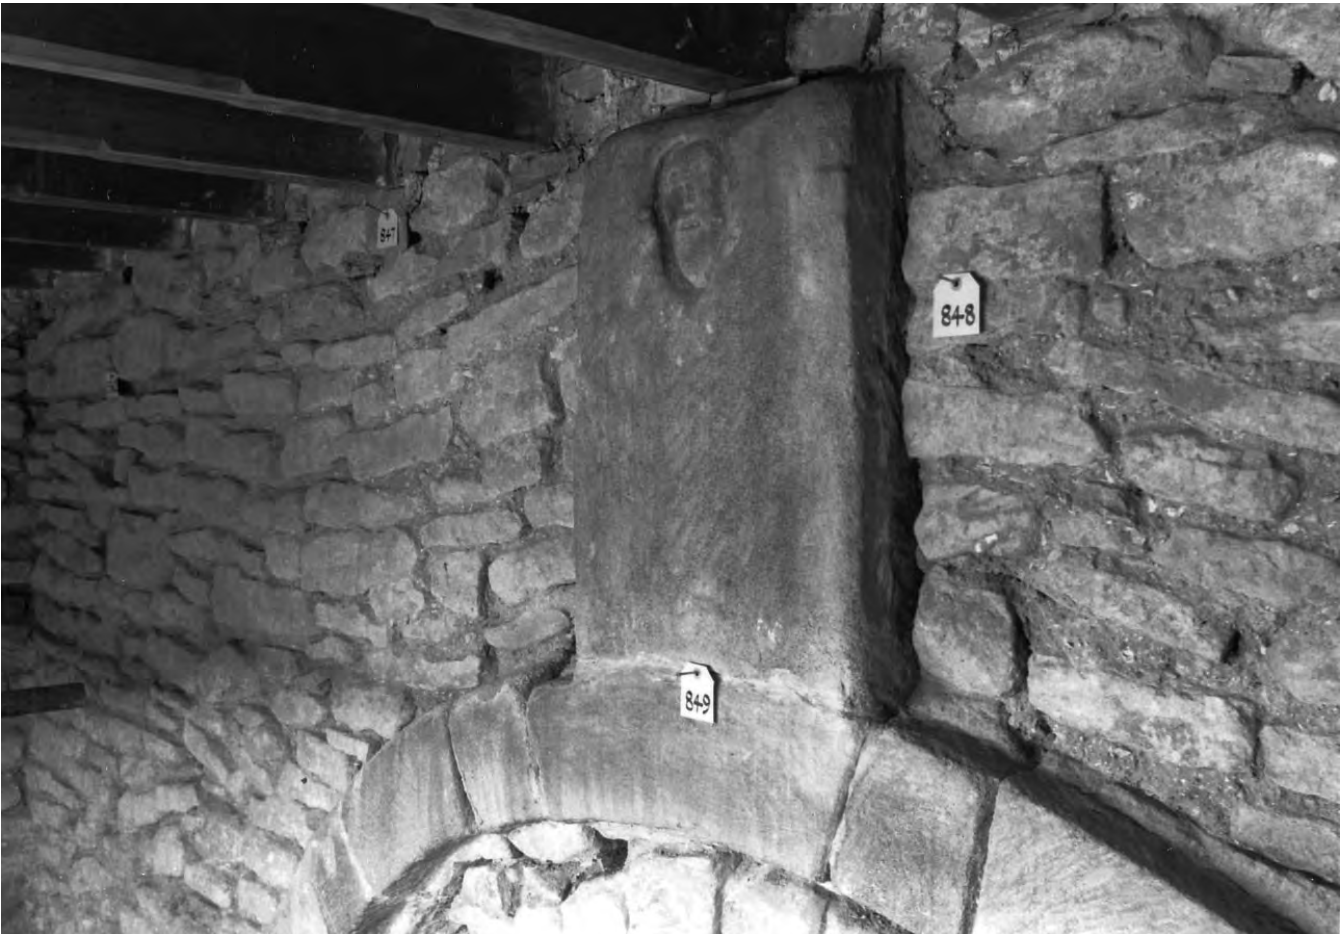
Fig. 309: Tower. 'Humping' of the masonry courses over the eastern arch. View north-east. Photo: Warwick Rodwell

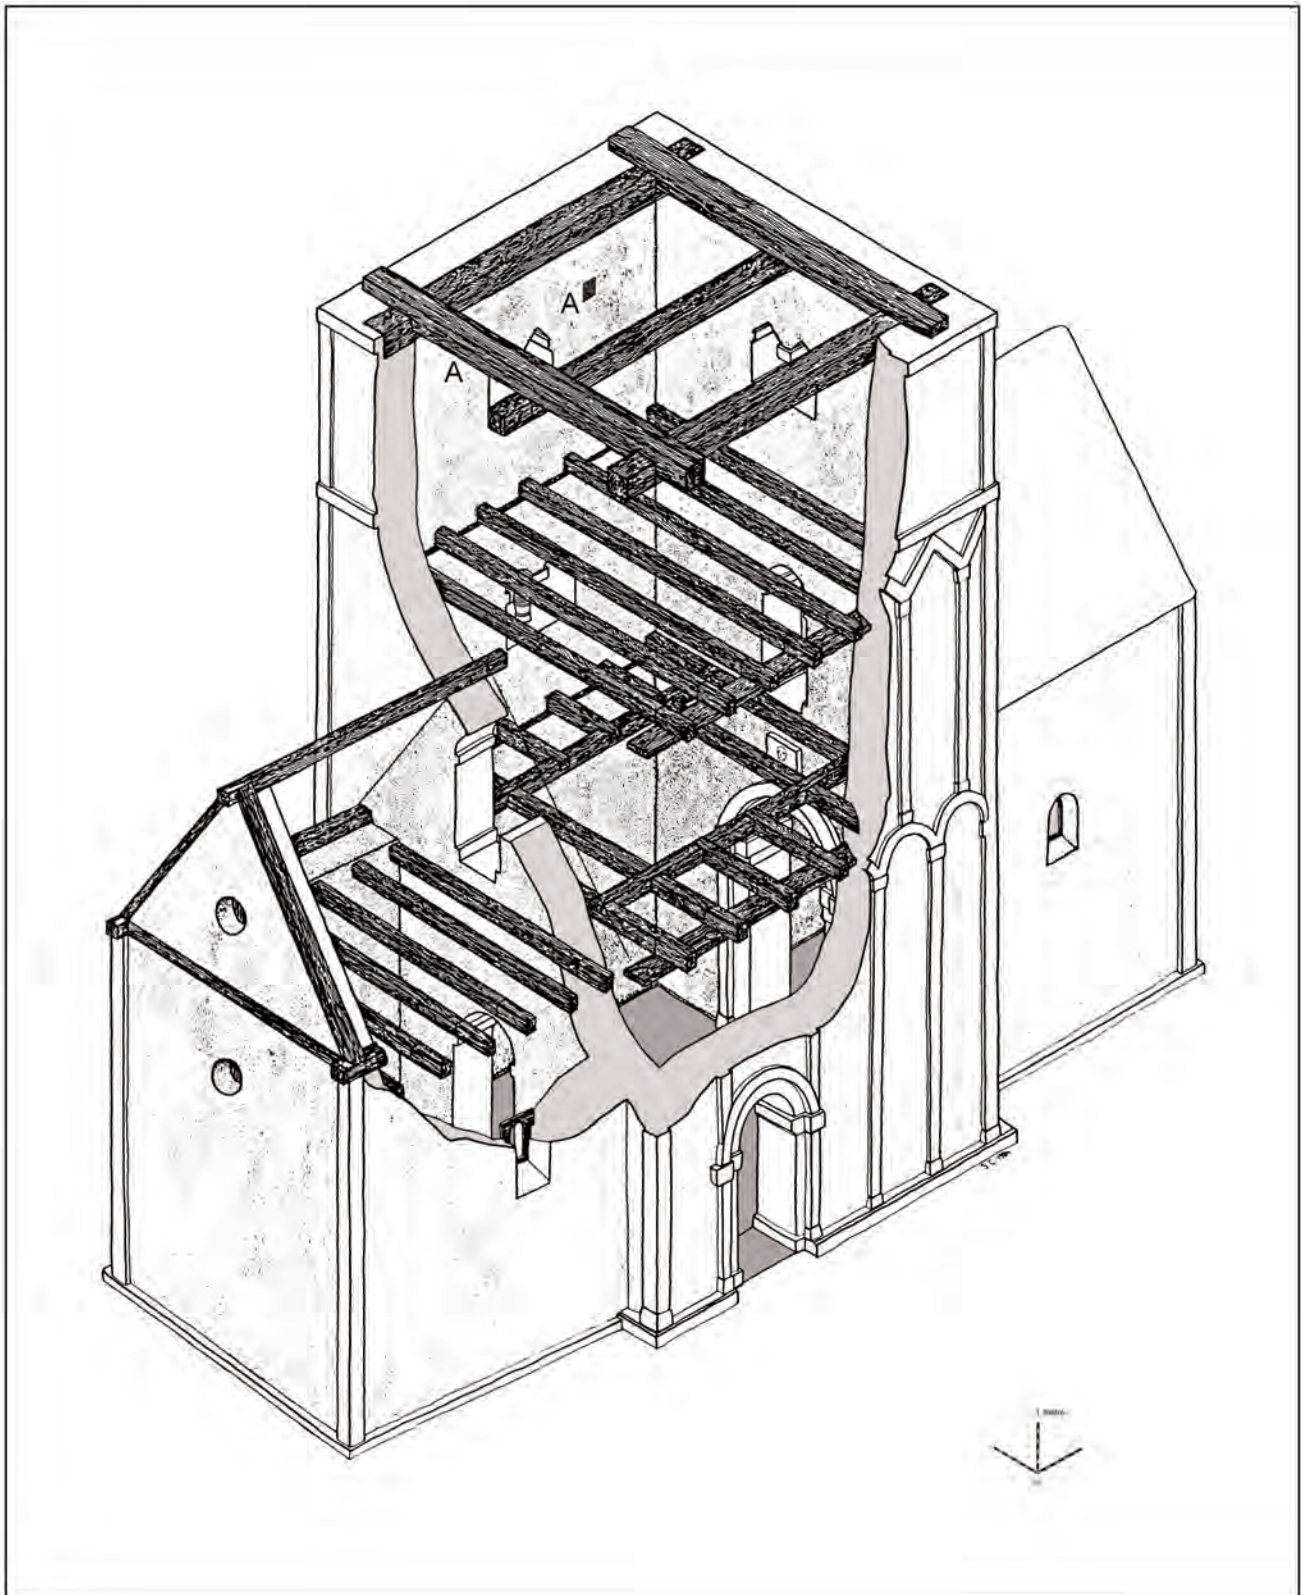
Fig. 311: Cutaway isometric reconstruction of the floor and roof timbers in the tower-nave and baptistery, based on evidence encapsulated in the walls (cf. Fig. 301). Bell-hanging beams (AA) are omitted for clarity. View north-east. Drawing: Stephen Coll

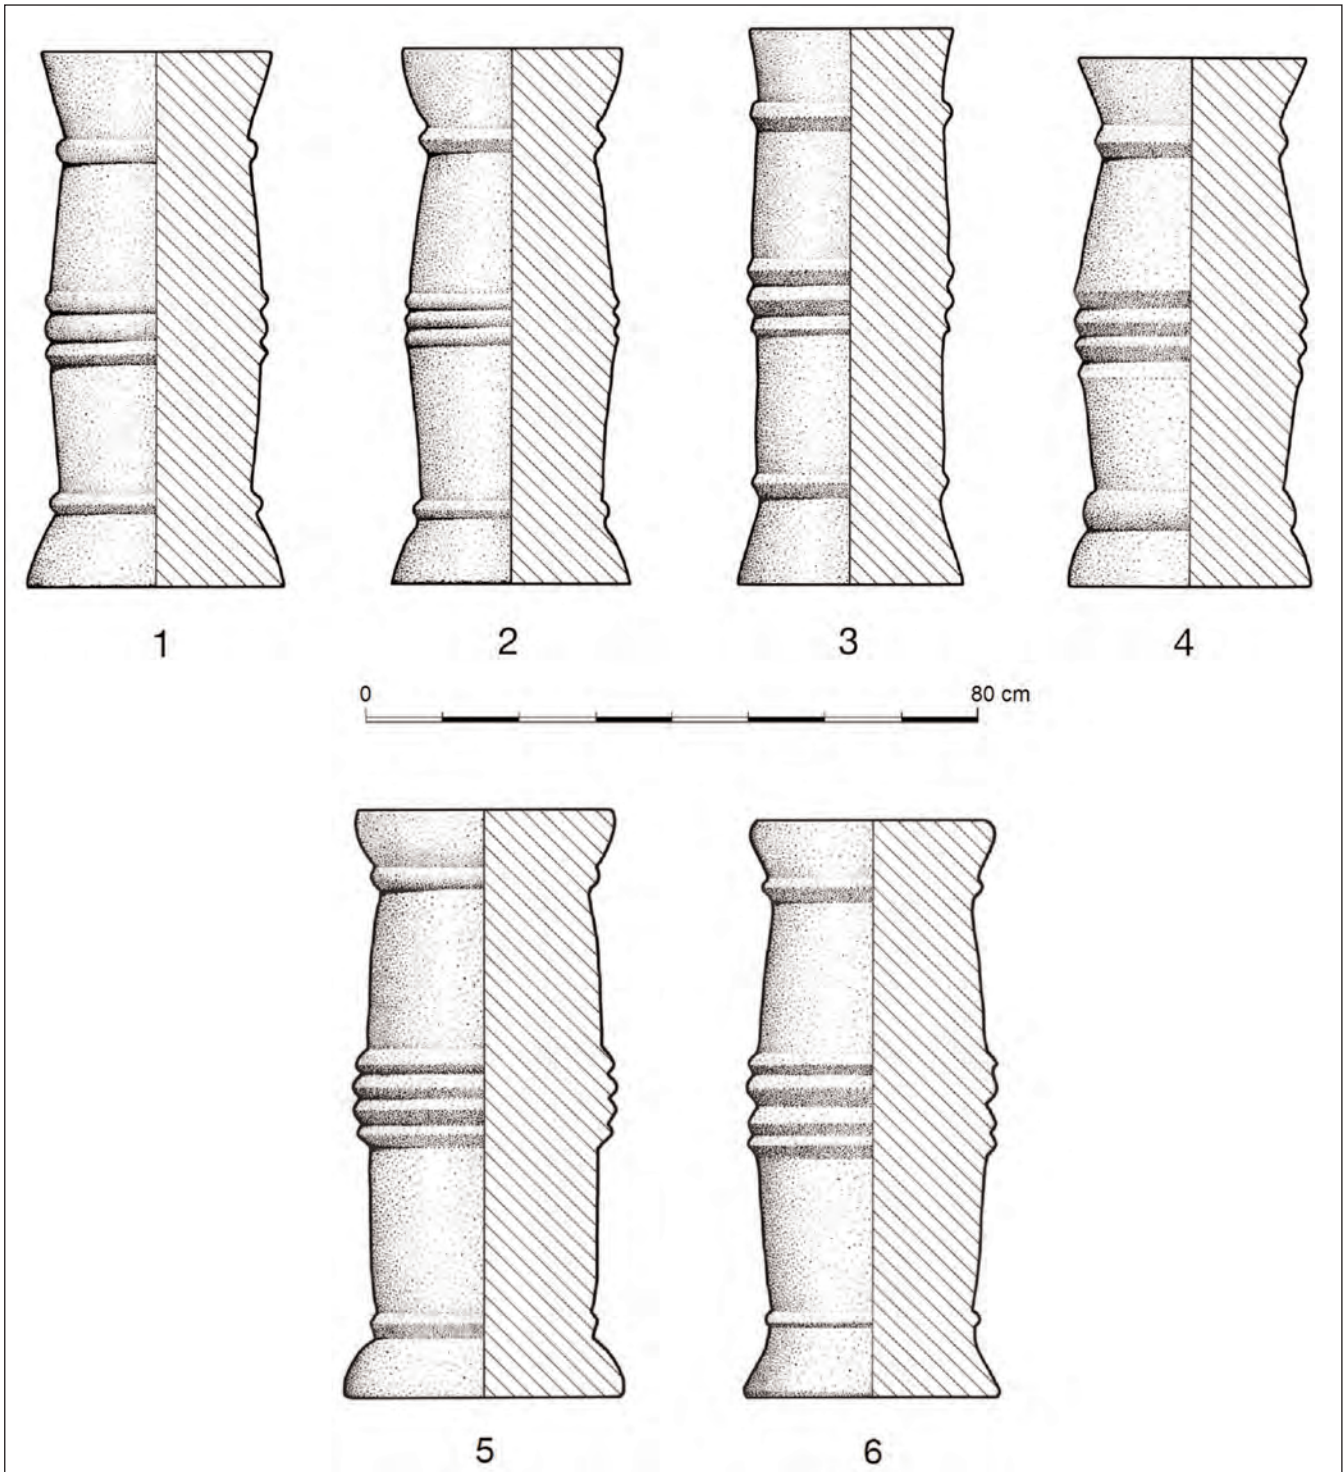
Fig. 312: Tower: Stages 1B and 2. Profiles of the six gritstone baluster-shafts employed in the double openings. Belfry: 1, north; 2, south; 3, east; 4, west. Gallery: 5, north; 6, south. Scale 1:10. Drawing: Simon Hayfield

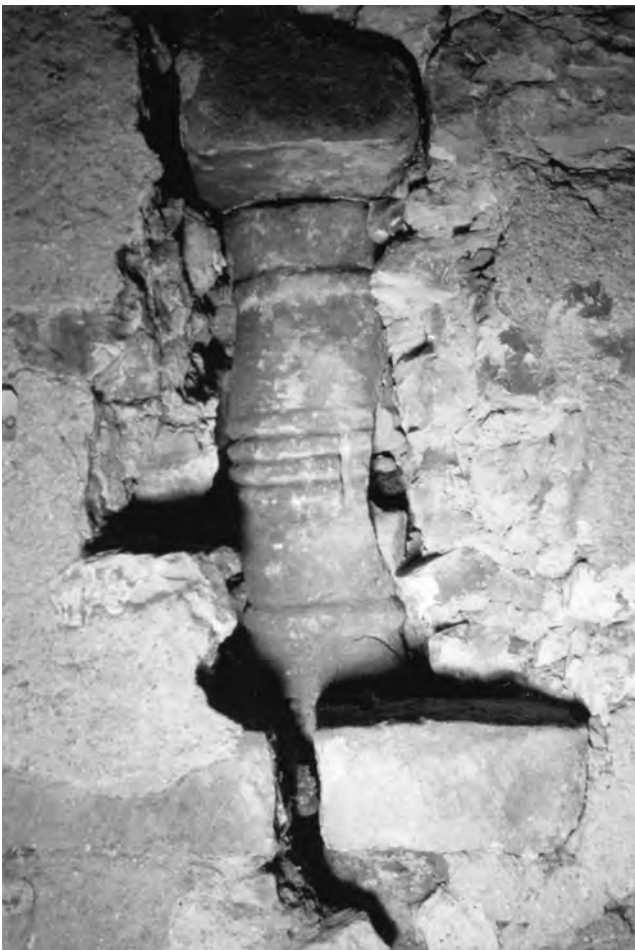
Fig. 313: Tower: Stage 2, interior. Damaged baluster in the blocked western belfry opening. Note also the fracture in the gritstone pad upon which the baluster rests.

Differences occur in three areas. First, the bulbousness of the shaft varies: that in the west belfry is firmly biconical, while its counterpart on the east is essentially cylindrical (Figs. 313 and 314). Second, the ‘capitals/bases’ range between cushion and conical forms, even on opposite ends of the same baluster. Third, there is variety in the number and prominence of the shaft-rings. In all but the west belfry opening, the rings stand proud of the shaft: there, however, they are sunk. The gallery-window balusters each have four rings, while those in the belfry have three, except in the case of the west baluster, which has only two but, in that instance, because the rings are sunk into the shaft, they give the impression of being more numerous. For further discussion of the baluster assemblage, see Everson and Stocker 1999, 102–4.

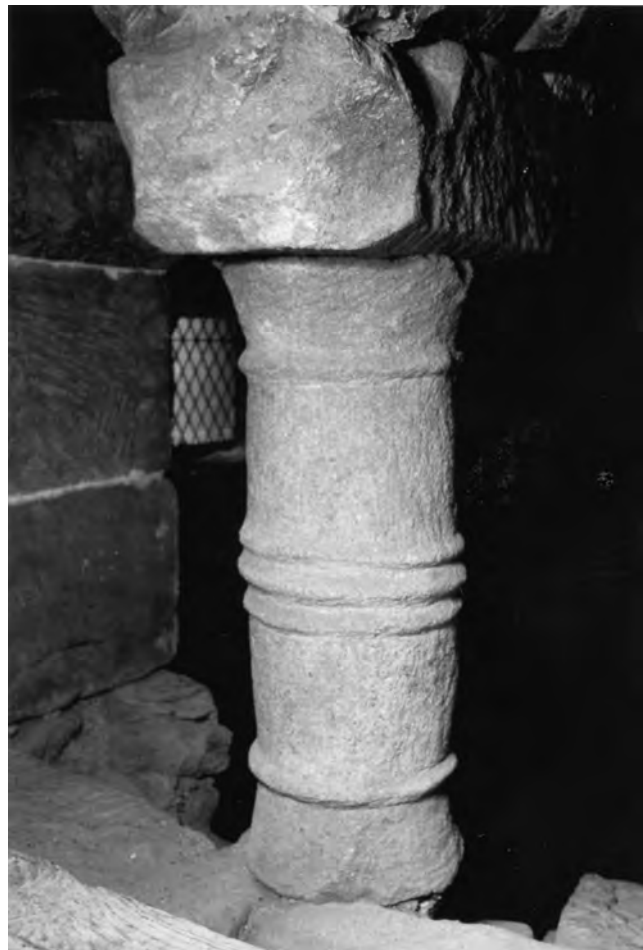
Fig. 314: Tower: Stage 2, exterior. Baluster and through-stone in the eastern belfry opening. View south-west. Photos Figs 313 and 314: Warwick Rodwell

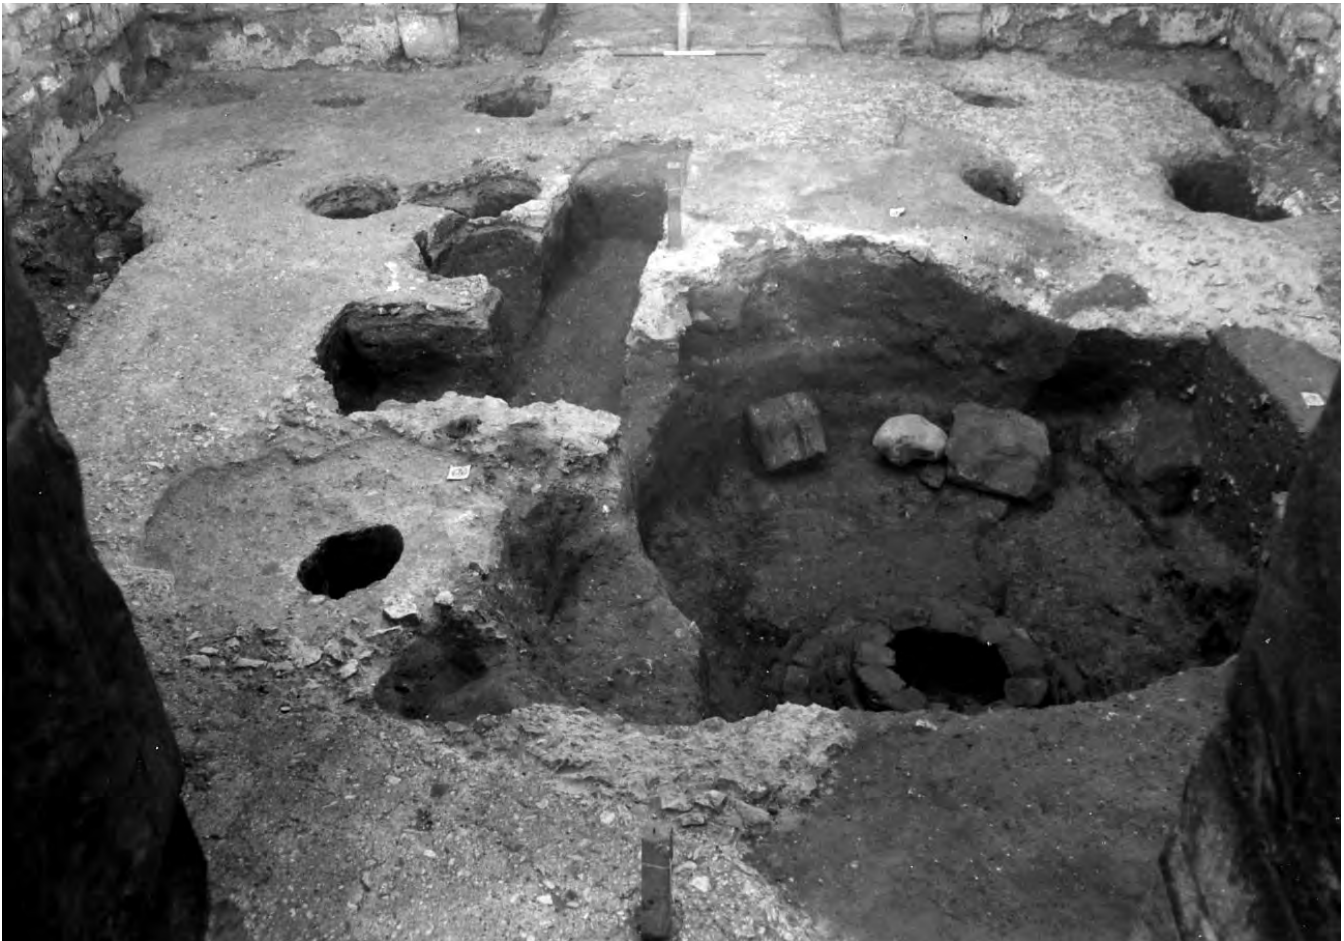
Fig. 315: Tower: primary lime-concrete floor, pierced by many later features. View east. Scale of 75 cm. Photo: Warwick Rodwell

(F534; Fig. 315).⁶⁴ The intention was to lay a monolithic floor slab, and the technique was basically the same as that used in recent centuries.

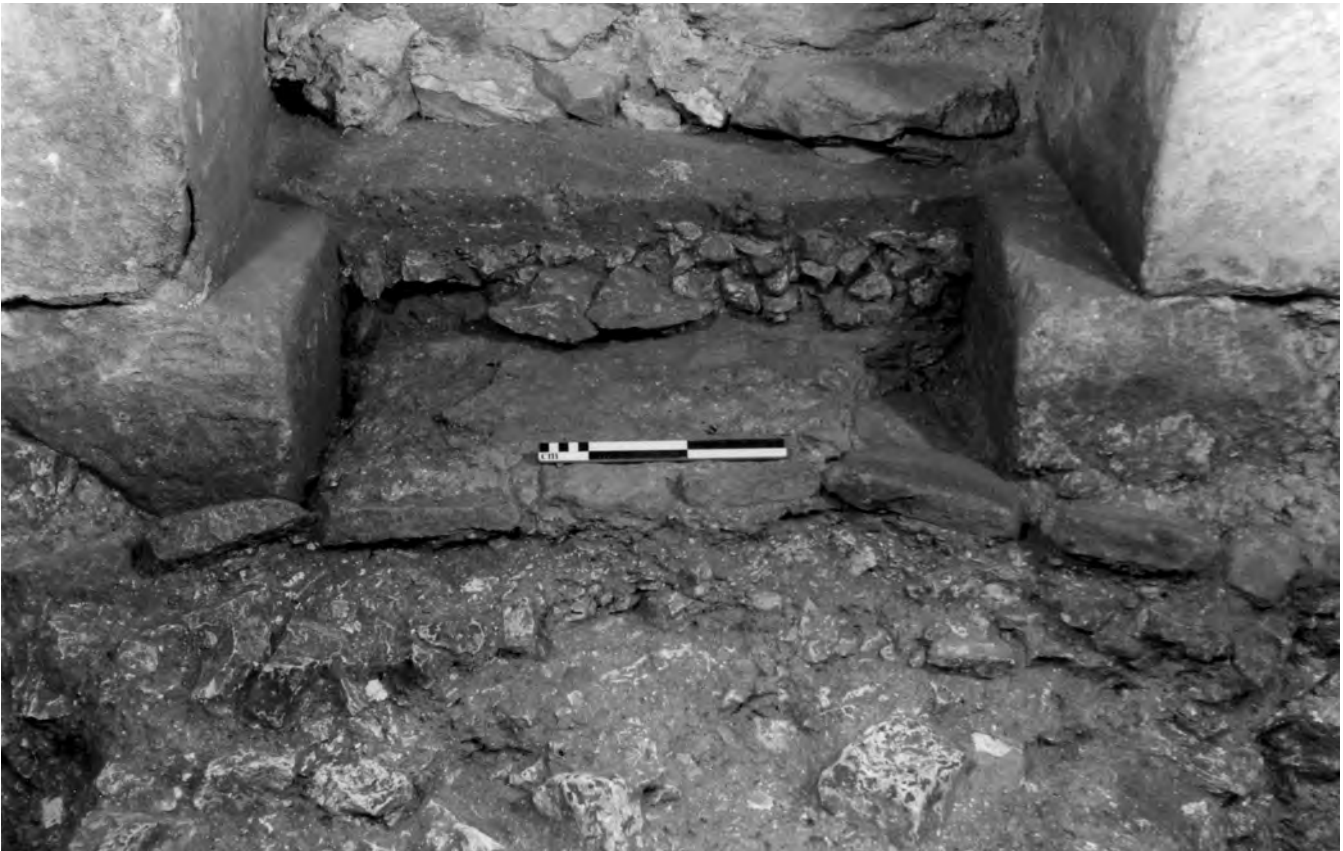
Fig. 316: Tower: threshold of the north doorway. The opening was originally edged with flat pieces of stone and finished with lime concrete; small rubble and a layer of grey loam were deposited over the threshold in Period 5, before the doorway was completely infilled with rubble. View north. Scale of 25 cm. Photo: Warwick Rodwell

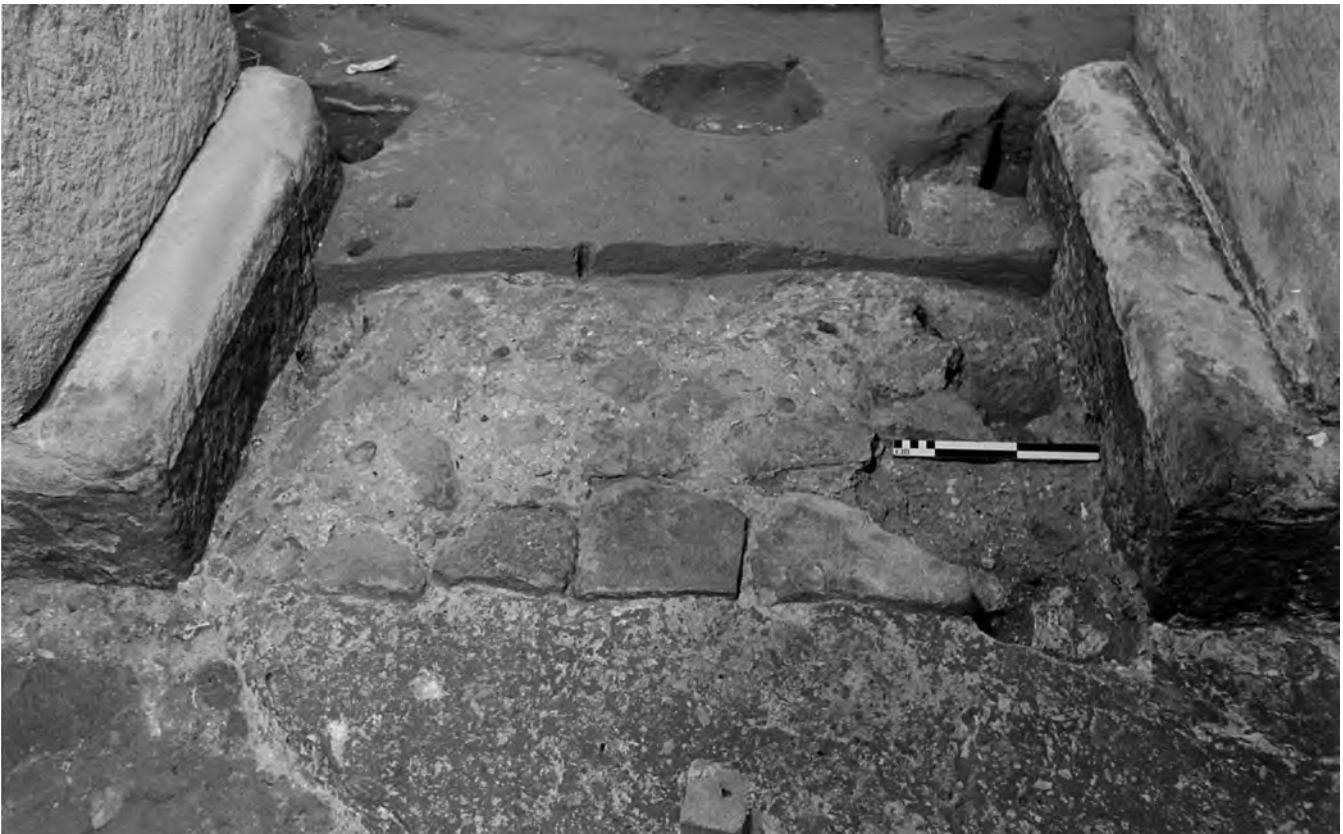
Fig. 317: Tower: threshold of the western arch, edged with flat stones. Overlying the primary lime-concrete surface is an accumulation of grey silty soil. View west. Scale of 25 cm. Photo: Warwick Rodwell

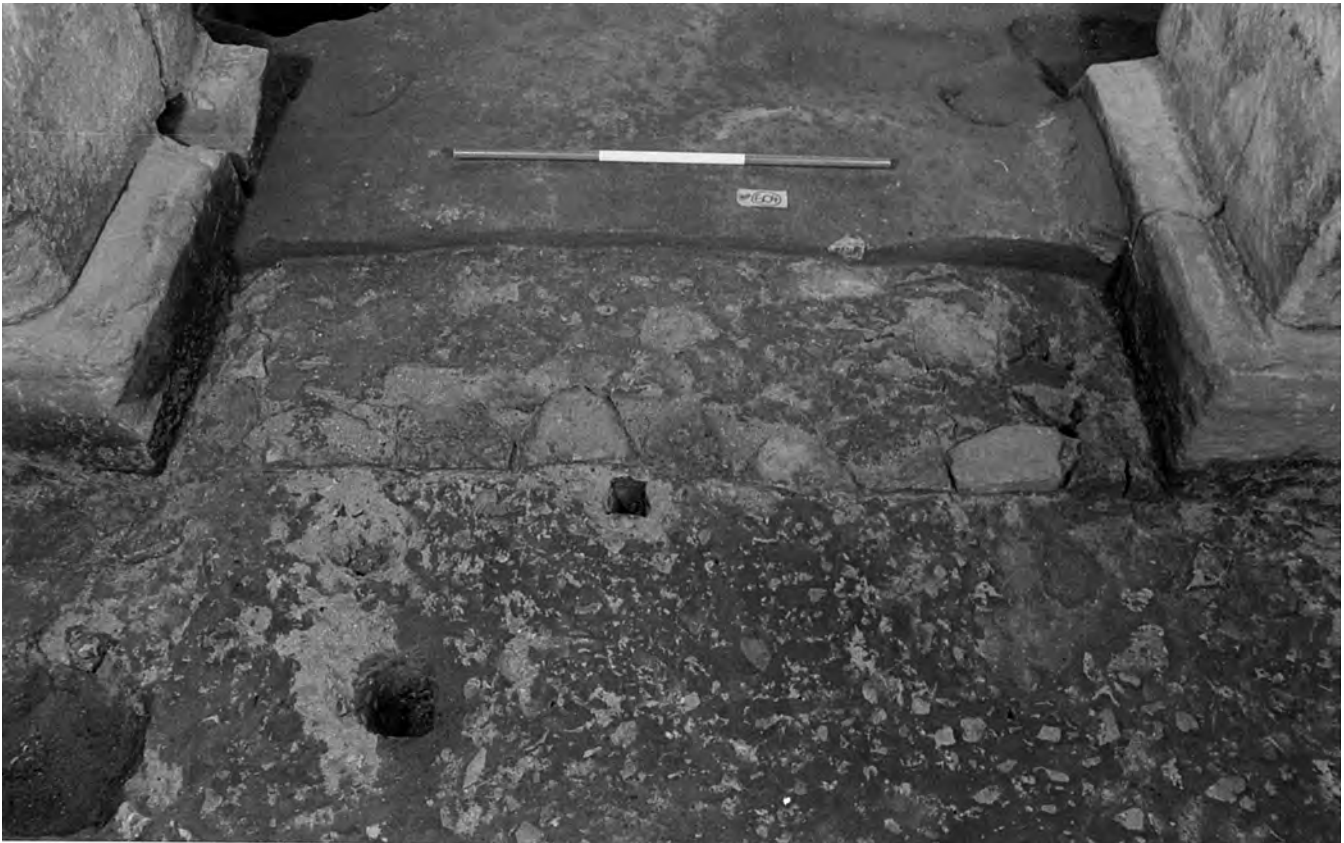
Fig. 318: Tower: threshold of the eastern arch, with the primary lime-concrete floor intact. View east. Scale of 75 cm. Photo: Warwick Rodwell
