ST PETER'S

Barton-upon-Humber, Lincolnshire

A Parish Church and its Community

HISTORY, ARCHAEOLOGY AND ARCHITECTURE

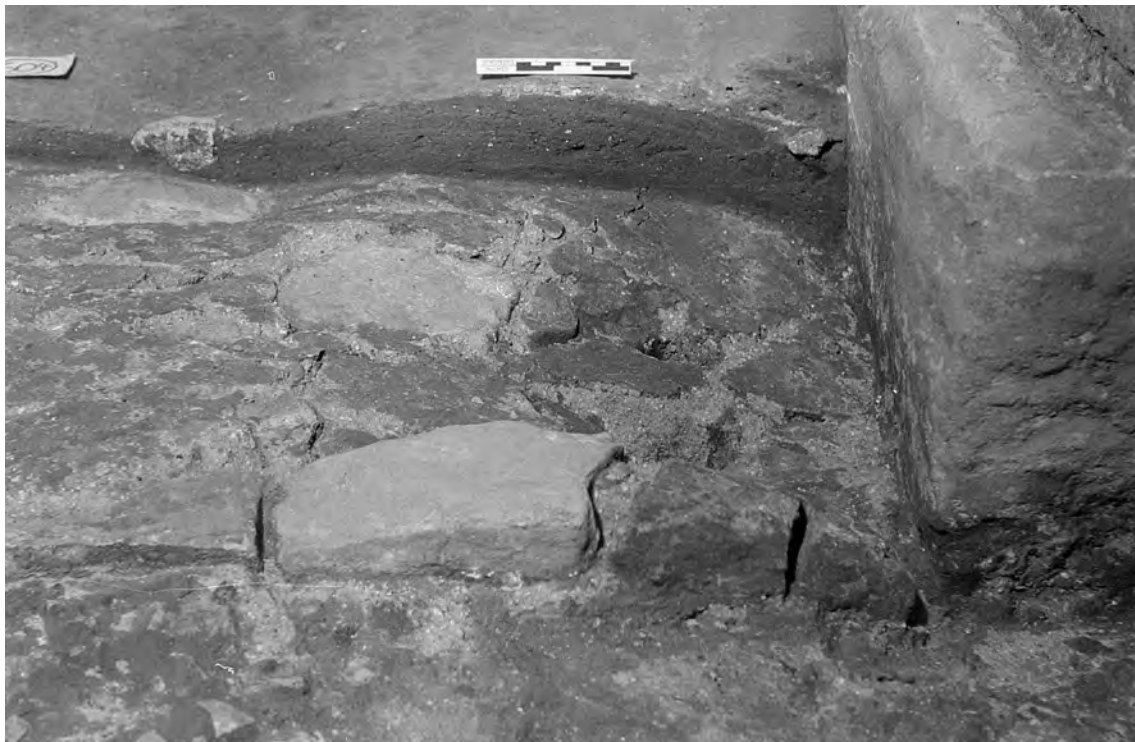
Fig. 319: Tower: detail of the threshold in the eastern arch, with the floor and its stone edging depressed through settlement adjacent to the reveal. The section shows the undulating profile of the accumulated grey soil, where it has been worn away by foot-traffic in the centre of the opening. View east. Scale of centimetres and inches. Photo: Warwick Rodwell

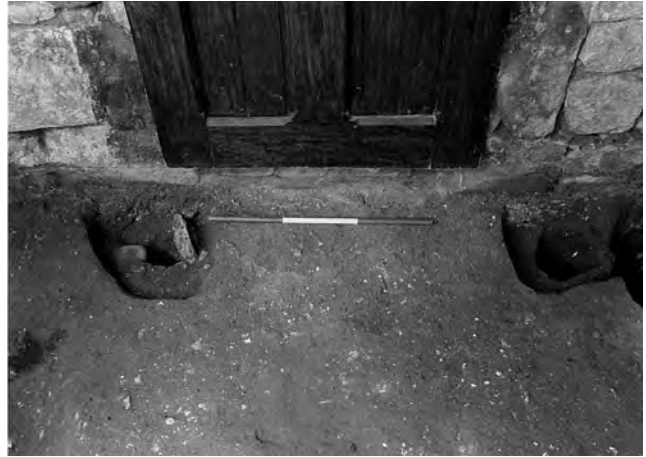
Fig. 320: Tower: south doorway. Postholes for a portal-frame flanking the opening internally. Scale of 75 cm. Photo: Warwick Rodwell

The primary floor was intact over approximately half of the interior of the tower, and was best preserved towards the north; survival was poorest in the centre and in the south-west quarter, doubtless as a result of prolonged use of the south door. The floor was pierced by various postholes and other small features, most if not all of which related to post-Saxon phases. Although no stratigraphic relationship with the floor was preserved, it seems clear that postholes flanking the north and south doorways belonged to the primary phase: three of the four survived intact (F674, F675 and F677; Figs. 320 and 321). A later feature had largely removed evidence for the posthole on the east flank of the north doorway. The fillings of all three retained evidence for the rectangular form of the timbers that they once held. The postholes were

45–60 cm in depth, indicating the need for the timbers to be securely groundfast. The evidence points to the provision of portal-frames around the doors,

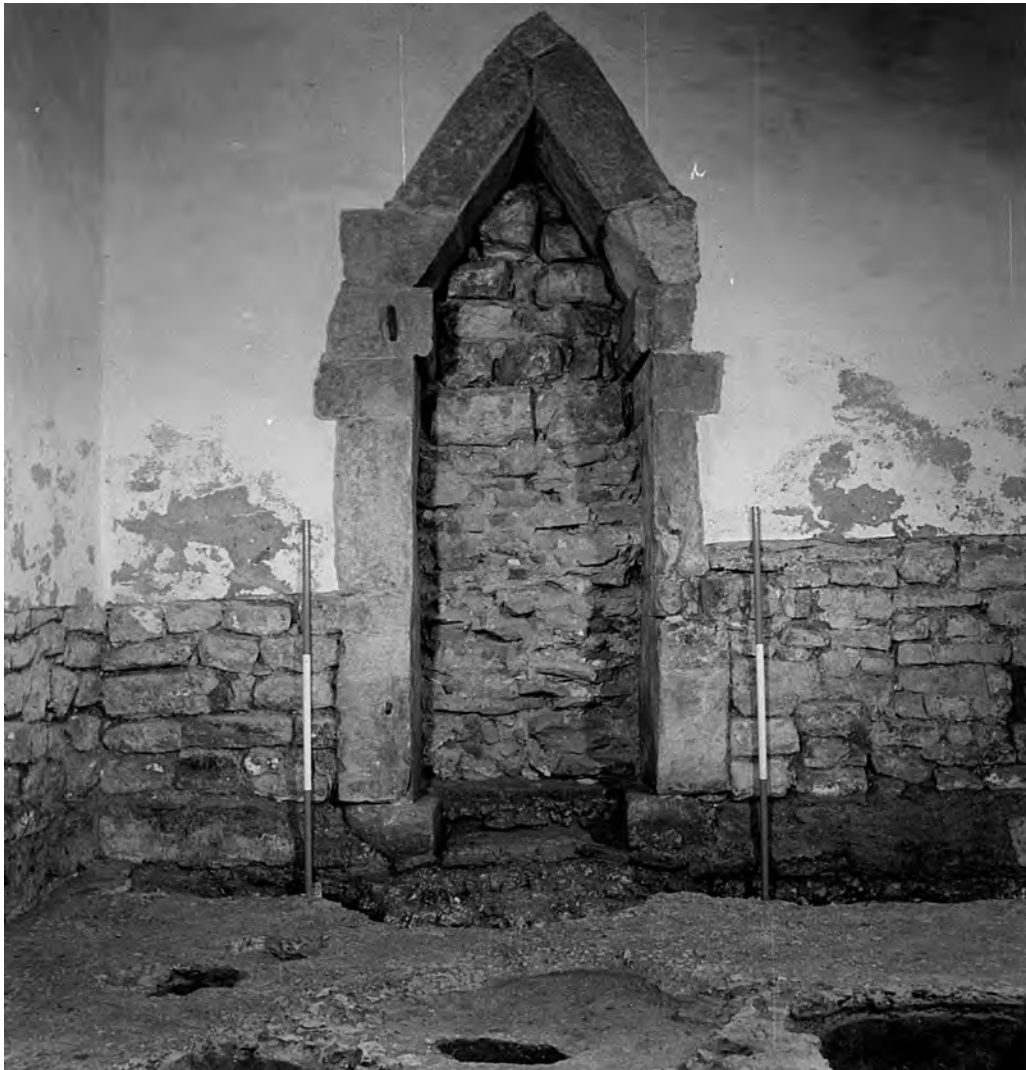
Fig. 321: Tower: north doorway. The 2 m ranging-poles mark the positions of the postholes for a portal-frame flanking the opening. Photo: Warwick Rodwell

which would do much to explain why the inner faces of these (and other) Anglo-Saxon doorways were utterly plain and devoid of projecting masonry. The possibility that the doors were framed by decoratively carved surrounds – as seen in some early Scandinavian churches – should be seriously considered (Rodwell 1986, 165–7).

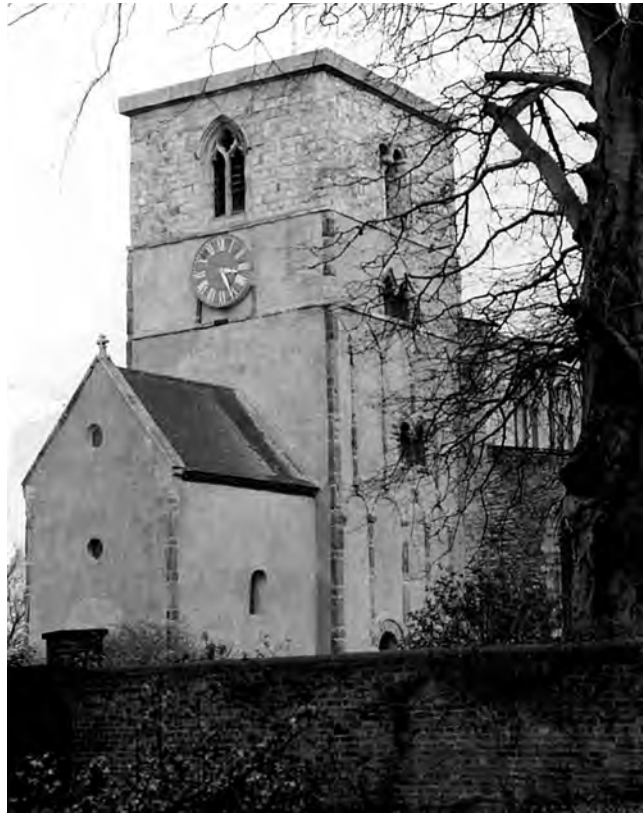
Fig. 322: Western annexe and tower. Viewed from the south-west in the 1970s. Photo: David Lee Photography

The walls are now finished with hard cement pebbledash-rendering, applied in 1965 (Fig. 322). Prior to this the rubble construction of the south and west walls was exposed to view for many years, having been stripped of the pebbledash rendering that had been applied in *c.* 1870. The north wall had not been deliberately stripped, but large areas of rendering had fallen off. Early photographs show all three walls in varying states of exposure (Figs. 255 and 323).⁶⁶

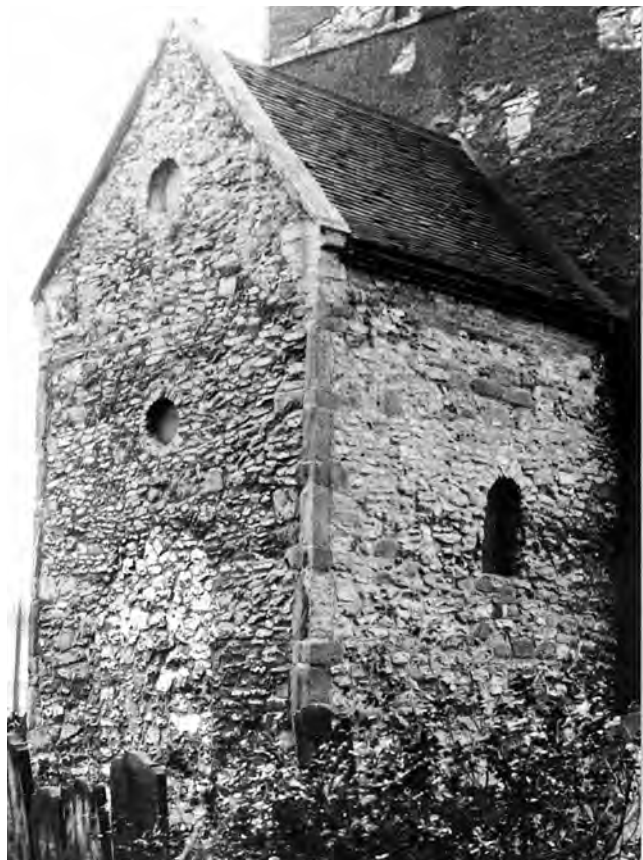
Fig. 323: Western annexe. Viewed from the south-west, 1946. Photo: R.H. Linsell, courtesy of the Church Buildings Council

The walls are composed of small mixed rubble, with scattered inclusions of larger pieces of gritstone (Figs. 323 and 327). The rubble comprises limestone, chalk and water-worn boulders. As with the tower, banding is discernible in the construction, reflecting the arrival on site of different loads of rubble. A few building-lifts could be defined, and paired putlog holes

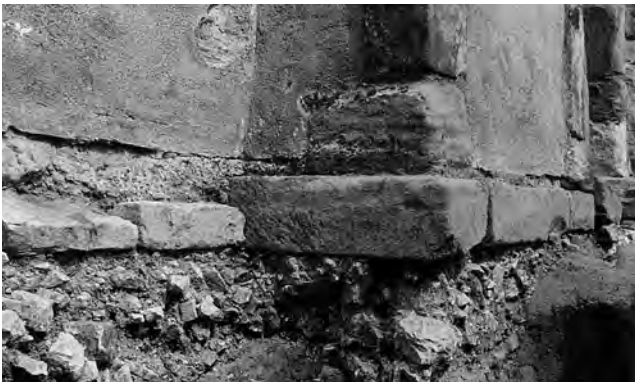
Fig. 325: Tower: gritstone plinth at the south-west corner, abutted (left) by the shallower limestone plinth of the western annexe. Photo: Warwick Rodwell

Externally, the annexe is a plain structure, with rendered rubble walls rising from a plain, un moulded plinth at ground level. The latter is composed of small, flat slabs of Lincolnshire limestone, which were only roughly dressed and butted up to the tower plinth (Fig. 325). They are now frost-shattered and badly decayed; some are missing altogether (Figs. 260 and 326). The two western quoins are formed with blocks of gritstone, arranged as long-and-short work, and these stand slightly proud of the adjacent wall-faces. As with the tower, the 'tails' of the horizontal blocks, which are tied into the rubblework, were dressed back *in situ*, so that they would be concealed by rendering (see further, p. 327). The quoins were thus designed to appear pilaster-like, with sharp arrises. The west end terminates in a gable with an upstanding verge; this has nineteenth-century limestone kneelers and copings, and is crowned by a gable-cross that appears to be fourteenth century (Figs. 324 and 539). The eaves are finished with three projecting courses of eighteenth-century brickwork with dogtooth ornament, and the roof is covered with modern red clay tiles.

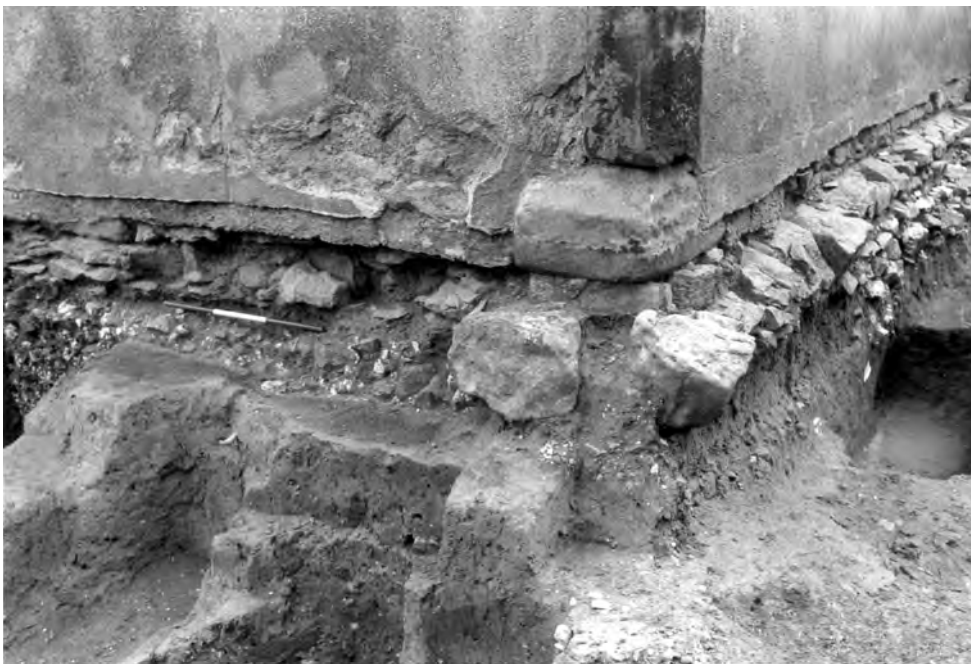
Fig. 326: Western annexe: south-west corner. The limestone plinth running around the base of the walls is present but heavily decayed on the south (right), while on the west (left) it has largely disappeared. Scale of 75 cm. Photo: Warwick Rodwell

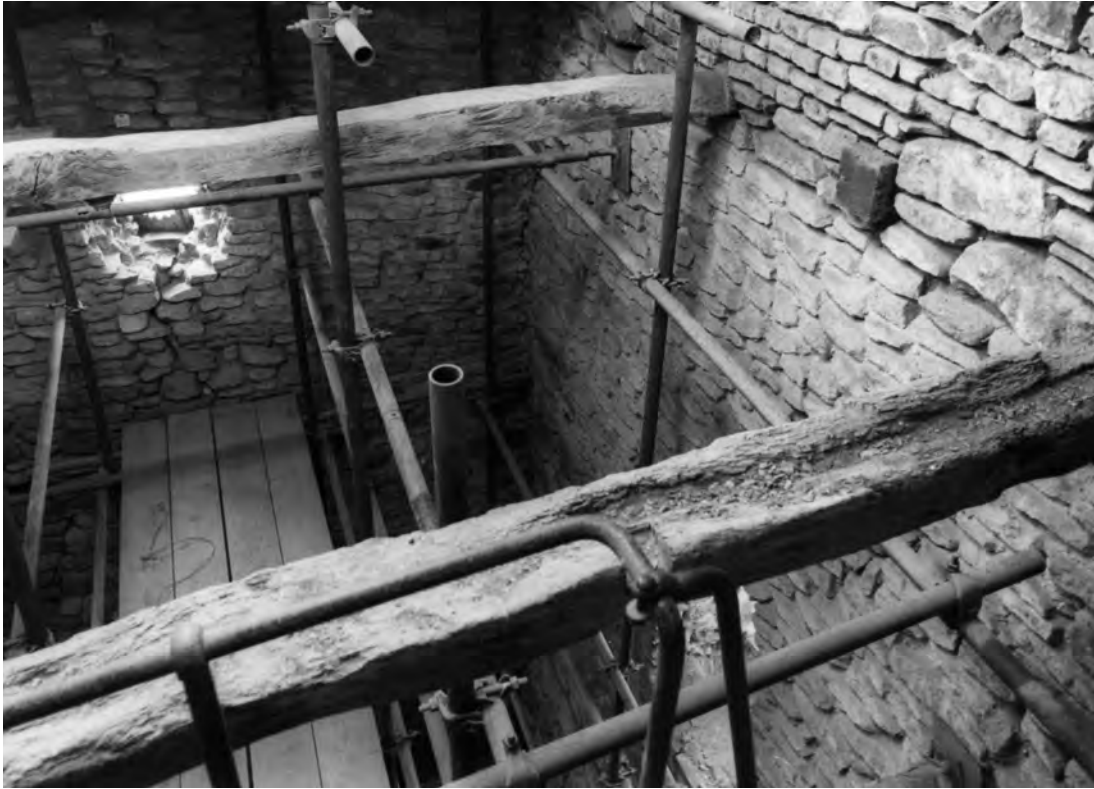
Fig. 328: Western annexe: the upper part of the north wall, showing two existing floor joists (the nearer one being primary) and the sawn-off stump of a third in between. View north-west, 1983. Photo: English Heritage

the north, the latter dimension (20½ ft) equating with the threshold of the gallery-level doorway in the tower (Fig. 308). The tops of the walls are much disturbed by works associated with later roofs, but nevertheless they retain evidence of former flooring at eaves level. One complete oak joist remains, with its ends embedded in primary construction mortar, and the sawn-off end of another occurs next to it in the north wall (Figs. 328 and 329). Further joist-ends exist in both walls, but these are set in post-medieval masonry and brickwork, and are unlikely to be primary timbers.⁶⁹

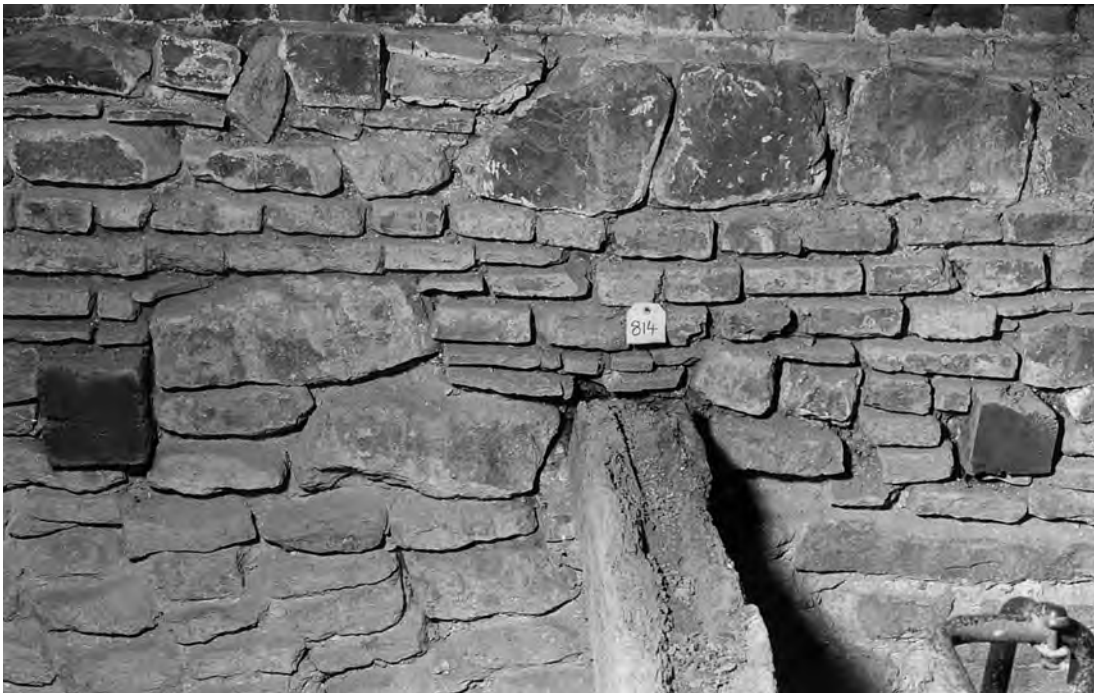
Fig. 329: Western annexe. The top of the north wall, showing one primary floor joist in situ and the stumps of two others that have been sawn off. Photo: Warwick Rodwell

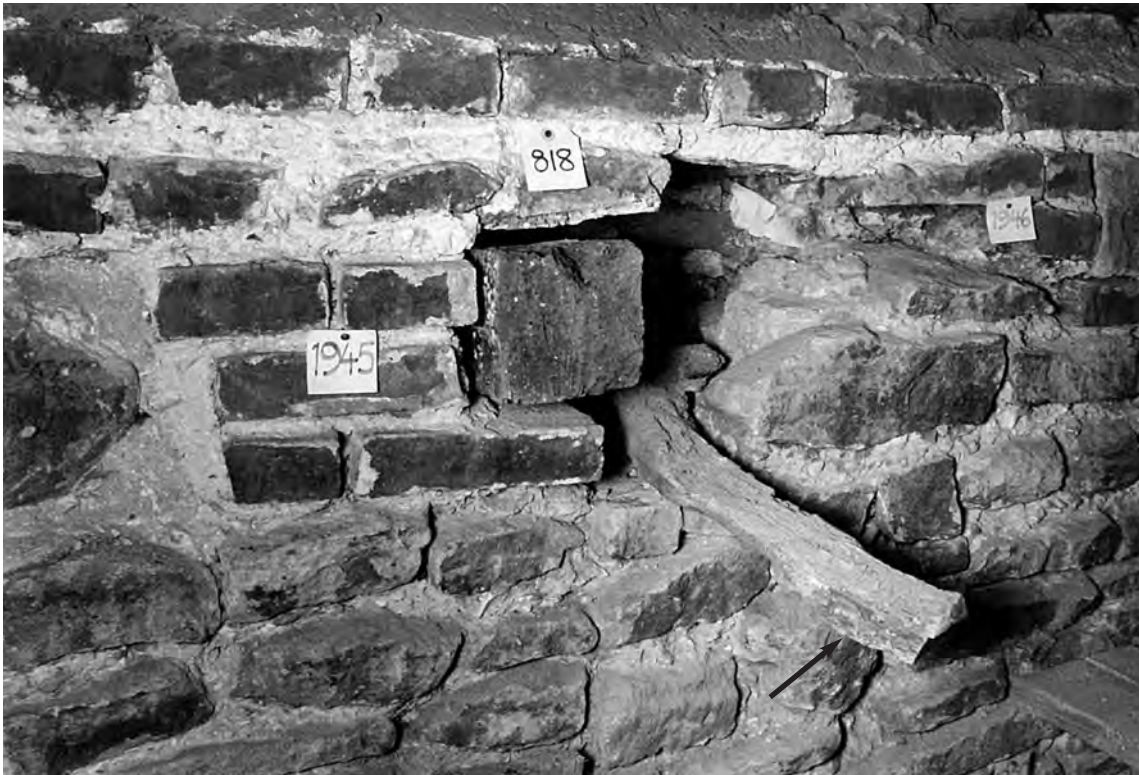
Fig. 330: Western annexe. Fragment of oak branch-wood (arrowed) partially embedded in the south wall, close to the west angle and adjacent to a sawn-off primary floor joist, 1983. This was probably a remnant of the Anglo-Saxon scaffolding. Photo: Warwick Rodwell

Inside the church, a further primary detail was noted in the south wall, close to the western corner and just below the eaves. Here, a fragment of oak branch-wood with a cleanly sawn-off end formerly projected from the wall-face (Fig. 330). Repairs were needed to the top of the wall, and investigation revealed that the branch was embedded in the masonry to a depth of *c.* 35 cm and, although there was post-medieval brickwork above, there was no doubt that the branch was set in the primary Anglo-Saxon mortar. It was neither large enough in diameter nor straight enough to have been a putlog, but could have been part of a hurdle which was used by builders as decking on the scaffolding. Whatever its use, the end of the branch was firmly trapped in the masonry and when it was no longer wanted it had to be sawn off.⁷¹

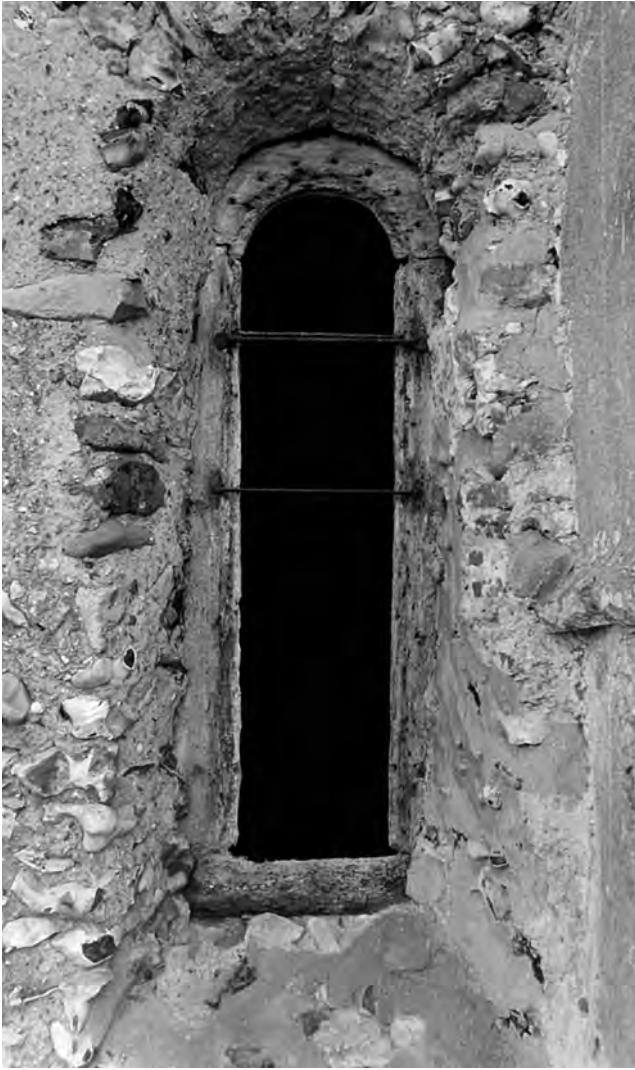
Fig. 331: *St Botolph, Hadstock (Essex)*. Jointed oak frame of a double-splayed window in the north wall of the nave, integrally built with the flint-rubble masonry. Note also remains of the original lime-render in the reveal and on the external wall face (upper left). Photo: Warwick Rodwell

carpentered oak frames of the type that still survive at Hadstock (Essex) and elsewhere:⁷² each comprised a sill, a pair of stiles and a shaped head (Fig. 331). The head was a rectangular baulk of timber with a semicircular cut-out to form the window arch. A series of small holes drilled into each face, concentrically around the arch, provided anchoring points for the basketwork hoods that supported the masonry heads of the outer and inner splays while their bedding mortar was setting (Fig. 332). Although no evidence survives at St Peter's, it was usual for the basketwork to be left in place, providing a useful key for the plaster lining to the head of the splay. Impressions left by woven cane-work in the mortar have been recorded in window heads at Hadstock, Hales (Norf.) and elsewhere (Rodwell 1986, 164–6).

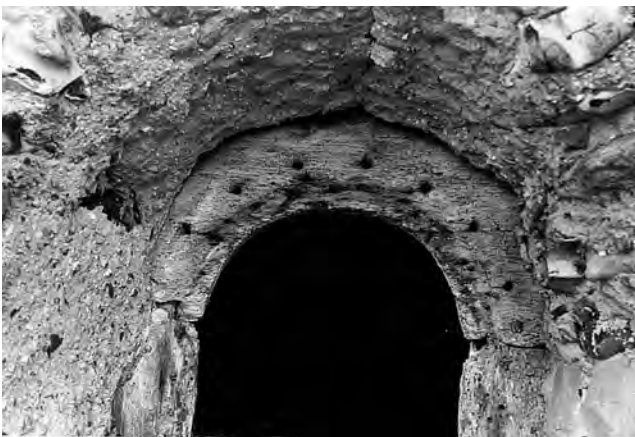
Fig. 332: *St Botolph, Hadstock (Essex)*. Semicircular head of a jointed window frame in the nave, showing the arc of small holes used to anchor the basketwork hood which served as a former for the arch of flint rubble. Note the preserved wattle impressions in the soffit. Photo: Warwick Rodwell

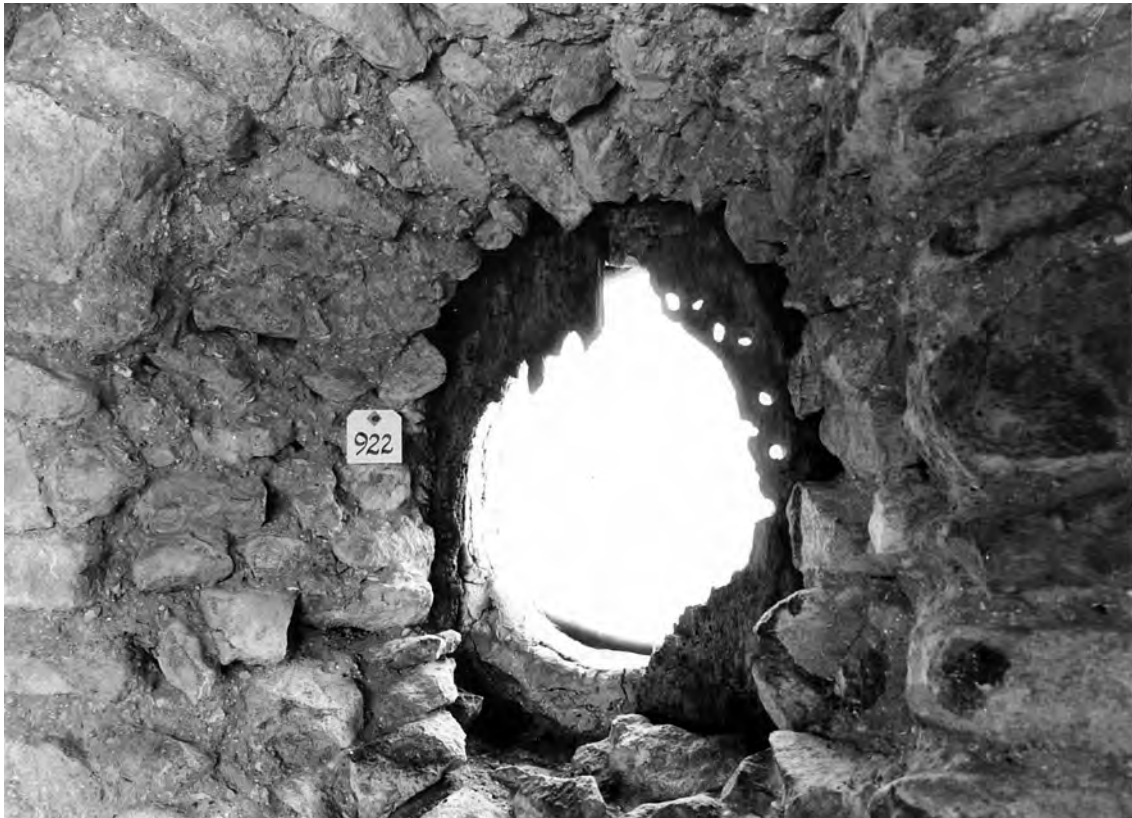
Fig. 334: Western annexe, interior. Remains of the pierced oak mid-wall board in the upper oculus. Photo: Warwick Rodwell

The two circular windows in the west wall were constructed on the same principles. The upper was slightly larger (70 cm diam., externally) than the lower (60 cm diam.). The mid-wall apertures, after making allowance for the missing plaster layer, had a diameter of c. 35 cm. Instead of having carpentered frames, these openings were each fitted with a pierced oak board. Parts of both boards remain *in situ* (Fig. 333). The timbers are very fragmentary, but more survives in the upper *oculus*, where it appears that the board was pierced with a series of vertical slots, the ends of which were rounded as a result of being formed with a drill (Fig. 334).⁷³ Also, a semicircle of small drilled holes around the upper half of the board – on both faces – provides confirmation that hoods of basketwork had been attached. Once again, their function was to support the arched heads of the openings while the construction mortar was setting.

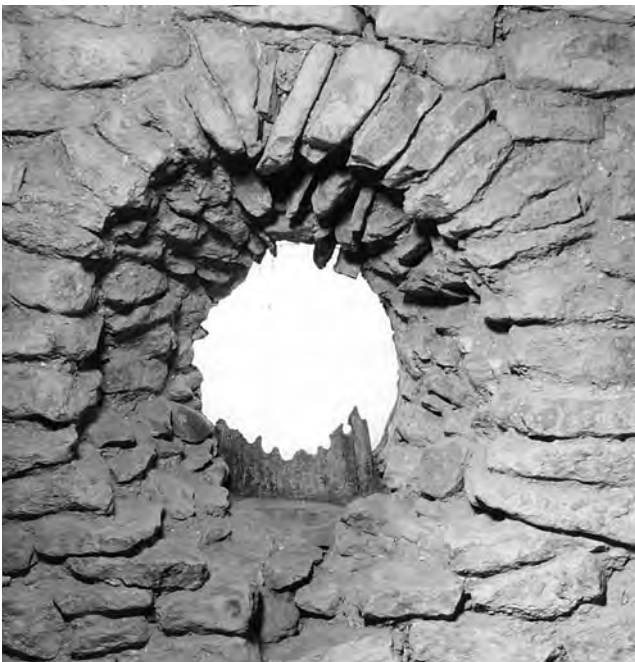
Fig. 335: Western annexe, interior. Remains of the pierced oak mid-wall board in the lower oculus. Photo: Warwick Rodwell

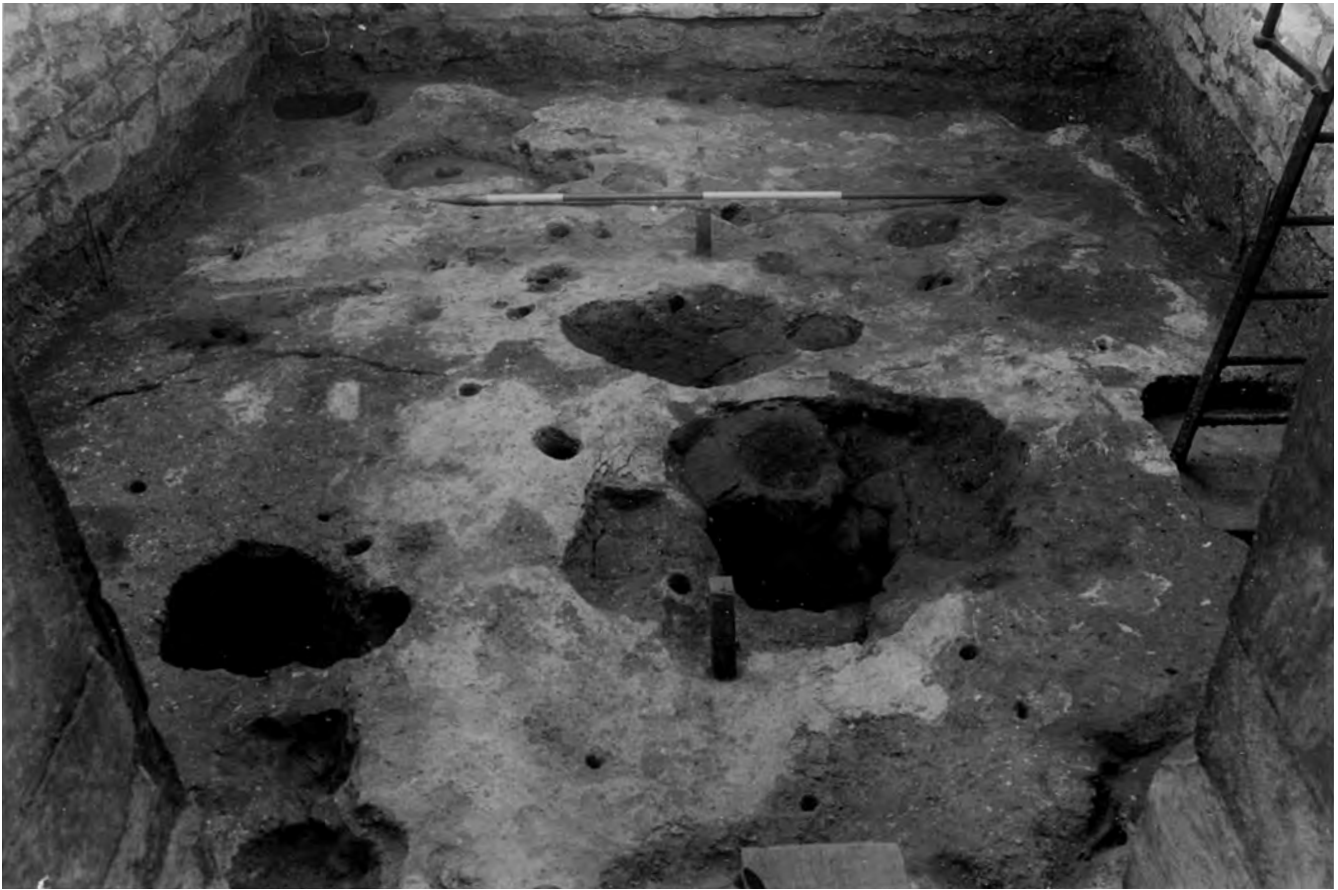
Fig. 336: Western annexe. Remains of the primary lime-concrete floor (F534) of the baptistery, after the excavation of all later deposits. View west through the tower arch. Scale of 2 m. Photo: Warwick Rodwell

was spread over the interior, concealing the tops of the foundations and abutting the walls. A lime-concrete floor (as in the tower, F534) was laid on this (Fig. 336). Several postholes cut into the clay, and doubtless associated with scaffolding, were sealed by the floor.

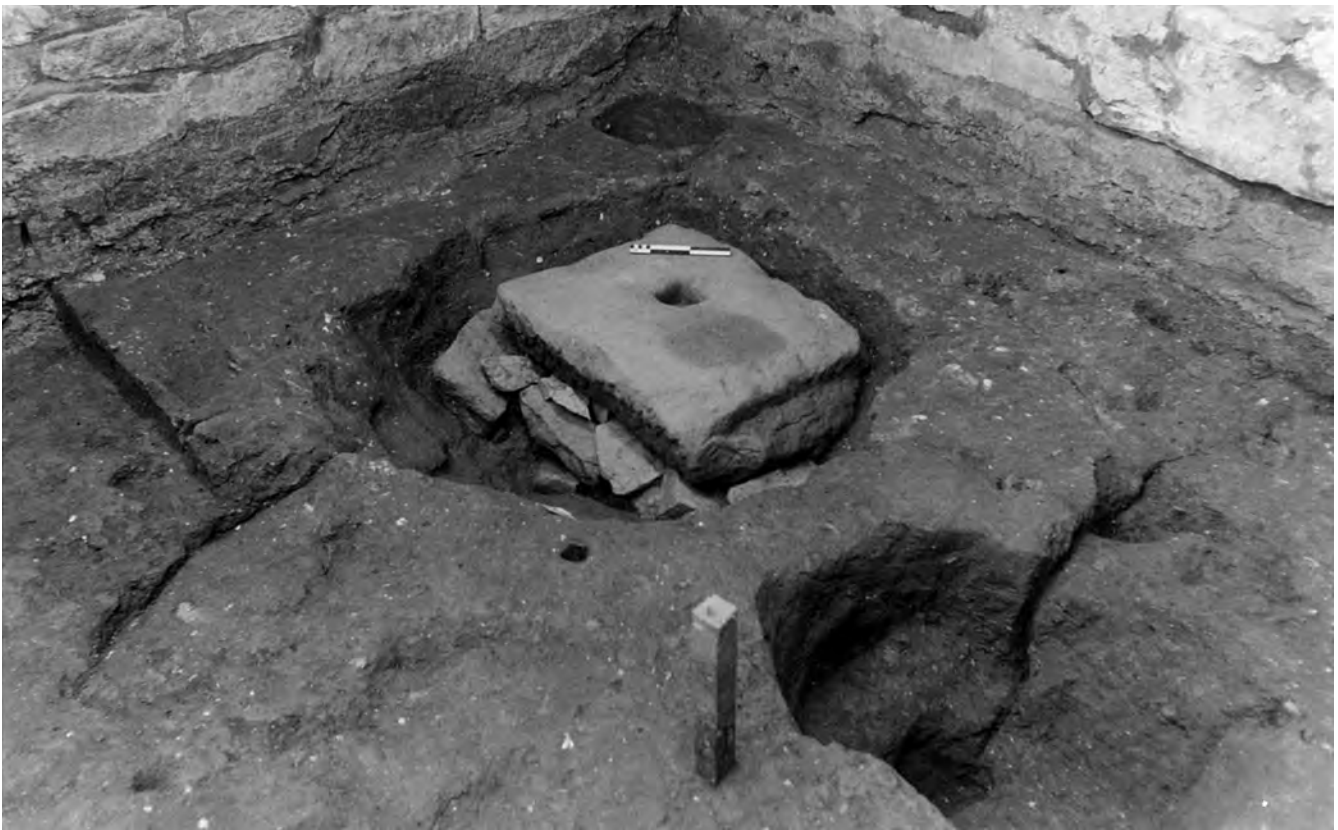
Fig. 337: Western annexe. View into the south-west corner, after excavation of all internal deposits, showing the pit containing the gritstone block to support the Anglo-Saxon font. Scale of 25 cm. Photo: Warwick Rodwell

block of gritstone, measuring 70 cm by 60 cm, with a mortice in its upper face (F793; Figs. 256 and 337). The latter was roughly level with the top of the clay spread, and the block was supported on a rubble 'footing' comprising small pieces of limestone that had been

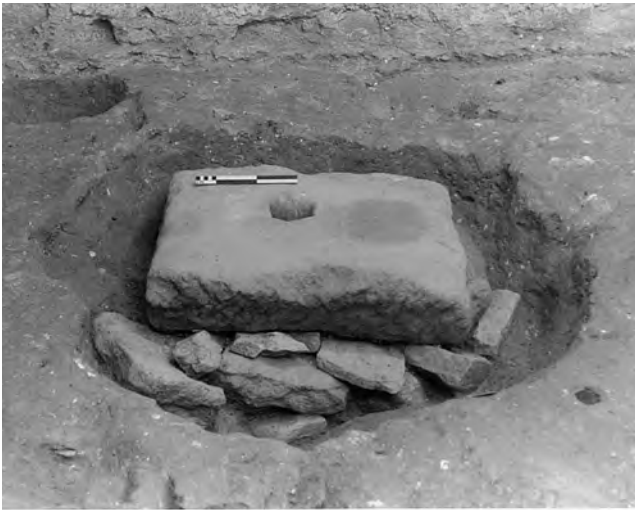
Fig. 338: Western annexe. Gritstone block to support the Anglo-Saxon font, showing the construction pit and soak-away made of limestone fragments. Note also the pattern of wear on the upper face of the block, especially at the near right-hand corner, the side from which the font would principally have been approached. View west. Scale of 25 cm. Photo: Warwick Rodwell

thrown into the hole; this was not a constructed foundation, the rubble being loose and voided (Fig. 338). The filling of the pit, around the gritstone block, was in two layers: the lower 10 cm comprised clay, above which was clean chalk and flint gravel. The lime-concrete floor was then laid, lapping over the surface of the block and masking its outline.

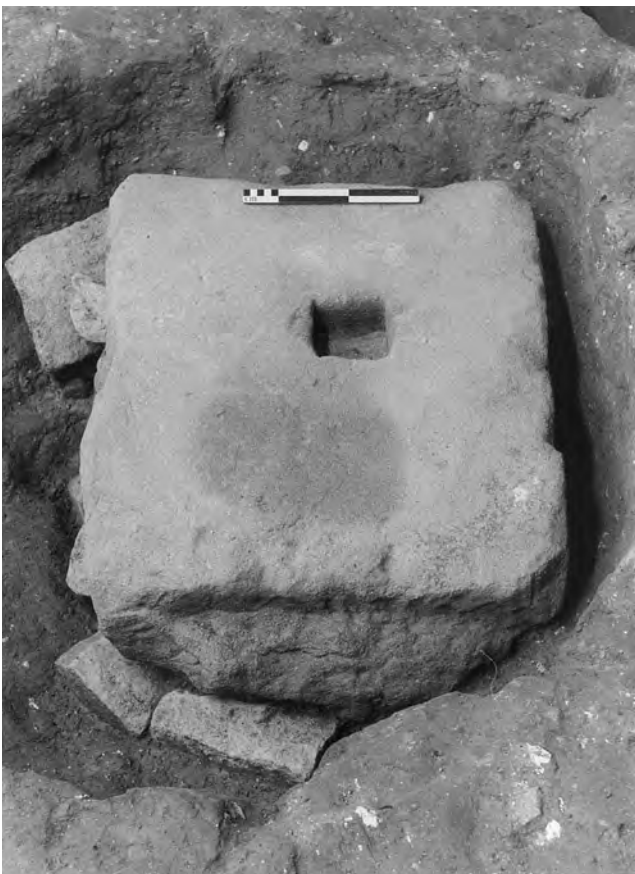
Fig. 339: Western annexe. Close-up view of the gritstone font base, showing the mortice in the upper face and the cut-and-break line along the near edge. View south. Scale of 25 cm. Photo: Warwick Rodwell

the stem and bowl. The surviving base exhibits various features which point to its earlier history: first, it has been fashioned from a longer block, as shown by the cut-line on its north end and the different types of tool-marks on its edges (Figs. 339 and 817). Second, the upper surface exhibits considerable signs of wear, and the arrises are rounded: this occurred before use in the church. Third, the mortice is primary. Collectively, these features point to the stone having originated as a stylobate block from a Roman portico or colonnade, the column-bases of which were secured with tenons. When the block was cut down the mortice was retained as a near-central feature, possibly implying that it was reused to locate the font stem in position (although that must be very doubtful, since the stems of fonts were not normally tenoned into their bases).

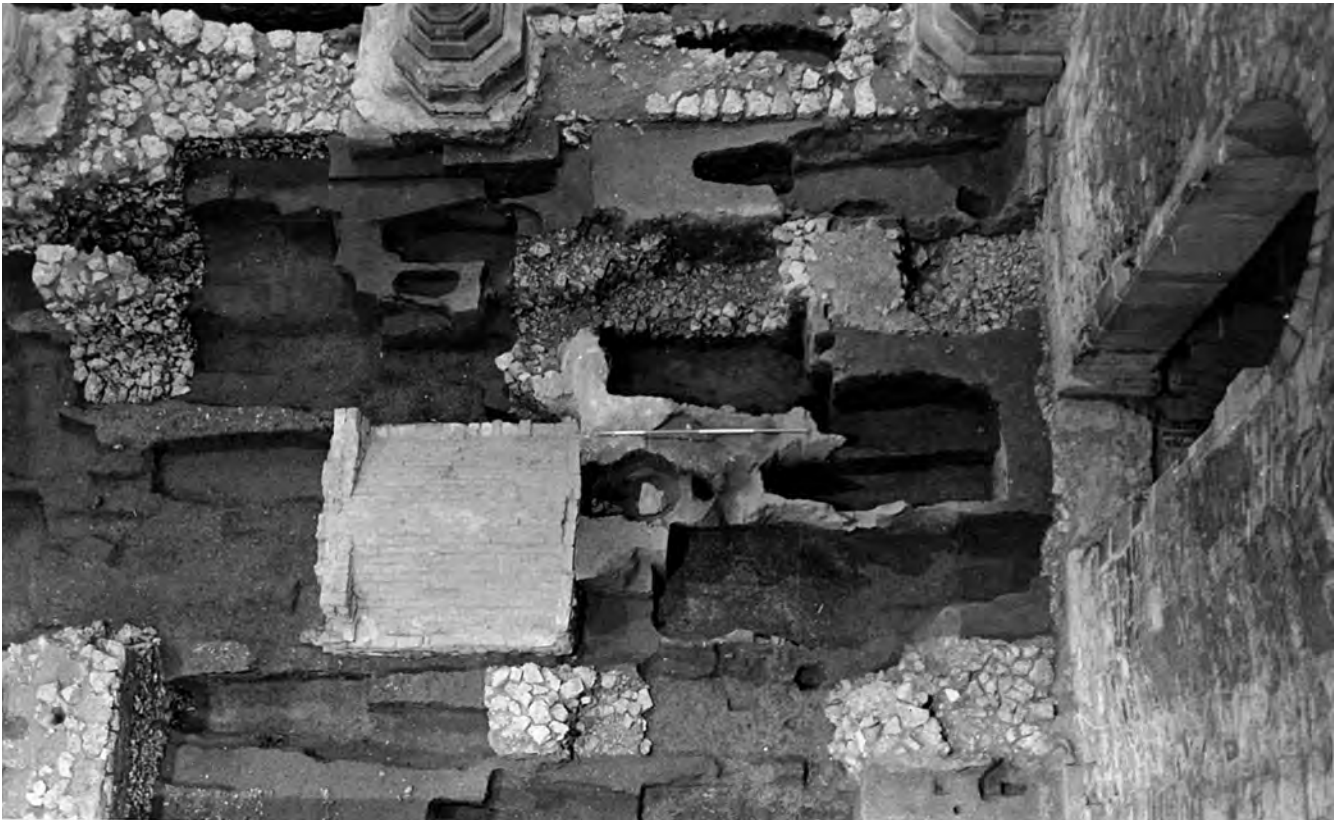
Fig. 340: Foundations of the Anglo-Saxon chancel and the nave of the Saxo-Norman church which encased it. The chancel arch of the tower-nave is on the right. View south. Scale of 2 m. Photo: Warwick Rodwell

Nothing survives of the chancel above ground level, except the vertical scars where its north and south walls were keyed into the east face of the tower (Figs. 252, 258 and 347). Excavation beneath the floor of the present nave (Area 1) revealed the foundation plan, although much cut about by later features (Figs. 256, 340 and 341). The construction was identical to that

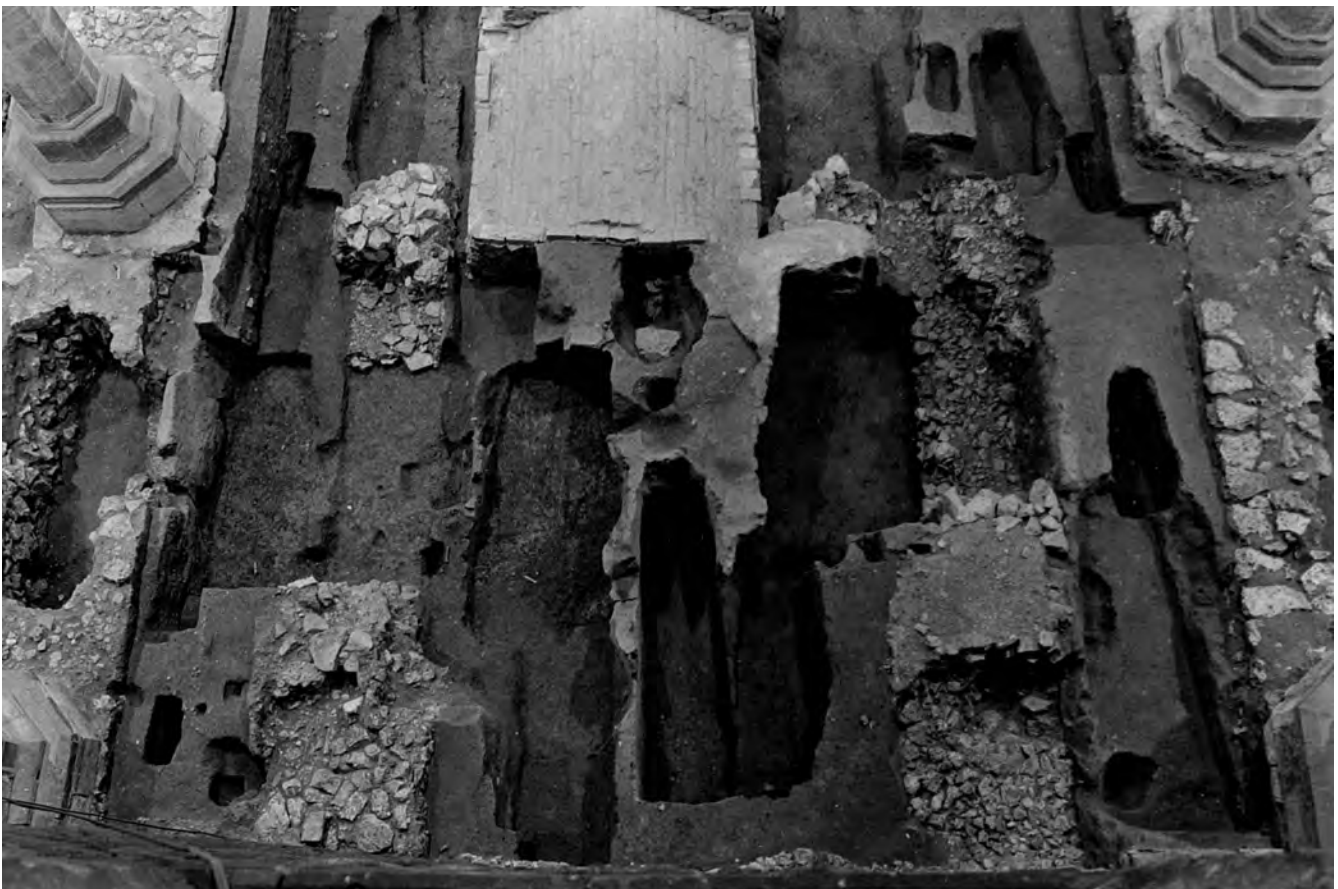
Fig. 341: Fragmentary foundations of the demolished Anglo-Saxon chancel, after the excavation of all later features. Overhead view from the high-level doorway in the tower. East is at the top. Scale of 2 m. Photo: Warwick Rodwell

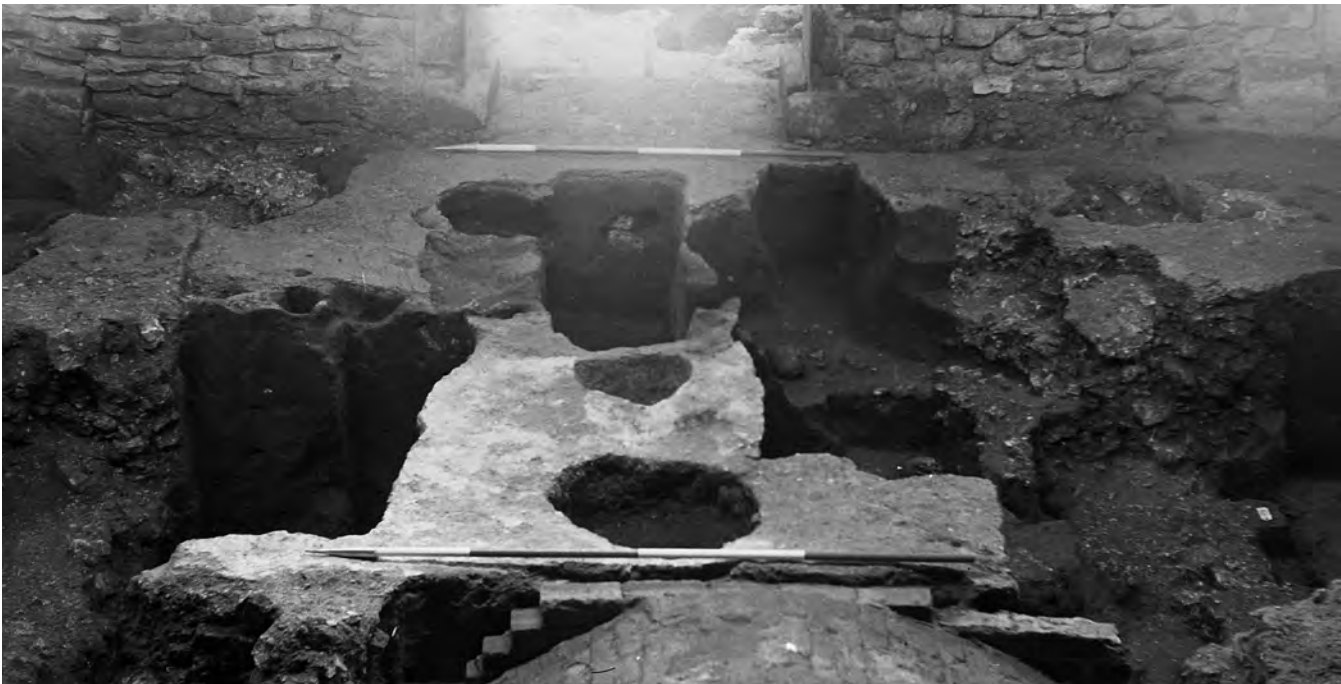
Fig. 343: Site of the Anglo-Saxon chancel with primary white lime-concrete floor, much disturbed by later features. The south wall foundation is glimpsed on the left; the north foundation is on the right, but largely dug away. The east wall was removed by the brick vault in the foreground. View west. Scales of 2 m. Photo: Warwick Rodwell

The lime-concrete floor of the tower continued into the chancel, but its survival was very patchy. It appears to have covered only the western half, ending at the line of a timber screen which ran across the chancel at its mid-point (Fig. 256). Evidence for the screen was found abutting the south wall, where several slots and small postholes had survived later disturbances (F215–F218). The existence of a permanent division here is also reinforced by the fact that the primary lime-concrete floor (F534) did not occur in the eastern half of the chancel: instead, a different type of floor was present which appeared to be composed entirely of crushed chalk and small gravel (F219; Figs. 343 and 344). The surface was worn and undulating, but there was no change of level between the two floors.

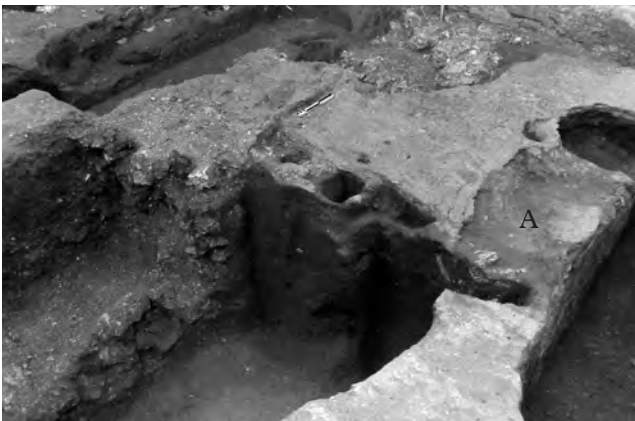
Fig. 344: Floors in the Anglo-Saxon chancel. In the foreground is the pale lime-concrete floor of the eastern half. Beyond is the darker floor of the western half, the two separated by a line of small postholes. The site of the southern foundation for the altar is labelled 'A'. The scale (25 cm) lies against the south wall, where a narrow ribbon of primary wallplaster survives on the upstand. View south-west. Photo: Warwick Rodwell

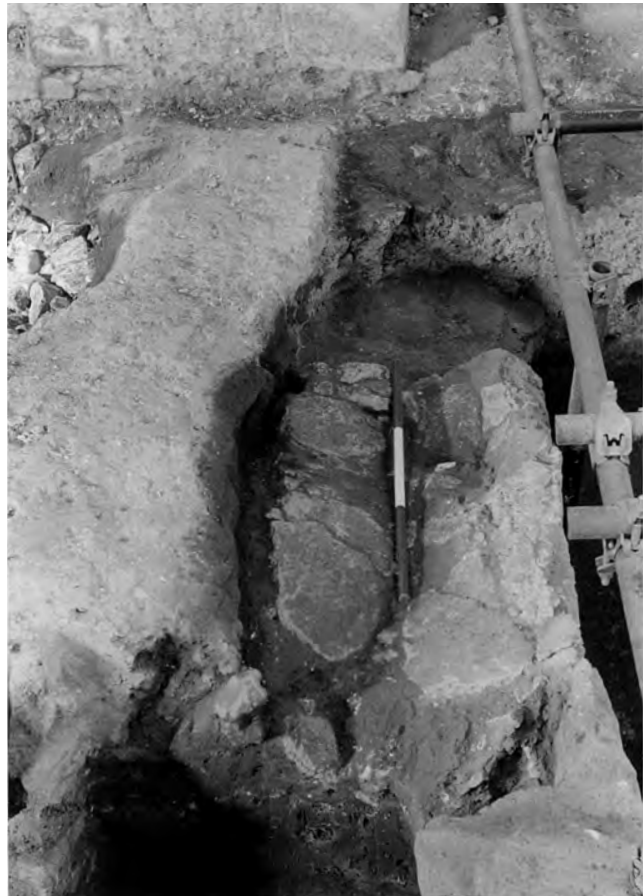
Fig. 345: Chancel: grave F1386. The filling of the grave subsided, taking the lime-concrete floor with it. View west. Scale of 75 cm. Photo: Warwick Rodwell

grave (F1386) had been dug before the lime-concrete floor was laid, and thus the interment presumably took place while the church was in the final stage of construction. The outline of a coffin was partly preserved on account of the timber from which it was made having been charred. After the lime-concrete floor had been laid, the filling of the grave subsided and the floor broke up and sunk (Fig. 345). The burial was unusual for Barton in that the bones of the pelvis and torso had decayed to such an extent that nothing was recoverable: they appeared in the ground as cream-coloured pulp. In contrast, the bones of the skull, right arm (the left was missing) and legs were in average condition (Fig. 346). Such markedly different decay mechanisms, within a single adult grave, raise the possibility that some form of treatment, such as embalming, was applied to the corpse. Although positive evidence for embalming is lacking, this pattern of differential bone decay is regularly encountered on high-status sites.⁸³

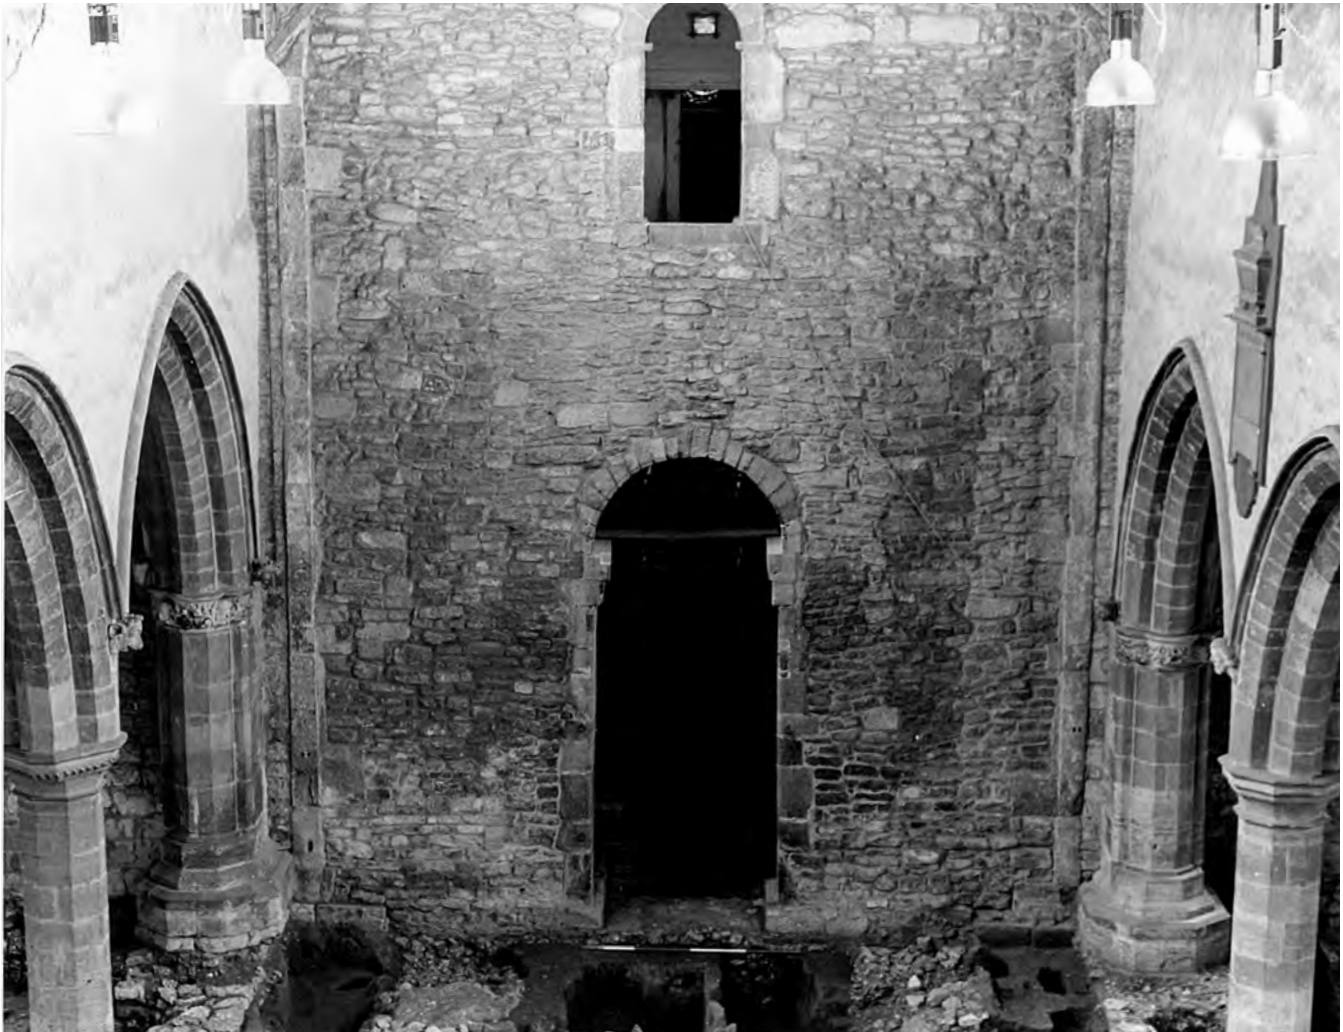
Fig. 347: Tower: east face, showing bonding scars (patched with darker coloured rubble), where the Anglo-Saxon chancel walls were formerly attached. Scale of 2 m. Photo: Warwick Rodwell

The height of the chancel walls can be determined as approximately coinciding with the threshold of the doorway in Stage 1B of the tower, which is 6.25 m (20½ ft) above foundation level (Fig. 347). The scars of both the north and south walls exhibit a step at the

The chancel was entered from the tower-nave through a monumental arch which, although elaborated on its west face, was entirely plain on the east (Fig. 347).
