ST PETER'S

Barton-upon-Humber, Lincolnshire

A Parish Church and its Community

HISTORY, ARCHAEOLOGY AND ARCHITECTURE

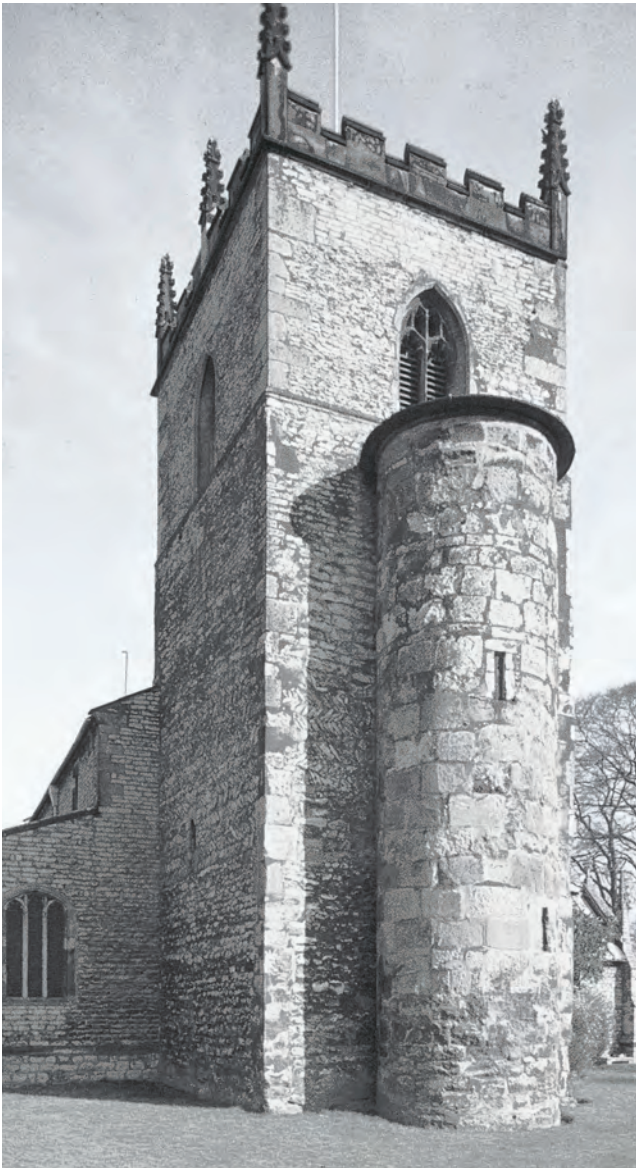
Fig. 353: *St Mary, Broughton (Lincs.)*. Turriform nave and western stair-turret. West elevation. Photo: Warwick Rodwell

Only a short distance from Barton-upon-Humber is Broughton, a medieval church with a remarkable western tower, the lower part of which is Saxo-Norman (Fig. 353) (Taylor and Taylor 1965, 115–16; Shapland 2008). In plan it is decidedly rectangular; there is a doorway in the south wall (west of centre), flanked by recessed nook-shafts, and a chancel arch in the east wall with two orders of similar shafts. A small plain doorway in the west wall leads to a spiral stone stair which is housed in an attached circular turret that appears to be secondary. Like Barton, this tower was once a turriform nave, and the foundations of the tiny, long-lost chancel have been recorded beneath the floor of the later nave to the east.⁹² Broughton is certainly later in date than Barton, but there are some similarities, including the use of recycled Roman gritstone blocks. These do not occur in the lowest 2.5 m of the tower and stair, suggesting that, unlike at Barton, this material was not specially acquired at the outset with a view to its use for dressings. Where gritstone does occur in dressings, as in the outer order of the south doorway and in the arch to the stair-turret, its employment is markedly haphazard, and it is mixed with ironstone and other materials. However, the stair-newel is made from reused sections of Roman column-shaft of varying length.

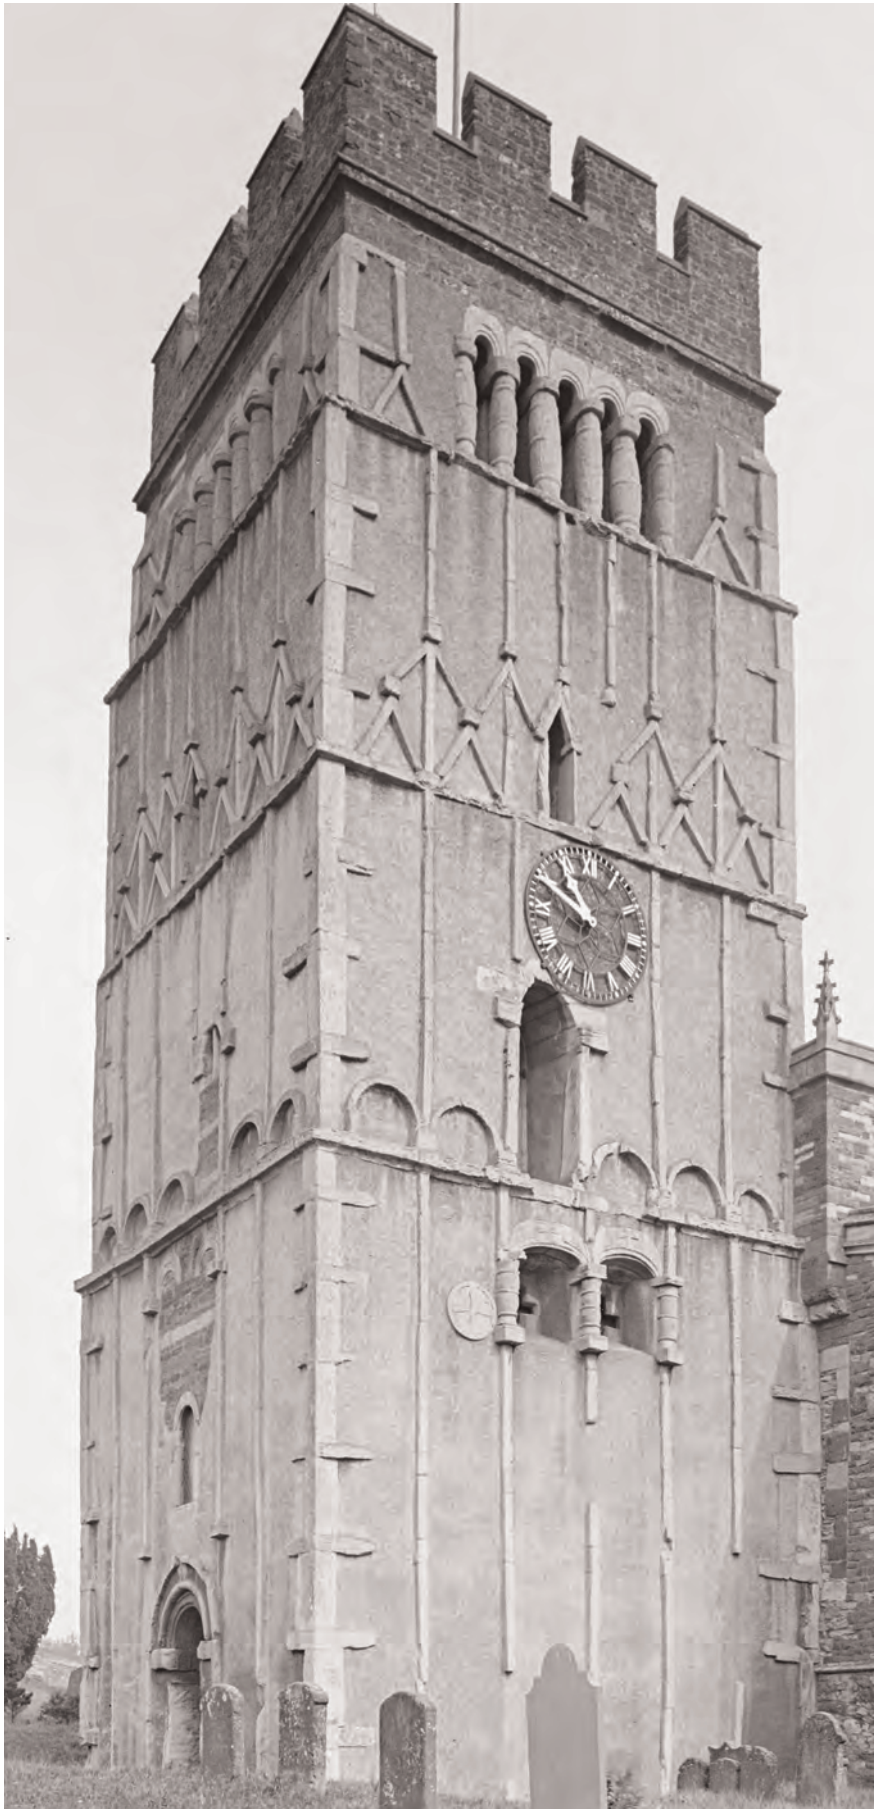
Fig. 354: All Saints, Earls Barton (Northants.). Turriform nave of Saxo-Norman date. View from the south-west. Photo: English Heritage, RCHME

Next to Barton-upon-Humber, this is the most important example, where interpretation of the surviving tower as a turriform nave, with a small but now-lost chancel to the east, is demanded by the architectural evidence (Fig. 354, Audouy *et al.* 1995). It did not have any appendage to the west.

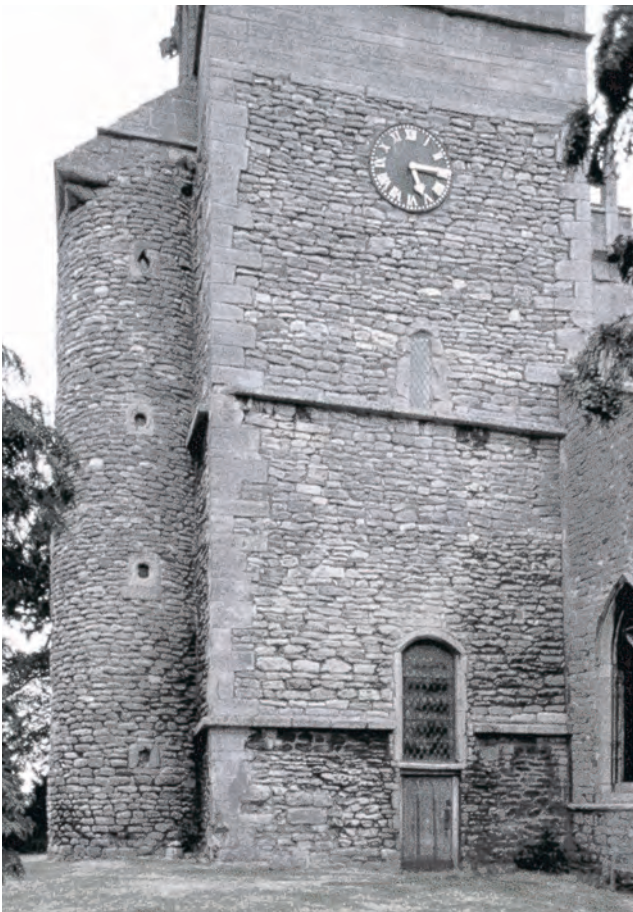
Fig. 356: *All Saints, Hough-on-the-Hill (Lincs.)*. Tower with attached western stair-turret. South elevation. Photo: Warwick Rodwell

This has been claimed as the third turriform church in Lincolnshire, although the evidence is equivocal. It has a lofty, unbuttressed tower 6.9 m square externally, which appears to abut the west end of an earlier nave of similar width (Taylor and Taylor 1965, 321). Attached centrally to the west side is a circular stair-tower 3.4 m in diameter (Thurlby 2003, fig. 51).

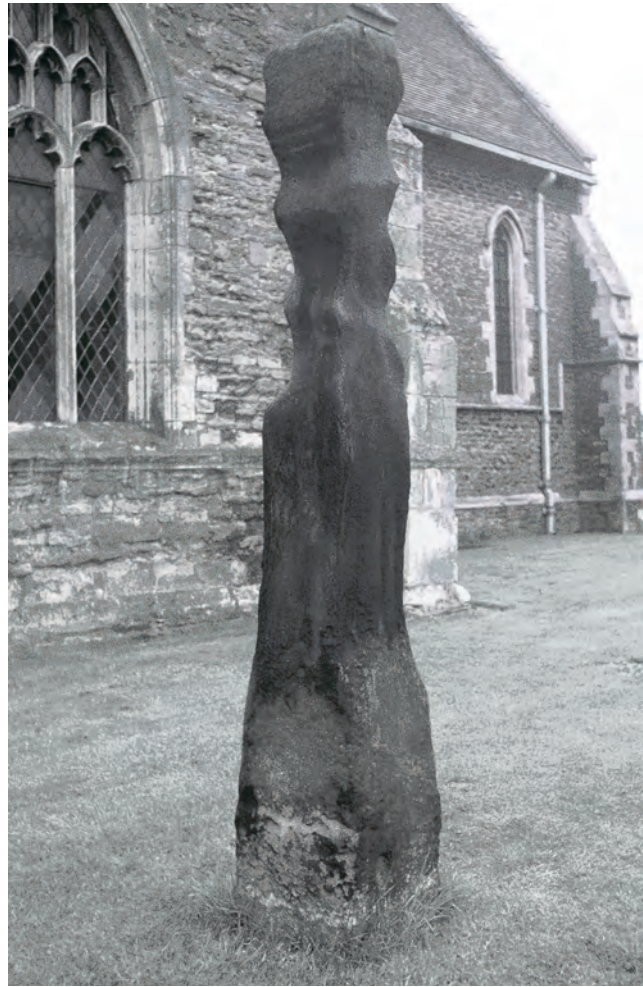
Fig. 358: St John the Baptist, Alkborough (Lincs.). Shaft of the churchyard cross, made of gritstone. Its serpentine profile is the result of prolonged use as a sharpening stone for metal implements. View north-east. Photo: Warwick Rodwell

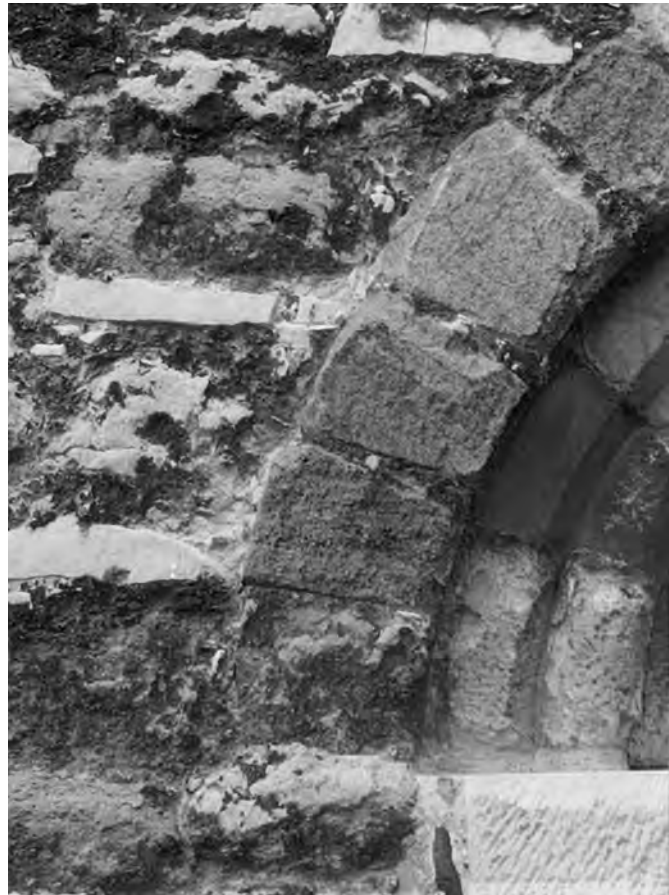
Fig. 359: *St Mary, Broughton (Lincs.)*. A, south doorway to the tower; B, detail of the reused, non-fitting gritstone voussoirs in the outer arch of the doorway. Photos: Warwick Rodwell

As a result of a recent detailed study of this church by Michael Shapland, a much clearer understanding of its complex petrological make-up and architectural evolution has emerged. The late eleventh-century turriform nave and attached stair-turret to the west both contain small quantities of gritstone ashlar, the employment of which is markedly different from Barton. In the first place, gritstone does not appear in the fabric until 2.25 m above ground level (Fig. 353). Up to that point the masonry is mainly ironstone. The voussoirs in the moulded inner order of the south door arch are of sandstone, and those of the plain outer order are gritstone: some are clearly reused components from an arch of smaller radius, presumably Roman (Fig. 359).

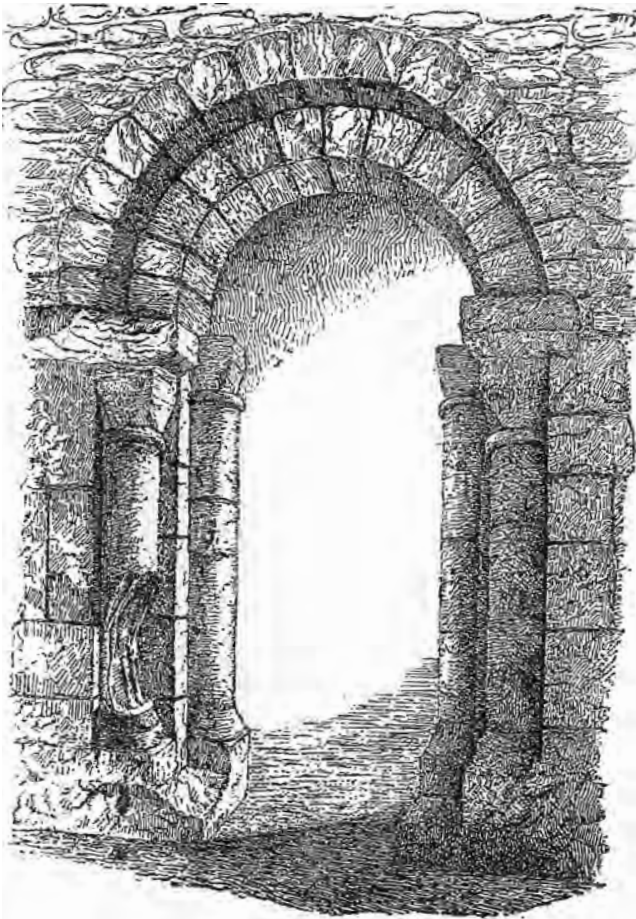
Fig. 360: *St Mary, Broughton (Lincs.)*. Original chancel arch in the east face of the tower. View east. Brown 1903

a mixture of ironstone and gritstone: they are possibly all recycled components (Fig. 360; Shapland 2008, 478–82, illus. 9–15). There is a large chamfered gritstone block incorporated in the base of the stair, and the newel is formed from recycled column drums.

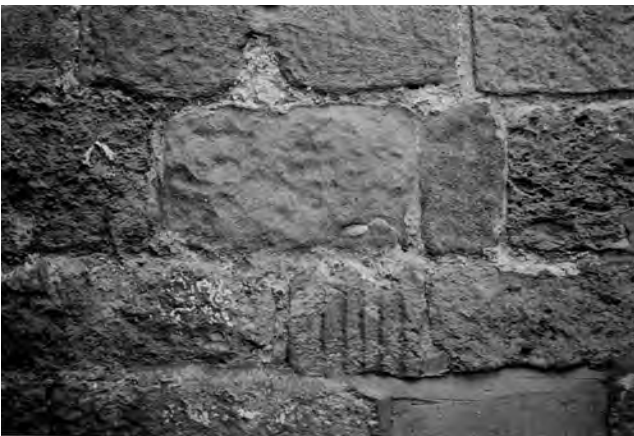
Fig. 361: *All Saints, Winteringham (Lincs.)*. Fragments of Roman monumental sculpture in gritstone reused in the tower. (above) imbricated leaves; (below) fluted pilaster. Photos: Warwick Rodwell

Characteristic Roman tooling is present on faces which have not been subjected to secondary re-dressing, and the occasional Lewis hole and cramp-hole has been noted (Figs. 305 and 362). For the most part, the original use of the gritstone blocks is not readily identifiable, but those now in the tower at Winteringham are exceptional. They include fragments of fluted pilasters and imbricated leaves, the kind of detail one might expect to be derived from a Roman temple, monumental arch, or other major public structure. Stones used in the chancel arch at Barton appear to be recut voussoirs from a domical vault, and the morticed block which formed the font base has the appearance of a section of stylobate. Reused Roman voussoirs occur at Broughton, too. Finally, at both Barton and Broughton column drums are present, and at least three different diameters are represented.

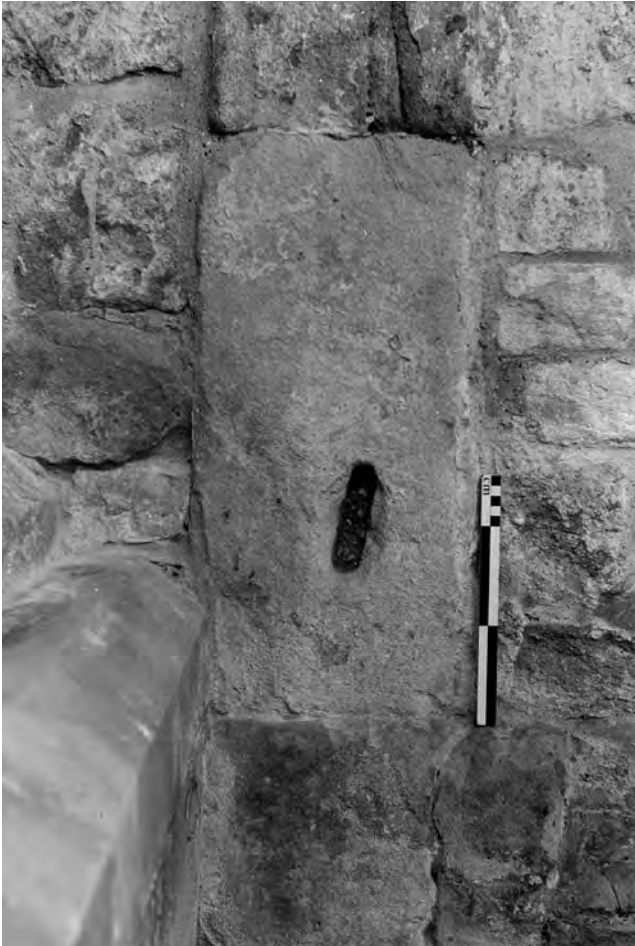
Fig. 362: *St Peter, Barton-upon-Humber. Tower: south-east quoin. Lewis hole in the east face of the first upright block of gritstone (now visible inside the nave). Scale of 25 cm. Photo: Warwick Rodwell*

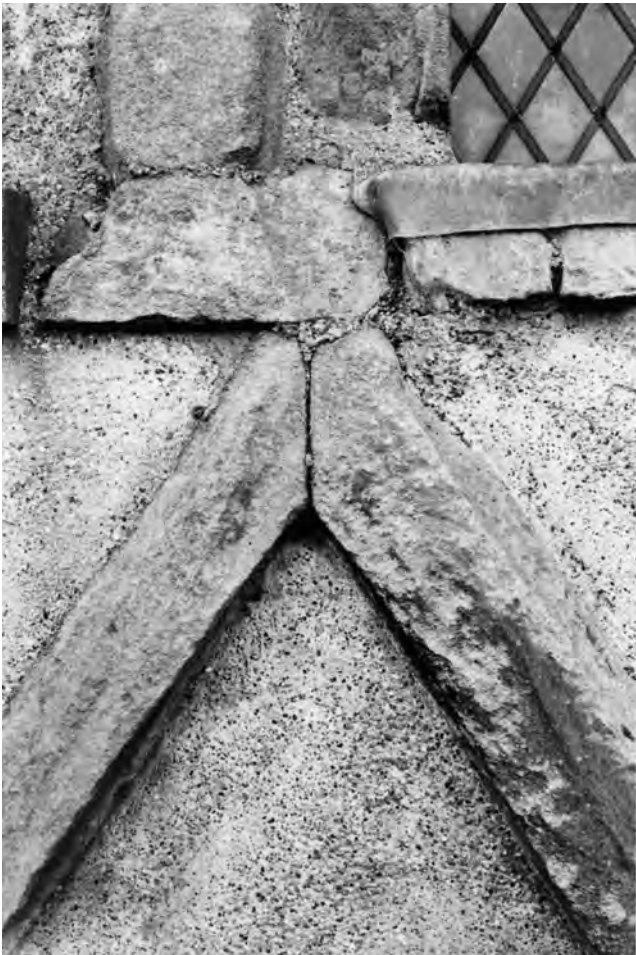
Fig. 365: *St Peter, Barton-upon-Humber. Tower: Stage 1B. Detail of stone jointing from the triangular-headed arcading on the north elevation, showing a carpenter's mitre. Photo: Warwick Rodwell*

Indeed, the term 'stone carpentry' was coined by some earlier writers on the subject.¹²⁹ One of the most commonly seen and evocative examples of a carpenter's joint being copied by a stonemason is the mitre which is found in the apices of many triangular-headed openings and arcades (Figs. 365 and 366).¹³⁰ The construction of the head of the north doorway clearly owes much to carpentry (Fig. 271).

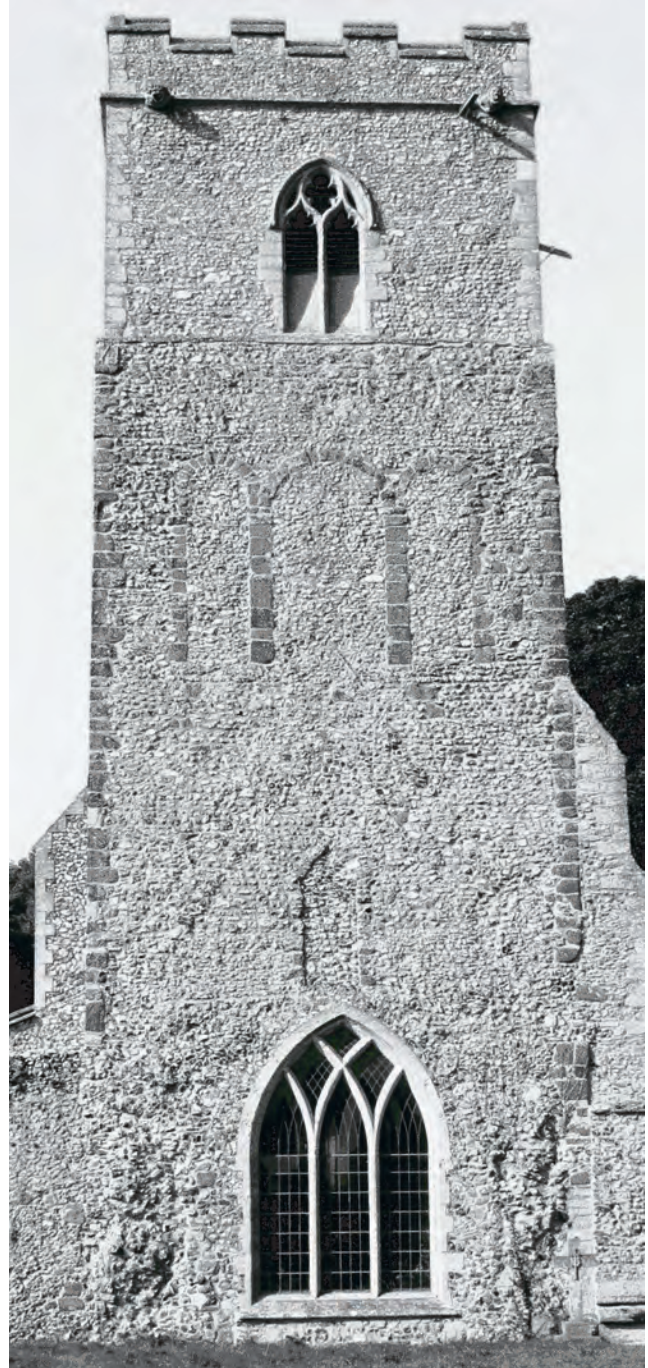
Fig. 369: St Mary, Flitcham (Norf.). East face of the former axial tower, showing the blind arcade of three bays on the third stage. The chancel has been demolished and the window marks the site of the chancel arch; above is a triangular-headed doorway that probably opened from a gallery into a chamber above the chancel. Photo: Warwick Rodwell

date these features more closely than to the eleventh century: Flicham (Norf.) is a case in point. There, an axial tower of flint rubble with Carstone dressings has the second stage decorated with an arcade of three blind arches on each face (Fig. 369).¹³³ The central bay is segmentally arched and is wider than those that flank it: this is reminiscent of the laterally 'stretched' arches above the north and south doorways at Barton (p. 255). Flicham church has lost its chancel, which evidently had an upper floor that was entered from the tower via a triangular-headed doorway.

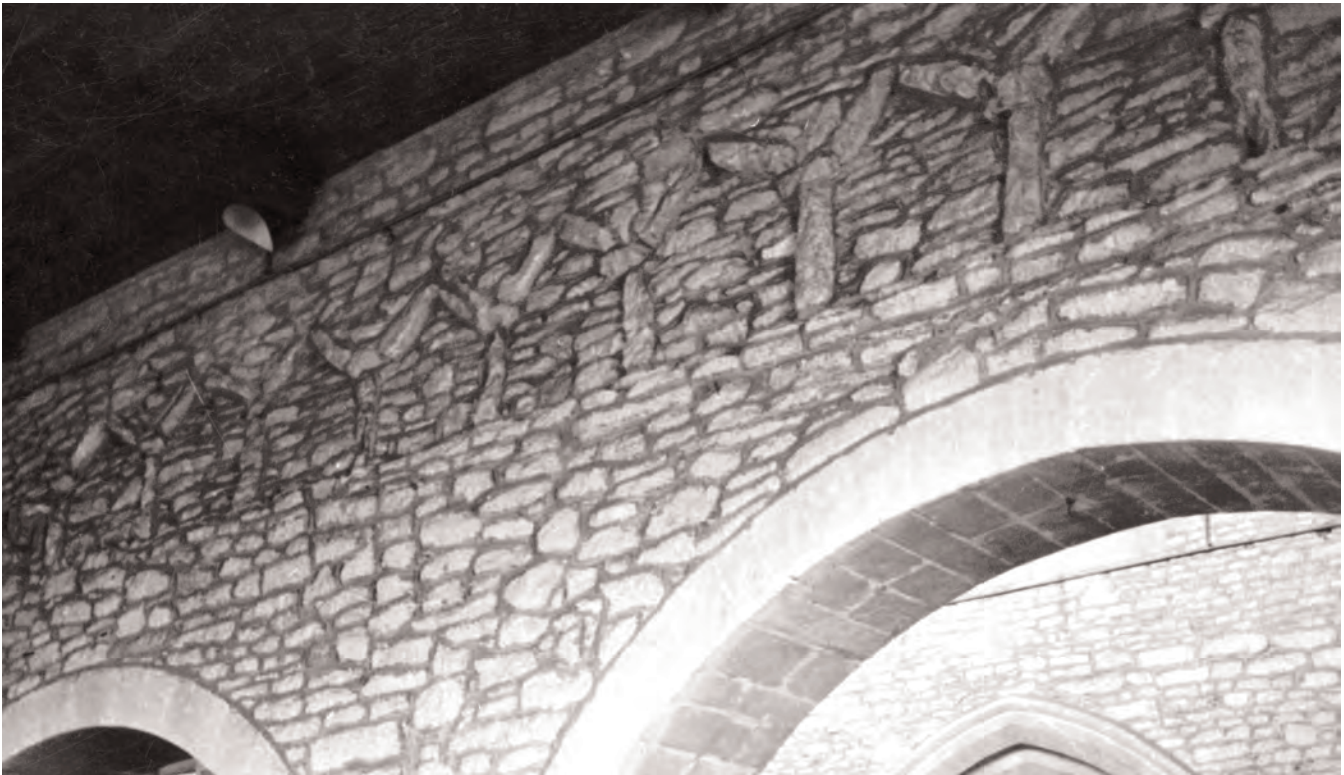
Fig. 370: *St Mary Magdalene, Geddington (Northants.)*. Triangular-headed arcading (mutilated) on the exterior of the north wall of the nave. Photo: English Heritage, NMR

cannot really be described as arcading (Fig. 363). Those features bear a distinct resemblance to the stripwork on the apse at Deerhurst (Glos.) (Rahtz and Watts 1997, fig. 104). Nevertheless, Barton finds a ready parallel at Geddington (Northants.), where the entire north wall of the Anglo-Saxon nave was decorated externally with a high-level blind arcade of triangular form. The dressings are now in a sadly mutilated state, all the projections having been hacked back, making them flush with the rubble wall, to facilitate later plastering (Fig. 370).¹³⁴

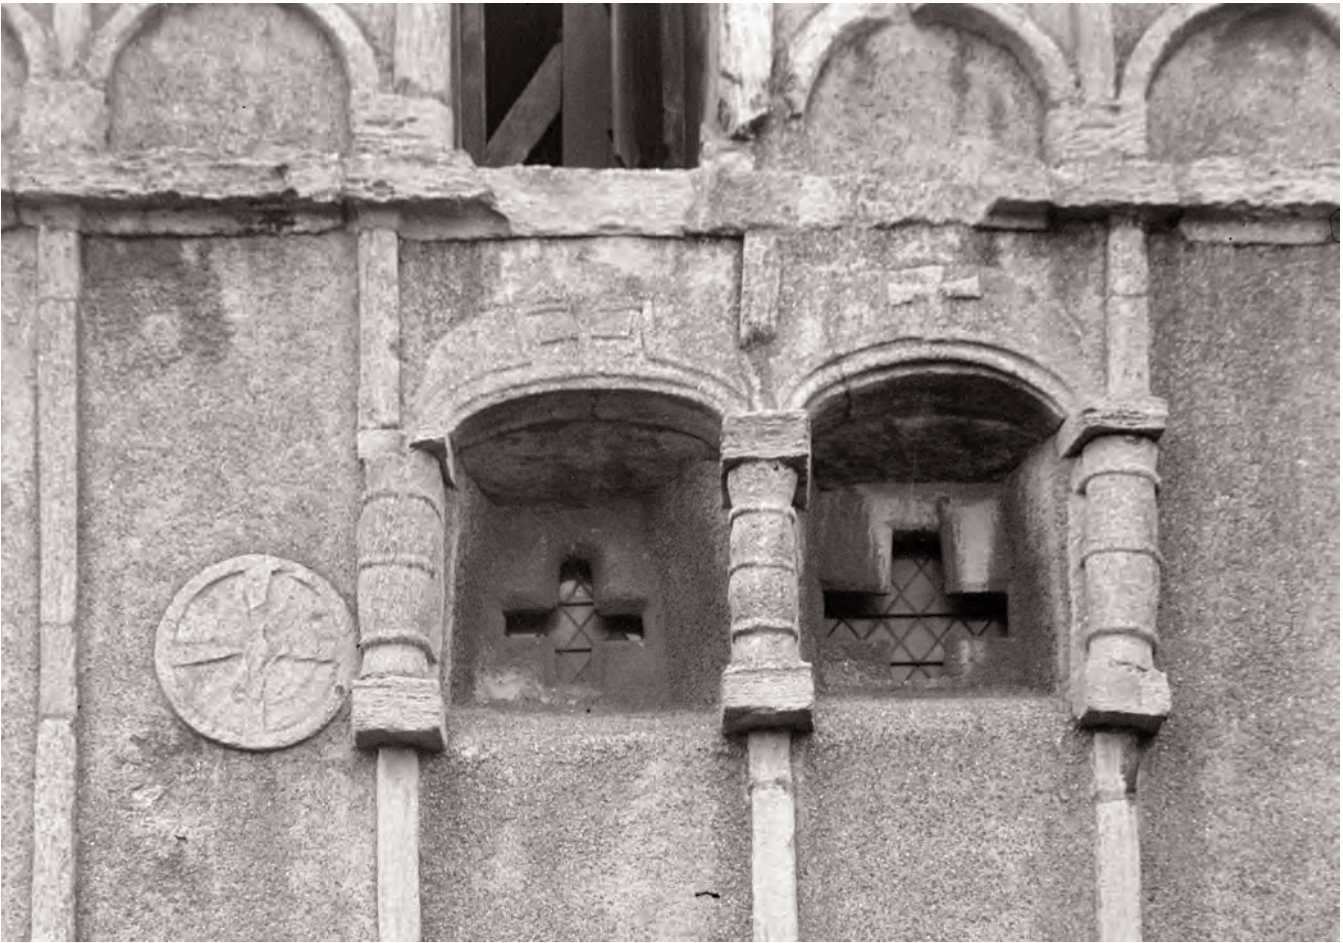
Fig. 372: *All Saints, Earls Barton. Detail of the double opening in the ground stage of the south wall, showing the visually 'applied' balusters with profiles similar to those of the mid-wall shafts at Barton. Photo: English Heritage, NMR*

St Michael, Oxford.¹³⁹ A variation occurs at Earls Barton, where the balusters are located at the outer wall face and are not freestanding but are frontally attached to thin upright slabs of stone that form solid divisions between the openings.¹⁴⁰ Apart from this, and the fact that they have only one mid-shaft ring, these balusters are visually a close match for those at Barton (Fig. 372). Finally, a fragment of impost from Hough-on-the-Hill (Lincs.) bears not only interlace decoration but also two miniature representations of biconical balusters which are remarkably similar to the shafts at Barton (Everson and Stocker 1999, 180–2, illus. 204). The fragment has been assigned to the later tenth century.

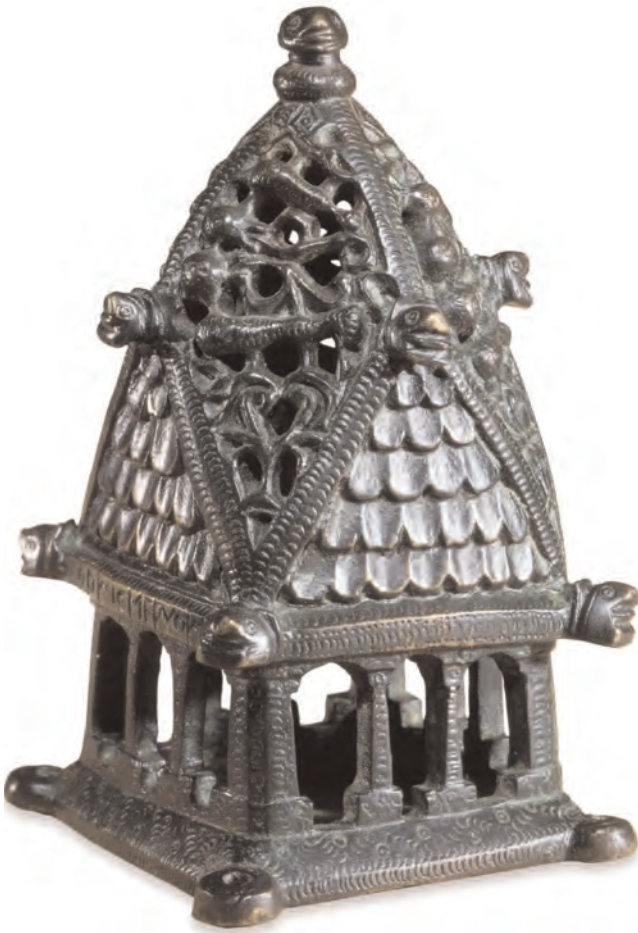
Fig. 373: Late Saxon bronze censer-cover from Pershore, depicting a shingled helm-like roof: tenth century. Height 9.7 cm. Photo: © Trustees of the British Museum

in the form of bronze censer-covers found at Pershore, London and Canterbury.¹⁴² The most informative of these is the cover from Pershore (Worcs.) (Fig. 373). This represents the belfry stage of a tower, crowned by a spire of the type loosely referred to as a 'Rhenish helm'. Four shingled gables rise from an eaves-course, with projecting beast-heads both at their apices and at the corners of the tower. The gables support a four-sided spire: the facets are pierced and decoratively embellished, whereas in reality they would have been shingled, like the gables. The 'belfry' stage of the Pershore cover comprises an open arcade of three semicircular arches on each face, with pilaster-like detail at the angles; the shafts are carried on square, chunky bases.

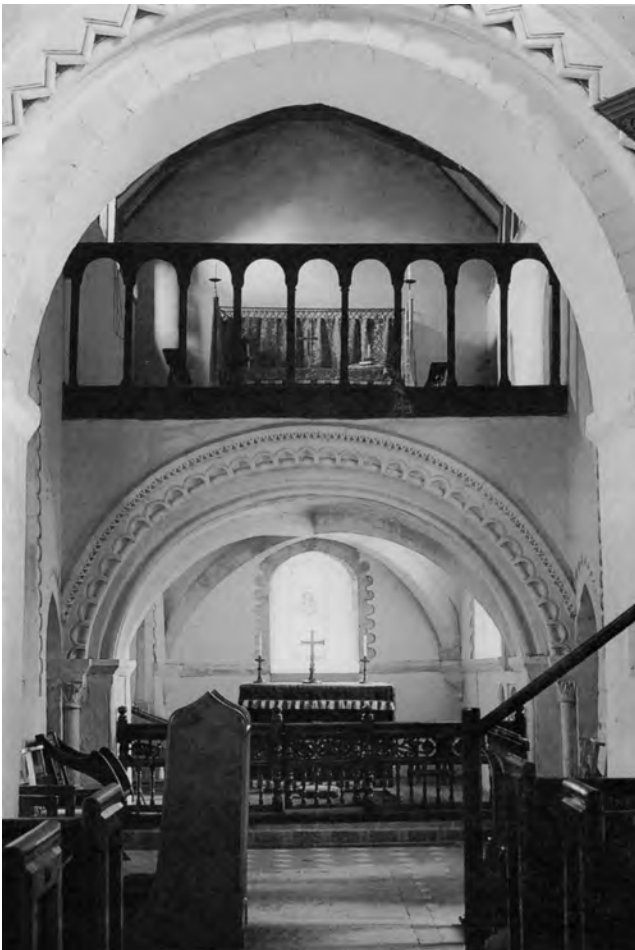
Fig. 376: *St Nicholas, Compton (Surrey). Romanesque arcaded timber balustrade to the gallery chapel above the chancel. View east. Photo: Mervyn Blatch*

At Barton, a ladder-stair with an angle of 60 degrees, rising from east to west, could have been comfortably sited against the north wall; its carriages would have been 6.8 m (22¼ ft) long. The stair width would have been no more than 60–70 cm, as would have been the required aperture in the floor of the gallery at the point of emergence; that would not have obstructed free passage around a gallery 1.25 m in width. The stair may or may not have had a handrail and balustrade, but the gallery almost certainly would have done. Although it can only be supposition, the case for an arcaded balustrade in this architectural setting seems strong, since the semicircular arch is the dominant feature of the tower, both externally and internally. The only surviving Romanesque timber gallery balustrade is at Compton church (Surrey), the form and scale of which would be wholly in keeping for Barton (Fig. 376; Pevsner and Cherry 1971, 166; Blatch 1997, 94).

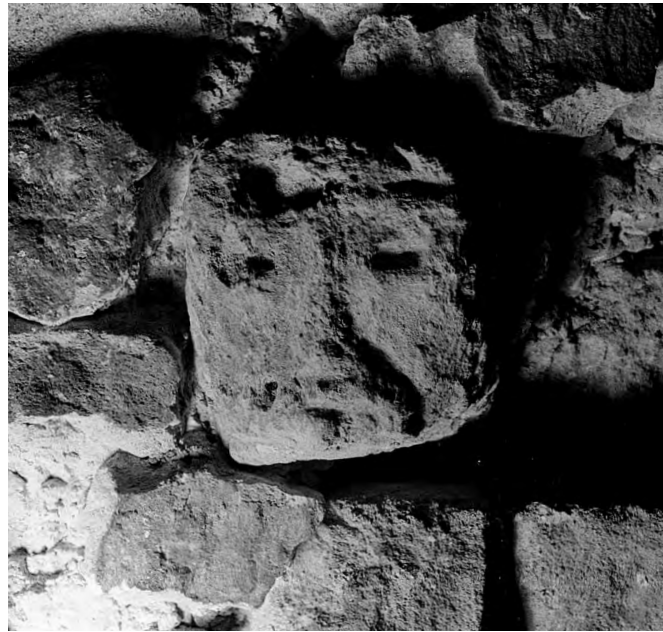
Fig. 377: St Peter, Barton-upon-Humber. Tower: Stage 2, exterior. Southern label-stop on the eastern belfry opening, in the form of a human head. Height c. 15 cm. Photos: Warwick Rodwell

The two heavily weathered human heads forming the label-stops of the eastern double belfry-opening are seemingly unique (Fig. 377), although there are animal-heads over doorways at St Mary, Deerhurst and Limpley Stoke (Som.) (Taylor and Taylor 1966; Taylor 1978, 1057–8), and at Barnack and Alkborough (the latter 15 km west of Barton) beast-heads were placed centrally over the west window in the tower.¹⁴⁵ However, a single male head, of generally similar appearance to one at Barton, occurs internally on the division between the openings of the northern double window on the first floor at Sompting,¹⁴⁶ and at Great Hale an apparently female figure occupies one complete jamb of a small window in the south face of the tower.¹⁴⁷ Pairs of moustachioed and bearded male heads flanking openings, and door-jambs in particular, are known from Scandinavia in the twelfth century, and it is instructive to compare the Barton heads with those at Timmele, Sweden (Svanberg 1970, pl. 56).

The Barton heads are so badly weathered that their features cannot be described in detail. They were originally external but, considering that they have been protected by the nave roof since the fifteenth century, it is surprising how eroded they are. The northern head is now almost featureless and even the sex cannot be determined with certainty, although it is probably male, but the southern head is better preserved, and it clearly represents a moustachioed male. The eyes are sunken, and now have the appearance of gouged-out pits, but may originally have been drilled; the nose is long and flattened, and the lips are prominent. A horizontal line across the forehead may represent a fringe of hair, or a headdress. The deep hollowing of the eyes

strongly suggests that these were originally filled with a contrasting material – glass or coloured stones – to impart greater vibrancy to the faces. Drilled eyes are a well-known feature of Anglo-Saxon figure sculpture found all over central England. They are crisply

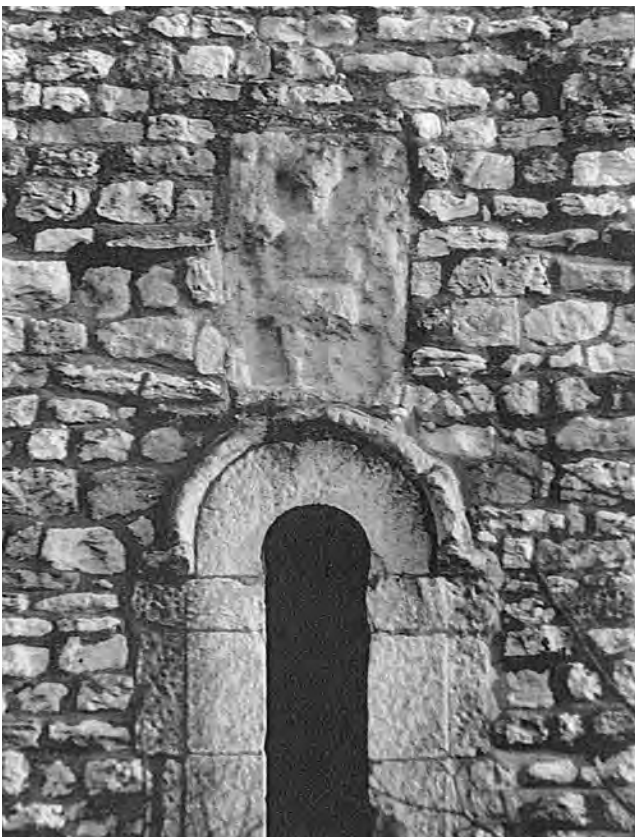
Fig. 378: St Peter-at-Gowts, Lincoln. Reused Roman sculptured panel above the west window of the tower. Photo: David Stocker

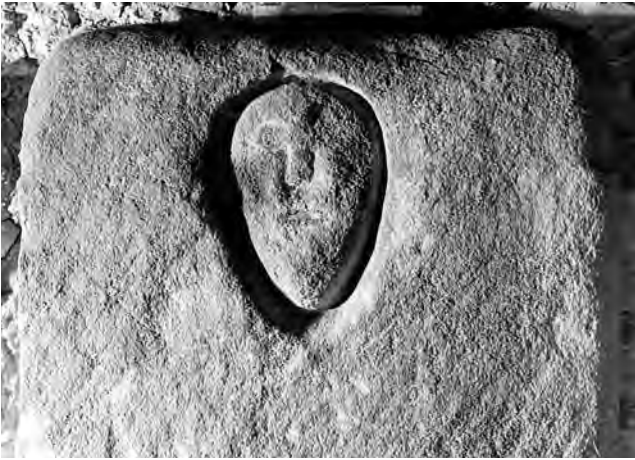
Fig. 379: *St Peter, Barton-upon-Humber. Tower: detail of the incised head on the panel above the eastern arch. Photo: Warwick Rodwell*

Only the head of the figure on the Barton panel was sculpted, the remainder being applied in paint. The face is essentially an outline, which includes the beard (Fig. 379). Details of the beard and the head-hair

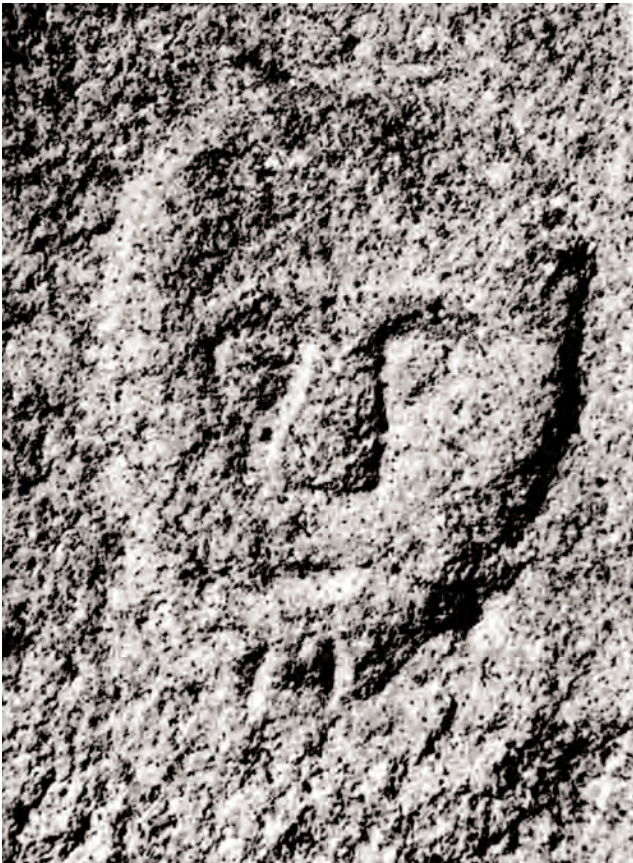
Fig. 381: *St Lawrence, Jersey*. Detail from an early medieval granite panel, sculpted with a bearded head; the remainder of the figure would have been executed in paint. Photo: Warwick Rodwell

Closely similar in appearance, scale and execution to the Barton face is one on a slab of granite in St Lawrence's church, Jersey. Although now cut down and presented as an antiquarian exhibit in a nineteenth-century buttress, this slab was clearly once part of an early medieval panel depicting an unidentified figure: again, only the facial outline was lightly incised in the stone, although in this instance two small incisions on the chin indicate the beard; and the remainder of the image must have been executed in paint (Fig. 381). The identity of the figure cannot be determined, and the date is uncertain but is likely to be eleventh or twelfth century. Some idea of the intended appearance of the Barton face may be gained by comparison with the heads of the Apostles carved on the Norman font bowl at North Grimston (Yorks.), which are uncannily similar (Fig. 382; Pevsner and Neave 1995, pl. 14). A small bearded head of late Saxon date,

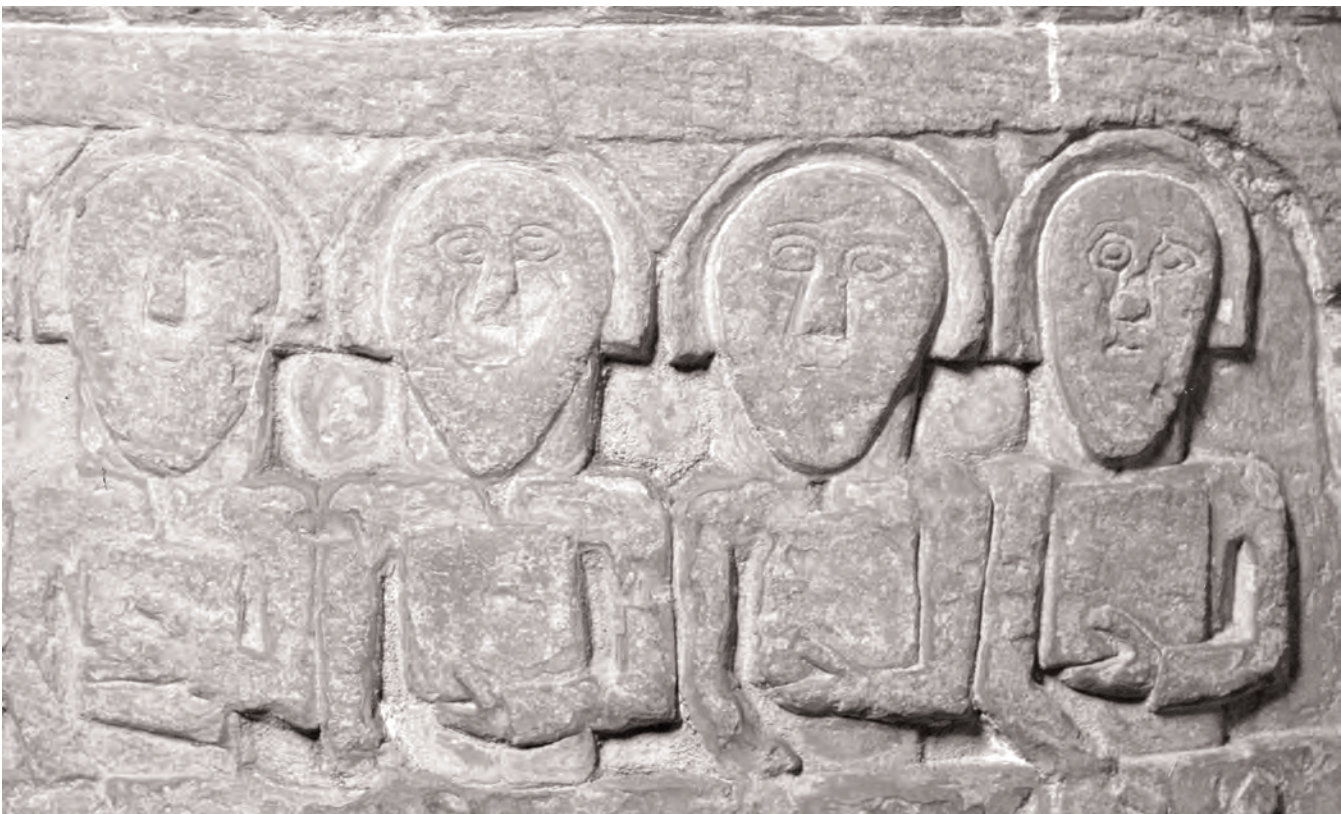
Fig. 382: *St Nicholas, North Grimston (E. Yorks)*. Detail of heads portrayed on the font bowl. Photo: English Heritage, NMR

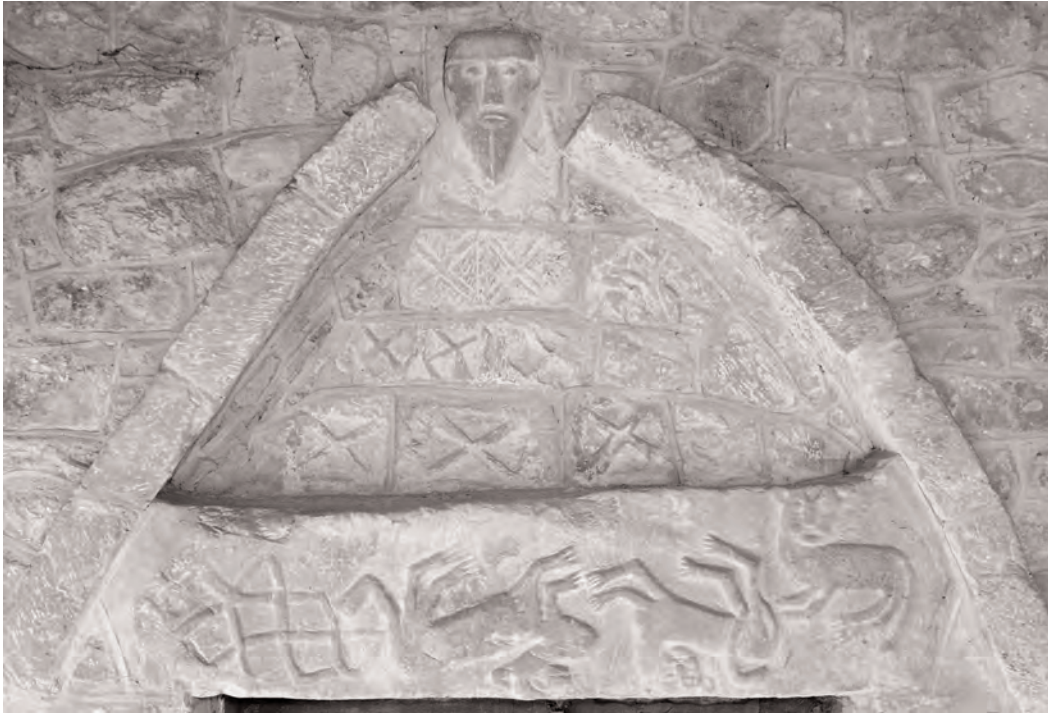
Fig. 383: *St Mary, Stottesdon (Salop.)*. Reset Anglo-Saxon head sculpture in the tympanum over the west tower doorway. Photo: English Heritage, RCHME

reset over the Norman west doorway at Stottesdon church (Salop.), also has similar facial features to that at Barton (Fig. 383; Croom 1988, fig. 14).

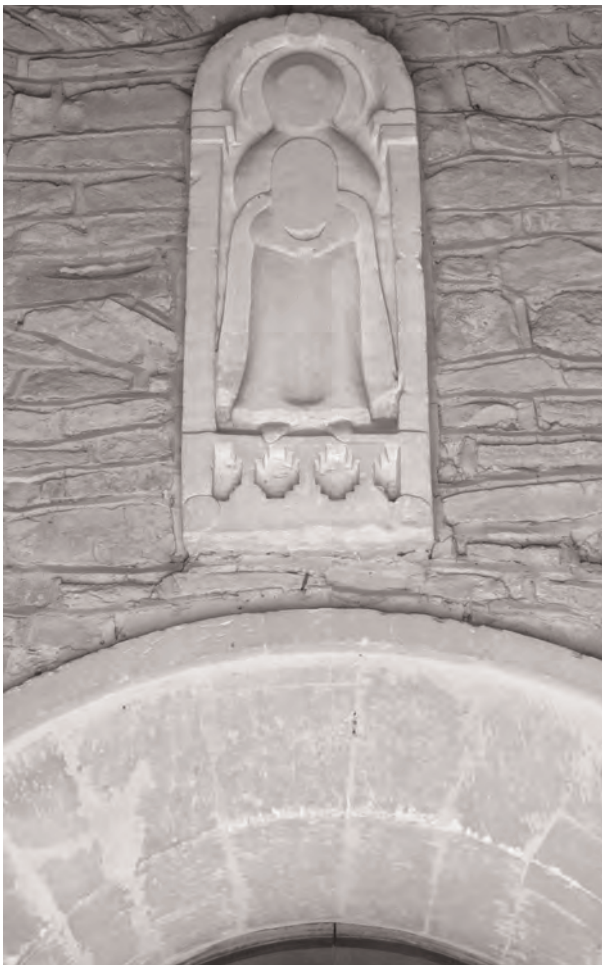
Fig. 384: *St Mary, Deerhurst (Glos.)*. Part-sculptured panel of the Virgin and Child, above a high-level arch in the west tower. Photo: Richard Bryant

It is not difficult to find analogues for figures executed partly in sculpture and partly in paint. Flanking the late Saxon arch leading into the former apsidal sanctuary at Deerhurst, is a pair of high-level stone panels with gabled tops, which appear to be plain. However, substantial traces of paint remain on one of these, showing that it formerly carried a depiction of a standing, nimbed figure within an architectural frame (Bagshaw *et al.* 2006). Also at Deerhurst, in the east wall of the tower, is a round-headed panel which stands just above the major arch, and there is no reason to doubt that it is in its original position. The panel is a *bas-relief* of the Virgin Mary, apparently seated, and displaying on her lap an oval shield (Fig. 384). The Virgin is depicted in simple outline, and has no carved facial detail. The shield is also represented by a plain oval area of uncarved stone, with no hint of the Christ Child who would have been portrayed on it. The finer details of the Virgin, and the Child in his entirety, were depicted in paint, and considerable traces of pigment survive, enabling an outline reconstruction¹⁴⁹ (Bailey 2005, 8–9; Gem and Howe 2008, 139–42). The systematic examination, recording and analysis of paint traces at Deerhurst has revealed how vividly the sculpture, mouldings and walls of this church were decorated in the ninth century (Gem and Howe 2008).

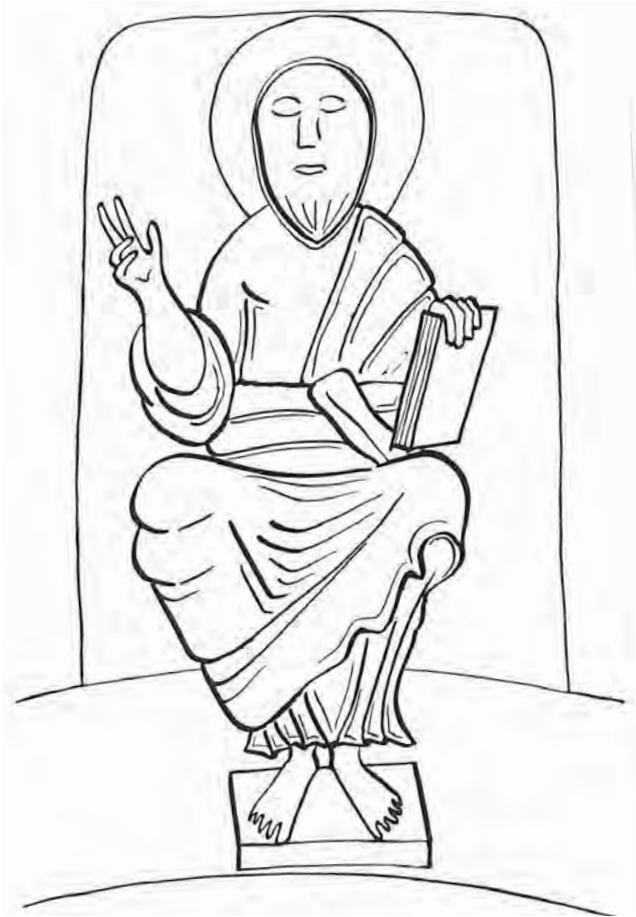
Fig. 385: *St Peter, Barton-upon-Humber. Tower: Suggested reconstruction of the painted features of the Christ in Majesty above the chancel arch. Scale approx. 1:8. Drawing: Kirsty Rodwell*

The proportions plainly argue for a seated figure, and a depiction of Christ in Majesty would be most likely (Rodwell 1990, 165); a possible reconstruction, demonstrating how such a figure could be comfortably accommodated on the stone, is given in Figure 385. It may perhaps be compared with the rectangular panel depicting Christ in Majesty at Barnack, a relief sculpture dating from the early eleventh century (Fig. 386; Dickinson 1968, 13). The panel is *ex situ* and its original function is unknown. Unfortunately, no trace of ancient painting survives on the coarse-grained stone at Barton, which was thoroughly scoured in the restoration of 1858–59, when the surrounding wallplaster was also stripped. It would not be surprising if the panel were once flanked by a pair of angels, painted on the wallplaster. For a fuller discussion of the Barton panel in relation to other representations of the Crucifixion and Christ in Majesty above chancel arches, see Everson and Stocker 1999, 101–2.¹⁵⁴

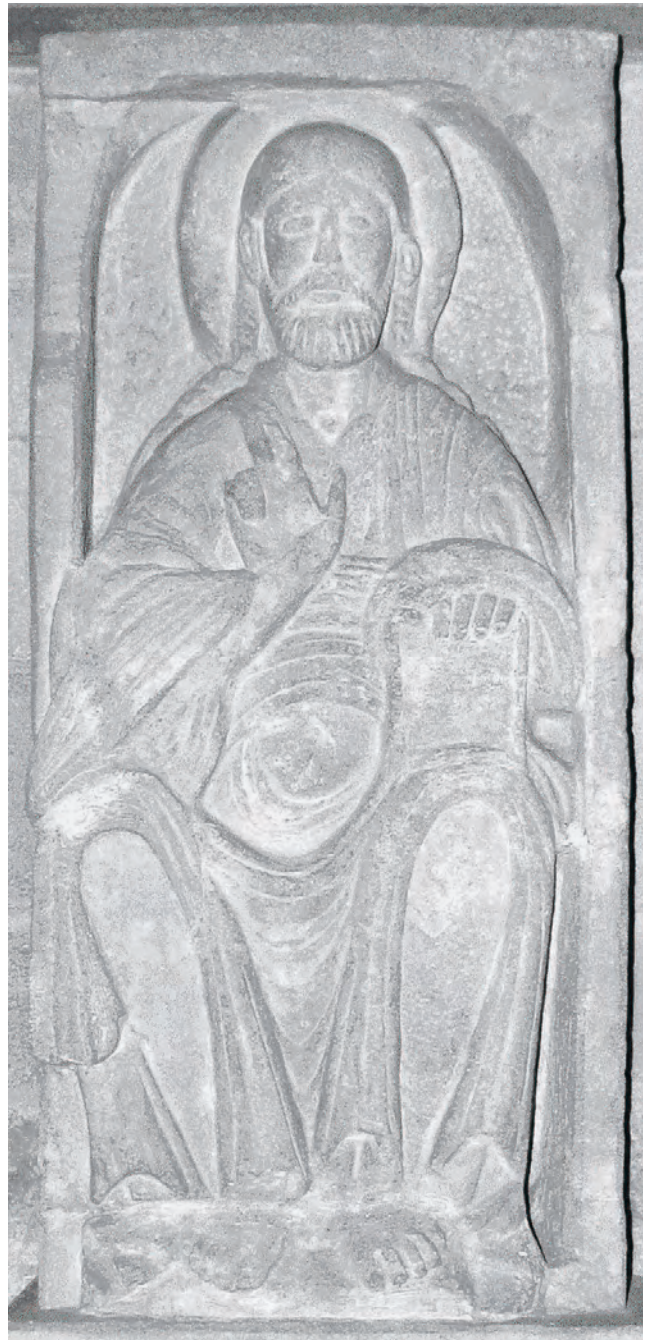
Fig. 386: *St John the Baptist, Barnack (Northants./ Cambs). Ex situ sculptured panel depicting Christ in Majesty. Photo: Warwick Rodwell*

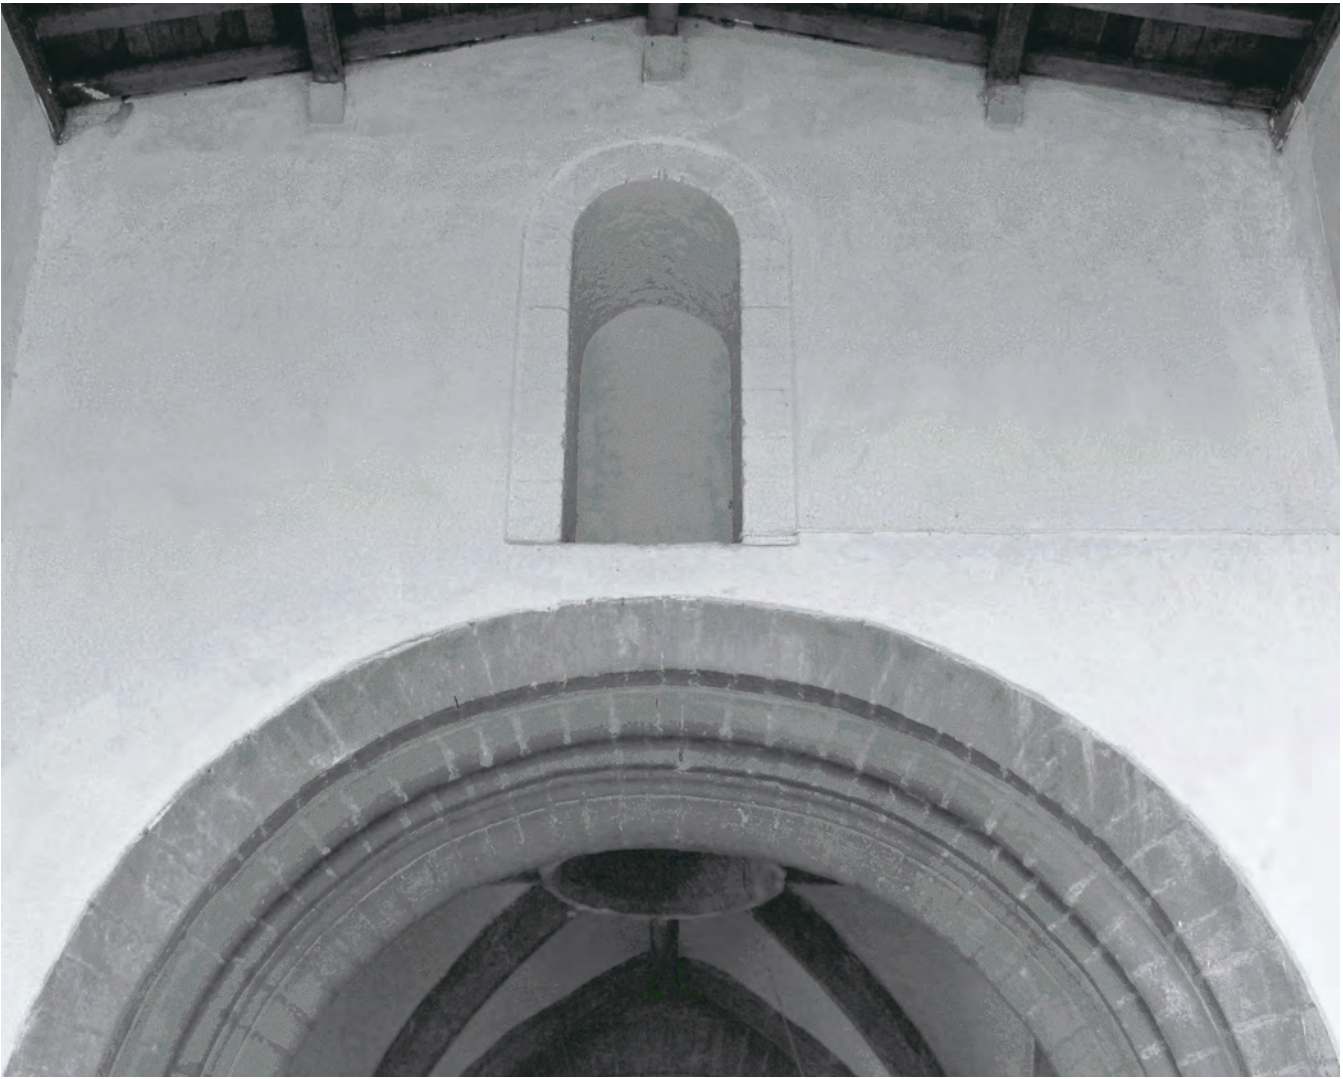
Fig. 388: *St Kyneburgha, Castor (Cambs.)*. High-level doorway at the east end of the nave. Photo: Warwick Rodwell
