ST PETER'S

Barton-upon-Humber, Lincolnshire

A Parish Church and its Community

HISTORY, ARCHAEOLOGY AND ARCHITECTURE

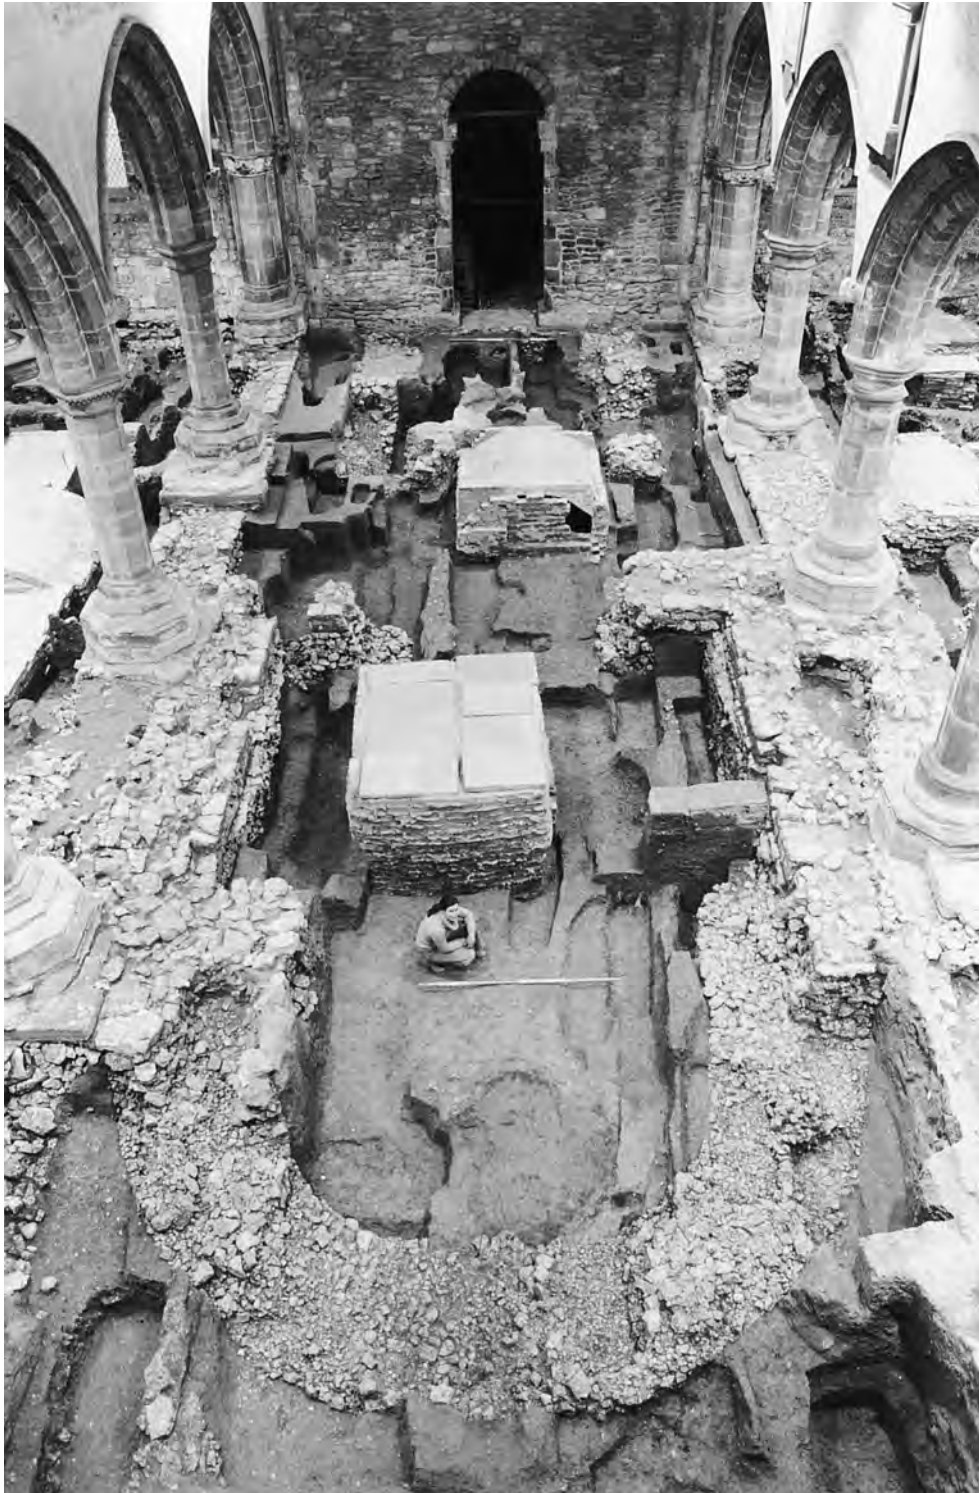
Fig. 390: The three-celled Saxo-Norman church revealed during excavation in the nave in 1980. View west. Scales of 2 m. Photo: Warwick Rodwell

The tiny Anglo-Saxon chancel was replaced by a new rectangular nave and a chancel with an apsidal sanctuary (Fig. 390). Only the foundations of these have survived, and even they are fragmentary at the east end (Fig. 391). The foundation trenches were up to 1.3 m deep and taken down to a firm clay bed, cutting through numerous graves in the process: no prior exhumation of skeletal remains took place on this occasion. The lower levels of the trenches were filled with compacted chalk nodules and brown clay, laid in alternating bands (F484). Towards the top, however, the outer faces of the foundation were constructed of larger chalk blocks, roughly squared, coursed and bedded in hard, brown gravelly mortar. Between the facings was a banded core of small chalk rubble and mortar; up to four of these footing courses survived on the north side. On average, the foundation trench was 1.2 m (4 ft) wide, but increased to 1.4 m in the apse, where

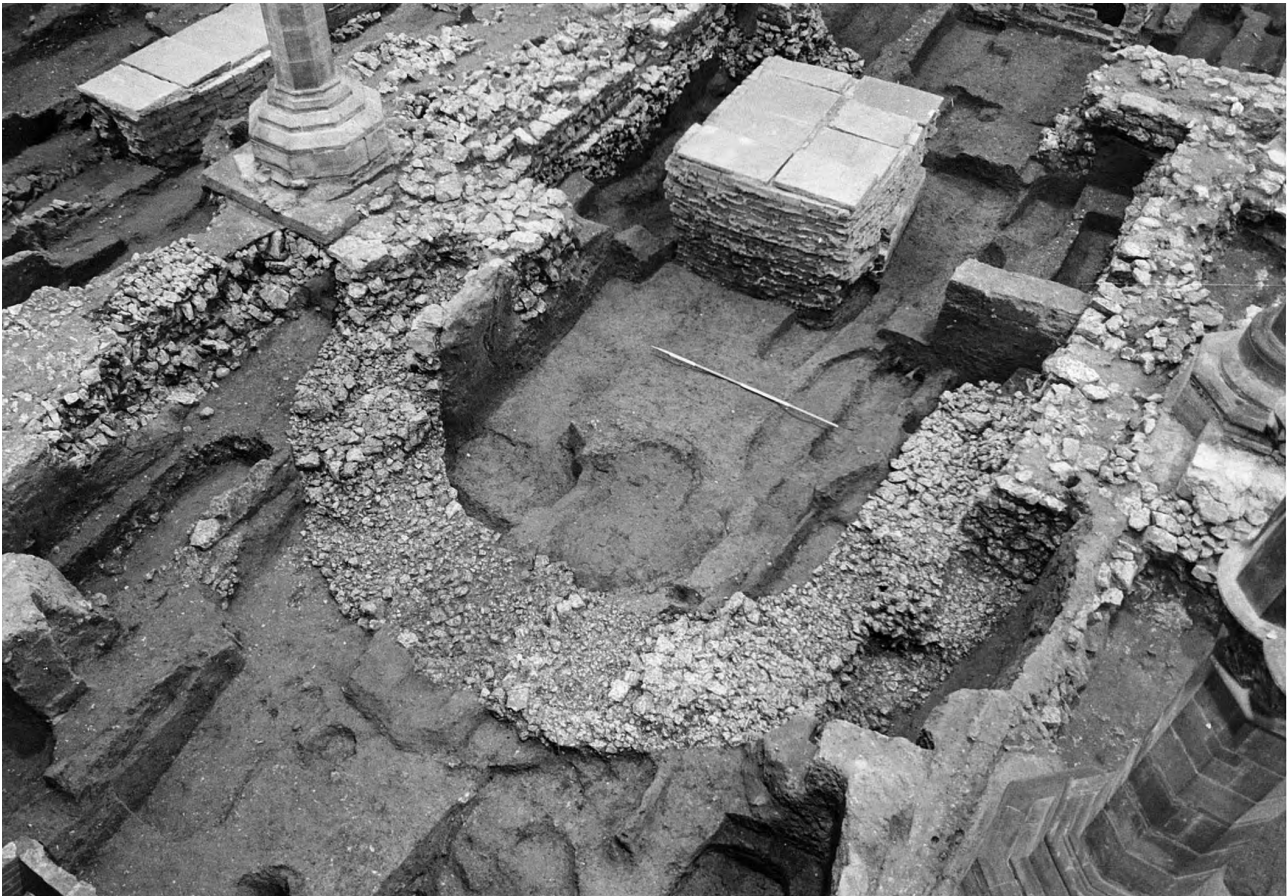
Fig. 392: Foundations of the chancel and apsidal sanctuary of the Period 3 church. View south-west. Scale of 2 m. Photo: Warwick Rodwell

The nave was of squat proportions, being only 8.65 m (28½ ft) long internally, and was not quite a true rectangle in plan. On average, it measured *c.* 10 m (33 ft) by 9.3 m (30½ ft) externally, and the also-squat chancel was 5.6 m (18½ ft) long by 7.6 m (25 ft) wide, with an unstilted, apsidal sanctuary (Figs. 393 and 394). The offset in plan between the chancel and nave was equivalent to almost a wall's thickness on either side, while the offset between the sanctuary and chancel was half that amount. It is clear that walls were laid out by their centre-lines and a regular system of measurement was employed. There is no hint of separate provision for buttressing, but shallow pilasters could have been accommodated on the foundation.

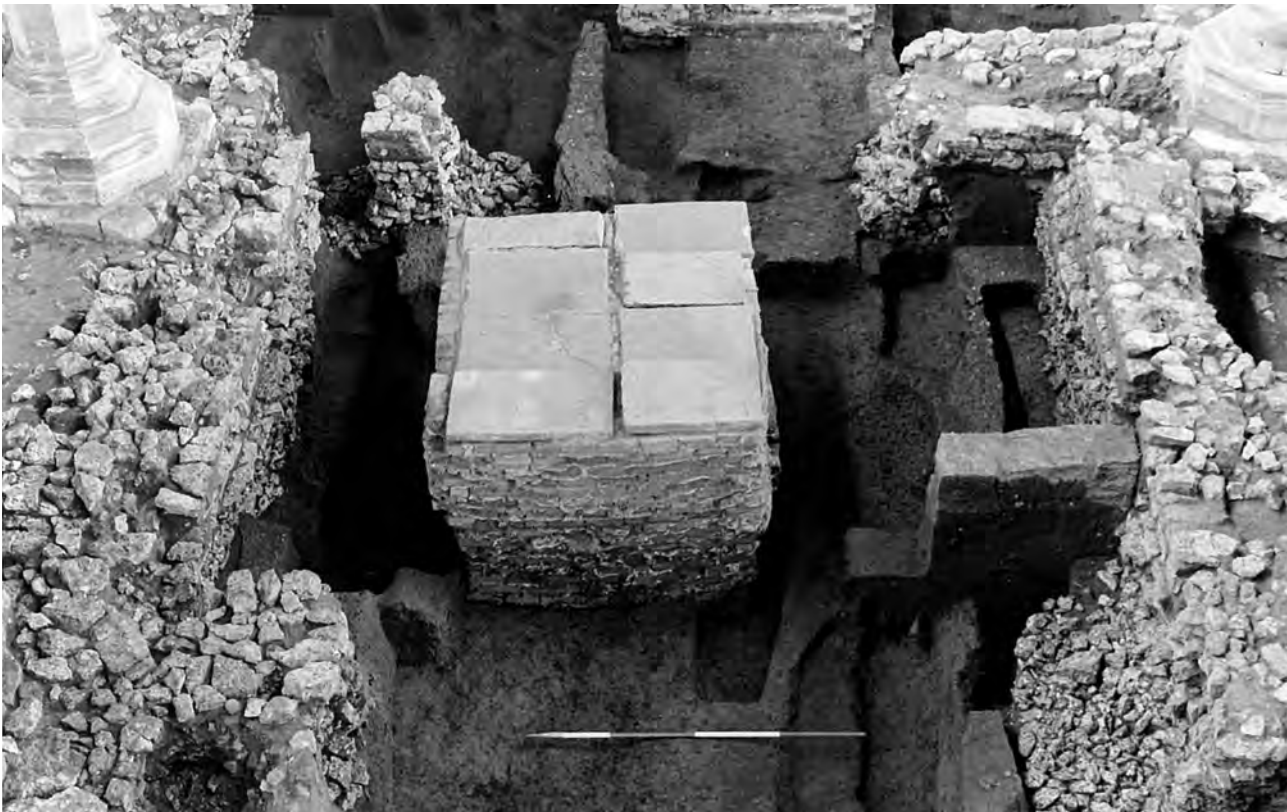
Fig. 393: Foundations of the chancel of the Period 3 church. In the centre is the brick-lined, double-burial shaft of the Scriveners. View west. Scale of 2 m. Photo: Warwick Rodwell

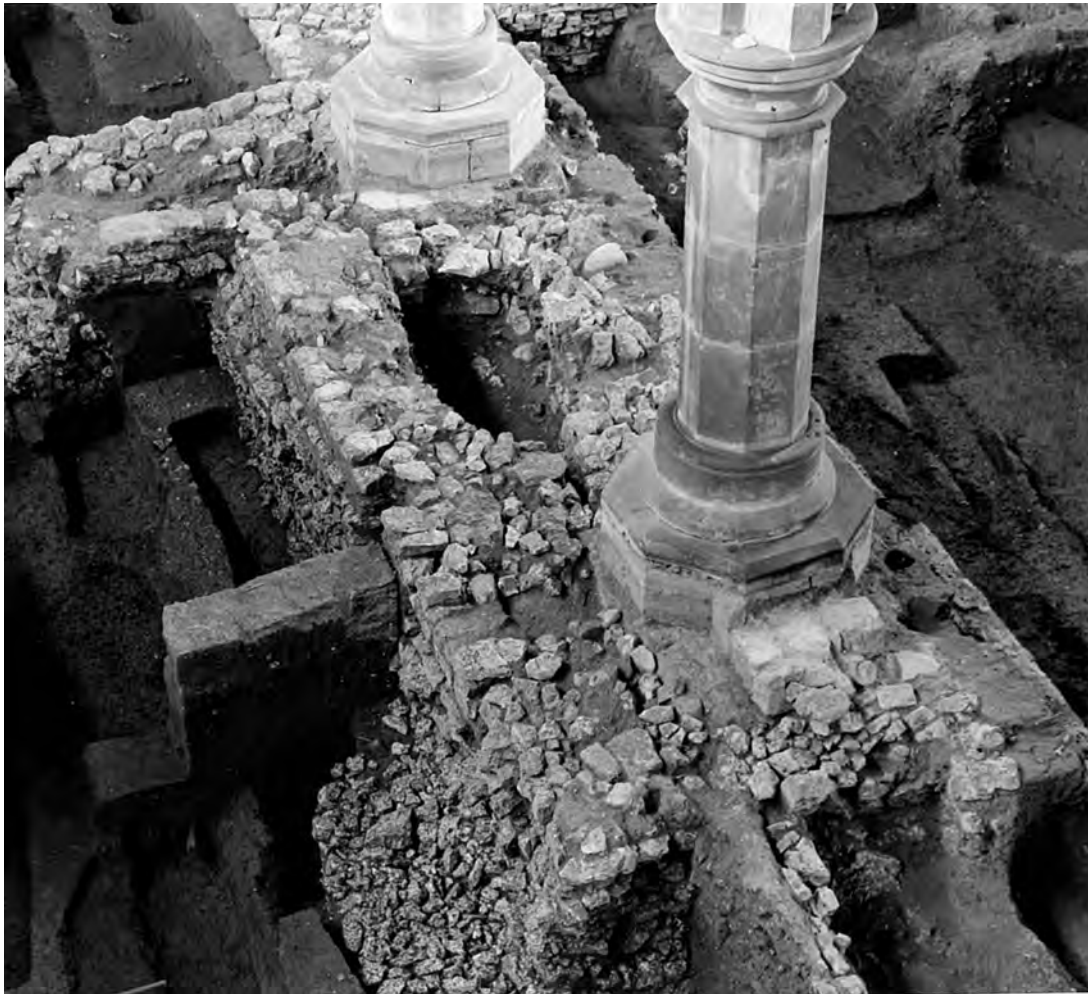
Fig. 394: Saxo-Norman chancel. Foundation of the north wall, with the Period 4A Norman nave wall alongside (supporting later arcade piers). View north-west. Photo: Warwick Rodwell

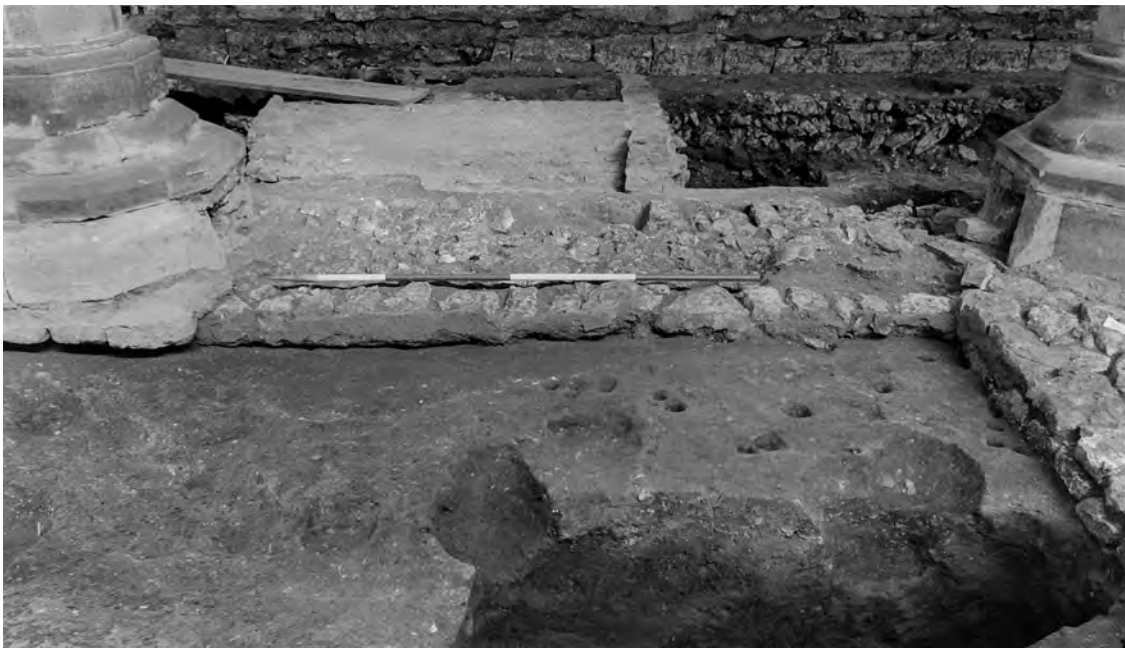
Fig. 395 Saxo-Norman nave. Surface of the construction level in the north-east angle. View north. Scale of 2 m. Photo: Warwick Rodwell

The upcast soil from the foundation trenches (F1537, sandy clay with occasional pieces of chalk and mortar) was spread within the walls of the new church, raising its level and forming a sub-floor (F1522). A few small post-holes cut into this layer must have been associated with the construction work (Fig. 395). After the new church was built, the redundant Anglo-Saxon chancel was demolished, down to its foundations, the mortar and small rubble deriving from its walls being spread to form a floor (F187), sealing all previous features and deposits.

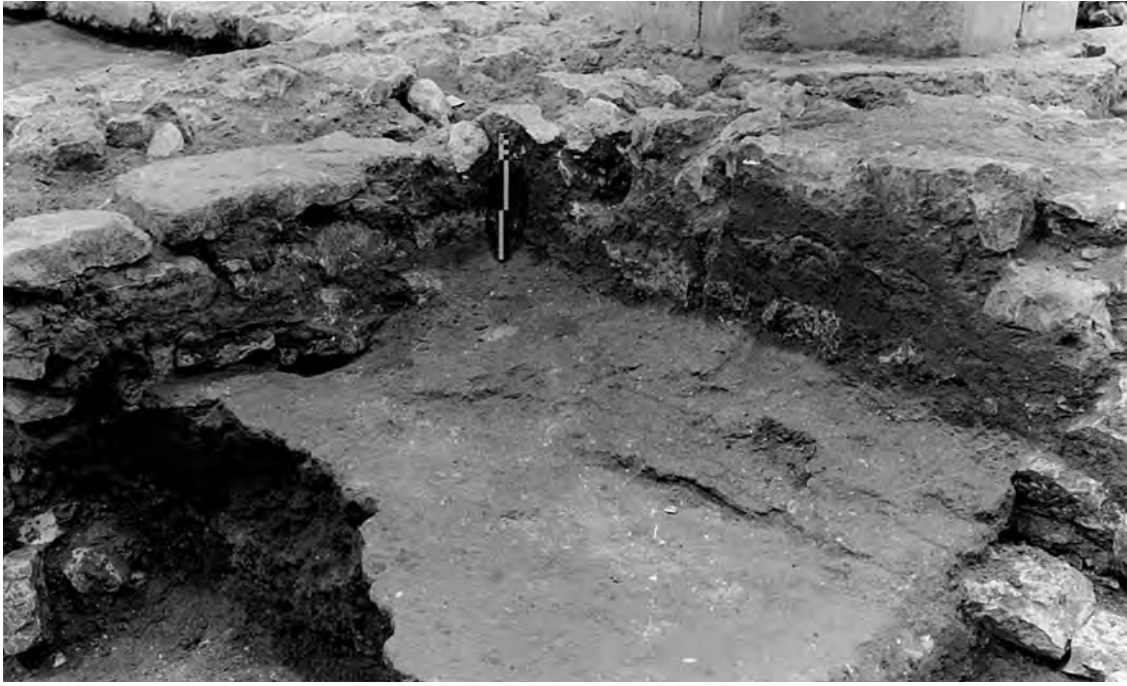
Fig. 396: Saxo-Norman chancel. Construction level in the north-west corner. Note the spread of mortar and masons' waste rising up alongside the north wall. View north-west. Scale of 25 cm. Photo: Warwick Rodwell

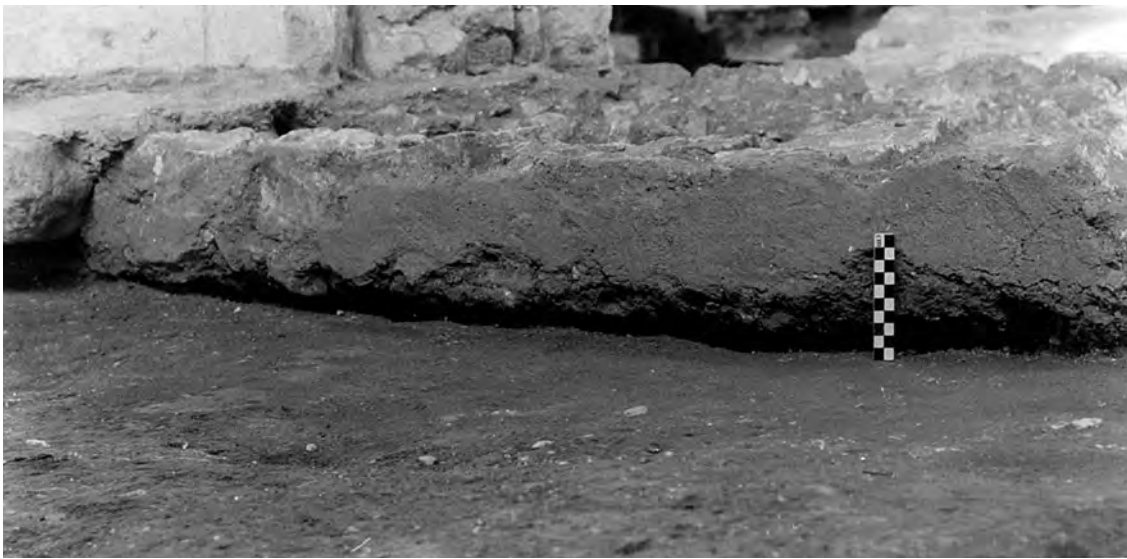
Fig. 397: Saxo-Norman nave. Primary rendering surviving at the base of the north wall. Scale of 10 cm. Photo: Warwick Rodwell

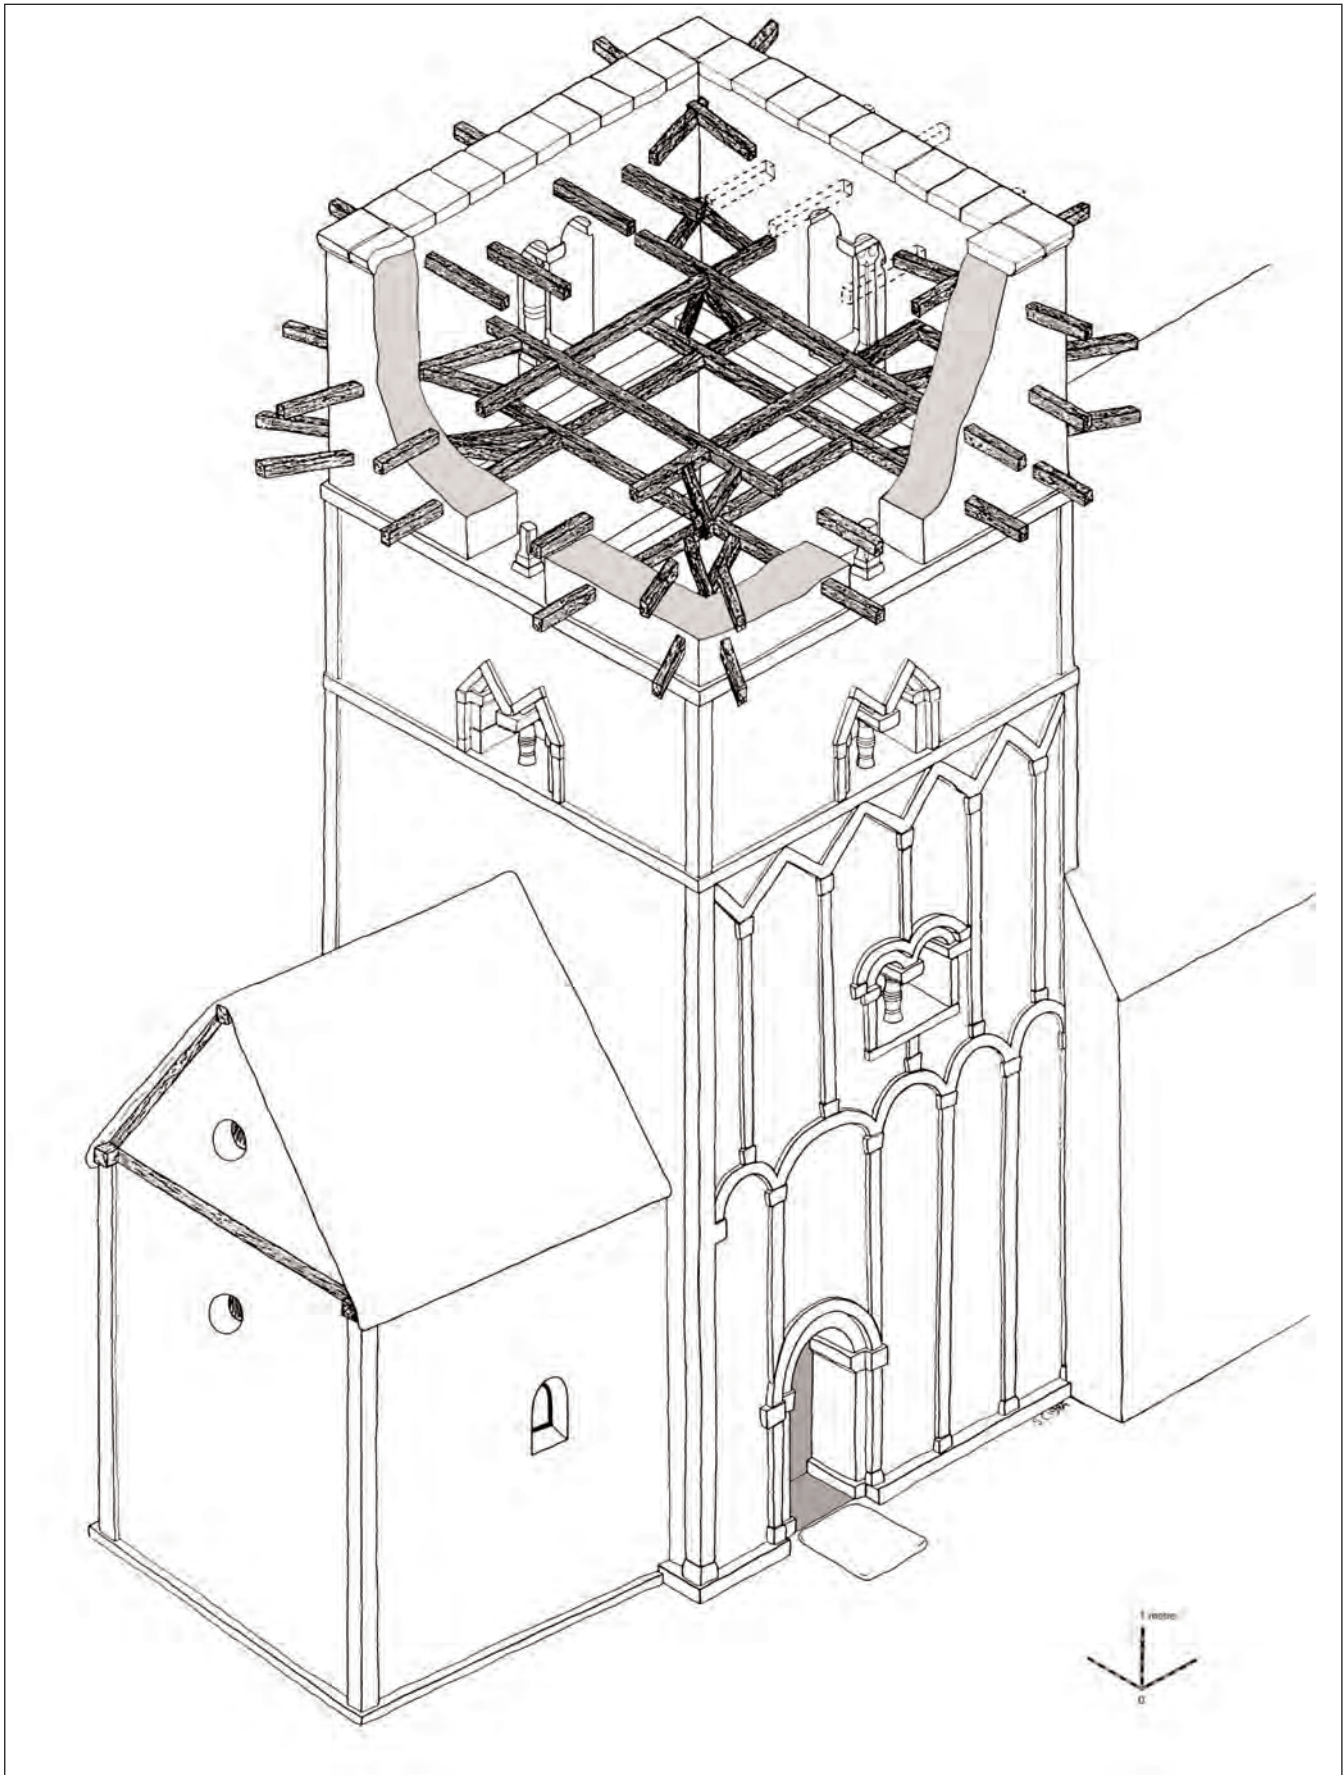
Fig. 401: Tower. Cutaway isometric view, showing a reconstruction of the timber framing erected integrally with the Saxo-Norman belfry. This framing probably acted as an anchor for a roof spire, as well as supporting the bells. Initially, the timbers projected through the walls, to provide cantilevered scaffolding platforms. Drawing: Stephen Coll

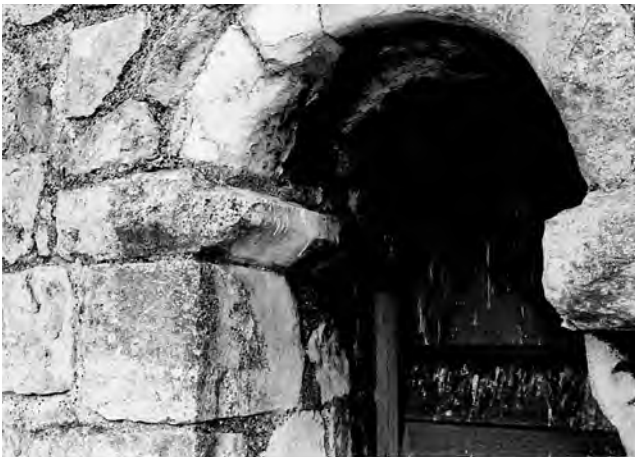
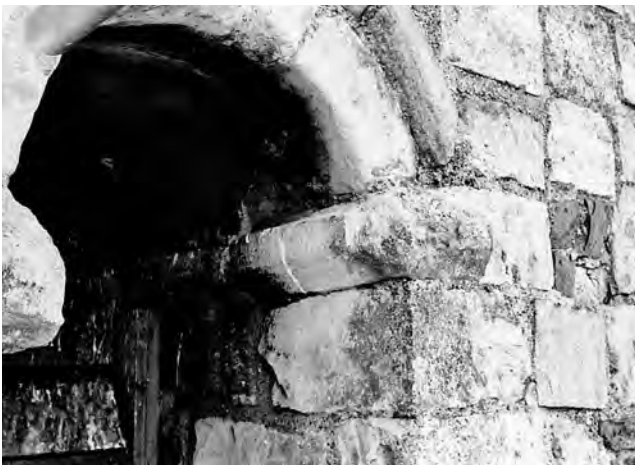
Fig. 403: Tower: Stage 3, southern belfry openings. Details of the double-chamfered string-course blocks reused as imposts. Upper, western aperture. Lower, eastern aperture. Photos: Warwick Rodwell

slabs are similar, but deeper. However, the impost on the south face differ by being double chamfered (Fig. 403), and while these have the appearance of being reused string-course mouldings (perhaps deriving from the chancel of the previous church, p. 305), similar double-chamfered impost occur on the belfry openings at St Mary-le-Wigford, Lincoln (Taylor and Taylor 1965, fig. 177).

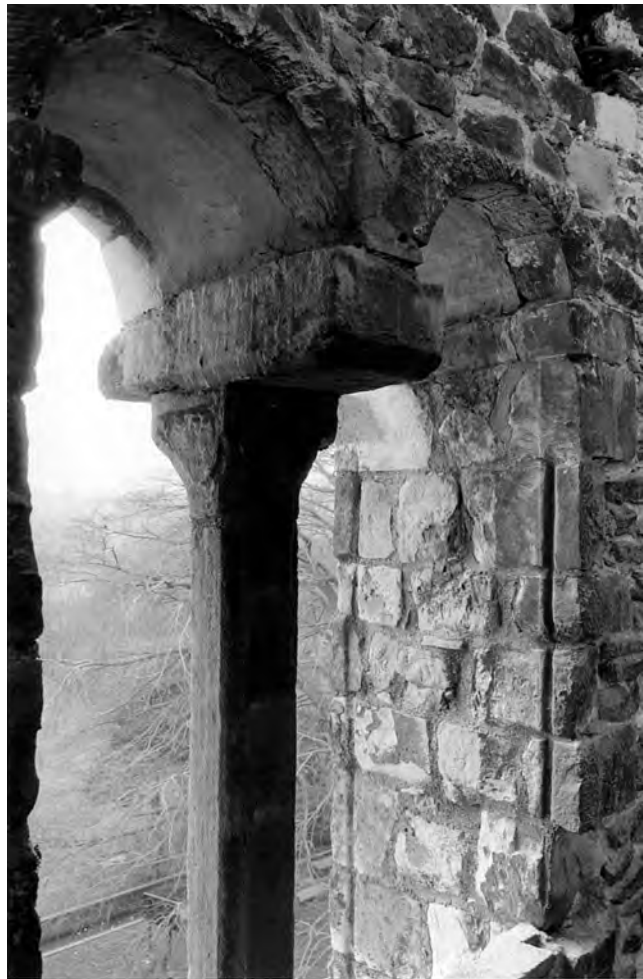
Fig. 404: Tower: Stage 3. Interior of the southern belfry opening, showing the plastered soffits to the arches and vertical channels in the jambs. Photo: Warwick Rodwell

The unmoulded, arched heads are each composed of inner and outer rings of voussoirs of varying sizes, and the jointing is mostly non-radial. The intervening rubble soffits are plastered (Fig. 404). Most unusually, there are simple hood-mouldings, but these are so heavily weathered that it is difficult to be certain of their original profiles (which, anyway, seem to have differed from one opening to another). All this work is in limestone. The mid-wall shafts and their capitals are of differing designs, and are now so eroded that some details are difficult to describe precisely.⁶

The reveals of the three surviving belfry openings all have vertical channels, set back *c.* 4 cm from both the external and internal faces (Fig. 404). They rise

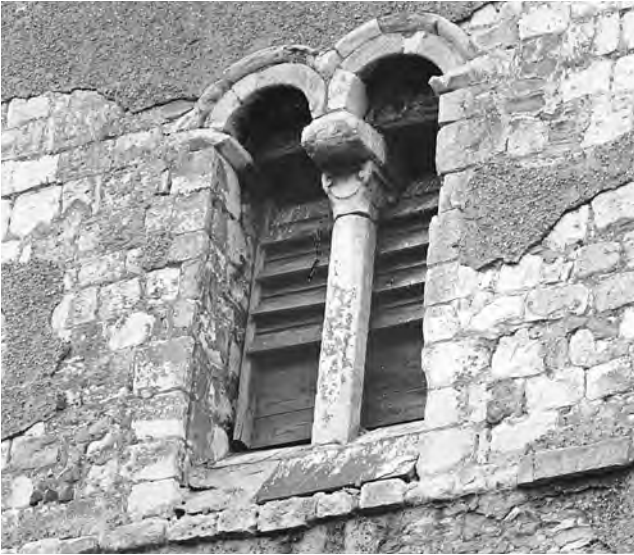
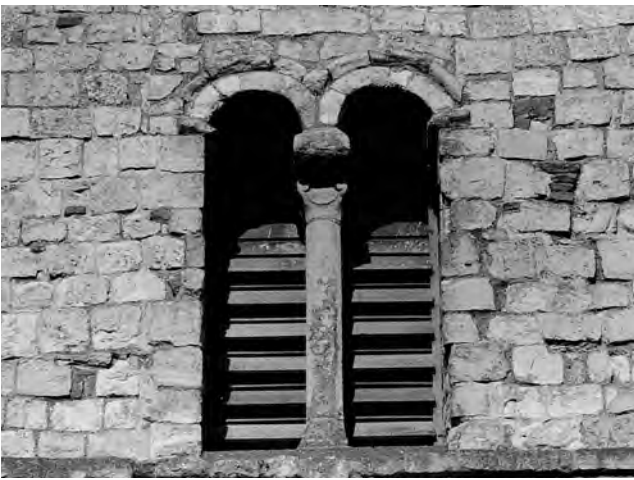
Fig. 405: Tower: Stage 3, south face of belfry. Upper, before restoration in 1965 (note the raised sill and decayed rendering of c. 1870). Lower, in 2000. Photos: David Lee Photography; Warwick Rodwell

South opening (Fig. 405)

The single-piece shaft is square in section, with broad chamfers that convert it into an irregular octagon. It is fitted with a separate capital and base, and all facets of the shaft merge continuously into these, there being no

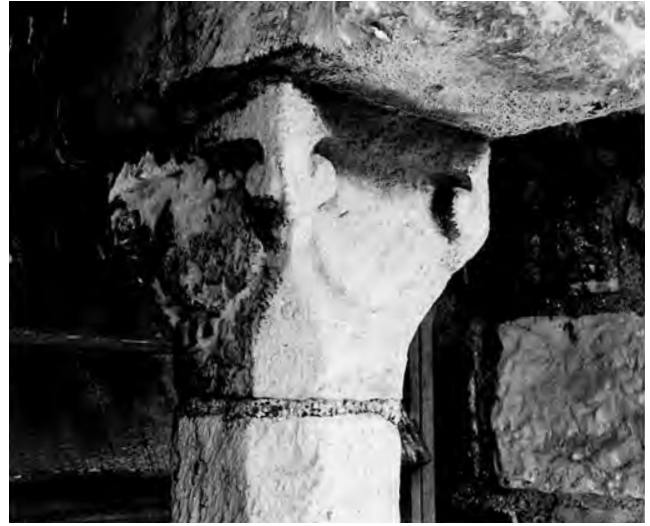
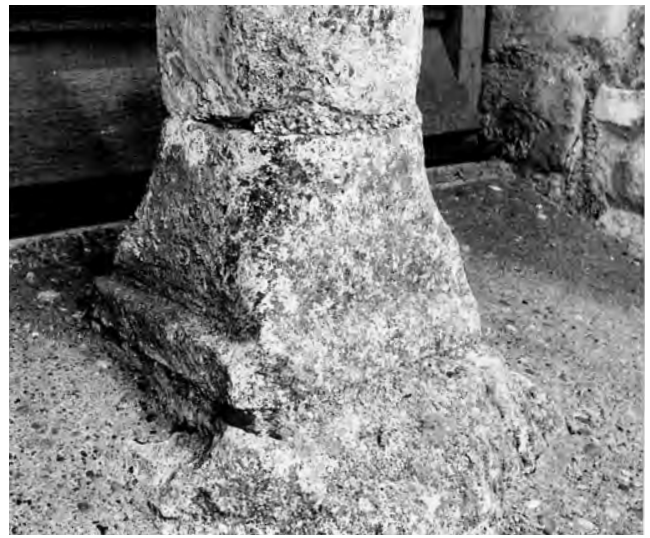
Fig. 406: Tower: Stage 3, south side of belfry. Capital and base of the mid-wall shaft. Both viewed from the south-west. Photos: Warwick Rodwell

neck-ring. The capital is cubical and faceted. The top is square and unmoulded, and a trilobed leaf curls down from each corner, clasping the body of the capital below.⁸ On all four faces is a slightly raised, pendant semicircle, like an imbrication (Figs. 406 and 407).

The base is square, tapers on all four sides, and is faceted on the angles to connect with all eight sides of the shaft (Fig. 406). At the bottom of the base-block is a shallow, integral step, more like a flange; it survives intact only on the western side, where original diagonal tooling is preserved. This base-block has the appearance of being the upturned rough-out for a cubical capital with an integral abacus.

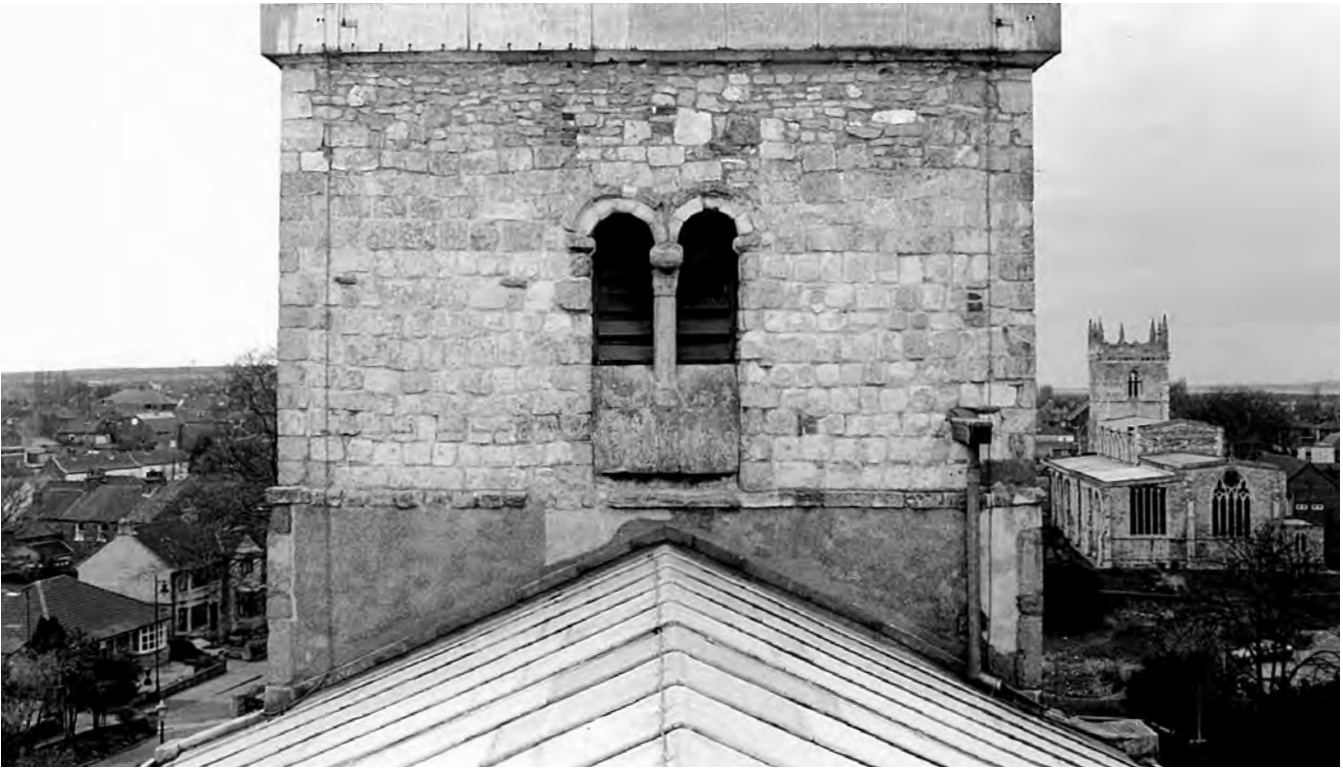
Fig. 408: Tower: Stage 3, east face. Saxo-Norman belfry in 2000, with St Mary's church beyond. Photo: Warwick Rodwell

East opening (Figs. 408 and 409)

Again, the single-piece shaft is an irregular octagon in section and has a separate faceted capital; presumably there is also a separate base, but this has been obscured by later infilling of the lower part of the belfry opening. The capital is square with a moulded abacus, and the facets of the shaft run directly on to it. Three faces of the capital are ornamented with raised imbrications, or shingles, there being two each on the east and north faces, but only one on the south; the west face is undecorated (Fig. 410). The treatment mimics tegulation, as found on some later eleventh-century grave-covers.⁹

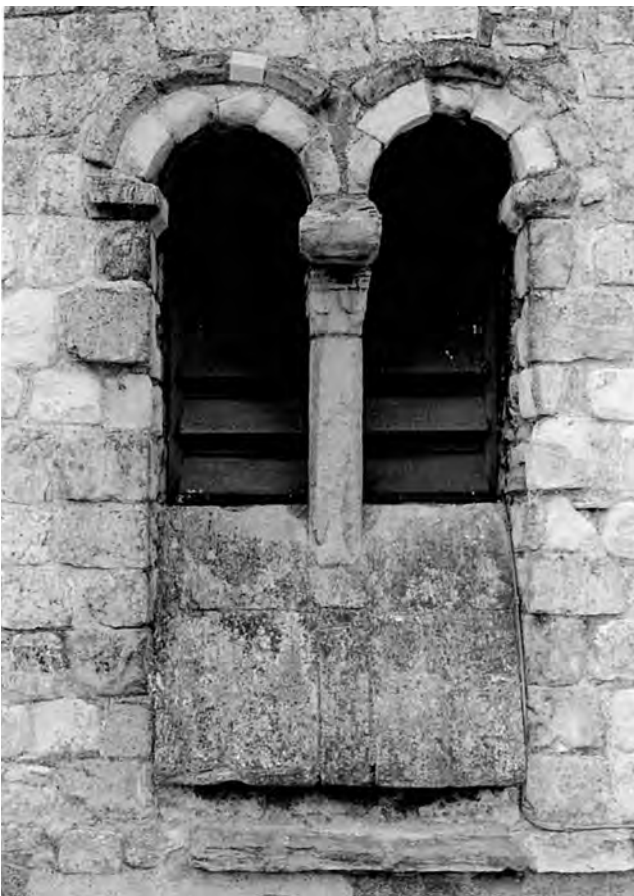
Fig. 409: Tower: Stage 3, east face. Double belfry-opening with later raised sill. Photo: Warwick Rodwell

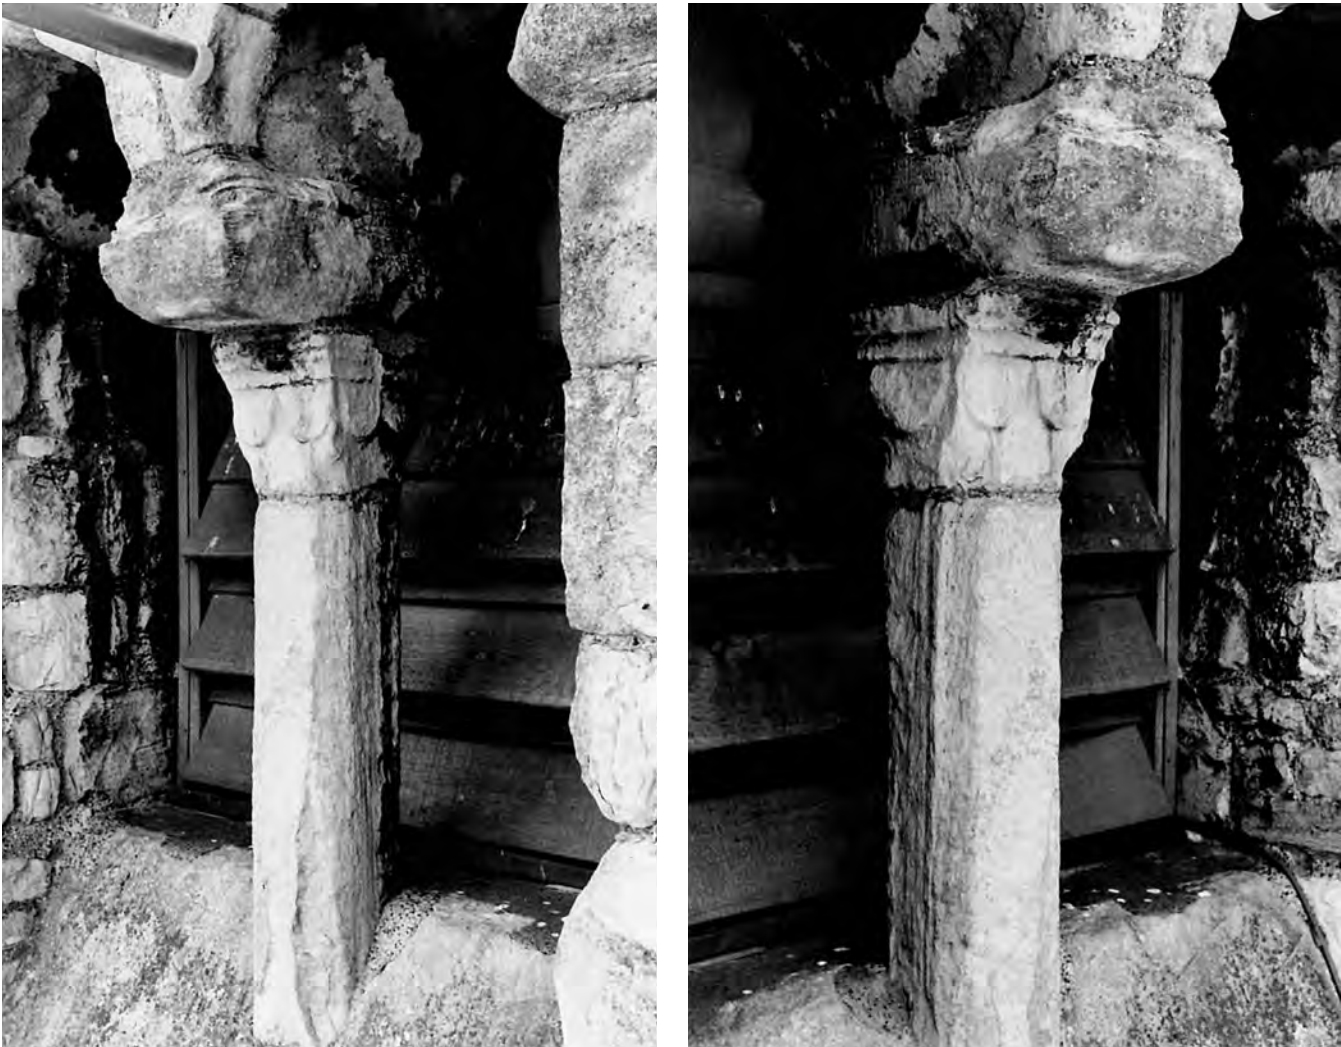
Fig. 410: Tower: Stage 3, east face. Capital of the mid-wall shaft, 2005. Left, view south-west. Right, view north-west. Photos: Warwick Rodwell

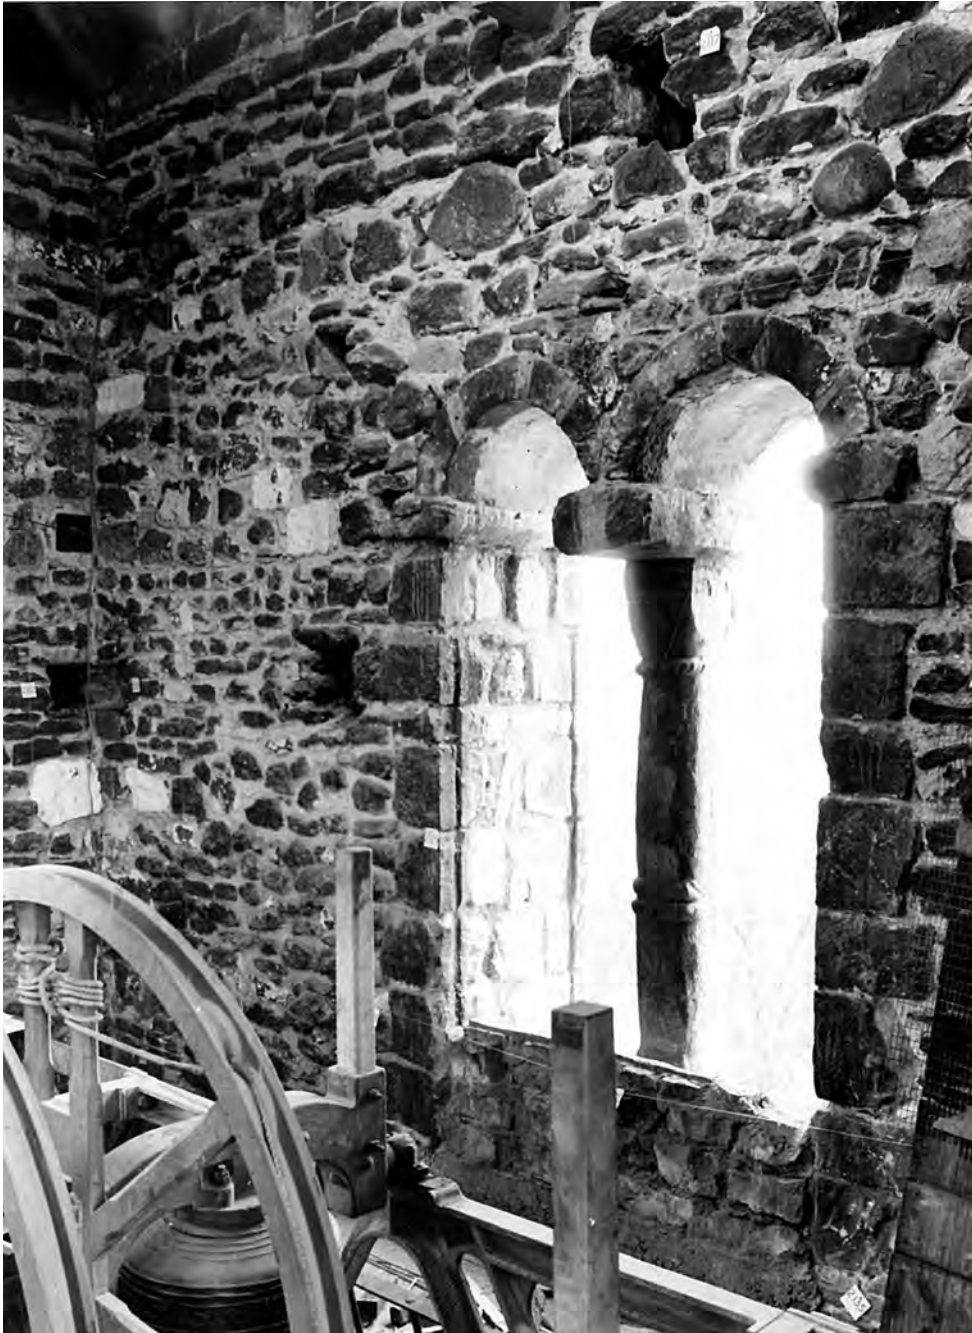
Fig. 411: Tower: Stage 3, interior. View of the north wall and double belfry-opening (louvres removed), 1980. Photo: Warwick Rodwell

North opening (Figs. 411 and 412)

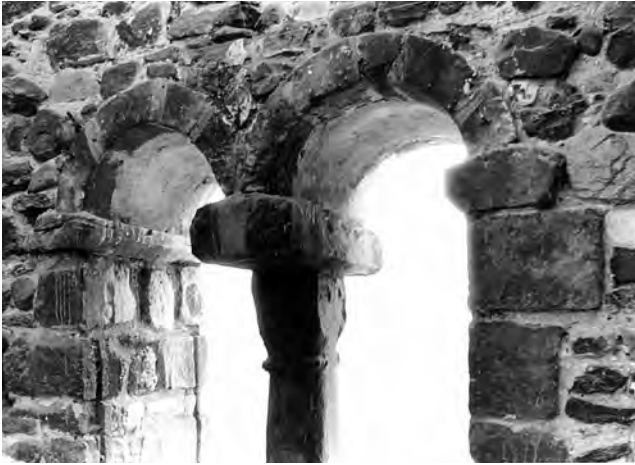
Fig. 412: Tower: Stage 3, interior. Detail of the neatly cut voussoirs in the head of the north belfry opening, 1980. Photo: Warwick Rodwell

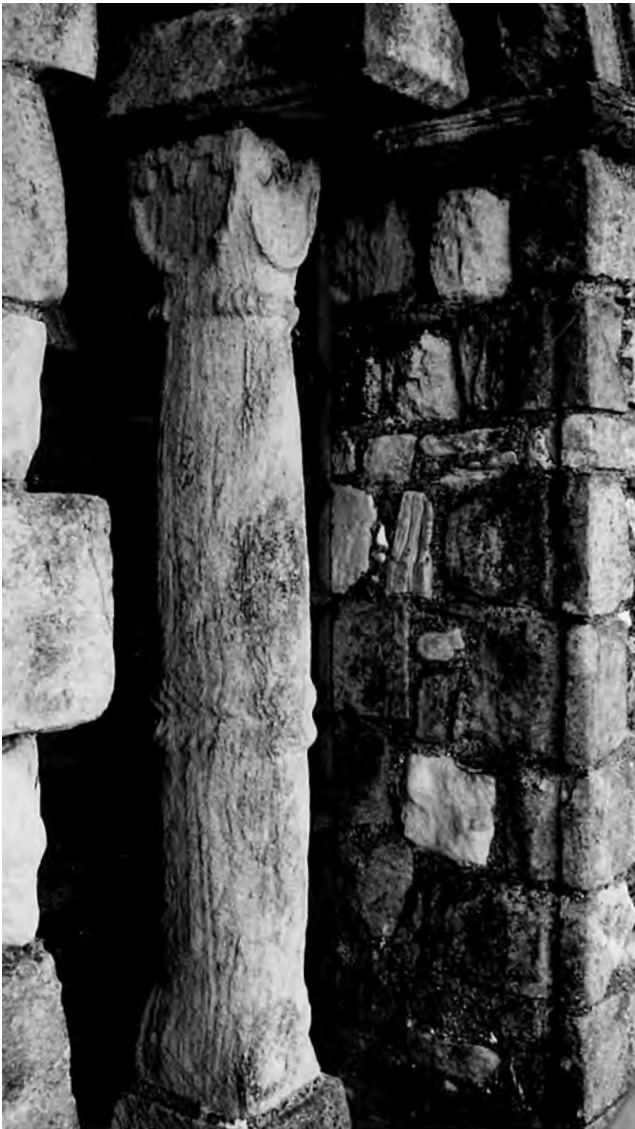
Fig. 413: Tower: Stage 3, north. Mid-wall shaft in the double belfry-opening. View from the north-east, 2005. Photo: Warwick Rodwell

The mid-wall support is distinctly different from the previous two, being a one-piece baluster with integral capital and base (Figs. 413 and 414). It is of soft limestone, and is now too eroded to confirm whether it could have been partially lathe-turned. The double-tapering baluster is decorated with a pair of mid-shaft rings, which now appear to be plain, but close inspection under suitable lighting conditions shows that they were once both decorated with cabling (Fig. 416).¹⁰ There is also a cable-moulded neck-ring (Fig. 415), as occurs at Bracebridge (Lincs.) (Brown 1925, fig. 192), and on the capitals of the columns flanking the chancel arch at Marton (Lincs.) (Brown 1925, fig. 193.3). Stocker and Everson (2006, 44) have compared the Barton baluster with the degraded fragments of one-piece balusters from Grasby and Hagworthingham (Lincs.).¹¹

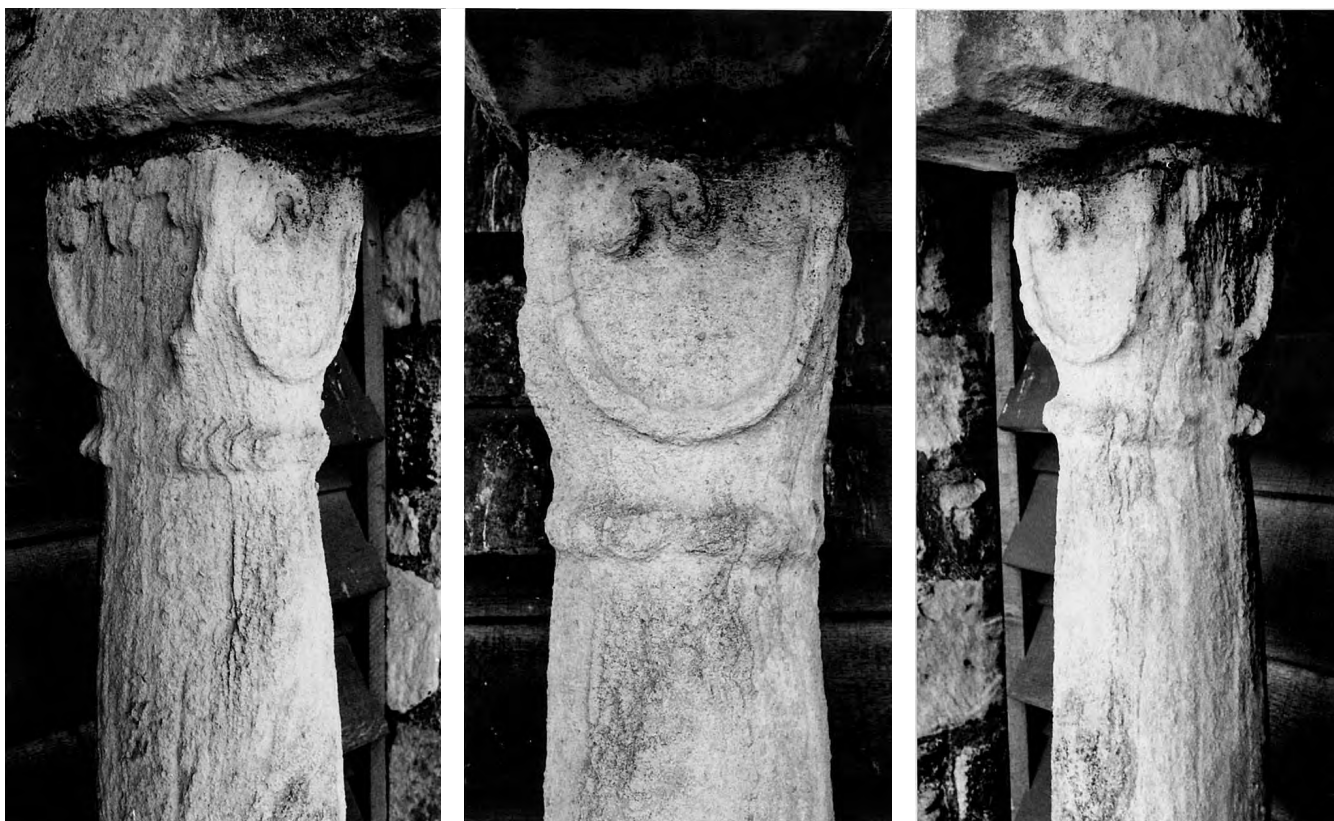
Fig. 415: Tower: Stage 3, north. Capital and cable-moulded neck-ring of the mid-wall shaft. Left, from the north-east; centre, north face; right, from the north-west. Photos: Warwick Rodwell

The capital is square-topped and difficult to classify: it is a hybrid cubical and cushion. It has three visible faces, each carrying a simple swag sculpted in relief; also, at the top of the swag, are two pellet-like motifs on the north and west, and three on the east (Fig. 415). The south face of the capital is decorated with a large, inverted triangle, the outline of which is formed by a raised rib (Fig. 416). The lower end of the shaft merges into a cubical base.

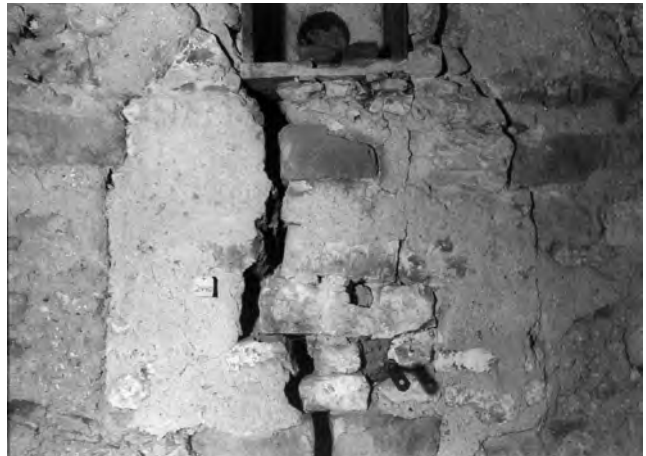
Fig. 418: Tower: Stage 3, west. Infilled double belfry-opening. The three darker rectangular blocks in line near the top are the impost and through-stone. Note also the major vertical crack. Photo: Warwick Rodwell

time, namely east and west. It is likely that the purpose of the infilling was, at least in part, to stiffen the fabric of the tower. The blocking still survives in the western opening: the masonry and the mortar used are consistent with a late eleventh-century date (p. 397; Fig. 418).¹³

At an unknown date, but probably not long after the two belfry openings were infilled, the tower walls fractured vertically, the cracks still being apparent today, although long since stabilized. The major rupture is on the east-west axis of the tower, where masonry joints in the lower belfry have opened by 2–3 cm, and the gritstone pad upon which the mid-wall shaft rests in the western opening has fractured. Varah (1984, 15) asserted that the cracks were the result of earthquake damage; this is feasible, but movement in the underlying clay might be another explanation.

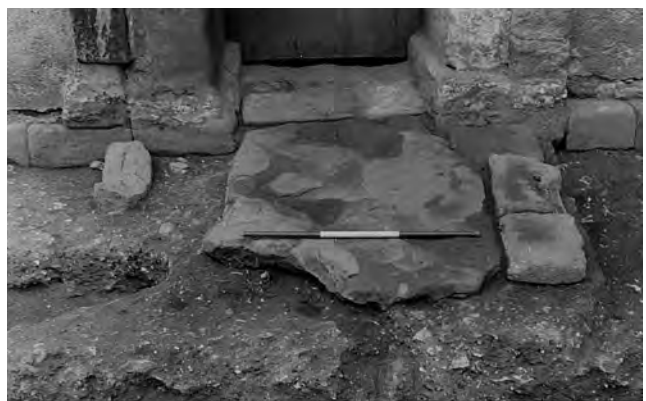
Fig. 419: Tower: south doorway. Step (F3282) and threshold slab (F3035) lying on the Period 2 churchyard surface. Scale of 75 cm. Photo: Warwick Rodwell

Another modification to the tower is attributable to Period 3. The raised floor level of the new church was carried through into the tower, and that required the thresholds of the north and south doorways to be raised. On the south, the step down to the churchyard was made from two blocks of salvaged gritstone, set on a mortar bed (F3282). Outside the door, a rectangular threshold slab of coarse limestone was laid (F3035; Figs. 391, 401 and 419).¹⁴ The slab may have been flanked by a pair of postholes, aligned with the strip-work pilasters of the doorway and sited 50 cm forward of them. Only one posthole was present (F3218), the
