ST PETER'S

Barton-upon-Humber, Lincolnshire

A Parish Church and its Community

HISTORY, ARCHAEOLOGY AND ARCHITECTURE

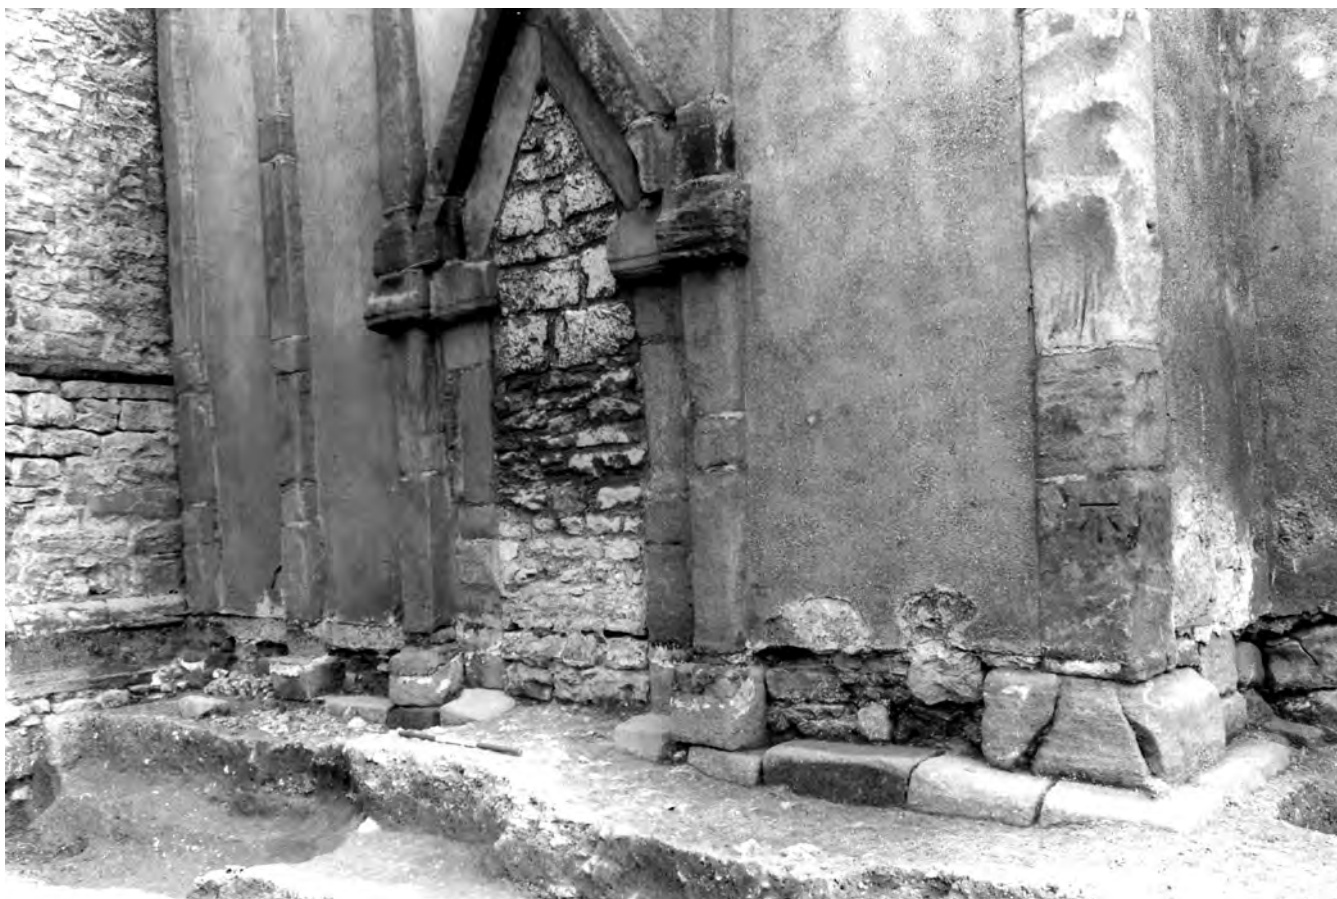
Fig. 420: Tower: north doorway. Period 3 churchyard surface with masons' debris, alongside the tower plinth. View looking south-east. Scale of 75 cm. Photo: Warwick Rodwell

On the north side of the tower, contemporary churchyard level was preserved in a narrow strip which had escaped destruction by later grave-digging. Here lay a spread of chalk, apparently forming a metallated surface on which the masons engaged in heightening the tower had worked (F7252). Strewn over the metallating was an accumulation of mortar and masons' waste from dressing limestone (Fig. 420). This activity had slightly raised the ground level alongside the

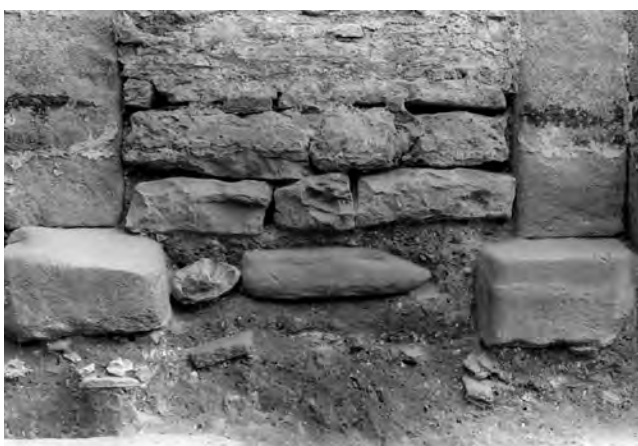
Fig. 421: Tower: north doorway. Period 3 soil and pebble infill, raising the threshold to the level of the respond bases. Photo: Warwick Rodwell

tower, so that a step was not needed in the north doorway. Instead, several large pebbles were deposited in the threshold in a soil matrix, and the projecting bases to the door jambs now disappeared from view (Fig. 421).

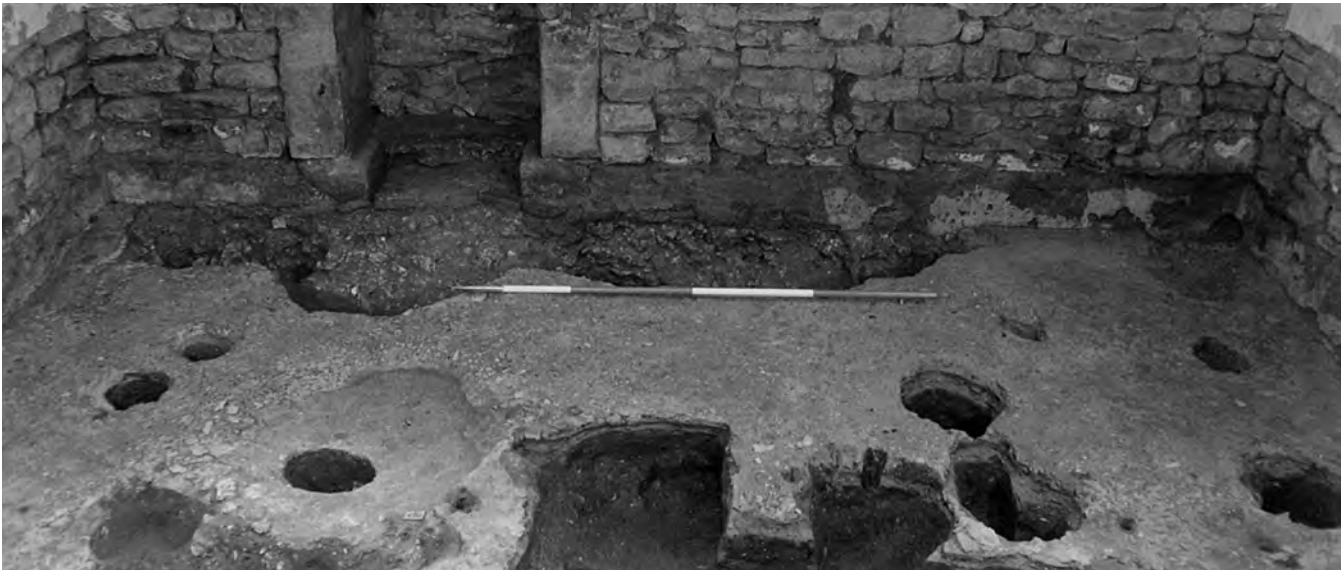
Fig. 422: Tower: interior. Lime concrete floor of Period 3 in the northern half of the tower. View north. Scale of 2 m. Photo: Warwick Rodwell

Within the tower, a new lime-concrete floor was laid over the accumulated material on the primary floor (Fig. 422). In the process, this sealed some of the primary plaster around the base of the walls (Fig. 423).

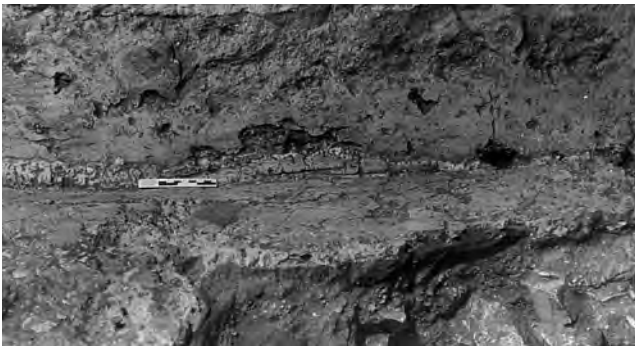
Fig. 423: Tower: interior. Lime concrete floor of Period 3 abutting the west wall. Note how the new floor has been joined into the damaged earlier wallplaster, just above the scale of 8 cm. Photo: Warwick Rodwell

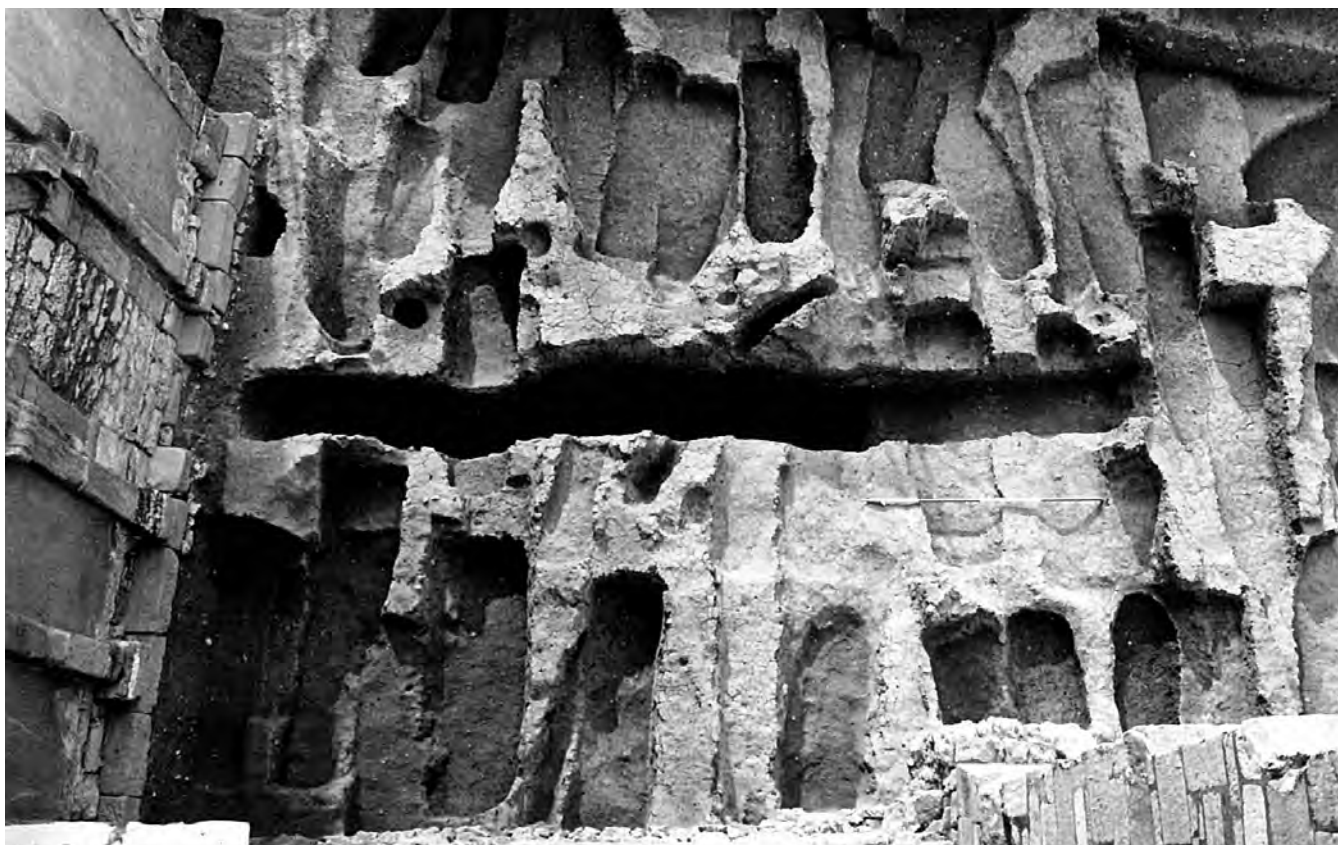
Fig. 424: Area 14: cemetery after complete excavation. The unused Saxo-Norman foundation trench (F7302, seen at the centre), running north from the tower, was earlier than the majority of the graves. West is at the top. Scale of 2 m. Photo: Warwick Rodwell

North of the tower, in Area 14, a substantial linear feature was discovered which has defied convincing explanation (F7302). It took the form of a trench 7.4 m long, had an average width of 0.6 m, and had been dug to a depth of *c.* 1.2 m below contemporary ground level (Figs. 391, 424 and 425). The sides were intended to be vertical, but in places the clay had caved. The feature had the appearance of being a foundation trench for a masonry wall. The trench ran north–south and was nearly at right-angles to the axis of the church; it cut through two graves of Phase E (F7382 and

The feature was too precisely cut to be a palisade trench for a timber construction, and the evidence does not convincingly suggest that it was a robbed masonry foundation. Nevertheless, the vertical sides, depth and flat bottom strongly suggest that it was intended to be the foundation trench for a substantial wall, but was abandoned at an early stage of construction. We can only speculate as to the nature of the aborted scheme. The southern end of the wall was clearly intended to abut the tower, the north doorway of which would have been obstructed, and its infilling must have been envisaged (incidentally providing the facility for keying the two elements together). No intended termination towards the north can be suggested, and it is likely that at some point within the next five metres or so (*i.e.* before the break of slope), the wall trench would have turned a right-angle, and run eastwards. The intention may have been to enclose a cemetery or possibly even residential structures, if there were ambitious intentions, for example, to raise the church to collegiate status. However, the project was never completed, the trench was backfilled and a large number of burials of Phases D and E masked its site.

The narrow band of chalk metallage, noted above, which survived along the north side of the tower and annexe (F7252), sealed the abandoned and backfilled 'wall trench' (F7302). This sequence is important for demonstrating that the abortive wall trench was dug either in Period 2, or was associated with the beginning

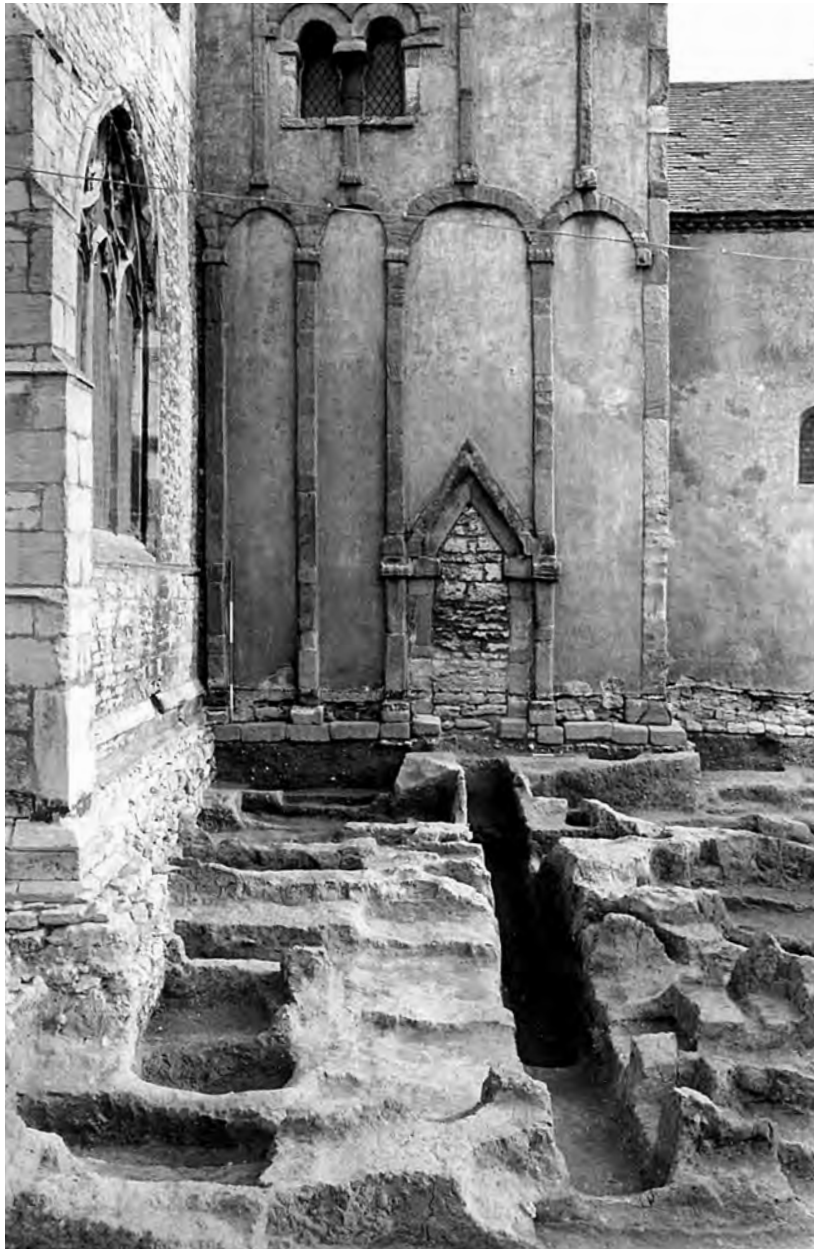
Fig. 425: Area 14. Saxo-Norman foundation trench (F7302) running up to the north door of the tower. Scale of 2 m. Photo: Warwick Rodwell

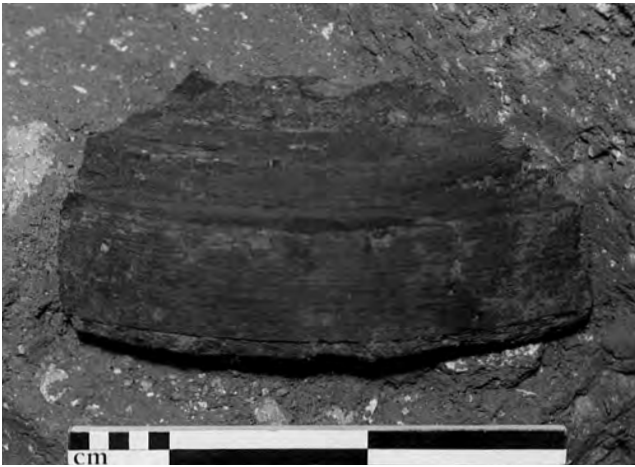
Fig. 427: Nave. Fragment of rim of the inner (core) mould for a bell, in pit F181. Scale of 25 cm. Photo: Warwick Rodwell

Contemporary floor level was not identifiable in the nave, and the only features of significance occurred in the north-west corner. Here, fragmentary remains of an oval pit were encountered, containing burnt earth, charcoal and remnants of bell-mould (F181/199; Fig. 427). Set within the pit was also the damaged base of an *in situ* clay mould for casting a small bell (F205); this was the core-mould for a bell with a diameter of 57 cm (22½ ins) produced by the 'lost-wax' process.¹⁶ Adjacent to the casting pit was a small hearth pit of elongated plan, with a rounded base and burnt sides (F170). Although incomplete, this was too small to be a furnace for melting bell-metal in a crucible. While these features are included here, the possibility should be acknowledged that they could have related to the Saxo-Norman church (Period 3).

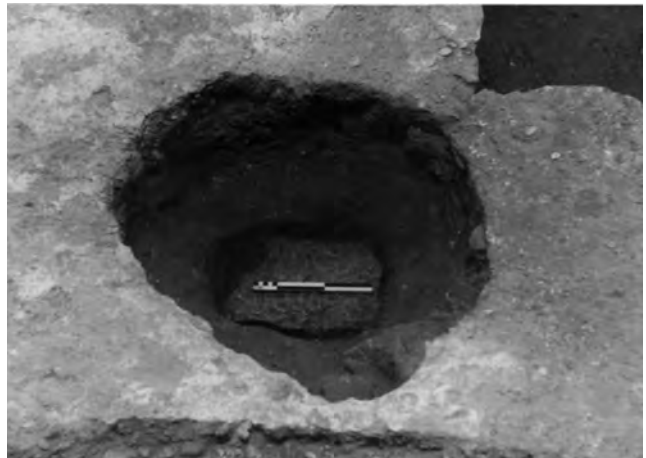
Fig. 428: Nave. Font drain pit (F56). View west. Scale of 25 cm. Photo: Warwick Rodwell

A feature encountered at the west end of the nave, on the central axis, was a circular pit with a slab of limestone in the base and a filling of small rubble above (F56). This was clearly a font drain (Fig. 428).

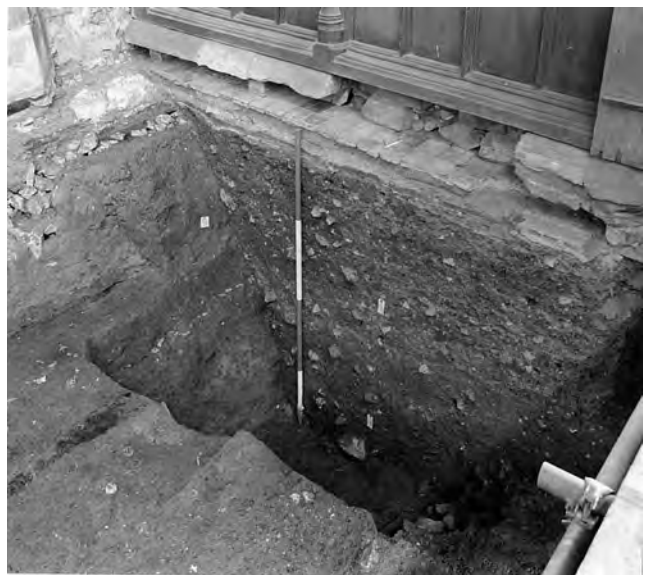
Fig. 429: Collapsed well shaft (F1651) in the north-east corner of the Norman nave. View north-east. Scale of 2 m. Photo: Warwick Rodwell

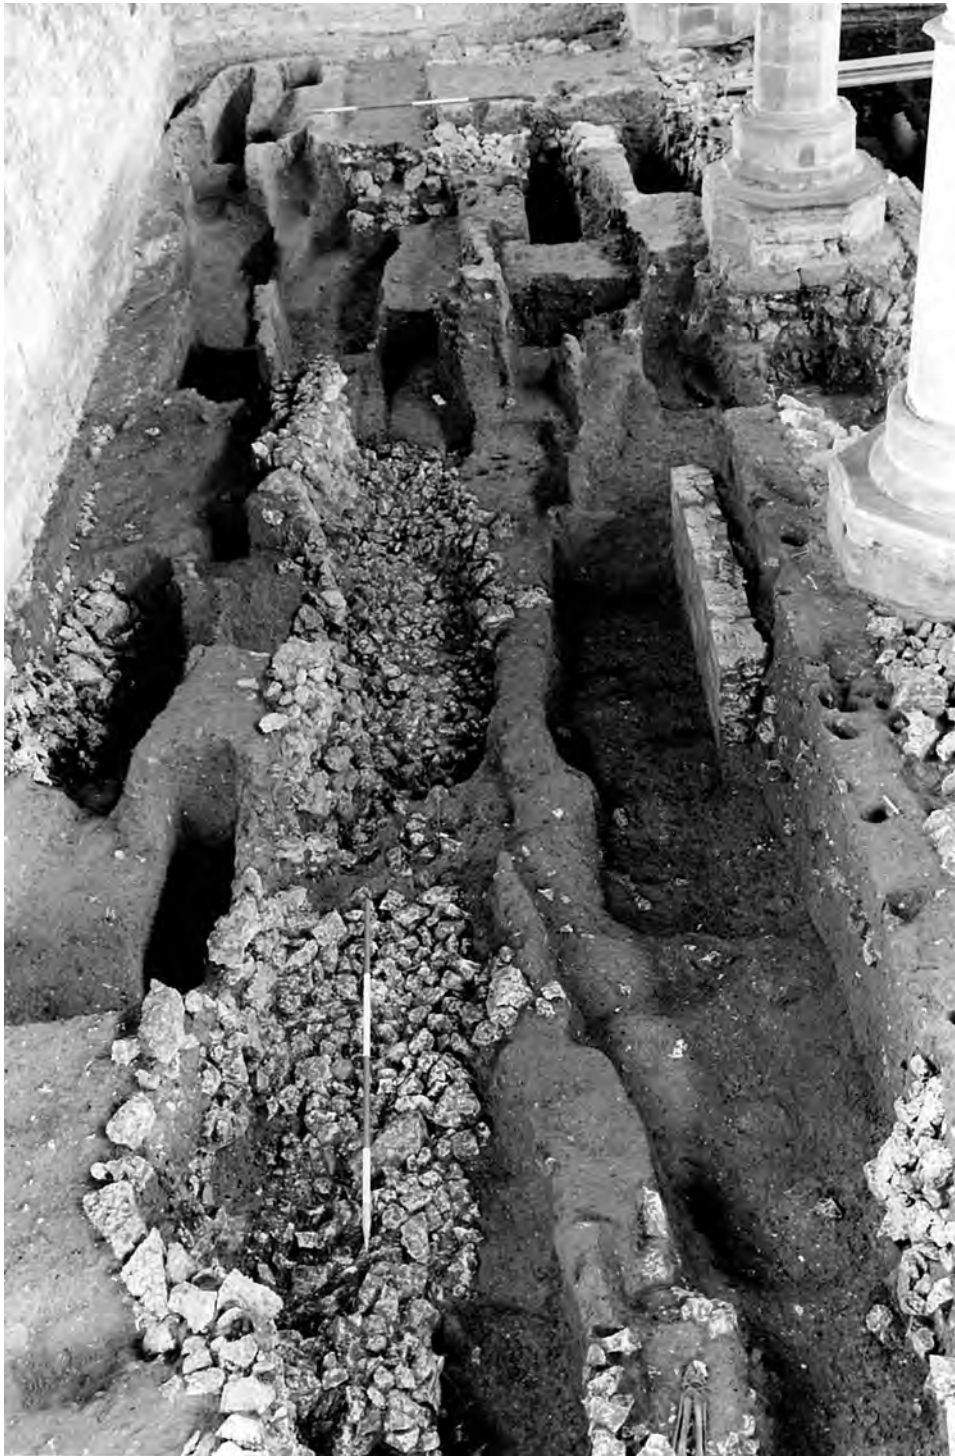
Fig. 431: North aisle, Period 4C. The fragmentary and irregular chalk rubble foundation of the outer wall of the narrow aisle (F314). View east. Scales of 2 m. Photo: Warwick Rodwell

A long, narrow aisle flanking the north side of the Norman nave was erected, incorporating the two-celled structure of the previous phase. A foundation at least 1.1 m wide, and somewhat sinuous in plan, was laid for the north wall and its western return (F314). The width of the trench varied on account of the presence of earlier grave fillings, and preservation of the evidence was very slight in some places (Figs. 426 and 431). The maximum width of the construction trench was 1.4 m. The base of the trench became markedly deeper towards the east, where it terminated in a butt-end against the corner of the earlier two-celled structure.¹⁹ The foundation was U-shaped in cross-section and comprised a mixture of both large and small blocks of chalk rubble, in a matrix of brown clay; viewed in long-section, it was apparent that some attempt had been made to lay the uppermost courses in pitched formation.

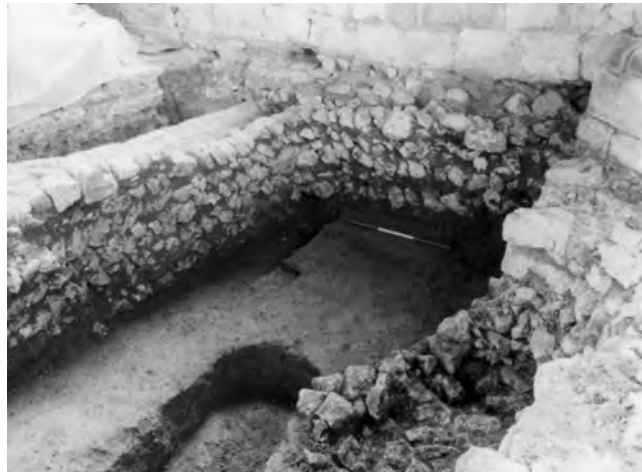
Fig. 432: South aisle, Period 4D. Chalk rubble foundation of part of the south wall (left) and west wall of the narrow aisle (F965). View south-west. Scale of 75 cm. Photo: Warwick Rodwell

The next addition to the nave took the form of a south aisle with an integral porch. Four lengths of rubble foundation (F965) are all that survive; these constitute parts of the south wall, west-end return (Figs. 426 and 432), and the east side of the porch (Fig. 433). A ghosted outline was preserved where the west side of the porch had lain. The edges of the aisle foundation were sinuous as a result of their trenches having been cut through unstable grave fillings.²⁰ Nowhere was the top of the foundation extant, but the intended width seems to have been *c.* 1.0 m, which points to the walls having been 3 ft (0.92 m) thick. The foundation was *c.* 0.90 m deep and consisted of chalk rubble, flints and occasional pieces of limestone with mortar adhering, set in a matrix of stiff grey clay.

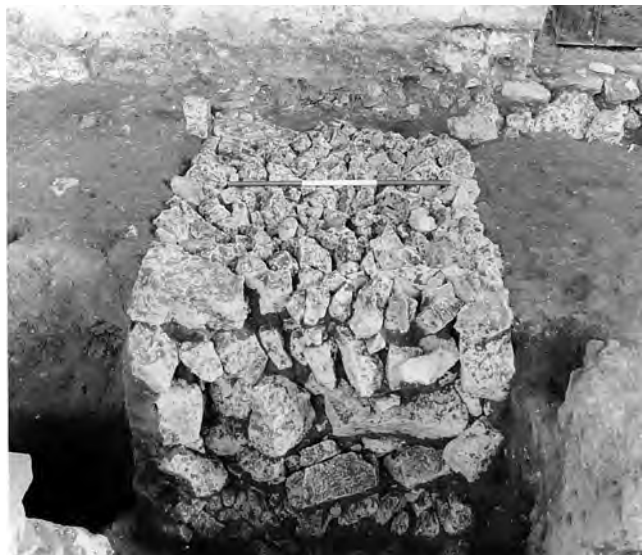
Fig. 433: South porch, Period 4D. Section through the chalk rubble foundation (F965) of the east wall of the porch associated with the narrow aisle. View south. Scale of 75 cm. Photo: Warwick Rodwell

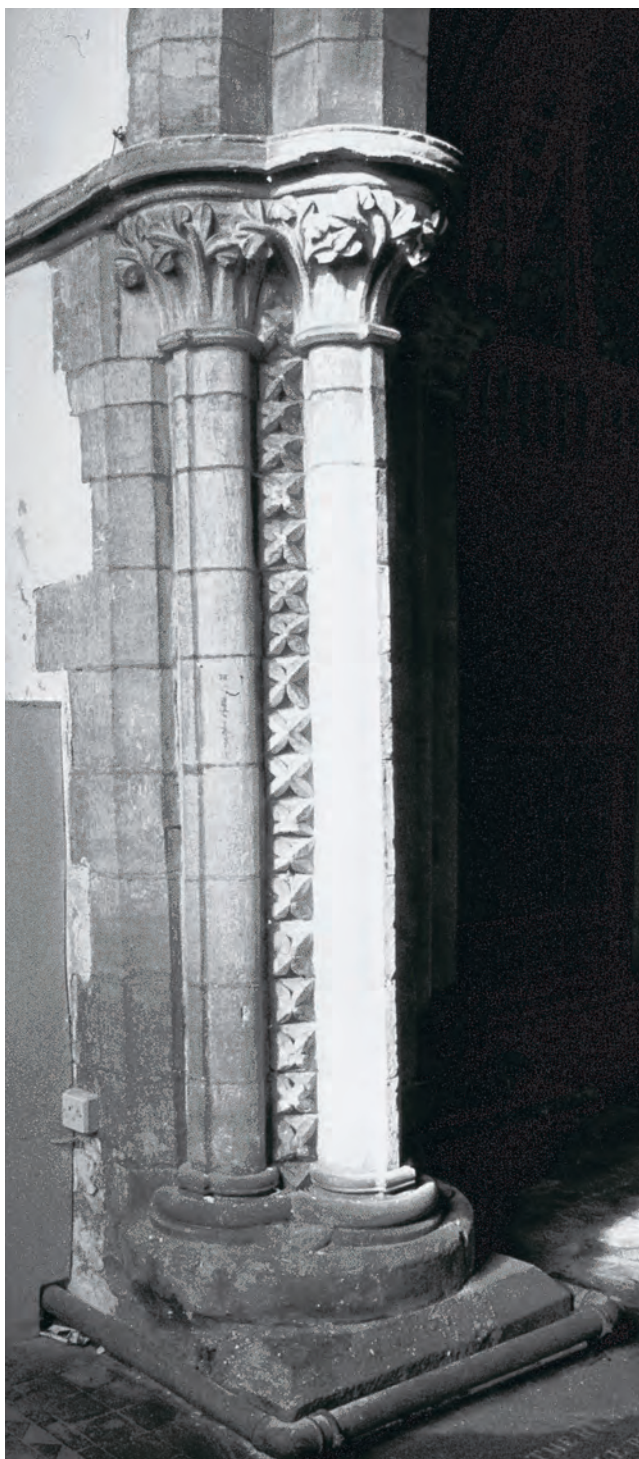
Fig. 434: St Lawrence, Thornton Curtis (Lincs.). Dog-tooth ornament in the west respond of the south aisle. Photo: Warwick Rodwell

pitch of *c.* 4.2 m. Unfortunately, no evidence survived for the locations of the pier bases. The doorways in the aisle and porch were doubtless enriched with moulded arches and at least one order of shafting, and there was perhaps some dog-toothing to complement that on the arcade capitals. The porch doorway at Thornton Curtis, albeit now a reconstruction of 1883, is potentially analogous,²³ as may be the dog-tooth ornament on the arcade responds there (Fig. 434).

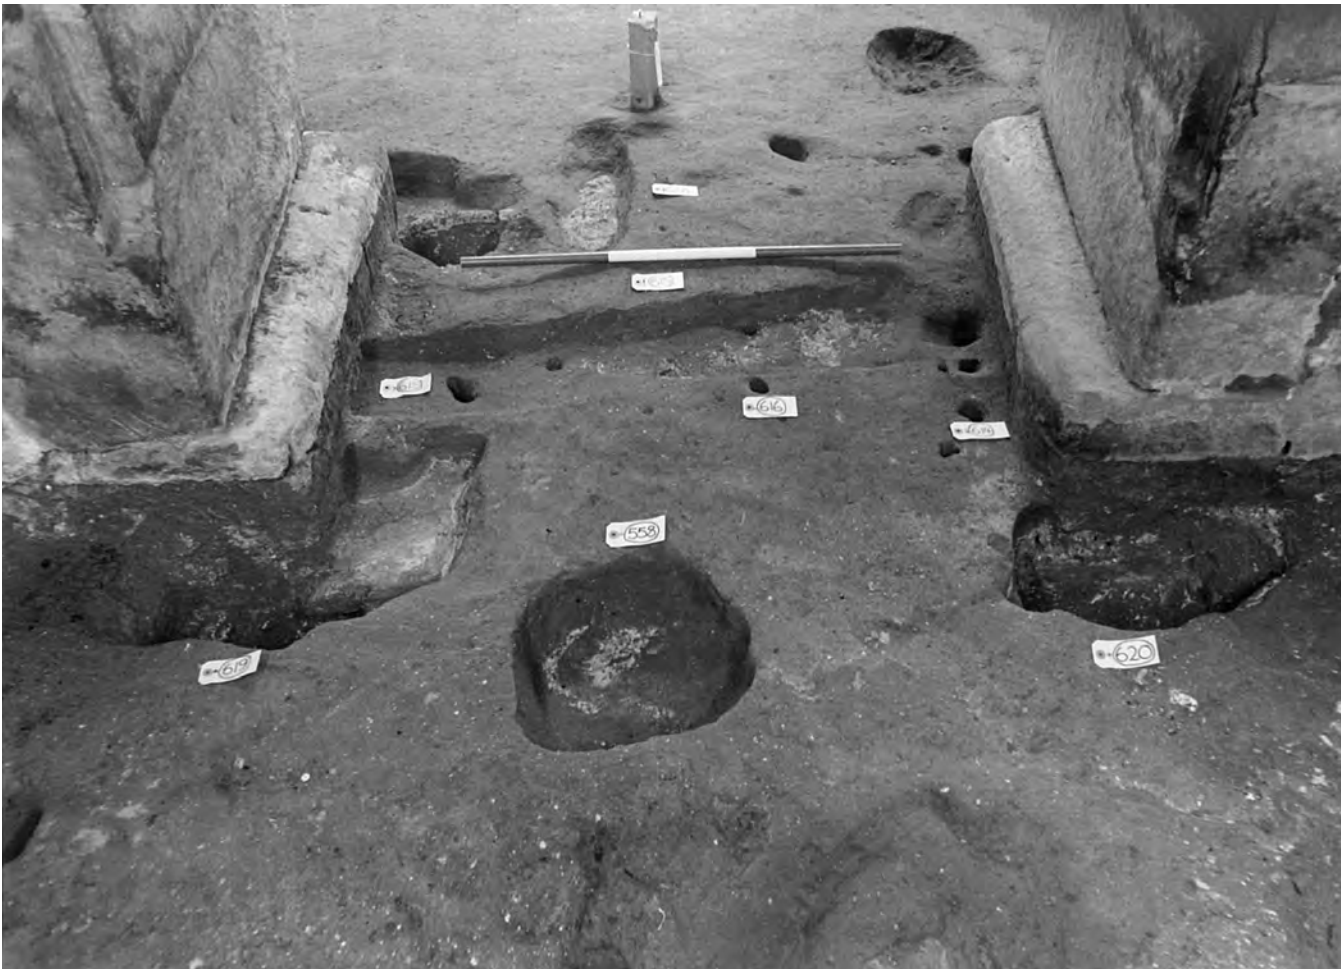
Fig. 435: Western annexe: base of tower arch. Saxo-Norman earth floors punctured by early medieval features, including a pair of postholes (F619 and F620) for a portal frame and a slot for a threshold timber (F618, in front of the scale). View east. Scale of 75 cm. Photo: Warwick Rodwell

was created; that in turn was only short-lived (p. 522). Also broadly contemporary and under the western tower arch was a flat-bottomed slot which had evidently contained a timber (F618), and was potentially the threshold of another doorframe set within the reveal. It lay slightly askew to the axis of the arch, midway through the opening (Fig. 435).

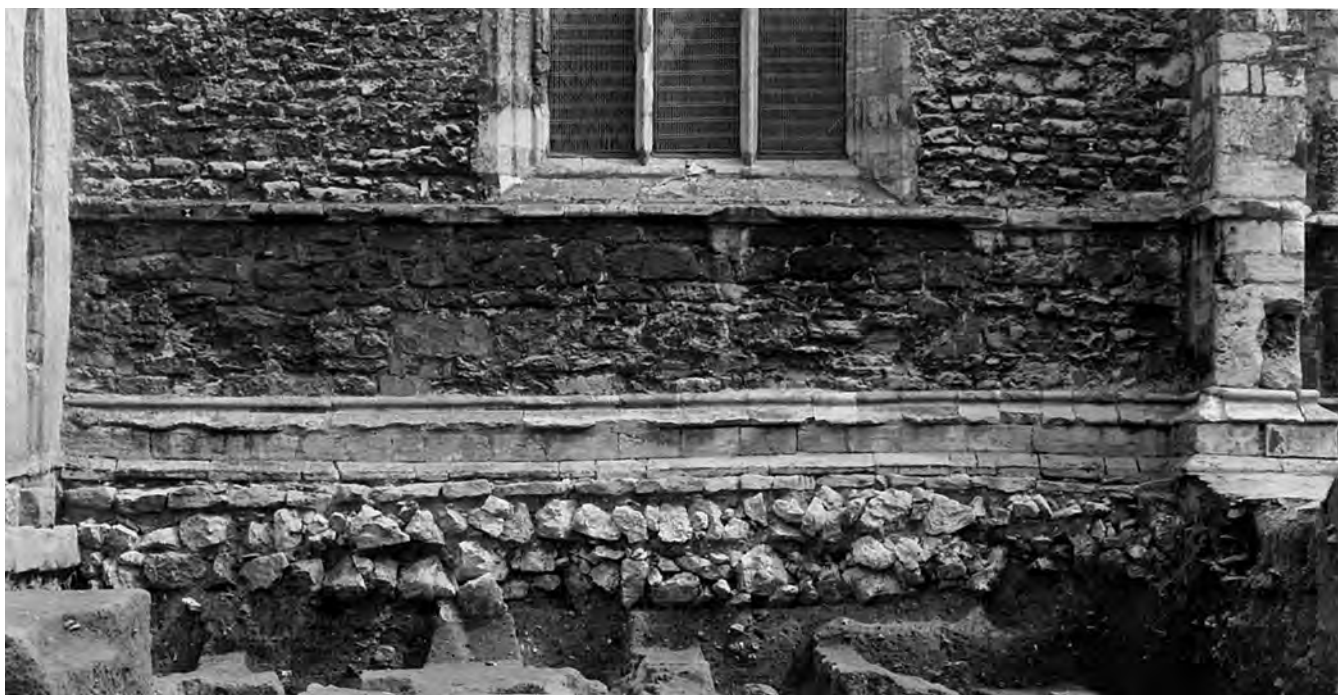
Fig. 440: South aisle, Period 5: west wall. Thirteenth-century chalk rubble foundation, encasing and extending the foundation of the Norman narrow aisle. Note the slightly undulating profile of the plinth, resulting from subsidence. Photo: Warwick Rodwell

extended southwards. Slight subsidence in the plinth is visible at the south-west corner of the aisle (Fig. 440). Only the jambs of the three-light Early English west window survive, the traceried head being a later replacement. It is of the same width as the south windows and may well have been *en suite*, although the external mouldings of the jambs are more elaborate,³⁸ and the sill is of two chamfered courses, both internally and externally. The rear-arch is more widely splayed and its present pointed head comprises thin, flat voussoirs of limestone without a chamfer on the arris.

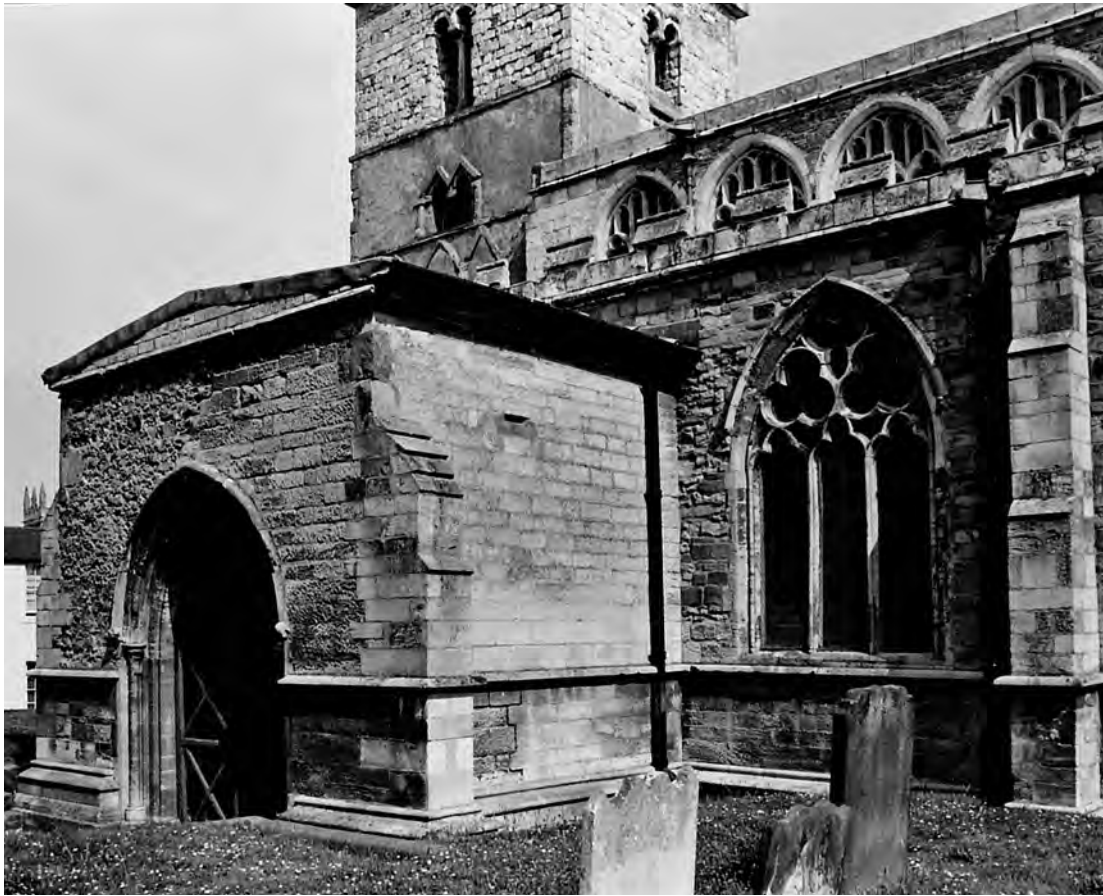
Fig. 441: South porch, Period 5. South-east view, 1999, showing the late medieval reduction in height and roof pitch. Note also the modern partial refacing in ashlar. Photo: Warwick Rodwell

The porch is integral with the construction of the aisle; its plan is rectangular and there is lateral buttressing to the east and west on the salient angles (Figs. 426 and

441). The buttresses have two chamfered weatherings. The aisle plinth and string-course are continuous around the porch, although now mainly renewed. A square sub-plinth was inserted under the south side in the nineteenth century, when the floor and external ground were reduced to a level 15 cm below that obtaining in the Middle Ages. Like the aisle, the porch was built of mixed rubble, but the whole of the east side, one half of the south face, and the lower parts of the west side, were all refaced in the 1950s–60s; in one restoration campaign smooth ashlar was used, while in another it was artificially distressed.³⁹

The porch was originally of two storeys, but was reduced slightly in height and the timber upper floor was removed: that probably occurred in the fifteenth century, when the original steeply pitched roof was replaced with the present low one. A single timber that was undoubtedly associated with the original roof was subsequently reused as a wallplate on the south side of the truncated porch (Fig. 547; p. 468). The timber would appear to have been a tie-beam at the base of a gable, and various mortices in it may be associated with a floor, or a ceiling to the chamber below. The remains of a tusk-tenon at the west end indicate where a principal rafter was jointed: the roof pitch was *c.* 54 degrees.⁴¹ Also, a single upper-face mortice towards the west end is likely to have held an ashlar-piece.

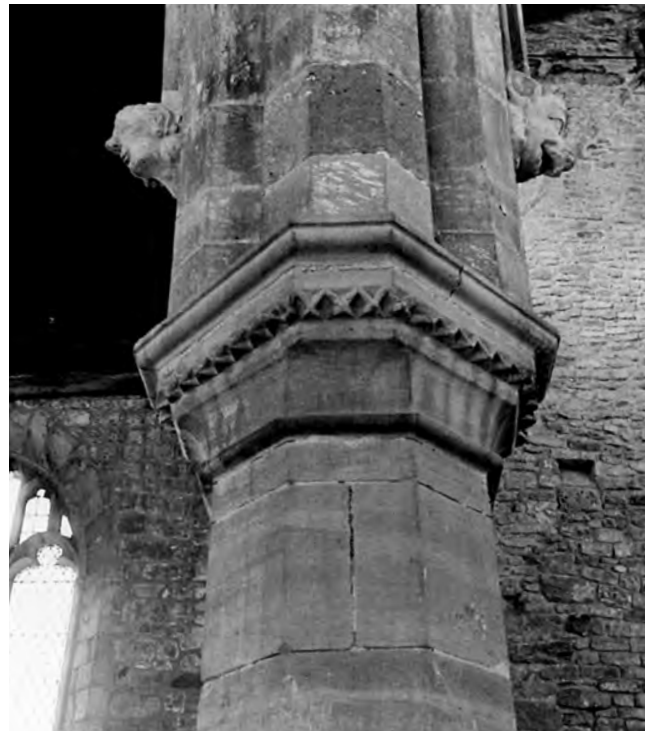
Fig. 442: South arcade. Octagonal shaft and capital with dogtooth ornament (Period 4), reused in the pier, bay 4/5. View west. Photo: Warwick Rodwell

The present five-bay south arcade essentially dates from the fourteenth century and does not synchronize with the bay divisions in the outer aisle wall (Figs. 23, 460 and 464). Nevertheless it incorporates elements derived from an Early English arcade, notably the capitals of the four piers (Fig. 442).

The capitals and separate abaci of the four piers are identical, and have been reused from the two previous thirteenth-century arcades, along with the octagonal shafts (p. 393; Fig. 442). Many of the reused stones exhibit signs of damage through rough handling: mainly the corners have been broken. Some of the major blocks, including capitals, have been fractured and the pieces reunited using hot-mastic, a repair technique commonly seen in medieval buildings (Pl. 46).²² The bases and sub-bases are all octagonal and set at a constant level, with the exception of the two responds. The plinth of the east respond stands 34 cm higher, and again indicates the presence of an altar dais at the end of the aisle.²³ The base and plinth of the west respond are raised by 12 cm, and there is no obvious explanation for this.

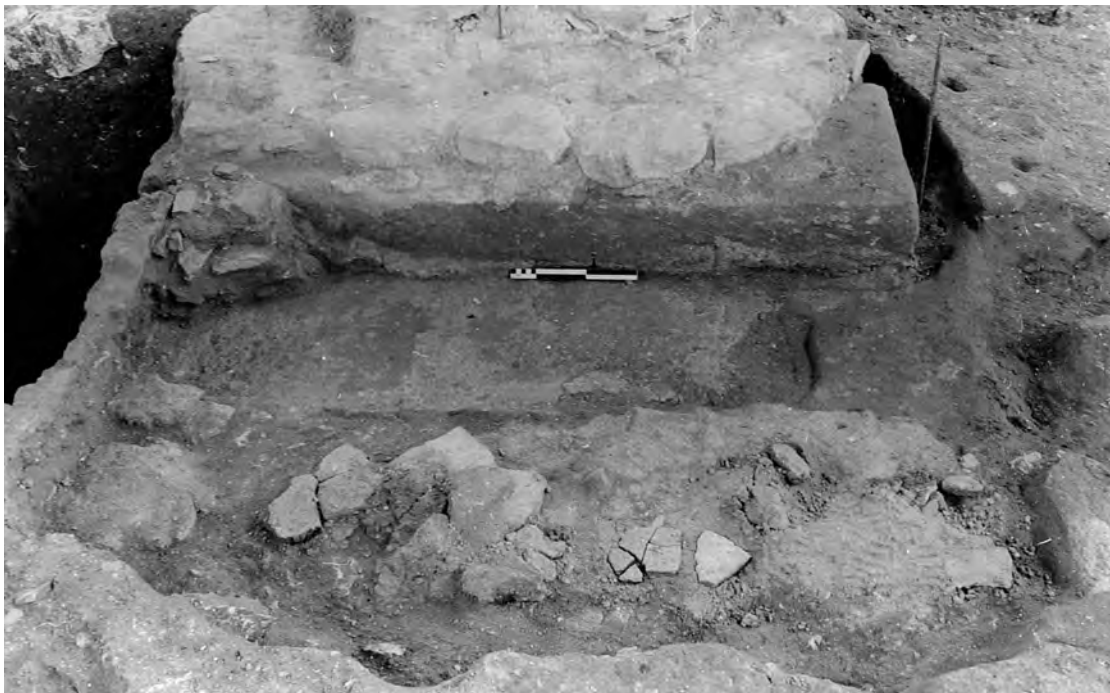
Fig. 443: South arcade. Remains of a base (F1306), apparently made from three reused grave-covers, which carried the late thirteenth-century pier between bays 4 and 5. In the foreground is the robber pit where one slab has been removed; in the middle is the mortar bed for the second (the scale lying on it); and beyond is the third slab, still *in situ* and largely concealed beneath the later arcade pier. View west. Scale of 25 cm. Photo: Warwick Rodwell

least two reused grave-covers set on a mortar bed (F1306). One remains in place (Figs. 485 and 711, no. 7), and excavation revealed the pocket and mortar bed for another immediately alongside. Next to that in turn

was a robber pit where a third slab had apparently once been (Fig. 443). Together, the three slabs would have constituted a squarish footing to carry an arcade pier.

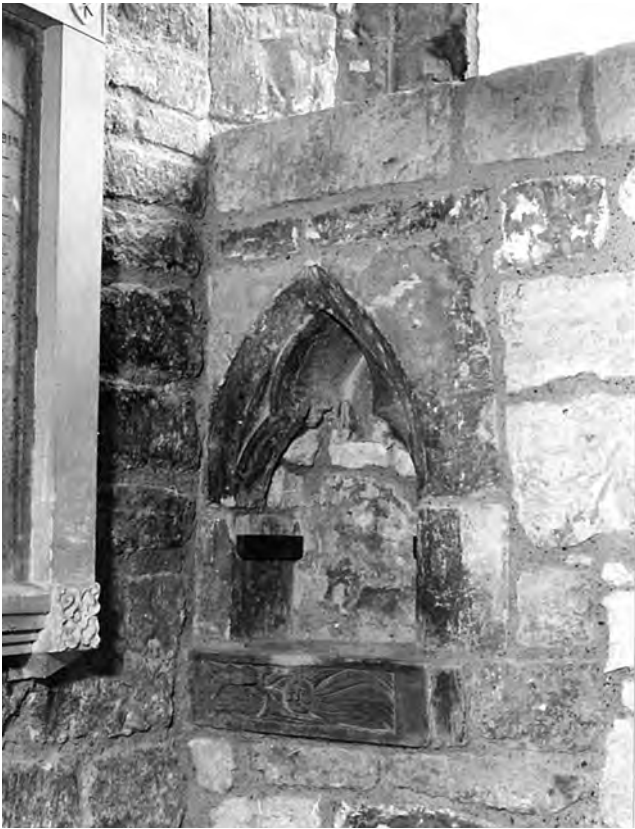
Fig. 444: South aisle, bay 1. Piscina in the south wall. View south-east. Photo: Warwick Rodwell

Apart from burials, there were no preserved floor levels or other features of significance excavated in the south aisle. A small, original piscina survives in the south wall at the east end. It has a pointed trefoil head cut from a single block of limestone, is without a hood or other projecting mouldings, and has chamfered jambs (Fig. 444). The interior was once plastered, and an oak credence shelf was added in the 1920s. The front of the hemispherical basin had been destroyed, and was renewed in a curious fashion in the early twentieth century. Instead of fitting a new curving section to complete the missing one-third, the original stone was cut back well behind the wall-face, and a rectangular kerb-like piece of limestone was inserted. This carries a crude *bas-relief* carving, the iconography of which is unclear: the sun is represented (Fig. 643).⁴⁷

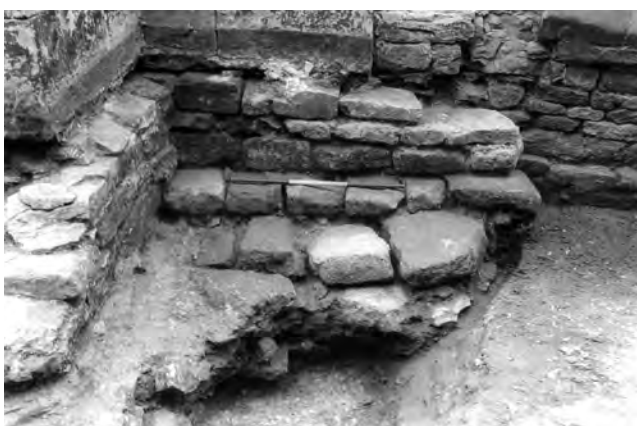
Fig. 446: Chancel: north-east corner. Foundation for a thirteenth-century north-facing buttress, oversailed (top right) by the fourteenth-century east wall of the vestry. View west. Scale of 75 cm. Photo: Warwick Rodwell

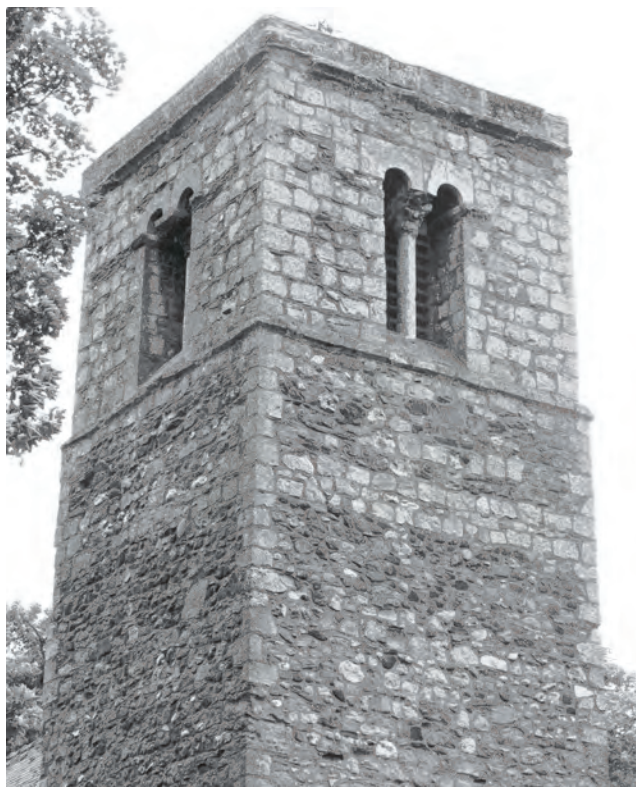
Fig. 448: St Giles, Scartho (Lincs.). Tower of rubble construction with the belfry faced in Magnesian Limestone. North-west view. Photo: Warwick Rodwell

difference in its materials, the lower stage being of rough rubble construction, which would have been rendered (Stocker and Everson 2006, figs. 2.28 and 4.153) (Pl. 27B; Fig. 448). The same occurs at nearby Waithe, although there the use of squared Magnesian Limestone begins a few courses below the belfry stage (Fig. 449) (Stocker and Everson 2006, figs. 4.178 and 4.179). This construction differential is not shared by any of the other Lincolnshire towers, pointing to the strong likelihood that the same masons were engaged at Barton, Scartho and Waithe. Although somewhat different, Brigsley should probably be added to this list, where the ground and first-floor stages of the tower are largely faced with Magnesian Limestone (the original belfry does not survive), and the masoncraft is again similar to that at Barton (Pl. 27B) (Stocker and Everson 2006, 18–19, 118–20, figs. 2.26 and 4.27).

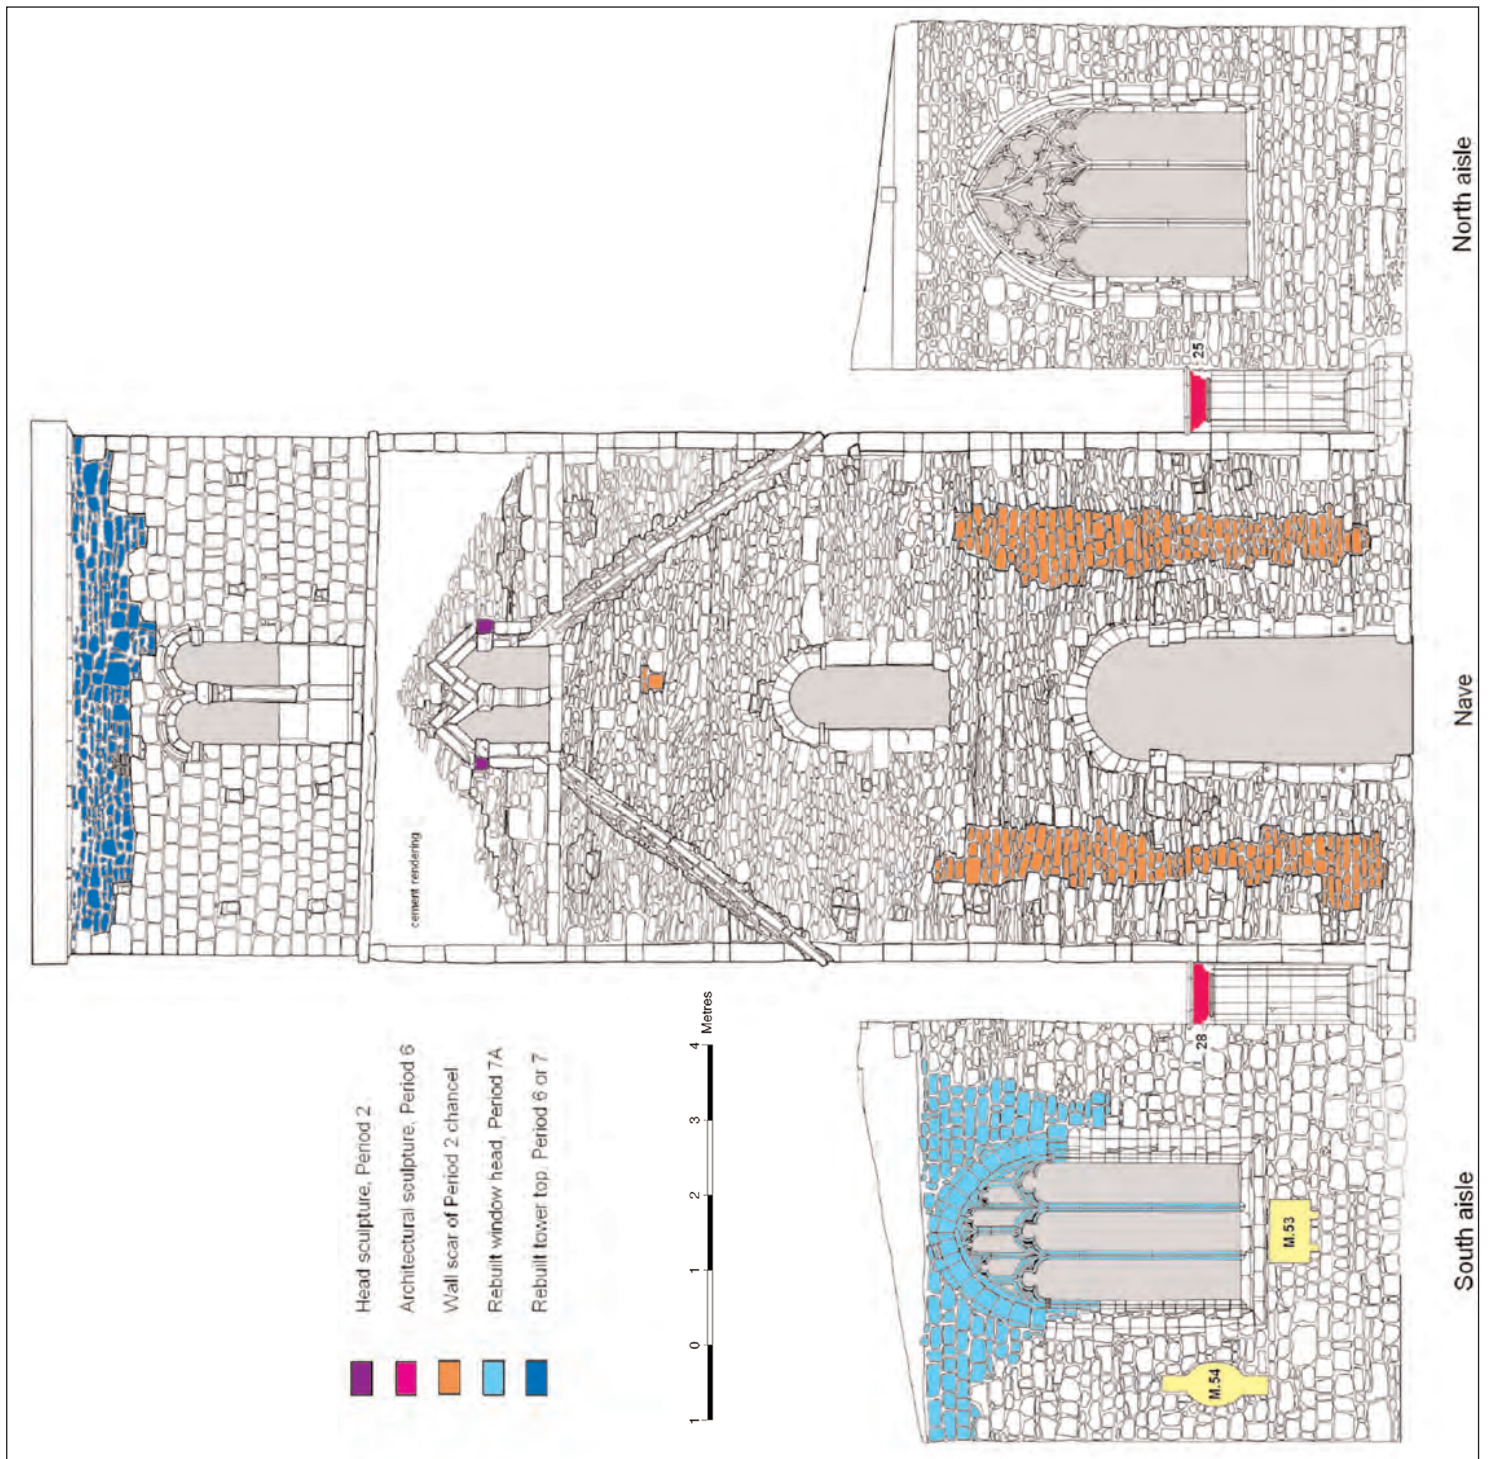
Fig. 462: Nave and aisles. Internal sectional elevation, looking west, 1984. The external east face of the tower above the nave is also shown. Scale 1:100. Drawing: Simon Hayfield

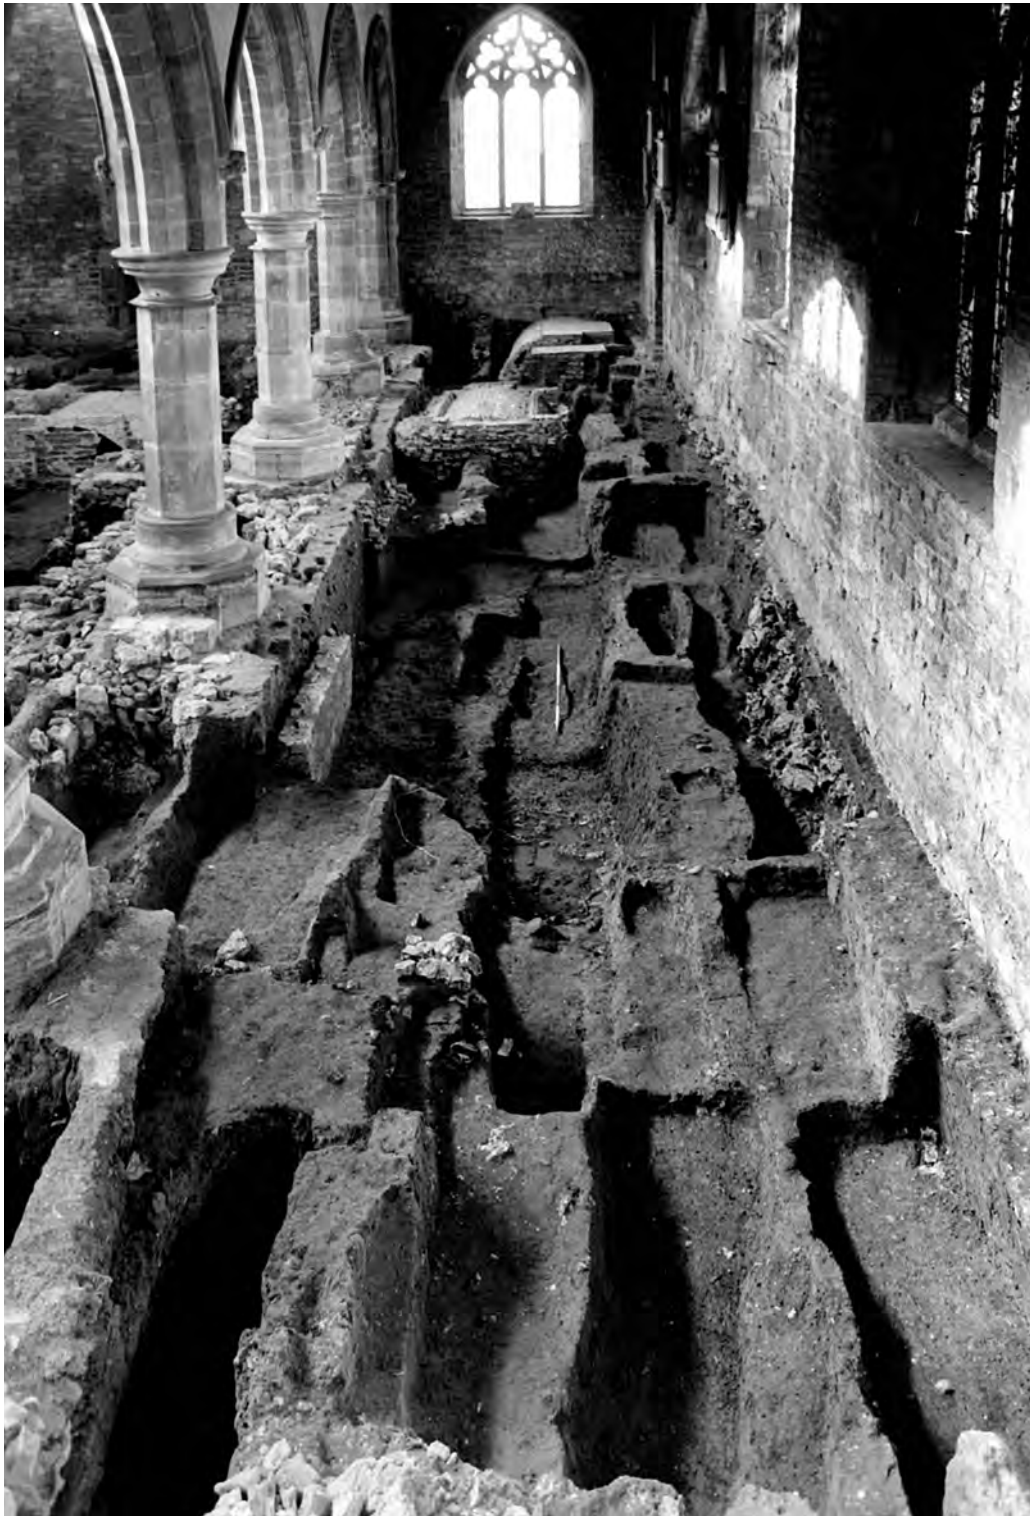
Fig. 465: North aisle: view west, after excavation, 1980. The foundation for the wall-bench appears on the right. The 2 m ranging pole rests in the base of the robbed foundation trench for the preceding narrow aisle. At the far end are the Scrivener/Tombleson and Branston burial vaults. Photo: Warwick Rodwell
