ST PETER'S

Barton-upon-Humber, Lincolnshire

A Parish Church and its Community

HISTORY, ARCHAEOLOGY AND ARCHITECTURE

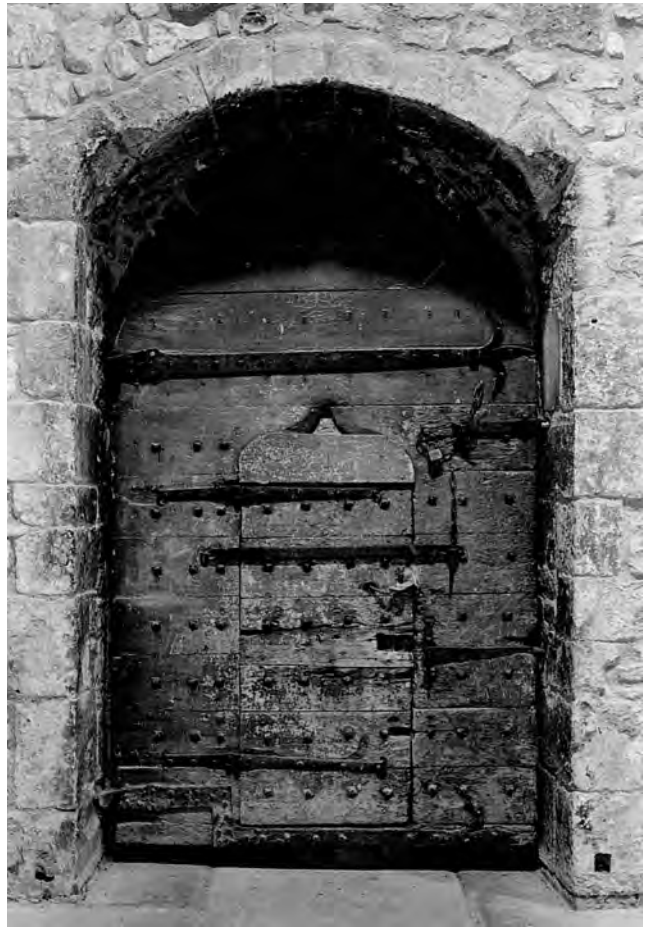
Fig. 467: North doorway: interior. Photo: Warwick Rodwell

The north doorway is remarkably plain and is asymmetrically sited in bay 5. The threshold occurs part-way up the north wall plinth, indicating that there must have been a step *ab initio*. The opening has a two-centred head and two chamfered orders, both with continuous wave mouldings and weak bull-nosed stops; there are no imposts or hood-moulding (Fig. 466). The south doorway at Barrow-upon-Humber is almost identical, but is provided with a hood-moulding. The segmental rear-arch is entirely without mouldings and, unlike St Mary's, there are no pockets in the reveals for a draw-bar (Fig. 467).

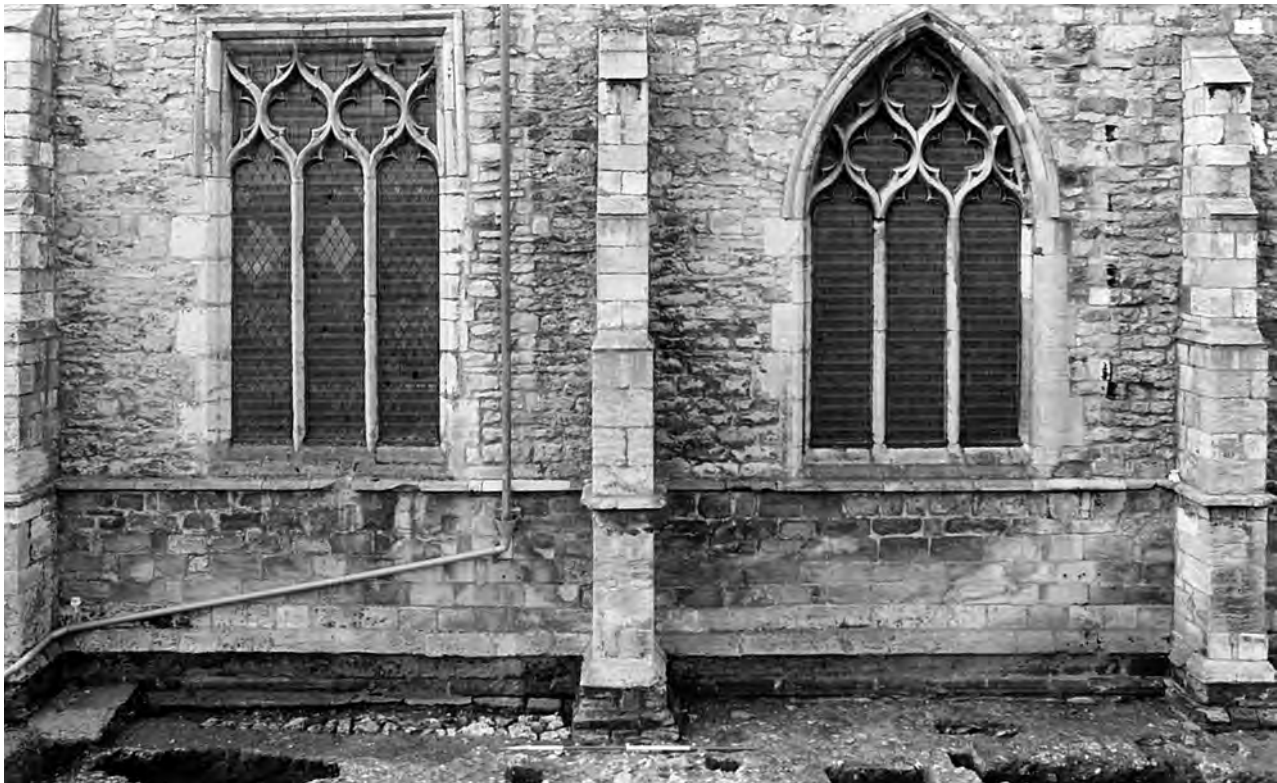
Fig. 468: North aisle windows, bays 1 and 2. The windows have reticulated tracery, and are alternately square-headed and pointed. Contemporary construction level for the aisle has been exposed by excavation externally, 1982. Scale of 2 m. Photo: Warwick Rodwell

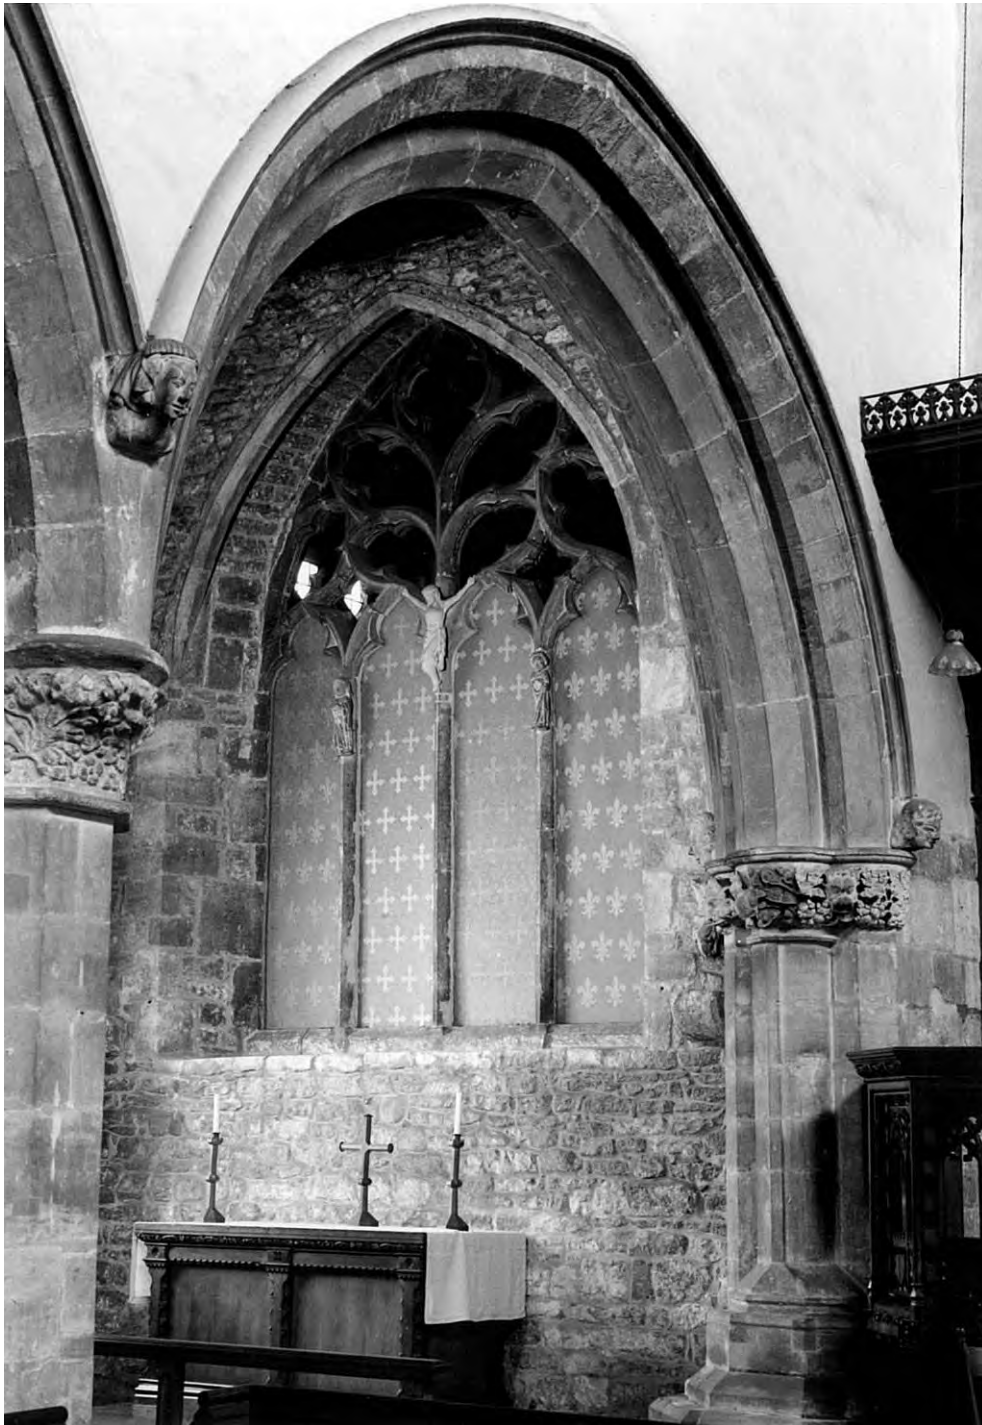
Fig. 469: North aisle: east window, mid-1960s. The glazing was removed in 1898, the figure of Christ was renewed in c. 1924, and the painted boards were inserted in the main lights soon after. Photo: David Lee Photography

The east and west windows in the aisle have flowing tracery of good quality, but the two are not closely related (Fig. 49, 12 and 13). The four-light east window is of unusual elaboration (Figs. 469 and 470). It has trefoil-headed lights arranged in two pairs under ogival sub-arches with central quatrefoils. Rising from the central mullion is a flowing tracery pattern having the appearance of a five-lobed leaf. Its components are a quatrefoil and four *mouchettes*. Thus far, the design is unexceptional, but is elaborated in a unique fashion by the *en suite* incorporation of a rood composition. The three figures are sculpted on the mullions: St Mary the Virgin on the north and St John on the south occupy the uppermost stones of their respective mullions (Figs. 471, 473 and 474). The figure of the crucified Christ is sculpted on the central springer-mullion, the beginnings of the ogival tracery to either side notionally forming the arms of the cross. The window was clearly a representation in stone of the Tree of the Cross (p. 489).

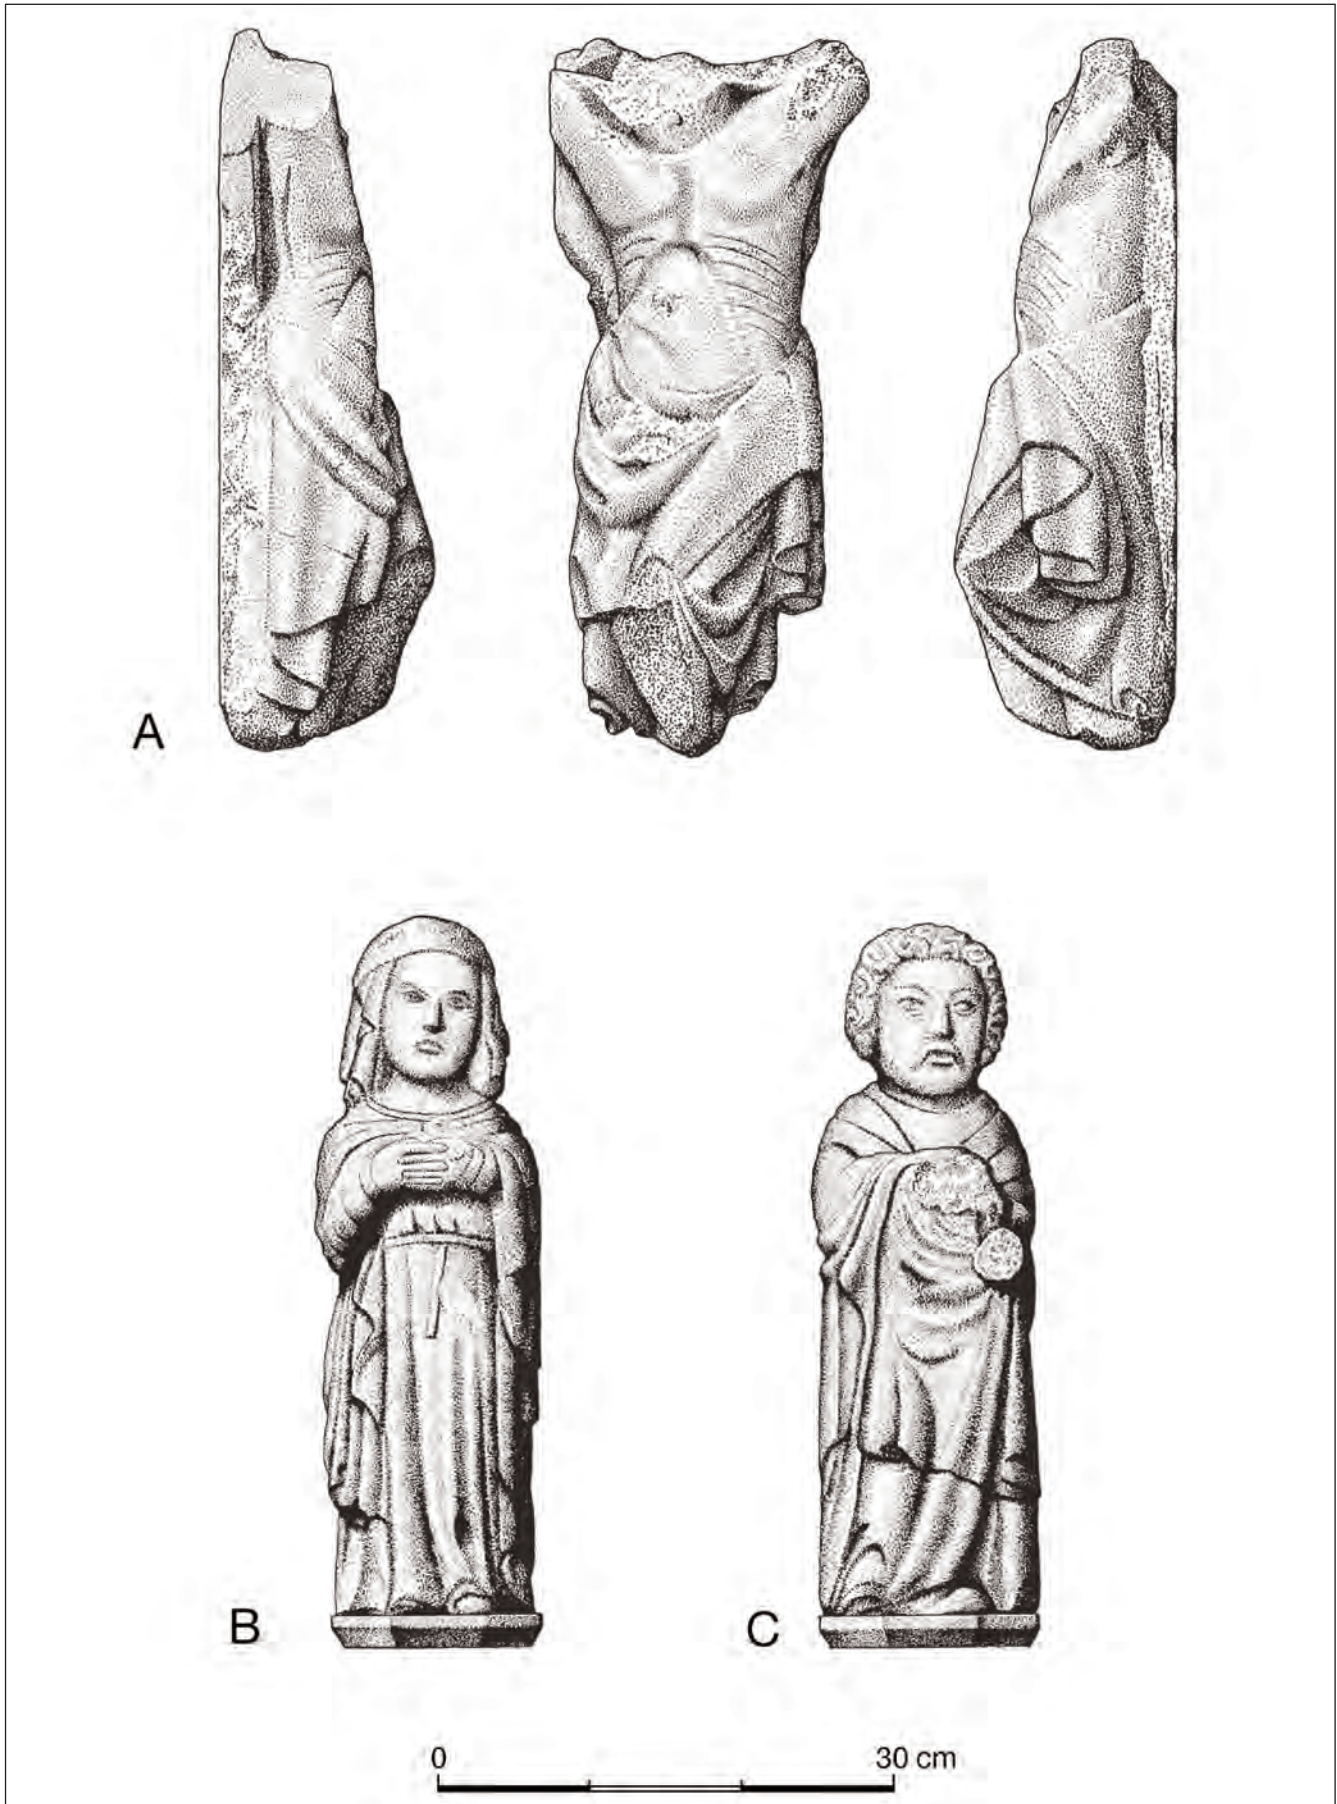
Fig. 471: North aisle: east window. A, Torso of the mutilated medieval figure of Christ (now ex situ); B, Mullion figure of St Mary the Virgin; C, Mullion figure of St John. Scale 1:5. Drawing: Simon Hayfield

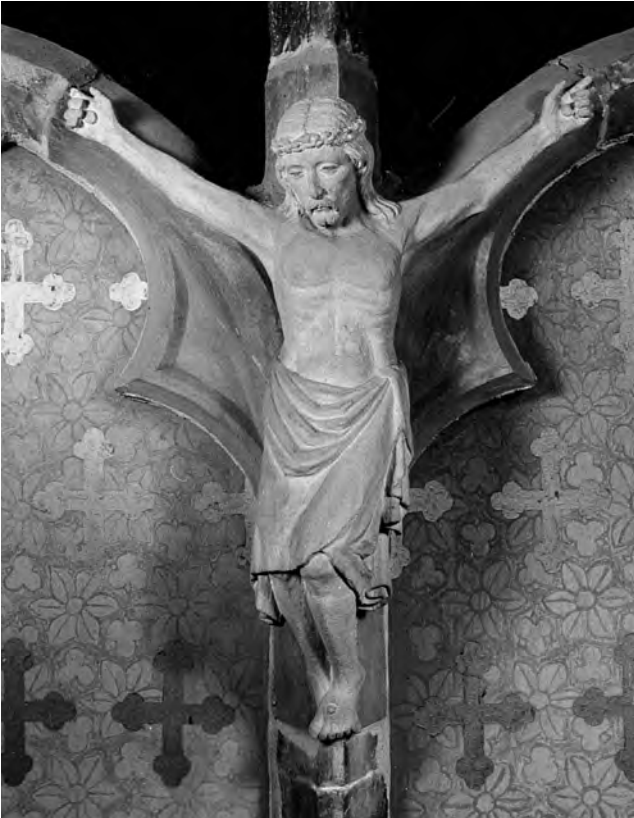
Fig. 472: North aisle: east window. Replacement limestone figure of Christ (c. 1924) on the central mullion (sculpture no. 33), 1982. Photo: Warwick Rodwell

mullion in c. 1924, and the stumps of tracery bearing the remains of the arms to either side were hacked away. A newly carved section of tracery bearing the figure, conjecturally completed, was then fitted (Fig. 472). The old fragment of torso was mounted as an exhibit on the southern flank of the window (Pl. 48).⁸ Pockets in the mullions, jambs and sill show that the

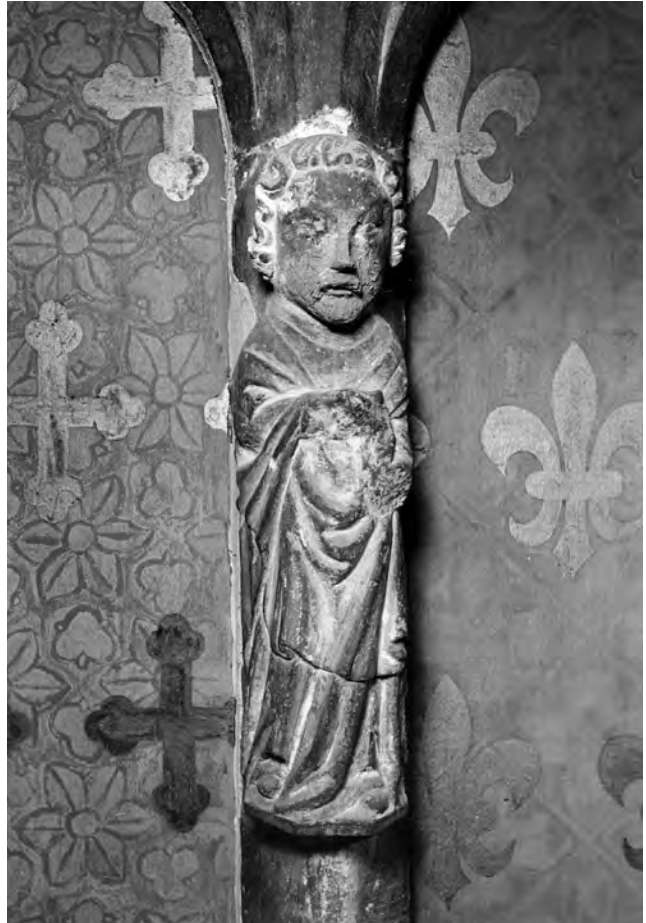
Fig. 474: North aisle: east window. Limestone figure of St John on the southern mullion (sculpture no. 34). Photo: Warwick Rodwell

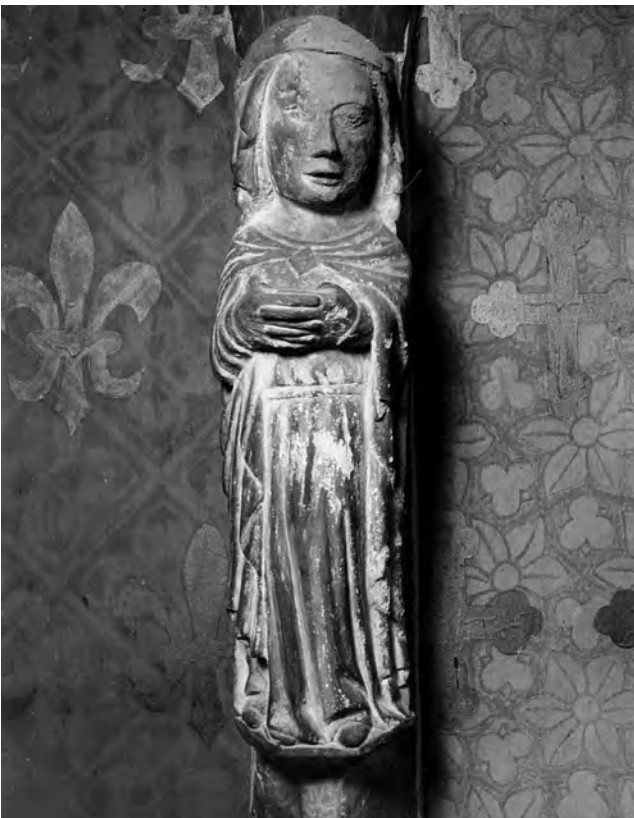
Fig. 473: North aisle: east window. Limestone figure of St Mary the Virgin on the northern mullion (sculpture no. 32). Photo: Warwick Rodwell

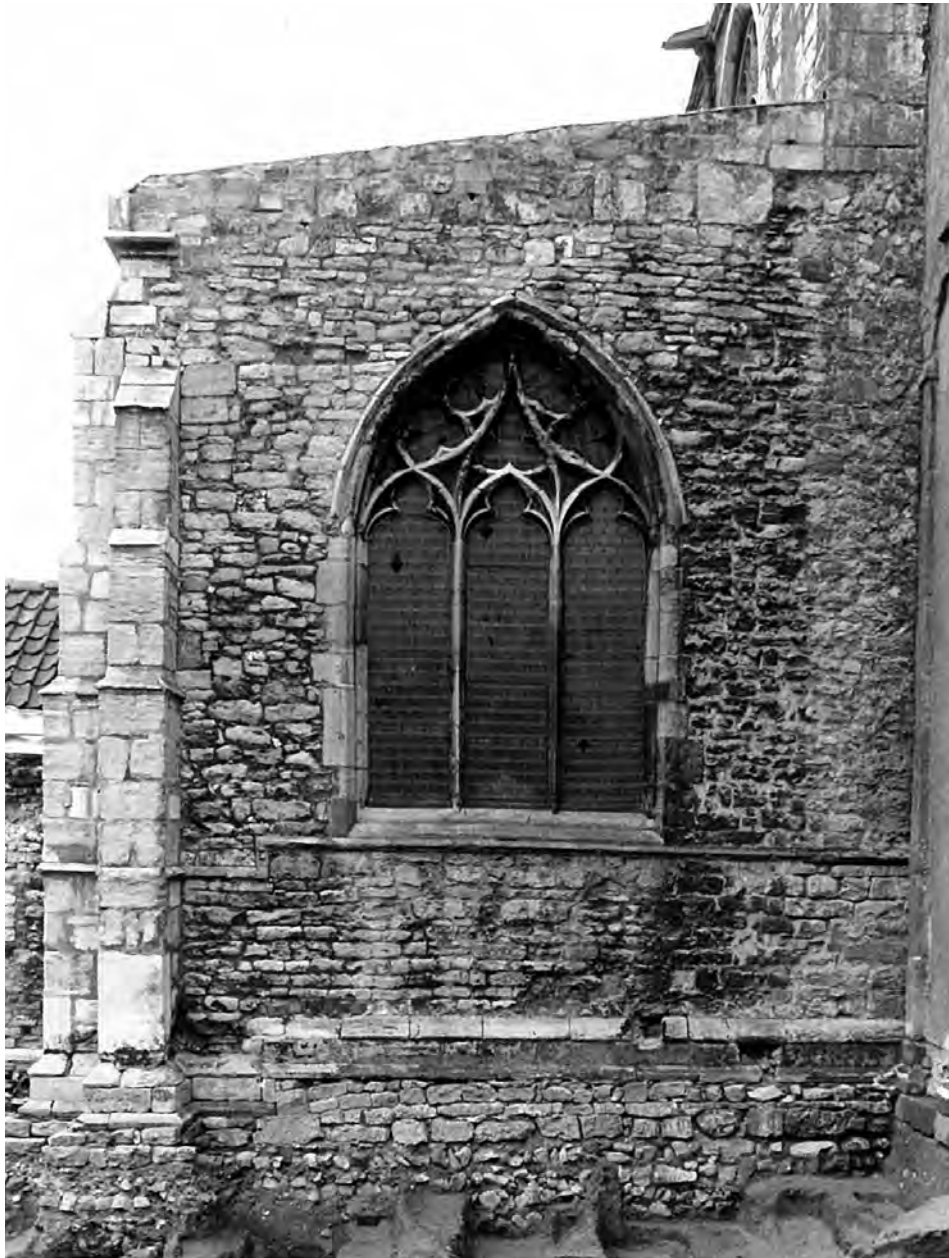
Fig. 475: North aisle. The exterior of the west wall in 1983, then largely unrestored. Photo: Warwick Rodwell

building styles is apparent, but it is uncertain to what extent this represents original work; the pointing is all relatively modern. In bays 1–3 of the north wall the masonry beneath the string-course is almost exclusively squared limestone laid in regular courses; in bay 4 it is similar but the lowest course comprises large blocks while the remainder are much smaller. This all appears to be the result of extensive refacing.³ Glimpses of what may represent the original construction are seen on the east and west ends, where the walls are composed entirely of mixed rubble, apart from a single course of limestone ashlar directly above the plinth (Fig. 475).⁴

The west window has three trefoil-headed lights surmounted by flowing tracery incorporating three trefoils and two daggers (Fig. 475). The principal elements of the tracery spring from the jambs and mullions, and are all in the same plane, whereas the infill details (trefoils and daggers) are set back on a dif-

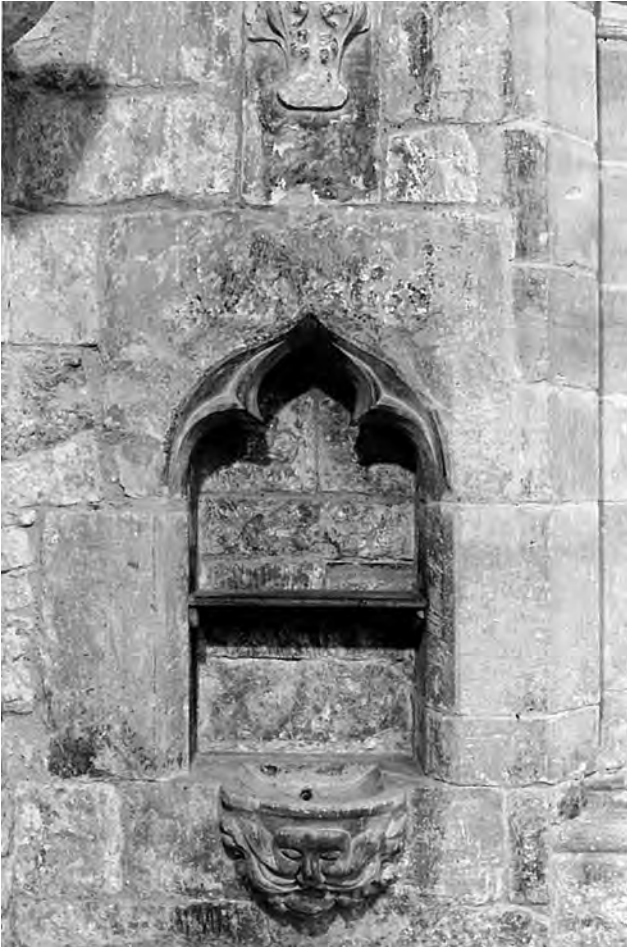
Fig. 476: North aisle. Mutilated piscina in the south-east corner, with sculpture nos. 30 and 31. Photo: Warwick Rodwell

The second feature is a piscina, set into the eastern nib of the nave arcade (Figs. 476 and 491). It is a small rectangular opening with chamfered reveals, and the head is formed from a single block of limestone: it is trefoiled with spandrels, under a weak ogee arch.¹² There is now no hood-moulding, but scarring reveals that there was originally an ogee hood-moulding over the arch, which appears to have been foliate and to have terminated in two little finials. All this was chiselled off sometime after the Reformation. Also, set in the wall centrally above the piscina is an upright block

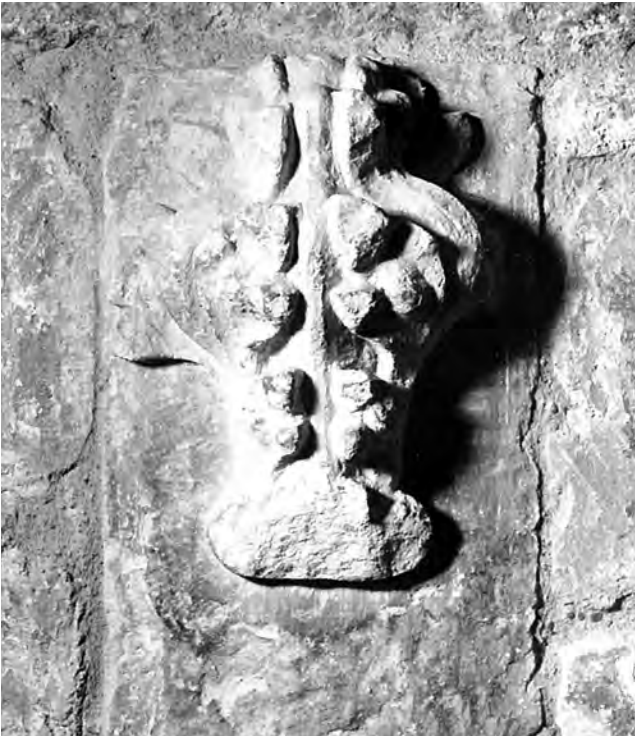
Fig. 477: North aisle: poppyhead finial of piscina (sculpture no. 31). Photo: Warwick Rodwell

bearing the damaged remains of a poppy-head finial, which seems to have been detached from the hood-moulding (sculpture no. 31; Fig. 477). The original bowl of the piscina had been hacked off nearly flush with the wall face, but a new projecting section was made and fixed in the 1920s (sculpture no. 30; Fig. 478). It is corbel-like and decorated with a head in the form of a 'green man'. Although the face is new, the lower lip and foliage issuing to either side are original. The basin is internally scalloped.

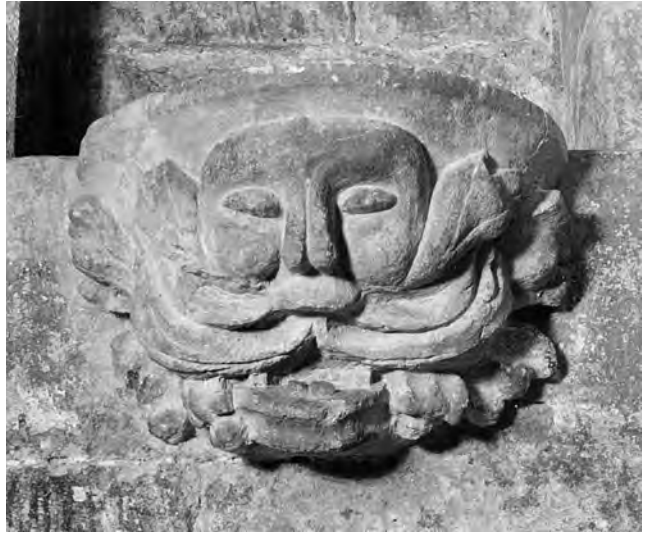
Fig. 478: North aisle piscina: restored bowl with 'green man' (sculpture no. 30). Photo: Warwick Rodwell

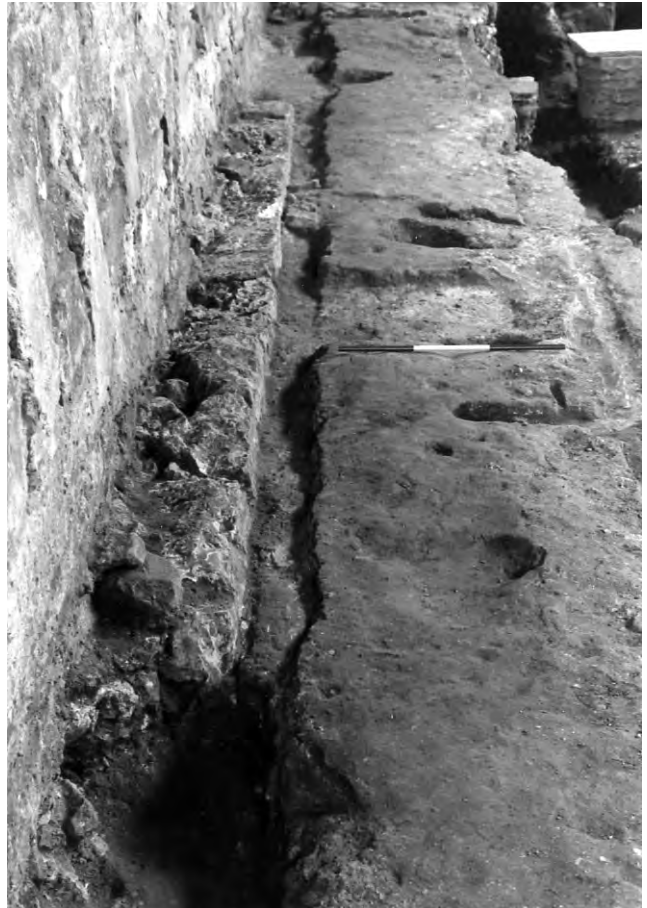
Fig. 479: North aisle. View east along the surviving remains of the masonry bench adjoining the north wall, 1980. Scale of 75 cm. Photo: Warwick Rodwell

Finally, the aisle had a stone wall-bench along the north and west sides, the footings of which were found. In part, the lowest ashlar course survived and was abutted by floor layers; there were also scars on the walls resulting from the removal of these benches (Figs. 479 and 480).

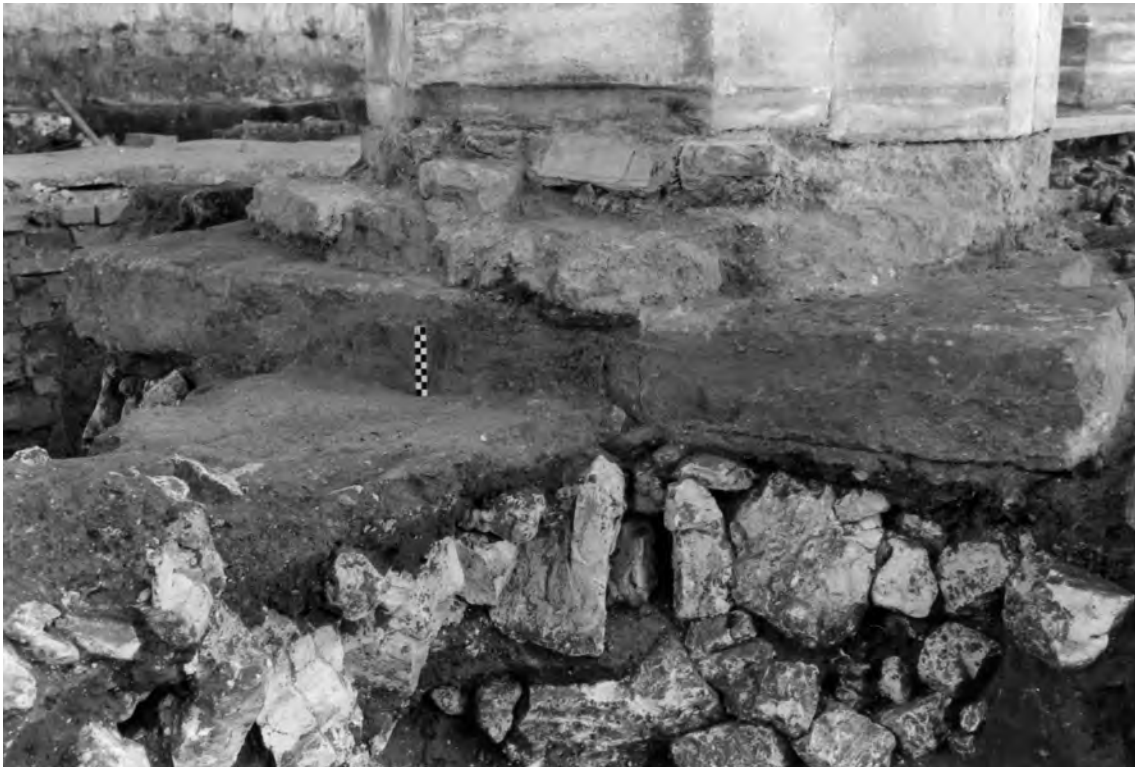
Fig. 480: North aisle. Lowest ashlar course of the wall bench. View north, 1980. Scale of 2 m. Photo: Warwick Rodwell

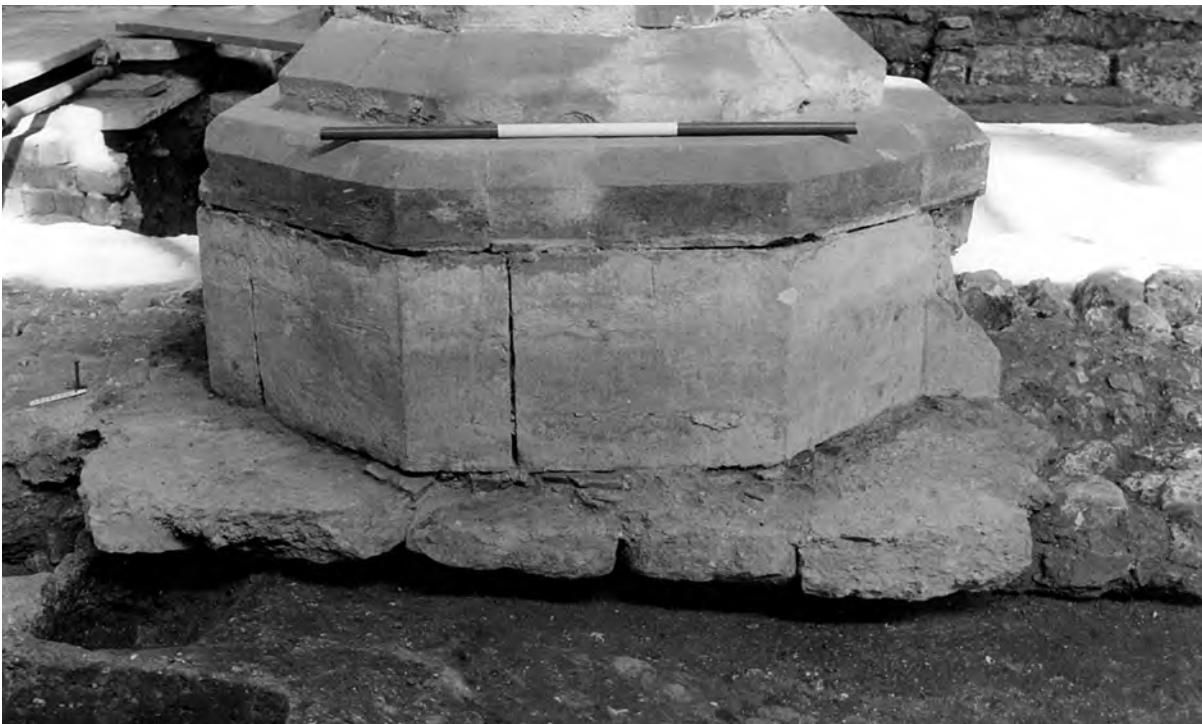
Fig. 482: North arcade. Pier base 4/5 with its shallow footing resting on the Saxo-Norman nave foundation. View north. Scale of 75 cm. Photo: Warwick Rodwell

The piers supporting both arcades were reconstructed using some old materials and some new; in particular, chamfered octagonal plinths were provided under each pier. The Norman nave foundations continued to act as sleeper walls, but the dimensions of the new plinths slightly exceeded their widths. Consequently, foundation pads were laid over the old walls, to provide secure bases for the piers. In the north arcade, these pads comprised flat pieces of rough limestone laid in mortar (Fig. 482). In the south arcade, however, there were two instances where the footings

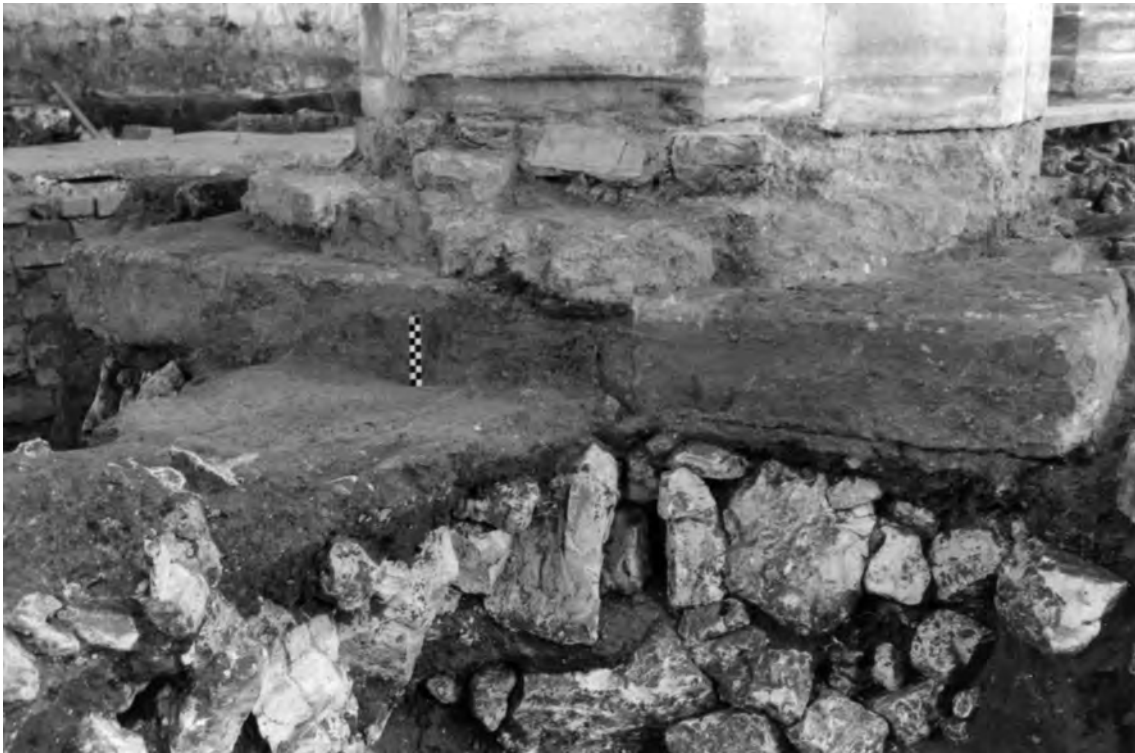
Fig. 483: South arcade. Pier base 2/3, showing a reused grave-cover (F4199) laid transversely over the Norman nave foundation, to provide a footing for the new pier. View south-west. Scale of 10 cm. Photo: Warwick Rodwell

incorporated thirteenth-century decorated grave-covers: the slabs were laid side by side, transversely over the old foundations (Fig. 483). Excavation revealed most of an incised slab (F4199), and the extreme ends of a second laid alongside it (F4198), projecting from beneath the eastern edge of pier 2/3 (Figs. 484 and 711, nos. 8 and 9). Similarly revealed, beside pier 4/5, was most of another slab (F4197; Figs. 485 and 711, no. 7). That had, however, been laid originally as part of a pier base for the early thirteenth-century arcade (p. 393).

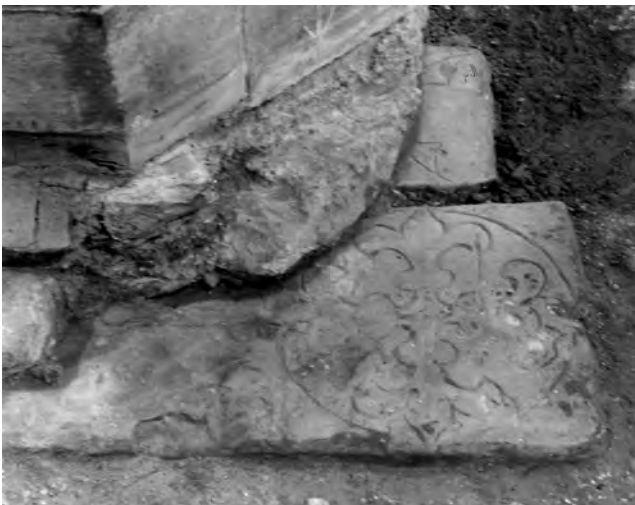
Fig. 484: South arcade. Pier base 2/3, showing the upper end of a grave-cover (F4199) reused in the footing; beyond is glimpsed the lower end of a second grave-cover (F4198). View west. Photo: Warwick Rodwell

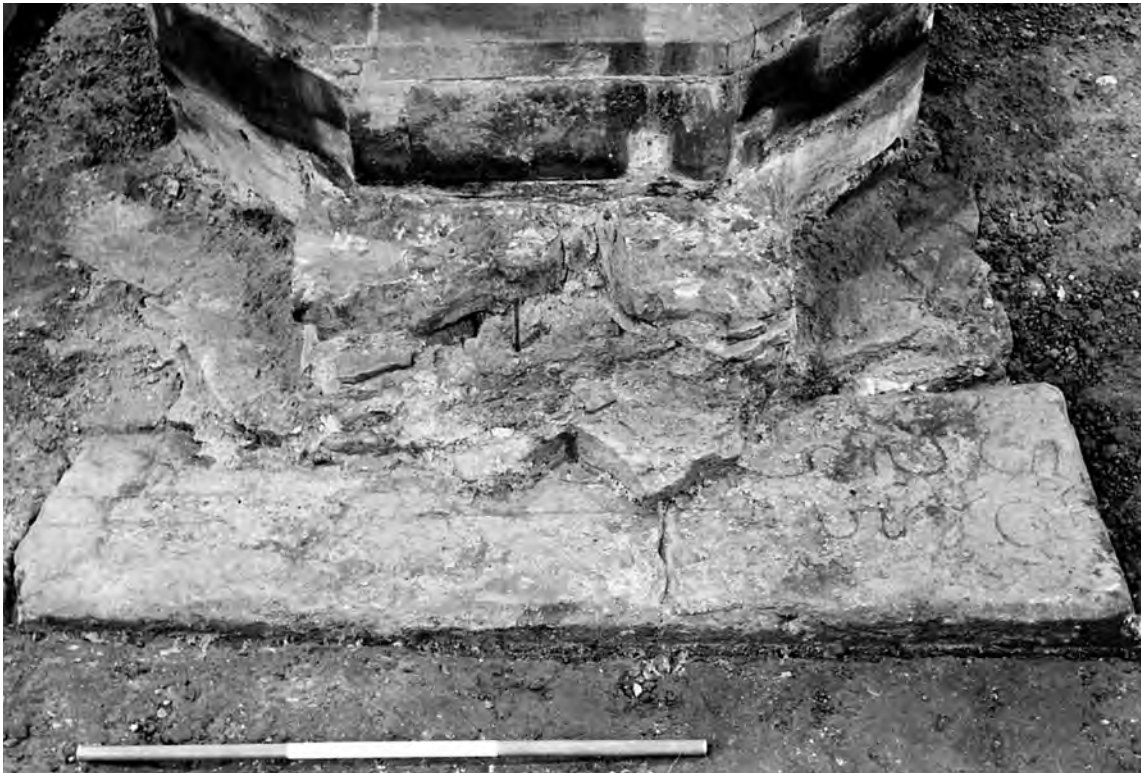
Fig. 485: South arcade, bay 4. Stub of the destroyed arcade bench adjoining pier 4/5. Note the thirteenth-century decorated grave-cover (F4197) reused as a footing for the pier. View west. Scale of 75 cm. Photo: Warwick Rodwell

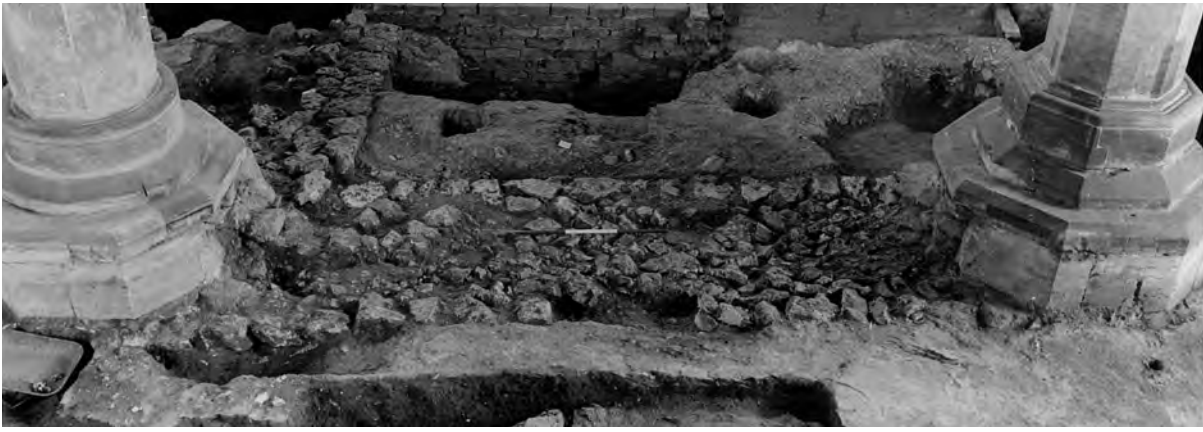
Fig. 487: North arcade, bay 4. The top of the Norman sleeper-wall upon which an arcade bench had been constructed; the latter now entirely destroyed except for scarring on the faces of the plinths of piers 3/4 and 4/5. View south. Scale of 75 cm. Photo: Warwick Rodwell

The bay pitch is 4.5 m (14¾ ft). The piers and responds comprise a heterogeneous mixture of forms and styles (Fig. 486). The bases all rest on their own chamfered sub-bases (circular or octagonal) which in turn stand on chamfered octagonal plinths. Integrated with these plinths were arcade benches in bays 2 and 4, but only the scars remain where the returns have been cut away (Fig. 487). The tops of the plinths have variously been altered and repaired to eliminate the scar evidence, and are now symmetrically chamfered on all sides (Fig. 488). The base of the east respond stands 32 cm higher than the others in this arcade, indicating that there was a dais at that end of the aisle.¹⁶

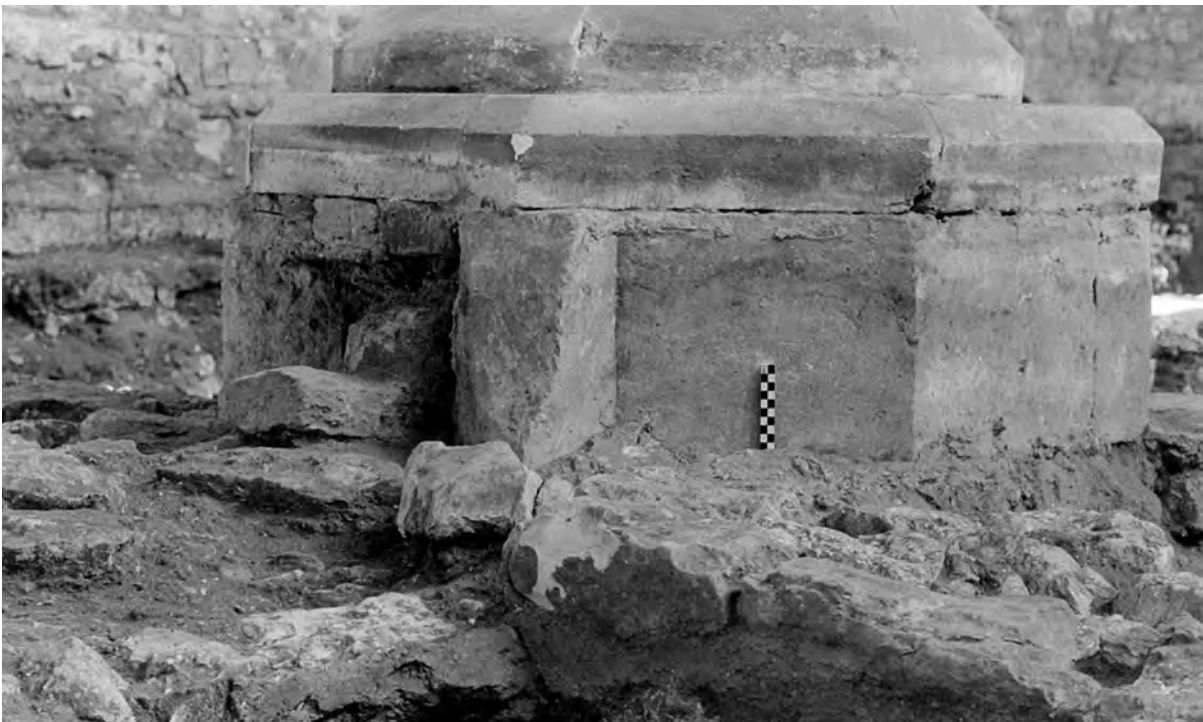
Fig. 488: North arcade. Stub of broken ashlar indicating where the arcade bench in bay 2 was bonded to the plinth of pier 1/2. View north-east. Scale of 10 cm. Photo: Warwick Rodwell

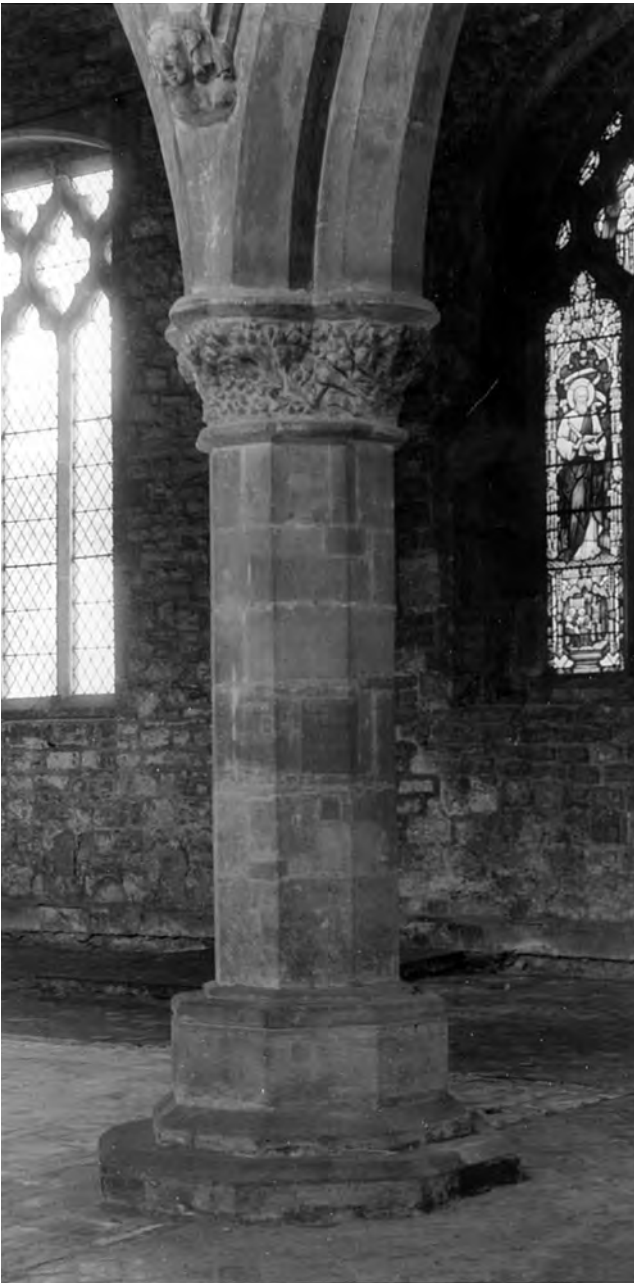
Pier, bay 1/2 (Fig. 490)

Fig. 490: North arcade pier, bay 1/2. Viewed from the south-east, 1979. Note the Victorian brick floor which conceals the lower part of the plinth. Photo: Warwick Rodwell

Two of the capitals are circular and have matching bases (on piers 2/3 and 3/4), and one capital is octagonal (pier 4/5) with the same moulding profile; these were clearly derived from a late twelfth-century arcade with alternating circular and octagonal piers (p. 384; Fig. 489). The capital of pier 1/2 has also been recycled and, in this instance, reworked as well (Fig. 490). Apart from the two circular bases, the remainder are

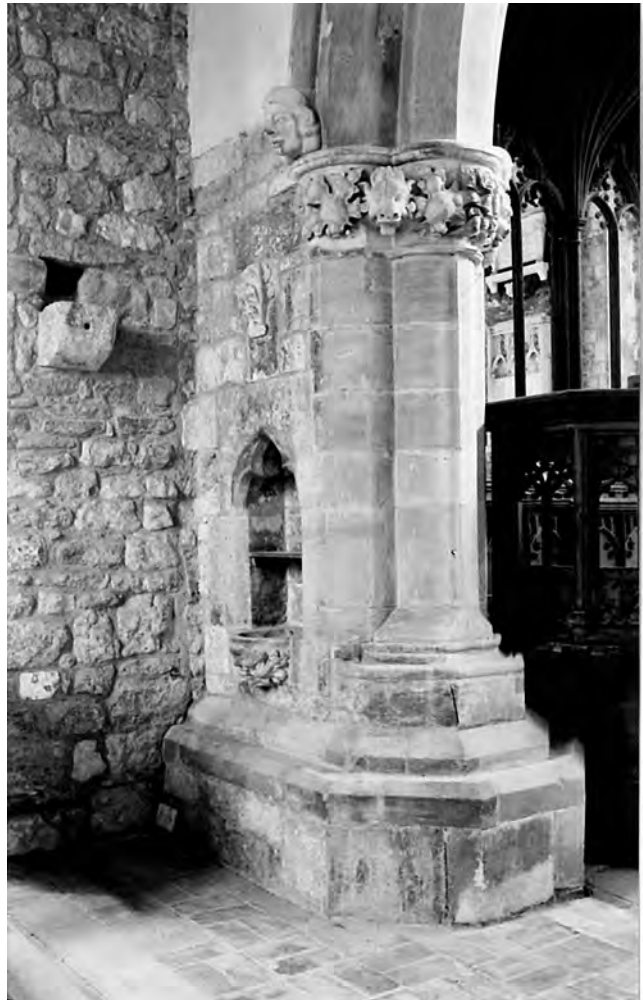
East respond (Fig. 491)

Fig. 491: North arcade. East respond, showing also the piscina and stone bracket on the east wall of the aisle. Photo: Warwick Rodwell

The filleted shaft has almost certainly been reused from a thirteenth-century respond, which was potentially associated with the chapel that preceded the present aisle. It is devoid of masons' marks. The chamfered top of the plinth is at least partly made from fragments of incised medieval grave-covers (Fig. 712, nos. 11–14), although it has not been determined whether they were deployed here in the fourteenth century, or represent much later repairs.

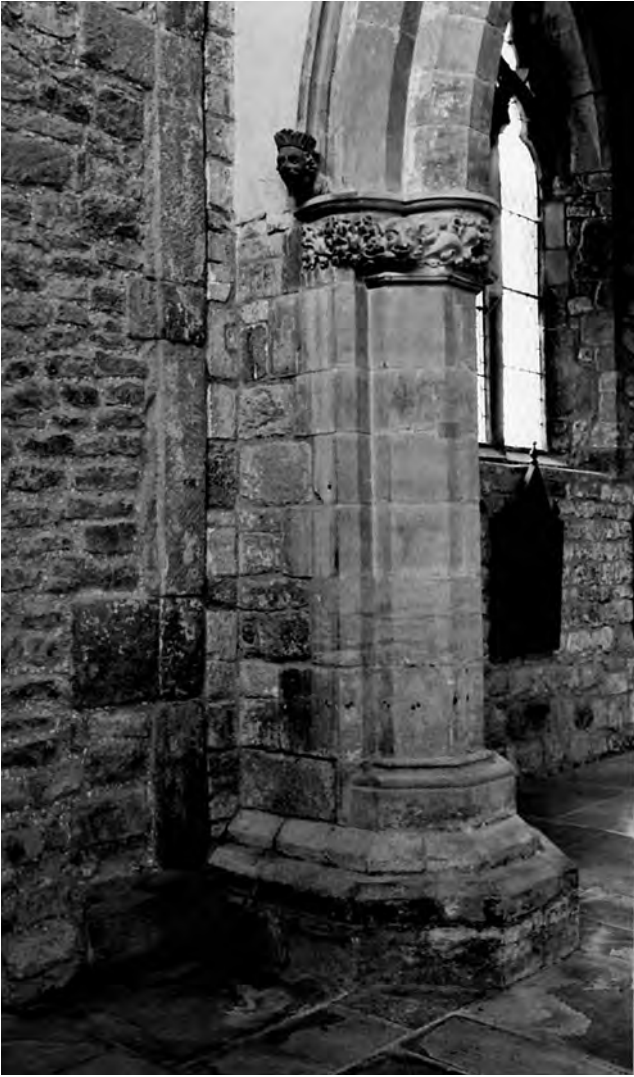
West respond (Fig. 492)

Fig. 492: North arcade. West respond, from the south-east, showing also the abutment of the arcade to the long-and-short quoin of the late Saxon tower. Photo: Warwick Rodwell

The respond is chamfered and carries an attached semi-octagonal shaft, coursed with the adjoining masonry. One mason's mark (a pentacle) occurs ten times on the shaft, another twice (six-armed cross: Fig. 825).²¹ The impost is carved with knobby foliage and 'green men' (sculpture no. 25). The trefoil-plan abacus

is separate from the impost, but the neck-ring is integral; both are ogivally beaked rolls. The base is semi-octagonal and finished with a cavetto and roll moulding.

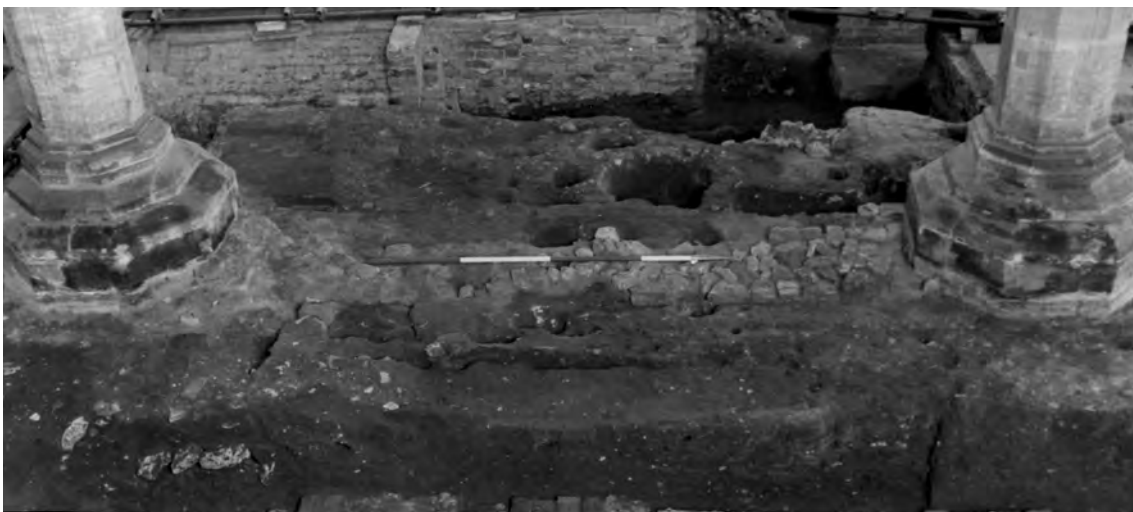
Fig. 493: South arcade. Remains of the rubble foundation of the arcade bench in bay 4. View north. Scale of 2 m. Photo: Warwick Rodwell

The bay pitch is 4.9 m (16 ft) and, as with the north arcade, stone benches were incorporated in bays 2 and 4, but these too have been destroyed. In places, the last course of foundation rubble associated with the bench remained on top of the Norman sleeper wall (Fig. 493), and tell-tale scarring occurs on the sides of the plinths. However, the chamfered tops of the latter have been modified, as in the north arcade, to give the appearance of being complete octagons (*e.g.* Fig. 494).

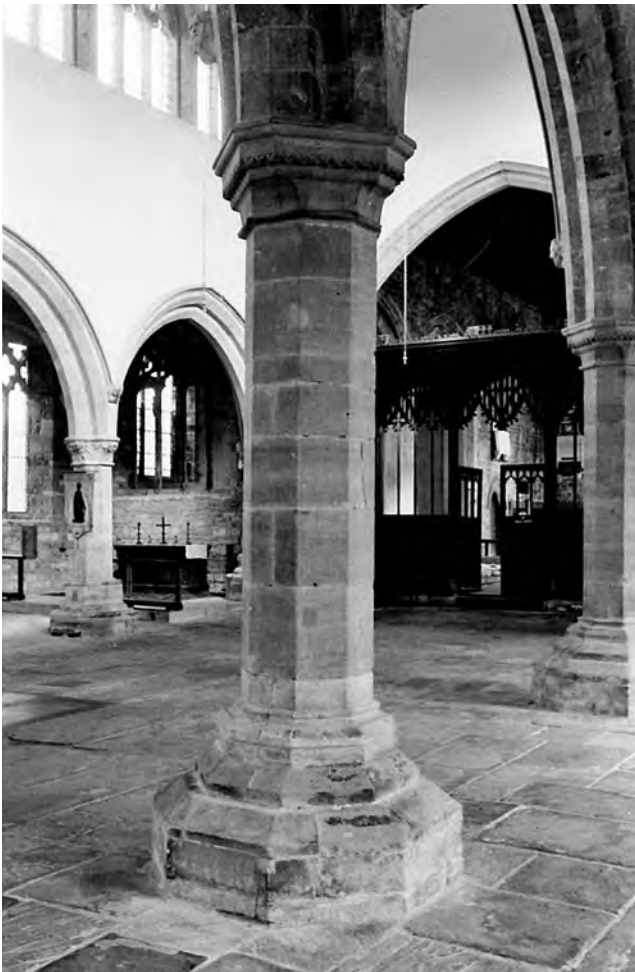
Pier, bay 3/4 (Fig. 494)

Fig. 494: South arcade. Pier 3/4 from the south-west, 2005. Photo: Warwick Rodwell

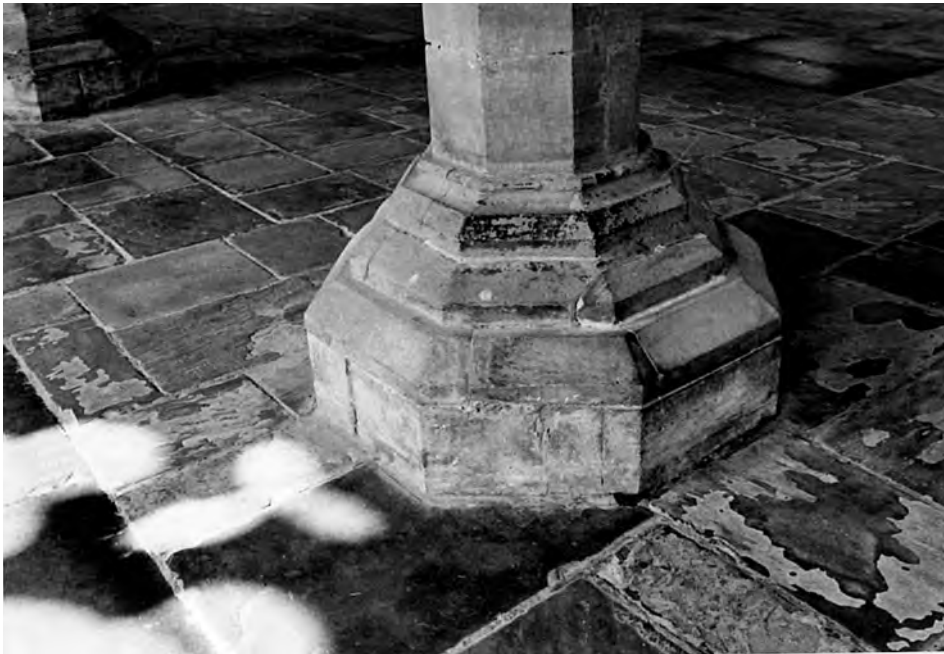
Fig. 496: South arcade. Base of pier 2/3, from the south-east. Photo: Warwick Rodwell

The capital bears traces of red paint on the dog-tooth ornament. There is some damage to the dog-tooth and abacus, and the neck-roll on the north-west face has been renewed, using hot mastic to secure the joint. The octagonal shaft is composed of evenly sized ashlar. The second stone of the shaft, below the capital, has also been fractured and repaired with hot mastic.²⁷ The base lacks the horizontal groove beneath the angular

arris-moulding, and the chamfer below is larger and cruder than on the other bases (Fig. 496).
