ST PETER'S

Barton-upon-Humber, Lincolnshire

A Parish Church and its Community

HISTORY, ARCHAEOLOGY AND ARCHITECTURE

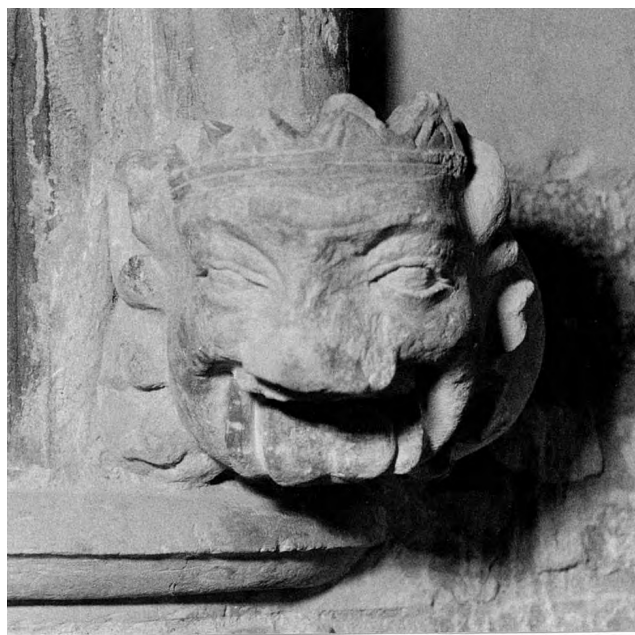
Fig. 498: North aisle, arcade. Label-stop no. 1. Photos: Warwick Rodwell

1. Crowned lion's head (Fig. 498).
Carved on an angled block, reflecting its position at the end of the arcade, facing the north door. The lion wears a simple crown with four points and crudely incised zigzag decoration. The top of the head is rough and unfinished. The mouth is open, with the tongue protruding and curling over the lower lip; the upper lip and palate are broken away, and the animal was probably baring its teeth, but these too have been lost (*cf.* the respond capital immediately below, no. 25).

The sculpture was boldly carved and coarsely rasped subsequently, leaving characteristic striations over most of the surface. Similar evidence of rasping is found on many of the other sculptures, and appears to be associated with Victorian scraping.

The point of the sinister ear is missing, and the nose was renewed in mortar in the eighteenth/nineteenth century; traces of dark grey paint, including on the replaced nose. There is a speck of red paint close to the dexter ear.

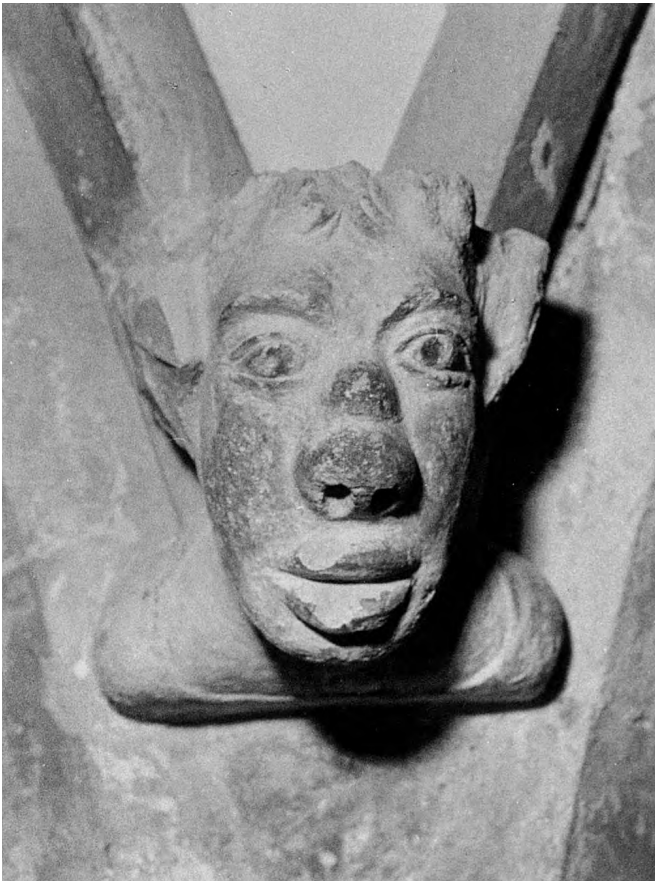
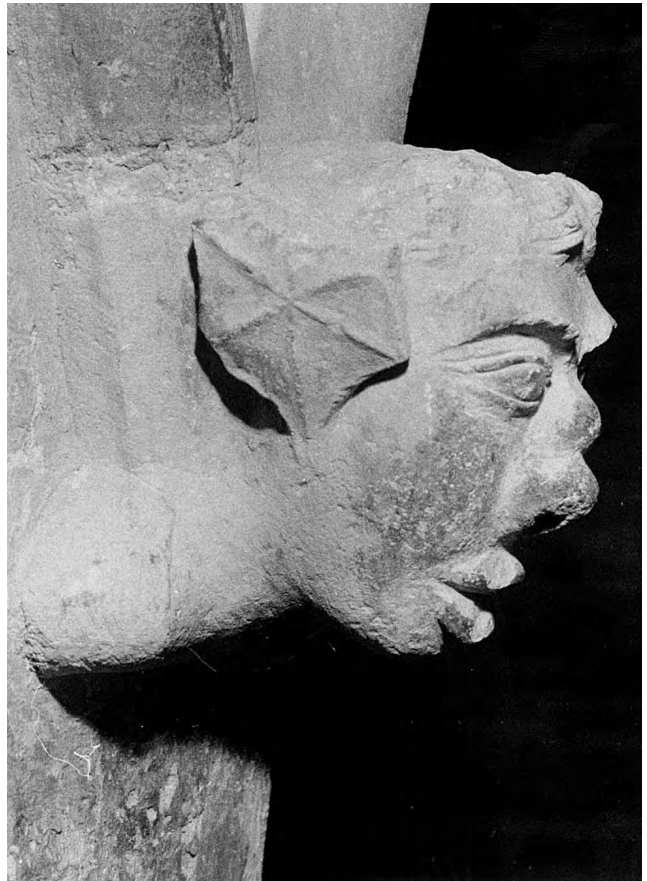
Fig. 499: North aisle, arcade. Label-stop no. 2. Photos: Warwick Rodwell

2. Head of a negroid male (Fig. 499).
The face is clearly negroid, with a bulbous nose, pronounced brow-ridges and thick lips. The head has, however, been turned into a grotesque by adding angular ears, somewhat akin to bats' wings. The head was finely finished, but the top is rough and unfinished. The tufts of hair on the forehead are partly damaged, and there is an indication of the neck-line of a garment.
The head has been coloured. The irises of the eyes are purplish-black; the lips and possibly the nose are dark grey-black. In the dexter nostril is a hint of brownish-pink, and another trace under the sinister eyebrow. The surviving paint is potentially medieval. Post-medieval white and yellow ochre limewashes on the underside of the shoulders run on to the pointed spandrel below.

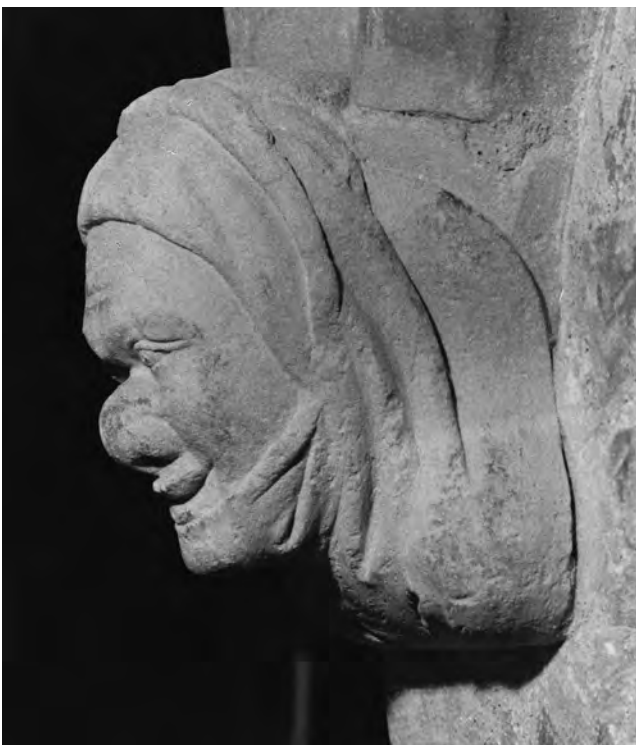
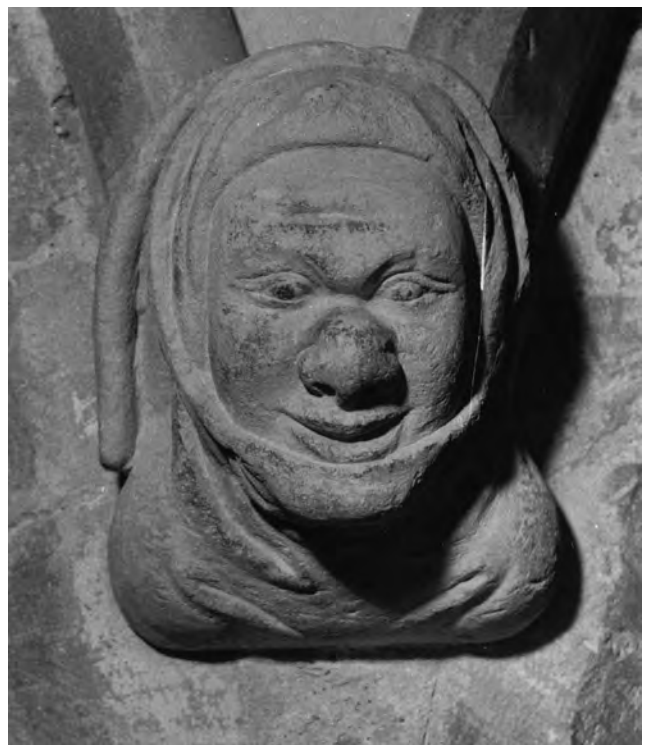
Fig. 500: North aisle, arcade. Label-stop no. 3. Photos: Warwick Rodwell

3. Head of a ?negroid lady (Fig. 500).
This figure has a furrowed brow and bulbous nose, but the lips are not pronounced (*cf.* no. 2). She wears a garment wrapped around her head and under the chin, and there is a V-shaped neck-line to her dress. Slight traces remain of a rasped finish, presumably associated with Victorian scraping. The irises of the eyes are painted purplish-black, the nose dark grey; again, this may be original colouring. Elsewhere, are remains of yellow ochre, over white limewash.

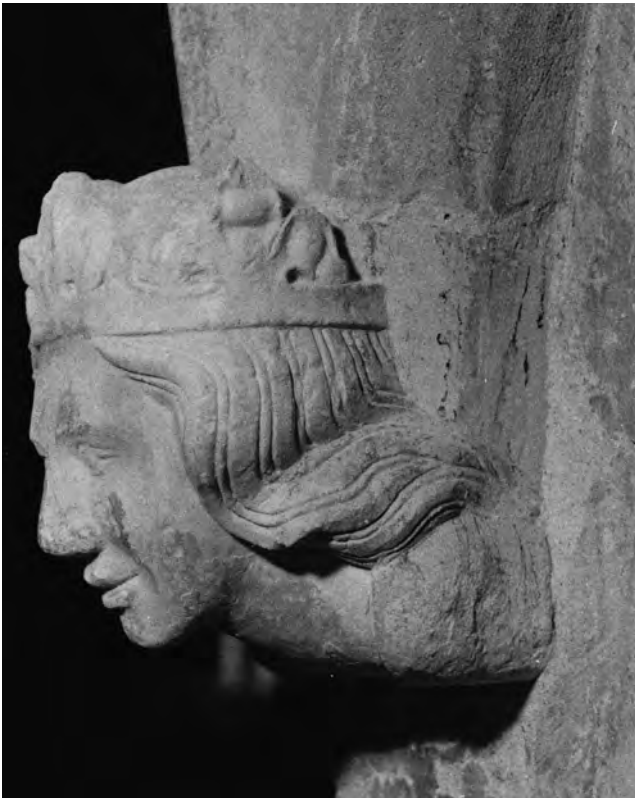
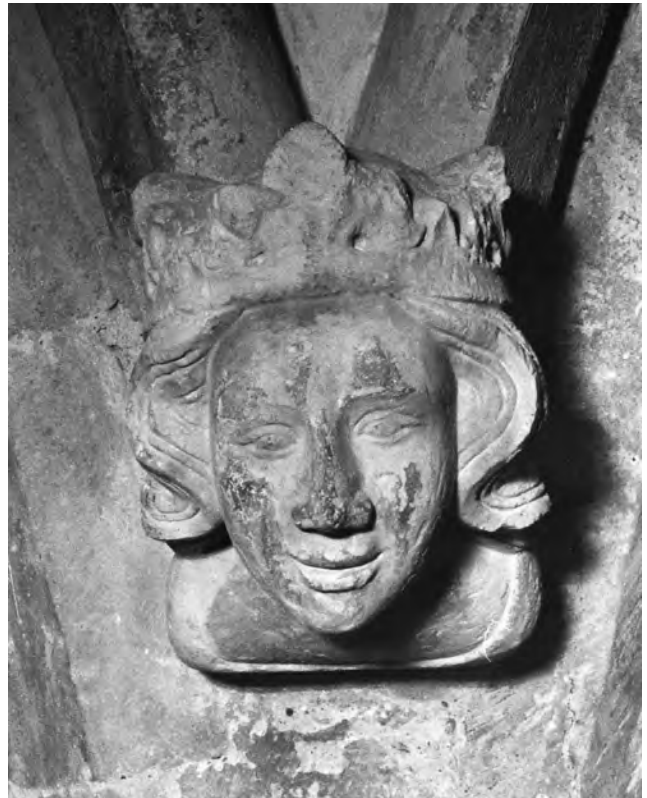
Fig. 501: North aisle, arcade. Label-stop no. 4. Photos: Warwick Rodwell

4. Head of a prince (Fig. 501).
Crowned, with long wavy hair and a low-necked gown. Delicately executed and in fine condition. The defoil points of the crown are in the form of knobbly foliage. A fine rasp has been used on the plainer parts of the

bust, particularly the neck. The chin and neck have a polished appearance and there are hints of a thin application of a terracotta-coloured pigment, probably original. A speck of pinkish-red paint was noted on the dexter side of the neck, at the junction with the hair-line; much yellow ochre limewash is in the hair.

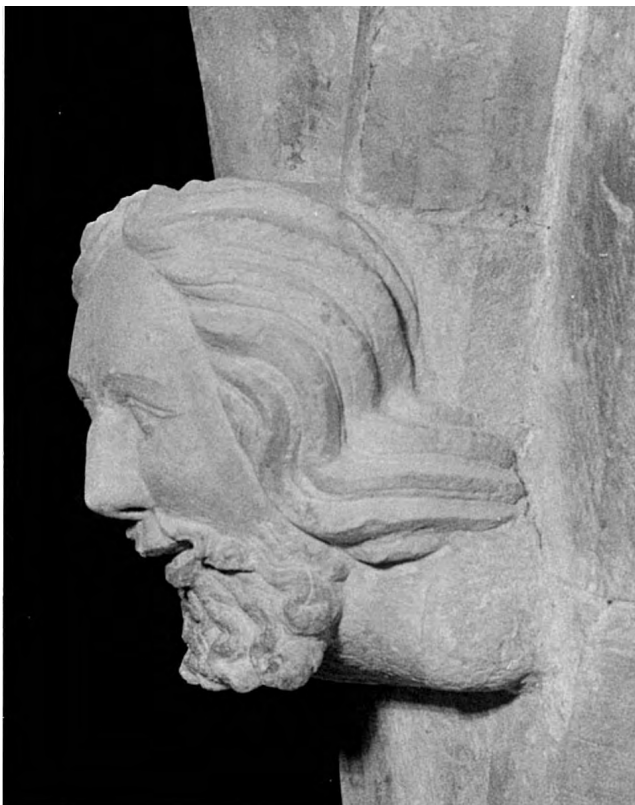
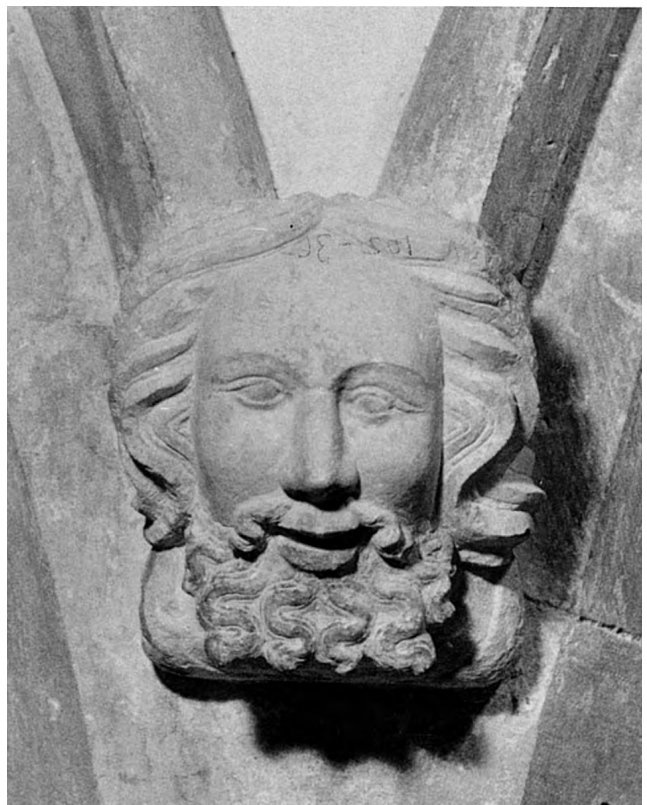
Fig. 502: North aisle, arcade. Label-stop no. 5. Photos: Warwick Rodwell

5. Head of a young male (Fig. 502).

A powerful head with a beard, moustache and wavy hair; the lips are parted to show the teeth. He wears a low-necked garment, similar to no. 4 (*cf.* also no. 11). Faint traces of rasping and slight hints of a smooth terracotta-coloured finish. The irises are painted purplish-black³⁰ and there is much white and yellow ochre limewash over the neck and shoulders.

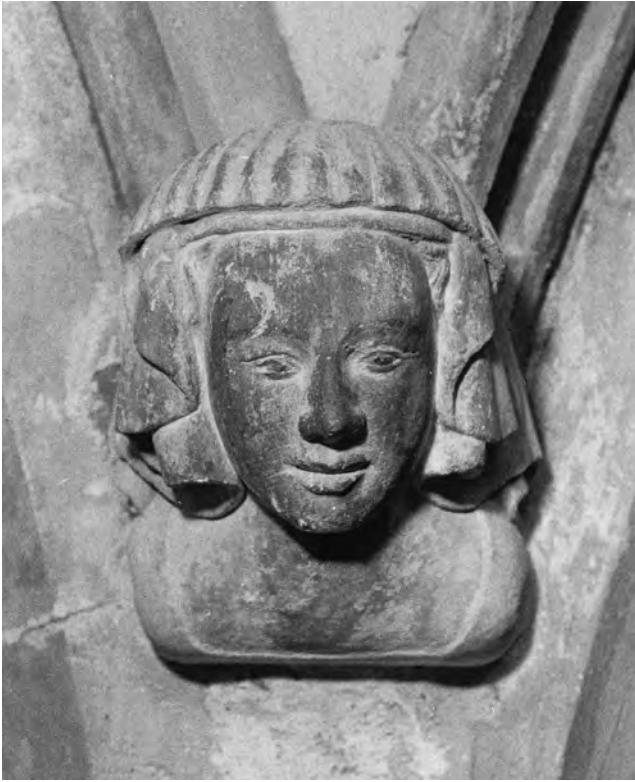
Fig. 505: Nave, north arcade. Label-stop no. 8. Photos: Warwick Rodwell

8. Head of a lady (Fig. 505).

Wearing a headdress; finely executed features; low neckline to her garment. The eyes appear to have had the

irises blackened, and there is crimson paint in both nostrils; also remnants of limewash. Bright red paint occurs on the adjacent arches and hood-mouldings of bays 1 and 2.

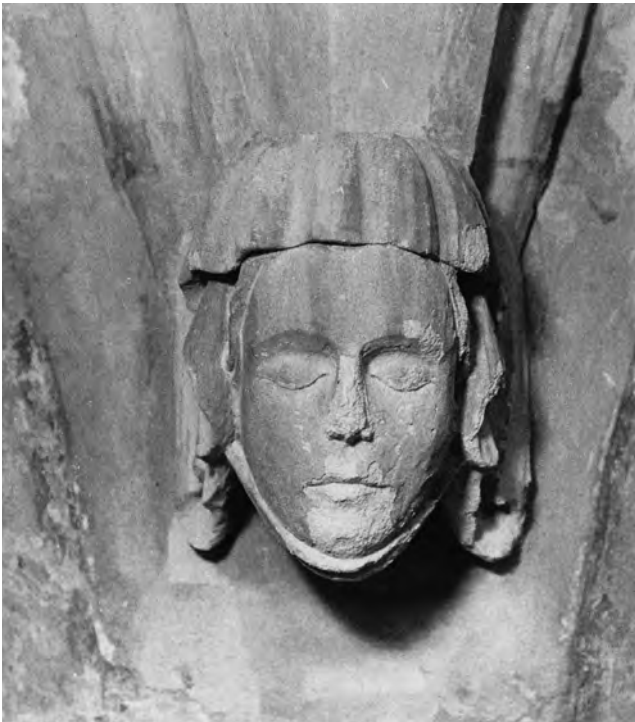
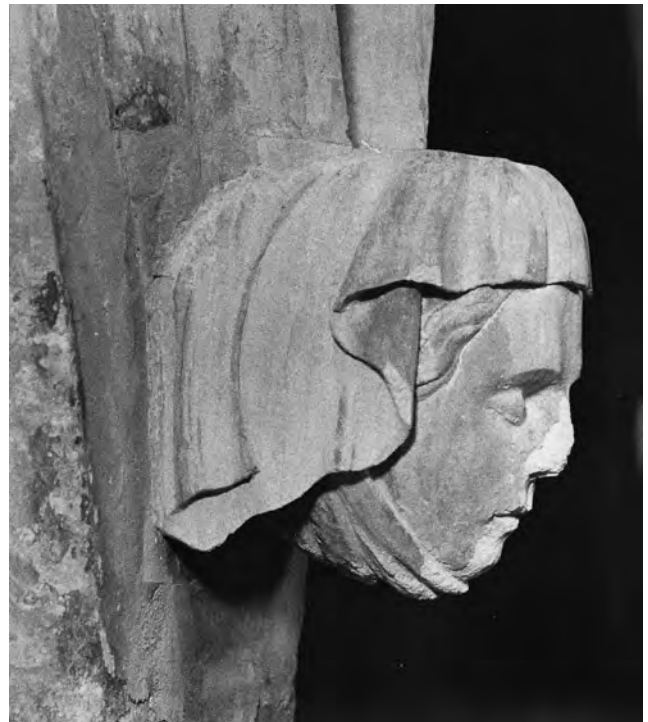
Fig. 506: Nave, north arcade. Label-stop no. 9. Photos: Warwick Rodwell

9. Head of a lady (Fig. 506). Wearing a headdress with a strap under the chin. This is a Victorian replacement for a lost head, probably dating from 1858–59. The features are coarsely executed. The head is set in brown Roman cement, and the limestone is exfoliating badly. The same cement was used to repair *c.* 75 cm of hood-moulding to either side. There is no paint or limewash on the sculpture, although the Roman cement has had ochre-coloured paint applied, to tone it in with the surrounding masonry. The original head was probably removed and the hood-mouldings cut back when the three-decker pulpit was installed during the refurbishment of 1711 (p. 501). It is very likely that the original head-stop is the one now set into the gable of the north porch (male head: see no. 35).

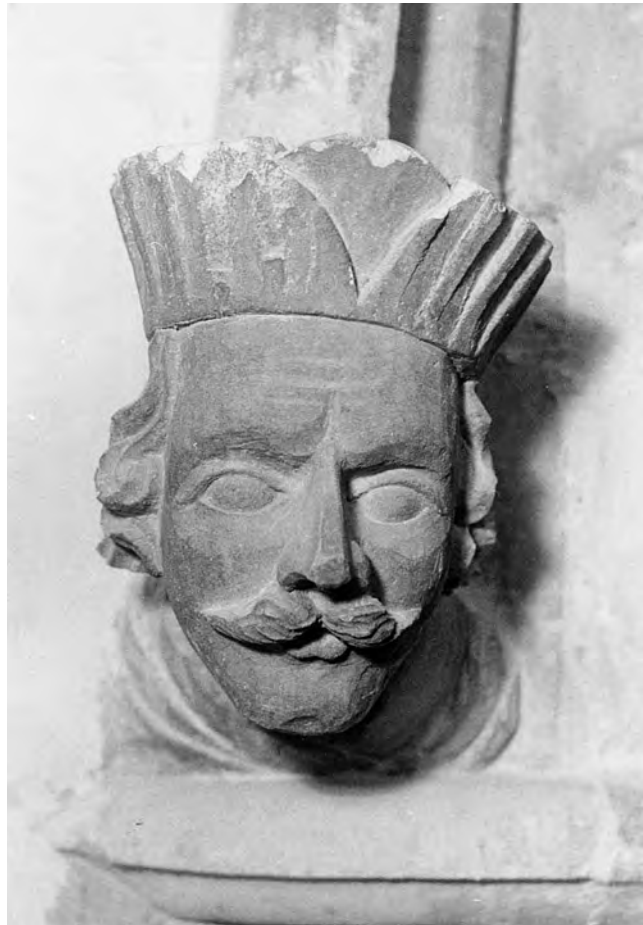
Fig. 509: Nave, north arcade. Label-stop no. 12. Photos: Warwick Rodwell

12. Royal male head (Fig. 509). With moustache and wearing a hat. A crudely carved, almost comic Victorian figure, in the spirit of Tenniel's illustration of the 'Red King' in Lewis Carroll's, *Alice through the Looking-Glass*.³¹ Head slightly turned to sinister. No traces of colour or limewash. This head, which dates from the period 1858 to 1897 (and is paired with no. 13), is a replacement for one which was lost when the western gallery was constructed in the nave (in 1803, or earlier).³²

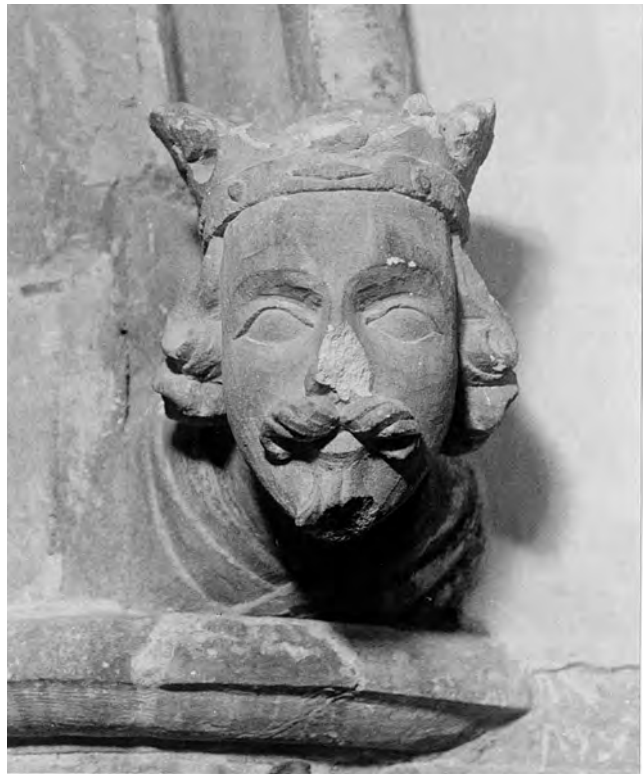
Fig. 510: Nave, south arcade. Label-stop no. 13. Photos: Warwick Rodwell

13. Crowned male head (Fig. 510). Moustache and diminutive beard.³³ Another crudely carved, slightly comic Victorian figure, reminiscent of Tenniel's 'White King'. Head turned to dexter. It is a pair with no. 12, and again replaces a head that was lost when the western gallery was erected.

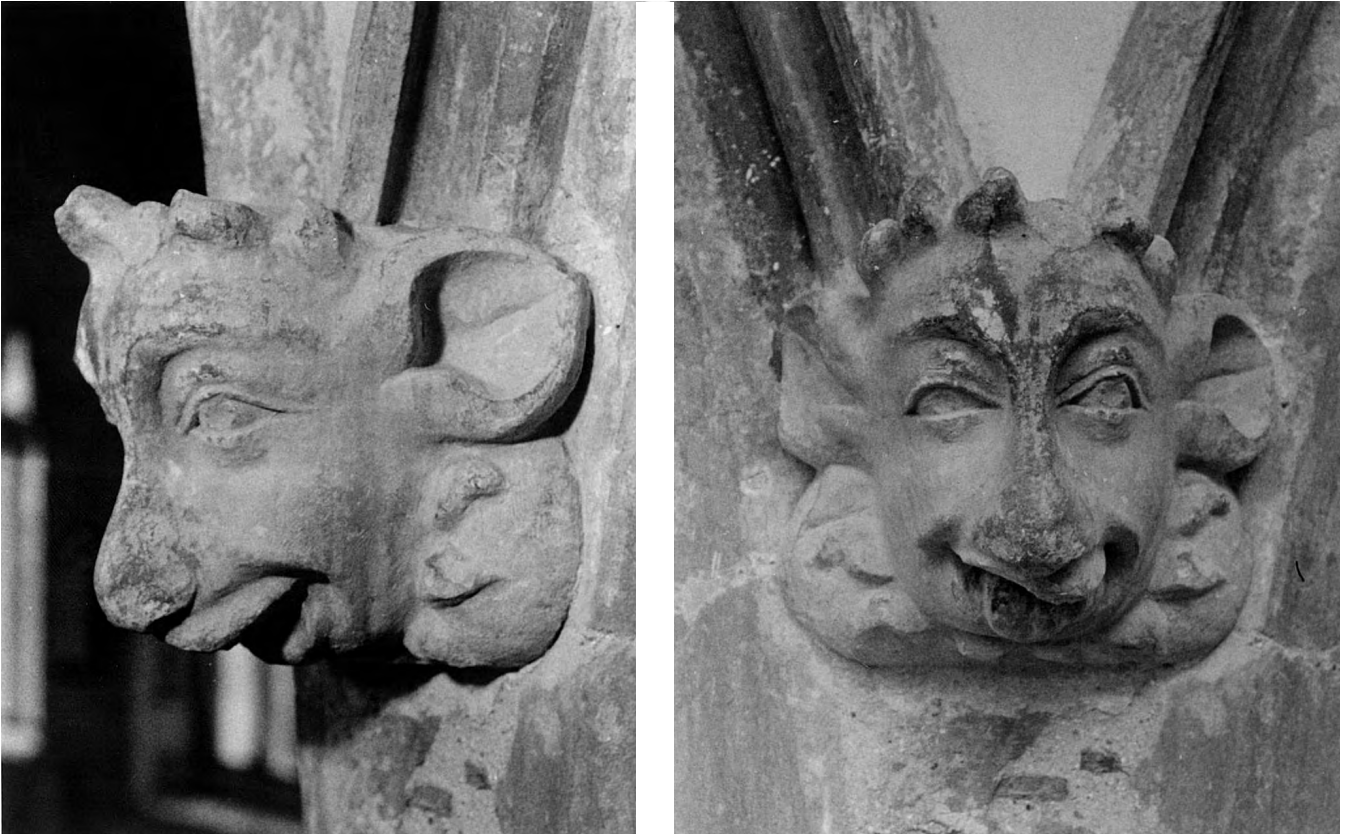
Fig. 511: Nave, south arcade. Label-stop no. 14. Photos: Warwick Rodwell

14. Grotesque head (Fig. 511). A large, lion-like head, powerful in appearance and crude in execution. The animal has prominent ears (identical to those on no. 10) and a protruding tongue. There are no stoolings for the hood-mouldings. Some repairs, and one curl is missing from the forehead; part of the upper jaw is broken away on the dexter side.

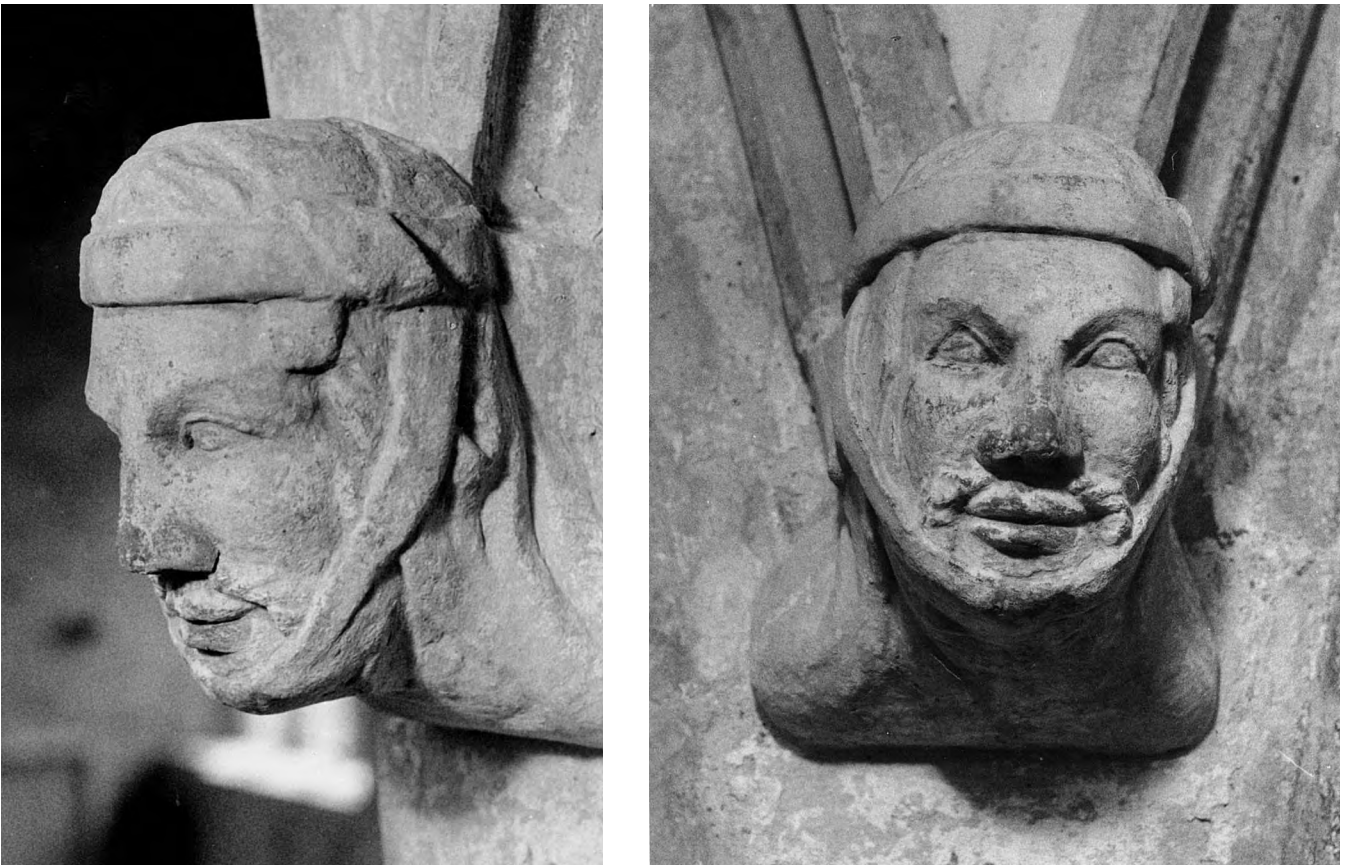
Fig. 512: Nave, south arcade. Label-stop no. 15. Photos: Warwick Rodwell

15. Head of a knight (Fig. 512). A well-carved head with moustache and helmet of chain-mail. The stoolings for the hood-mouldings are plain-chamfered, indicating that this head was intended for fixing in an aisle rather than in the nave. The dexter nostril has been re-formed in cement.

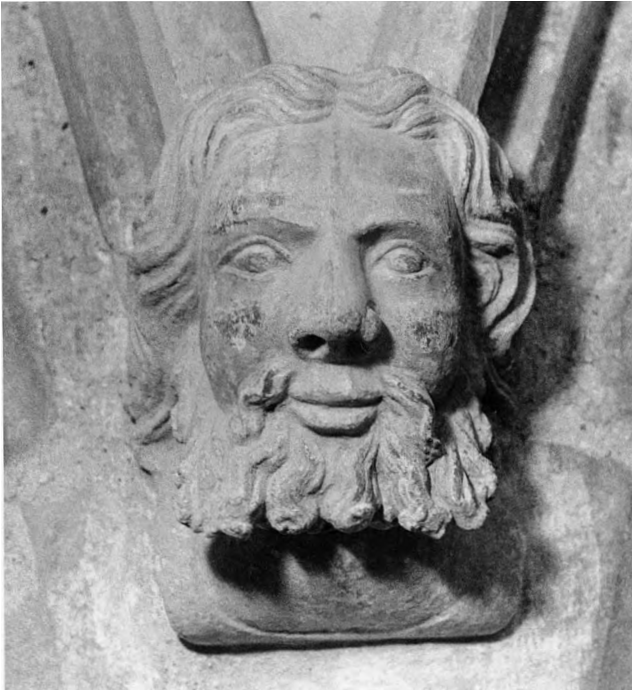
Fig. 513: Nave, south arcade. Label-stop no. 16. Photos: Warwick Rodwell

16. Bearded male head (Fig. 513).

A finely executed head in good condition, distinguished in appearance, and probably representing a nobleman. The hair is carefully finished on the top of the head. Black paint in the irises of the eyes.

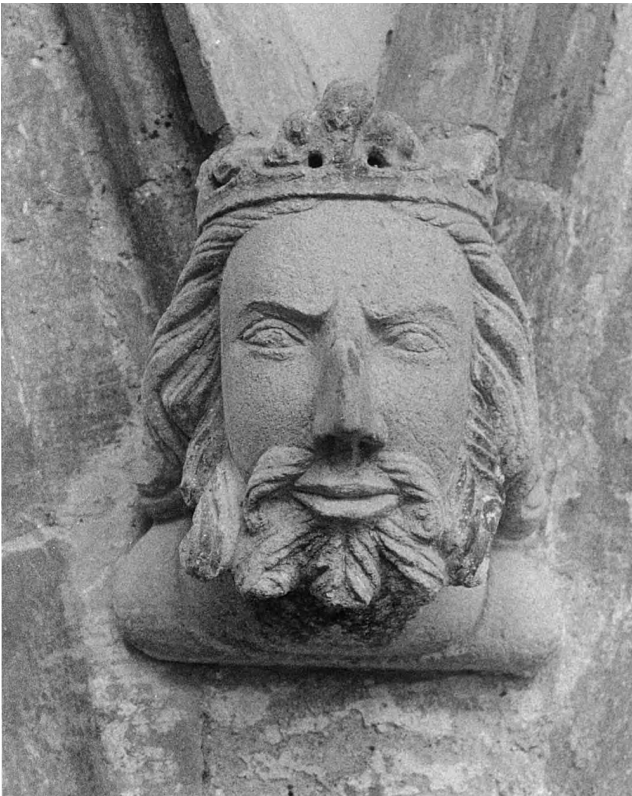
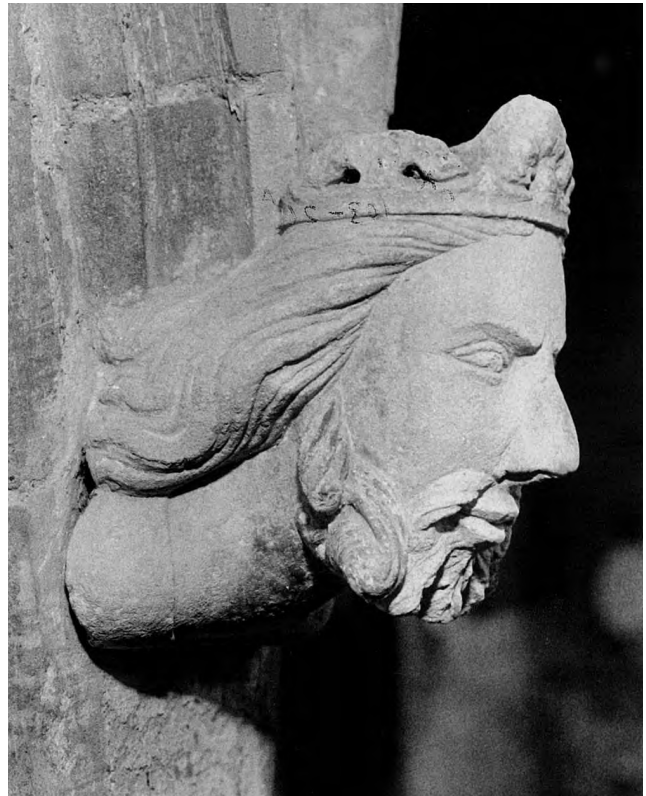
Fig. 514: Nave, south arcade. Label-stop no. 17. Photos: Warwick Rodwell

17. Head of a king (Fig. 514).

Moustache, beard and long flowing hair; nose replaced in cement. Two points are broken off the crown, which also exhibits original drill holes.

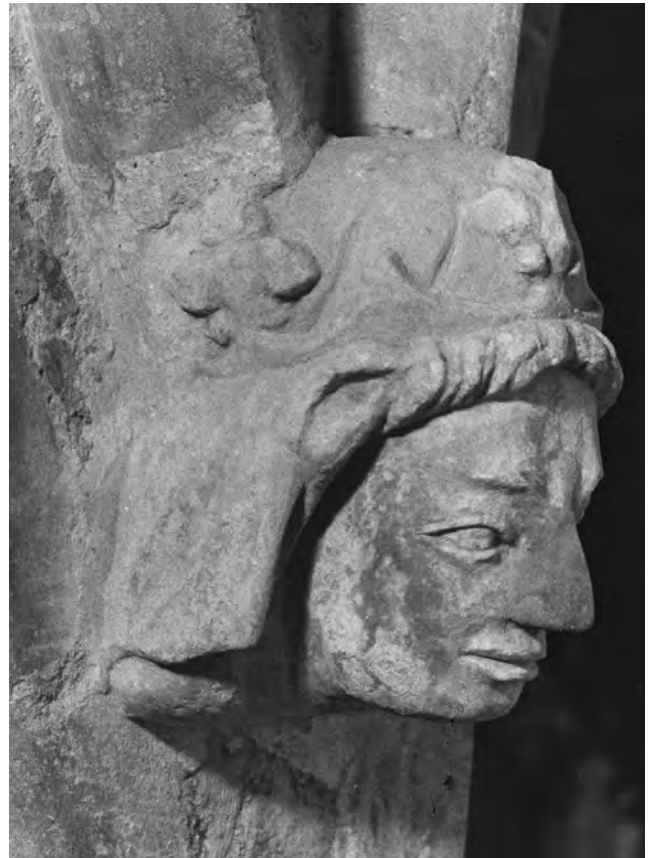
Fig. 515: South aisle, arcade. Label-stop no. 20. Photos: Warwick Rodwell

19. Missing, probably removed in the fifteenth century. No evidence visible to prove the existence of a head-stop, but one would be expected.
20. Head of a queen (Fig. 515).
She wears a crown and headdress, and has a high neckline to her garment. The front of the crown is damaged and the nose has been replaced in cement. Prominent traces of red paint on the hair; ochre and pink on the jewels of the crown. The original plaster skim survives on the small spandrel below this head.
Brown (1908, 138) wondered whether this might represent Isabella of France, wife of Edward II, partly on the basis that it is addorsed on the same pier as the head which he confidently identified as that king's (no. 17).

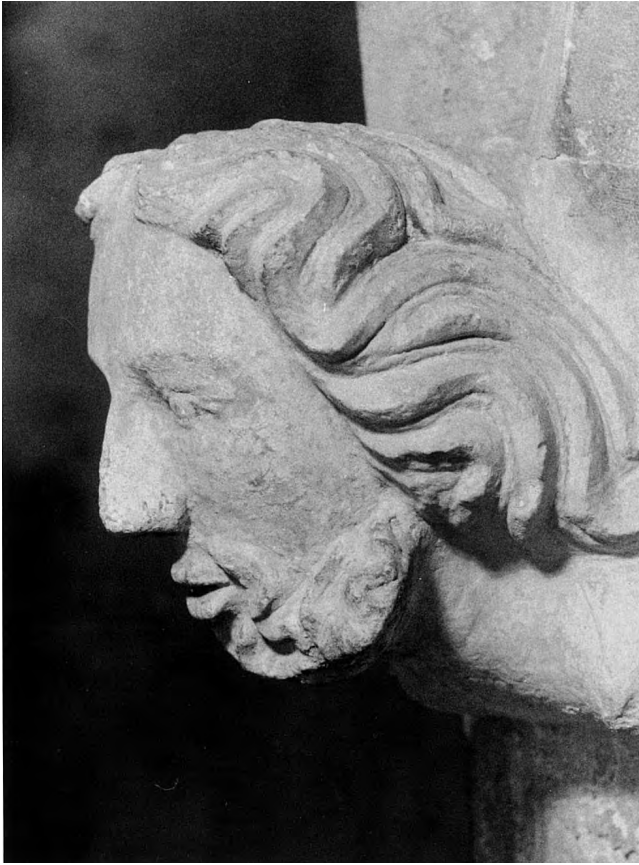
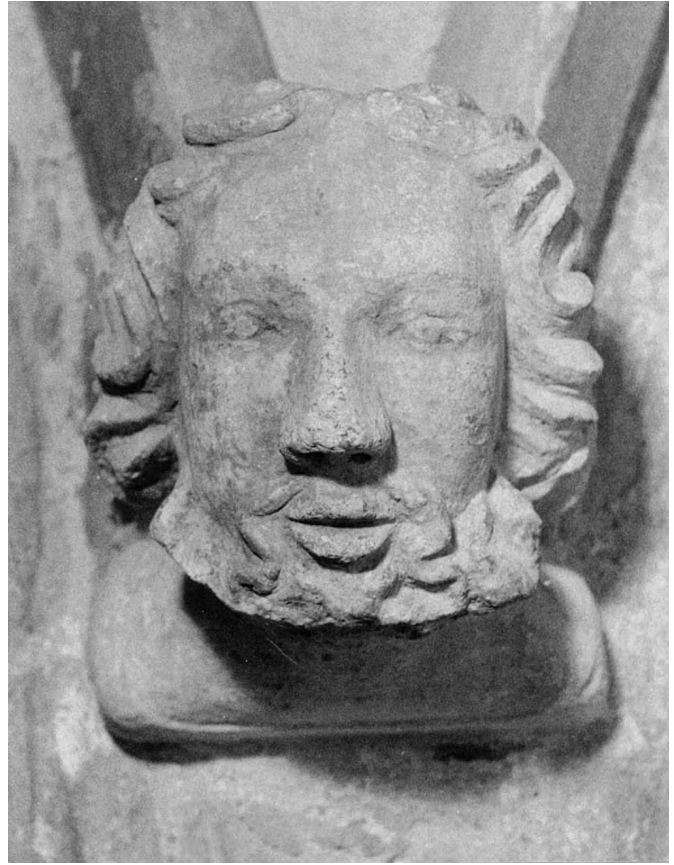
Fig. 516: South aisle, arcade. Label-stop no. 21. Photos: Warwick Rodwell

21. Bearded male head (Fig. 516).
A well-carved head, distinguished in appearance, and probably representing a nobleman. The hair is carefully finished on the top of the head in a chevron pattern. Much red paint of doubtful age is present on the hair. The beard is broken away under the chin and has lost some of its length.

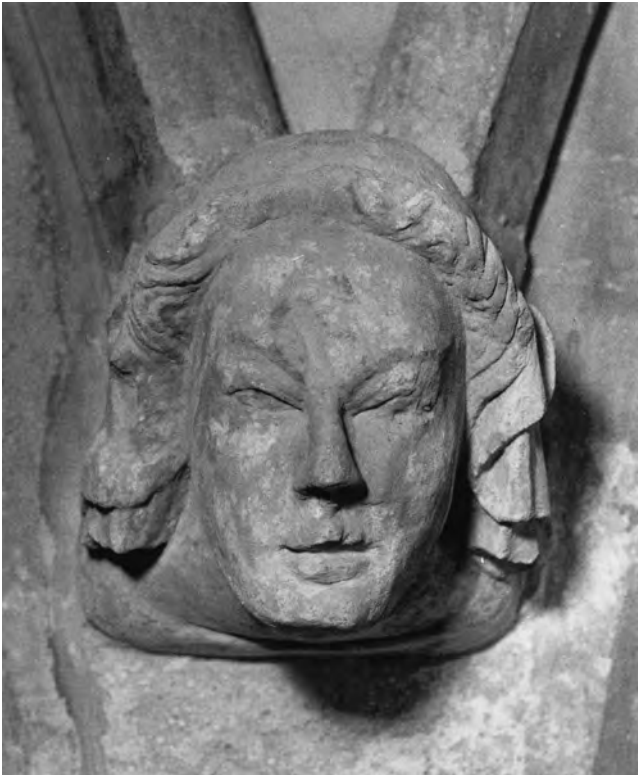
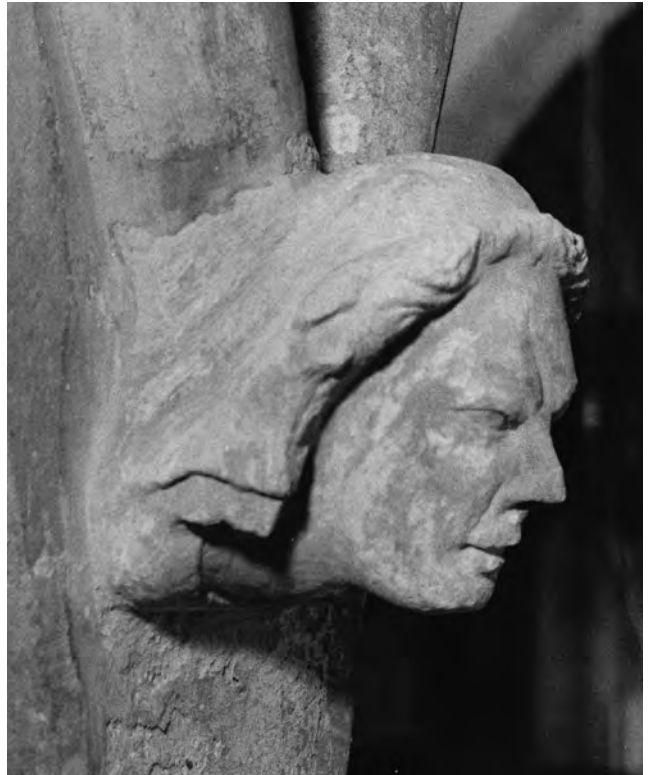
Fig. 517: South aisle, arcade. Label-stop no. 22. Photos: Warwick Rodwell

22. Head of a lady (Fig. 517).
The lady wears a veil which is drawn back. The nose has been replaced; also there is damage to the sinister eye and cheek, which have been reconstructed in cement.

The hair and veil have also been damaged and partially reconstructed in a clumsy manner. The hair-style is similar to that of no. 20.

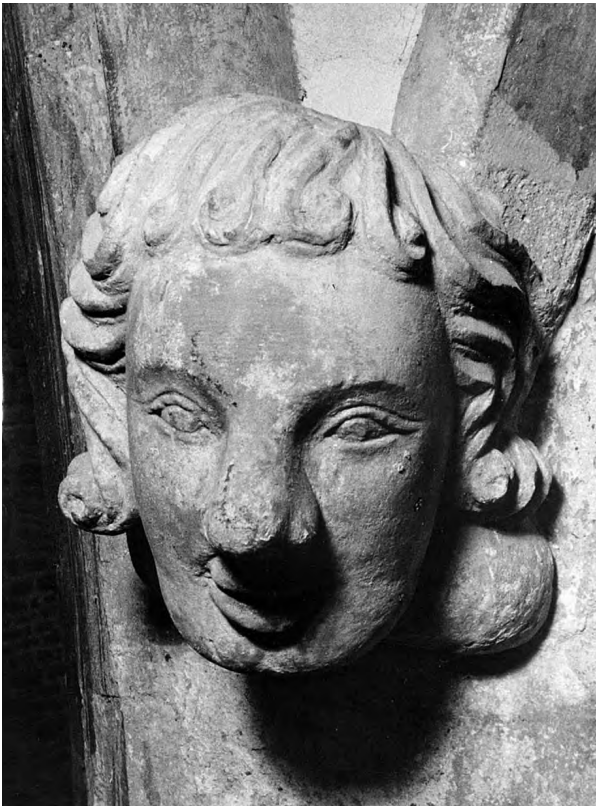
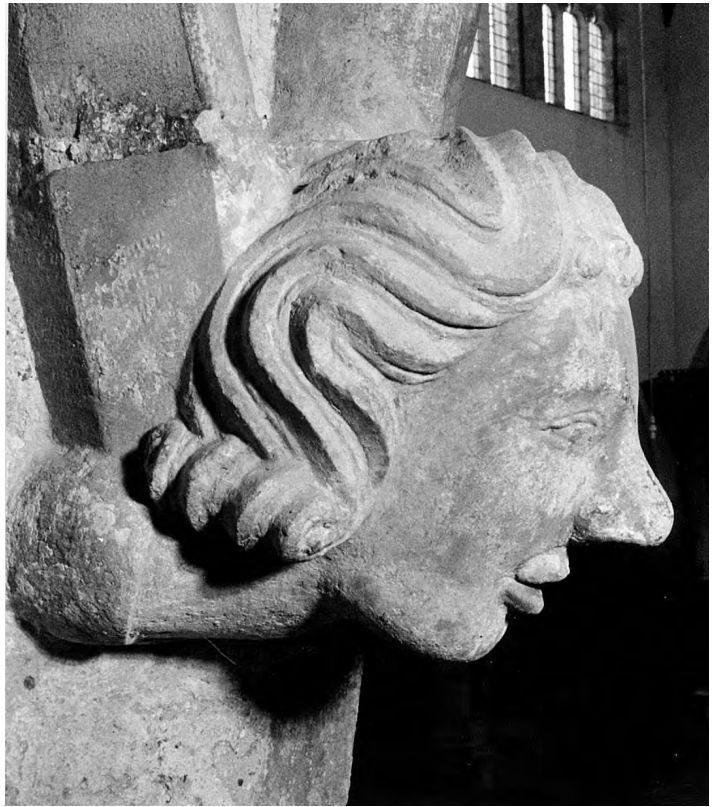
Fig. 518: South aisle, arcade. Label-stop no. 23. Photos: Warwick Rodwell

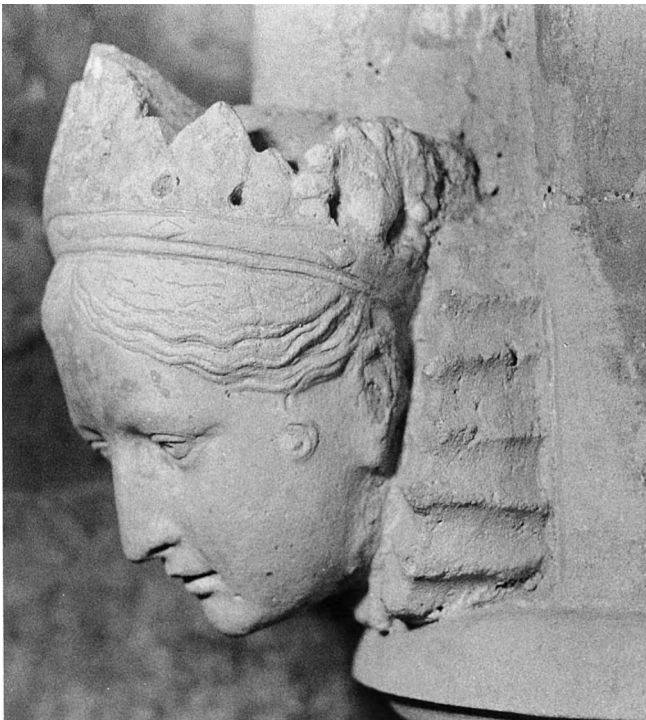
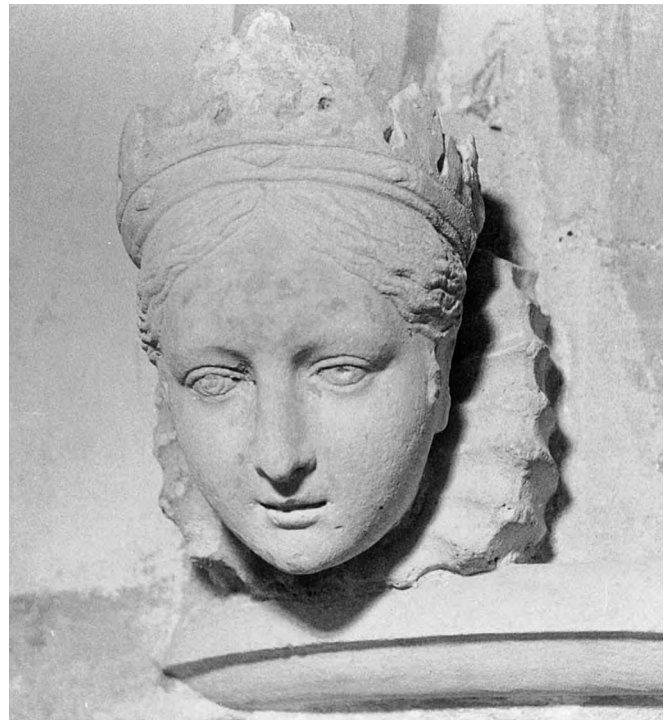
Fig. 519: South aisle, arcade. Label-stop no. 24. Photos: Warwick Rodwell

The location of this head is particularly conspicuous, catching the eye as one enters the church by the main door. Determining its age is, however, problematical. Brown (1908, 137) unquestioningly accepted that it was medieval, and sought to identify it with Eleanor of Castile. He explained the appearance of the ruff as an Elizabethan addition. Varah, on the other hand, claimed

that the head itself represented Queen Elizabeth I.³⁵ Most recently, Pamela Tudor-Craig wondered whether it might not be a depiction of the 'young head' of Queen Victoria. However, it bears no resemblance in stone type, style or quality to the other nineteenth-century replacement heads, adding force to the suggestion that it is reused.

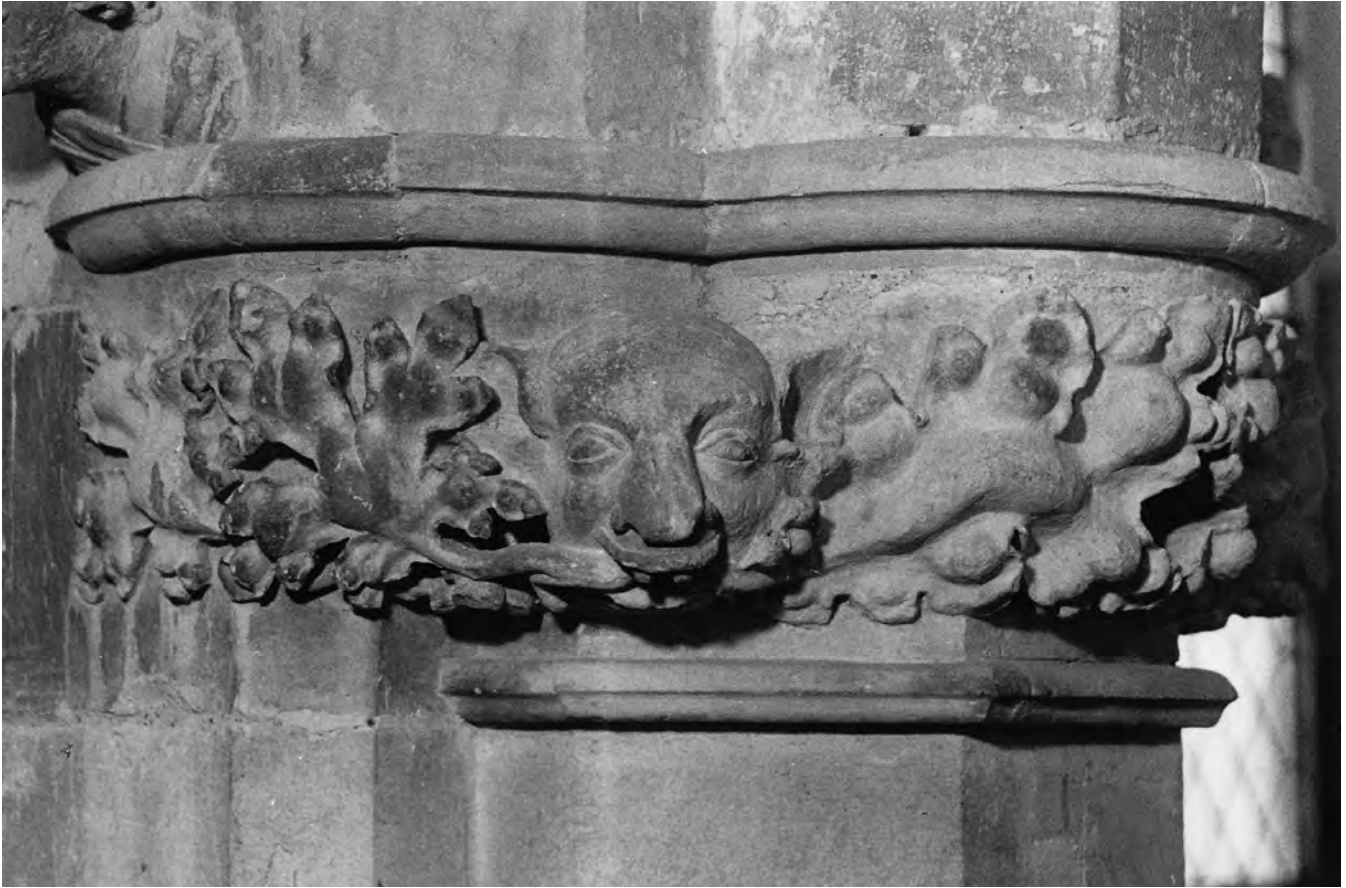
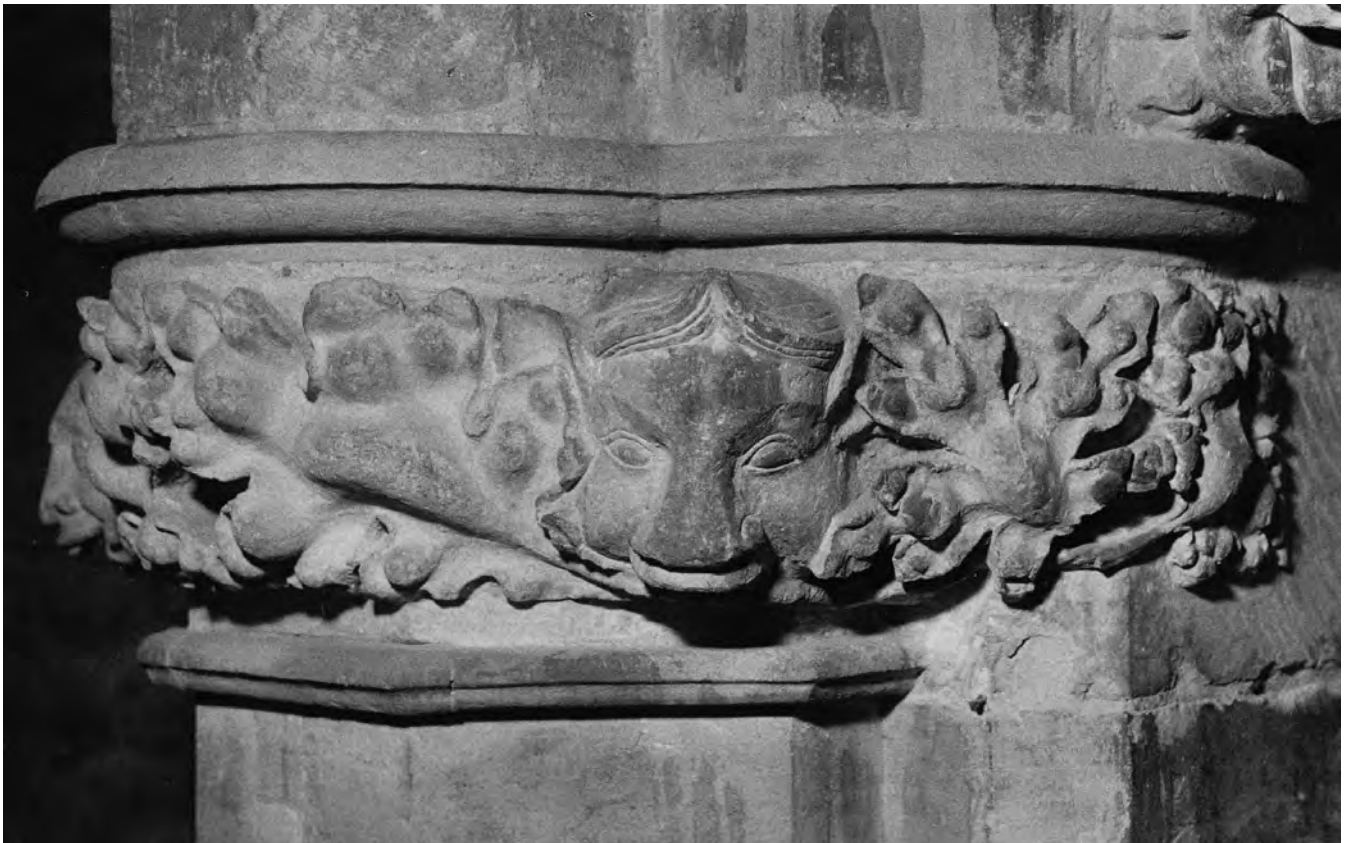
Fig. 520: North arcade, west respond. Sculpture no. 25. Photos: Warwick Rodwell

The impost is carved with two grotesque lion-like heads facing south-east and north-east, respectively; the latter is wearing a headdress or crown. Both heads have broad noses and pointed ears, and knobbly foliage issues from their mouths, wrapping round on to the faces of the arcade. The teeth have been broken from the upper jaw of the north-east head. Incorporated among the foliage on the south side, and facing vertically downwards, is a small rose (*cf.* capital, no. 26). Dark red paint survives on the background in many places; this extends on to the abacus and the neck-ring.

The respond sustained a little damage when the west gallery was inserted in the nave. Parts of the abacus and hood-moulding on the south face of the arcade were renewed in 1858–59, when the gallery was removed.

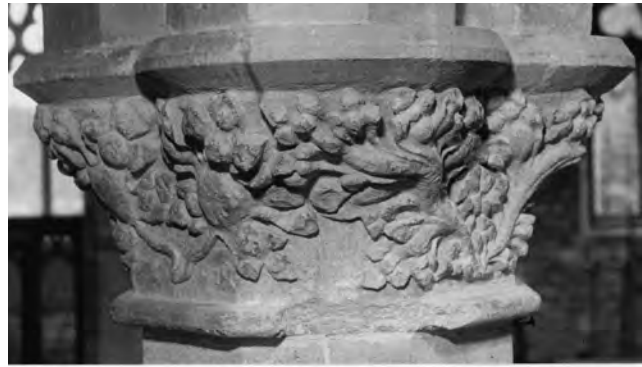
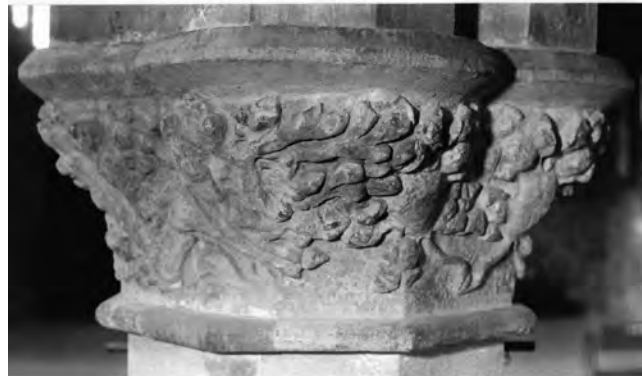
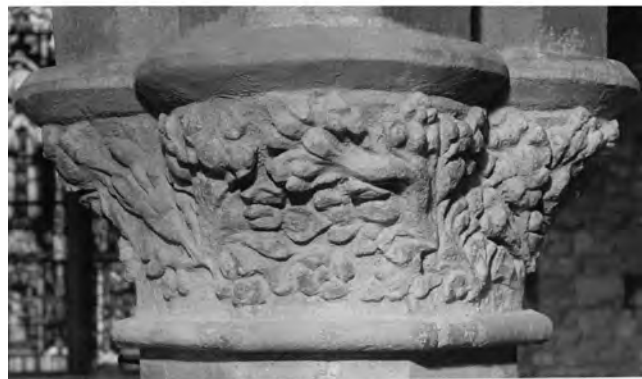
Fig. 521: North arcade, capital pier 1/2. Sculpture no. 26. The four cardinal faces. Photos: Warwick Rodwell

The trefoiled abacus is separate from the impost, but the semi-octagonal neck-ring is integral. The impost is decorated with two male heads wearing caps and facing north-east and south-east, respectively. Knobbly foliage issues from the mouths of both. The north-east head has prominent teeth; the nose and part of the face have been repaired. The south-east head has a wide-open mouth and no teeth.

Repairs to the foliage have taken place, especially where it runs on to the north face of the arcade; there, the abacus and hood-moulding have also been repaired,

and label-stop no. 13 has been renewed. This damage was all caused by the insertion of a west gallery in the nave.
