ST PETER'S

Barton-upon-Humber, Lincolnshire

A Parish Church and its Community

HISTORY, ARCHAEOLOGY AND ARCHITECTURE

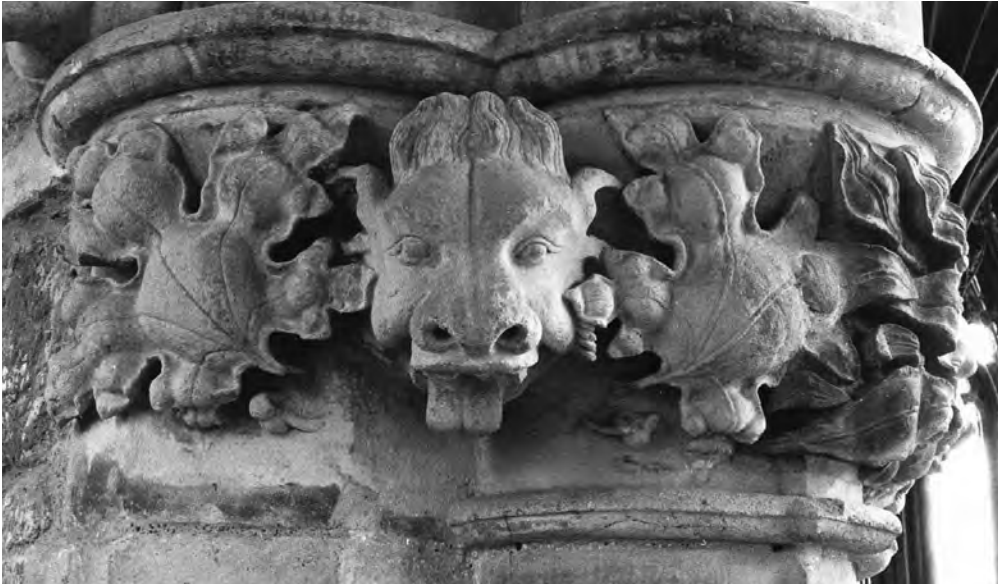
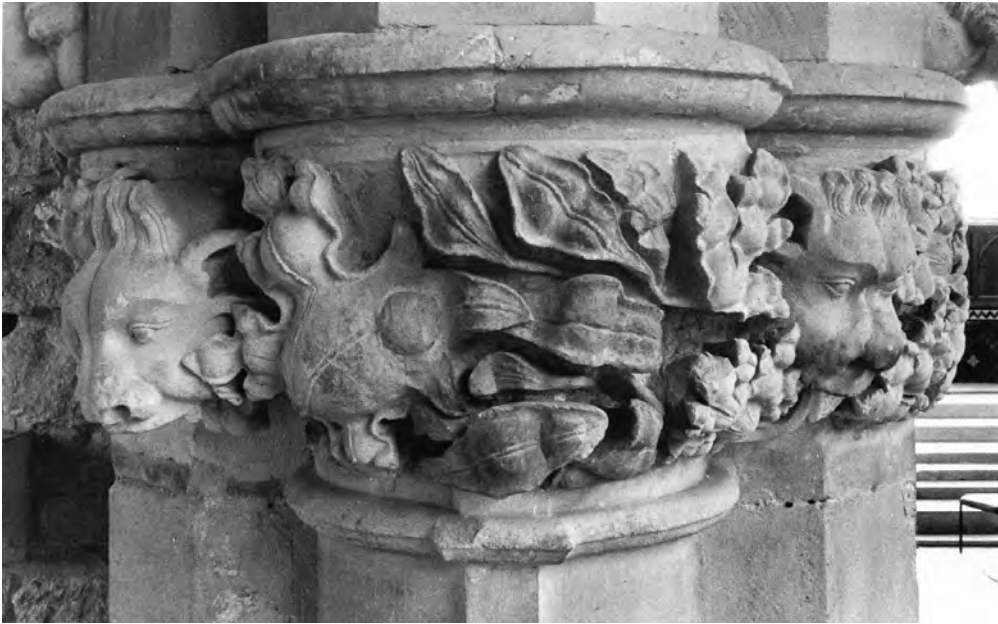
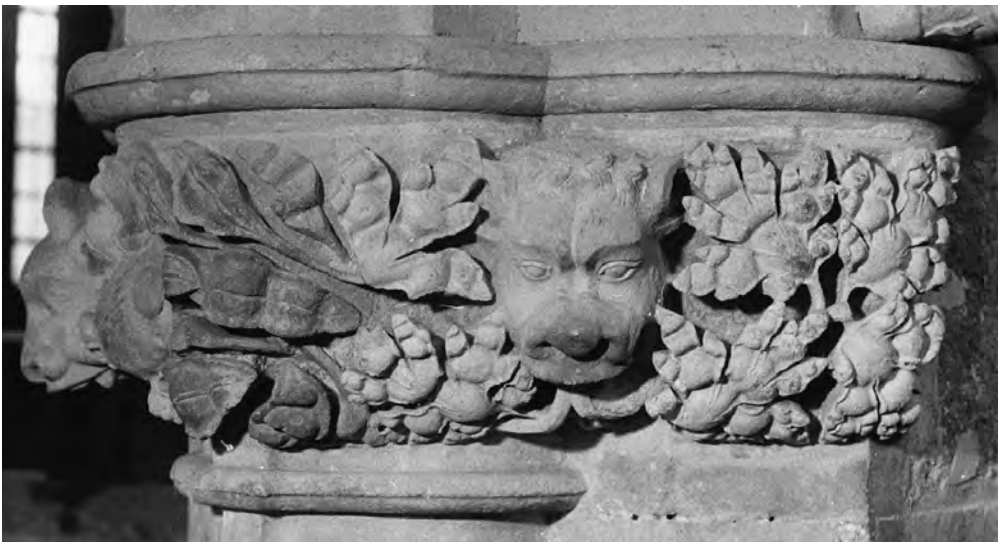
Fig. 522: North arcade, east respond. Sculpture no. 27. Photos: Warwick Rodwell

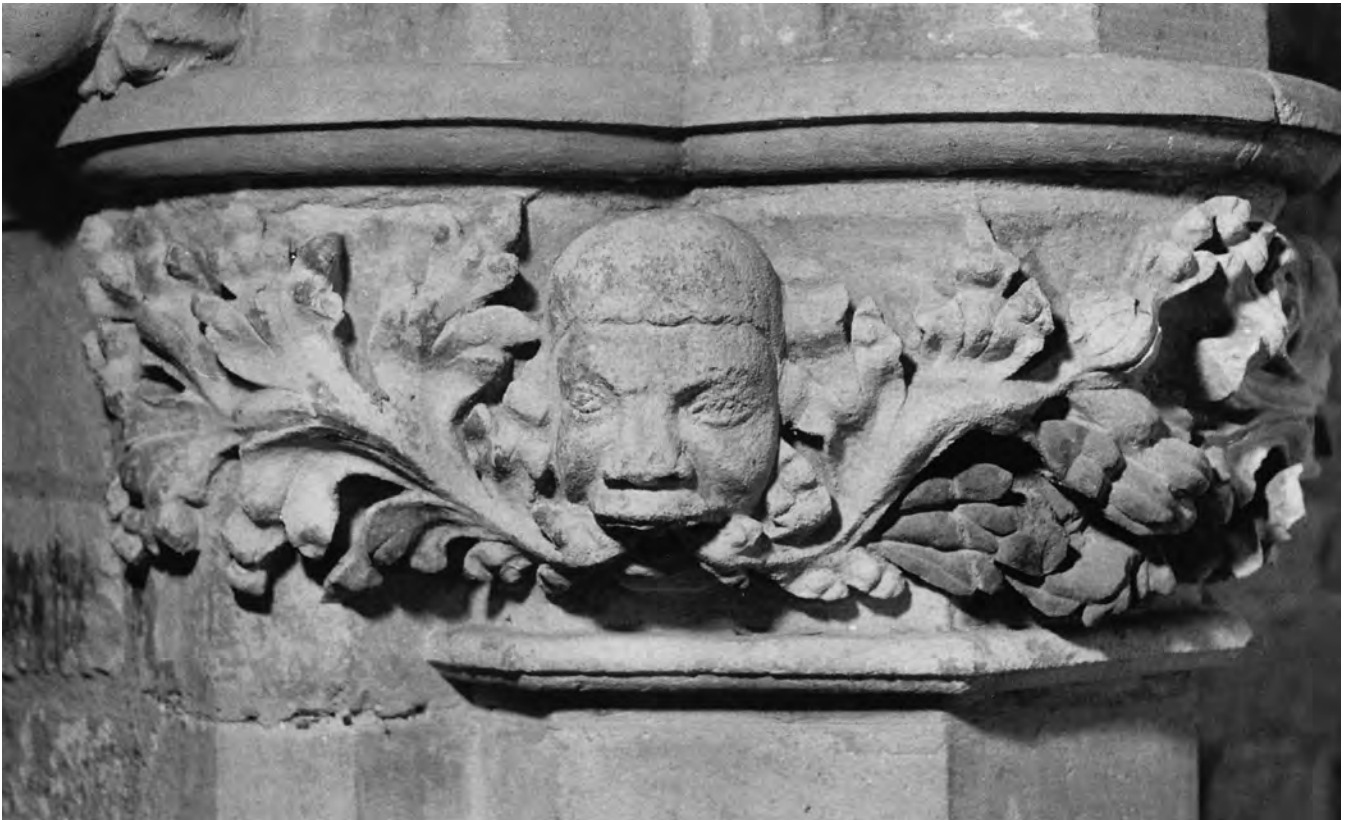
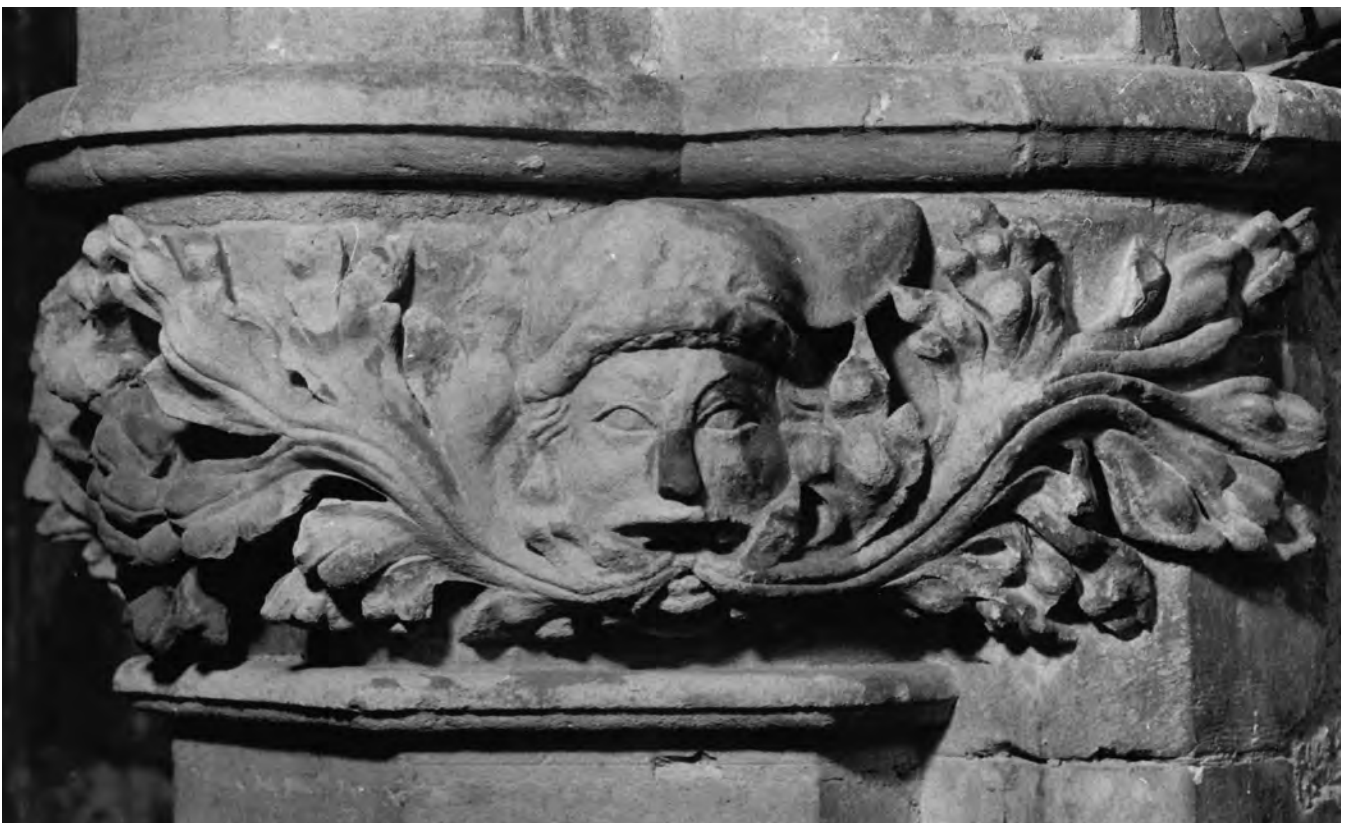
Fig. 523: South arcade, west respond. Sculpture no. 28. Photos: Warwick Rodwell

The impost is carved with two lion-like masks facing south-west and north-west, respectively. The muzzle of the former has been renewed in cement; the latter has pointed ears, a projecting tongue and drilled nostrils. Knobbly foliage issues from the mouths of both, although the stalks which sprang from the north-west head are now missing. The west-facing central section of foliage was also renewed in the mid-nineteenth century, having been destroyed by the insertion of a timber screen in arcade bay 1. The pupils of the eyes in both masks have been painted purplish-black,³⁹ but there is no sign of polychromy on any other features, or on the background areas around the foliage (in contrast to no. 25). Indeed, the background is rough and unsuitable for painting. A few rasp-marks are visible and much yellow ochre limewash is present in the interstices.

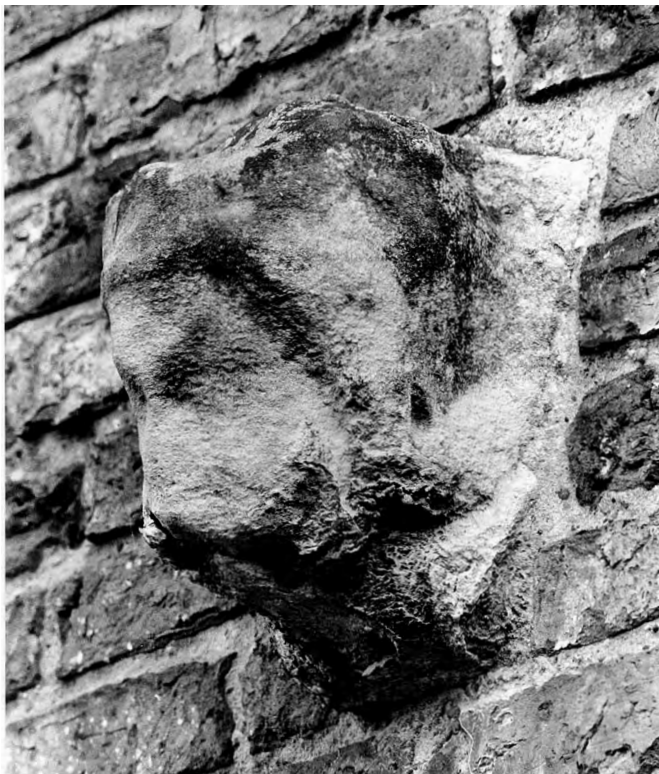
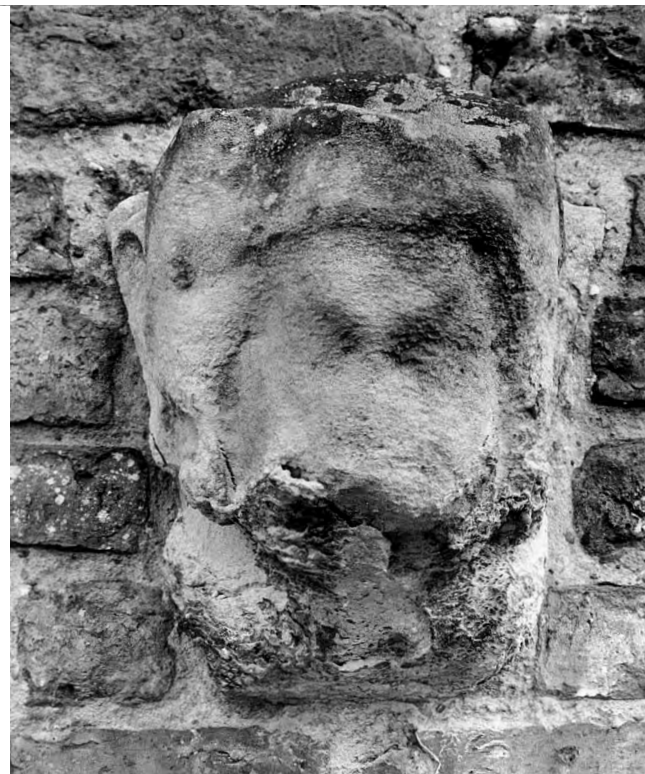
Fig. 524: North porch, exterior. Reset head sculpture, no. 35. Photos: Warwick Rodwell

35. Head of a male, wearing a hat (Fig. 524).
Now outdoors and heavily weathered, having been built into the brick gable of the north porch in the eighteenth century. This was formerly a head-stop from an arcade and retains the stoolings for the two hood-mouldings that sprung from it; very likely that it was the original no. 9, in the north arcade.

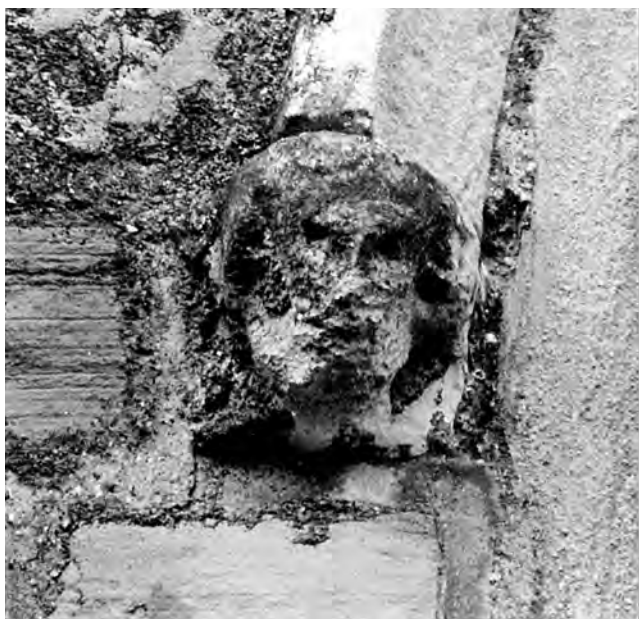
Fig. 525: South aisle window, bay 1. West label-stop, no. 37. Photo: Warwick Rodwell

36. Bay 1 (E). Young ?male head. Almost lost through weathering.
37. Bay 1 (W). Male bearded head with drilled eyes. Heavily weathered (Fig. 525).
38. Bay 2 (E). Head wearing a hood, meeting under the chin. Almost lost (Fig. 526).
39. Bay 2 (W). Torso of a beast with forepaws and drilled eyes (Fig. 527).
40. Bay 3 (E). Female head, veiled (Fig. 528).
41. Bay 3 (W). Head of young male wearing a turned-up cap (Fig. 529).

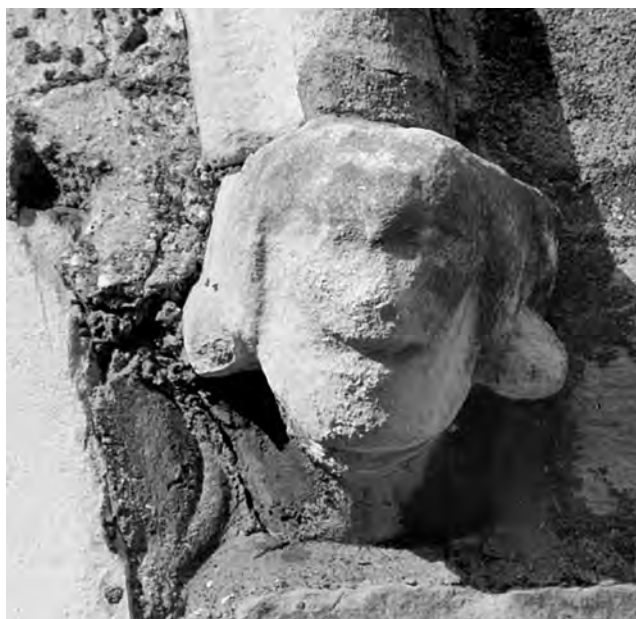
Fig. 526: South aisle window, bay 2. East label-stop, no. 38. Photo: Warwick Rodwell

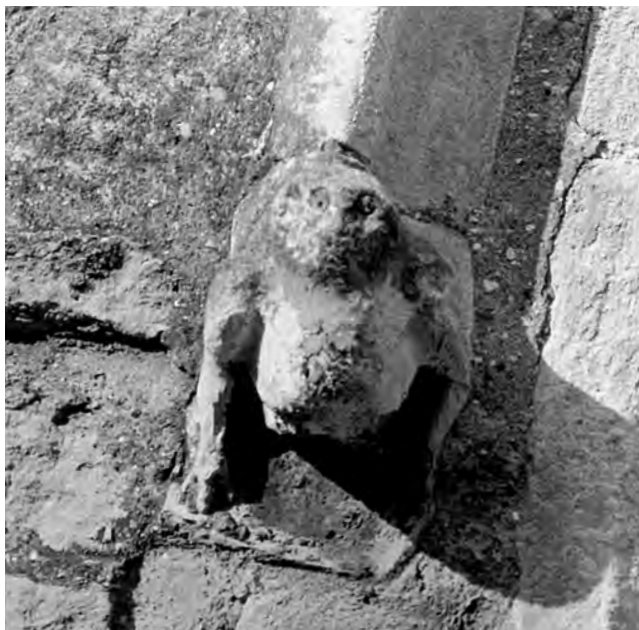
Fig. 527: South aisle window, bay 2. West label-stop, no. 39. Photo: Warwick Rodwell

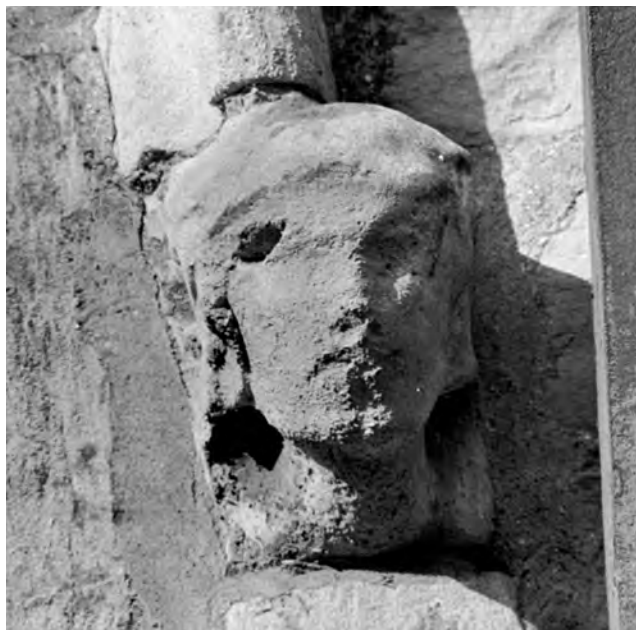
Fig. 528: South aisle window, bay 3. East label-stop, no. 40. Photo: Warwick Rodwell

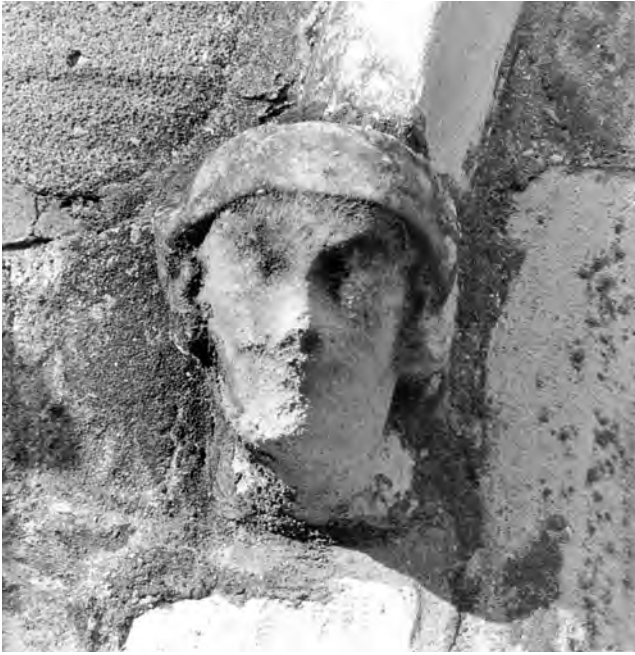
Fig. 529: South aisle window, bay 3. West label-stop, no. 41. Photo: Warwick Rodwell

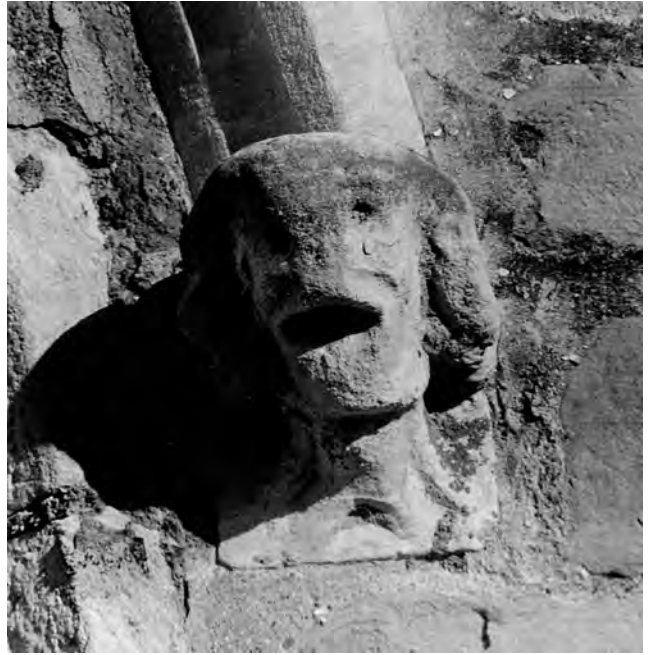
Fig. 530: South aisle window, bay 4. East label-stop, no. 42. Photo: Warwick Rodwell

- 42. Bay 4 (E). Distressed male head with drilled eyes and open mouth (Fig. 530).
- 43. Bay 4 (W). Head missing, broken off at the neck.
- 44. Bay 5 doorway (E). Destroyed: a formless lump.
- 45. Bay 5 doorway (W). Destroyed: a formless lump.
- 46. Bay 5 porch (E). Male head. Heavily weathered; no features visible except hair.
- 47. Bay 5 porch (W). Female head. Heavily weathered; no features visible except hair and veil.

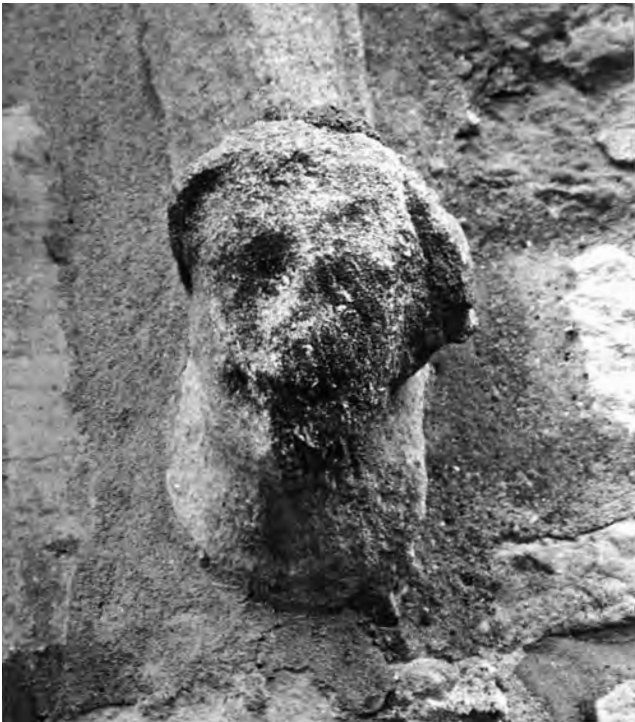
Fig. 531: North aisle window, bay 4. East label-stop, no. 48. Photo: Warwick Rodwell

- 48. Bay 4 (E). Round smiling face of a fool. Nineteenth or early twentieth century (Fig. 531).
- 49. Bay 4 (W). Head of young woman, turning in towards the window, her veil flying away behind her (*cf.* south porch) (Fig. 532). Thirteenth or fourteenth century, but potentially a secondary insertion.

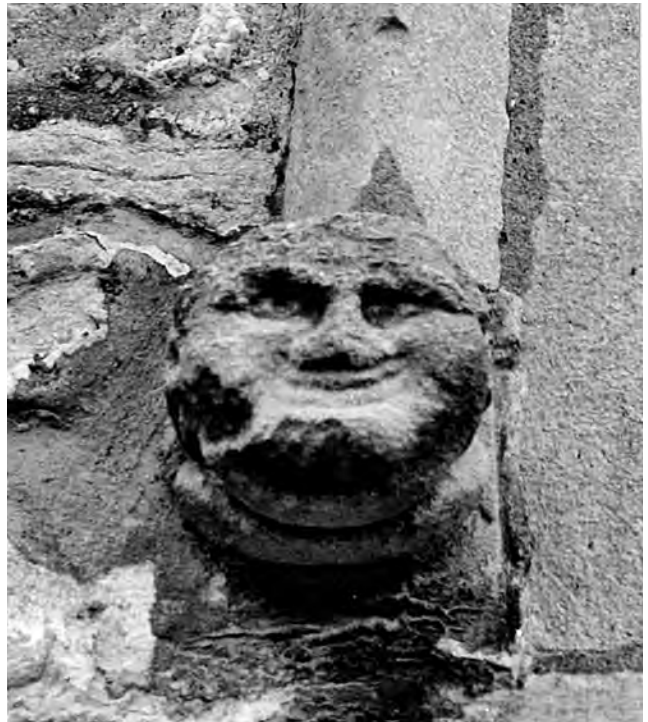
Fig. 532: North aisle window, bay 4. West label-stop, no. 49. Photo: Warwick Rodwell

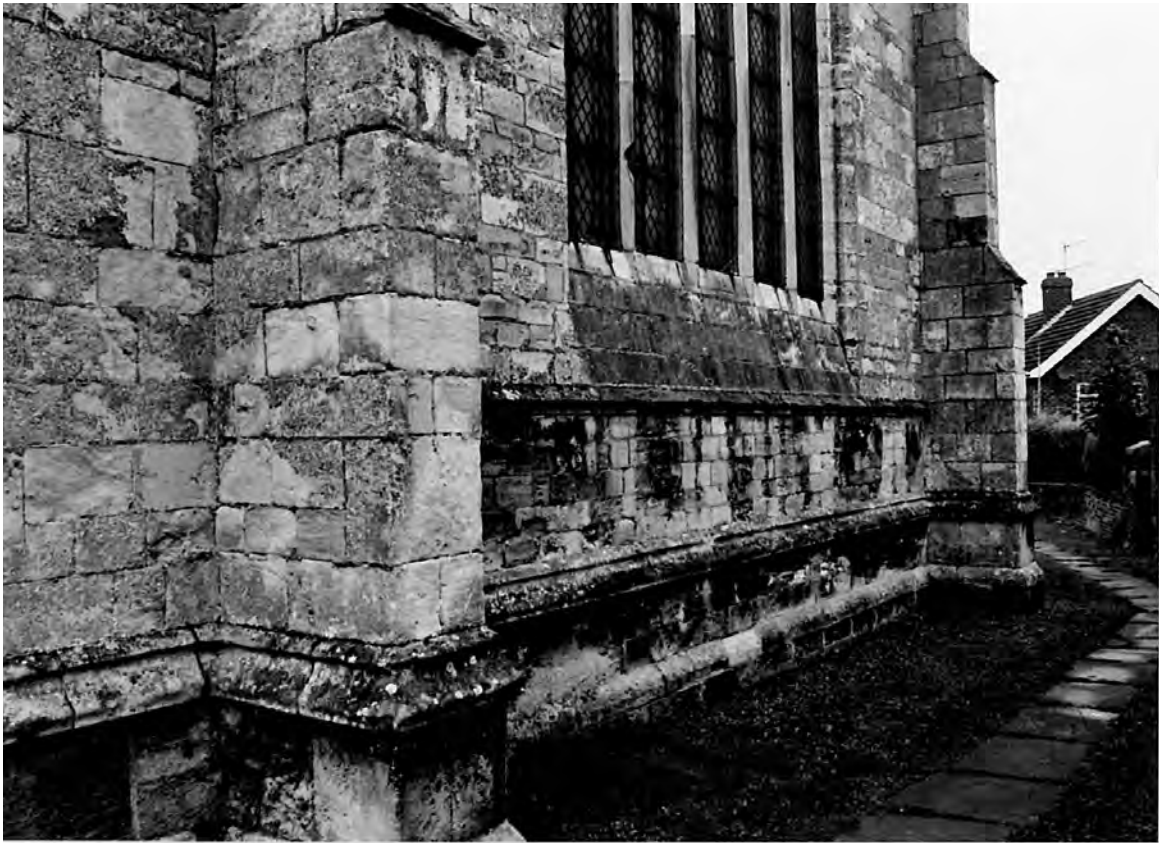
Fig. 534: Chancel. Lower part of the east wall, showing details of the plinth, string-course and raised window sill, 2005. Photo: Warwick Rodwell

The large east window, now of five wide lights, has been substantially modified. Only the chamfered and rebated jambs, to about three-quarters of their present height, are original: the head and tracery are later (Figs. 50 and 535). Also, the sill once rested directly on the string-course, but has subsequently been raised by three masonry courses (p. 518; Fig. 534). This is the

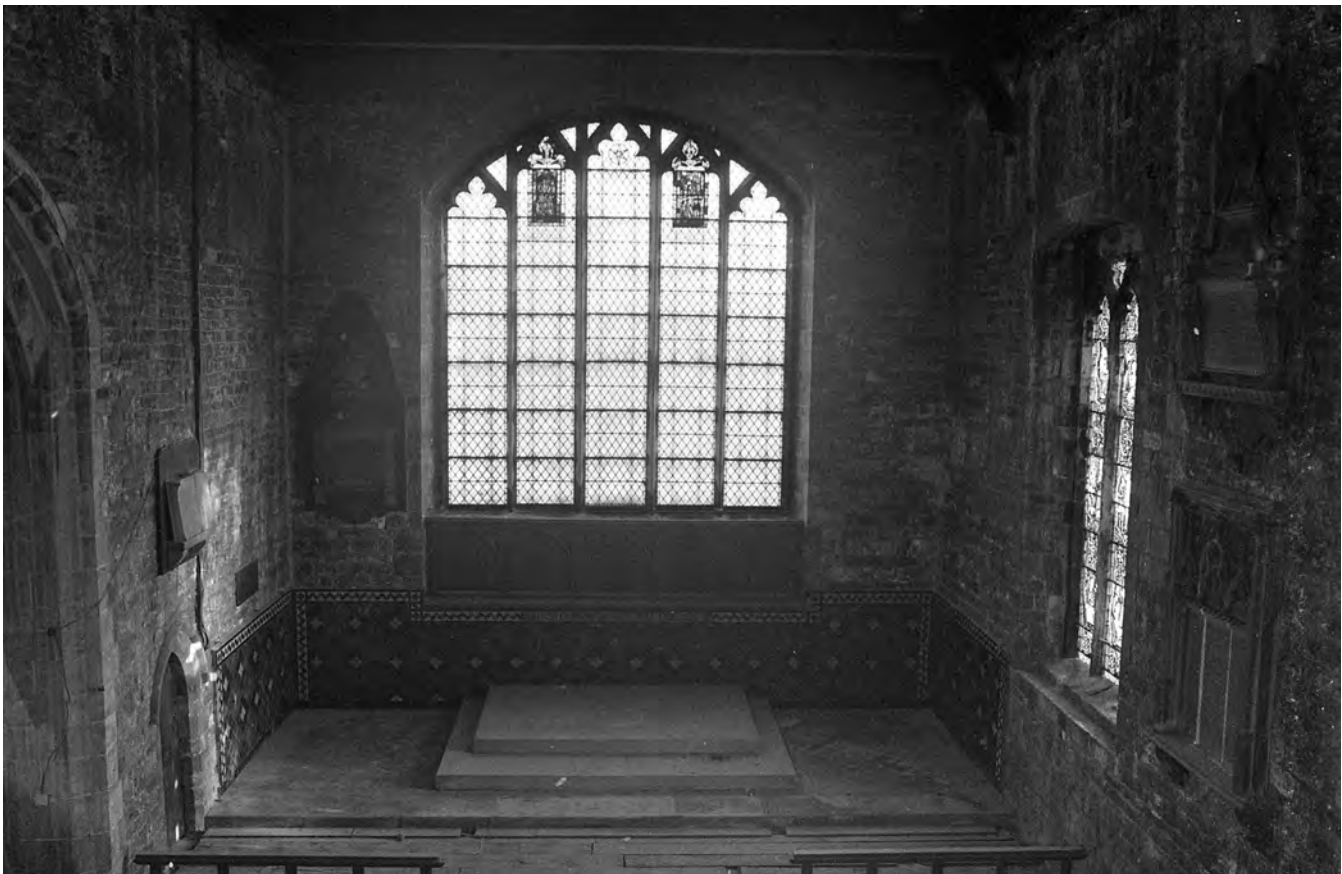
Fig. 535: Chancel. Interior looking east from the screen, 1983. Photo: Warwick Rodwell

Internally, the chancel walls were stripped of plaster in the nineteenth century, revealing their construction of coursed limestone and chalk (Fig. 535). No architectural features, such as a piscina, sedilia or tomb-recess, are visible in the walls. Nevertheless, it can hardly be doubted that a piscina and sedilia were present in the south-east corner, where Victorian wall-tiling now obscures the evidence. However, since nothing shows in the masonry above the tiling, it is certain that these features were not on a monumental scale.

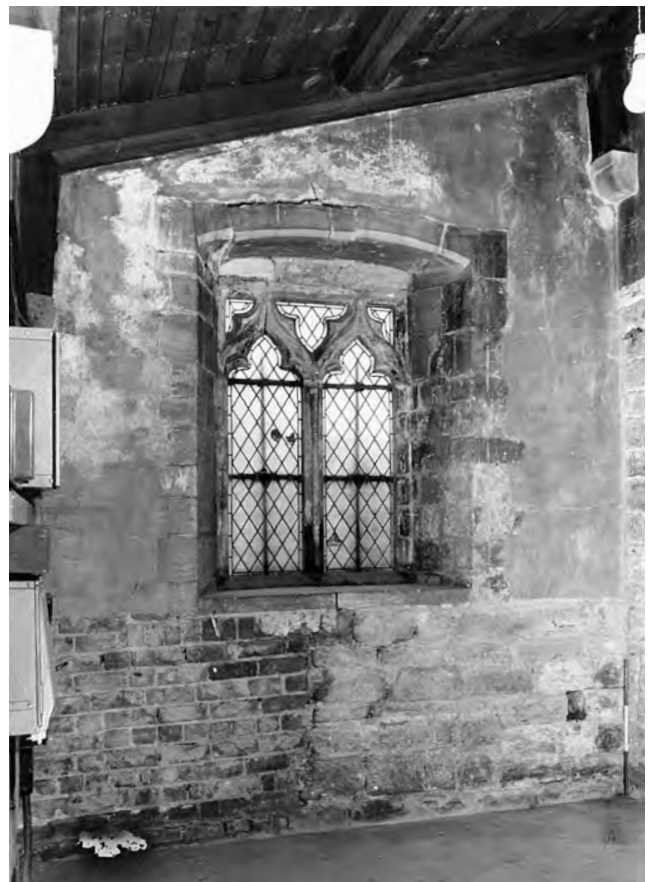
Fig. 537: Vestry. Interior showing the east wall which was partly rebuilt in brick in 1897. Photo: Warwick Rodwell

The four lateral windows of the chancel are all square-topped, and have three trefoil-headed main lights and half-quatrefoils in the tracery. Superficially, they resemble truncated versions of the reticulated fenestration of the north aisle. However, they are not derived from the same templates: the lights in the chancel are a little narrower and the cusping of their trefoiled heads is slightly different. The window sills (including those now resited in the organ chamber) are broad and have low-angled chamfers, and the mullions are bevelled, with acute angles.⁵⁰ There are hollow-chamfered hood-mouldings with diminutive label-stops in the form of a small pyramid between two horizontal bars.⁵¹ The two-light east window of the vestry is a diminutive version of those in the chancel (Fig. 537).

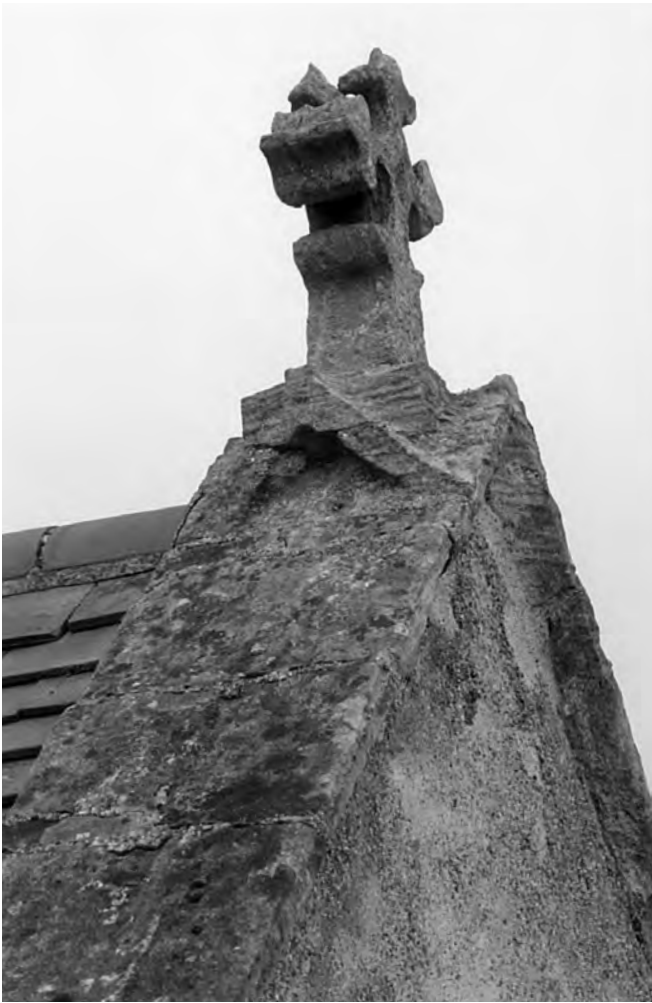
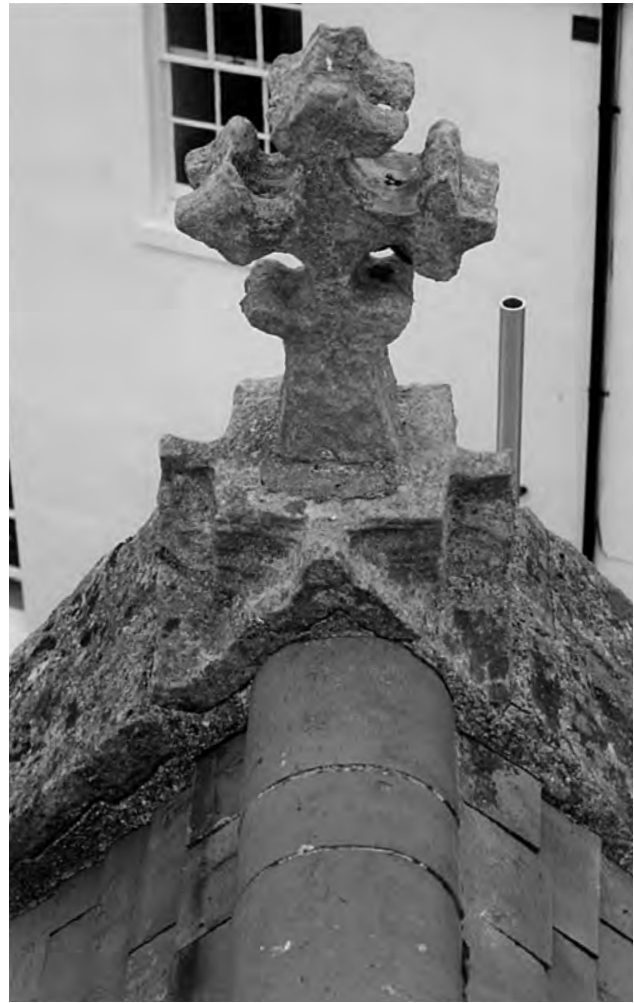
Fig. 539: Western annexe. Two views of the gable cross. Photos: Warwick Rodwell

It is likely that the western annexe was reroofed at the same time as work was undertaken on the tower. No roof timbers survive, but the chamfered limestone gable-coping and its floriated finial cross are fourteenth century. The latter was mentioned in 1832 by Loft.⁵⁶ The cross, which has fleur-de-lys terminals to the arms, has a square stem and rises from a block with four-way gablets (Fig. 539). The west-facing gablet is integrated with the adjacent chamfered coping, while the other gablets are finished with apex-rolls.

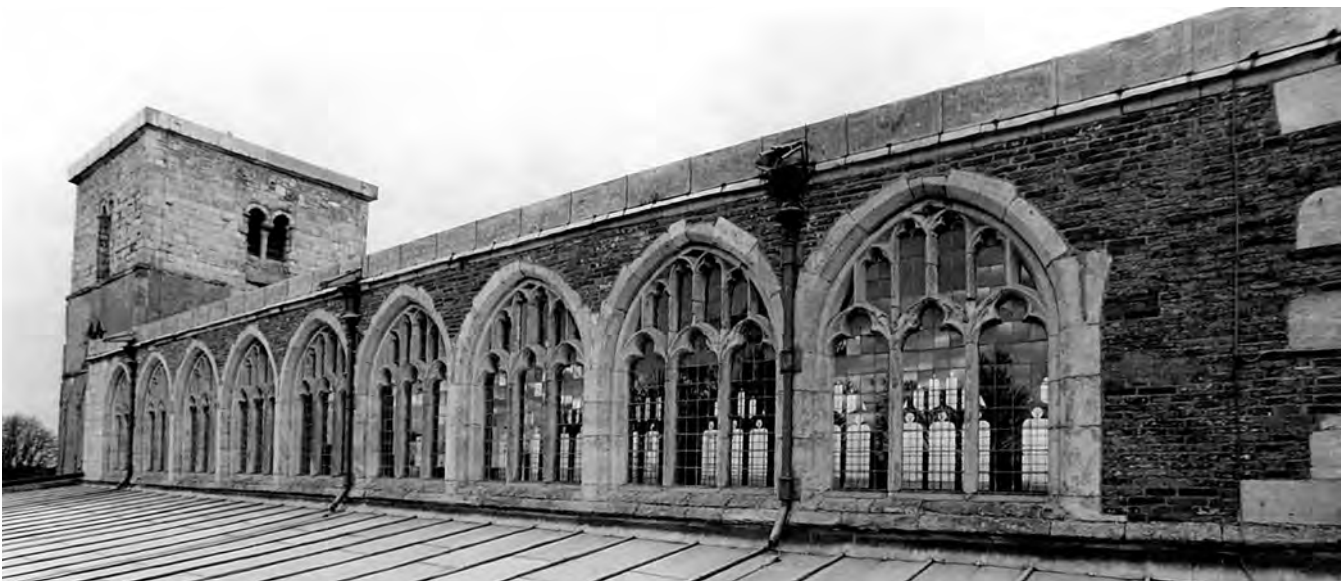
Fig. 541: South clerestory. View from the south-east, 2000. Photo: Warwick Rodwell

The most substantial work, certainly since the building of the Norman nave, was the raising of an elegantly fenestrated clerestory of nine bays (Fig. 541). In order to facilitate this, the nave and aisles were all unroofed, and construction proceeded as a single operation. After the tie-beams and wall-plates had been removed, the tops of the fourteenth-century nave walls were reduced to the apex-levels of their respective arcades: *c.* 50 cm higher on the south than on the north (p. 453). Scaffolding was erected, using rectangular, through-putlogs which were built into the tops of the arcade walls. In the case of the south arcade, the putlogs were laid in the bottoms of the largely destroyed pockets that formerly held the tie-beams.

Again, the remainder of the wall up to sill level was raised in brick, and it incorporated a more regularly spaced line of putlogs. Both clerestories have a limestone chamfered weathering-course on the external face, immediately below window-sill level, to house the lead-flashing of the aisle roof (Fig. 541).

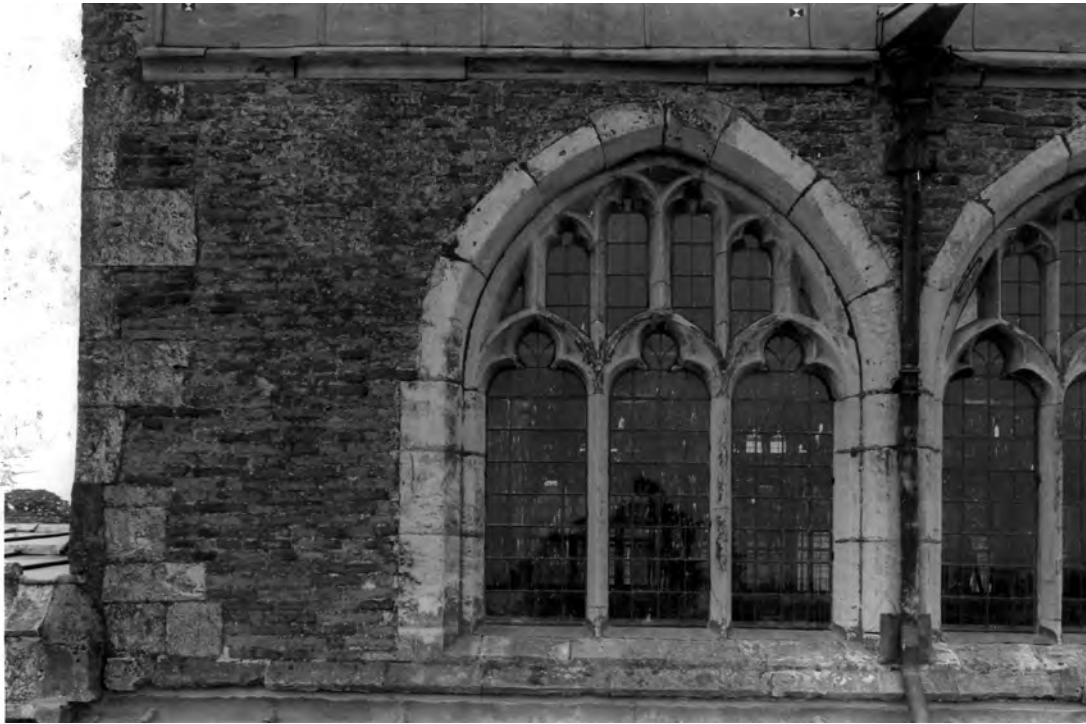
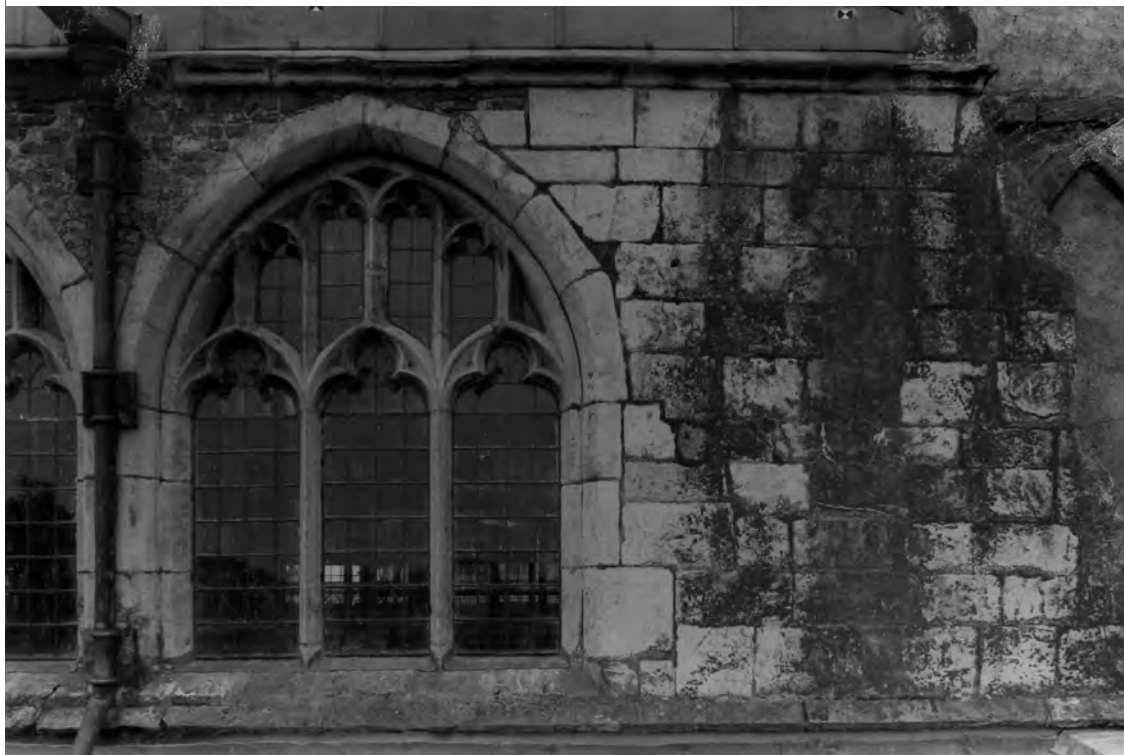
Fig. 542: North clerestory. A, Bay 1 (east); B, Bay 9 (west); showing windows and adjoining nibs of brickwork and ashlar masonry, 1983. Photos: Warwick Rodwell

Unlike at the west end, the nib of wall between the easternmost (ninth) window and the corner was not built of limestone ashlar: brick was used instead, with ashlar reserved for the quoins alone (Figs. 542A and 543B). Even then, brick was employed at a low level in the quoins, where they were abutted and concealed by the parapets of the chancel and aisles.⁶¹ The clerestory is closed on the east by a plain brick gable-wall, which is carried by the chancel arch and rises well above the chancel roof (Figs. 457 and 590).

The abutment of the aisle leads to the clerestory was sealed by a continuous limestone weathering-course, immediately below the window sills (Fig. 542).

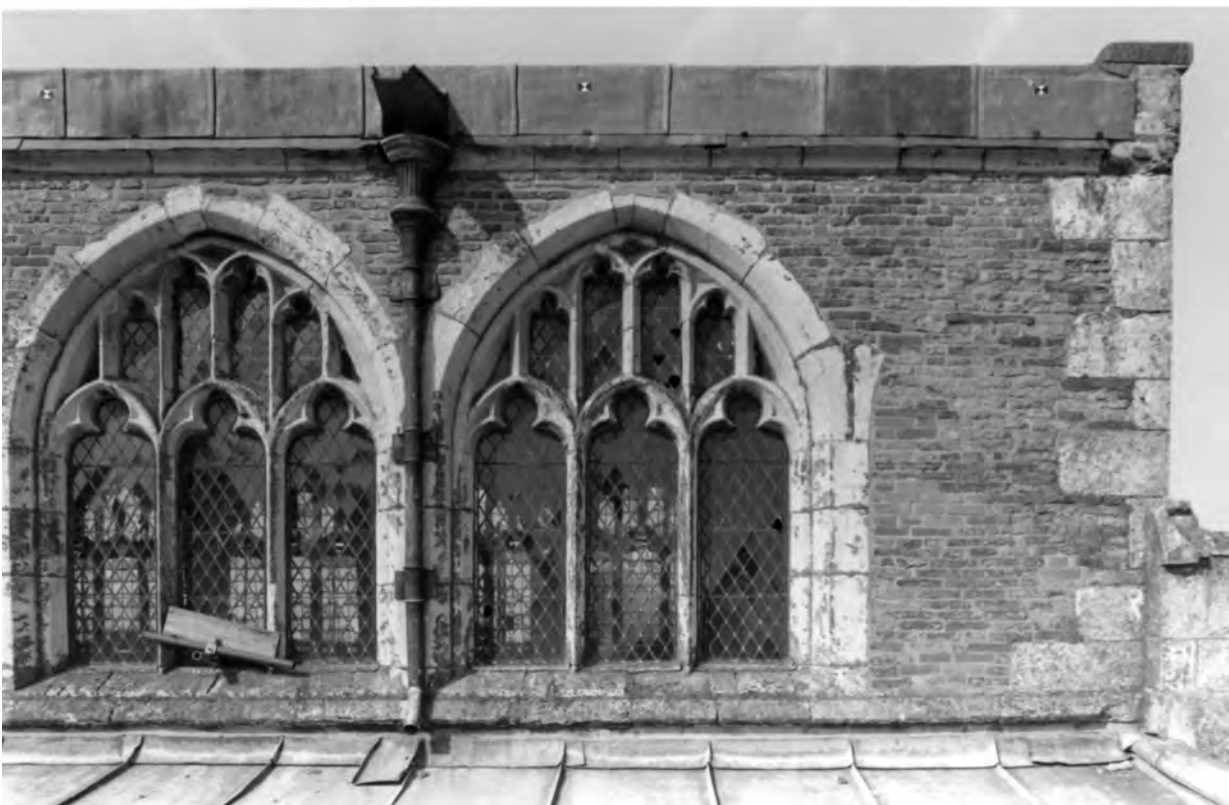
B

Fig. 543: South clerestory. A, Bay 9 (west); B, Bay 1 (east); showing windows and adjoining nibs of brickwork and ashlar masonry, 1980. Note also the springing for an unbuilt tenth bay to the east. Photos: Warwick Rodwell

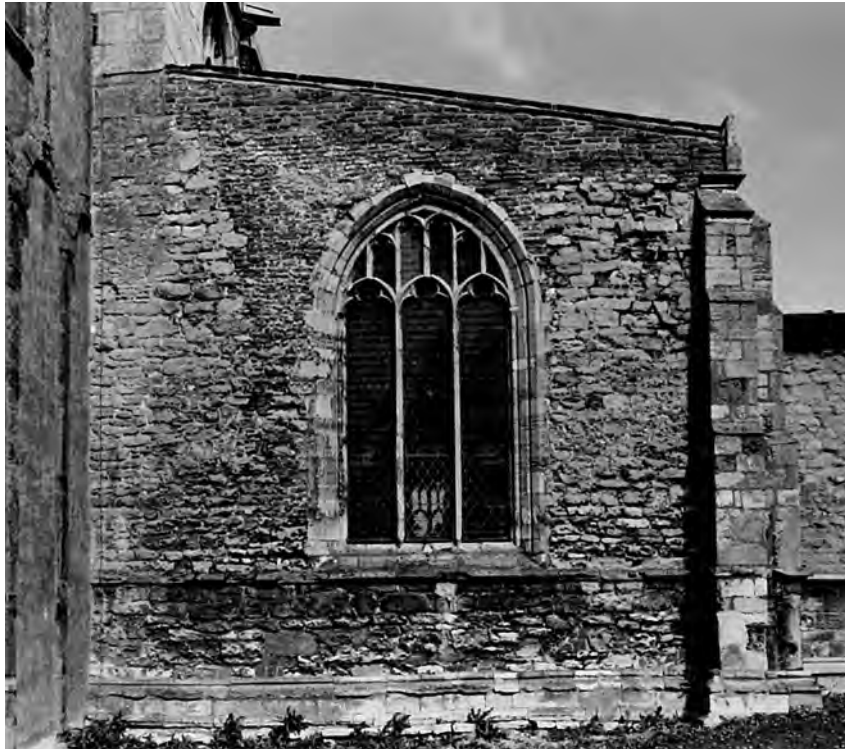
Fig. 545: South aisle. Modified west window, with partial rebuilding of the wall above in brick; unrestored, 1999. Photo: Warwick Rodwell

The upper part of the west wall was taken down and rebuilt, including the head and one jamb of the three-light window (Figs. 456 and 545). It is not apparent why this rebuilding occurred, except that there was obviously a problem relating to the window. It may simply have been a desire to increase the height of the main lights, and thus provide better proportions for painted figures in the glazing, the thirteenth-century lights being decidedly stumpy.

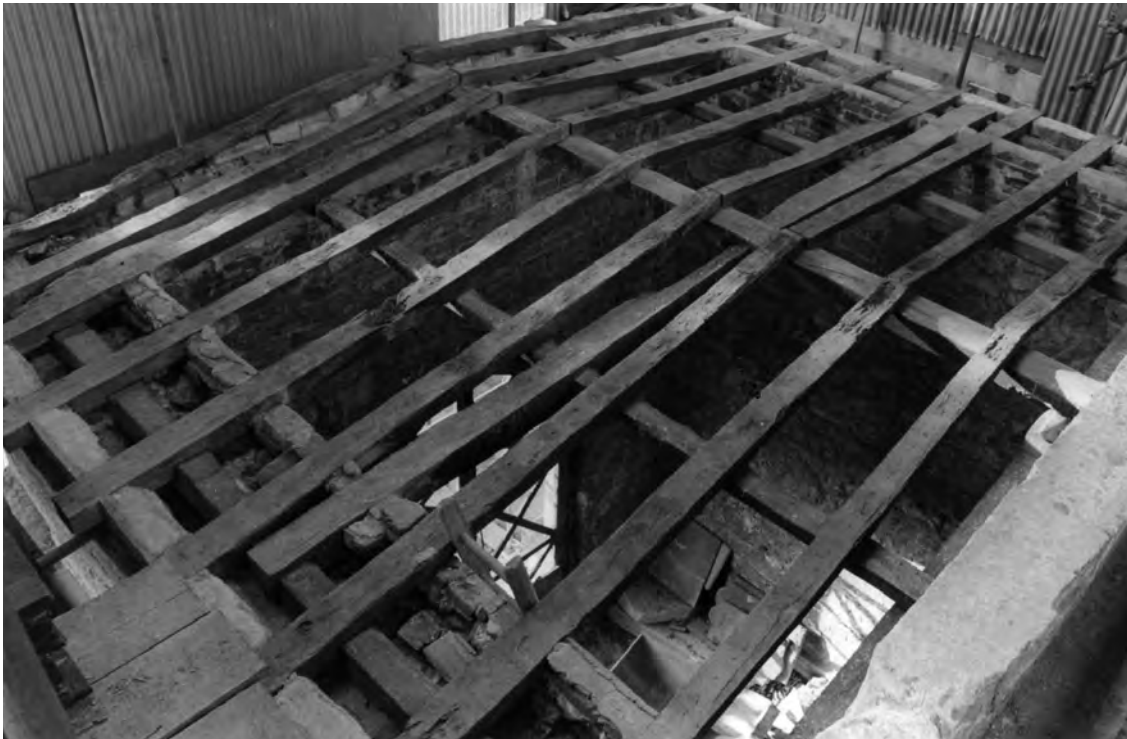
Fig. 546: South porch. View of the roof, from the north-east, after stripping the lead and boarding, 1983. Photo: Warwick Rodwell

the ends of six rafters oversailing the west wall (Fig. 11). The structure was studied when the lead and boarding were stripped in 1983 (Fig. 546).

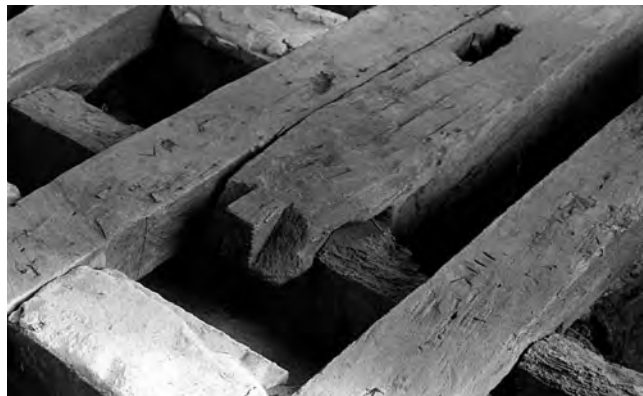
Fig. 547: South porch roof. Detail of reused timber (with mortice on the upper side) at the south-west corner of the roof; view looking north-east. Photo: Warwick Rodwell

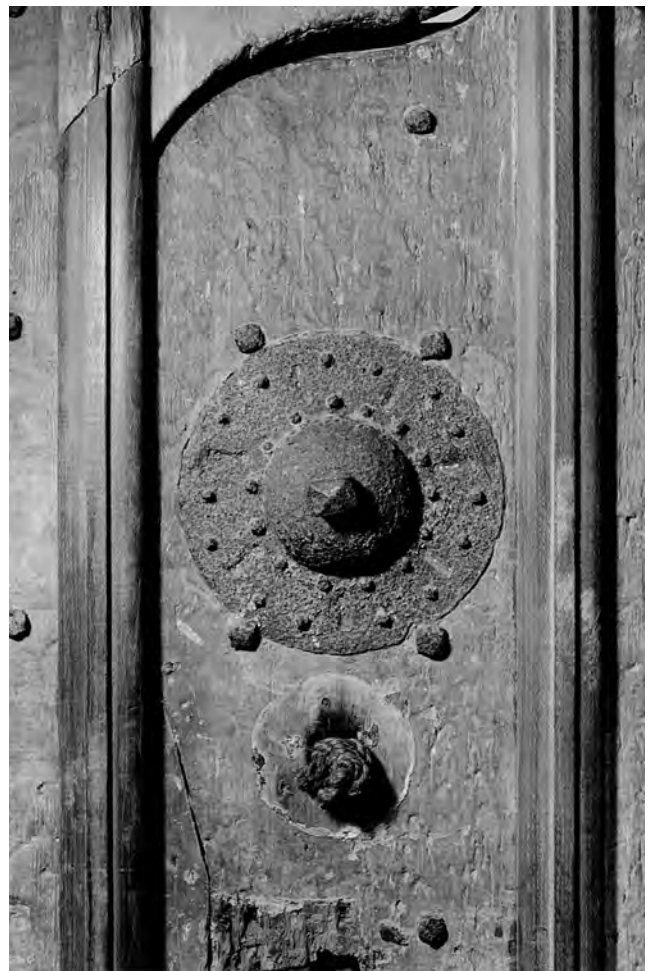
Fig. 549: North door, detail of wicket. Ornamental studwork on the exterior and the pierced iron backplate of the medieval closing-ring. Photo: Warwick Rodwell

On the exterior of the wicket are the remains of the original iron closing-ring with an umbo-shaped, pierced backplate secured with small nails; the ring itself is missing (Fig. 549). Internally, evidence for the primary securing arrangements for both the door and the wicket are preserved. A box-lock (now missing) was fitted to the wicket and the associated keep, which still survives, was mounted on the door alongside. The main door was secured by a short, square-section bar, one end of which was formed into a ring and was attached to a staple driven into the masonry of the east jamb; the free end of the bar latched into the keep

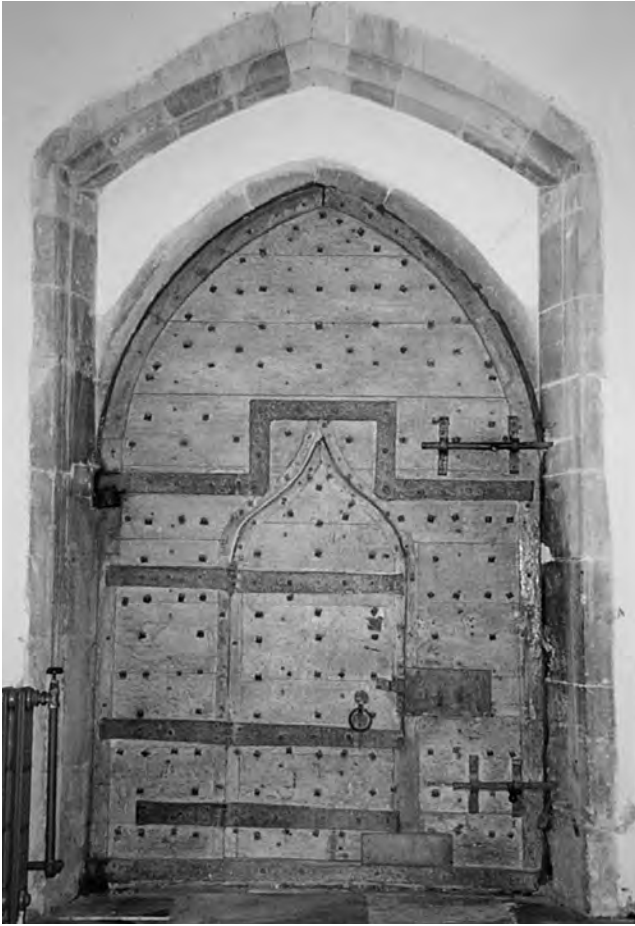
Fig. 550: *St Mary, West Walton (Norf.)*. Interior of a door of similar construction to that in the north aisle at *St Peter's*. Photo: Warwick Rodwell
