ST PETER'S

Barton-upon-Humber, Lincolnshire

A Parish Church and its Community

HISTORY, ARCHAEOLOGY AND ARCHITECTURE

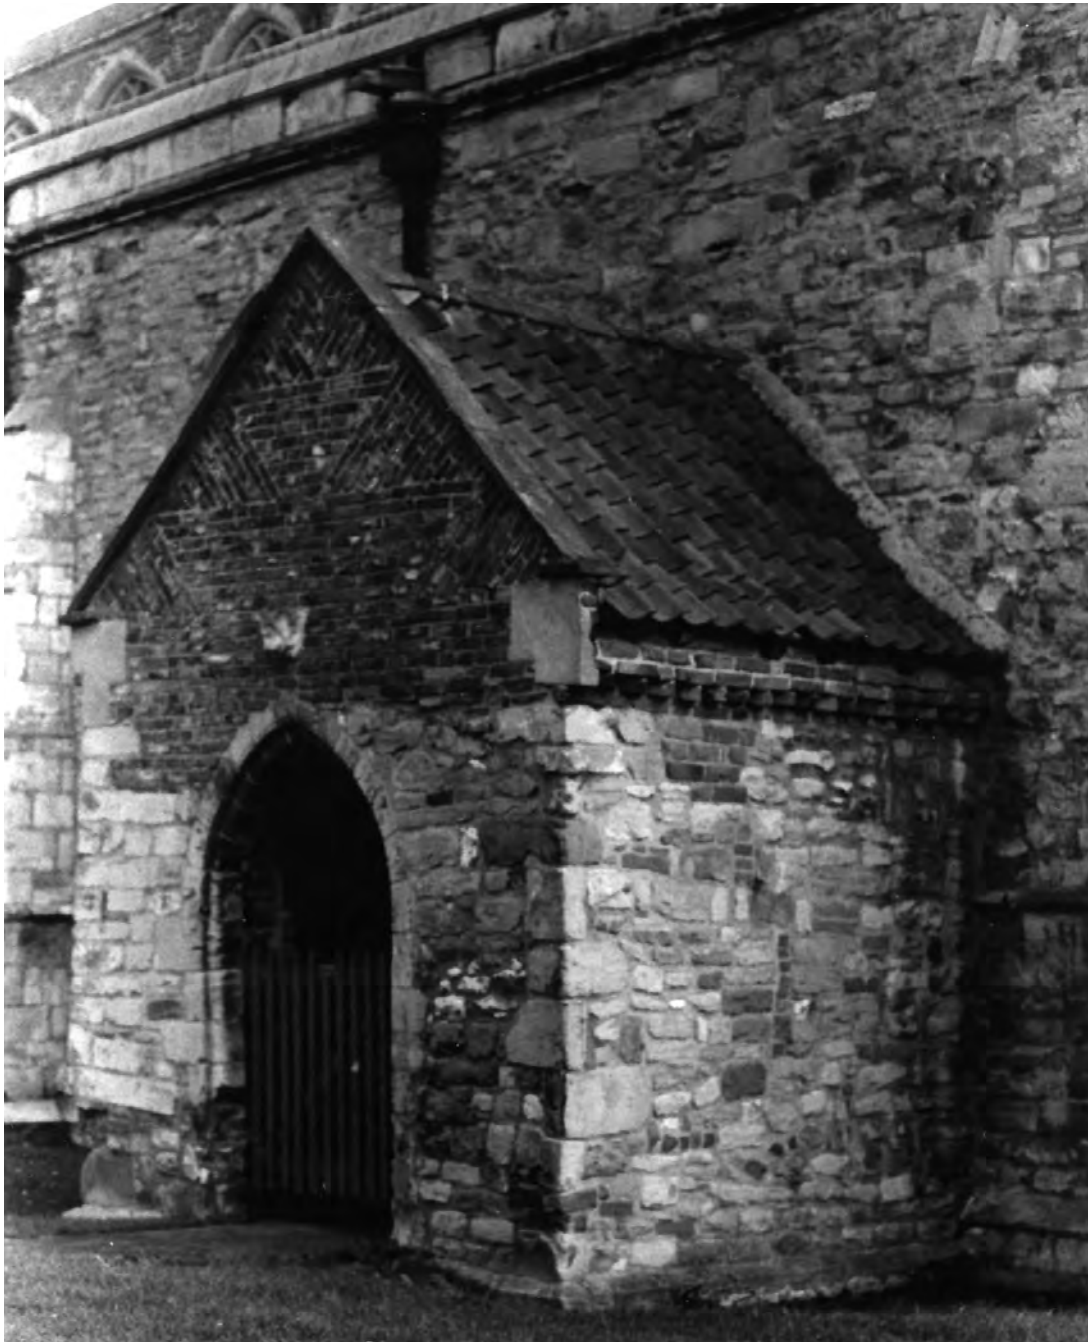
Fig. 551: North porch. View from the north-west, 1999. Photo: Warwick Rodwell

The small, very plain north porch is secondary to the construction of the aisle, and its east wall incorporates one of the aisle's buttresses (Figs. 455, 464, 551 and 552).⁹¹ The porch has a simple chamfered limestone plinth which rides over the lower chamfer of the aisle plinth. The walls are constructed of mixed rubble, but with some coursed limestone slabs in the lower part of the east side.⁹² Substantial refacing has occurred, especially on the east (which is now mainly eighteenth-century brick), and the north-east quoin was rebuilt at a time when the churchyard level had risen by some 60 cm above the plinth. The north gable has also been rebuilt in brick, replacing timber framing (Fig. 553): the three walls of the medieval porch were all of the same height, and there was never a stone gable.

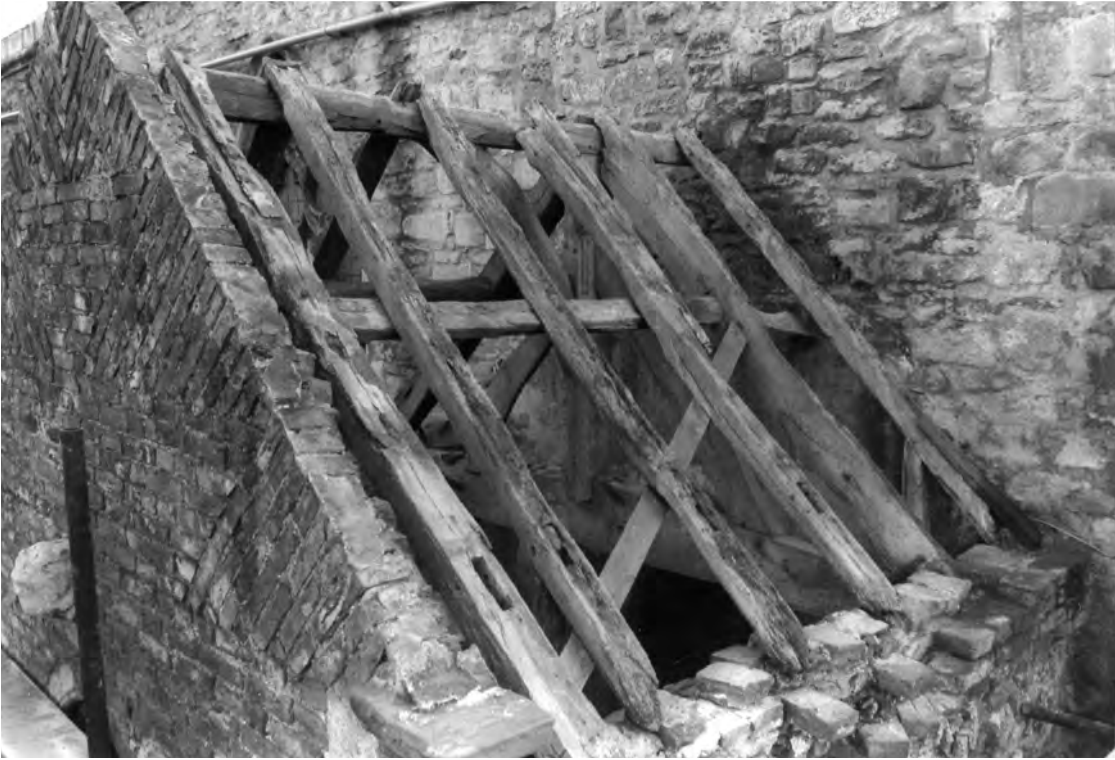
Fig. 553: North porch roof. Viewed from the north-west during repair, 1983. Photo: Warwick Rodwell

The oak roof is of crude construction but is nevertheless medieval, and is undoubtedly original to the porch; unfortunately, the timbers are flimsy, knotty and contain too few rings to permit dating by dendrochronology (Tyers 2001b). The roof is a structure of one bay, but there is a single crown-post truss placed a short distance away from the north wall of the aisle (Fig. 554),⁹³ and there was formerly a complementary gable-truss over the outer entrance, now superseded by the thin brick gable. The crown-post is tenoned directly into the ridge, which is also clasped by the principals. A brace links the crown-post to the ridge on its north side, and there was also a corresponding brace

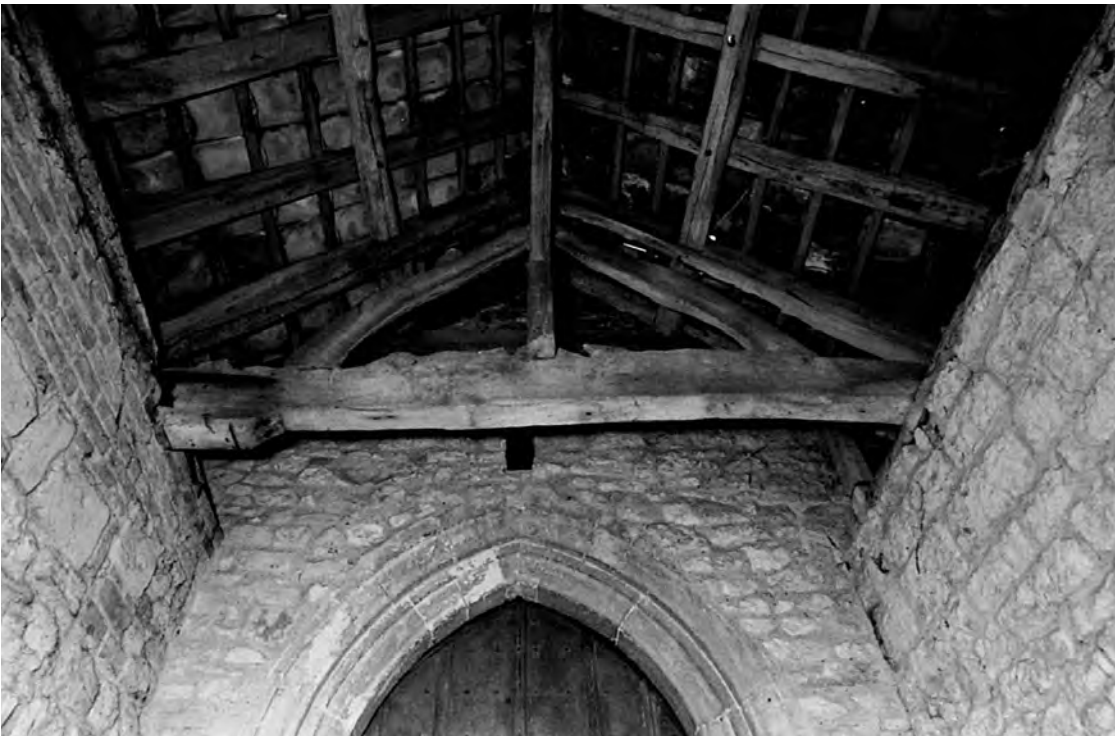
Fig. 554: North porch roof. View of the underside, 2000. Photo: Warwick Rodwell

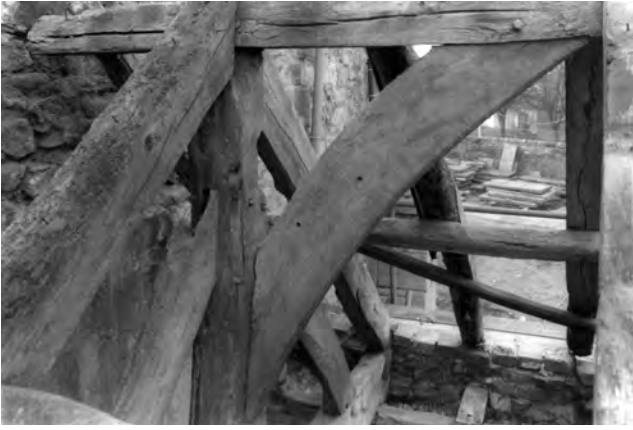
Fig. 555: North porch roof. Detail of the crown-post truss, from the north-east. Photo: Warwick Rodwell

rising from the gable truss to the ridge (Fig. 555). The plain rectangular crown-post sits awkwardly on the tie-beam (which has a narrow, rectangular cross-section) and is braced by two struts.⁹⁴ Butt-purlins run between the main and gable trusses, and short lengths of purlin span the gap between the main truss and the aisle wall.⁹⁵ There were pairs of wallplates on each side, with sole-pieces connecting them: only the inner plates survive, and short ashlar-pieces rise from these to the undersides of the rafters. The latter are face-pegged to the purlins.⁹⁶ The east end of the tie-beam decayed and an oak knee was inserted to provide support, most likely in the seventeenth century; it has an ogee moulding on its end and is nailed to the tie-beam.

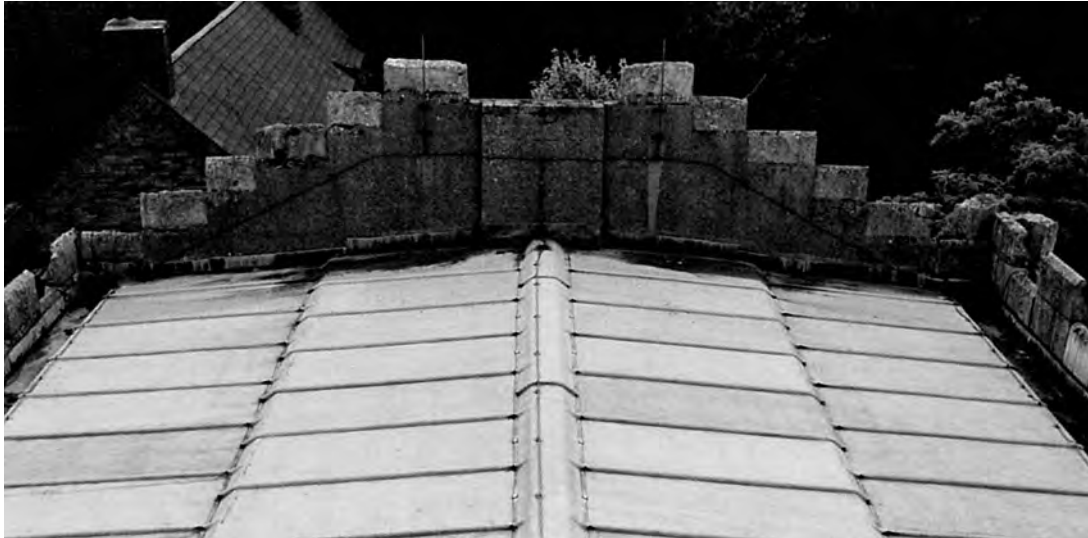
Fig. 557: Chancel roof. Back of the crow-stepped east gable, as reconstructed in the nineteenth century. Photo: Warwick Rodwell

south aisle. The same apparently occurred on the north, but the aisle lost its eastern parapet when the Victorian organ chamber was added. The existing crow-stepped east gable to the chancel is a late nineteenth-century reconstruction of an earlier feature, using a mixture of medieval copings and new brick (Fig. 557).

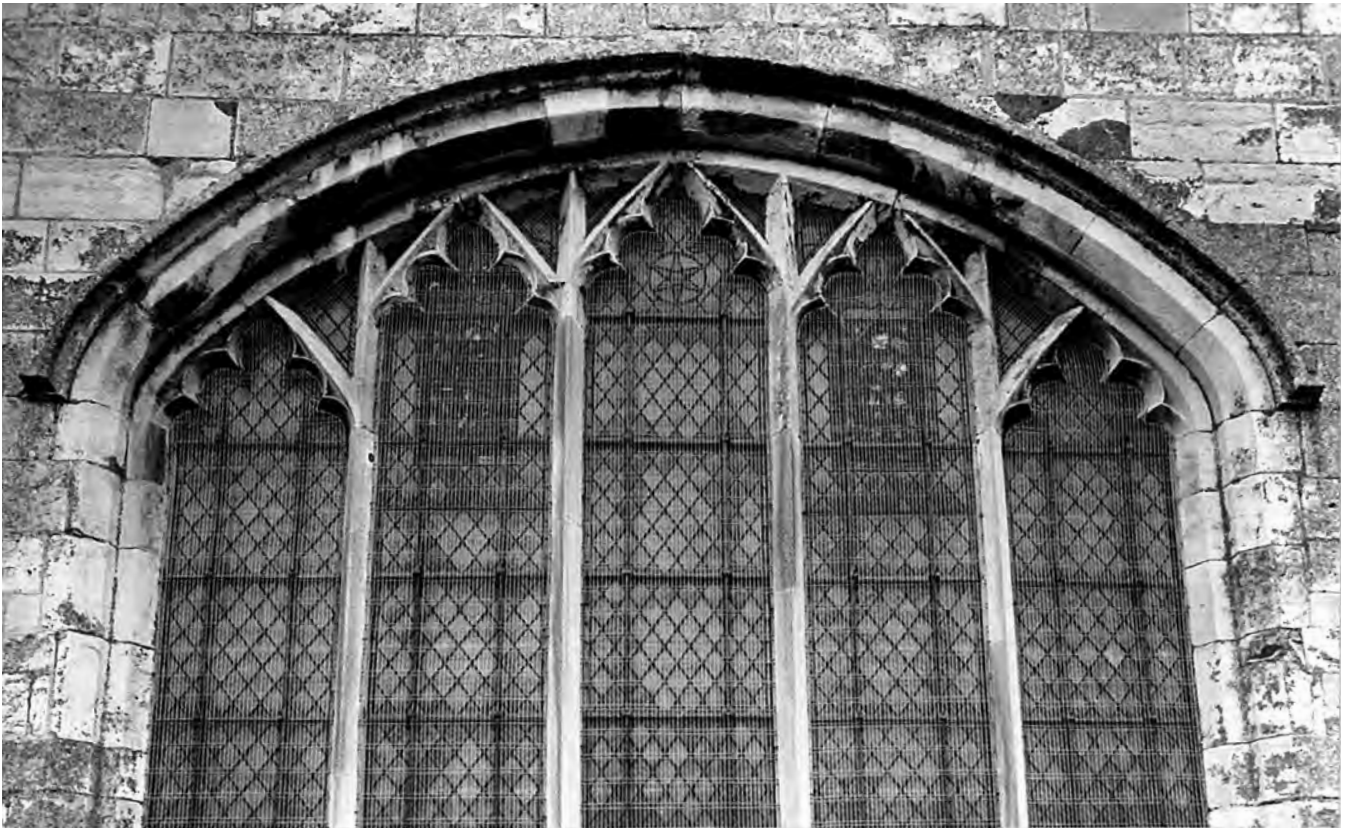
Fig. 559: Chancel east window. Late Perpendicular head and tracery, replacing Decorated tracery. Photo: Warwick Rodwell

constructed (Figs. 50, 21 and 559). The window has five cinquefoil-headed lights that are wider than all the others in the church, and the chamfered mullions are acutely angled. The original sill has gone, and four bevelled courses of masonry (the uppermost being the new sill) have been inserted in the opening, between the jambs (Fig. 534). The head is three-centred and has a hollowed hood-moulding with short returns, but no label-stops.

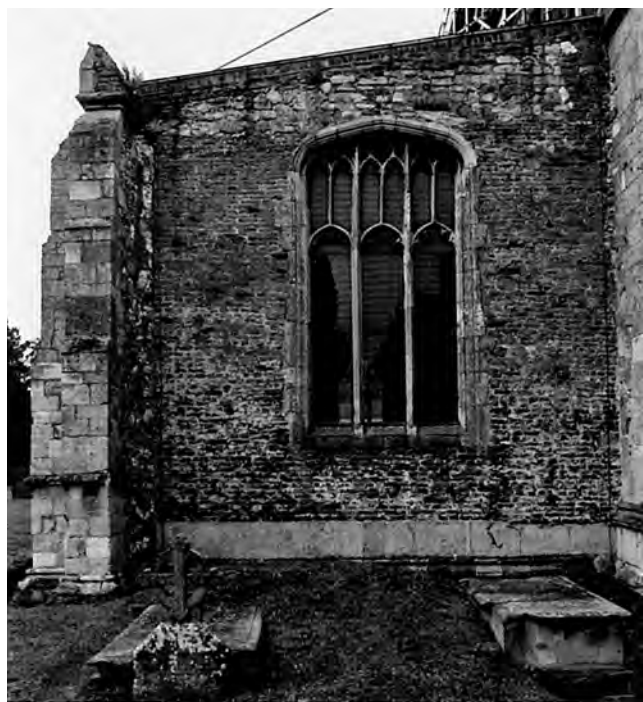
Fig. 561: South aisle. East wall unrestored, 1999. Photo: Warwick Rodwell

The thirteenth-century east wall of the south aisle was completely taken down and rebuilt 80 cm to the west of its original position. The south-east corner of the aisle, with its clasping buttresses was, however, left intact (Figs. 561 and 562). The reason for repositioning the

Externally, the wall is largely faced with Tudor brick, laid to English bond (Fig. 561),¹⁰⁵ while internally it is mainly constructed of small, roughly squared blocks of limestone with about a ten per cent inclusion of chalk blocks (Fig. 459);¹⁰⁶ three tiers of putlog holes are present. The wall was clearly intended for plastering on both faces. The new east wall rests on the thirteenth-century moulded limestone plinth, which was reclaimed from the old wall; the plinth is surmounted by a single course of large limestone ashlar (Fig. 563). The top of the wall, above the window head, is a later rebuild in mixed rubble and brick, and now has a plain modern parapet, but was previously finished with the same roll-topped stone coping as the south wall of the aisle.¹⁰⁷

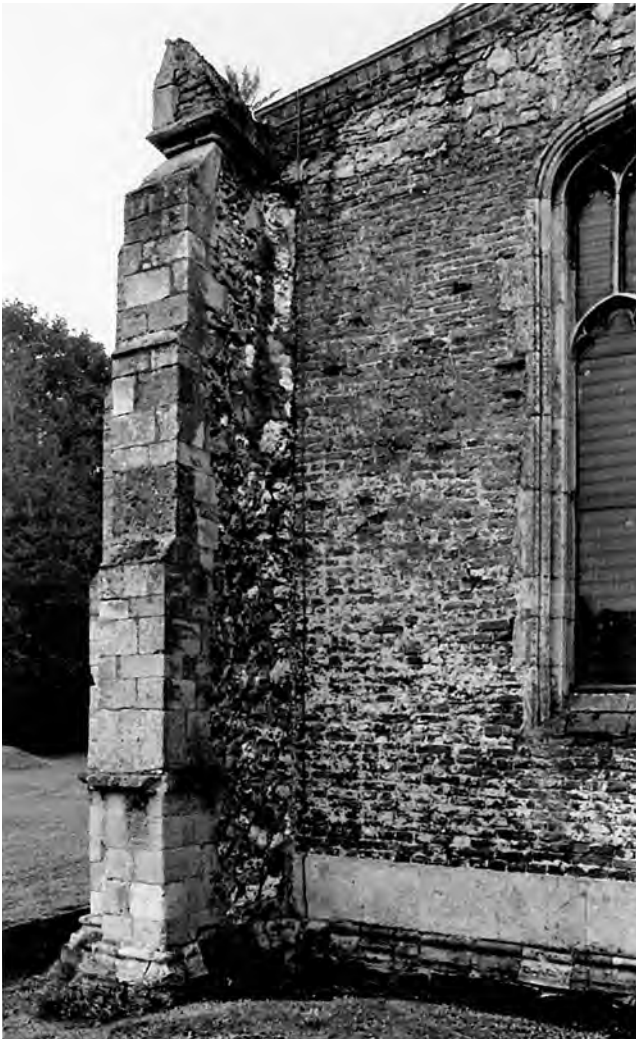
Fig. 562: South aisle. Detail of the south-east clasp buttress, showing how the Tudor east wall was set further west than its predecessor, leaving a rubble scar on the side of the buttress. Photo: Warwick Rodwell

east end of the aisle was to provide support for the lateral thrust of the relatively new chancel arch, which was apparently showing signs of structural failure. Its southern end was sinking into the soft filling of one of the underlying Anglo-Saxon ditches, probably the same one that caused distortion in the east end of the north aisle (p. 474).

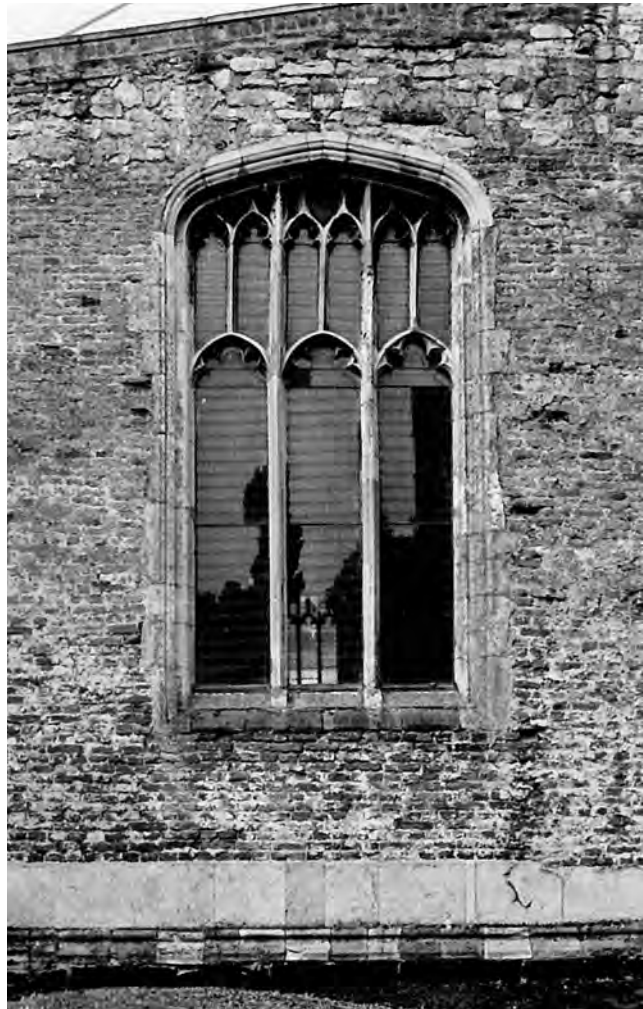
Fig. 563: South aisle. Detail of the east window, 1999. Photo: Warwick Rodwell

The thirteenth-century east window was discarded and a new one incorporated in the rebuild; the glazing is set at the mid-point of the wall's thickness, and the complex mouldings extend symmetrically to both faces (Figs. 50, 19, and 563). The same distinctive, fine-grained, yellow limestone was used as occurs in the clerestory and chancel arch. The window has three cinquefoil-headed main lights and six small ones in the tracery. The four-centred arch, jambs and principal mullions are all moulded, but there is no label. The mullions rise from sill to head without interruption; they have thin, filleted frontal rolls. The sill has two chamfered orders and the block-stoolings are very prominent.

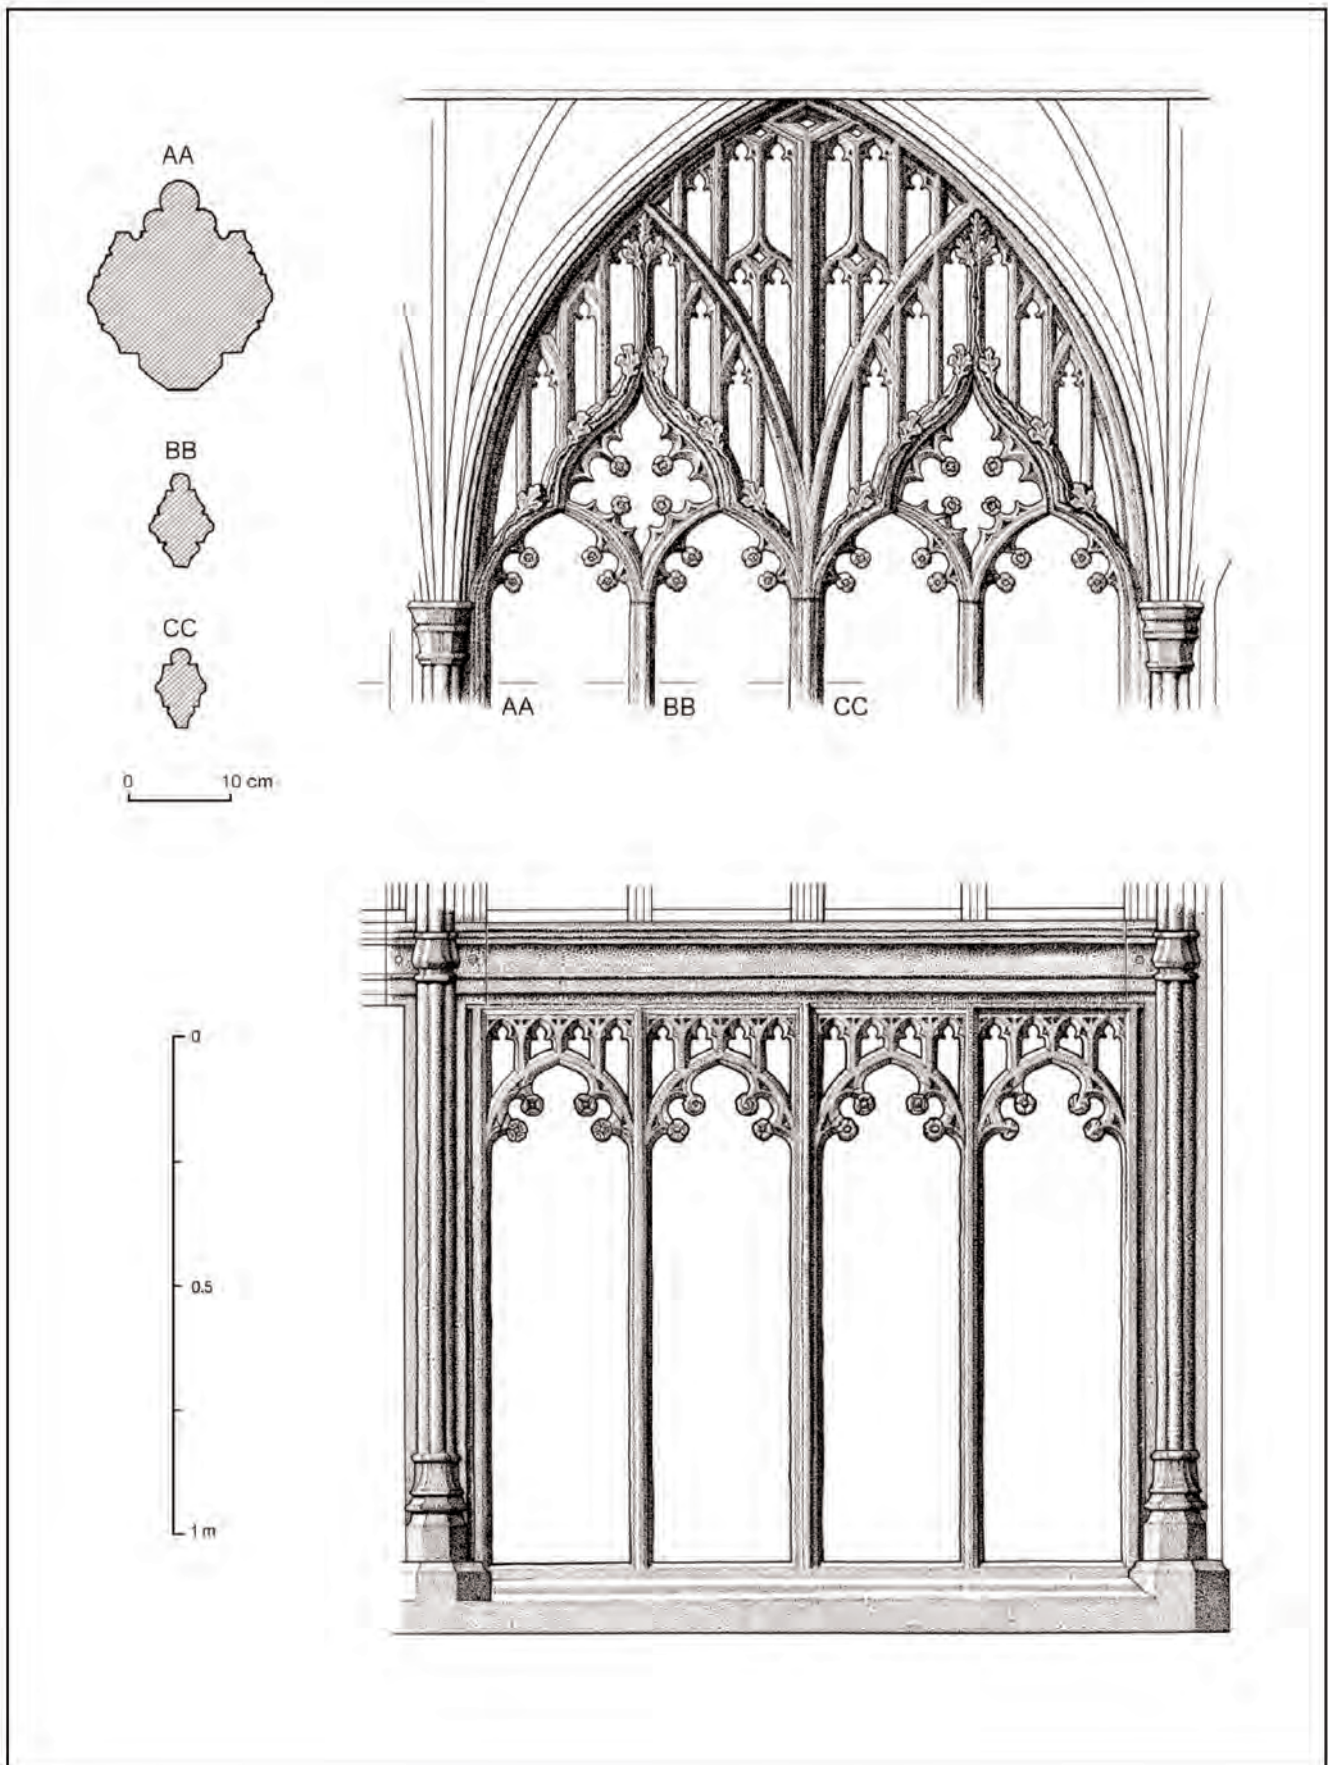
Fig. 565: Chancel screen. Detail of the traceried upper and lower registers of one bay (west face). Scale 1:15; moulding profiles 1:7.5. Drawing: Simon Hayfield

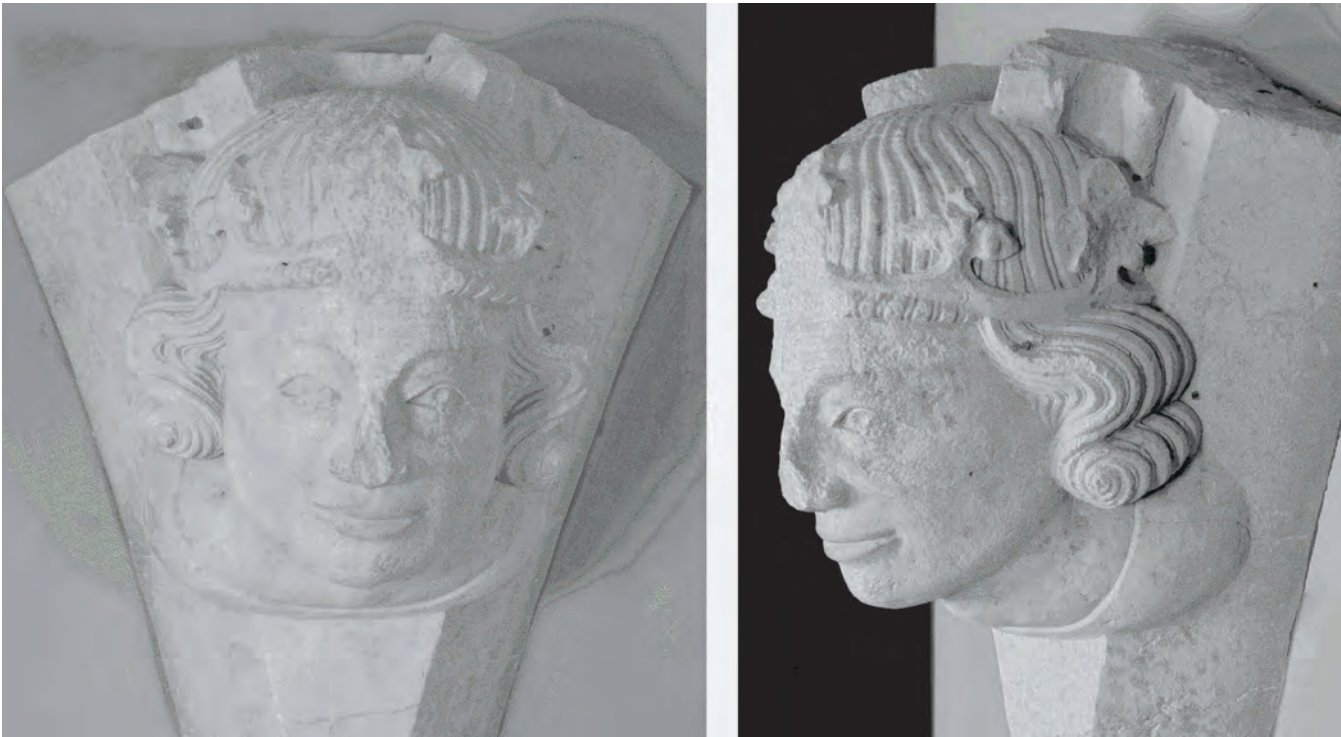
Fig. 568: Thornton Abbey (Lincs.). Arcade label-stop: king's head. Photos: English Heritage

Thornton include the pointed and slightly receding chins of the Barton males, and in particular their full and somewhat pouting lips. The more subtle carving at Thornton is exaggerated at Barton into a definite local characteristic.

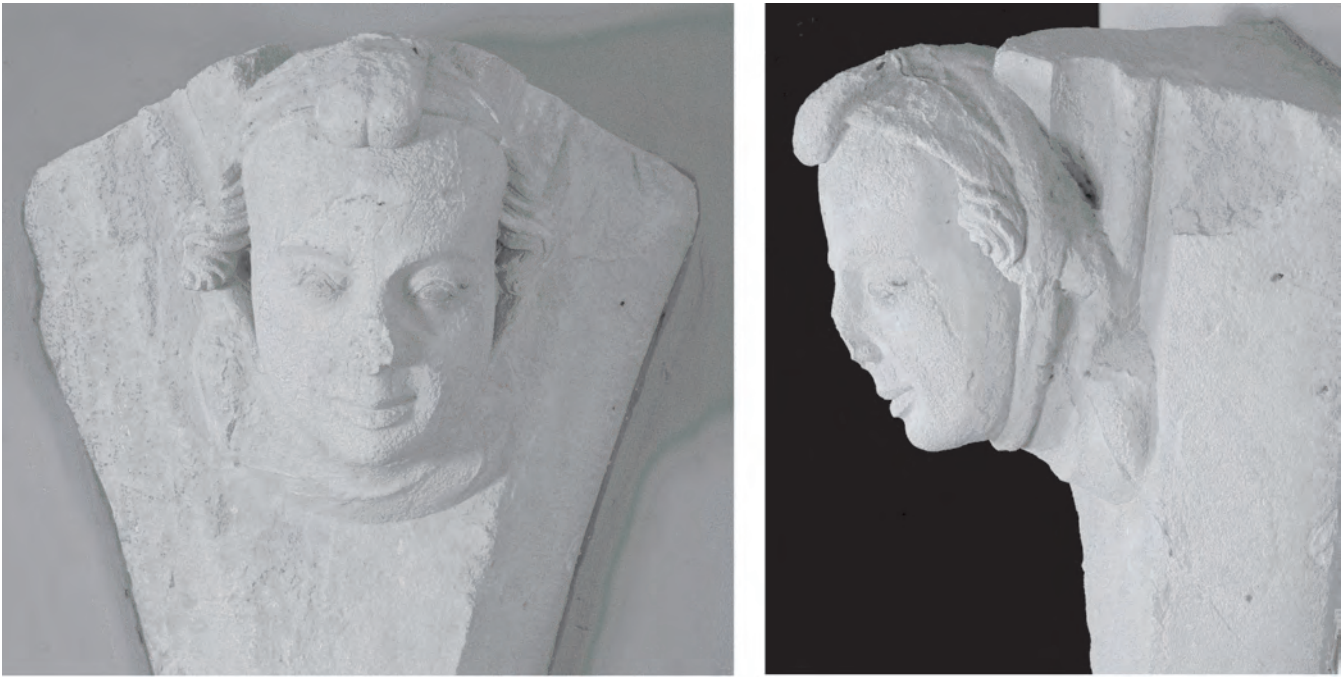
Fig. 569: Thornton Abbey (Lincs.). Arcade label-stop: male head. Photos: English Heritage

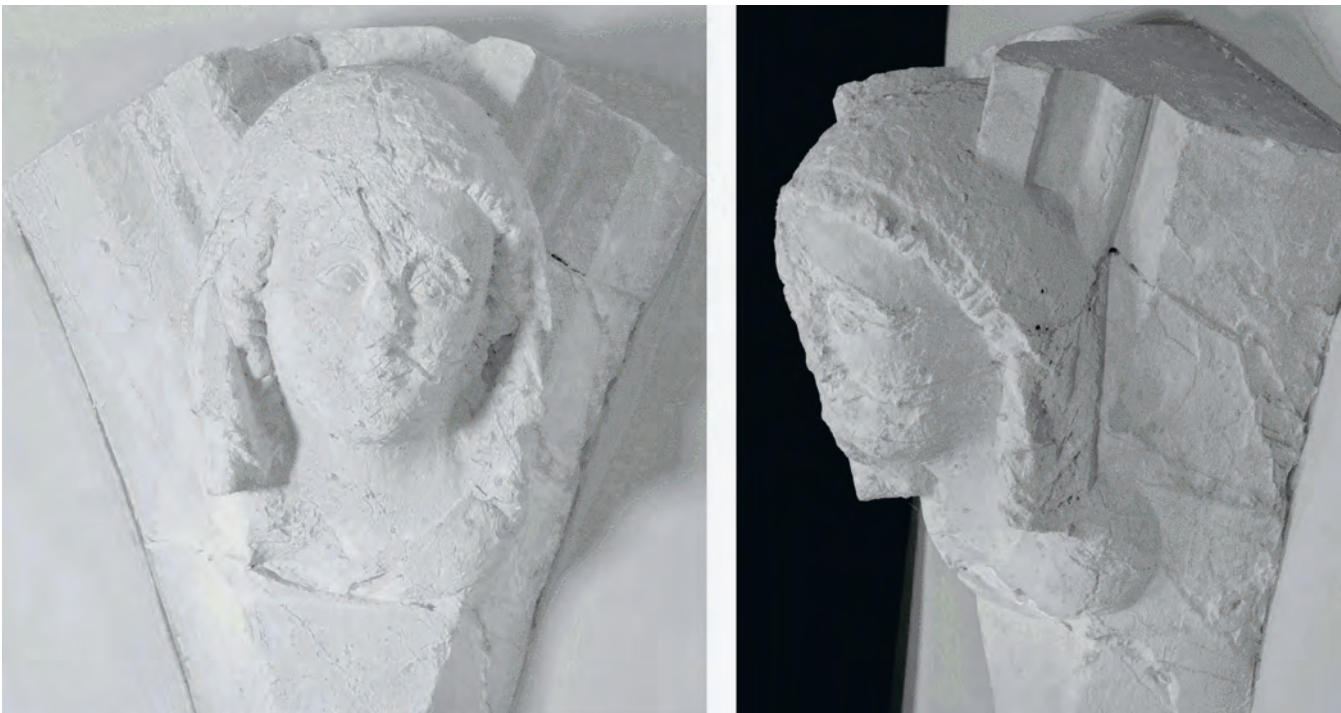
Fig. 570: Thornton Abbey (Lincs.). Arcade label-stop: female head. Photos: English Heritage

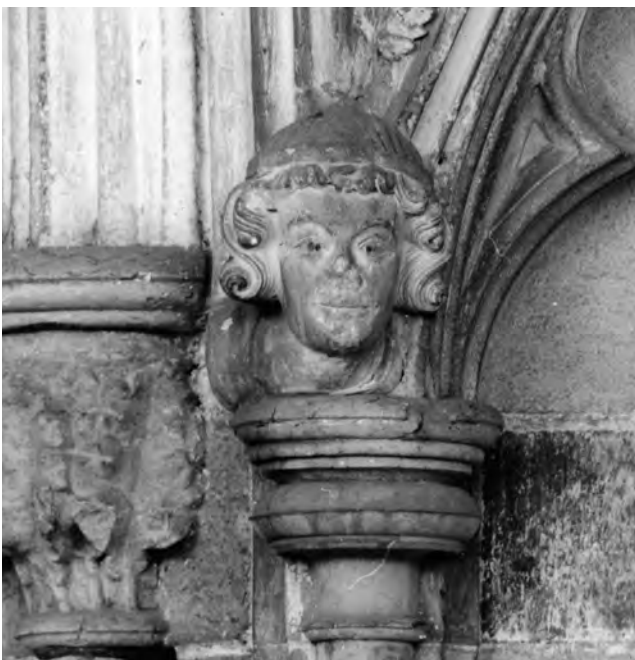
Fig. 571: Wells Cathedral (Som.). Label-stop in the chapter house, depicting a male head wearing a mason's cap. Photo: The Courtauld Institute of Art, London

It is striking that in neither of the Barton churches is there a cleric's head. At St Peter's they may have taken their place in the chancel (although there were no arcades), but at St Mary's there is nowhere for them. The specifically lay and relatively humble nature of one of the most prominent head-stops in St Peter's, no. 7, a youth wearing a cap, could suggest that he was the master mason in the early fourteenth century. Such caps were, however, also worn by scholars. In either case his important place in what we might term the procession of the nave head-stops underlines the lay initiative, and surely patronage, of this part of the building. No doubt things were otherwise beyond the chancel arch where the abbot of Bardney paid, and ruled. A close parallel for the Barton head is found in the chapter house at Wells Cathedral, where coincidentally it is the first head-stop one encounters on the north side. It dates from the first decade of the fourteenth century (Fig. 571).

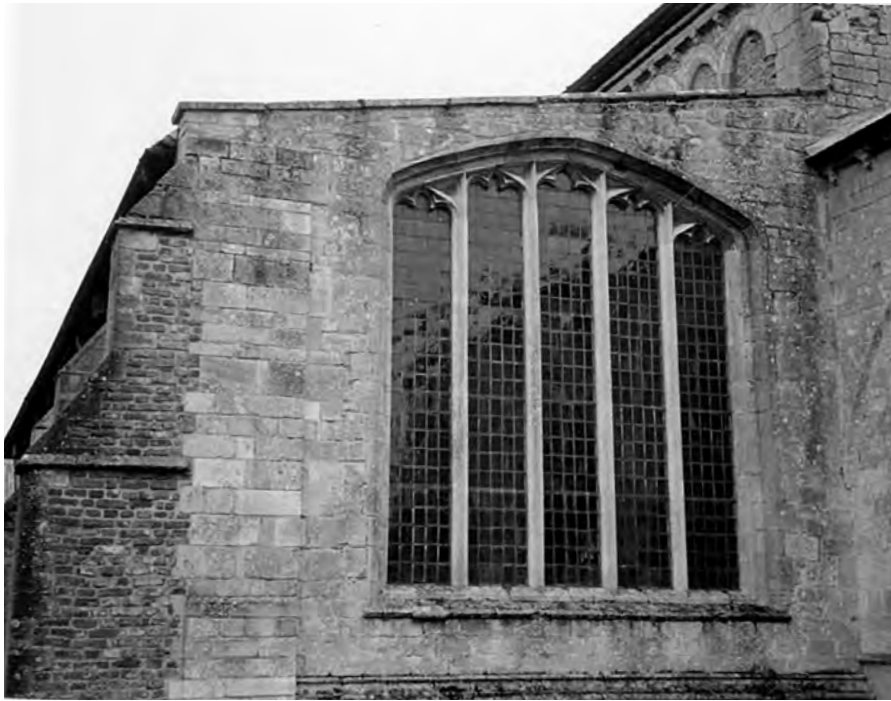
Fig. 574: *St Mary, West Walton (Norf.). Tudor east window of the south aisle. Photo: Warwick Rodwell*

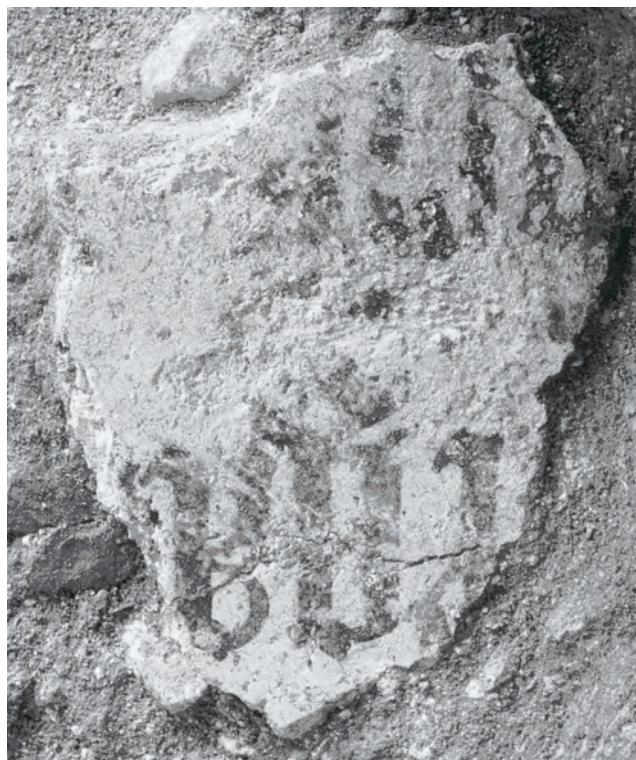
Fig. 575: North porch. Fragment of wallplaster with two lines of a painted black-letter inscription; found under the floor (F3672). Max. width 16.5 cm. Photo: Warwick Rodwell

While there are vestigial traces of medieval polychromy in both St Peter's and St Mary's, nothing is known of decorative schemes in these churches. The sole evidence for post-Reformation texts is provided by a detached piece of wallplaster bearing a few black painted letters, on two lines: it was found in rubble under the floor of the north porch of St Peter's (F3672; Fig. 575).

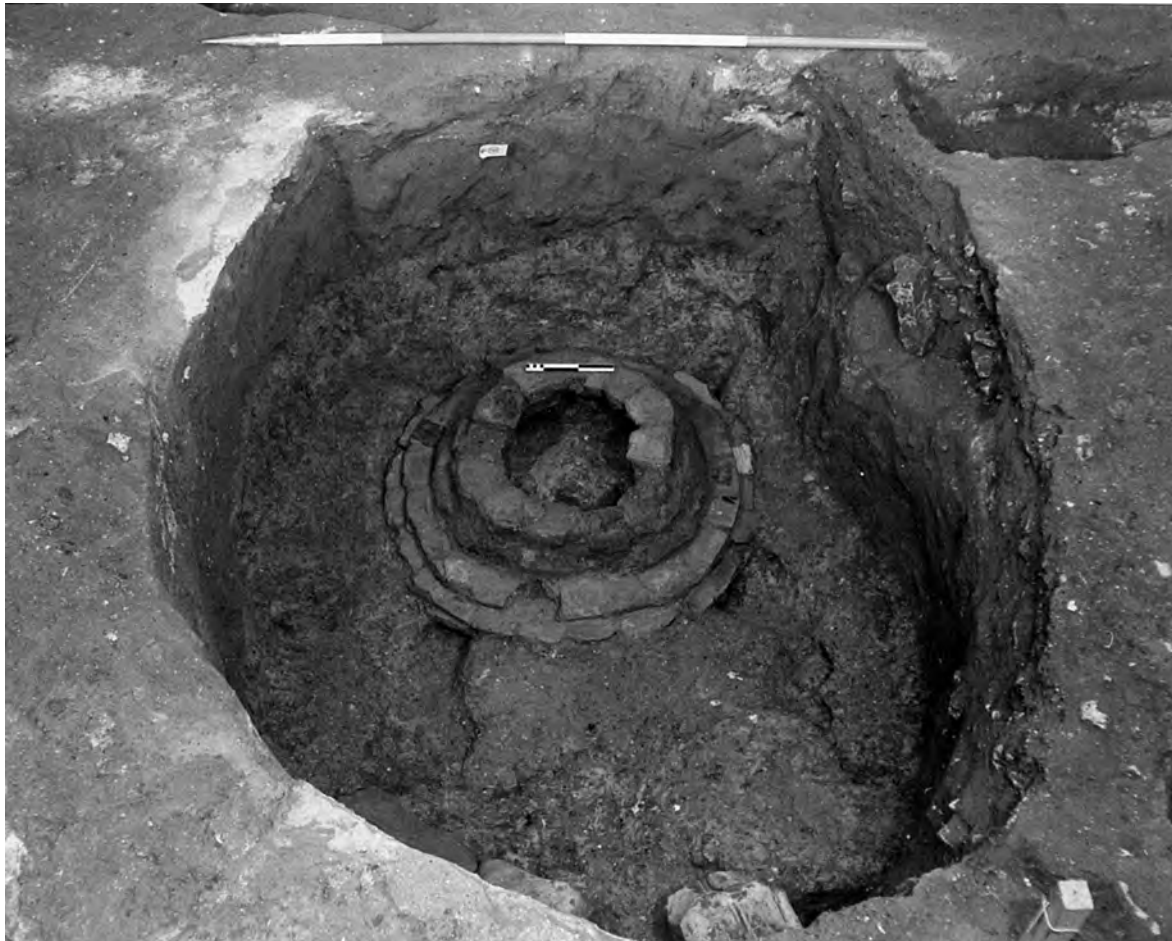
Fig. 577: Tower. Bell-casting pit (F511) with part of the inner core of the bell-mould remaining in situ. View west. Scales of 2 m and 25 cm. Photo: Warwick Rodwell

Excavation revealed a slightly elongated, sub-circular pit, dug into the natural clay close to the centre of the tower floor (F511; Fig. 577). It had near-vertical sides and a flat bottom, and averaged 2.2 m (7¼ ft) in diameter by *c.* 1.0 m (3¼ ft) deep. In the base of the pit (towards the west side) a cone was constructed, reusing broken bricks and fragments of floor tiles, set in a matrix of stiff brown clay (F553) and laid to courses (Fig. 578). Only the lowest five courses of the cone survived intact, and debris from the destruction of the remainder of the feature littered the bottom of the pit. The interior of the cone was hollow and at its centre, in the clay floor of the pit, was a stake-hole 2 cm in diameter by 10 cm deep. Also, dug radially under the base of the cone, from the outside to the hollow interior, were four channels. The tiles, all well worn, were of the fourteenth-century glazed type found in the nave and aisles (p. 459); the bricks were Tudor.

The conical structure was clearly identifiable as the inner core of a clay mould for casting a large bell by the *cire perdue* or 'lost wax' process. There were several different ways of making and handling medieval and later bell-moulds,³ but the relevant particulars in this instance are as follows. The hollow core, which was strengthened by the inclusion of brick and tile rubble, would have been built up to the full internal height of the bell, then coated with a layer of fine clay. The central stake-hole contained an upright stick, acting as an arbor, around which was rotated a wooden template to smooth the clay into the required internal profile of the bell. Next, a thick layer of wax was built up on the core, and another template used to mould and scribe

the wax to correspond to the desired external profile of the bell. The wax now comprised a full-size model of the bell, exact in every detail. Inscriptions and decoration were impressed into the wax, using wooden dies. An outer clay envelope, known as the 'cope' or 'mantle', was then built up over the wax model. Finally, combustible material was piled into the pit and packed around the mould, and a fire was lit. This had two functions: first, to melt the wax that was sandwiched between the inner and outer envelopes of the mould and, second, to drive all the moisture out of the clay. The molten wax drained into the four channels under the base of the mould, where it could be retrieved. Once the mould had been thoroughly dried out, it was ready for casting the bell. A pouring cup to receive the molten metal, and vents for the escaping gasses, were formed in the top of the cope. After casting, and when the metal had cooled, the clay mould (which would have become semi-fired in the process) was smashed and the bell hauled directly up into the tower.

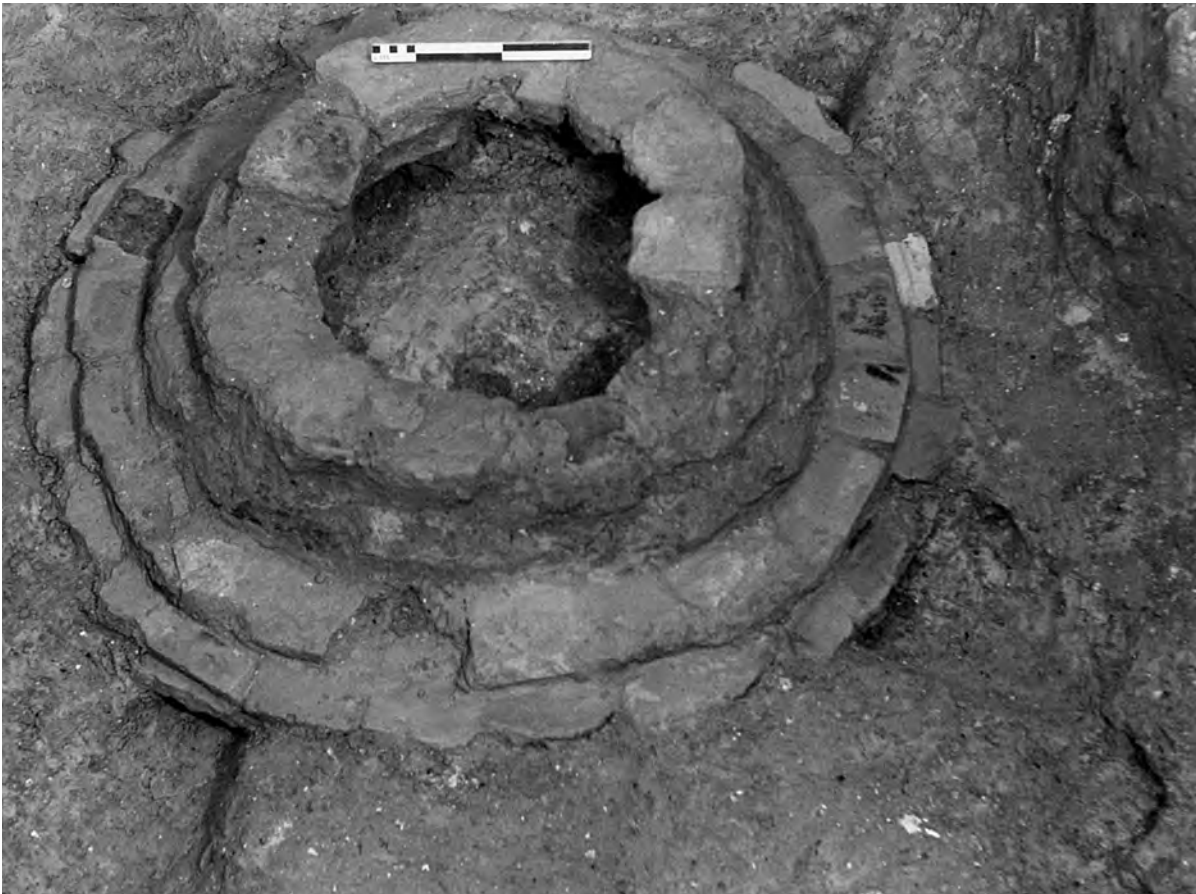
Fig. 578: Tower. Detail of the surviving inner core of the bell-mould, made of reused medieval bricks and floor tiles. Note the radiating channels emerging from beneath the core. View west. Scale of 25 cm. Photo: Warwick Rodwell

Following excavation and dismantling of the core, it was discovered that partly underlying it and extending to the east was evidence of another, earlier bell-mould in the base of the pit. It was approximately the same diameter as the later mould, but the evidence does not admit of a precise dimension: all that survived was a circular indentation in the base of the pit, a central stake-hole and four radial channels. Hence, two bells had been cast in the same pit. However, that does not necessarily establish that two bells were successfully produced and hung in the tower. Mishaps in casting were not uncommon, and it could be that the second mould represented the recasting of a bell that failed on the first attempt. On the other hand, it is perhaps no coincidence that St Peter's tower contains a second bell by Henry Oldfield which is only 7.5 cm (3 ins) smaller in diameter. This could have been cast first, in the same pit.

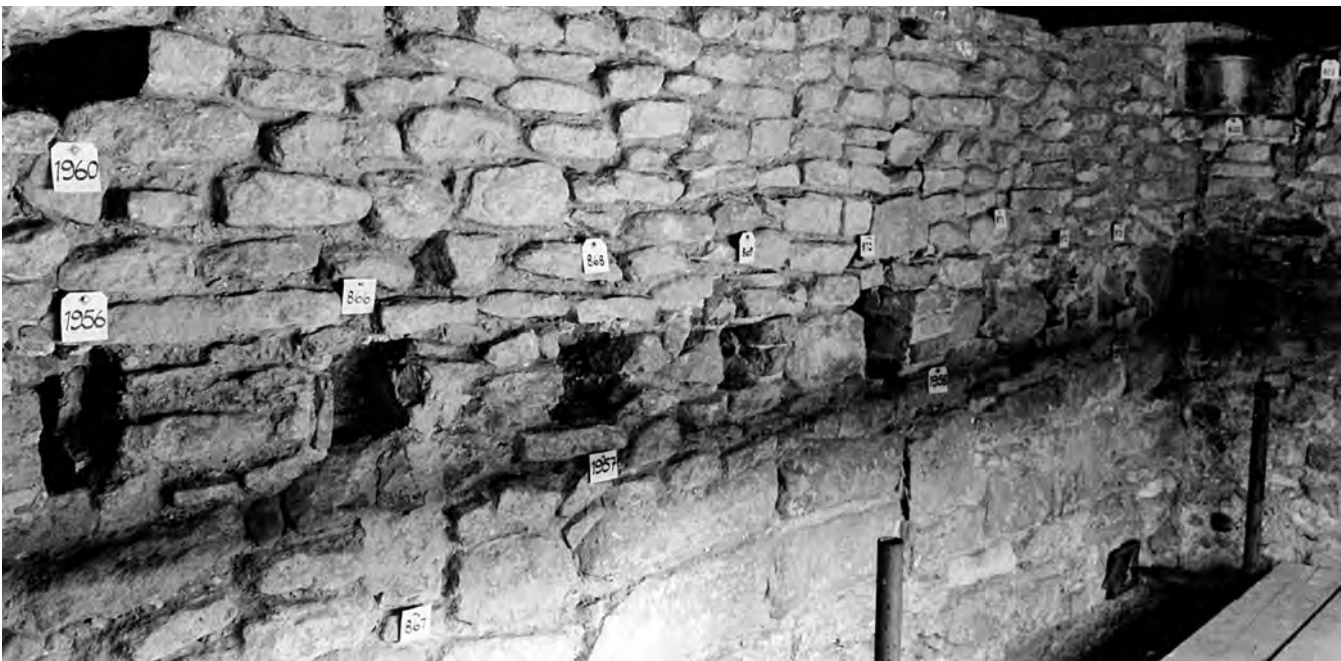
Fig. 579: Tower, south wall. A series of pockets cut to receive the joists for a post-medieval ringing-chamber floor which was removed again in 1858. Note the stone corner-bowl at top right (see Fig. 580). View south-west, 1980. Photo: Warwick Rodwell

Until 1858, an old floor existed in the first stage of the tower: it was not at the same level as the former Anglo-Saxon gallery, but lay 90 cm below it. The floor was carried on twelve closely spaced joists, running north–south (Fig. 579); pockets for these had been cut into the Anglo-Saxon masonry. When the floor was inserted, an integral staircase was constructed against the north wall: it rose from the ground at the north-east corner of the tower, to first-floor level at the north-west corner. It seems to have been seventeenth or early eighteenth century.¹⁵ The floor had doubtless been lowered in order to provide more manoeuvring space in the ringing-chamber.

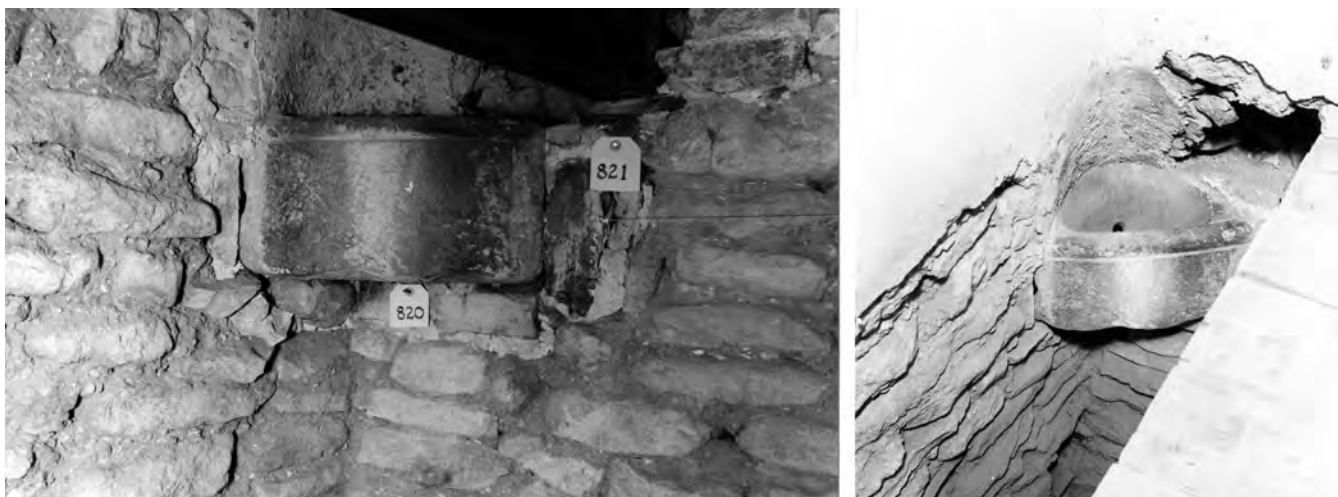
Fig. 580: Tower. Two views of the quadrant-shaped limestone bowl, probably originally a stoup, reset in the south-west corner of the ringing-chamber for use as a bellringers' urinal. Photos: Warwick Rodwell

Related to the lowered floor was the installation of a segmentally shaped limestone bowl in the south-west corner of the ringing-chamber (Figs. 579 and 580). The bowl, which is 23 cm deep overall and was designed to fit in a corner, has a curved front with a plain roll-moulded rim. Originally, it is likely to have been a holy water stoup, but is difficult to date: it could be later twelfth or thirteenth century. However, the bowl cannot have been placed in its present position until the post-medieval period, when the floor was lowered. Since the rim of the bowl is only 65 cm above floor level, it is too low to have been used as a lavabo, but was ideal as a urinal for the bellringers. There is a drilled hole in the base of the bowl, which presumably drained to the outside, via a channel in the wall core. The hole must be secondary, since stoups did not have drains. A simple recess with a plastered soffit was formed in the masonry at the corner of the tower, creating a partial hood over the basin.

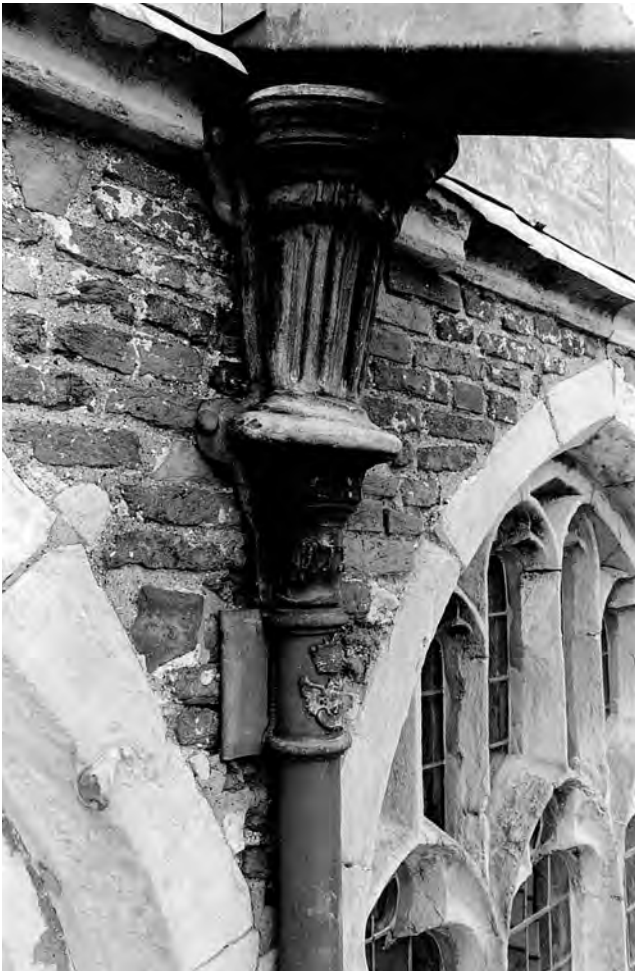
Fig. 583: South clerestory, central rainwater pipe. Inscribed lead hopper-head and decorated downpipe between window bays 4 and 5. Photo: Warwick Rodwell

Dates and initials are frequently found on lead rainwater goods, and it is not uncommon for the pipe-collars and their flanges to bear cast decoration, such as rosettes, fleurs-de-lys, lions' heads and human masks. Neo-classical figures appear more rarely, but there is also an example from St Mary's church (p. 127). Winged cherubs sometimes occur, as on the hopper-heads of 1707 at Westminster Abbey. Coronets are generally found on domestic leadwork associated with noble families, and the appearance of a coronet at St Peter's must surely indicate that Lord Nelthorpe paid for the work. The Nelthorpes were the only titled family in Barton in the eighteenth century (p. 50).
