ST PETER'S

Barton-upon-Humber, Lincolnshire

A Parish Church and its Community

HISTORY, ARCHAEOLOGY AND ARCHITECTURE

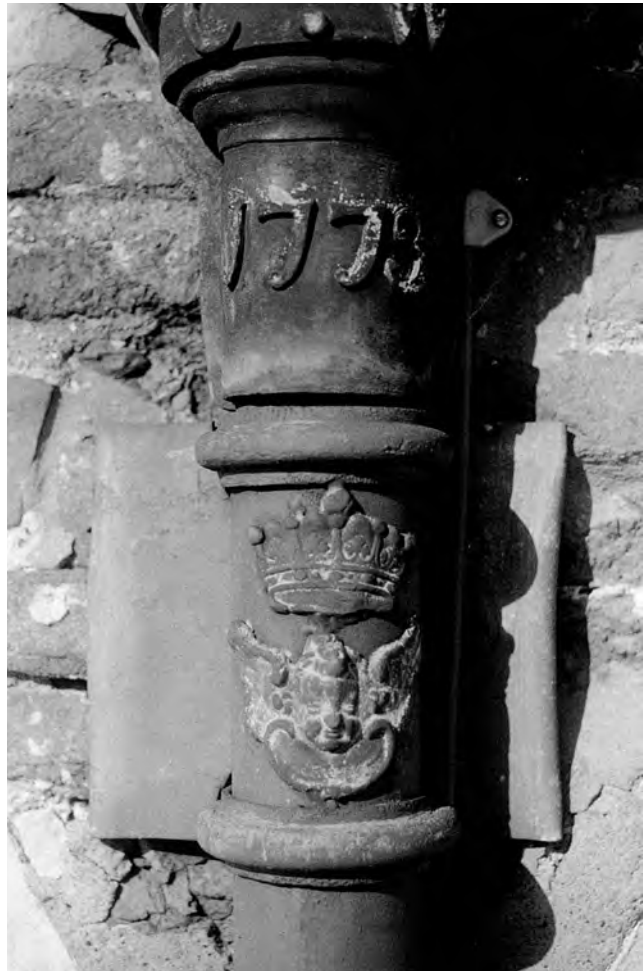
Fig. 584: South clerestory, central rainwater pipe. Detail of the dated hopper-head and cast lead plaques on the uppermost collar of the downpipe. Photo: Warwick Rodwell

Dates and initials are frequently found on lead rainwater goods, and it is not uncommon for the pipe-collars and their flanges to bear cast decoration, such as rosettes, fleurs-de-lys, lions' heads and human masks. Neo-classical figures appear more rarely, but there is also an example from St Mary's church (p. 127). Winged cherubs sometimes occur, as on the hopper-heads of 1707 at Westminster Abbey. Coronets are generally found on domestic leadwork associated with noble families, and the appearance of a coronet at St Peter's must surely indicate that Lord Nelthorpe paid for the work. The Nelthorpes were the only titled family in Barton in the eighteenth century (p. 50).

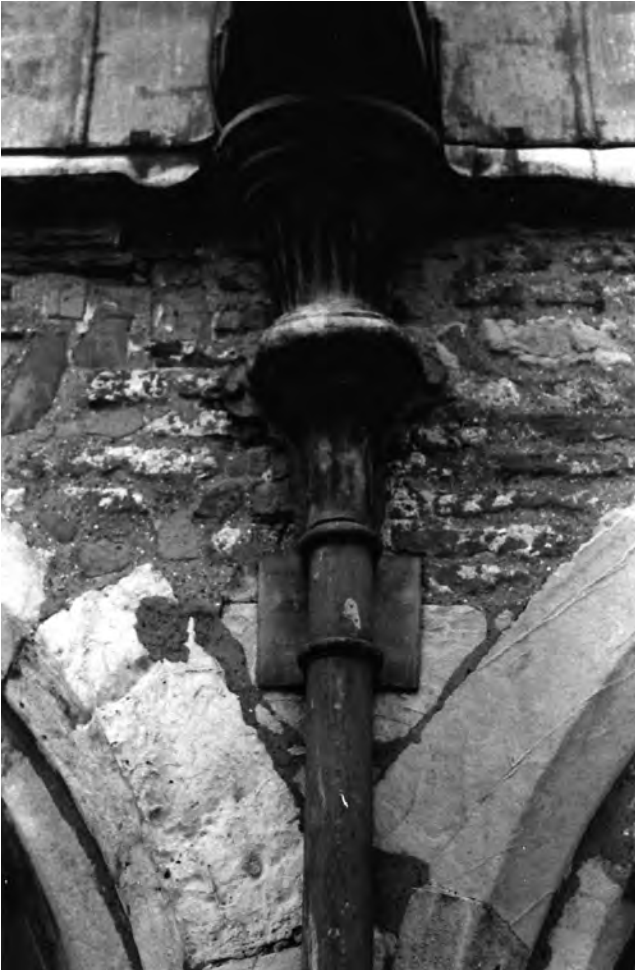
Fig. 585: South clerestory, western rainwater pipe. Fluted lead hopper-head and plain modern downpipe between window bays 8 and 9. Photo: Warwick Rodwell

A pair, generally similar in design, but smaller in size than the last (Fig. 585). Welded onto a modern replacement length of the western downpipe, below the medial collar, is an oval plaque of cast lead depicting a standing figure; this was originally affixed to the medial collar on the central downpipe (Fig. 586). It was relocated when the pipework was largely renewed in 1983. Much of the detail is poorly cast but the figure appears to be male and is wearing a short tunic which stops just above the knees. The feet are together, and the hands are on the chest, apparently holding something; the elbows project laterally and the arms are partly covered by voluminous sleeves. This is a rudimentary neo-classical figure, probably a *Lar* (household god).³²

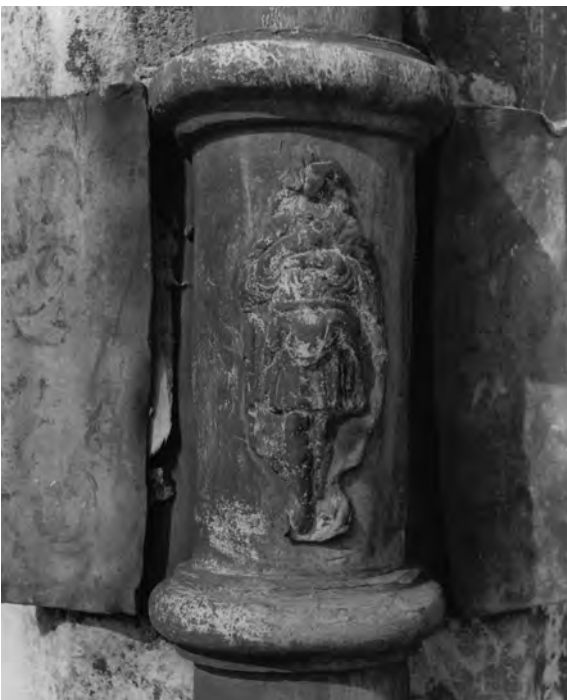
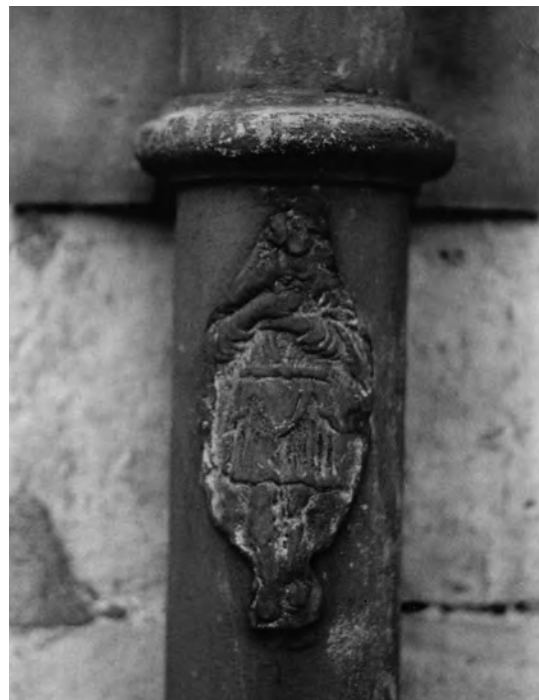
Fig. 586: South clerestory. Neo-classical cast lead figure of a Lar. A, in its original location (1980) on the medial collar of the central downpipe; B, in its present location, below the medial collar of the renewed western downpipe. Photos: Warwick Rodwell

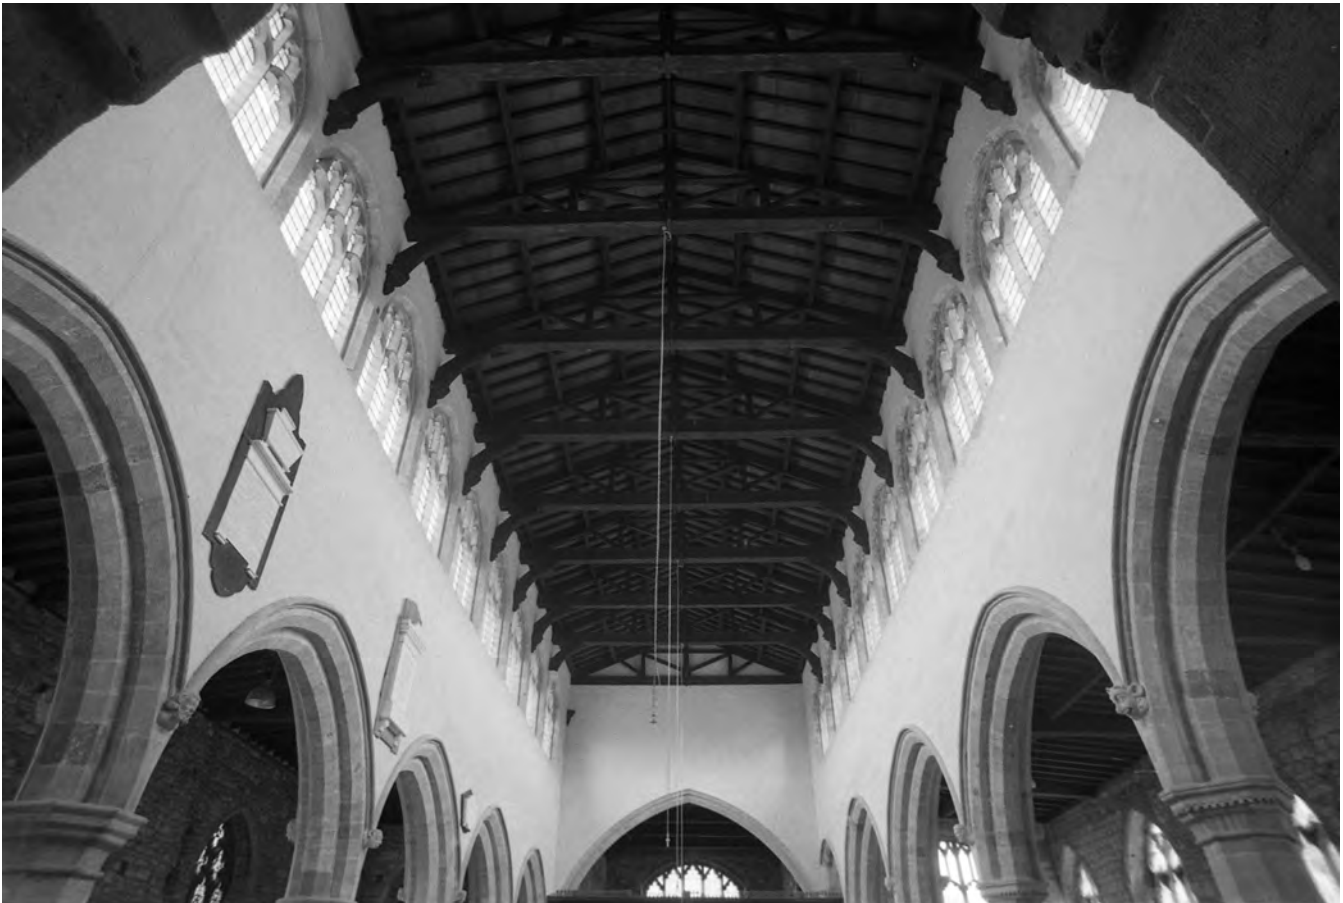
Fig. 589: Nave roof, looking east, 2005. Photo: Warwick Rodwell

erected over the nave of the church, which is under drawn and divided into compartments, forming cross elliptical arches, that spring from neatly executed brackets between each of the upper windows'. The present oak corbels (1858) occupy the sites of those brackets (Figs. 589 and 591).⁴⁵

While the king-post trusses with their queen struts date from 1805 (Fig. 591), the extant ornamental brackets and timber corbels beneath the tie-beams were clearly designed to be seen from below, and thus cannot be earlier than 1858: they must have been added to the existing structure, after the removal of the ceiling and the brackets that supported it (Fig. 589).

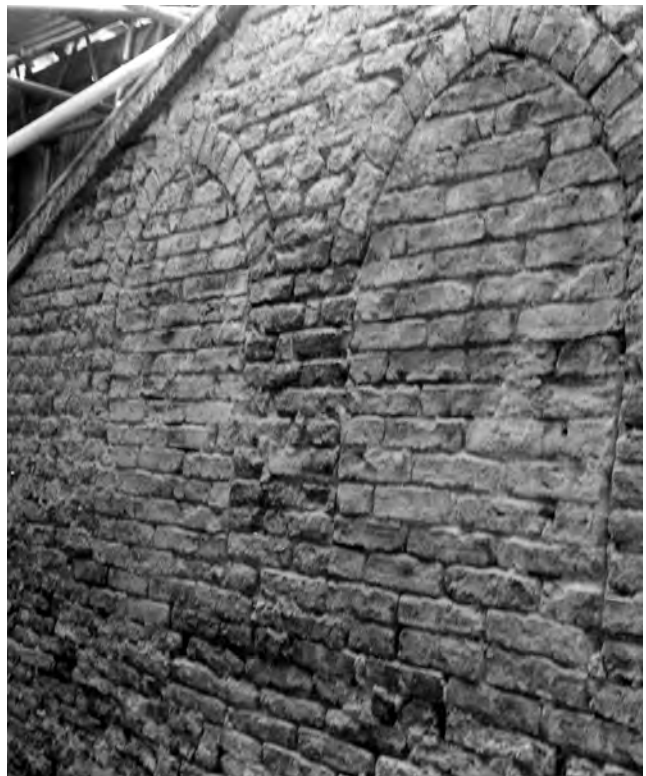
Fig. 590: Nave, exterior of the east gable, 1984. Two blocked openings which formerly ventilated the space between the roof and the ceiling. Photo: Warwick Rodwell

adequately ventilating a ceiling of this kind, to prevent condensation on the underside of the lead, and the possible outbreak of dry rot, was appreciated and consequently two arched openings into the roof void were provided at the east end (Fig. 590), and on the west the conveniently situated lower double belfry-opening in the tower was unblocked.⁴⁹ A through-draught was thereby created. Iron railings were installed in the belfry openings, to prevent bellringers and others from gaining access to the void above the nave ceiling (glimpsed in Fig. 289).

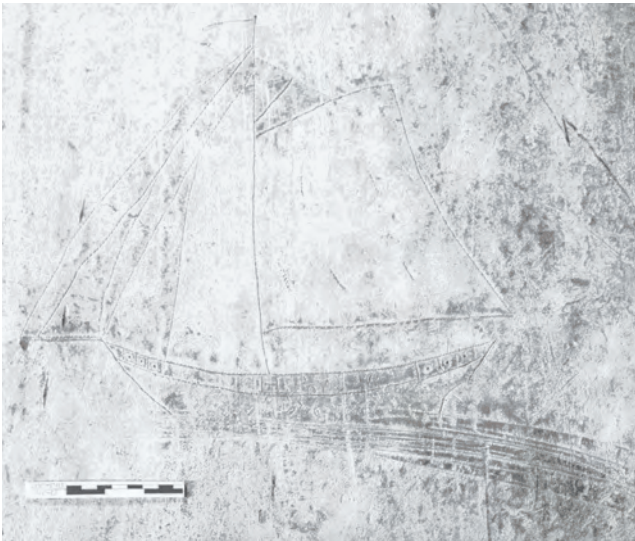
Fig. 592: Nave roof, 1978. Graffiti on lead. A, Sailing ship, inscribed by H. Porter, 1806. Photo: Warwick Rodwell

- Punched outline of a sailing ship, bearing the inscription on the side of the hull, *H. Porter / 18[0]6*⁵⁰
Incised lines below the ship represent the sea (Fig. 592, A).

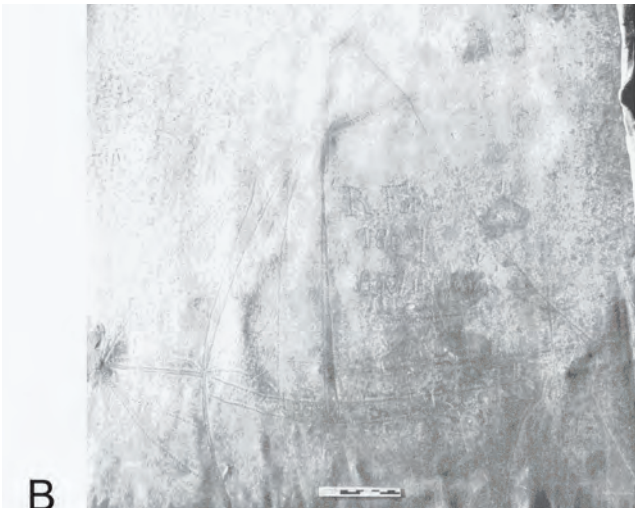
Fig. 593: Nave roof, 1978. Graffiti on lead. B, Sailing ship, inscribed by R. Ford, 1807. C, Sailing ship, inscribed by H. P[orter], 1807. Photos: Warwick Rodwell

- Bay 11 Punched outline of a sailing ship, with the inscription on the sails *R. FORD / 1807 / Aged 14 Years*
Also the initials *R.F.* on the side of the ship (Fig. 593, B).

- Bay 23 Punched outline of a sailing ship containing the inscription *H.P. 1807*.
Presumably this refers to H. Porter (Fig. 593, C).⁵¹
- Bay 25 Three punched inscriptions on one sheet:

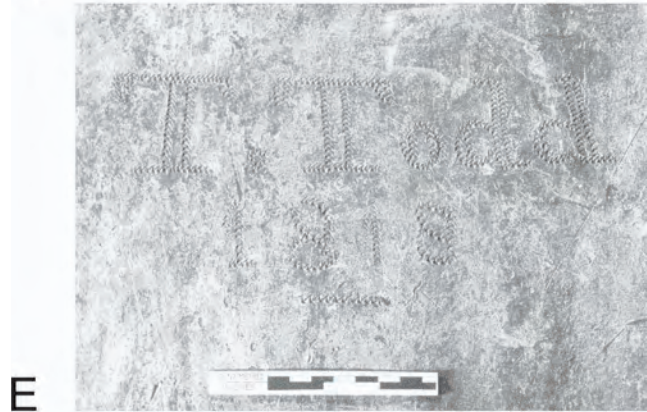
Fig. 594: Nave roof, 1978. Graffiti on lead. D, Panelled inscription, W. Green, 1833. E, Inscription, T. Todd, 1818. Photos: Warwick Rodwell

- Bay 22 Incised rectangular panel with a border and concave ends, containing the inscription *W. Green / 1833*.
The lettering is incised, but infilled with punching to add emphasis (Fig. 594, D).

- a) *T. Todd / 1818* (Fig. 594, E).
 - b) Outline of a shoe, inscribed *I Robinsons / 1833*.
The local name is 'Robinson', and the reason for the additional 's' at the end is uncertain, but perhaps indicates the possessive: 'Robinson's' (Fig. 595, F).

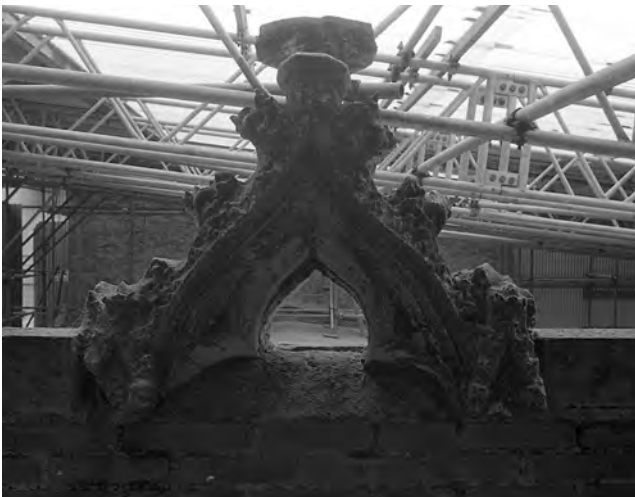
Fig. 598: Chancel, east wall. Fourteenth-century ogival canopy, reused as a central ornament to the crow-stepped gable; removed 1984. View west. Photo: Warwick Rodwell

and when a woodcut was made in the early 1830s (Fig. 15). Other evidence confirms that the gables were all intact in *c.* 1830 (Pl. 10), but had gone before the clock was installed in the tower in 1852. The most plausible context for the removal of the stepped gables is the reroofing of the aisles in 1830s. Whether the east gable of the chancel was rebuilt at the same time, with a lower pitch, is uncertain. Nattes shows a moderately high-pitched, crow-stepped gable, but by the early 1860s it was certainly lower and a fragment of fourteenth-century ogival canopywork had been set on the apex as an antiquarian embellishment (p. 798; Fig. 598). The gable was again rebuilt in *c.* 1903.

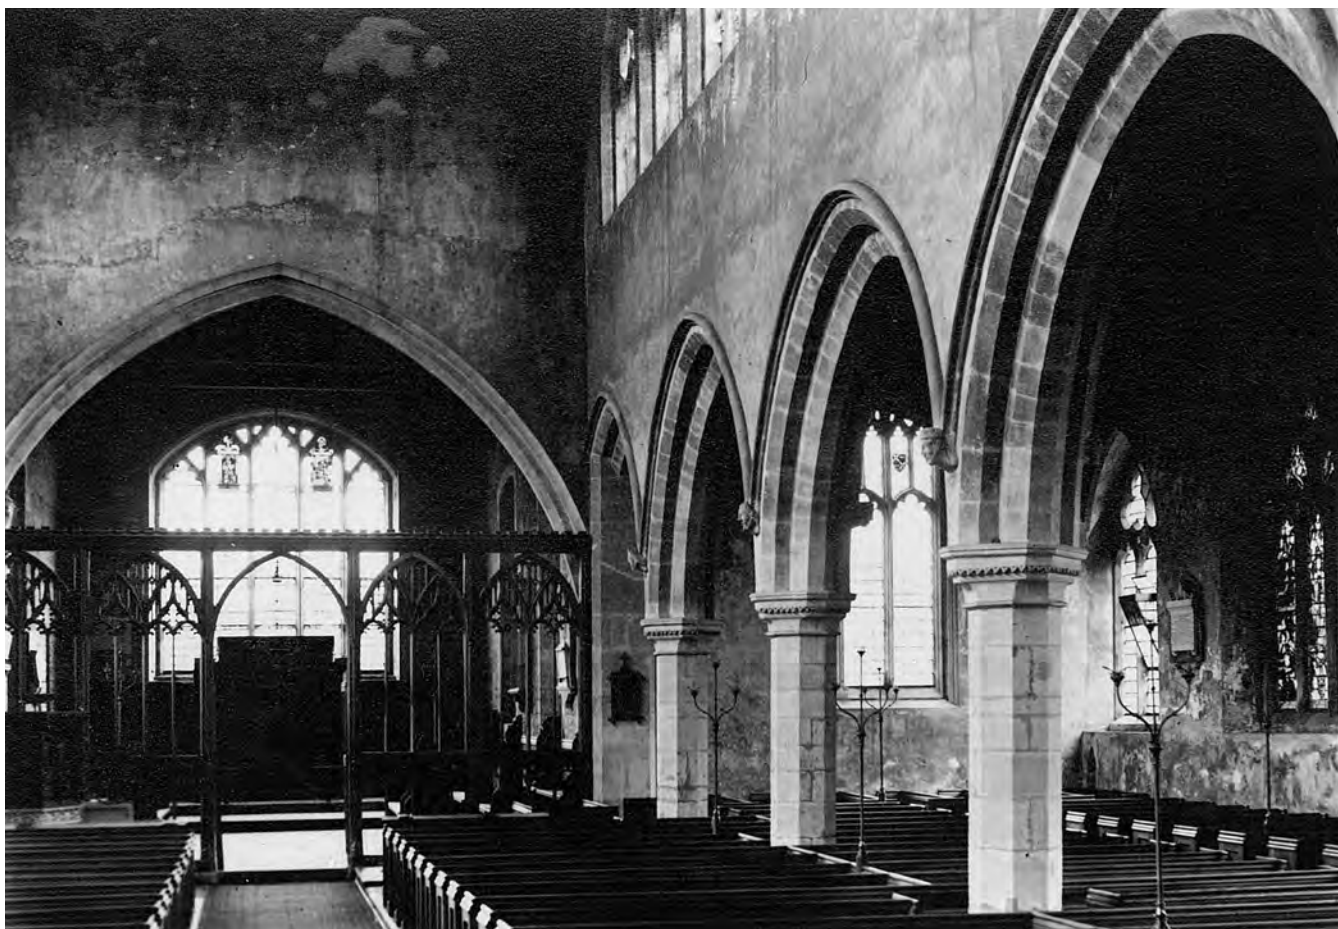
Fig. 601: View of the nave, chancel and south aisle, c. 1890, showing the internal arrangement created by the restoration of 1858–59. Photo: ex. Varah Coll., Lincolnshire Archives

There was no mention in Brodrick's specification of the stained pine choir stalls (although they appear on the plan), restoration of the chancel screen, wall-tiling in the sanctuary, the reredos, ornamental brackets for the nave roof and other works that must have taken place at this time. Nor is a new font mentioned, or the breaking of a pseudo-Saxon doorway through the west wall of the annexe. Regrettably, only one internal photograph of the church is known, ante-dating the restoration of 1897⁶⁹ (Fig. 601).

Gas lighting was installed, and early photographs show standards with triple burners attached to pews in the nave (Figs. 601 and 607).⁸² Hanging in the centre

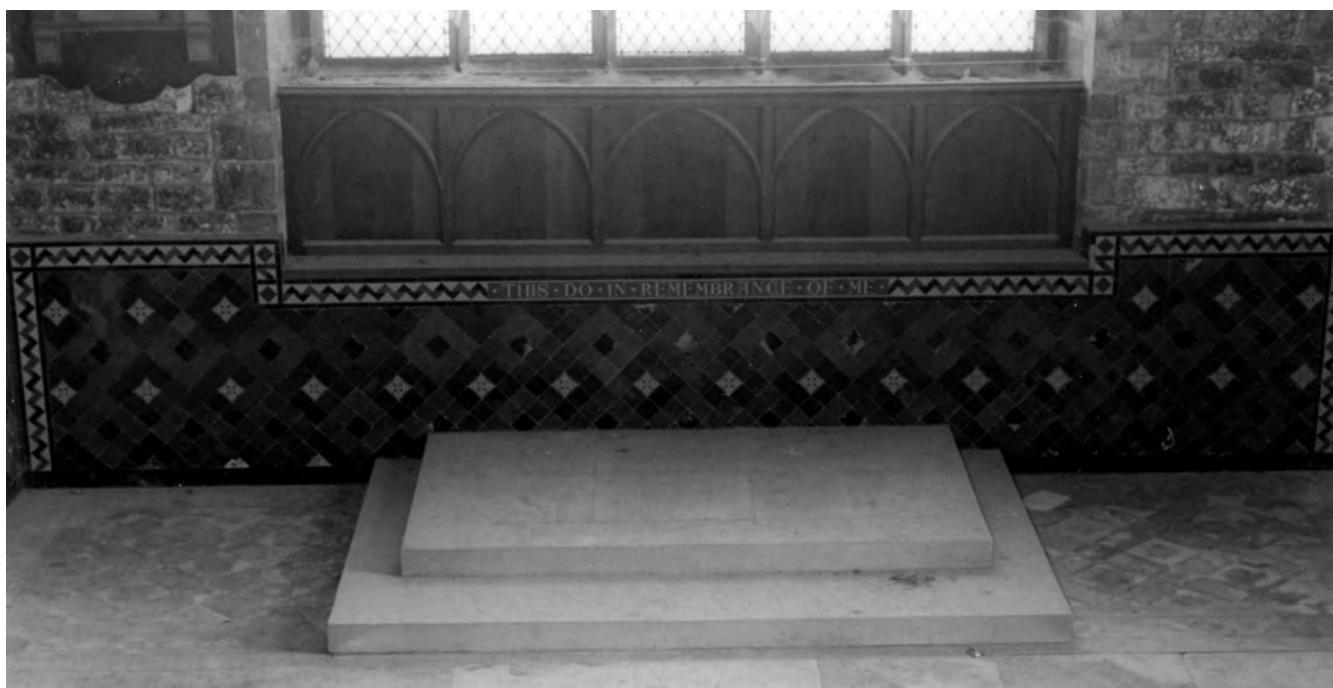
Fig. 605: Sanctuary, showing the tile pavement and wall tiling of 1858–59; also the later dais and reredos. View east. Photo: Warwick Rodwell

the east the tiling stands forward of the wall face by 14 cm, the top forming a continuous shelf (also tile-finished). Two shades of brown comprise the majority of the colour, interspersed at regular intervals by both plain green tiles, and a small number bearing a single decorated motif. The latter carry a four-way fleur-de-lis pattern executed in cream slip on a brown background, and glazed.⁷⁶ There is a black tiled skirting and the whole ensemble is framed by a zigzag border executed in triangular tiles of yellow, brown and black. A centrally placed inscription in the tile border reads: · THIS · DO · IN · REMEMBRANCE · OF · ME · (Luke, 22:19; Fig. 605). The inscription was originally intended to be seen just above the short altar, but was obscured when the dais was raised in 1897 (p. 528).

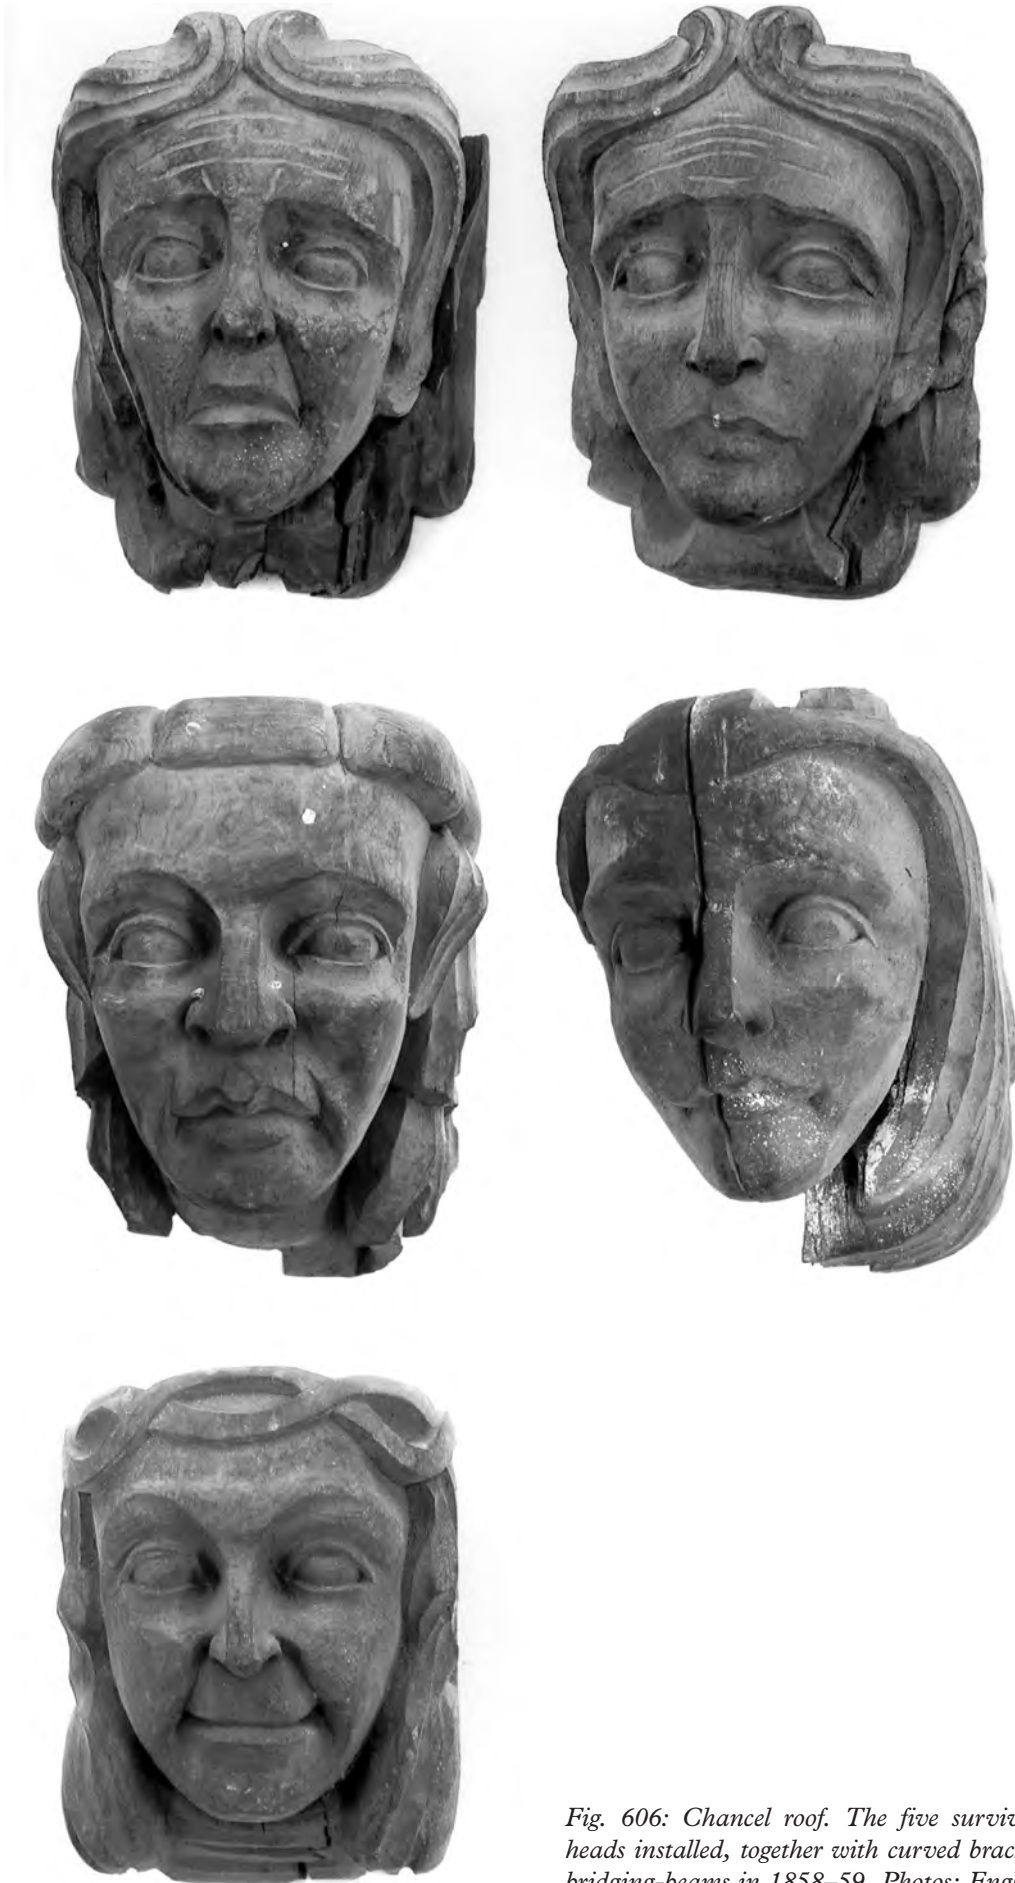
Fig. 606: Chancel roof. The five surviving pine corbel-heads installed, together with curved brackets, beneath the bridging-beams in 1858–59. Photos: English Heritage

The cosmetic work carried out to the chancel roof, after the ceiling was taken down, is apparent. The bridging-beams were given simple stopped chamfers, and mortices were cut in the soffit face, near to the ends; curved wall-brackets were fitted, descending on to timber corbels enlivened with boldly carved heads. Lengths of moulded timber cornice were fitted on the wall-tops, between the beams. The eight corbels and brackets, which were purely decorative, were partly consumed by dry rot in the mid-twentieth century.⁷⁸ Five of the heads have survived more-or-less complete, and there is a fragment of a sixth; these and the brackets were all taken down in 1981 (Fig. 606). The other two heads were lost at an earlier date. The features are bold and crudely carved, but nevertheless pay homage to the fourteenth century: two of the survivors are female.⁷⁹

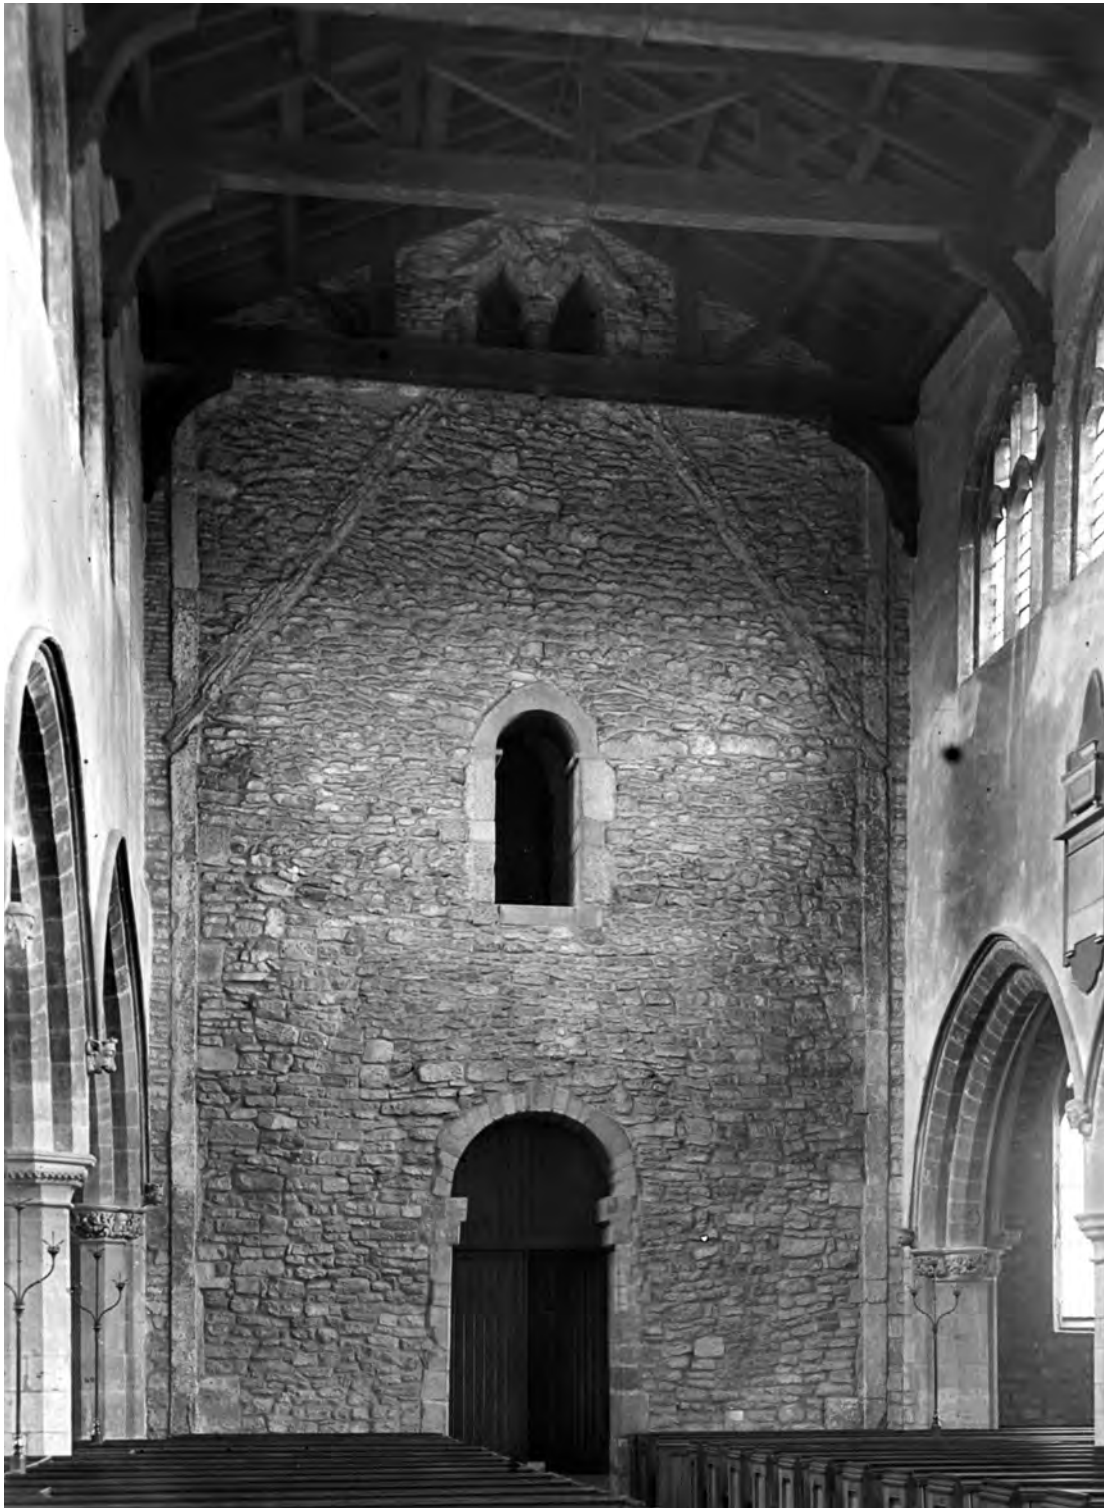
Fig. 607: Nave. View of the west end, showing Brodrick's benches, gasoliers and doors to the tower. Note the over-restored tower arch and small doorway above. Photograph taken between 1898 and 1912. Photo: English Heritage, NMR

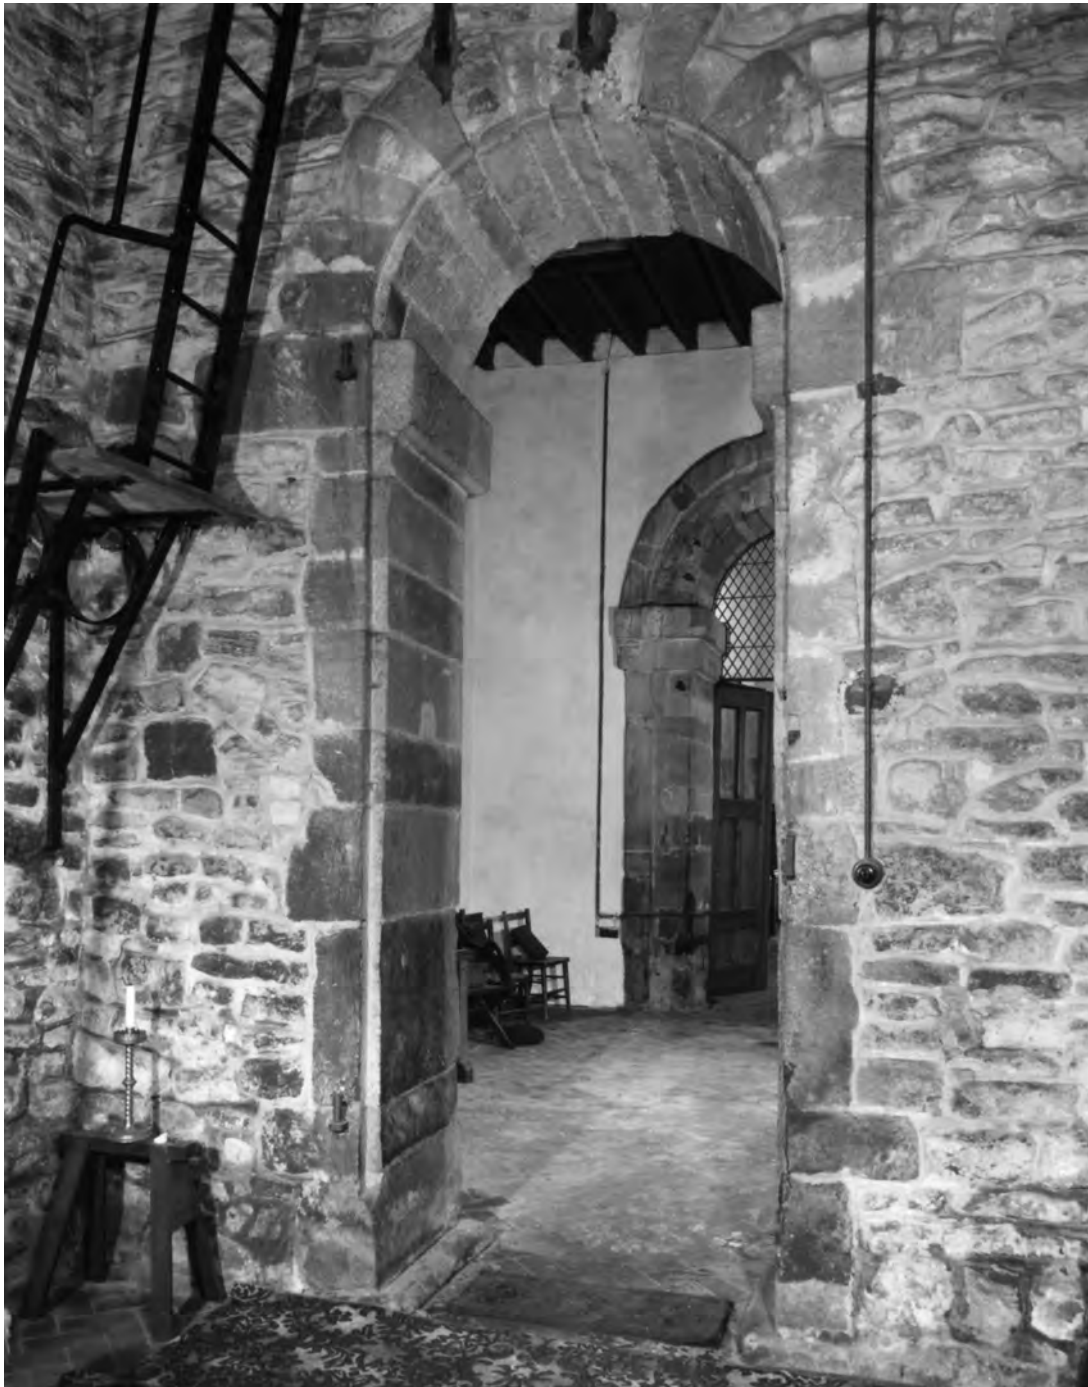
Fig. 609: Tower, western arch seen from within the annexe, 1972. The iron fixings and rebate for Brodrick's door remain. Photo: English Heritage, RCHME

round-headed, panelled door was hung to open into the annexe (Fig. 608, A). The iron crooks, latching plate and staples for the lock all remain. In order to fit this door, a rebate was cut into the masonry of the Anglo-Saxon arch, a brutal and unnecessary intervention (Figs. 609 and 620). Chamfers were added too.

and damp' in winter.¹⁴⁵ A fuel store was built in the churchyard, on the western boundary (Fig. 24); wooden cupboards and Brodrick's staircase were removed, and a fixed iron ladder provided for access to the upper levels (Fig. 609). The fireplace and chimney were removed too.¹⁴⁶

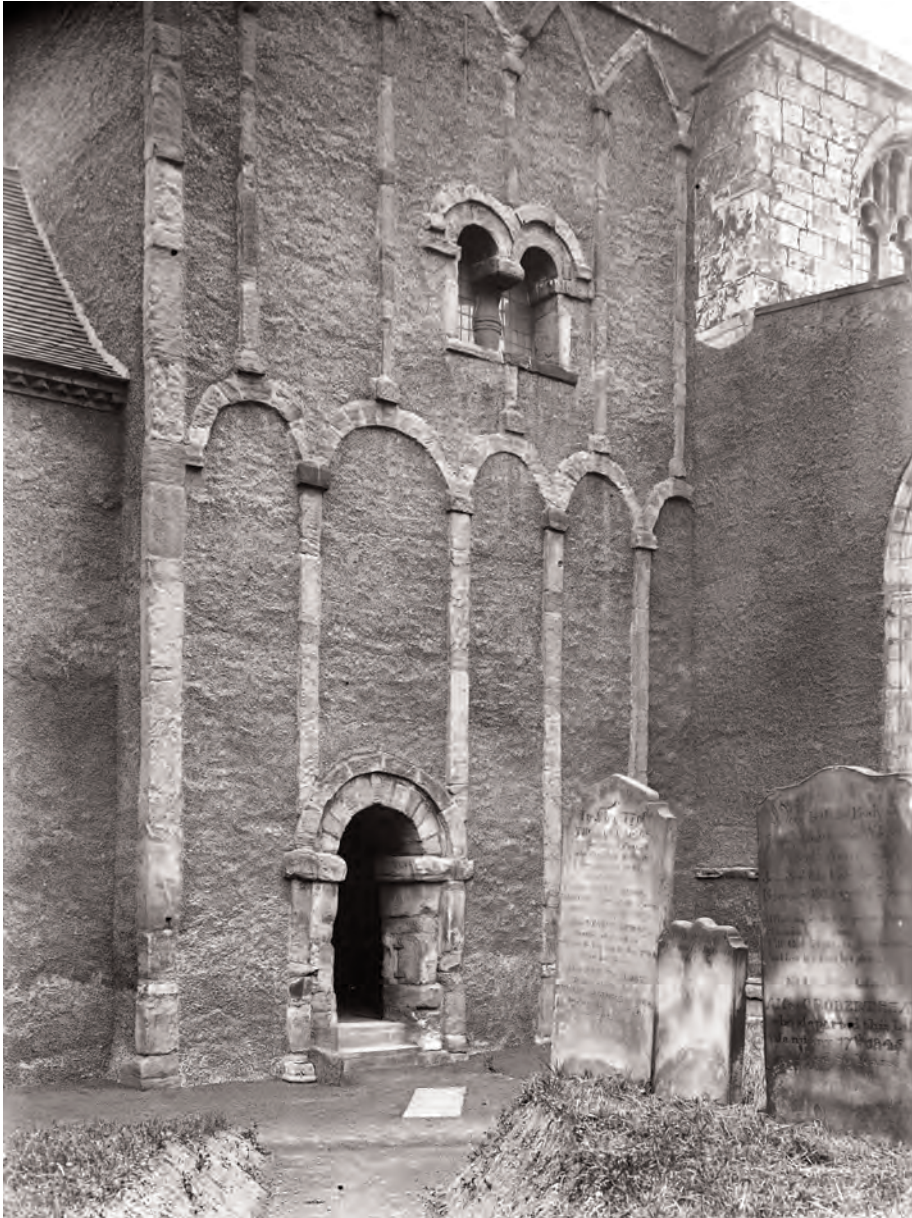
Fig. 610: Roughcast rendering on the tower, western annexe and south aisle, applied in 1868–70. View from the south-west, c. 1900. Photo: English Heritage, NMR

'the exterior of much of the church is covered with stucco of old standing, and some of the stone masonry is bad and patched with brick. The south aisle with its battlement is of excellent stone' (Glynne 1898, 202). As a consequence of a visit by the Royal Archaeological Institute, also in 1867 (p. 13), the architect-antiquary, J.H. Parker, recommended that the tower should be covered with pebbledash stucco, rather than the plain limeplaster, which had peeled off patchily. Parker provided directions for mixing the pebbledash, the application of which he claimed would better preserve the stonework of the tower.⁹⁷ This is often stated to have been carried out in 1868,⁹⁸ when it was reported that the roughcast was renewed on the south aisle and west end of the annexe.⁹⁹ The north aisle was to be tackled in the following year. Then, in 1870, a quotation was provided by a local builder for pebbledashing the tower and south porch, for the sum of £50. Shortly afterwards he was paid £20 for 'repairing St Peter's Church steeple, &c.'¹⁰⁰ Hence the rendering process seems to have been protracted, but several early photographs show the effect upon completion (Figs. 610, 672 and 687).

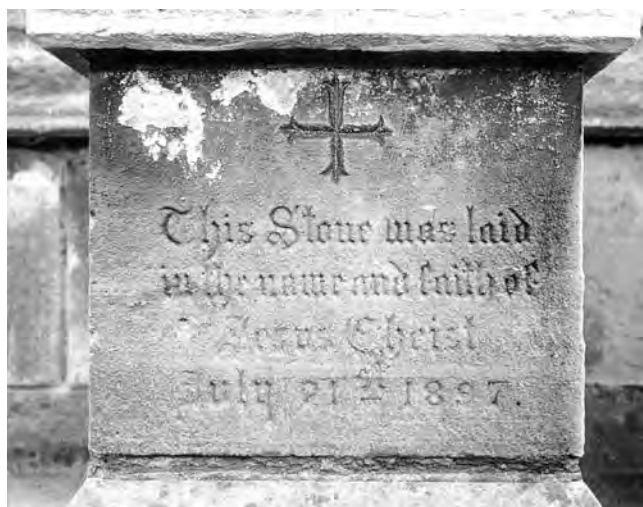
Fig. 612: Organ chamber. Foundation stone in the north-eastern buttress, 1897. Photo: Warwick Rodwell

Before the end of 1896, the gift of £1,000 by Mrs Holt, widow of the vicar who had instigated the last great restoration, was used to set up a new fund. She also gave the £250 required to restore the chancel screen in accordance with a scheme prepared by Fowler. It was estimated that £1,800–£2,000 would be required to: rebuild the vestry, construct an organ chamber on the north side of the chancel, restore the screen and renovate the internal walls.¹¹⁹ This restoration is well documented.¹²⁰ Within a few months J.W. Briggs of Barton had been given the contract for the building work, the old organ was sold for £40, and Bowman and Sons of Stamford were entrusted with the restoration of the screen.¹²¹ Services were transferred to St Mary's, to allow work to proceed unhindered. A stone-laying ceremony for the organ chamber took place on 21 July 1897, which was carried out by Canon Moor, the former vicar of Barton. The limestone plaque, now eroded, is built into the north-eastern buttress (Fig. 612).¹²² The inscription reads:

+ / This Stone was laid / in the name and faith of / Jesus Christ / July 21st 1897.

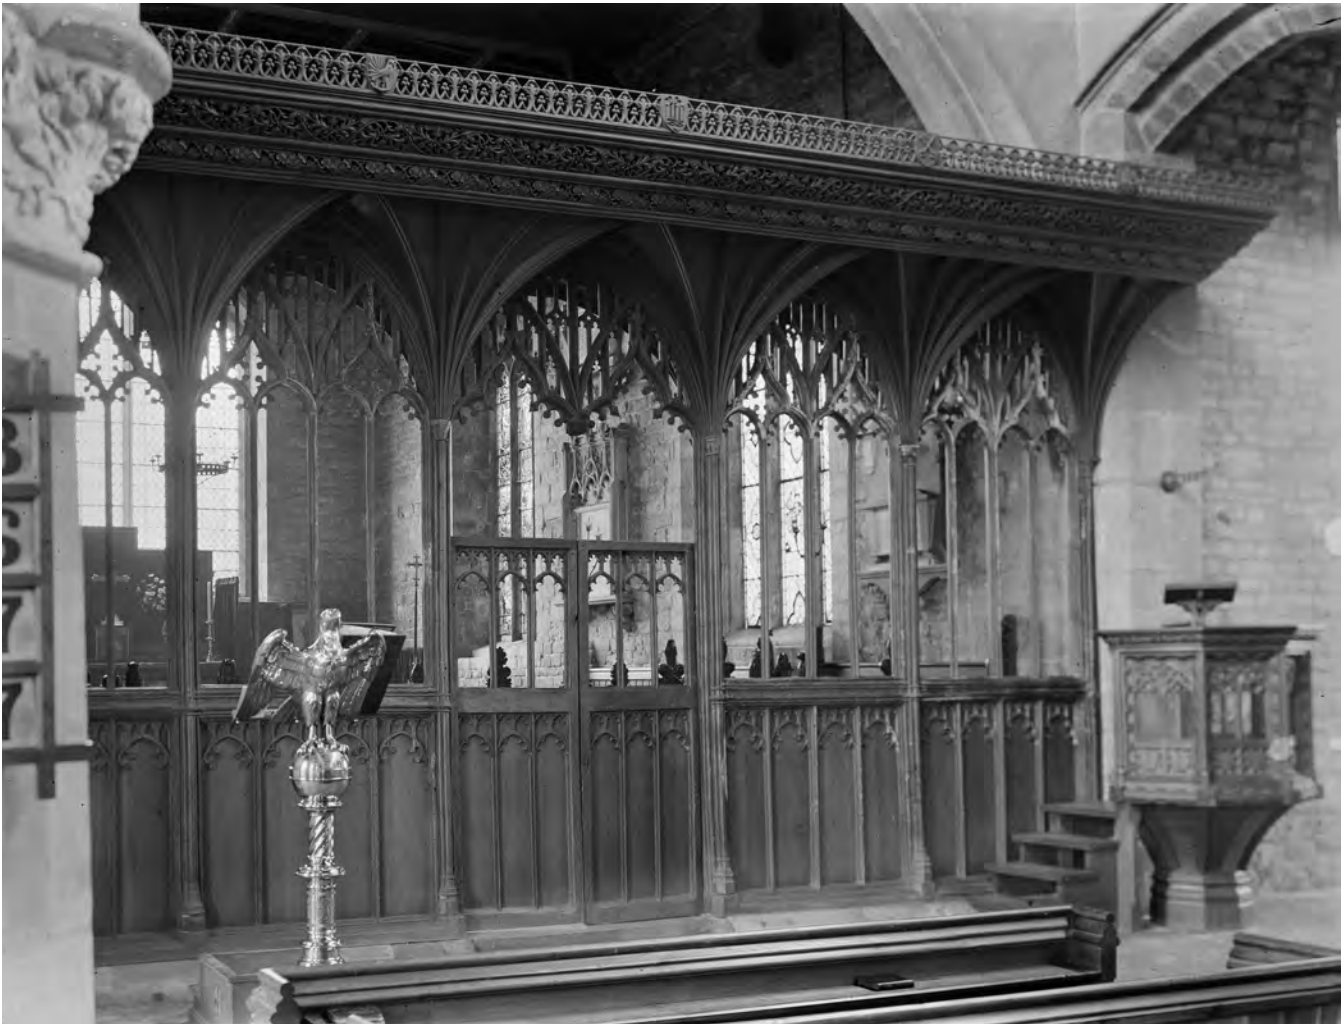
Fig. 613: Chancel and screen. View south-east from the nave, through the screen, into the chancel, c. 1900. This shows the pulpit and lectern in their original positions. Photo: English Heritage, NMR

A new three-manual organ costing £800 was commissioned from Forster and Andrews, and a new pulpit, designed by Fowler, was given by Canon and Mrs Moor; the pulpit was placed on the south side of the nave. A string of other gifts to the church was recorded, including altar rails, reredos and dossal, sanctuary hangings, and a brass eagle lectern (Fig. 613).¹²³

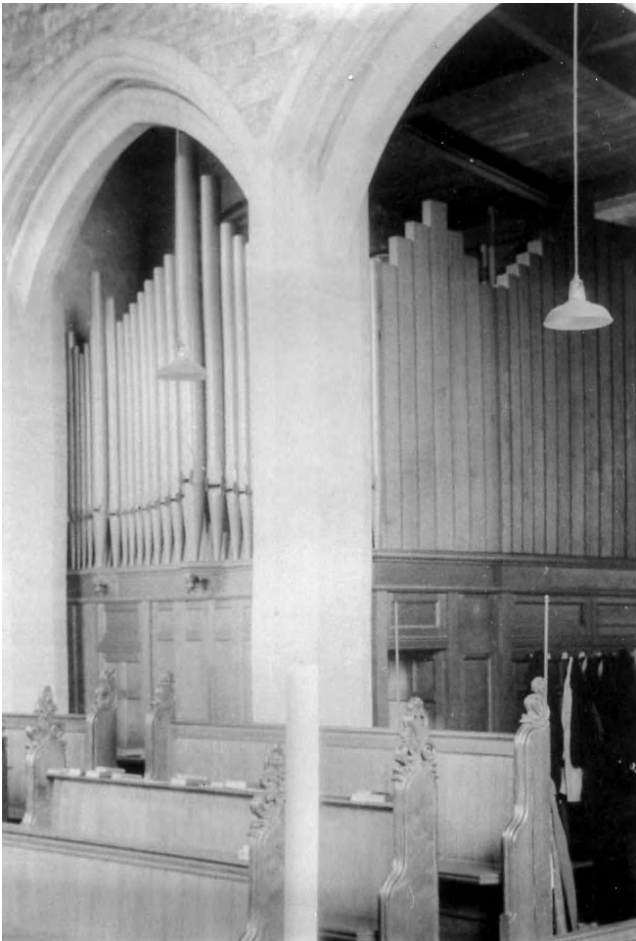
Fig. 618: Chancel and organ chamber, 1945. Arcade of two bays in the north wall of the chancel, with the organ beyond. Photo: Courtesy of the Church Buildings Council (F. Huntley Woodcock Coll.)

The new limestone arcade in the chancel wall was made as lofty as possible, with plain jambs and low, two-centred arches with hollow-chamfered mouldings (Fig. 618). The lower part was meant to be filled with a traceried oak screen, but that was never constructed, and the eventual disposition of the organ differed from

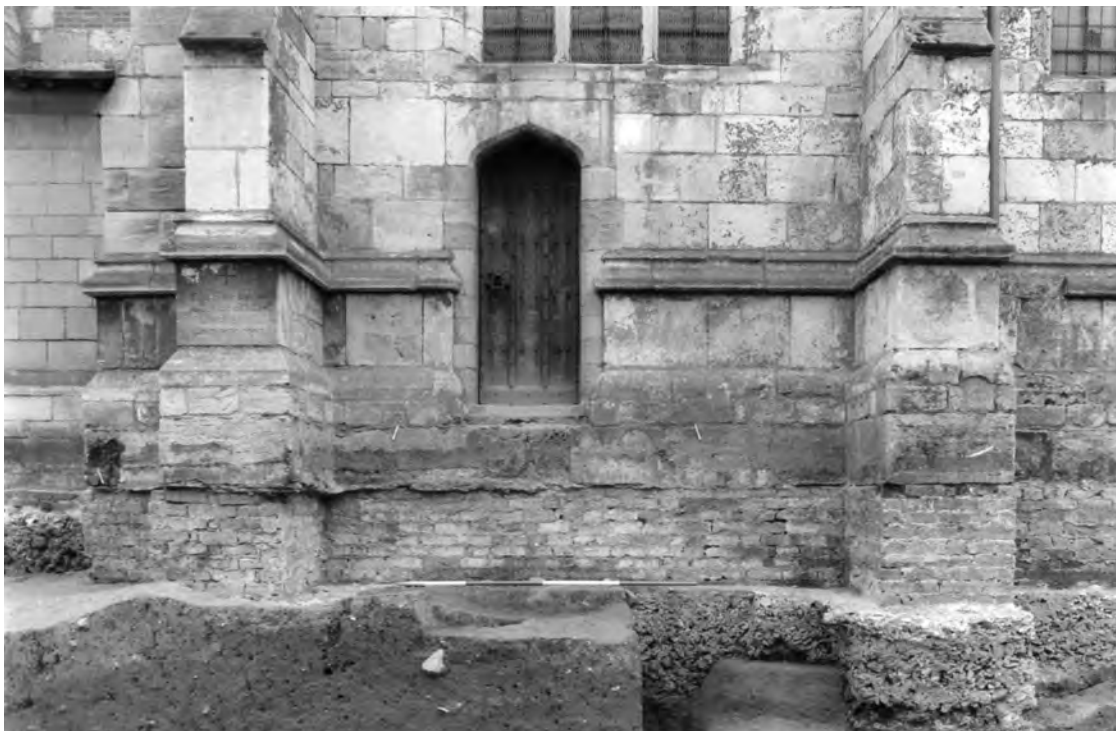
Fig. 619: Organ chamber. Foundations of the north wall (bay 2) during excavation. Scale of 2 m. Photo: Warwick Rodwell

The rebuilt north wall stands on a brick footing, with a poured concrete foundation (Fig. 619). The wall carries the deep bolection-moulded plinth salvaged from the medieval chancel. The central buttress is of reused masonry, but the clasping buttresses at the north-east angle (including the plinth mouldings) were new in 1897. The plain parapet with a coping-roll, and the chamfered eaves-course supporting it, are of similar date. The east wall, which was partly abutted by the vestry, was completely rebuilt and faced with new limestone ashlar. Internally, the chamber is plastered.

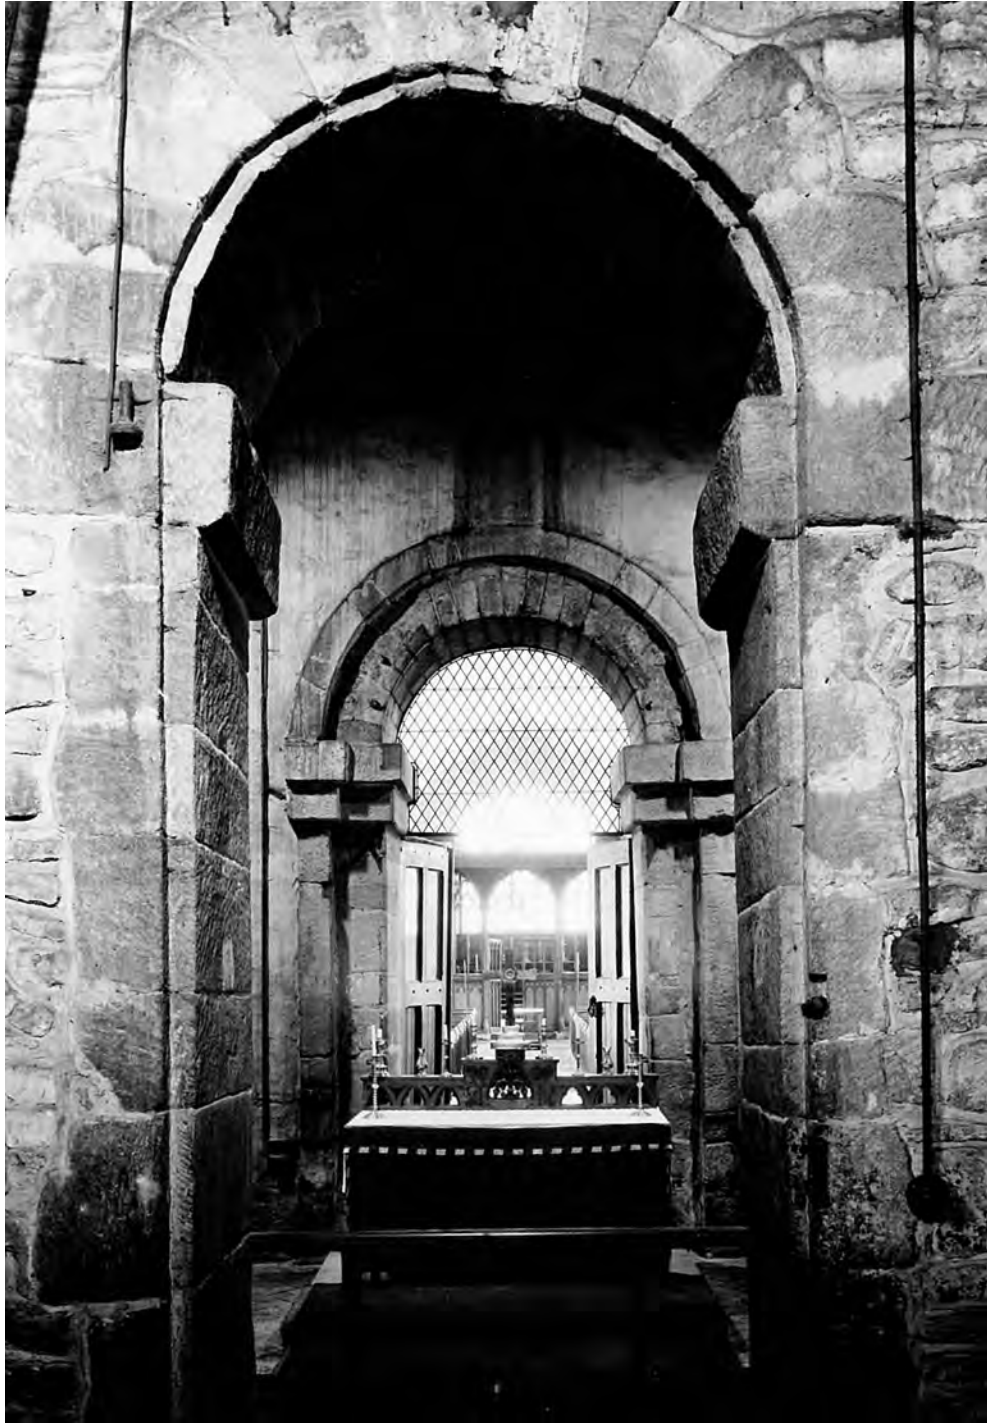
Fig. 620 Tower. View east from the western annexe, showing the furnished altar in the base of the tower, 1965. Photo: David Lee Photography

coined for the tower and annexe, and subsequently the remainder of the church was dubbed 'Great St Peter's'. These are artificial and confusing, and have given rise to the erroneous impression that there are two adjoining churches.¹⁴⁴ After restoration, the base of the tower was furnished with an altar (Fig. 620).

- i) The cross is a plain brass plate with rectangular terminals to the arms, and a rosette at the centre; no inscription (Fig. 620). Height 60 cm. Early twentieth century.³⁹
- ii) Pair of heavy cast brass candlesticks in Baroque style; twisted stem mounted on heavy tripod base with *putti*.⁴⁰ Height 61 cm. Probably late nineteenth century, copying early eighteenth-century examples; poor casting suggests that a mould may have been taken from a damaged original. No inscription.⁴¹
- iii) Pair of brass candlesticks used on the credence table. Height *c.* 20 cm. No details.⁴²
- iv) Pair of plain brass altar flower vases, *c.* 1900; originally on the chancel altar.⁴³ Height 18 cm.
