ST PETER'S

Barton-upon-Humber, Lincolnshire

A Parish Church and its Community

HISTORY, ARCHAEOLOGY AND ARCHITECTURE

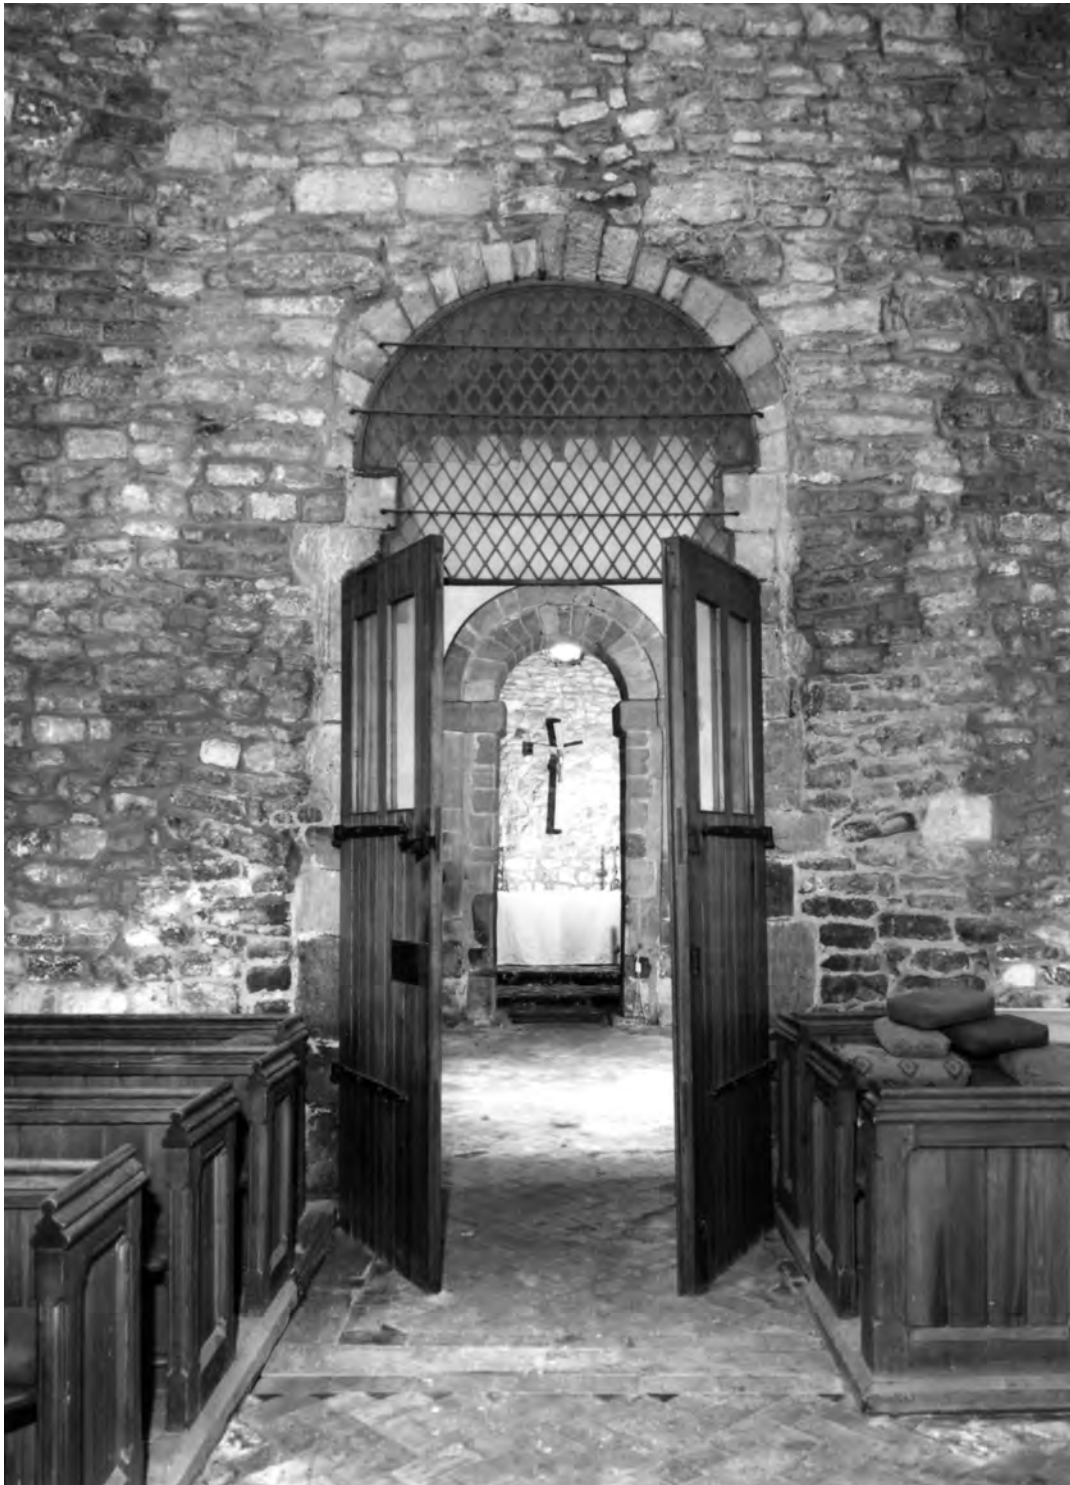
Fig. 621: View west from the nave, through the tower, to the western sanctuary created in the annexe in 1972; dismantled in 1978. Photo: English Heritage, RCHME

face of the arch: they were partly glazed (Fig. 621).¹⁴⁷ Also, the tympanum was filled with plain leaded glazing of lattice pattern (removed 1979). The nineteenth-century door in the western tower arch was probably discarded at the same time, and the glazed lights installed in the south door.

how such a scheme might be funded, and it was simply assumed that the backlog of repairs would be shouldered by the Redundant Churches Fund. Despite the failure of the scheme to receive approval, in 1972 the altar under the tower was nevertheless moved into the annexe and a western sanctuary created (Fig. 621).

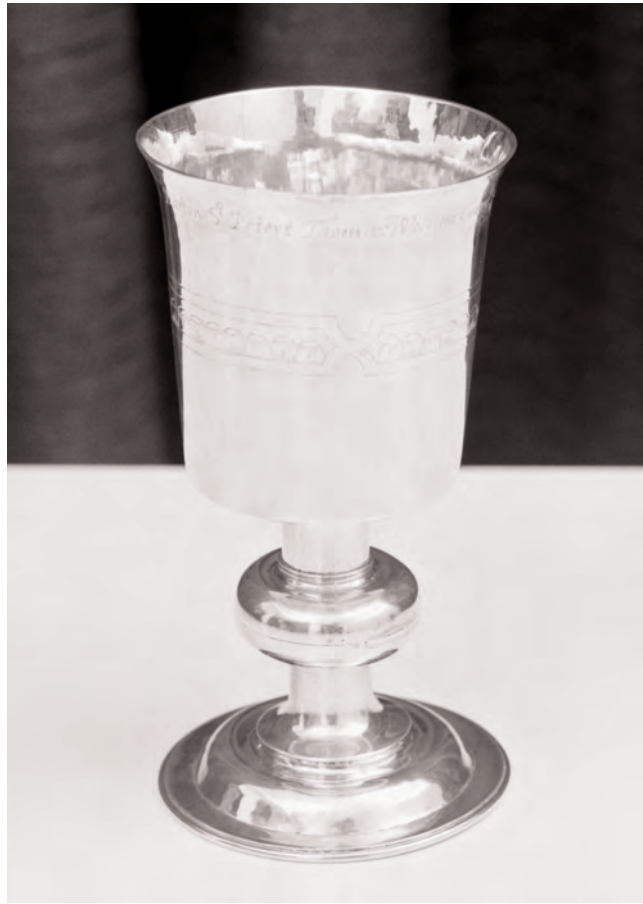
Fig. 633: St Peter's church plate. Chalice by Edward Mangy, 1674. Photo: David Lee Photography

- i) Chalice and footed cover-paten, undated, but marked by Edward Mangy of Hull (Figs. 633 and 634).⁴⁹ The chalice is inscribed around the rim: *Barton S^t Peters Thomas Willson Curet: Georg Ffry Will. Reynold Churchwardens*. The paten is uninscribed, but bears identical marks to the chalice.⁵⁰ The only year in which Ffry and Reynold held office together was 1674,⁵¹ which therefore provides a firm basis for dating the vessels.

In style, they are Elizabethan, and this, together with the absence of a specific year in the inscription, must explain the rural dean's assumption in 1859 that the chalice and cover dated from 'about 1560'. Chalice: height 17.2 cm; rim diam. 9.4 cm; weight 10½ oz. Paten: diam. 10.4 cm; weight 3 oz.⁵² The bowl of the chalice is decorated at

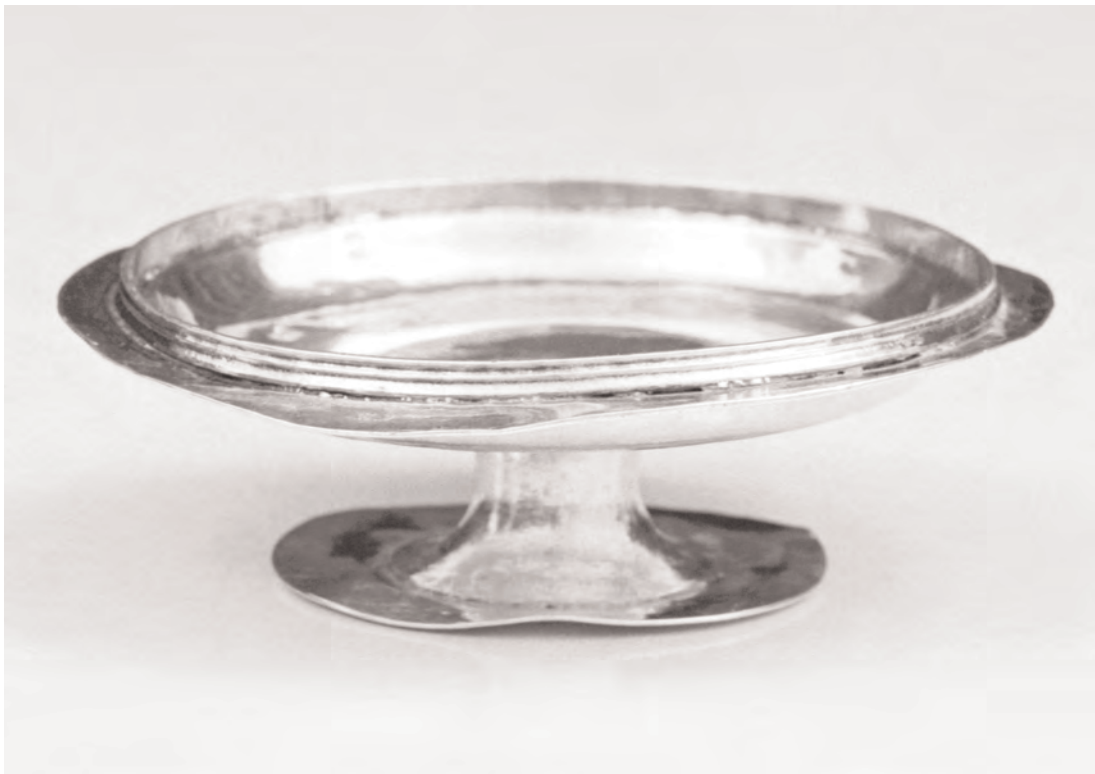
Fig. 634: St Peter's church plate. Footed cover-paten by Edward Mangy, 1674. Photo: David Lee Photography

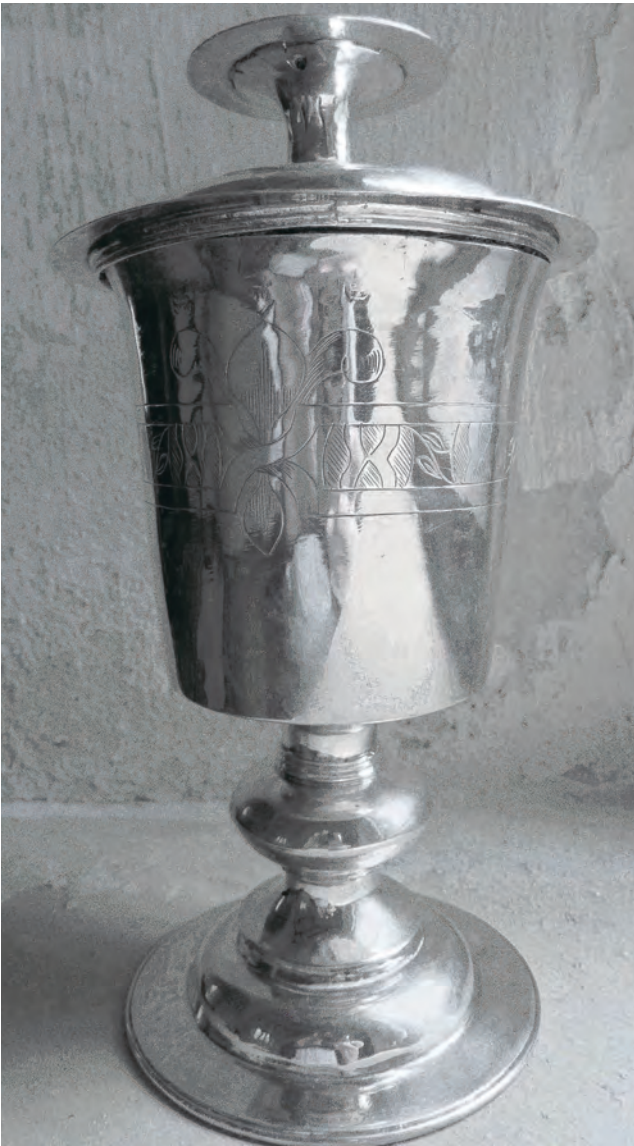
Fig. 635: St Maurice, Horkstow (Lincs.). Chalice and cover-paten by Edward Mangy, c. 1670. Photo: Gordon Plumb

The same vessel profile and basic layout of the decoration is found in chalices by the same maker at Horkstow (Fig. 635) and South Ferriby. It appears that Edward Mangy supplied almost identical chalices and cover-patens to a number of churches in the Humber region. These were doubtless replacements for losses incurred during the turmoil of the Commonwealth.⁵³

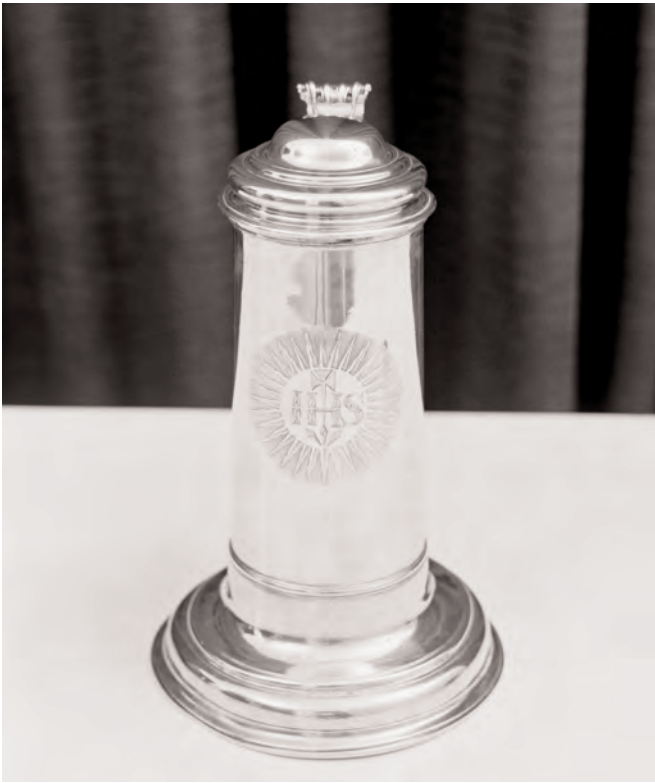
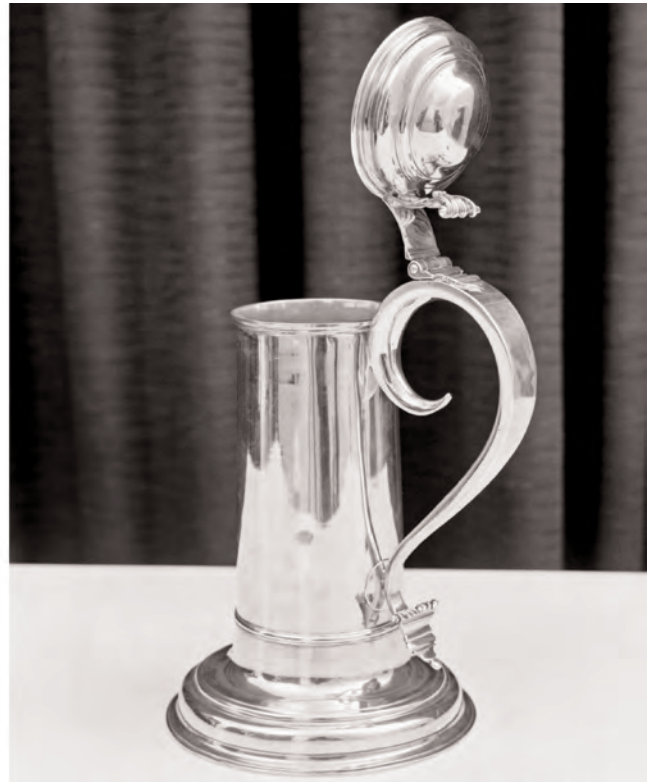
Fig. 636: *St Peter's church plate. Flagon by Thomas Wright, 1754. Photos: David Lee Photography*

- ii) Flagon, by Thomas Wright, hallmarked London, 1754 (Fig. 636). Inscribed under the foot: *The Gift of Dame Elizth Nelthorpe to S^t Peter's Barton*

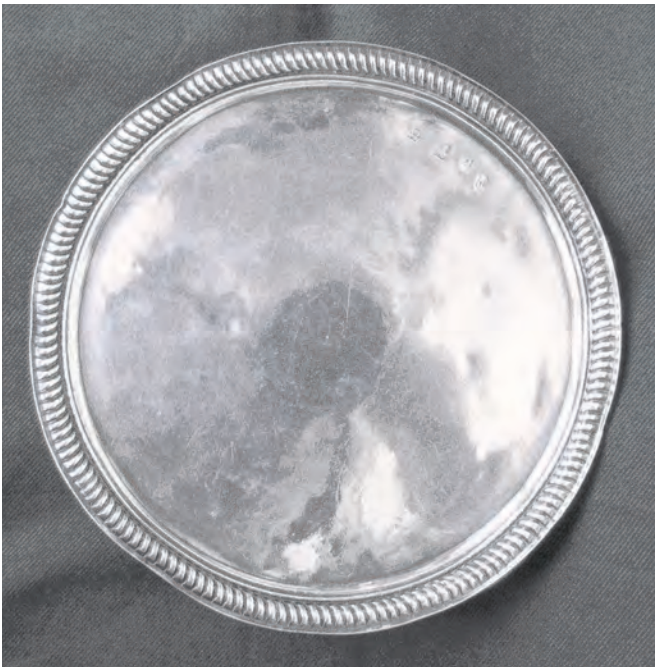
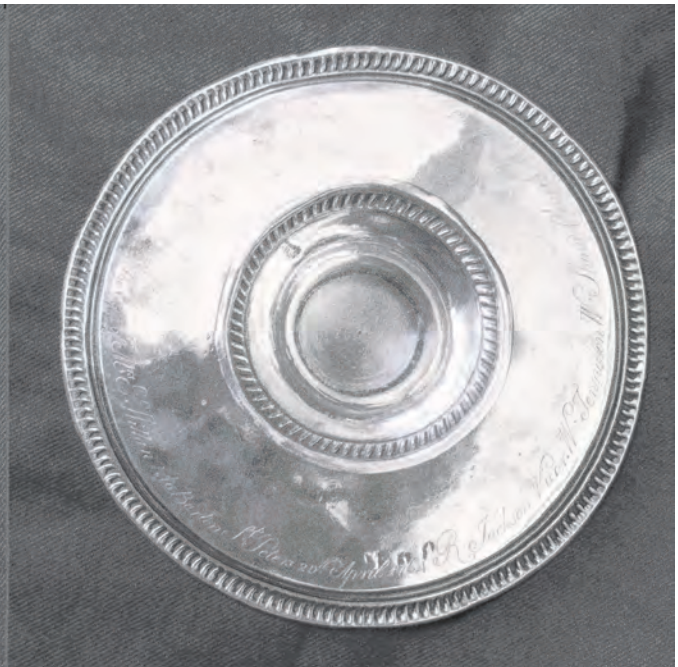
Fig. 637: *St Peter's church plate. Credence paten by Benjamin Pyne. Left, upper side, hallmarked 1706. Right, underside with inscription dated 1764. Photos: Warwick Rodwell*

- iii) Credence paten, by Benjamin Pyne, hallmarked London, 1706⁵⁴ (Fig. 637). It is inscribed on the underside: *The Gift of M^{rs} E. Willan to Barton S^t Peters 20th April 1764. R. Jackson Vicar. W. Tenmyson W. Shaw Church Wardens*. The paten has rope-moulding around the rim and foot. Diam. 19.6 cm.

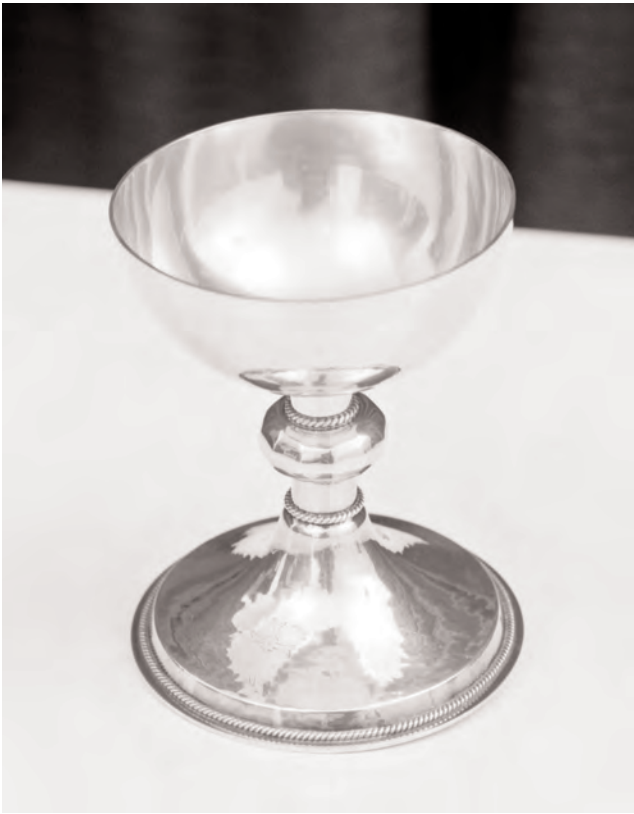
Fig. 638: *St Peter's church plate. Small chalice with undated inscription; early twentieth century. Photo: David Lee Photography*

- iv) Chalice of late medieval form with a hemispherical bowl, knopped stem and flared foot (Fig. 638). It has rope mouldings around the stem and foot. The latter bears an incised Latin cross, elaborated with tapering arms and bifid terminals, on the upper side. An inscription in Gothic lettering under the foot records: *To the Glory of God and for the use of the Church of St Peter, Barton on Humber. This Chalice is given by Kate in memory of her husband Elwick Stow & of her children Arthur and Mary Stow*. It is undated, but is presumably early twentieth century.⁵⁵
- v) Chalice and paten. Inscribed: *For use at the high altar of the Parish Church of Saint Peter Barton on Humber. Given by the wife and son of the late Fred Hopper, Christmas 1937*.⁵⁶

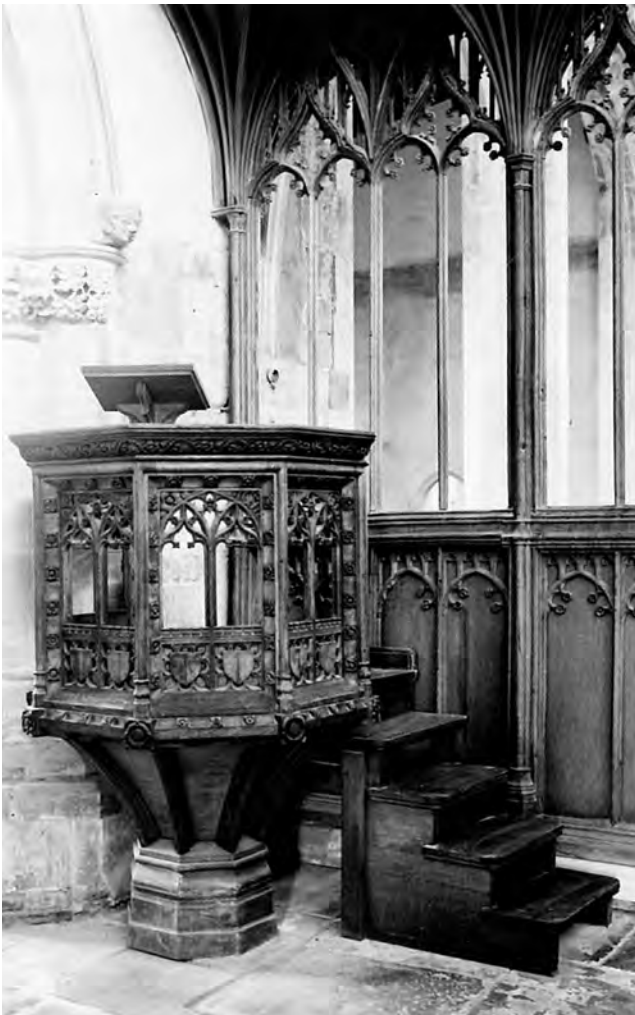
Fig. 641: Pulpit. In the north-east corner of the nave, 2005. Photo: Warwick Rodwell

- iii) The present oak pulpit, designed by Fowler, was made in 1898, and was initially located on the south side of the nave, against the arcade respond (Figs. 613, 614 and 640); it was moved to the north side in 1914 (Fig. 641).⁸⁰ The pulpit is octagonal, late medieval in inspiration, and raised on a moulded 'umbrella' base, with an attached flight of timber steps. Each side comprises a pair of trefoil-headed openwork panels, above smaller solid panels with uncarved shields. The whole is ornately decorated with carving, including florets on all the chamfers around the openings. An inscription divided between four of the sides, reads: *LVSTRI / FELICIS / MEMORES DEO / DEDERE DVO.*

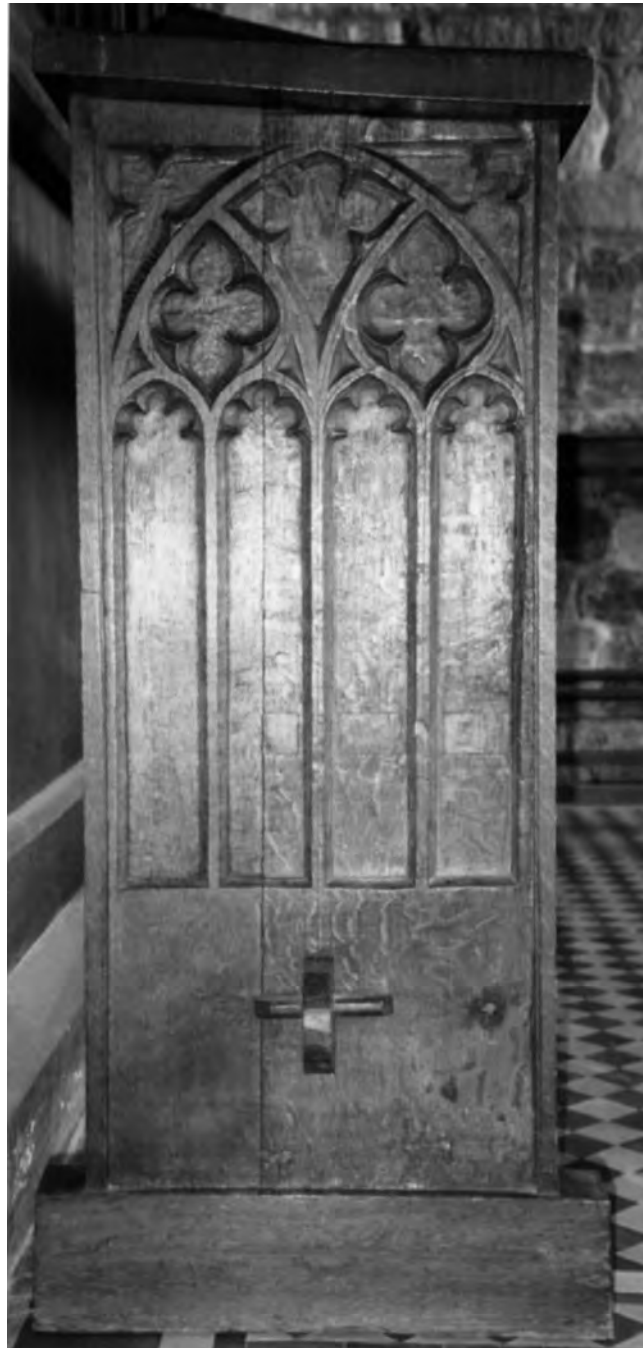
Fig. 642: Medieval bench-end, now incorporated into a twentieth-century desk in St Mary’s church. Photo: Warwick Rodwell

One incomplete medieval bench-end was, however, saved, which was later noted in St Mary's vestry. This was incorporated in a new oak desk, probably at the beginning of the twentieth century: that is still in St Mary's church (Fig. 642). It is carved with a fourteenth-century pattern of cusped Y-tracery enclosing four cinquefoil-headed main lights with elongated quatrefoils above. Stylistically, it relates to the window traceries in the north aisle. Only two-thirds of the width of the bench-end survives, the remainder having been restored. The height of the panel (slightly trimmed) is 80 cm and the width 35 cm. A little below mid-height is a line of infilled mortices where the seat was jointed,⁹³ and scribed setting-out lines for the medieval carving are well preserved.

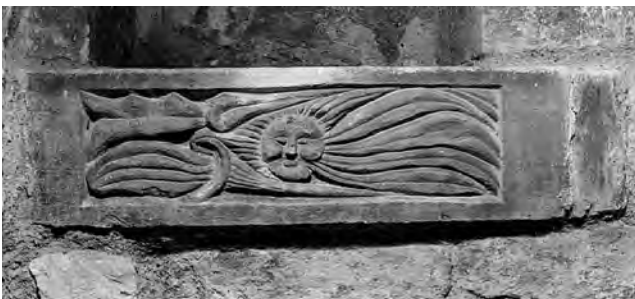
Fig. 643: Pulpit. South aisle. Replaced piscina bowl with 1920s carving. Photo: Warwick Rodwell

- i) Nothing is known of a piscina or sedilia in the chancel, although they must have been present. There may be surviving evidence behind the Victorian tiling on the south wall. An elaborate, nodding-ogee canopy is most likely from an early fourteenth-century sedilium, which could only have been in the chancel (Fig. 820, no. 18).
- ii) A damaged, but once profusely carved piscina of the early fourteenth century remains in the south-east corner of the north aisle (Fig. 476). Opposite, in the north wall, is a simple rectangular stone cupboard with a modern oak door; it is contemporaneous with the aisle, and served as an aumbry (Pl. 66).
- iii) A small piscina of the late thirteenth century with a trefoil head and damaged bowl survives in the south aisle (Fig. 444). The bowl was restored in an unorthodox fashion in the early twentieth century (Fig. 643).

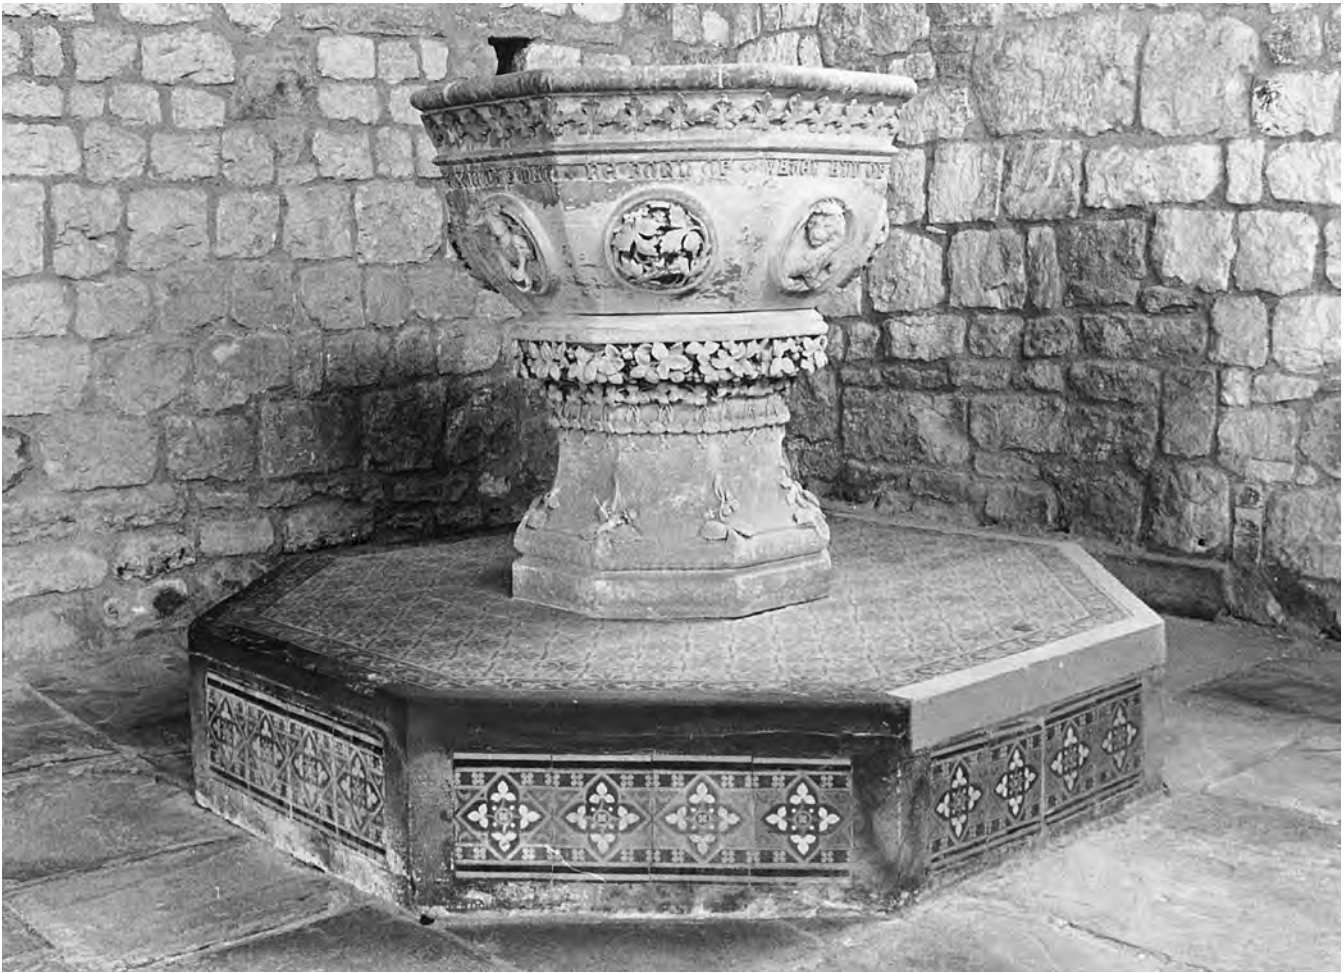
Fig. 644: South aisle. The font (1859) and its tiled plinth from the north-east. Photo: Warwick Rodwell

- iv) A new, exuberant font of octagonal form was given by George Hogarth in 1858, and placed in the south-west corner of the south aisle (Figs. 644 and 645).⁹⁶ It was described at the time, 'though not in keeping with the character of the building, [it] is an exquisite work of art'.⁹⁷ The font is on top of the Gelder family vault, which was infilled with rubble to provide support. The bowl is carved from a single block of Caen stone, and the pedestal from another. The bowl has a moulded profile with a rolled rim, below which is a frieze of upright, naturalistic leaves and a fillet inscription in counter-relief extending around all eight faces.⁹⁸ The lettering is Gothic:

The font stands on an octagonal Yorkstone plinth into the top and sides of which are set Minton polychrome tiles (11 cm square). On the top is a single pattern, cream inlaid on a red ground: it depicts an eight-petalled rosette in a diagonally set square, with stiff-leaf sprigs in the corners. There is a border of rectangular relief-patterned tiles (15 × 7.5 cm), depicting a raised vine scroll in cream against a glazed royal blue background (Pl. 69).

Set into each vertical face of the plinth is a band of four tiles (15 cm square) flanked above and below by narrow border tiles (15 × 3 cm); the latter comprise continuous lines of red, buff and black (Pl. 70). The square tiles are cream-buff, partly relief-decorated, having a flush red inlay and sunken inlays of royal blue, white and apple green. They too are border tiles, which incorporate four-petalled rosettes along two edges, and these are overlapped by a diagonally set square

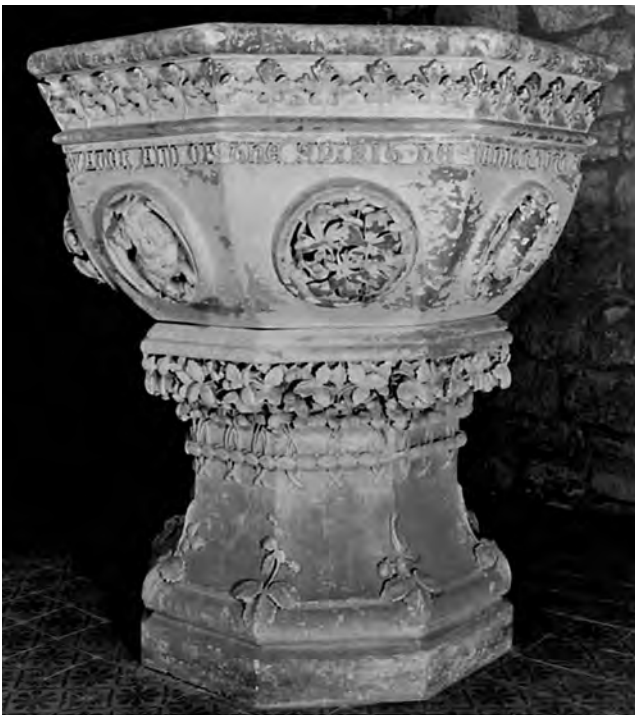
Fig. 645: Font. Viewed from the north-west, showing details of the decoration and inscription. Photo: Warwick Rodwell

Below the inscription band, on four of the faces are the emblems of the Evangelists carved in high relief in roundels. On the intermediate faces are swirls of naturalistic foliage and berries. The octagonal pedestal has a small moulding at the junction with the bowl, below which is a collar of tightly clustered naturalistic foliage and fruits. On the waist stand a series of upright leaves with long

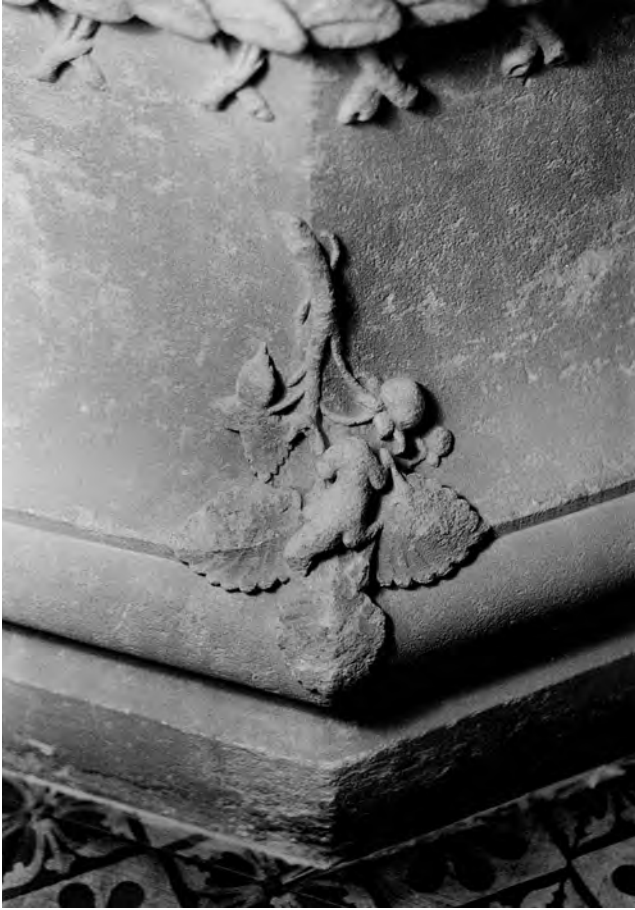
Fig. 646: Font. Detail of the base, showing a strawberry leaf and fruit, together with a frog (damaged) on the east-north-east angle. Photo: Warwick Rodwell

stems intertwined. These are overlaid by a narrow collar of small overlapping leaves, visually acting as a tie-band. The pedestal has a simple moulded base, and at the angle of each facet is a single strawberry leaf, fruit and stem. On one angle is also carved a frog (Fig. 646).

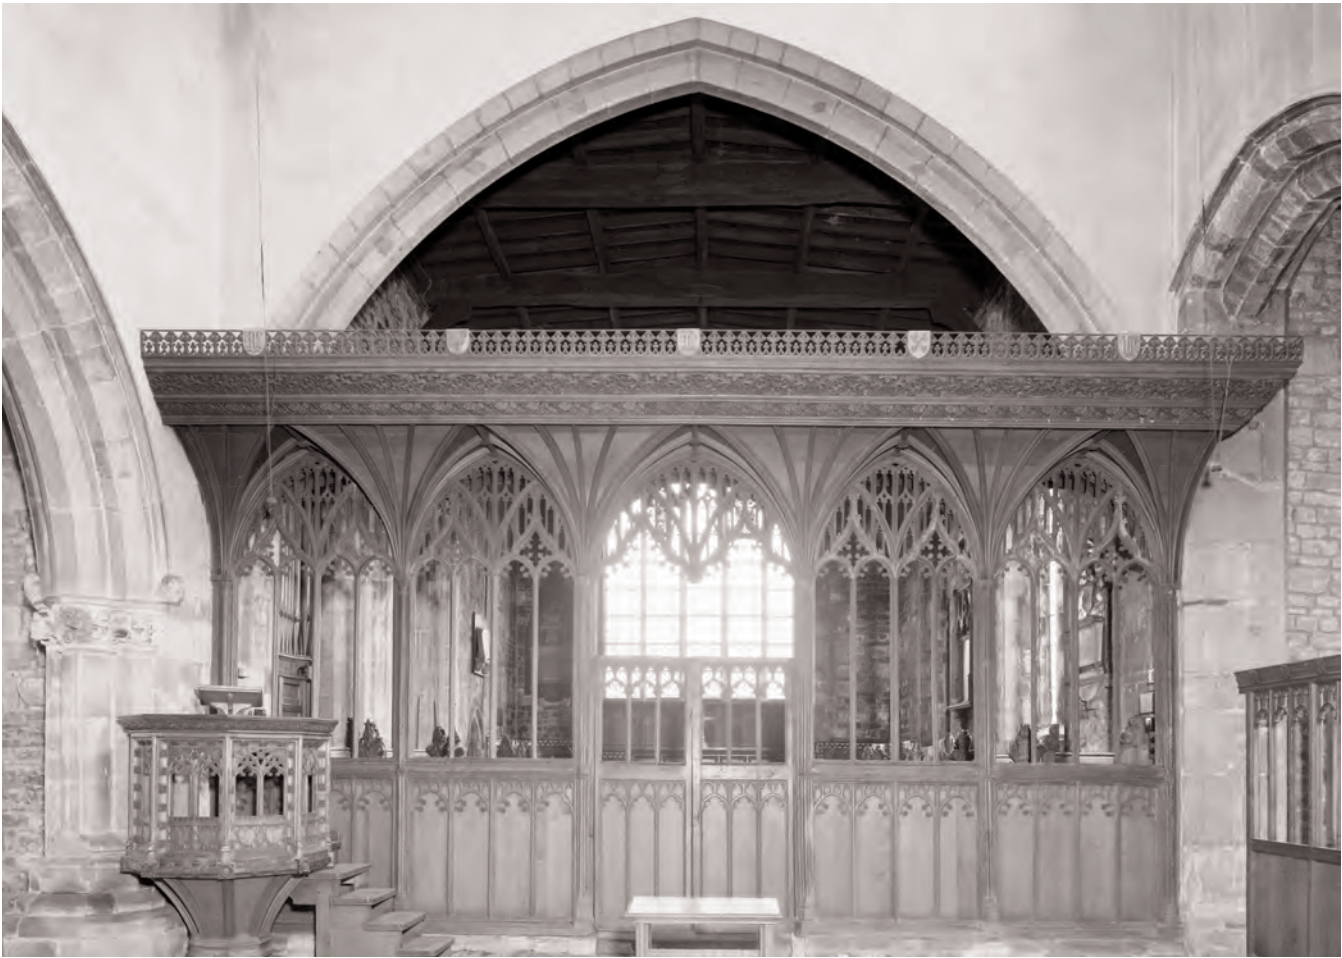
Fig. 647: Chancel screen. West side, 1972. Photo: English Heritage, RCHME

bays with cinquefoil traceried openwork in the upper register and plain panels below; the simple cornice is relieved with a few carved motifs.¹⁰⁰ The screen (glimpsed in Fig. 647) was made by J.H. Goddard of Lincoln.¹⁰¹

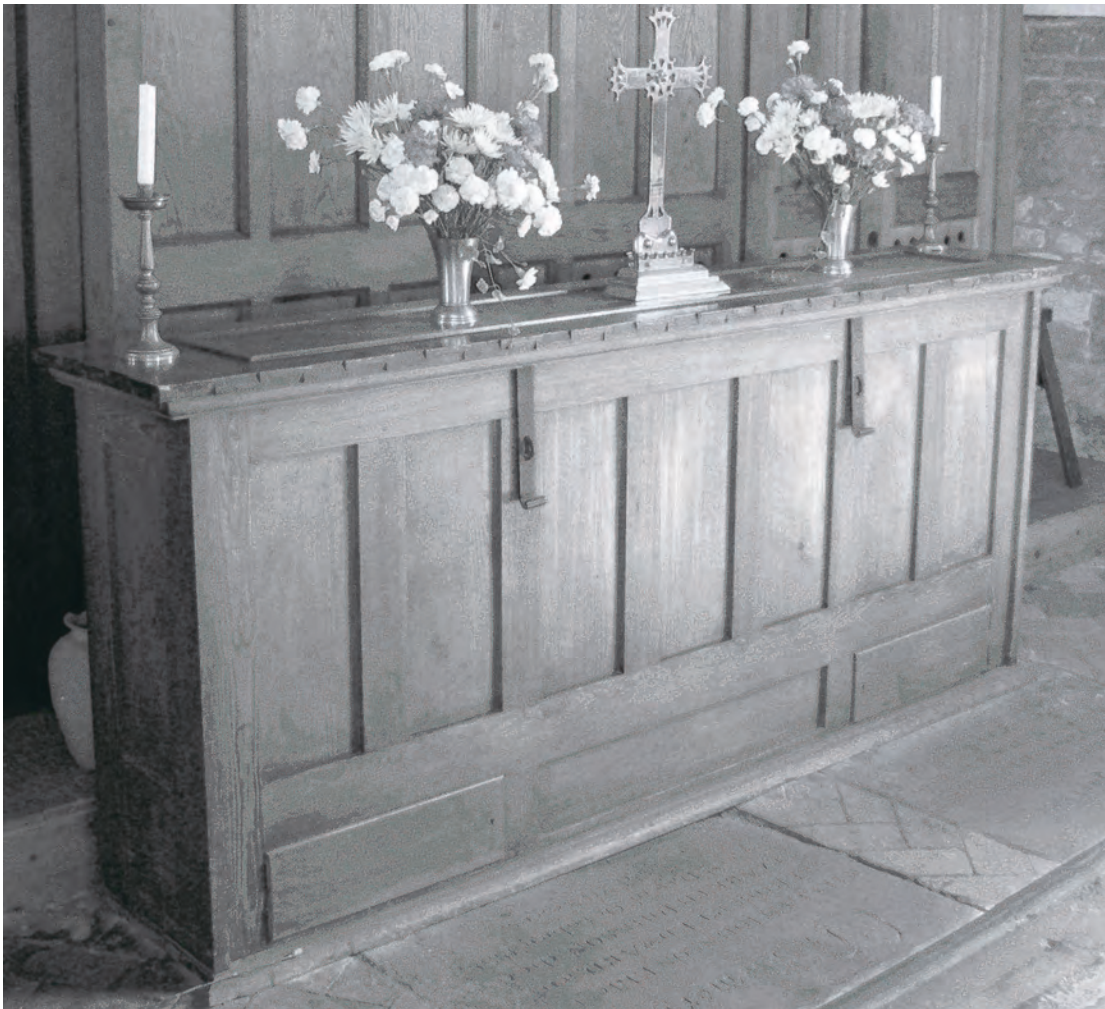
Fig. 650: Pine frontal chest (1896) from St Peter's; now serving as an altar in St Mary's church. Photo: Warwick Rodwell

iv) A new stained-pine chest to house the altar frontals was given in 1896.¹²² It was said to be of the same design as one in St Mary's, but with the addition of three drawers. The chest with the drawers is now in St Mary's church, where it serves as an altar in the south nave aisle (Fig. 650).¹²³

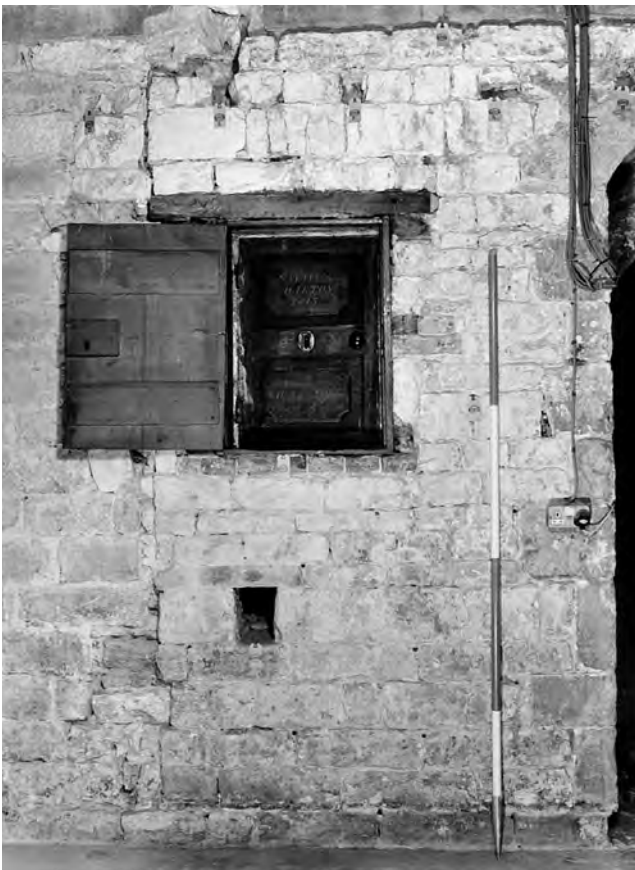
Fig. 651: Vestry. Wall safe (1813) and exposed masonry of the north wall (exterior) of the chancel. Photo: Warwick Rodwell

Built into the south wall of the vestry is a safe, its front recessed and concealed by a timber door and frame (Fig. 651). The cupboard door is of pine boarding, with T-hinges and an oak box-lock. The steel door of the safe is panelled with astragal mouldings, quadranted at the corners, in the style of Regency furniture (Pl. 107). The steel is even decorated with wood-graining. An inscription on the door dates the safe to 1813;¹²⁴ it has a brass knob and keyhole escutcheon. Inside is a metal shelf with an ogivally moulded front edge. In 1830 the safe was referred to as the 'iron chest' in the vestry. A similar safe in St Mary's church vestry has now lost its door; it is also recorded that an 'iron chest' was purchased for the Vicarage in 1813.

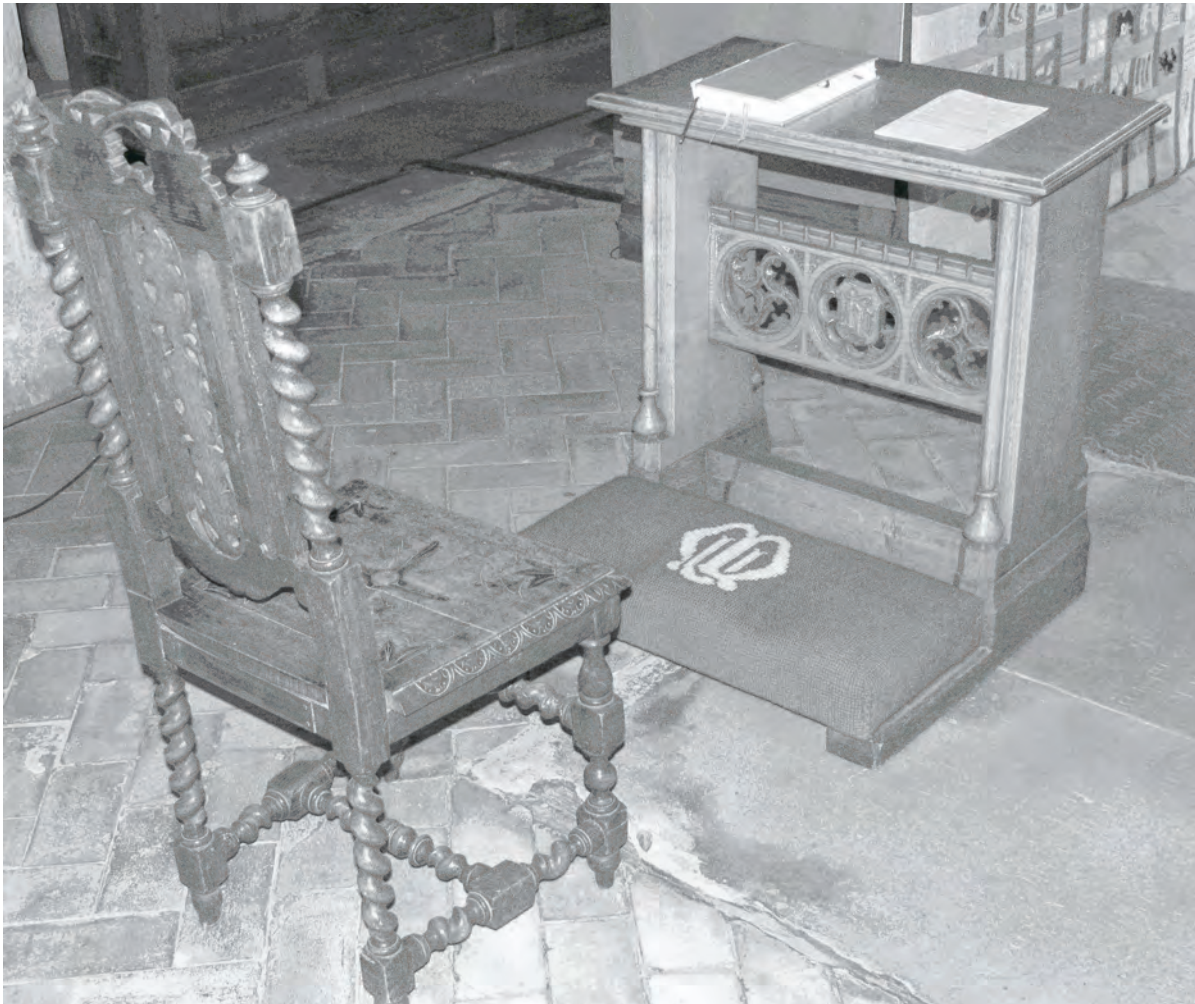
Fig. 657: Oak litany desk (1897) and a Jacobean-style chair (1870) from St Peter's. Now in St Mary's church. Photo: Warwick Rodwell

- i) A litany desk was given in 1897.¹⁶⁷ It was 'temporarily' transferred to St Mary's in the 1970s, where it remains.¹⁶⁸ It is of oak and has a decoratively pierced central rail (Fig. 657). The desk appears in early photographs of the nave, where it stood in front of the chancel screen (Fig. 614).
- ii) Two 'sanctuary prayer desks' were listed in 1984 as having been 'temporarily' transferred to St Mary's, where they remain.¹⁶⁹ They are made of oak and date from the early twentieth century.

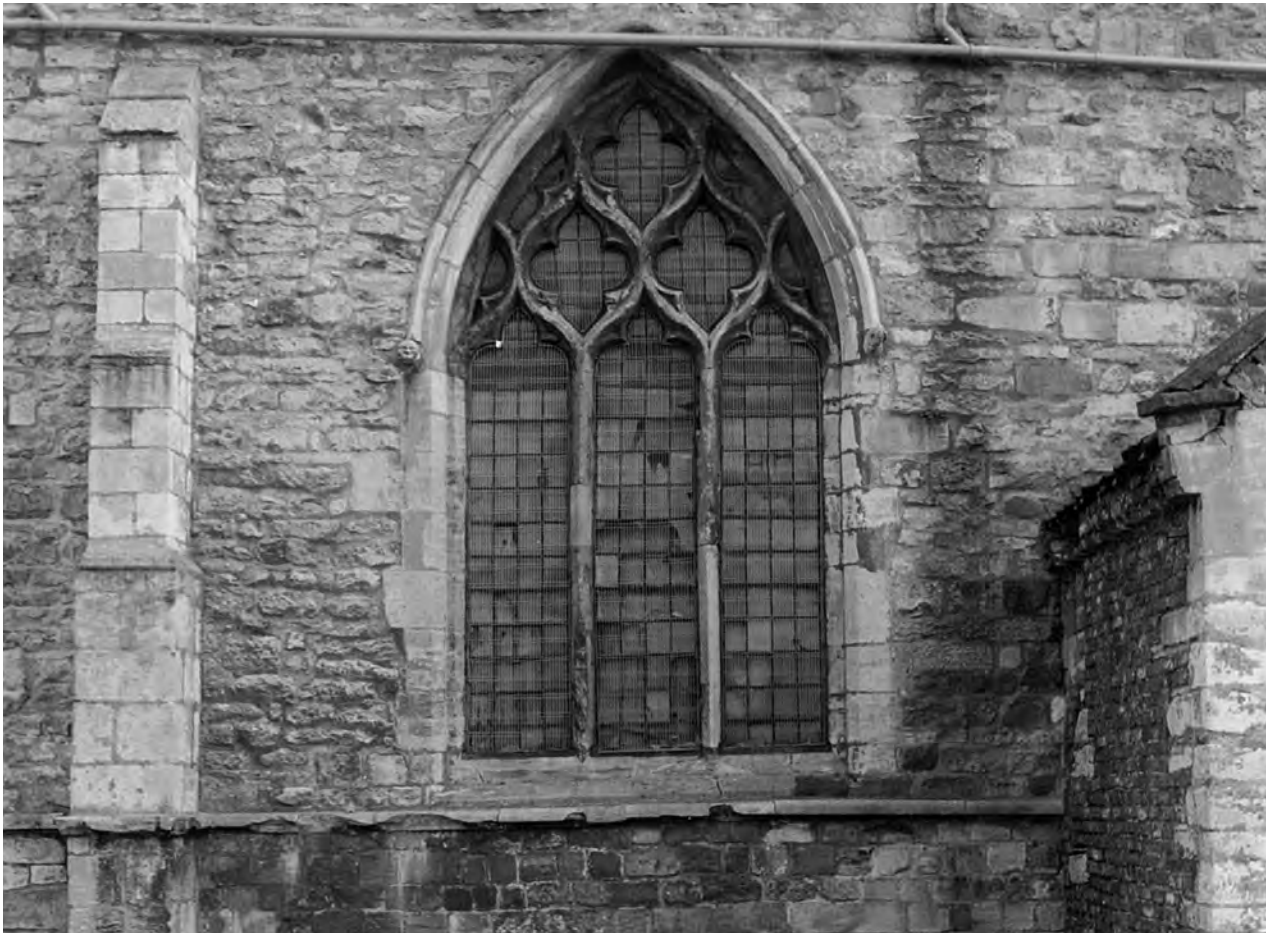
Fig. 658: North aisle, bay 4. The last surviving window (nIX) with its complete scheme of eighteenth-century clear glazing, 1983. Photo: English Heritage

It is apparent from old illustrations that the church was completely reglazed in the eighteenth century in clear glass, using rectangular quarries (averaging 12 × 18 cm; Fig. 658); the date when this was done is unknown but the 1740s is a strong possibility. Only fragments of this glazing now survive, although much was present down to the 1970s. Four small panels of medieval stained glass (from tracery lights and elsewhere), were incorporated in the east windows of the chancel and the south aisle. Although Nattes appears to show external ferramenta in the south clerestory windows (but not in the aisle) in 1796 (Fig. 11), none survive today. If ferramenta were present, their removal must have occurred in the first half of the nineteenth century, since none are visible in the 1860s photograph (Fig. 687). There are external ferramenta in the east window of the chancel, the organ chamber and the vestry, but these were introduced between 1897 and 1903. Otherwise, all the glazing is tied to slender bars of round or square section. That there were internal medieval ferramenta in at least some windows is apparent from the surviving pockets for saddle-bars (*e.g.* in the north aisle, east window).

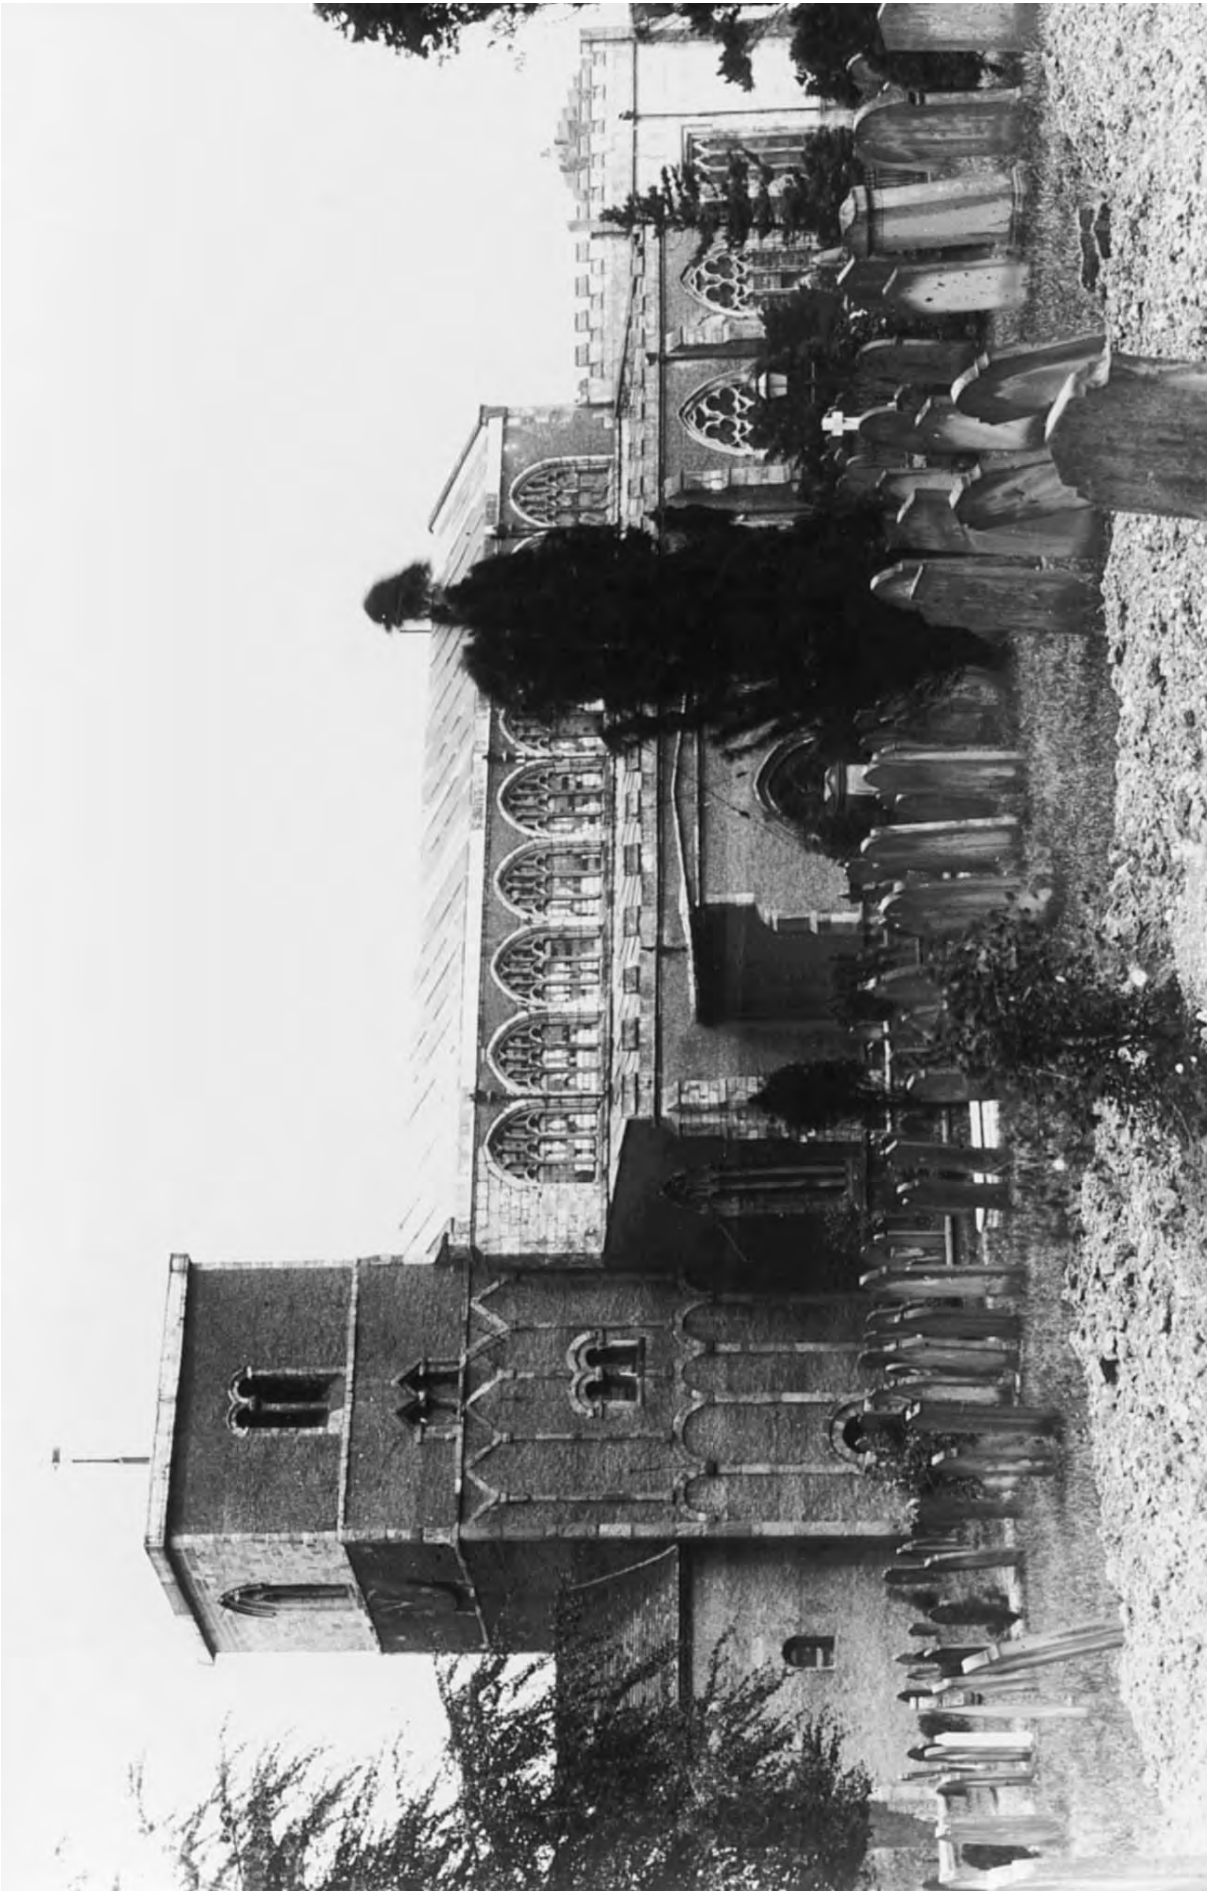
Fig. 672: St Peter's churchyard from the south-west, in the early 1870s, showing a profusion of tombstones of the late eighteenth and early nineteenth centuries. Note the new rendering on the tower and south porch (1868–70). Photo: ex. Vārah coll., Lincolnshire Archives

Soil level had risen around the church to the extent that it was necessary to descend three steps to reach the floor of the south porch. Plinths all round the church had disappeared below ground and brick gutters were laid around the walls at various times, some later replaced with tarmac. It was possibly in 1858 that the sunken path flanked by brick retaining walls, leading to

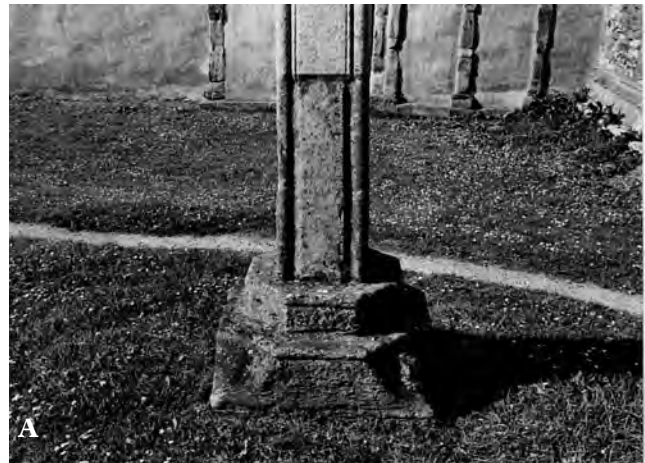
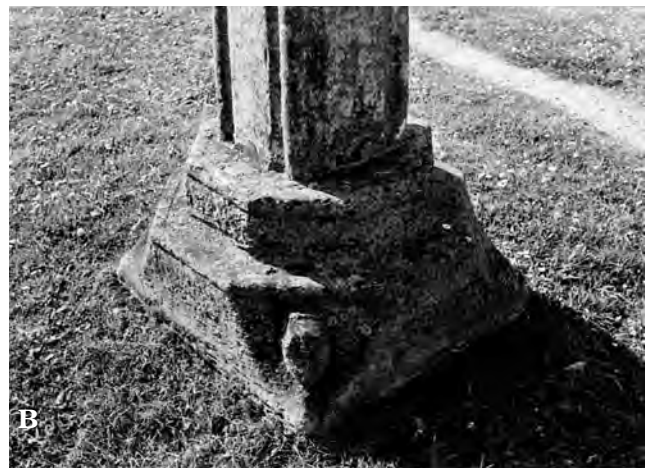
Fig. 674: Churchyard cross: base and surviving stump of the medieval shaft. A, The setting, axially in front of the tower doorway. From the south. B, Base, showing the eroded mask on the south-east facet. Photos: Warwick Rodwell

stepped at a height of 26 cm (Figs. 673 and 674). The corners of the lower stage are cut away so that the top is octagonal in plan, and has a simple roll and water-holding moulding around its arris; the upper stage is octagonal and is similarly moulded. Two of the corner facets of the lower stage are sculpted in relief with human masks (south-east and north-west; Fig. 674), but these are now so eroded that their facial features cannot be readily distinguished. The other two facets carry what appear to be vestigial brooch-stops, but again these are very worn. The square cross base at Thornton Curtis also has faceted corners, each of which bears a human head (Fig. 675); the two-stage base at Winterton is almost identical to that at Barton, except that none of the faceted corners carries a mask (Fig. 676, B). They were arguably products of the same workshop.

The cross-shaft is rectangular in section, tapering as it rises, and has a roll flanked by bold hollows on each arris. It is evidently tenoned into the base, and there is a thick lead flange visible in the joint. The original cross-shaft was composed of several sections of Lower
