ST PETER'S

Barton-upon-Humber, Lincolnshire

A Parish Church and its Community

HISTORY, ARCHAEOLOGY AND ARCHITECTURE

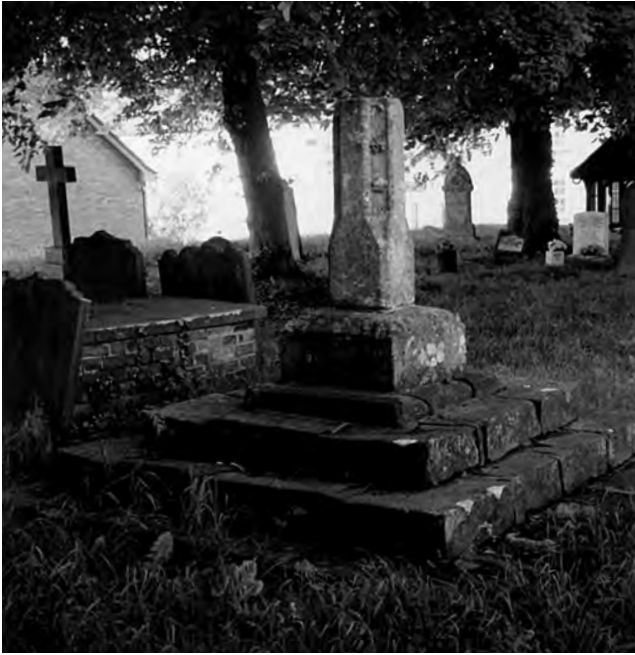
Fig. 675: Thornton Curtis (Lincs.). Stump of the medieval churchyard cross, reused as a sundial pillar (with original sub-base and three-stepped plinth). Photo: Warwick Rodwell

The base at Thornton Curtis is raised on a separate, chamfered sub-base, as are several others in the region. The proportions of the base at Barton call for its elevation on a similar sub-base, but this was probably lost when the cross was reset on its present brick foundation, if not earlier.

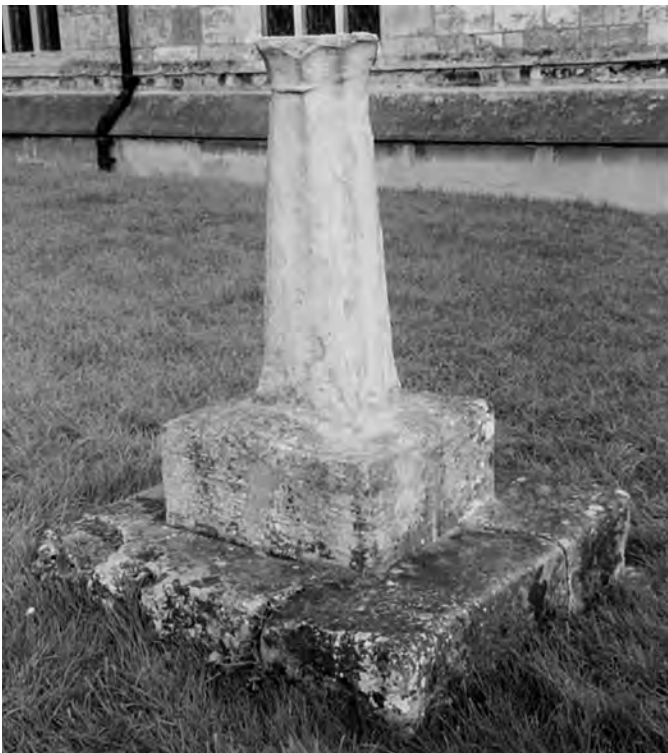
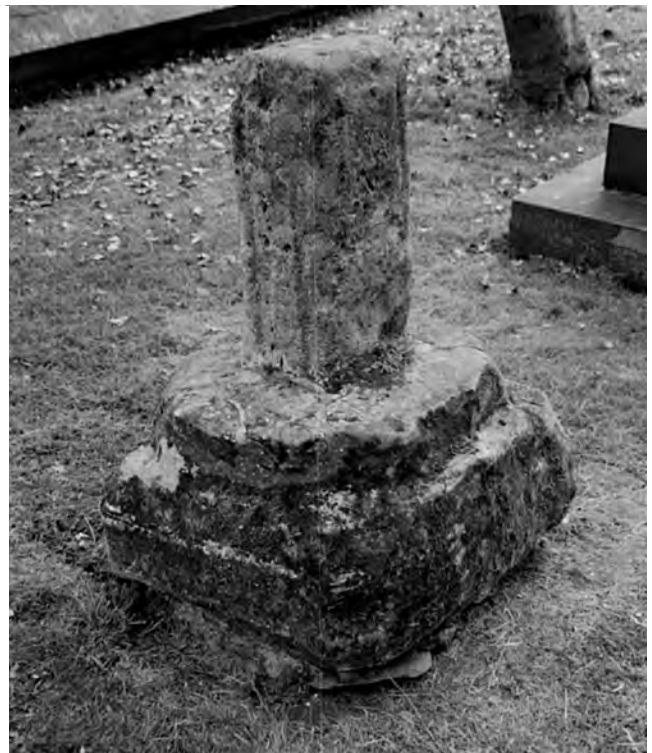
Fig. 676: Stumps of medieval churchyard crosses, reused as sundial pillars. A (left), Barrow-upon-Humber (shaft modified and base probably reset on blocks reclaimed from the original plinth); B (right), Winterton (base reset, without plinth). Photos: Warwick Rodwell

stepped at a height of 26 cm (Figs. 673 and 674). The corners of the lower stage are cut away so that the top is octagonal in plan, and has a simple roll and water-holding moulding around its arris; the upper stage is octagonal and is similarly moulded. Two of the corner facets of the lower stage are sculpted in relief with human masks (south-east and north-west; Fig. 674), but these are now so eroded that their facial features cannot be readily distinguished. The other two facets carry what appear to be vestigial brooch-stops, but again these are very worn. The square cross base at Thornton Curtis also has faceted corners, each of which bears a human head (Fig. 675); the two-stage base at Winterton is almost identical to that at Barton, except that none of the faceted corners carries a mask (Fig. 676, B). They were arguably products of the same workshop.

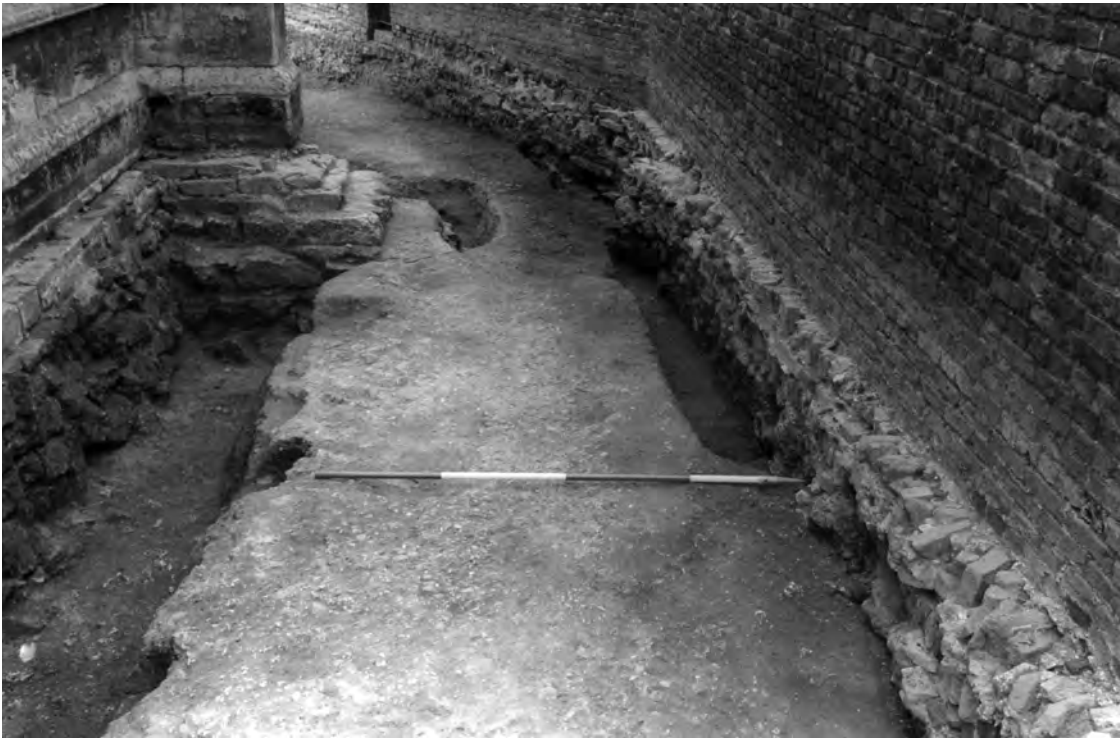
Fig. 677: Medieval path around the east end of the church, cut by the foundation trench for the present chancel. View north. Scale of 2 m. Photo: Warwick Rodwell

began the succession of metalled paths to which reference has already been made. While the present red brick wall and most of its mortared rubble foundation belong to the early or mid-eighteenth century (Figs. 677 and 683), there were sufficient residual traces to confirm that it had a predecessor, more-or-less on the same line. A considerable amount of medieval brick was reused in the foundation and footing courses, suggesting that the previous boundary was perhaps a fifteenth-century brick wall. The site of an early entrance to Tyrwhitt Hall was preserved in the foundations, and is still marked by a small gateway (Fig. 685). A medieval surface-water drain, made of brick, was encountered passing under the eighteenth-century wall (F5255; Fig. 686).

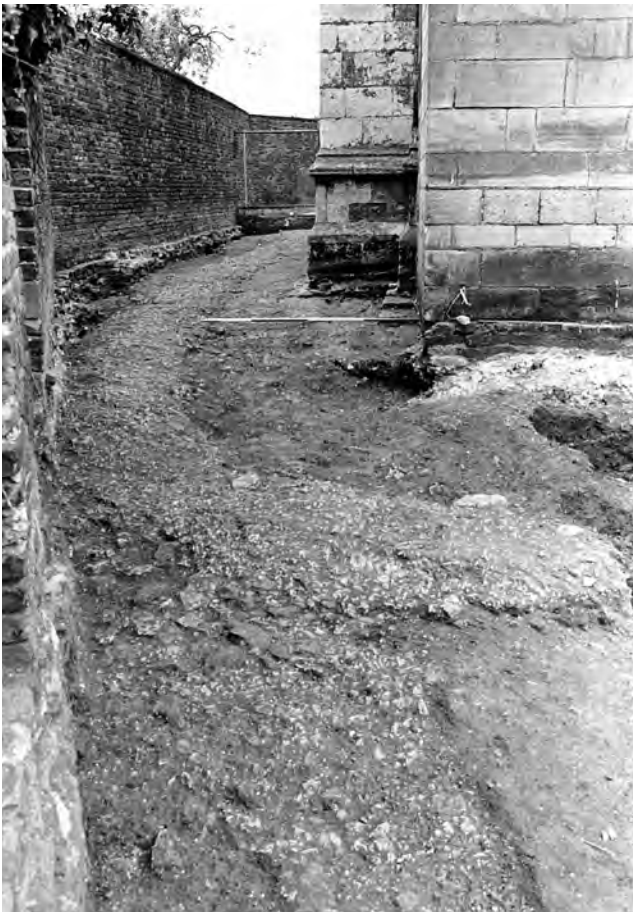
Fig. 678 Late medieval path curving around the north-east corner of the church. In the foreground is the branch of the path which continues to the north-east entrance of the churchyard. View south. Scale of 2 m. Photo: Warwick Rodwell

Not only is the present north-east entrance to the churchyard on the line of the path just described, but the modern footpath alongside the boundary wall with Tyrwhitt Hall also runs southward from that entrance. Excavation in Areas 15 and 16 revealed a series of metalled footpaths here extending back at least to the fourteenth century. The earliest metalling was cut by the foundation trench for the chancel (Fig. 677). A later surface, probably sixteenth century, contained a large quantity of medieval ceramic roof tile (F5209; Figs. 678 and 679).

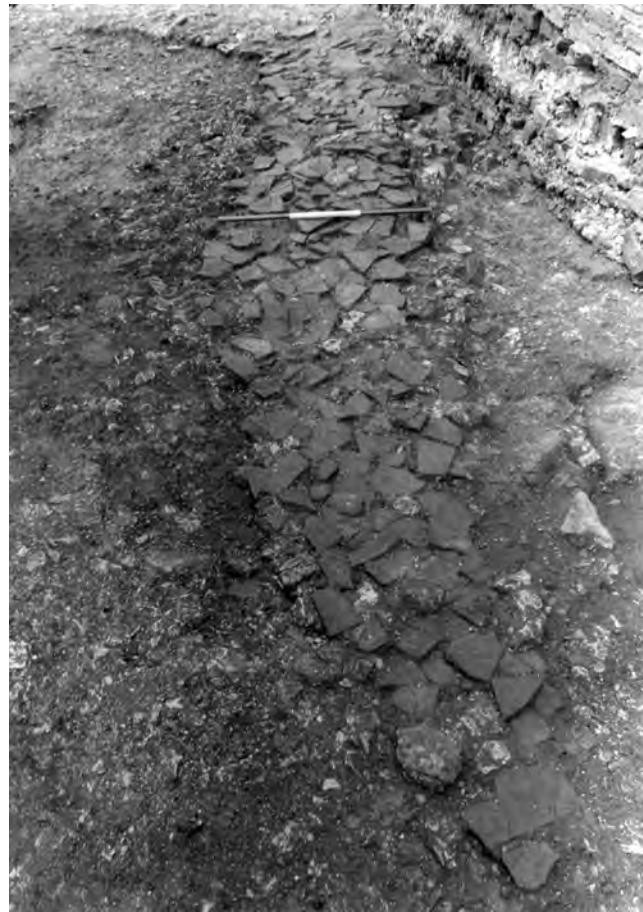
Fig. 679 Detail of the late medieval patch in the path (F5209) at the east end of the church, showing a layer of broken medieval roof tile. View north. Scale of 75 cm. Photo: Warwick Rodwell

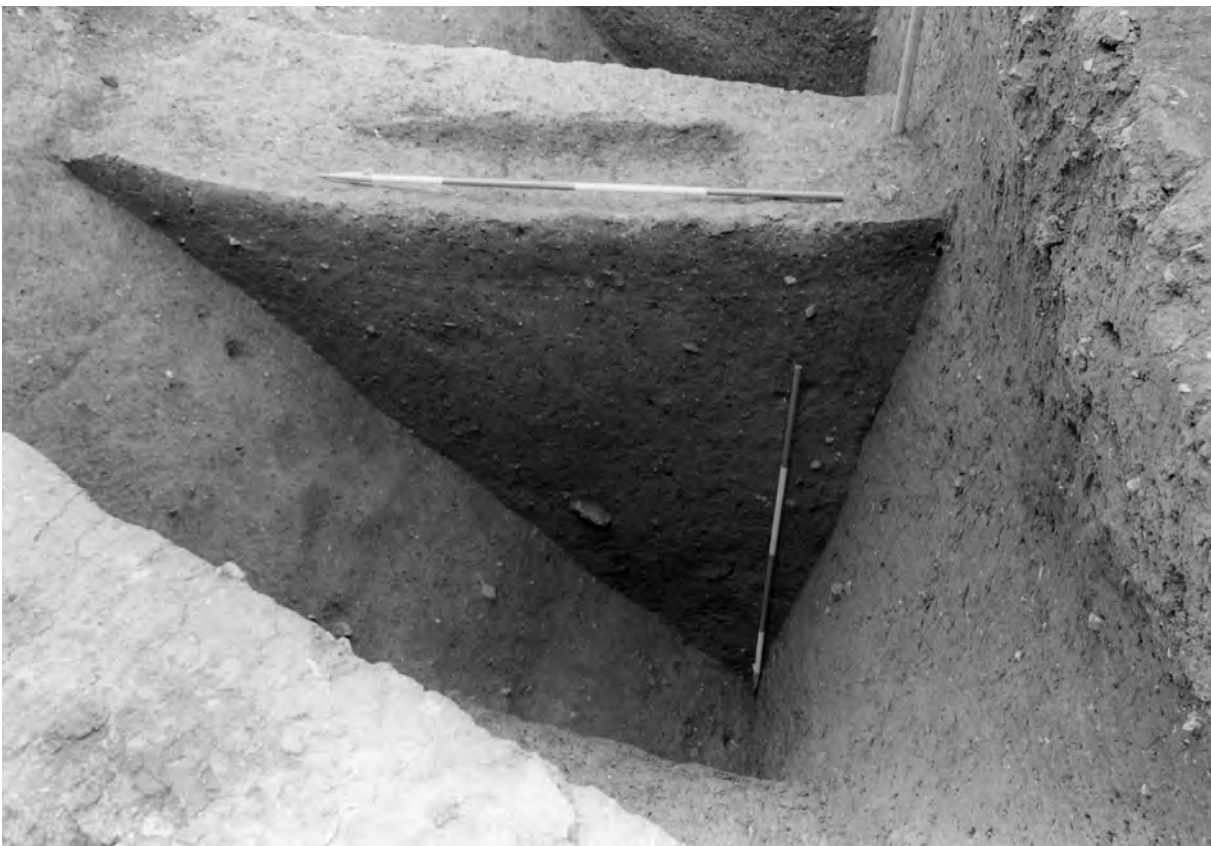
Fig. 681: Part section of the defensive ditch F5458, showing the steep inner slope (left). View north. Scales of 2 m. Photo: Warwick Rodwell

The palisade was superseded by an earthwork of such large proportions that its purpose could only have been defensive. In part, the ditch was dug just outside (east of) the palisade, but also sliced obliquely across its line; the two were clearly not contemporaneous (Fig. 680). The western lip of the ditch and less than half of its width fell within the excavation, the remainder lying beyond the present churchyard wall, in the garden of Tyrwhitt Hall. The ditch (F5458) had a steep V-shaped profile (Fig. 681): the bottom was not found, but the minimum depth was 4.8 m (16 ft) and, assuming symmetry, the width must have been at least 9 m (30 ft). The intention may have been to excavate a ditch 30 ft wide by 15 ft deep, or even larger (Fig. 682).

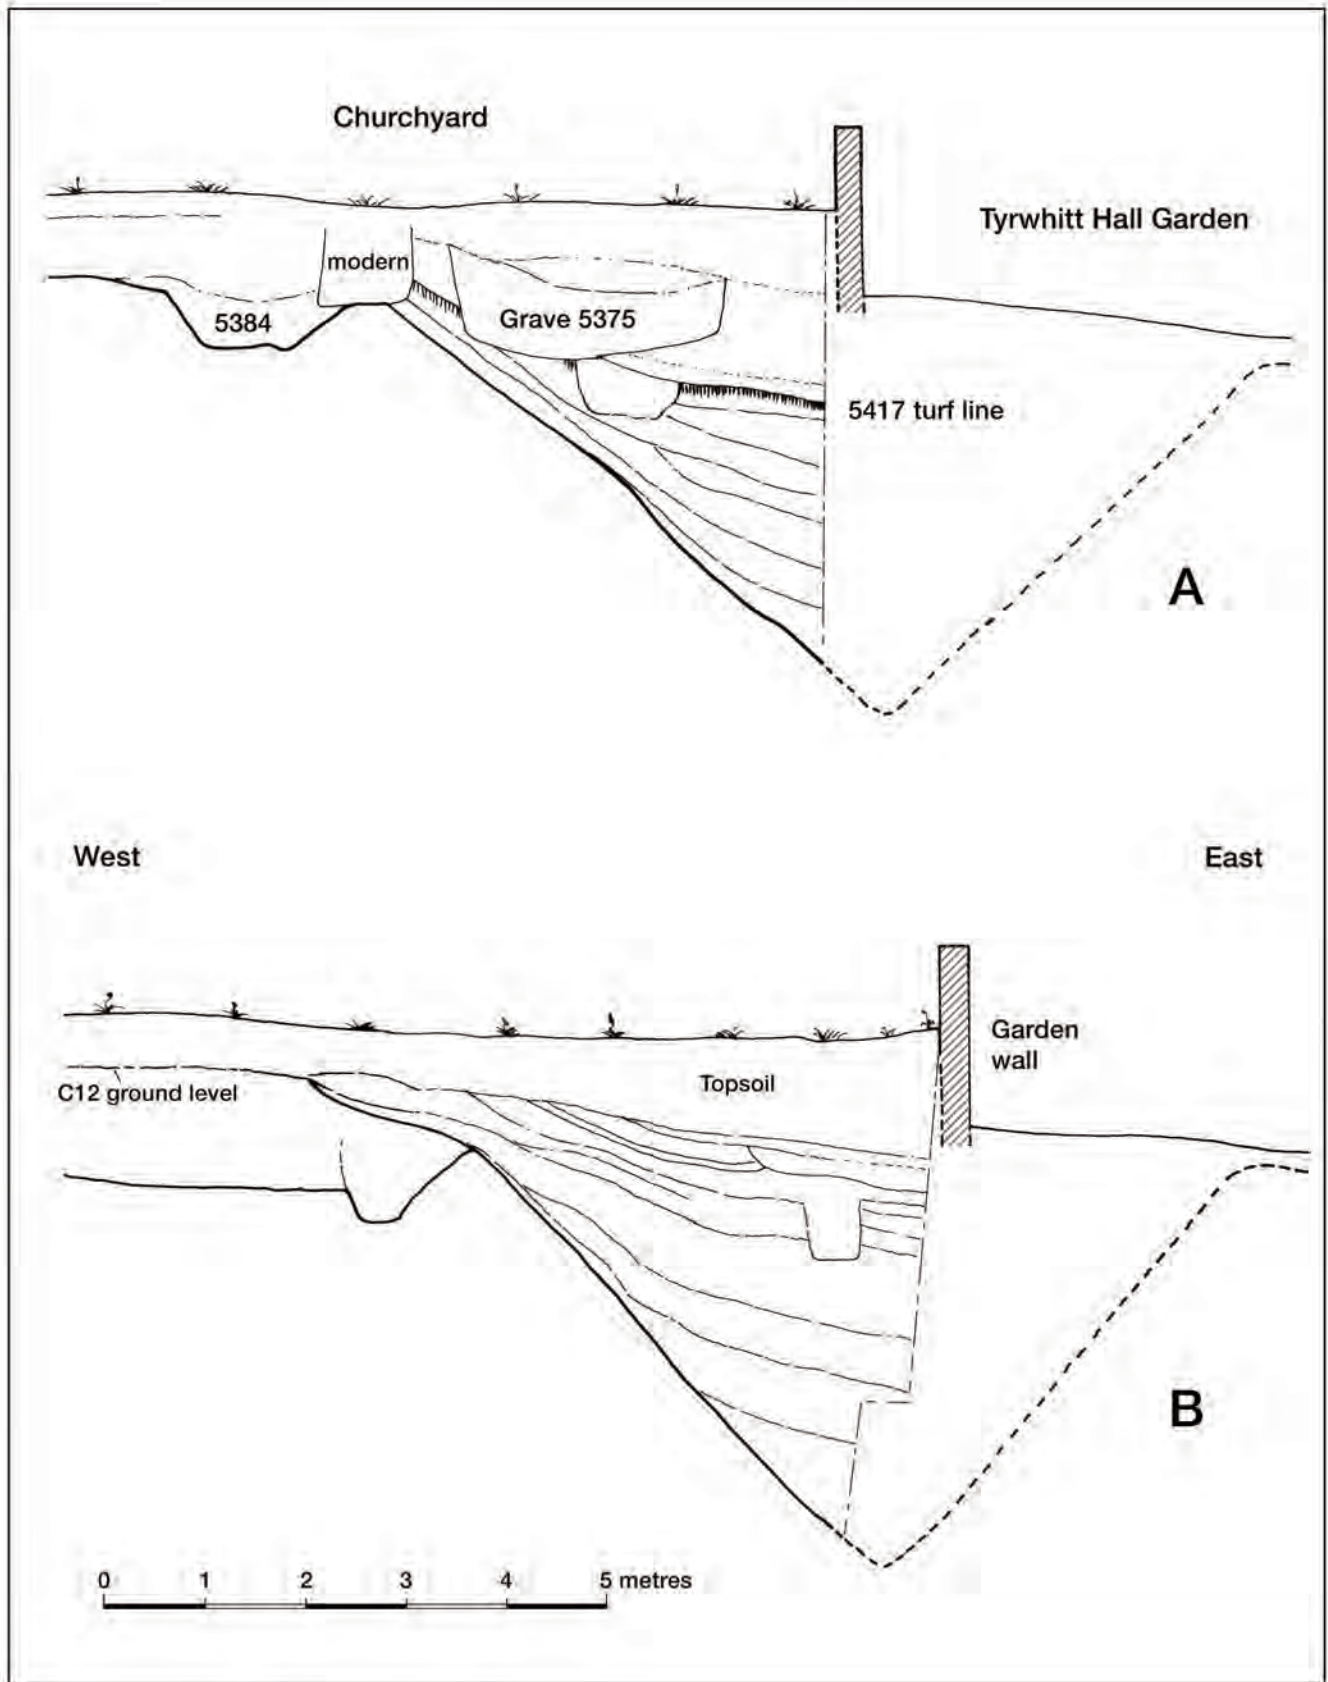
Fig. 682: Drawn sections through the defensive ditch (F5458), forming the eastern boundary of the Norman town. Section A is mildly oblique and therefore the ditch profile is slightly distorted. Suggested reconstructions of the profile (minimum dimensions) are indicated with broken lines. Scale 1:75. Drawing: Warwick Rodwell

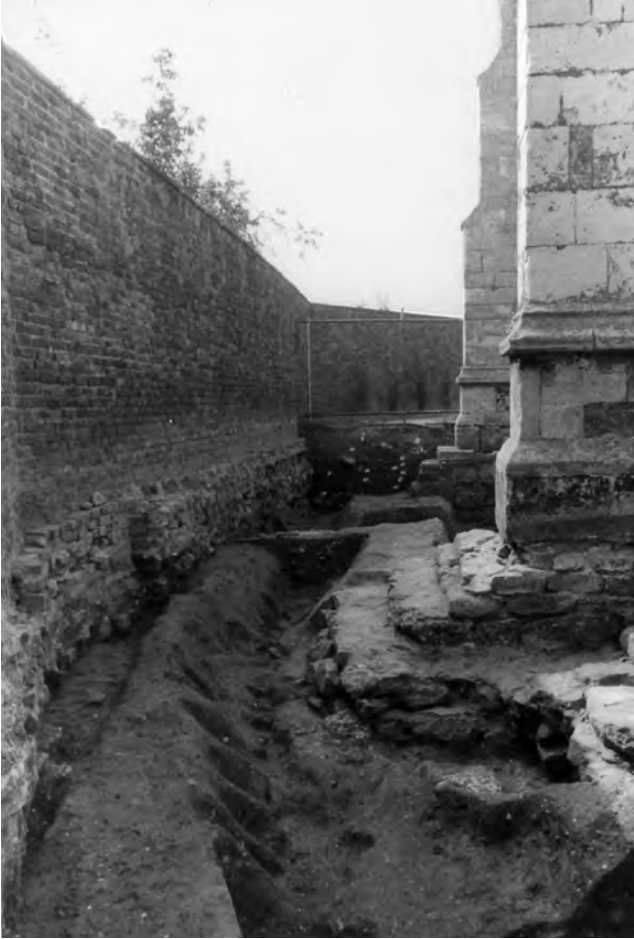
Fig. 683: Thirteenth-century palisade trench (F5348) defining the boundary between the churchyard and Tyrwhitt Hall. This was succeeded by a late medieval wall, the foundation trench for which appears on the left, beneath the eighteenth-century wall which forms the present boundary. View south. Scale of 75 cm (on baulk). Photo: Warwick Rodwell

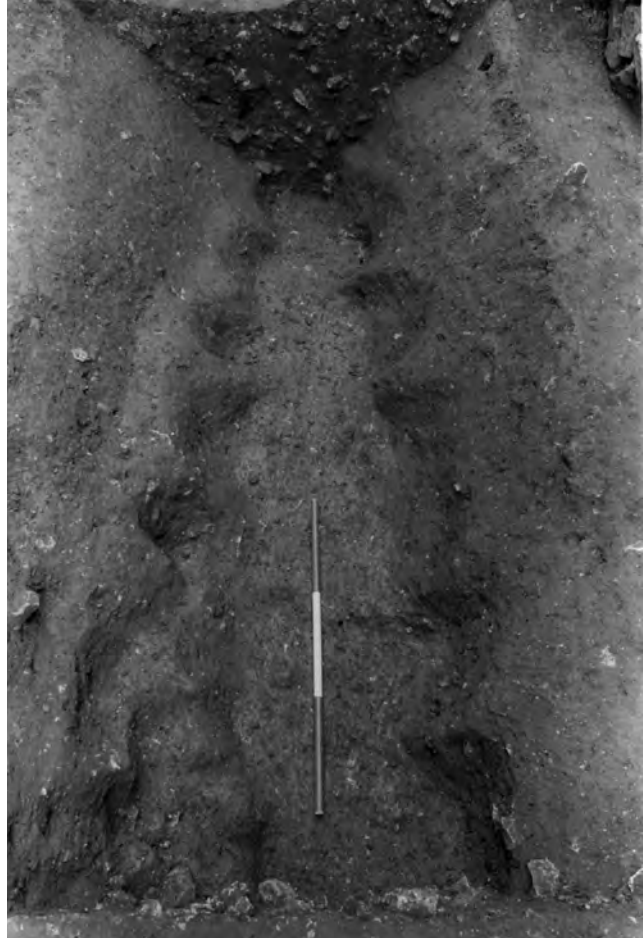
Fig. 684: Detail of post impressions in the palisade trench, F5348. View south. Scale of 75 cm. Photo: Warwick Rodwell

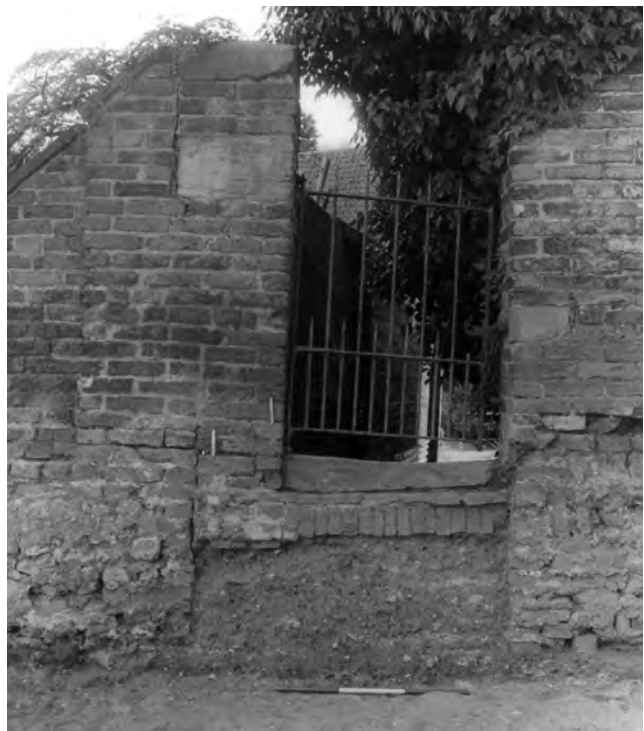
Fig. 685: East boundary wall of the churchyard, with the private entrance (C) from Tyrwhitt Hall. View east. Scale of 75 cm. Photo: Warwick Rodwell

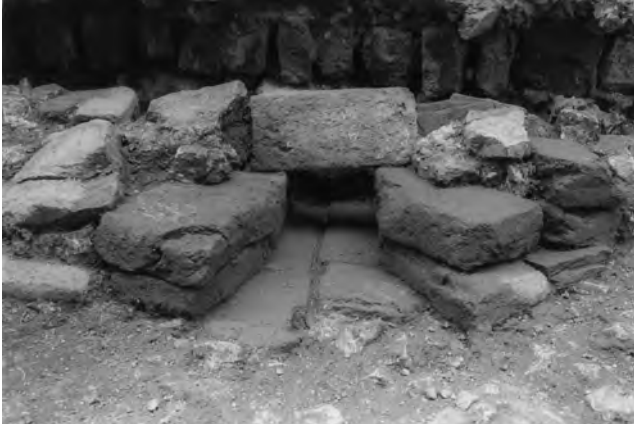
Fig. 686: Detail of a late medieval brick drain (F5255) running under the east boundary of the churchyard. View east. Photo: Warwick Rodwell

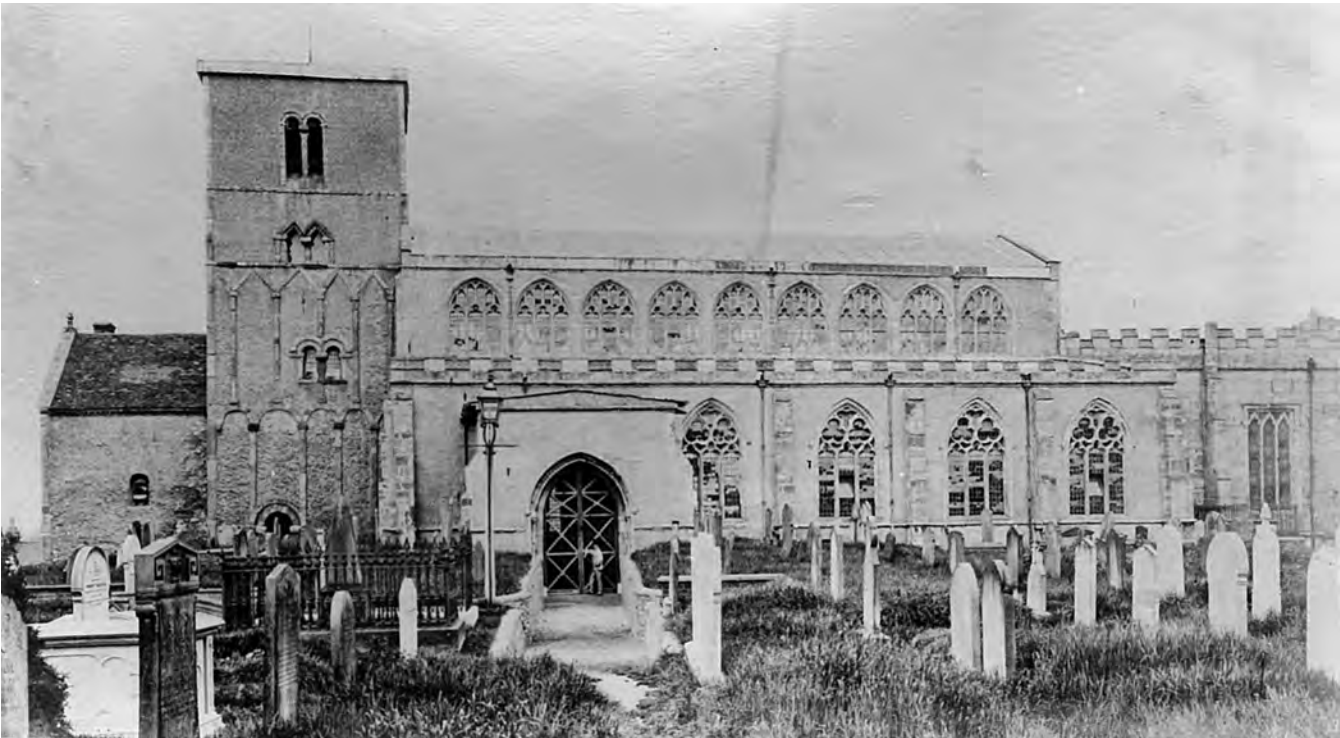
Fig. 687: The earliest known photograph of St Peter's church, taken from the middle of the churchyard extension in the early 1860s (probably taken between 1862 and 1865). The gas lamp is on the east-west path, and the iron-railed tombs are just within the extension. Note the lumpy rendering on the tower and western annexe, the old tiles on the roof of the latter, and the absence of trees and shrubs. The stained glass windows (memorials of 1861 and 1886) had not been installed in the aisle, but that in bay 2 of the chancel (1856) is visible. Also, the gates were fitted on the porch in 1862. Courtesy of North Lincolnshire Museum Service (Ball, scrapbook 2)

The Victorian churchyard extension was not affected by the clearance operation of 1967, but many stones have been lost subsequently through vandalism and neglect; rapid depletion continues, and destruction will be complete within a decade or two. No record of the stones here was made in 1966, but a plan and schedule of the surviving inscriptions was compiled in 1978–84 (see above). The oldest known photograph of St Peter's was taken from the extended graveyard in the early 1860s, and shows some of its headstones and iron-railed tombs (Fig. 687).

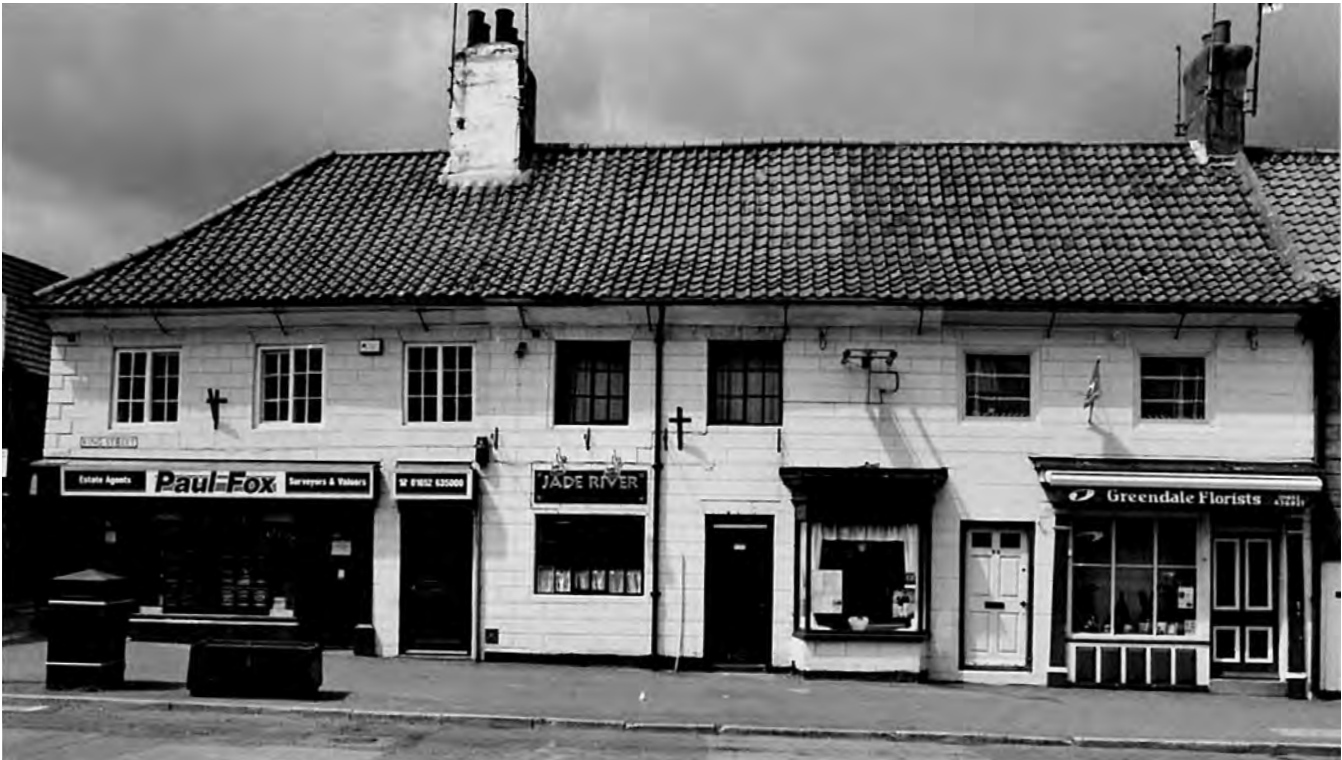
Fig. 689: King Street, Barton, 2006. The late seventeenth-century vicarage house on the west side of the street. The lower rooms were converted into shops in the nineteenth century. Photo: Warwick Rodwell

Consequently, a new site was purchased in the middle of the town, on the corner of King Street and Chapel Lane (Fig. 20), and this became known as the 'Vicarage House'. The present building here is a substantial house seven bays in length, with a hipped pantile roof and boldly moulded cornice made of timber and plaster (Fig. 689).⁴⁴ There are traces of a stone plinth on the southern end; the first-floor windows survive, and five of them still retain sliding sashes. The openings have closely jointed, flat-headed, rubbed-brick arches typical of the Queen Anne period. The structure may date from the late seventeenth century (Neave 1991, fig. 4), or the early eighteenth. If the former, it was presumably built with Trippe's bequest. The house was described as having four rooms, with chambers above, and outbuildings including a stable and barn.⁴⁵ However, the property was not retained by the Church for very long, before it was sold again. Consequently, it is just possible that a pre-existing house on the King Street site might have served as a temporary residence for the vicar, with the present building being erected by the next lay owner. It was presumably the King Street property that was referred to as 'the Parsonage Hall' in 1700 and 'the Parsonage House' in 1713 (Cameron 1991, 46). But there is room for doubt.⁴⁶

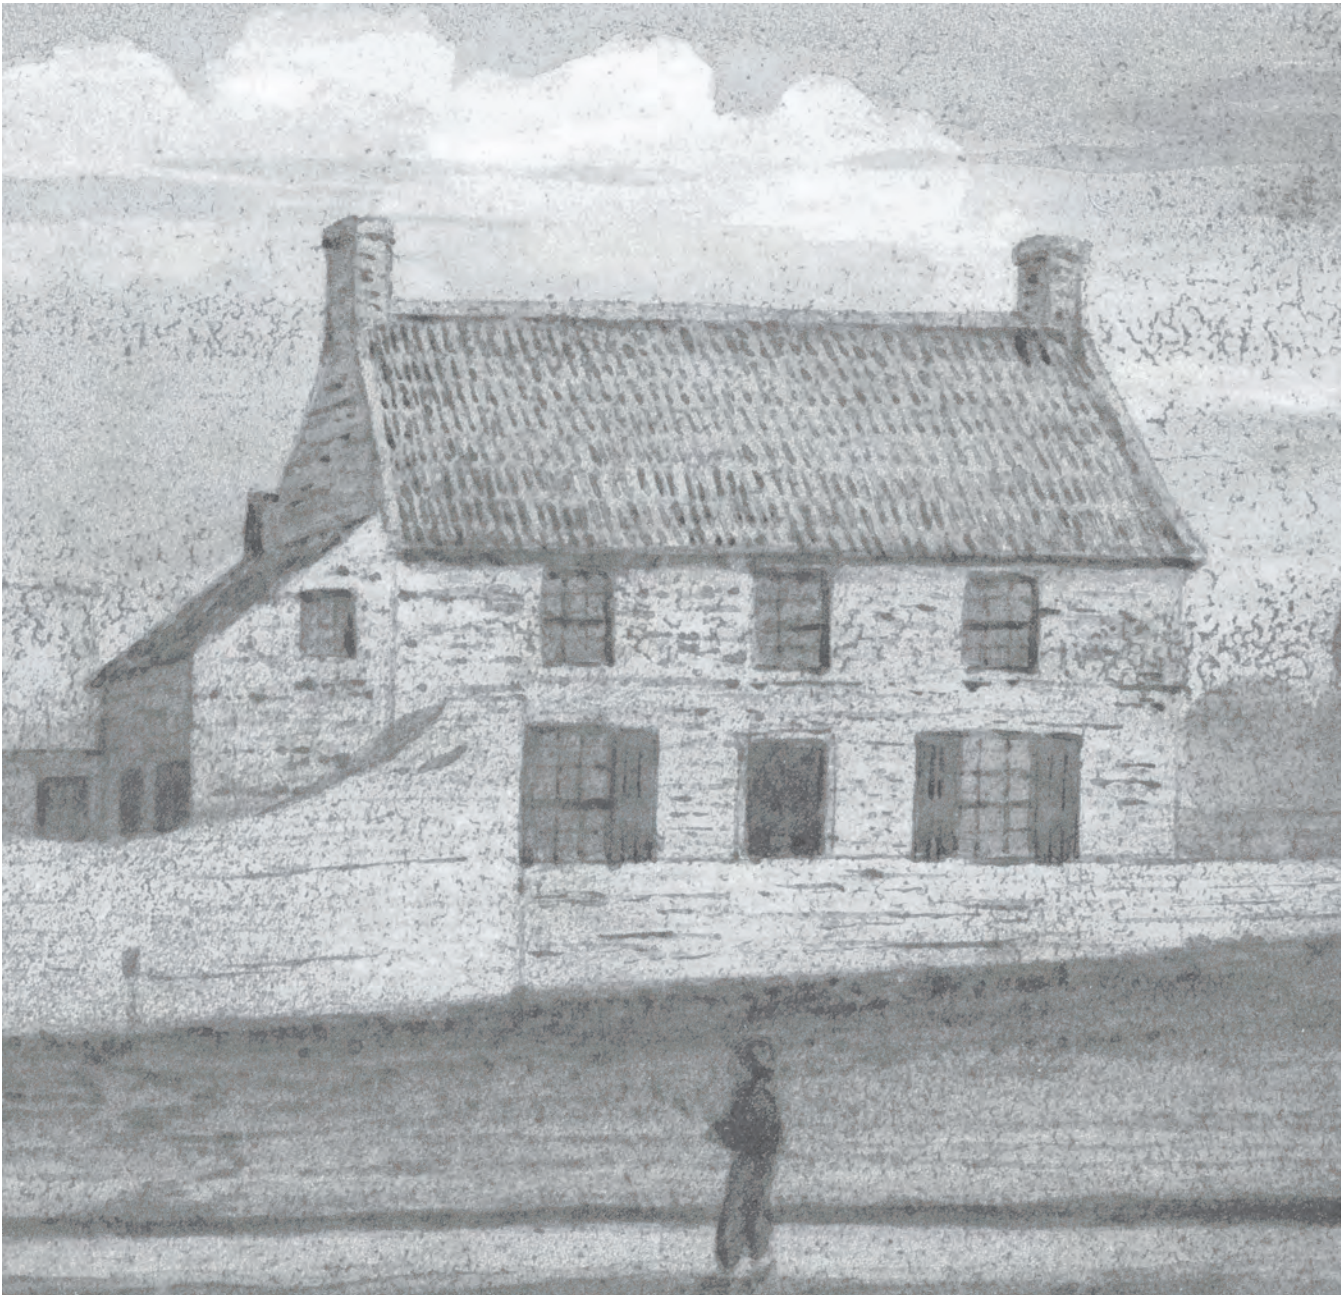
Fig. 690: Vicarage, ?1823. View from the west: detail from Pl. 9. Photo: David Lambert, courtesy of Andrew King

Fig. 692: Barton (old) vicarage, 2000. West side, including the service wing, built in the former yard. Compare the reworked façade here with the original seen in the view of ?1823 (Fig. 690). Photo: Warwick Rodwell

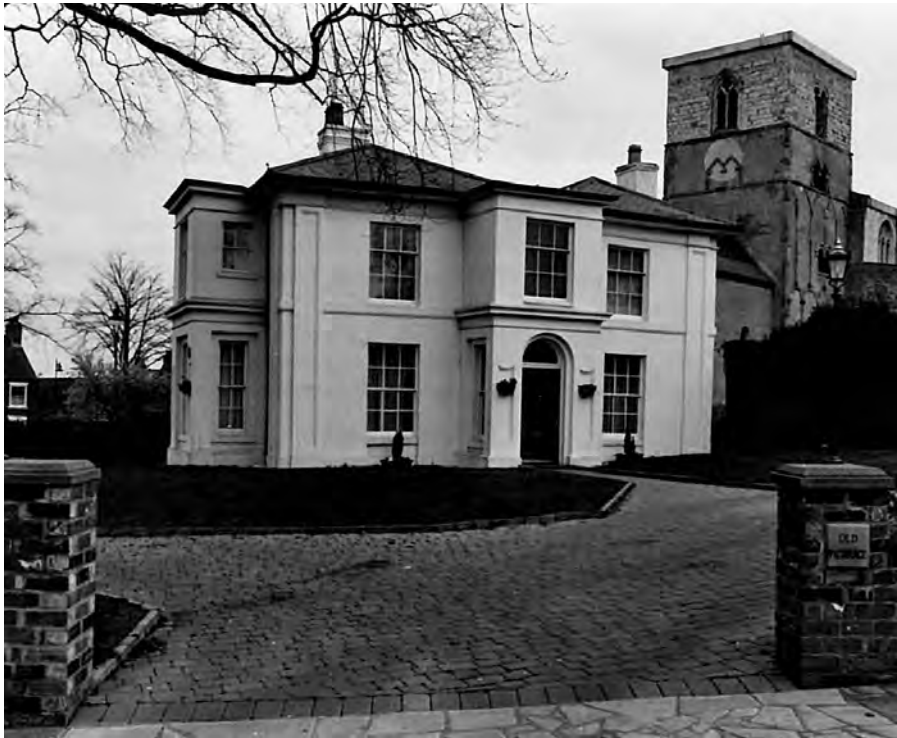
Fig. 691: Barton (old) vicarage, 2000. South side, with entrance porch of c. 1850. Photo: Warwick Rodwell

The vicarage now presents a late Regency aspect, with a stuccoed exterior and low-pitched slate roofs (Pls. 2 and 4; Figs. 691 and 692). Several additions have been made to the Georgian house, and it was probably to give it a 'facelift' and rebuild the service wing on the north that a mortgage was taken out in 1851.⁵⁵ There is a walled yard, now mostly built over, on that side, and a small garden on the south. Further improvements were carried out in the 1920s.⁵⁶ No archaeological survey of the vicarage has been conducted.

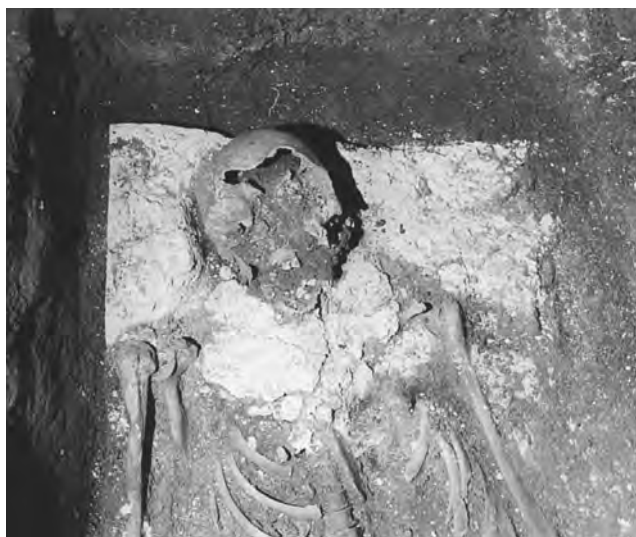
Fig. 693: Grave F1164 (sk. 204), buried inside the church. The head and shoulders were covered with lime, the crisp edges of which define the outline of the timber coffin. Photo: Warwick Rodwell

placed in one. The evidence was provided by the square-cut outline preserved by the substance that had partially filled the coffin at its western end: this was lime (Fig. 693). It surrounded and overlay the bones, but did not occur beneath the skull and vertebrae. Hence, the lime was poured into the coffin, over the corpse, as either powder or liquid. This is clearly not an example of a coffin with a shallow bed of lime (or mortar), on top of which the corpse was laid (Gilchrist and Sloane 2005, 123–4), but an attempt to cover or encapsulate at least part of the body.

At the south-west corner of the coffin the lime survived to a maximum depth of 6 cm, thinning out rapidly towards the east and north. Presumably the entire body was originally covered, but if so localized ground conditions have militated against the survival of the lime except in this one corner. Lime is a sterilizing and desiccating agent, and has been traditionally used for enveloping diseased farm animals, particularly in cases of anthrax. Its use in this coffin most likely points to the woman's having died of a contagious disease (see further discussion on this subject, p. 193).

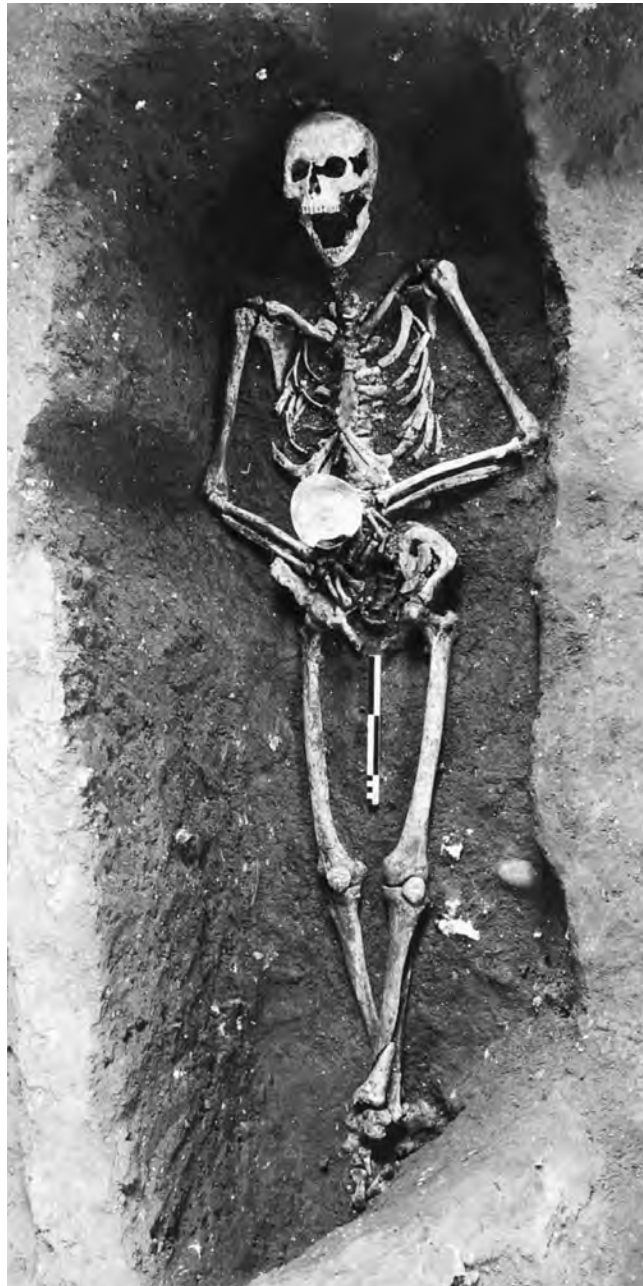
Fig. 694: Uncoffined burial (F1186) of a priest inside the early thirteenth-century south porch. On his stomach he holds a pewter chalice and paten. Note also the crossed ankles. Scale of 25 cm. Photo: Warwick Rodwell

Grave F1186 (Fig. 694). An uncoffined supine burial of a male, *c.* 25 years of age, in an irregularly shaped grave (sk. 228). Both hands lay on the pelvis, where the left one appeared to be clasping the chalice, which had been placed upright on the lower abdomen, with the paten on top (Fig. 695). The projecting elbows touched the sides of the grave-cut. An iron buckle lying centrally over the pelvis indicates that the deceased was wearing a belt. The legs were crossed at the ankles, a position noted in only two other burials at St Peter's (F7246; p. 188).

Burial F1186 (Figs. 694, 695 and 701)

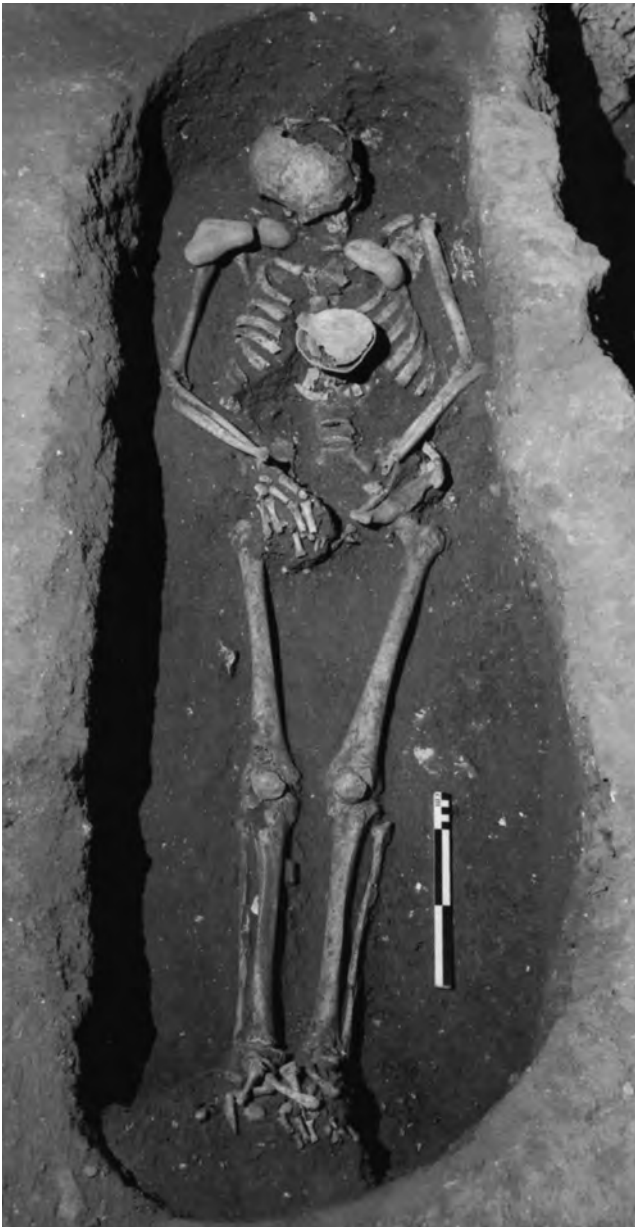
Fig. 696: Uncoffined burial (F4115) of a priest inside the early thirteenth-century south porch, with a pewter mortuary chalice and paten placed on the chest. Scale of 25 cm. Photo: Warwick Rodwell

Grave F4115 (Fig. 696). An uncoffined supine burial of a male, *c.* 25 years of age, in a grave with rounded ends (sk. 1157). This was the shallowest of the four graves,

Burial F4115 (Figs. 696, 697 and 702; Pl. 117)

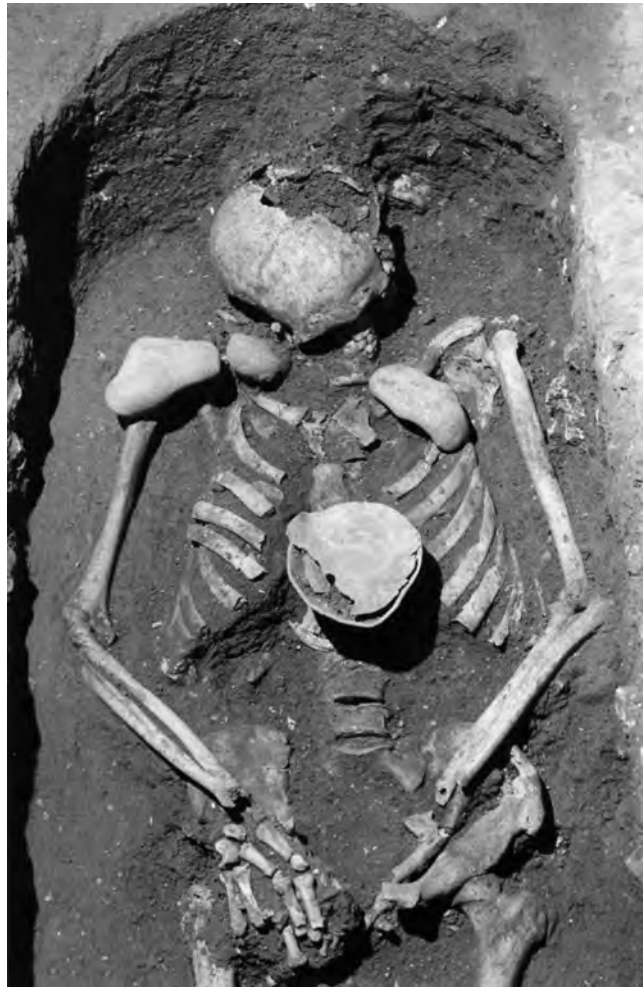
Fig. 697: Grave F4115. Detail of the torso, showing the chalice and paten, and the stones placed on both shoulders. Photo: Warwick Rodwell

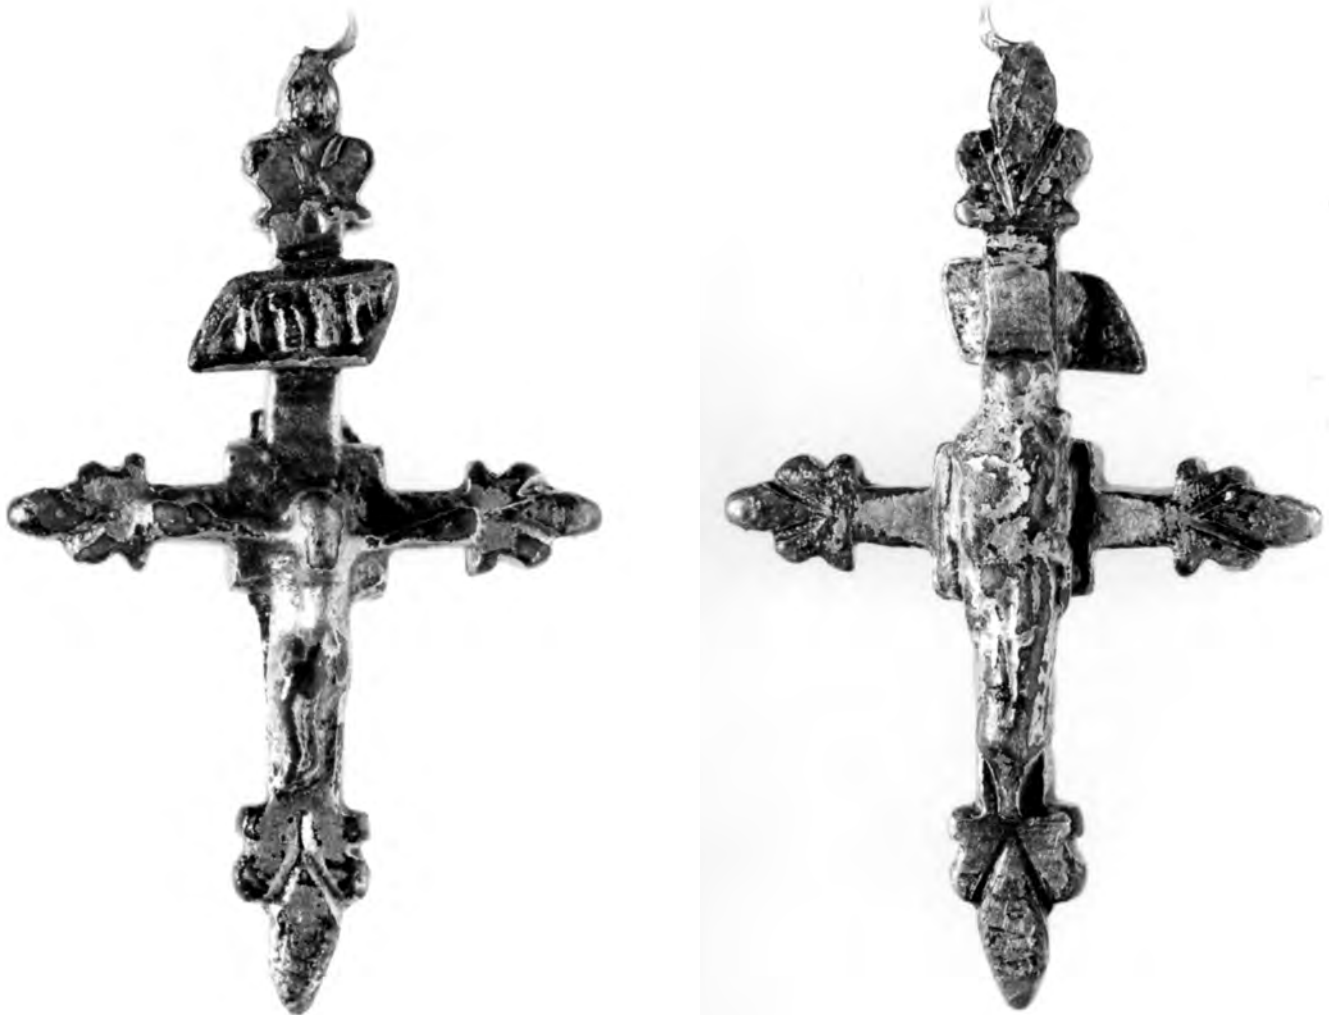
Fig. 704: Silver crucifix from grave F499: front and rear views. Ht 32 mm. Photo: British Museum

Between the north arcade piers in bay 3 of the nave lay the burial of another young woman, aged *c.* 17 years (F449). She was accompanied by a silver crucifix on her chest and a silver-alloy finger-ring on her left hand (see p. 633 and Figs. 703 and 704).

Burial F449, a young woman of c. 17 years of age, was located under the north arcade (bay 3) of the nave. In addition to coffin nails, at the bottom of the grave, close to the left hand, lay a finger-ring of silver alloy. The ring has a hoop of plano-convex section with triple mouldings at each shoulder and a central, rectangular bezel between. A solid silver pendant crucifix was found between the rib cage and the left arm at elbow level (Figs. 703 and 704).¹² John Cherry contributes the following note on this piece.

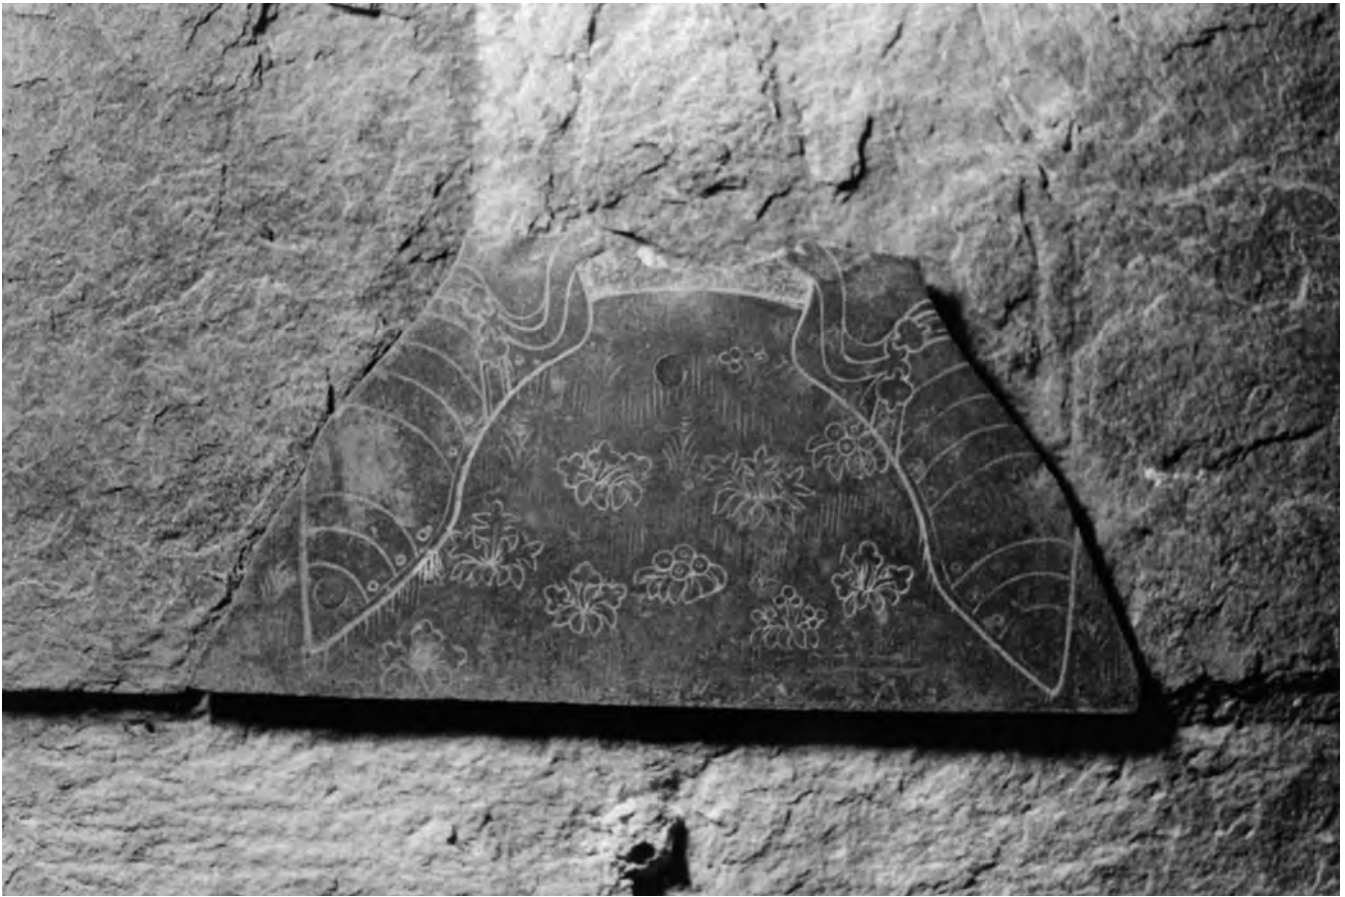
Fig. 715: Grave-cover no. 26. Surviving feet of the memorial brass. Photo: Warwick Rodwell

The monument appears to have been substantially complete in the mid-seventeenth century, when it was described by Holles (Cole 1911, 80); now the only surviving brass inlay is the bottom part of the figure, showing a pair of plate-clad feet on a flowery mound (Figs. 714, 26A and 715). Below was a rectangular, two-line inscription panel (46 × 6 cm), fixed with three brass rivets (Fig. 716). The inscription plate had become detached in the 1970s, and was subsequently stolen.⁴³
