ST PETER'S

Barton-upon-Humber, Lincolnshire

A Parish Church and its Community

HISTORY, ARCHAEOLOGY AND ARCHITECTURE

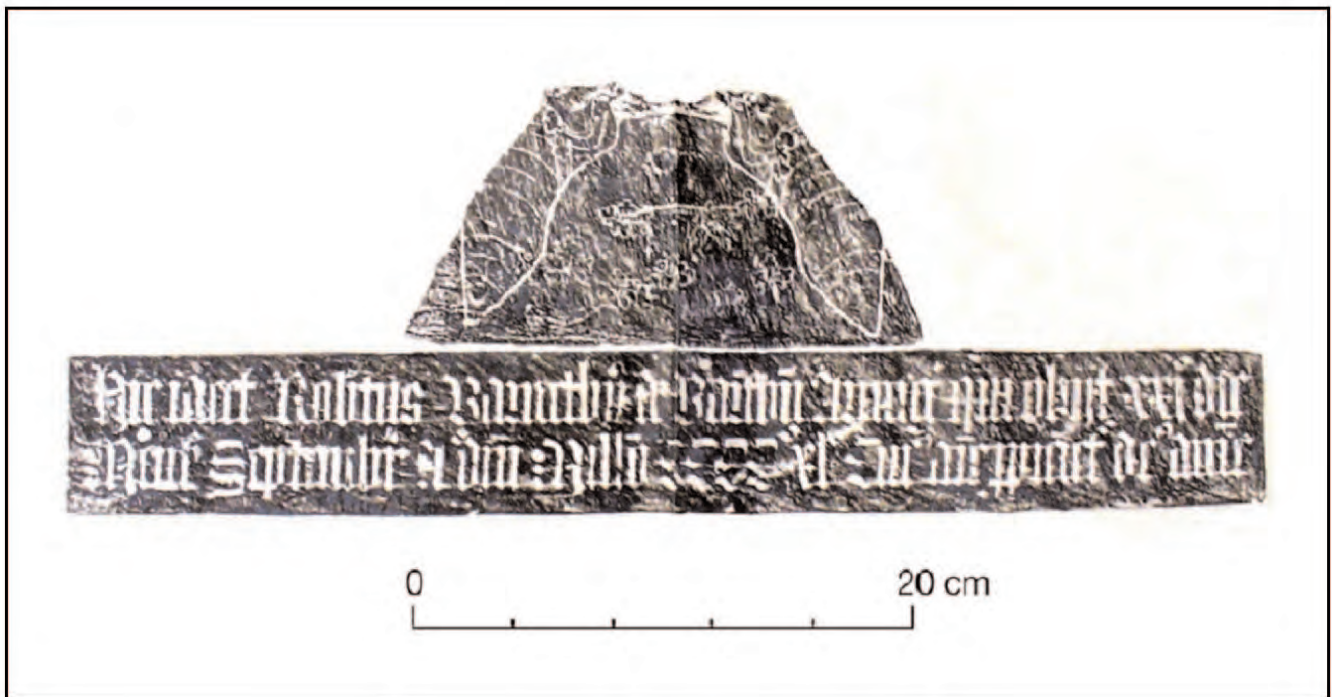
Fig. 716: Grave-cover no. 26. Rubbing of the remains of the brass figure and inscription (now lost). Scale 1:3. Photo: Jerome Bertram, courtesy of the Society of Antiquaries

The monument appears to have been substantially complete in the mid-seventeenth century, when it was described by Holles (Cole 1911, 80); now the only surviving brass inlay is the bottom part of the figure, showing a pair of plate-clad feet on a flowery mound (Figs. 714, 26A and 715). Below was a rectangular, two-line inscription panel (46 × 6 cm), fixed with three brass rivets (Fig. 716). The inscription plate had become detached in the 1970s, and was subsequently stolen.⁴³

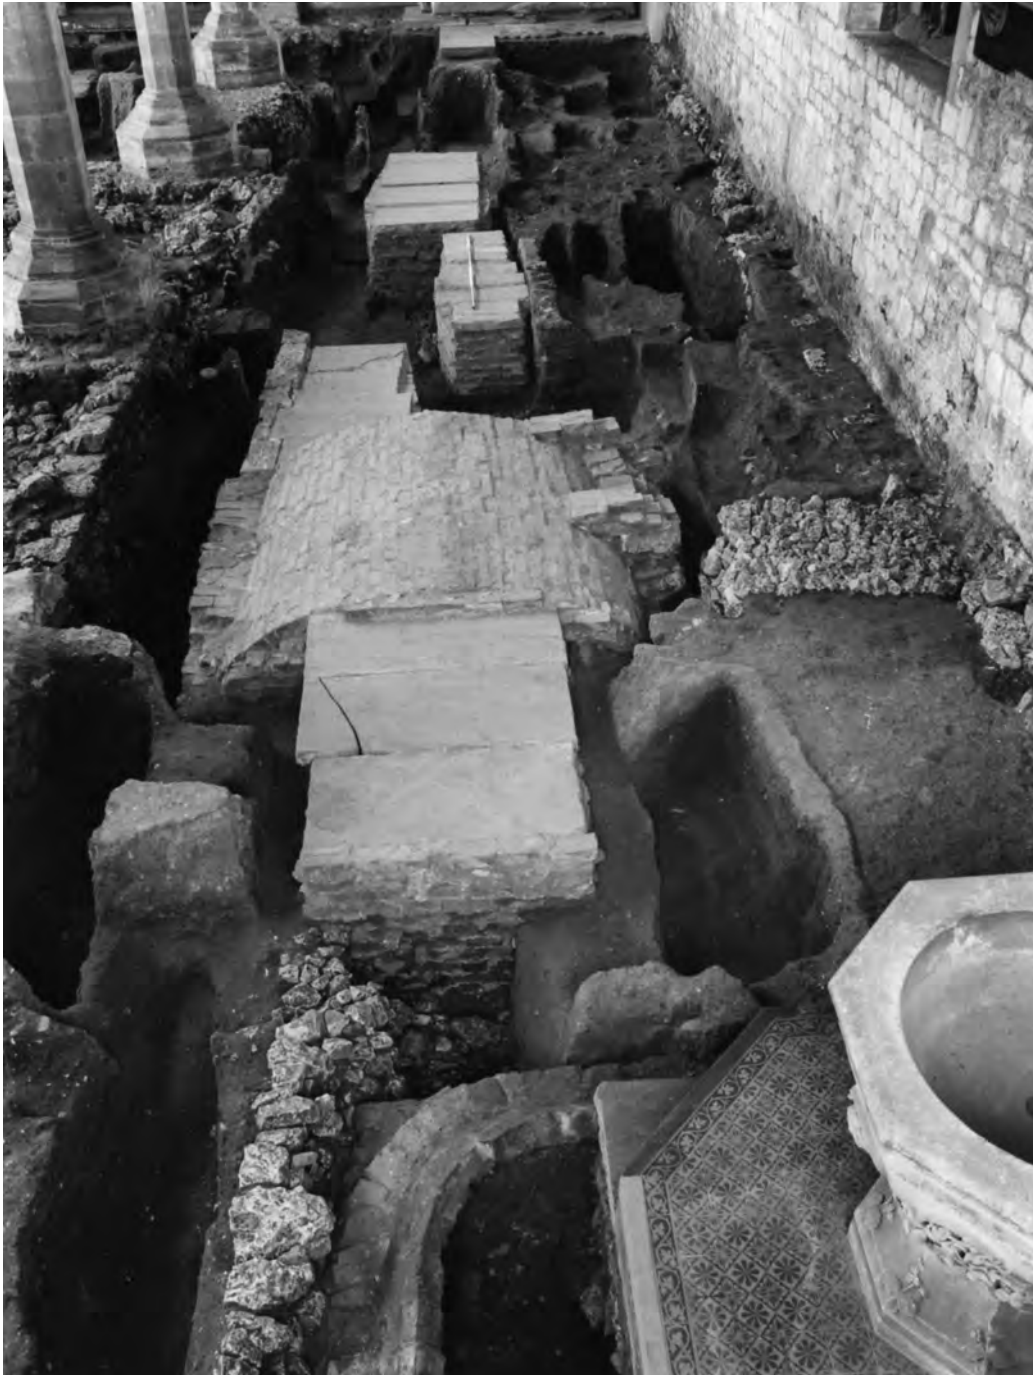
Fig. 720: South aisle. Post-medieval burial vaults and shafts; view east. In the foreground the font overlies the Gelder/Willan vault (F1013), the crown of which was first demolished. In the middle is the vault F939, with F957, F958 and F927 beyond. Scale of 2 m. Photo: Warwick Rodwell

(F1013). The faculty for its construction described the site as ‘a spare and vacant piece of ground’, measuring 9 ft by 10 ft.⁶ A vaulted brick chamber was built and the floor above was enclosed, apparently with railings; the outline is indicated on the 1803 plan, where it is marked as ‘The Rev^d Mr Willan’s Vault’ (Fig. 587). Willan’s presence here can be explained by the fact that he married Gelder’s widow, Elizabeth. Mrs Willan buried both her husbands in the Gelder vault, joining them herself in 1779. There were presumably inscribed floor slabs, but all were swept away in 1858, when the crown of the brick vault was demolished and the chamber infilled with rubble, to support the base for a new font (p. 556; Figs. 720 and 721). Only the northern edge of the vault was exposed during excavation, when it was found to have a rounded north-east corner. It is unclear how access was obtained, and whether the construction might comprise two chambers, side by side. There was no separate entrance chamber. The overall dimensions of the structure (2.9 m by 3.2 m) correspond reasonably well with those quoted in 1735.

Also in the south aisle, just east of the Gelder vault, is another large brick vault of the early nineteenth century (F939), the occupants of which have not been identified with certainty (Fig. 720). There were no ledgers overlying the vault or its entrance chamber, but there are two ledgers in the aisle nearby commemorating the Brown family (M.30 and M.31), and on the wall is the large monument (M.56; Fig. 788) to Robert Brown, grandfather of Barton’s historian of the same name.⁷ The brick-lined entrance chamber to the vault was on the west, slabbed with Yorkstone.

In bay 3/4 of the south aisle, adjoining the presumed Brown family vault on the east was a double-tapered shaft, capped with Yorkstone slabs (F957; Fig. 720). Alongside, to the south was ledger-slab M.31 with a fragmentary inscription, apparently commemorating John Watt Brown.¹⁶ It is not unlikely that the slab was associated with the burial shaft, but was displaced southwards when the aisle was replanned in 1858.

A brick shaft capped with Yorkstone slabs occurred in bay 3 of the south aisle (F958; Fig. 720), where it was directly overlain by ledger-slab M.30. Almost certainly they were associated, and the fragmentary inscription on the slab commemorated several members of the Brown family, beginning with Joseph.

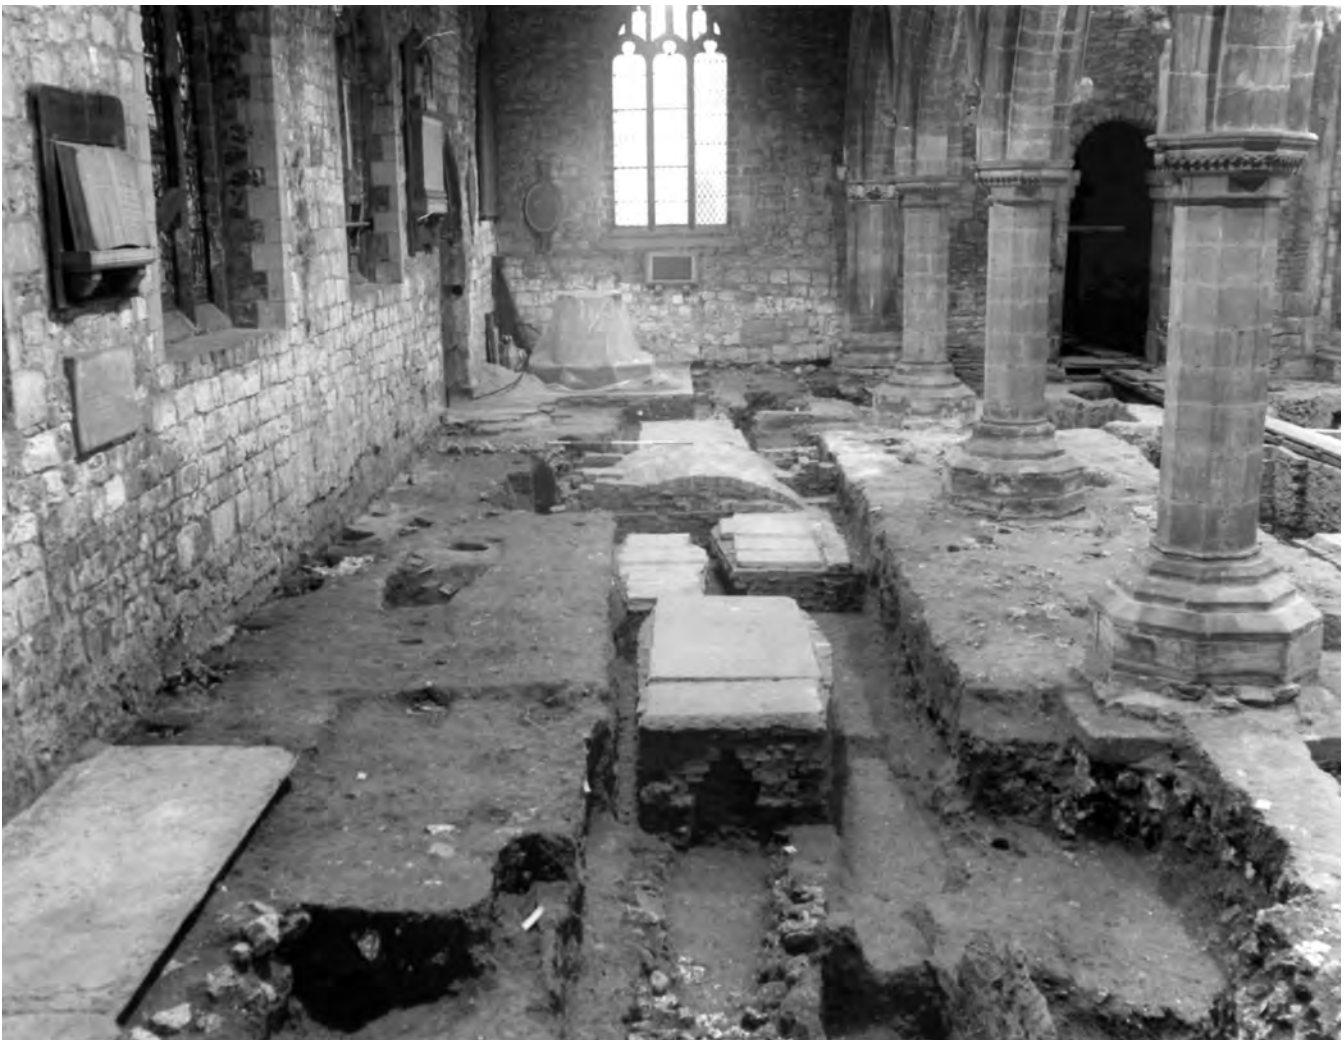
Fig. 721: South aisle. View west after the excavation of the central corridor of post-medieval burials, but with the brick-lined shafts and vaults remaining: F927 is in the foreground, with F958, F957 and F939 beyond. Scale of 2 m. Photo: Warwick Rodwell

Also in bay 3 of the south aisle was a brick chamber, capped by Yorkstone slabs (F927; Fig. 721). Partly overlying this was a ledger-slab containing an inset brass plate engraved with the deceased's arms (M.29; Fig. 777).

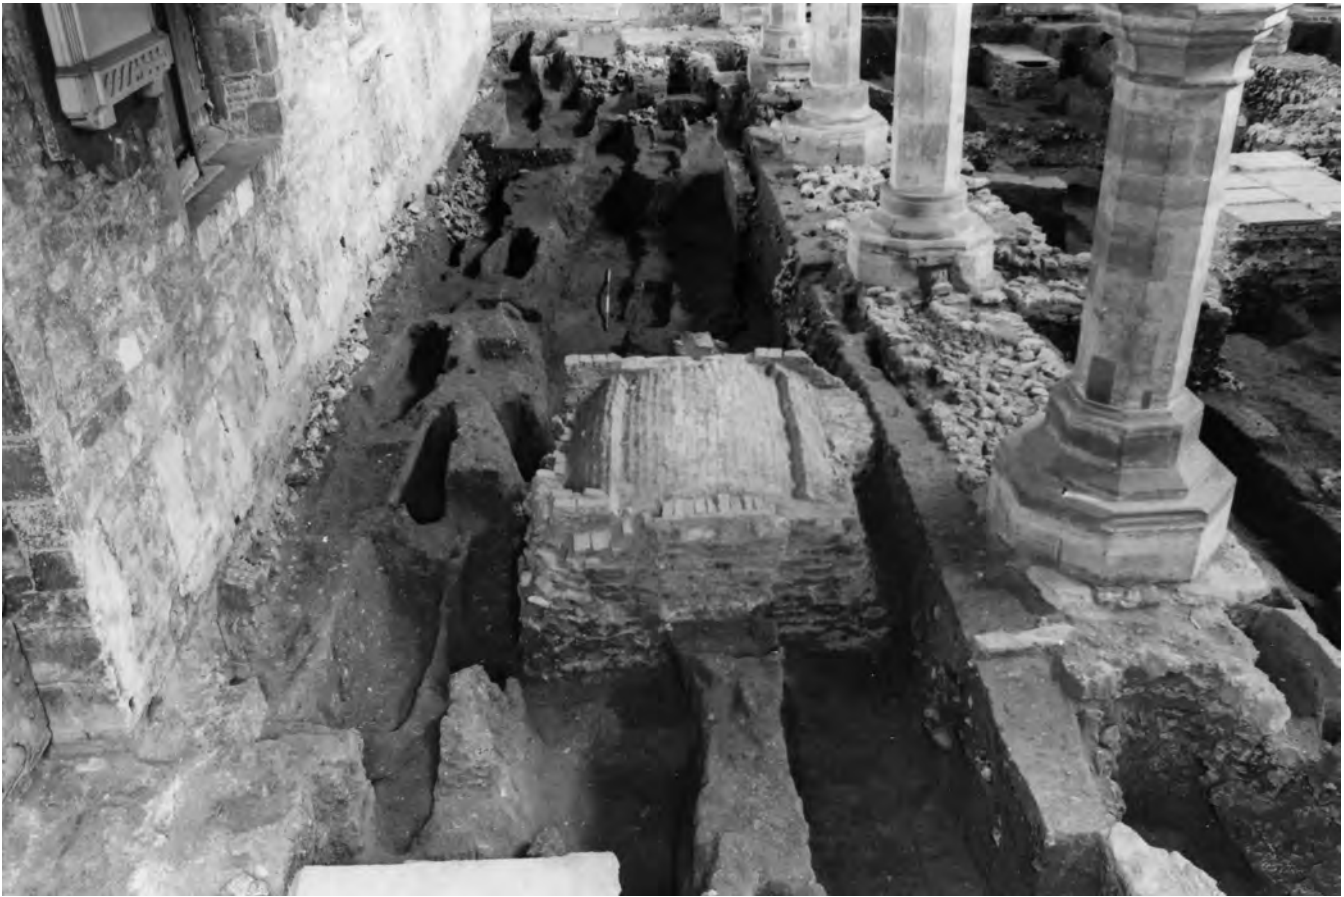
Fig. 722: North aisle. View east after the excavation of the central corridor of post-medieval burials, but with the Branston vault remaining (F227). Scale of 2 m. Photo: Warwick Rodwell

The vault (F227) in bay 4 of the north aisle was probably constructed by the Branston family 1775. It is likely to contain the three burials recorded on the slab that directly overlay the chamber (M.40). There was no access-chamber for this vault, and it is likely that the brick arch was only turned after the burials had been inserted.⁹ The crown of the arch had subsequently been reduced in thickness (to accommodate the Victorian floor level) by removing the outer of two rings of brickwork (Fig. 722).

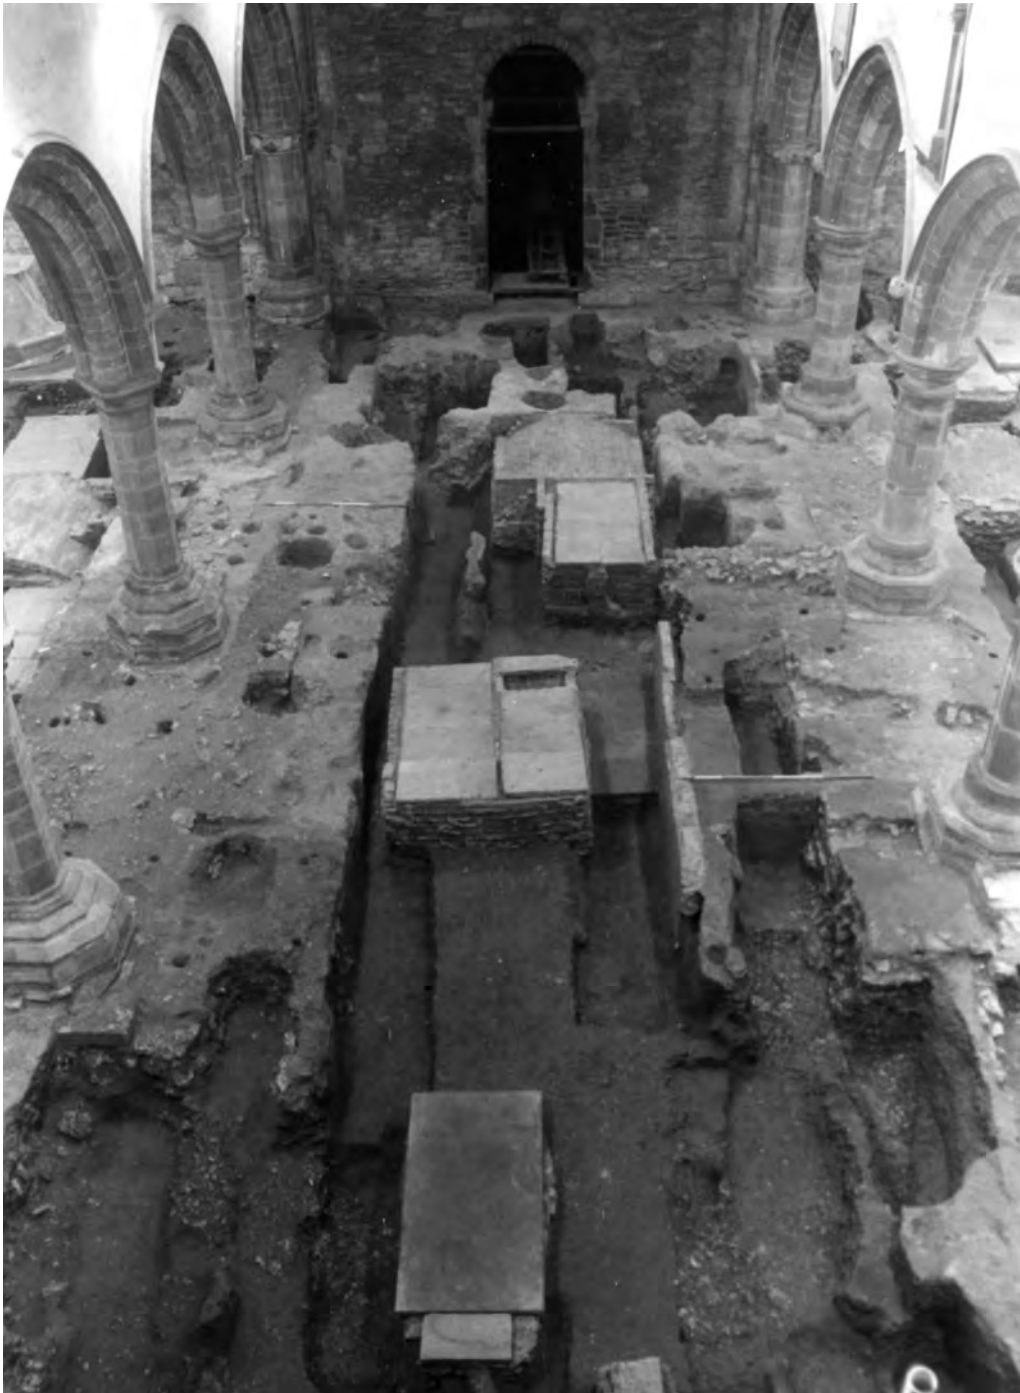
Fig. 723: Nave. View west after the excavation of the central corridor of post-medieval burials (and other features), but with the brick-lined shafts and vaults remaining: F284 and F940 are in the foreground, with F929, F1667 and F53 beyond). Scales of 2 m. Photo: Warwick Rodwell

In the middle of the nave, in bay 4/5, is the Preston vault (F53), which was constructed in or by 1837 (Figs. 723, 724 and 725); it also contains the last recorded burial to take place inside St Peter's church, of John Preston in 1844.¹⁰ Of barrel-vaulted construction, the

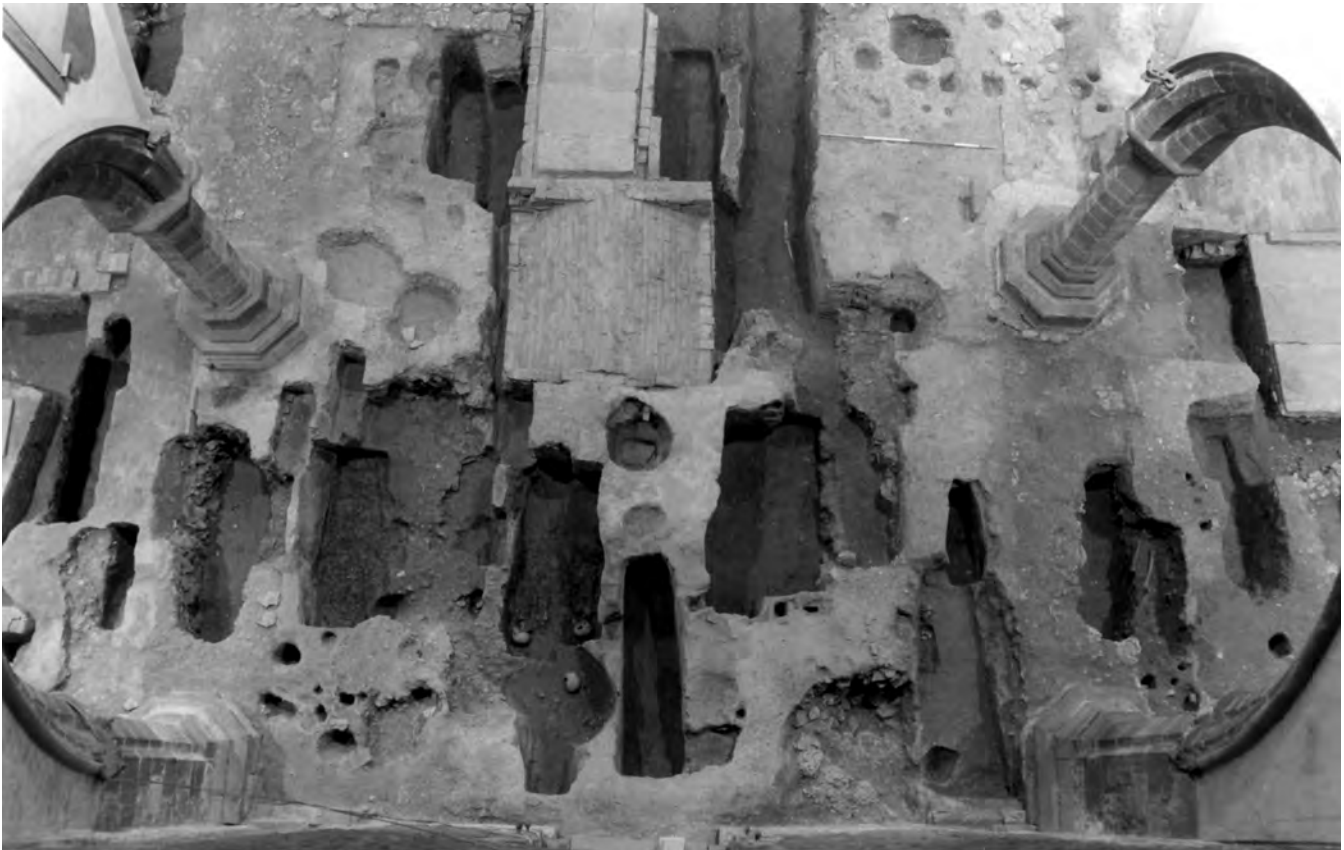
Fig. 724: Nave. A vertical view showing the pattern of post-medieval burial in bays 4 and 5. East is at the top. In the centre is the Preston vault (F53). Many of the graves forming a north-south row across bay 5 belonged to the Marris family: monuments M.1-5 and M.50 are related to these. Scale of 2 m. Photo: Warwick Rodwell

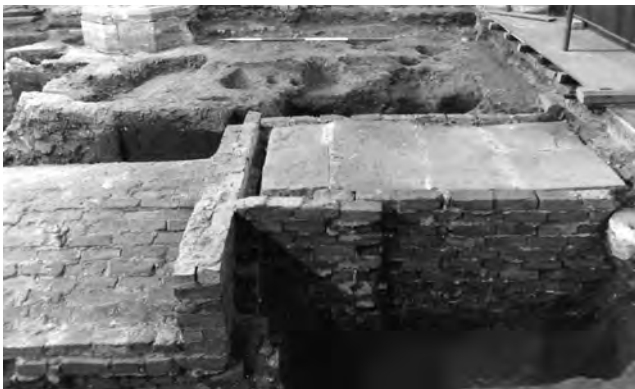
Fig. 725: Nave: Preston vault (F53). The slab-covered entrance chamber on the right gave access to the barrel vault. View north. Scale of 2 m. Photo: Warwick Rodwell

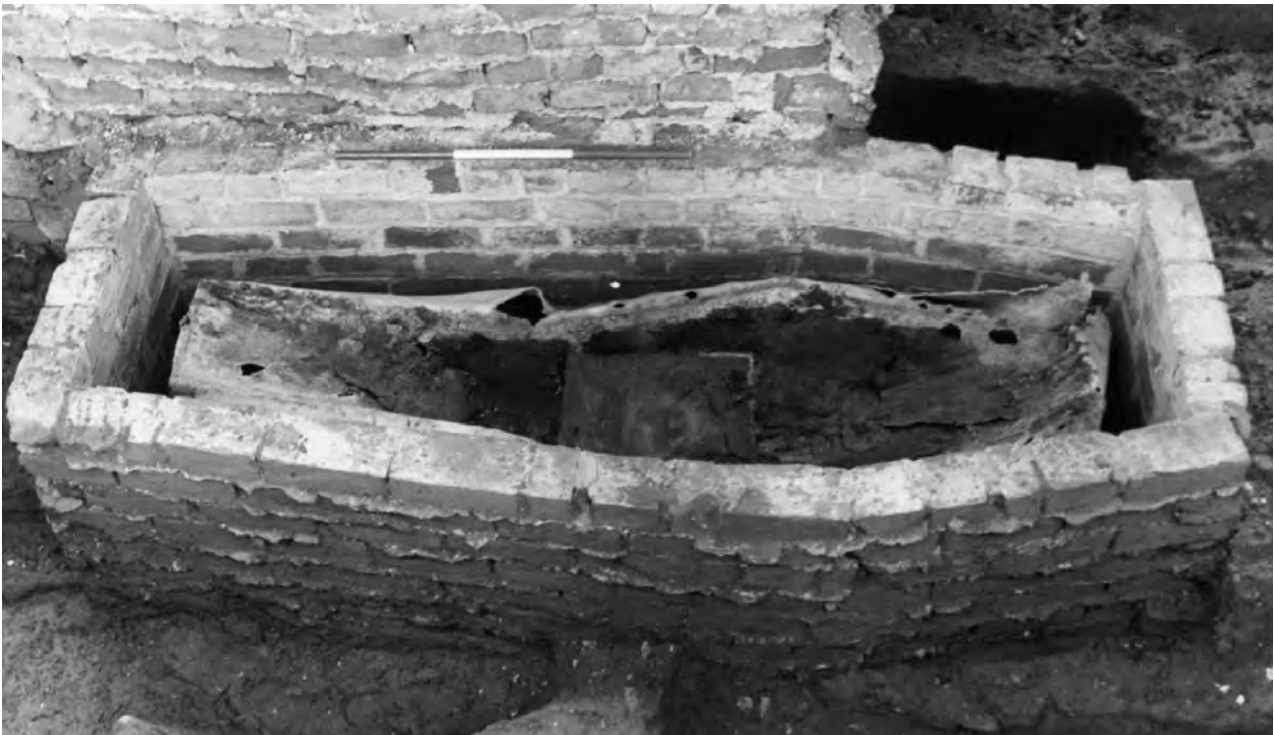
Fig. 727: Nave. Brick-lined shaft with lead coffin-shell in situ (F1667; with F929 behind). View south. Scale of 75 cm. Photo: Warwick Rodwell

A double-tapered shaft, capped at a low level with Yorkstone slabs, was found in bay 3 of the nave (F1667). Inside was a lead-lined coffin with pressed iron plates on the lid of the outer elm casing (Fig. 727).¹¹ The inscription on the *depositum* plate had been painted, but nothing legible survived. As found, the tomb was largely overlain by ledger-slab M.9 (Rev'd William Uppleby, d. 1834), but it seems very unlikely that the two were connected since the tomb was structurally earlier than the adjoining pair of brick shafts

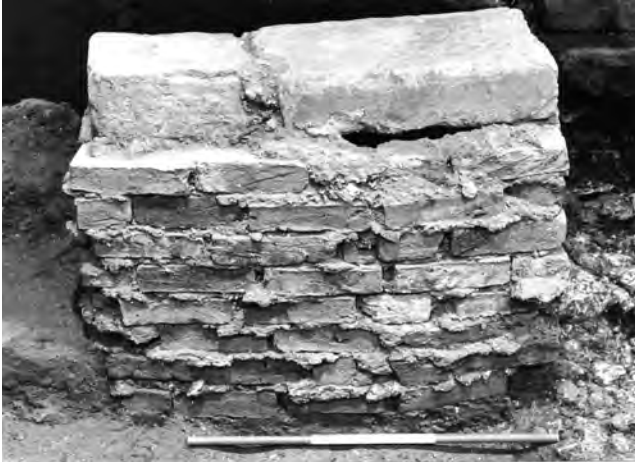
Fig. 728: Nave. Brick tomb of Mary Wörthington (d. 1823), capped with limestone blocks (F284). View south. Scale of 75 cm. Photo: Warwick Rodwell

Close to the last was a tiny shaft, roughly constructed, and capped with two blocks of limestone (F284) (Fig. 728). Inside was a double-tapered elm coffin for an infant, resting on two bricks. The base had decayed,

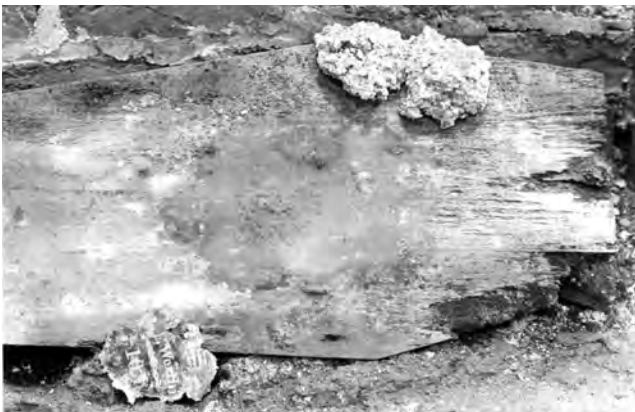
Fig. 730: Nave. Detail of the remaining fragment of the depositum plate in tomb F284. The full outline of the plate is discernible as a shadow on the lid. Photo: Warwick Rodwell

the north side fallen away, and the remainder of the coffin slumped onto its side, with the lid facing towards the north (Figs. 729, 730 and 731). The pressed iron *depositum* plate had mostly disappeared, but a fragment of the painted inscription survived: it bore part of the child's name.¹⁵ The burial was formerly marked in the floor by a small, double-tapered Yorkstone ledger-slab (M.17C), which had been broken up and used as paving under a nearby pew platform in 1858–59.

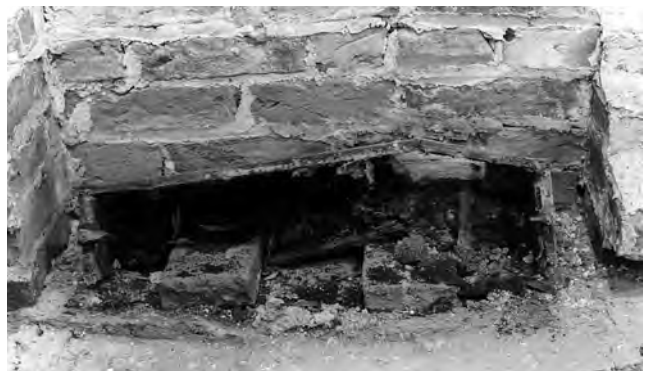
Fig. 731: Nave. Tomb F284, with the coffin lid removed to reveal the collapsed remains of the coffin and the bricks upon which it stood. Photo: Warwick Rodwell

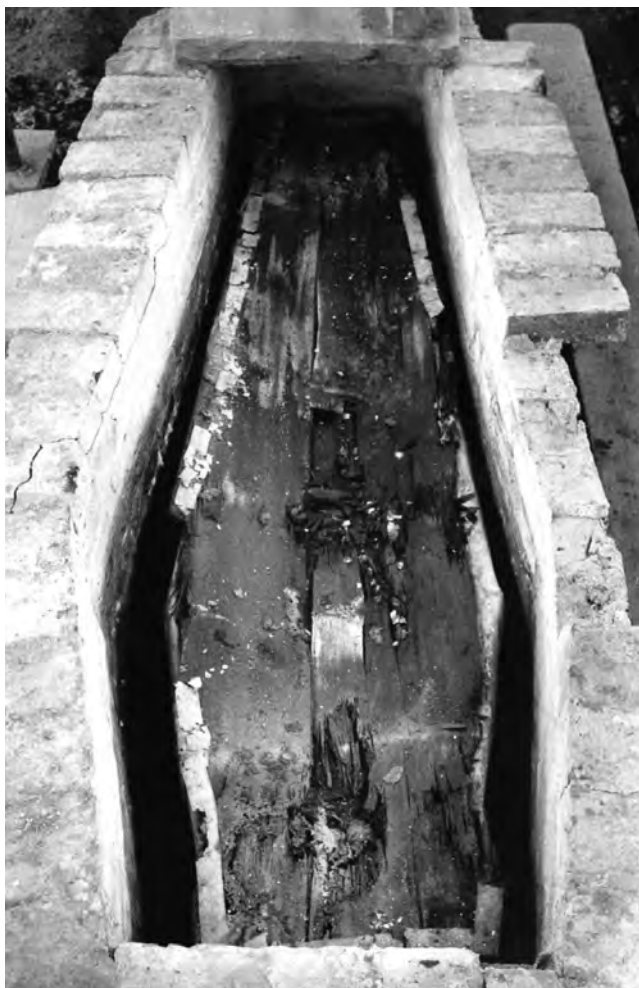
Fig. 732: Nave. Brick-lined shaft of double-tapered plan (F940), containing an elm coffin with a lead shell and decorative embellishments: Mary Thorley (d. 1833). View east. Photo: Warwick Rodwell

Her burial lay in bay 1/2 of the nave, in a double-tapered brick shaft, the interior of which was lime-washed (F940; Fig. 732). The shaft was capped, well below floor level, with a redundant ledger-slab (M.43). The coffin had a lead shell with an attached cartouche bearing a cursive inscription (p. 677; Fig. 733). Associated with the burial was ledger-slab M.14, at floor level. The slab was still *in situ* above the grave.

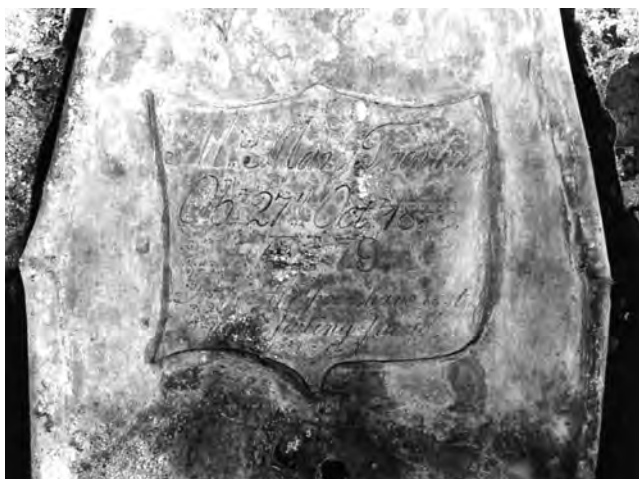
Fig. 733: Nave. Tomb F940, after the removal of the outer timber casing, revealing a shield-shaped identification plate affixed to the lead coffin-shell. The inscription records that it was the burial of Mary Thorley (d. 1833). Photo: Warwick Rodwell

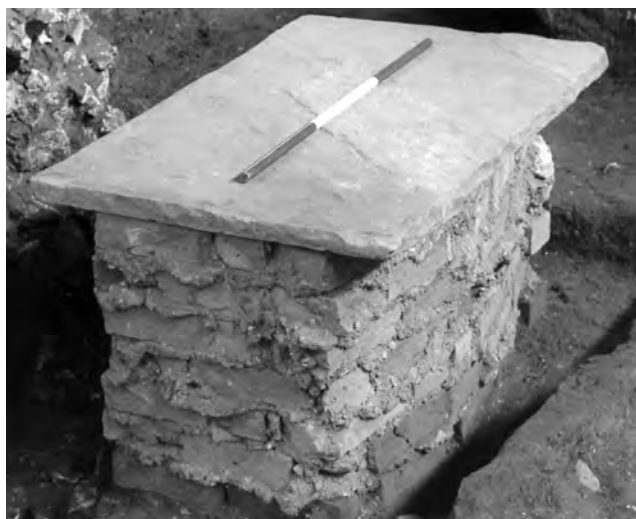
Fig. 734: North aisle. Brick tomb of William Graburn (d. 1828), capped with a slab of Yorkstone (F300). View from the south-west. Scale of 75 cm. Photo: Warwick Rodwell

In the second bay of the north aisle lay an infant, in a brick shaft of double-tapered plan, capped by a slab of Yorkstone (F300) (Fig. 734). Directly overlying the tomb was ledger-slab M.36, still in its original location. Inside the chamber was a lead coffin-shell with the remains of an elm casing (Fig. 735).¹⁷ The name was punched into the top of the lead shell: 'W. H. Graburn / 1828' (Fig. 736).

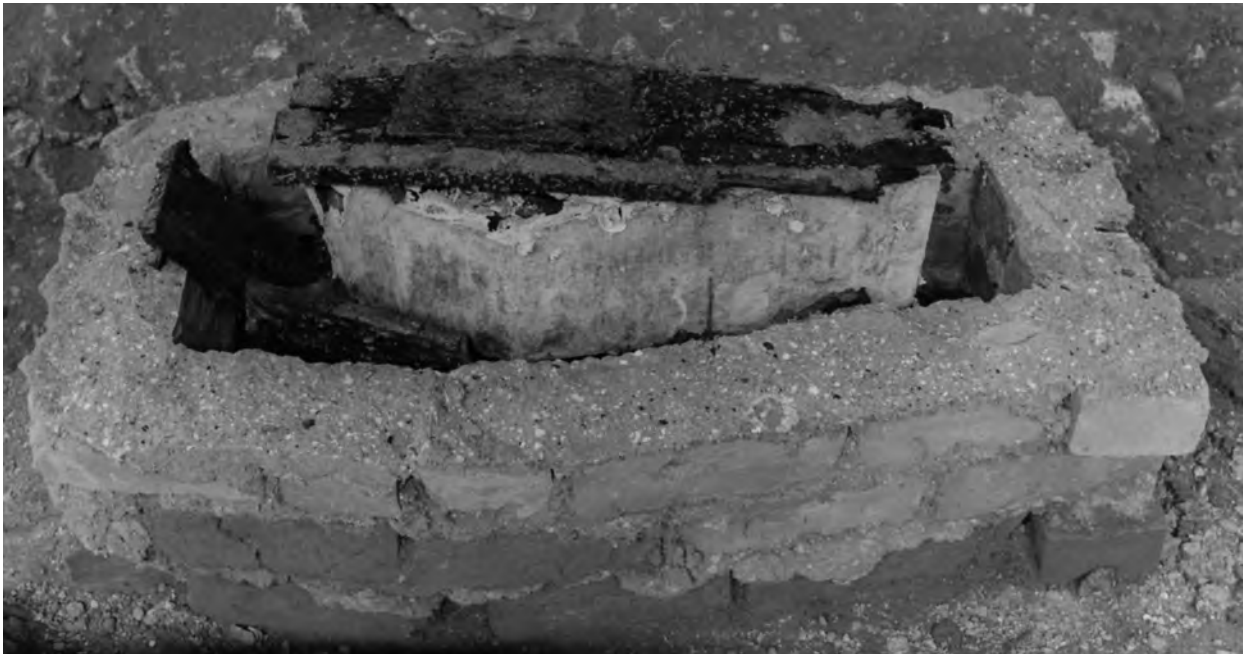
Fig. 735: North aisle. Tomb F300 during dismantling, showing the lead shell and remains of the outer timber casing of the coffin. View north. Photo: Warwick Rodwell

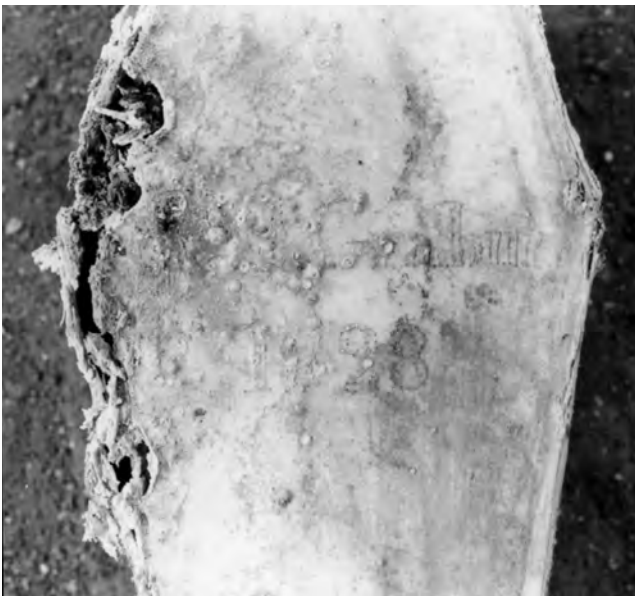
Fig. 736: North aisle. Tomb F300: detail of the incised and punched inscription on the top of the lead coffin-shell: W.H. Graburn, 1828. Photo: Warwick Rodwell

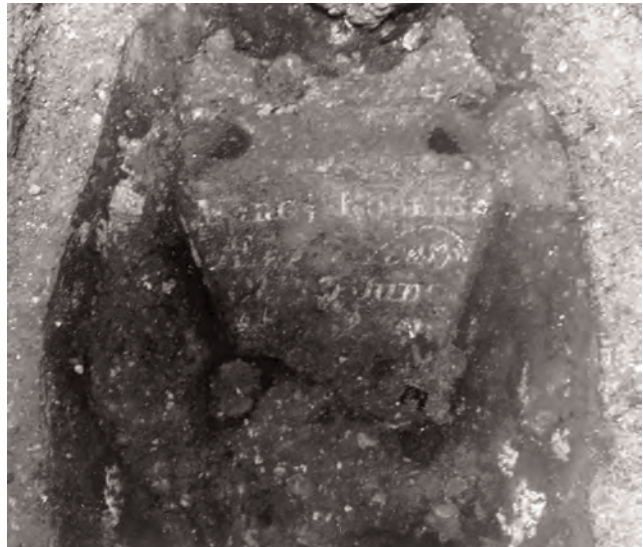
Fig. 740: South aisle. Remains of the painted iron depositum plate identifying the burial of Margaret Roberts (d. 1822; F973). The timber coffin was represented only by a dark stain in the soil. Photo: Warwick Rodwell

In the south aisle the burial of Margaret Roberts (d. 1822) was fortuitously identified by her painted *depositum* plate (F973), the survival of which in a soil-filled grave was exceptional (Fig. 740). At the east end of the nave lay Ann Latham (d. 1831) in a lead-lined coffin which was inscribed (F1341).

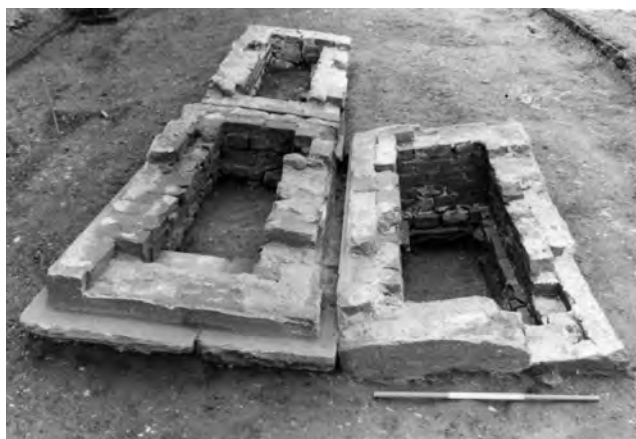
Fig. 741: Churchyard, Area 11. Remains of three brick-built table-tombs, demolished in 1967. Dating from the 1820s and 1830s, each contained a member of the Goy family. View west. Scale of 75 cm. Photo: Warwick Rodwell

The removal of headstones in 1967 had divorced virtually all the inscribed evidence from the corporeal. Exceptions were three members of the Goy family, buried together under separate brick table-tombs outside the north aisle, in Area 11 (Fig. 741). Mary (d. 1820, while pregnant) (F3641); Ann (d. 1825) (F3638) and William (d. 1836), who was buried in a brick-lined shaft capped with slabs (F3640). The interior of the shaft was limewashed. Just to the west of the Goys lay the burial of Margaret Swallow (d. 1845) (F3697); she was interred wearing a gold wedding-ring (Pl. 118). Alongside her was Joseph Swallow (d. 1842), a victim of poliomyelitis (F3683).

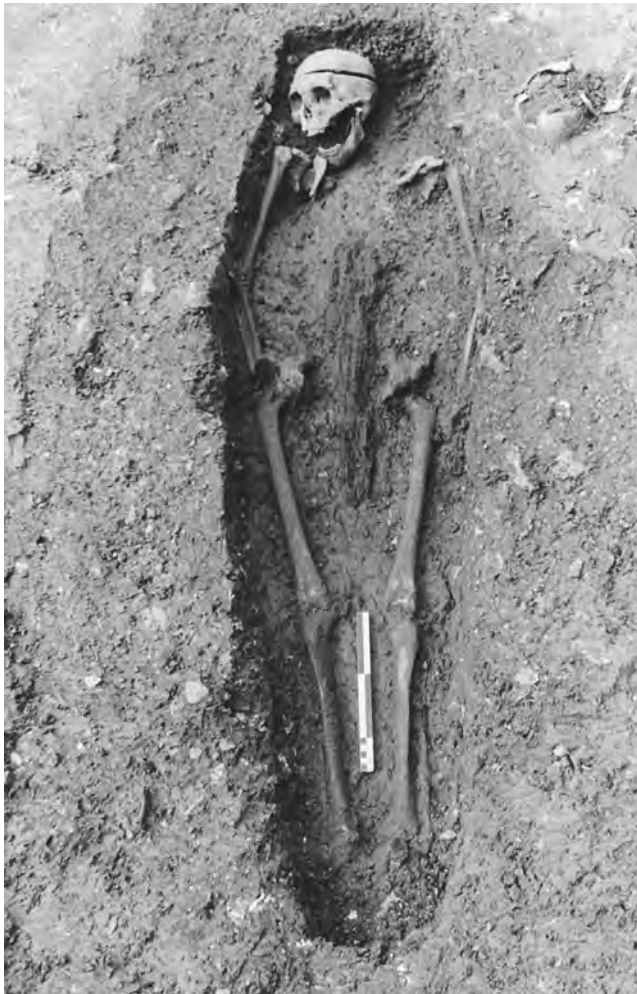
An autopsy (Fig. 742)

Fig. 742: Churchyard, Area 8. Coffined burial F3033 (skeleton 219) which had been subjected to a post mortem investigation. Note the charred stake inserted in the torso as a substitute for the vertebral column. Scale of 25 cm. Photo: Warwick Rodwell

The sole example of a burial that showed unmistakable evidence of being subjected to a *post mortem* investigation was found in Area 8 (F3033; sk. 219). It was part of the second orderly row of burials west of the aisle. The grave was relatively shallow and the corpse was contained in a coffin that had tin-plate fixtures; there was no identifying evidence, but the date is probably early nineteenth century.²⁹ The vault of the cranium had been sawn off, doubtless in order to remove the brain (Fig. 743). The two parts of the skull had then been reunited and the cut secured with animal or fish glue, evidence of which was still visible. The joint would have been concealed by hair. The entire spinal column, rib-cage and, inevitably, all the organs had been removed: everything between the scapulae and the pelvis was missing, while the arms and legs were intact. The pelvis and clavicles had been cut (Fig. 744).

The spine had been replaced with a timber stake, which largely survived because it had been charred (although that was probably fortuitous and not intentional in this context). It must be presumed that, after the autopsy, the torso was no more than a skin bag which was stuffed with material such as wood shavings or vegetation, and sewn up. This would have restored a seemly appearance to the body, for burial. The stake, which was of the same length as the torso, had partly slipped down between the legs, presumably when the coffin was being manhandled during burial.

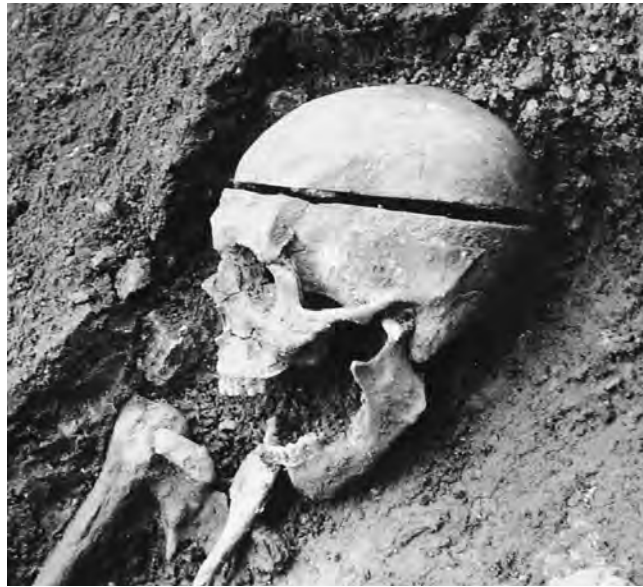
Fig. 743: Grave F3033. Detail of the skull, showing the saw-cut which had removed the cranial vault. The two parts had been reunited, and glued, for burial. Photo: Warwick Rodwell

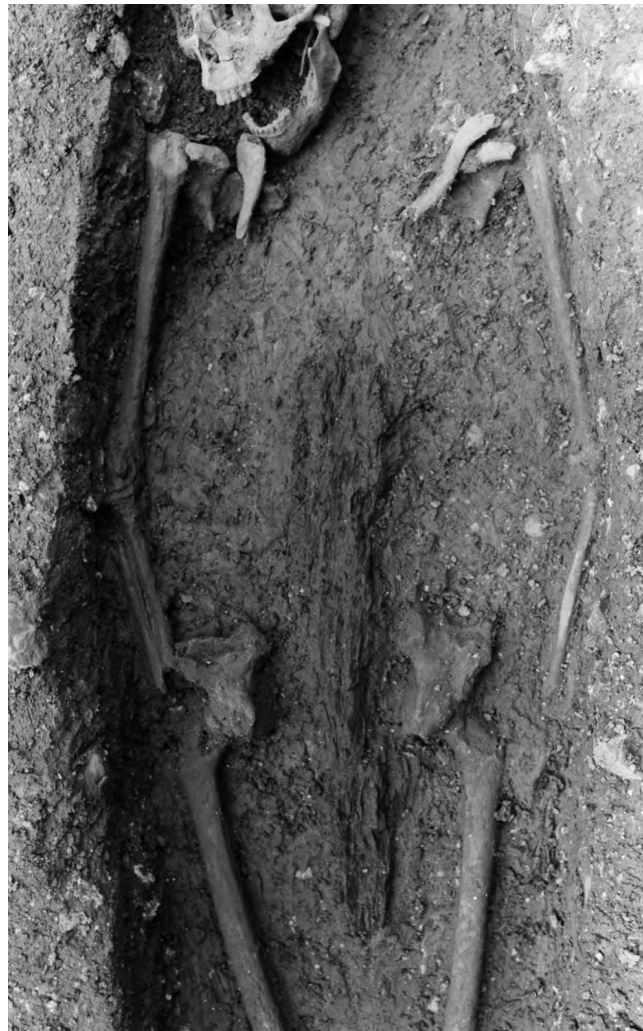
Fig. 744: Grave F3033. Detail of the torso, showing the cuts in the pelvis and clavicles, and the charred stake which was inserted to stiffen the body. Photo: Warwick Rodwell

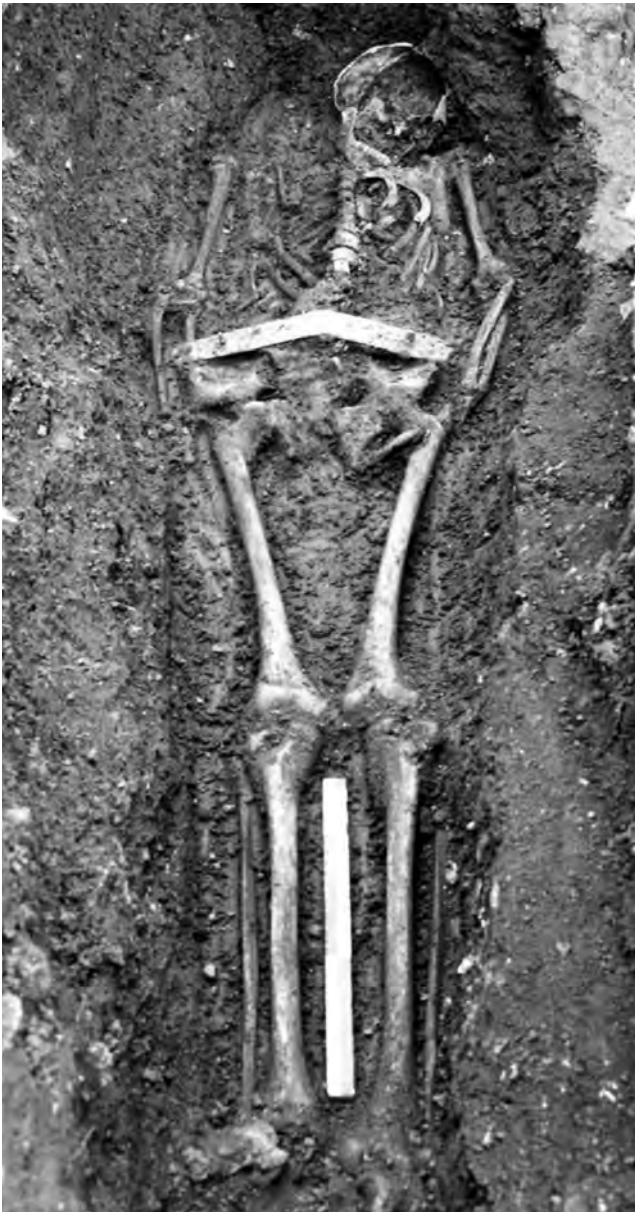
Fig. 745: Churchyard. Grave F7106, showing the obtuse-angled iron bracket which supported a low-gabled lid to the coffin. Scale of 25 cm. Photo: Warwick Rodwell

Other constructional metalwork was very scarce: only three iron angle-brackets (for strengthening corners of coffins) and one obtuse-angled bracket (for supporting a gabled lid) were found (Fig. 745). Several graves yielded one or two pieces of iron strap, and some copper-alloy plates were attached to one coffin: these items were variously associated with joining pieces of timber together, to make up boards of adequate size.

Gable-lidded coffins were in use in the Middle Ages, but this form of lid cannot easily be detected in excavated graves. The use of gabled, or coped, lids declined and was replaced by flat lids *c.* 1660–75 (Litten 2002, 99). Two examples of gable-lidded coffins were noted at St Peter's, occurring in burials attributed to Phase A. In Area 14, a grave (F7106) was found with an obtuse-angled iron bracket which was set centrally on the underside of the lid, showing this to have been a ridged coffin (Fig. 745). Nails were also present in the grave.

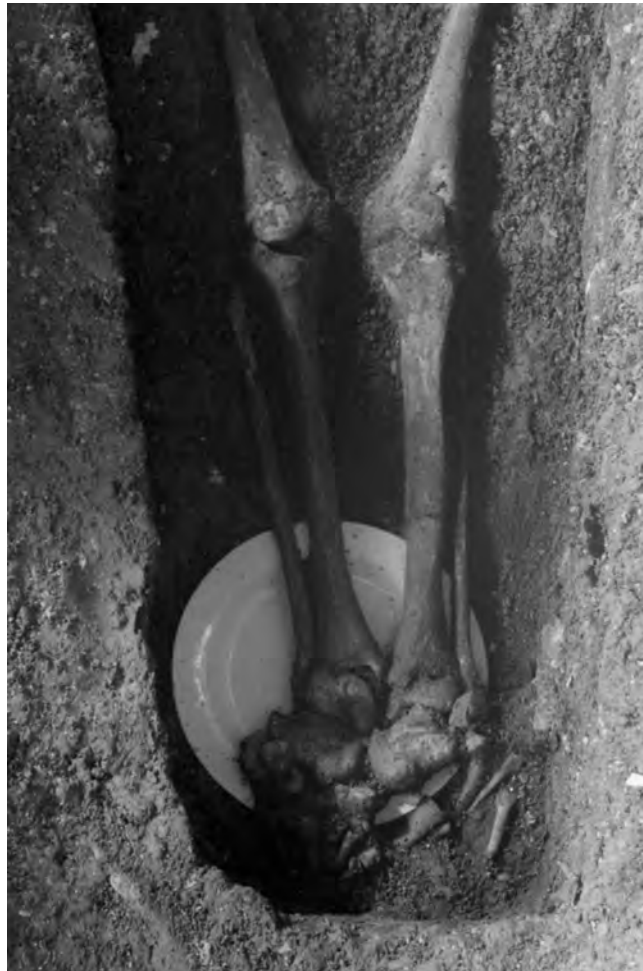
Fig. 746: North aisle. Coffined burial F365, with the feet resting on a cream china plate. Photo: Warwick Rodwell

male (Fig. 746). Outside the church, in Area 8, an incomplete small china bowl with blue-and-white transfer decoration was placed at the south-west corner of the grave, immediately under a coffin containing an adult female (F3027; Pl. 115). Although many small metal pins were recovered, few were in close contact with skeletons, and are thus admissible as evidence for shroud burial. Likewise, many of the buttons, buckles, aiglets and other indicators of clothing were not recovered in close juxtaposition with the skeleton, and must be regarded as casual losses or residual items from disturbed graves of earlier date. Some items, such as the early nineteenth-century 'Pinchbeck' brooch, were doubtless lost by worshippers attending church, or relatives visiting graves (Fig. 844, no. 23; Pl. 119).

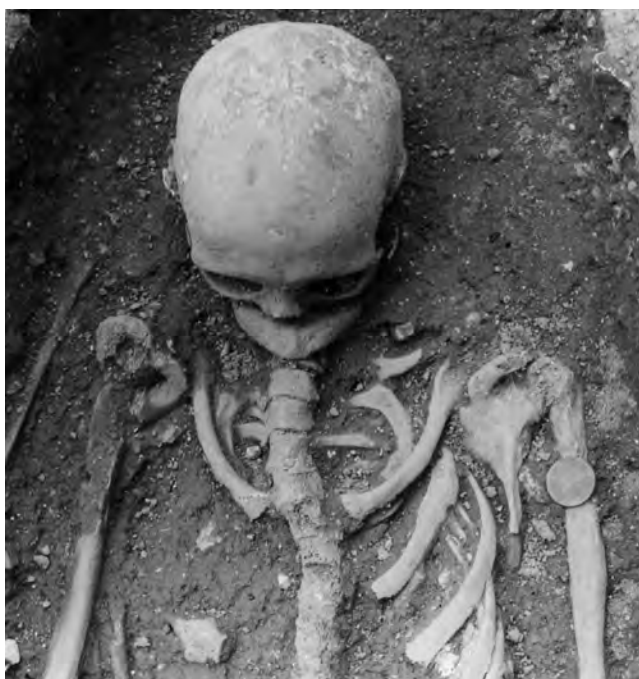
Fig. 747: Churchyard, Area 8. Coffined burial F3022, with a halfpenny of George III placed on the left upper arm. Photo: Warwick Rodwell

- F365. Two George III cartwheel pennies (1797) placed inside the coffin.
- F463. George III cartwheel penny (1797).
- F973. Illegible farthing (1760–1901).
- F3022. George III halfpenny (1760–1820) placed on the upper left arm (Fig. 747).
- F3650. Two George III cartwheel pennies (1797).
- F3707. George III halfpenny (1806).
- F3723. Three illegible halfpennies (1672–1820 and 1820–1901) found behind the skull and under the front of the mandible.
- F3742. Illegible halfpenny (1714–1970) inside coffin.
- F4646. Illegible halfpenny (1672–1820).
- F5102. George III penny (1760–1820).
- F5192. William IV farthing (1830–37).
- F7509. Charles I royal farthing token (1625–34).

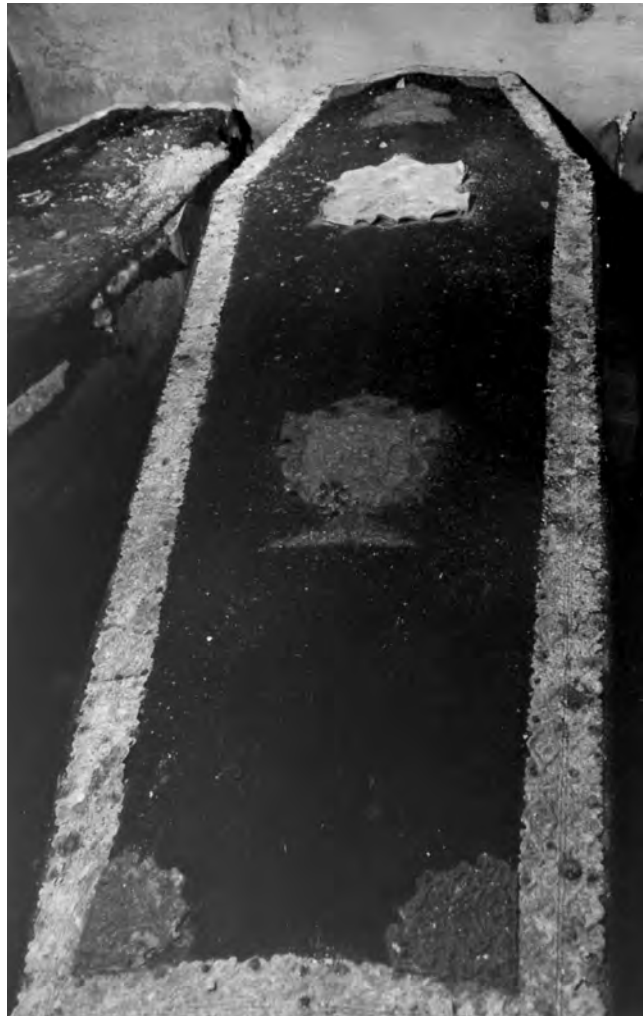
Fig. 755: Nave: Preston vault (F53). Coffin of John Preston (F1700) with its lid fittings. View west. Photo: Warwick Rodwell

The coffin of John Preston (d. 1844), which was interred in a brick vault (F929) in the nave, was observed also to have a low-angled gable-lid (p. 666; Fig. 755). The *depositum* plate and lid motifs from this coffin are described below (p. 692). The coffin was not disturbed further, so that no details of its construction could be noted.

burial vault (Fig. 755). A shield-shaped plate made of Britannia metal (Baldi 1998, 61) from the coffin of John Preston (d. 1844) was spattered with wax from dripping candles, perhaps those illuminating the burial service. A large *depositum* plate of pressed, tin-dipped iron, with black baize textile from the coffin-cover remaining, was retrieved from the same vault, and records the burial of Henrietta Jane Preston (d. 1837), wife of John. The inscription, in gold paint in a trapezoidal panel, is flanked by two angels each holding a lowered palm frond.
