ST PETER'S

Barton-upon-Humber, Lincolnshire

A Parish Church and its Community

HISTORY, ARCHAEOLOGY AND ARCHITECTURE

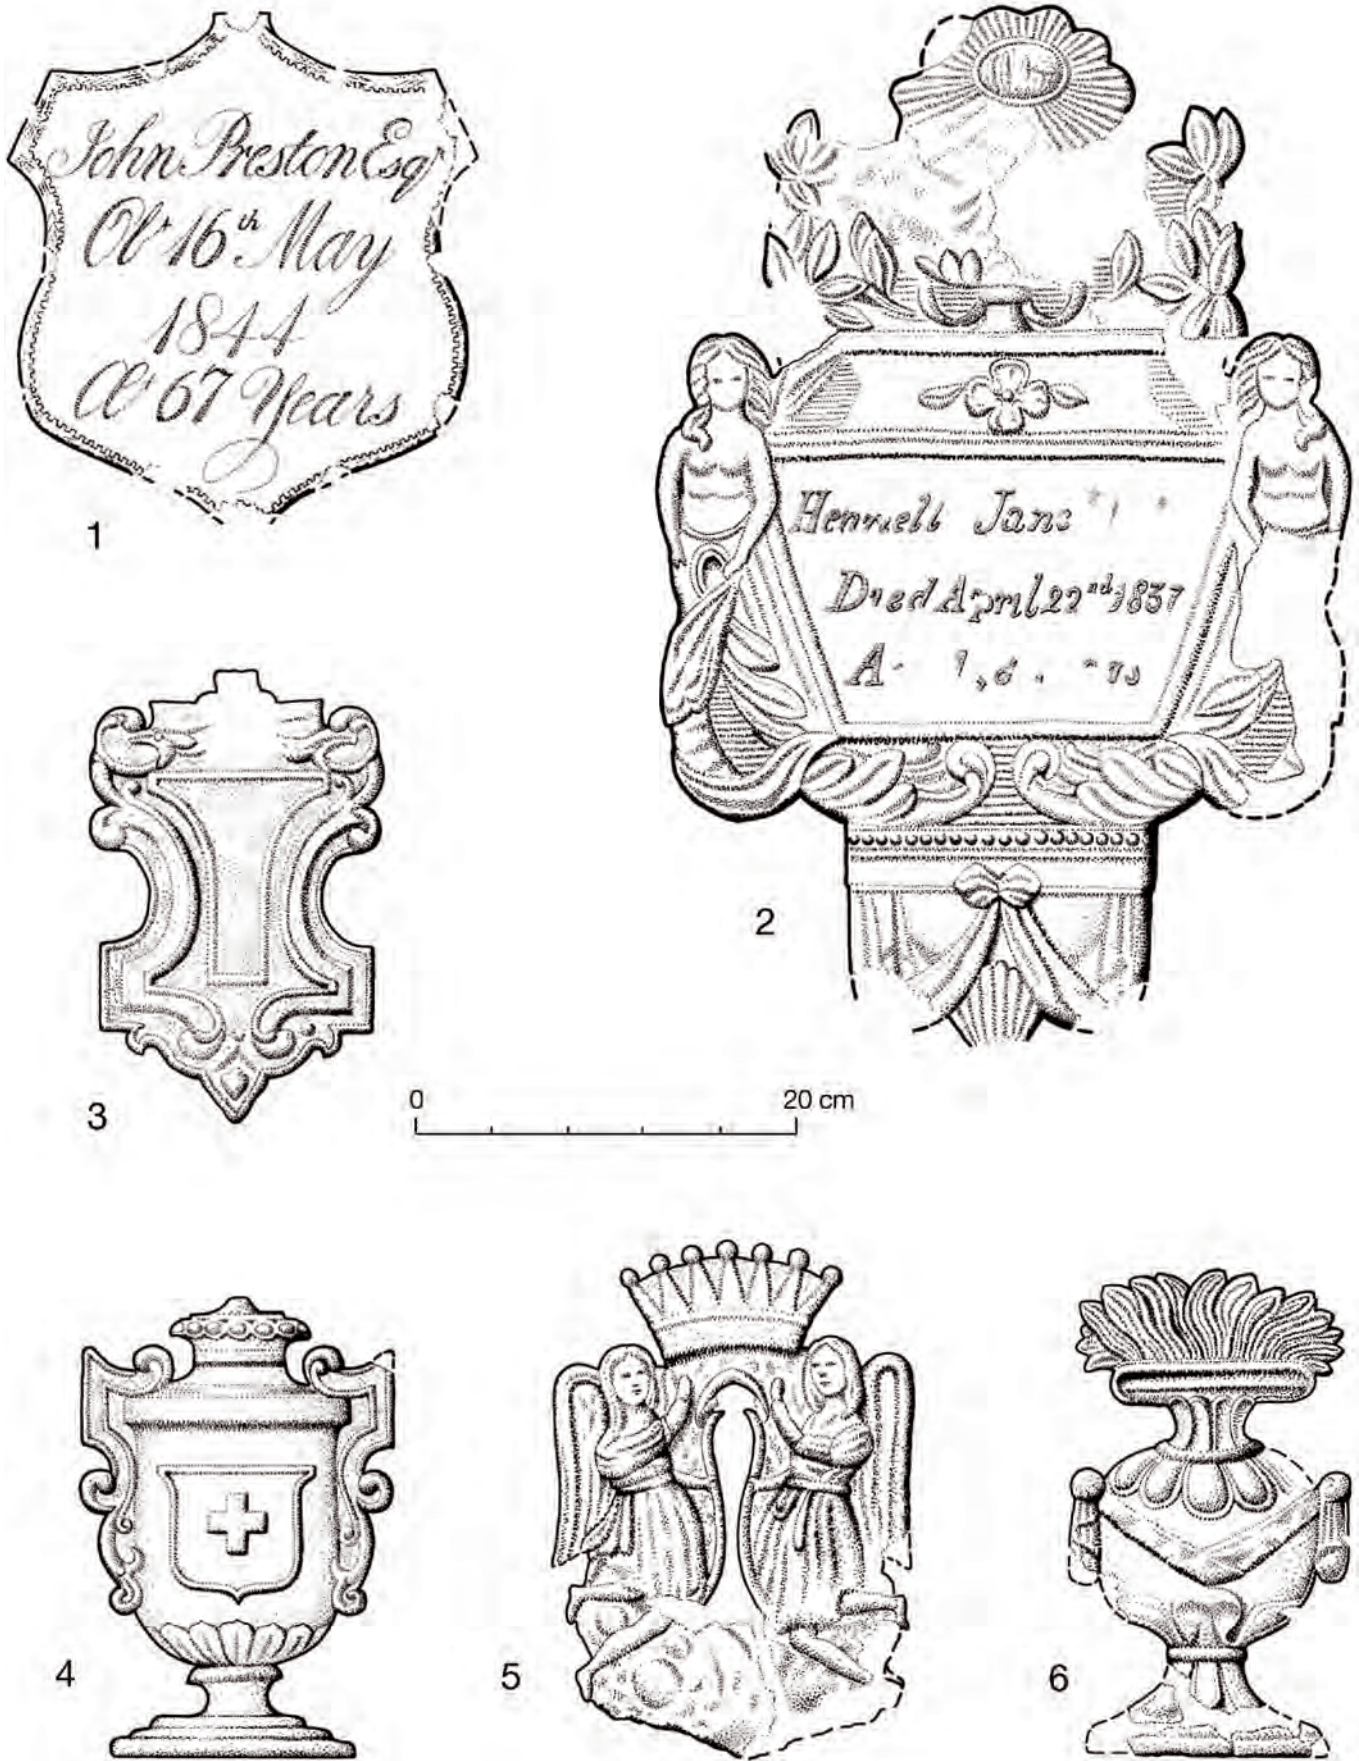
1. Shield-shaped depositum plate of Britannia metal, engraved: John Preston, 1844. L 280 mm, W 245 mm. Coffin F1700, in vault F53.

Fig. 756: Coffin fittings. 1–2, Depositum plates; 3–6, Lid motifs. Scale 1:4. Drawing: Simon Hayfield

Coffin furniture was not found in the quantities that might have been expected and, moreover, a curious assortment was present. While some of the latest graves yielded a 'standard' set of four or six iron grips (handles), a *depositum* (breast) plate and other lid decorations, these were mostly of iron, with some tin-plate. Names and other details were painted on the plates and thus, with only two or three exceptions, the information was lost through decay. No brass handles and no engraved brass or copper plates were discovered in earth-cut graves, or in the several brick-lined shafts that were excavated. The more substantial vaults were not archaeologically investigated and may have contained coffins with fittings of higher quality. A cursory inspection of the Preston vault (F929) in the nave revealed an engraved Britannia-metal *depositum* plate and one of tin-dipped pressed iron with a painted inscription (Fig. 756).

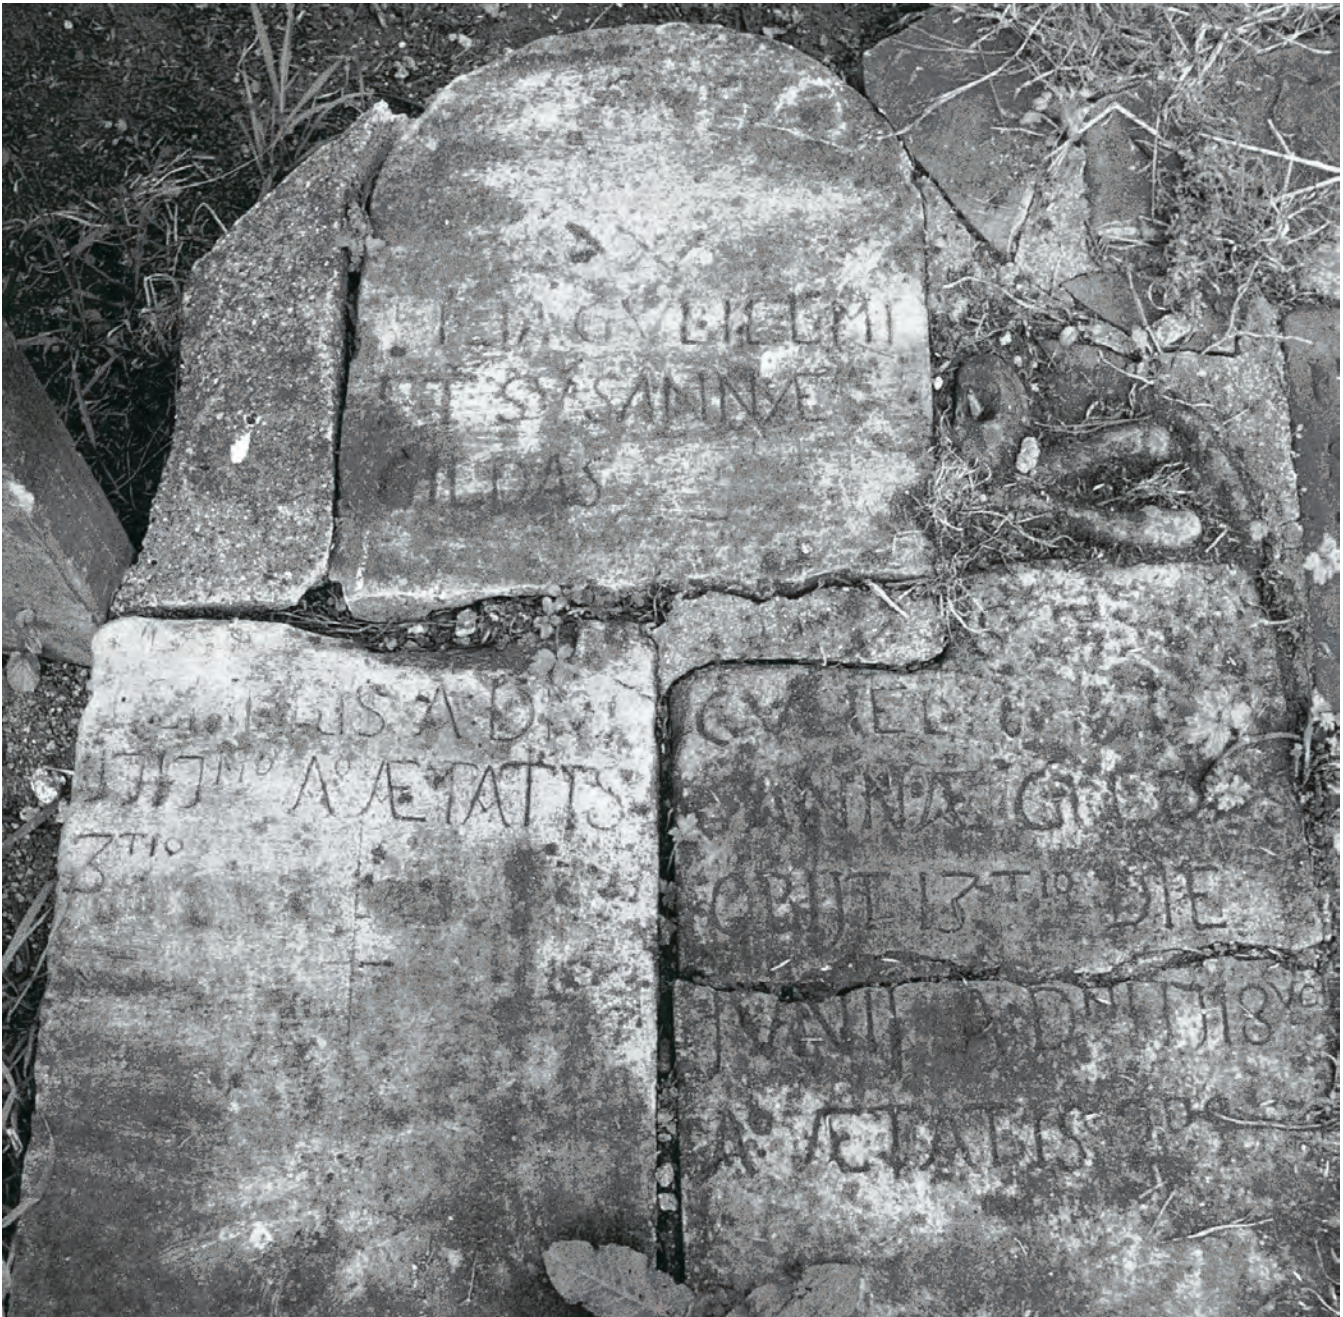
Fig. 769: Fragmentary remains of three early eighteenth-century limestone memorials of the Gildas family (M.145–147). Laid as paving outside the south entrance to the church in 1967; seen here in 1978; M.145 and M.146 are now lost; for M.147, see Fig. 770, 1. Photo: Warwick Rodwell

Headstone with arched top, M.145 (Fig. 769).
Limestone (17—).

Headstone M.146 (Fig. 769). Limestone (1717).
Loft noted ‘the top is broken off this’. The date of
decease correlates with the entry in the burial register
for Judith Gelder, who was baptized in Feb, 1715,

Headstone M.147. Lower Magnesian Limestone
(1718) (Figs. 769 and 770, 5).

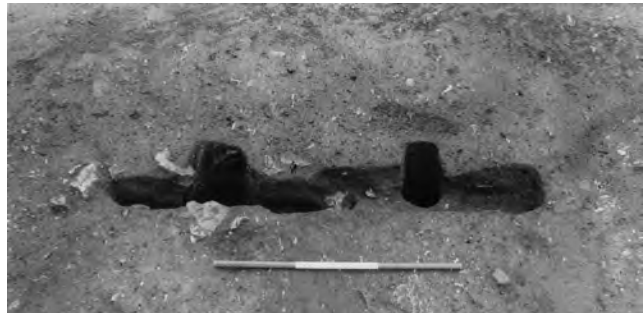
Fig. 771: Excavated slot for a lost headstone which was supported by two timber posts in Area 10. Scale of 75 cm. Photo: Warwick Rodwell

Headstones of the late eighteenth and early nineteenth centuries were often given added support against toppling in the unconsolidated soil of a back-filled grave by installing one, or two, square-section oak posts against the rear face; the slab and post were drilled and an iron bolt inserted (Fig. 771). For the most part, headstones at Barton were relatively plain: the top edge was generally shaped, but not heavily moulded; the inscription was straightforward, although the initial words (usually *Sacred* or *In Memory*) were sometimes in more elaborate script. Very few headstones were pictorial, but several examples bearing incised sailing ships were present, being allusions to the Humber sloop; one survived *in situ* until the 1980s to the north of the chancel (Fig. 772).⁹⁵ Unsurprisingly, some epitaphs reflected connections with the sea:

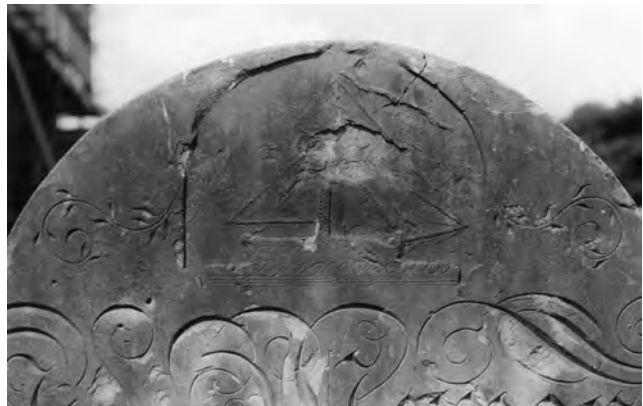
Fig. 772: Churchyard. Headstone to James Hamilton (d. 1827), depicting a sailing ship. Photo: Warwick Rodwell

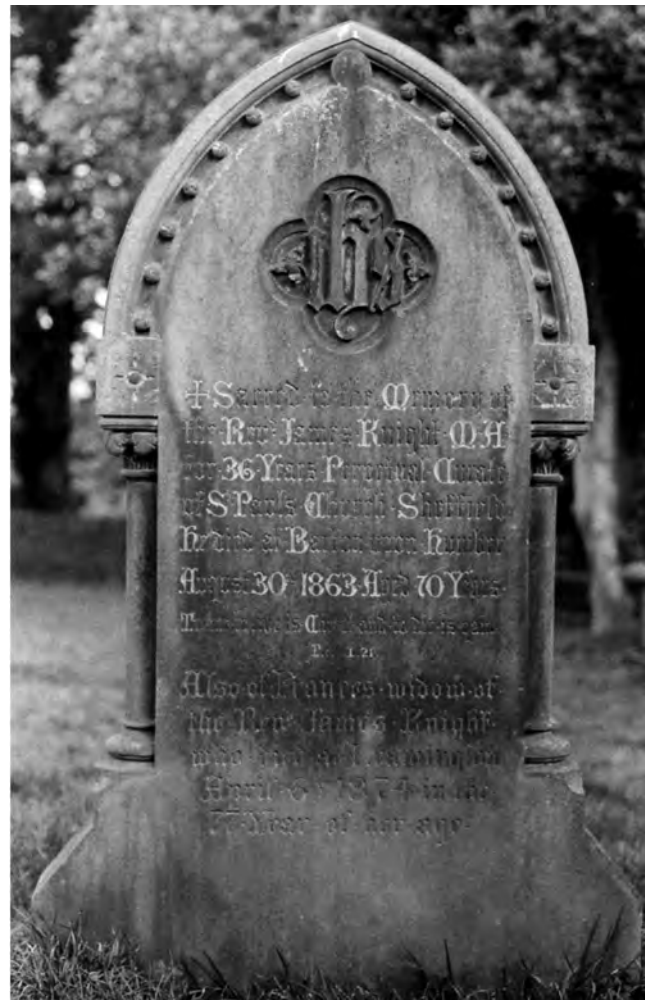
Fig. 773: Churchyard. Gothick headstone with polychromed lettering to the Rev'd James Knight (d. 1863). Photo: Warwick Rodwell

Still extant in the south-west quarter of the churchyard is a Victorian gothick headstone to James Knight, a curate from Sheffield who evidently retired to Barton.¹⁰³ The incised lettering retains considerable traces of the red and black pigment with which it was originally coloured (Fig. 773).¹⁰⁴

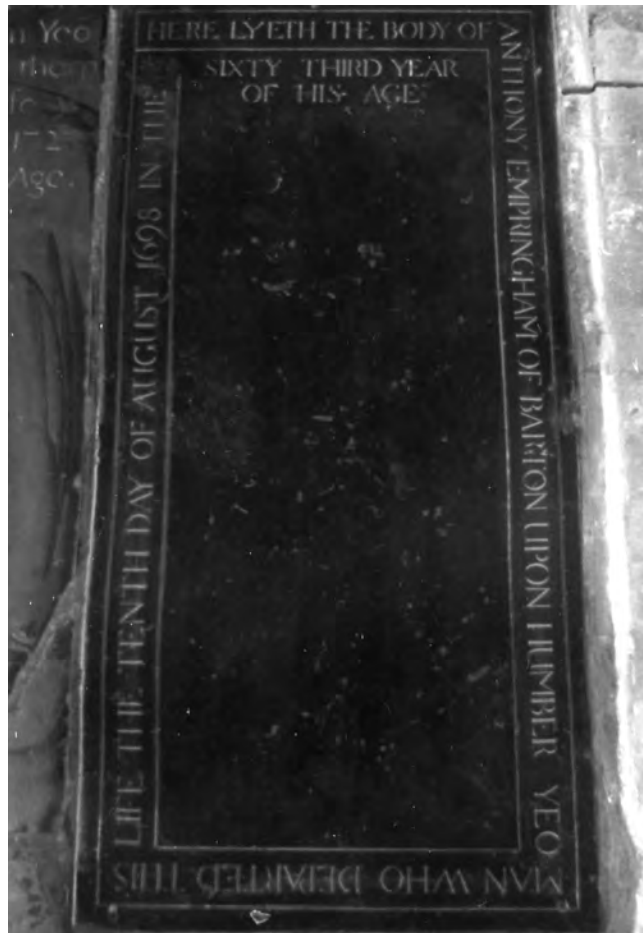
Fig. 775: Nave. Carboniferous limestone ledger-slab to Anthony Empringham (d. 1698; M.7)

The earliest post-medieval ledgers in St Peter's are of blue-grey Carboniferous limestone: the slab commemorating Anthony Empringham (d. 1698; M.7) follows the medieval tradition of having a marginal inscription running around all four sides. The lettering is in *bas-relief* (Fig. 775). The memorial to Simon Emperingham [*sic*] (d. 1723; M.6), however, has a conventional six-line incised inscription (Fig. 776, 1). Those to Kirke Nelthorpe (d. 1734; M.25), Dorothy Nelthorpe (d. 1735; M.27) and John Nelthorpe (d. 1749; M.26) follow the same formula (Fig. 776, 2–4). Finally, a slab of Carboniferous limestone with an indent for a rectangular brass plate has been lost since 1979: it may have been the monument to Edward Tripp (d. 1619; M.21), whose plate was noted by Ball (1856, 1, 58). There are no post-medieval ledger-slabs of Carboniferous limestone in St Mary's church.

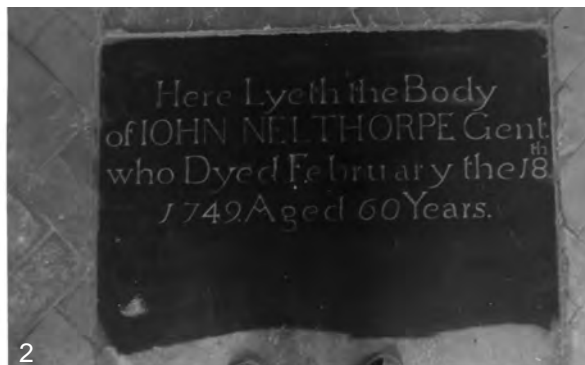
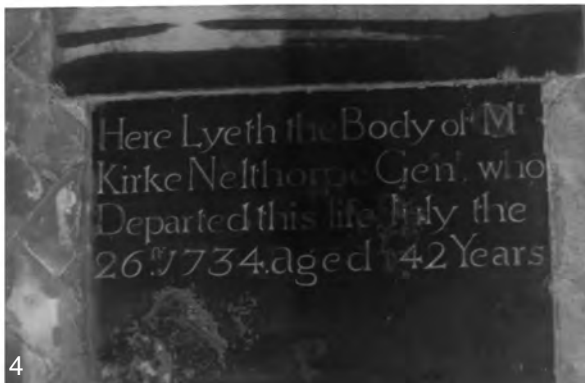
Fig. 776: Nave and south aisle. Carboniferous limestone ledger-slabs with inscriptions: 1, Simon Empringham (d. 1723; M.6); 2, John Nelthorpe (d. 1749; M.26); 3, Dorothy Nelthorpe (d. 1735; M.27); 4, Kirke Nelthorpe (d. 1734; M.25). Photos (Figs. 775 and 776): Warwick Rodwell

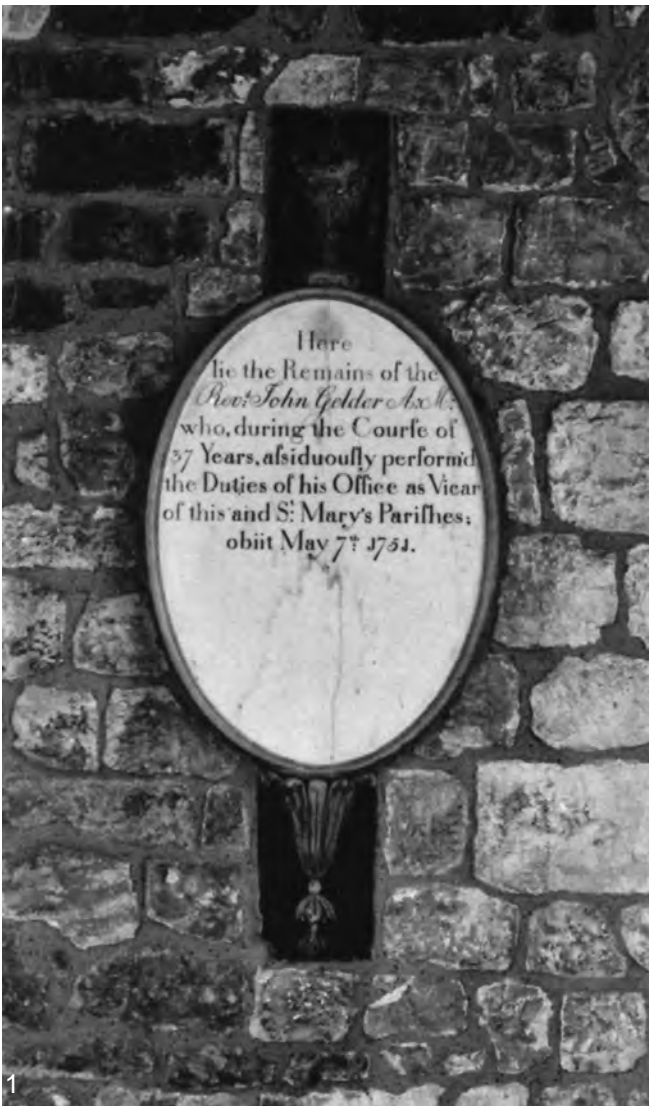
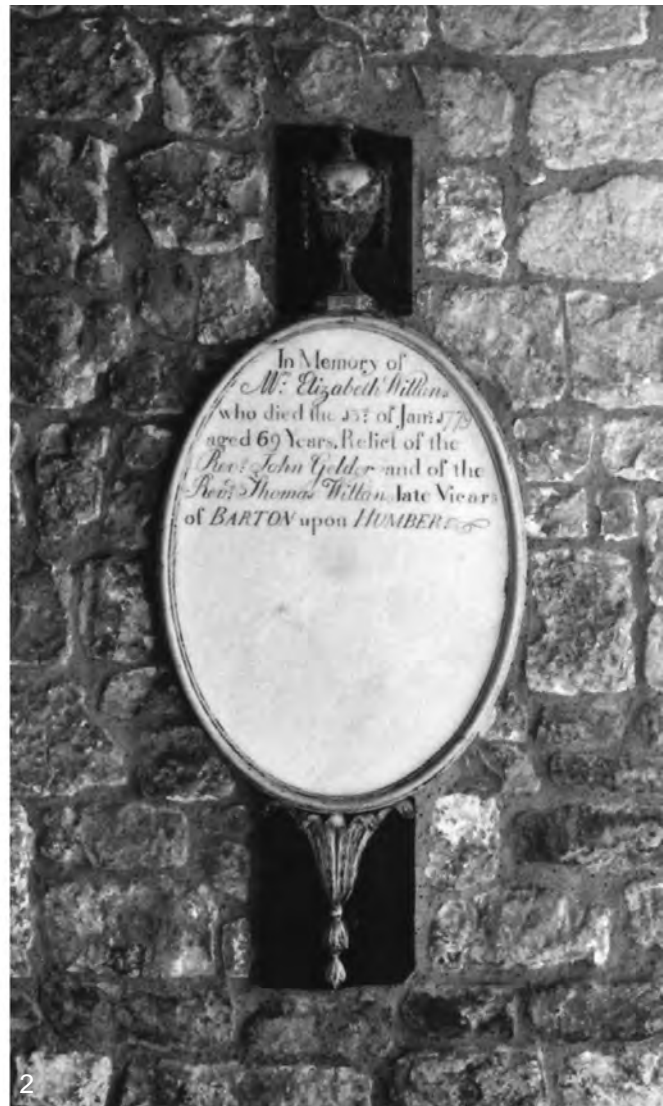
Fig. 778: South aisle. Two Coade stone and Carrara marble wall plaques above the Gelder vault. 1 (left), Rev'd John Gelder (d. 1751; M.55); 2 (right), Elizabeth Willan (d. 1779; M.54). Photos: Warwick Rodwell

The two earliest wall monuments occur at the west end of the south aisle, where they form a non-identical pair, and relate to the Gelder (Gildas) vault here. Each consists of an oval plaque of Carrara marble, set within a slender, moulded frame of Coade stone (Fig. 778). Outside the frame, at top and bottom, are separately moulded blocks of similar material. The lower block is modelled with an unfurling calyx which visually supports the oval frame, and the upper takes the form of a delicately moulded demi-urn which surmounts the frame (Fig. 779). One monument is to the Rev'd John

These monuments are of particular interest for their use of Coade stone, which is not to be expected in funerary art in a small provincial town before the end of the eighteenth century. Mrs Eleanor Coade only moved to London and set up her factory in c. 1769 and very few surviving examples of her work are known to date before c. 1780 (Kelly 1990). To have the Willan monument at Barton in Coade stone as early as 1779 is remarkable but not impossible. The same may not be said of the Gelder monument, which clearly cannot date from 1751: it must be a retrospective memorial. It is impossible to determine which was made first, but it is perhaps more plausible to envisage the Gelder monument as loosely 'copying' the Willan one. While superficially similar, the two were not made at the

The two monuments exhibit strong Regency characteristics and were originally highly decorative: the form is based on a popular feature of the period, a cameo attached to a black ribbon. The frames were gilded, and the urns and calyxes were painted orange-brown (probably a base for water-gilding), set against a black background. The inscriptions were filled with reddish-brown pigment.¹⁰⁹ Although now surrounded by stripped rubble walling, the monuments were intended to be viewed against a plastered background decorated with tinted limewash. The coloured components were probably over-painted in black by the Victorians, to attune with their sense of morbidity.¹¹⁰ Unfortunately, the maker of these plaques is unrecorded, but he is most likely to have been York-based.

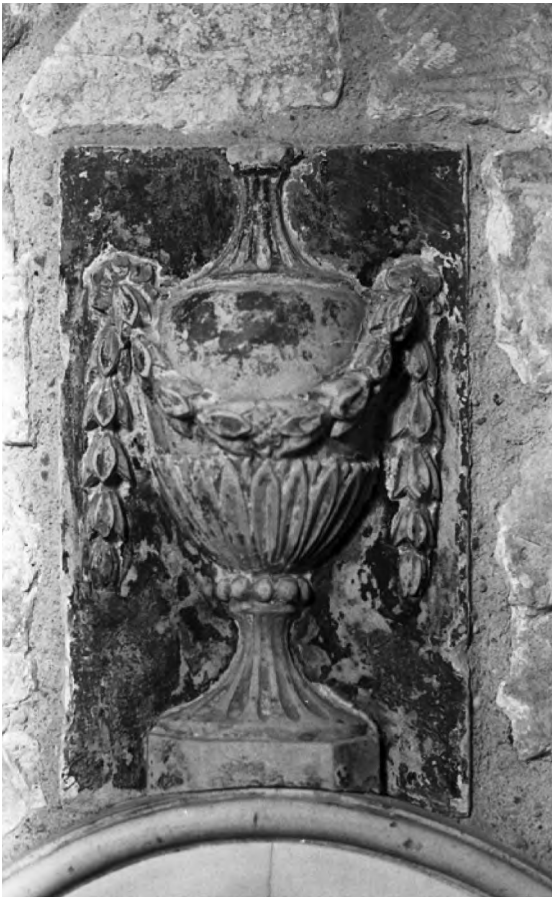
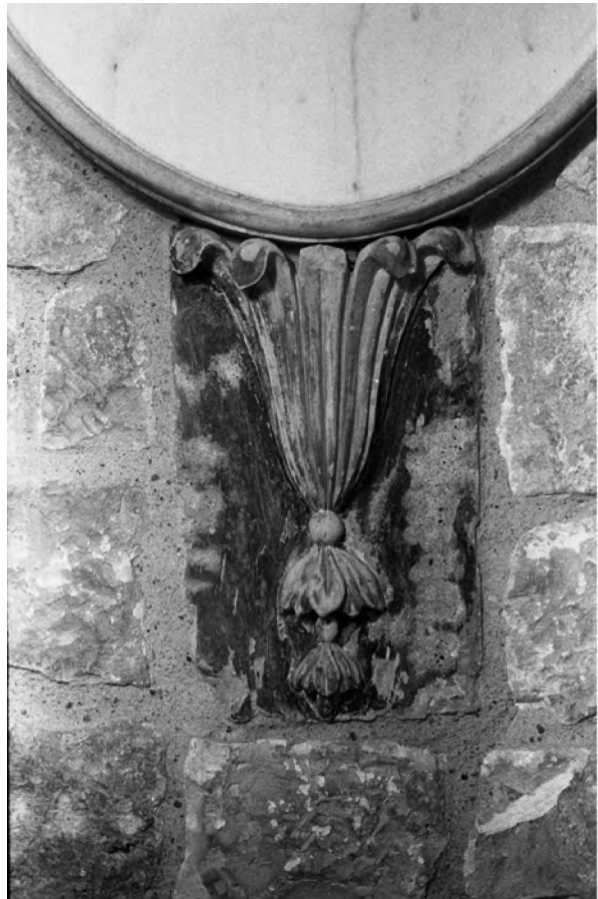
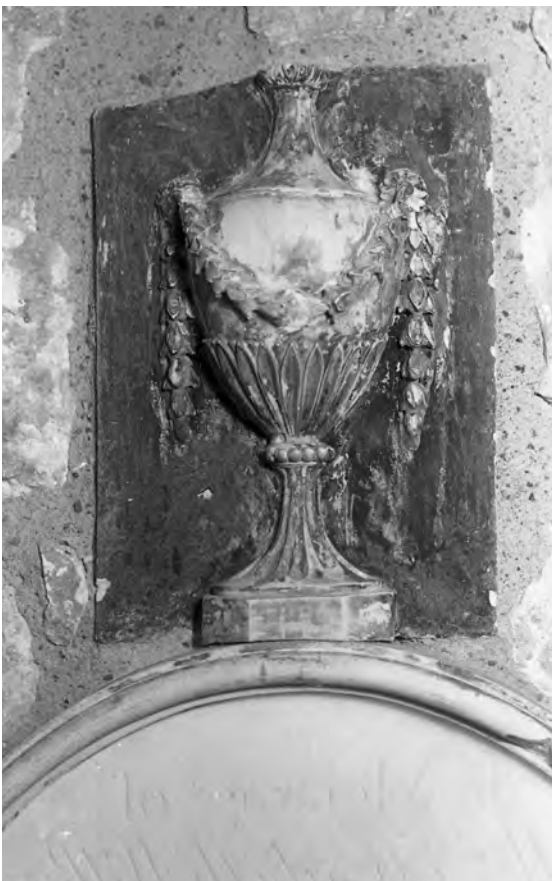
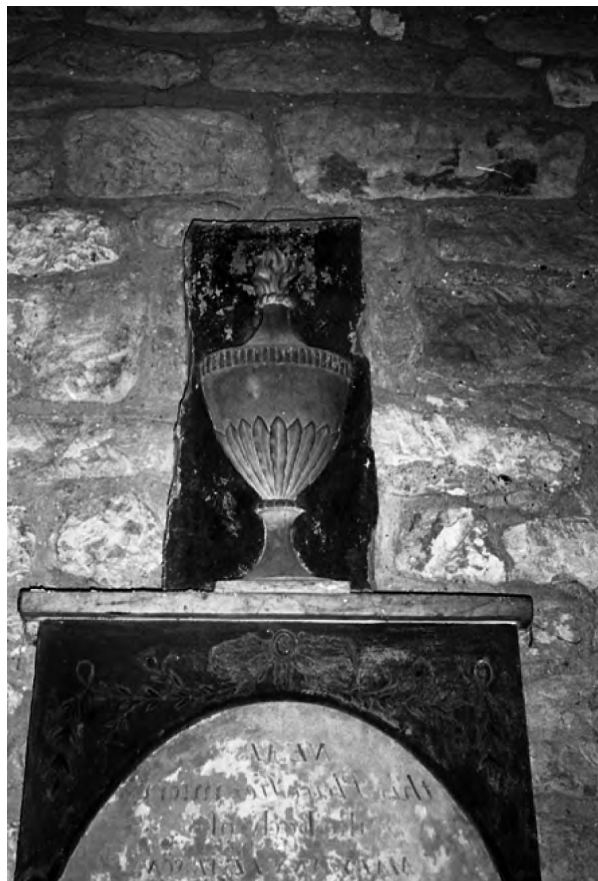
Fig. 779: Details of the Coade stone mounts, before conservation. 1, 2, urn and calyx of M.55; 3, urn of M.54; 4, All Saints, Goxhill, urn on Pearson monument (1800). Photos: Warwick Rodwell

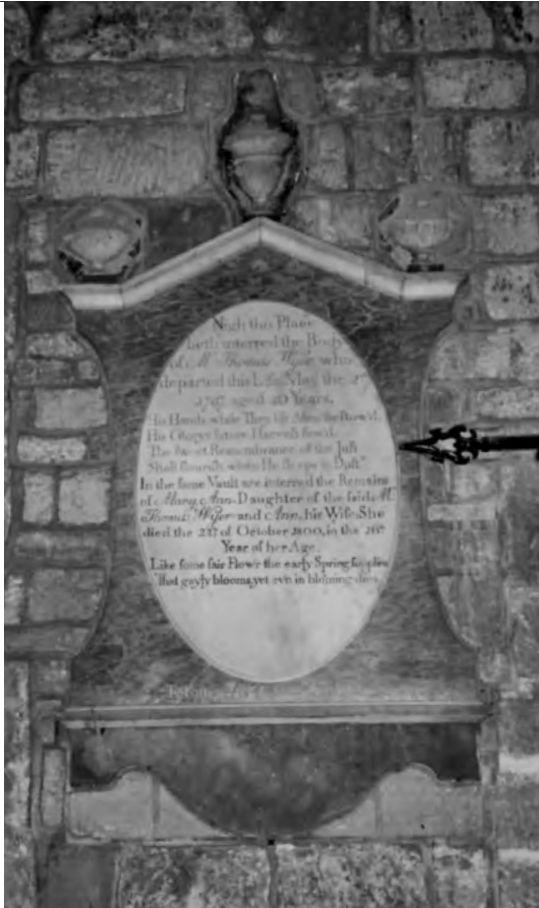
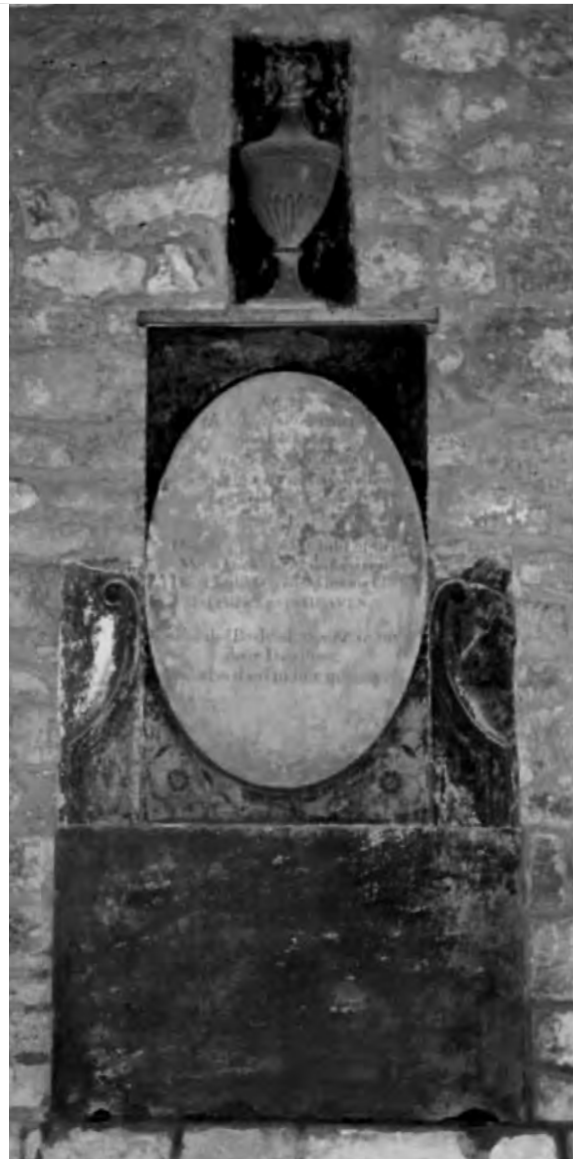
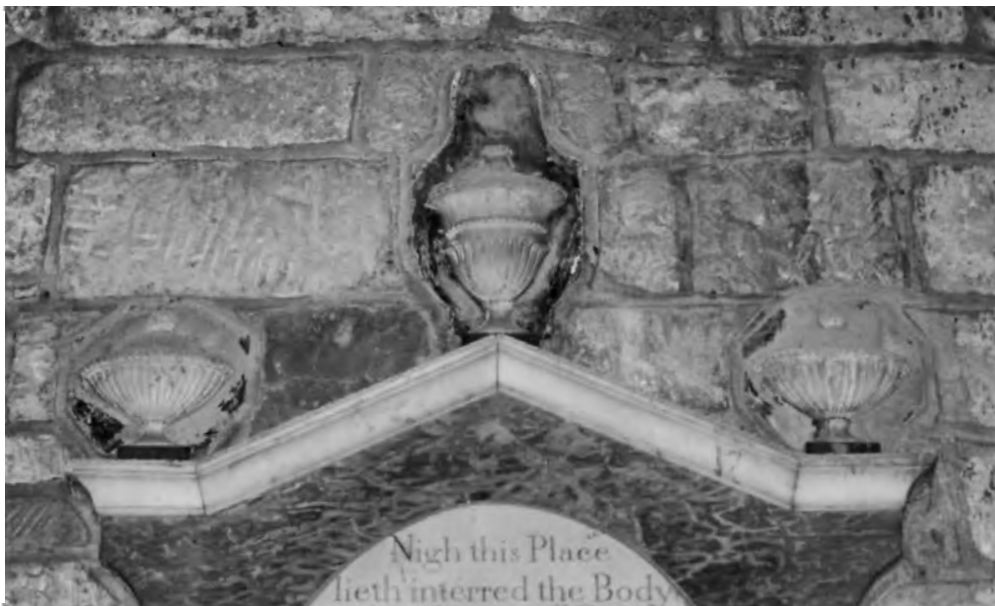
Fig. 780: All Saints, Goxhill (Lincs.). Wall plaques in the chancel, with urn-mounts and remains of black painted background. 1, 2, Hyer (1787), by Edmund Foster; 3, Pearson (1800). Photos: Warwick Rodwell

Two wall monuments of related type, still retaining some of their black paint, are in the chancel of nearby Goxhill church. There, the memorial to Thomas Hyer (d. 1787) comprises an inscribed oval plaque, mounted on a grey marble backplate with a pedimented top framed with moulding of Carrara marble. The pediment is

surmounted by three classical demi-urns with black-painted grounds (Fig. 780).¹¹¹ Prior to the plaster being stripped from the wall, there would have been a broad, black-painted band all round the monument. The second monument, to Mary Ann Pearson (d. 1800), again has an inscribed oval plaque, mounted on a rectangular Yorkstone backplate with incised decoration that has been eclipsed by Victorian black paint (Figs. 779 and 780). The backplate and a flanking pair of scrolls stand on a large plain rectangular base, all in Yorkstone. The monument is topped by an elegant classical demi-urn. The Goxhill monuments are slightly less refined and were made with less expensive materials than those at Barton, but evidently by sculptors

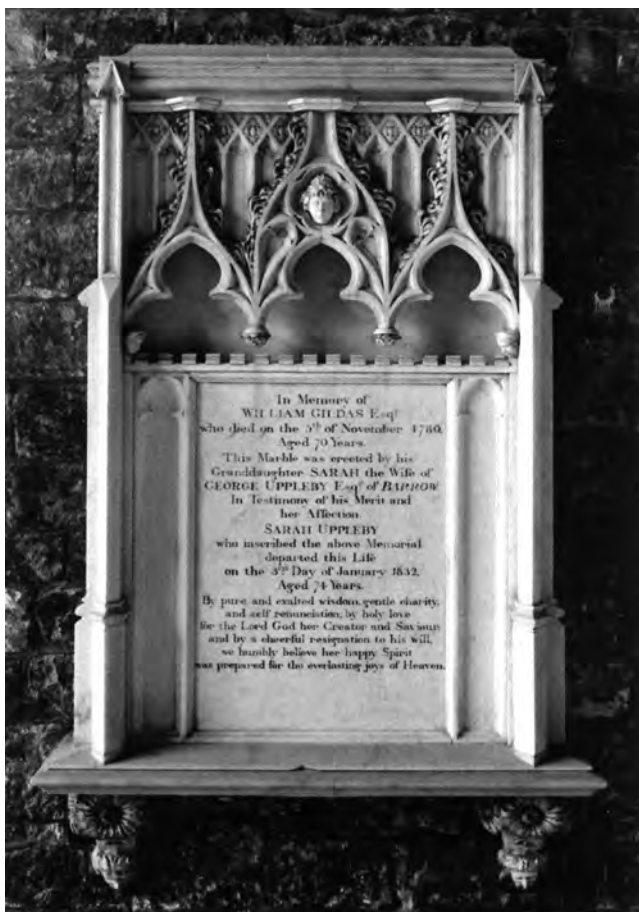
Fig. 781: Chancel (before replastering). Gothic wall monument in Carrara marble to William Gildas (d. 1780; M. 65) by John Earle. Photo: Warwick Rodwell

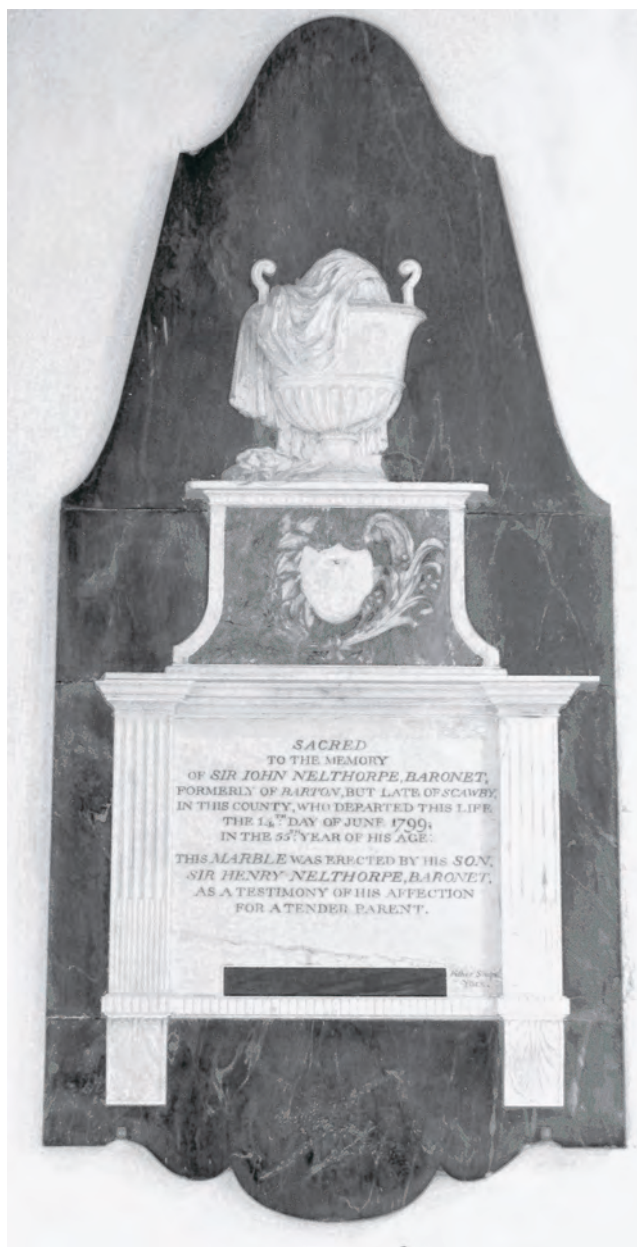
Fig. 782: Chancel. Carrara marble monument with a shaped Belgian marble backplate to Sir John Nelthorpe (d. 1799; M. 63), by Fisher. The pedestal supporting the urn formerly carried the Nelthorpe arms and was polychromed. Photo: Warwick Rodwell

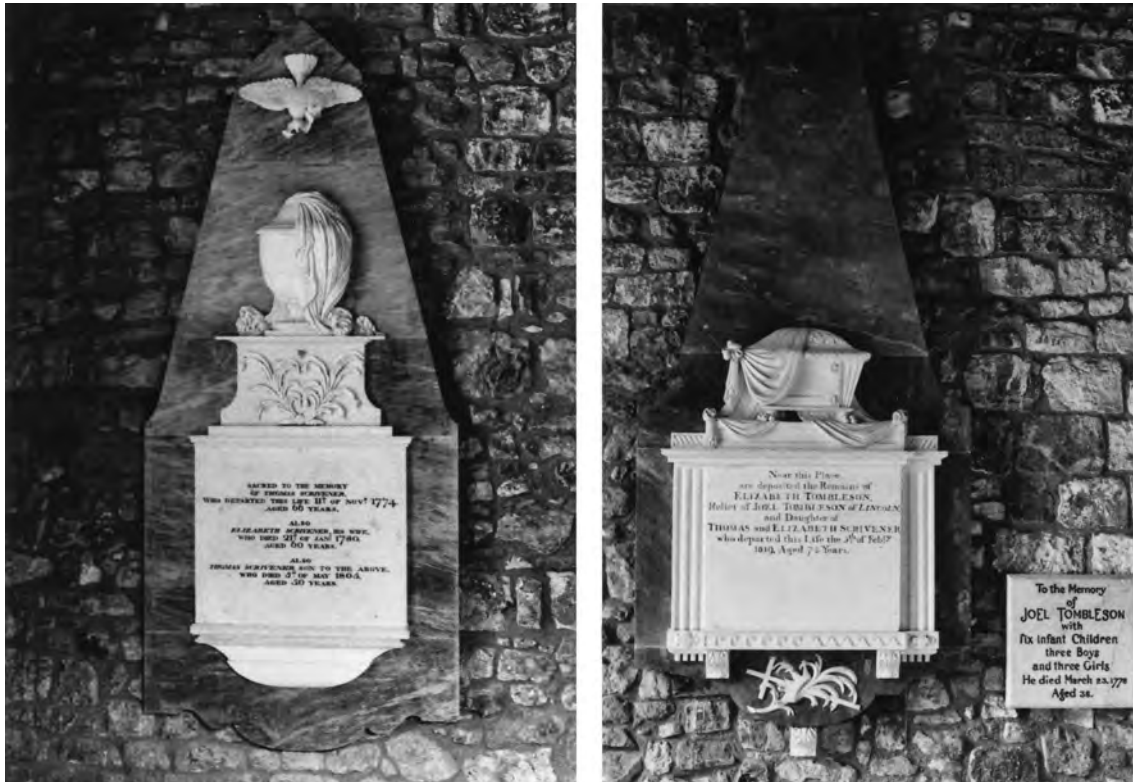
Fig. 783: North aisle. Two Carrara marble monuments with black or grey obelisk-shaped backplates. 1 (left), Thomas Scrivener (d. 1774; M.44) by Fishers; 2 (right), Elizabeth Tombleson (d. 1819; M.45), by L. Earle. The small, retrospective (modern) plaque to Joel Tombleson (d. 1778; M.46) also appears on the right. Photos: Warwick Rodwell

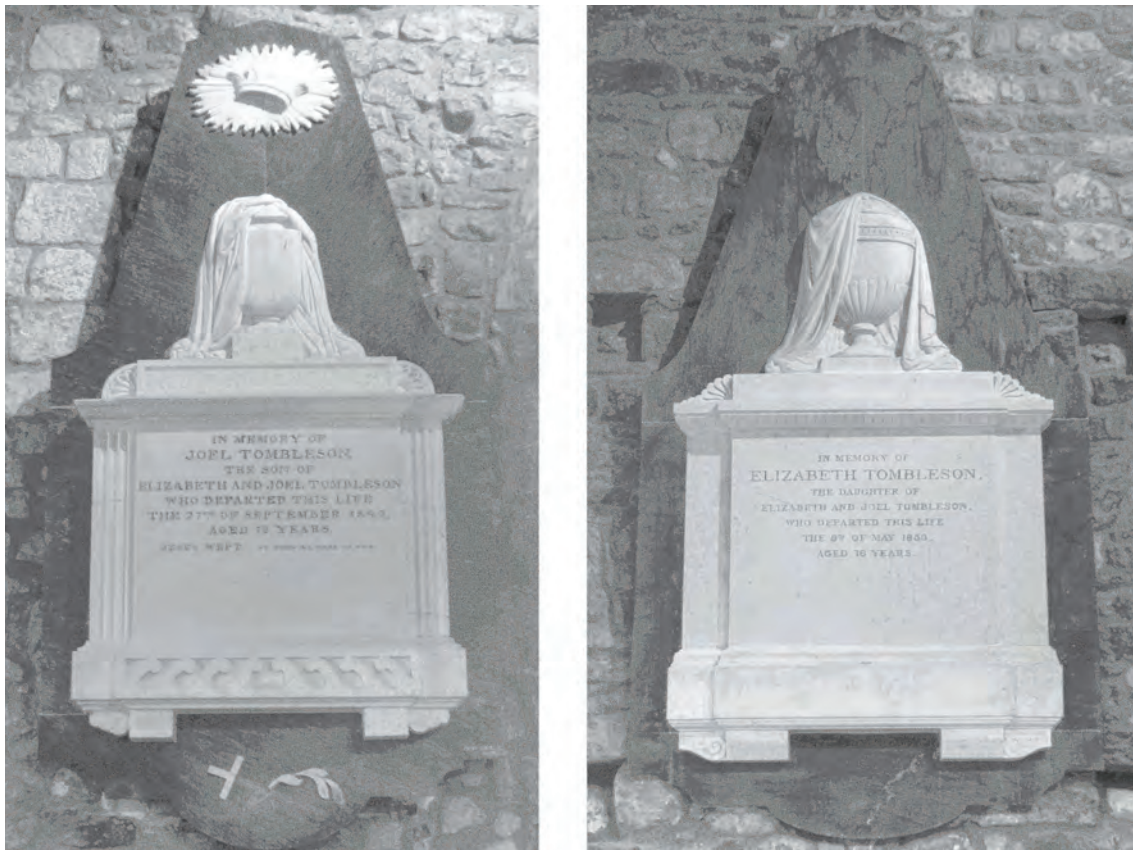
Fig. 784: North aisle. A pair of Carrara marble monuments with grey backplates, commemorating a brother and sister. 1, Joel Tombleson (d. 1842; M.47), by Joshua Earle; 2, Elizabeth Tombleson (d. 1853, M.48), unsigned but undoubtedly by Earle. Photos: Warwick Rodwell

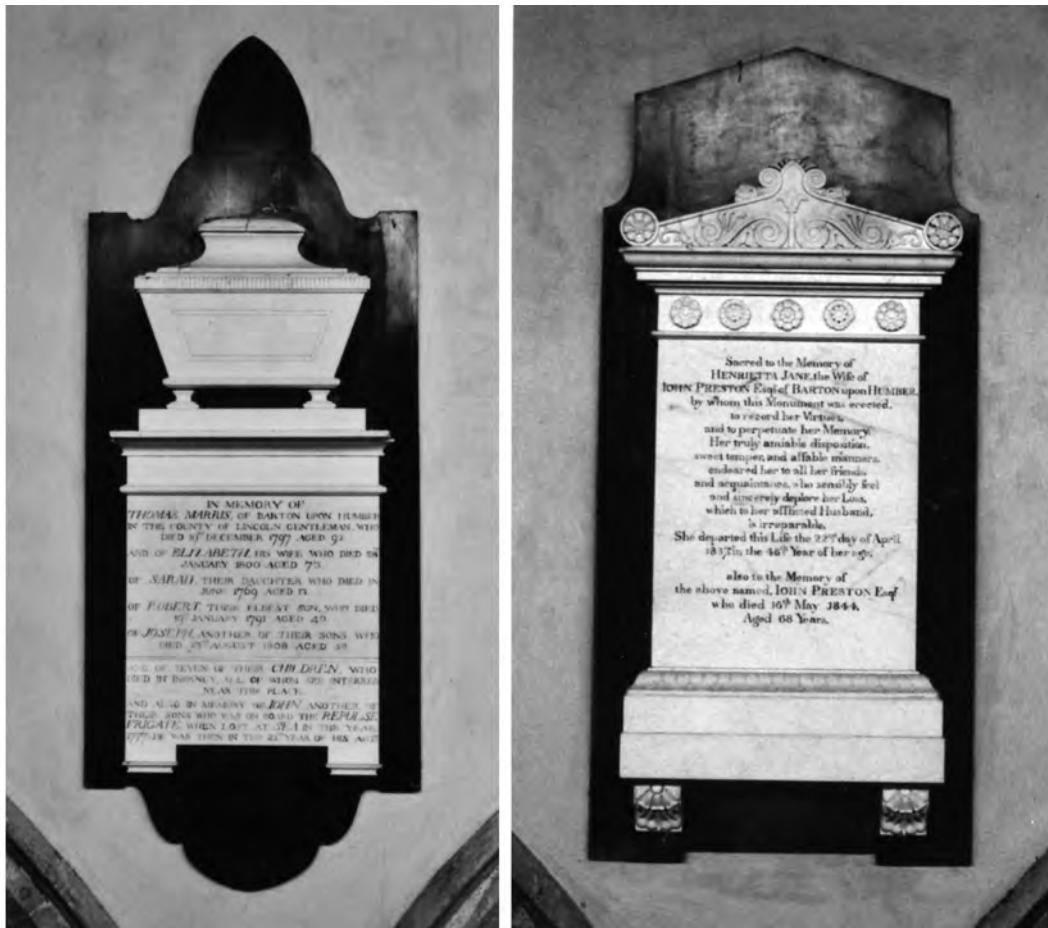
Fig. 785: Nave, north arcade. Two classical monuments in Carrara marble with Belgian marble backplates. 1 (left), Thomas Marris (d. 1797; M.50) by Fisher; 2 (right), Henrietta Preston (d. 1837; M.51) by George Earle Jun. Photos: Warwick Rodwell

together. A memorial of 1837 takes the form of a Roman altar (Fig. 785, 2). Another altar-inspired monument of 1834 in St Mary's is probably by the same maker; it is surmounted by a draped urn (Fig. 132, B).

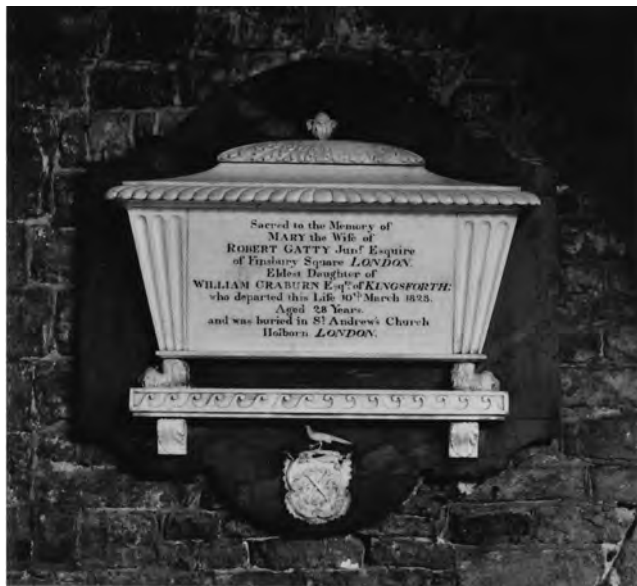
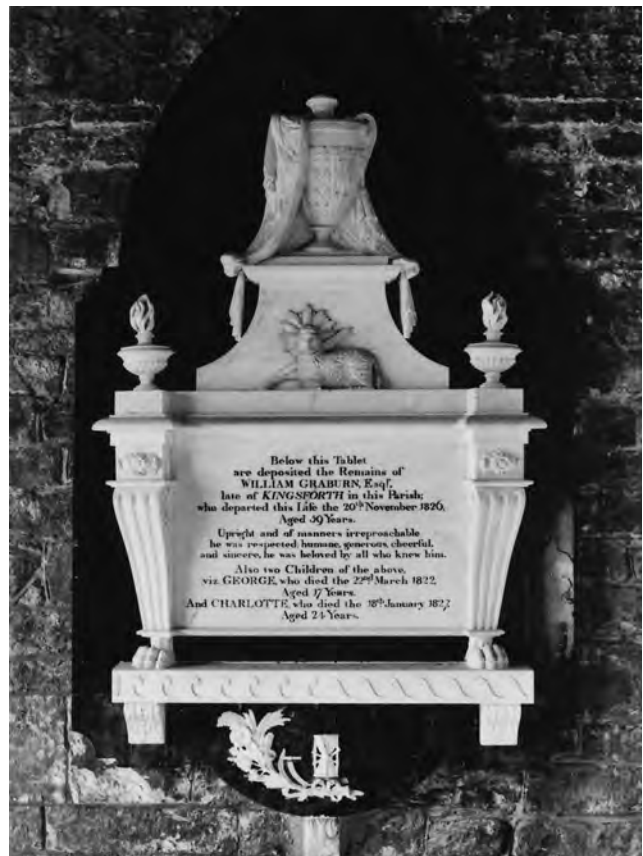
Fig. 786: Chancel (before replastering). Two sarcophagus monuments in Carrara marble. 1 (above), Mary Gatty (d. 1823; M.66), unsigned but probably by Fisher; 2 (right), William Graburn (d. 1826; M.64), unsigned but attributable to Fisher. Compare with Fig. 787. Photos: Warwick Rodwell

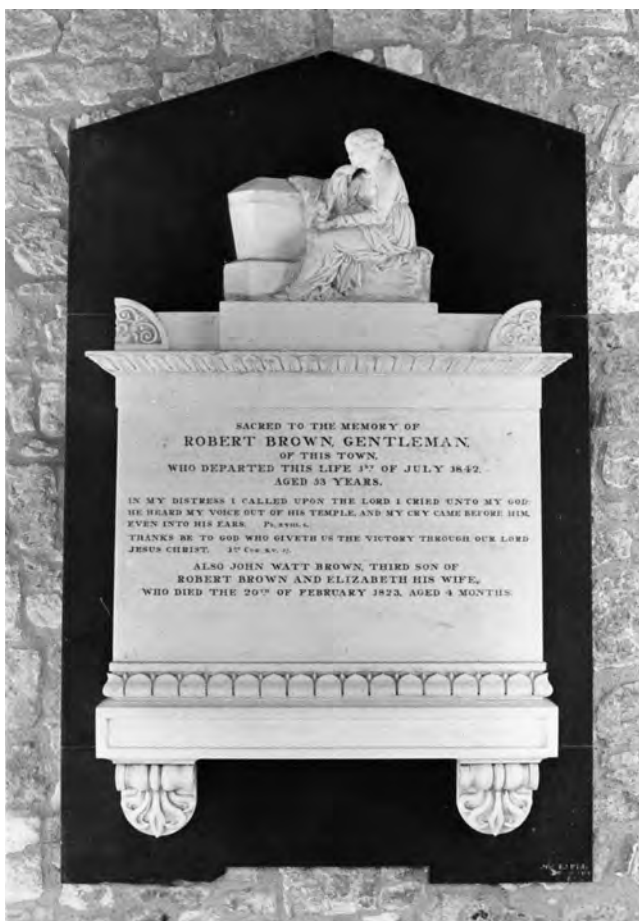
Fig. 788: South aisle. Large black and white marble monument to Robert Brown (d. 1842; M.56) by Joshua Earle. Photo: Warwick Rodwell

Victorian monuments are surprisingly few, and plain. The most substantial is that to Robert Brown, grandfather of Barton's namesake historian (Fig. 788). Two take the form of a book of remembrance, supported on a shelf, while others are modest plaques (Fig. 789).

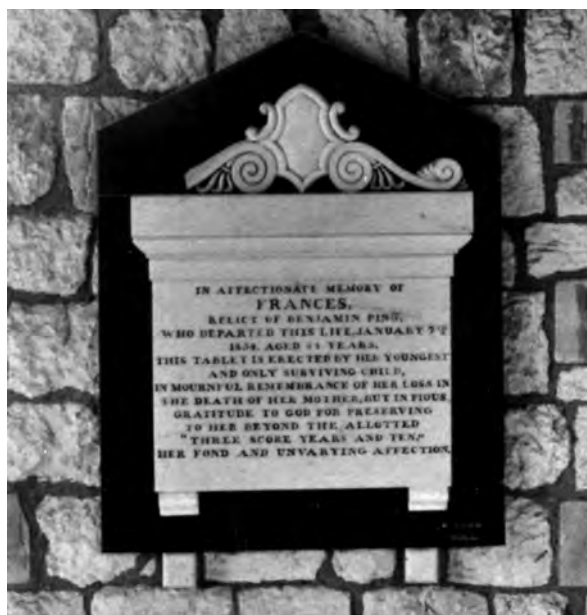
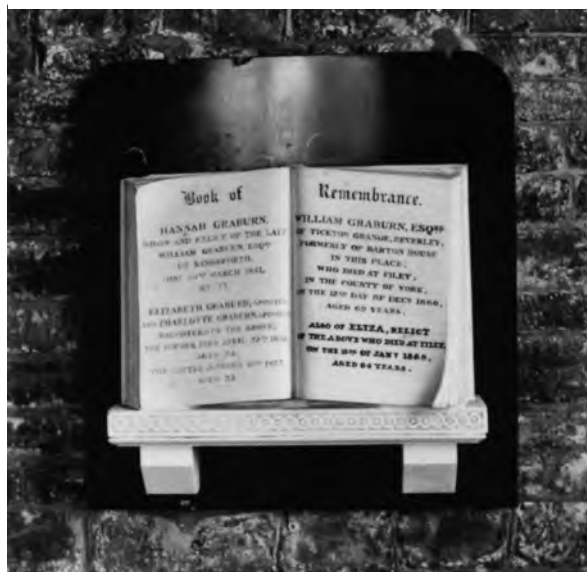
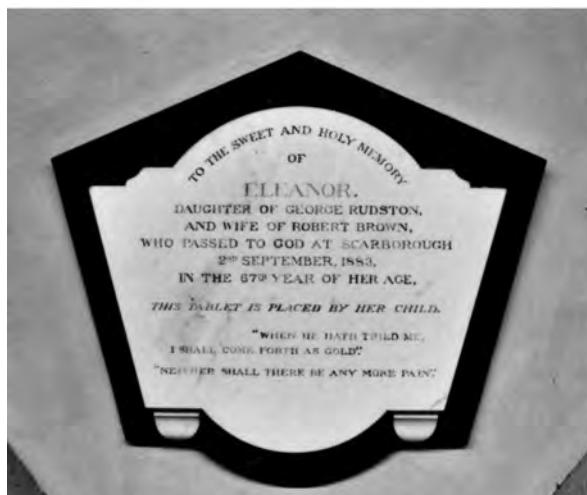
Fig. 789: Three simple Victorian monuments in black and white marbles. 1 (top), Frances Ping (d. 1854; M.59, south aisle); 2 (middle), Hannah Graburn (d. 1851), et al. (M.61, chancel); 3 (bottom), Eleanor Brown (d. 1883; M.52, nave). Photos: Warwick Rodwell

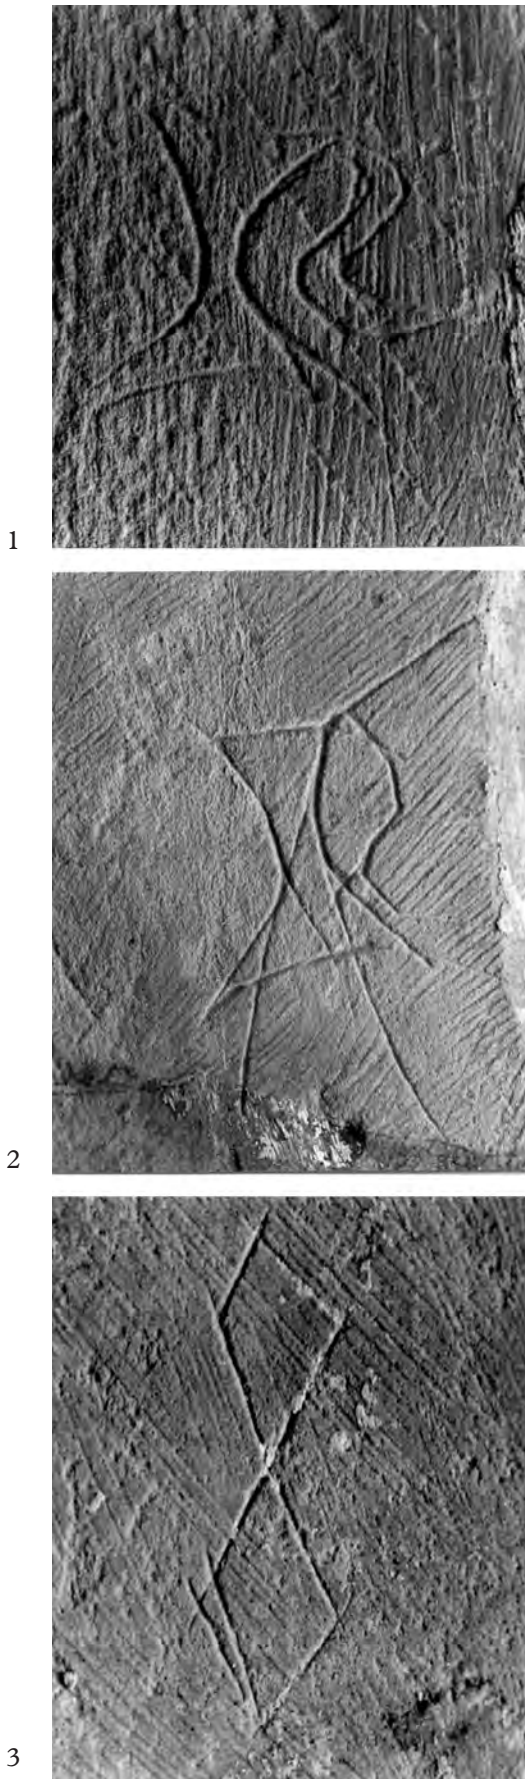
Fig. 827: Masons' marks. 1, Ligatured initials 'IR'; 2, A crude copy of the same initials, perhaps by an apprentice; 3, Double lozenge. Photos: Warwick Rodwell

date, incised in the north doorway of the tower, has already been noted (Fig. 57, 1). Otherwise, the earliest marks were found in the south aisle, where they dated from the later thirteenth century (Fig. 825, nos. 1–4). Fourteenth-century marks occurred on the arches and piers of the nave arcades (nos. 6–25), but were seemingly absent from the windows and north doorway, except for a single, crude cross on the latter (no. 5). In the fifteenth century, masons' marks were more prolific, and it seems that almost every moulded stone in the chancel arch and clerestory windows originally bore one (Fig. 826, nos. 26–50). The jambs and heads of the Perpendicular windows were also marked, along with the two piers that were renewed in the north arcade (p. 468), and the inserted eastern respond of the south arcade. Elaborate letters and numerals rank among the marks; these include the ligatured initials 'IR' and the Arabic numeral '7' (Figs. 826 and 827).
