ST PETER'S

Barton-upon-Humber, Lincolnshire

A Parish Church and its Community

HISTORY, ARCHAEOLOGY AND ARCHITECTURE

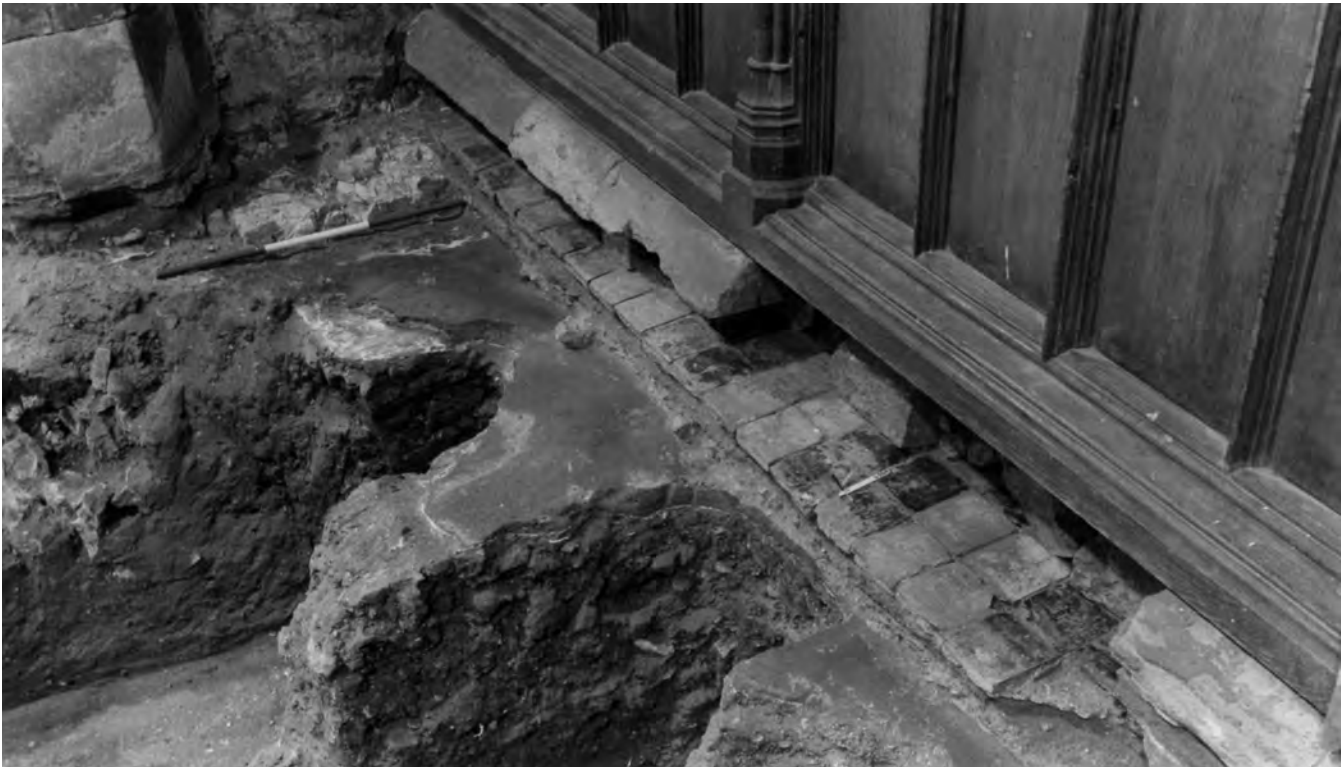
Fig. 832: Medieval floor tiling (Area A, F1508) surviving beneath the chancel screen. View north-east. Scale of 75 cm. Photo: Warwick Rodwell

A strip of tiling survived in largely unworn condition at the east end of the nave, extending beneath a plinth supporting the fifteenth-century chancel screen (F1508; Fig. 832). These tiles were laid square to the

church, in alternating sets of four of each colour (Pl. 53). Of the thirty-two tiles from this context, twenty-five were assigned to Group 5, four to Group 2, one fragment to Group 7. There were two unassigned fragments.

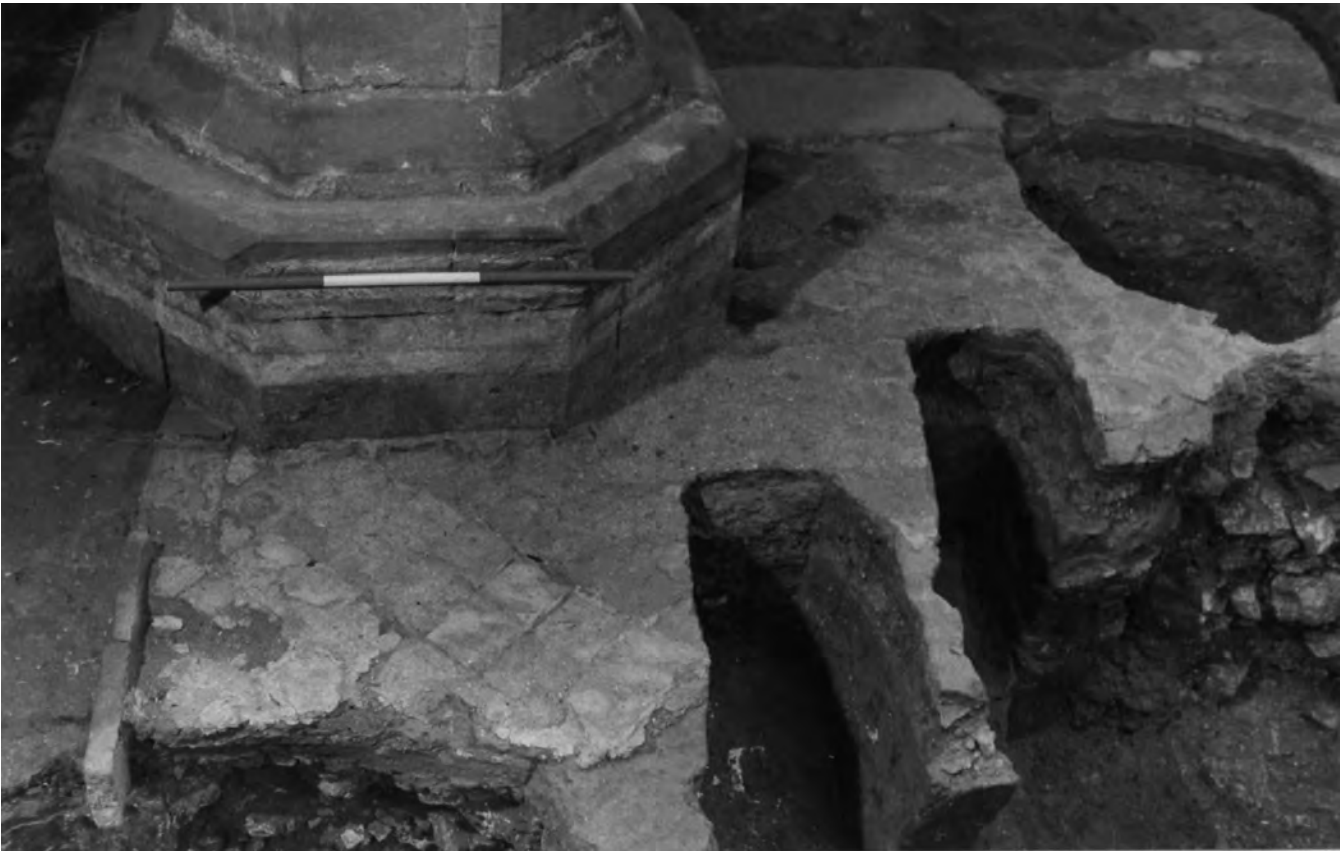
Fig. 833: Mortar bedding for a tile floor (Area E, F12) in bay 5 of the nave, abutting pier 4/5 of the north arcade. Note the brick-on-edge (left) defining the limit of the paving. View east. Scale of 75 cm. Photo: Warwick Rodwell

Several large areas of mortar impressions and some paving survived intact in the westernmost bay of the nave (F11/12; Fig. 833). These suggest that the whole of bay 5 was tiled and that there was a liturgical or functional demarcation running north–south between the opposing piers of the two arcades. The tiles had been laid on the diagonal, but no arrangement by colour could be established from the worn examples found *in situ* (Pls. 56–58). The thirty-two extant tiles consisted of twenty-five of Group 2, five of Group 5, and two unassigned fragments.

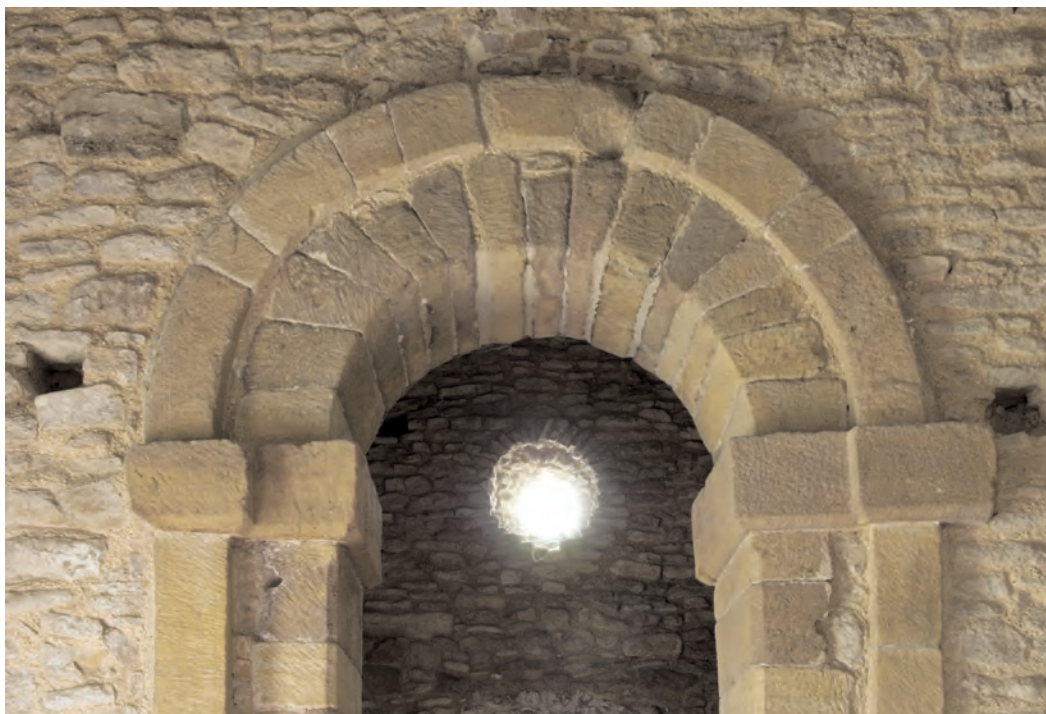
Plate 21: Detail of the gritstone voussoirs of the western arch in the ground stage of the tower. Photo: English Heritage Photo Library

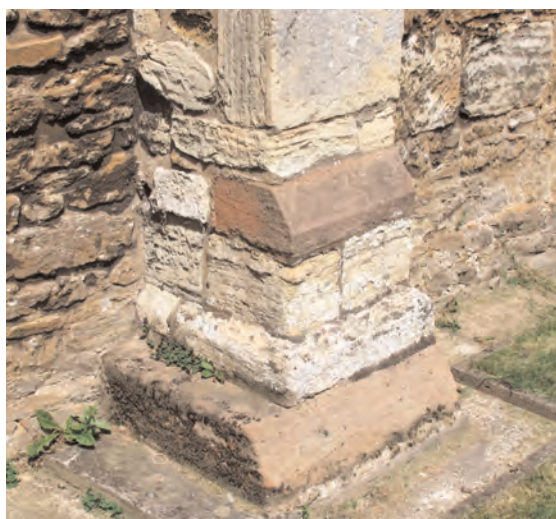
Plate 23: A gritstone block cut to form the complex eastern impost of the north door of the tower. The same block serves as the impost for the adjoining stripwork and as the springer for the triangular door-head. Heavy weathering has created the appearance of mouldings on the stone. Photo: Warwick Rodwell

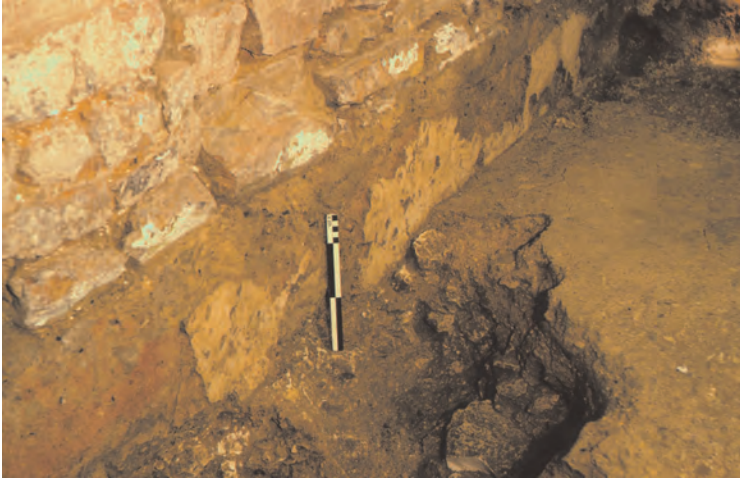
Plate 28: Tower. Remains of the primary plaster finish at the base of the north wall, abutted by the Saxo-Norman lime-concrete floor. Scale of 25 cm. View north-east. Photo: Warwick Rodwell

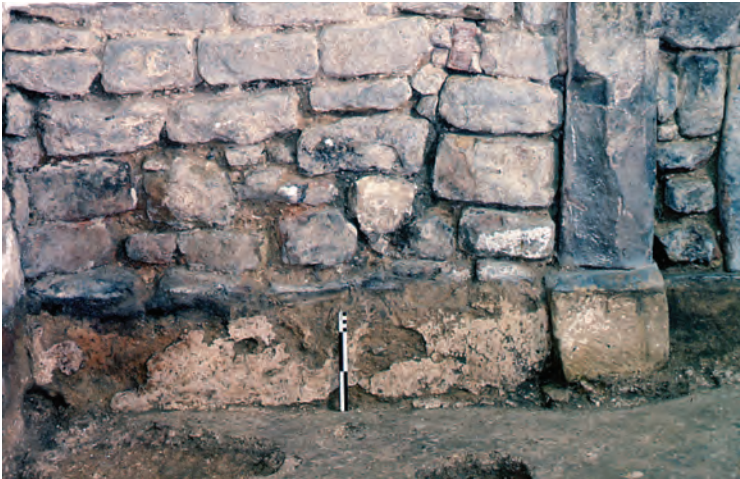
Plate 29: Tower. Surviving band of primary plaster at the base of the east wall, abutting the base for the pilaster-strip flanking the chancel arch. Note how the lower end of the pilaster is spalled as a result of fire. View east. Scale of 25 cm. Photo: Warwick Rodwell

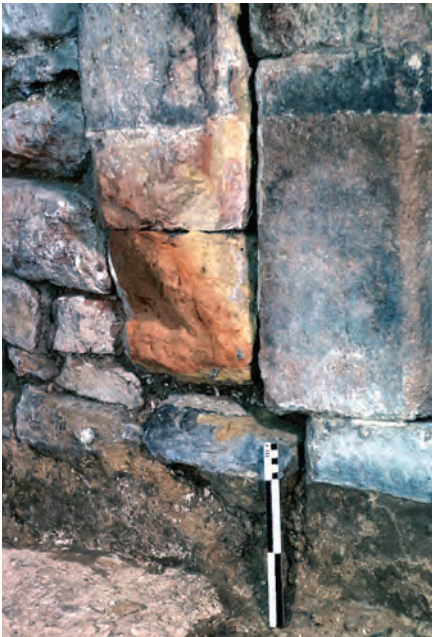
Plate 30: Tower, western arch. The base of the southern pilaster-strip, burnt and shattered by fire. Scale of 25 cm. Photo: Warwick Rodwell

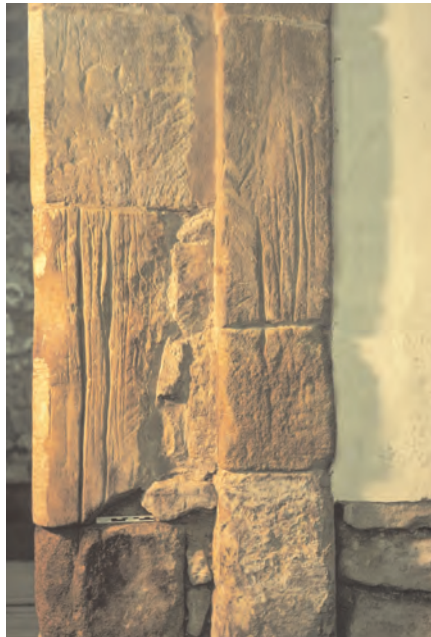
Plate 31: Tower, western arch. Northern pilaster-strip with scars resulting from sharpening implements or weapons, and subsequent damage inflicted through burning. Photo: Warwick Rodwell

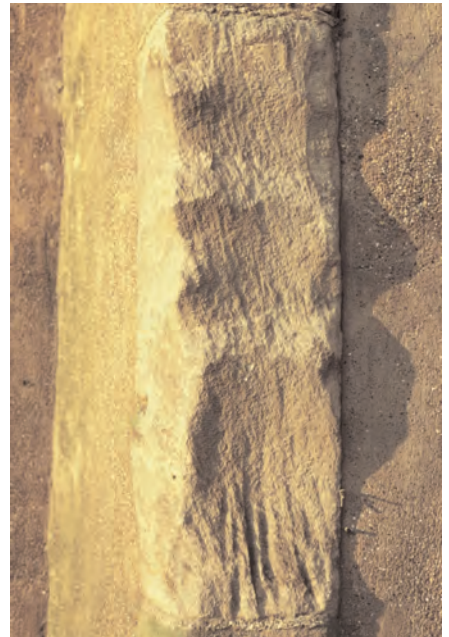
Plate 32: Tower, north-west quoin. Scars resulting from sharpening implements or weapons. Photo: Warwick Rodwell

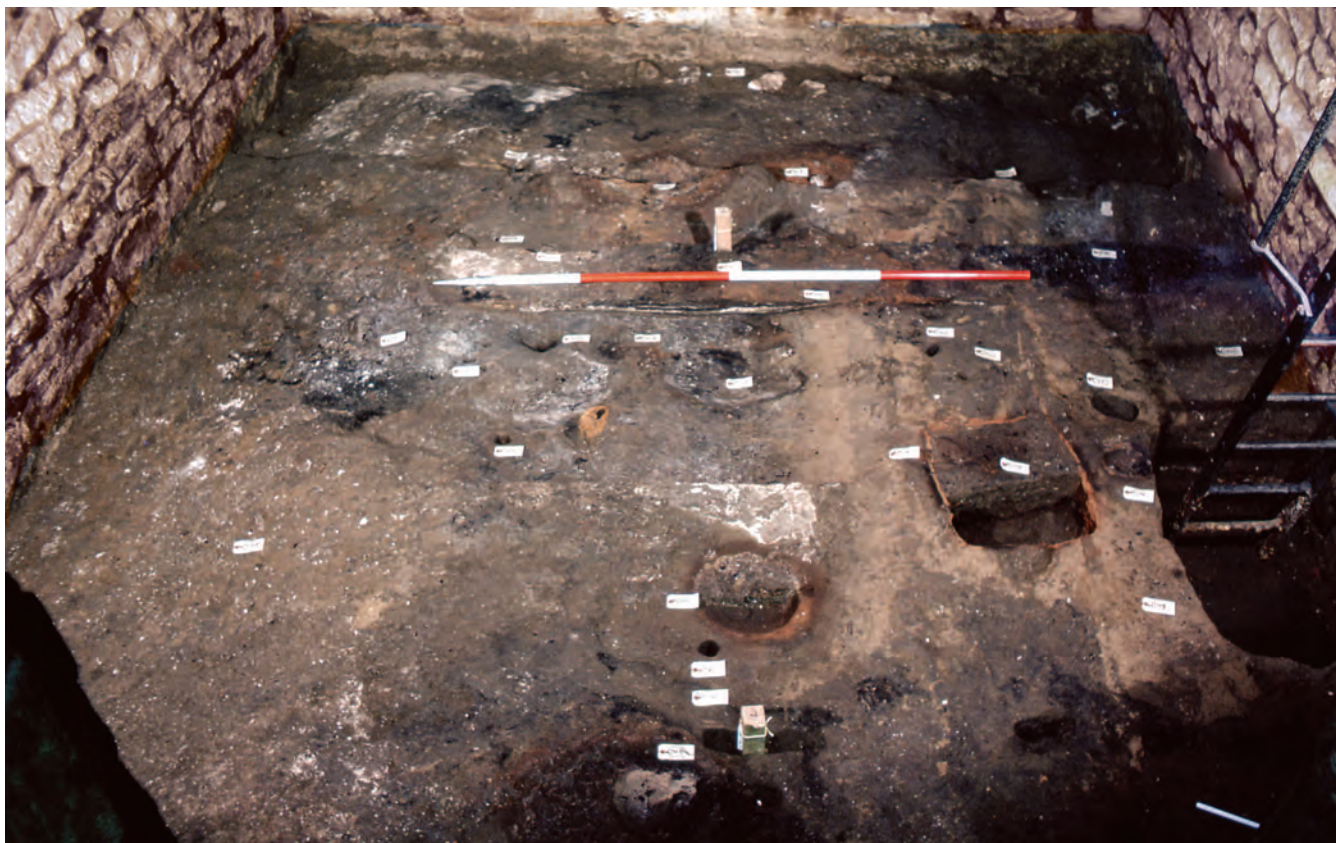
Plate 33: Western annexe. Interior view looking west during excavation of the hearths and burnt deposits associated with the medieval plumbers. Scale of 2 m. Photo: Warwick Rodwell

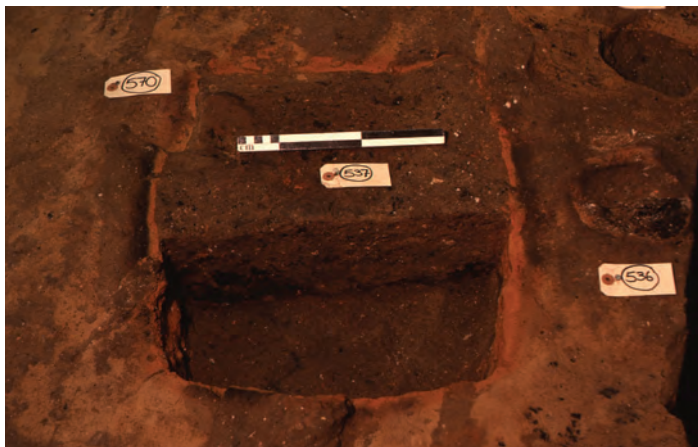
Plate 34: Western annexe. Detail of a rectangular furnace pit with a burnt clay lining (F537). View west. Scale of 25 cm. Photo: Warwick Rodwell

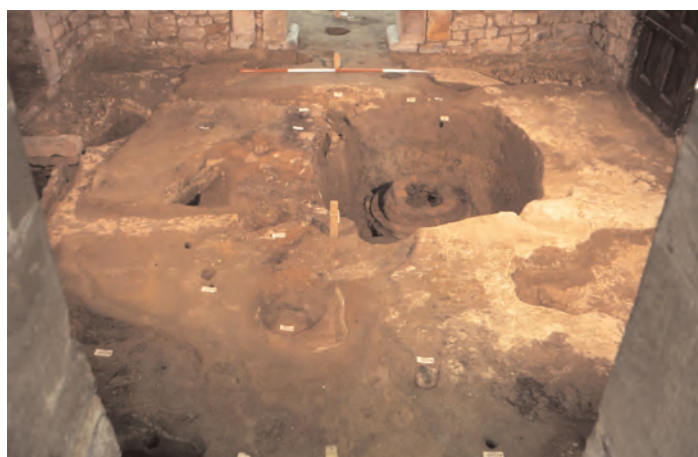
Plate 35: View east across the floor of the tower, showing the fragmentary medieval deposits during excavation in 1978. The large pit in the centre is the bell foundry, F511. Scale of 2 m. Photo: Warwick Rodwell

The material examined comprised bell-mould, hearth lining, slag and metal spillages associated with the casting of at least two bells. The first period of bell-founding dates to the twelfth or thirteenth century and took place inside the west of the nave. The second period dates to the late sixteenth century and took place in the tower. None of the archaeological evidence for bell-founding can be linked directly to the known bells from St Peter's (late sixteenth to mid-eighteenth centuries). Samples of casting debris and a possible bell fragment were analyzed: all had high tin contents typical of bells.

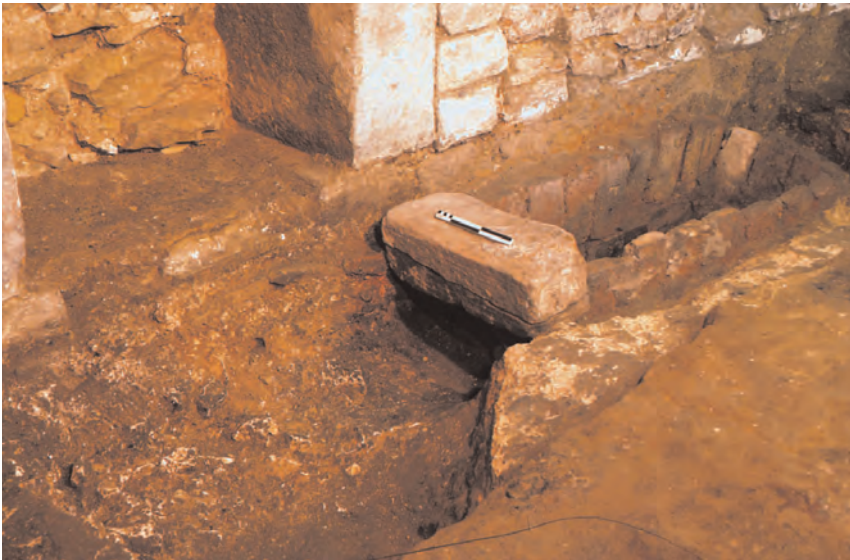
Plate 36: Tower. Furnace for melting bell-metal alongside the north wall, F527. View north-east, with the stoke-pit to the left. Scale of 25 cm resting on the flue lintel. Photo: Warwick Rodwell

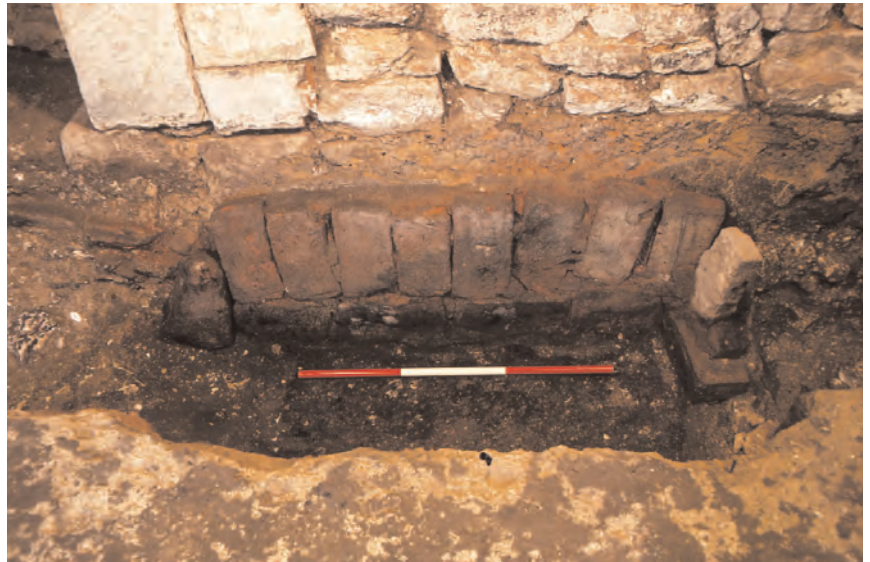
Plate 37: The chamber of the bell-metal furnace, longitudinally sectioned. View north. Scale of 75 cm. Photo: Warwick Rodwell

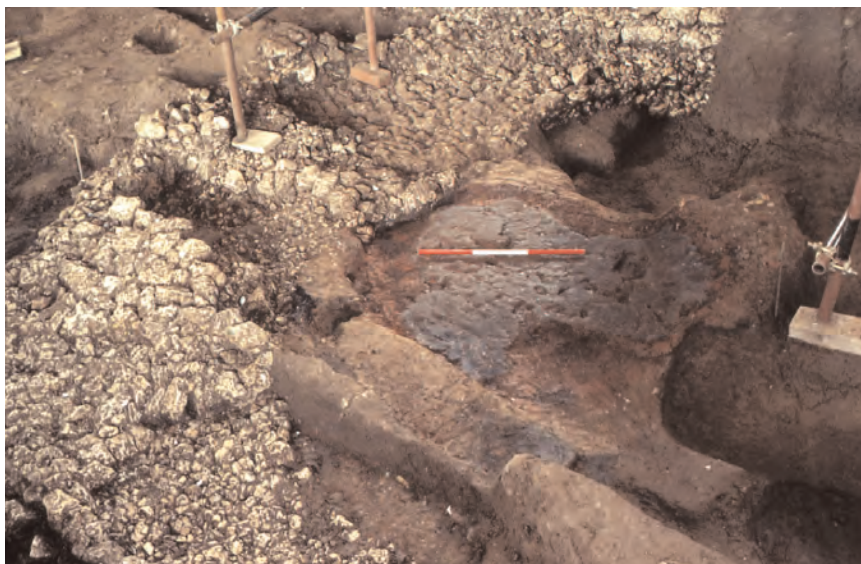
Plate 38: Burnt clay floor of the latest phase of the kiln F1727 partly underlying the Saxo-Norman apse of Period 3. View south-east. Scale of 75 cm. Photo: Warwick Rodwell

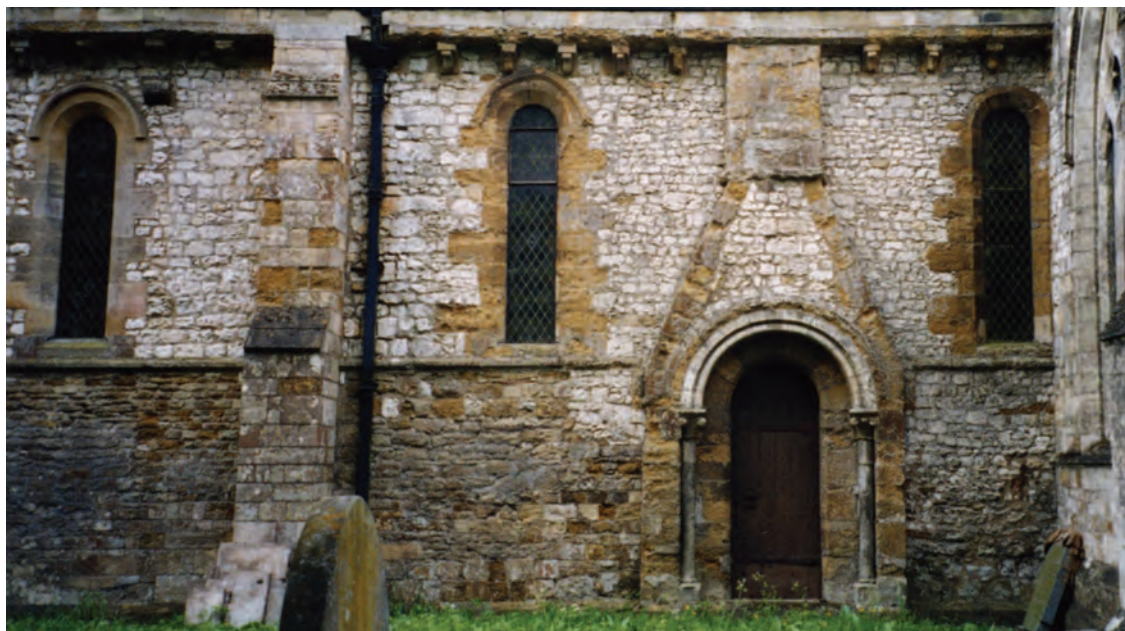
Plate 43: *St Lawrence, Thornton Curtis (Lincs.). North wall of the Norman chancel, showing the construction of small rubble (mainly chalk) with dressings of ironstone. Photo: Warwick Rodwell*

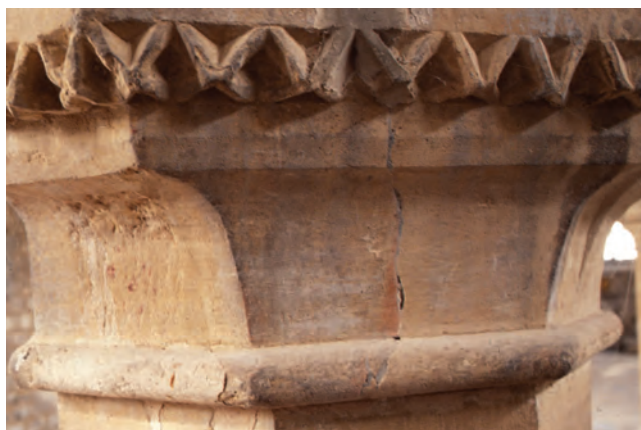
Plate 44: (left) *South arcade, pier 1/2. Traces of a red rosette painted on the east (left) face of the capital. The fracture in the adjoining face has been repaired with hot mastic, as evidenced by the line of reddening caused by heating the stone. Photo: Warwick Rodwell*

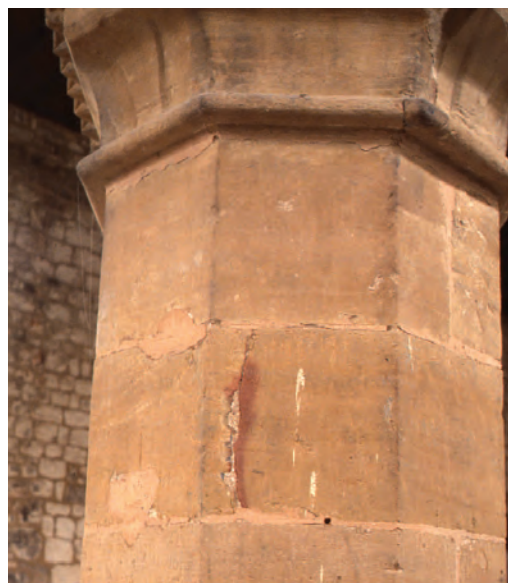
Plate 46: *South arcade, pier 1/2. Masonry fracture repaired using hot mastic, and subsequently pointed with lime mortar. Photo: Warwick Rodwell*

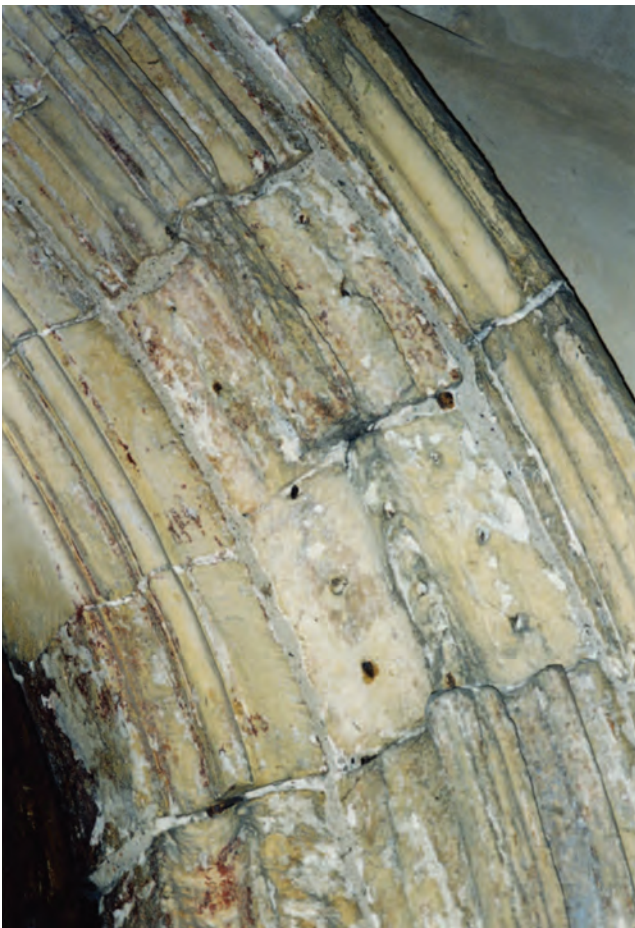
Plate 50: South doorway. Red paint on the eastern part of the external arch, showing also the marks where nails were driven in for modelling repairs to fractured limestone mouldings in Roman cement. Photo: Warwick Rodwell

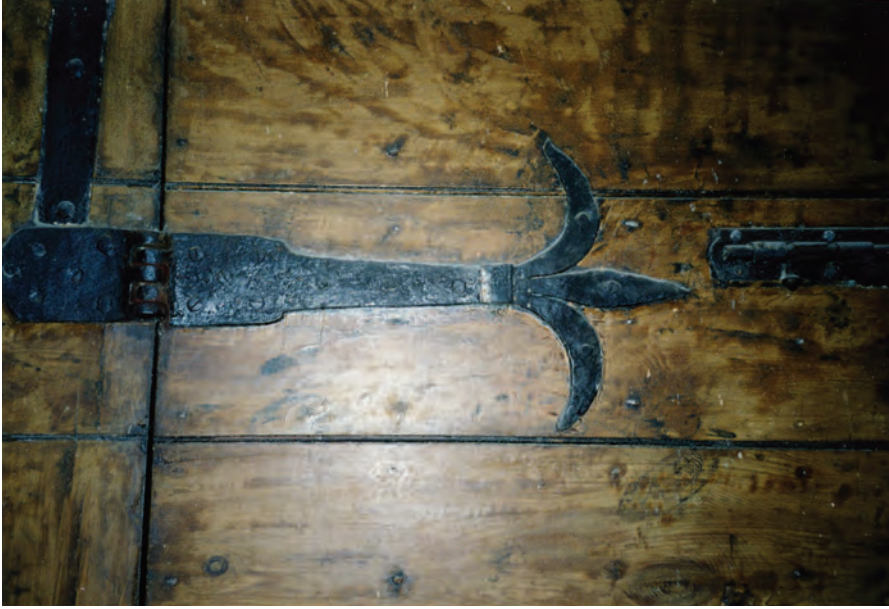
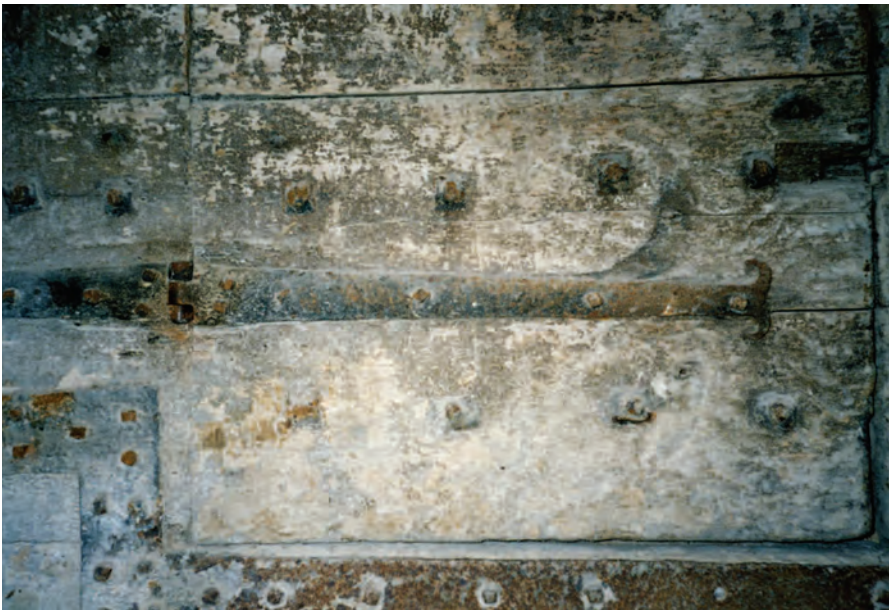
Plate 52: Medieval hinges. A, Reused hinge with fleur-de-lys terminal on the south aisle door. B, Tudor lower hinge on the wicket of the north aisle door, with the 'ghost' outline of the former hinge partly showing. C, Diagram to illustrate the relationship between the superimposed hinges. Photos: Warwick Rodwell

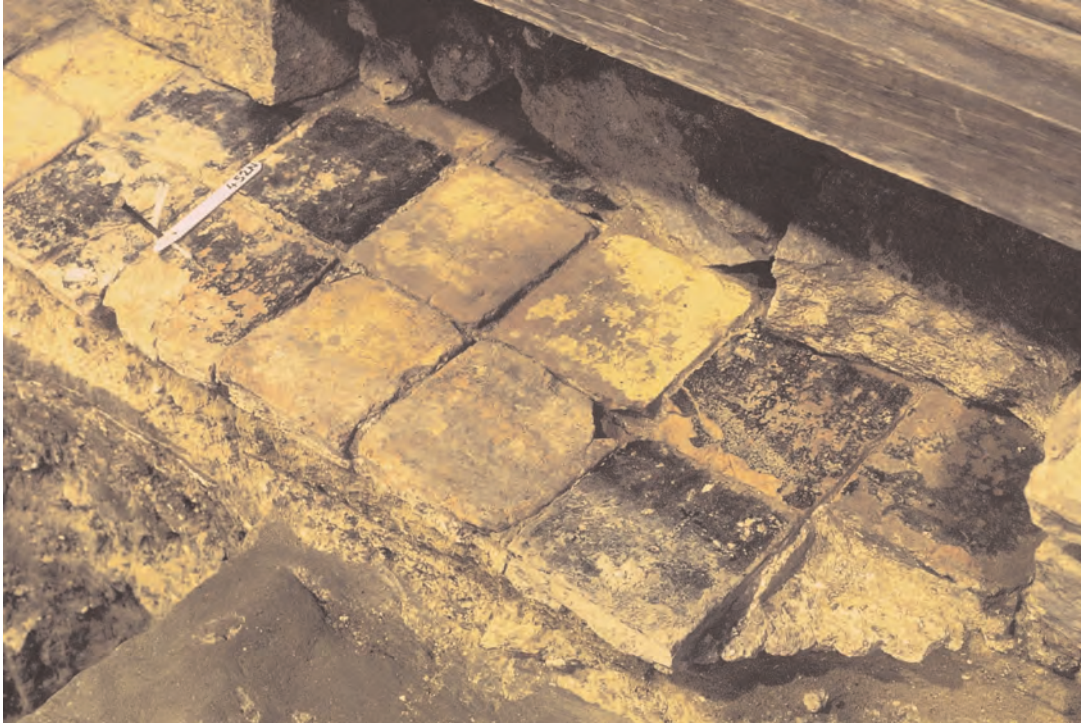
Plate 53: Four-tile chequered arrangement of plain glazed medieval floor tiles at the east end of the nave, beneath the chancel screen (F1508). View north-east. Photo: Warwick Rodwell

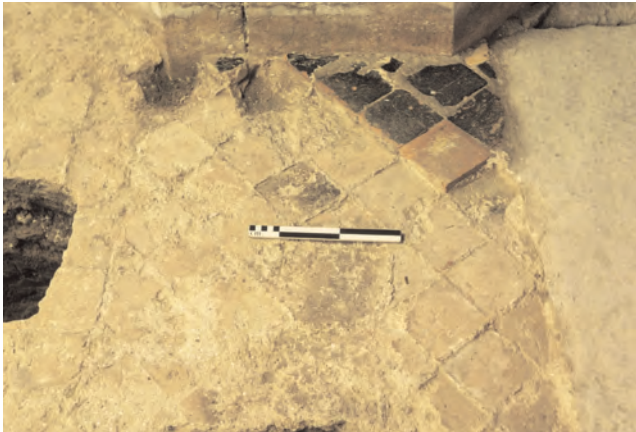
Plate 57: (above left) Tiles and mortar-bed impressions of a 'carpet' of diagonally laid paving running across the nave (F12), abutting north arcade pier 4/5. The carpet was bordered on the left by a single row of square-set tiles, and on the right (east) by a stone slab (F169). Scale of 25 cm. Photo: Warwick Rodwell

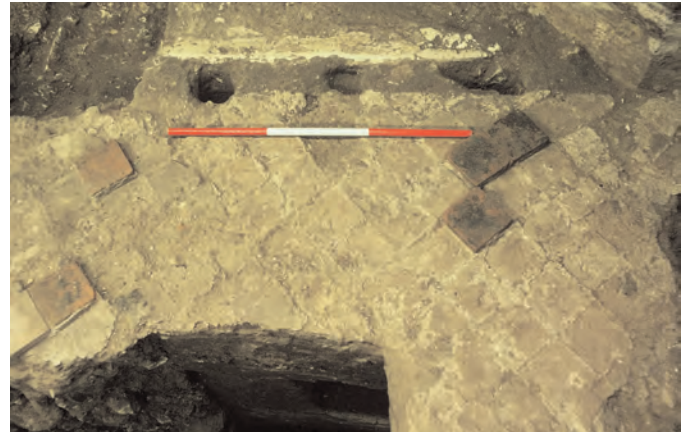
Plate 58: (above right) Tiles and mortar impressions of paving in bay 5 of the nave (F12); the western edge of the floor abutted a timber structure, possibly a stair enclosure, the line of which is marked by three postholes and a mortar fillet. West is at the top. Scale of 75 cm. Photo: Warwick Rodwell

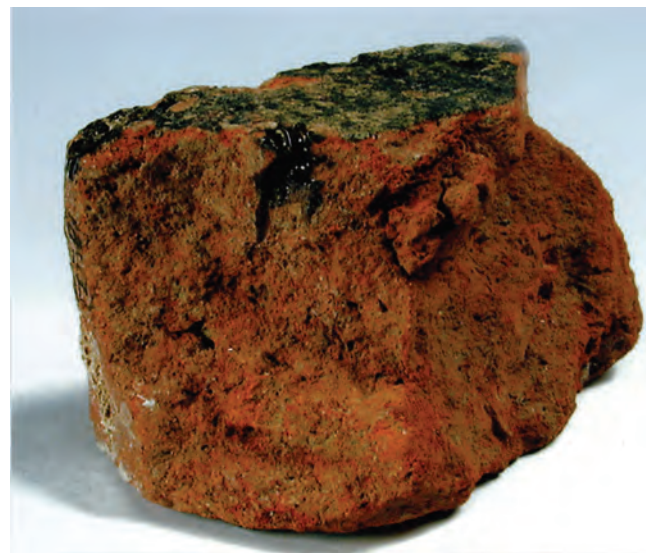
Plate 59: (below right) Section through a Flemish floor tile showing how the glaze had run into and filled one of the small nail-holes in the upper surface. The thickness of the tile is 22 mm. Photo: Jennie Stopford

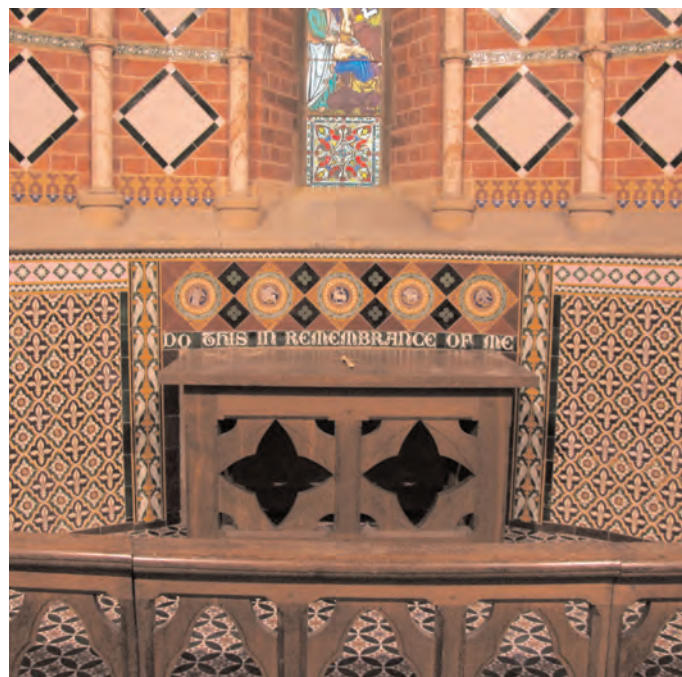
Plate 64: St Martin, Waithe (Lincs.). Detail of the sanctuary with polychromatic floor and wall tiling, the latter incorporating an inscription above the altar. Photo: Warwick Rodwell

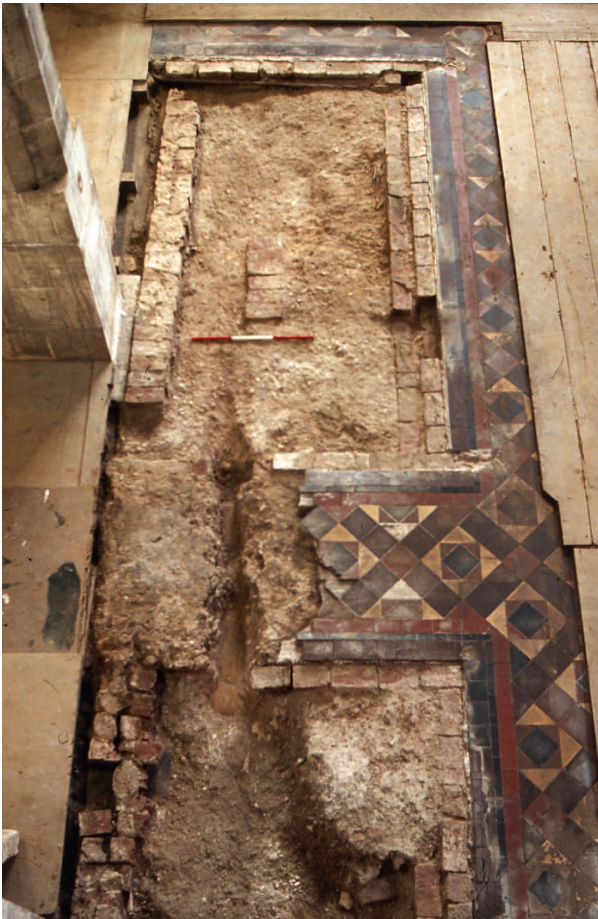
Plate 67: (left) Chancel. Staffordshire polychrome floor tiling and the substructure of the choir stalls on the north side, 1859. View east. Scale of 75 cm. Photo: Warwick Rodwell

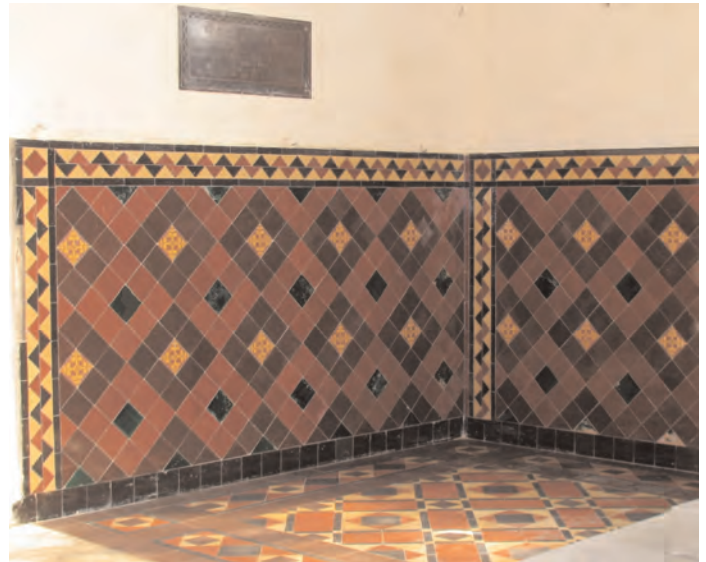
Plate 68: (above) Dado of glazed polychrome tiles around the sanctuary, 1859. Photo: Warwick Rodwell

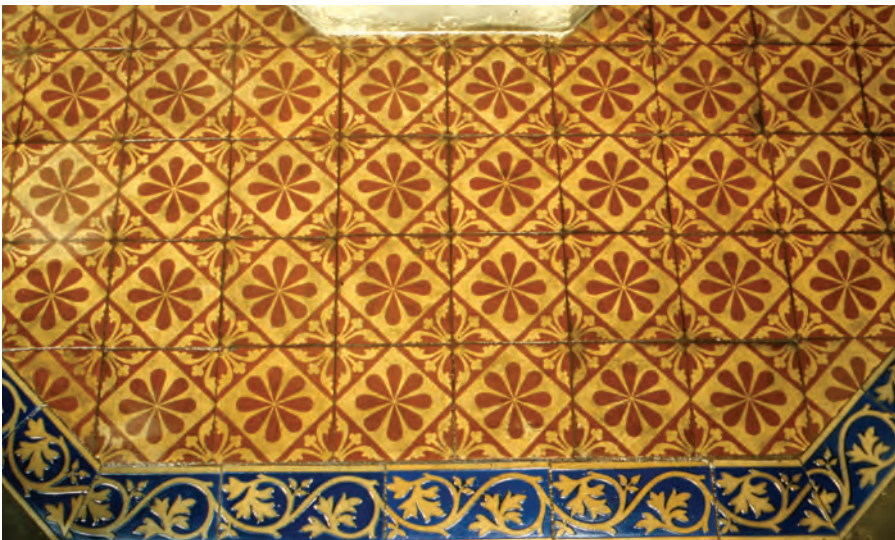
Plate 69: Staffordshire polychrome tiling on the plinth of the font, 1859. Photo: Warwick Rodwell

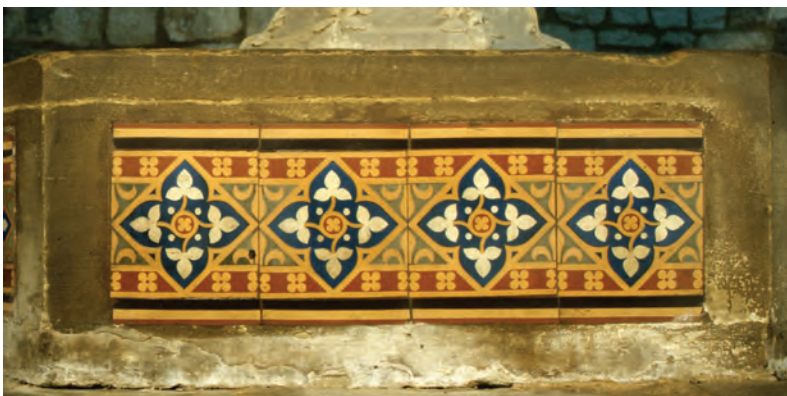
Plate 70: Staffordshire polychrome tile panels on the sides of the font plinth, 1859. Photo: Warwick Rodwell

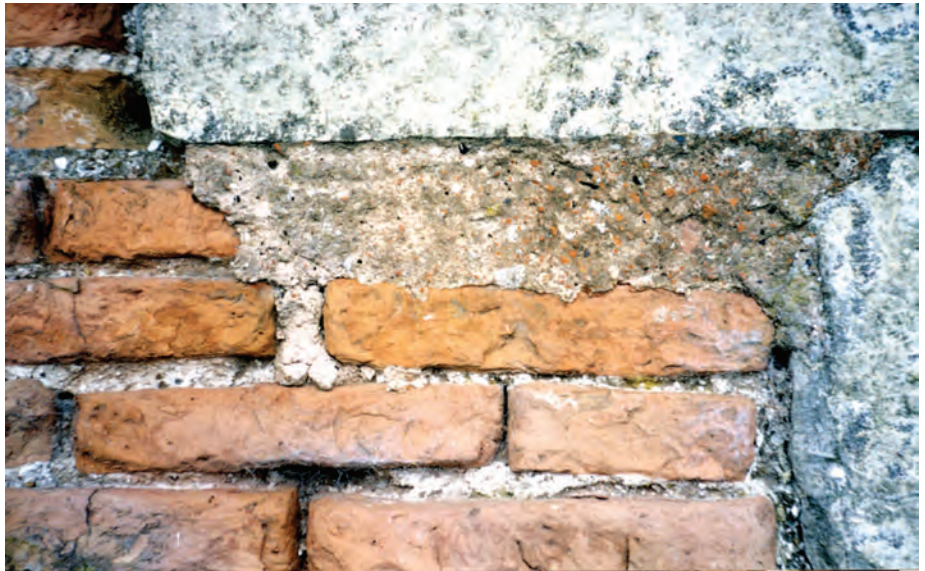
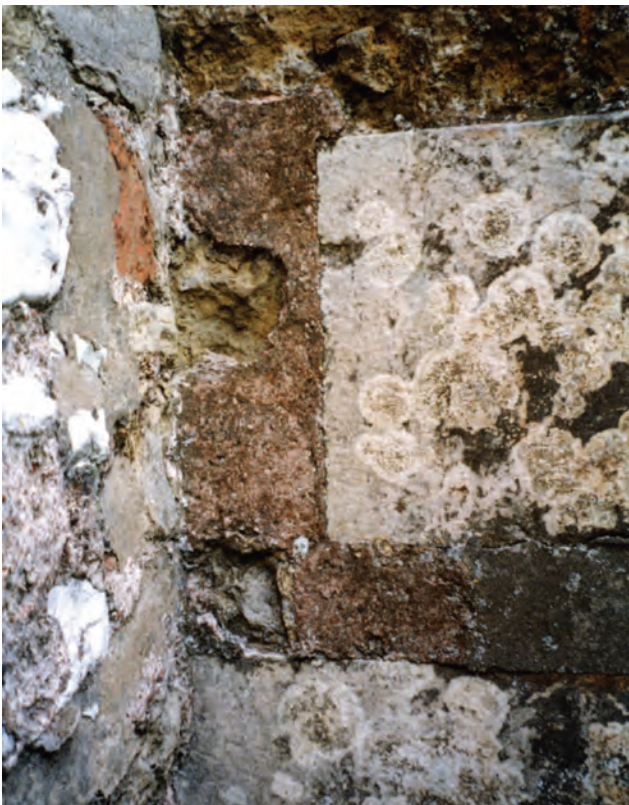
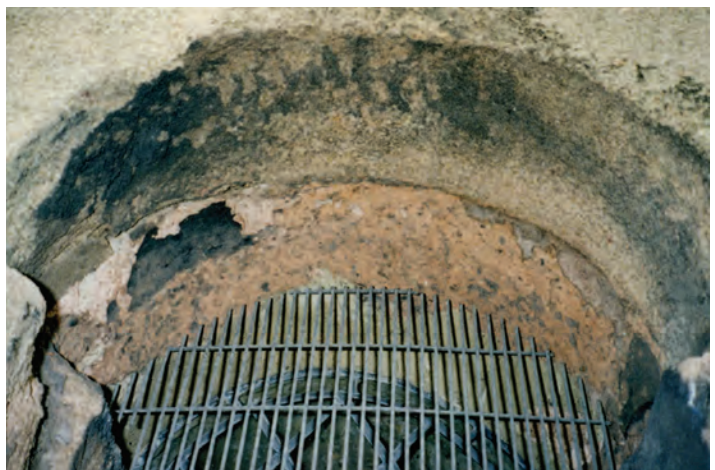
Plate 71: Lime mortars containing crushed brick as an aggregate. A, Clerestory of St Peter's at the north-east corner of the nave. Fifteenth-century brickwork and limestone quoins, with eroded remains of pink lime rendering containing coarse aggregate of crushed brick. B, St Lawrence, Thornton Curtis. Pink lime rendering finished flush with the ashlar-work of a buttress on the south side of the chancel. C, St Peter's, south aisle window, bay 3. Fractured limestone mullion repaired with pink lime mortar containing coarse aggregate of crushed brick. D, St Peter's tower. Soffit of a gallery-stage window (south) showing fine, pink lime rendering between the outer and inner gritstone arches. Photos: Warwick Rodwell

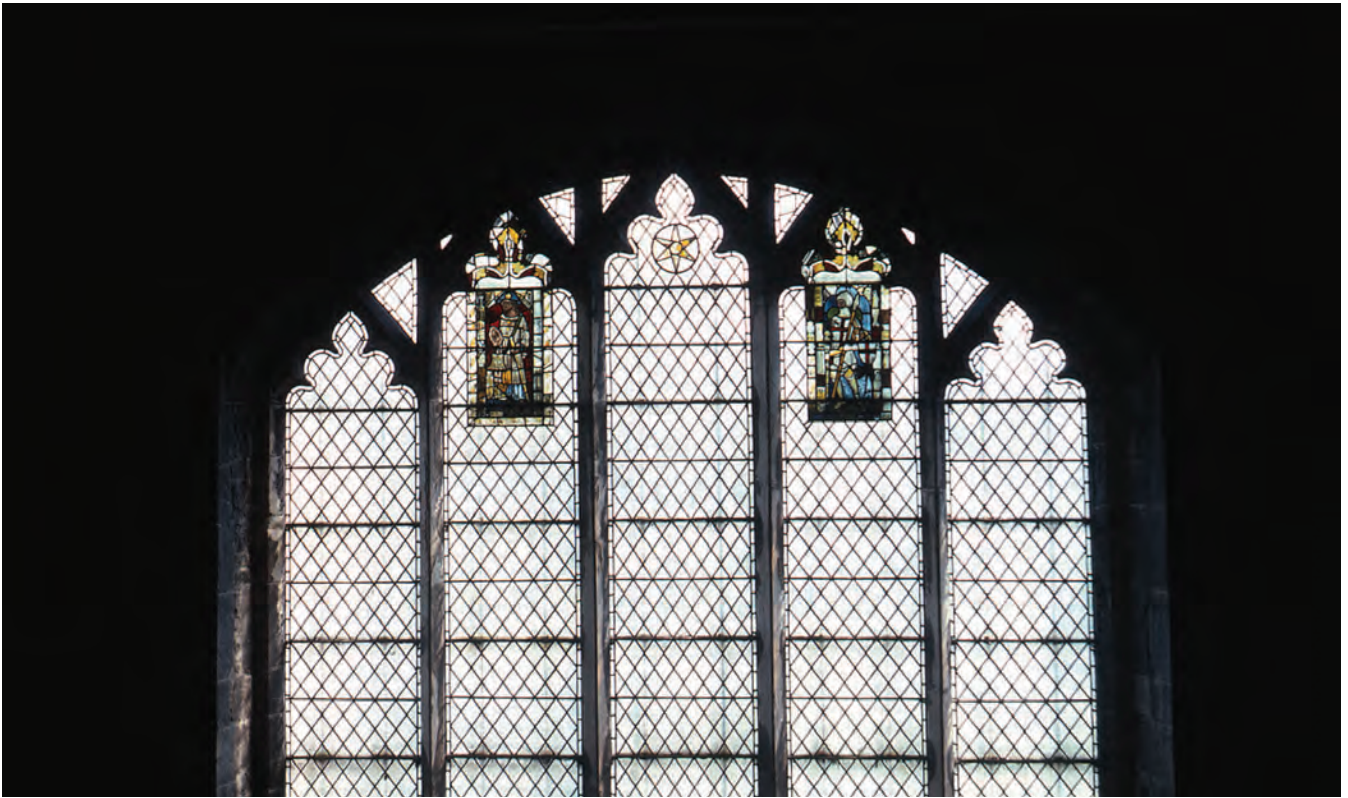
Plate 72: Chancel. Upper part of the east window, showing stained glass in situ, 1979. Note the panels were reversed when the window was re-fixed in 1902, and consequently the figures face left (north). Photo: Warwick Rodwell

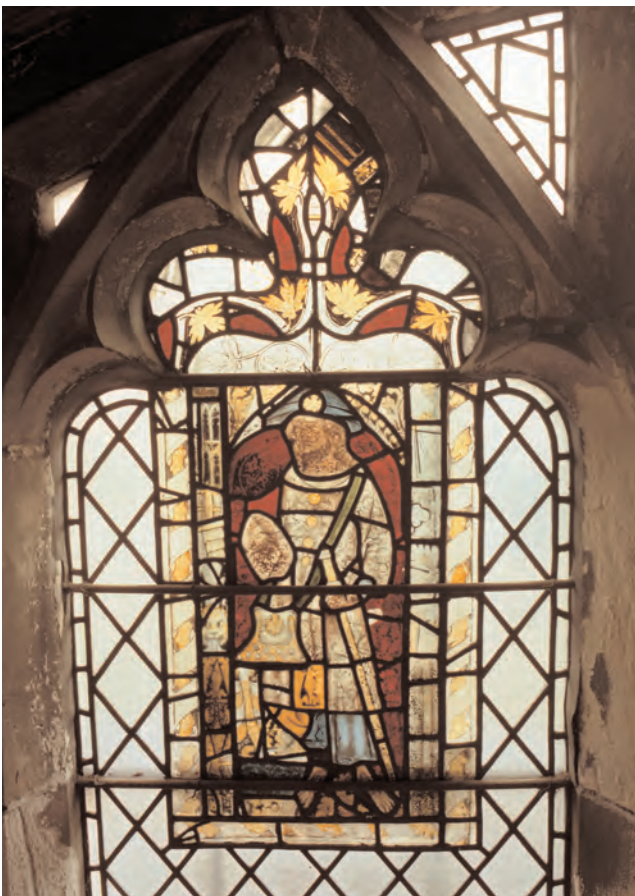
Plate 73: Chancel, east window. The reversed St James panel in situ, 1984. Photo: Colin Briden

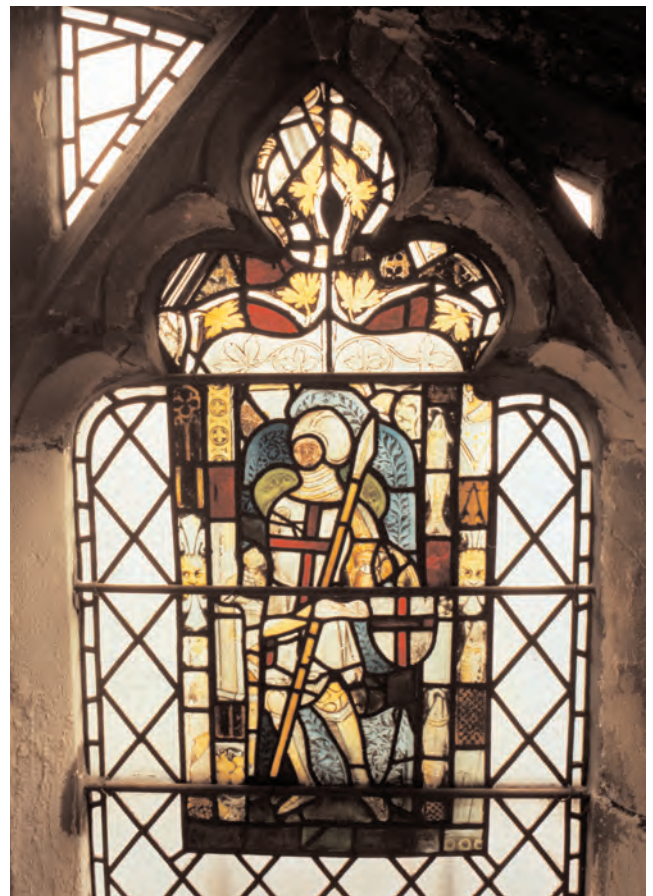
Plate 74: Chancel, east window. The reversed St George panel in situ, 1984. Photo: Colin Briden

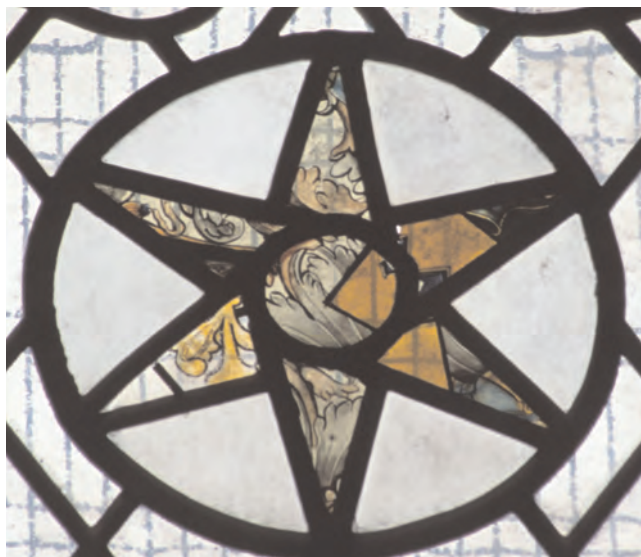
Plate 77: Chancel, east window. Close-up of the central star in the tracery, showing its composition, 2005. Photo: Gordon Plumb

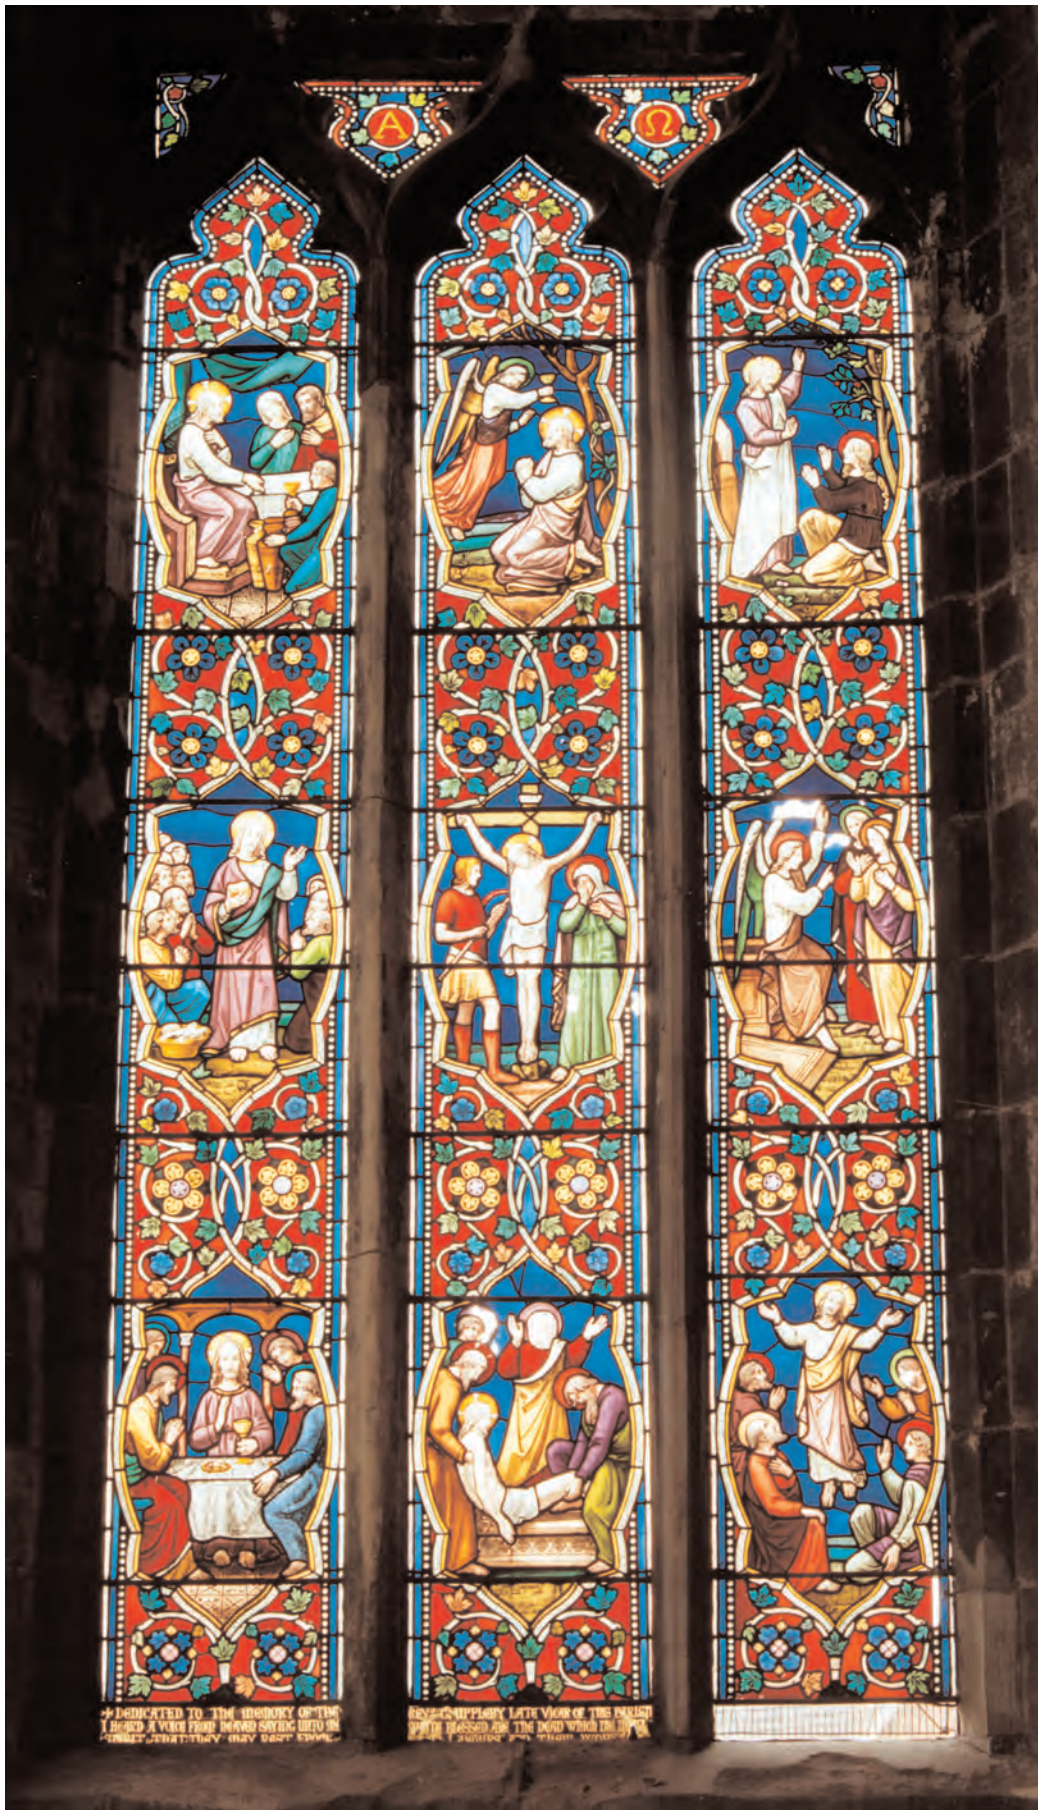
Plate 96: Chancel, bay 2. Stained glass window sII, by William Warrington, 1856. Photographed in situ, 1985. Photo: Colin Briden

- Pl. 96 Chancel: window by William Warrington
- Pl. 97 Chancel: detail of four scenes from Plate 96
- Pl. 98 Organ chamber: window by William Warrington
