ST PETER'S

Barton-upon-Humber, Lincolnshire

A Parish Church and its Community

HISTORY, ARCHAEOLOGY AND ARCHITECTURE

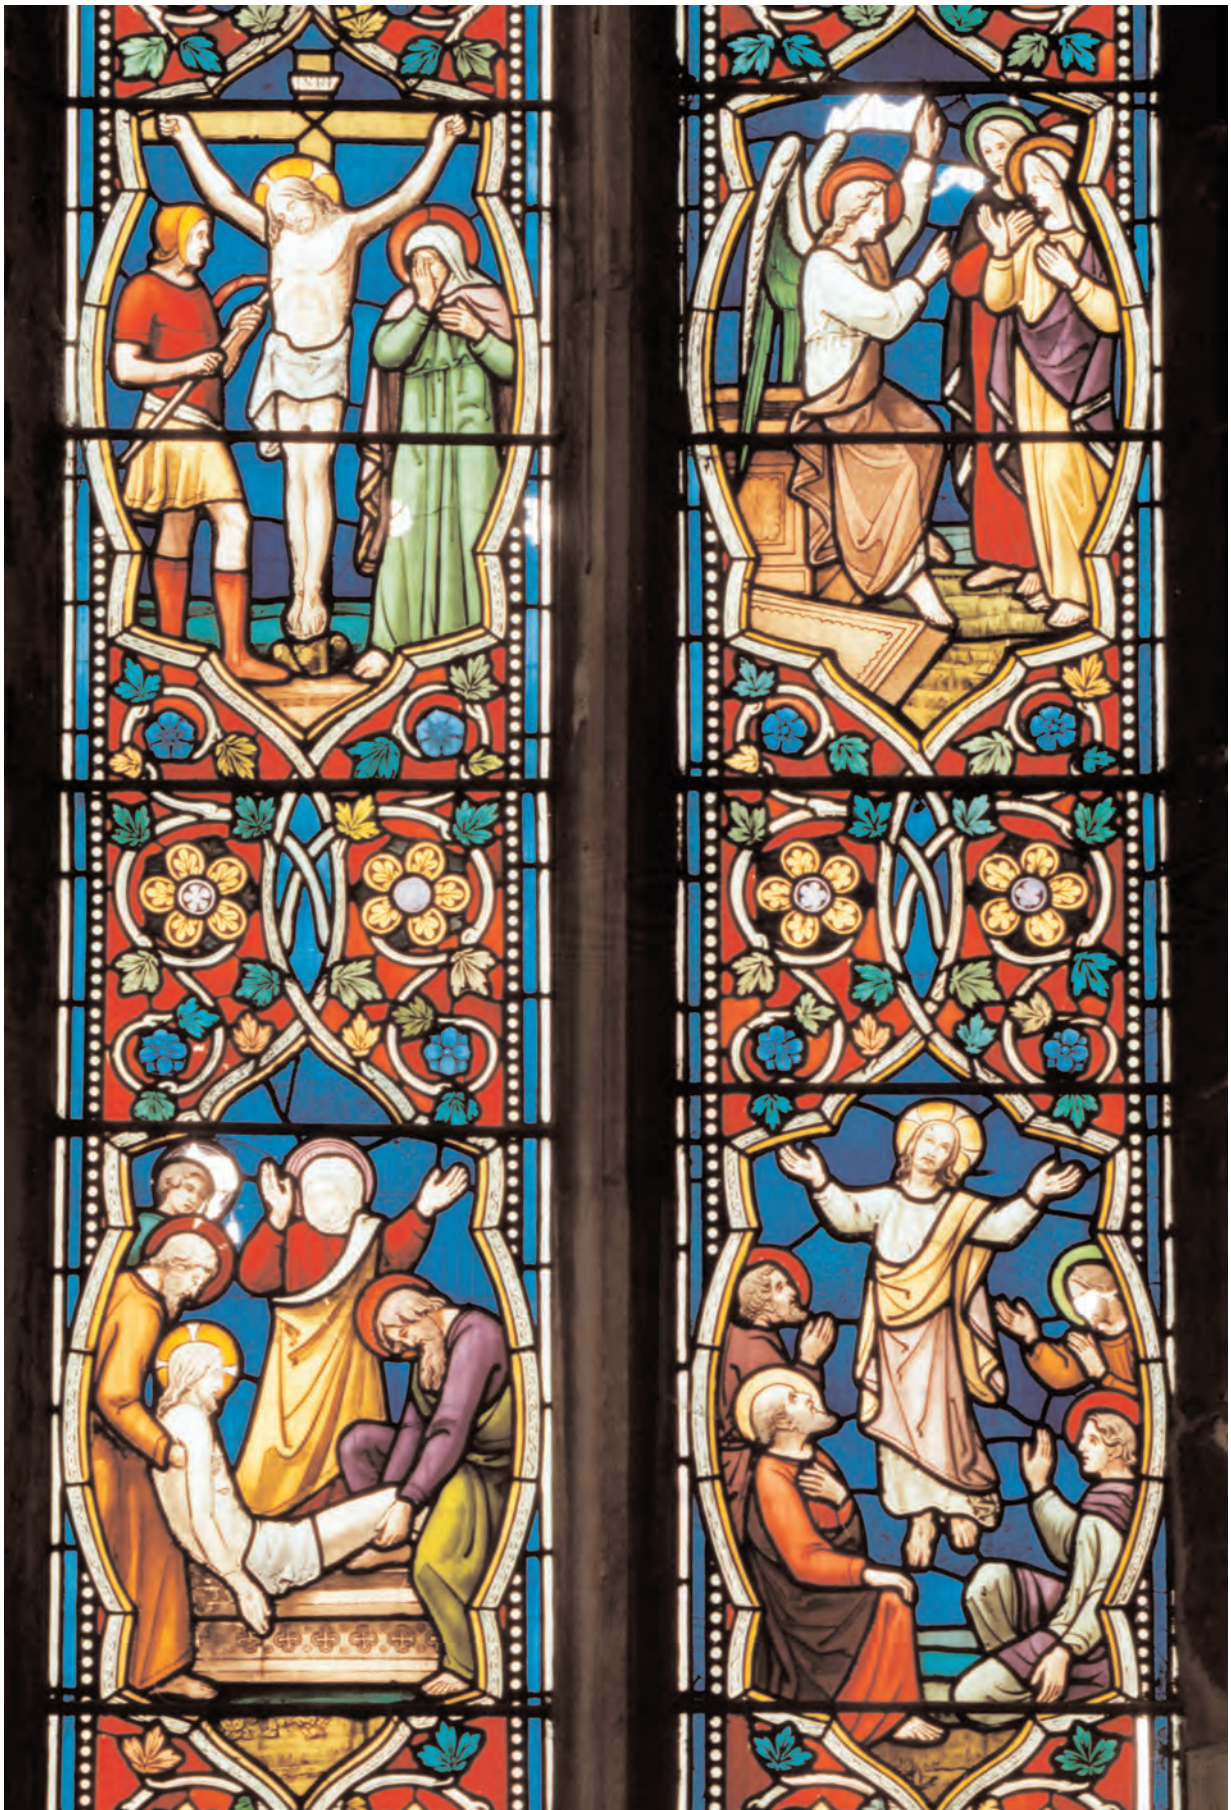
Plate 97: Chancel, bay 2. Detail of four scenes from window sII (Pl. 96), 1985. The scenes represent the Crucifixion, Entombment, Angel at the Tomb and Ascension. Photo: Colin Briden

- Pl. 96 Chancel: window by William Warrington
- Pl. 97 Chancel: detail of four scenes from Plate 96
- Pl. 98 Organ chamber: window by William Warrington

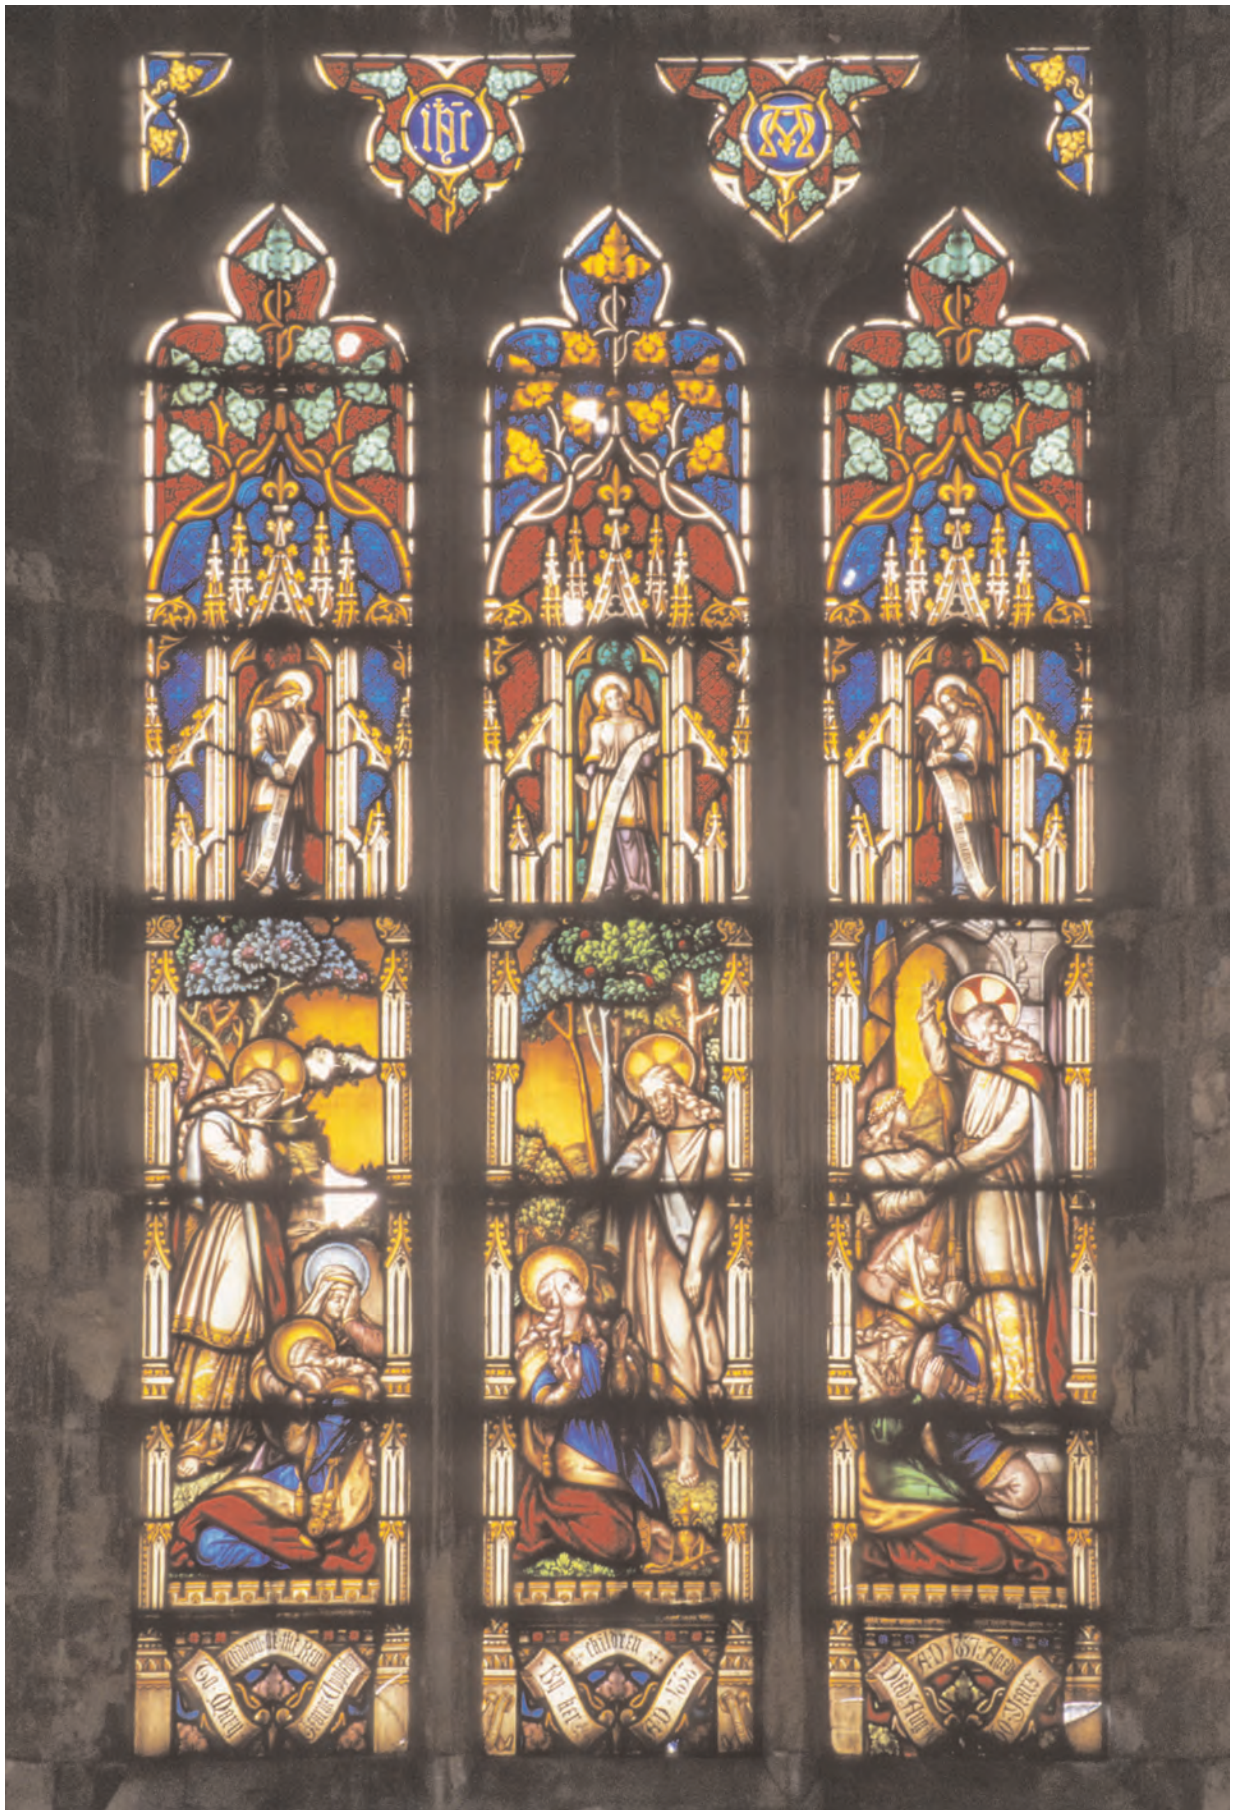
Plate 98: Organ chamber, bay 2. Stained glass window nIII, by William Warrington, 1858. Photographed in situ, 2005. Photo: Gordon Plumb

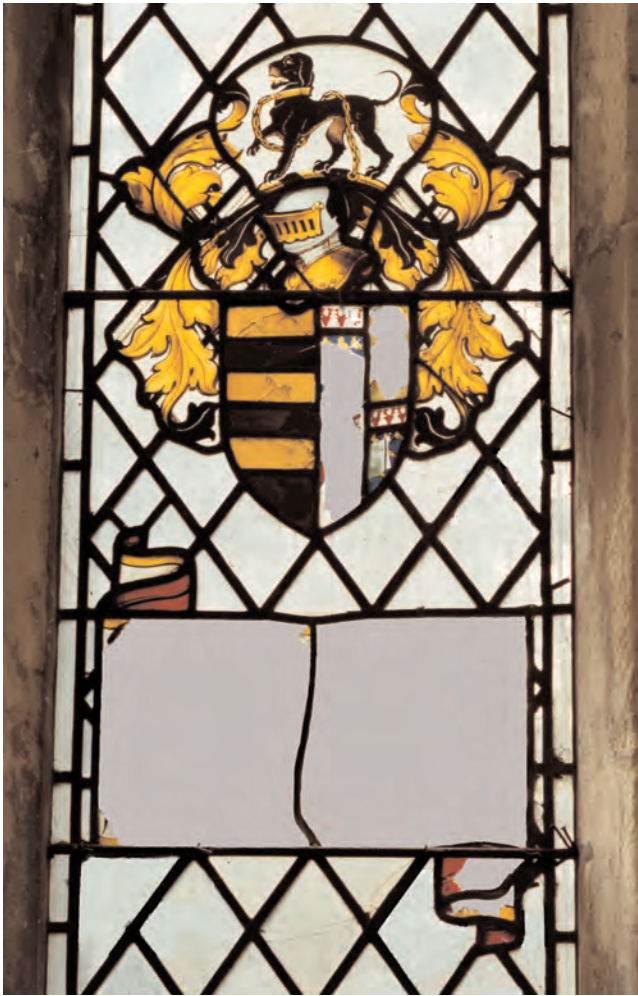
Plate 99: (left) Chancel, bay 1. Stained glass panel in window sIII. Retained and reset in 1924 from a destroyed window by Thomas Willement, 1847. Vandalized remains of heraldic shield and inscription panel, photographed in situ, 1985. The areas of lost glass are indicated in grey tone. Photo: Colin Briden

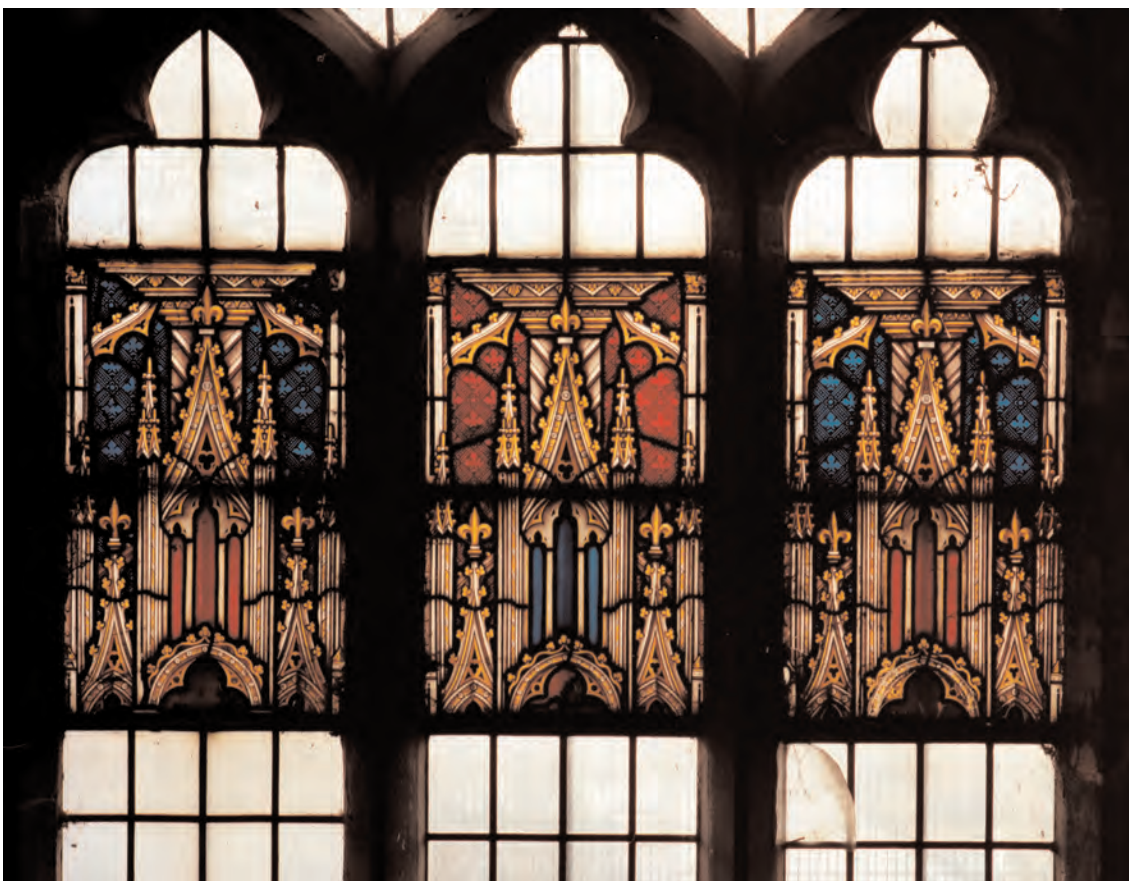
Plate 100: (below) Organ chamber, bay 1. Stained glass panels in window nIV; these were originally part of Warrington's window in nIII (Pl. 98). Photographed in situ, 1985. Photo: Colin Briden

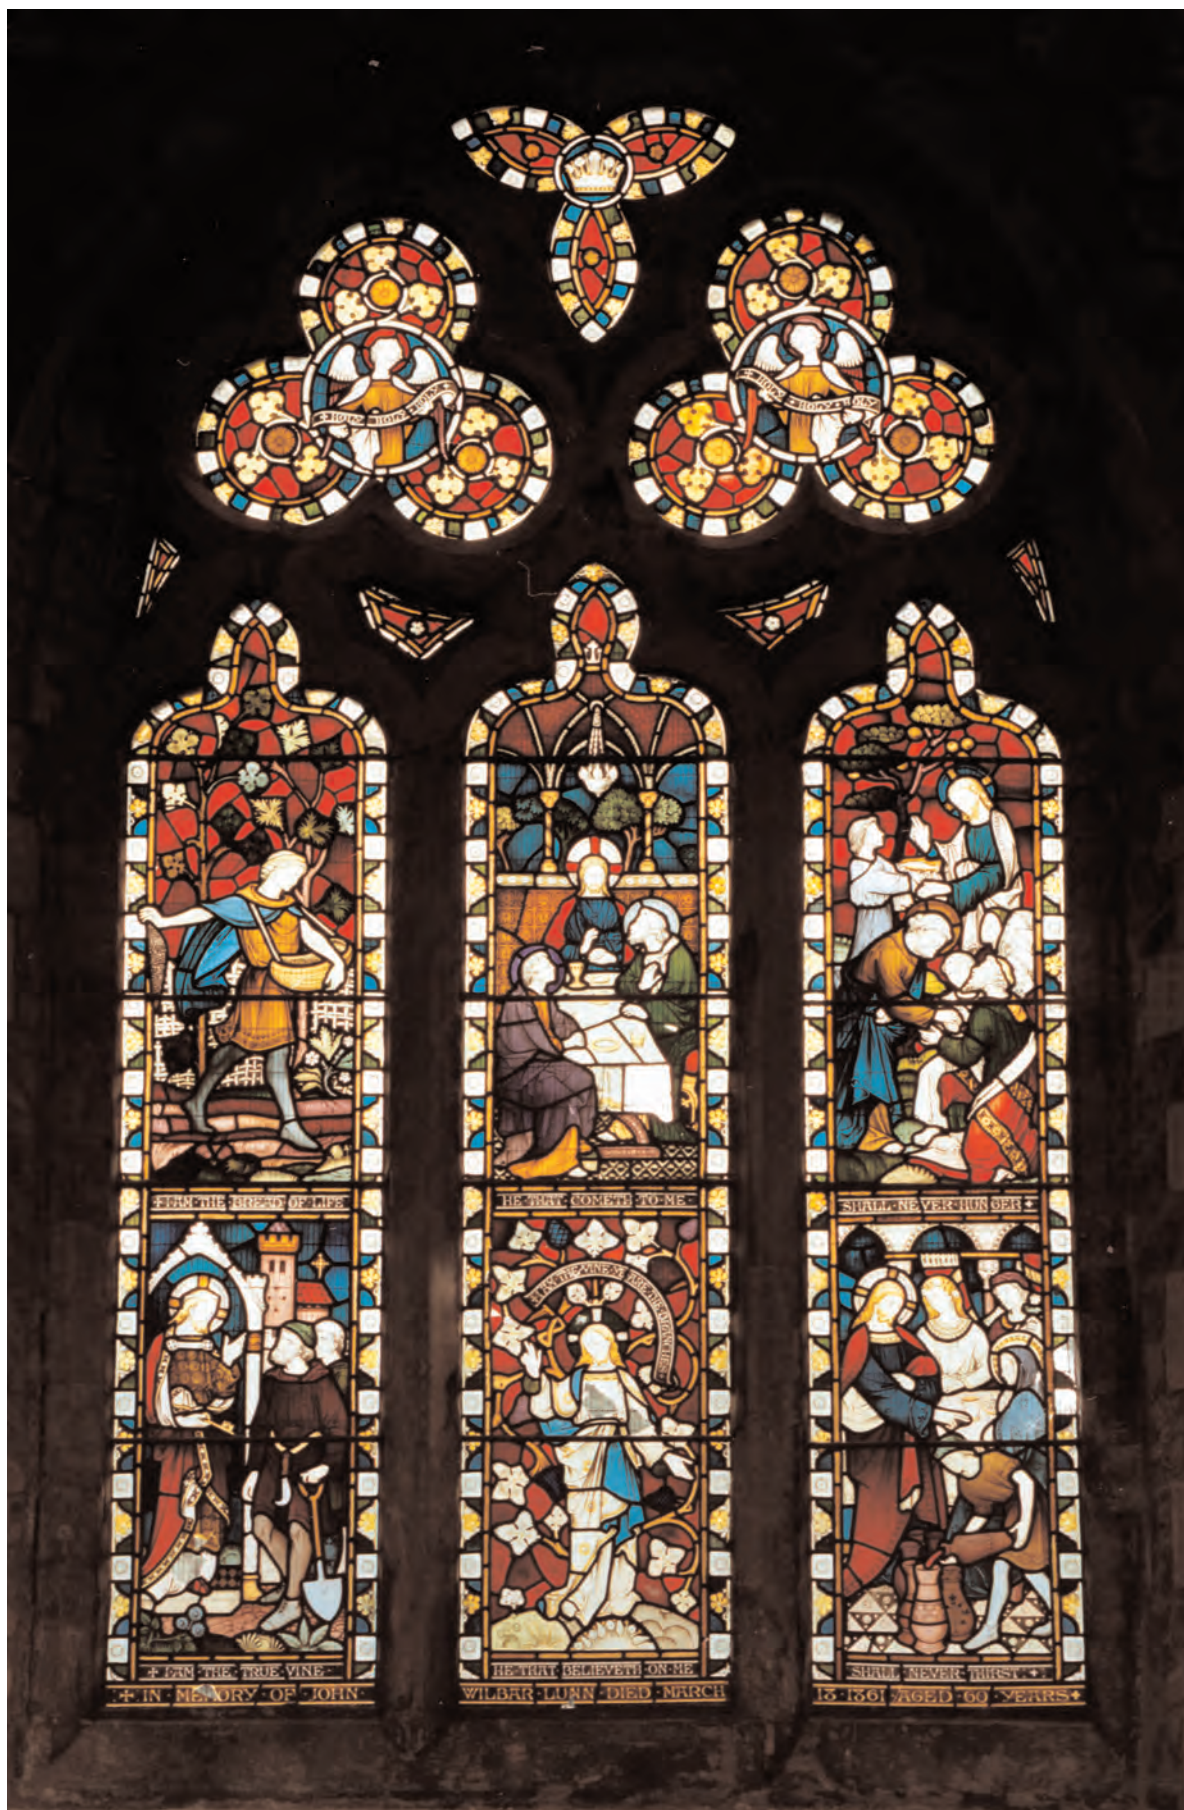
Plate 101: South aisle, bay 3. Stained glass window sVII, in the style of Clayton and Bell, early 1860s. Photographed in situ, 1985. Photo: Colin Briden

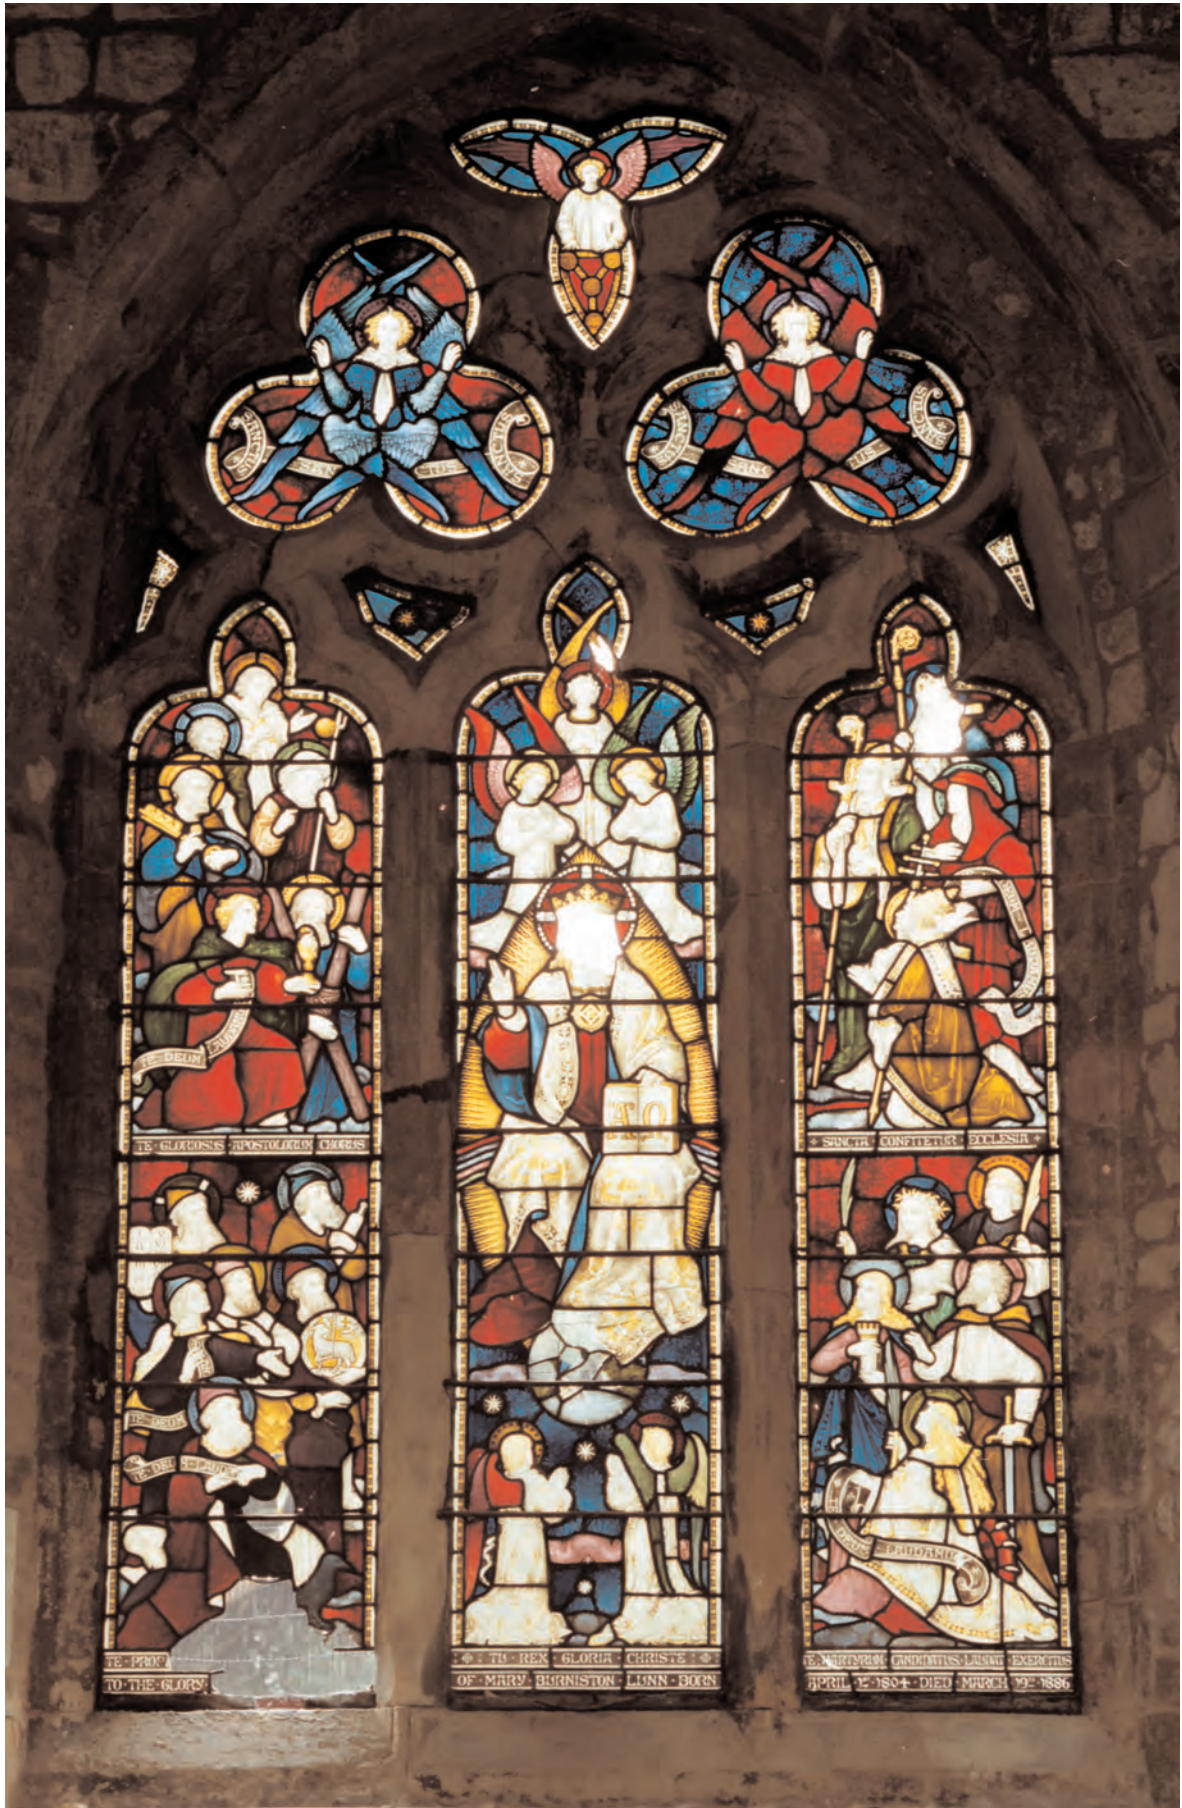
Plate 102: South aisle, bay 2. Stained glass window sVI, in the style of Clayton and Bell, late 1880s. Photographed in situ, 1985. Photo: Colin Briden

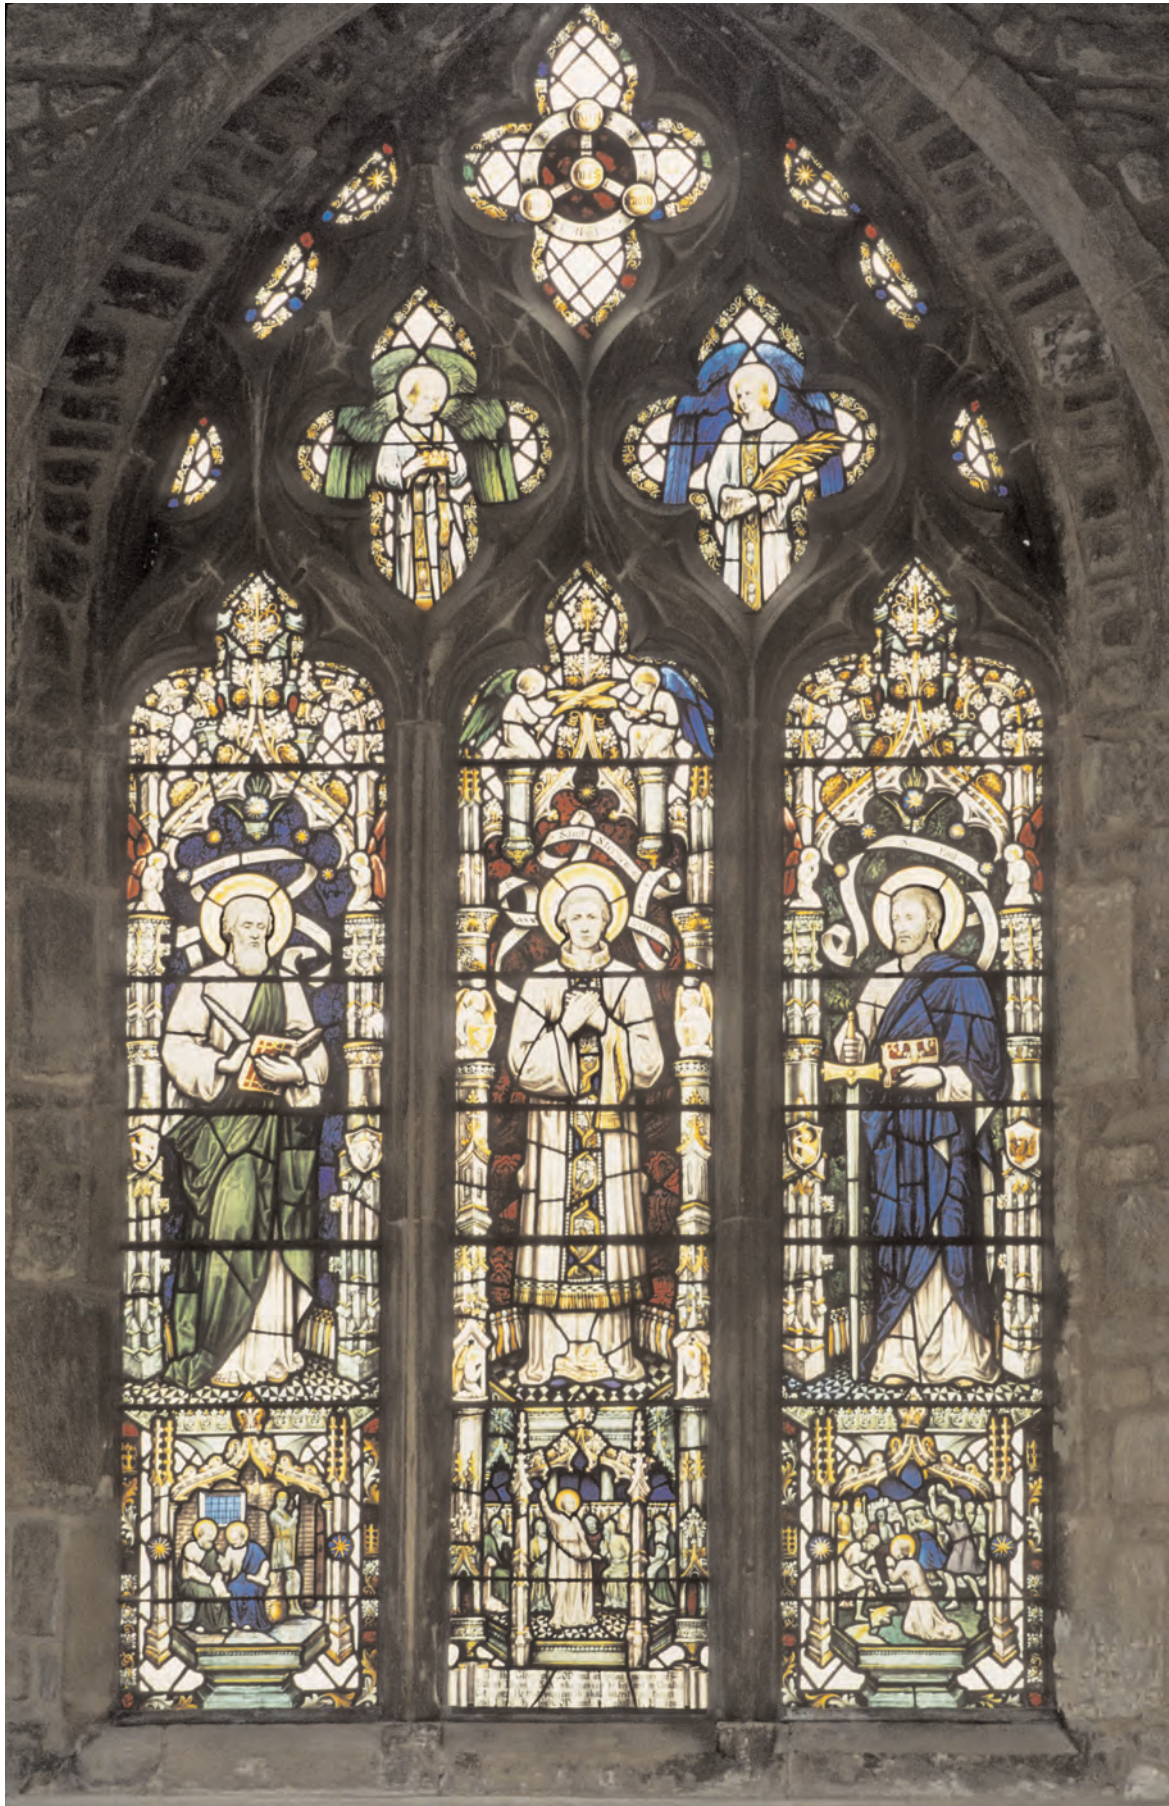
Plate 103: North aisle, bay 2. Stained glass window nVII, by A.K. Nicholson, 1914. Photographed in situ, 2005. Photo: Gordon Plumb

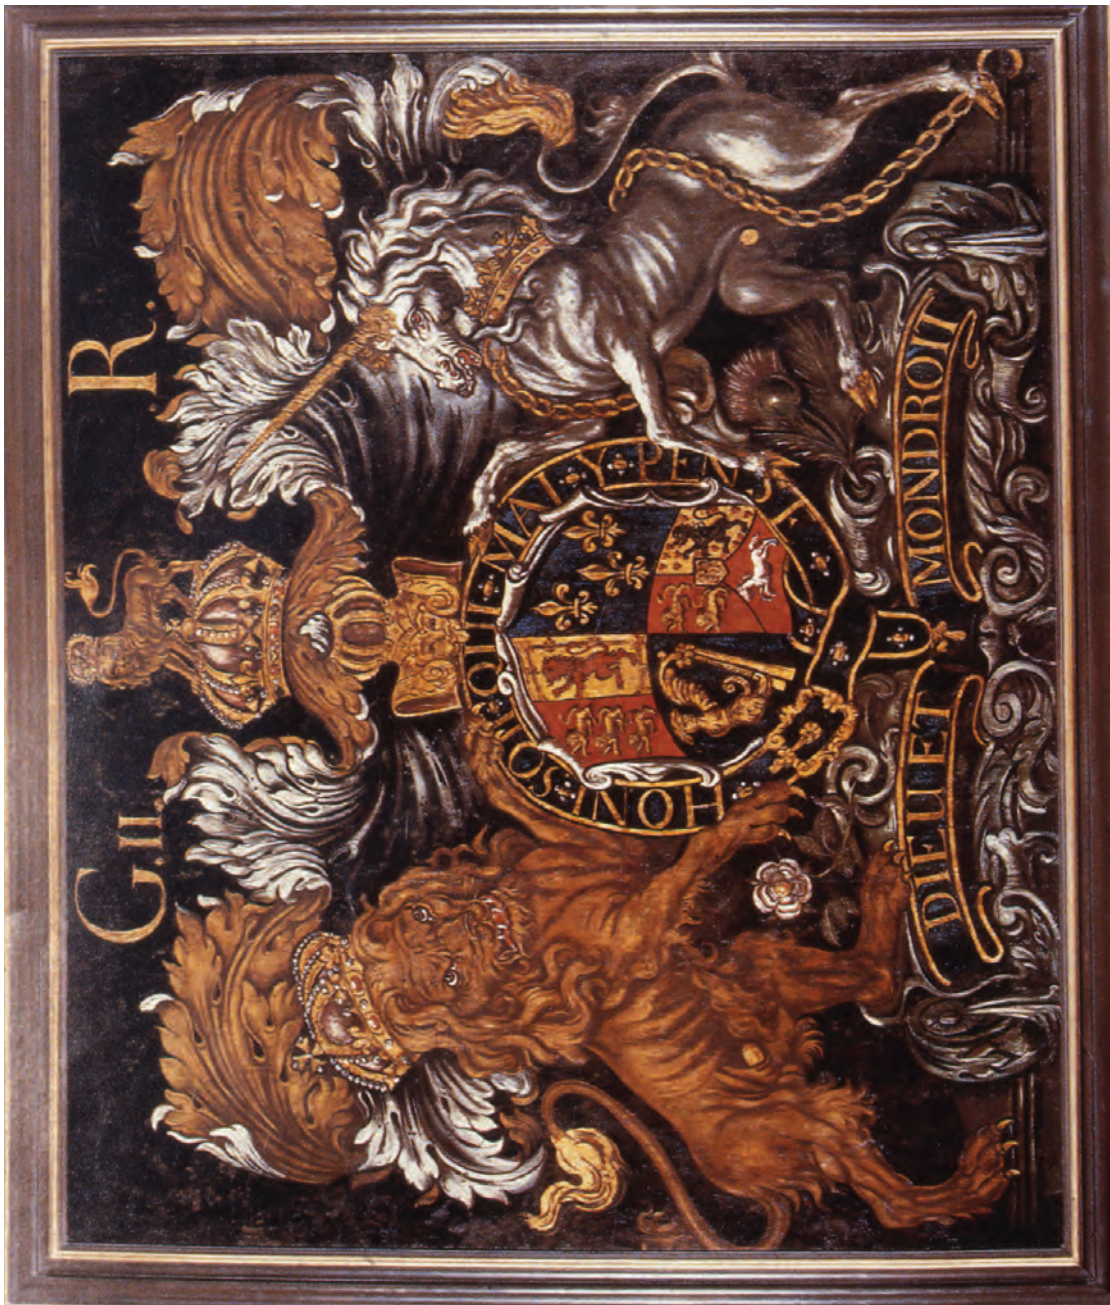
Plate 104: Royal Arms of George II on carvings,
commissioned in 1740. Photo: Geoffrey Bryant

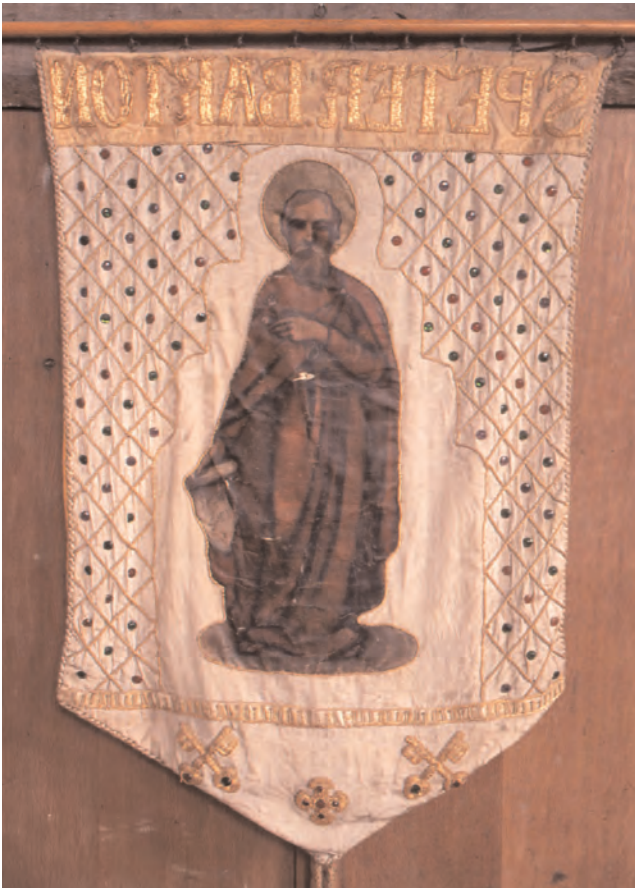
Plate 106: St Peter's church banner, early twentieth century. Photo: Warwick Rodwell

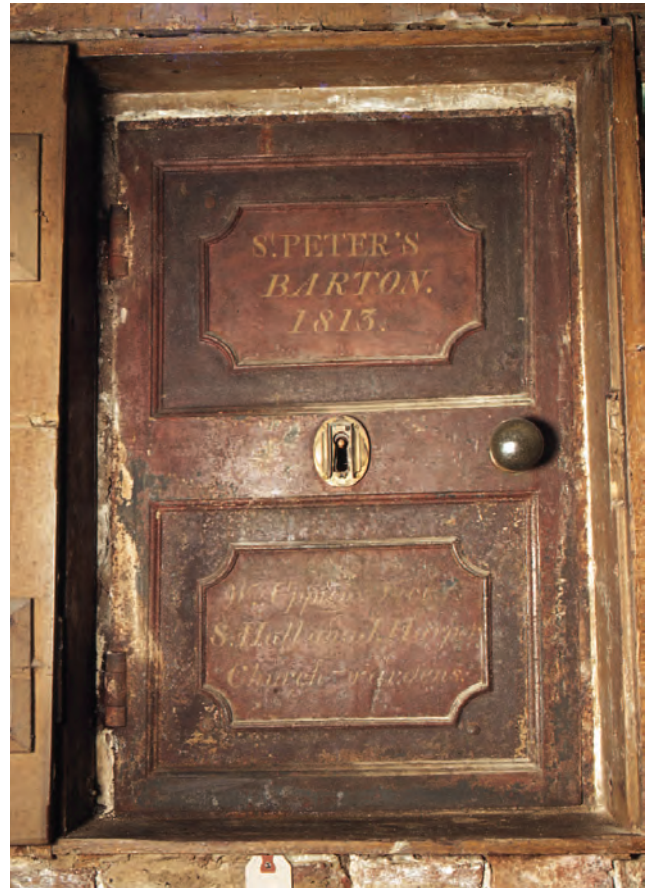
Plate 107: Vestry. Door to safe with contemporary paint and inscription, 1813. Photo: Warwick Rodwell

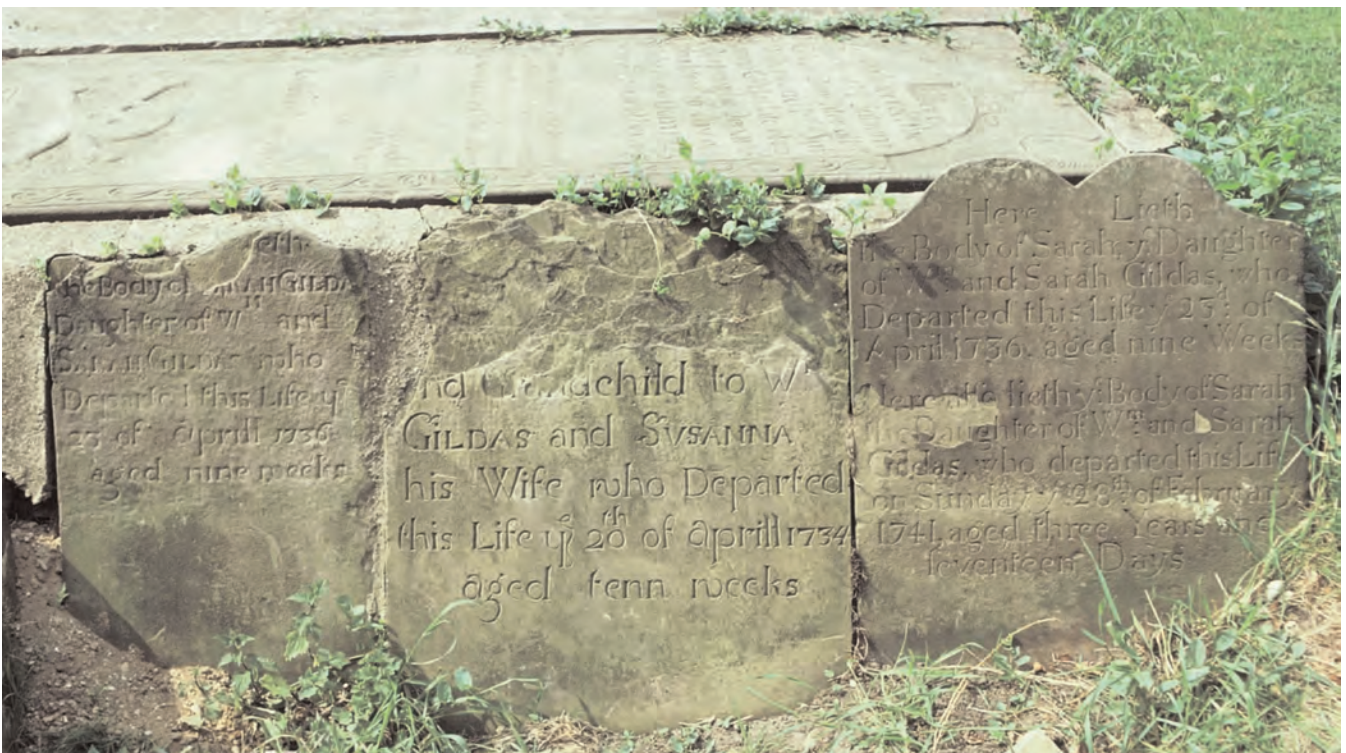
Plate 108: Churchyard. Three disintegrating Yorkstone grave-markers of the Gildas family, 1730s (M.136–138). Behind them is the Gildas table-tomb top, 1723 (M.139). Reused as revetting beside the south porch in 1967; photographed in 1978. The three headstones have since been lost. Photo: Warwick Rodwell

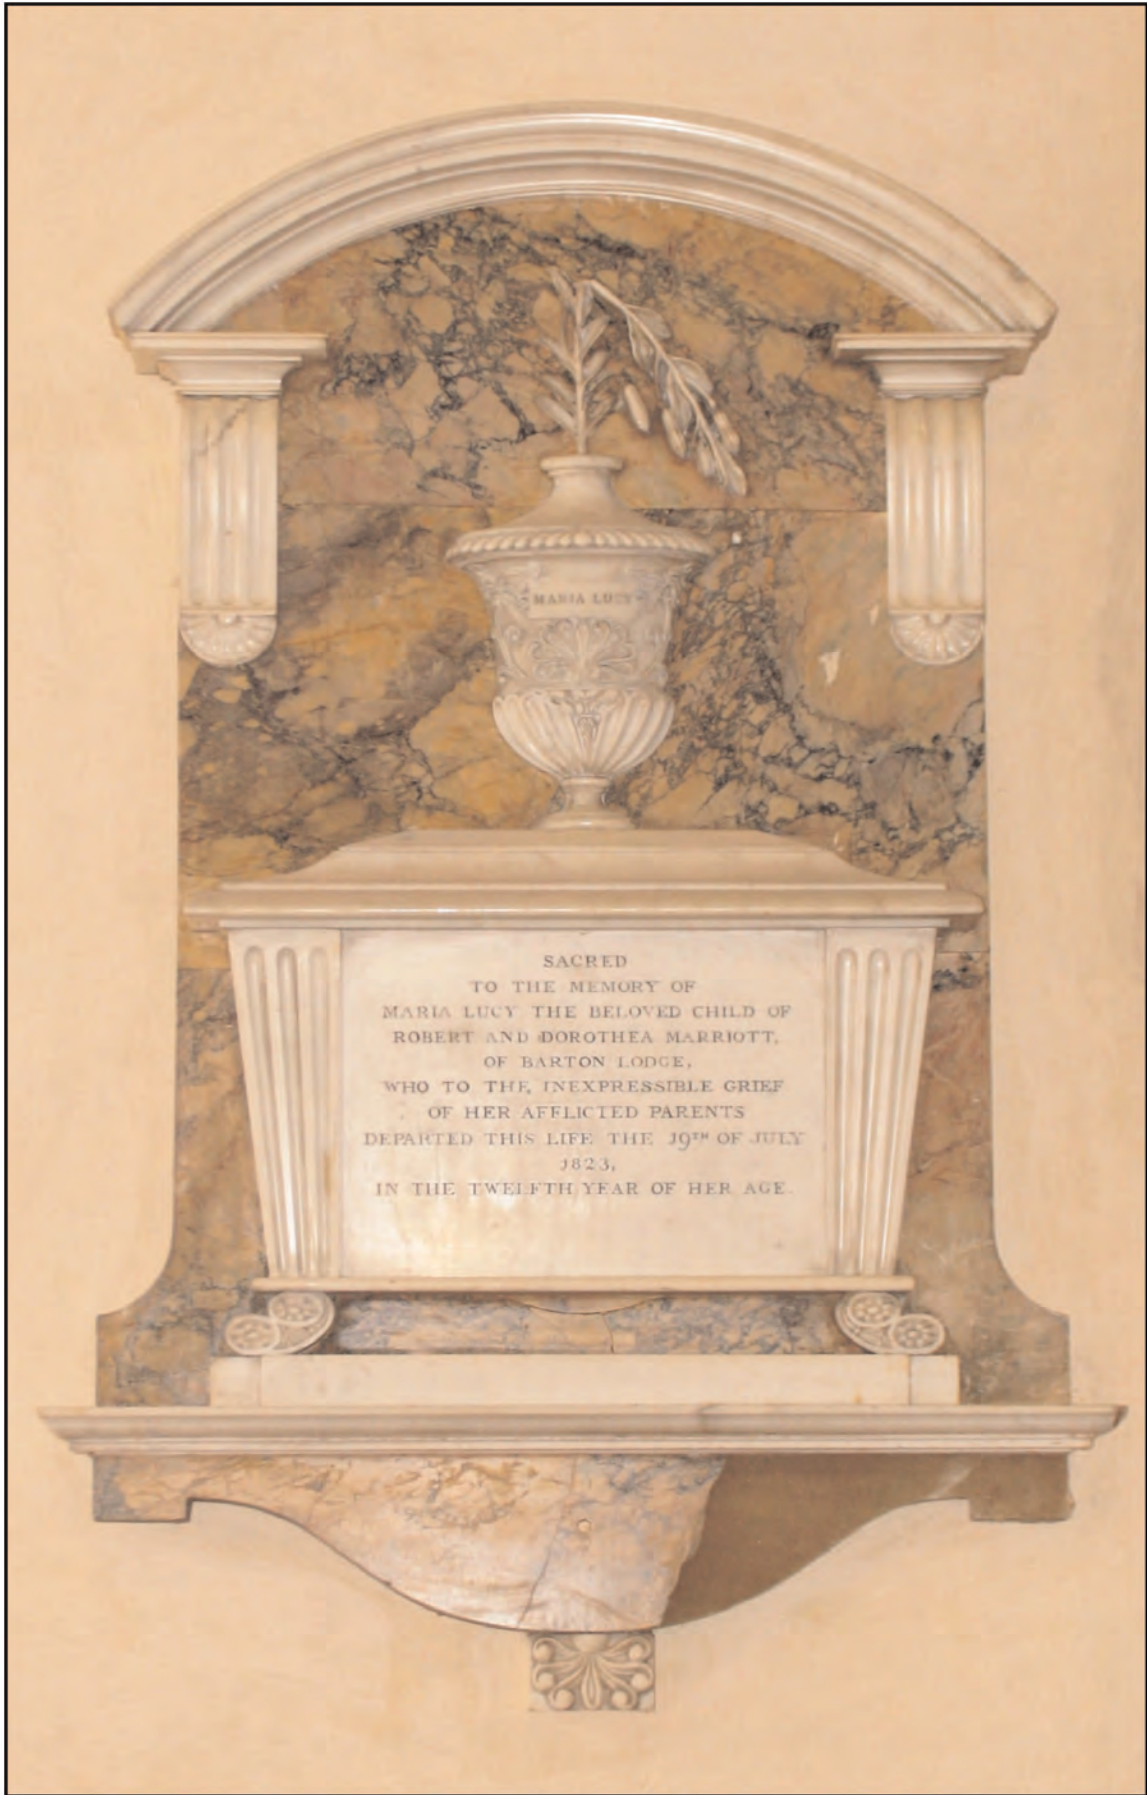
Plate 109: Chancel. Monument on the south wall to Maria Lucy Marriott (d. 1823; M.67) with a yellow Sienna marble backplate. Photo: Warwick Rodwell

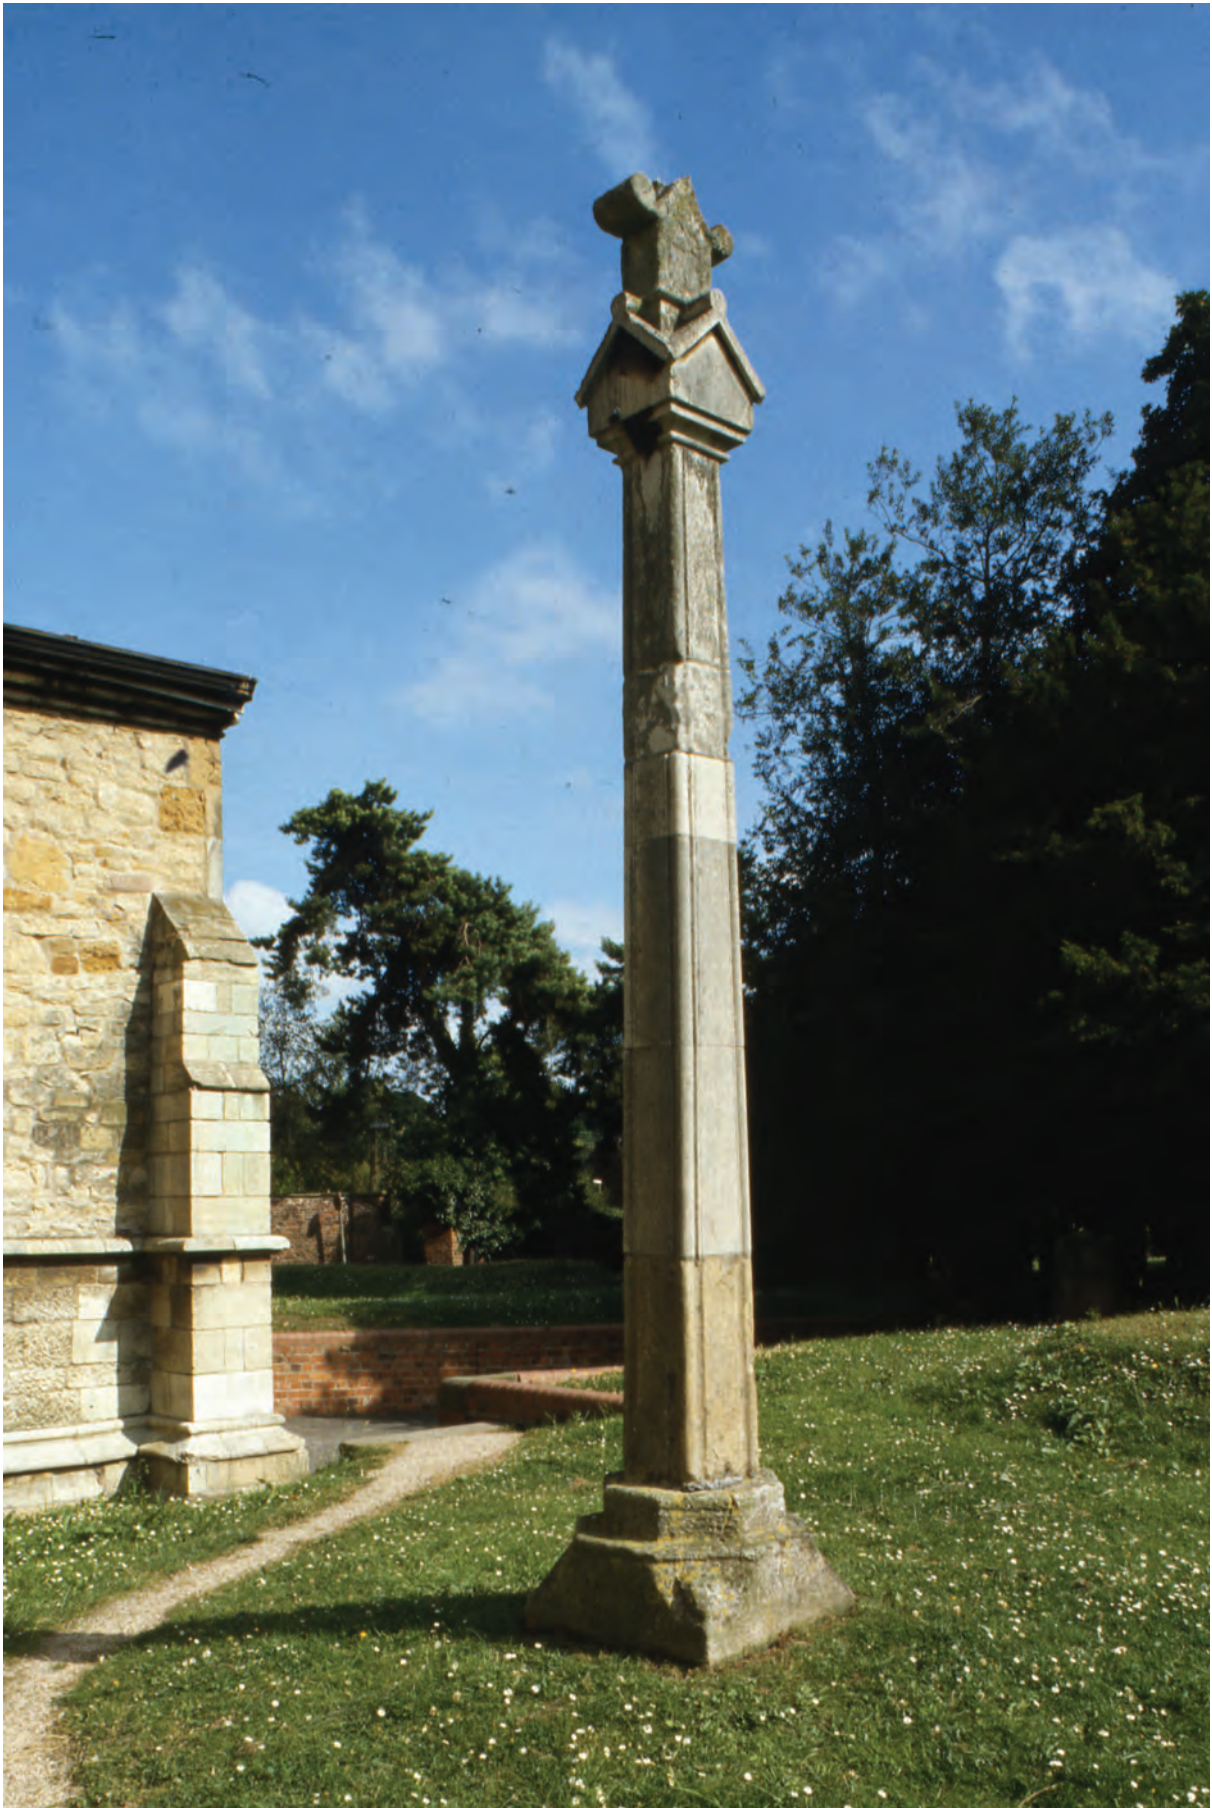
Plate 112: St Peter's churchyard cross from the north-west in 1999, showing the different colour shades of stone used in the restoration of 1904. The south porch is seen on the left. Photo: Warwick Rodwell

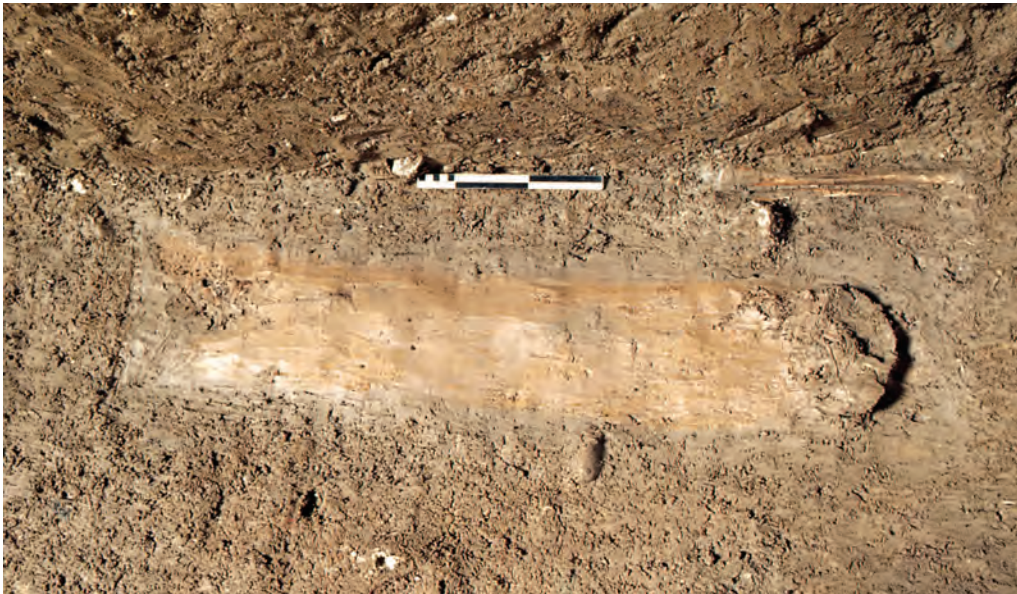
Plate 113: Smooth clay filling defining the outline of the coffin in burial F4100. View south. Scale of 25 cm. Photo: Warwick Rodwell

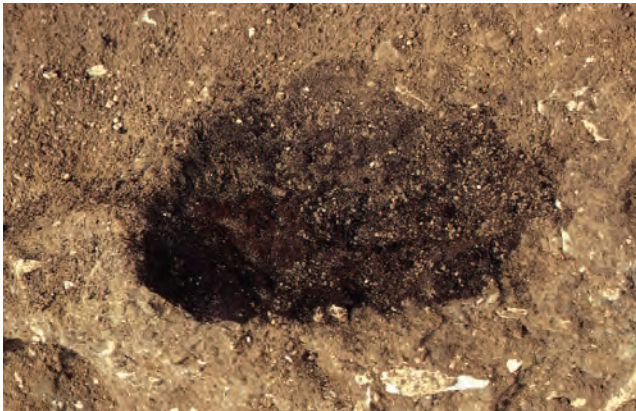
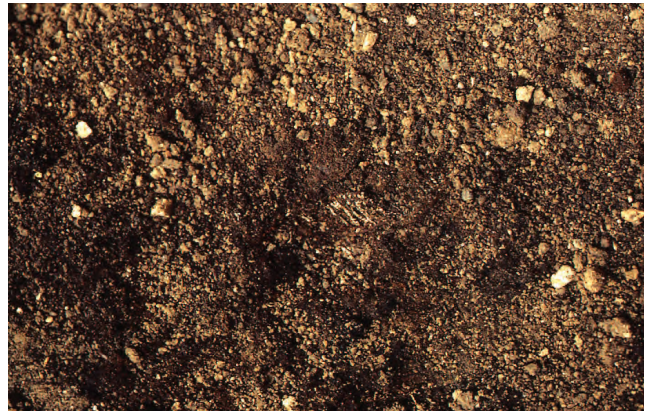
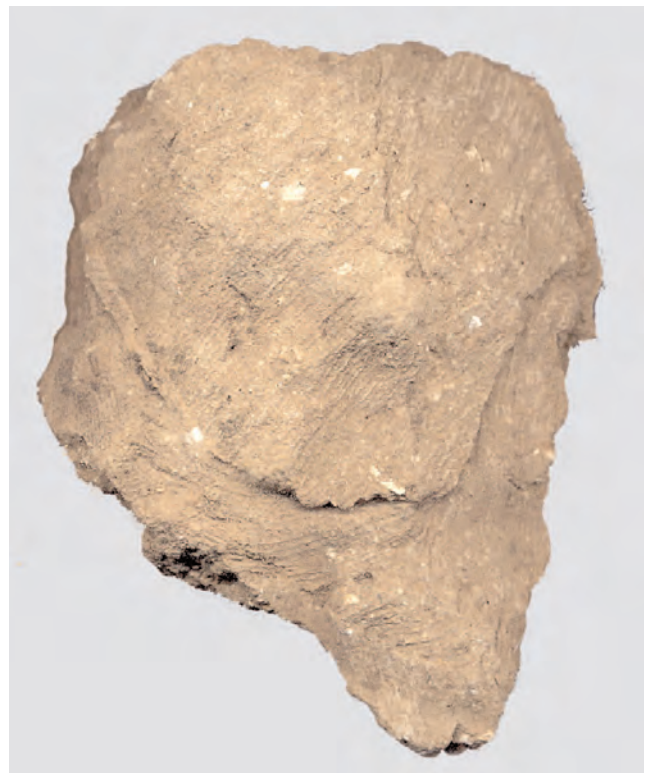
Plate 114: Grave F325, cloth of gold. A, Circular area of decayed material, as found, lying on the lid of the coffin; B, Detail, showing gold thread; C, Impressions preserved in lime-hardened soil (after drying). Photos: (A, B) Warwick Rodwell; (C) The Anglo-Saxon Laboratory
