ST PETER'S

Barton-upon-Humber, Lincolnshire

A Parish Church and its Community

HISTORY, ARCHAEOLOGY AND ARCHITECTURE

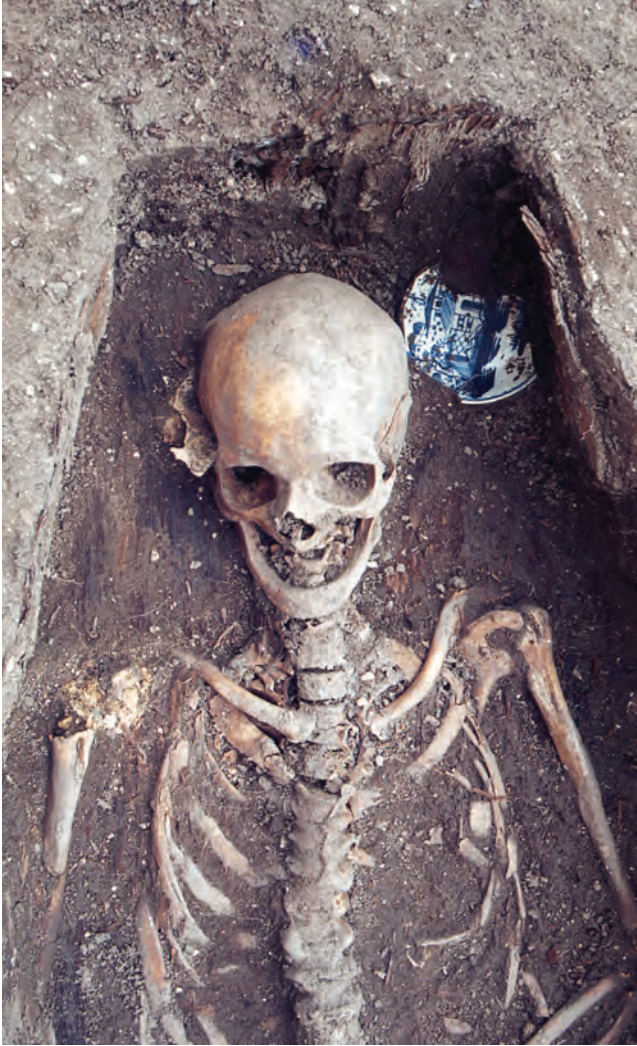
Plate 115 Churchyard, Area 8. Grave F3027, containing a transfer-decorated china bowl beneath the coffin. Photo: Warwick Rodwell

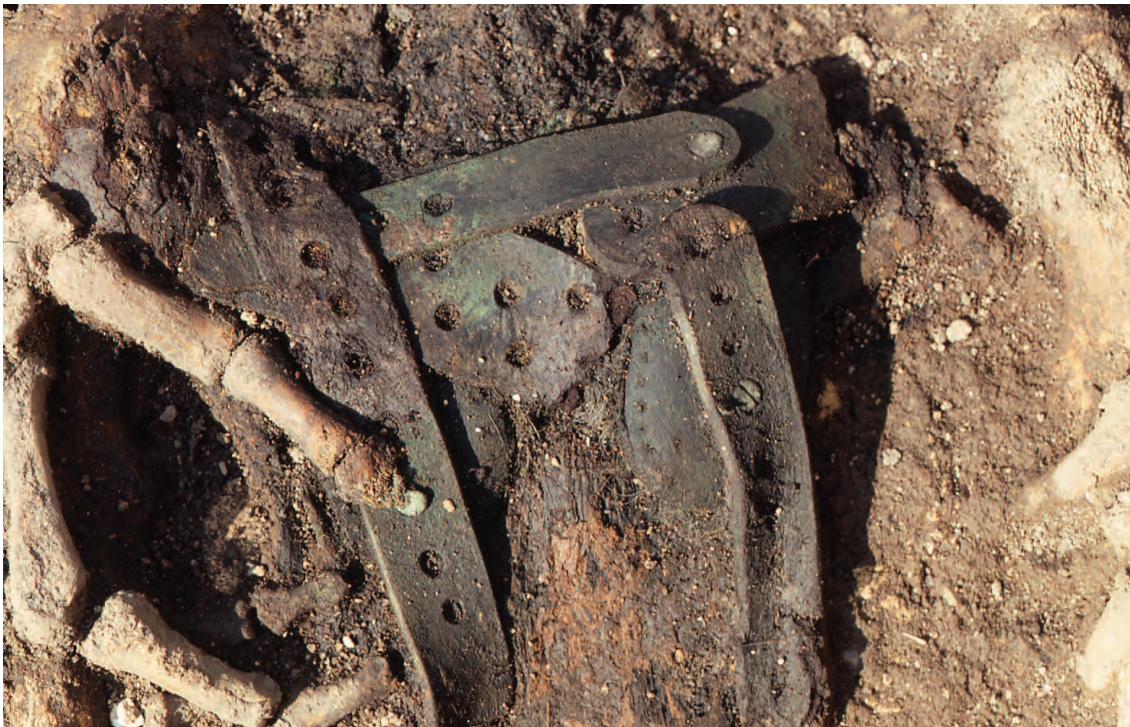
Plate 116: Churchyard, Area 8. Detail of the hernia truss in burial F3041 (sk. 258). The various components were adjustable and held together with brass studs. Photo: Warwick Rodwell

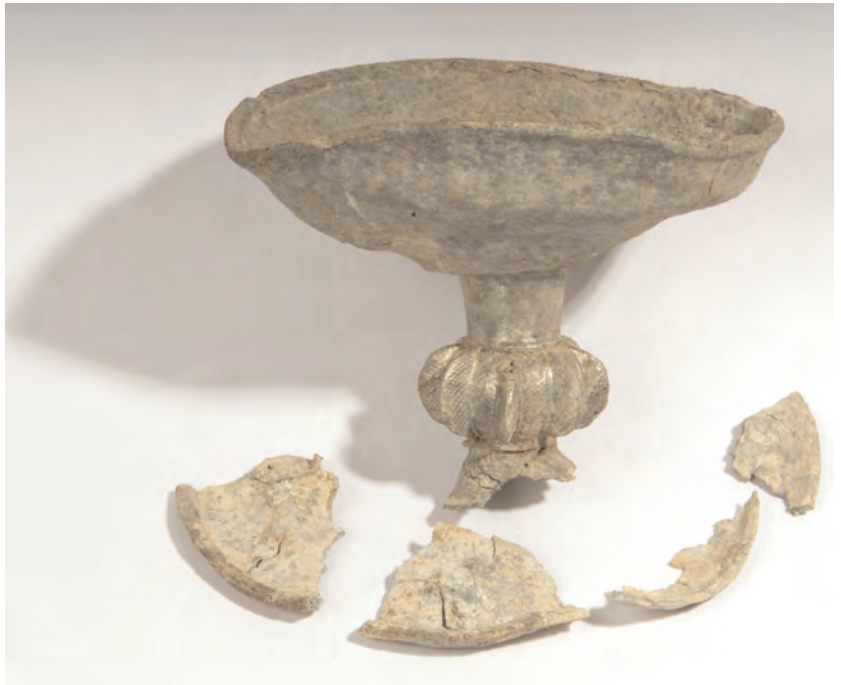
Plate 117: Pewter mortuary chalice from the priest's grave F4115. Late medieval. Photo: English Heritage Photo Library

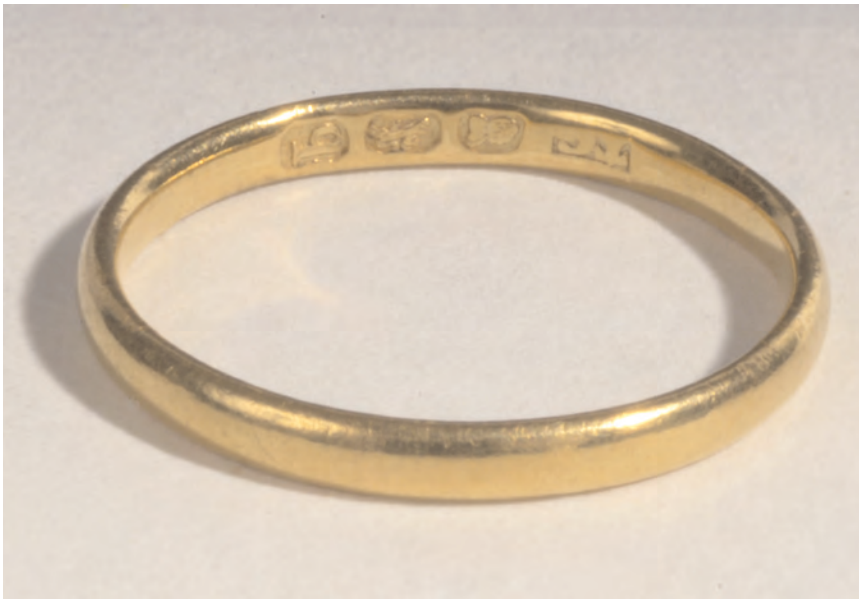
Plate 118: Gold finger-ring with a London hallmark for 1831–32. From grave F3697. Photo: English Heritage Photo Library

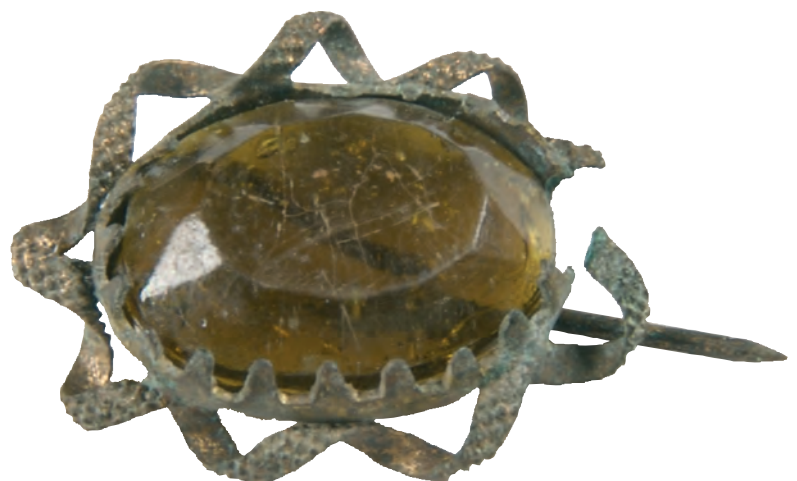
Plate 119: Pinchbeck brooch with yellow faceted glass inset. Nineteenth century; unstratified. Photo: English Heritage Photo Library
