# Geotechnical Engineering for the Preservation of Monuments and Historic Sites III

Edited by  
Renato Lancellotta, Carlo Viggiani,  
Alessandro Flora, Filomena de Silva,  
and Lucia Mele

PROCEEDINGS OF THE THIRD INTERNATIONAL ISSMGE TC301  
SYMPOSIUM, NAPOLI, ITALY, 22–24 JUNE 2022

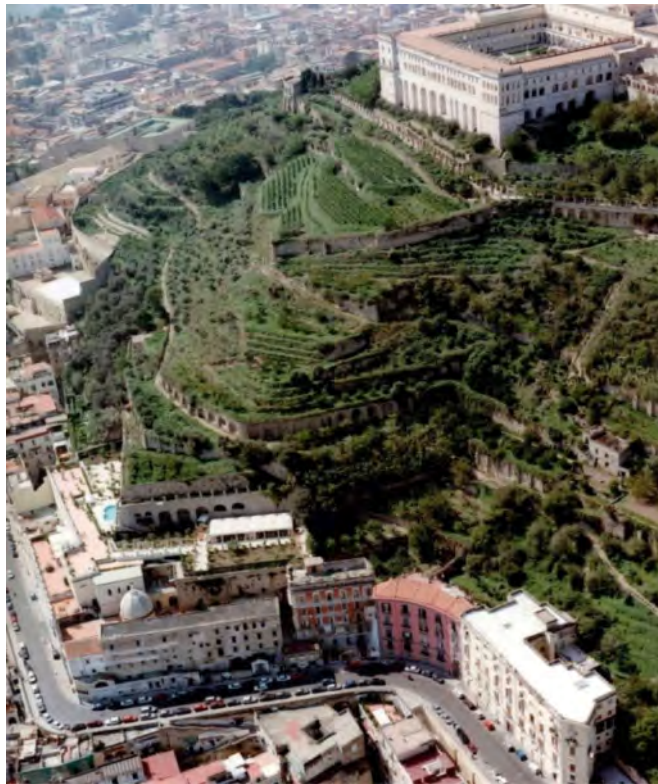
Figure 9. Bird's eye view of the S. Martino hill today.

The vineyard contains more than 7 Km of retaining walls with a height over 3 m. The system of retaining walls shows evident signs of degradation because of lack of any maintenance and uncontrolled runoff of water; the densely inhabited underlying built environment is exposed to a high landslide risk. Geotechnical engineering has thus a central role in preserving the underlying city, the S. Martino monastery and the Presepi!

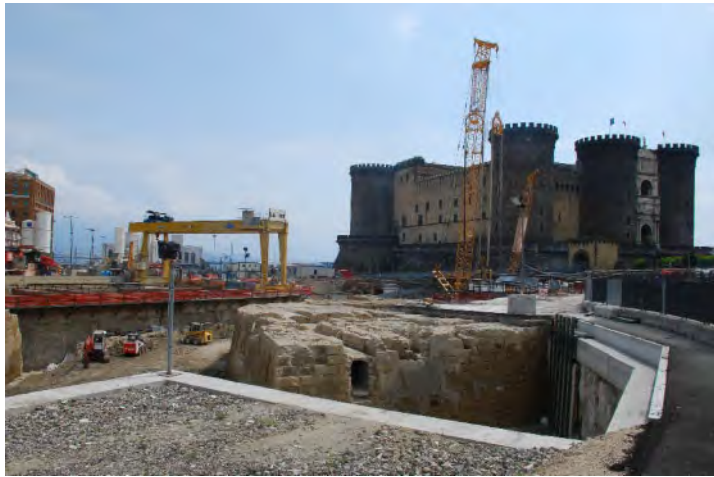
Figure 14. Excavation for a Metro station in Town Hall Square.

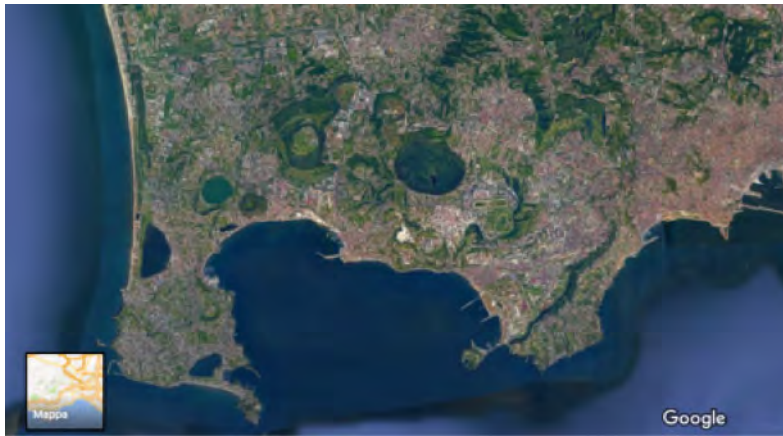
Figure 18. The volcanic origin of the Phlegrean Fields.

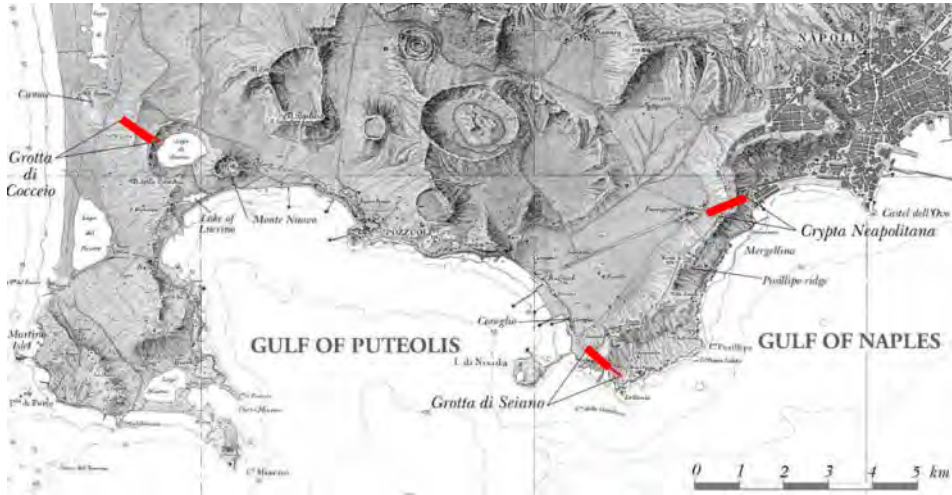
Figure 21. Map of the Phlegrean Fields showing the location of the Roman tunnels.

Table 1. Characteristics of the Roman Tunnels in the Phlegrean Fields.

Name	Length (m)	Width (m)	Height (m)	Notes
Crypta Neapolitana	711	4.5	4.6 ÷ 5.2	2 inclined ventilation shafts
Seianus Grotto	780	4.0 ÷ 6.5	5.0 ÷ 8.0	3 lateral ventilation tunnels
Cocceius Grotto	970	4.5	4.5 ÷ 8.0	5 inclined or vertical vent. shafts

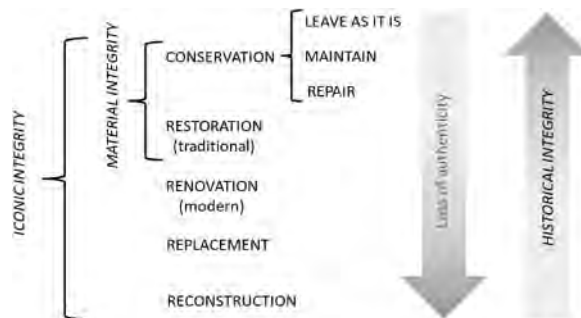
Figure 1. Conventional relationship between iconic, material and historical integrity as a function of different kinds of engineering actions.

Figure 1 schematically summarizes the author’s personal view of what we could call the conventional relationship between the different kinds of integrity and some possible engineering actions to be carried out for preservation goals. An insight into the meaning of each action, from conservation to reconstruction, can be found in Petzet (2004). This scheme is a conceptual framework posing constraints that cannot be overlooked, even when dealing with the least visible, underground part of built heritage, and with the subsoil directly interacting with it.

Indeed, the scheme reported in Figure 1 may not be fully satisfactory, because historical integrity and authenticity are somehow elusive concepts, as already mentioned. An enlightening example of such elusiveness can be taken with reference to the conservation of some shrines in Japan (Flora, 2013): up to the mid of the 19th century, several wooden Shinto shrines periodically underwent complete reconstruction ever since the inception of this custom in the 7th century. Such a practice had the character of an important religious ritual, but was probably set forth to answer to the need of substituting spoiled or damaged parts. Later on, in the 19th century, all the Shinto shrines but one (Ise shrine, Figure 2) stopped the periodic reconstruction because of political changes and economic crisis. Nowadays, while the Ise shrine still keeps its ritual reconstruction every 20 years, all the other shrines are protected by law as architectural heritage, assuming as an indicator of their relevance and integrity the material value, in accordance with Figure 1.

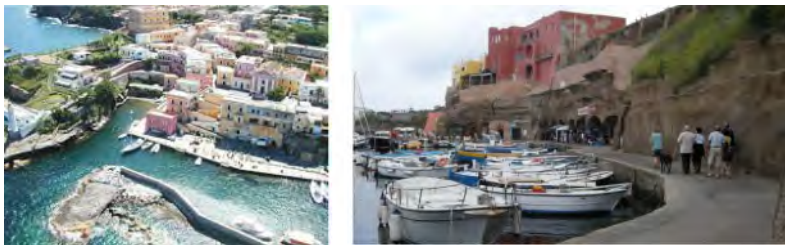
Figure 7. The Roman port of Ventotene (one of the Pontine islands, Italy), still in use (thus at the highest possible level of functional integrity), was entirely excavated in the rock bank, removing some 60.000 m<sup>3</sup> of material, to support emperor Augustus' (63 BC – AD 14) summer residence, as there was no natural harbour on the island.

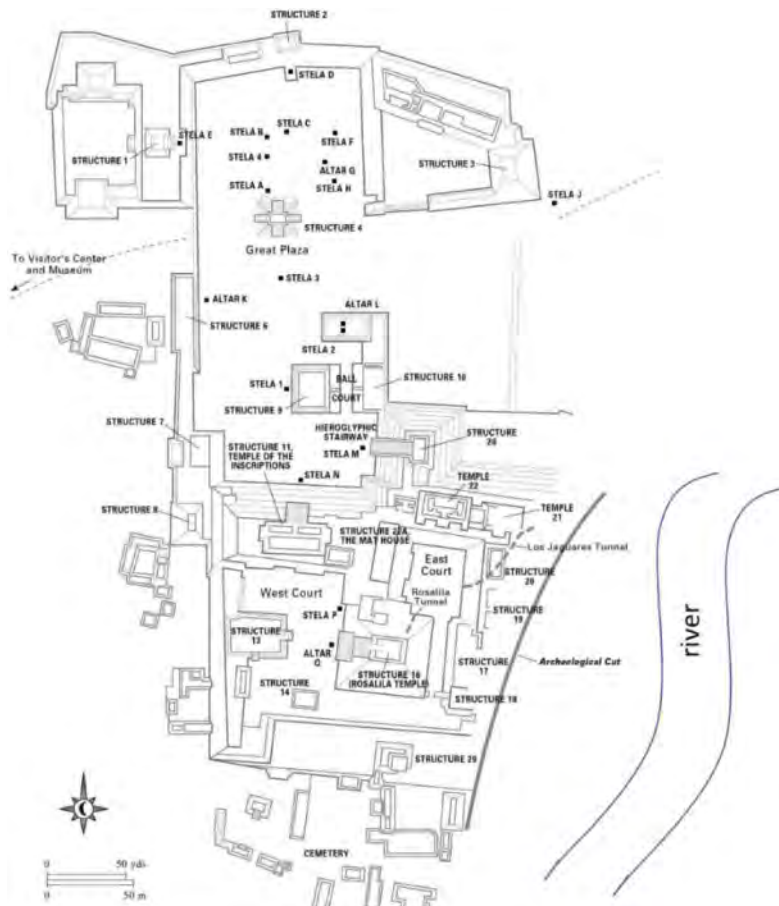
Figure 10. Plan view of the Copan archaeological area, with (sketched, non on scale) the nearby Copan river (modified after Pires, 2020).

Copan (UNESCO site since 1980) is an ancient Maya settlement located in the extreme western highlands of Honduras, close to the Copan river (Figure 10). This city-state flourished from the 5th to the 9th century AD – a time-span known as the Classic Maya period – during which it became one of the most important sites of Maya civilization, in that period spread in contemporary southern Mexico, Guatemala, Belize, Honduras and El Salvador. Copan was the intellectual centre of the Classic Maya civilization, where important advances in astronomy and mathematics were achieved (Thompson, 1958). The site was brought to the attention of Europeans in 1576, when Diego Pedro de Palacio visited it and reported on the magnificence of its architecture and sculptures.

Copan is most famous for the so-called Main Group (Figure 10), an architectural compound exquisitely decorated with stone sculptures, comprised of a massive elevated royal complex located south, known as the Acropolis, and a series of connecting plazas and smaller structures located north. One of the most famous pieces of stonework is the superb Hieroglyphic Stairway (Figure 11), the longest known Maya hieroglyphic text, and it's incredibly high relief sculpture, some of the finest ever carved in antiquity (Sharer and Traxler, 2006). Centuries of abandonment left heavy

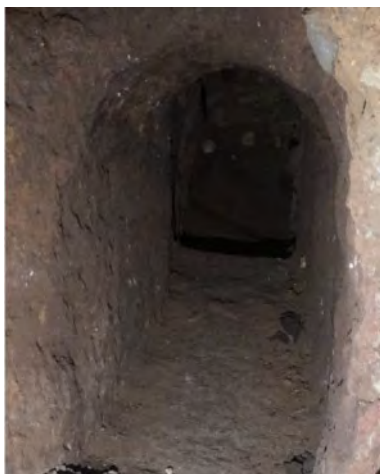
Figure 16. Unlined stretch of a tunnel excavated in the *tierra café oscuro* (modified after Lacombe *et al.*, 2020).

The unlined tunnels in the *tierra café oscuro* layer have a typically stable arched vault (Figure 16), while the lined ones are vaulted on the top with a triangular corbelled arch. In most lined tunnels the lower walls are slanted. Section T4 is rather irregular and the final shape identified in the figure is just a rough approximation. The dimensions vary within each type but, in general, tunnels are small, serving as pathways for the archeologists, with an average width of about 1.0 m and a height ranging from 2.0 m to 3.0 m. Table 1 provides the statistical information obtained from the 3D survey. The distance between tunnels and external surfaces is represented in Figure 15 by the minimum distance  $R_{min}$ . This is measured from the axis at the base of the tunnel to the nearest ground surface.

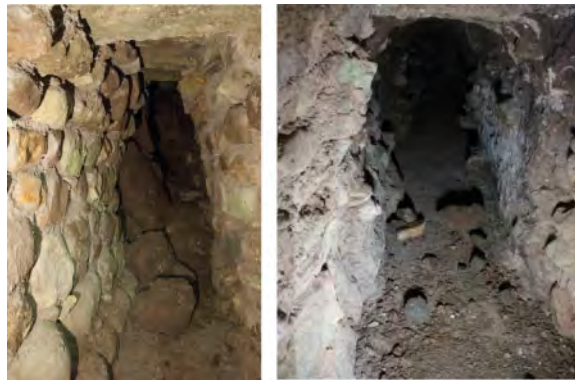
Figure 17. Examples of local collapses: (left) at the interface between lined and unlined stretches; (right) in an unlined tunnel excavated in fine yellow sand (*girín*) (modified after Lacombe *et al.*, 2020).

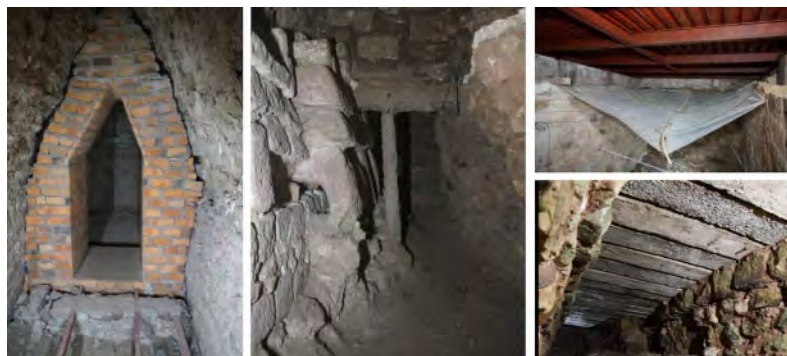
Figure 18. Different kinds of local stabilisation interventions (modified after Lacombe *et al.*, 2020).

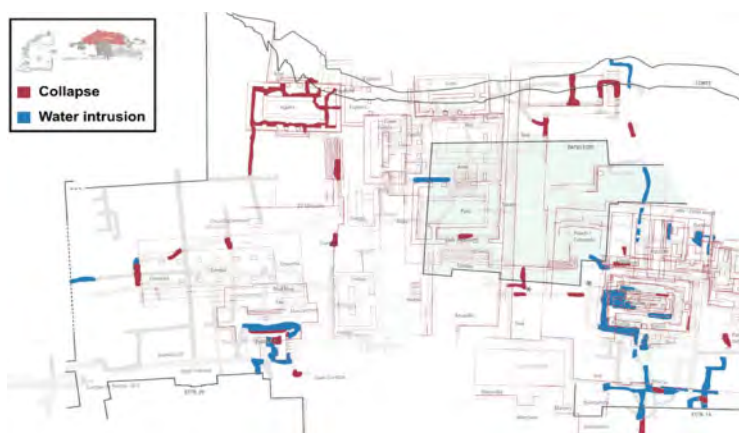
Figure 19 shows in red the tunnel stretches where local collapse was observed from 2017 to 2020, and in blue the ones where the main problem was massive water intrusion during the storms of 2017. Clearly, the extension of damage is such to make the use of the tunnels network critical and dangerous. When looking jointly to the history of collapses and heavy rain or storms, a correlation is observed. Furthermore, the critical sections where collapse concentrates are in the unlined part, but close to the lined ones.

Figure 19. Map of local tunnel collapse and of water intrusion observed from 2017 to 2020 (modified after Pires, 2020).

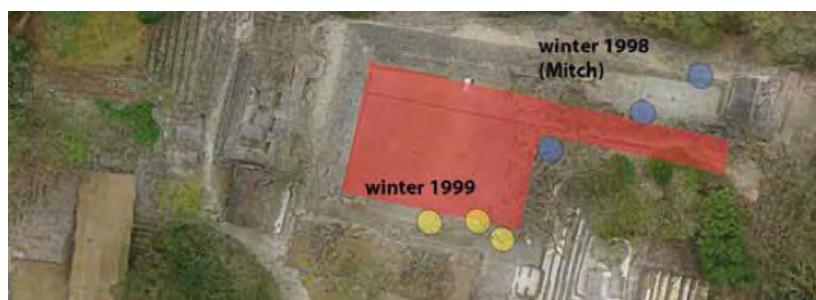
Since the soil was originally compacted in unsaturated conditions, it has to be expected that a change in the degree of saturation has a mechanical effect, obviously more critical in the unlined sections. A main instance, happened after the installation of an impermeable geomembrane over the East Court (Patio Este) in 1998, confirms this observation: shortly after the installation (which was done without proper collection and disposal of rain water accumulated on top of the geomembrane), an hurricane (hurricane *Mitch*) struck the region, bringing intense rainfalls. Three areas along the East Court perimeter suffered tunnel collapse at the time of the hurricane, and three more the year after (Figure 20).

Figure 20. Aerial photo of the Copan Acropolis (east at top) showing approximate positions of tunnel collapses after hurricane Mitch (1998 in blue, and 1999 in yellow), with the position of the East Court membrane marked in red (modified after Lacombe et al., 2020).

In fact, the tunnel sections adjacent to the perimeter of the East Court suffered major infiltration in the earth fill from the edges of the improperly installed geomembrane because of the water build-up at ground level.

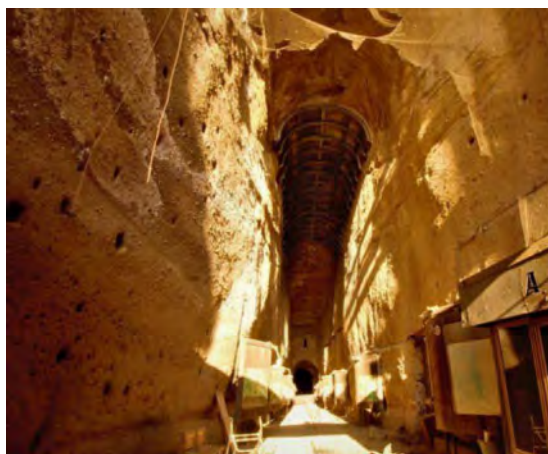
Figures 27 and 28 show the two entrances of the tunnel. Recently, bolted steel arches were placed to support the vault in the first 30–40 m on the western side (Figure 27).

Figure 27. Western entrance of the Crypta Neapolitana in a recent photo. On the vault, the recently placed bolted steel arches.

The tunnel is actually in very bad static conditions, with diffused collapse of large blocks along its axis, especially in the central part, where site survey is now almost impossible for safety reasons. The Roman masonry lining has collapsed along the whole lined stretch, with only few parts, with no static role, still standing. A large part of the masonry supporting structures placed in the 19th century collapsed. Figures 29 and 30 show some photos of a recent survey (January 2022) from both entrances of the tunnel, giving a clear idea of the widespread state of instability.

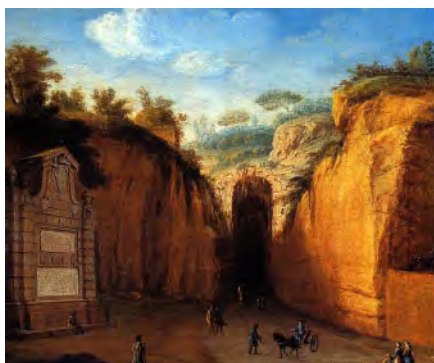
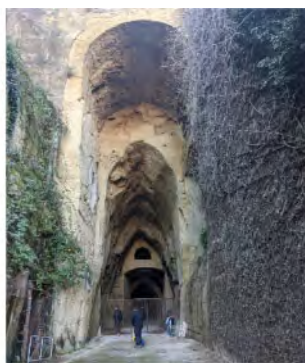
Figure 28. Eastern entrance of the Crypta Neapolitana in a painting (van Wittel, XVIII century, oil on copper) and in a recent photo.

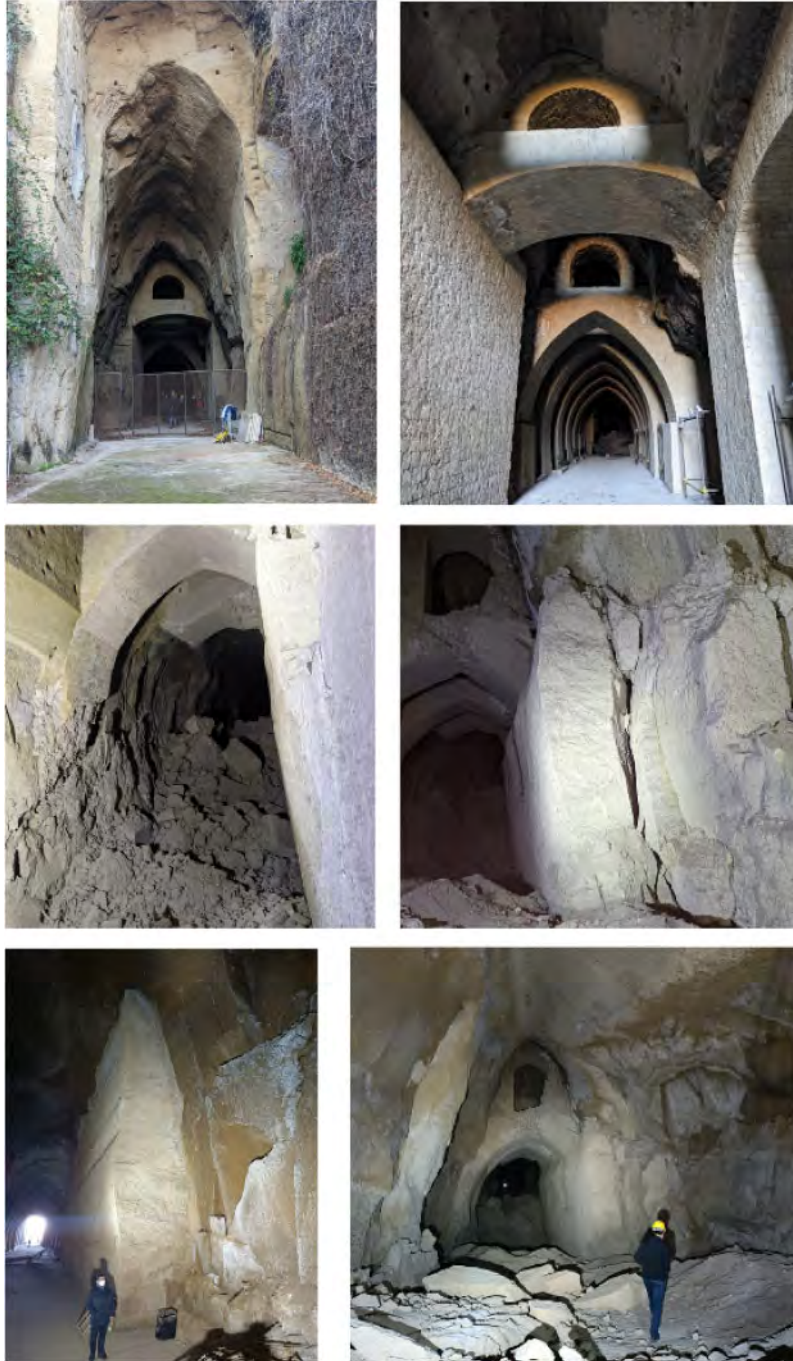
Figure 30. From top left: pictures from the eastern entrance till ca. progressive 150 m. Masonry arches well preserved in the first part, with complete collapse of side walls in the final part. Large subvertical rectangular blocks sometimes on the verge of instability failure.

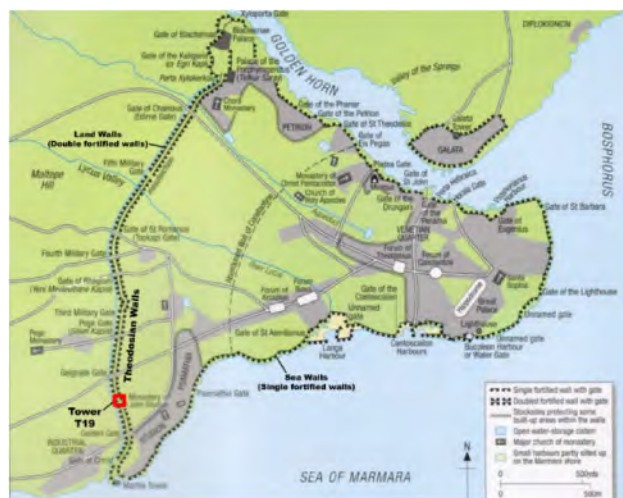
Figure 35. Map of Constantinople at the beginning of the Ottoman Period, with the location of the first defensive wall of Constantine and the location of the outer, much longer Theodosian walls (<http://romeartlover.tripod.com/Murter.html>). Tower T19, dealt with in this section, is indicated in the south reach of the latter wall.

Since the city was initially located on the European side, it was naturally protected by the sea on the north, east and south, the major problem being to protect it from possible attacks from the inland, on the west side. Constantine arranged a wall to be built (Figure 35) from the Golden Horn to the

Sea of Marmara. As the city grew, however, this confine had to be overcome to accommodate all the people attracted from the new status of the city. An impressive double line of walls was then built on the land side during the reign of Emperor Theodosius II (408–450 AD), after whom they were named, about 2 km to the west of the old Constantinian Wall. The protective system, completed in AD 423, is the result of the skills and dedicated work of Anthemius, a Praetorian Prefect of the East, who did not see his work completed as he died in 414. In their final configuration, the Theodosian walls had a length of about 7 km, completely surrounding the city (Figure 35), thus creating a barrier not only on the west side but also along the whole coastal perimeter.

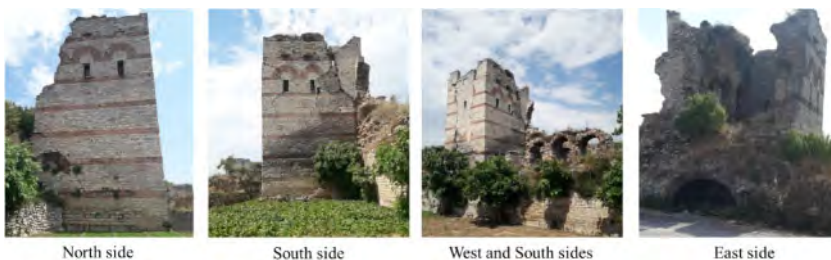
Figure 40. Recent views of all sides of tower 19. The damages caused by 1999 Kocaeli earthquake are clearly visible.

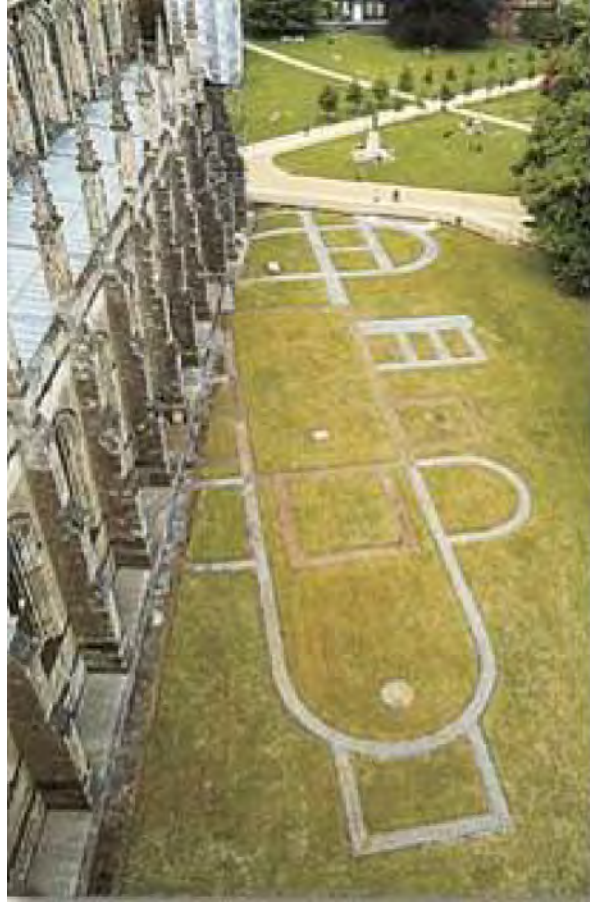
Figure 4. Location of Old and New Minster on the north side of Winchester Cathedral.

can be seen just north of the west end of the present Cathedral as shown in Figure 4. Its location may well have been chosen because it is sited in an area where the foundation conditions are more favourable than elsewhere in the area.

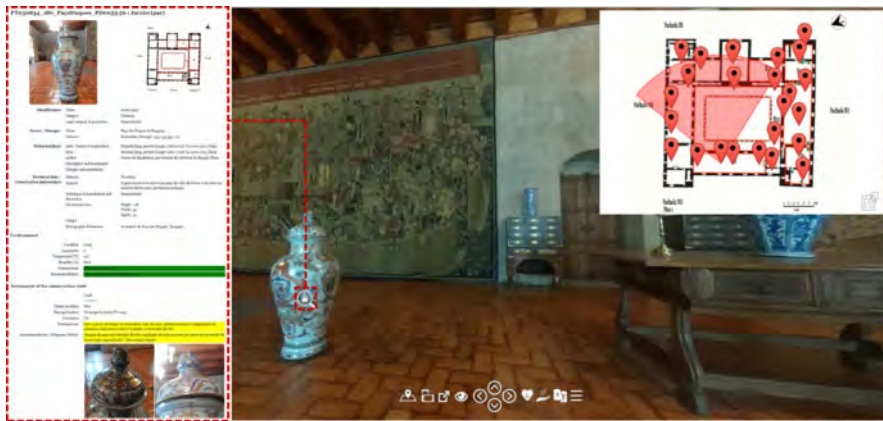
Figure 7. Virtual tour enriched with asset hotspots, linked to condition survey report.

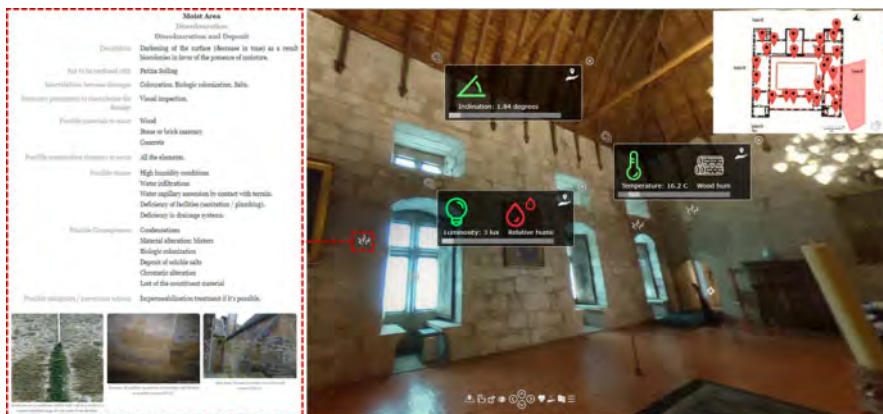
Figure 8. Virtual tour enriched with sensors and damage hotspots, linked to recent acquisition and damage report, respectively.

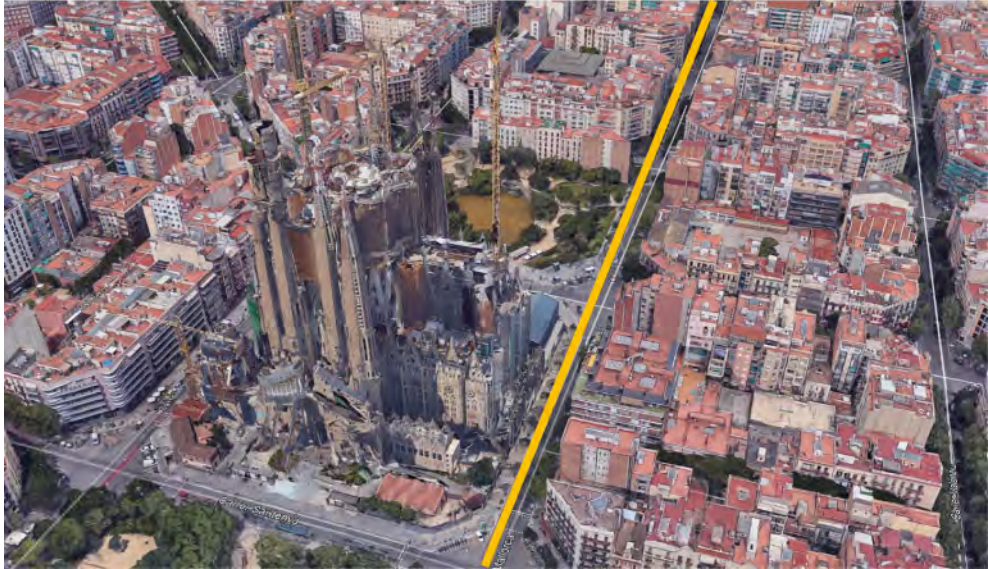
Figure 4. Work in progress and Mallorca street at the time of the construction of the tunnel.

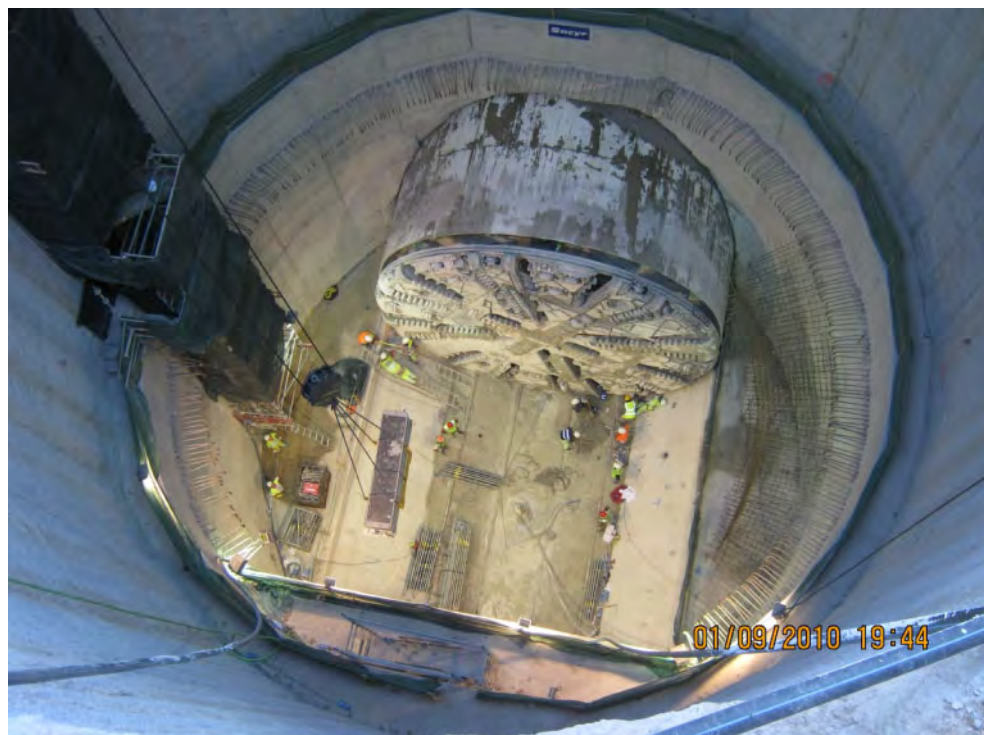
Figure 33. Photograph of the Padilla shaft and the head of the EPB Shield, before approaching the Sagrada Familia Temple.

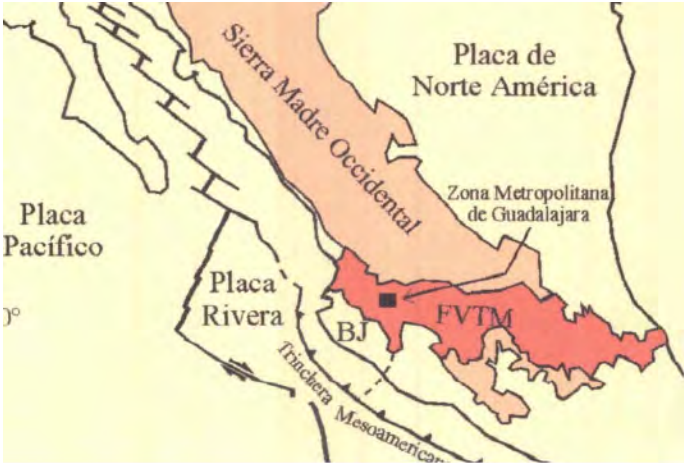
Figure 2. Tectonic environment around Guadalajara.

Seismicity in the city is determined by the interaction of the Rivera and Pacific Plates with the North America Plate, as seen in Figure 2. Several large earthquakes have hit the city in the past

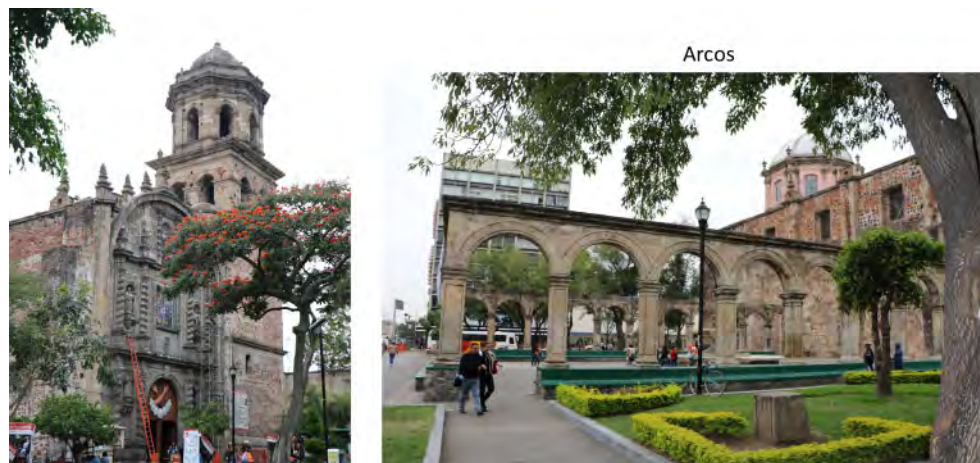
Figure 3. Left hand side: view of the main façade; right hand side: view of the reconstructed archway of the former cloister along the East side of the church.

The San Francisco de Asis church is a masonry building whose construction began in 1554 was finalized in 1611. This structure in addition to the Aranzazu church are the remains of the former San Francisco monastery that was demolished when it was relocated elsewhere in the city. The photographs in Figure 3 show a view of the main façade and of a reconstructed archery of the former cloister.

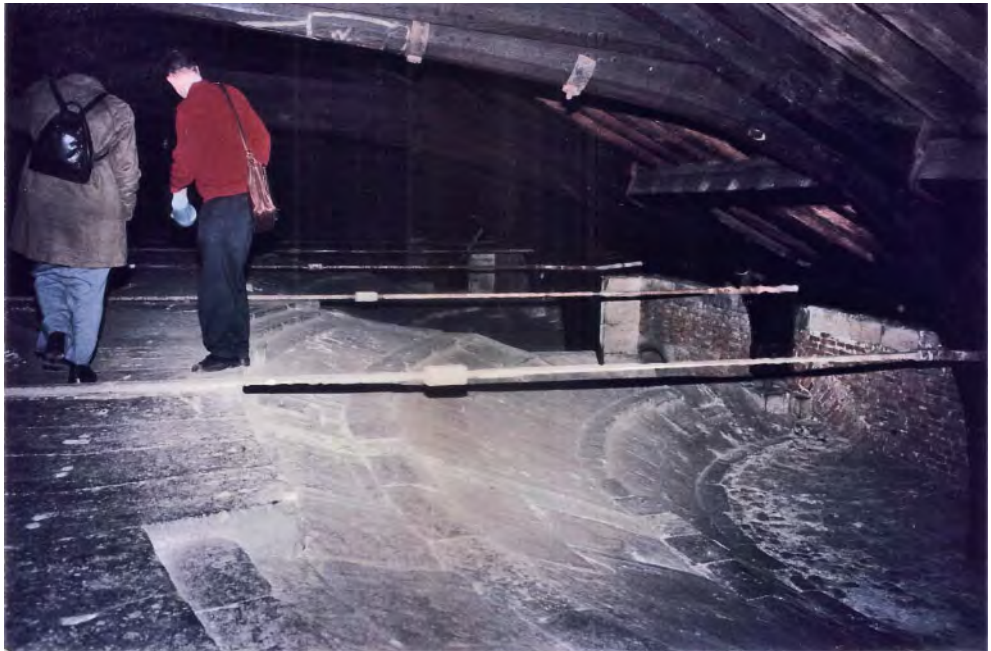
Figure 7. Extrados of the vaults of King's College Chapel. Cambridge, UK. Ph.: P. Smars, 2002.

In the broader context of cultural heritage protection, even if, as discussed above, the importance of the authenticity of the substance is challenged, it is still officially listed as an important criterion in international documents. Among the 10 criteria used by UNESCO to assess whether a property has an Outstanding Universal Value, criteria 1 to 4 may benefit from contributions related to technique, construction and engineering (Figure 7). In the Operational guidelines (UNESCO 2021, point 82),

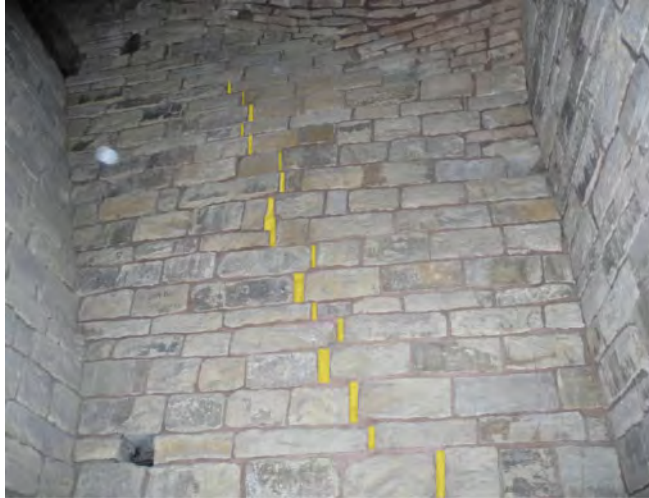
Figure 4. Transversal partition wall above the scarsella; the crack (in yellow) sealed by vertical plates is visible; the extrados of the dome can be seen on the left.

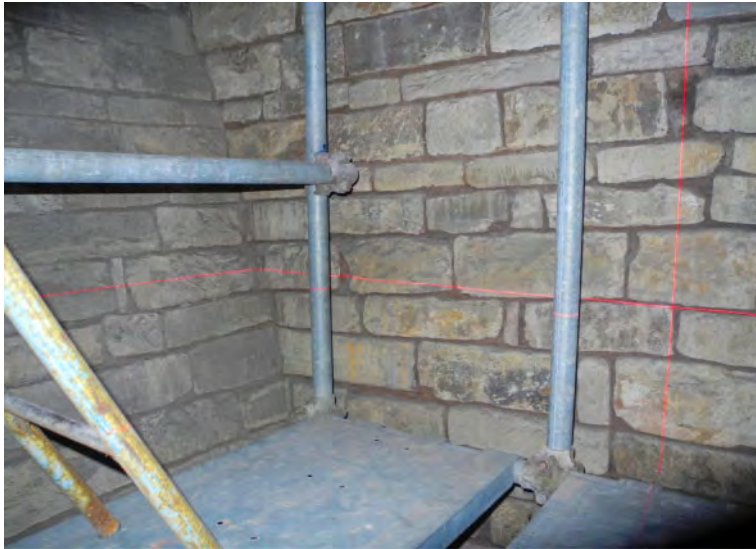
Figure 6. Detail of a partition wall (right) and the extrados of the dome (left) of the Baptistery; the intersection between the vertical and horizontal red lines of the laser highlight the part of the partition wall with masonry in inclined rows perfectly connected with those of the dome.

The inspection of the top part of the garrets showed that the transversal bearing walls are not adjacent to each other, but are connected with the dome in continuous rows. This results in unique feature: to obtain a better connection between the inclined rows of the dome and the partition

walls, for a stretch the rows of the latter are also arranged on an inclined plane (Figure 6), and then become horizontal again, creating masonry in continuous rows with the external wall of the Baptistery (Giorgi & Matracchi 2017, p. 198).

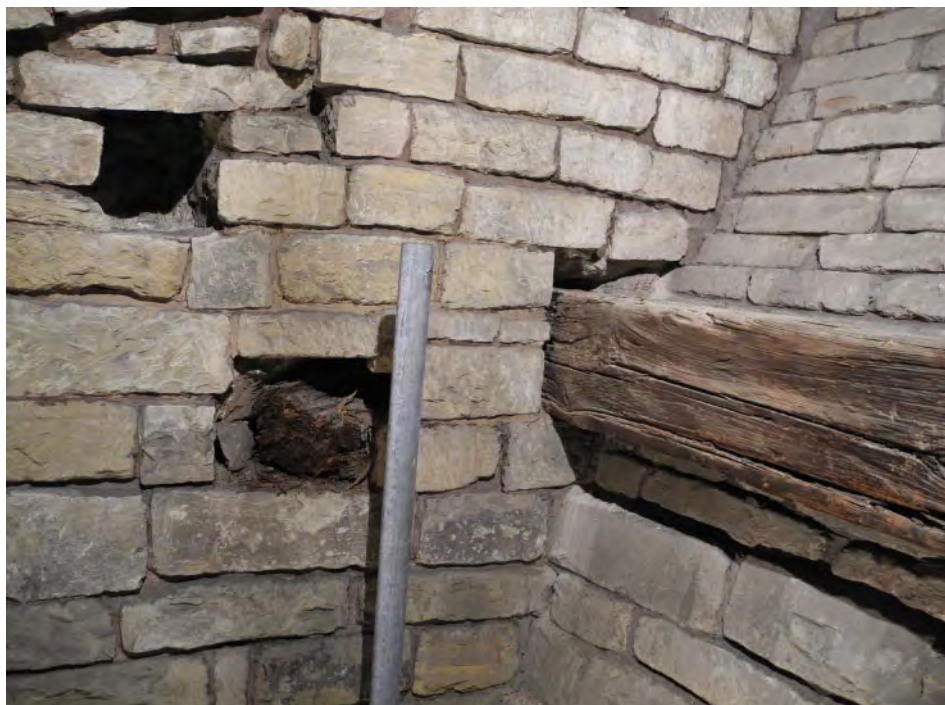
Figure 11. The wooden ties intersect at the corners of the octagonal plan of the Baptistery; the image shows the change in material of the dome at the level of the tie: below the masonry is stone, and above brick.

Where the box structure ends, the dome continues with the use of bricks, for the most part salvaged material most likely obtained from the dismantling of the Roman walls of Florence (Giorgi & Matracchi 2017, p. 205). In the transition from the box structure to the single shell structure, a wooden tie is placed along the extrados of the pavilion crossing the transversal partition walls (Figure 11). The original connections visible between the wooden elements show tooth connections with the use of wooden nails. The tests of the state of tension of the wooden tie revealed a modest amount of tensile strength (Negri et al. 2017); the brick dome, with its springer on the inclined row of the stone one, transmits the thrust mainly to the box structure of the stone dome.

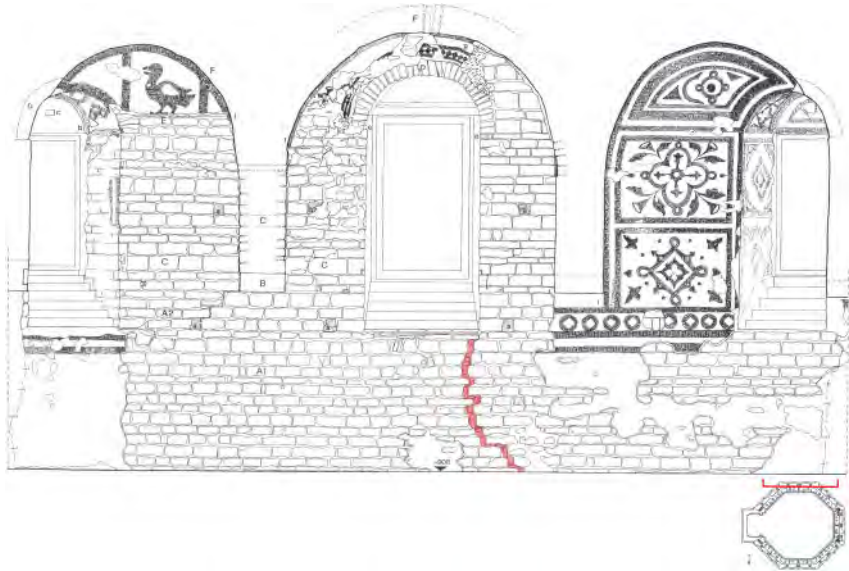
Figure 12. Detail of the outer wall of the north side of the attic; the obvious repaired crack is shown (in red) (by Giovannini 1996).

More extensive cracks have been observed in particular in the sides of the entrance door (up to 4–5 cm wide). On the inner side of north wall of the matroneum there is a highly visible vertical crack, which has been repaired with brick fragments and extends to the barrel vault above and the wall abutting the mullion window. The small column of the mullion window itself in turn generates a crack in the lintel below supported by columns (Giovannini 1996). On the outer sides clad in marble the cracks have been repaired by inserting marble plugs which restore the continuity of the horizontal cornices (Blasi et al. 2017, pp. 121–122).

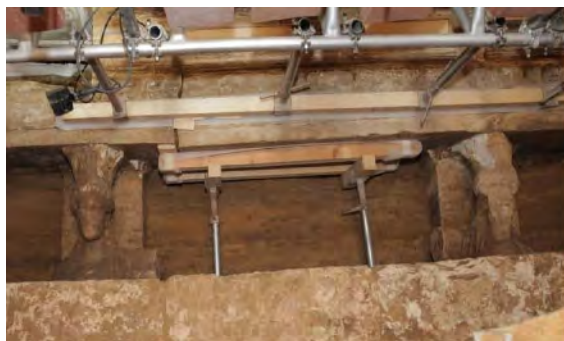
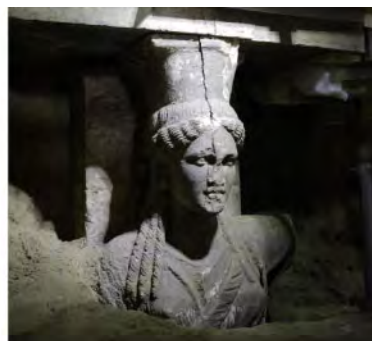
Figure 5. a. The Wall of the Maidens, as found, before the dismantling of the sealing wall, b. detail showing the vertical fracture in the west Maiden.

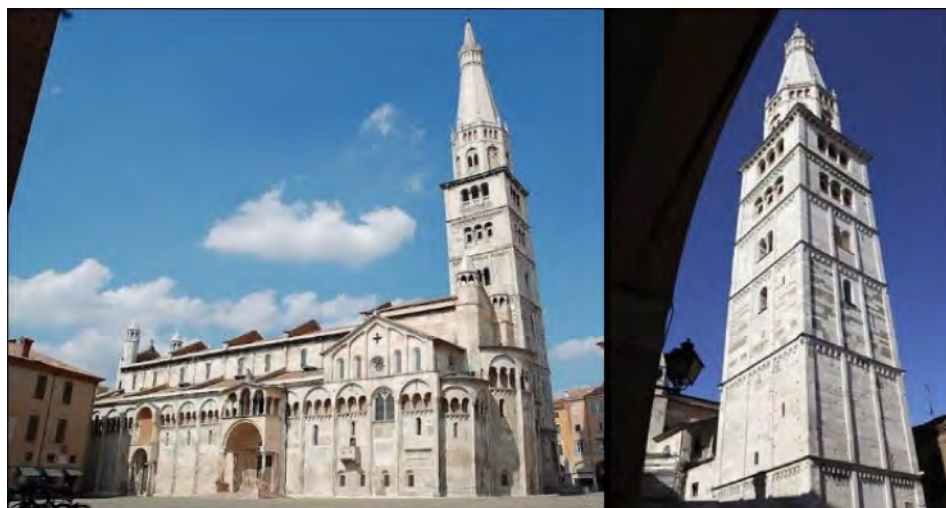
Figure 1. The Cathedral of Modena and the Ghirlandina Tower.

During the first half of 2012 an experimental modal analysis was carried out so to characterize the dynamics of the tower by measuring its response to the ambient excitation. The results obtained showed the interaction with the cathedral and the important contribution of the soil-structure interaction on the tower's modes of vibration (Lancellotta R & Sabia D 2013; Lancellotta R & Sabia D 2014; Sabia D et al. 2015; Cosentini R et al. 2015).

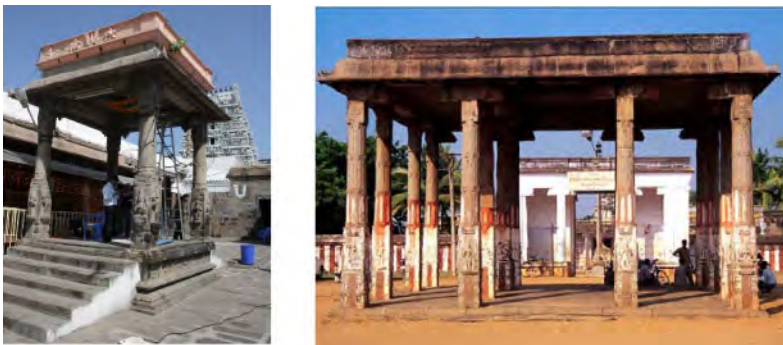
Figure 1. Typical Dravidian style four-pillared and sixteen-pillared symmetrical granite mandapa.

A *mandapam* is a multi-purpose trabeated hypostyle hall, a common archetypal feature of the ancient Dravidian temple architecture of south India (see Figure 1). *Mandapas* typically originated as a single storied entrance hall with multifunctional use near the sanctum sanctorum of the presiding deity in a temple (Manohar et al., 2020, 2021; Ronald et al., 2018). In larger temple complexes, the *mandapam* serves as a spatial linkage between various hierarchical spaces of a Hindu temple, with a series of intricately carved stone pillars (e.g., thousand-pillared hall of Madurai Meenakshi Temple in south India). The primary structural members of a *mandapam* are the monolithic stone pillars and corbels, stone beams, and slabs, all typically in granite, which is found in abundance in peninsular India.

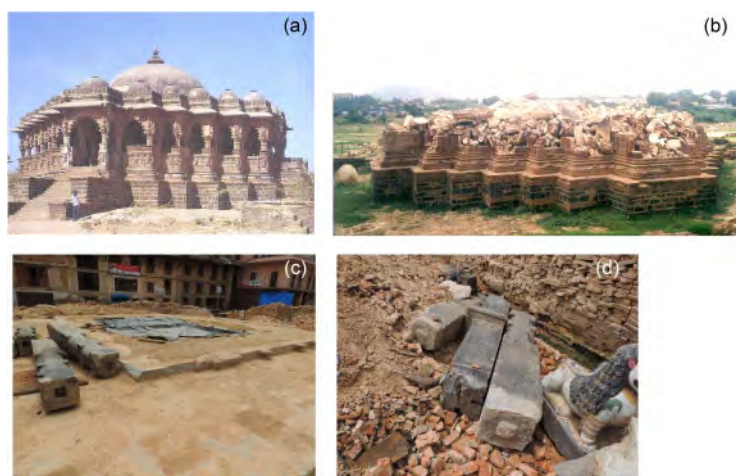
Figure 2. (a)-(b) Observed collapse in historical mandapa Rao Lakha Chattri in Gujarat (Bhuj, 2001) and (c)-(d) Collapse in a stone mandapa in Nepal (2015) with significant tenon-mortise joints.

Extreme damage and loss of historical constructions of such architectural typology have been encountered in the past significant seismic events in the active regions in India such as Bhuj earthquake in 2001 (Mathews et al. 2003) and Barpak and Kodari earthquakes in Nepal in 2015 (Menon et al. 2017). A total collapse of pillared halls in sandstone triggered by the mass of the heavy domical roof in Rao Lakha Chattri in Bhuj (see Figure 2a-b) and complete overturning of the stone pillared construction in Nepal, despite the interlocking provided by the tenon and mortise joint (see Figure 2c-d) are common. Historical constructions in these seismically active regions do show evidence of seismic-resistant features such as positive interconnections between pillars and beams using iron dowels or articulated joints in stone. However, they prove to be inadequate in the presence of significant acceleration and displacement demands.

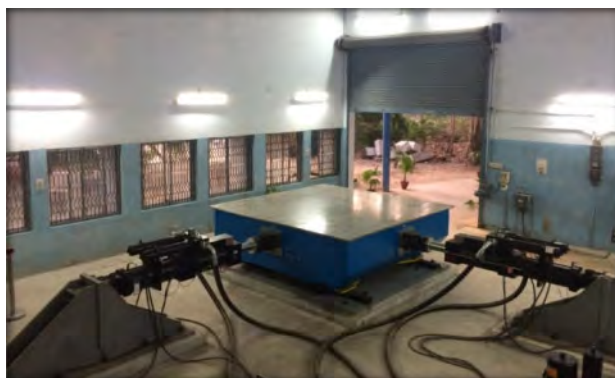
The biaxial seismic test simulator (see Figure 7) is a shake table of dimension 3.0 m x 3.0 m in plan, operated by two 25-tonne servo-hydraulic actuators in two horizontal directions. The table has a maximum payload of 10 tons and can generate a maximum velocity of 1.0 m/s, a maximum stroke (displacement) of +/- 250 mm, and a maximum acceleration of 1.1 g (110% of g), all with maximum payload. The bare table can generate a maximum velocity of 1.4 m/s, and a maximum acceleration of 2.17 g (217% of g). Scaled or full-scale specimens of structural components and systems can be mounted on the table and subjected to real earthquake acceleration records or sine sweeps within a frequency range: 0-50 Hz. The table is supported on a reaction mass of 750 T created by in-situ concreting, going down to a depth of 4.5 m from the finished floor. The actuators are protected by a raised steel structural floor from falling debris of the test specimen. In the current testing program, only one actuator was active, while the second was kept locked.

Figure 7. Biaxial 3.0x3.0m shake table test facility at structural dynamics laboratory at IIT Madras.

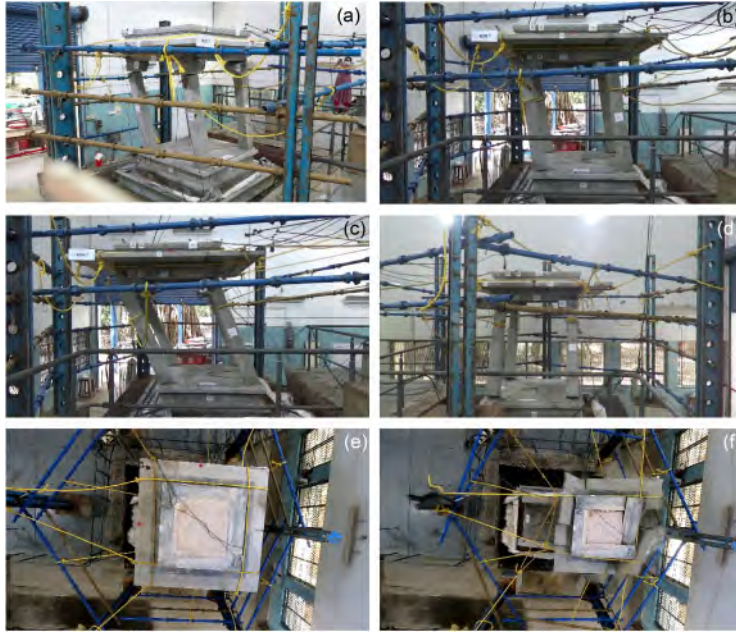
Figure 11. Images from video capture during Run-7 (a)-(b) Overturning mechanism with hinges at the bottom and top of the corbels in the lead pillars versus the rear pillars, respectively; (c)-(d) side views of the model at the verge of collapse; (e) top view of the model at initiation of mechanism; (f) top view at collapse showing disintegration of the stone slabs of the sunshades.

The test was prematurely terminated after the loss of the specimen in Run-7 at a table peak acceleration of 0.146 g with a maximum displacement demand of 46 mm. The first instance of formation of overturning mechanism was observed in Run-7, while even in Run-6 when the table PGA reached 0.12g with the peak displacement demand at 30.5 mm, overturning was apparently not triggered.

Images in Figure 11e-f show the top view of the model confirming almost total response in the fundamental lateral mode. No slippage of the cantilevered sunshades or stone blocks of the parapet were observed during the tests, implying monolithic response of the construction. Disintegration was observed only at collapse of the model and upon impact of parts of the model with the protective steel scaffolding positioned around the model.

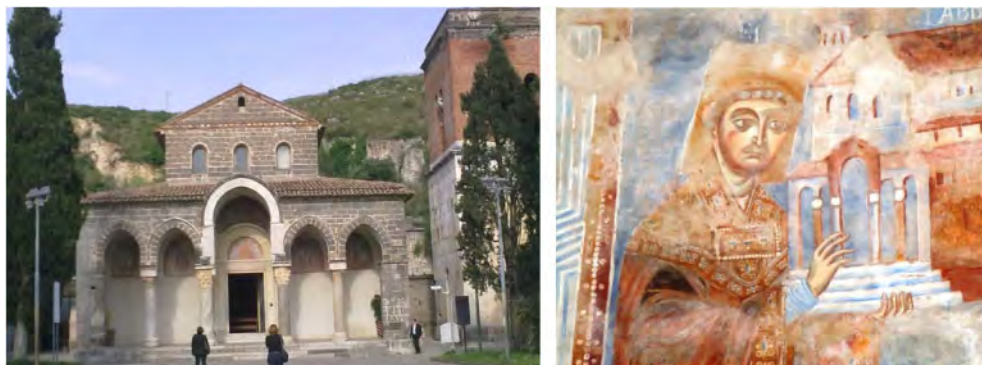
Figure 1. The Benedictine Basilica of S. Angelo in Formis: on the left the present façade and on the right a painting representing an old version of the main façade.

On the right of the same Figure 1 a detail of the internal paintings is reported for comparison and is rather evident the difference between the two porticos: the present portico is characterized by 5 pointed arches while the one depicted in the painting show 5 round arches. This is in agreement with the findings occurred during relatively recent archeological excavations which provides the proof of the collapse of the original portico.

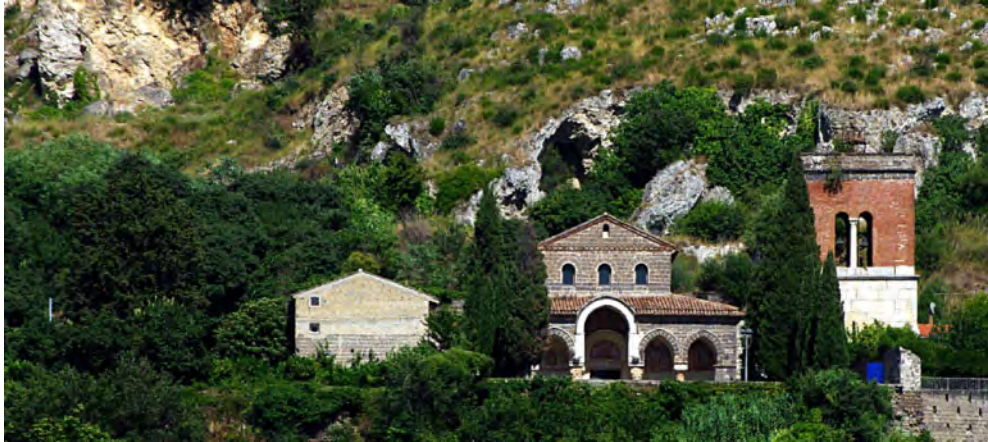
Figure 4. The basilica in the calcareous dolomitic slope.

The water table is generally found at the boundary of the limestone, very permeable by fracturation and the Boreholes and geophysical investigations allowed a detailed reconstruction of the subsoil of the zone surrounding the Basilica, which includes three horizons. The upper one is composed by made ground, for a thickness ranging from a few decimeters to some meters. Below the made ground a layer of fractured rock is found with a thickness variable between 15 and 30 m; it includes dolomite, slightly cemented dolomitic limestone and intensely fractured dolomite, besides cemented calcareous debris. Finally, the base formation of sandstones and variegated shaly clays is found. The geological sketch in Figure 6 shows clearly that the Basilica is located across a stratigraphic discontinuity, with the apses and the backward part of the naves founded on rock, and the front on the debris cover or even on the made ground.

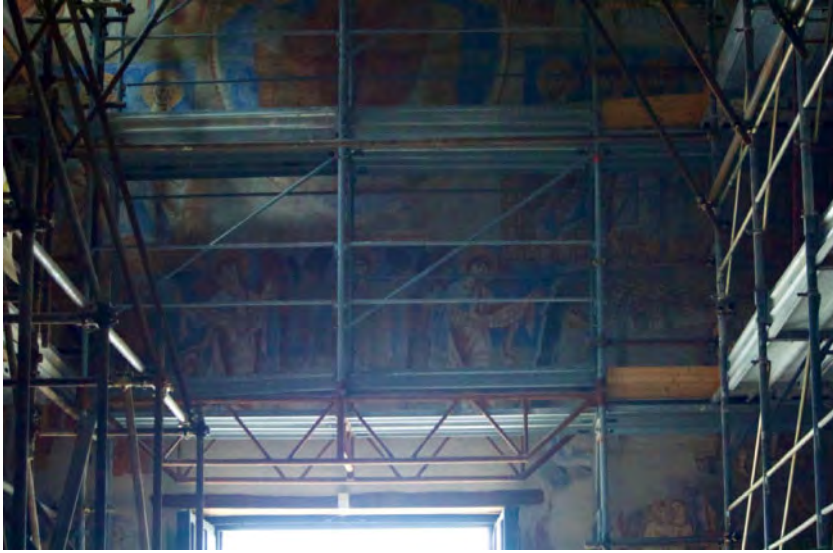
Figure 12. Recently carried out remedial works in the church.

The deflection ratios calculated separately for the two naves and already introduced in the previous section are compatible with the occurrence of fissuring (Burland & Wroth 1975) which were clearly present in the church in the period 2012–2014. In those years some remedial works were decided, planned and carried out (Figure 12).

The interventions could only cure the symptoms rather than removing the cause(s).

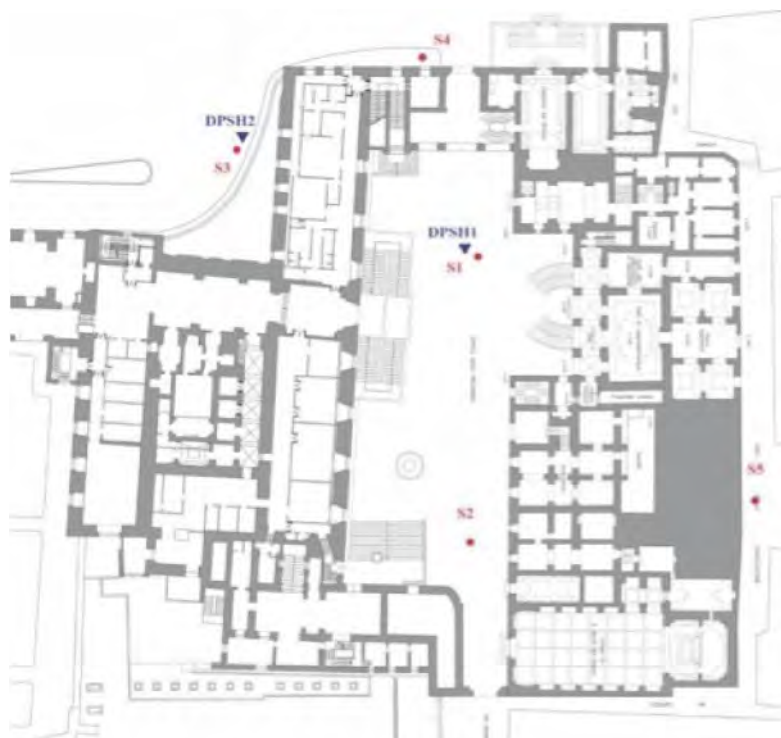
Figure 16. Plan view with locations of boreholes Si and Dpsh tests.

The soil layering as deduced by boreholes reported in Figure 16 can be summarized as follows:

- a) topsoil with a thickness varying from a minimum of a few decimetres in the borehole S4 to less than a metre in soundings S2 and S3 and up to a little less than three metres in the soundings S1 (in the center of the courtyard) and S5, along the Consolazione alley;

The yellow Neapolitan tuff found in the final part of all the surveys is at a rather constant level above sea level ranging between +26 m and +30 m asl. The deepest point of the roof of the tuff is just that relative to the borehole S4 that is on the line of the ancient Greek walls (+26 m asl).
