# Geotechnical Engineering for the Preservation of Monuments and Historic Sites III

Edited by  
Renato Lancellotta, Carlo Viggiani,  
Alessandro Flora, Filomena de Silva,  
and Lucia Mele

PROCEEDINGS OF THE THIRD INTERNATIONAL ISSMGE TC301  
SYMPOSIUM, NAPOLI, ITALY, 22–24 JUNE 2022

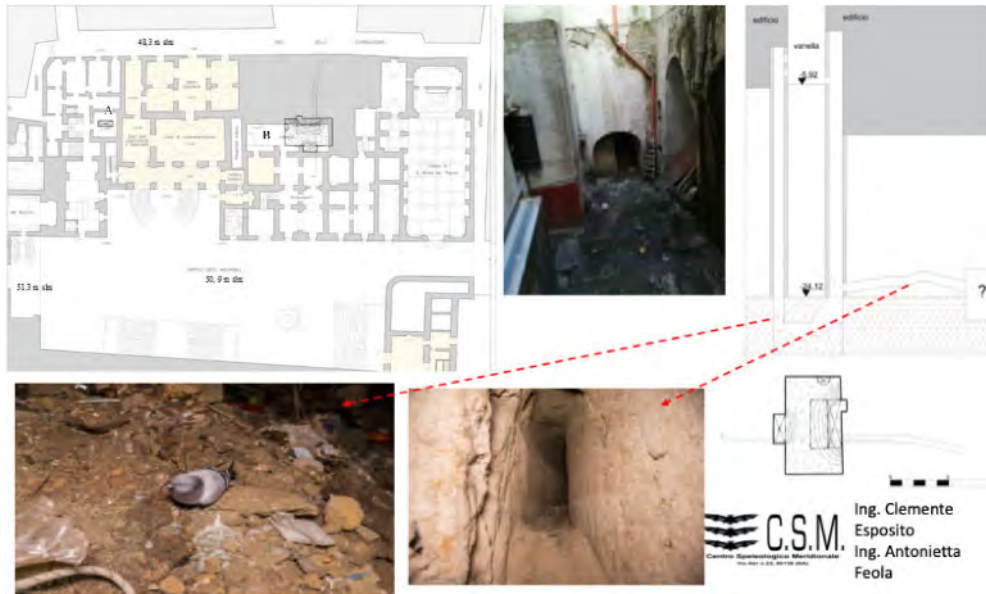
Figure 17. Shafts, cavities close to the Incurabili Pharmacy foundations.

In the area of the Incurabili Hospital during subsoil investigations several deep shafts have been detected. They connect the above buildings with a very deep network of rather small tunnels excavated in the tuff basement. The network is partially related to the famous ancient roman Bolla aqueduct. These vertical wells are 20 meters deep or more and generally end inside the tuff basement where a network of horizontal or sub-horizontal tunnels connects the most of them (Figure 17). The smaller wells were used to draw water inside the hospital complex and in the houses facing on the Consolazione alley. Many of these wells today are filled with debris and waste material. Some larger wells are empty, inspectable and located close to the foundations walls of the Incurabili Pharmacy on the edges of its plan area. In the recent past these shafts have been involved in problems with water infiltration from above produced by huge leaks caused by failures of the pipes of the internal white water drainage system. Some available video inspections carried out with the support of speleologists (Figure 17) show that the upper part of these wells, which is developed in loose and uncemented soils above the the water table, is lined with walls of tuff blocks that are not always in good conditions.

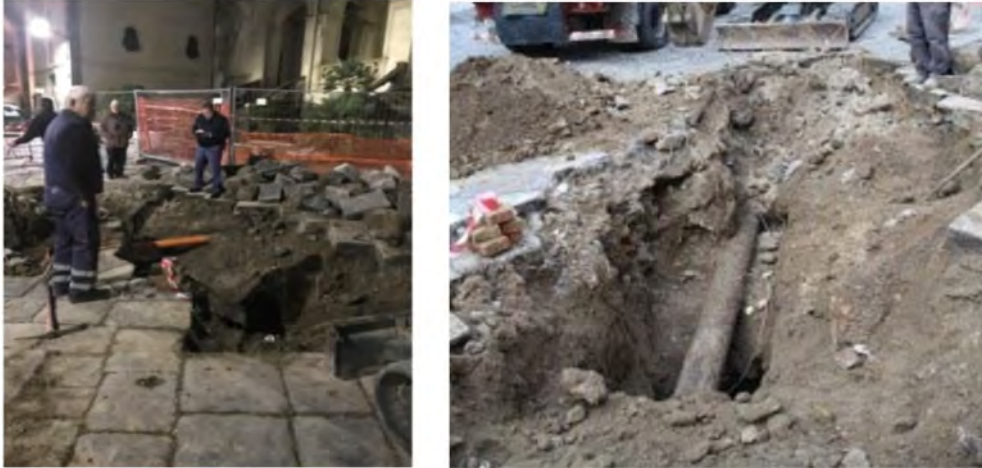
Once established a close relationship between the severe cracks in the monumental complex and the problems with water leakages in the sewer system, the patients of the hospital were quickly cleared out and the drains were quickly interrupted. It is to be underlined that also the inhabitants of the houses on the Consolazione alley immediately below the floor of the Pharmacy were for the first time in the history of the complex cleared out. The white-water network was sectioned at the base of the building and was delivered to the sewer with temporary by-passes. These decisions were promptly taken, and the actions consequently made just at the beginning of the monitoring period. Therefore, as anticipated above, it is extremely likely that the observed settlements or subsidence effects net of the thermal effects are simply the viscous tails of phenomena induced by erosion of

Figure 23. Evidence of damaged pipes of the sewer system of the Incurabili complex.

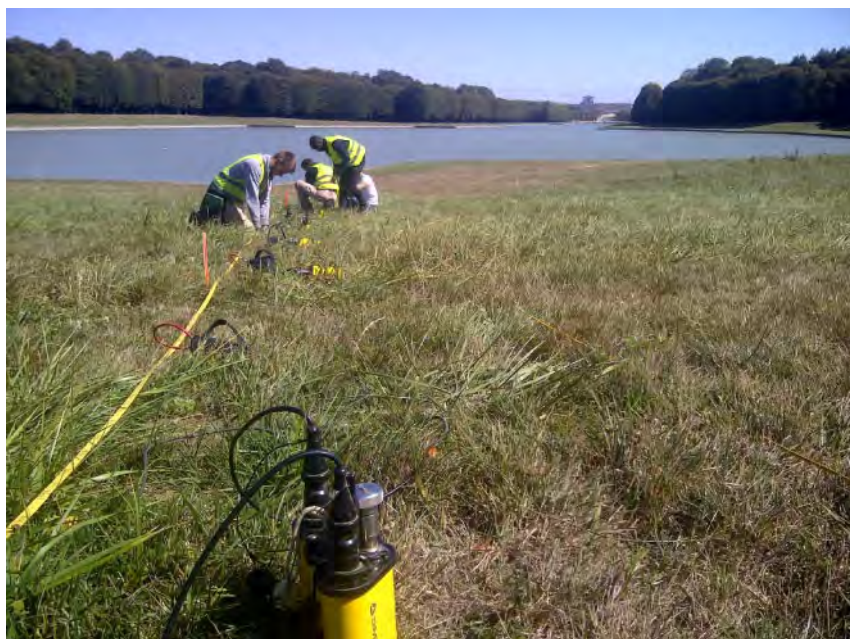
The purpose of the seismic refraction measurements (Figure 3) was comparable to the purpose of penetrometric tests. It has indeed been implemented in order to identify variations in the state of

Figure 3. Installation of a base of seismic refraction measurements (Sept. 2018). The device is installed near the Gally basin. To the east, above the other end of the canal, we can see the Palace.

compactness of the soil by correlation with the seismic velocities of the P wave in the ground. The depth of investigation of the method, with the adopted equipment and parameters, was in the order of 5 to 10 m.

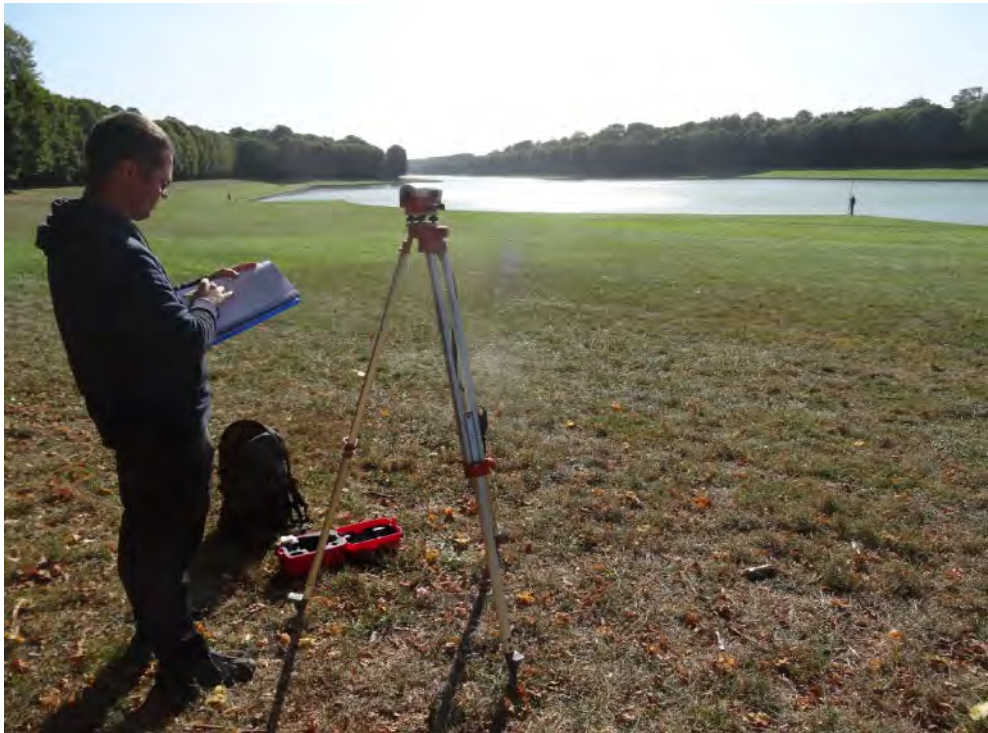
More modest means of topographical measurements were implemented by the teams of students, a levelling type according to a profile determined in advance (Figure 4). These profiles consist of points known by their horizontal distance to a point of origin ( $X$ ) and by their relative altitude to that point ( $Z$ ) measured with a level and a target. The resulting accuracy is in the order of one centimeter over aiming distances of a few tens of meters, very sufficient for a geotechnical objective. The advantage of these measures in the context of the site is that they have not been prevented, but only complicated, by vegetation. All the gathered data were then linked to a fixed reference, the limestone margin of the canal, established at 109 m NGF (General Levelling of France). The resolution (the measuring step) of the measured profiles is variable, the accuracy obtained is in the order of 1 to 10 cm in altimetry and from 10 cm to 1 m in planimetry.

Figure 4. Levelling measures (Sept. 2019). View taken to the East, the visible part of the Grand Canal is the Gally Basin.

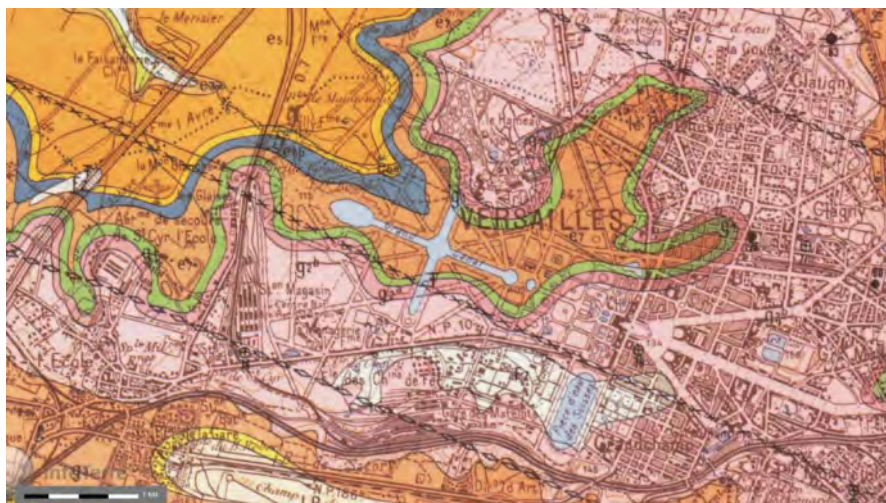
The geological map of France at 1:50,000, Versailles sheet (n° 182) was published in 1967 under the authority of Jean Goguel (Figure 5). It has not been updated since then. It highlights a system of Tertiary formations frequently encountered in the Paris Basin. These are the sandy, clayey, marly or limestone ensembles, from the Stampian to the Lutetian, aged about 30 to 45 million years. The principle of drawing the cartographic boundaries of these strata is to associate with their

sub-horizontal character the pattern of the relief, with the result of relating approximately these boundaries to the topographical level lines. The Grand Canal was mainly developed in the topographic depression of the ru de Gally, within which the geological map indicates as supragypsous Marls of the Ludien (code e7), level dated on average 35 million years, the most recent of the Eocene in the Paris Basin.

Figure 5. Extract from the geological map of France at 1:50,000, Versailles sheet (GOGUEL, 1967), centered on the Grand Canal. The castle is about 1 km east of the canal.

The 2018 and 2019 field measurements were based on the principle that, apart from a first decimetric layer of “topsoil” covering the entire site, the lithology encountered on site had to correspond to the stratigraphic data of this map or be affected by changes related to earthworks. These modifications were not meant to be purely random but to be unified by simple principles of excavated areas and deposit areas, in connection with the Grand Canal construction project of course.

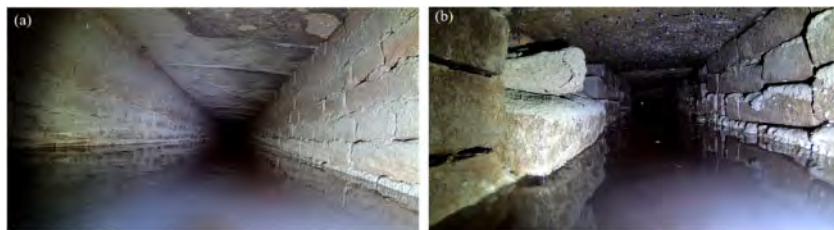
Figure ...shows an inner view of one conduct in good conditions and one in worst conditions.

Figure 4. Inner view of two drainage conducts in S. Mark's square: (a) *gatolo* in good conditions, (b) *gatolo* in bad conditions.

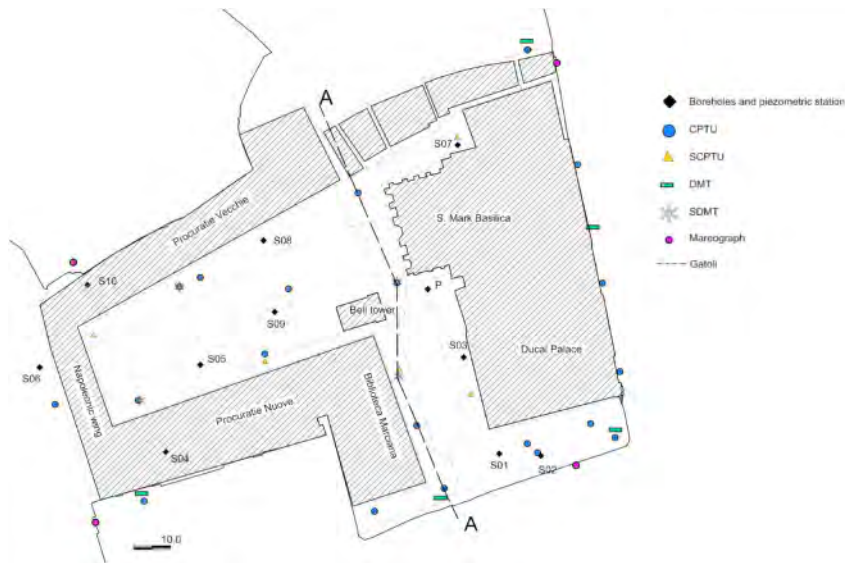
Figure 5. Position of in-situ geotechnical tests (CPTU, SCPTU, DMT, SDMT), boreholes, piezometric stations and old drainage pipes (*gatoli*).

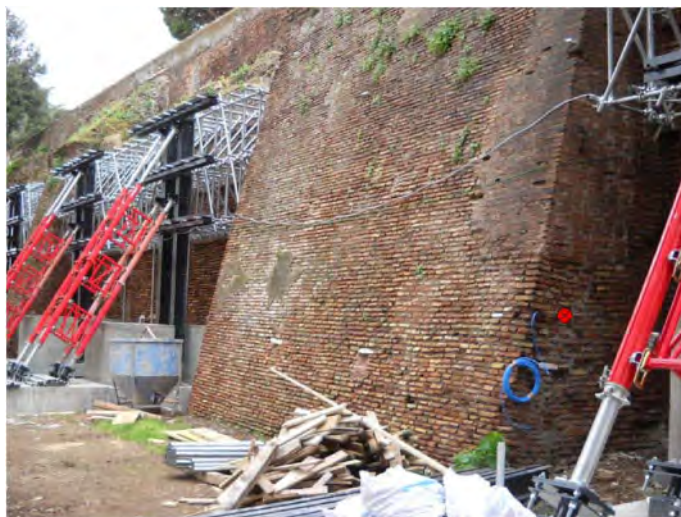
The Aurelian Walls at *Porta Asinaria* are about parallel to the tunnels in the portion facing sections MOM-06 to MOM-03. Prior to start with the excavation activities, Metro C implemented temporary safeguarding interventions on the city wall, consisting of buttresses made by steel tube-joint structures (Figure 9) to prevent any damage eventually induced by unexpected events.

Figure 9. Temporary safeguarding interventions installed at the Aurelian Walls.

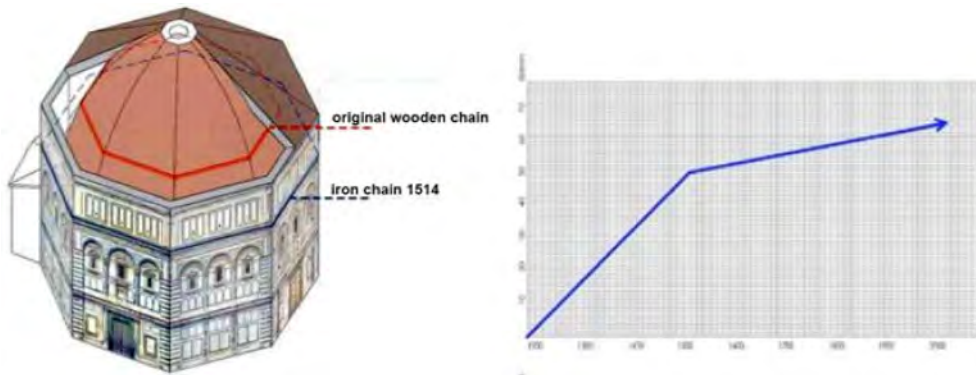
The thrust of the dome points for the outward opening of the curtain walls. In order to contrast the thrust, a wooden chain was placed during construction at middle height of the dome, and an iron chain (5×5 cm) was put in the year 1514 at the base of the dome; this last slowed the opening rate (Blasi et al. 2017) (Figure 8).

Figure 8. Left: chains position in the structure of the dome; right: outward displacement in the time.

But, in respect to a thrust force of 1,250 kN this chain only acts for 537.50 kN, therefore cracks opening is still active, even if at a slower rate (Blasi et al. 2017).

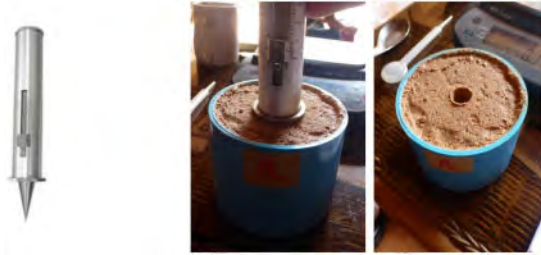
Figure 13. Yamanaka cone test.

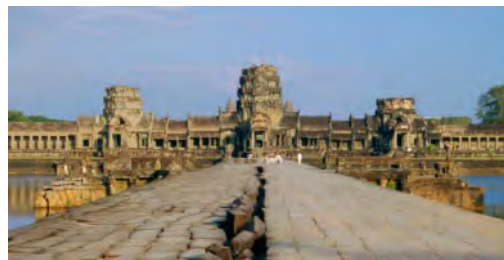
Figure 19. Retaining wall structure of the west causeway of Angkor Wat (south side).

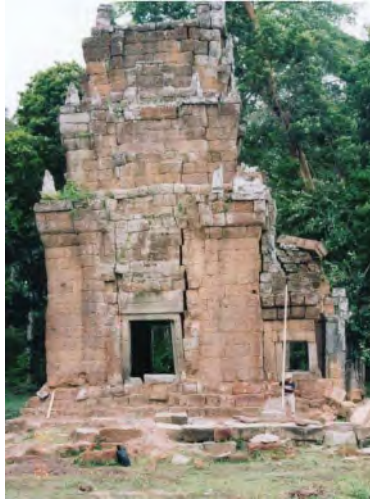
Figure 21 shows one of 12 towers and stands near the north pond and designated as N1 tower.

Figure 21. Prasat Suor Prat N1 tower (west side).

N1-tower has inclined 4–5 degrees northward from the vertical and represent the largest inclination in all towers of Prasat Suor Prat.

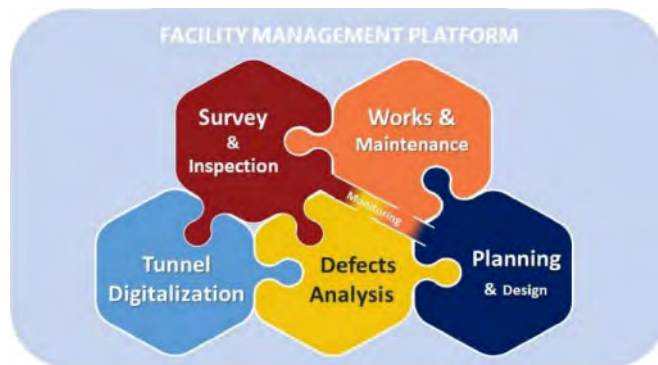
- **Facility Management Platform**: an environment in which it is possible to have a complete view of the conditions of the infrastructure (e.g., geometry, geomorphological context, and risk and hazard indices, etc.). Each index value falls within specific ranges which, (e.g., with a value from 1 to 4), indicate the health of the infrastructure. The index value is not defined a priori but varies according to the aspects considered, in fact, it is possible to deconstruct it to adapt the assessment to different situations and to make it more usable by different users. Moreover, it is possible to view monitoring alerts that show the exceeding of critical thresholds.

Figure 2. Puzzle chart of the workflow (Foria et al. 2021).

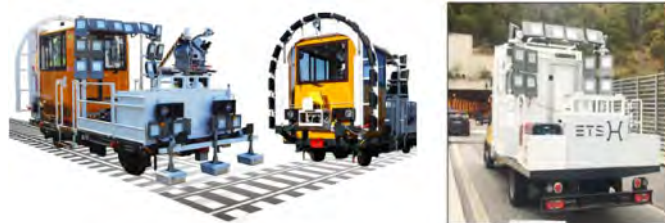
In the case of ETS srl, the system developed is ARCHITA, a multi-dimensional mobile mapping system consisting of linked and integrated equipment (Foria et al. 2019). It carries out the survey activity with an average speed of 15-30 km/h, minimizing the impact on existing lines with shortstop of the traffic and without disconnection of the electrical tension (for railway). The system can work in two different configurations (Figure 3): RAIL and ROAD.

Figure 3. ARCHITA: RAIL (on the left) and ROAD (on the right) configuration (Foria et al. 2019).

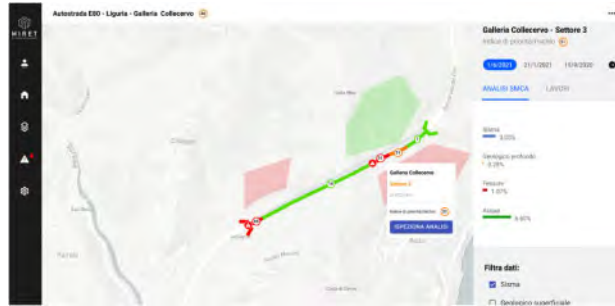
Figure 8. Priority Index of the Railway Line Andora-San Lorenzo: high priority (red), medium priority (orange), low priority (yellow), no priority (green).

This process is important to immediately highlight the critical issues and intervene promptly by identifying the causes of damages and to plan maintenance interventions effectively and efficiently (Foria et al. 2021). The priority index obtained fall within four priority classes that allow to establish which sectors have higher priority than others. This is important in the field of Facility Management to manage the budget correctly and intervene proactively. The results of this analysis can be showed in a single environment. An example in Figure 8 show of a platform currently undergoing development.

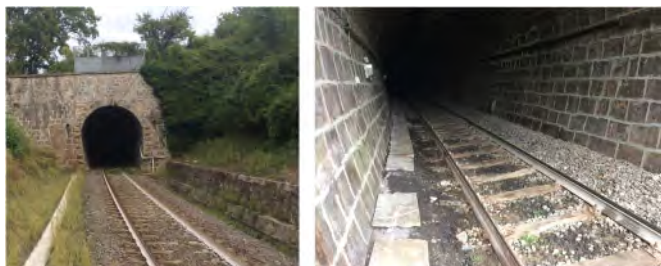
Figure 10. Galleria Sipicciano I: Photo of tunnel entrance ch. 7+228 (on the left) and photo inside the tunnel (on the right).

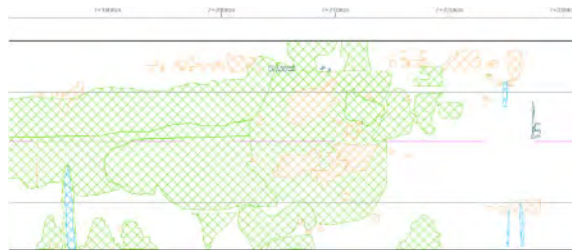
Figure 14. Defects map in CAD environment (Sector 1).

For this case study, it was possible to obtain the photogrammetric profile with the use of a software, to characterize the tunnel, to identify and map the presence, extent, and intensity of any defects as described in the next paragraph (Figures 13 and 14).

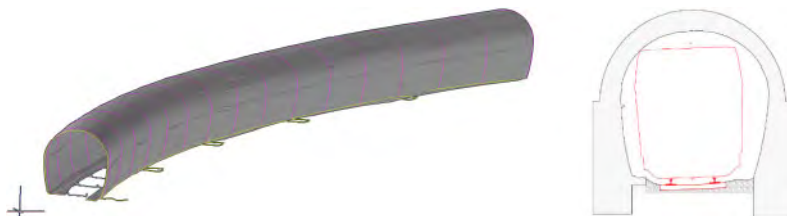
Figure 17. 3D model from geometric survey (on the left) and example of clearance overlapping (on the right): in grey the existing clearance of the tunnel, in red the clearance of the new train (PC80).

The digitalization of the tunnel has been carried out starting from the point cloud of the laser scanner set in relative coordinates. With Autodesk Recap it was possible to process the point and to obtain the 3D model of Galleria Sipicciano (Figure 17) that served as input for the BIM modelling.

On the 3D model obtained it was carried out a dynamic clearance analysis by overlapping the clearance of the new trains (PC80) with the existing clearance of the tunnel (Figure 17) (Foria et al. 2020).

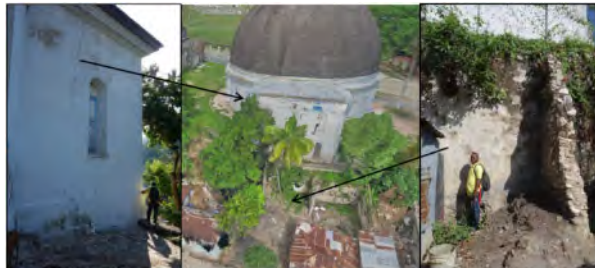
Figure 7. crack in the annex of the chapel (left), 3D view of the Chapel (center, source Iconem) and retaining wall in masonry (right).

The geotechnical interpretation of the site and the dynamic analysis are confirmed by the statement of a crack in the wall of the annex that it just above a masonry retaining wall (Figure 7).

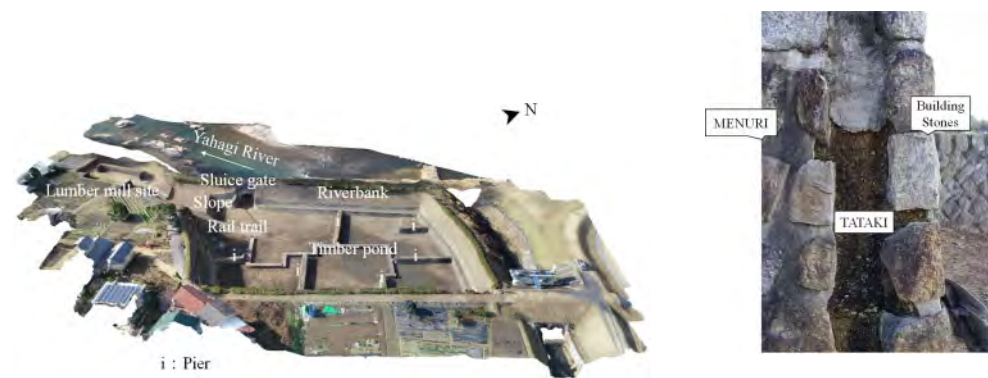
Figure 2. Perspective view of Doudo lumberyard.

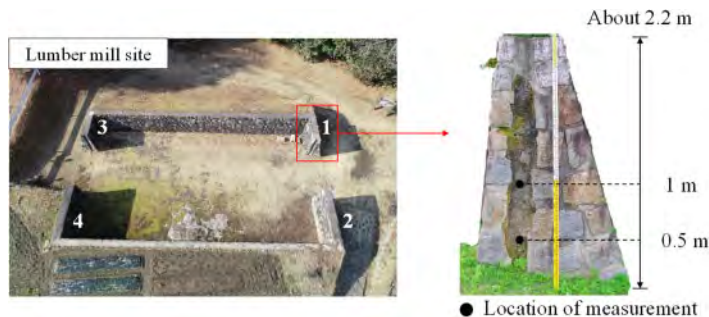
Figure 5. Measurement location.

was conducted at four locations, so totally eight points are selected. Five times measurements were taken at each point, and the average values were converted into the average unconfined compression strength.

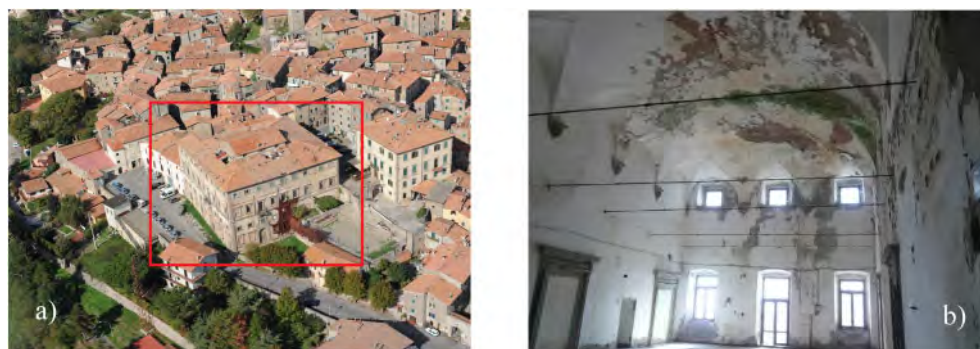
Figure 1. The Bourbon del Monte Palace in Piancastagnaio: (a) outside view; (b) inside view.

of the '80s of the last century when it was declared unfit for use by the Public Authorities. Such a drastic decision was motivated by the high degree of instability that characterizes the whole building and that started growing significantly from the '70-'80's. Figure 1a shows the outside of the Bourbon del Monte Palace with the South-East corner in the foreground. Figure 1b shows the extreme degradation in the biggest central room inside the building.

At date, severe degradation phenomena consist of multiple cracks' systems diffused along the external and the inner masonry, and of water infiltration from the basement at the South-East corner where the crack pattern is the most critical. Numerous investigations (geotechnical and geophysical surveys, numerical analysis of the building) have been performed in the past 30 years (e.g. Baldi 2008; Bartoli et al. 2008; Bartoli & Betti 2012; Betti et al. 2010; Montini 1990), trying to shed light on the origin of such a diffuse degradation. According to Bartoli & Betti (2012), the Palace has undergone two distinct differential settlements systems in the foundation soil underneath the South-East edge. The first dates before the 70's and may have caused the crack system along the South wall of the Palace, letting the edge starting to detach, while the second, developed during the second half of the 80's, may be the cause of the damage observed in the East wall. The latter system could also probably be related to the water infiltration from the basement, a phenomenon that has been observed since the '80s. The reasons for the two settlements systems have never been univocally clarified, although research results from numerical analysis on the Palace showed that the two mechanisms are distinct (Bartoli & Betti 2012). Figure 2 shows the crack systems along the South and East walls, as reported in Picchioni (2008); Bartoli et al. (2009).

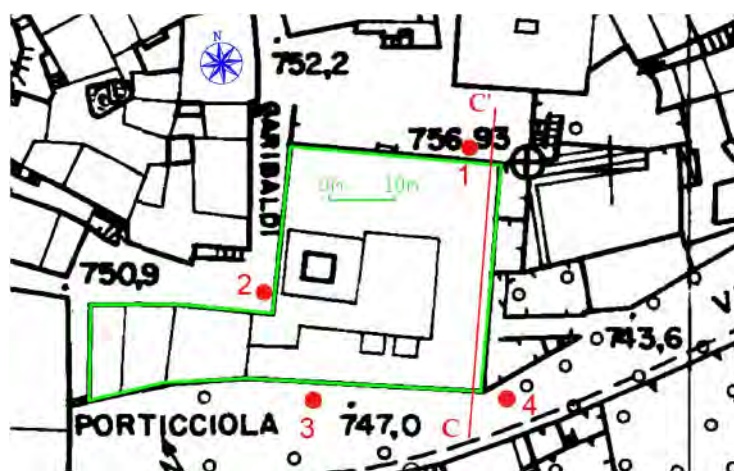
Figure 3. Survey Boreholes location (red dots) and Section CC'. The basement is located close to borehole n°4.

Seven different soil types can be distinguished from the 4 litho-stratigraphic borehole profiles (Baldi 2008): filling soil (R), loose brown sand (Sa), sand with trachyte small clusters (Sa+Tra), fractured trachyte (Tra), grey silty sand (Sl), grey-brown sandy silt (Ls), and silt (L). Figure 3 shows the location of the 4 boreholes described in Baldi (2008) and the cross Section CC' that was used for numerical analysis (see Section 3.2).

From borehole surveys, it follows that the soil profile at the Northern side of the building (borehole n°1) includes trachyte (Tra) blocks ( $\approx 26$  m thick) overlying silt (L); at borehole n°2, it is characterized by  $\approx 9$  m-thick Sa+Tra layer laying above silt (L), while boreholes n°3 and n°4 show the presence of a thin sand (Sa) layer ( $\approx 1.5$ – $1$  m thick at boreholes n°3 and n°4, respectively) overlying  $\approx 4.5$  m constant-thick sandy silt (Ls) layer, placed above a silt (L) layer. Shortly, some important conclusions can be drawn: a) the Palace lies on heterogeneous soil and rock types; b) significantly different subsoil configurations can be found at the Northern and Southern sides of the building. The Northern façade stands on trachyte blocks, while the subsoil under the Southern side is characterized by a sandy silt lens included between a thin Sa+Tra layer and the underlying L. The transition between trachyte and sandy silt at this side of the Palace is somewhere located at the entrance of the basement, where outcropping rock was used in the past as the foundation of the masonry arch that leads downward to the basement (Figure 4a).

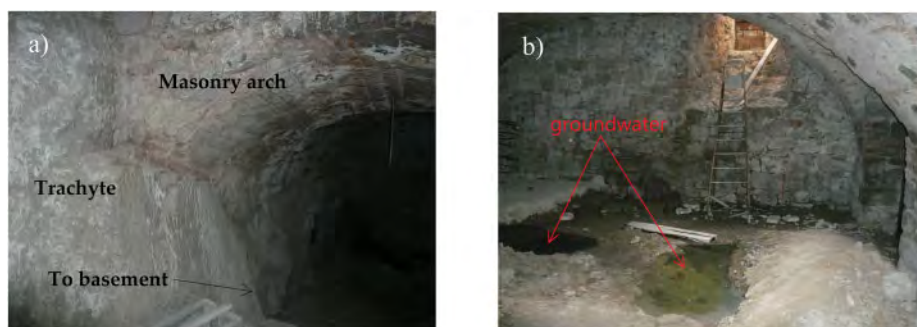
Figure 4. The basement: trachyte outcropping at the entrance (a); groundwater emerging from the floor (b).

According to piezometric measurements within the borehole n°3, the groundwater table is located at a depth of 3 m; a piezometer installed in the Palace basement (thus, at the South-East corner) revealed that the groundwater table is 0.5–1.0 m below the ground level. 2D electrical resistivity tomography performed within the basement (Losito 2010) confirmed that the subsoil was water-saturated. During a more recent visual survey conducted in 2015 by the authors, the groundwater had emerged and filled the survey excavations carried out at the basement (Figure 4b).

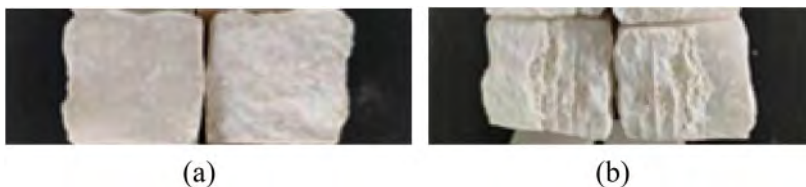
Figure 6. The failure mode of the repaired beams: (a) Group C-2, (b) Group D-3.

The injection grouted beams, i.e. Group A and C, are all broken with the same failure mode that the original stone beam separates from the bonding layer, as presented in Figure 6 (a). With respect to Group C where the sample has both a rough surface and a smooth surface, the damage always occurs to the smooth side, suggesting that the rough interface may improve the interface strength.

In comparison with the injection grouted beams, there are two different types for the specimens repaired by gravity-driven infiltration (Group B, D, and E): 4 (Group B-1, B-2, B-5, and Group D-5) of the 15 gravity-driven infiltration samples are cracked with the original stone beams separating from the bonding layer as well as the injection grouted beams; the other 11 specimens are cracked with another failure mode that the fracture surface arises from one side of the original beam and propagates through the bonding layer to the opposite side, as shown in Figure 6 (b). It is worth mentioning that Group D-4 is damaged with its fracture surface expanding through the original stone beam, showing that the white marble beam and the dolomite sand grains are bonded together well. The bending strength of Group D-4 is also the highest (5.46 MPa) among the beams repaired by gravity-driven infiltration. For the rest of the 10 samples, only the two original sections and the bonding layer are damaged. The results potentially demonstrate that in this study, for the beams treated by gravity-driven infiltration, the interface strength and the bonding layer strength are closed while the bonding layer strength of the injection grouted samples is clearly higher than the interface strength, meaning that there are some weak cementations in the bonding layer of the gravity-driven infiltration specimens.

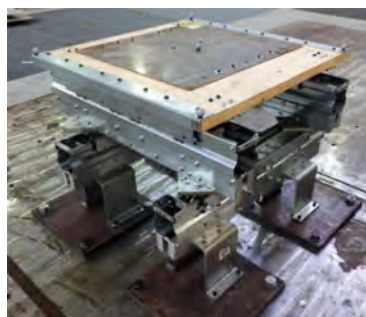
Figure 2. KSJ bidirectional isolator for seismic protection of statue-like structures.

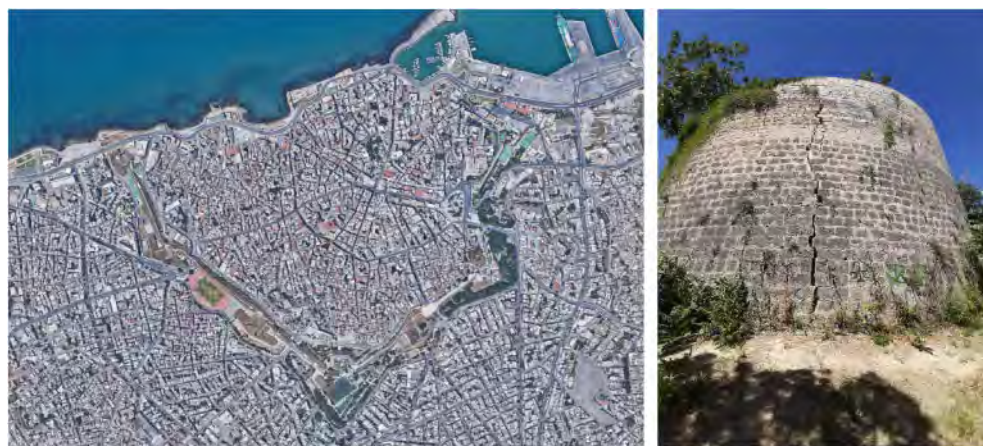
Figure 1. (a) A satellite image of the Heraklion City bastion fortification system (Google Earth). (b) A view of the Martinengo bastion, damaged by vertical cracks.

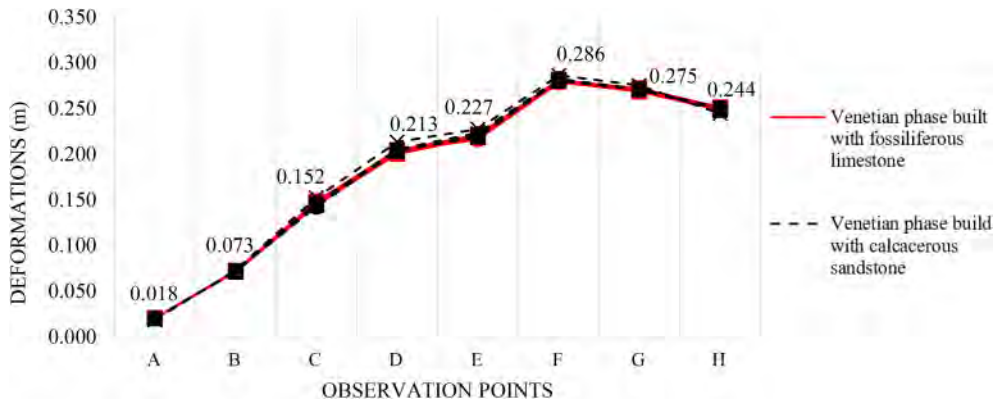
Figure 5. Deformations per analysis for the Group 3.

Figure 5, presents the simulation results when applying all possible combinations of building material as well as all possible values of modulus of elasticity, estimated by the methods listed in paragraph 4.2.2. The calculated deformations can be seen converging; thus, it is concluded that neither the method (equations and formulas) with which the modulus of elasticity of each phase is calculated nor the unit that Venetian phase is considered to be built with, play significant role in the overall stability of the system. The highest safety factor calculated is  $SF_{MAX} = 1.081$  and the lowest  $SF_{MIN} = 1.076$ .

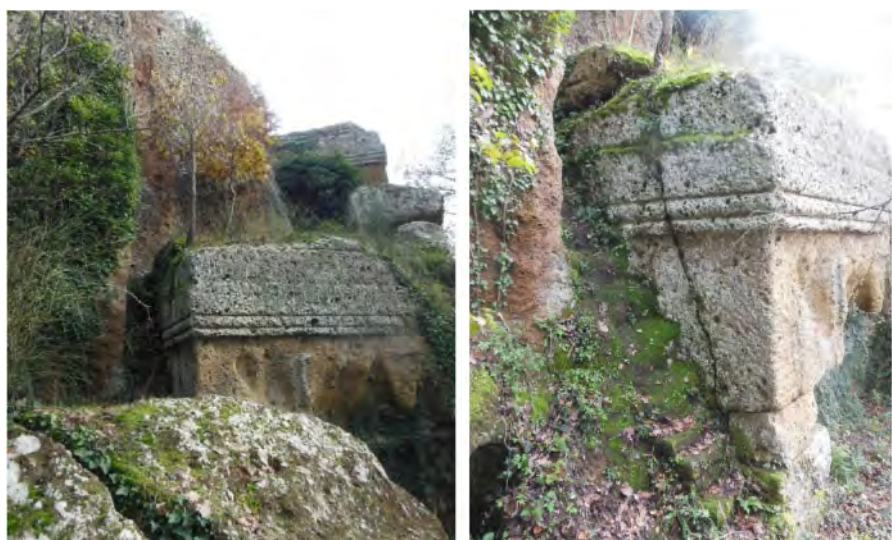
Figure 4. Frontal and lateral view of the tomb selected as a prototype example of analysis and mitigation measures.

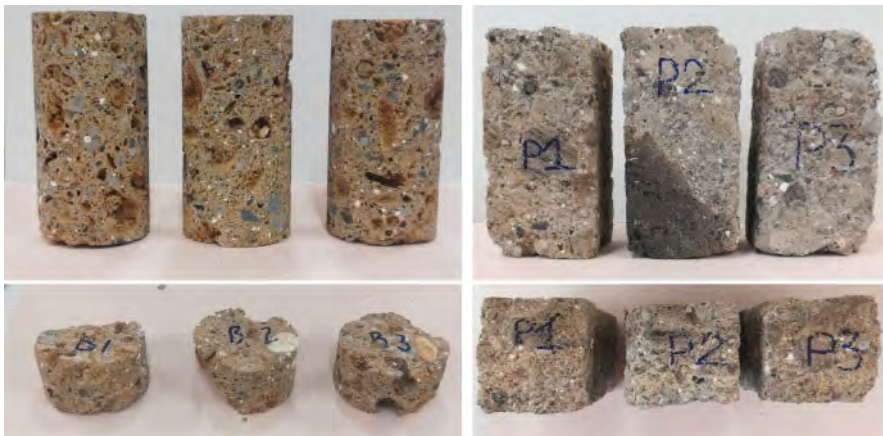
Figure 6. Specimens for the laboratory tests. Cylindrical specimen belonging to lithology A (left) and parallelepipeds to B (right).

The appearance of this block and the different altitude at which it was taken suggest also a different pyroclastic flow deposit and a different alteration, due to the different atmospheric conditions to which it was affected. Due to the extremely weak nature of the material, combined with the presence of clasts with a greater resistance than the soft matrix, it was not possible to realize cylindrical specimens of standard size for this block, but only parallelepiped specimens (Figure 6).

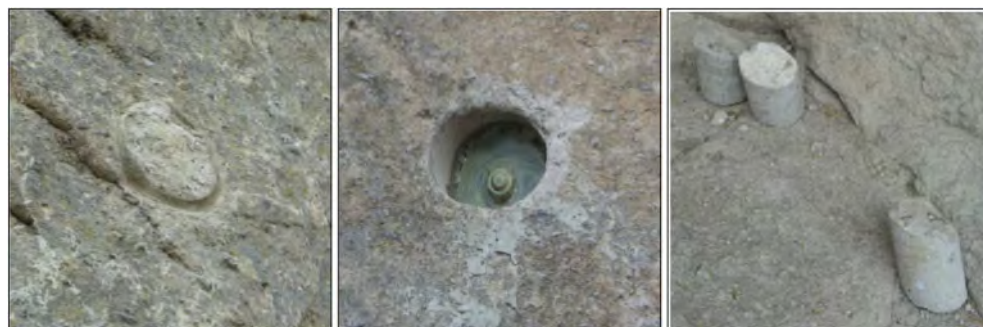
Figure 8. Rock core drilled used for mitigation (left), bar insertion (center) and bolt sealing (right).

Before the hole is drilled, a continuous bore of 15 cm will be carried out to preserve the core itself. Once the reinforcement is installed, the rock core drilled will be reinserted into the hole and cemented with a mortar with local aggregates, to hide the plate and mitigate the visual impact of the intervention.

To better integrate the interventions and decrease the visual impact, the head of the passive bars will be conveniently hidden from view by using same rock resulting from drilling activities (Figure 8).

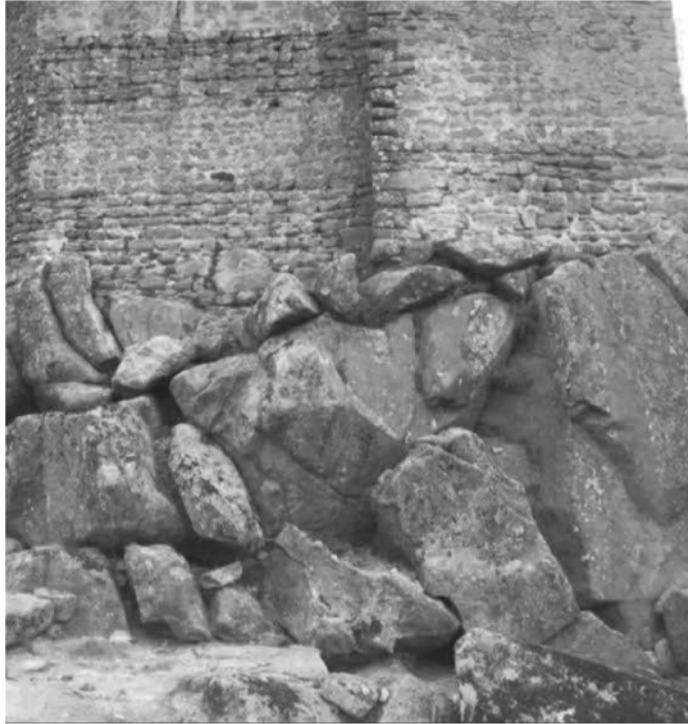
Figure 1. Examples of different degrees of weathering. To the right, moderately weathered granite (W3). On the left, slightly altered granite (W2).

In terms of weathering/alteration, the rock mass at the foundation is typically slightly weathered (W2), with the surfaces of the discontinuities presenting, sometimes, oxide stains (Figure 1). The smaller granite blocks show some weathering from the discontinuity zones towards the interior of the block and were classified as moderately weathered (W3). Occasionally, there are still more intensely weathered areas, which can be broken down, associated with more exposed and fractured areas.

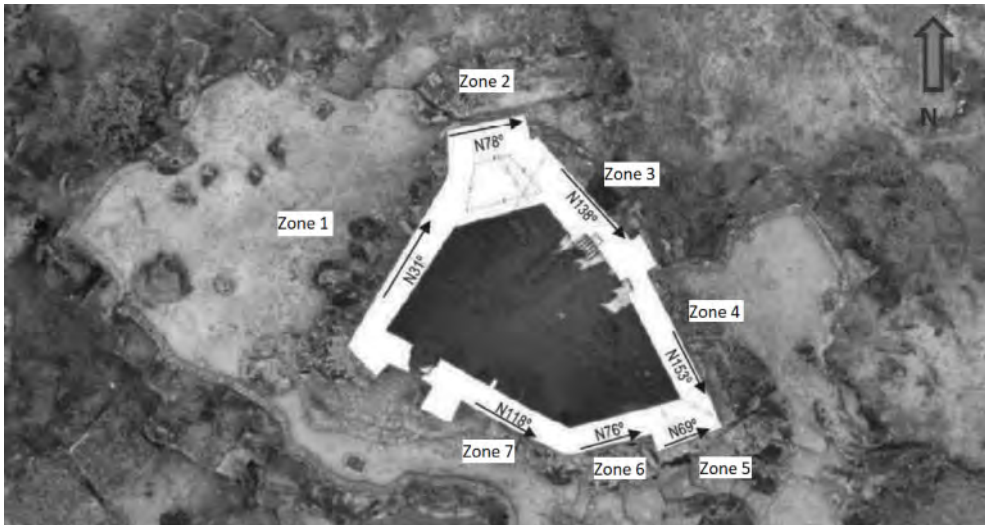
Zone #1 concerns the castle wall facing NW. Zone #2 is formed by the outer wall of the castle cistern. Zones #3 and #4 concern the castle wall without the outer platform (as formed by outer wall or barbican). Zone #5 is constituted by the outer wall of the turret next to the external access, whereas Zone #6 concerns the wall facing SE. Finally, Zone #7 concerns the wall of the castle's entrance door.

Figure 3. Castle zones and Castle wall orientations.

Geotechnical zonation was performed to duly differentiate potential mechanisms and to define specific stabilization procedures. Therefore, the castle was divided into 7 zones, as shown in Figure 3.

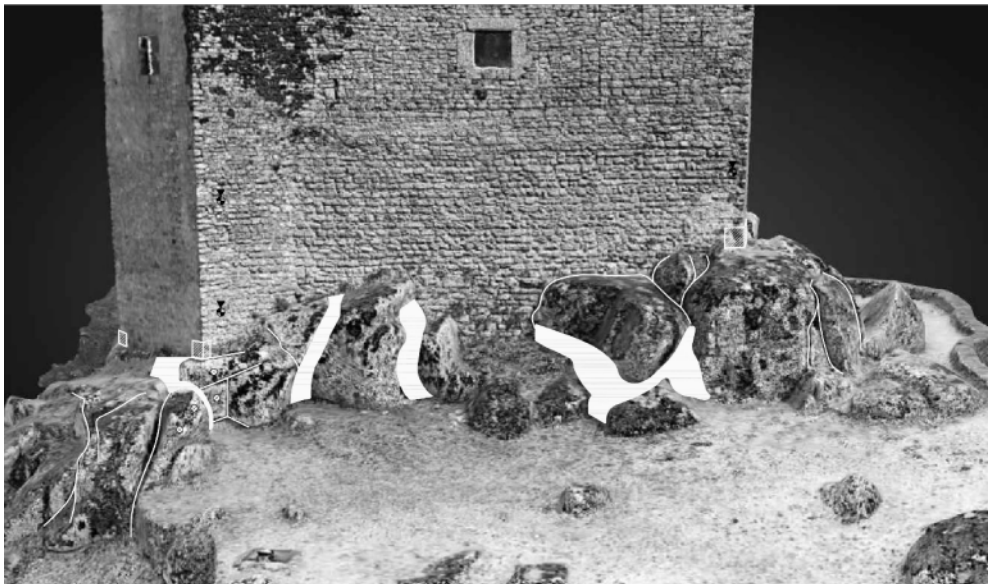
- White solid hatch: underpinning of rock outcrop blocks using stone mortar or cyclopean concrete.
- White line: execution of fracture and discontinuity sealing.
- White line hatch and envelope: underpinning works of the castle wall using hydraulic lime concrete.
- White circles: rock bolts.

Figure 9. Zone #1. Solution layout.

The following figures (Figure 9 to Figure 13) illustrate the adopted solutions along the zones presented in chapter 4. For all layouts, the solutions are presented as follows:

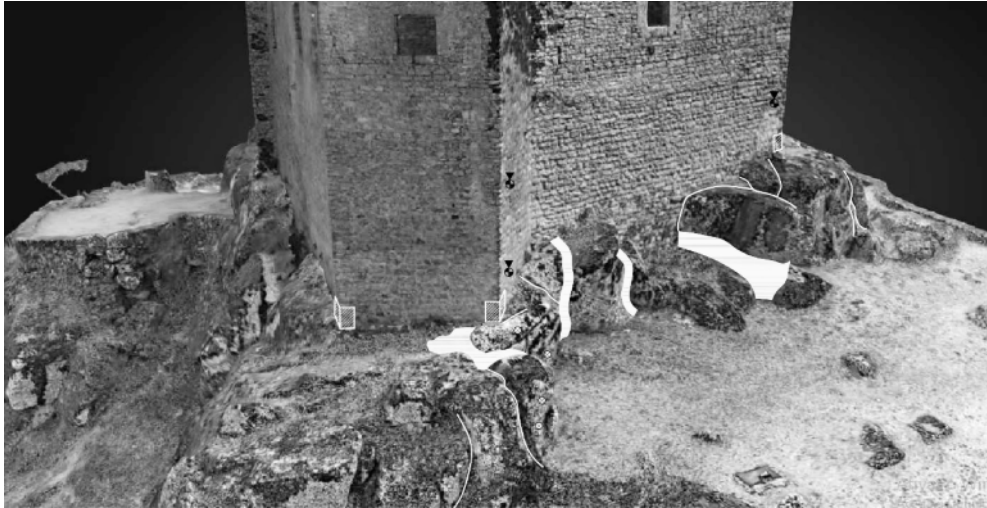
Figure 10. Zone #2. Solution layout.

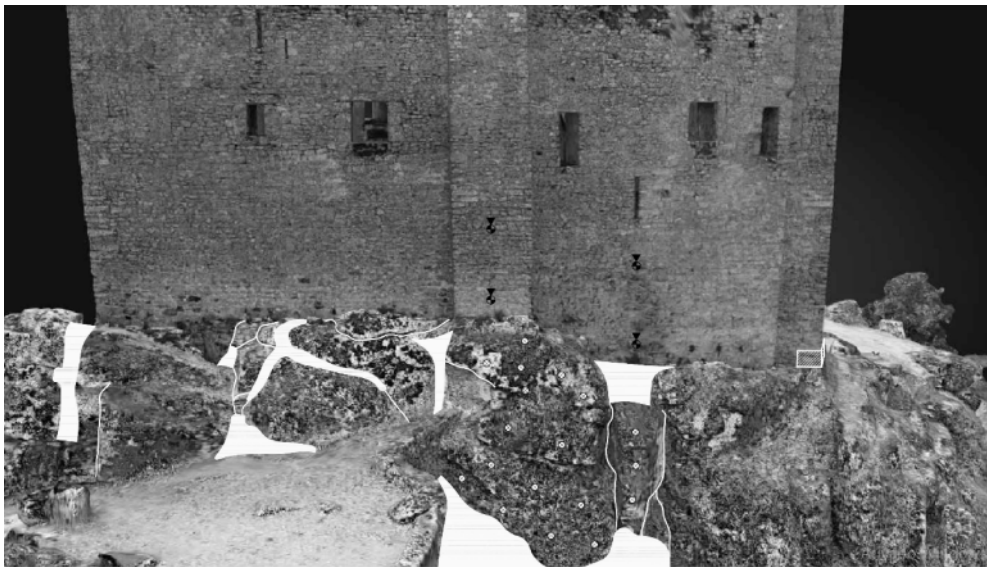
Figure 11. Zones #3 and #4. Solution layout.

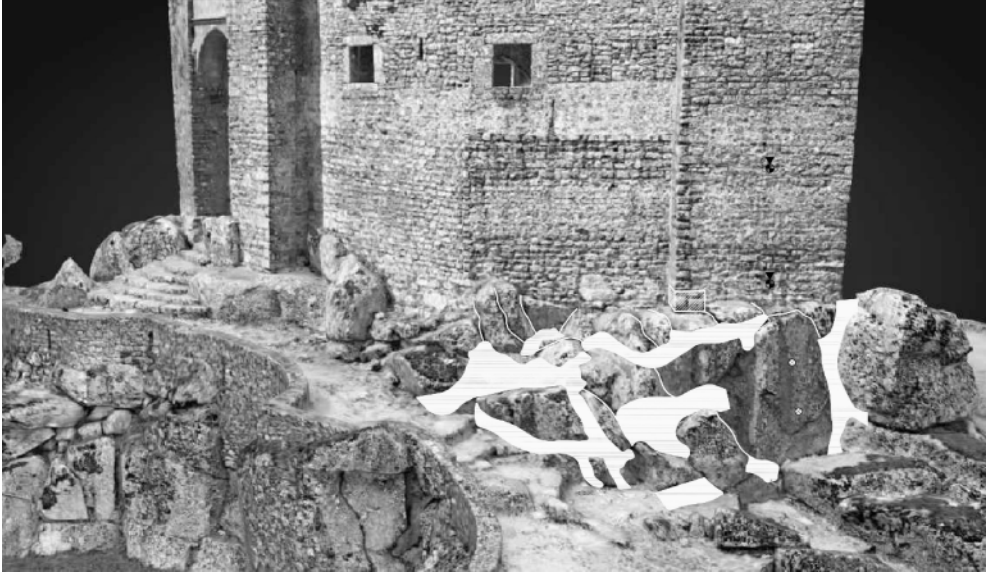
Figure 12. Zones #5 and #6. Solution layout.

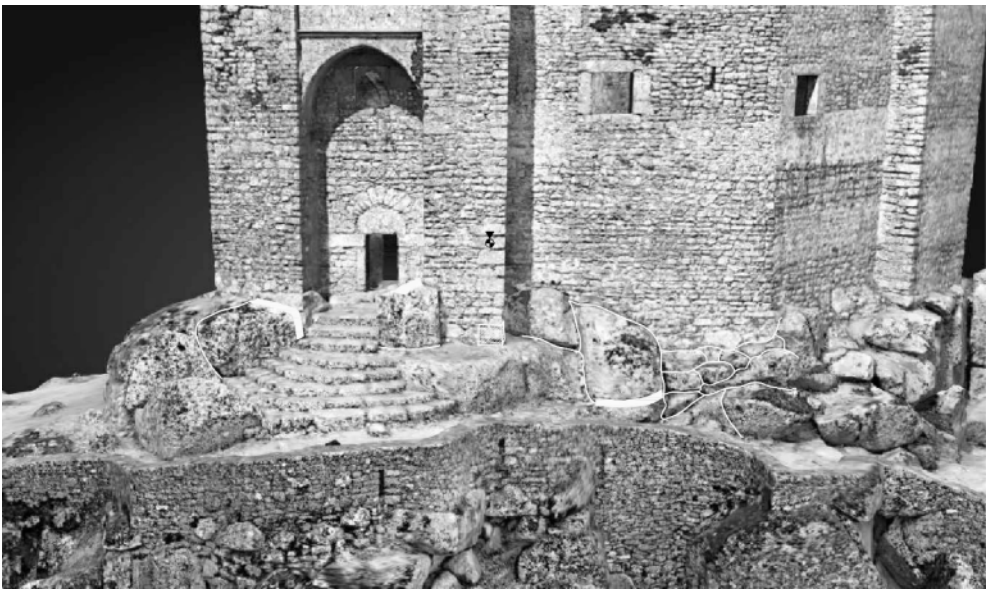
Figure 13. Zone #7. Solution layout.

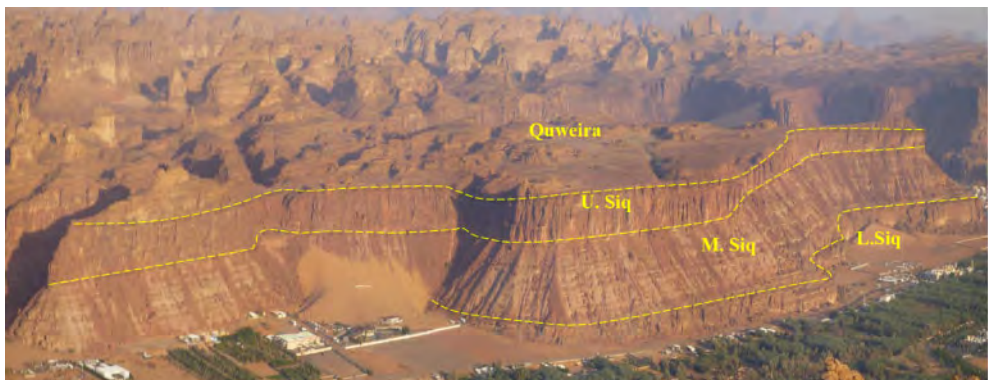
Figure 4. Panoramic view (slightly vertically-exaggerated) of the litho-stratigraphic succession in the AIUla area, taken from the highpoint of Harrat Al Uwayrid, West of the town of AIUla. Sandstone units are recognized in this section, except for the Saq Sandstone, which outcrops out further North of this area (Wahbi 2014).

The panoramic photograph in Figure 4, taken from the “highpoint” on top of Harrat (lava plain or volcanic field of Al Uwayrid west of AIUla – Wahbi 2014), displays most of the lytho-stratigraphic succession in the area. This division is evident from the weathering profile of the outcrops in the area (Figure 4).

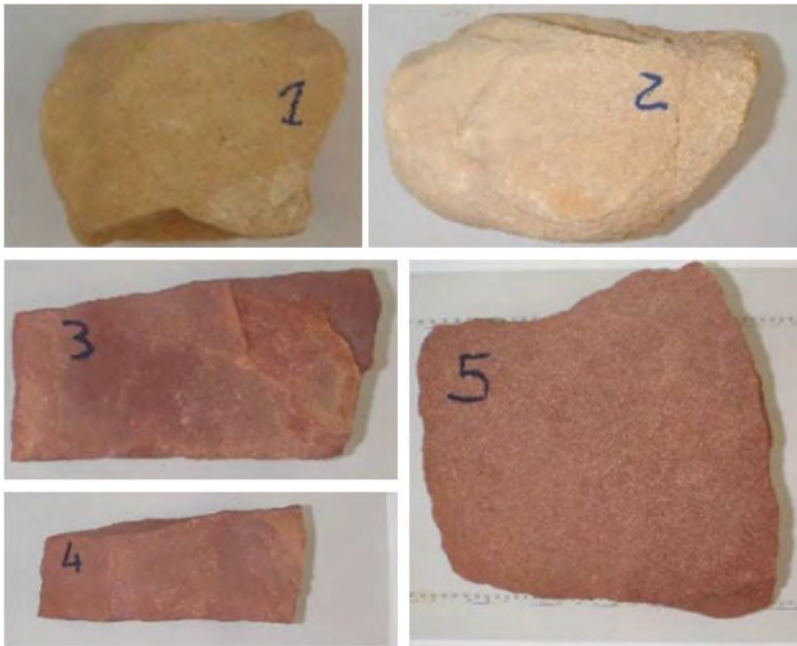
Figure 6. The five rock samples collected and analysed in the laboratory.

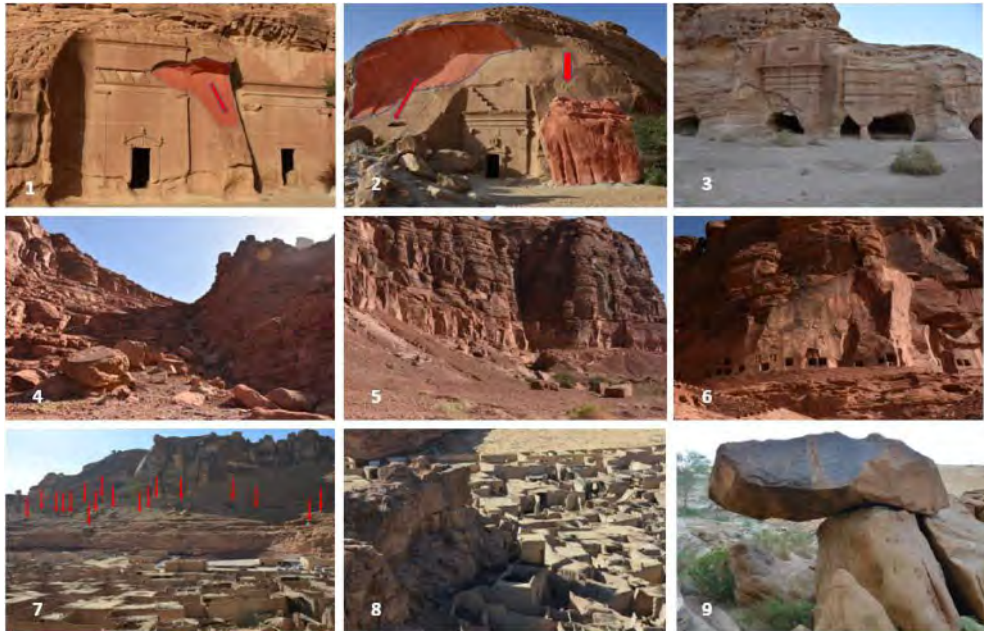
Figure 10. Example of the main instability processes affecting the different archaeological sites belonging to AIUla region: 1&2 rock slide and free fall in Hegra; 3 basal erosion affecting pillars and rock facades in Hegra; 4&5 rock blocks fallen in Dadan; 6 condition of rock cliff affecting the Lions tomb in Dadan; 7 rock blocks accumulation in AIUla Old town western cliff; 8 potential slope instability inside AIUla Old town; 9 unstable and fractured rock arts block in Jabal Ikma.

The slope angle for most of the rock faces is prevalently larger  $80^\circ$ , with frequent overhanging surfaces consequent to erosive processes or block collapses at their base. Slope kinematics, and thus potential failure modes, is mainly ruled by high and medium dip angle of the main discontinuities versus local slope orientation. Also the presence of horizontal discontinuities (bedding planes) causes failure modes and volumes of potential instability (see Figure 10).

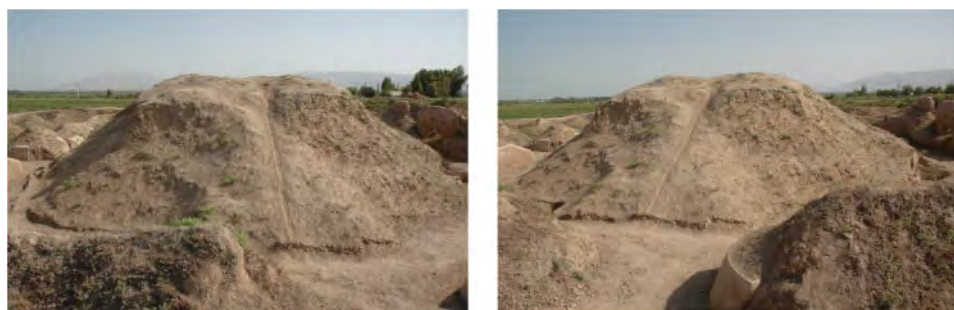
Figure 1. A pair of stereo-photographs of southwestern side of Stupa.

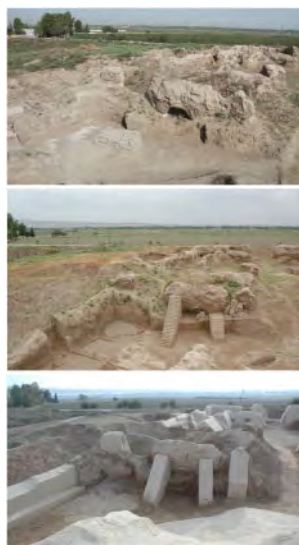
Figure 5. Chronological change of the site. Upper: 2006, Before conservation; Middle: 2007, During conservation; Low: 2008, After conservation.

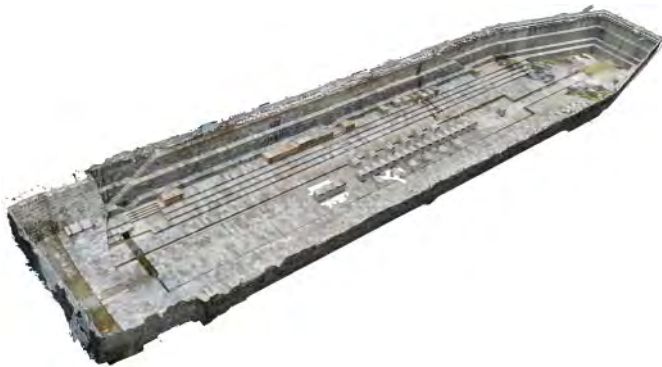
Figure 7. Perspective view of the 3-D texture model viewed from southern direction. The size of the dock, the length 134 m, the width 30 m, and depth is about 9 m.
