# Geotechnical Engineering for the Preservation of Monuments and Historic Sites III

Edited by  
Renato Lancellotta, Carlo Viggiani,  
Alessandro Flora, Filomena de Silva,  
and Lucia Mele

PROCEEDINGS OF THE THIRD INTERNATIONAL ISSMGE TC301  
SYMPOSIUM, NAPOLI, ITALY, 22–24 JUNE 2022

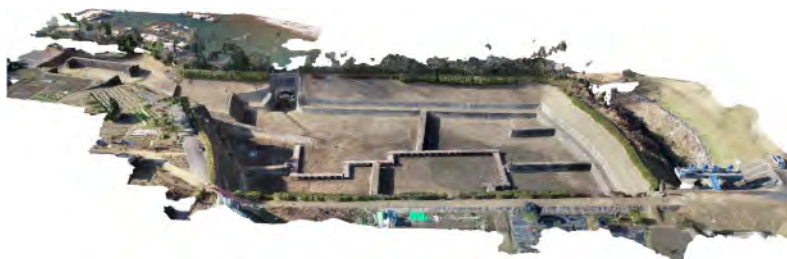
Figure 9. Perspective view of the 3-D texture model viewed from southeast direction. The size of the lumberyard, the length 100 m, the width 50 m, and depth is about 10 m.

The camera sensor has a resolution ( $\delta_{\text{CCD}}$ ) of 0.0024 mm. Therefore, GSD ( $\sigma_{\text{XY}}$ ) is calculated approximately 8 mm from the equation (1). The SfM/MVS software (Agisoft Metashpe) has been used to generate the 3-D model of the site (Figure 9). RMS of bundle adjustment is less than 15 mm. Trial comparison has been conducted the current 3-D model and the historical documentations (Takeuchi & Fujii 2022).

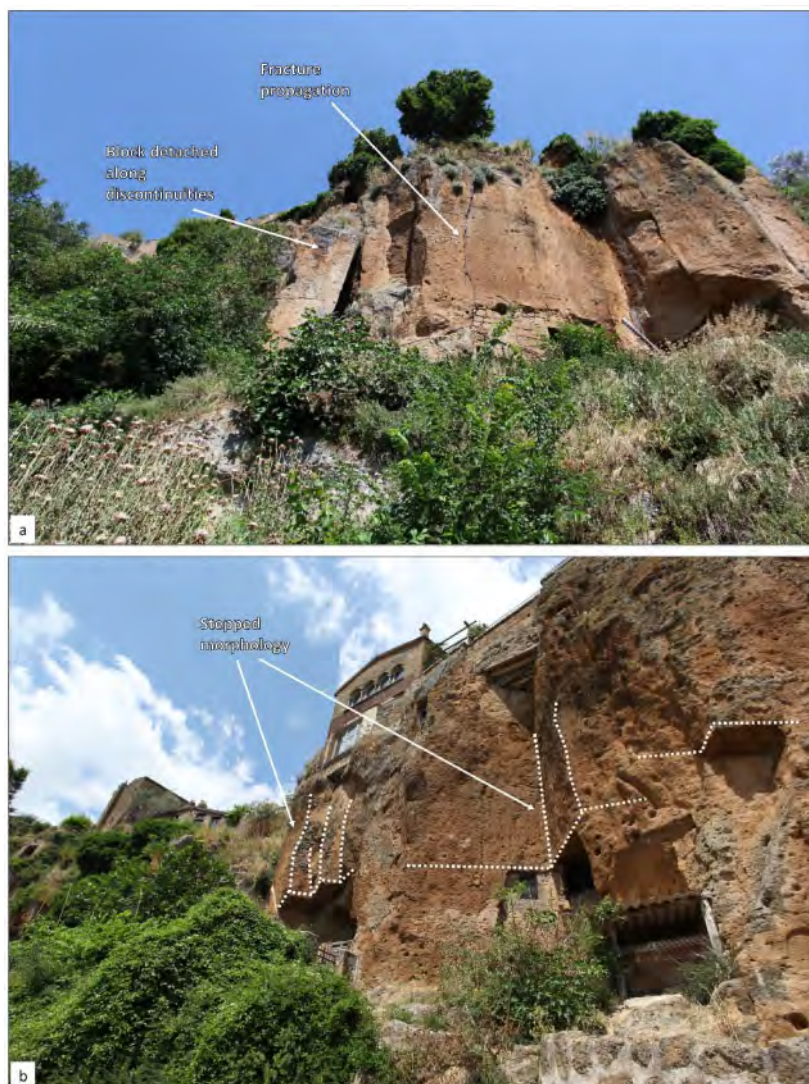
Figure 9. Overview of the processes affecting the evolution of the upper cliff. a: View of the southern cliff displaying fracture propagation and structurally controlled block detachments. b: Example of stepped morphology frequently observed within the massive ignimbrite deposit.

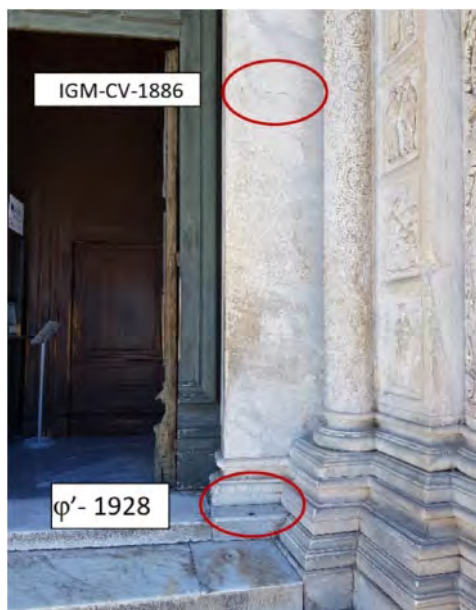
Figure 2. Location of IGM-CV-1886 and  $\varphi'$  benchmarks.

The earliest surveys aimed at the analysis of vertical shifts among benchmarks date back to 1911. In that occasion, the reference benchmark, i.e. the one whose elevation is assumed constant between successive surveys, was provided by a line, signed by the initials "L.P.", etched on the right-hand jamb of the main door of the Baptistery. The benchmark was included in the National Geodetic Levelling Network of the Italian Geographical Military Institute (I.G.M.), and in the present paper will be referred to as IGM-CV-1886 (Figure 2).

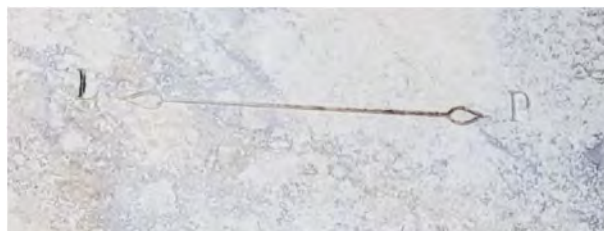
Figure 4. Detail of benchmark IGM-CV-1886.

- A circle, etched on the last step by the left-hand jamb of the door facing the Cathedral, acting as horizontal benchmark with absolute elevation of 4.2930 m. This benchmark, referred to as IGM-CO-1886 in the paper, was destroyed after 1943;
- Vertical benchmark IGM-CV-1886, made up by a line, captioned with the letters “L” and “P”, etched on the right-hand jamb of the above mentioned door (Figures 2 and 4), with absolute elevation equal to 6.7917 m.

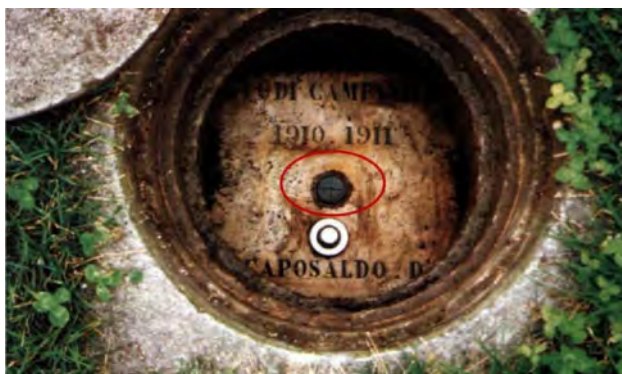
Figure 6. Detail of a 1911 benchmark.

These benchmarks served as both vertices of a small trigonometric network, providing framing support for the Tower overhang measures, and geometric levelling benchmarks of the historic levelling line for elevation surveys, along with benchmark IGM-CV-1886.

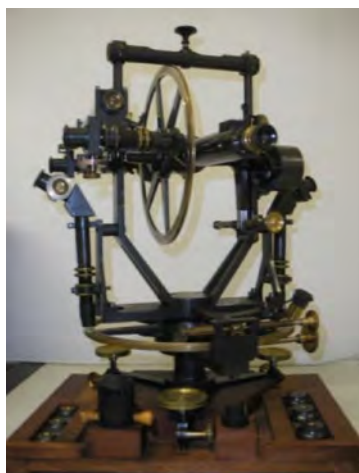
Figure 7. 1896 Universale Salmoiraghi n° 19701, used since 1911 for Bell Tower overhang measures.

The instrument used in these measurements was the 1896 Salmoiraghi Universale #19701 of the “Gabinetto di Topografia” of the Regia Università di Pisa (currently kept at the ASTRO Laboratory of the Pisa University), with 26 cm graduated circles, direct 2” readings and graduation division by movable micrometer (Figure 7).

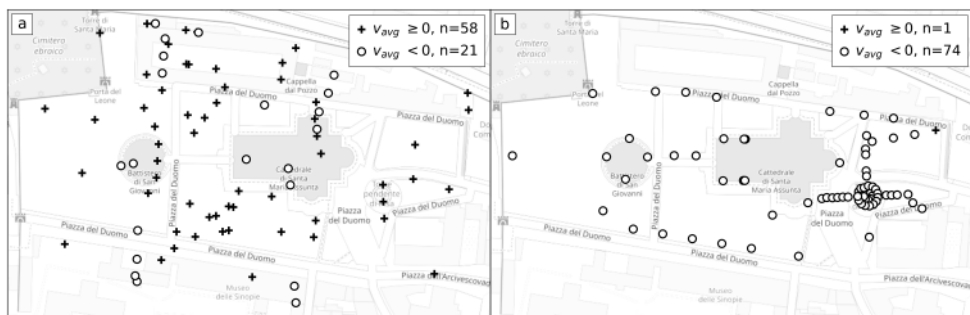
Figure 7. Sign of the average yearly settlement of Piazza del Duomo between June 2018 and 2020 as measured: (a) via Sentinel DInSAR; (b) via levelling surveys. The only cross in (b) is the deep reference point, which is considered fixed.

To corroborate this, a second investigation involved a direct comparison of the trend component of DInSAR and on site measured displacements. In Figure 7, each of the scatterers and ground benchmarks is marked according to the sign of its average yearly displacement between June 2018 and June 2020, indicating whether the point rose or subsided. There is a conspicuous difference between the two images. Subsidence has been recorded in all ground benchmarks (excluding the deep reference point, which is considered to be fixed), while more than 70% of SAR scatterers appear to be rising.

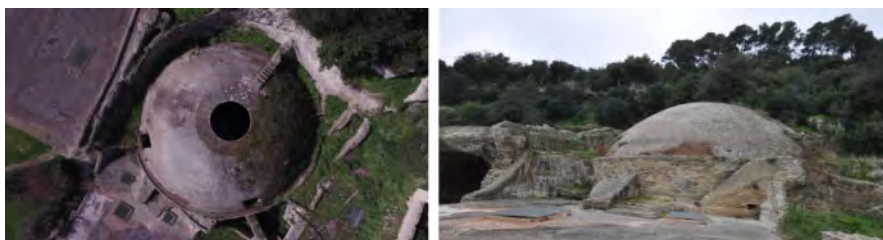
Figure 2. Mercurio Thermae, top and front view of the dome.

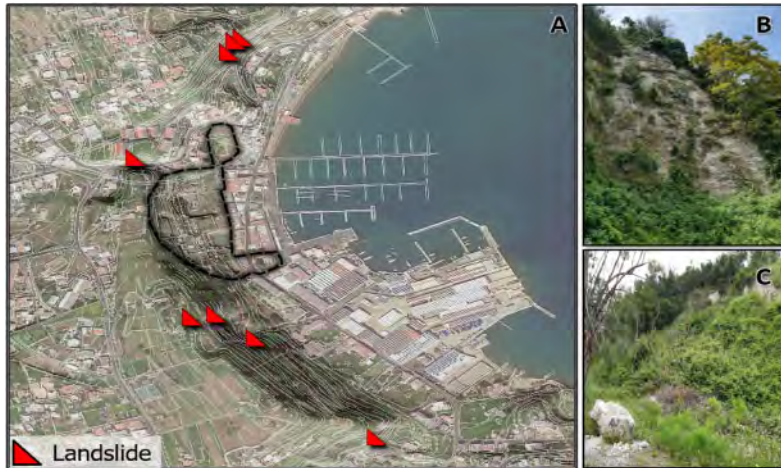
Figure 5. Landslides investigated in the selected area.

The most typical landslide of the area (Figure 5) are rock falls along the steep slopes of the volcano slope (Figure 5B). Falls usually involve not only soft rocks (volcanic tuffs), but also blocks of masonry, deriving from ancient buildings and archaeological structures (Figure 5C).

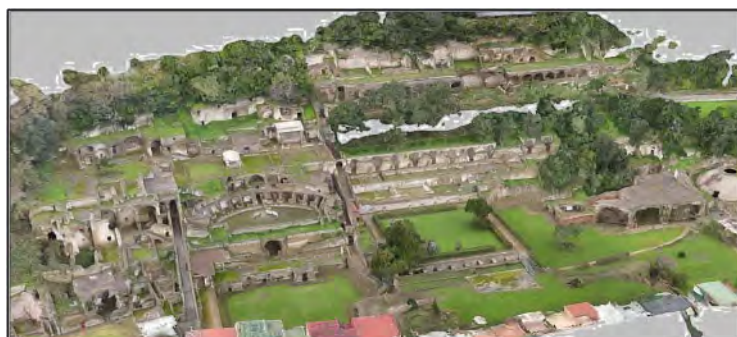
Figure 6. 3D Topographical model obtained by UAV survey.

To test InSAR techniques as a prediction model, during the last two years, field surveys were conducted on all the past and recent monuments' damages, as well as on the deformation phenomena, thus implementing a detailed and georeferenced damage inventory for the whole site. By a UAV survey, a 3D terrain model and an orthophoto were obtained. These tools help to analyze, from different viewpoints, the area as a whole and to understand the relationships among the different complexes of the settlement, as well as possible deformation patterns and geomorphological processes (Figure 6).

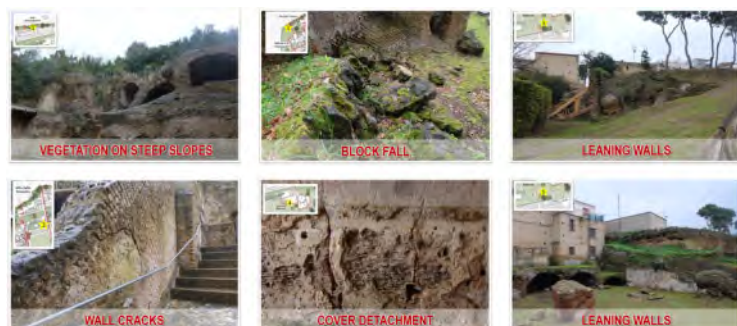
Figure 7. Main typologies of critical conditions surveyed in the site.

The analysis of the area and of the type of buildings helps to classify main typologies of critical conditions: vegetated areas on steep slopes which may trigger landslides, block fall, leaning walls which need shoring and scaffolding support, wall cracks and cover detachment (Figure 7).

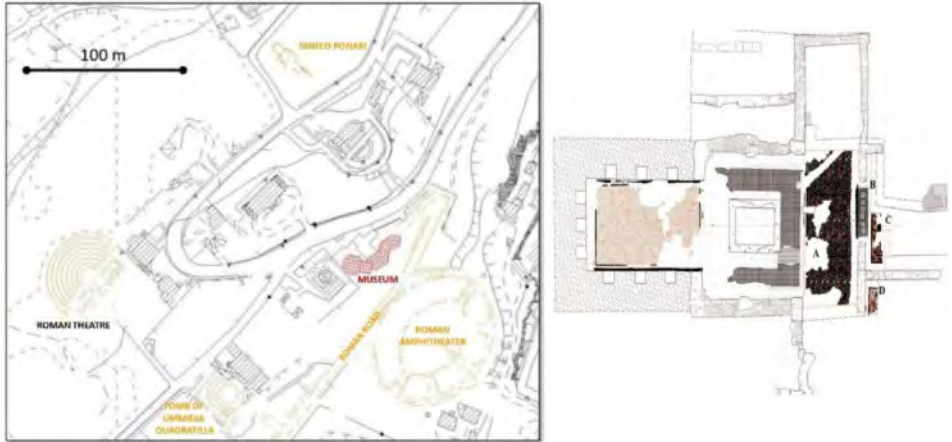
Figure 2. Layout of the archaeological area (a), plan view of the nymphaeum (b).

The walls, built with masonry and covered with plaster, form two contiguous and communicating rectangular spaces: a room covered with a barrel vault and provided with three niches on each side or front wall, 4.6 m wide, 7.5 m long and 4.6 m high in the top of the vault; an open atrium with a basin (impluvium) in the center, 7.5 m wide, 6.4 m long and surrounded by walls about 3.50 m high (Figure 2(b)) (Carettoni 1940; Ghini 1995).

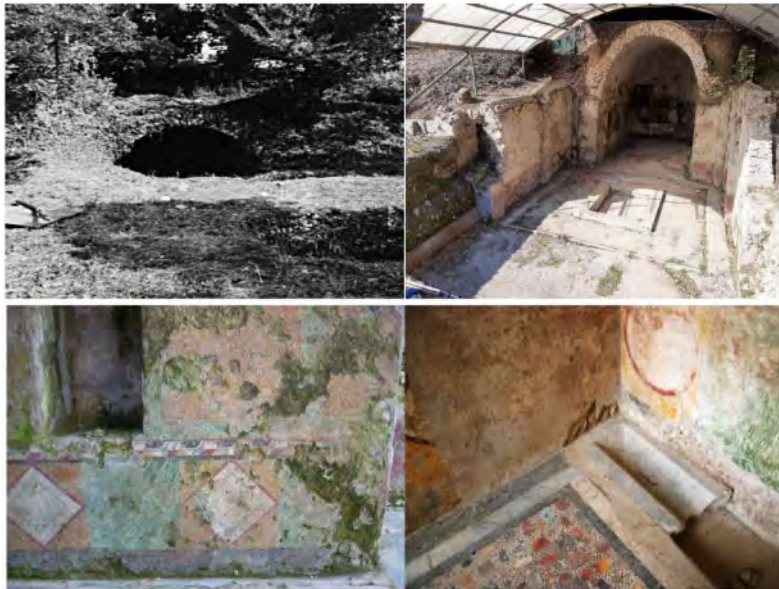
Figure 3. Picture of the Ninfeo Ponari before (a) and after excavation (b), example of painted wall with musk and vegetation (c) and of pavement (d).

Due to its similarity with other examples and the presence of shells and wall decorations, the building was classified as a nymphaeum, given its cave structure. It has been reasonably assumed that the nymphaeum, intended to host water games, was part of a luxurious private residence owned by one of the most important families of the ancient Casinum, the gens Ummidia. (Betori et al. 2009). Until the end of last century, the domus was left abandoned, being almost filled with earth and rubbles (Figure 3(a)). A first excavation, accomplished between 1998 and 2001 (Betori

et al. 2009), brought the structure to light and revealed a rich colored decoration (Figure 3(b)). The presence of debris around the walls and on the vault has determined for long time, and still determines, a meaningful overload on the masonry structures. Neither the inner excavation can be assumed to relief this state. In fact, the contact of the walls with the ground continuously determines infiltration of groundwater that leaks through the masonry and contributes to deteriorate the status of mortar joints and plaster forming musk and vegetation that cover the wall surfaces (Figure 3(c)).

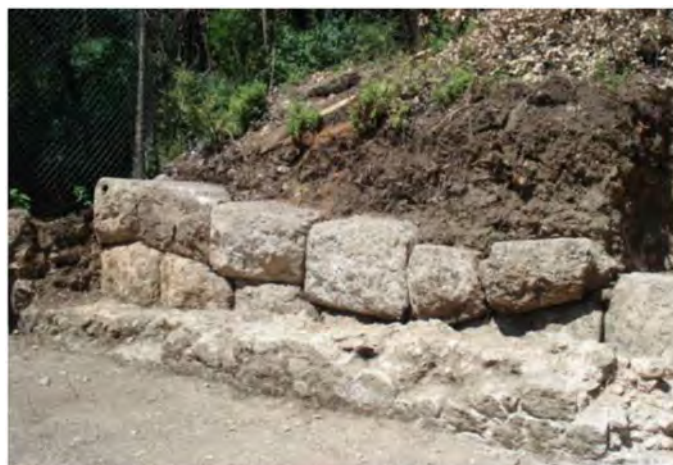
Figure 6. Picture of the polygonal wall (c). The geometrical model implemented in the analysis evolves as described in Figure 7 (from b to e).

unnatural white calcareous stones in the two boreholes and the presence of massive blocks near the *nymphaeum* (Figure 6), an arrangement in the form of terraces retained by polygonal walls was presumably created in the area at the time of *nymphaeum* erection. This assumption is confirmed by archeological studies which confirm the frequent use of the polygonal walls in the Casinum area (Valenti 2012). This polygonal wall, probably from the second century BC, is similar to others present in Latium, e.g. in Ferentino located 50 km to the north. The terrace of the *Nymphaeum*, discovered in the 70s, was probably partially dismantled for the construction of the *Nymphaeum*. With time, the whole area, including the interior of the *nymphaeum*, was filled with rubble mixed with debris fallen from the upper hill.

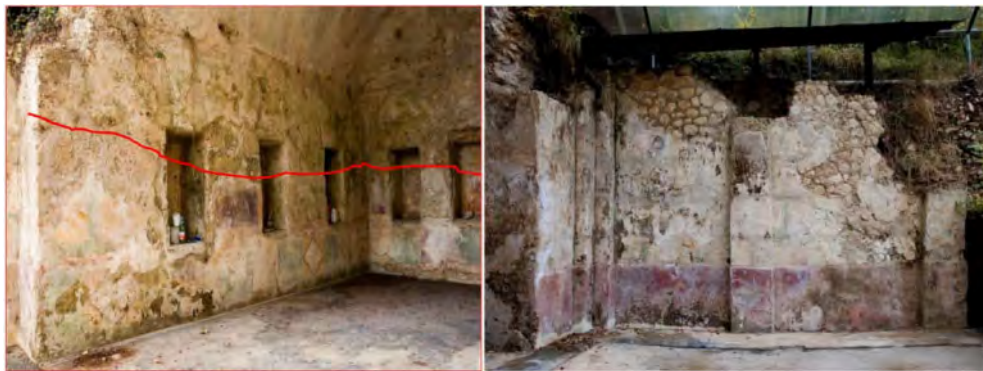
Figure 12. Cracks along the vaulted room (a) and rotated walls in the outer space (b) of the nymphaeum.

years. In conclusion, the structural response is dominated throughout the *nymphaeum* life by the interaction with the outer soil, that represents the main cause of concern, but severity increases with the weight of up-hill soil as confirmed by the increased number and extension of plastic and tension cut-offs points observed in the numerical calculation.

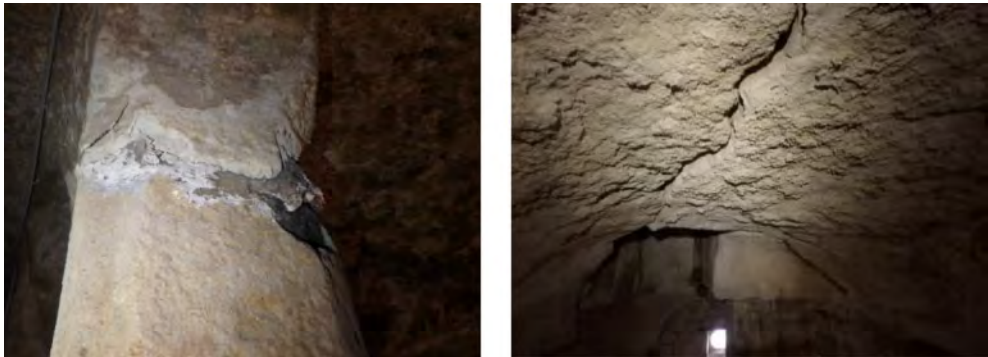
Figure 5. (a) Chipping of the reinforced concrete pillars of the Triforium (left) and (b) Crack in the north Aisle with outcrop (right).

- The alteration of the surface of the church roof, which ultimately results in flaking corresponding to a superficial detachment (centimeter or even decimetric) of the limestone slab on the roof of the galleries. These phenomena affect the roof of the several rooms, and particularly in the Vestibule, and are characterized by the partial collapse of limestone benches.
- Chipping of pillars of the Nave, which results in the superficial loosening of limestone slabs, particularly at the level of the arches.
- The weathering and chipping of the shotcrete reinforcements carried out during prior work from the Triforium pillars (Figure 5(a)).

This damage (with release of concrete scales and coating on an average thickness of 3 to 10 cm) of sprayed concrete surfaces can be explained by the absence of reinforcement, and the concrete projection on a weathered and saturated support. There is therefore no structure guaranteeing continuity and rigidity of the projected hull.

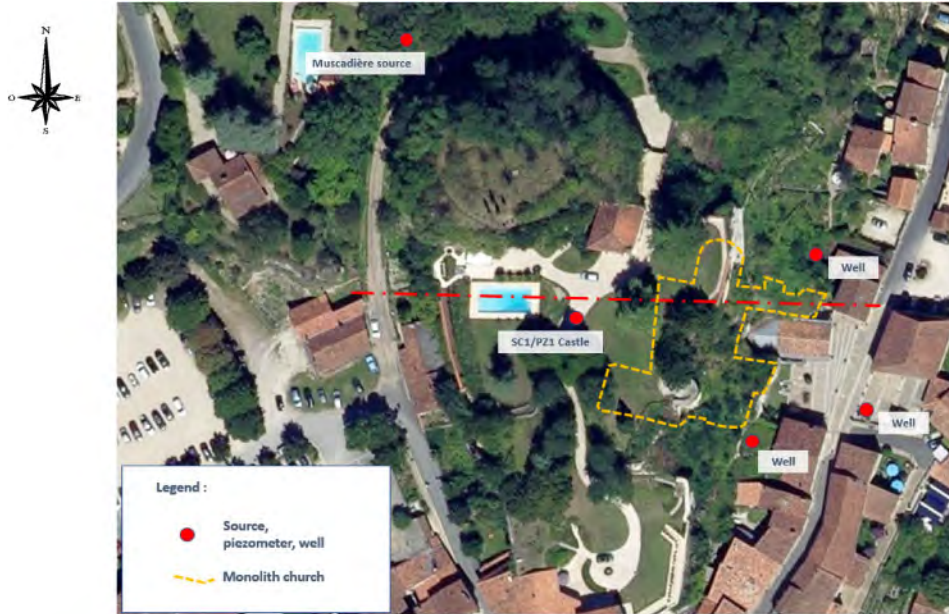
Figure 8. Position of the water level sensors on the outside and transverse cross section axis (Antea Group).

Also, four water table recorders (Figure 8) were installed outside the site (hydraulic upstream: piezometer installed on the castle hillock and hydraulic downstream: well around the esplanade at

the entrance to the church), and three recorders inside the monolith (cistern of the hose, well and pit in the church).

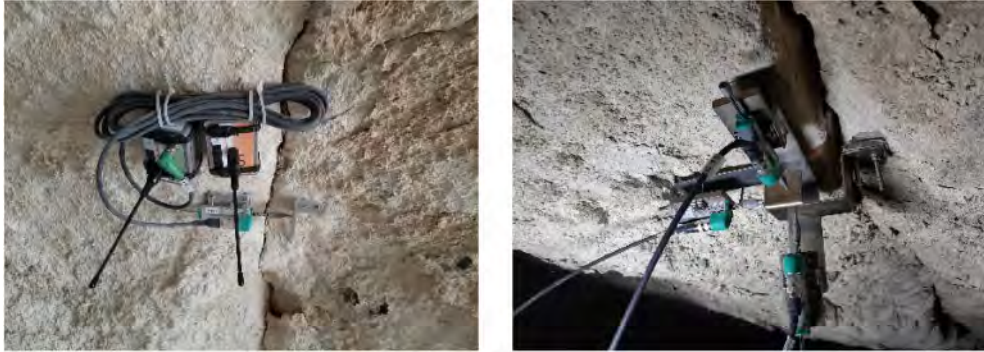
Figure 10. (a) 1D fissurometer (left) and (b) 3D fissurometer (right).

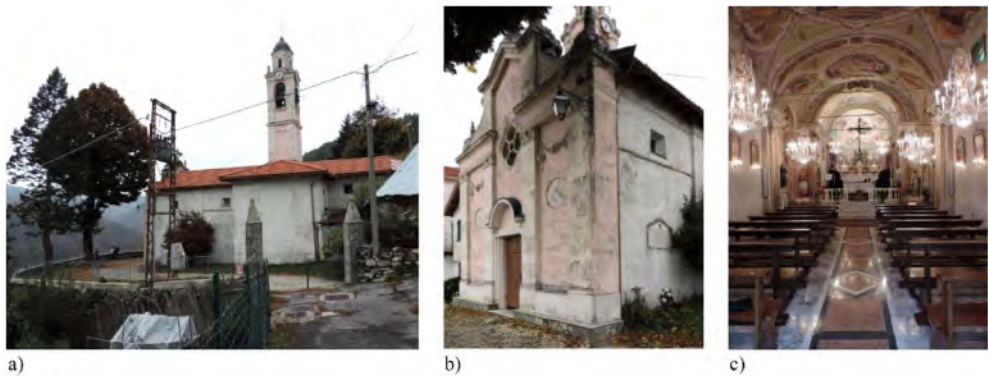
San Carlo Borromeo church (Figure 2) has a single nave, a presbytery, a semicircular apse, two lateral chapels and a belltower. Including the apse, the church is about 20 m long and 6 m wide. The nave and the presbytery are covered with barrel vaults, while the apse has a hemispherical dome. The entire building (both walls and vaults) is made of stone masonry and is covered by a recently built wooden roof. A clergy house and a sacristy, respectively made of stone and brick masonry, are also present on the north-western side of the church.

Figure 2. (a and b) Exterior. (c) Interior.

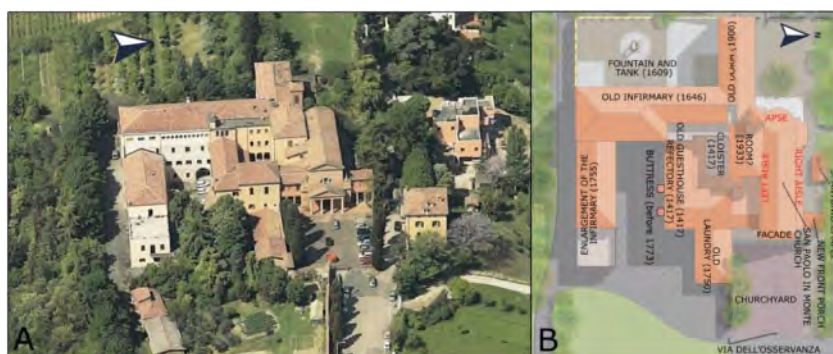
Figure 1. (A) Aerial view of the Osservanza church and of the adjacent Convent in their present configuration. (B) Plan view with indication of the main parts of the religious complex.

The Church of San Paolo in Monte, known as “Osservanza”, and its convent (Figure 1) have hosted the activities of the Friars minor in Bologna for more than 600 years. The religious complex is located in the south west area of the Bologna city center, on the top of the surrounding hills, about 227 m a.s.l. From the 1980's onwards, the church has been restored several times. In spring 2010, the crack progression caused the collapse of part of a capital of the fourth column of the right aisle (Figure 2). Immediately after, the church was closed to the public, for security reasons, and since then the building is still closed. The paper describes the results of a geotechnical investigation campaign and of a monitoring system, aimed at identifying the causes of damages. A preliminary analysis of historic events, which affected the church from the origin of its construction to its present configuration, was initially carried out, providing essential hints for devising an effective investigation programme.

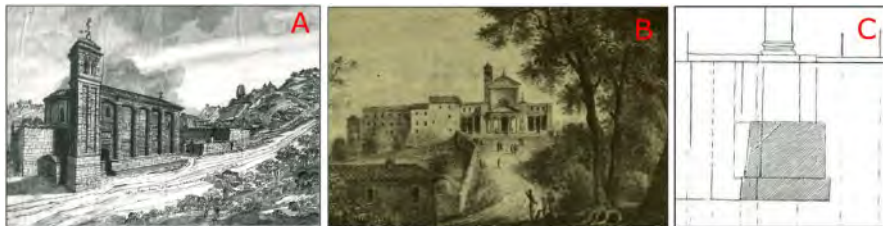
Figure 7. (A) The primitive church, showing the façade oriented toward the west, in a drawing of the 1793 by Giuseppe Fancelli. (B) Drawing of the new church of the 1828 (Osservanza Historical Archive). (C) Scheme of the underpinning work carried out on columns 5 and 6 of the right aisle (Osservanza Historical Archive, Section III, Vol. 1, doc. 15).

These events, related to differential settlements that the church suffered since its construction period, suggested that the foundations of the columns of the right aisle could not have been properly superimposed to those of the early church, as it can be inferred by a deeper scrutiny of Figure 6.

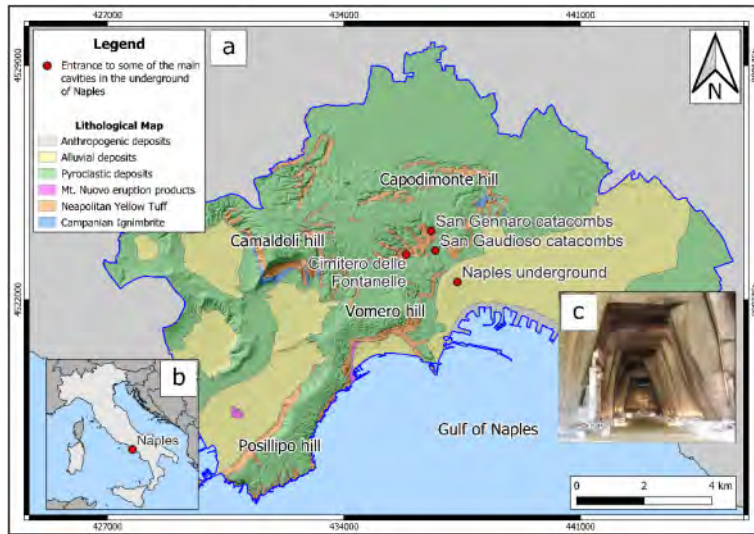
Figure 1. Location of the study area: a) Lithologic map of the city of Naples and location of some of the most famous underground cavities of Naples; b) Location of the city of Naples (Italy); c) Cimitero delle Fontanelle, main entrance.

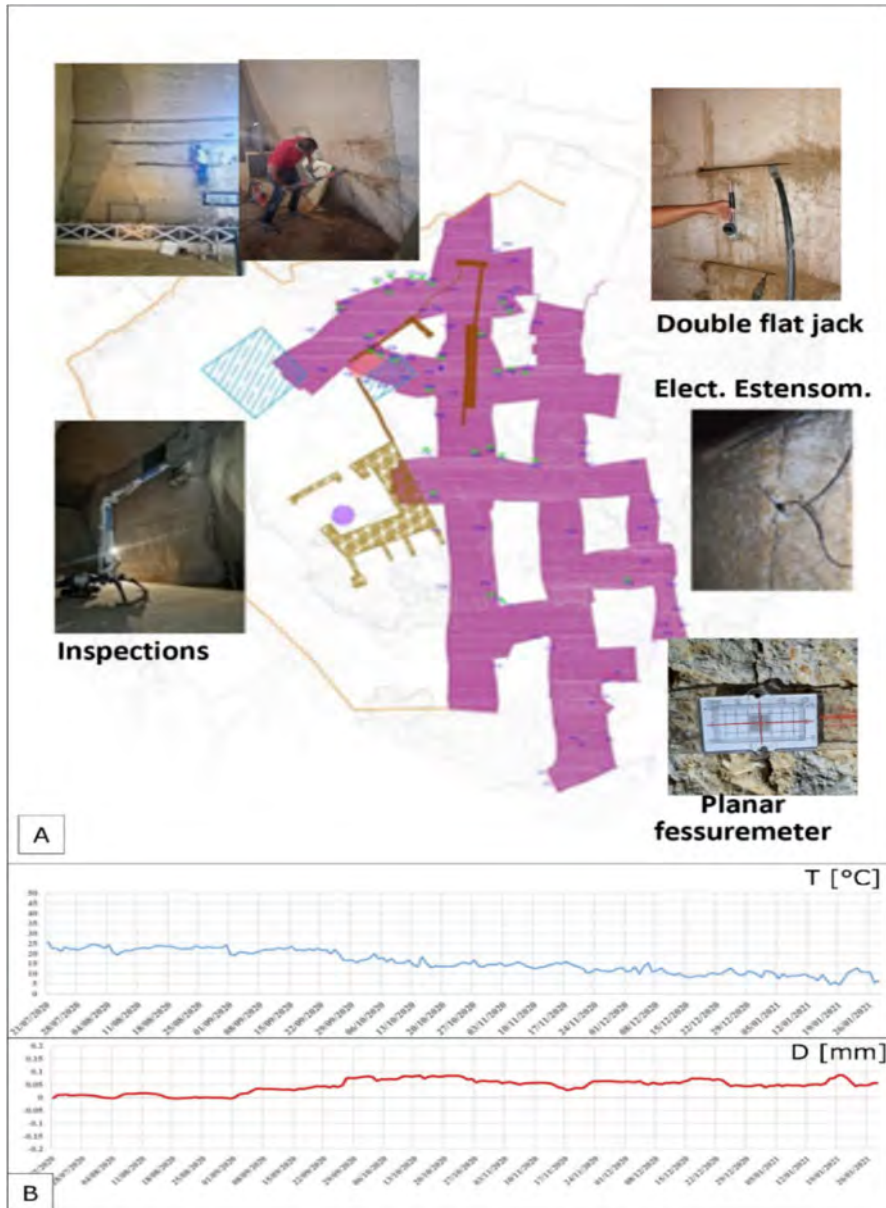
Figure 8. Set up of the monitoring system: a) plan view; b) temperature and movement data during the monitoring period.

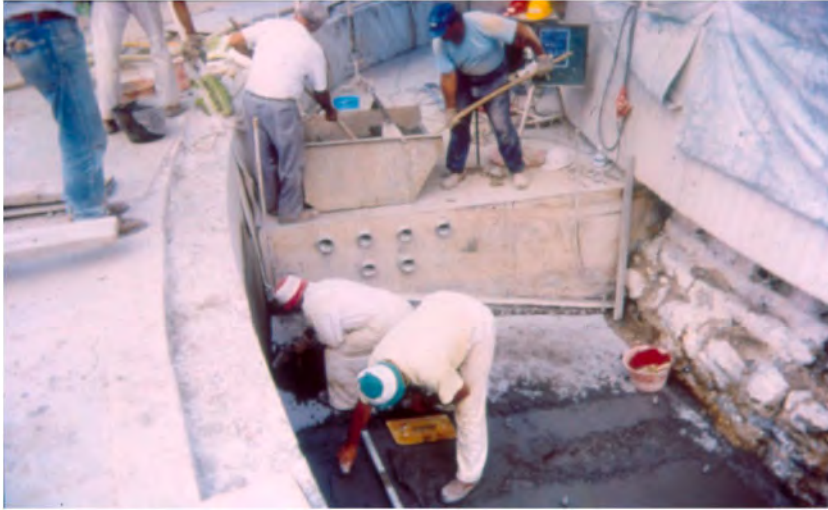
Figure 9. Construction of the northern sections of the ring beam for the ten anchors.

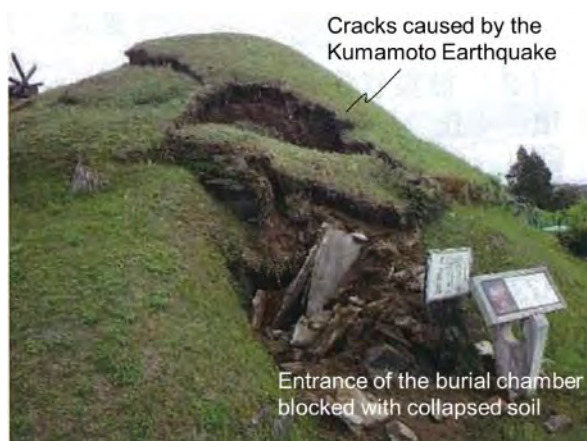
Figure 2. The Kamao Tumulus damaged by the Kumamoto Earthquake (Agency of Cultural Affairs, 2017).

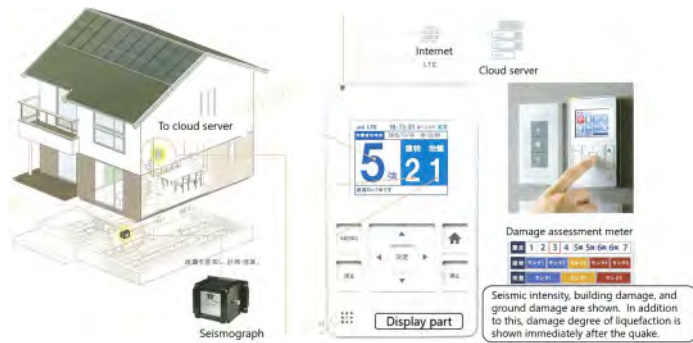
Under these circumstances, inexpensive accelerometers can be used to monitor the structural health of private wooden houses and ground, as shown in Figure 1 (Oki et al. 2019). This is a type of damage-assessment device that enables acceleration measurements. It can be installed in the foundation of a detached house and can be used to determine the degree of damage that occurs to the building in the event of an earthquake. The seismic intensity and extent of damage to the house can be analyzed in real time, based on the measured seismic response records and structural data. This system is expected to be used for evacuation support, based on the early determination of the level of damage, and can be used to determine whether repairs are necessary. This technology has already been put into practice by Japanese house makers.

Figure 1. Damage-assessment meter for private housing development of Misawa Home Co., Ltd., Japan.

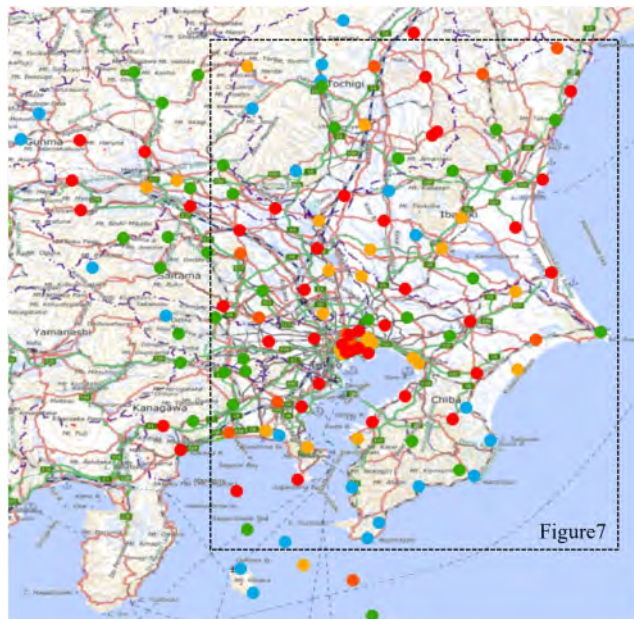
Figure 6 shows the DDL judgment results of each point using the deep-learning model plotted on a GIS using the strong-motion records of 140 points in the Kanto region, obtained from K-net as input data. As shown in Figure 4, the larger the DDL value, the higher the degree of liquefaction.

A high DDL is shown along Tokyo Bay, especially in the inner part. On the other hand, there are many points with low DDL on the inland side of Chiba and other prefectures. From these relative tendencies, it seems that the results are harmonious with the actual damage. Table 1 shows the breakdown of the DDL for all 140 points. It can be seen that the decisions are not biased towards a particular DDL.

Figure 6. Judgment result in the Kanto region by deep-learning of the liquefaction degree (DDL) of the Kanto region during the 2011 earthquake off the Pacific Coast of Tohoku.

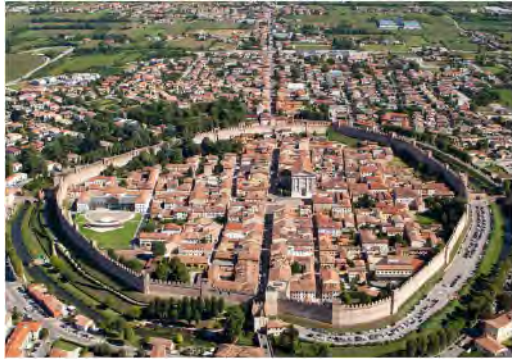
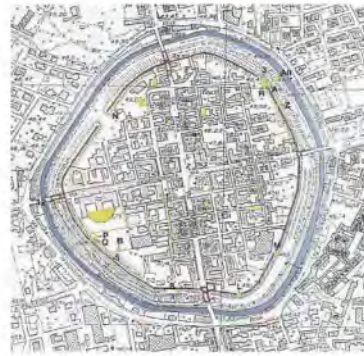
Figure 1. Air view (a) and planview (b) of Cittadella (Padova, Italy).

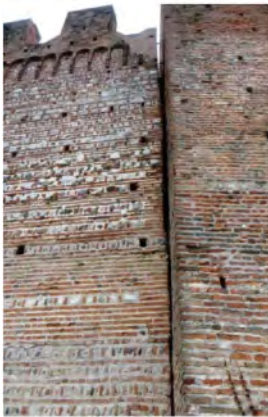
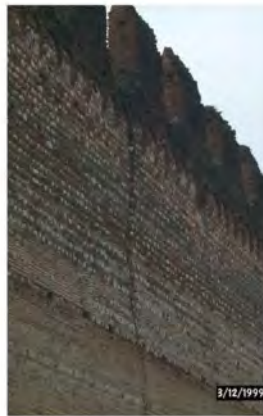
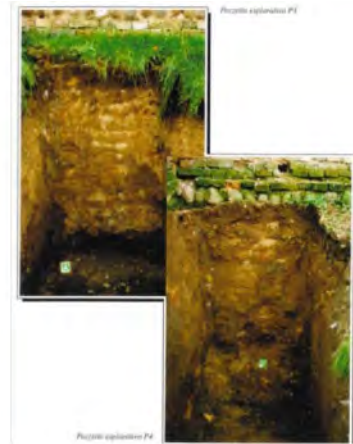
Figure 4. Separation of the masonry of walls from the tower (a) and vertical macro-cracks along the walls, and inspection of the foundations (c).

Since the 1990s, a number of investigations and surveys were carried out to deeply study the instability phenomena (settlements, cracks, out of plumb of some wall sections) that had involved over time the walls (Figure 4). Aero-photogrammetric surveys were used to determine the height of the various elements of the walls and embankments and to assess the out-of-plumbness of the walls, geognostic surveys to identify the properties of the underlying soil, inspections of the foundations, tests with flat jacks and core drilling in the walls.

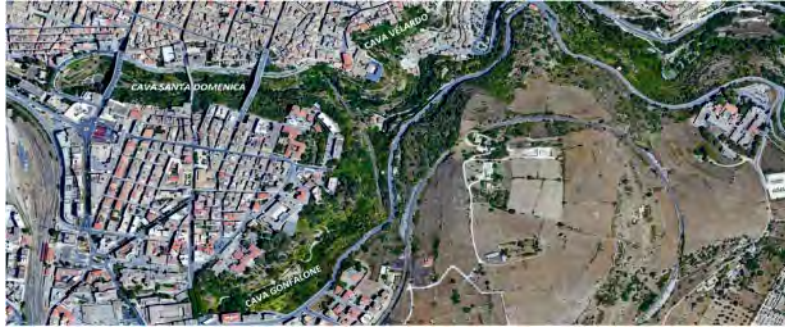
Figure 1. Perimeter of the quarries underlying the upper town of Ragusa.

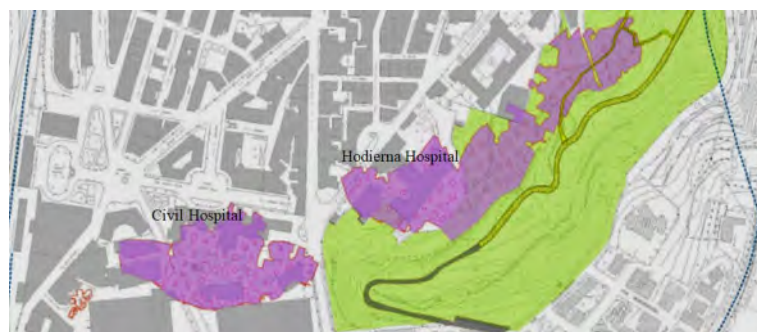
The recognition of the historical value of the Cava Gonfalone must initially pass from the understanding of the synergistic relationship between the local stratigraphy, the cultivation of stone material and the development of the town. Figure 2 shows a cartographic overlapping that outlines the perimeter of the current tunnel system underlying the built area in order to highlight interferences of the two urban realities.

Figure 2. Interference areas between underground structures and overlying town.

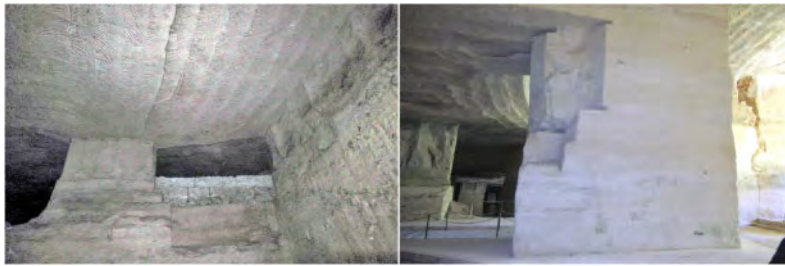
Figure 3. Western tunnels: bands, fan-shaped, and herringbone traces.

The traces left by this mining method are evident on the walls and on the roof in the western tunnels, with stripe (quarry pick; mallet and awls) and fan-shaped (pyramidal-pointed pick) signs (Figure 3). Moving towards east, the stone surfaces show more regular herringbone patterns marks (hack hammers – *martellina*). With the advent of circular saws, the last phase of the block extraction took place, which concerned only an area further east. Here the cut was made by engraving as it can be seen from the cross signs present in the lower parts of the walls, while the mining of the upper parts had already taken place with traditional impact tools (Figure 4). In the later extension to the east of the quarry the signs on the walls return in bands or fans, consistently with the date August 16, 1895, imprinted on a wall.

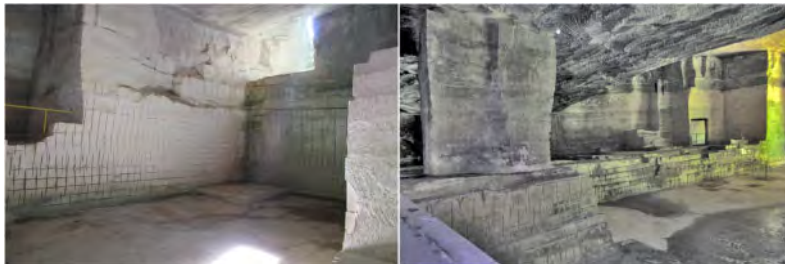
Figure 4. Eastern tunnels: cross traces in the lower part and traditional tools traces in the upper part.

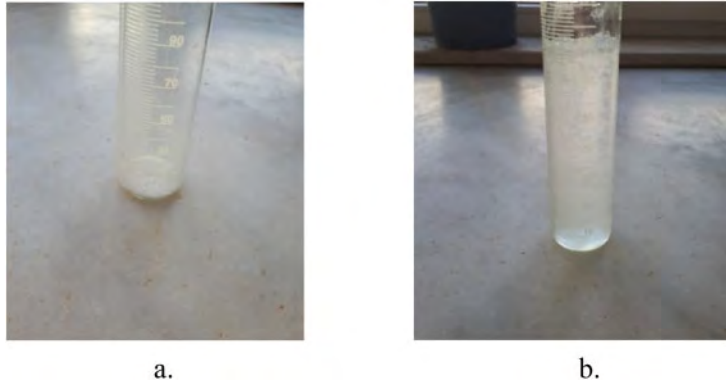
Figure 1. Sodium polyacrylate; a. Powder form, b. Gel form (Özbakan 2021).

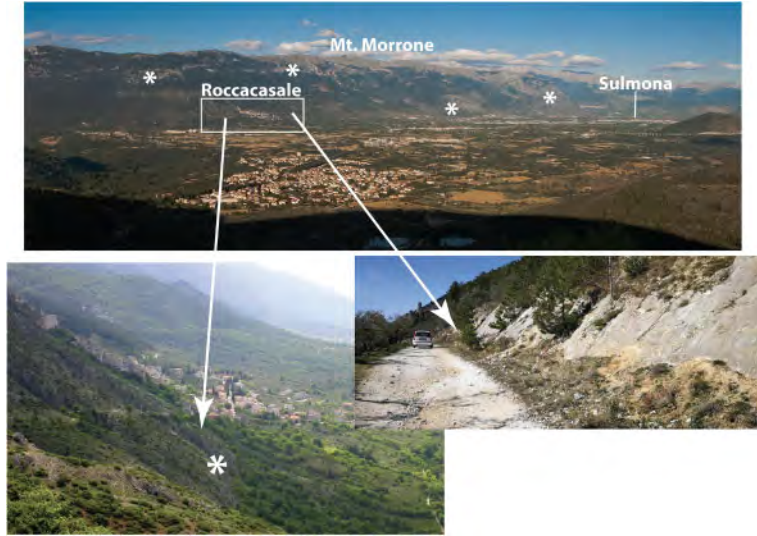
Figure 2. Panoramic view of the Sulmona Plain. Asterisks indicate some places where Mt. Morrone fault is emerging. Rectangle defines the area of Mt. Morrone bedrock fault scarp north of Roccacasale and the place where the fault plane is exposed south of the village.

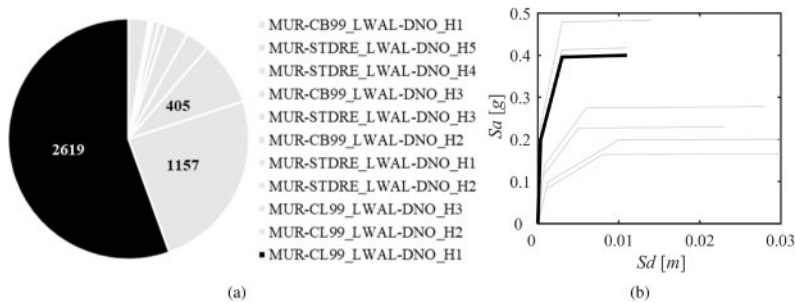
Figure 3. (a) Pie chart presenting the different masonry building classes in the Thessaloniki municipality and (b) corresponding capacity curves characterizing their nonlinear behaviour. The case-study building in class is highlighted in black.

structures, can be identified from the whole Thessaloniki exposure (Crowley et al. 2020). The following results are shown for the most popular masonry building class (namely MUR-CL99-LWAL-DN0-H1 following the GEM taxonomy (D’Ayala et al. 2014)) representative of low-rise unconfined masonry structures with wall force resisting frame and unknown types of concrete blocks. A total of 2619 buildings for such class were identified from all Thessaloniki exposure. Its spatial distribution in the whole Thessaloniki municipality is shown in Figure 4a.

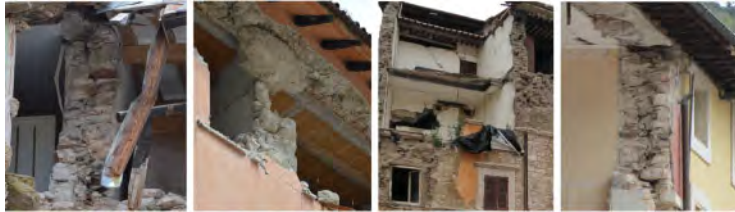
Figure 2. Example of walls and floors visible in other buildings of the historic center of Visso.

The main orientation of diaphragms is expected to develop perpendicularly to the Y-direction; all partition masonry walls were considered in the model as equivalent loads on the floors. From the photos of the other buildings in the historic center (see Figure 2), diaphragms are mostly characterized by brick and wooden decks. In some case, a very thin concrete slab (not reinforced) is also present. The same floor type was assumed in all units of the aggregate under examination since there is no evidence of any specific interventions and the units are considered substantially contemporary.

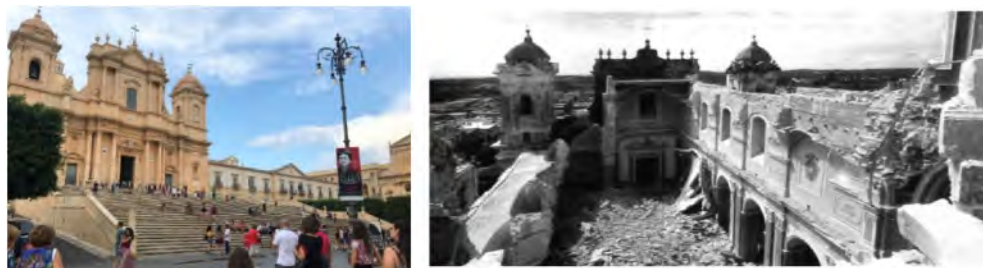
Figure 2. Noto cathedral. a) Front view of the building; b) Internal configuration after the 1996 collapse (Di Prisco et al. 2006).

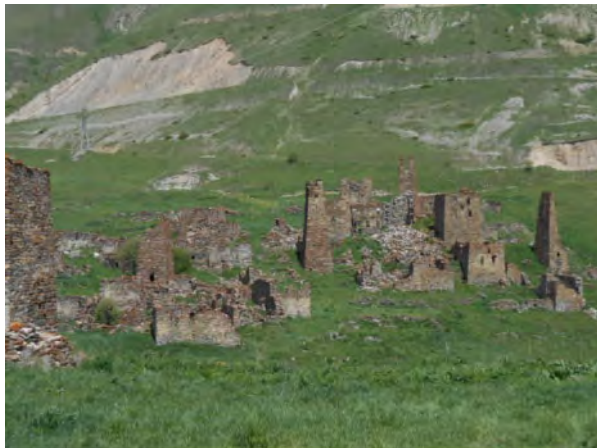
Figure 1. Typical condition of ancient village in the North slope of Caucasus mountains – towers and living houses after being abandoned by its inhabitants decades ago.

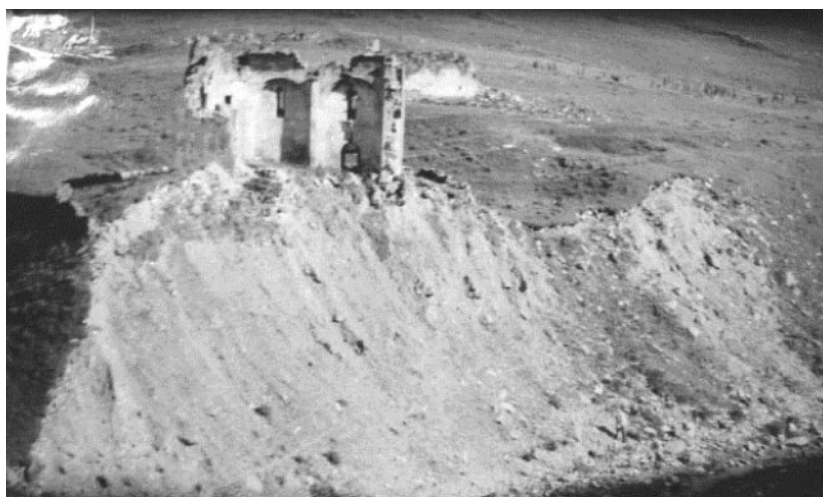
Figure 3. On the photo of 1967 we see only south-eastern half of the building, standing on the edge of the landslide. Photo made by architect V. Kulakov.

The effect of the landslide on the church was obviously indirect. Seismic shock had caused the change of the river under the hill and erosion of the slope gradually came up to the church and made the parts of the building fall by large blocks. Vibration of the earth could provoke streams of water-snow-stones-ground mixture called sel from nearby ravines and gorges that also could change riverbed and could lead to the destruction of the hill.

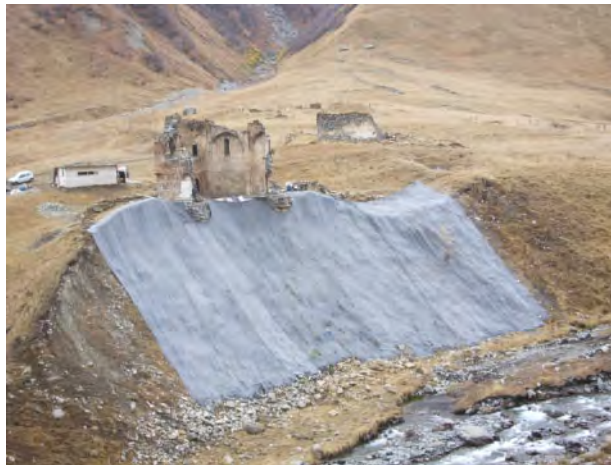
Figure 6. View of the church after the first part of emergency works.

1. The remaining structures of the church were tightened together by temporary metal bonds.
2. The main cracks, dividing the walls were repaired by hydraulic lime mix grouting reinforced with fiberglass rods.
3. The upper part of the remaining walls were covered by protective layer of mortar reinforced with plastic mesh
4. To reduce the effect of surface erosion of the hill, a geotextile carpet was laid on it.

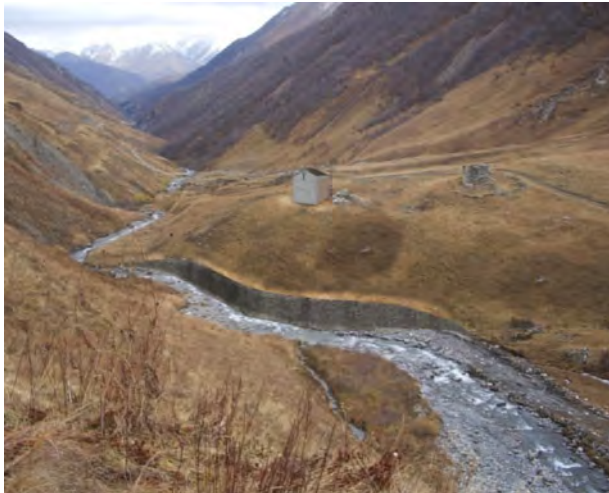
Figure 7. Proposed plan of restoration of the hill and the church after improving the riverbed and strengthening of its banks.

So the final plan is to reconstruct the missing part of the church, restore stone vault and the roof over the whole volume.

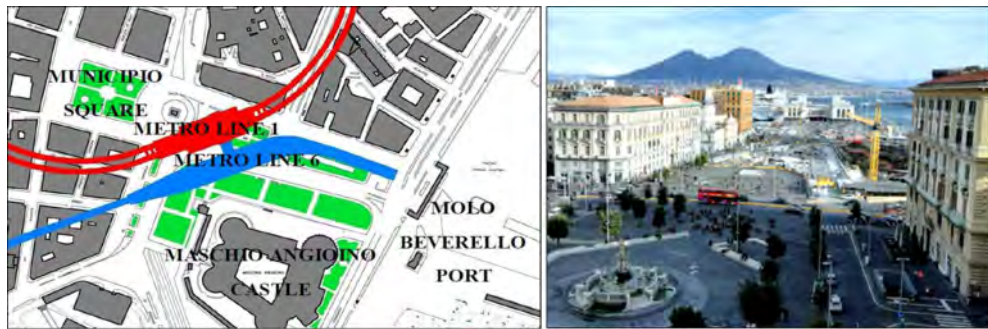
Figure 1. Municipio Station schematic plan view with highlighted (in red) Line 1 and (in blue) Line 6 and a picture of the site during construction stages.

Municipio Station is located in the urbanized historical centre of Naples (Italy), facing the impressive backdrop of *Maschio Angioino* Castel and next to the tourist harbor *Molo Beverello*, and it will provide an efficient interchange node between Line 1 and Line 6 of the metro system serving the city (Figure 1). In particular, the new downtown stretch of Line 1 consists of five new stations and twin rail tunnels EPB-TBM excavated, with a total length of about 5 km. This line has also expanded beyond the hilly area of the city towards Capodichino airport. The Line 6, partially constructed several years ago as a light surface rail transportation system, has been further developed with a 6 km new stretch with the use of mechanized excavation via an EPB machine with a large double-track section. Minor works are still going on for two out of four stations located along this stretch, while the other two stations are practically completed (Russo et al. 2012, 2015; Viggiani & de Sanctis 2009). Currently the portion of Municipio Station serving on Line 1 extension is open to the public, whereas Line 6 interchange portion is nearly finished. Two service tunnels, built in

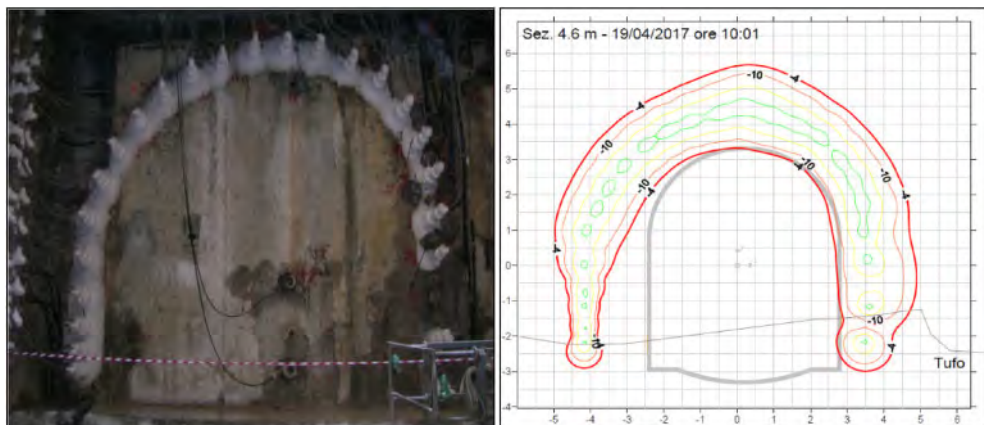
Figure 7. On the left, freeze and temperature pipes around the tunnel section; on the right, the isotherm contour map of the frozen body.

Besides, no. 10 sub-horizontal thermometric chains (instrumented by thermocouples arranged at intervals of 5 m) have been installed to obtain real-time distribution of temperatures in the frozen ground with particular reference to the isotherm  $-4^{\circ}\text{C}$ , which was assumed to be the isotherm limit of the effective frozen body (Figure 7). By summarizing, the frozen shells at the crown and at the upper part of the sides of the tunnels were built by circulating LN through 1955 m of freeze tubes. The average specific consumption of LN during the freezing phase for the two tunnels was of the order of  $1500\text{ l/m}^3$  of frozen soil. The maintenance of the frozen shells was carried out by circulating brine through the same freeze tubes, chilled by no. 2 industrial refrigeration plants of 250 kW capacity.

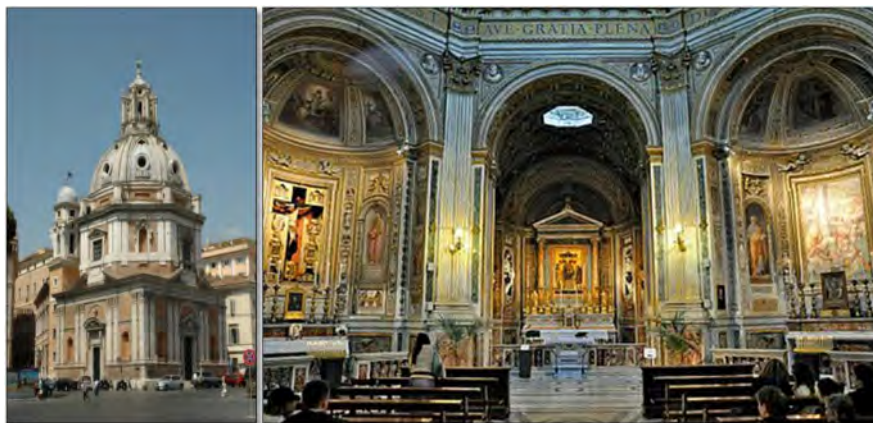
Figure 10. An external view of the Santa Maria di Loreto Church (left) and an internal one (right).

The interventions consist of steel hoops of the internal dome by means of two tiers of 30 mm diameter stainless steel wire ropes, the creation of a structural reinforced layer of lime mortar plaster on the eight wedges of the internal dome together with a circumferential stainless steel fiber bandage. For the radial walls that connect the two domes is instead provided a double order of 20 mm diameter stainless tie rods, together with the creation of a structural grout (reinforced with a basalt and stainless steel mesh) on the two faces of the walls themselves.

The steel hoops of the internal dome are an active structural intervention because they will be pre-loaded and so they exercise a pre-compression force on the masonry equal to 298 kN for each rope. The others are instead passive interventions, designed to contrast the potential opening of the cracks due to the subsidence induced by the excavations.

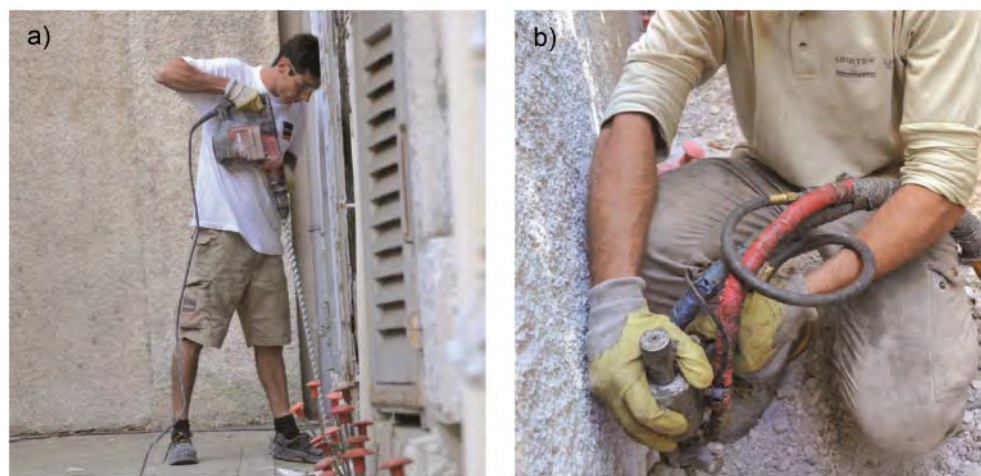
Figure 1. Example of operations: a) Drilling of the borehole; b) Equipment for the injection of the expanding polyurethane resin.

volume increase under unconfined conditions (null mechanical stress) of about thirty times (Buzzi et al. 2008; Dei Svaldi et al. 2005). When the resins are injected underground, the expansion process occurs in confined conditions leading to a compaction of the soil surrounding the injection point until a mechanical equilibrium is achieved between the resin and the soil (Dominijanni & Manassero 2014). The injection can be performed at different depths using either several injection tubes with single-point injection at the bottom end of the tube or a single tube with several lateral injection points (multi-point). In both cases, the injections are performed with small tubes (external diameter of about 10–15 mm) and equipment, reducing the treatment impact on the existing structure as much as possible. Figure 1 shows an example of the drilling operations carried out with a portable drill, and the equipment adopted to perform the injection of the resin in the installed tube from the ground surface.
