# Geotechnical Engineering for the Preservation of Monuments and Historic Sites III

Edited by  
Renato Lancellotta, Carlo Viggiani,  
Alessandro Flora, Filomena de Silva,  
and Lucia Mele

PROCEEDINGS OF THE THIRD INTERNATIONAL ISSMGE TC301  
SYMPOSIUM, NAPOLI, ITALY, 22–24 JUNE 2022

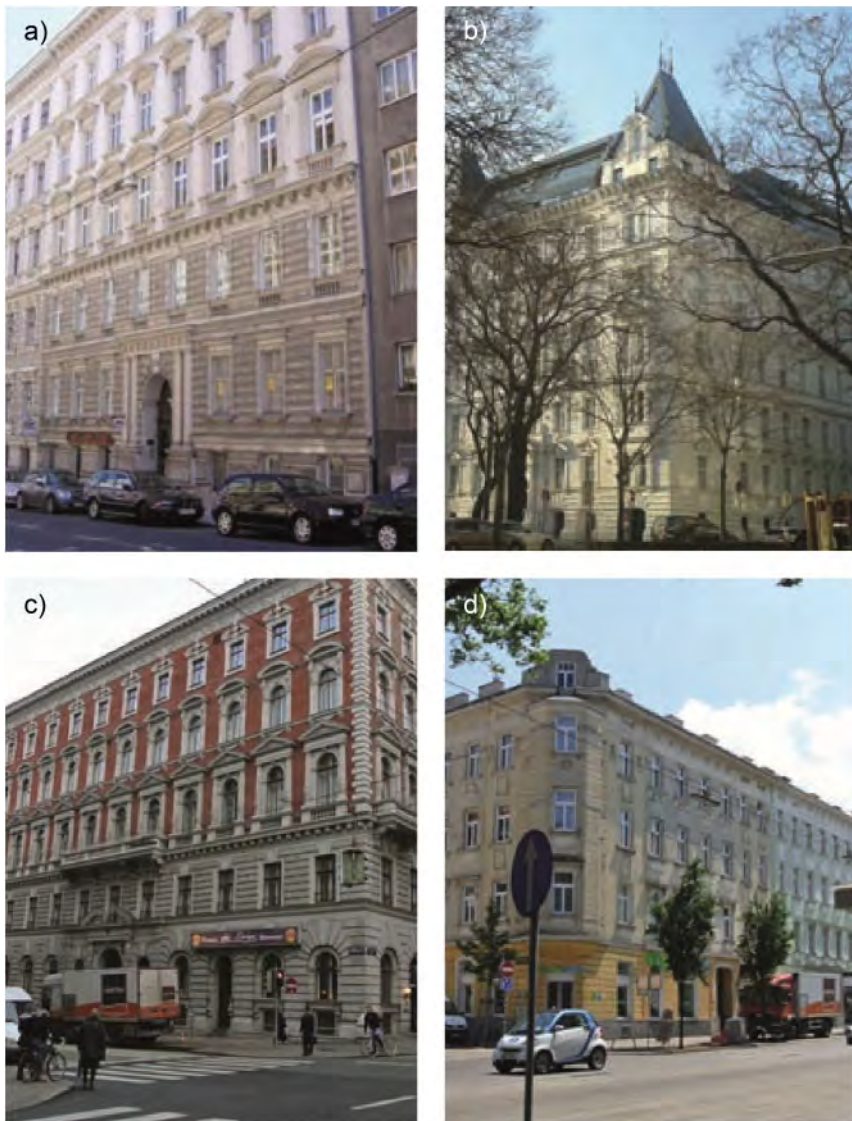
Figure 3. Overview of Gründerzeit buildings in the city of Vienna that undergone foundation soil treatment with expanding polyurethane resins.

An example of four historical buildings in Vienna, constructed during the Gründerzeit period, which have been subjected to soil foundation treatment with polyurethane resins for the construction of attics and/or renovation works, is illustrated in Figure 3. In all of the four cases, the buildings have shallow foundations at a depth in the interval 0.6–2.0 m below the ground surface. In this framework, the injections have been performed underneath the foundation beams. For the building in the image a) (Figure 3), about 260 m linear of strip foundations at a depth interval of 1.3–1.5 m were treated in 20 days of work. For the building in the image b), about 350 m linear of strip foundations at a depth

of 2.0 m were treated in 25 days of work. These two works were performed for the construction of an additional attic floor. For the buildings in the images c) and d) (Figure 3), about 200 m linear and 50 m linear of strip foundations were treated in 18 and 5 days, respectively; in these two last cases, the treatment aimed at the improvement of the foundation soil for settlements mitigation occurred during and after renovation works of the structures. In all the illustrated examples, the foundation soil was mainly composed of a silty sand/gravel. This feature has made the treatment of polyurethane resins extremely attractive. The performed works allowed the stabilization and improvement of the foundation soil, which is usually assessed through settlements monitoring system.

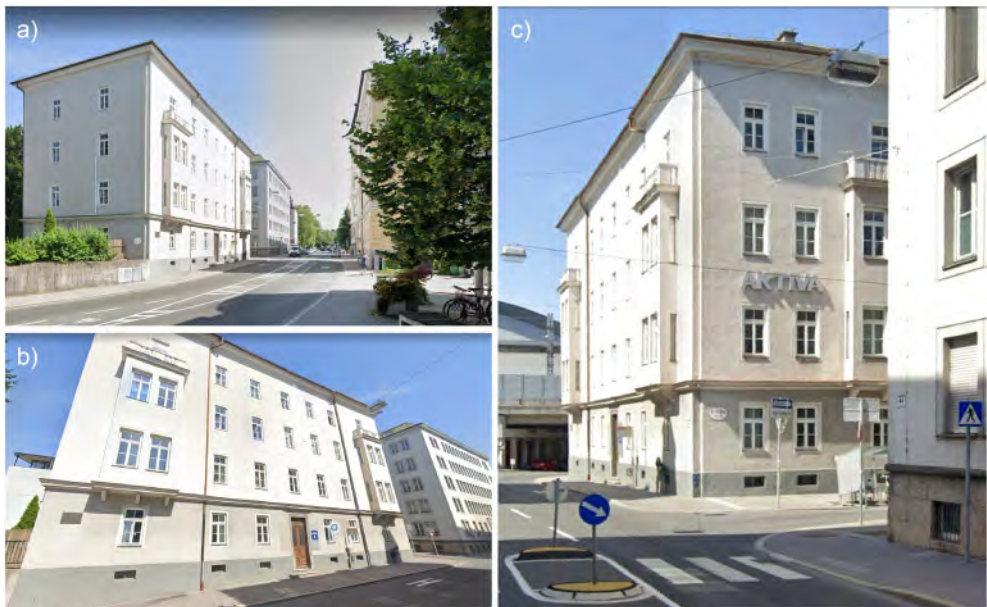
Figure 4. Overview of the building in Salzburg: a) north side of the building; b) west side and main entrance of the building; c) south side of the building.

The structure of the building is composed of four floors above the ground and one underground floor. In Figure 4 are reported some pictures of the building from the main street, named Schwarzs-trasse. The level of the basement is placed at a depth equal to 2 m from the ground surface (418.60 m a.s.l.). The strip foundations of the building have a width equal to 1 m and are located 1 m below the basement level (i.e. 3 m below the ground level). The foundations are composed of rock blocks obtained from the dismantling of the historical boundary wall of the old city.

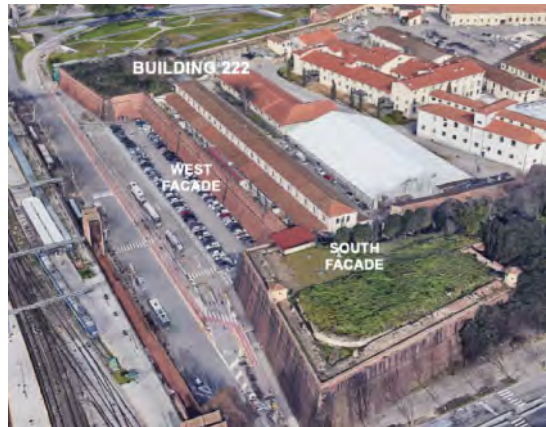
Figure 5. Building 222, monitored facades.

On the other hand, the control of the deformations of building 222 (Opificio delle Pietre Dure workshop) will be carried out by the data acquired using a system of miniprisms positioned on three sides in line with the extremities affected by the directional drilling, which is required to carry out the preliminary consolidation injections and any subsequent compensation grouting, under the Rastriglia bastion. The monitoring, therefore, will affect this part of the structure for an extent of about 30 m. The building has a central part higher than the two lateral bodies. The mini prisms will be arranged along the entire perimeter of the building, with two alignments along the east and west side walls: one will affect the taller central part and the other the lower part. They will be installed at every 6 m, according to the portal pattern which supports the structure. The ending prisms of the 4 planned alignments on the east and west elevations will reach the south elevation, so that the four edges where the main bearing walls end are also monitored.

To make this monitoring system redundant, 15 leveling datum points will also be installed near the base of the perimeter walls in proximity to the prisms.

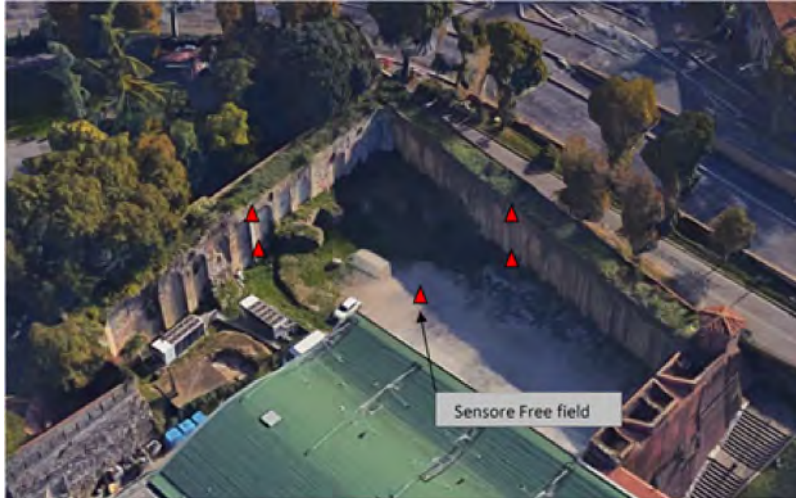
Figure 6. Fortezza da Basso –Bastione Rastriglia monitoring.

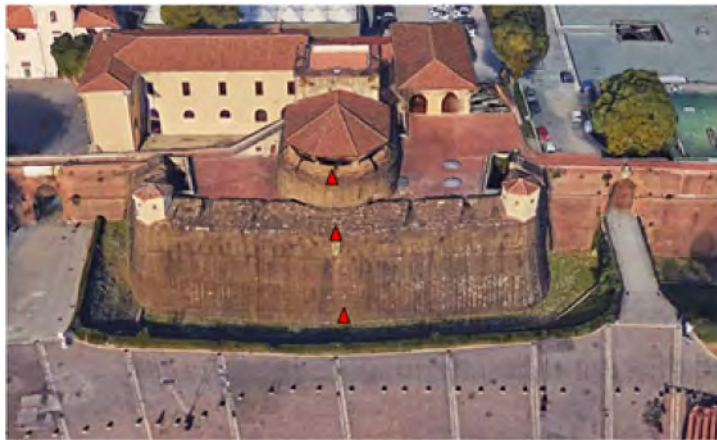
Figure 7. Fortezza da Basso –Mastio centrale monitoring.

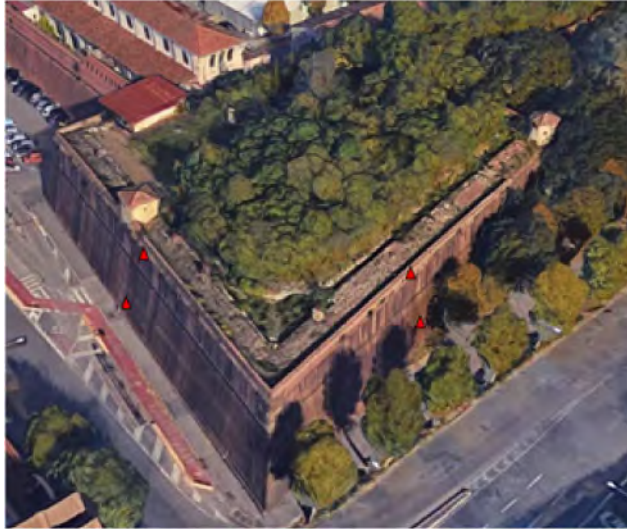
Figure 8. Fortezza da Basso –Bastione Cavaniglia monitoring.

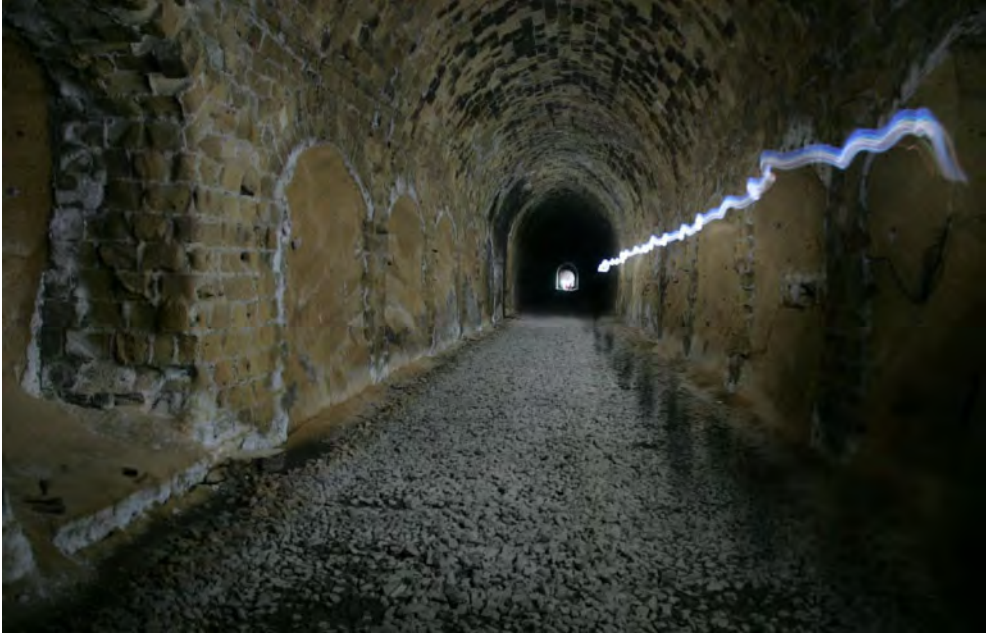
Figure 3. The dismissed Punta Epitaffio tunnel with the tuff layers exposed (photo by M. Fagnola – Cocceius Association).

The opening of the tunnel had further positive effects with regard to cultural heritage: in fact, other previously unknown ancient tunnels were intercepted: *“Of great interest is the fact that a number of Roman cuniculi have been encountered crossing the tunnel at various angles and at different levels. Many of these are inclined passages, just large enough for a man to descend, quite similar, in fact, to those at the Baths of Nero. Where these passages reach the drainage level, they are filled by hot mineral water. The tunnelling continues on for some distance beneath the water, so that it is impossible to know how the original excavation terminates. The present state shows that we have confirmatory evidence of subsidence since Roman times. Others have a horizontal course and extend into the hills, for in some cases over 100 meters.”* (Johnston-Lavis 1890), which, however, were never documented and were soon walled up. Finally, the depositional morphologies of the tuff banks cut by the tunnel provided paradigmatic indications on the eruptive sequences of the Phlegraean volcanoes. In order not to hide such an important geological section, the tunnel walls were not lined with tuff blocks masonry, but large sections of natural tuff were left in sight in the south-western half of the Punta Epitaffio tunnel (Figure 3).

Presently, the dismissed tunnel of Punta Epitaffio, between Lucrino and Baia, shows a first section reinforced with metal railings covered with shotcrete. This operation was carried out as a preliminary to the excavation of the nearby Lucrino-Fusaro tunnel, in order to avoid damage to the

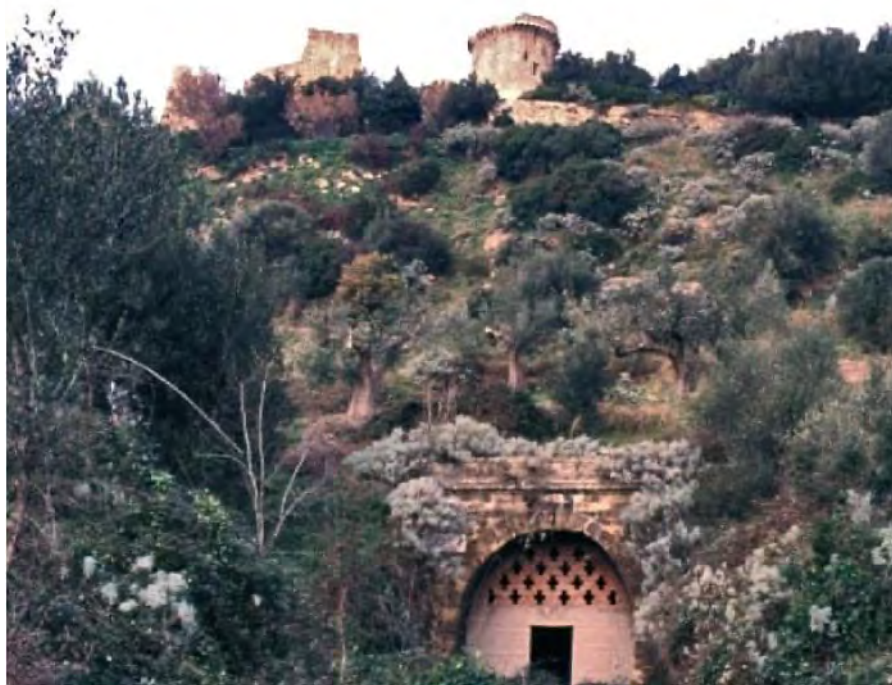
Figure 5. The railway tunnel southern entrance (Tocco Sciarelli 2006, Fig. V).

This opportunity, therefore, allowed to safeguard and to know a site of enormous importance for the knowledge of the evolution of this settlement in the Ancient Italy which, despite its long-known importance, at the time was almost completely unknown and still isolated in the panorama of Italian research (De Luynes 1829; Lenormant 1883; Münter 1818; Napoli 1966). It was precisely the works to extend the railway line towards Calabria, which allowed the correct identification of the site, the definition of its extension and the launch of a more active policy of protecting the territory and the ancient city (Krinzinger 1994; Napoli 1970; Schleuning 1889; Schmiedt 1970). In the area of Velia, in fact, the route of the railway line crosses the area of the ancient city in full (Figure 4), piercing the hill of the acropolis - known by the toponym of Castellammare della Bruca – thanks to the construction of an about 300-meter long tunnel (Figure 5).

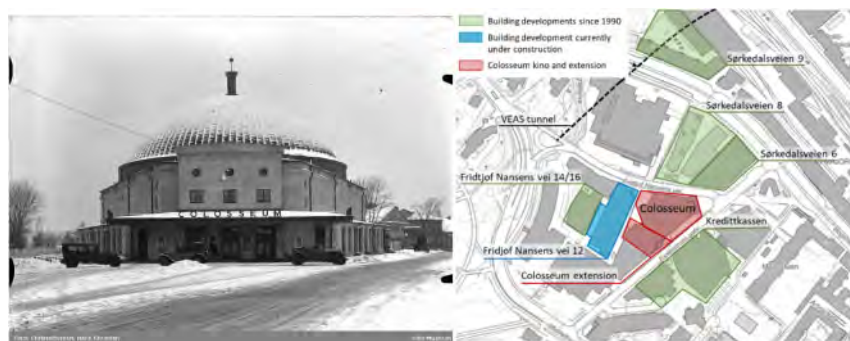
Figure 8. Colosseum cinema in 1933 (on the left, Photo by Christoffersen). Building activity around the Colosseum cinema since the 1990th (on the right).

Due to extensive construction activities in the area, the Colosseum building has continued to experience large settlements in recent years. In particular, the construction of the new building for "Kredittkassen" between 1990 and 1992 lead to immediate settlements of up to 10 cm and continuous settlements after 1992 (Figure 10). This historic construction activity influencing the Colosseum building is the focus of the GIBV application presented in this paper.

This excavation in Oslo had a depth of 16 m over an area of around 150 m × 100 m (see Kredittkassen area in Figure 8). The excavation was supported by a sheet pile wall installed to bedrock, supported by five levels of tie-back anchors drilled to bedrock. The soil conditions consisted of 1–2 m dry crust clay over normally consolidated soft clay. Beneath 8 m depth, the clay was quick. The depth to bedrock in that area varies from 10 to 30 m. Undrained shear strength,  $s_u$ , in clay is generally between 15 and 40 kPa. The natural water content is around 30–40%, and soil unit weight is 19 kN/m<sup>3</sup>. The groundwater level is at approximately 2–3 m below terrain.

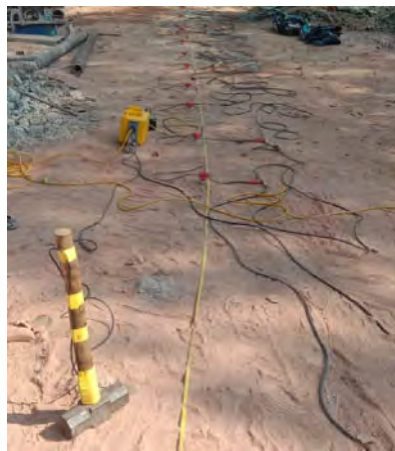
Figure 2. MASW test set up at site.

Based on the borehole profile and MASW test analysis, it was found that the top layer in the site predominantly consists of a filled-up layer up to a depth of about 3.5 m from the EGL. It is followed by the occurrence of an 18 m thick loose to medium dense sand layer with SPT N-value in the range of 10 to 35. In some locations, a thin layer of medium stiff clay occurred within a depth of 8.5 to 9.5 m below EGL. The highly disintegrated rock with the SPT N Value in the range of 40 to 50 occurs within a depth of 22 to 28.5 from EGL. The weathered rock stratum is encountered at 28.5 m below EGL. The groundwater table was observed at about 3.5 m below the ground level.

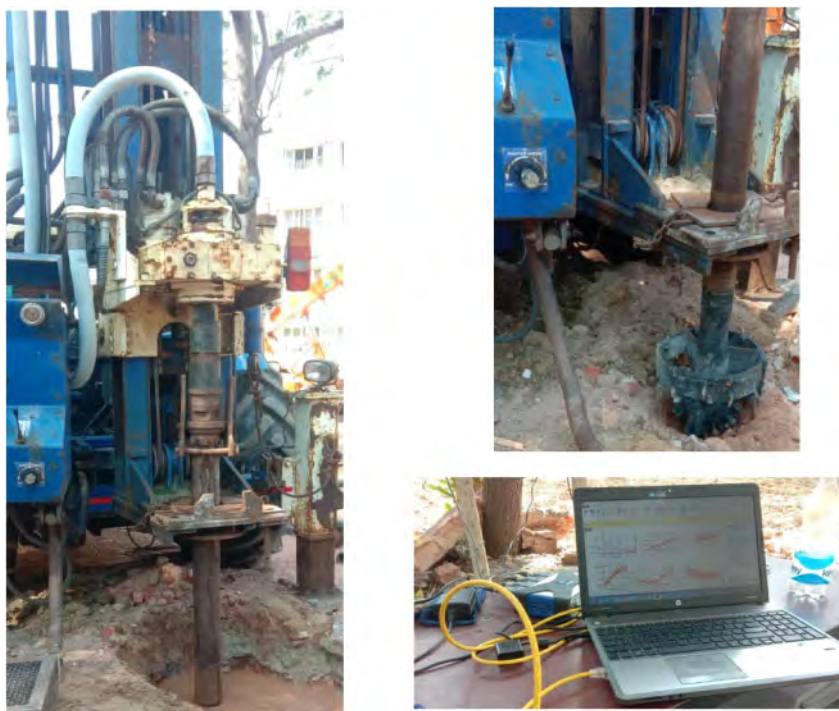
Figure 3. Pile driving operation at site.

It was planned to adopt 450 mm dia bored-cast-in-situ piles to support the proposed new building. It was decided by to terminate the pile at a depth of about 23 m at which highly disintegrated rock/dense sand layer occurs. Vibration monitoring studies were carried during the test pile boring operations. The pile adopted are bored cast-in-situ circular types of 450 mm diameter. The pile-boring operations were performed using rotary drill rigs up to a depth of around 23.5 m below the ground level. Boring is carried out using rotary drilling equipment with a tungsten drill bit. The drilling process was continued to the designed founding depth up to the commencement of soft disintegrated rock strata at 23.5 m depth. The piling operations is shown in Figure 3.

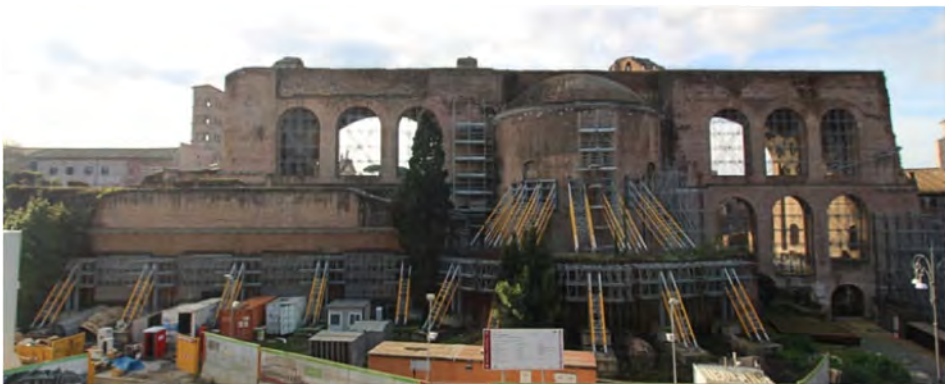
Figure 8. Temporary structural interventions installed on the Basilica.

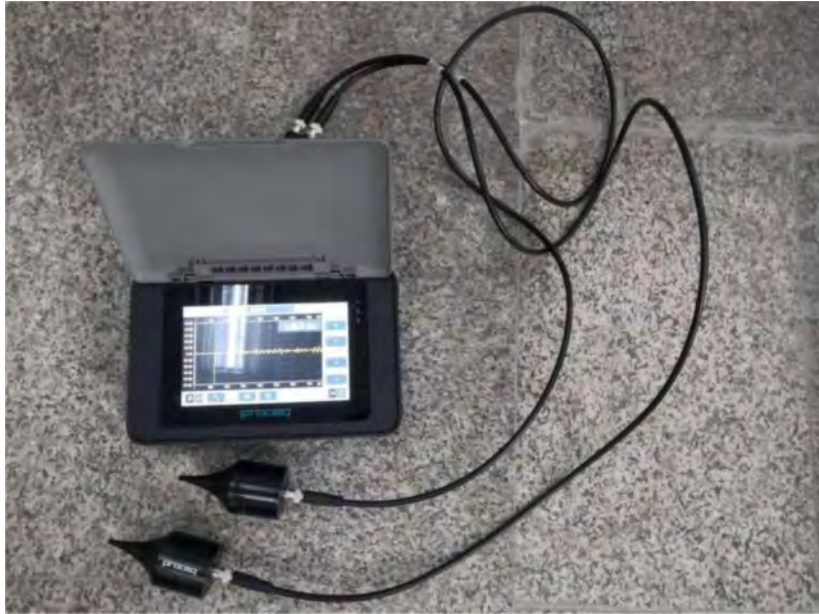
Figure 5. Type Proceq PL-200 ultrasonic apparatus.

The ultrasonic detection apparatus used in this experiment was type Proceq PL-200 (made in Switzerland, Figure 5) and a pair of ultrasonic probes with a frequency of 54 kHz, and its key parameters were shown in Table 1. As reported among articles worldwide, 54 kHz is more suitable for detecting internal defects of non-metallic materials, and also, the needle-nosed probes do not require coupling media.

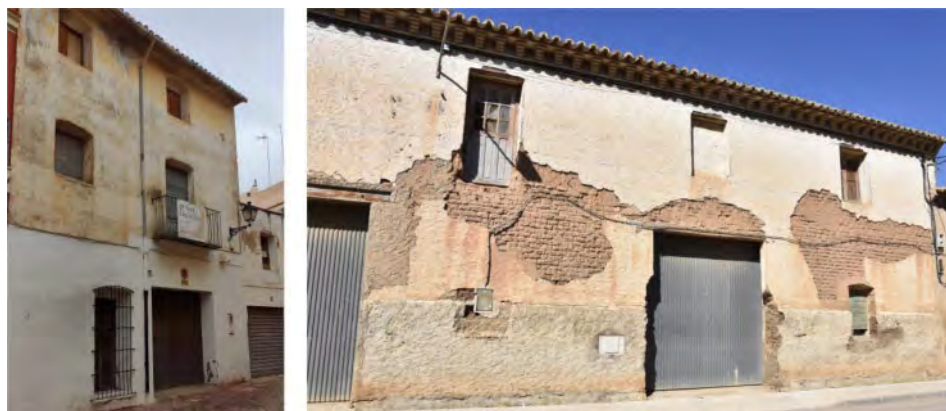
Figure 5. Rammed earth building in Alzira (left). Adobe building in Torres de Berellen (right).

Firstly, the earthen buildings found during fieldwork are mainly made of rammed earth or adobe walls. All the adobe buildings are in Torres de Berellen, while the rammed earth buildings are located in Alzira. From a constructive point of view, the buildings have one to three floors, and the walls are reinforced with bricks at the corners (Figure 5).

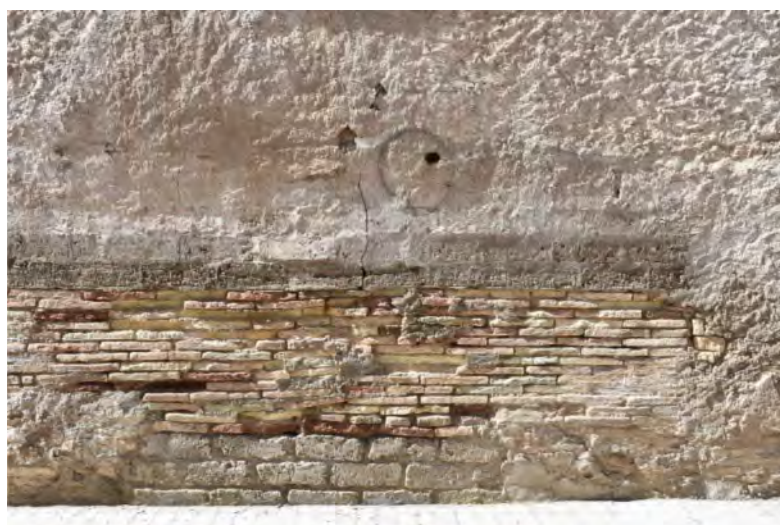
Figure 6. Repair with bricks and concrete blocks in a plinth (Torres de Berellen)

In 70% of cases, the plinth is made of bricks, and the remaining percentage of buildings has a plinth made of ashlars or concrete blocks. It should be noted that, in many cases, the concrete blocks were added to repair areas of the plinth that have suffered material loss after flooding events or due to other forms of deterioration of the architectural element (Figure 6).

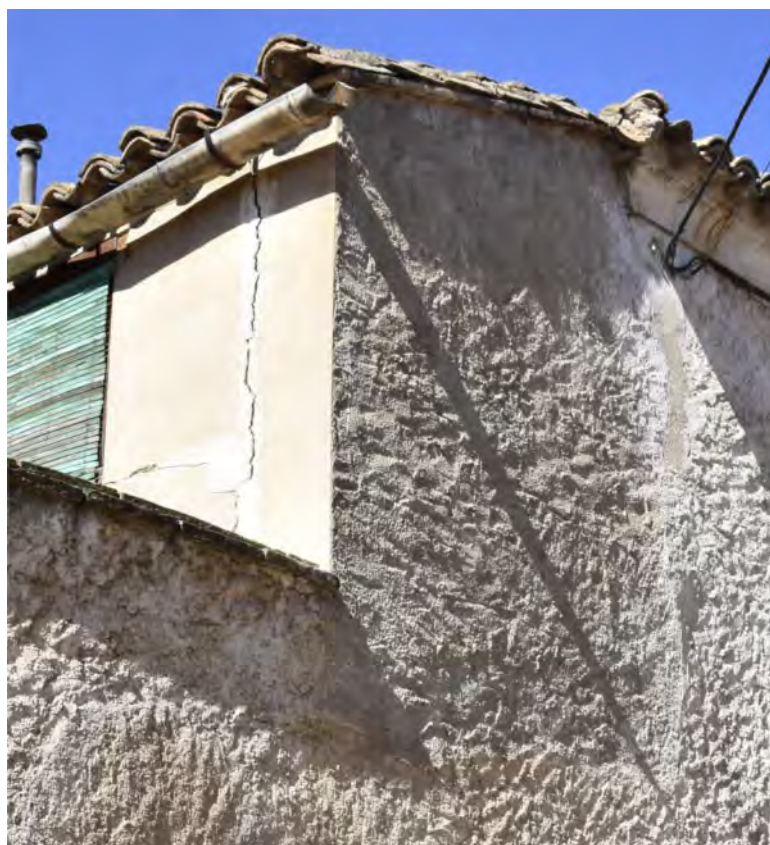
Figure 9. Crack due to the separation of the walls, probably caused by the erosion of the subsoil in Torres de Berellen.

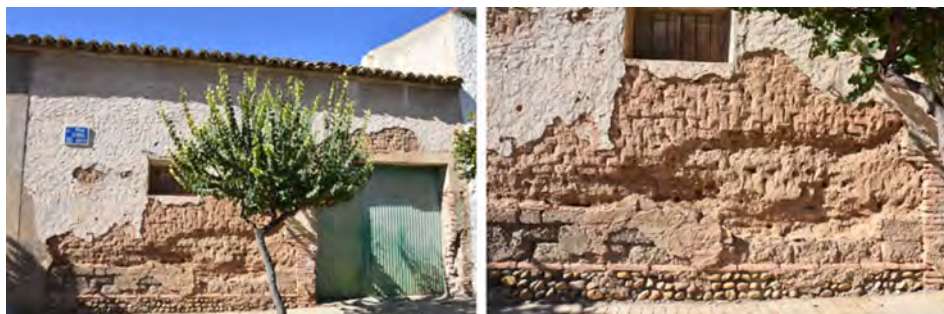
Figure 10. Adobe basement erosion. (Torres de Berellen).

which absorbs humidity from the environment for its hygroscopic nature. Buildings with more severe deterioration have a plinth made of adobe, whose outer layer has been covered with bricks or cement blocks with thick aggregate. However, this external protection is insufficient and ends up separating from its adobe support, which are left exposed to the action of external agents (floods, atmospheric agents, etc.) that triggers erosion on the material. (Figure 10).

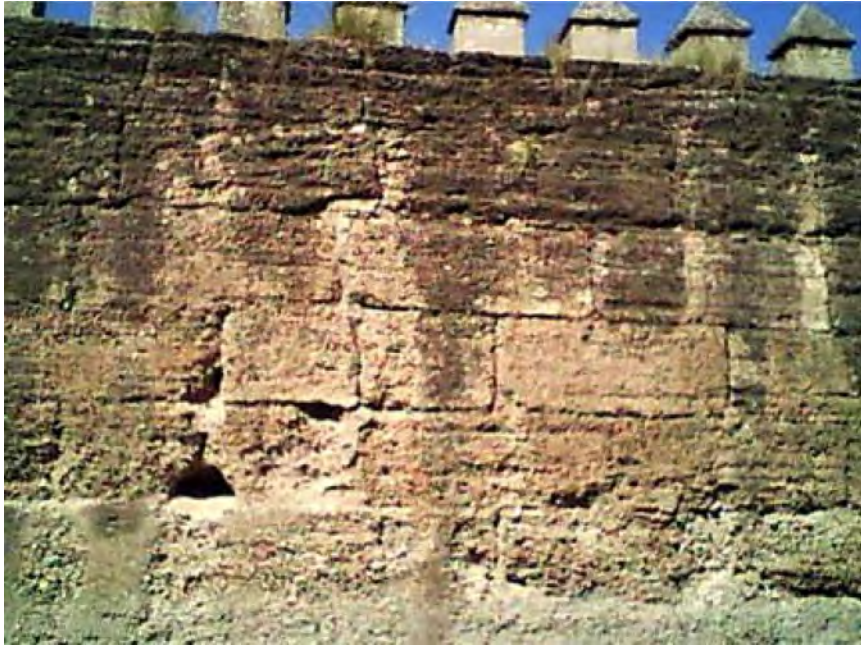
Figure 1. Biological degradation in the Macarena wall.

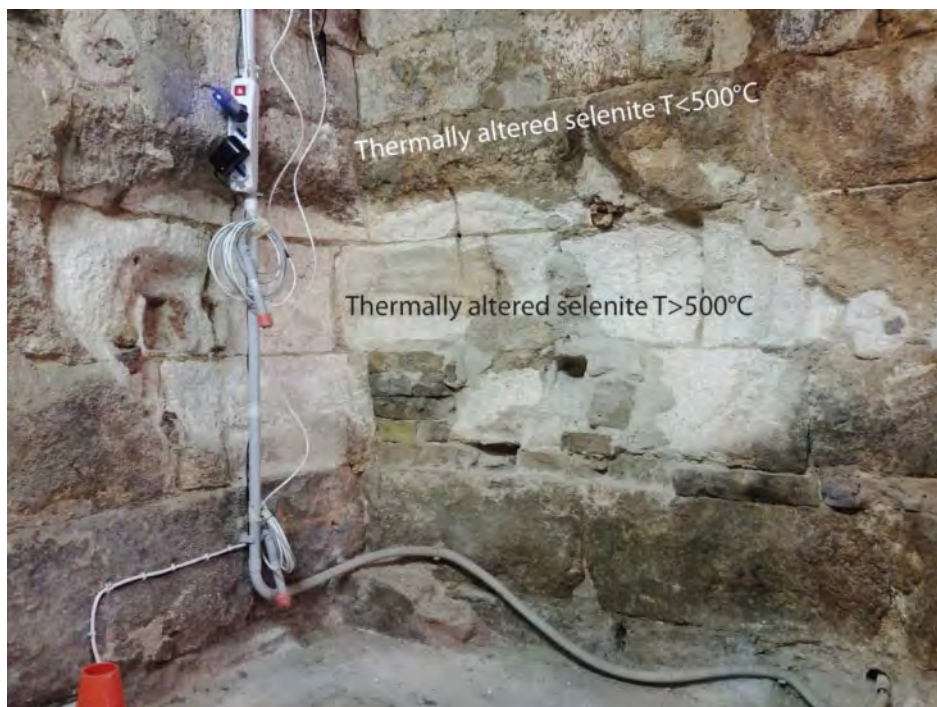
Figure 1. Different degrees of thermal alteration of the selenite rock in the southwestern corner of the Garisenda tower entrance room. Note the recession of the slab surface affected by higher temperature.

to gypsum (Figure 2). These characteristics demonstrate that the south-eastern corner of the tower was heated at temperatures above 500°C, which is the transition point for the formation of insoluble anhydrite. This calcium sulfate form is much slower in rehydrating back to gypsum compared to soluble anhydrite formed at the expenses of gypsum at lower temperatures. The hydration process in this case may even occur at geological time scale. The formation of insoluble anhydrite also induces the most extreme net volume decrease (up to 38.6 %), which contributed to disrupt the original texture of the rock.

The described dehydration phenomena are possibly the consequence of one of the blazes known to have affected the tower in the XIV and XVII centuries. The stronger alteration and the higher temperature reached in the south-eastern side of the tower may be related to the presence of flammable material during the blaze or by the activity of a forge installed in the corner of the room. The presence of active forges has been documented around the tower until the XIX century.

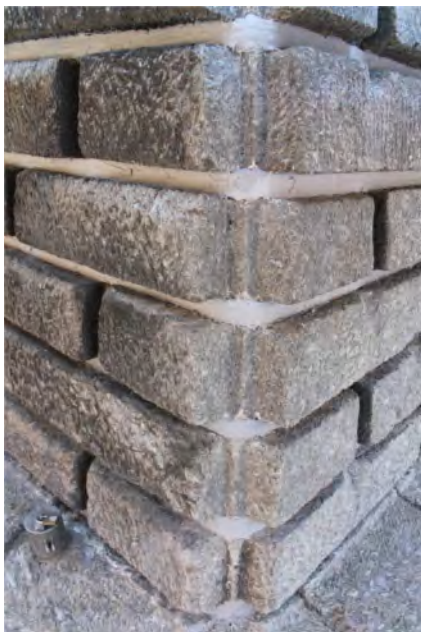
Figure 6. FRCM belting (A).

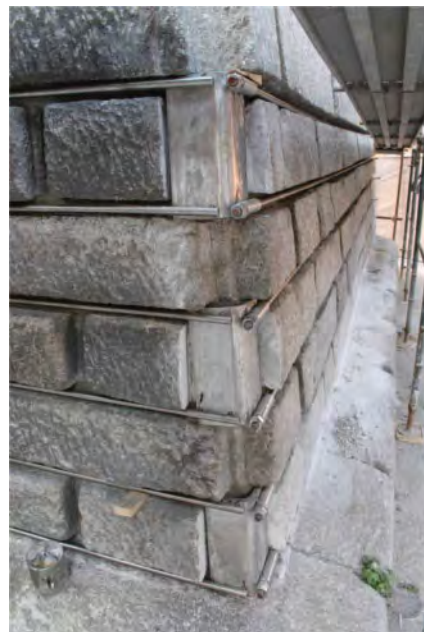
Figure 7. Post tensioned steel bars (B).

(b) active confinement of the tower corner by insertion of post tensioned stainless steel bars 24 mm in diameter (stainless steel AISI 304) and corner stainless-steel plates;

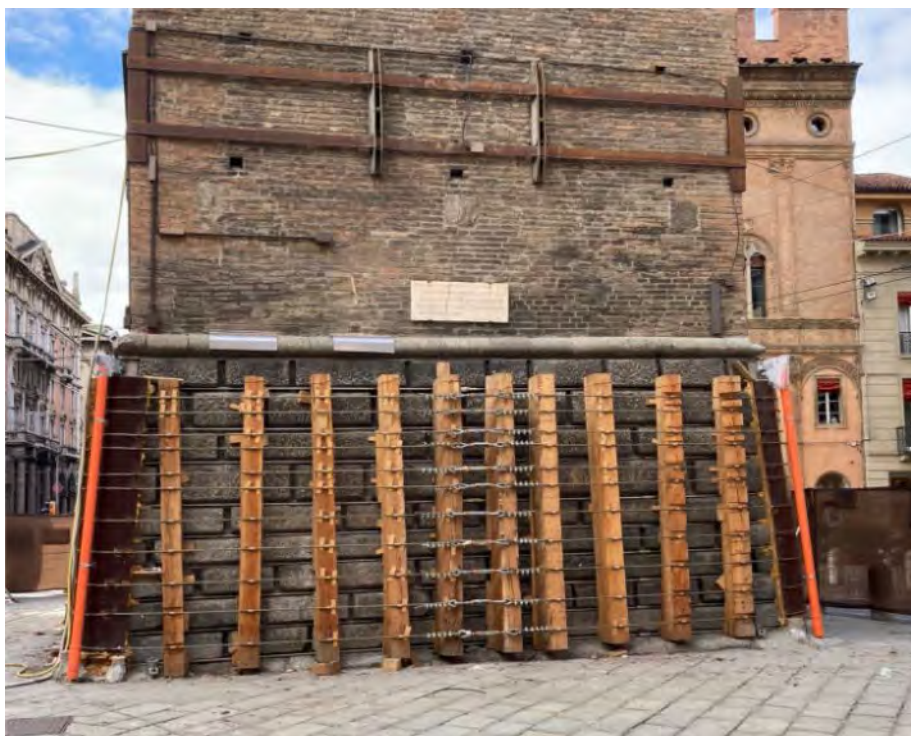
(c) active confinement of the “bugnato” through a funicular belting of the tower base. This was obtained by a monitored post tensioning of steel-cables with the insertion of wood blocks (of different thickness) between the “bugnato” and the cables.

Figure 6. Confinement of the bugnato (C).

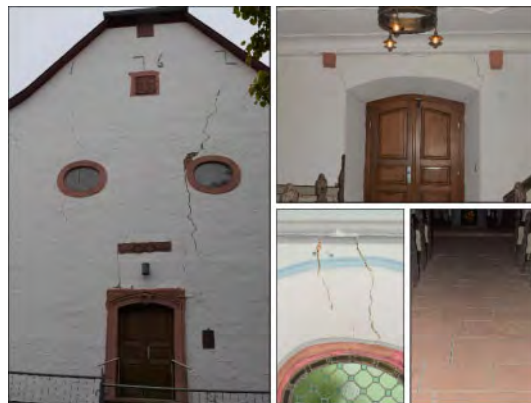
Cracking at the Massenheim church started about 70 years ago in 1930 (ECM 2000b). The first cracks were documented between 1930 and 1960 in the quarry stone masonry on the west facade. These cracks became visible again in 1980, when the iron bands of the door catch on the west facade came loose and the sandstone steps shifted outwards. From 1980 up to the renovation in 2001, there were no records of cracking. Only two years after the extensive renovations that cracking was again observed, appearing for the first time on the interior and exterior of the west facade. Since autumn 2003, cracks have also appeared in the altar area and in the floor (Figure 3). The structural integrity

Figure 3. Cracks on the exterior and interior of the west facade and in the floor.

Shrink-swell must have led to localized or nonuniform settlement of the church foundation. This is evident from the cracking in the exterior and interior walls that indicates movement of the framing, cracked and uneven floors, shifting of steps, and misaligned doors and windows. However, it was not possible to establish the amount of this differential settlement as the measuring point was dismantled during the repair and renovation work. Cracks on the floor run parallel to the slope face. Investigation of the slope ground also reveals cracks of the same orientation, indicating that the soil is creeping downhill.

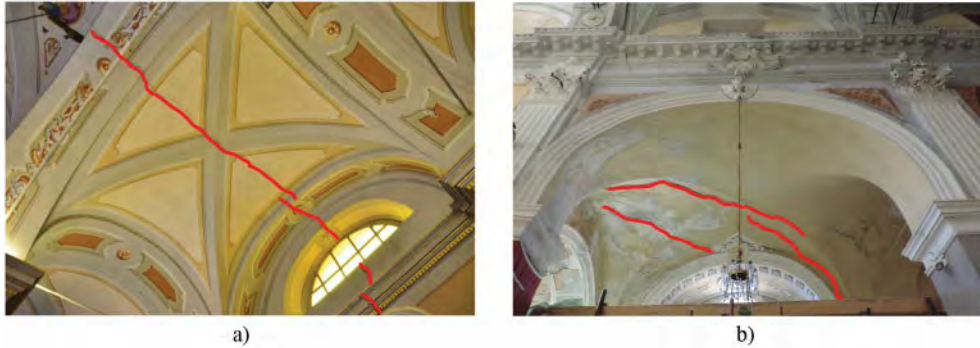
Several churches of the sample present extensive damage in the vaults in the form of longitudinal, transverse, and diagonal cracking. As shown in Figure 7a, in many cases, cracks propagate from the supporting walls into the vaults and are continuous between arches and vaults. It is interesting to observe that the vaults of several churches exhibit multiple parallel diagonal cracks, which are oriented in the same direction as the gaps of the floors (Figure 7b).

Figure 7. Damage in the vaults: a) cracks continuous between vault and supporting wall, b) multiple parallel diagonal cracks.

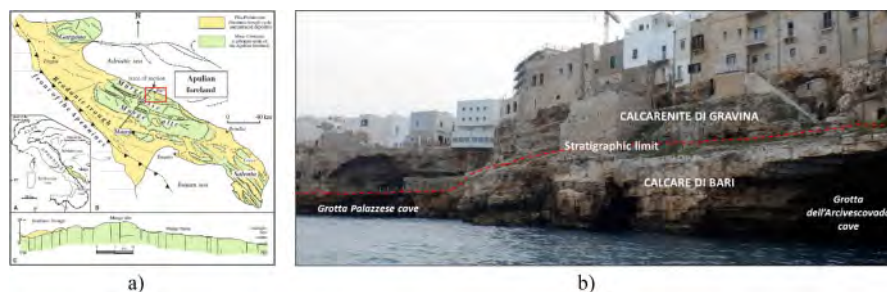
The anchor pullout tests presented in this study are all performed in Polignano a Mare. Figure 1a, taken from Spalluto (2012), reports the geology and the succession crops of the area. The coastal stretch is characterized by the outcropping of two main formations: well stratified micritic limestones of the *Calcarea di Bari* (CB) formations (Callovian pp.-early Turonian) are overlaid by discontinuous calcarenite deposits of the *Calcarenite di Gravina* (CG) formation (upper Pliocene–early Pleistocene). The latter, mainly constituted by biocalcarenites, is transgressive on the former through an angular erosional unconformity and thin conglomerate deposits (Andriani & Walsh 2002; Festa 2003; Spalluto 2012).

Figure 1. a) Location of the Apulian foreland in a synthetic structural map of Italy (Spalluto 2012); b) Stratigraphic limit between CB limestone and CG.

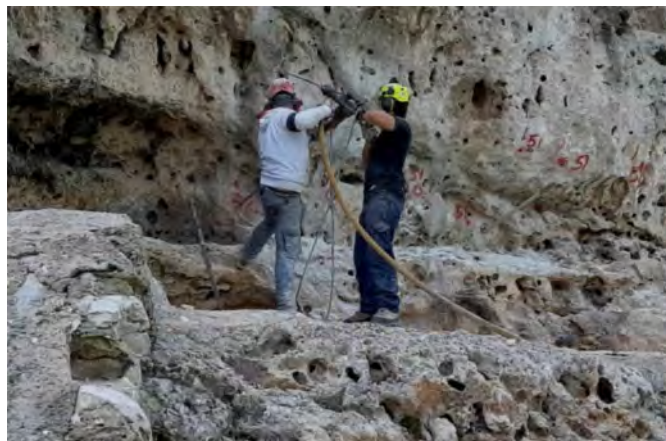
The choice of the diameter of the holes was made in relation to the diameters of the bars used. For, 32 mm holes were drilled while for both the Ø25 and Ø32 bars a 51 mm hole was used (Figure 6). All the bar (D) and hole (D<sub>h</sub>) diameters are reported in Table 3. All anchoring lengths were fixed to one meter.

Figure 6. Favellato SPA technician preparing the holes in the limestone.

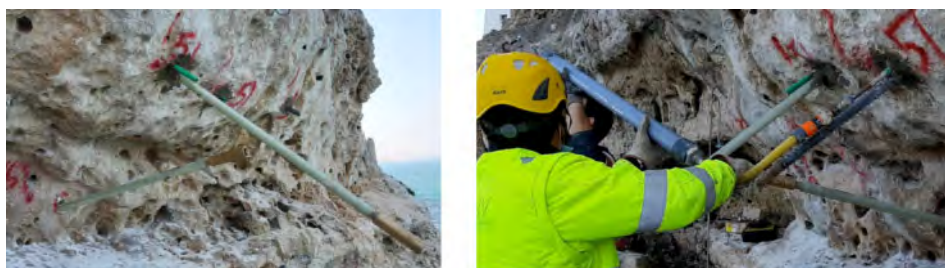
In FT1 12 bars were installed (4 in CG and 8 in CB limestone) and pulled to failure or to the maximum capacity of the jacking system (100 Tons). Of the 4 bars installed in the calcarenite, 2 were Ø32 GFRP hollow tubular bars and 2 were 26, 5 Ø DYWIDAG bar. The holes in zone 2 in Figure 3 (in CG calcarenite) with an upward inclination of approximately 45° were filled using a bespoke injection system (Figures 7a and 7b). First the bars were inserted into the holes for a length of 1 m with a tube for the injection of the consolidating material. Both the bar and the tube were fixed to the rock face using an ultra-fast cement mortar (*Lampocem* from Mapei) that helped to seal the hole preventing the consolidants to leak out during the injection. Once cured a very fluid lime-based mortar (*MasterInject 222* – Pozzolanic lime grout, cement-free) was injected through the preinstalled tube.

Figure 7. a) VTR bars blocked by *Lampocem* before injection; b) injection of *MasterEmaco 222* through injection tube in CG.

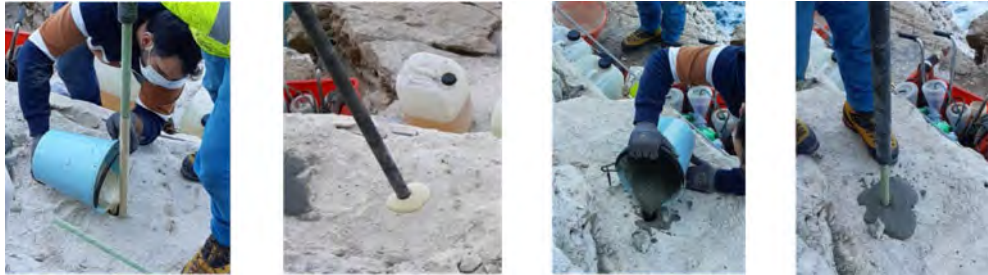
A few meters below the above described calcarenite anchors a bank of CB limestone was chosen (Zone 1 in Figure 3) and injected, by pour (see Figure 8). 4 different bars with different diameters, for a total of 8 holes were filled with either an organomineral resin (*MasterRoc RBA 380*) or a quick-setting cement mortar (*MasterEmaco T 1200 PG*).

Figure 8. Pouring to two different materials.

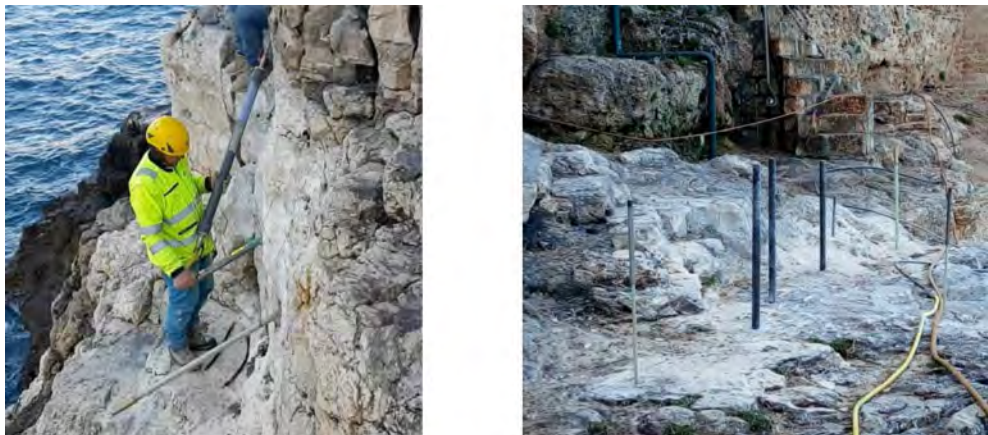
In FT2, 12 anchors were installed (all in CB limestone), with 8 different types of consolidating materials. Except for the CB1/2 and CB2/2 bars (Zone 2), where the consolidant material was injected with the same bespoke method used in FT1 and described above (Figure 9a), all the other bars were grouted by casting the chosen material (Figure 9b).

Figure 9. a) Technician during injection *MasterEmaco A 60* in CB1/2; b) anchor in FT2 zone 1.

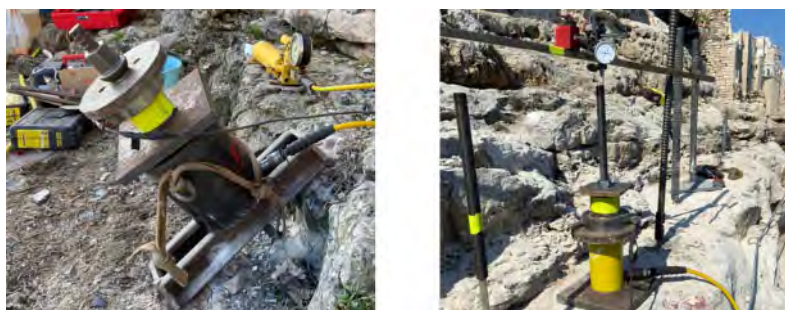
Figure 11. a) Pull test with 1000 kN capacity Hallow piston; b) pull test with 300 kN capacity hallow piston.

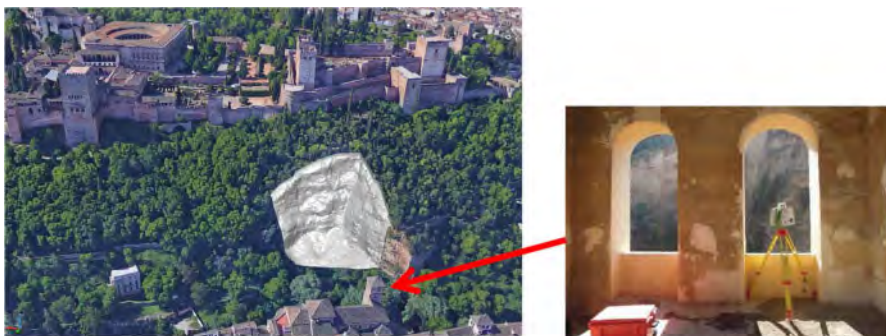
Terrestrial laser scanning (TLS) is a ground-based, active imaging method that rapidly acquires accurate, dense 3D point clouds of object surfaces by laser range finding. A TLS apparatus (LEICA ScanStation C10) was installed in the bell tower of San Pedro church located just in front the cliff 30 meters away (Figure 4).

Figure 4. TLS monitoring from the bell tower of San Pedro church.

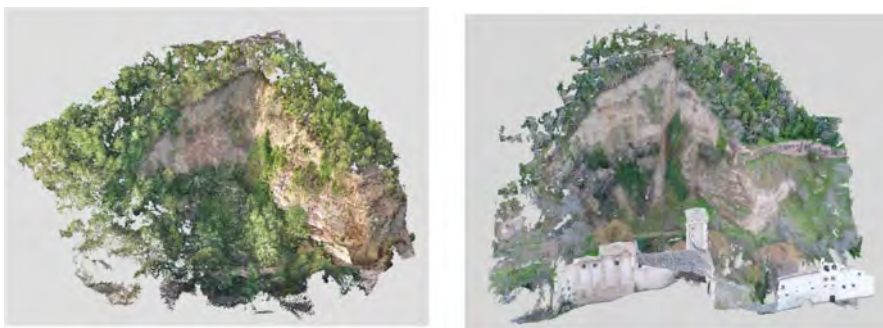
Figure 6 depicts the two generated high resolution point clouds, the left side corresponds to July 2017 with 26 million points, the right side corresponds to February 2018 with 11.6 million points. Some differences are glaring. First of all the coverage vegetation is much more pronounced during the summer season. Second and much more important an earth flow can be detected in the apse of the cliff who acts as a corridor. This event occurred the 6 January 2018 after an important snow event.

Figure 6. UAV photogrammetry monitoring results in the San Pedro cliff. Dense point clouds. Left: July 2017. Right: February 2018.

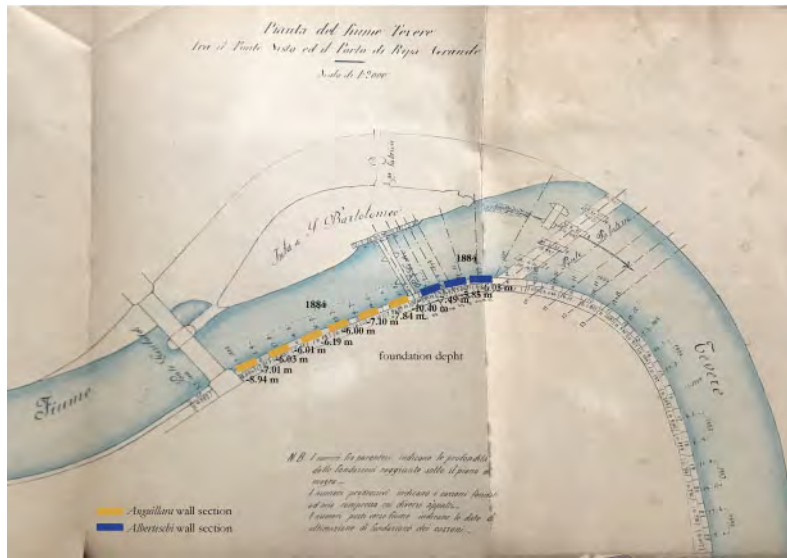
The Anguillara and Alberteschi sections are comprised in the area most damaged by the flood. That portion of the retaining walls ran between Garibaldi and Palatino bridges for about 350 m: the Anguillara section, located between Garibaldi and Cestio bridges, was 240.86 m-long; the second, between Cestio and Palatino bridges, was 111.76 m-long (Figure 3).

Figure 3. The Alberteschi and the Anguillara retaining walls: plan showing foundation deep and date of construction (courtesy Rome State Archive Roma, Genio Civile collection).

1.8 m ( $s_1$ ). The foundations of the Anguillara section were laid between  $-6$  m and  $-7.84$  m below the standard water level, reaching the depth of 8.94 m, at the Garibaldi bridge. The foundations of the Alberteschi section featured depths, ranging from 6.00 m to 7.49 m (Figure 3). The masonry wall was composed of tuff blocks with pozzolanic mortar joints, while the inclined external wall-line was coated with squared travertine blocks, with an average thickness of 30 cm. Both the wall cornice and the parapet were in travertine, while the base and the cover of the parapet were in granite (Giannetti & Casini 2021).
