# The Swash Channel Wreck

An Archaeological  
Investigation  
of a 17th-Century  
Armed Dutch  
Merchantman

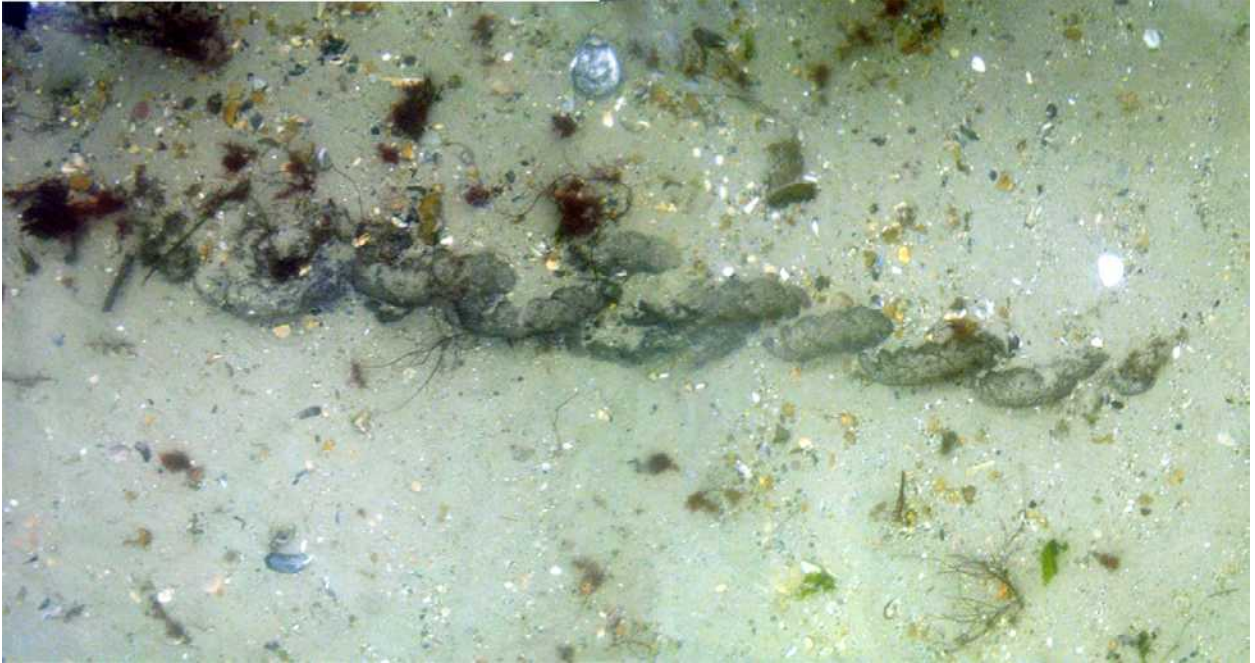
Figure 1.3. Cable potentially relating to the salvage

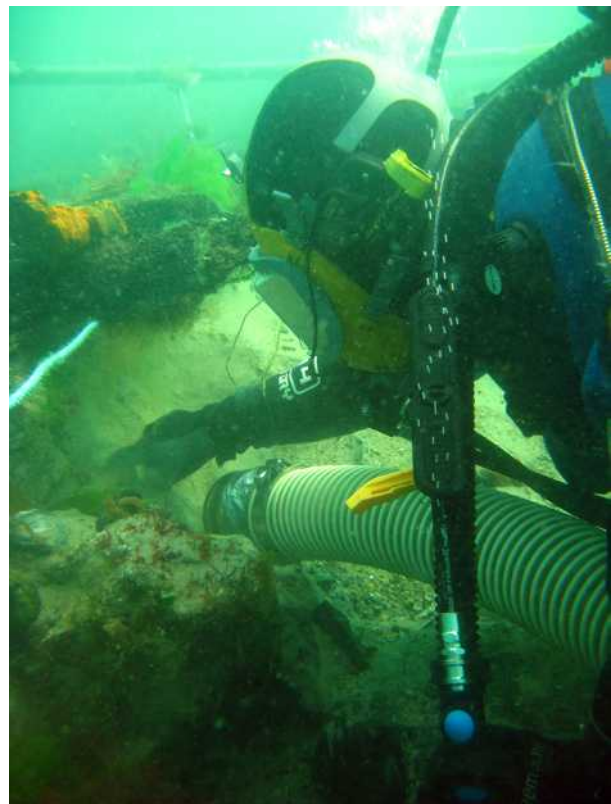
Figure 2.5. Diver excavating with dredge

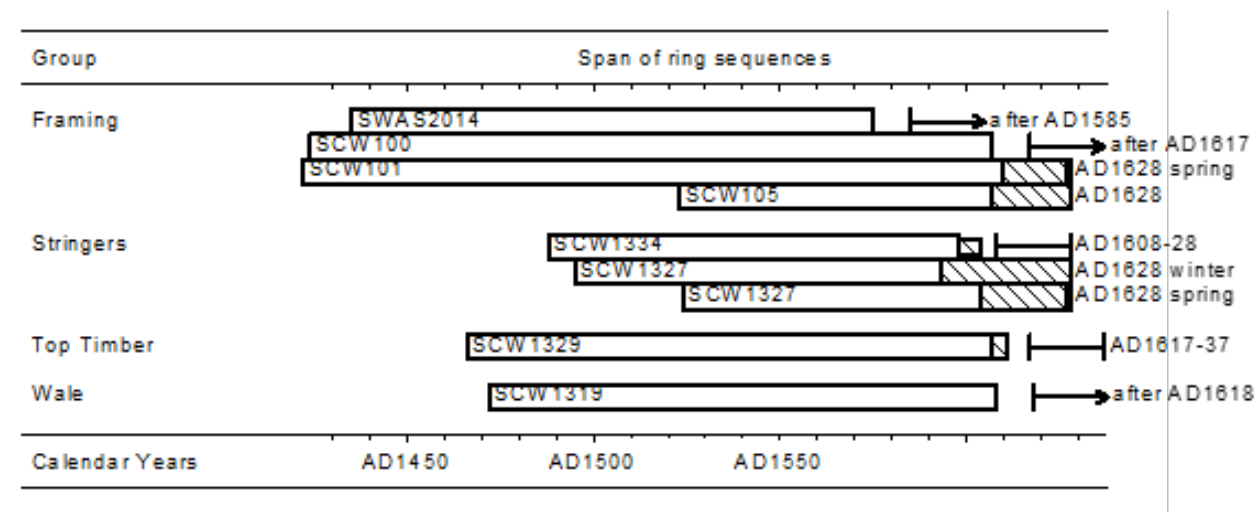
Figure 3.2. Bar diagram of dated timbers from the Swash Channel Wreck.

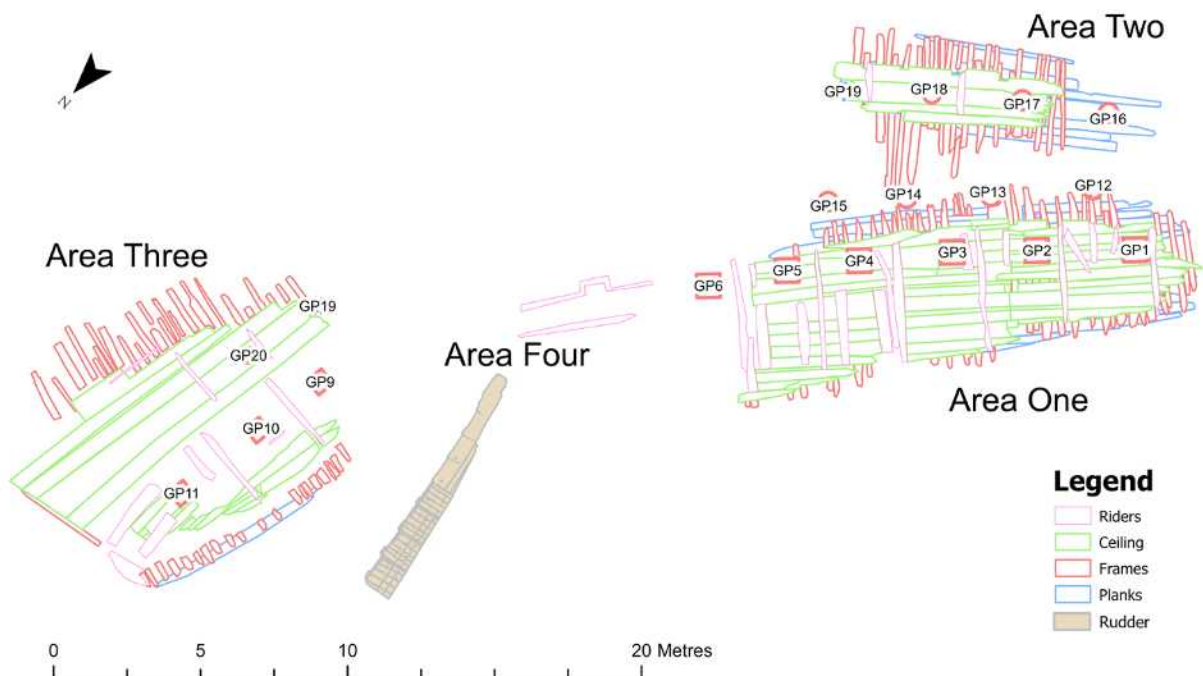
Figure 4.1. Overview of the structural timbers observed or recorded over the site

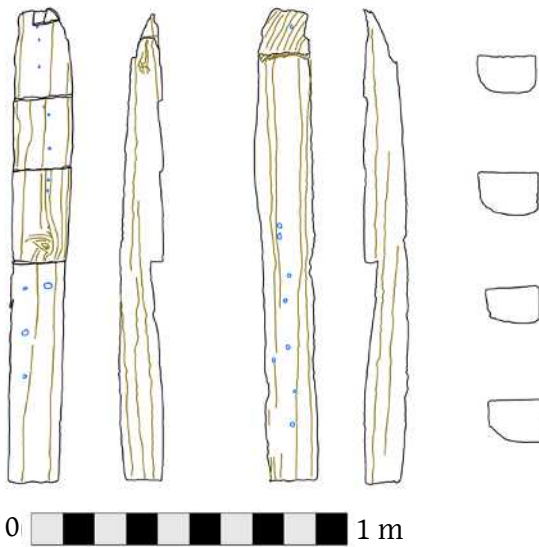
Figure 4.25 Stanchion frame SCW1227 showing the hook for the last strake and the joggles for the weatherboarding and rails

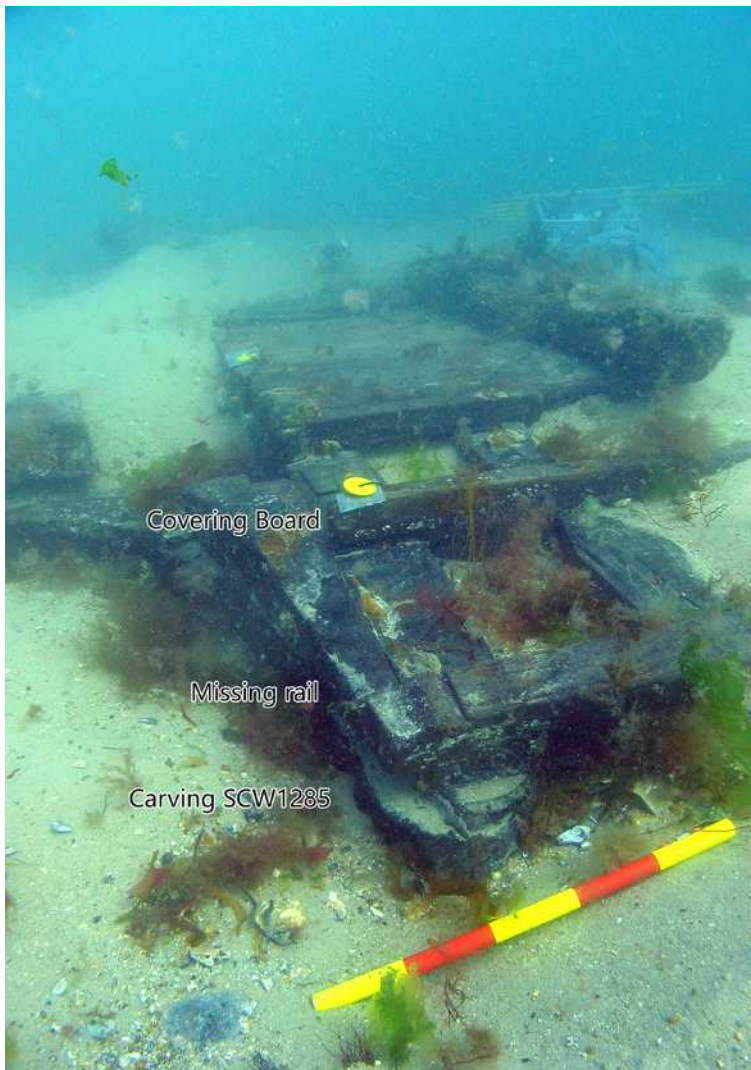
Figure 4.42. Missing rail shown in the 2004 photographs from Wessex Archaeology

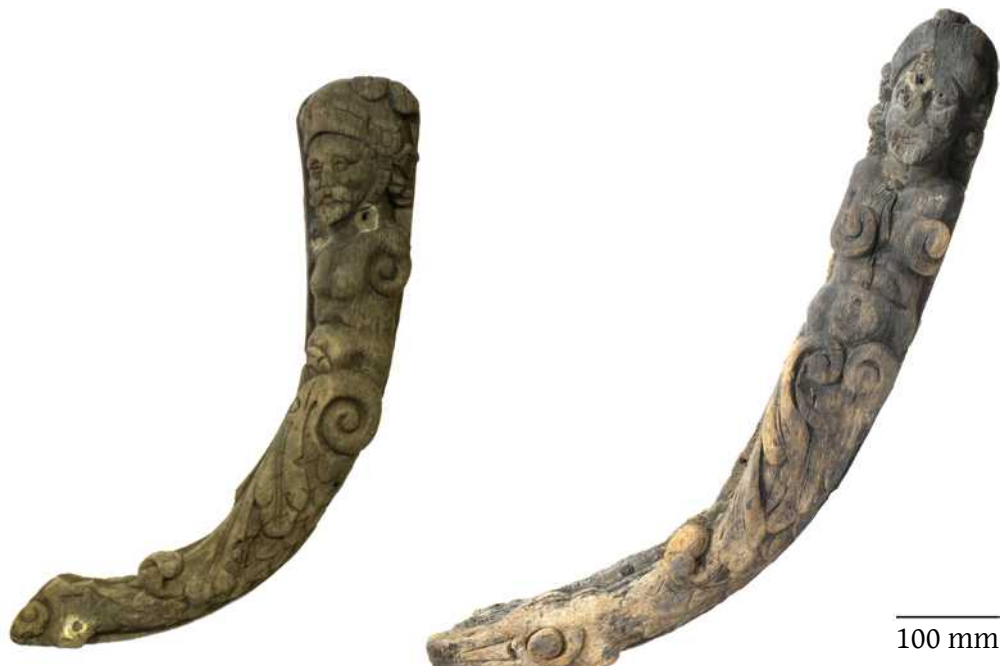
Figure 4.44. Tritons SCW18 (left) and SCW1285 (right)

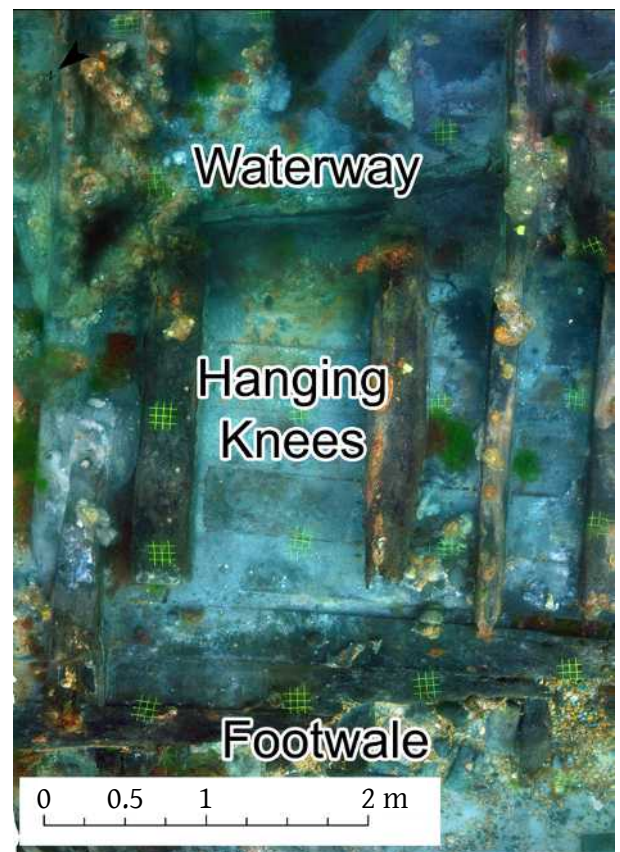
Figure 4.56. The hold at midships

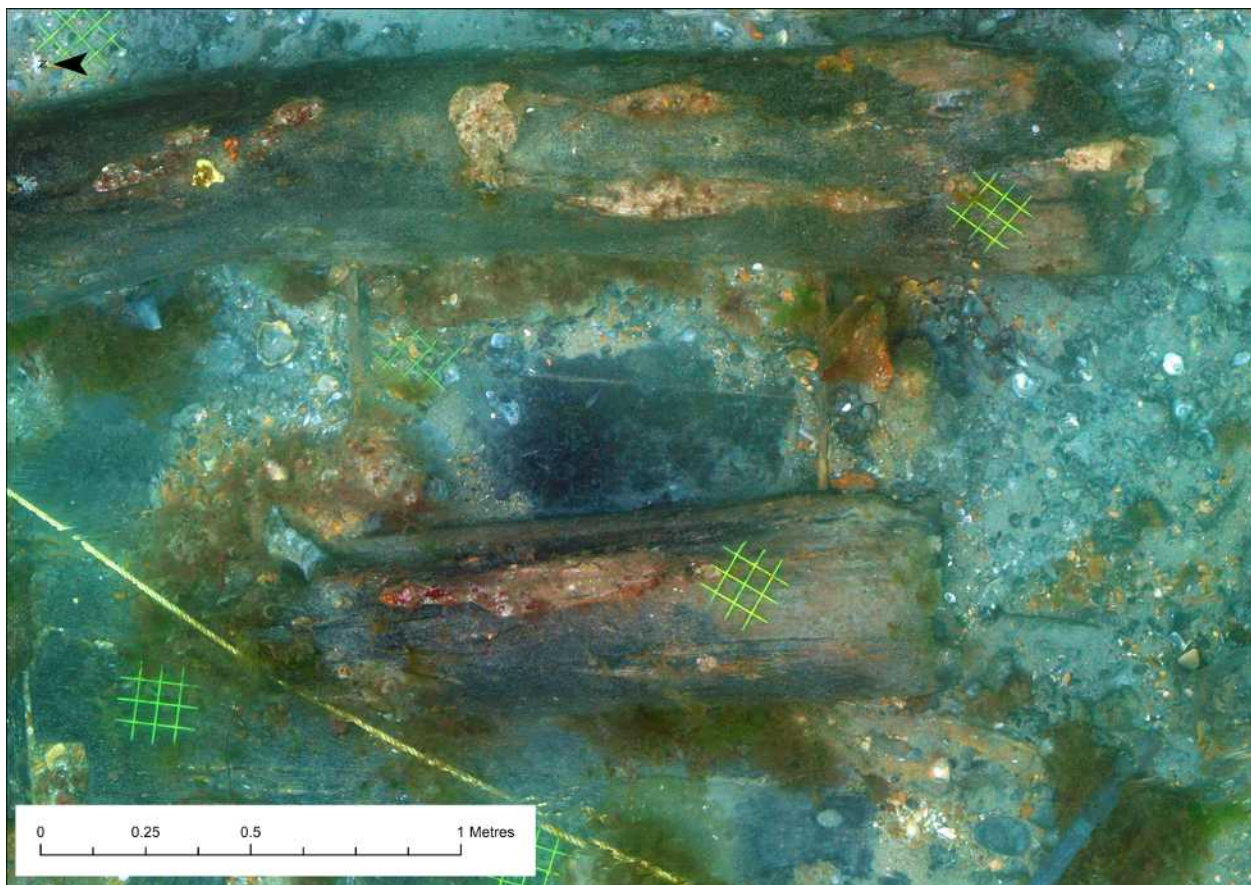
Figure 4.57. Shelves of the transom knees

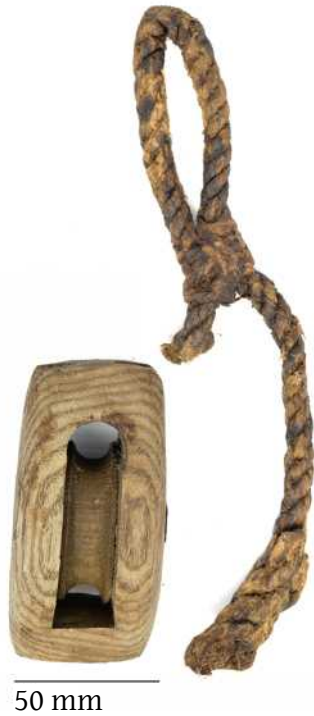
Figure 5.10. SCW435 next to its strop

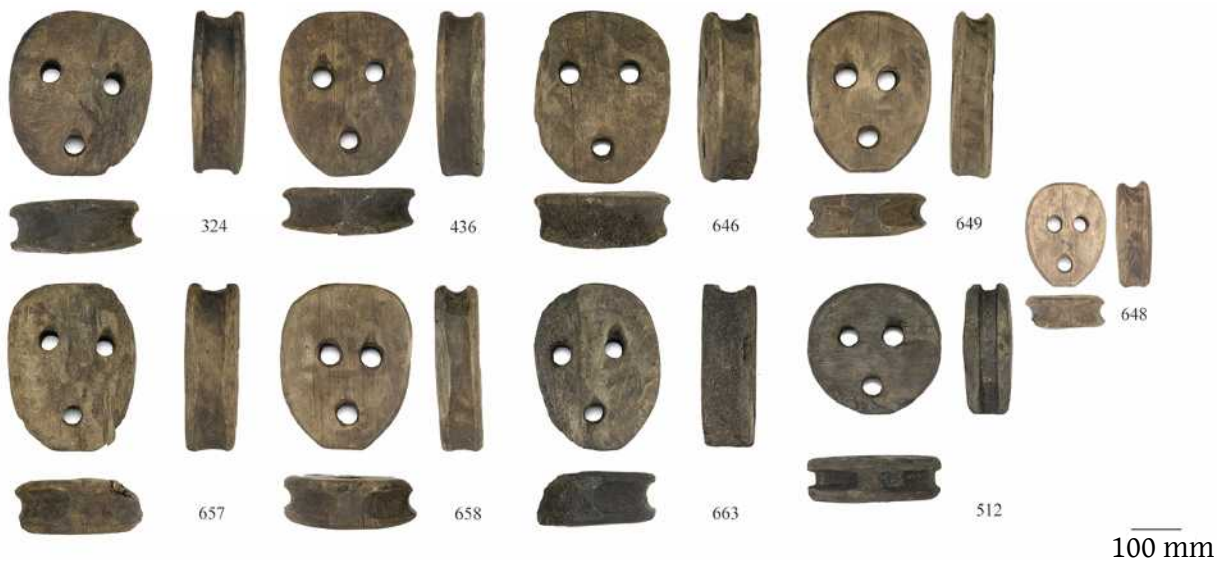
Figure 5.16. Deadeyes recovered from the wreck

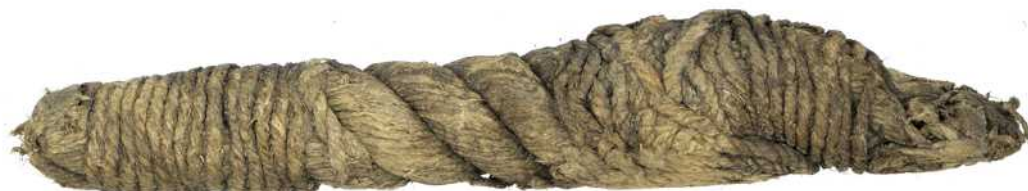
**SCW221** is a Z-laid hawser approximately 52mm diameter (6½" circumference). The mouse is in very poor condition but would have been c 12" in circumference when complete. The poor condition of the mouse allowed its composition to be ascertained: a possible layer of serving using a 4–5mm stuff, followed by a few layers of some heavier small stuff that on investigation was found to be a three-strand sennit or

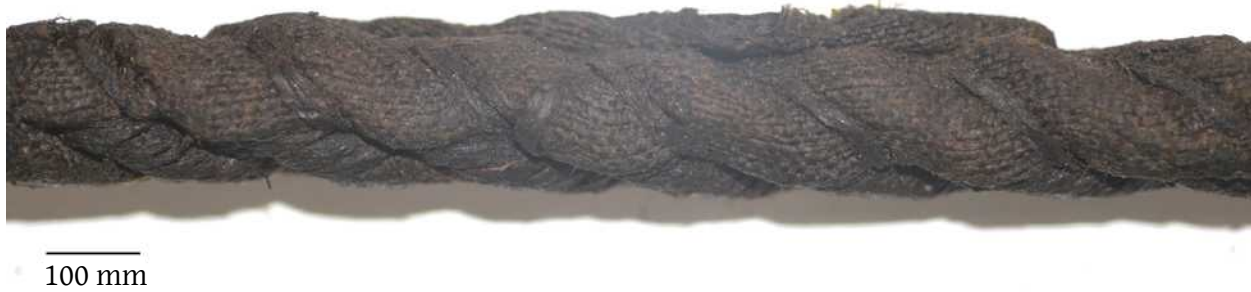
Figure 5.19. Sail cloth stitched to the boltrope

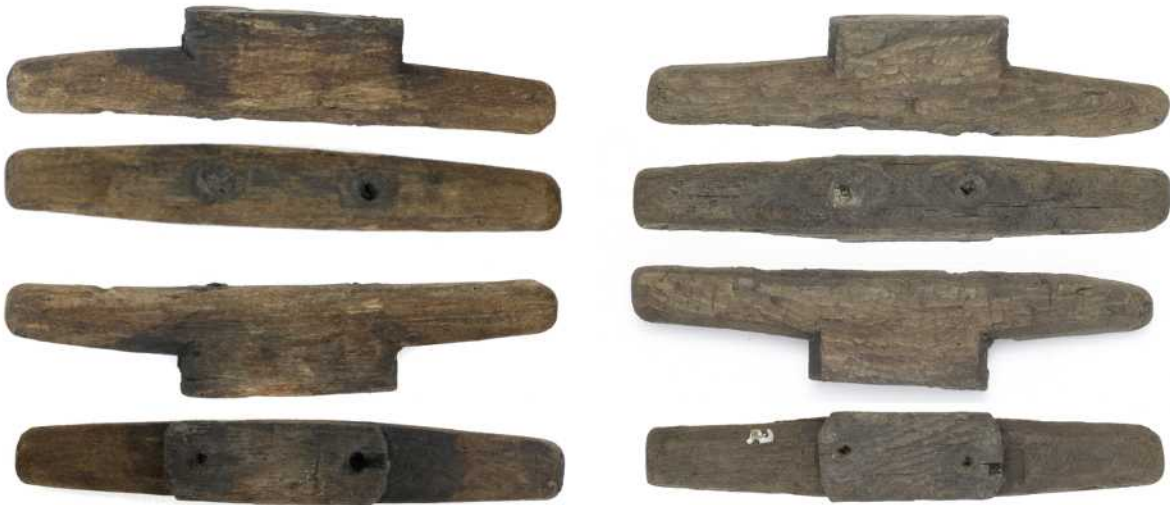
**SCW788** (Figure 5.24) is the most complete of the hanks, with both ends surviving. Estimated to be at least 100m of rope, approximately 9–10mm diameter (1½ – 1¼" circumference), each strand S-laid, from four Z-laid yarns. It was originally made up as a coil or hank measuring more than 650mm long, which it currently measures in a very relaxed state.

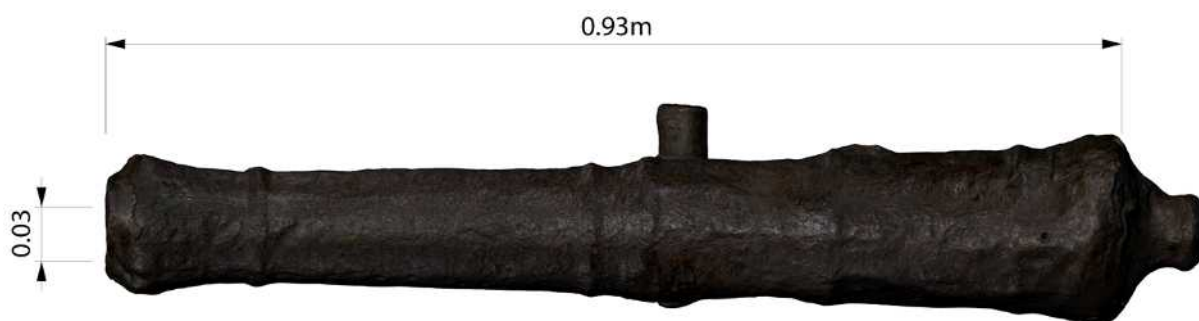
Figure 6.5. Gun SCW689

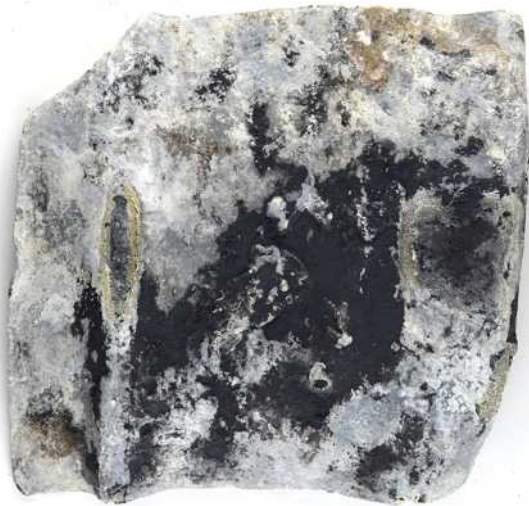
**SCW386** (Figure 6.6) is in exceptionally good condition and was found loose on the site so it was not subject to any concretion. Four small holes can be seen with fragments of the line used to tie the apron to the gun.

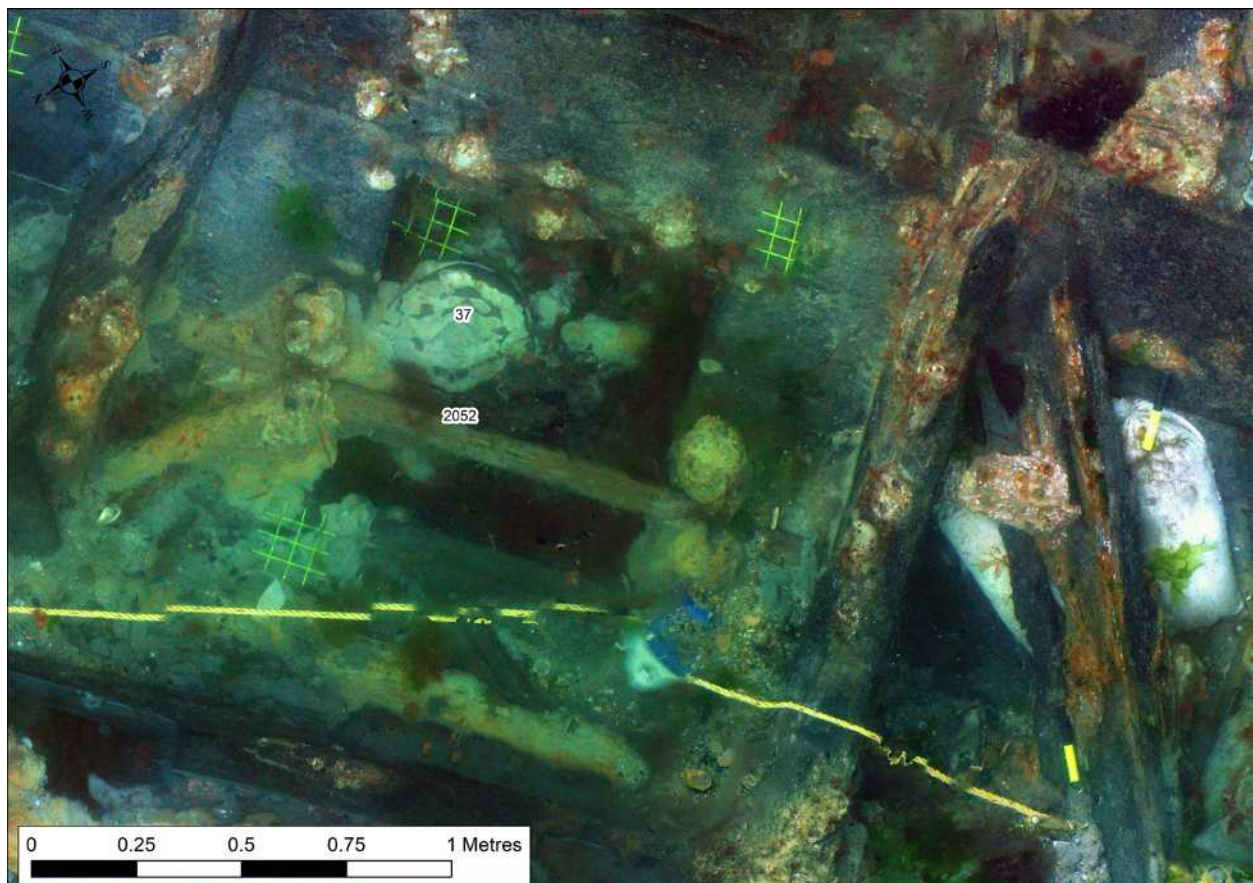
Figure 6.7. Truck SCW37 *in situ* inside gunport 2; also present is a possible handspike SCW2052 crossing the port

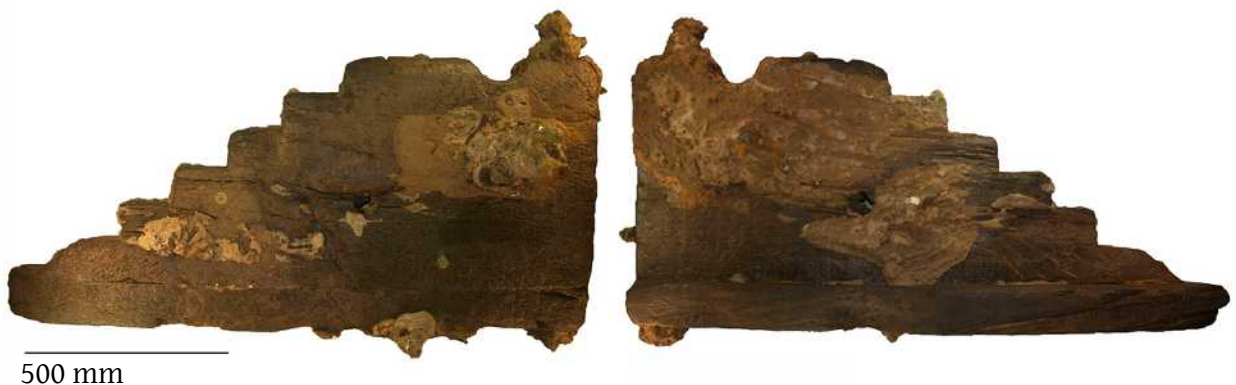
Figure 6.9. SCW52 carriage cheek

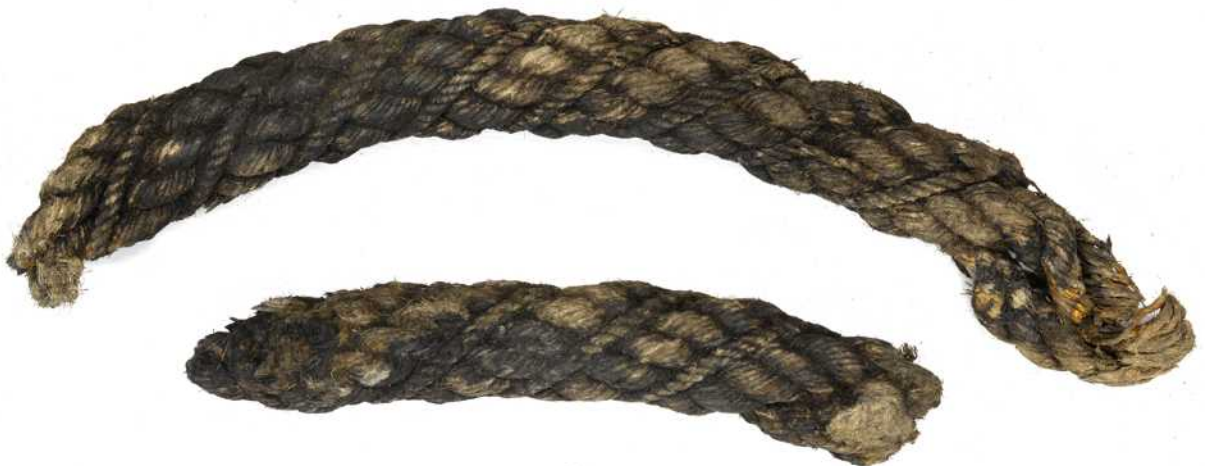
In addition, 17th-century carriages of a similar construction but with differing rears can be compared to give a general idea of guns at sea, such as the chock-based carriage on the *Swan* (Martin 2004), the three-wheeled carriage from the late 16th-century shipwreck *Scheurrak SO 1* near the Texel (Puype 2000) and the Windsor Castle cannon (Smith 2001).

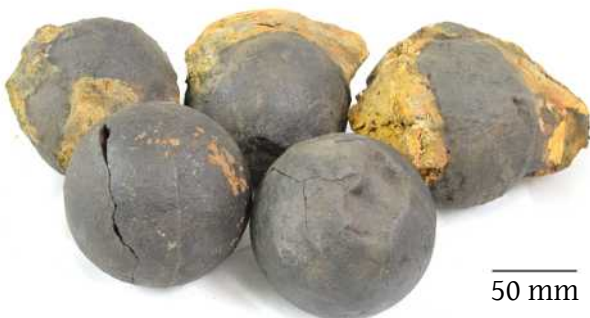
Figure 6.14. 120mm round shot

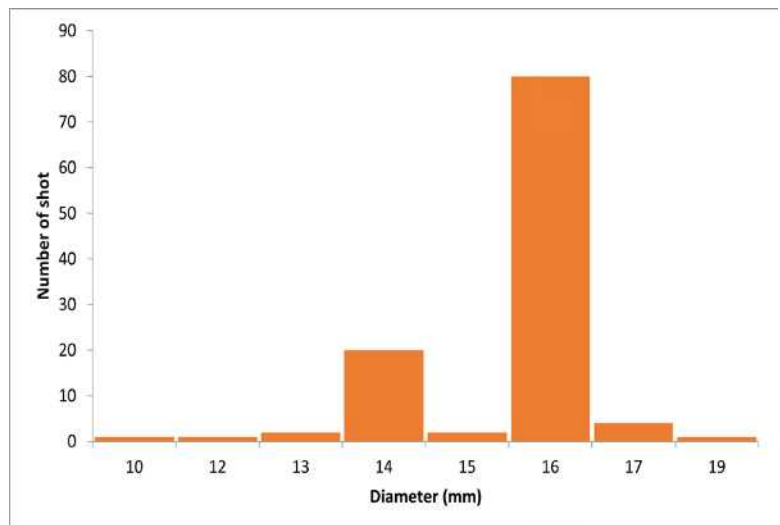
Figure 6.16. Diameters of shot found within canister SCW740

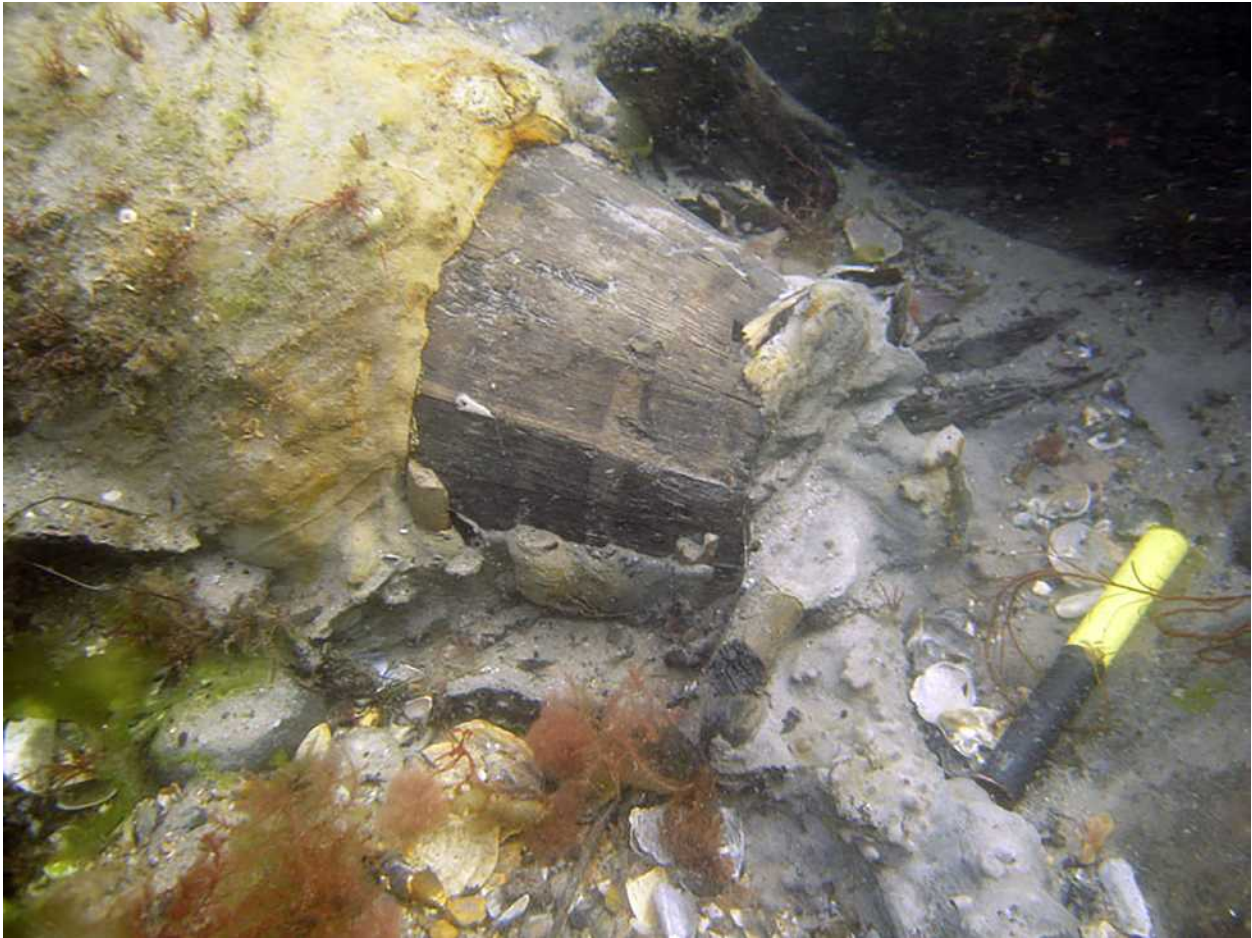
Figure 6.23. Conical container *in situ*

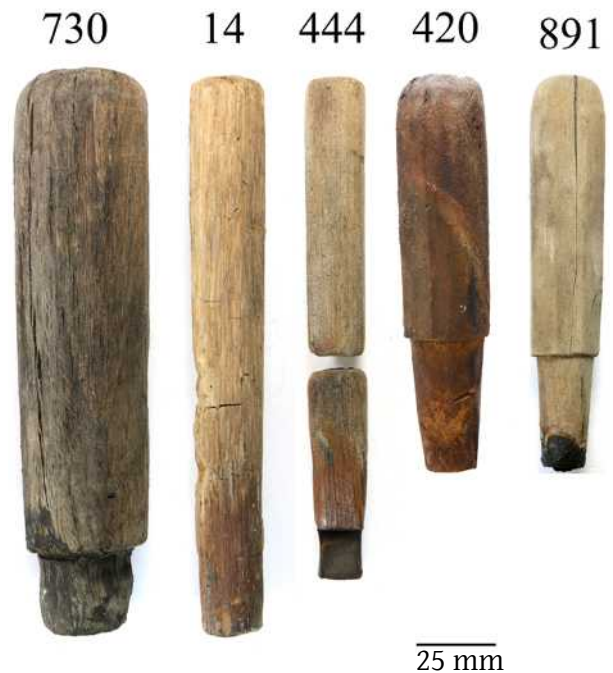
Figure 7.1. Tool handles recovered from the Swash Channel Wreck

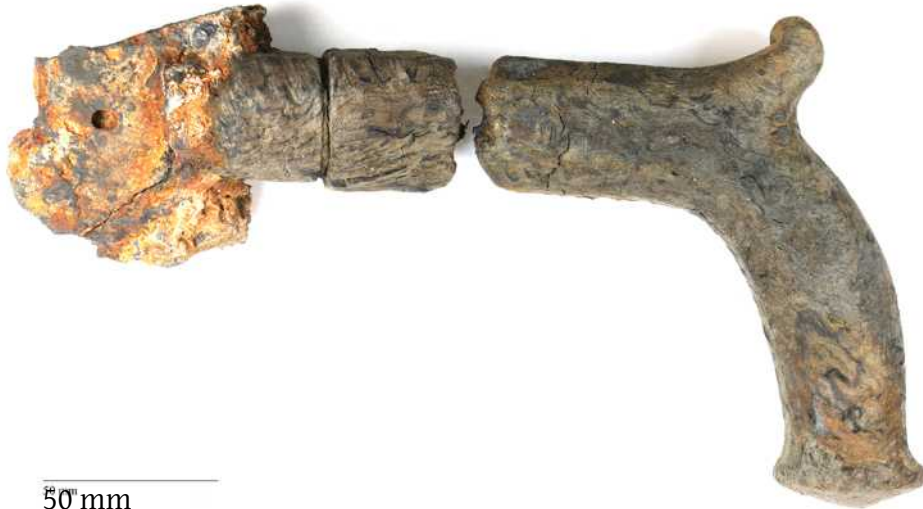
Figure 7.4. SCW789 handsaw handle

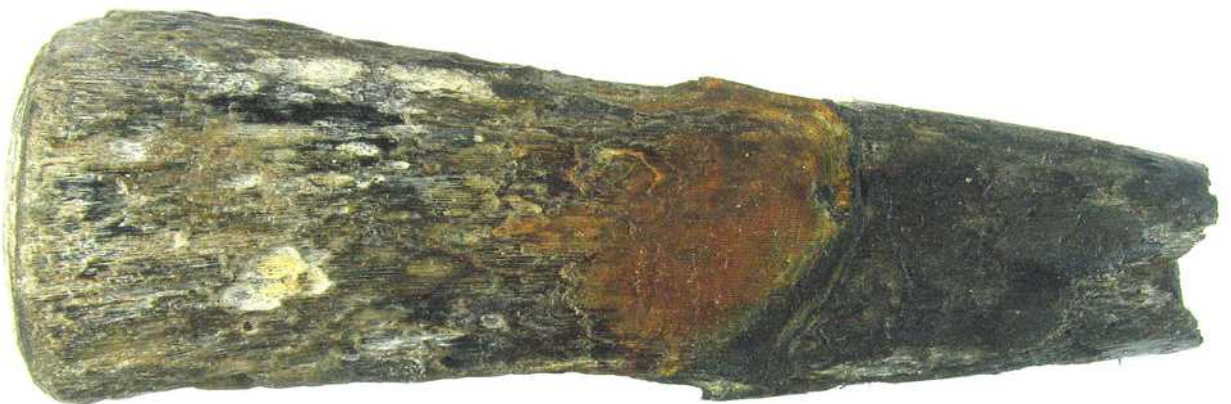
Figure 7.7. SCW890 horn tool handle

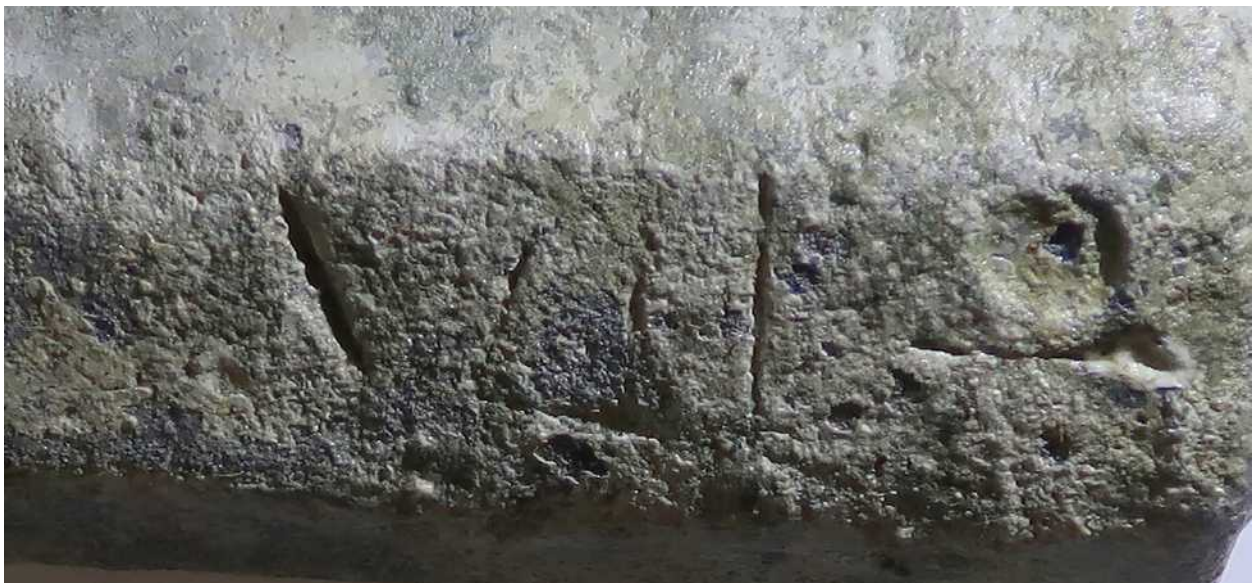
Figure 7.14. Possible VII  $\ominus$  markings on SCW45

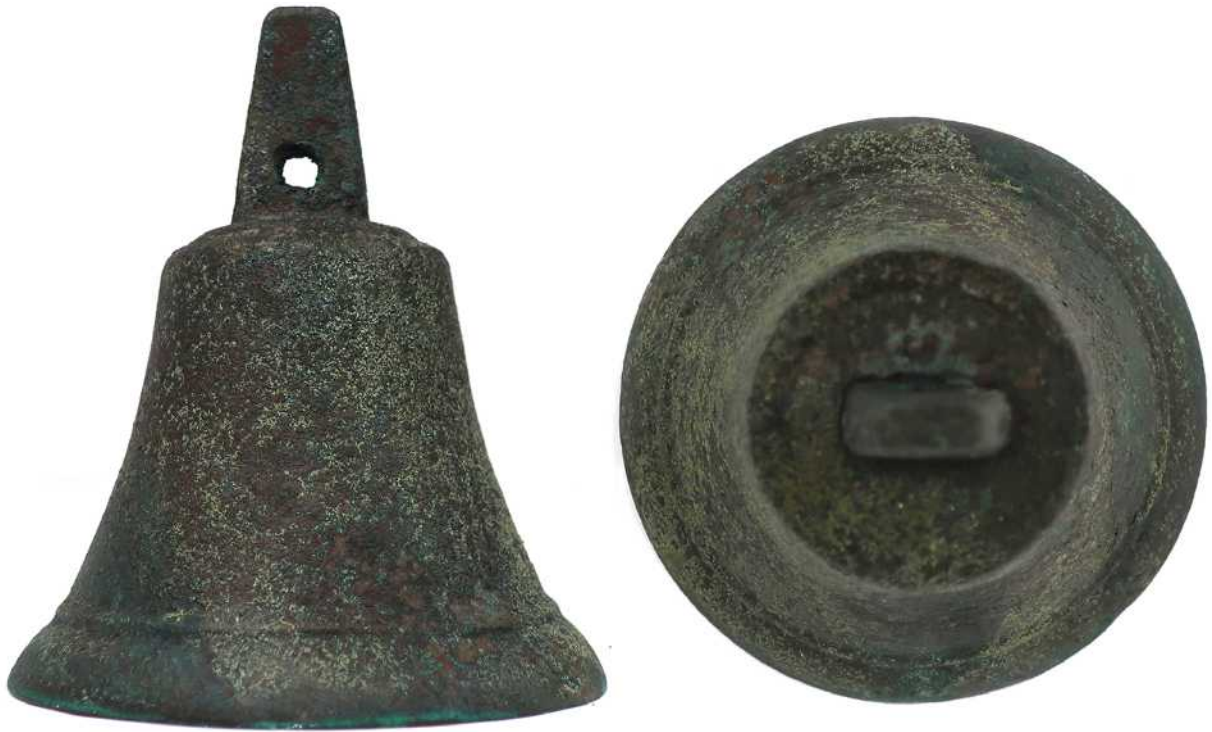
These items are likely to be horn 'lights' from wooden lanterns, although lanterns made principally of leather

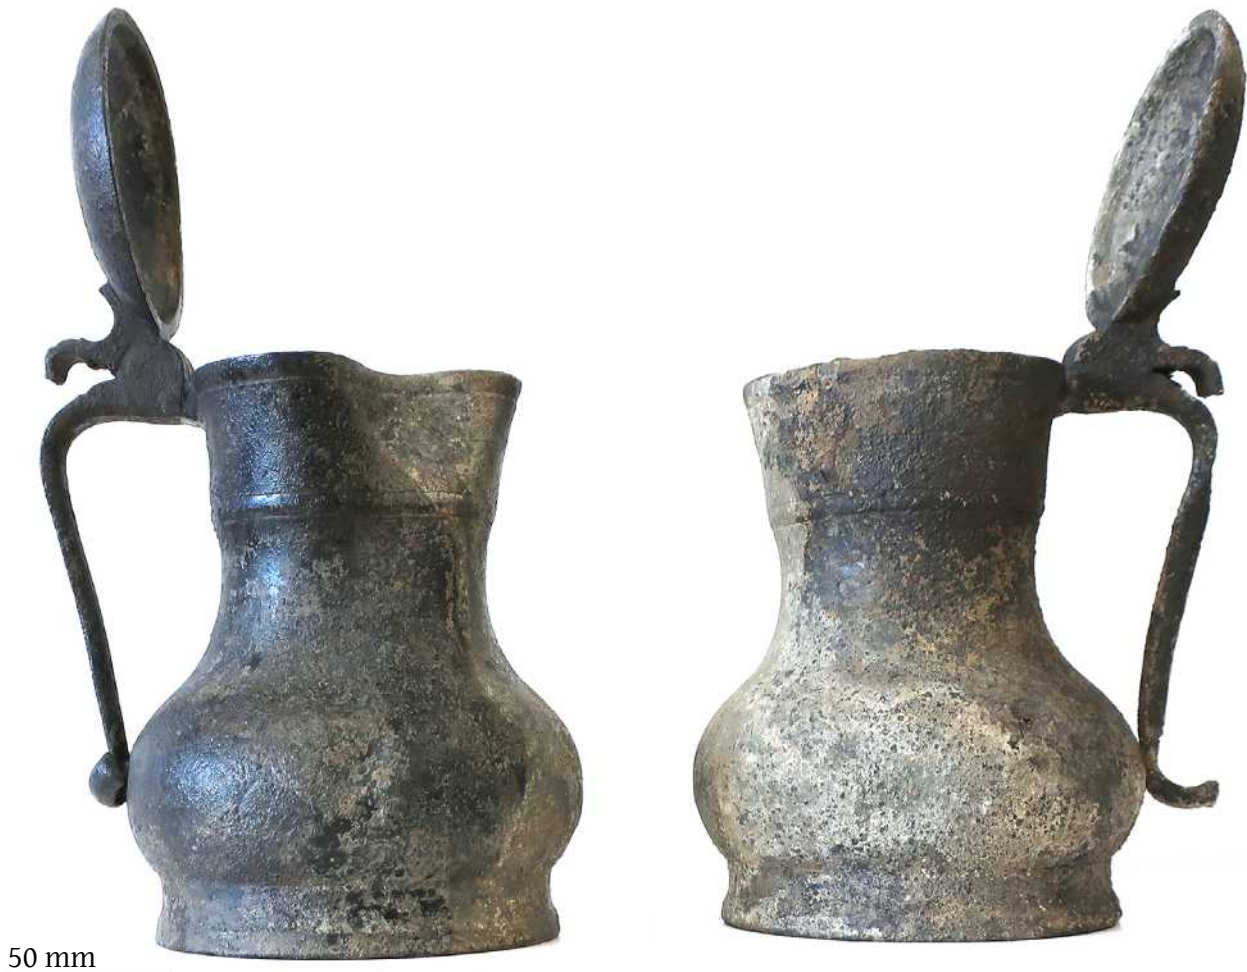
Figure 7.23. Pewter wine flagons SCW889 (left) and SCW897 (right)

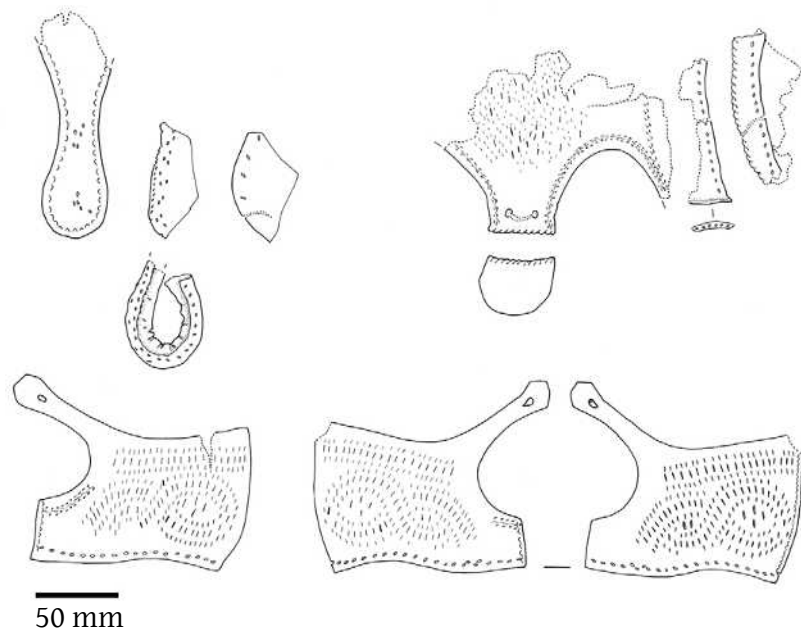
Figure 7.36. SCW343 decorated shoe (illustration by Sue Winterbottom)

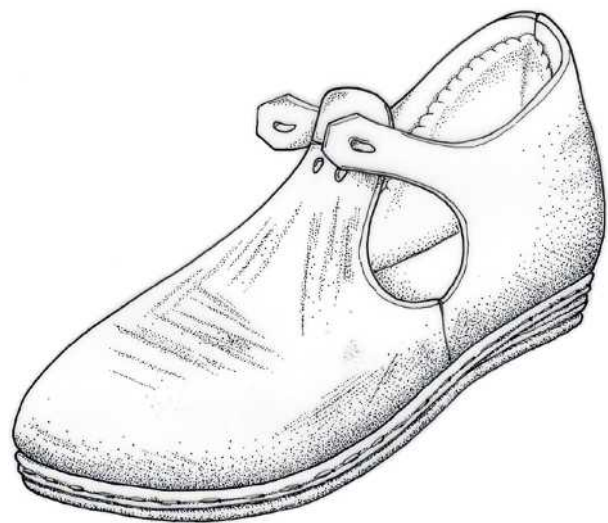
Figure 7.37. Shoe style represented by the Swash Channel Wreck finds (not to scale) (illustration by Sue Winterbottom)

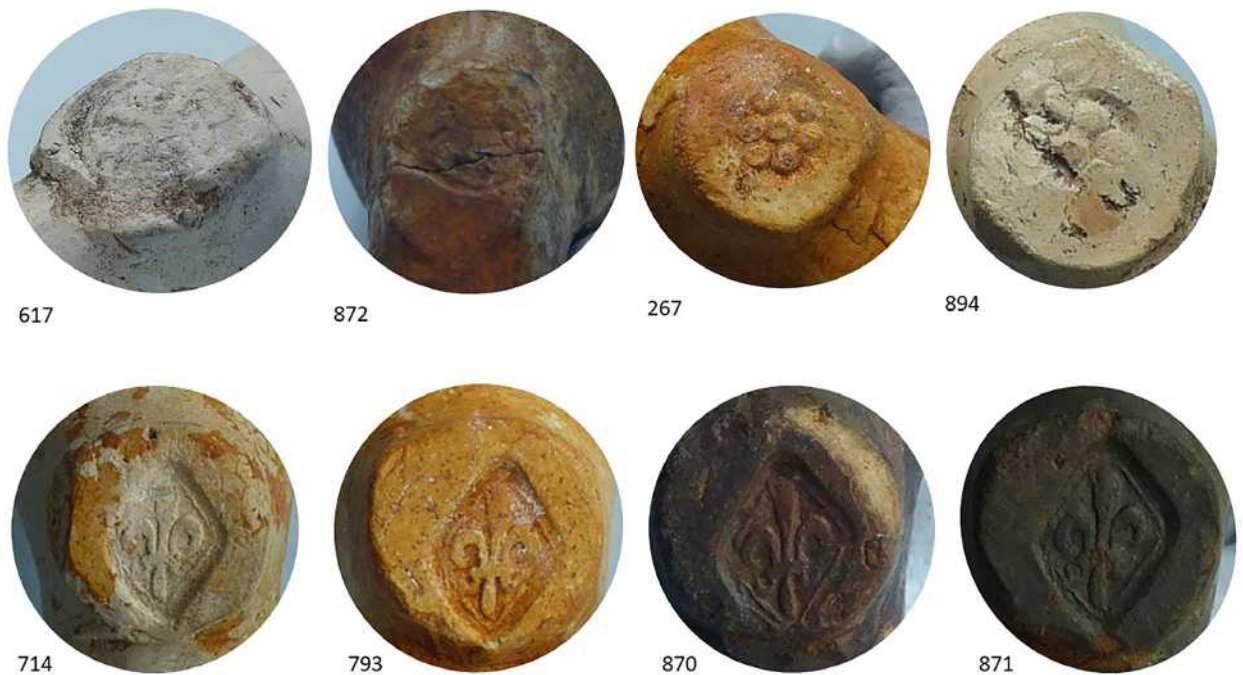
Figure 7.39. Stamps on the non-intrusive pipes
