ACROSSBORDERS I  
THE NEW KINGDOM TOWN OF SAI ISLAND, SECTOR SAV1 NORTH

# **ACROSSBORDERS I**

The New Kingdom Town of Sai Island,  
Sector SAV1 North

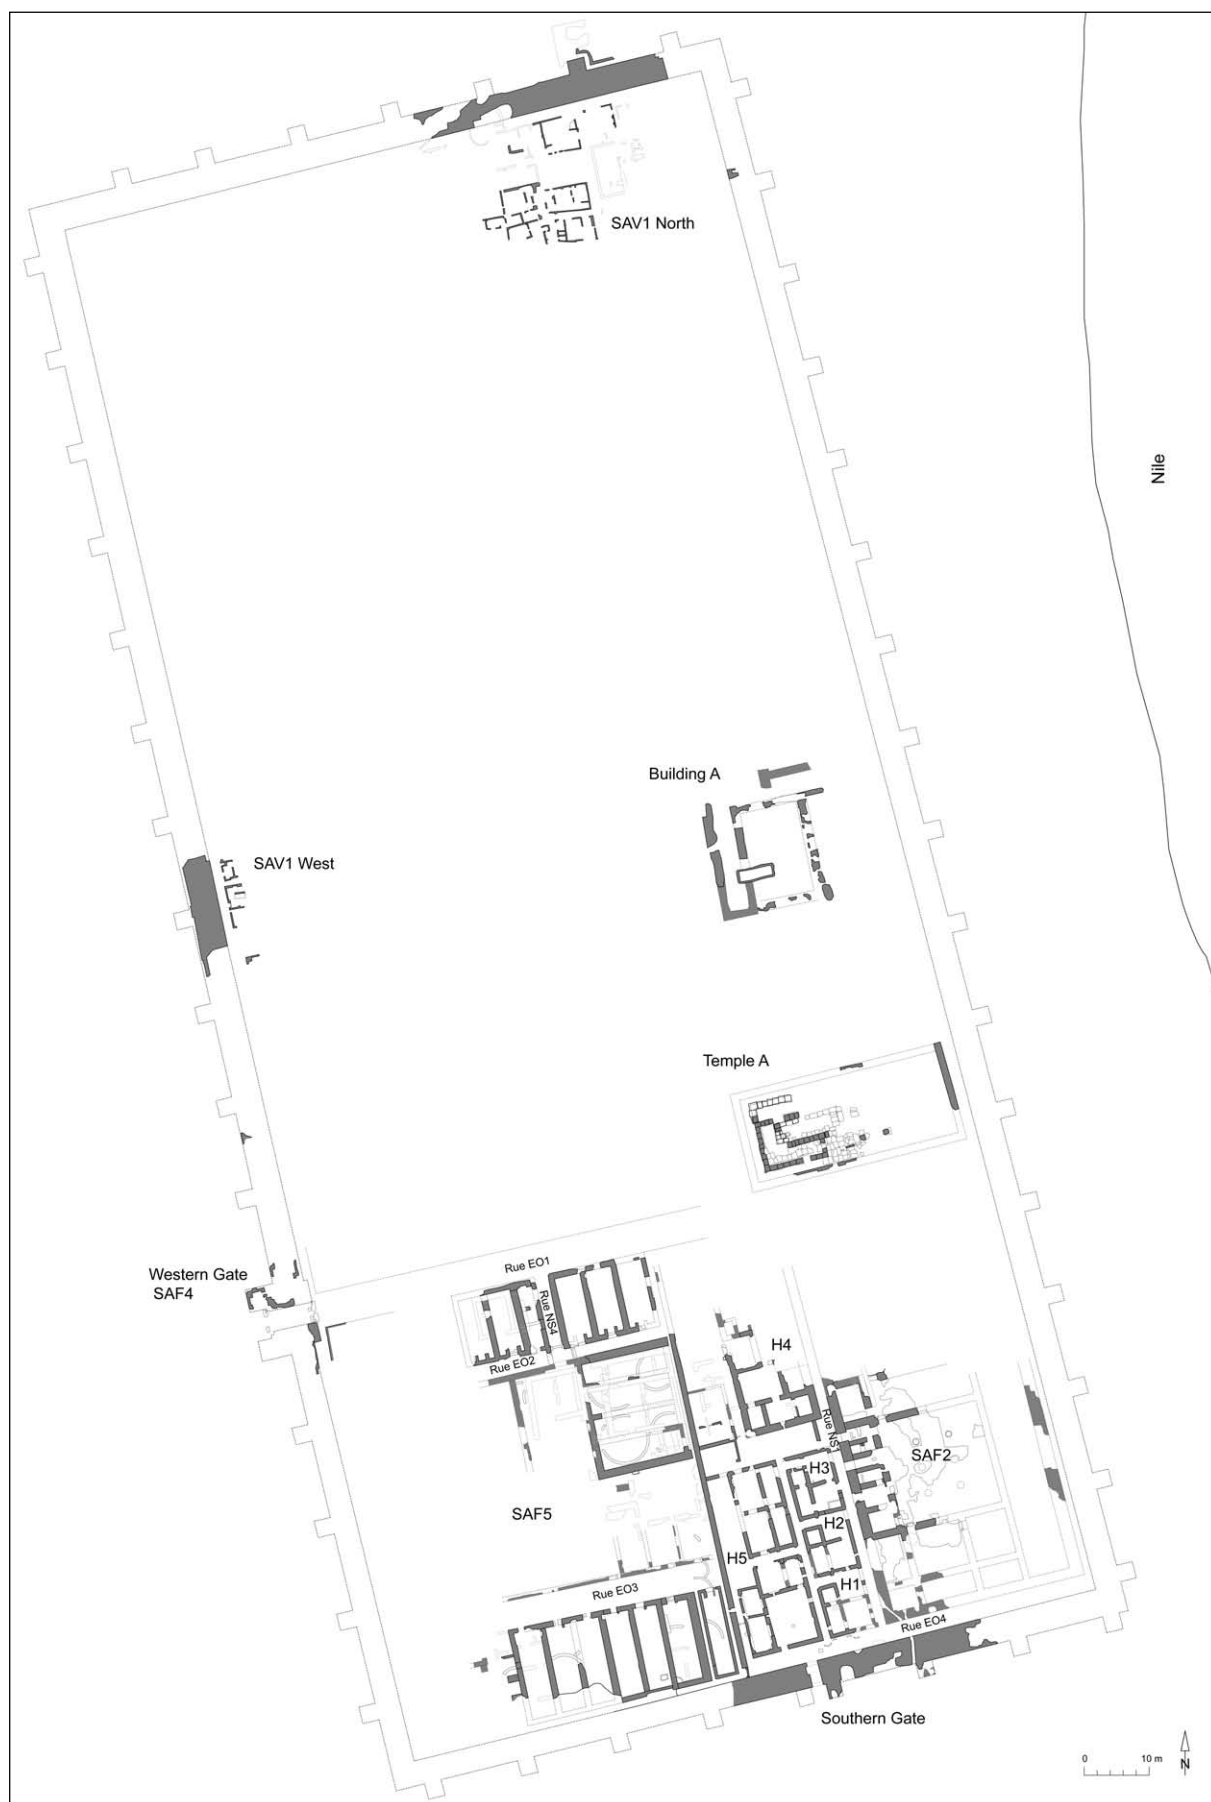
Fig. 1 Map of the New Kingdom town of Sai, including field work results up to 2016 (©AcrossBorders, Ingrid Adenstedt)

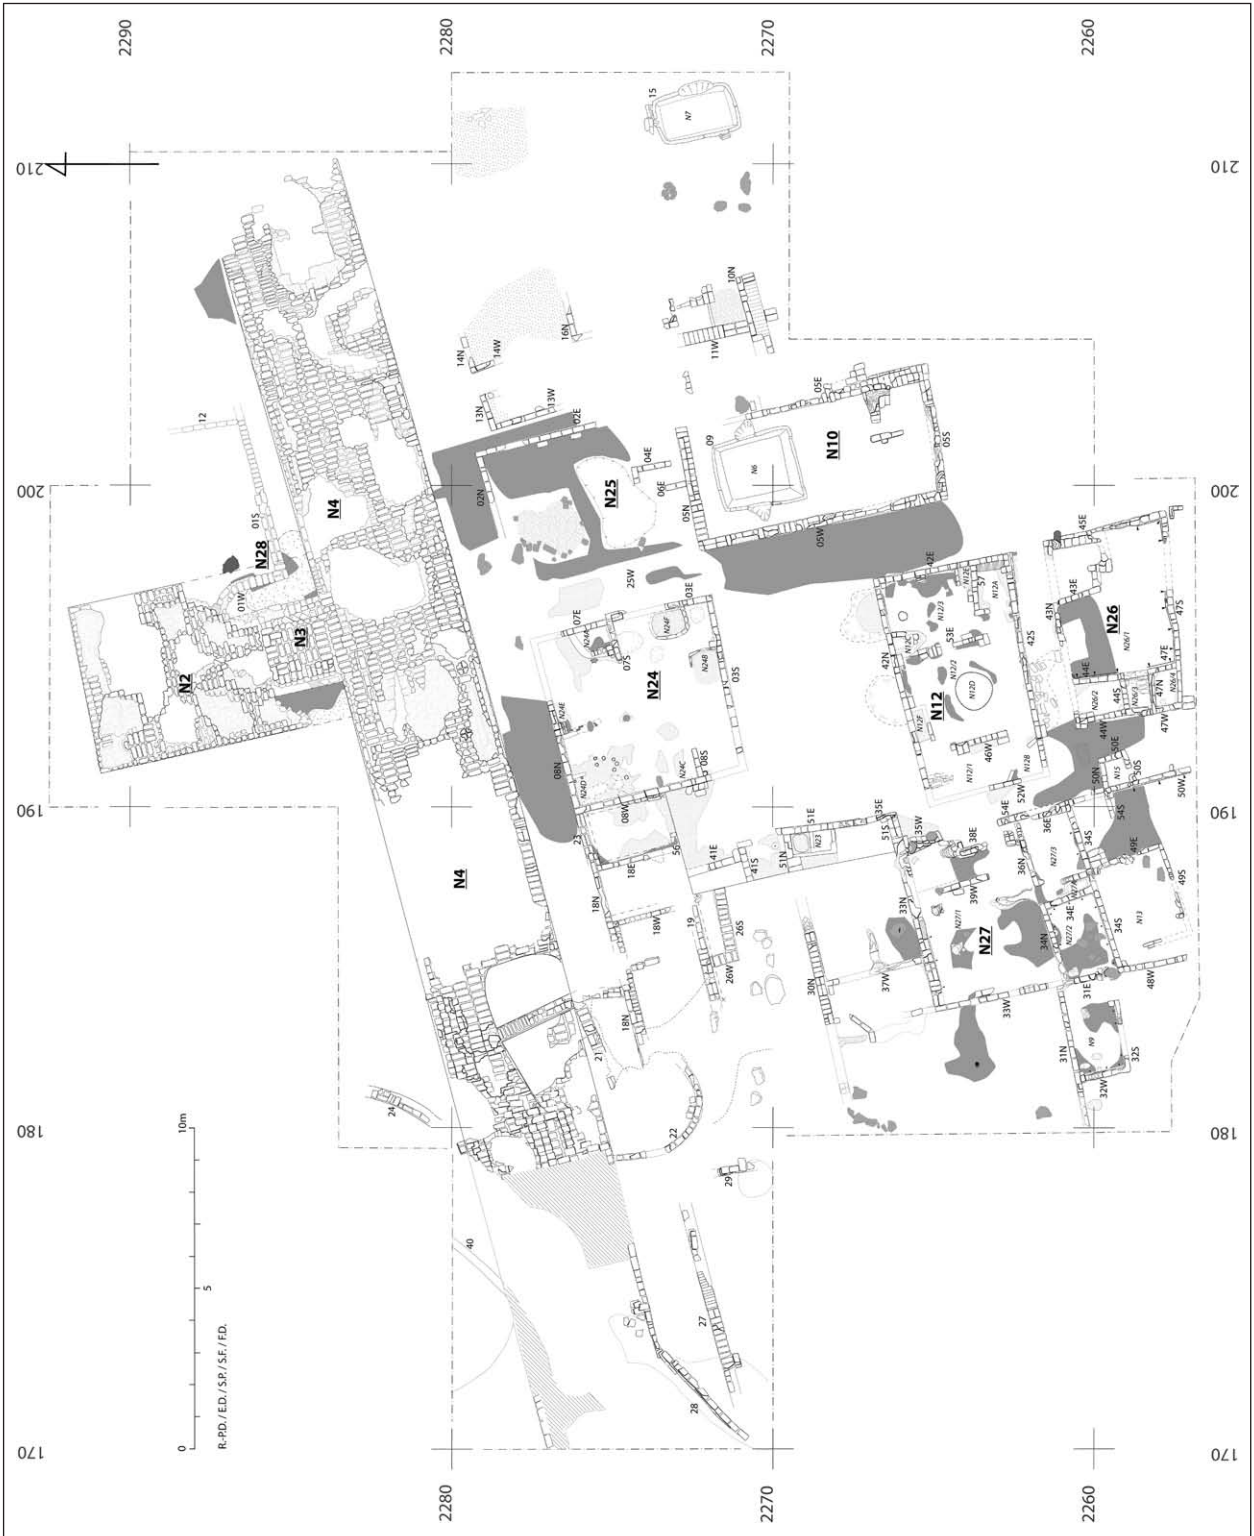
Fig. 3 Complete plan of the site SAVI North

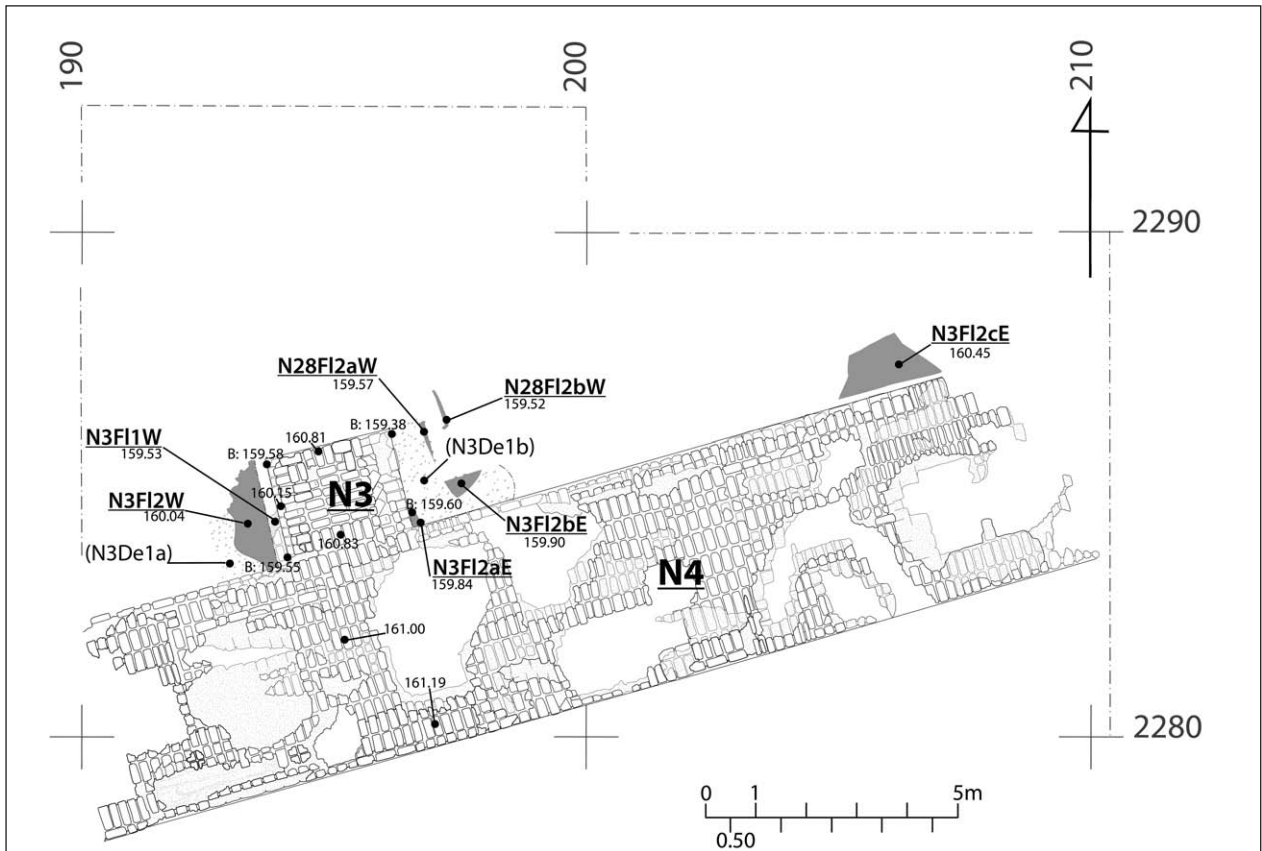
Fig. 8 Plan of Phase N3-b: levels of Structures N3, N4 and associated floors

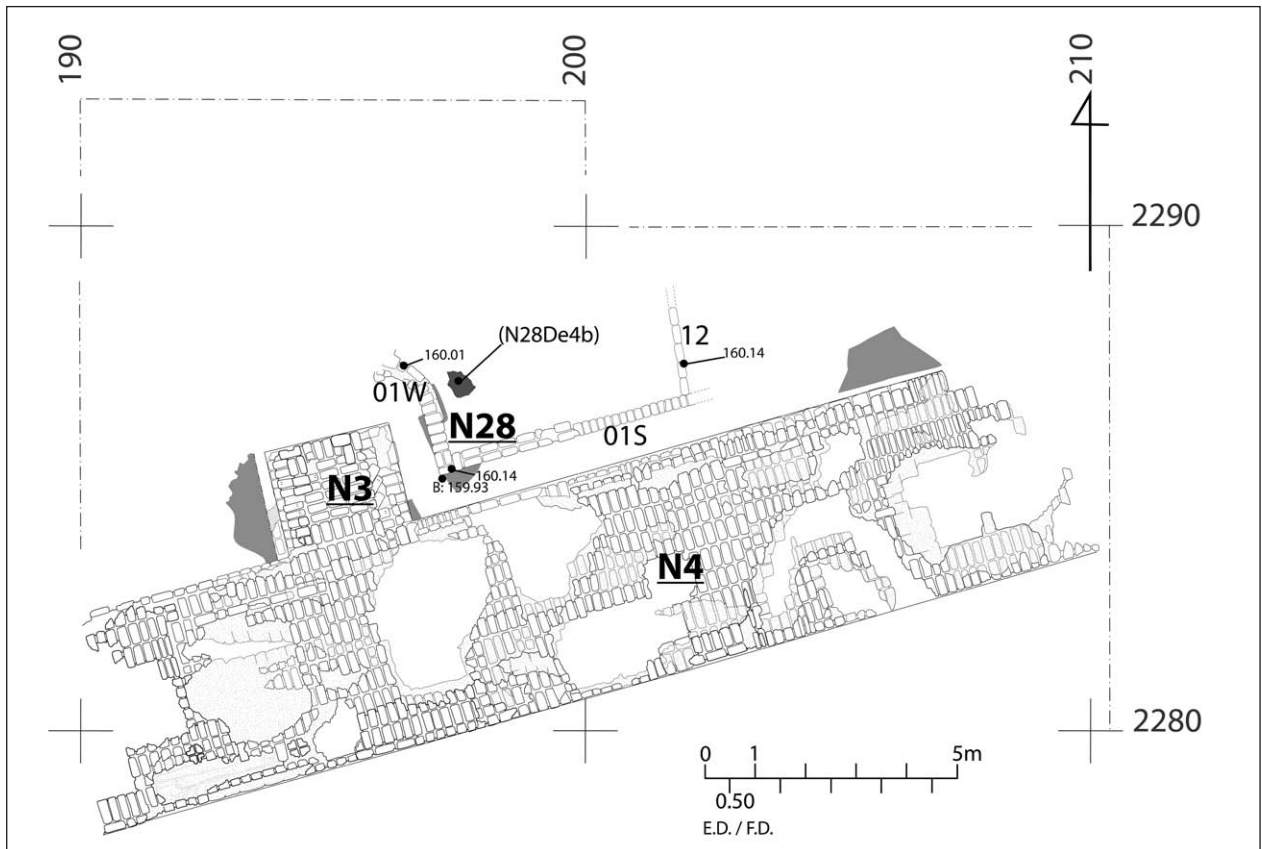
Fig. 9 Plan of Phase N3-a: levels of Structure N28

Structure N28 was built upon fill deposit, overlying a coated surface that floors the gravel fill of the N3 and N4 foundation trenches (IIA.4.3.4). The setting of Structure N28 thus belongs to Phase N3-a, a different and subsequent phase than the foundation of Enclosure Wall N4 and its external Brick Tower N3. N28 might be tentatively interpreted as a ram-

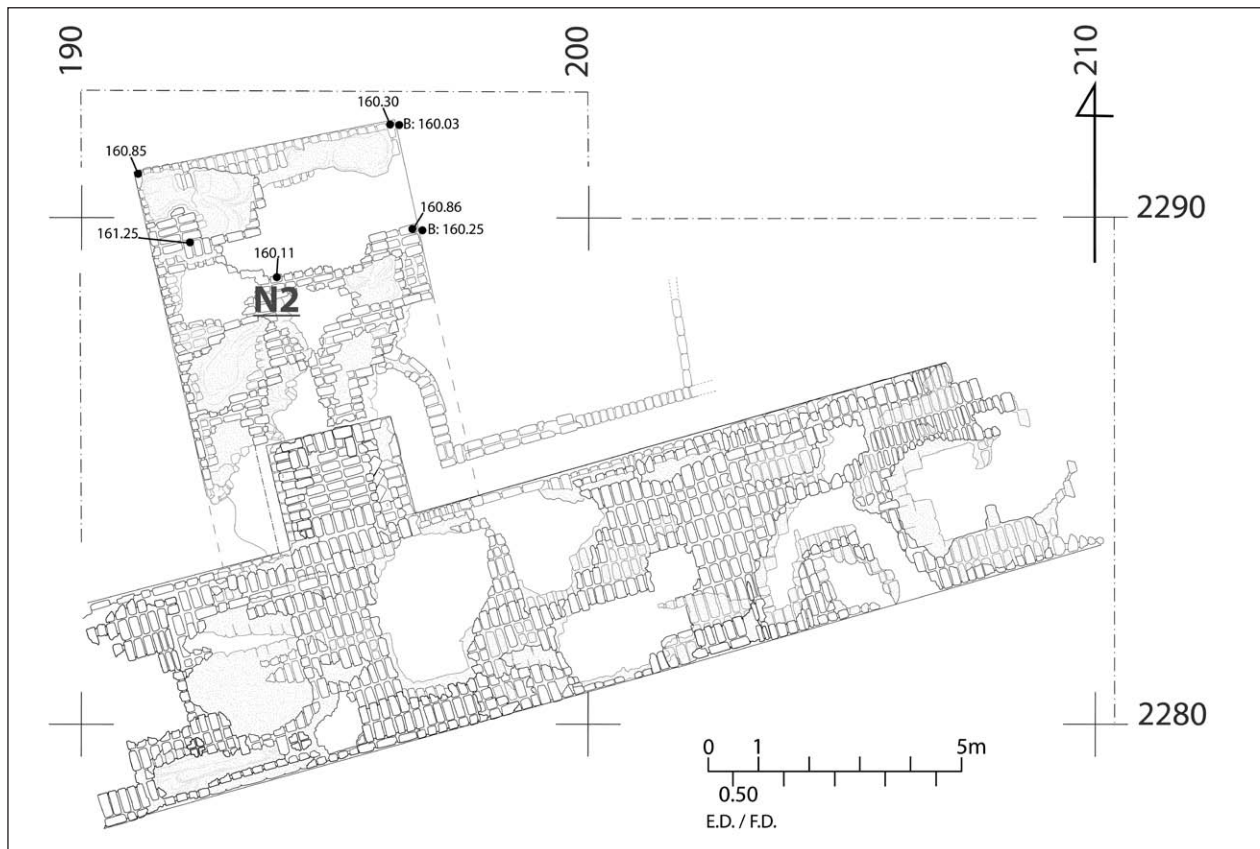
Fig. 10 Plan of N3 including Structure N2

To restore the smaller Brick Tower N3, a roughly rectangular shaped new bastion, N2, was built with a larger scale and proportions. The structure, measuring at the base c. 7.85 × 5.30m, significantly enlarges N3 by slightly more than to seven times.<sup>93</sup> Severely damaged by large holes dug into it,<sup>94</sup> the remaining perimeter of the Structure N2 is partial.<sup>95</sup> Brick tower N2 culminates at 161.25m and is preserved up to six layers of mud bricks that are 32/35 × 13/15 × 8cm in size (Fig. 5). The altitudes of its northwestern and northeastern corners are measured

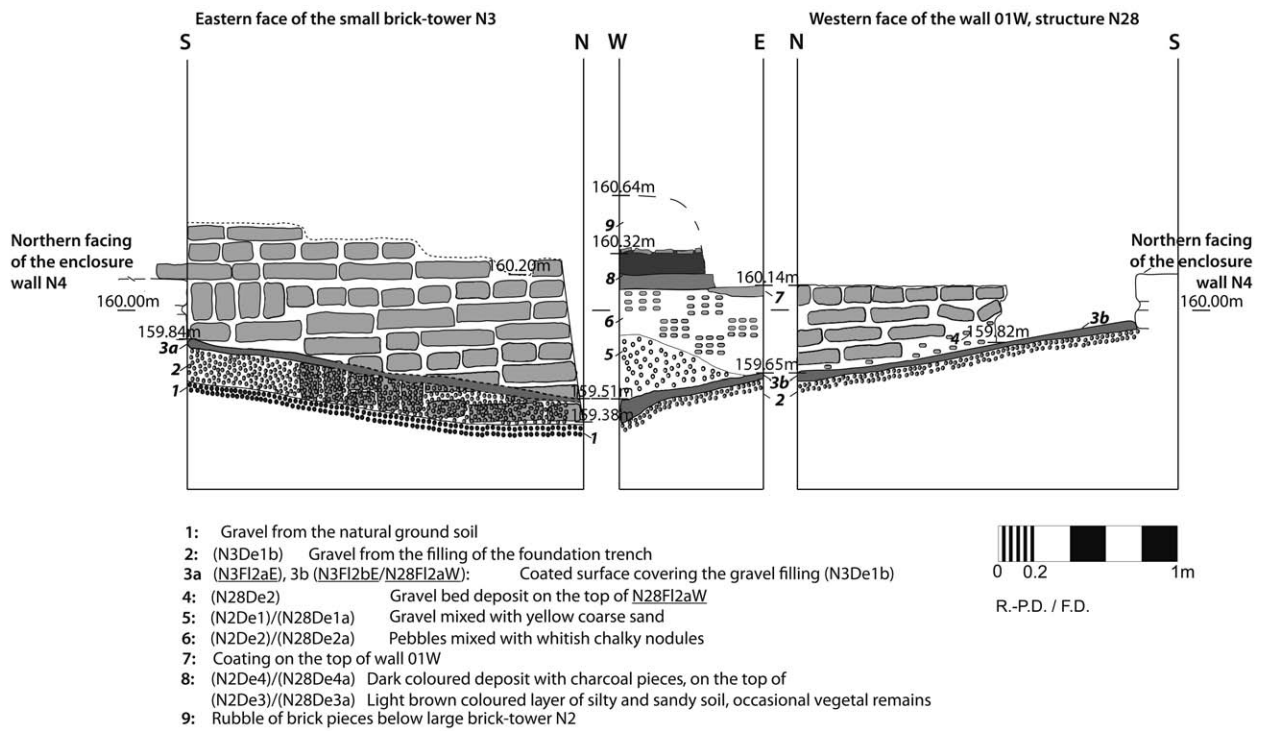
Fig. 11 Section drawing 007/2008 (east face of Brick Tower N3 and west face of Wall 01W)

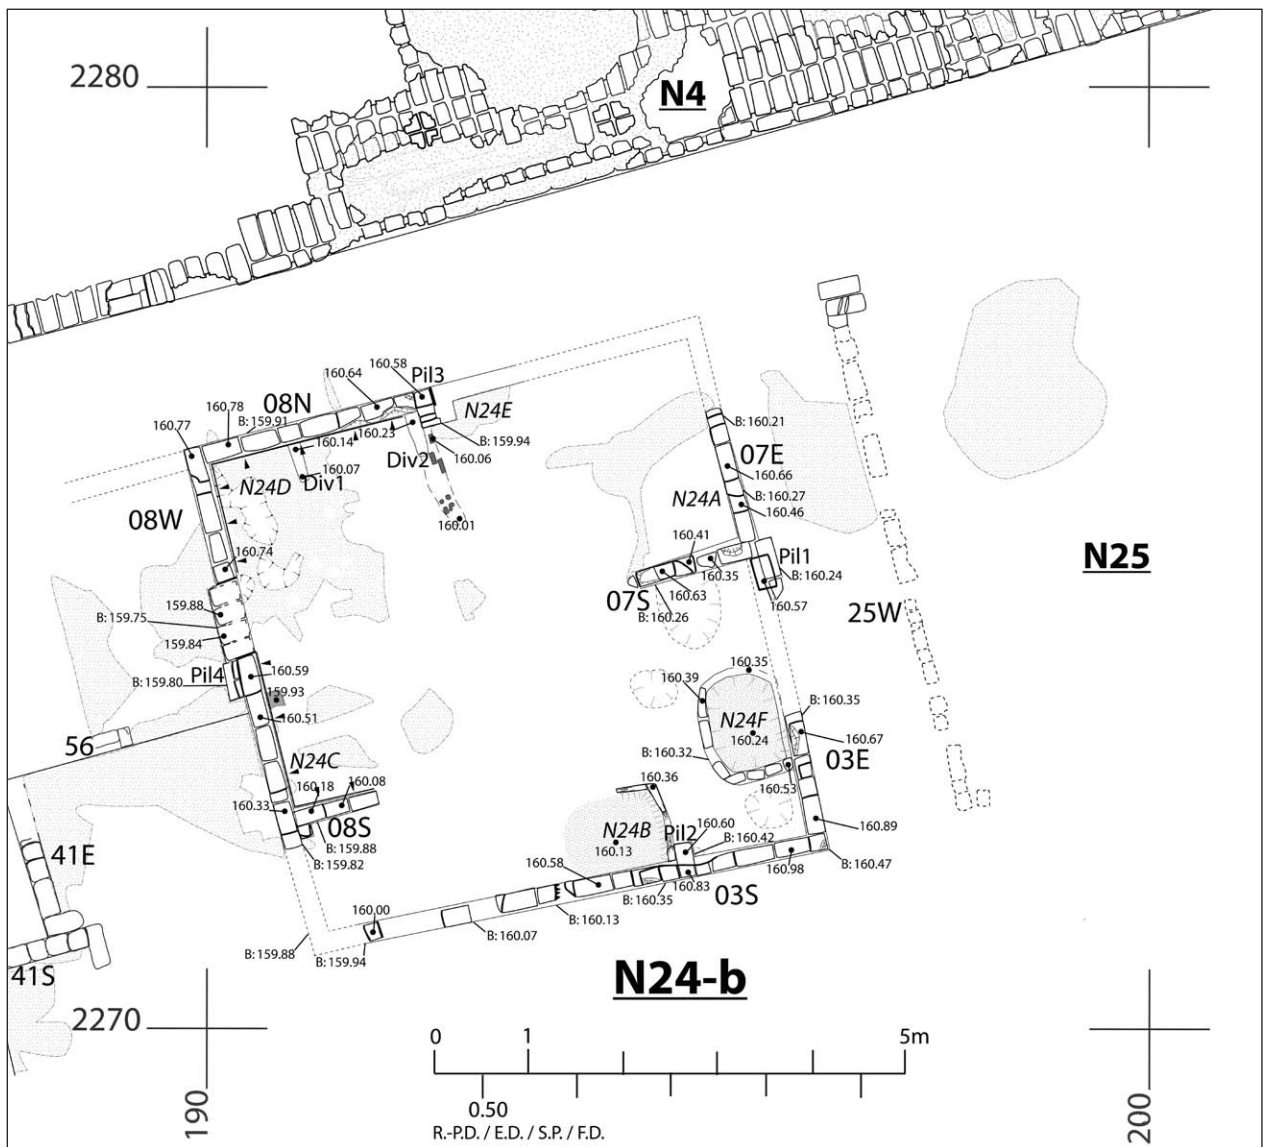
Fig. 15 Plan of Phase N24-b: levels of the perimeter/internal walls and installations

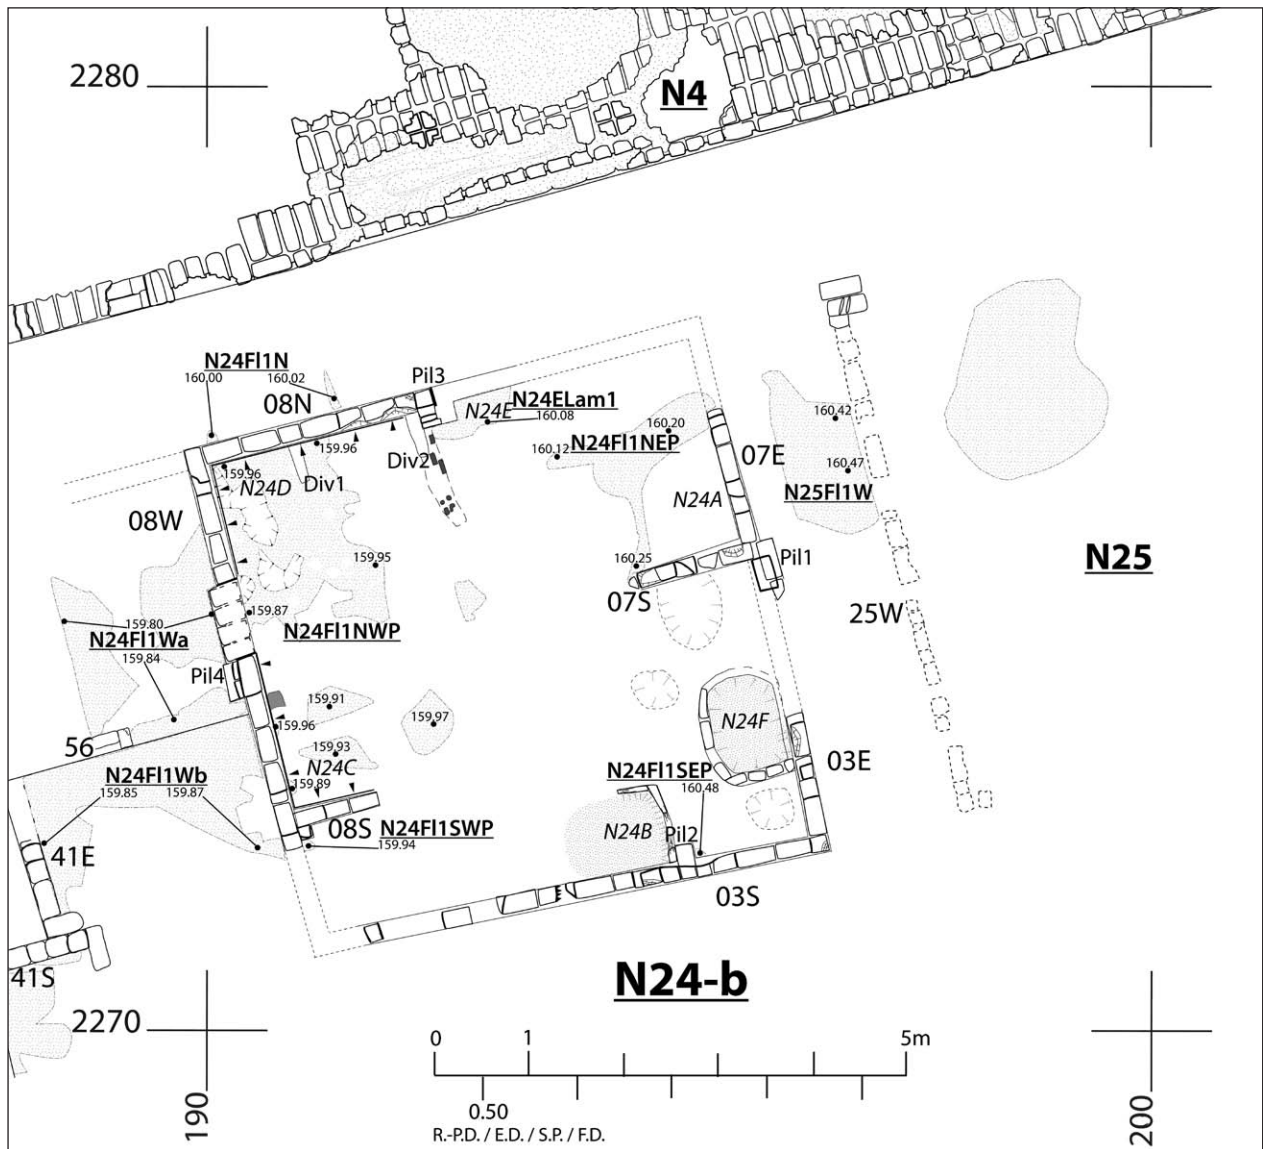
Fig. 16 Plan of Phase N24-b: levels of floors

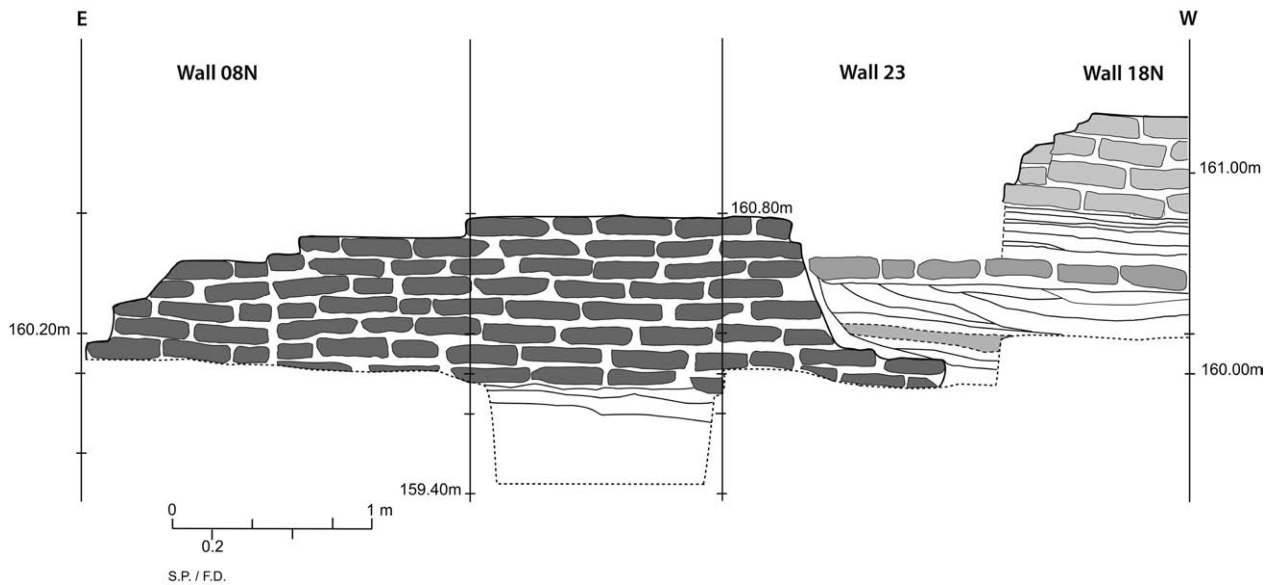
Fig. 17 Section drawing of Wall 08N's northern face

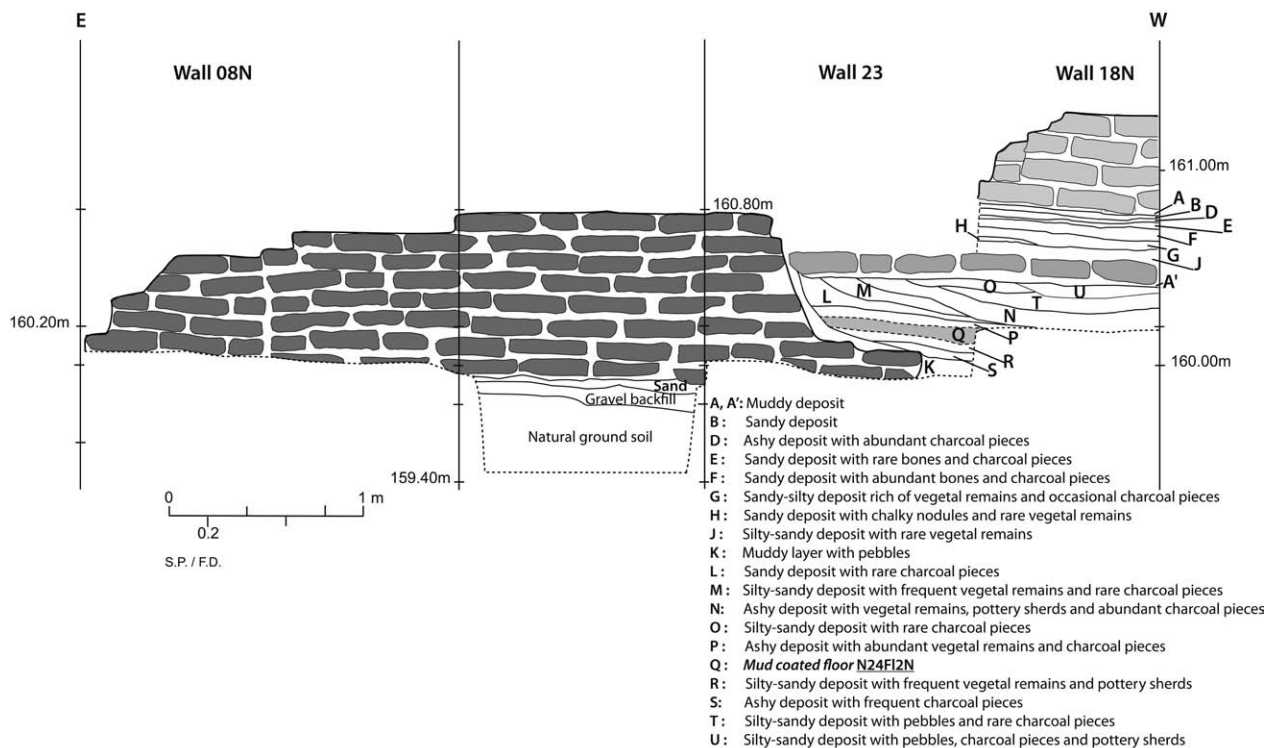
Fig. 18 Section drawing 021/2010 (Squares 190/2270 and 180/2270, north face of Walls 08N, 23 and 18N's eastern end)

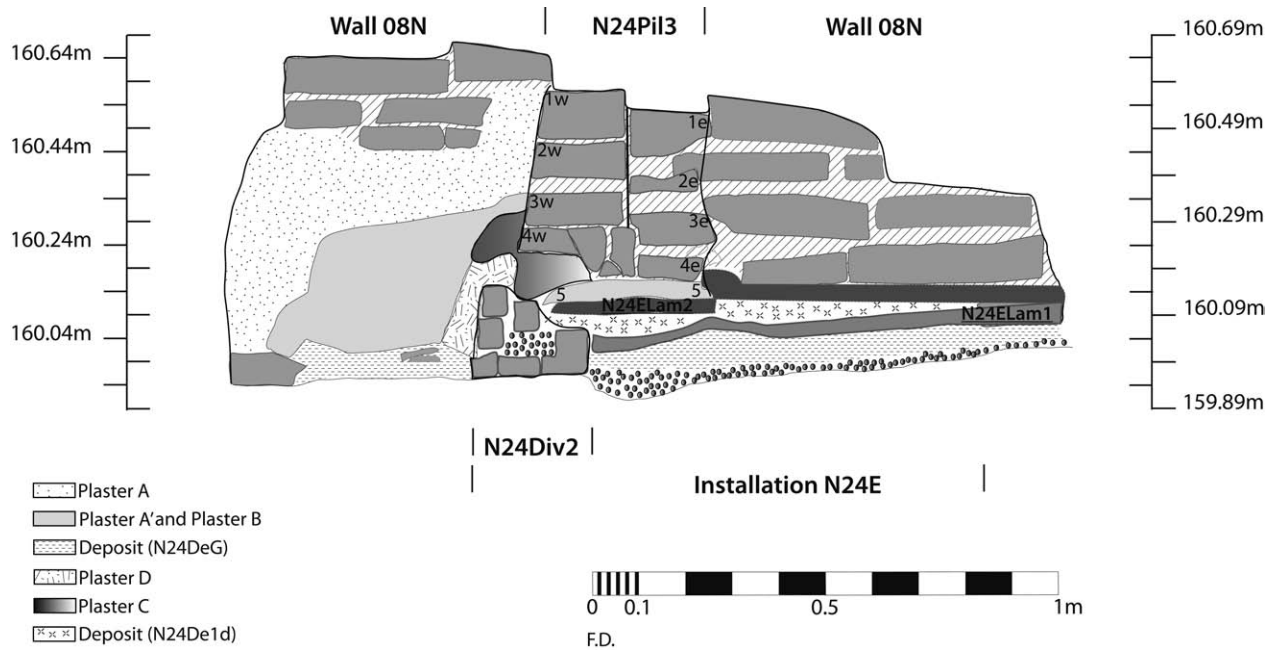
Fig. 19 Elevation drawing of Pilaster N24Pil3

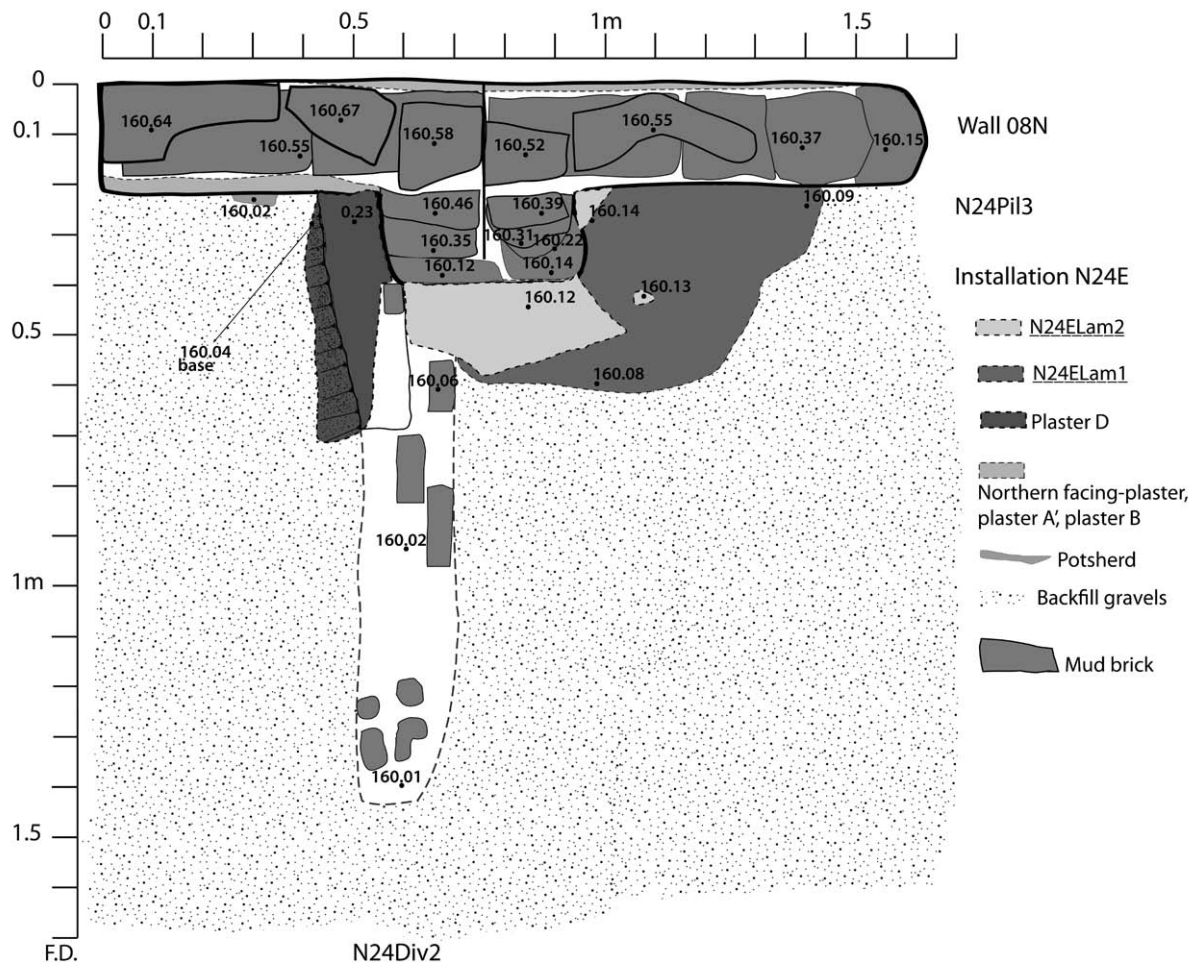
Fig. 20 Plan of Pilaster N24Pil3

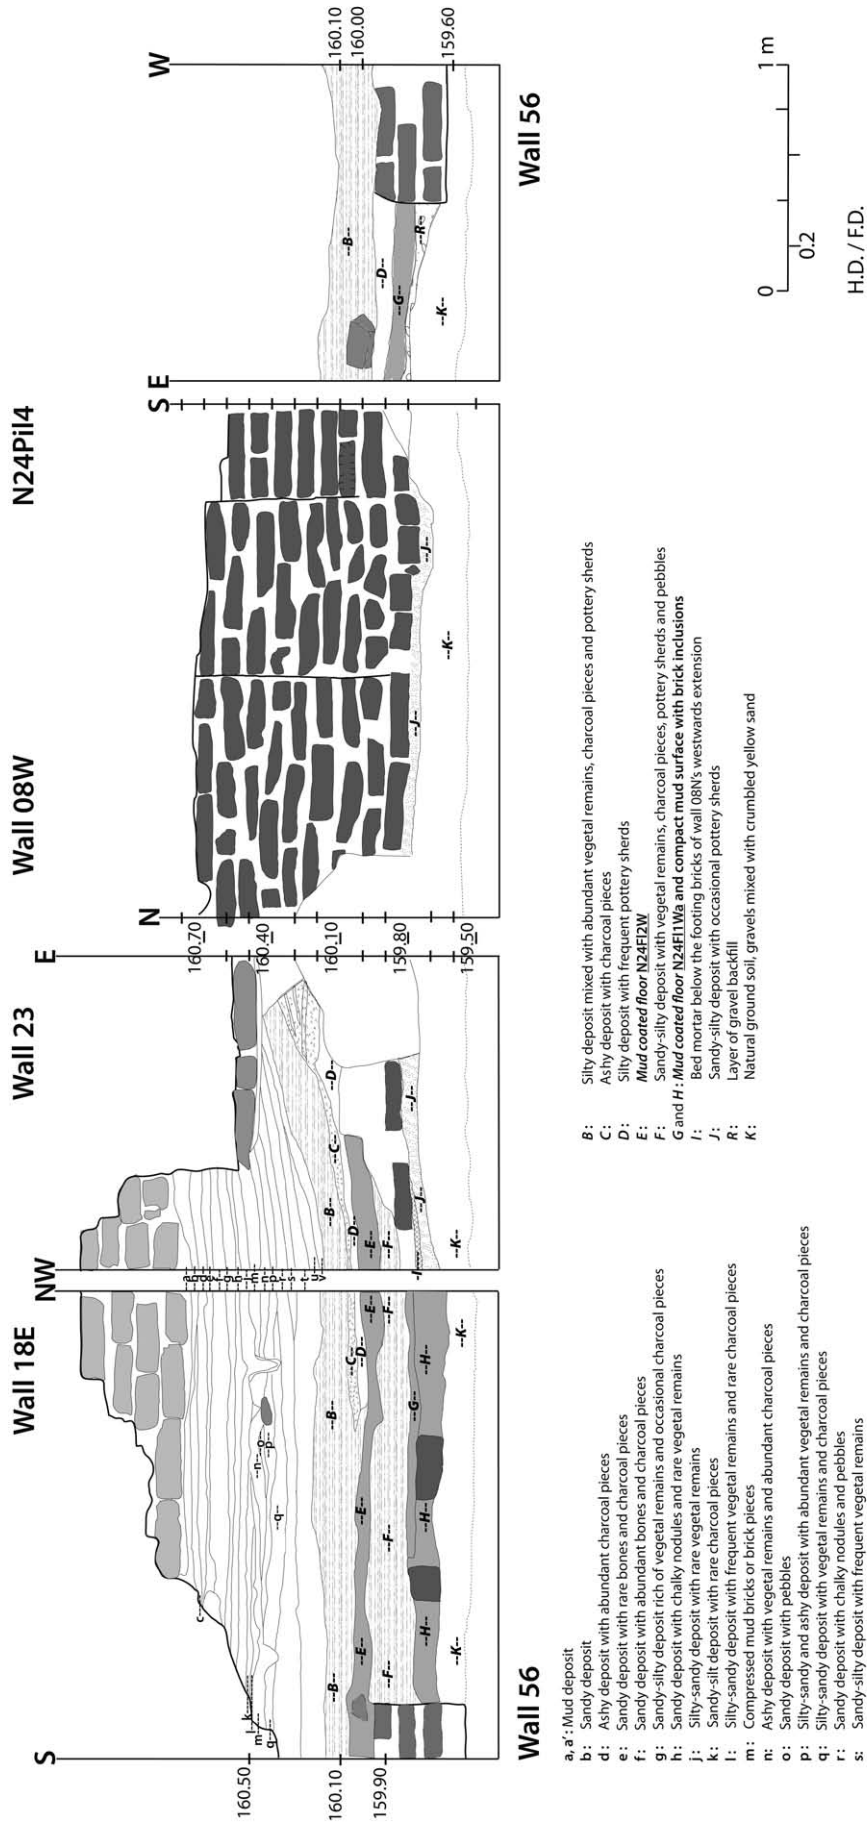
Fig. 21 Section drawing 35/2012 (Square 180/2270, sondage west of Wall 08W)

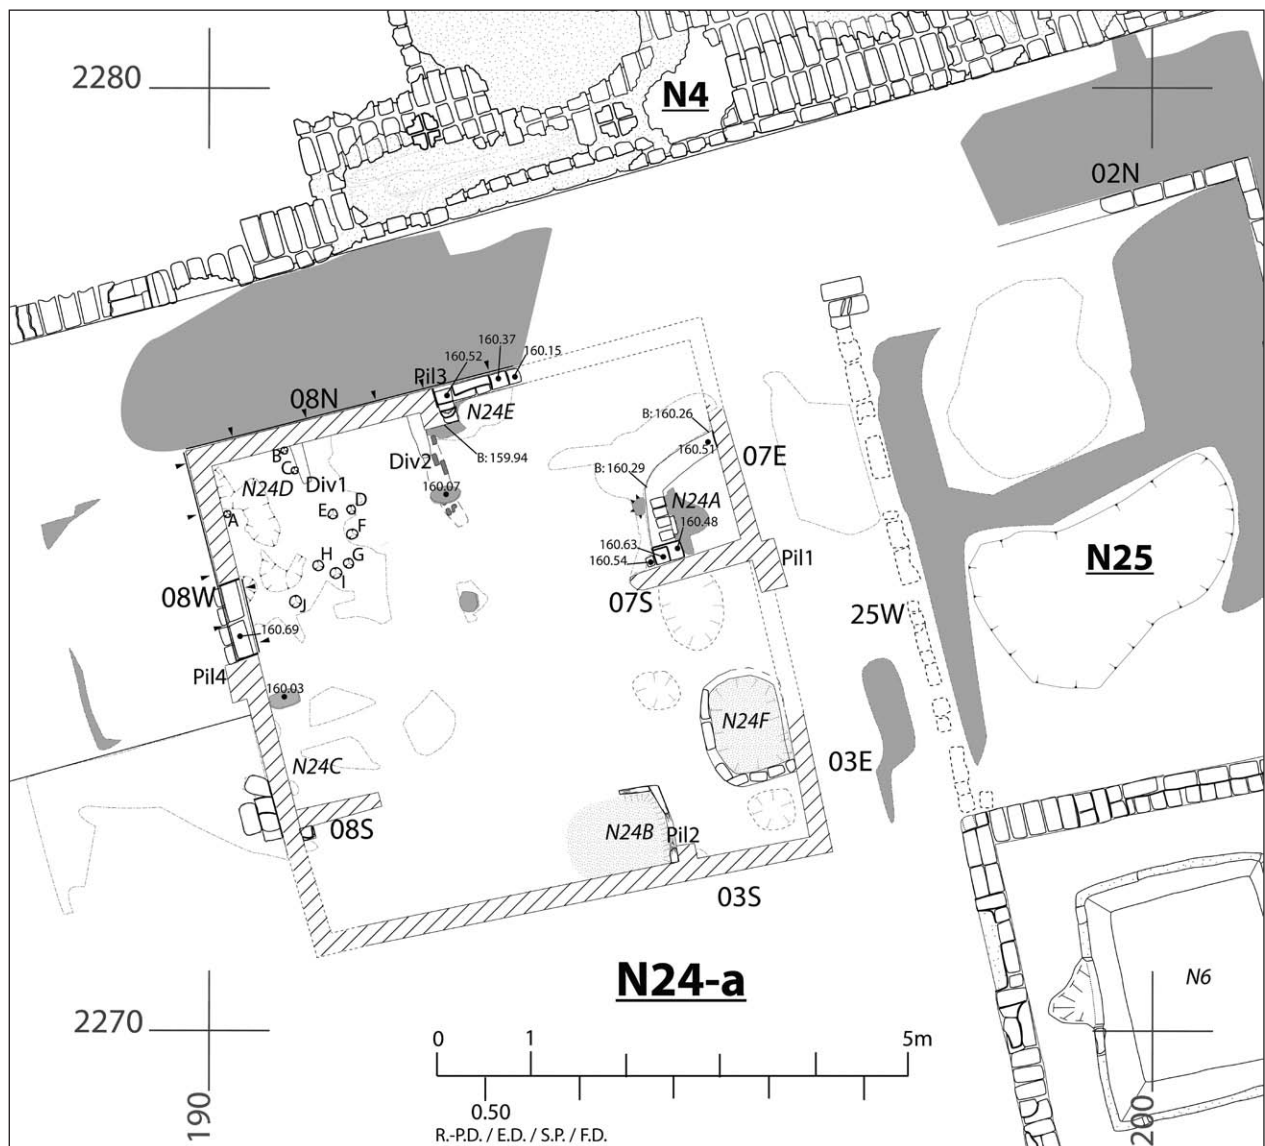
Fig. 22 Plan of Phase N24-a: levels of additional wall segments

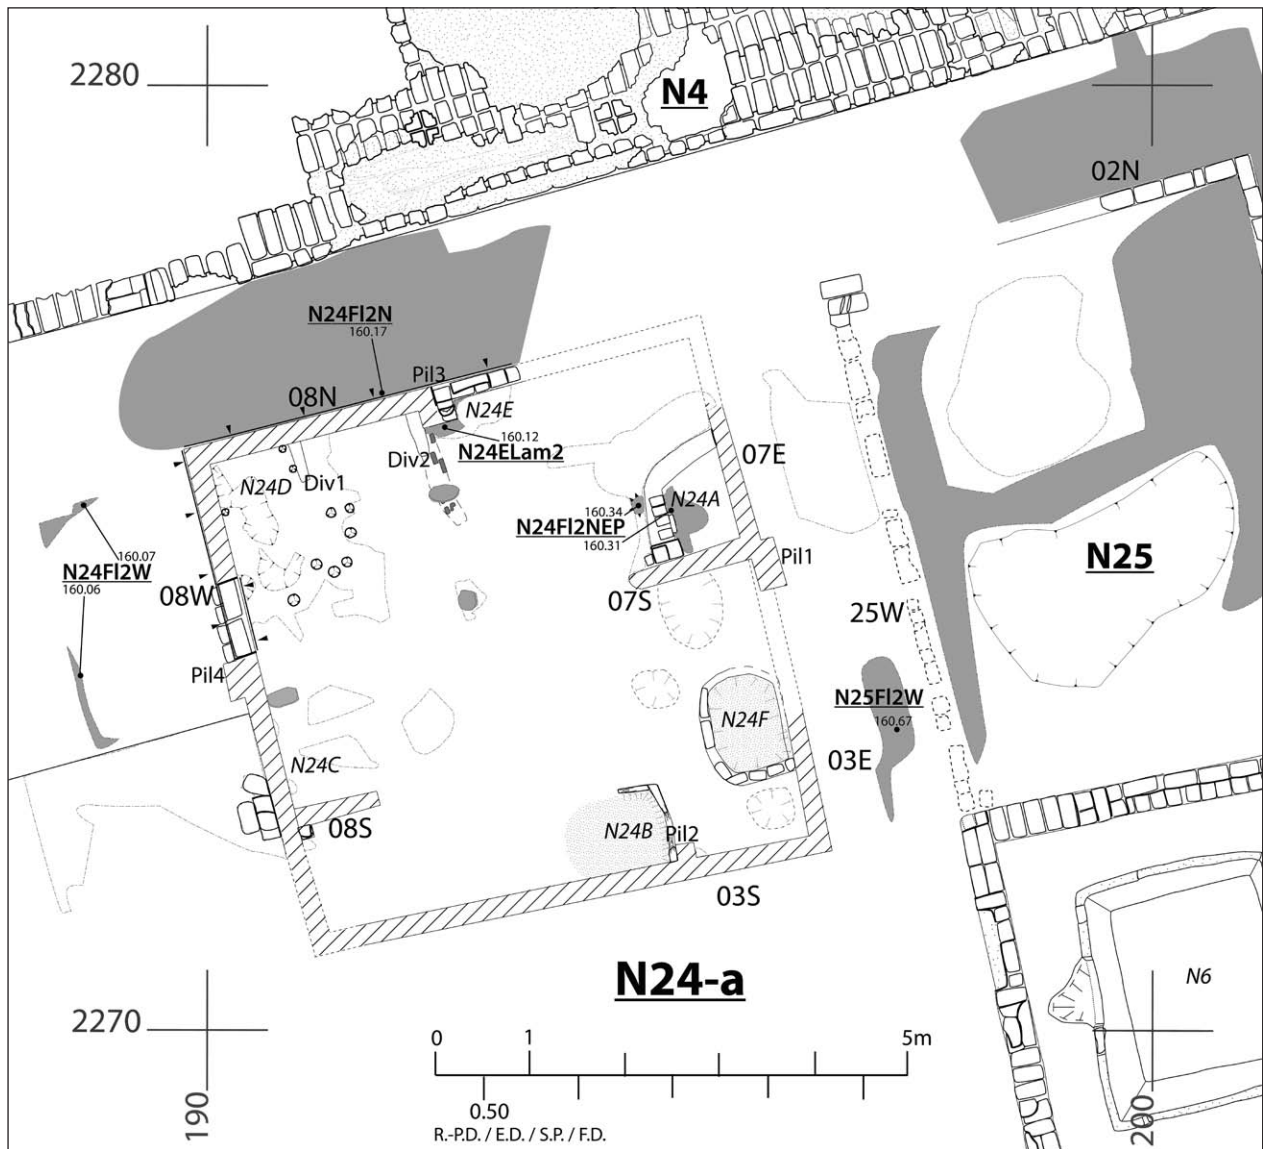
Fig. 23 Plan of Phase N24-a: levels of floors

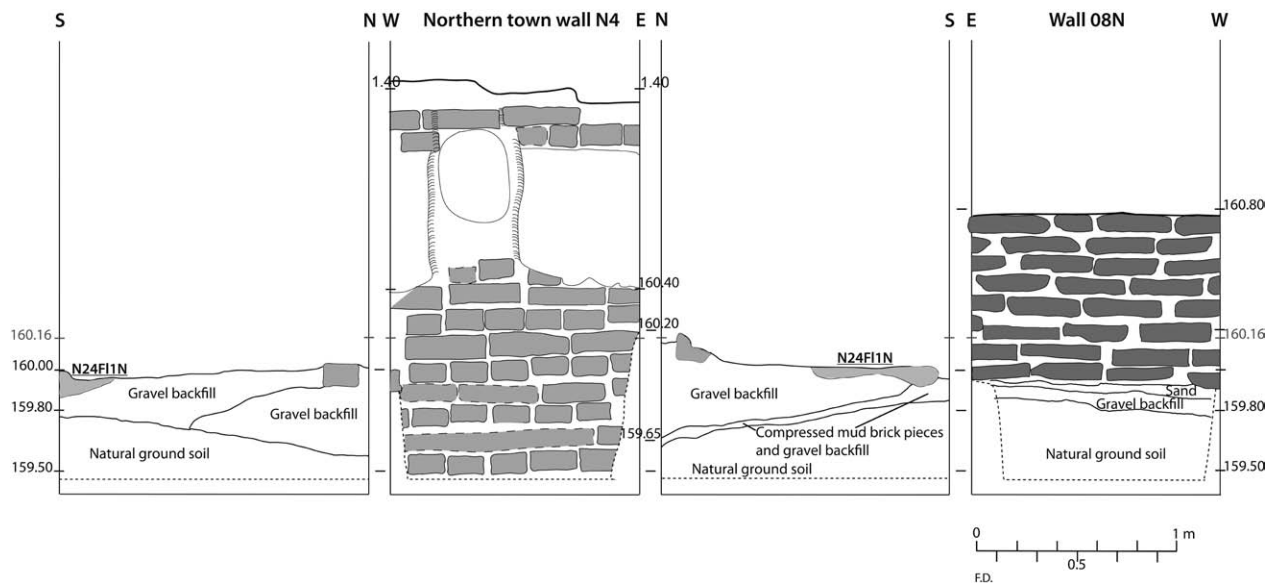
Fig. 24 Section drawing 033A & B/2012 (Square 190/2270, Sondage B north of Wall 08N)

<sup>115</sup> Sondage B, east of the bonded corner with Wall 08W (Fig. 24), exposed part of the northern face of Wall 08N, down to its footing course. At that point, it can be observed that the base of the footing course is levelled from 159.95–159.90m. These footing bricks overlay two successive layers of compact sand (5cm thick each) and a gravel backfill (10cm thick) upon the natural soil, levelled from 159.86–159.77m.

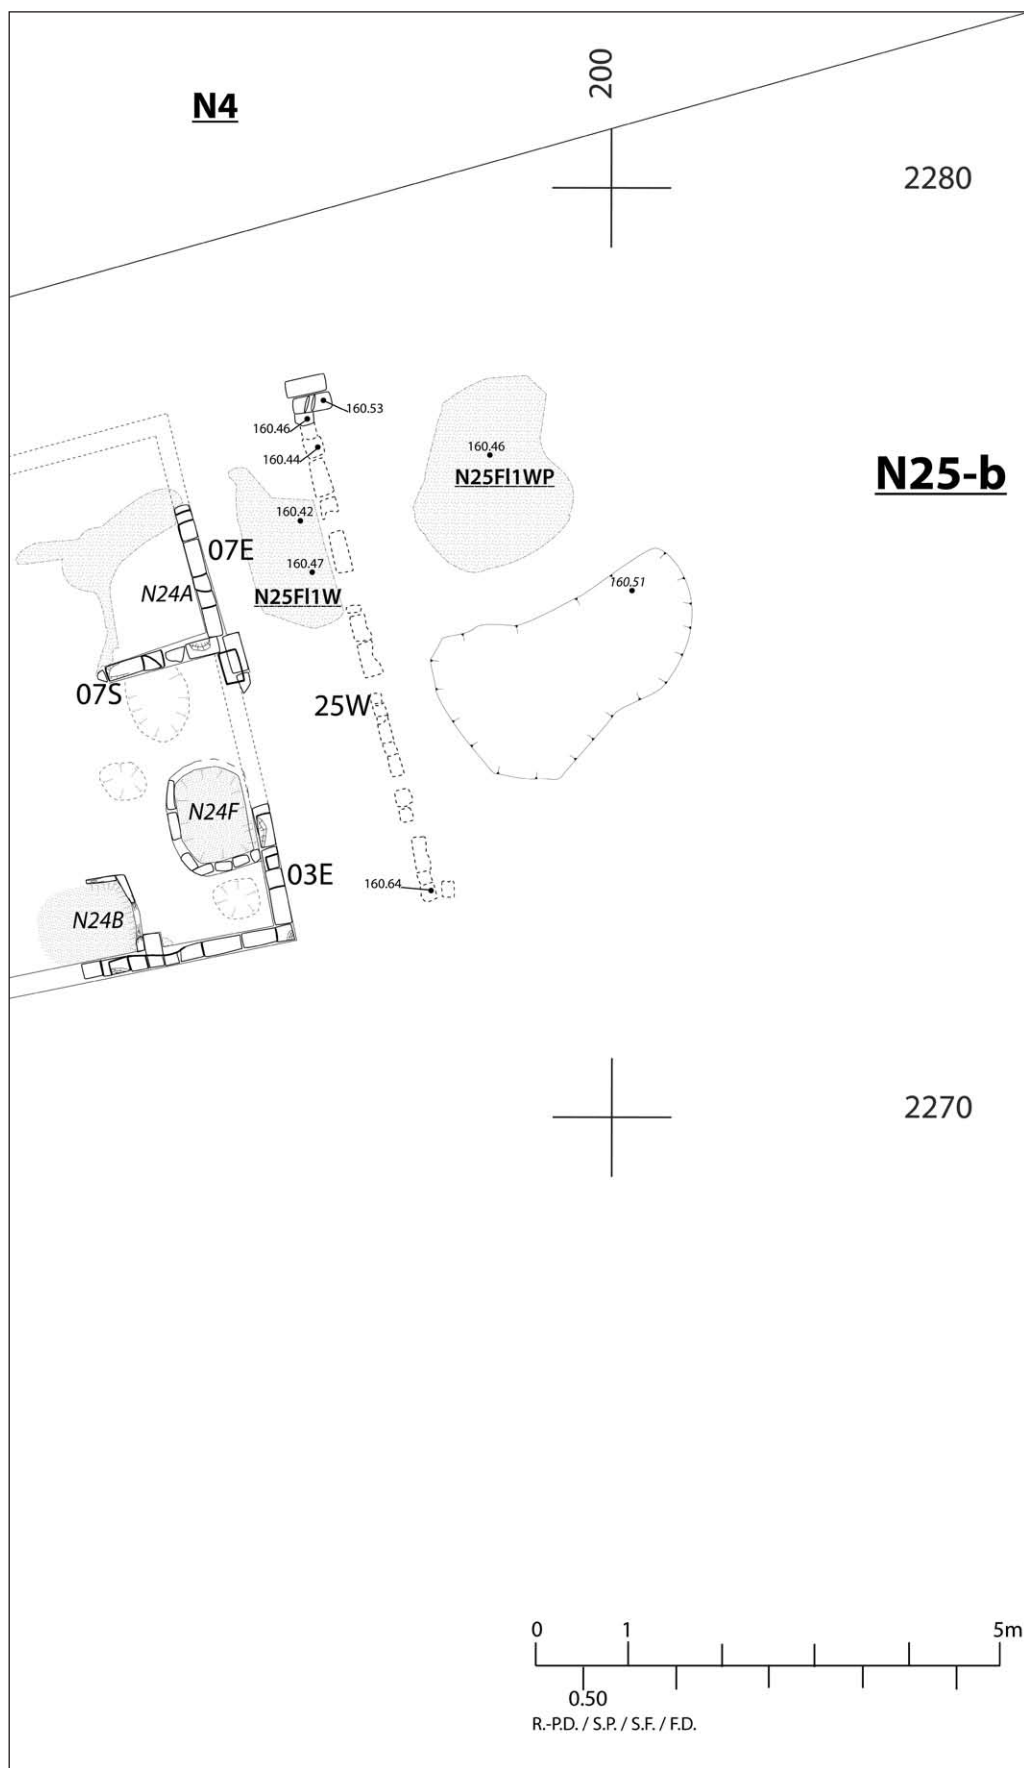
Fig. 27 Plan of Phase N25-b: levels of the perimeter walls and floors
