ACROSSBORDERS I  
THE NEW KINGDOM TOWN OF SAI ISLAND, SECTOR SAV1 NORTH

# **ACROSSBORDERS I**

The New Kingdom Town of Sai Island,  
Sector SAV1 North

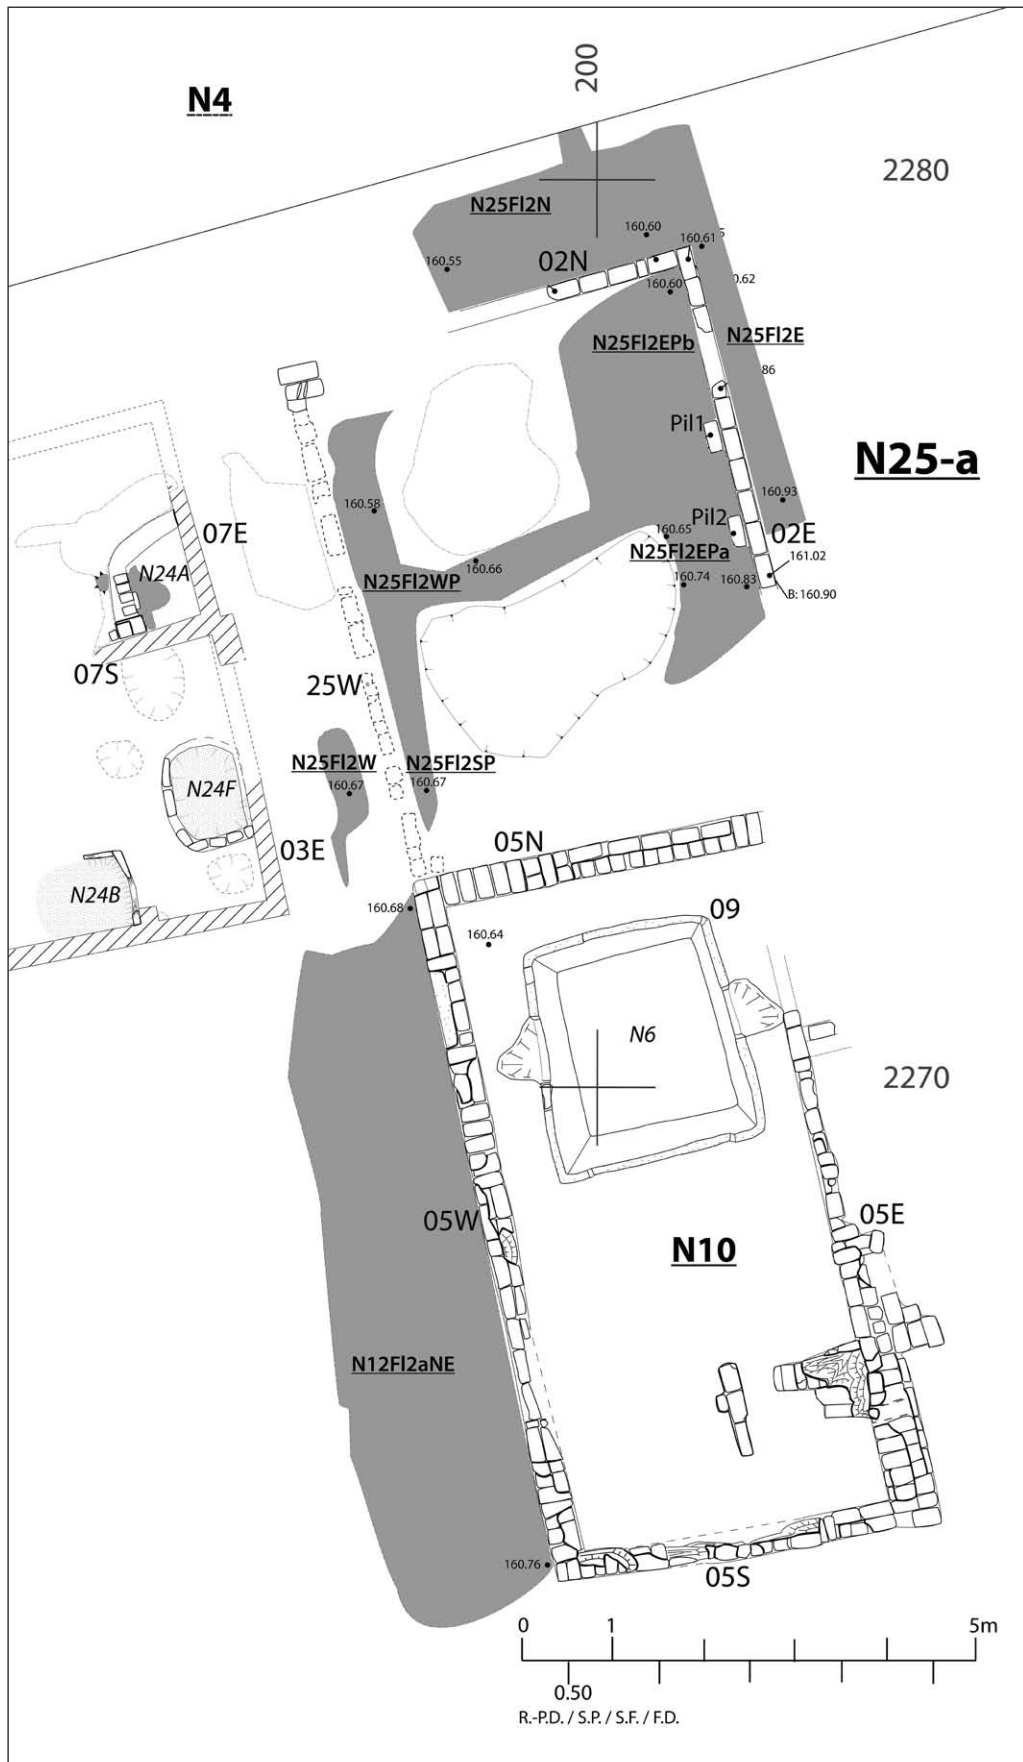
Fig. 28 Plan of Phase N25-a: levels of the perimeter walls and floors

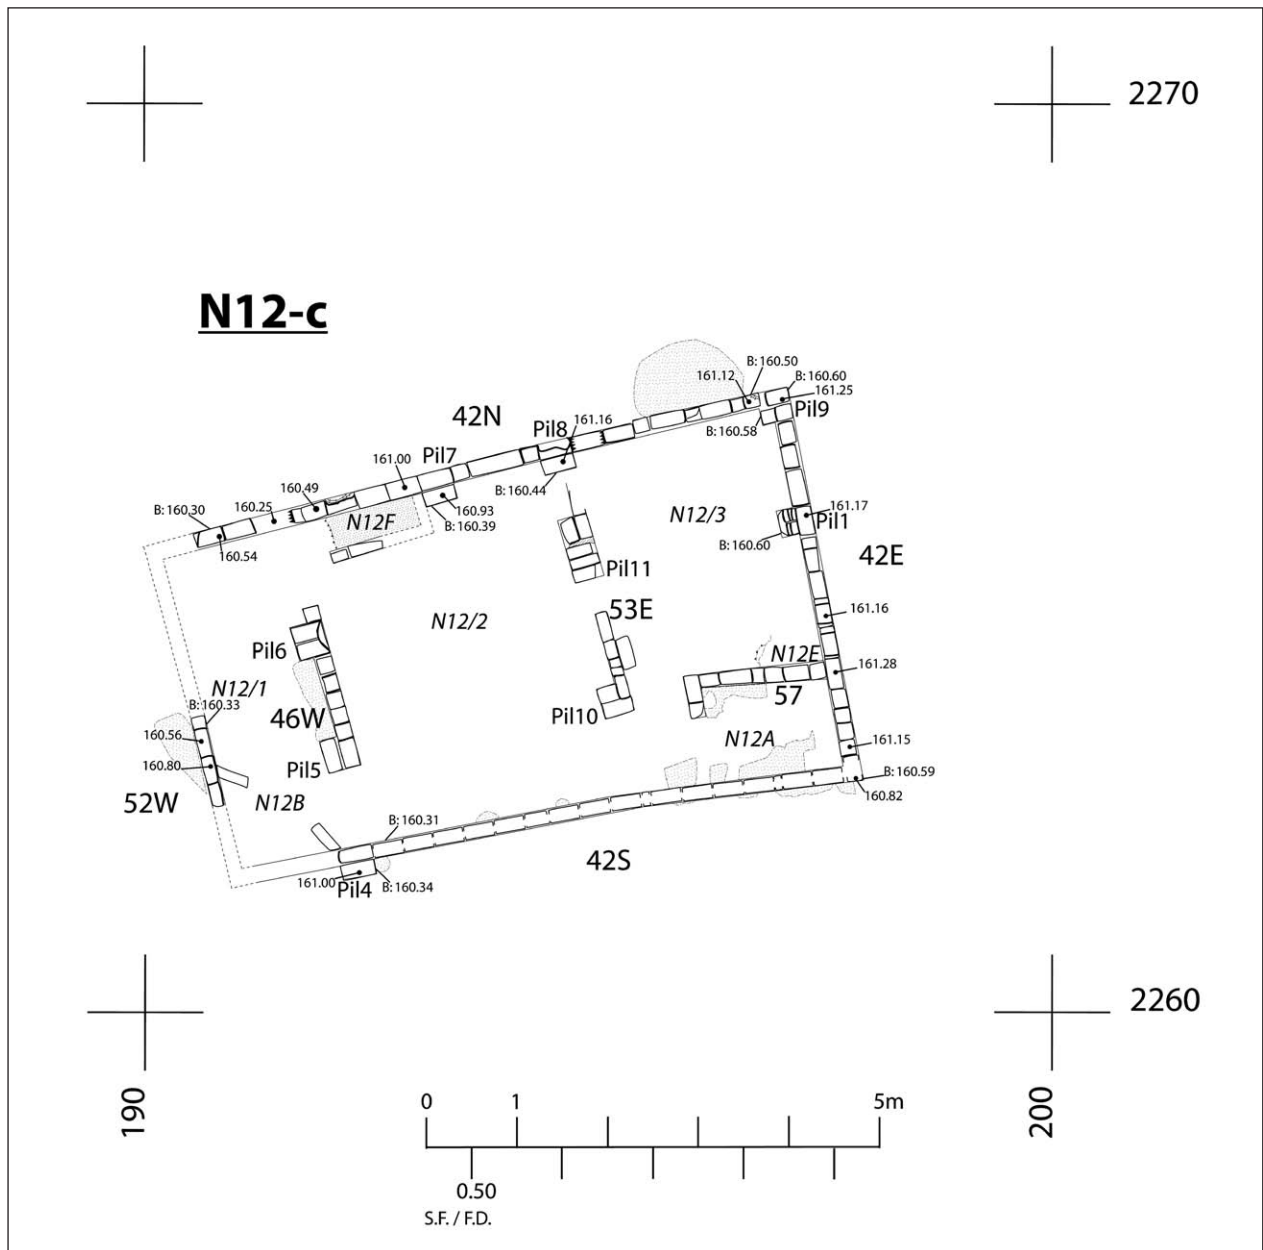
Fig. 31 Plan of Phase N12-c: levels of the perimeter walls

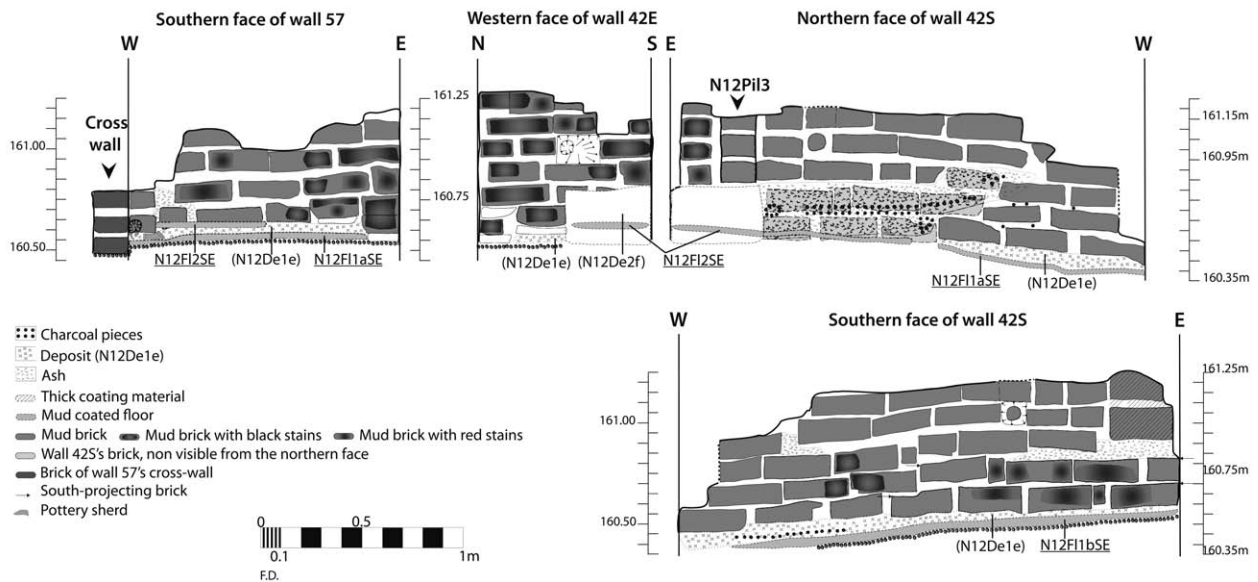
Fig. 32 Section drawing of Installation N12A

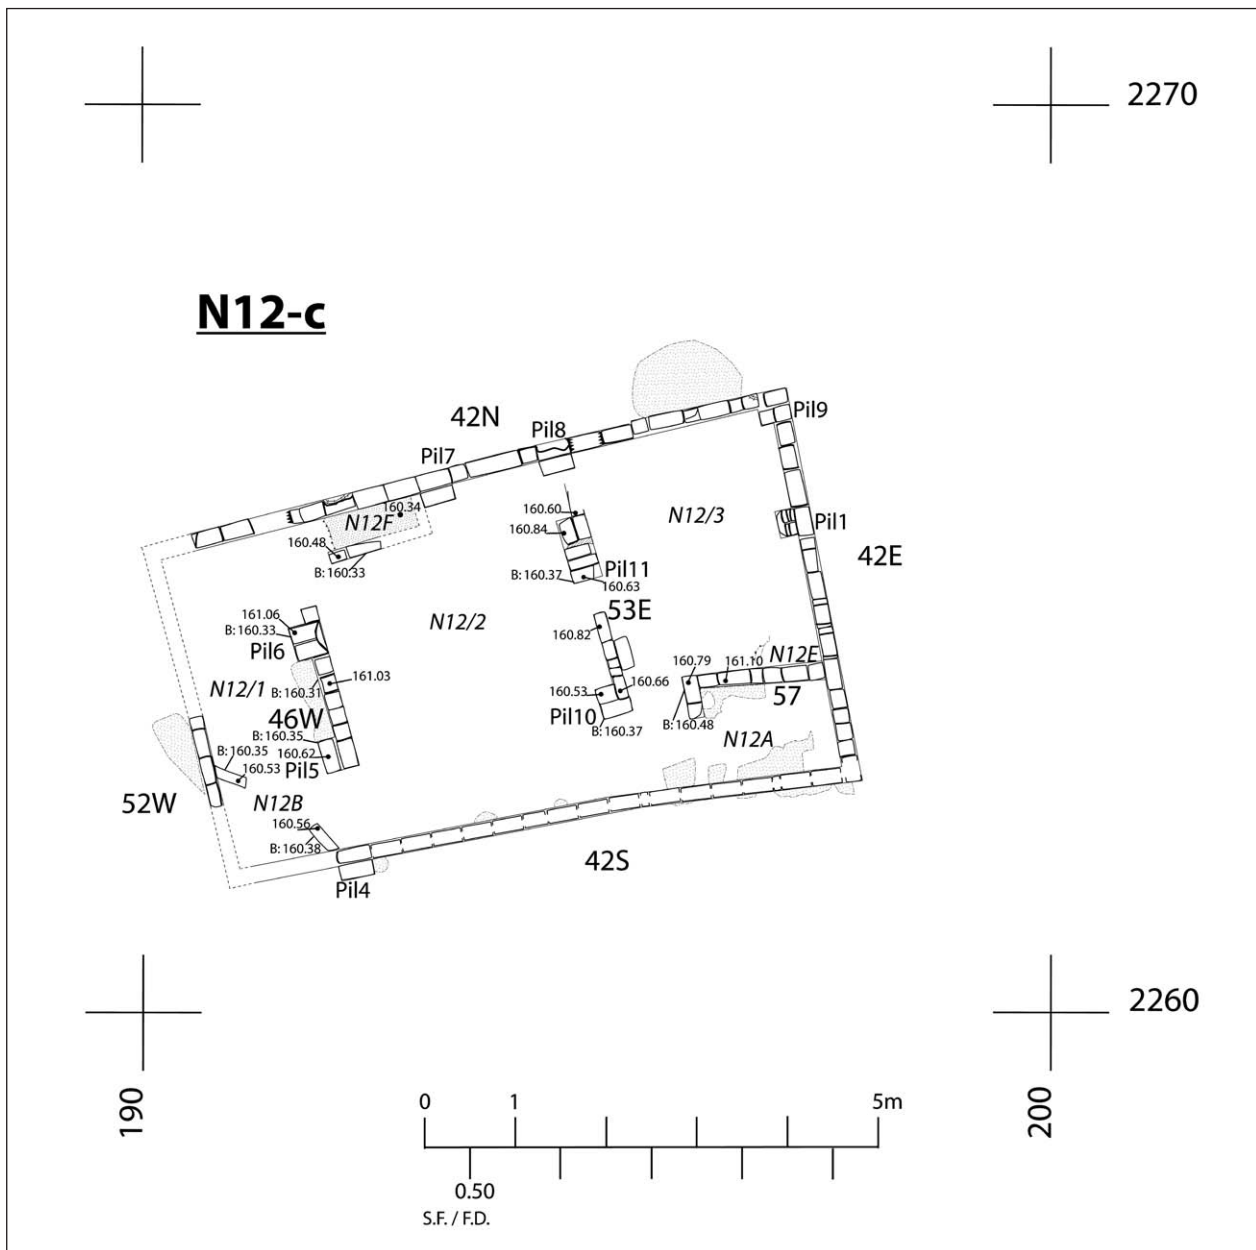
Fig. 33 Plan of Phase N12-c: levels of the internal walls

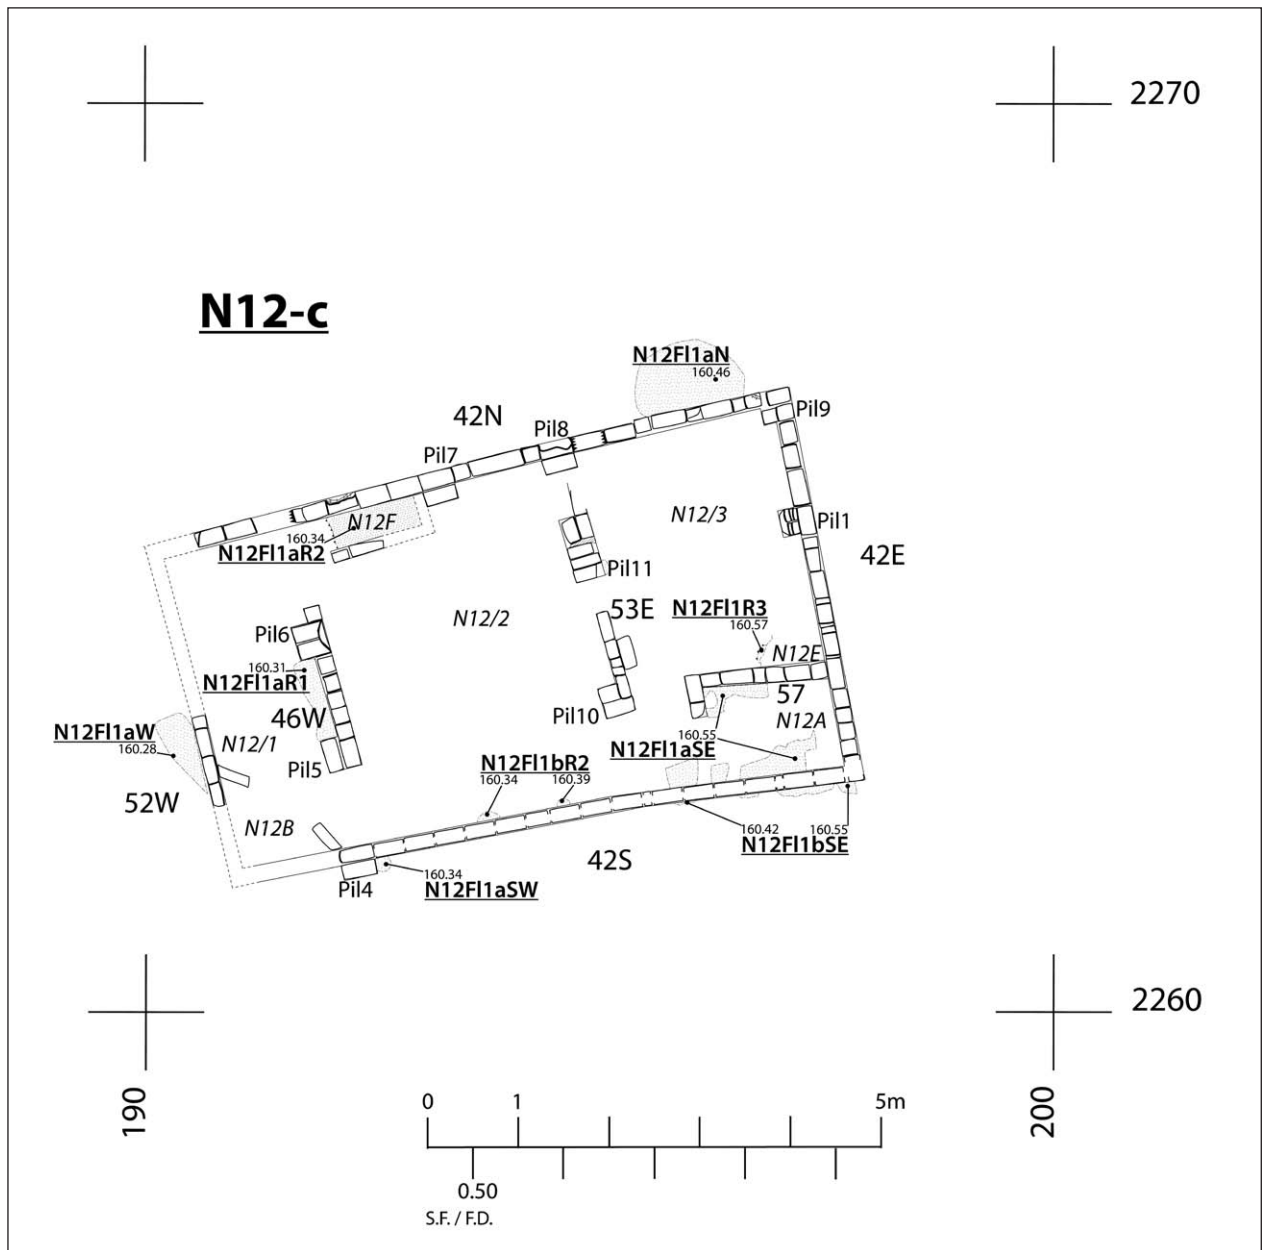
Fig. 34 Plan of Phase N12-c: levels of floors

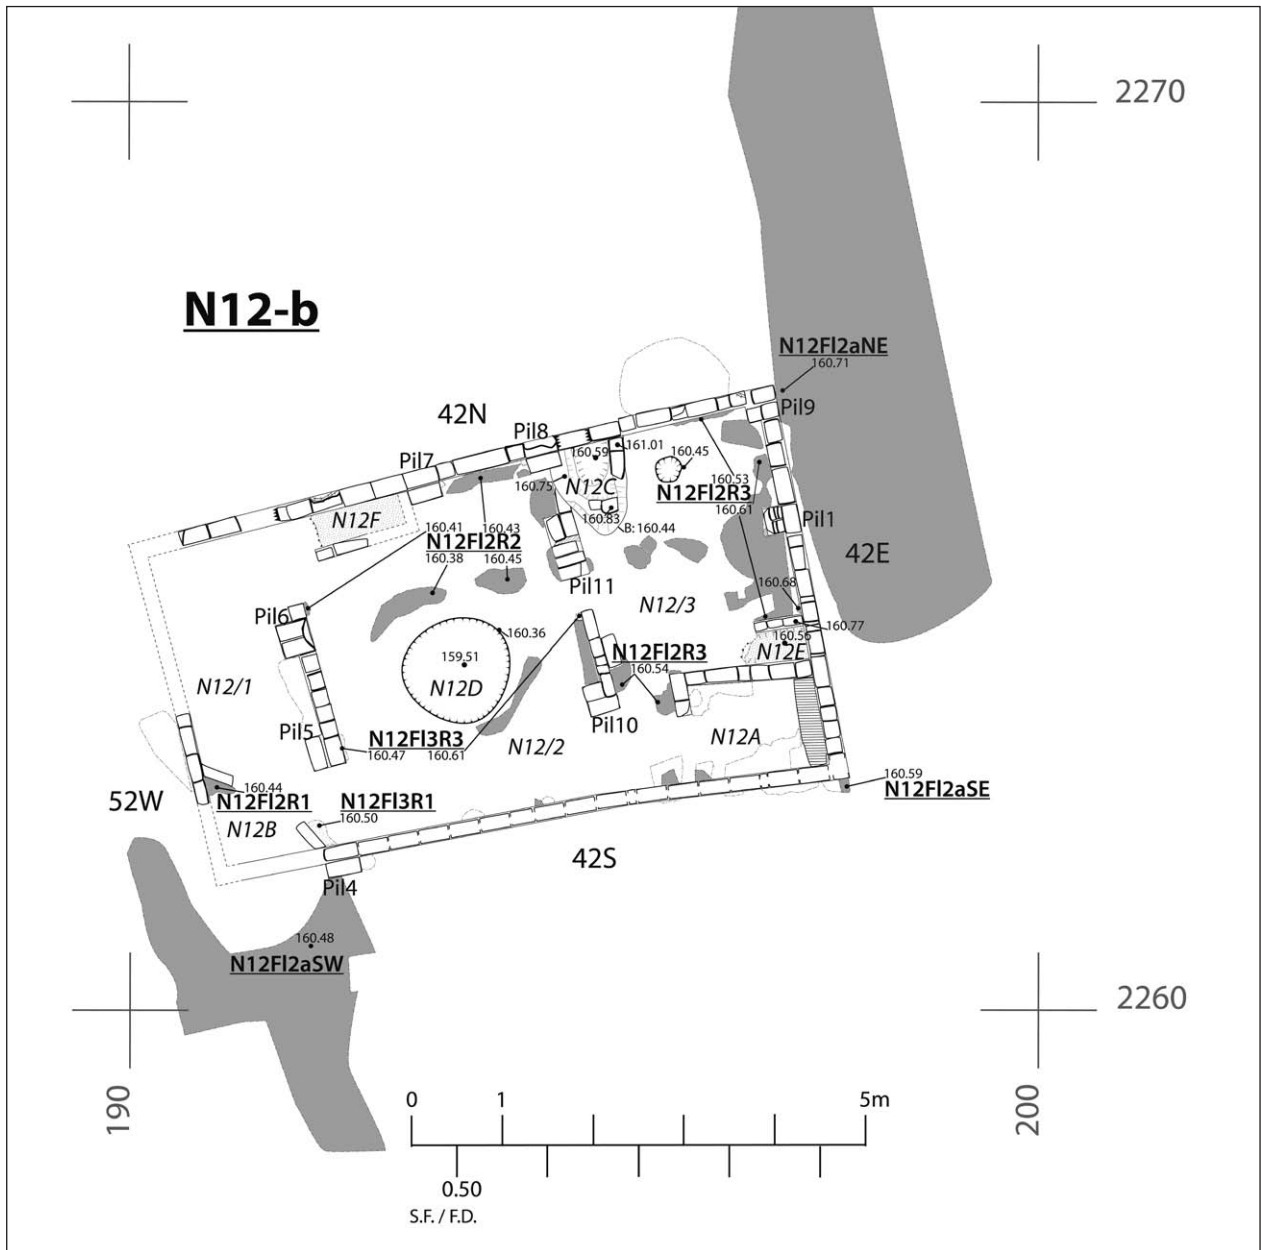
Fig. 35 Plan of Phase N12-b: levels of the installations and floors

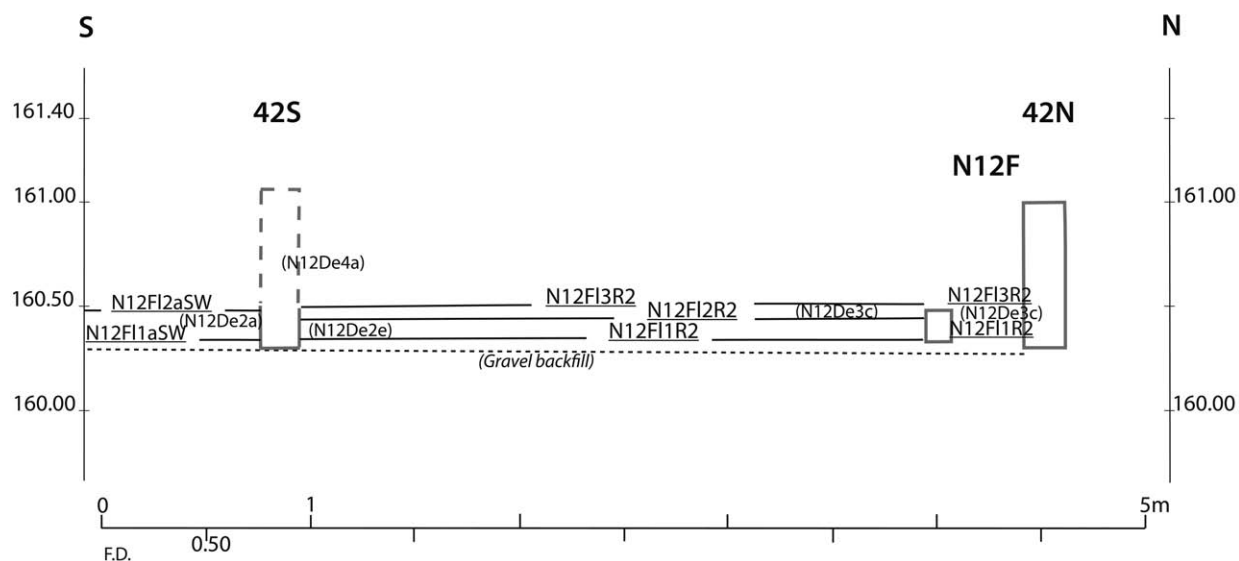
Fig. 36 Outline of the section west of N12

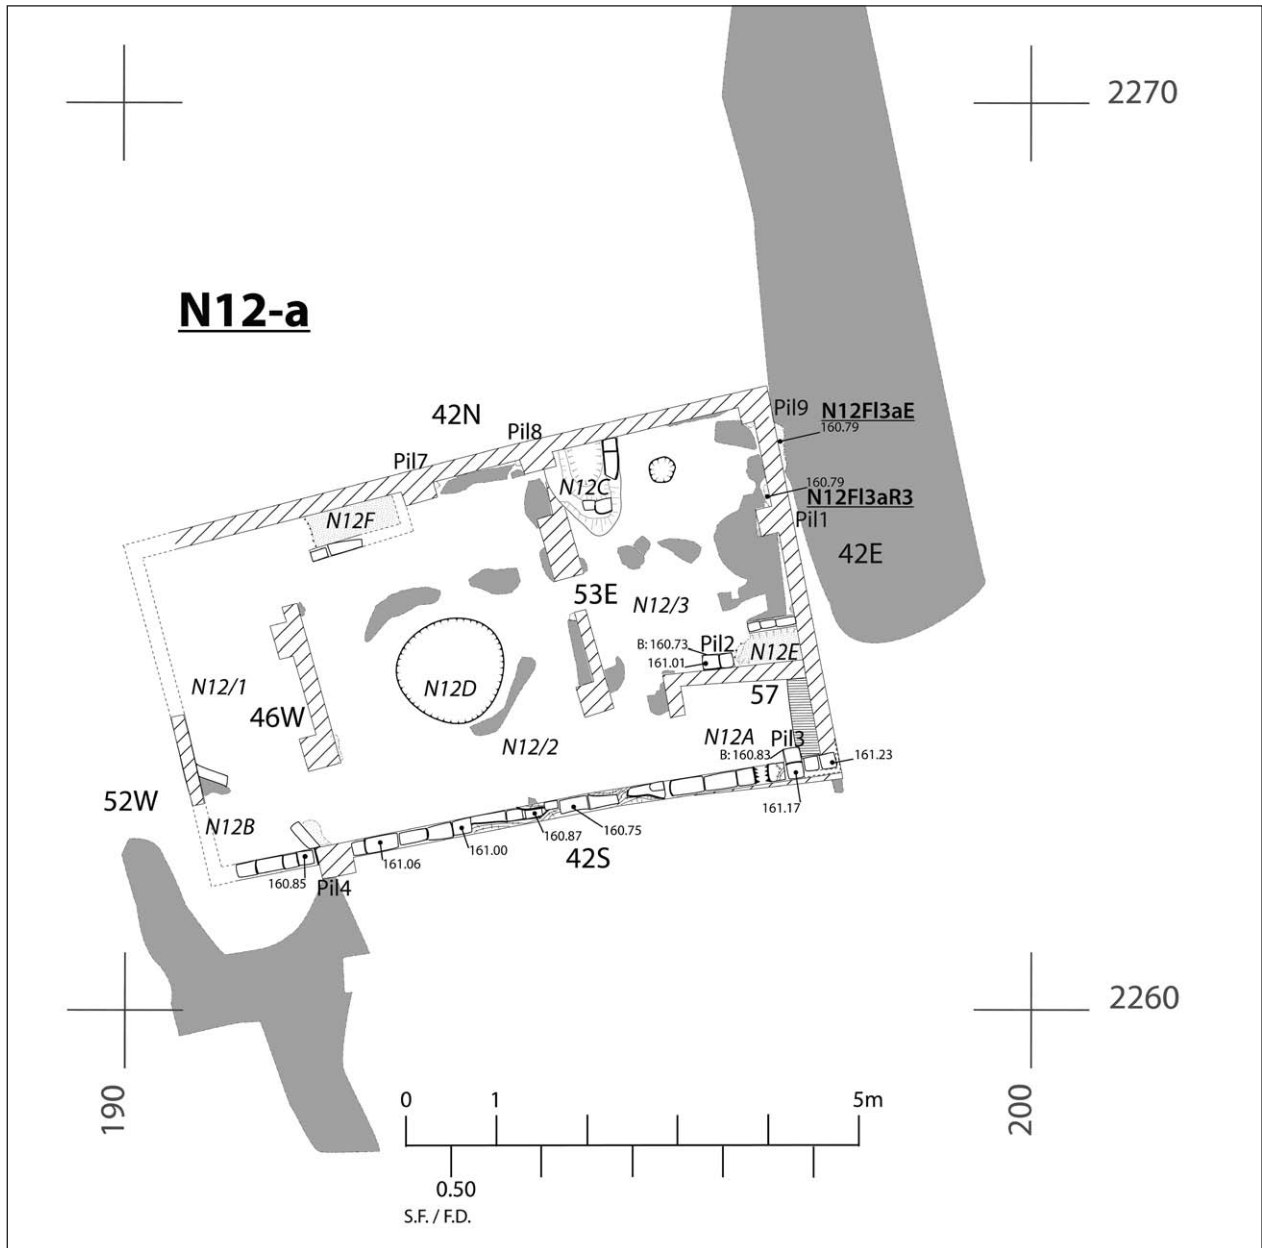
Fig. 37 Plan of Phase N12-a: levels of southern perimeter wall, additional pilasters, and floors

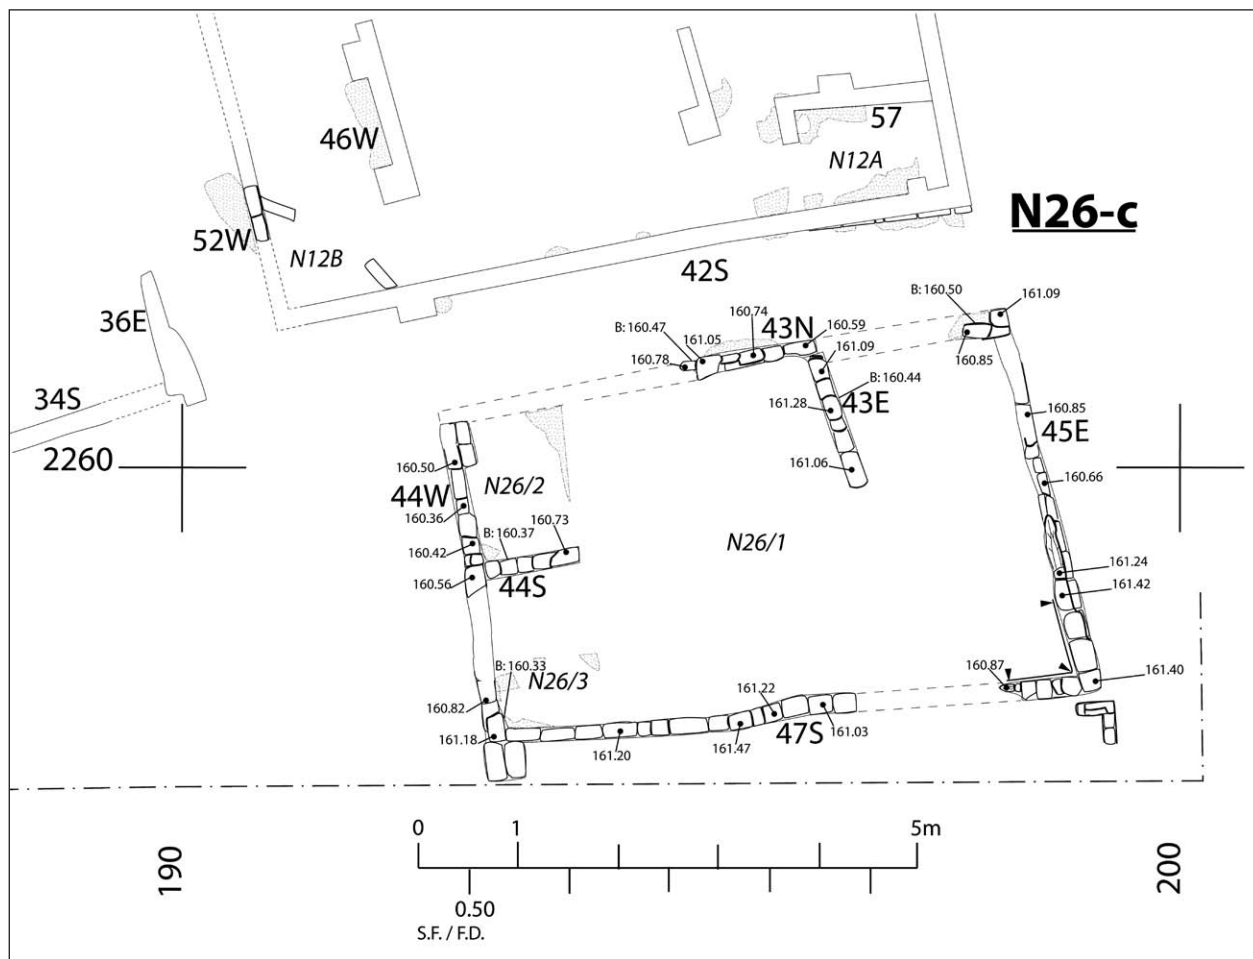
Fig. 40 Plan of Phase N26-c: levels of the perimeter and internal walls

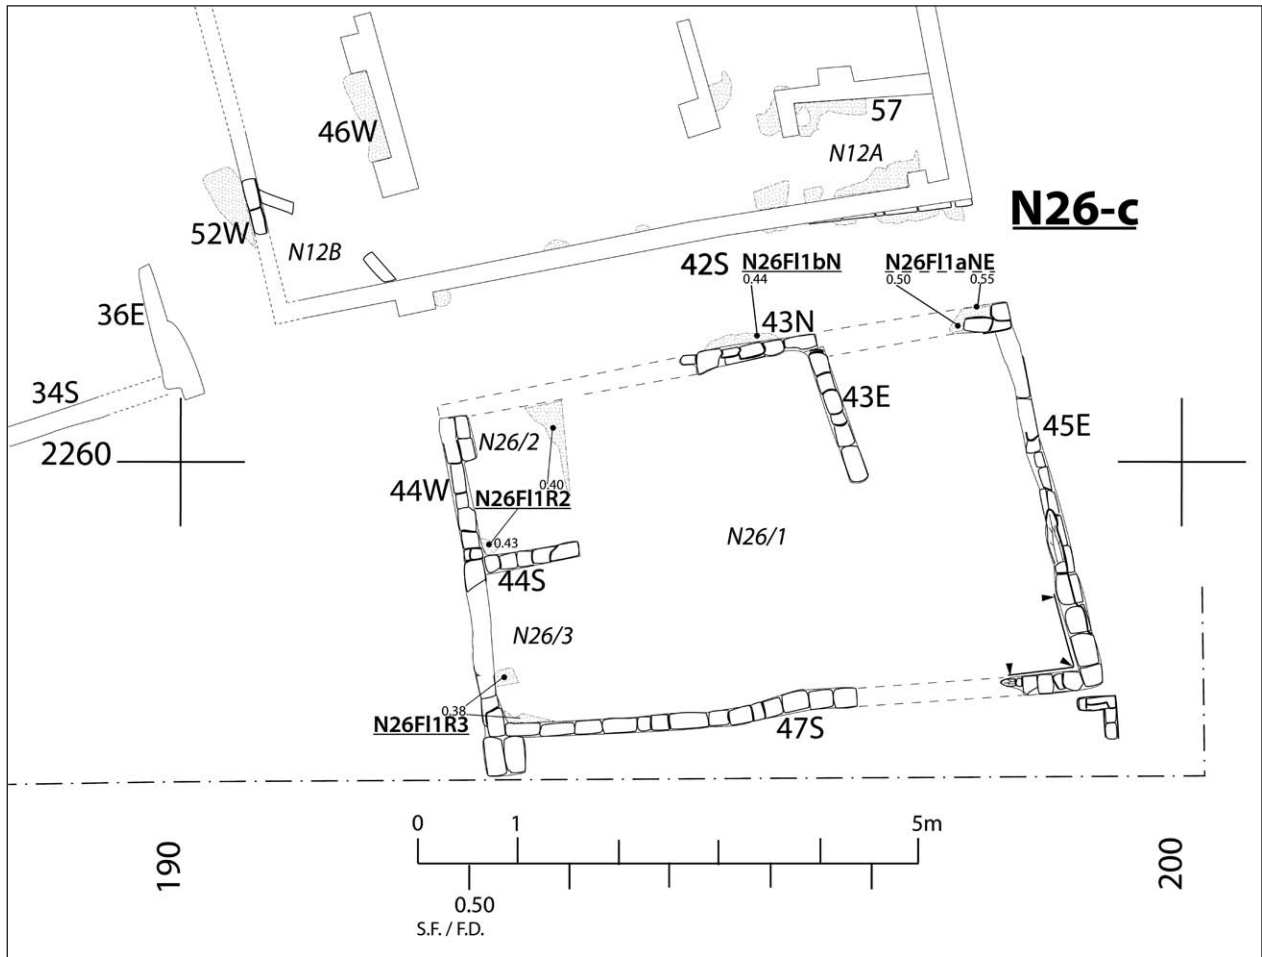
Fig. 41 Plan of Phase N26-c: levels of the floors

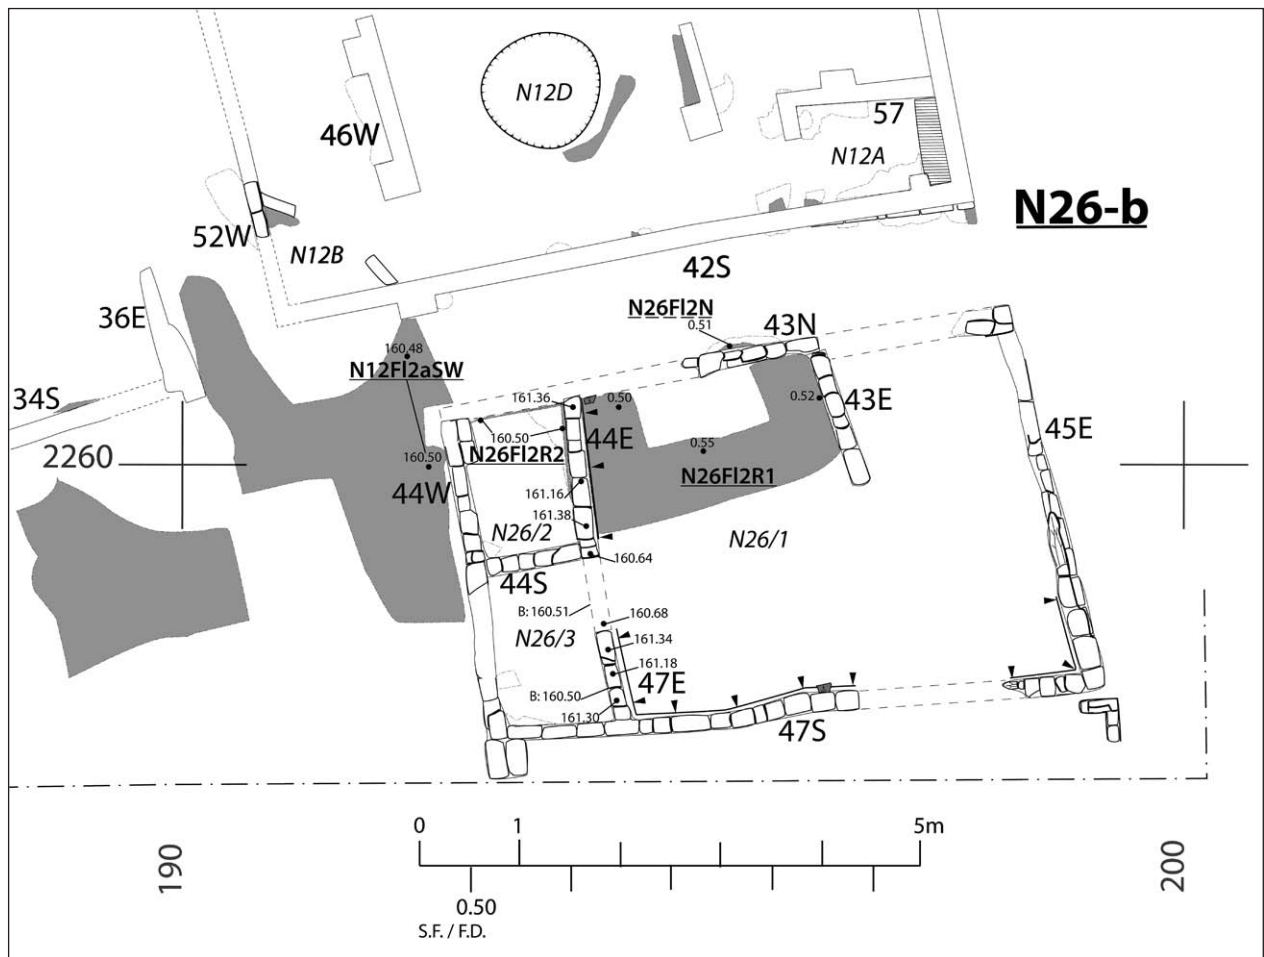
Fig. 42 Plan of Phase N26-b: levels of additional internal walls and floors

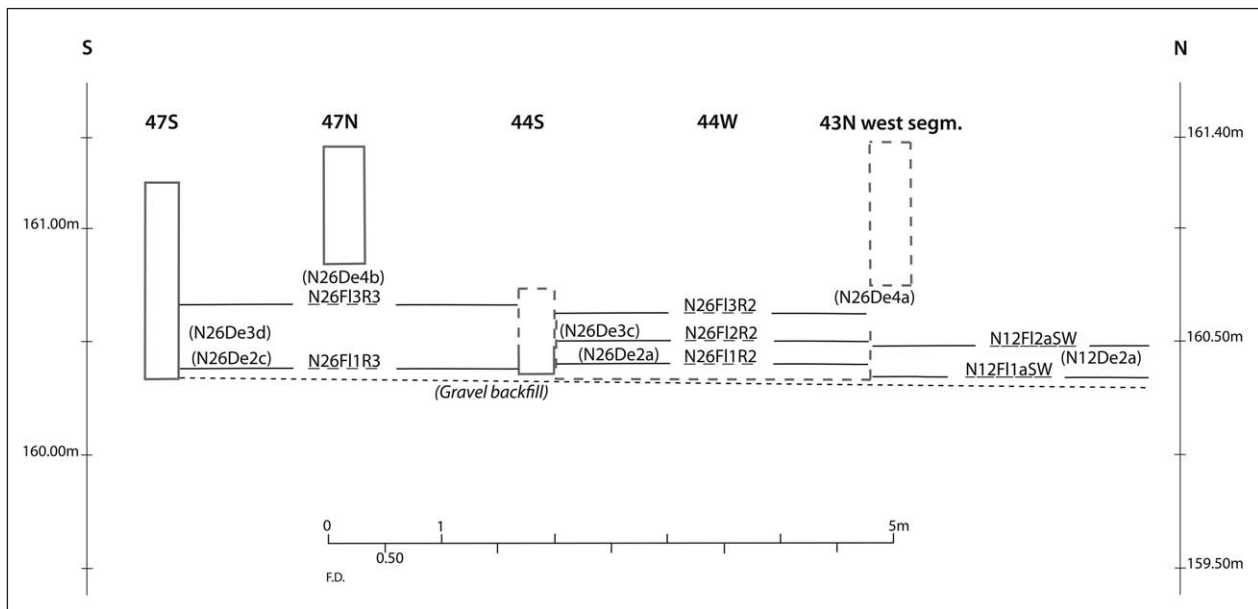
Fig. 43 Outline of the section west of N26

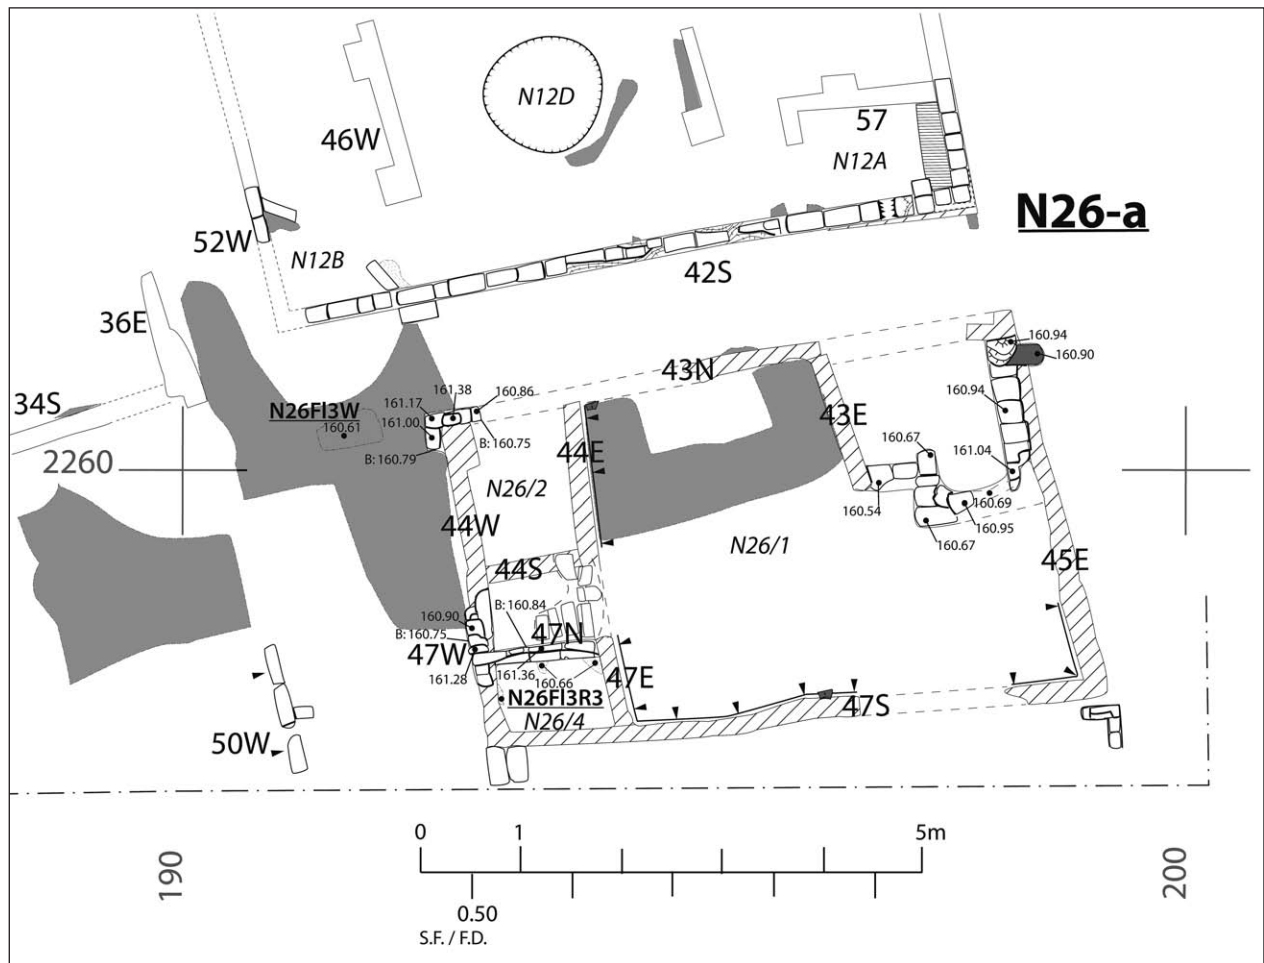
Fig. 44 Plan of Phase N26-a: levels of additional wall segments and floors

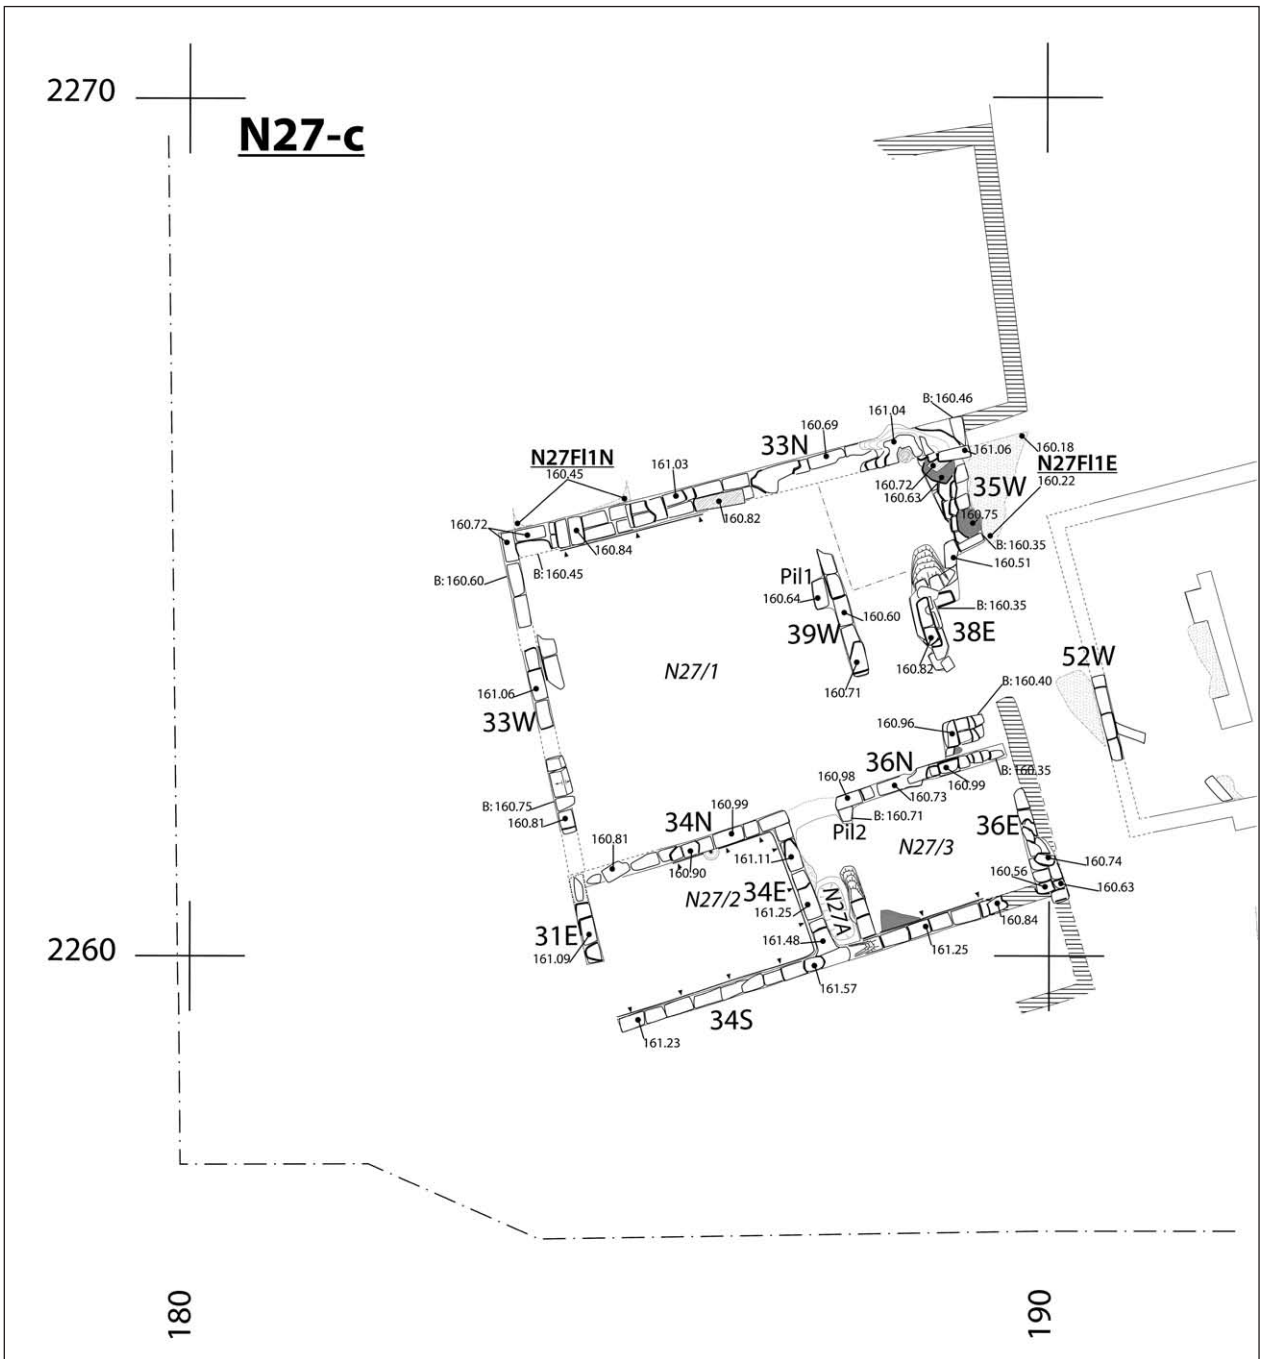
Fig. 47 Plan of Phase N27-c: levels of the perimeter/internal walls and floors 1

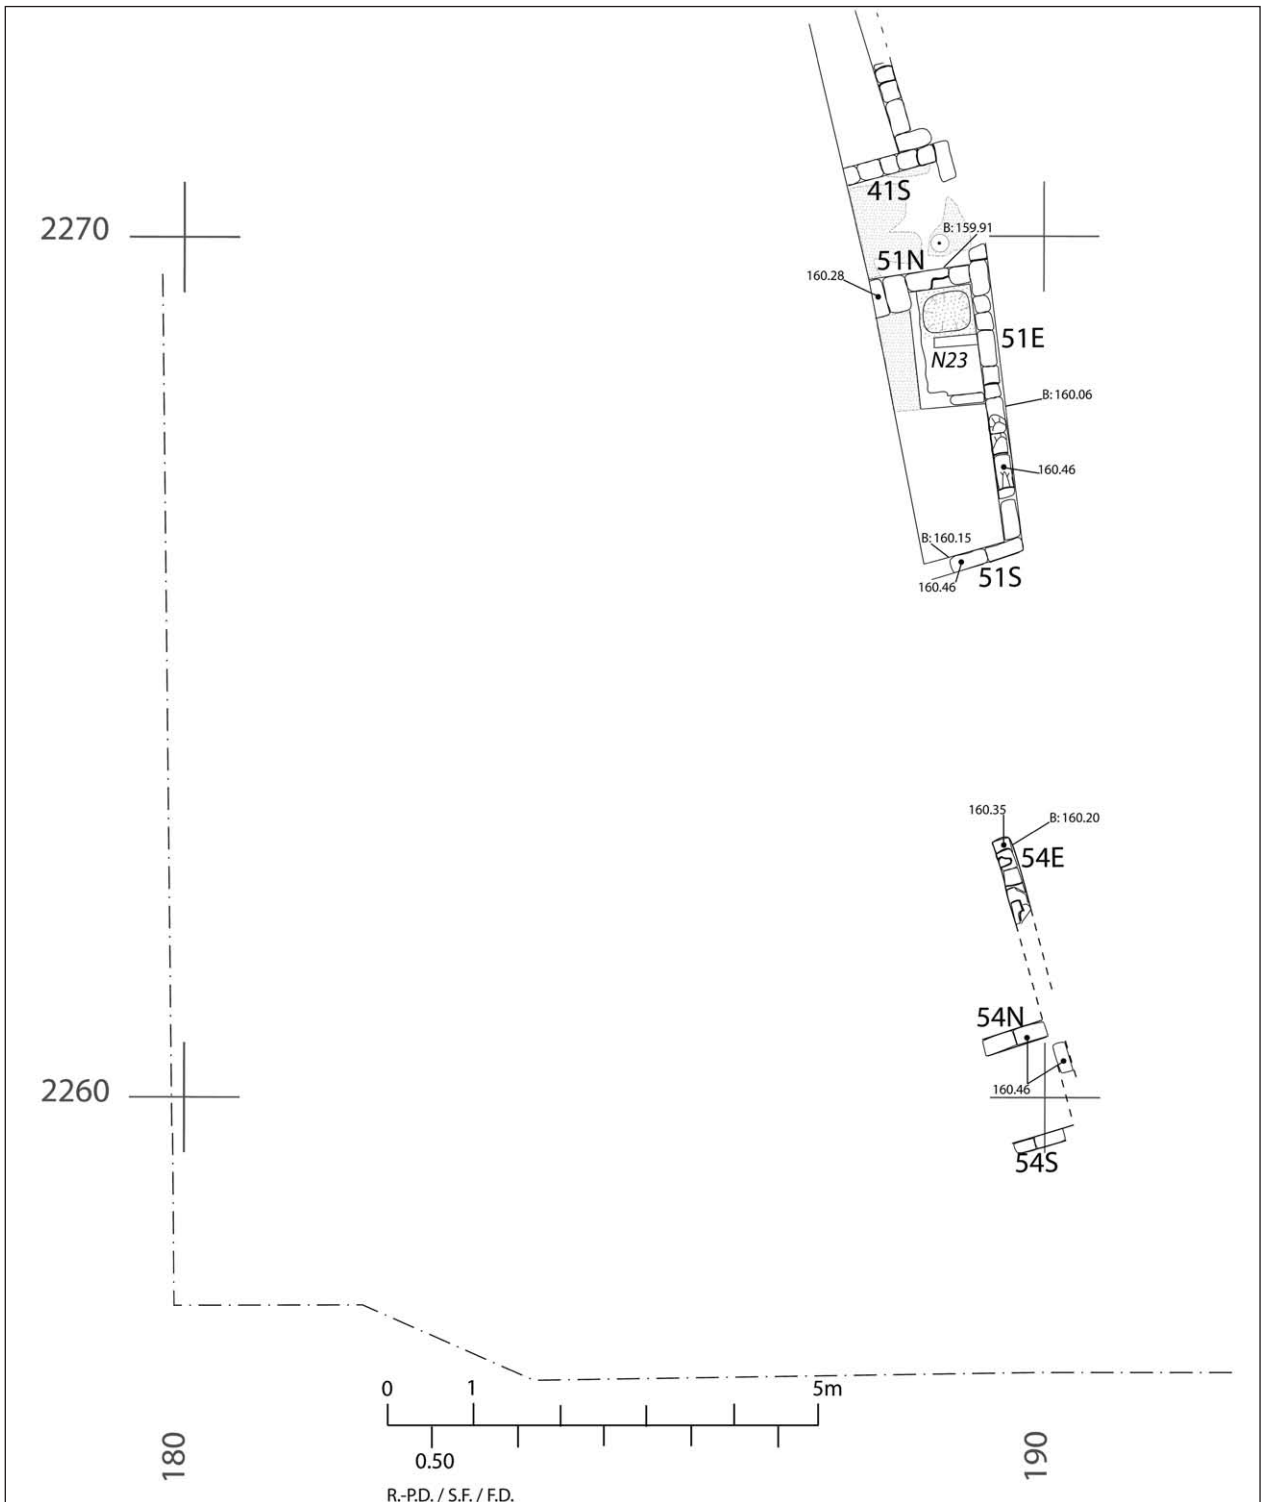
Fig. 48 Square 180/2260, plan of structures assigned to Level 4, including wall levels

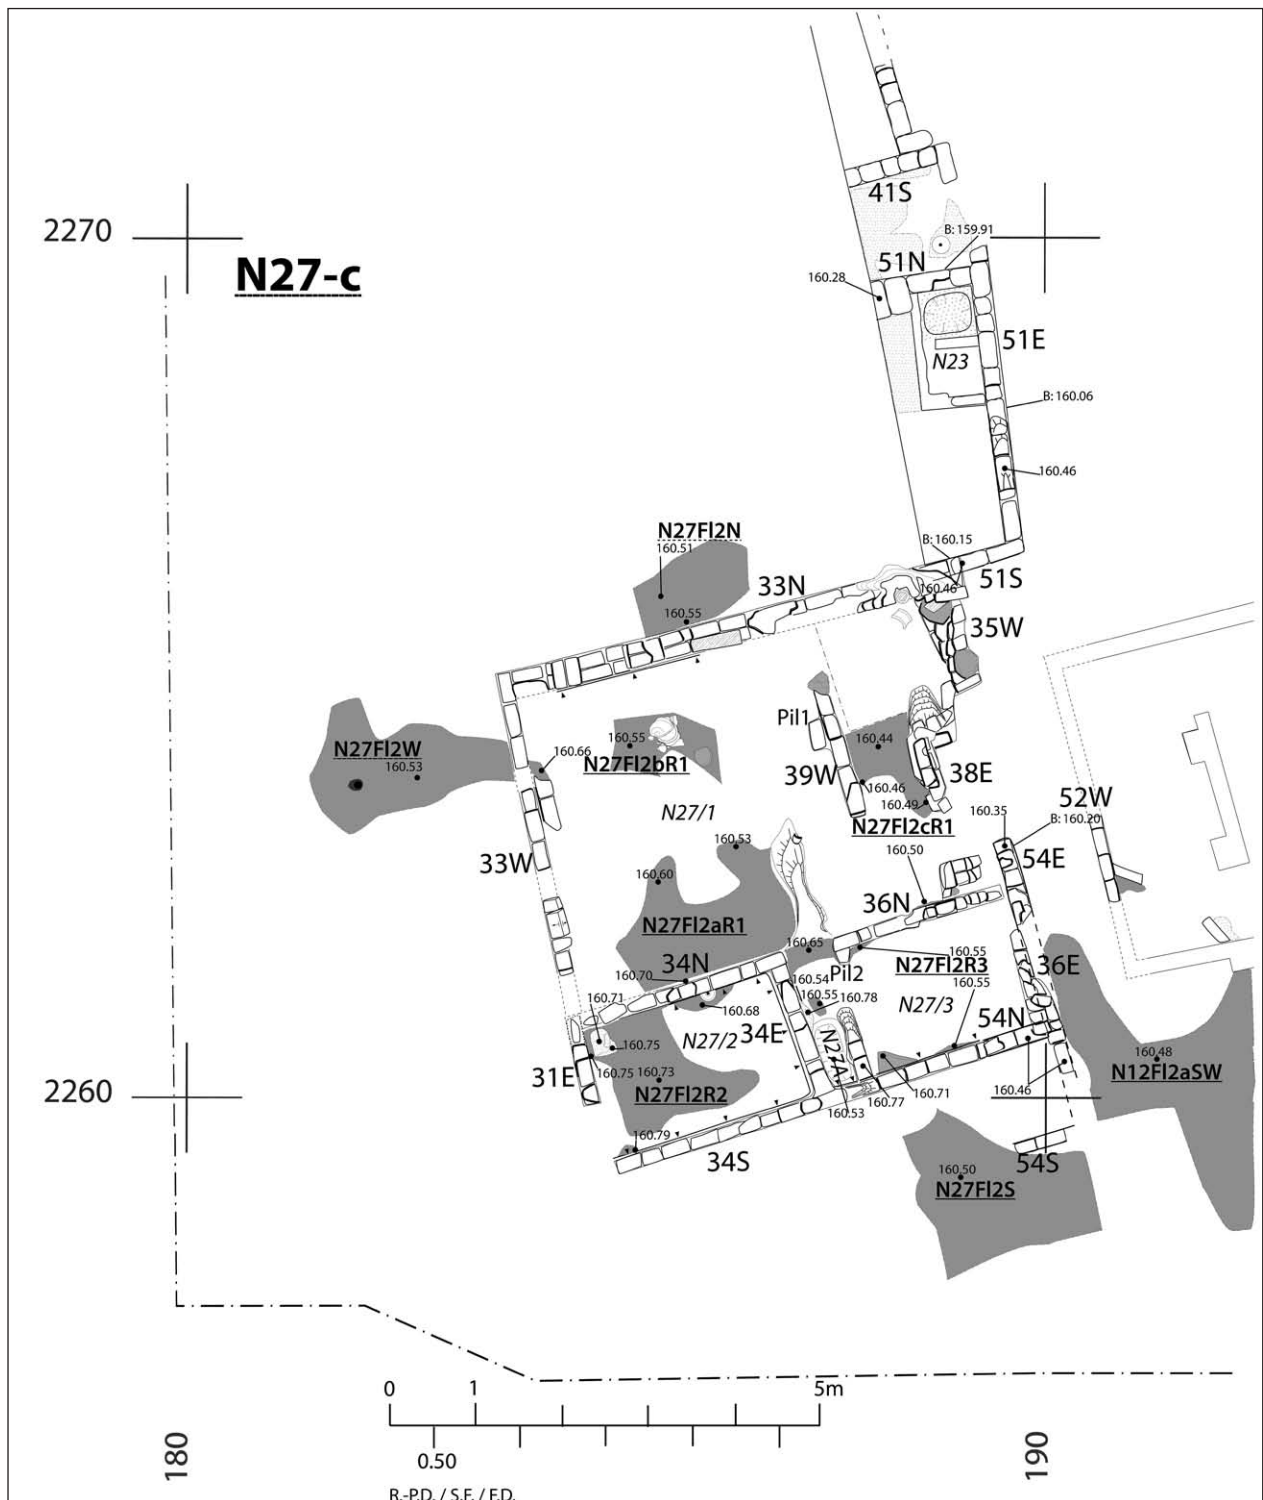
Fig. 49 Plan of Phase N27-c: levels of installations and floors 2
