LINCOLN ARCHAEOLOGICAL STUDIES No. 3

The Archaeology of The Upper City and Adjacent Suburbs

LINCOLN ARCHAEOLOGICAL STUDIES No. 3
GENERAL EDITORS: MICHAEL J. JONES AND ALAN VINCE

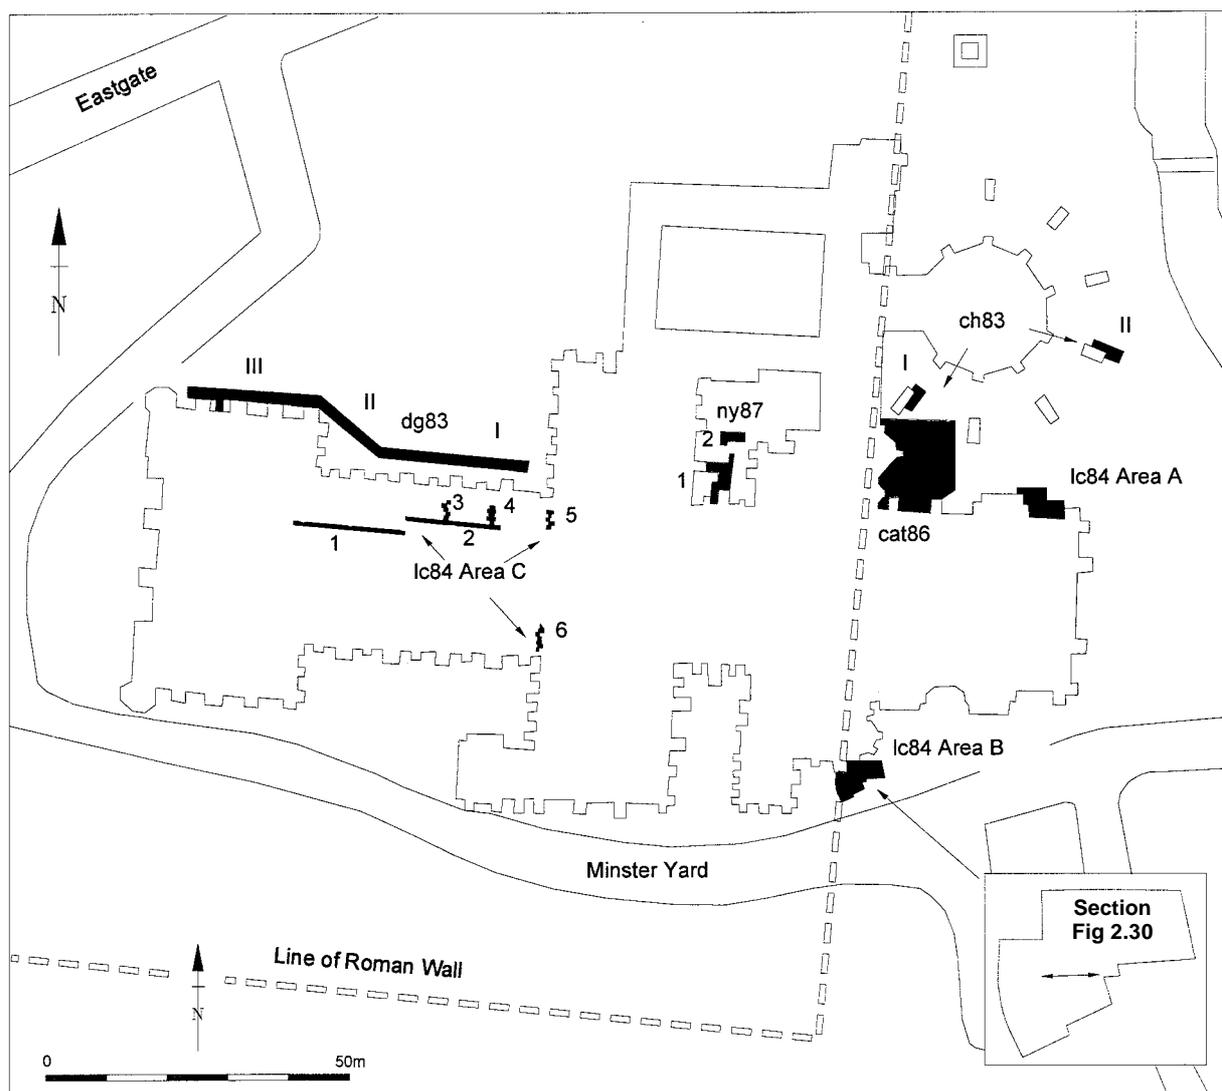
Fig. 2.1 Site location plan showing dg83, ch83, lc84 Areas A, B and C, cat86 and ny87.

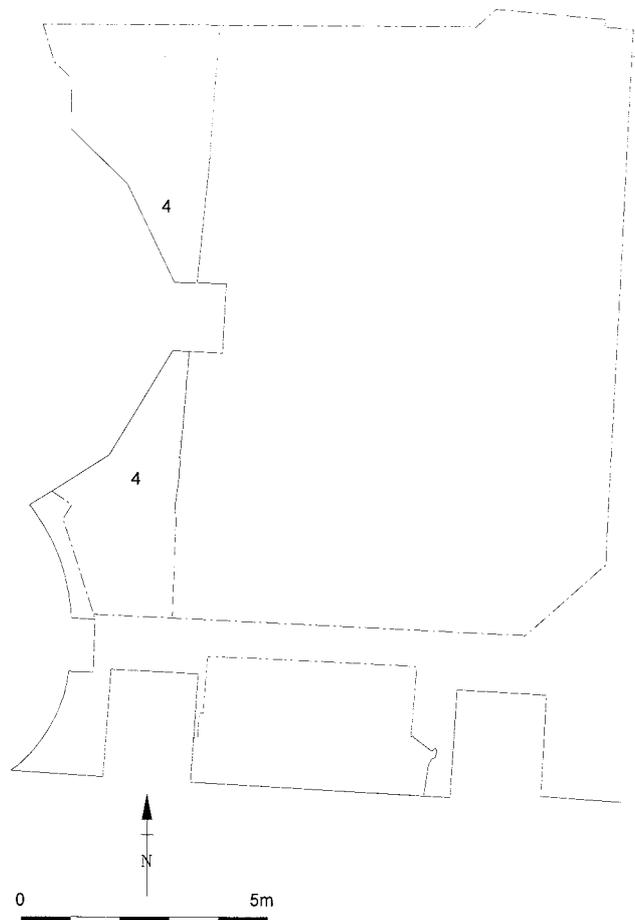
Fig 2.13 cat86: north-south wall cg4: LUB 9

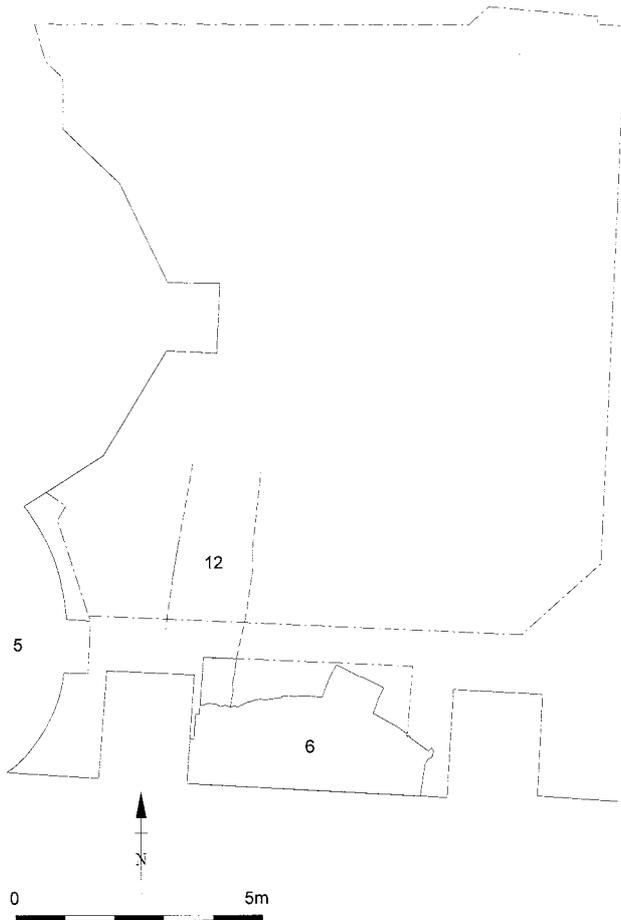
Fig 2.14 cat86: St Hugh's choir with chapel foundations cg6 and transept, and later wall cg12: LUBs 10 and 11

Wall foundations cg12 abutted the north side of St Hugh's Choir (cg6, LUB 10). They were approximately 1 metre wide, consisting of partly-mortared facing stones up to 0.50m by 0.40m and a rubble core. The wall survived to its highest level to the

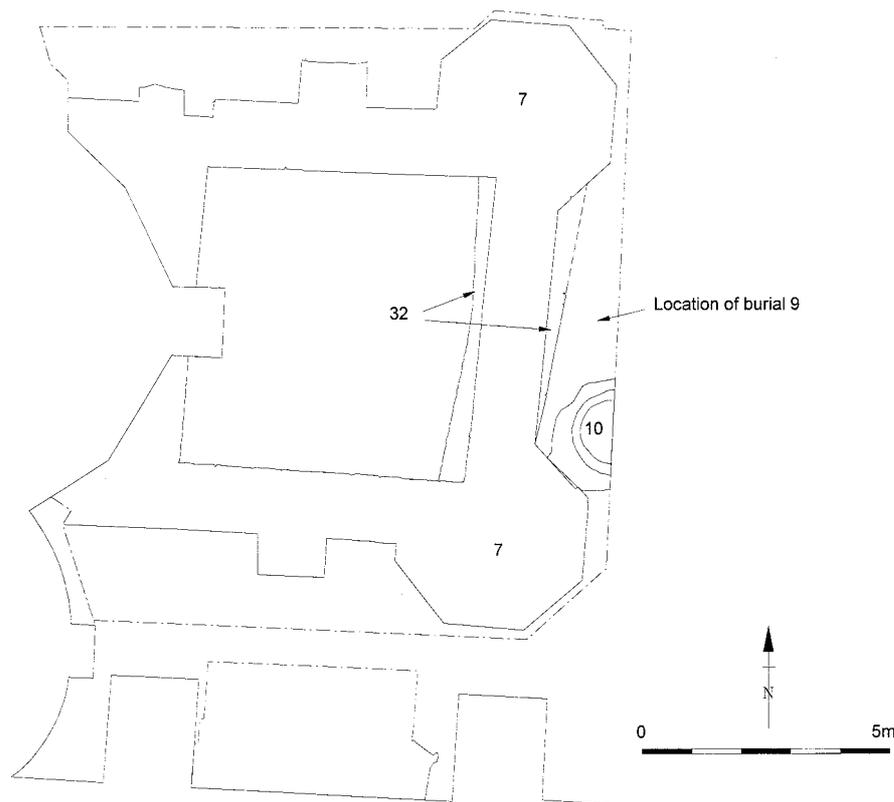
Fig 2.15 cat86: the chapel foundations cg32 and cg7 with well cg10 to east: LUBs 12 and 16

Three reused decorative stones in the foundations cg7 of the chapel are limestone blocks bearing raised 'lattice' or 'diaper' pattern on one face. This device appears in several other instances in the cathedral, in the upper areas of the central arch of the west front and in the lower stage of the crossing tower (both inside and out). This device has been

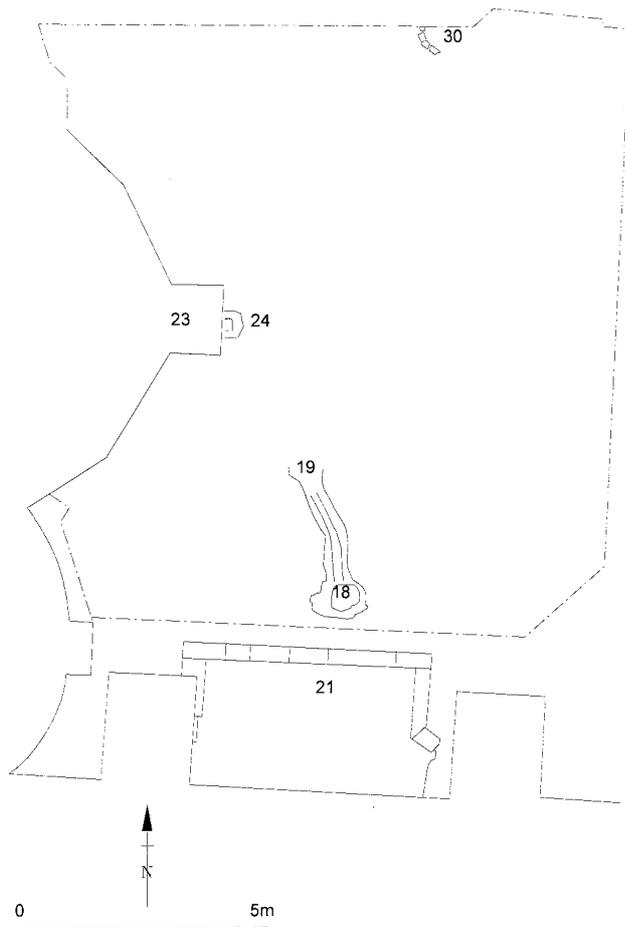
Fig 2.16 cat86: new chapel cg23 and drainage with wall cg21 to south: LUBs 20, 21 and 22

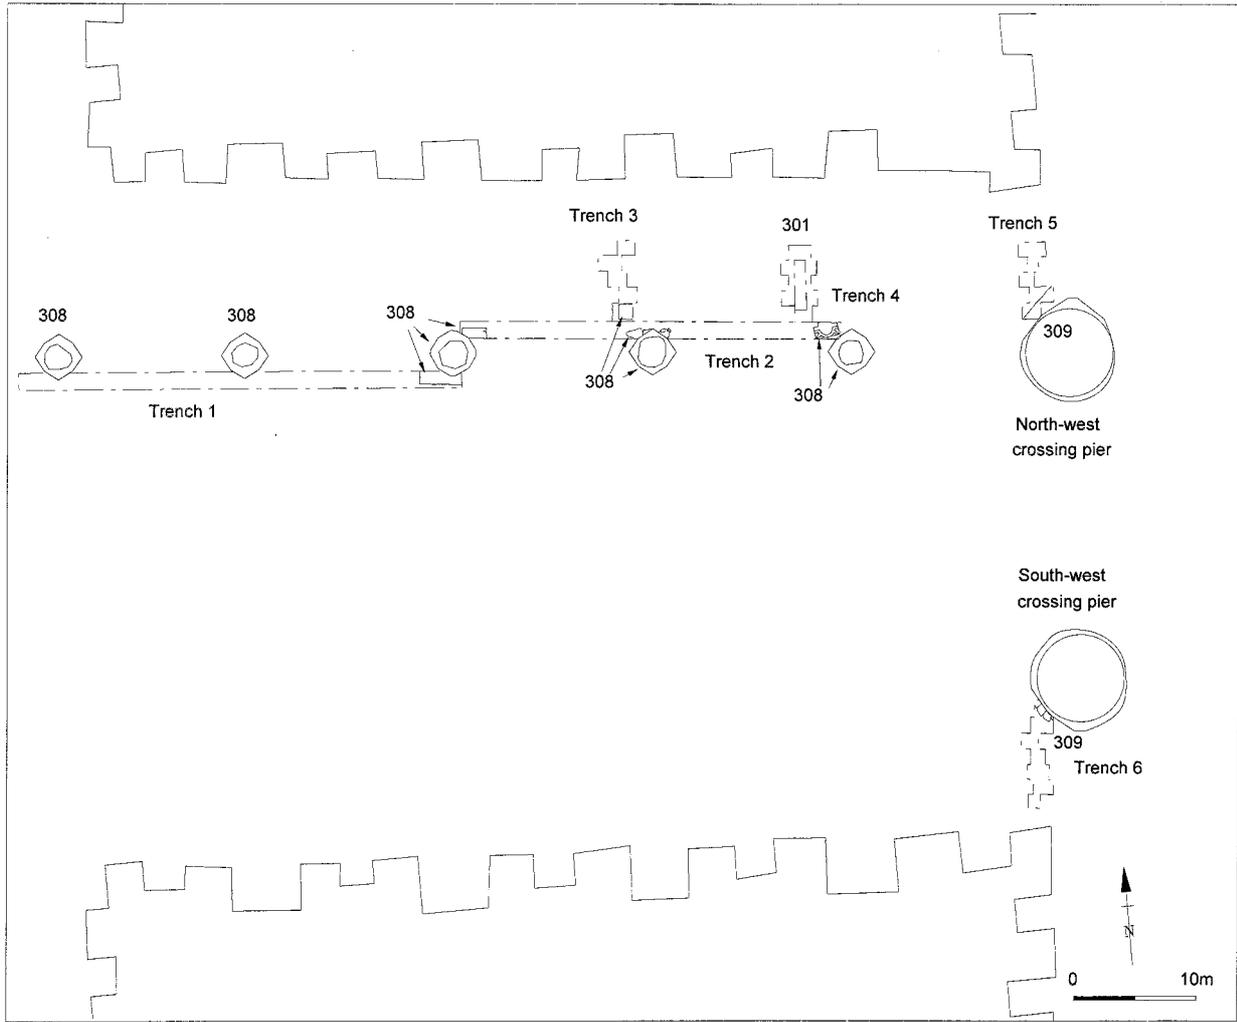
Fig 2.26 lc84 Area C: plan of trenches 1–6 and standing piers: LUB 40

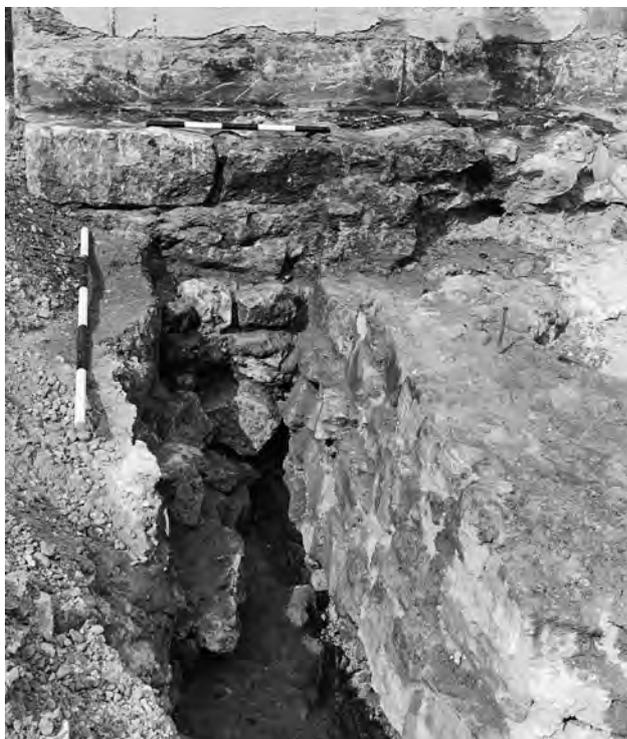
Fig 2.44 Looking north-east at the west side of the east wall cg201 of the upper colonia, reused to underpin the foundations cg229 of St Hugh's Choir: lc84 Area B, LUBs 25 and 26

Stocker's proposed sequence of events culminated in the construction of the eastern end of St Hugh's Choir. The excavations at lc84, Area B showed the truncated Roman wall being used as foundations for the cathedral, and dumps cg204, cg205 and cg226 (LUB 26) built up the ground over the Roman ditch. Fragments from the construction of St Hugh's Choir were recovered in dump cg206 (LUB 26), which sealed the earlier makeup dumps. Foundations cg203 (LUB 26) for the cathedral, perhaps the 'raft' mentioned above sealed cg206 (LUB 26).

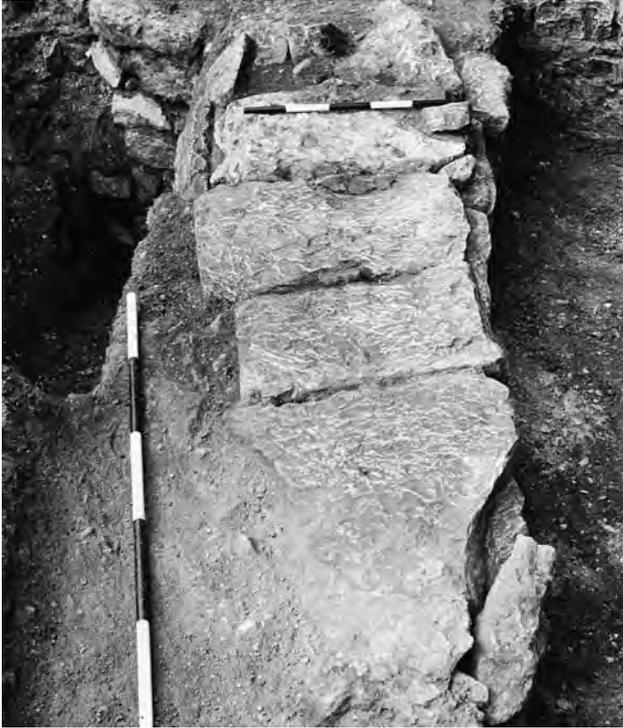
Fig 2.46 Looking west along intact cist burial cg219:
lc84 Area B, LUB 29

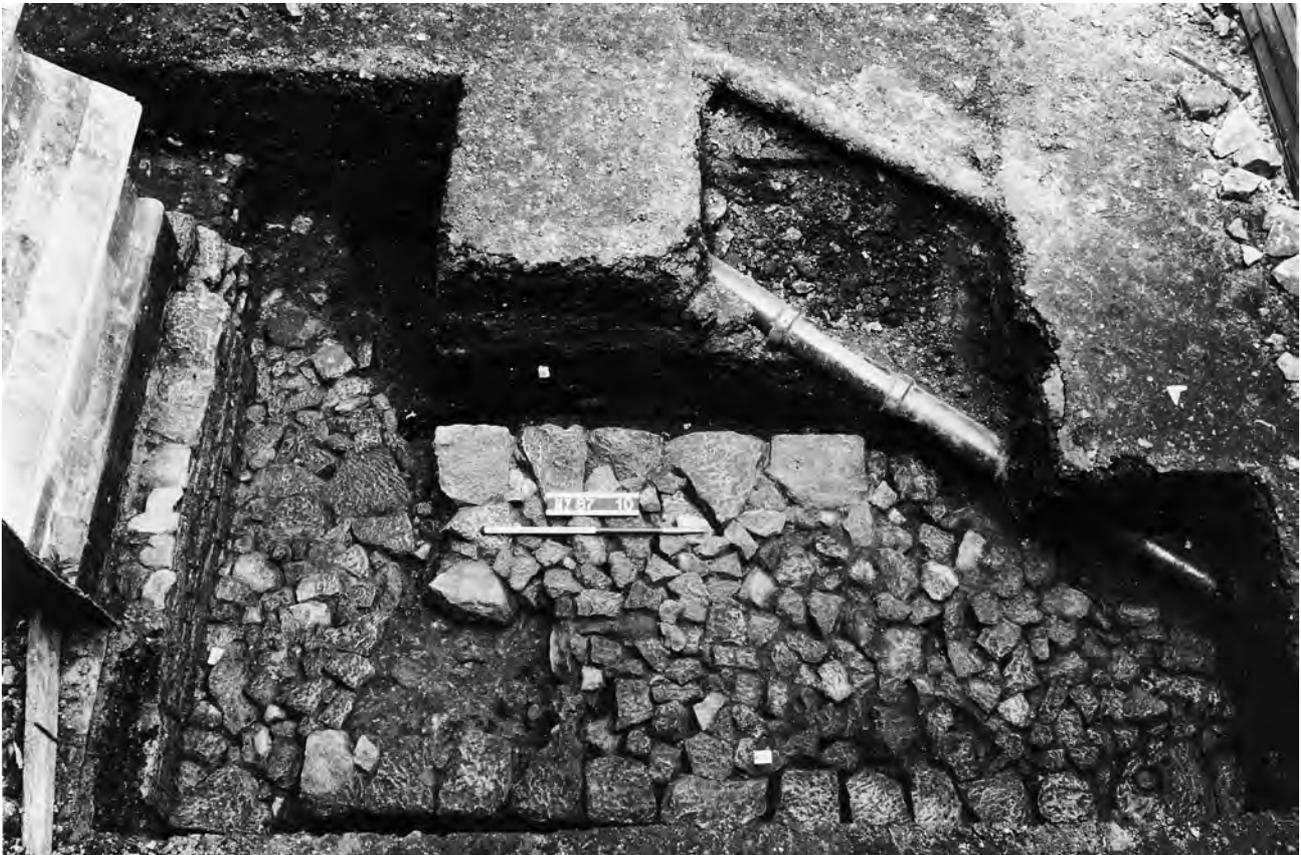
Fig 2.47 Almost vertical view looking west at the foundations of a massive wall cg503: ny87, LUB 31

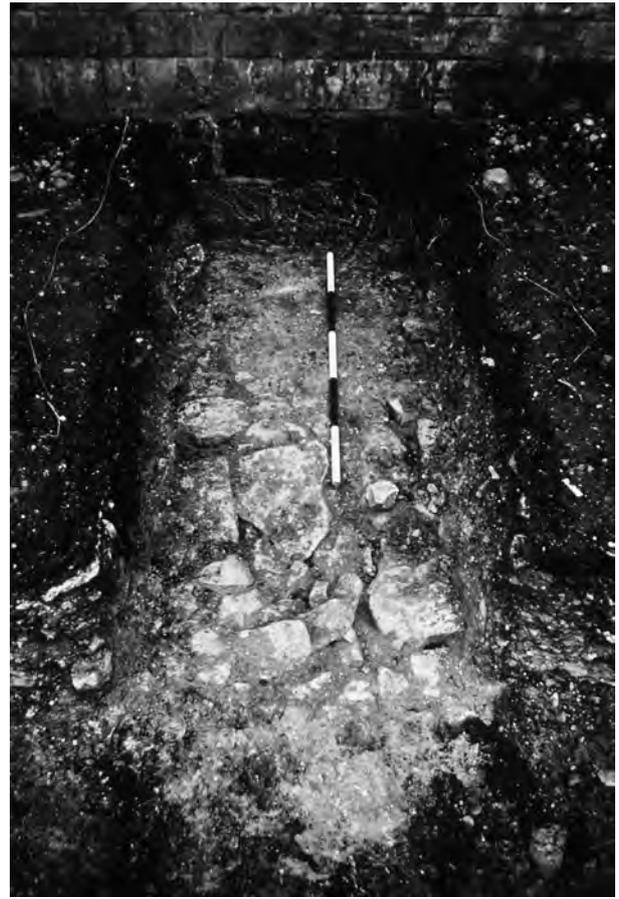
Fig 2.48 Looking south at foundations cg403: dg83, LUB 42

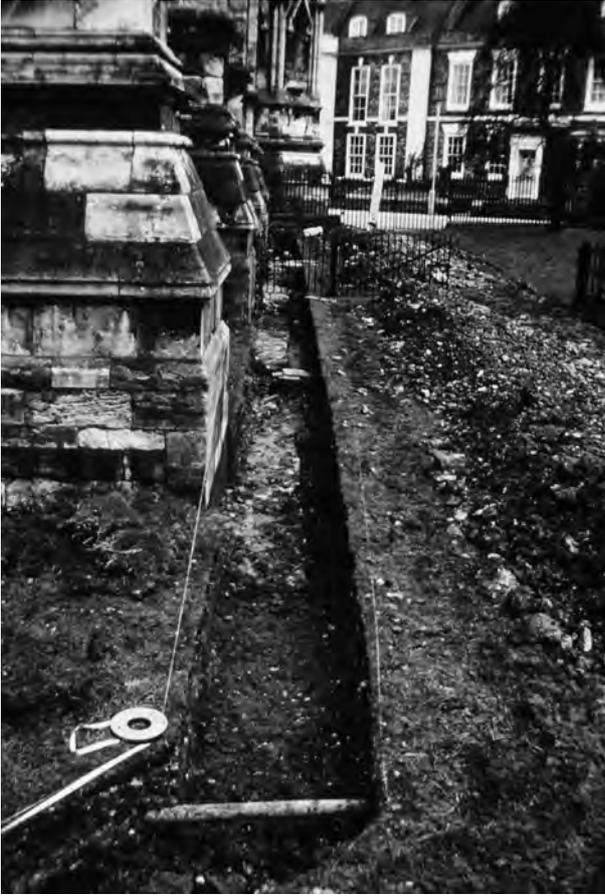
Fig 2.49 Looking west along trench III at foundations
cg417: dg83, LUB 43

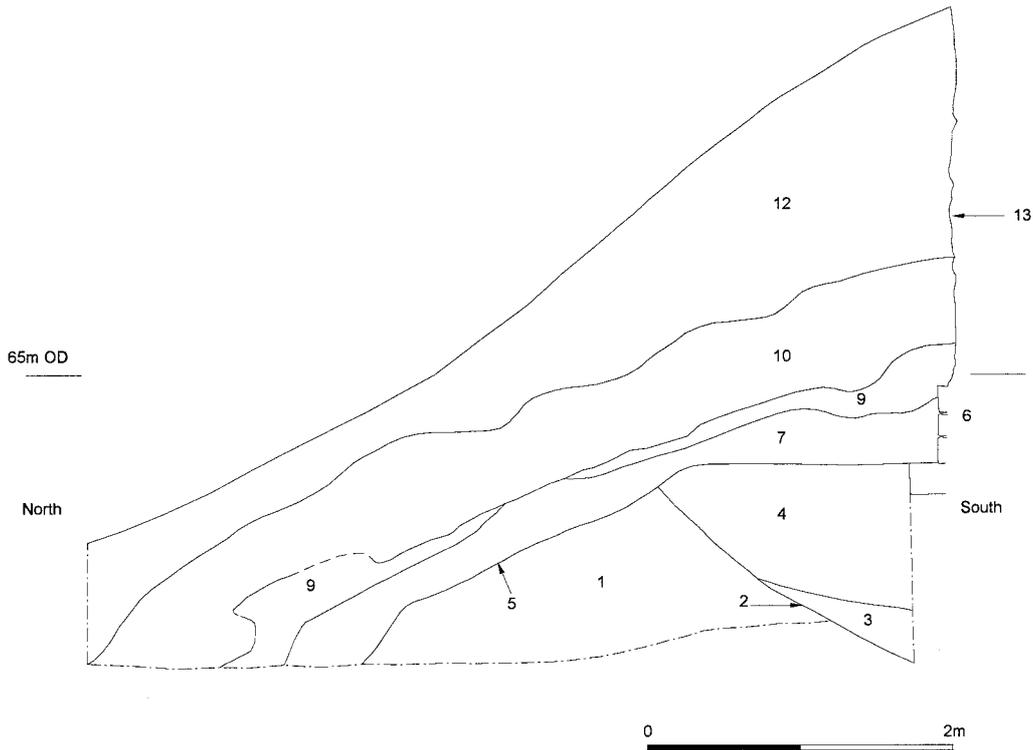
Fig 3.3 North-south section drawing for ce75

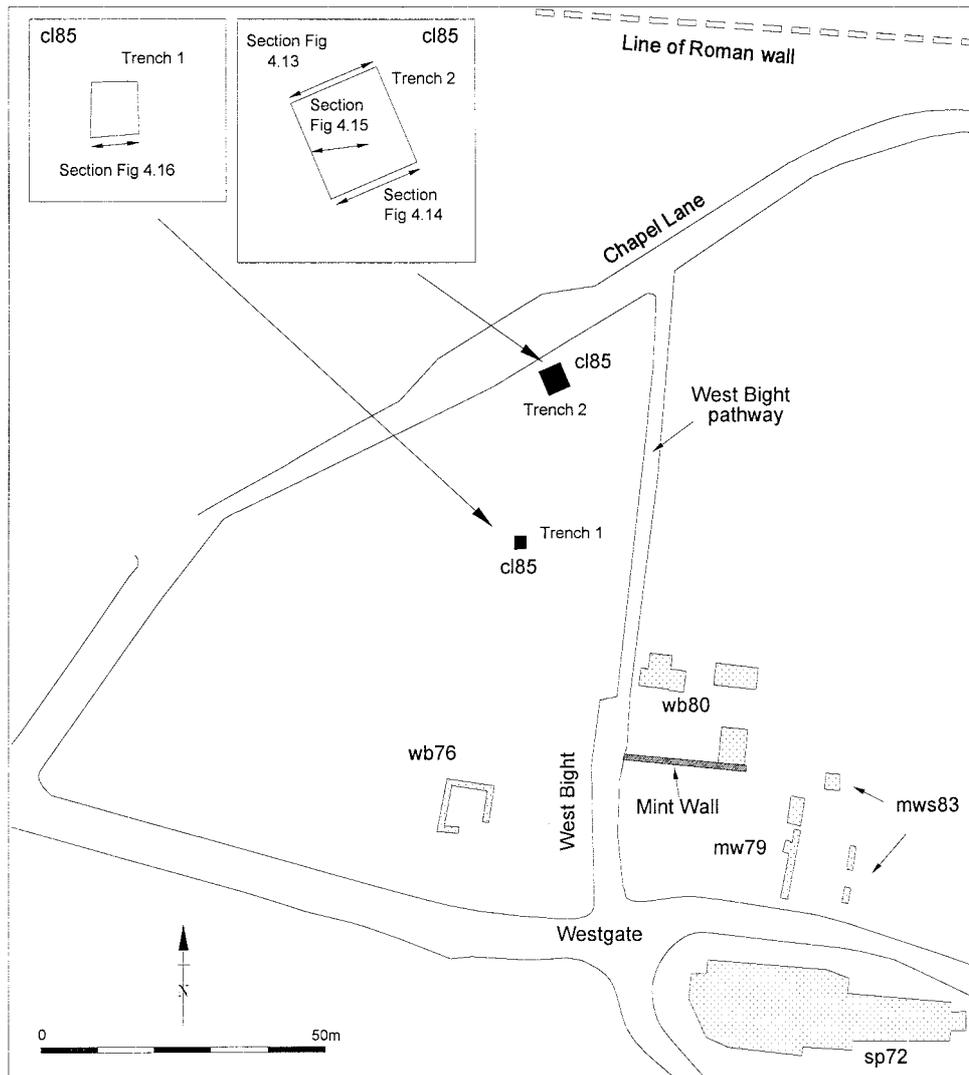
Fig 4.1 Site and section location plan for cl85

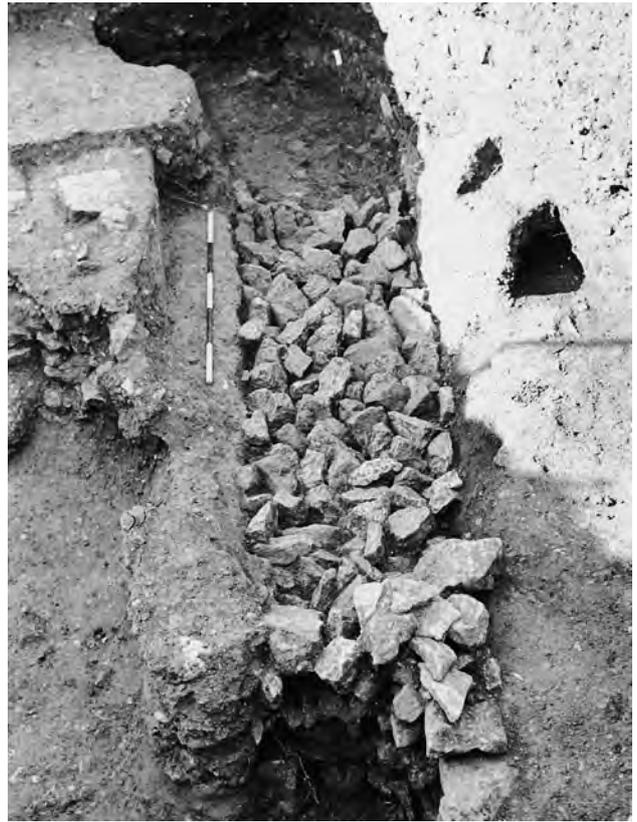
Fig 4.21 Looking south at the foundations of north–south limestone wall cg47: LUB 11

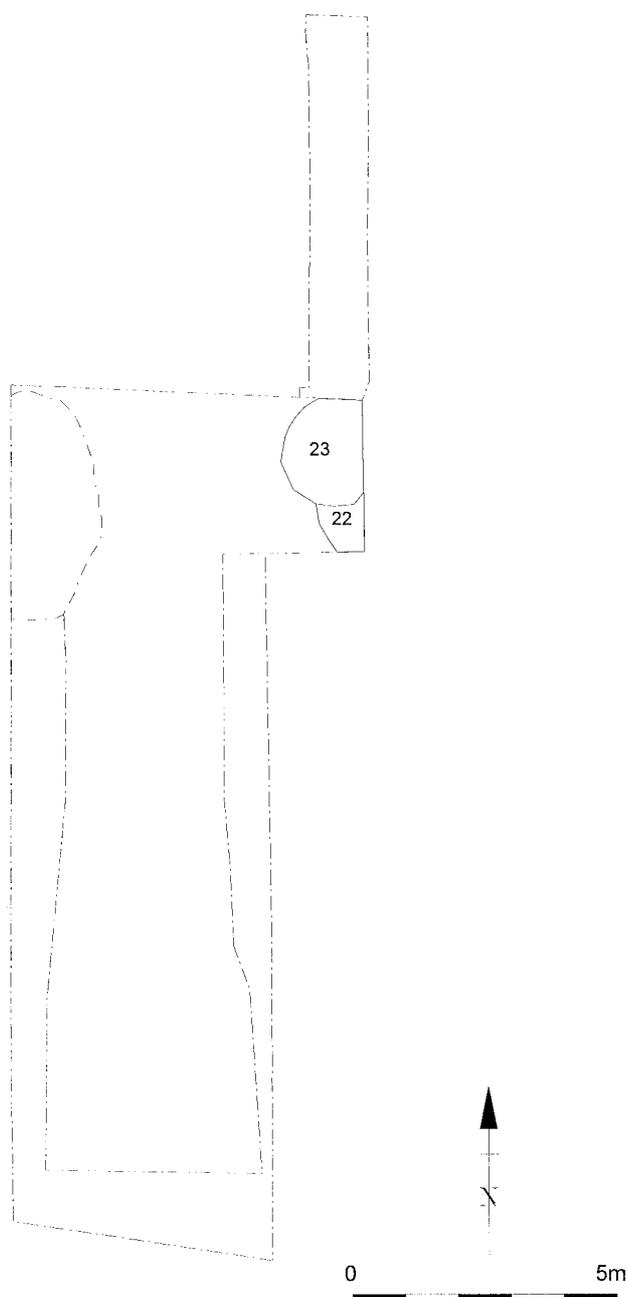
Fig 5.6 Pits associated with metalworking: LUB 10

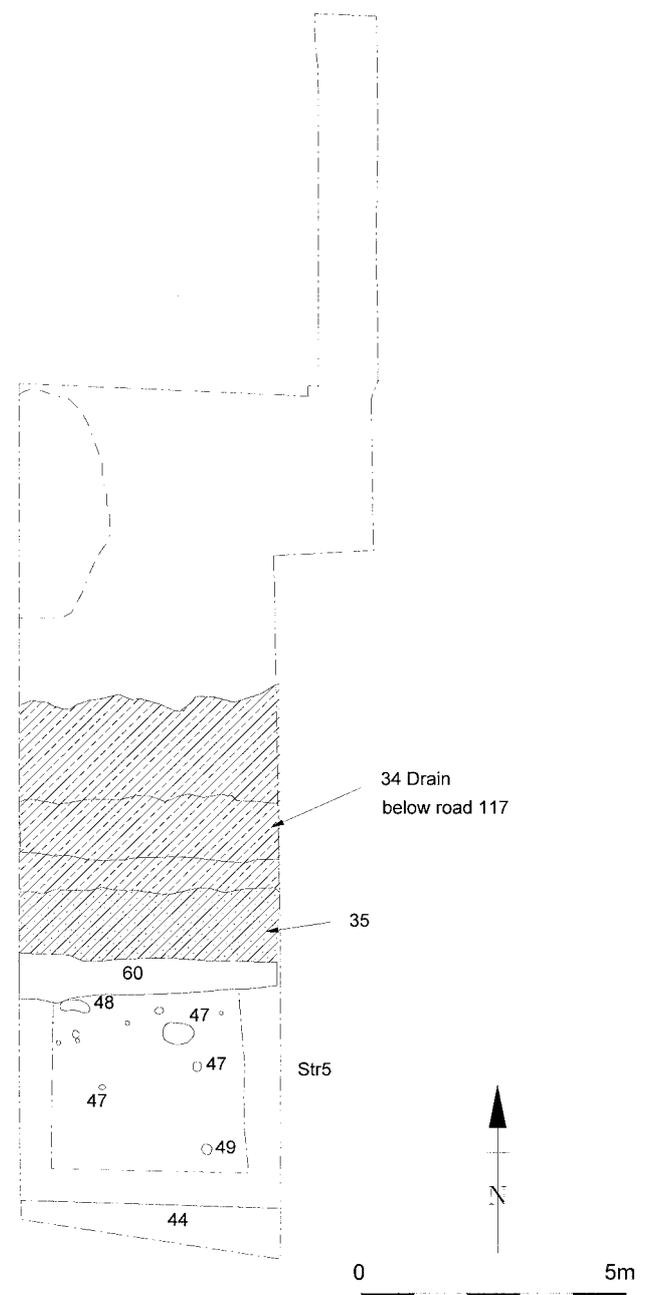
Fig 5.7 Construction of Structure 5 and road with drain: LUBs 13 and 15

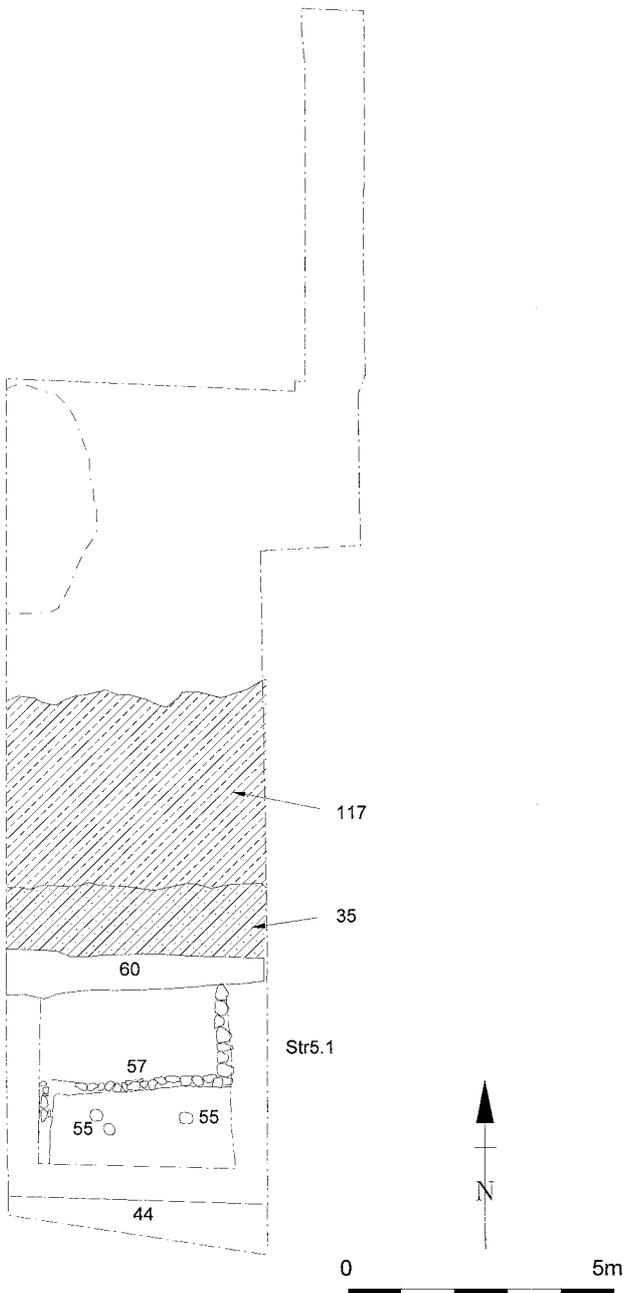
Fig 5.8 Structure 5.1 and road surface: LUBs 13 and 16

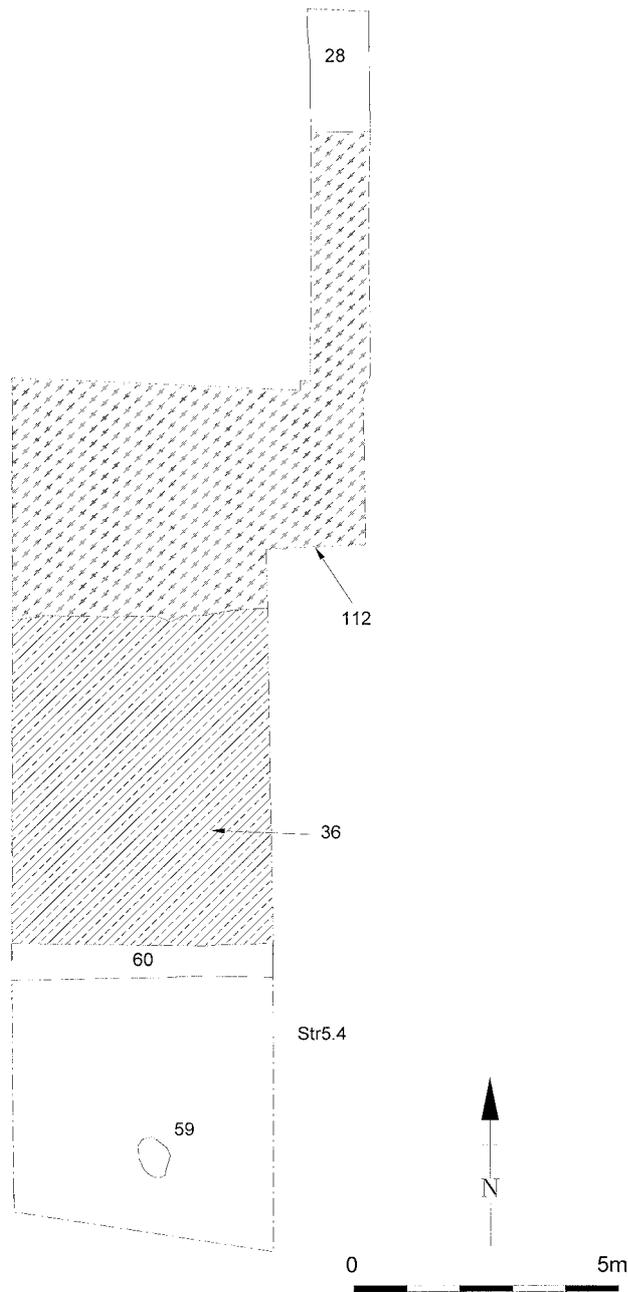
Fig 5.11 Structure 5.4, road surface, rampart and wall: LUBs 22, 23, 24 and 26

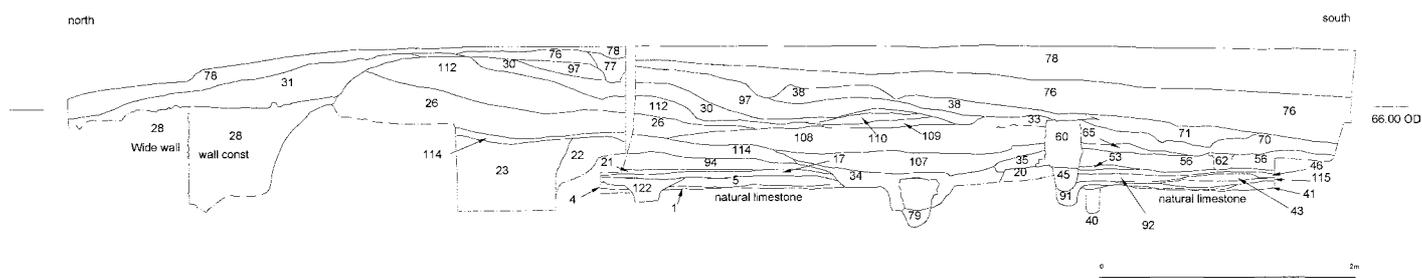
Fig 5.14 Composite north-south section to the east of the site

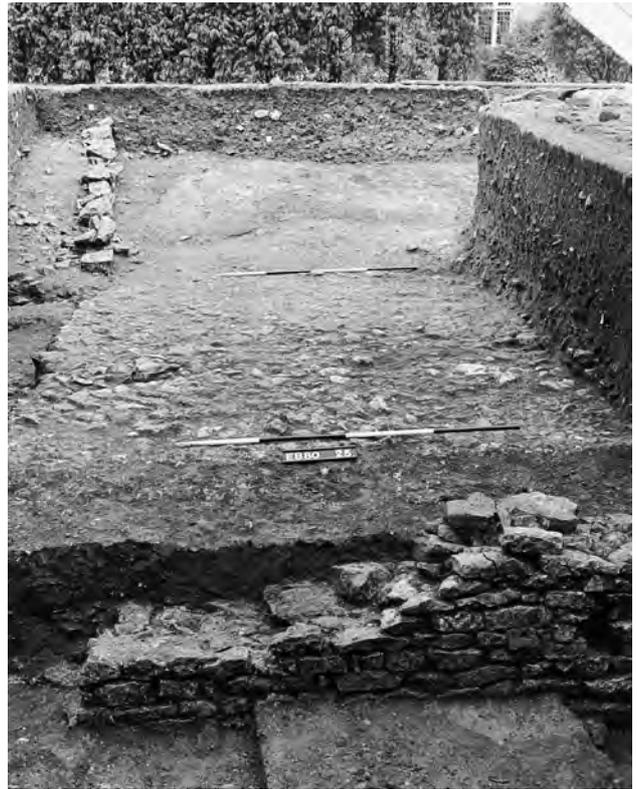
Fig 5.19 Looking north at the wall cg60, across the road cg109 towards the ramp cg27: LUBs 20, 21 and 25

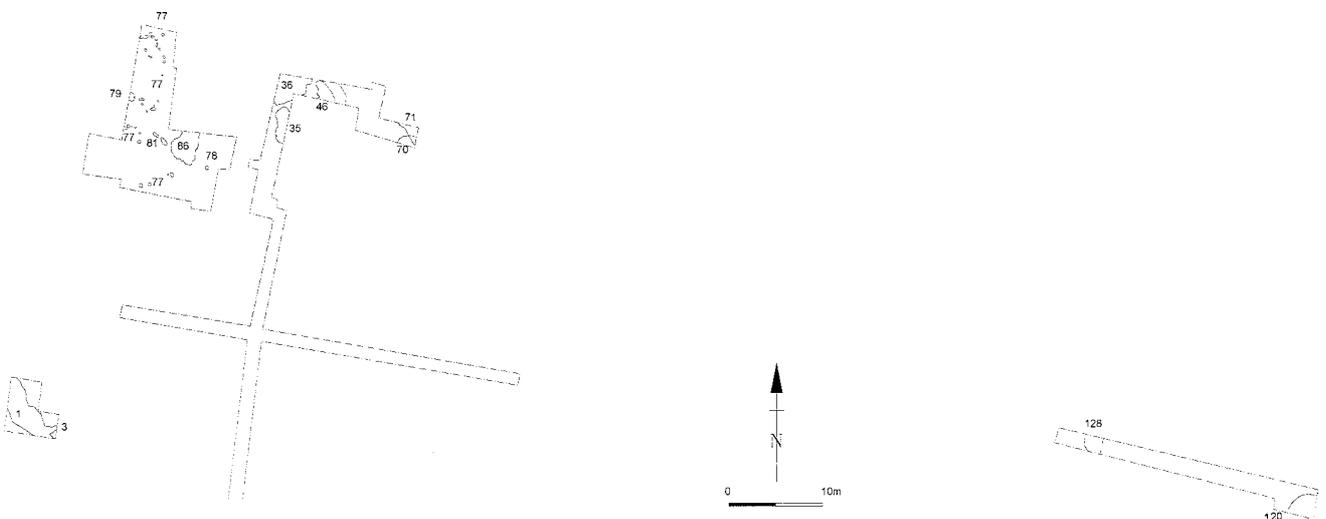
Fig 6.3 Possible legionary structures and pits: LUBs 1, 2, 3 and 4

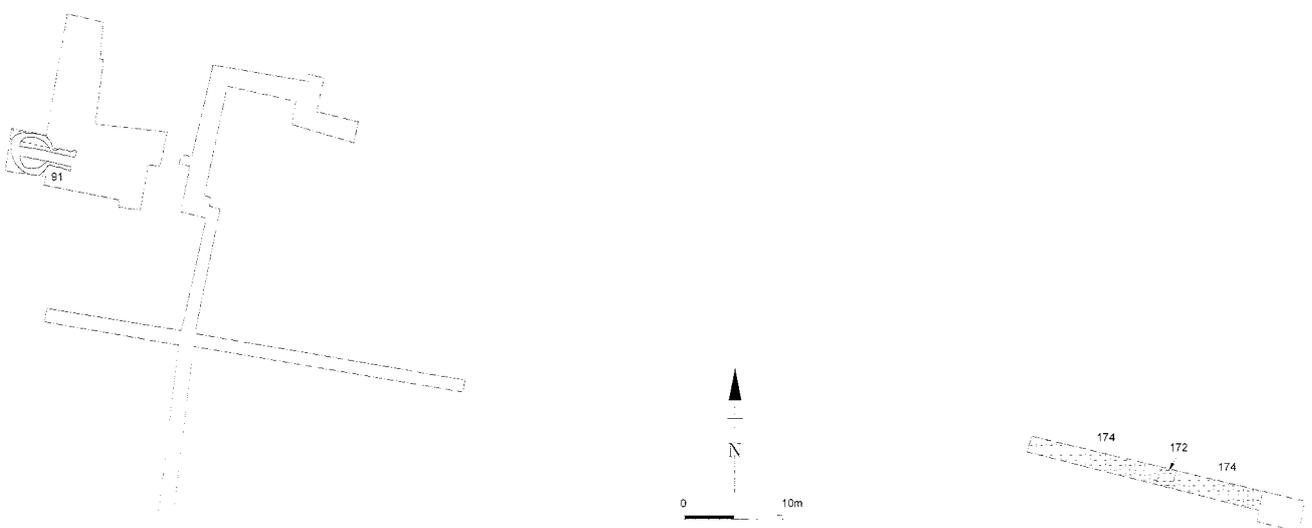
Fig 6.13 Dump cg174 cut by ditch cg172 in Area VII, and lime-kiln in Area II: LUBs 36, 37 and 38

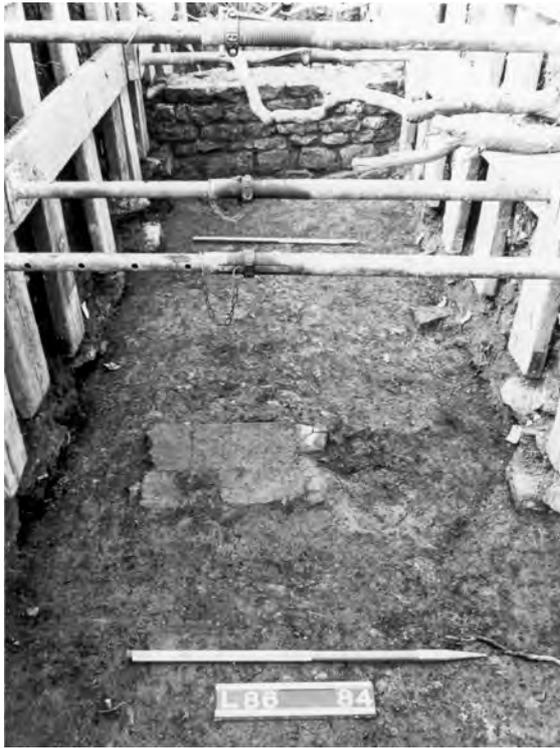
Fig 6.21 Looking west at tile hearth cg142, within Structure 1.2: LUB 12

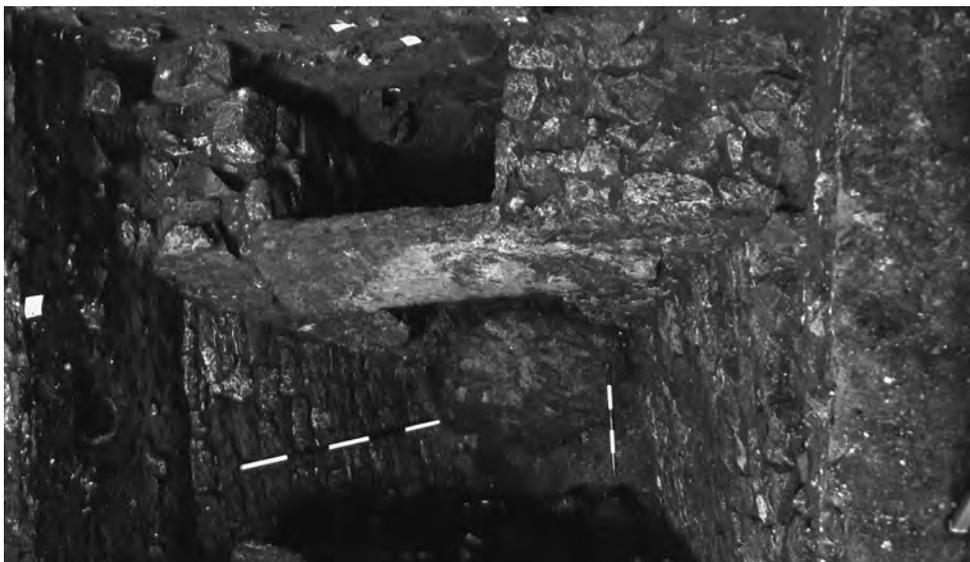
Fig 8.12 Looking east at kiln cg3, showing flue: LUB 4

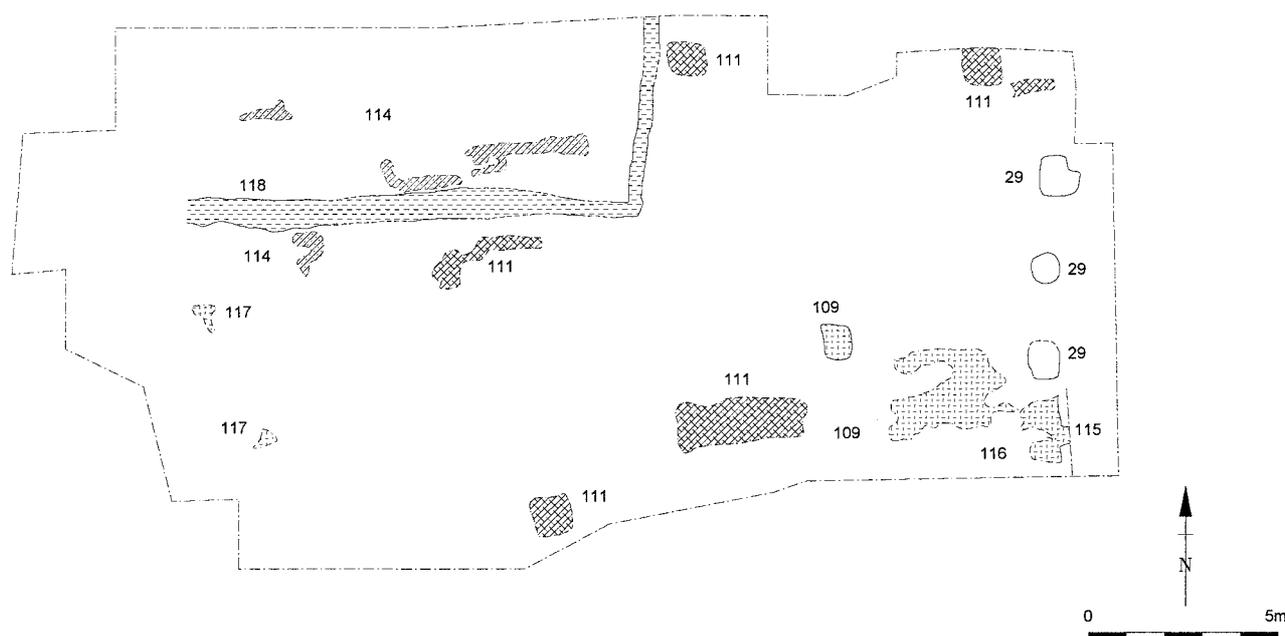
Fig 9.9 The forum courtyard (a): LUB 5

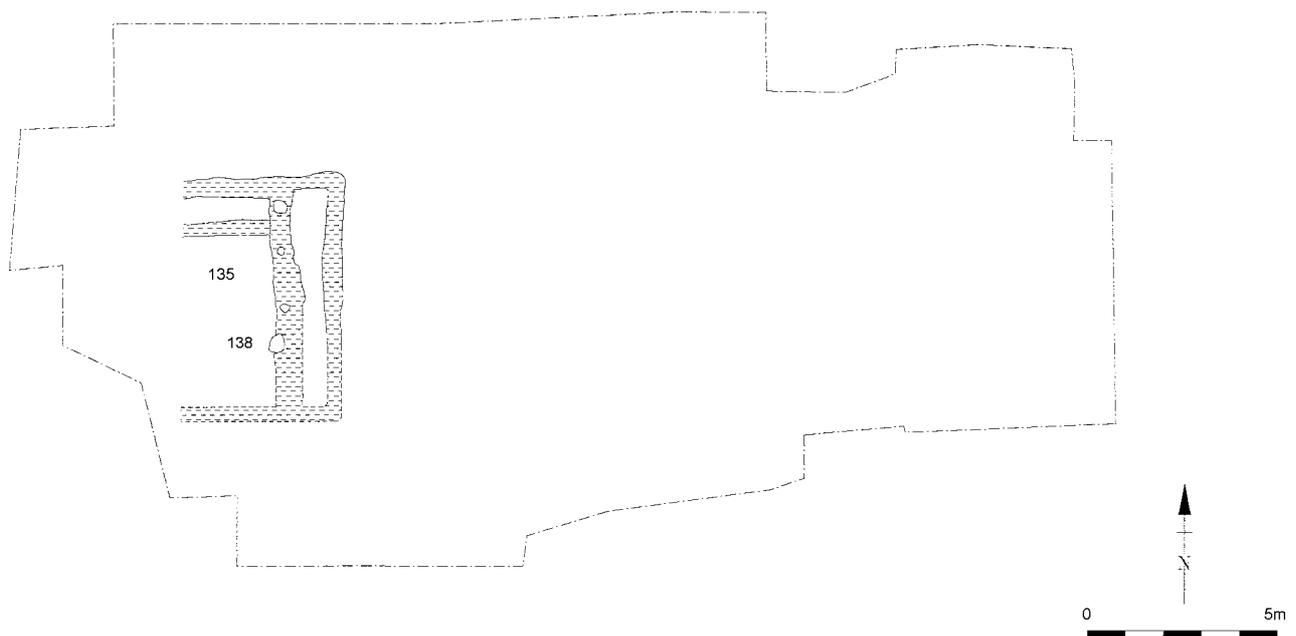
Fig 9.25 Possible church (Structure 3): LUB 19

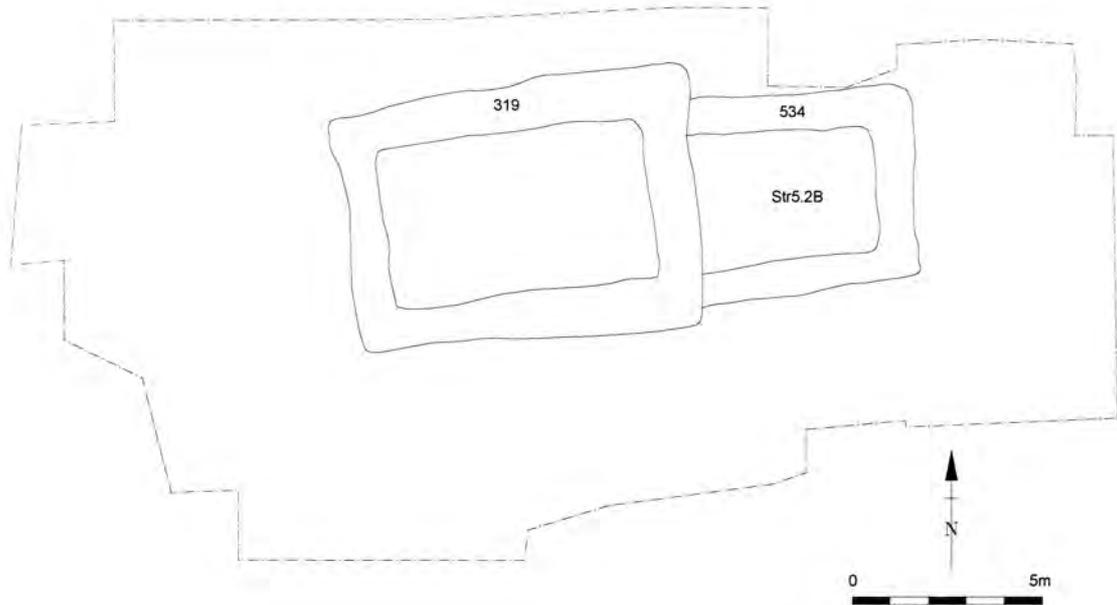
Fig 9.42 The early medieval church with added chancel, Structure 5.2B: LUB 70

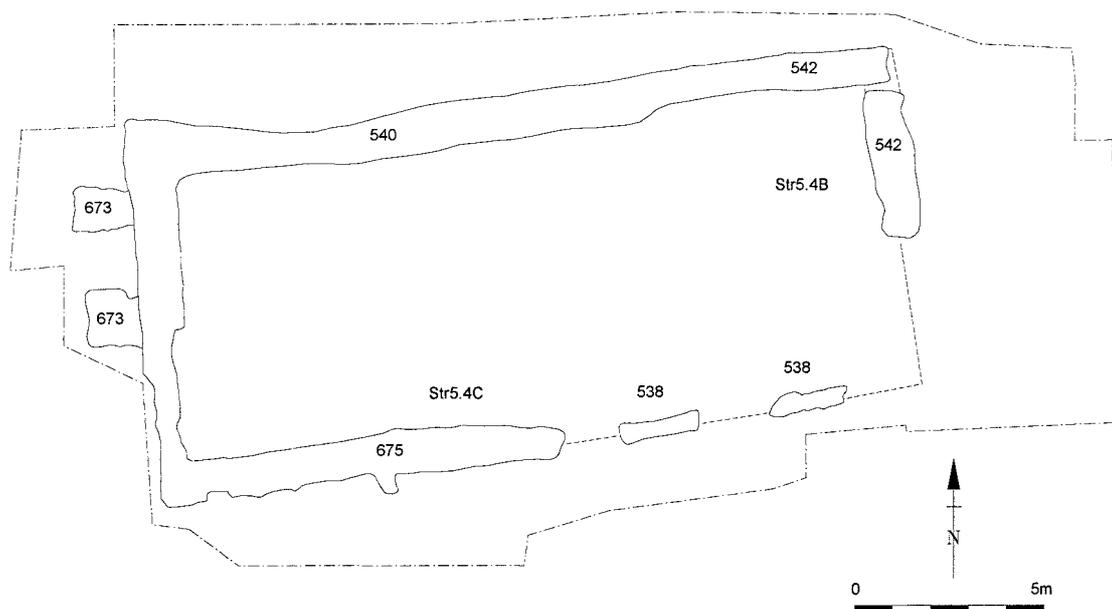
Fig 9.44 The Medieval church, Structure 5.4B with widened chancel and south aisle: LUBs 79 and 80

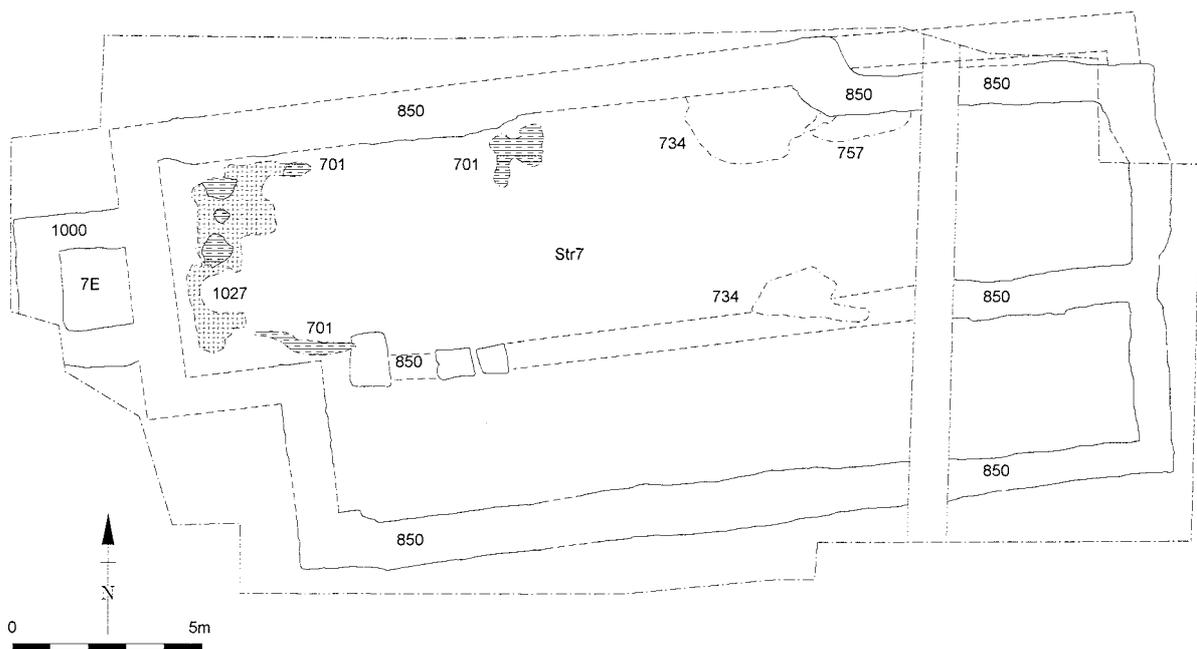
Fig 9.45 The late medieval church, Structure 7, after rebuilding following collapse in 1301: LUB 91 and 92

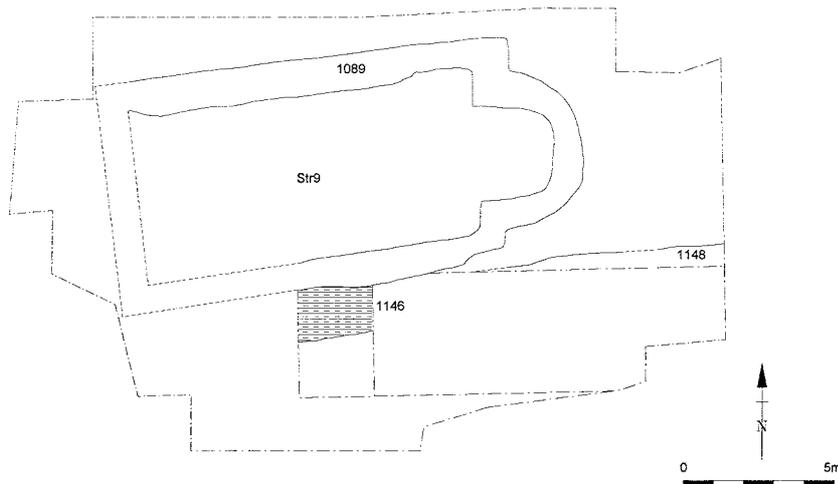
Fig 9.46 Georgian church, Structure 8 (built 1786), with path to south: LUBs 112, 113 and 115

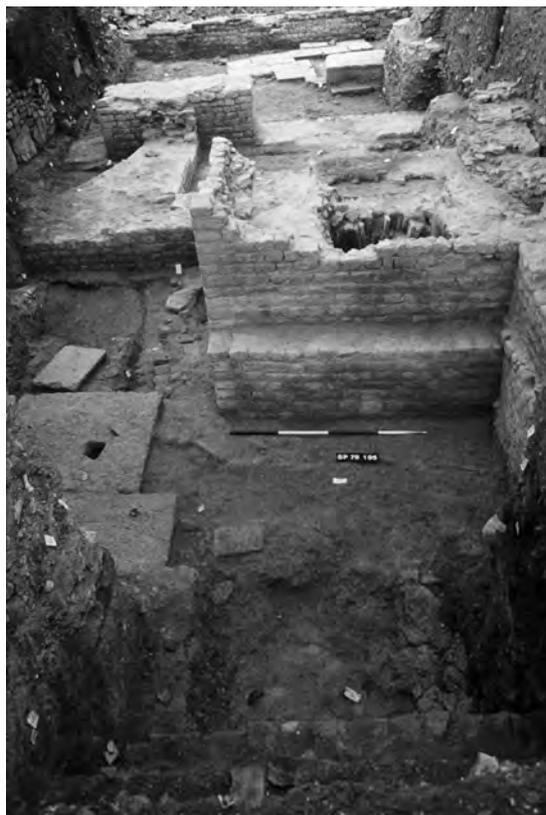
Fig 9.57 Looking west at the construction levels of the well-head cg65 and the east range of the forum. Although the paving stones seem to have mostly been removed to insert the well, one large stone (to the left of the well-head) appears to have been slightly undermined by the well foundation trench. The offset of the well-head cg65 is about a metre above the foundations. The well is abutted by wall cg67, whose offset is slightly higher. The associated floor was above the offset. LUB 8

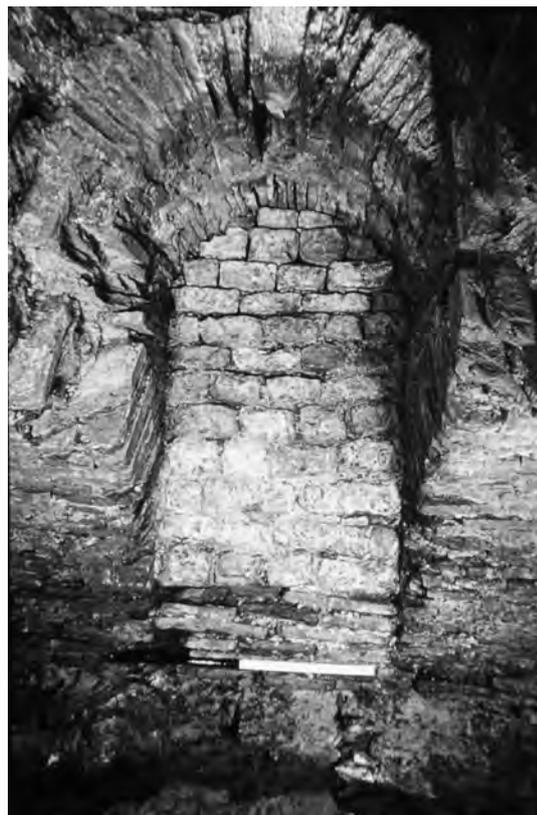
Fig 9.58 The interior of the well-head, looking north:
LUB 8
