LINCOLN ARCHAEOLOGICAL STUDIES No. 3

The Archaeology of The Upper City and Adjacent Suburbs

LINCOLN ARCHAEOLOGICAL STUDIES No. 3
GENERAL EDITORS: MICHAEL J. JONES AND ALAN VINCE

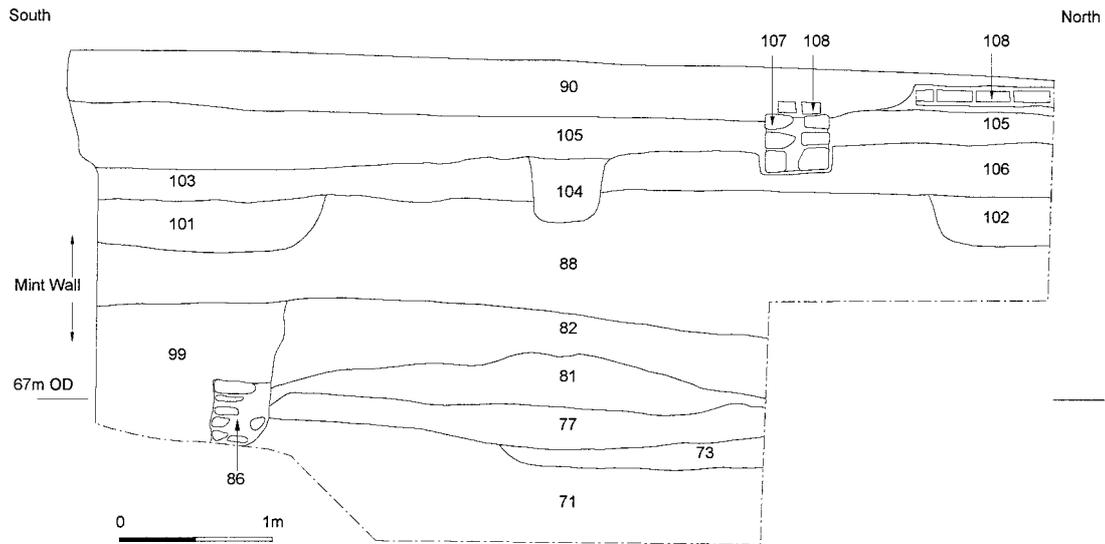
Fig 12.12 Section south to north, along the west side of Trench 3

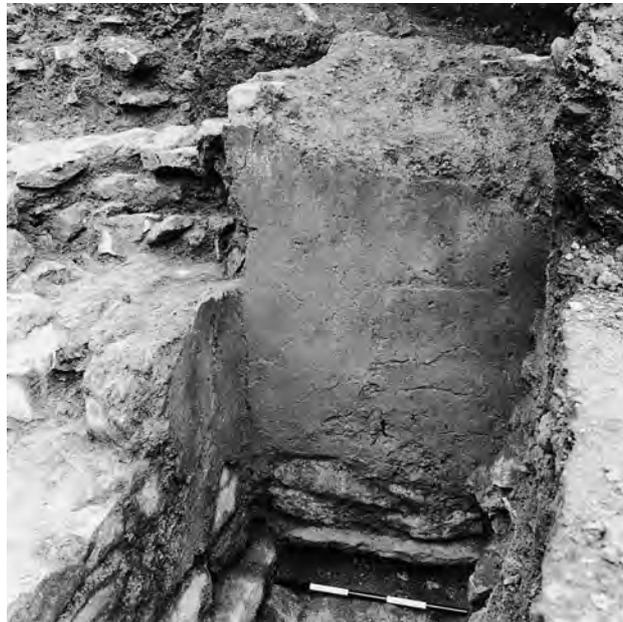
Fig 12.18 Looking west at Structure 3.1; the lintel for drain cg91 is shown beneath the plastered wall cg3: LUB 4

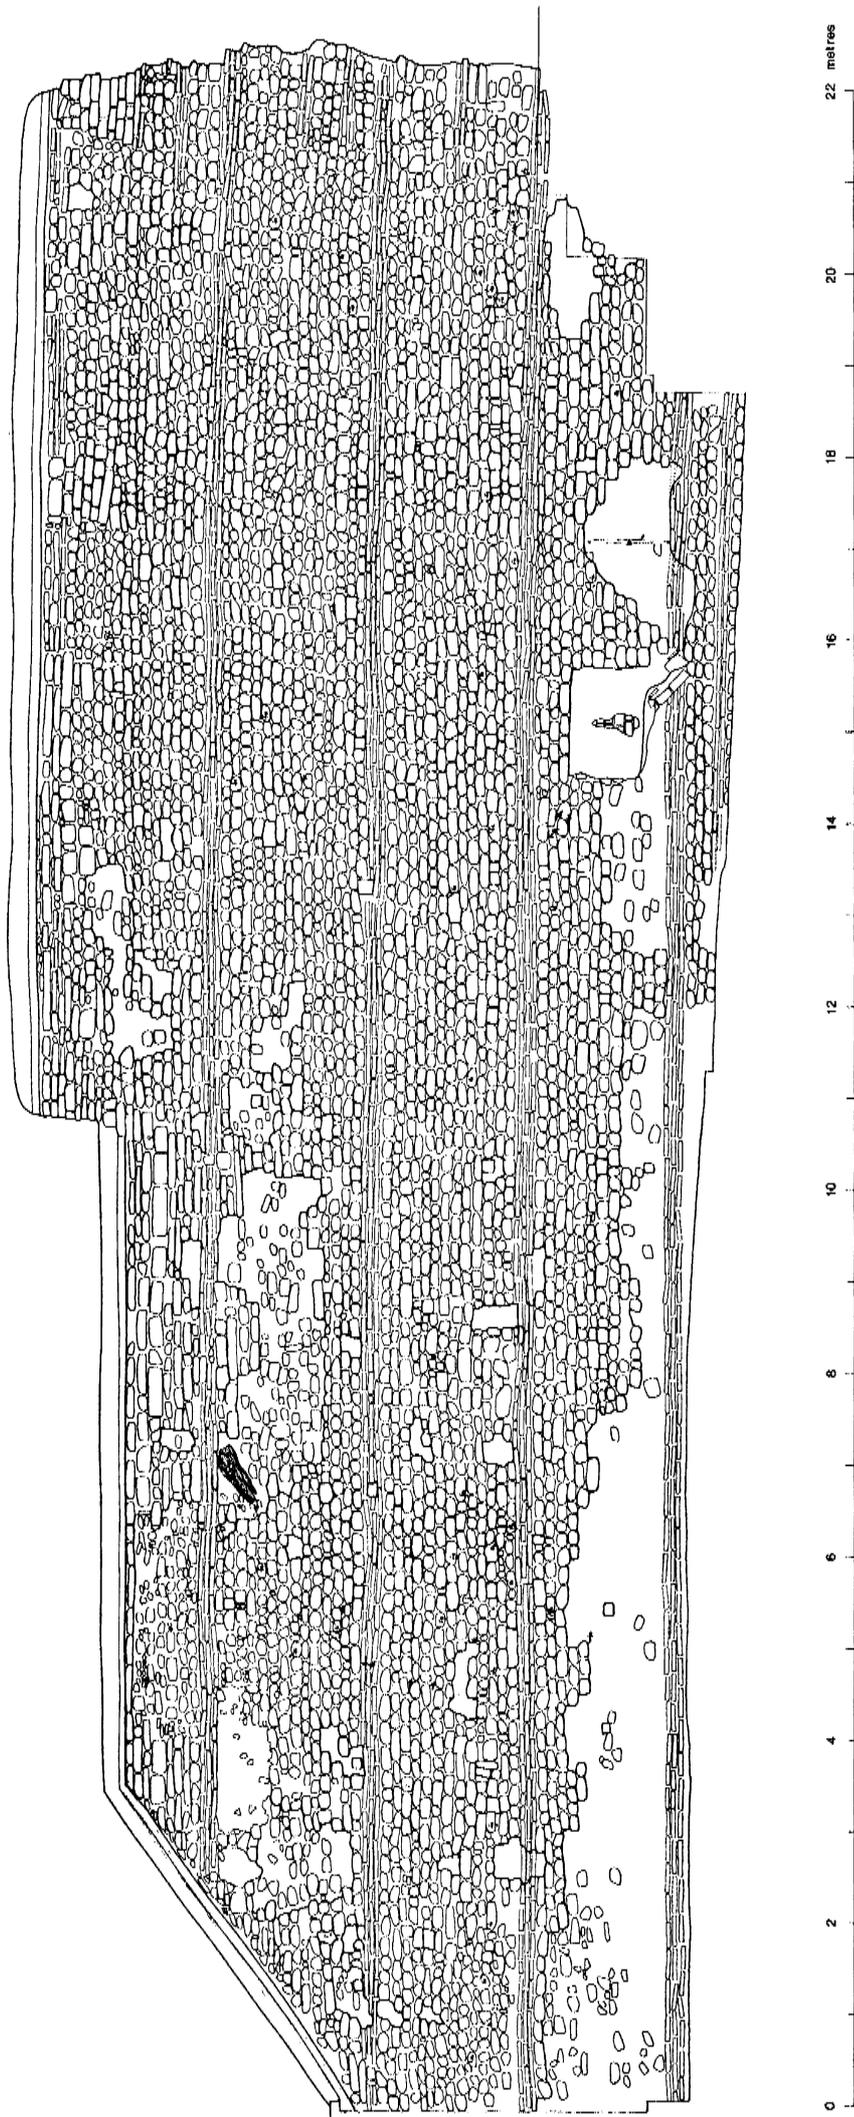
Fig 12.26 South elevation of the Mint Wall from modern ground surface

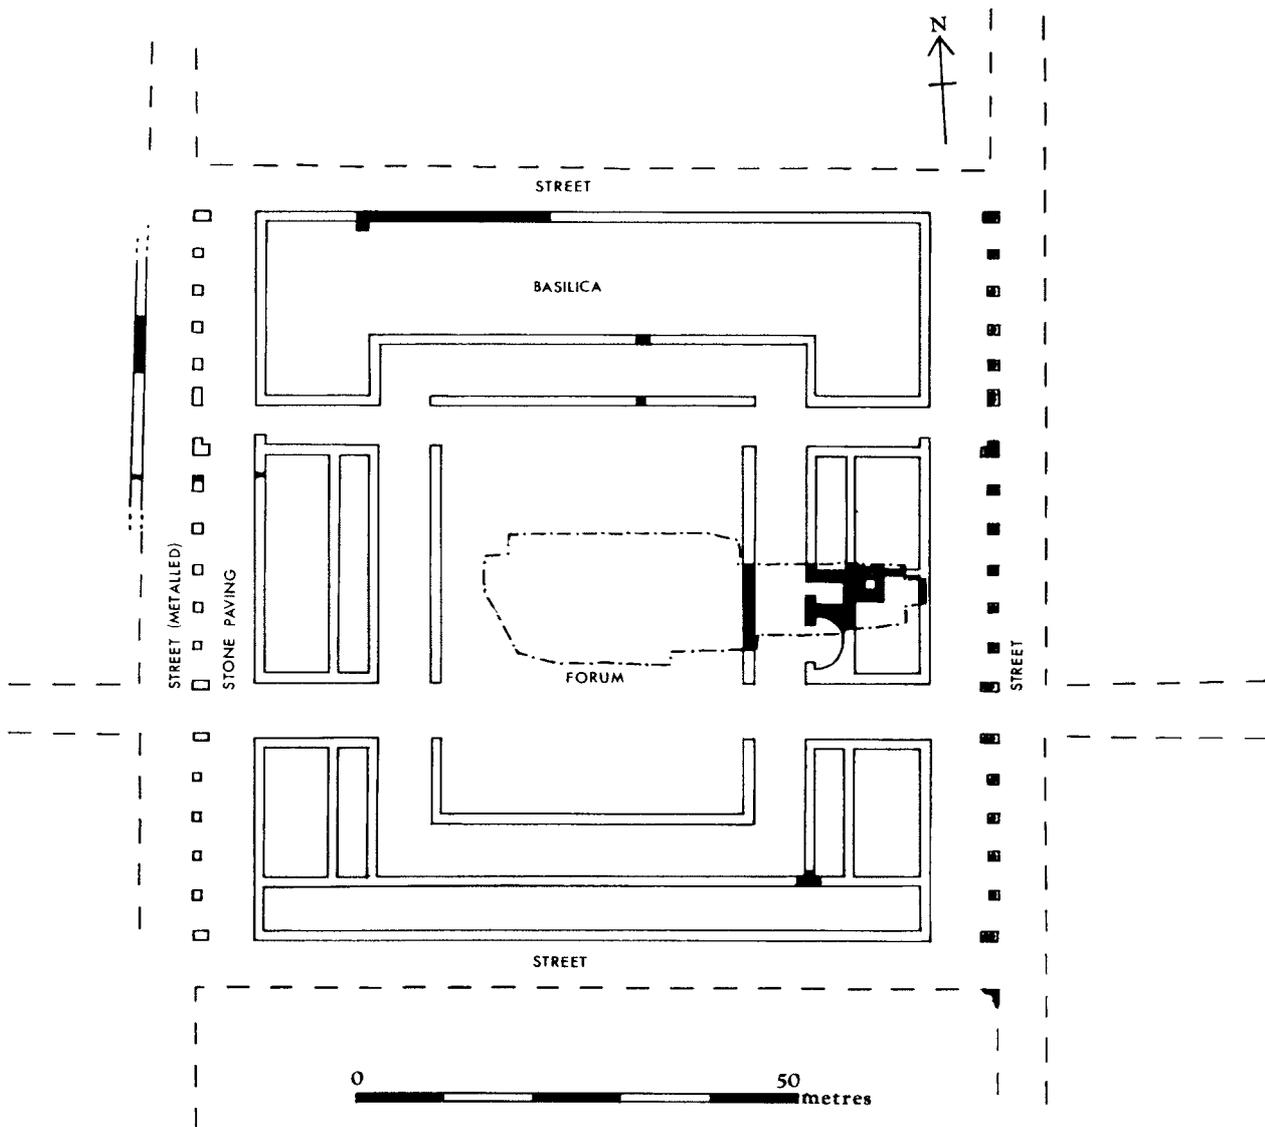
Fig 14.2 Hypothetical plan of the early 3rd-century forum-basilica
