The Excavation of the Roman Villa in Gadebridge Park Hemel Hempstead 1963-8

by David S. Neal

Reports of the Research Committee
of the
Society of Antiquaries of London

No. XXXI

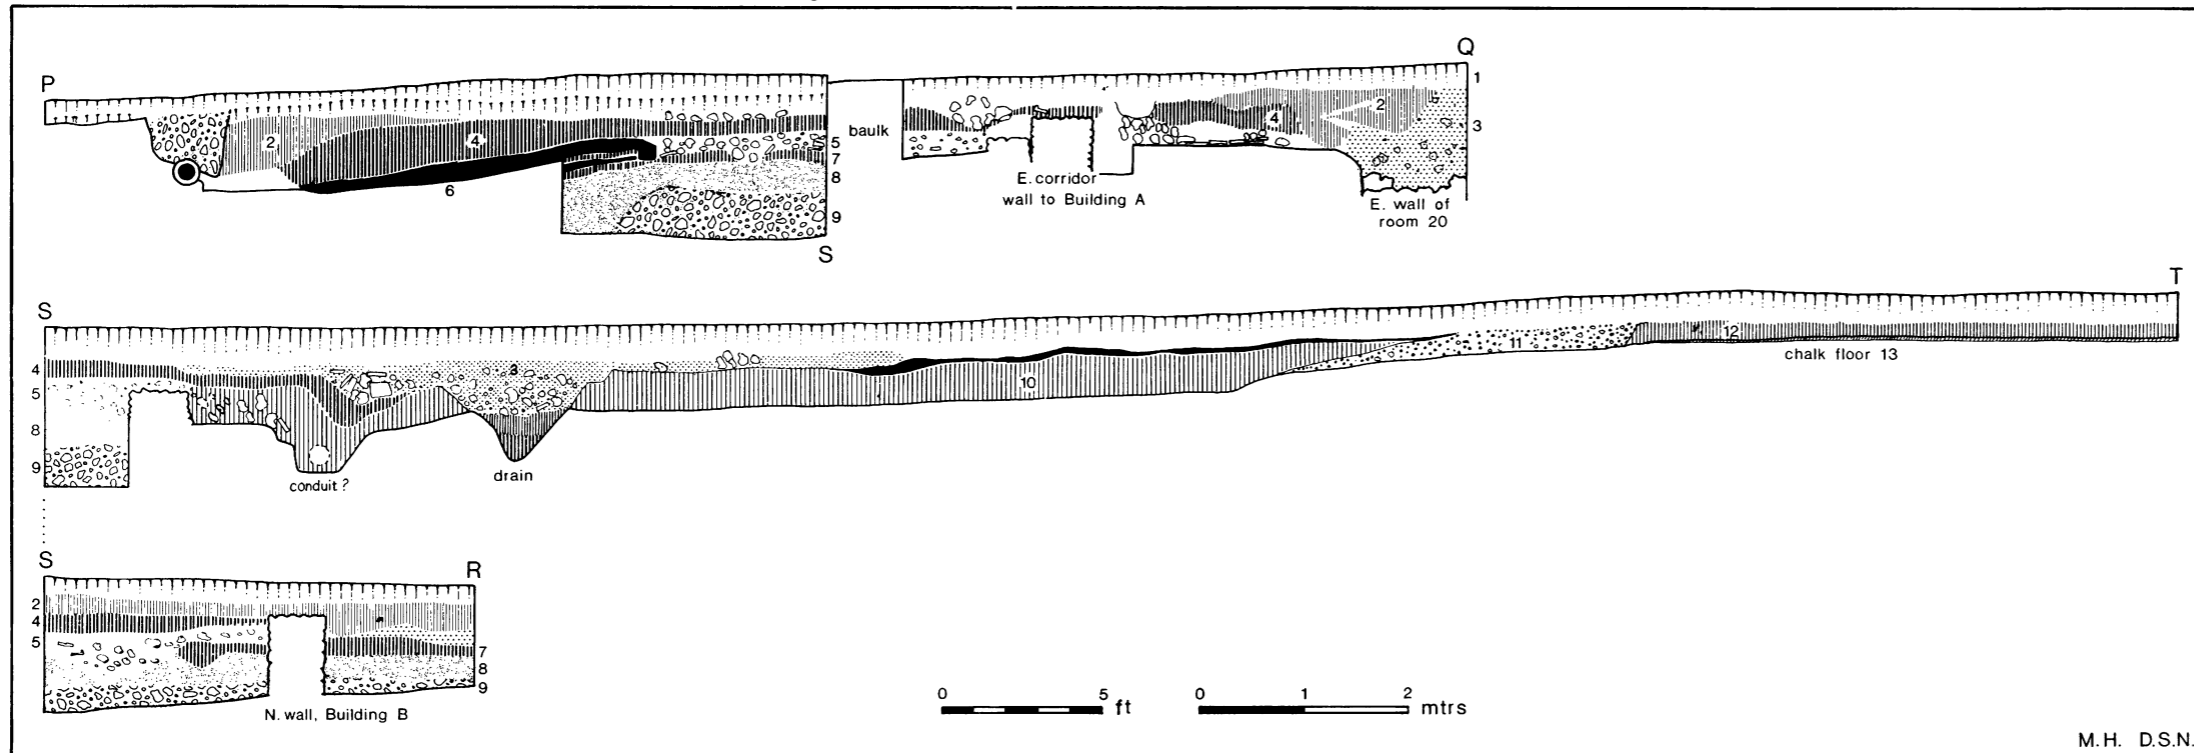
Section P-Q Northern Corridor, Building B, Section R-S-T — Building B and drains from Room 20

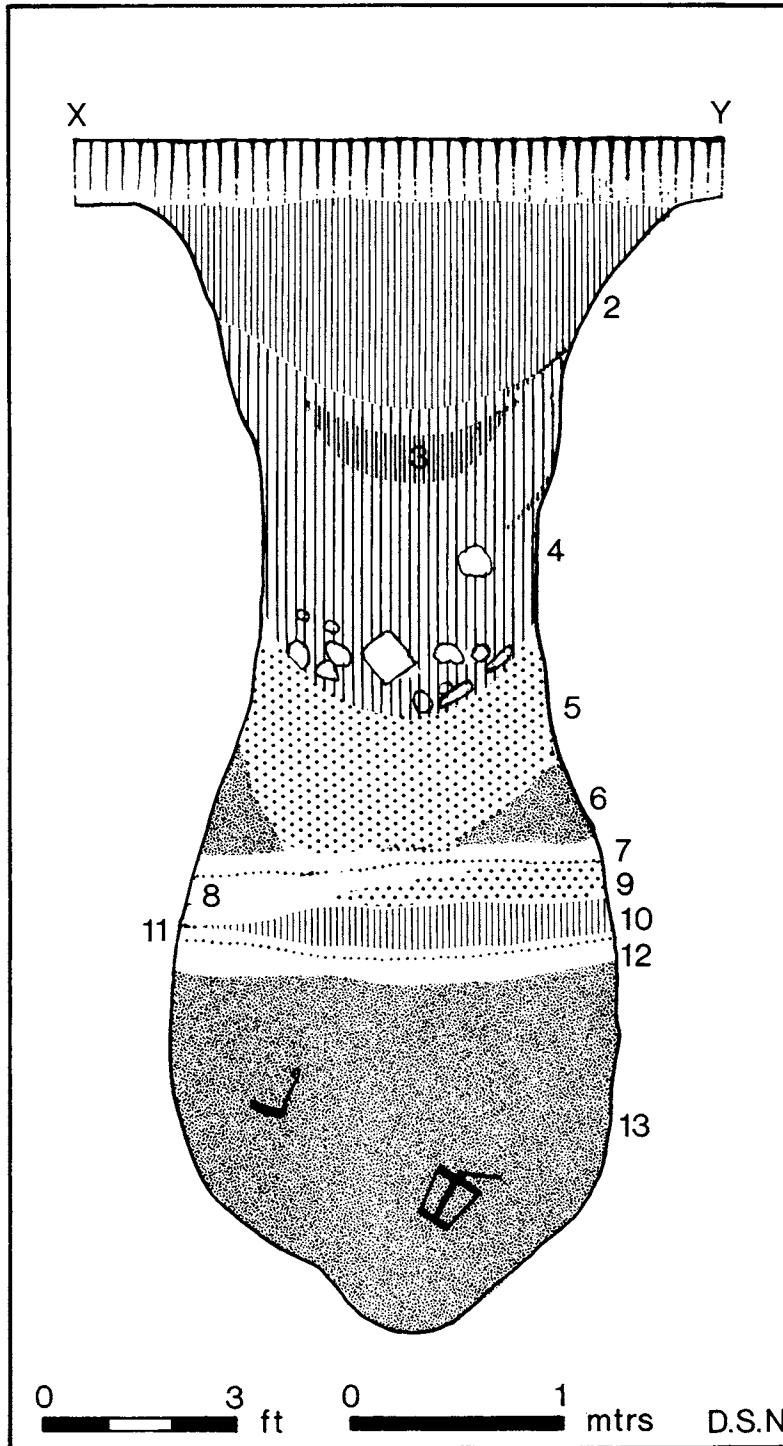
Well Section X-Y

326. Conical-headed needle from filling of well. L 11, Section X-Y (fig. 17). 10.7 cm.
327. Conical-headed needle from filling of well. L 12, Section X-Y (fig. 17). 8.2 cm.
328. Needle with broken head and eye. From filling of robber trench, east wall of Room 28, Building A. 8.1 cm.
329. Needle with broken head and eye. In Ditch I below inner courtyard, Building A. 4.4 cm.
330. Needle with broken head and eye. From black occupation on eastern corridor floor of Building B. 7.1 cm.

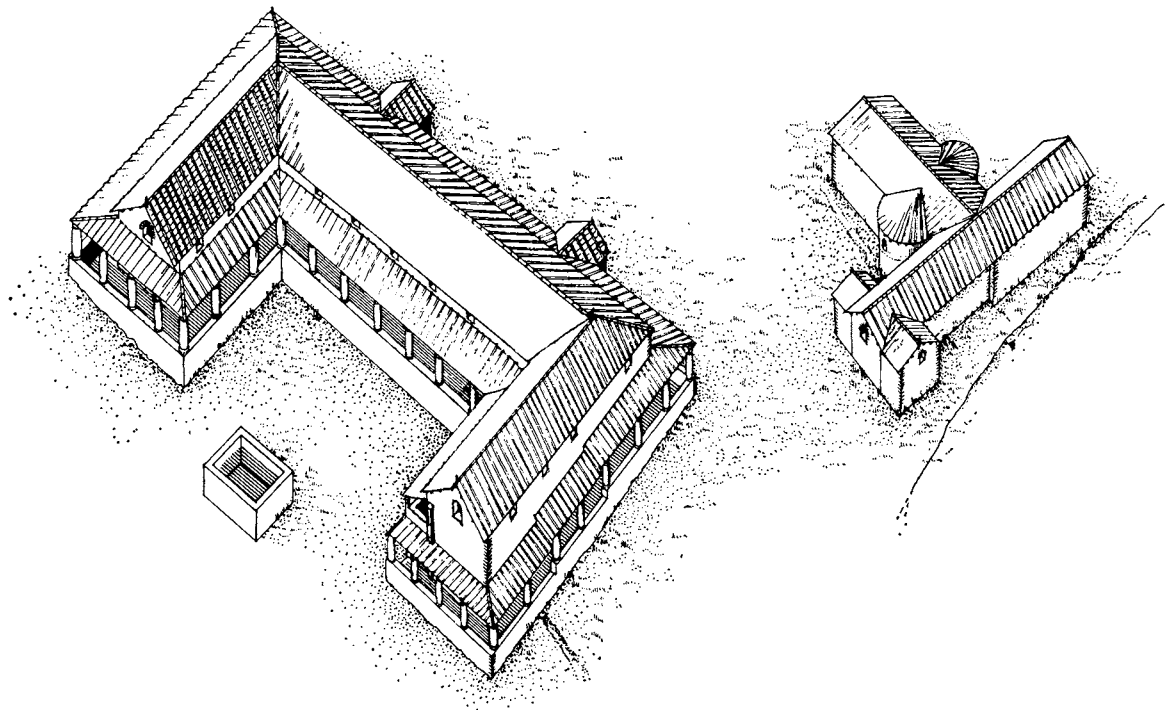
FIG. 28. Reconstruction drawing of villa in Period 3

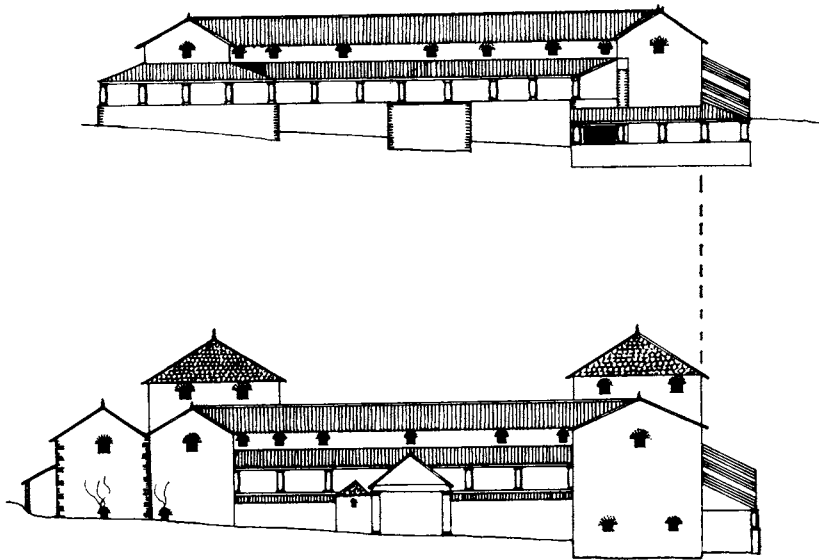
FIG. 29. Reconstruction drawings of front elevations of Building A in Periods 3 and 6

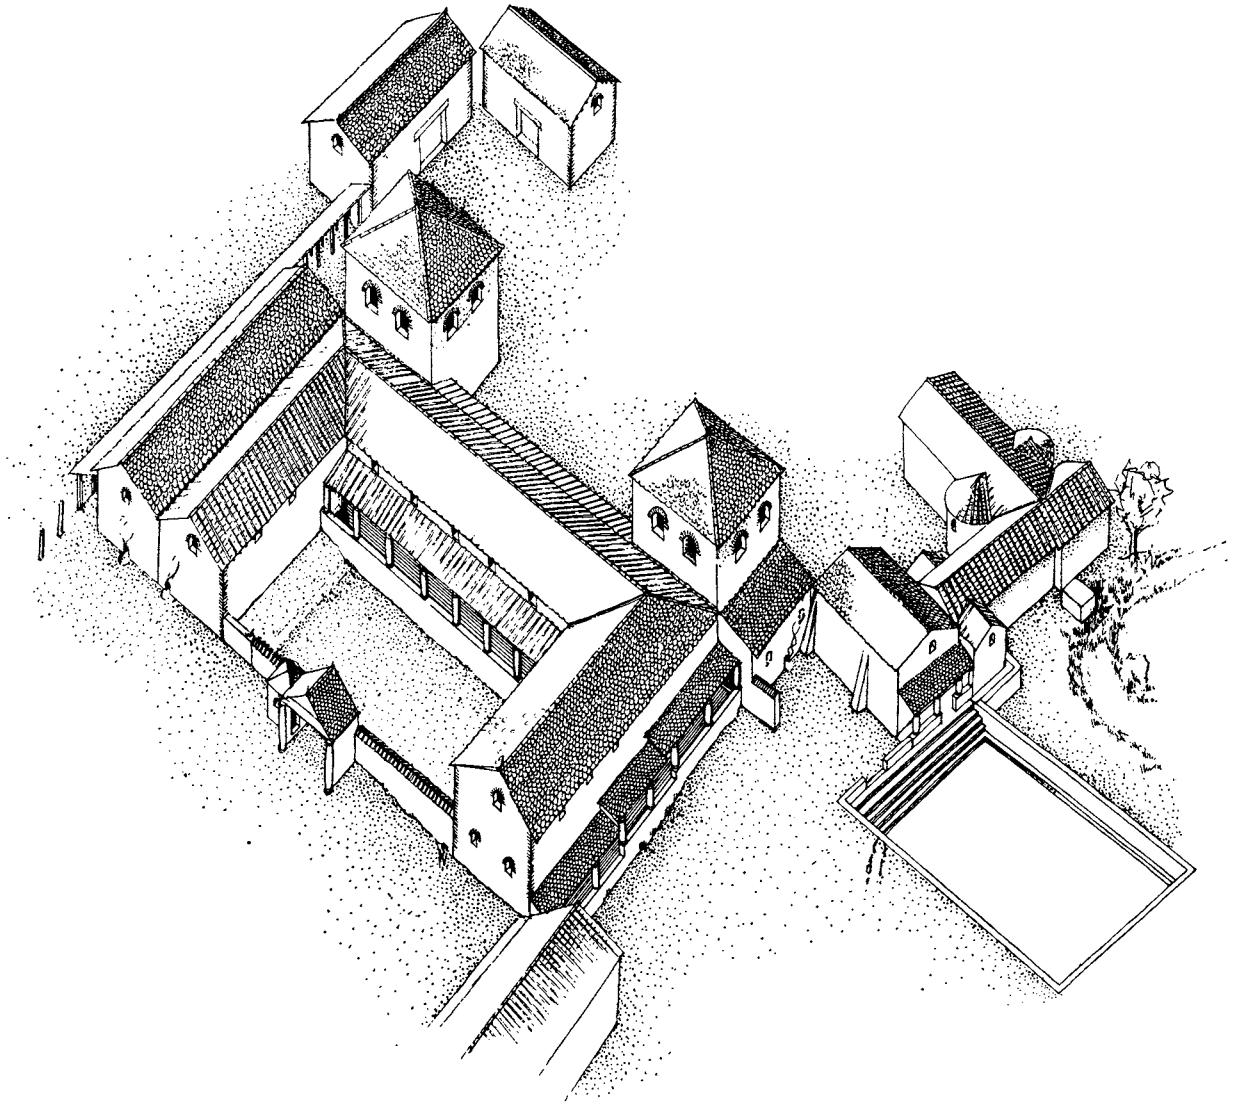
FIG. 30. Reconstruction drawing of villa in Period 6

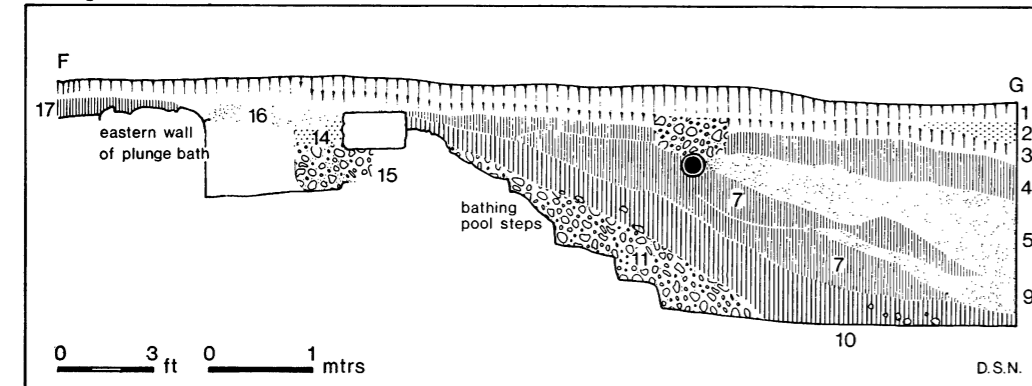
FIG. 38

Bathing Pool. Section F-G

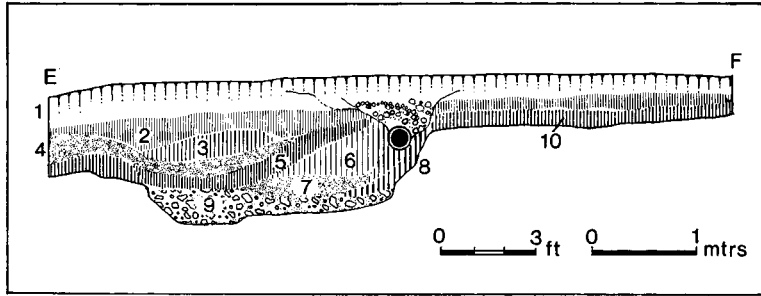
Section E-F

Immediately to the south of the Period 6 bathing pool was a gully (Section E-F, fig. 40) which, when found, was believed to be an overflow for the pool. This assumption was probably correct, but it is also possible that it was a leat from the river, and was originally associated with the early bath-suite. Pottery in the gully was contemporary with the pottery in the ditch below Building A. It was approximately 8 ft. (2.44 m.) wide and 2 ft. 6 in. (.76 m.) deep and was filled with river-gravels.

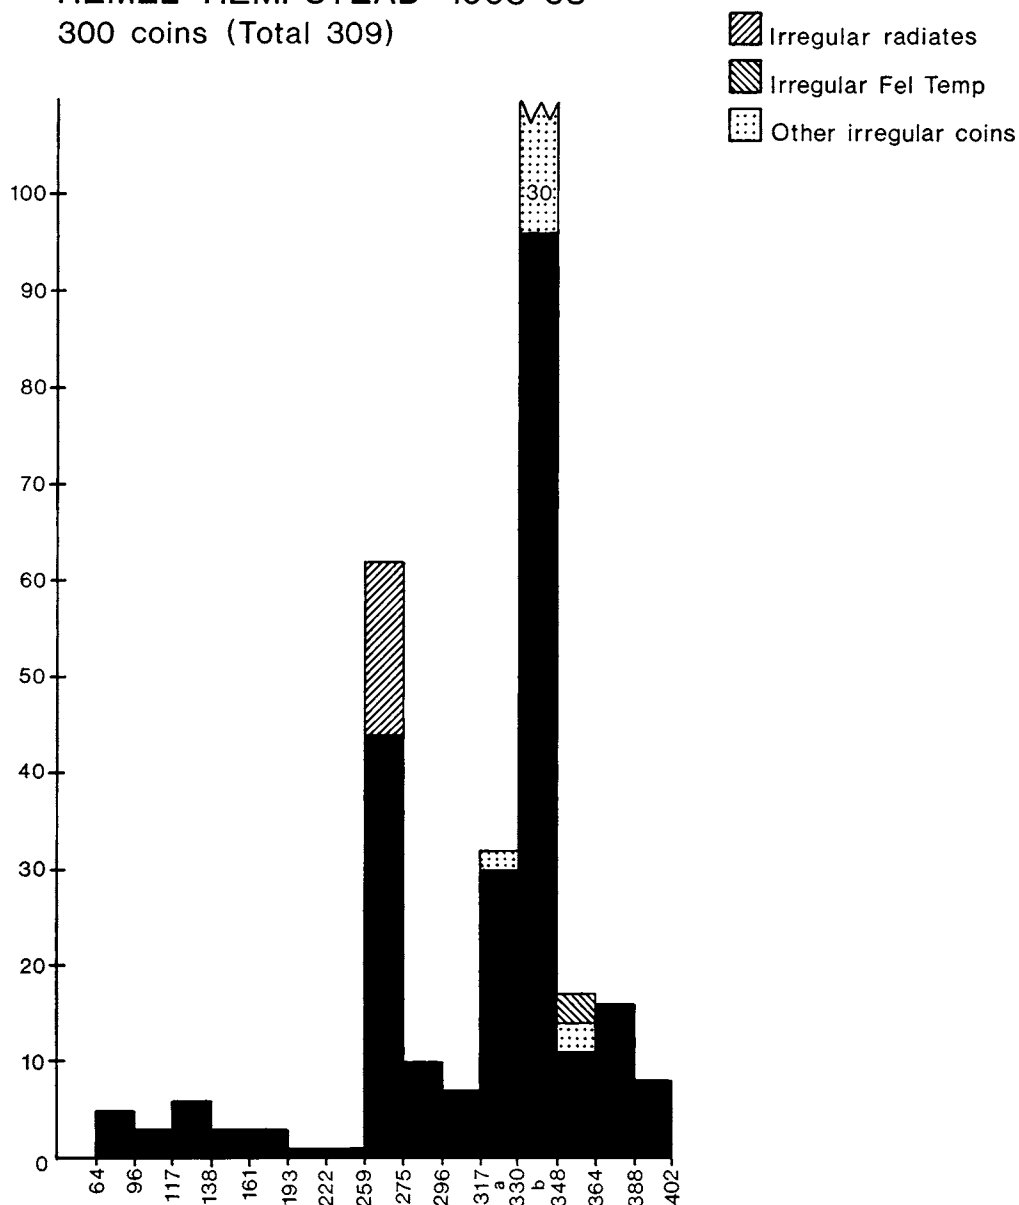
FIG. 52. Coin histogram for Gadebridge Park villa

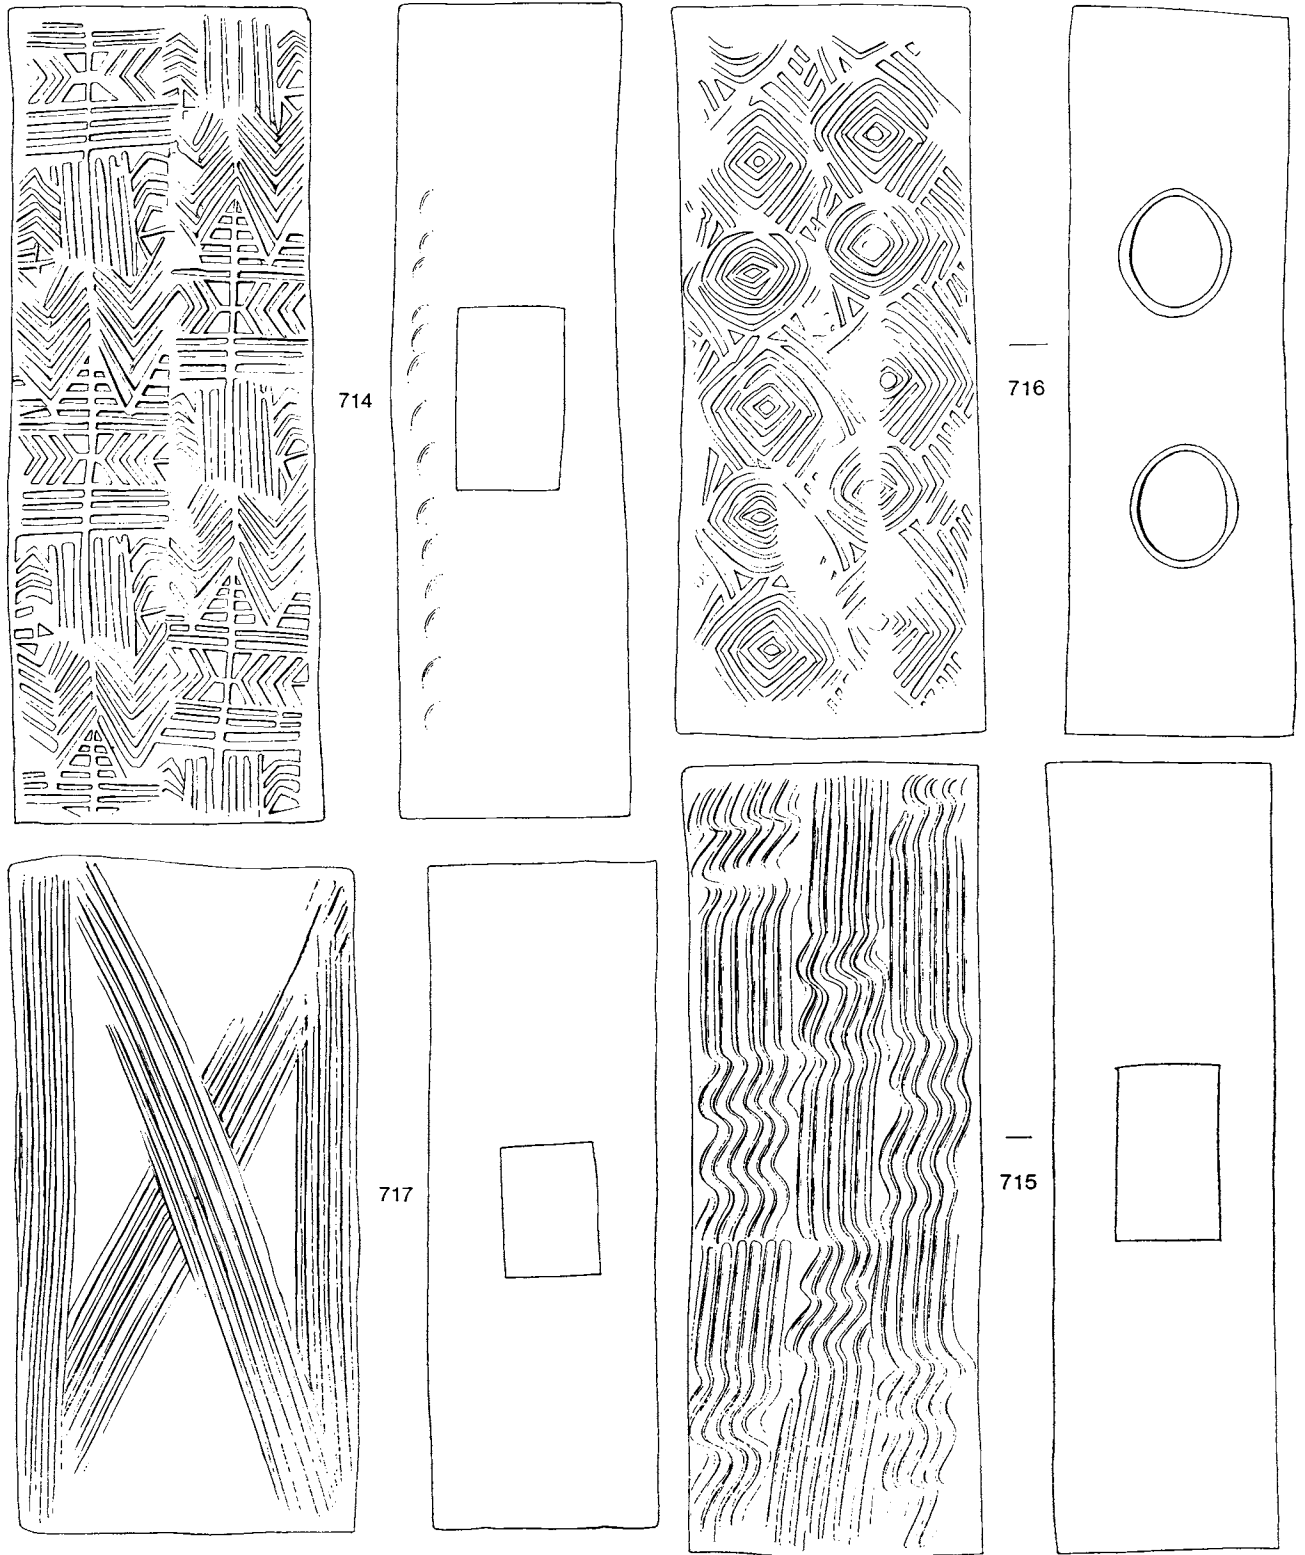
716. *Type B*. Shorter rectangular tile measuring 38 cm. tall, 16.5 cm. wide and 11.5 cm. deep and decorated with a roller stamp pattern of radiating lozenges. Both sides of the tile are pierced with a pair of circular holes measuring 5-6 cm. in diameter.

FIG. 86. Flue-tiles (scale $\frac{1}{4}$)

decorated with the 'W'-Chevron roller-stamp design (SF 714, fig. 86 and pl. IVb),¹ and others had comb-patterns. A single example was decorated with a 'diamond and lattice' pattern (SF 716, fig. 86); it was found at the easternmost point of the drain, outside the building, and may have been added at a later date. In the northern and southern apses square tiles supported circular *pilae*, yet no circular *pilae* were found *in situ* elsewhere. The variety of sizes and lack of arrangement among the other *pilae* suggest they were later than the wing, and were repairs. Frequent repairs to the upper floors and *pilae* were probably necessary, especially in the vicinity of the fire. The *pilae* on the floor of Rooms 1 and 2 belonged to Period 5.

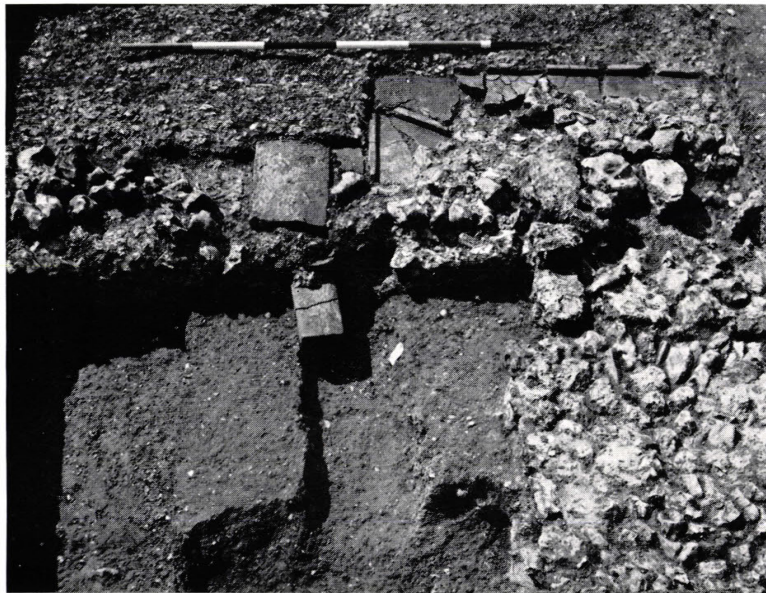
c. Drain emerging from east wall of Room 1. The 'dog-leg' in this wall is also visible. In the foreground is a flint foundation associated with the water leat. View west

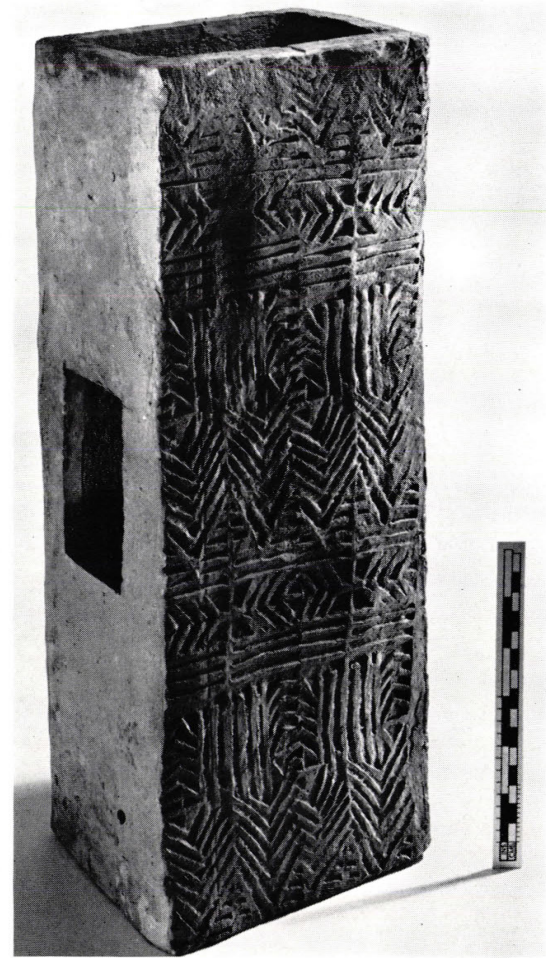
b. Decorated flue-tile from drain shown on Pl. IV*a*
