Reports of the Research Committee
of the
Society of Antiquaries of London

Clarendon Palace

The History and Archaeology of a Medieval Palace and
Hunting Lodge near Salisbury, Wiltshire

1988

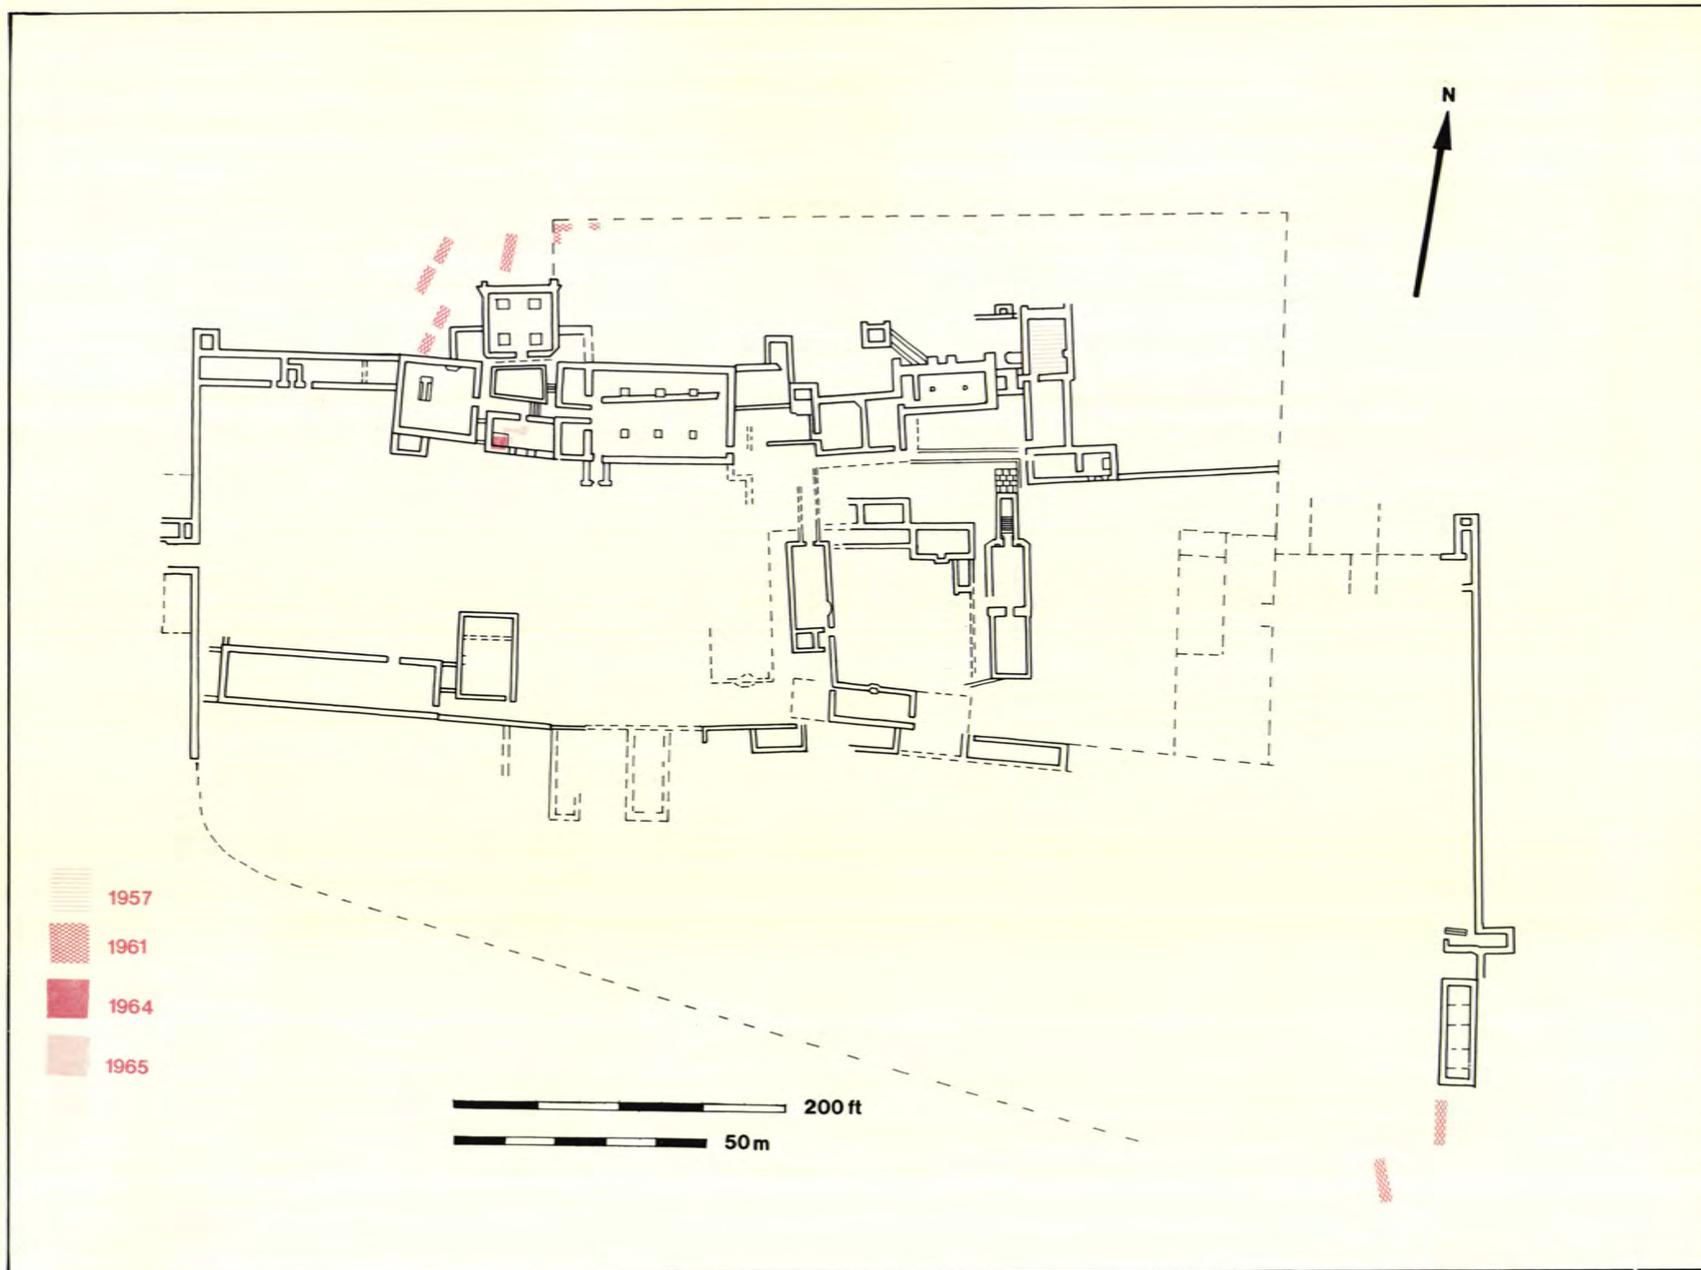
FIG. 2. Composite plan of Clarendon Palace (after Borenius 1943, with additions and amendments), showing the location of the excavations of the 1950s and 1960s

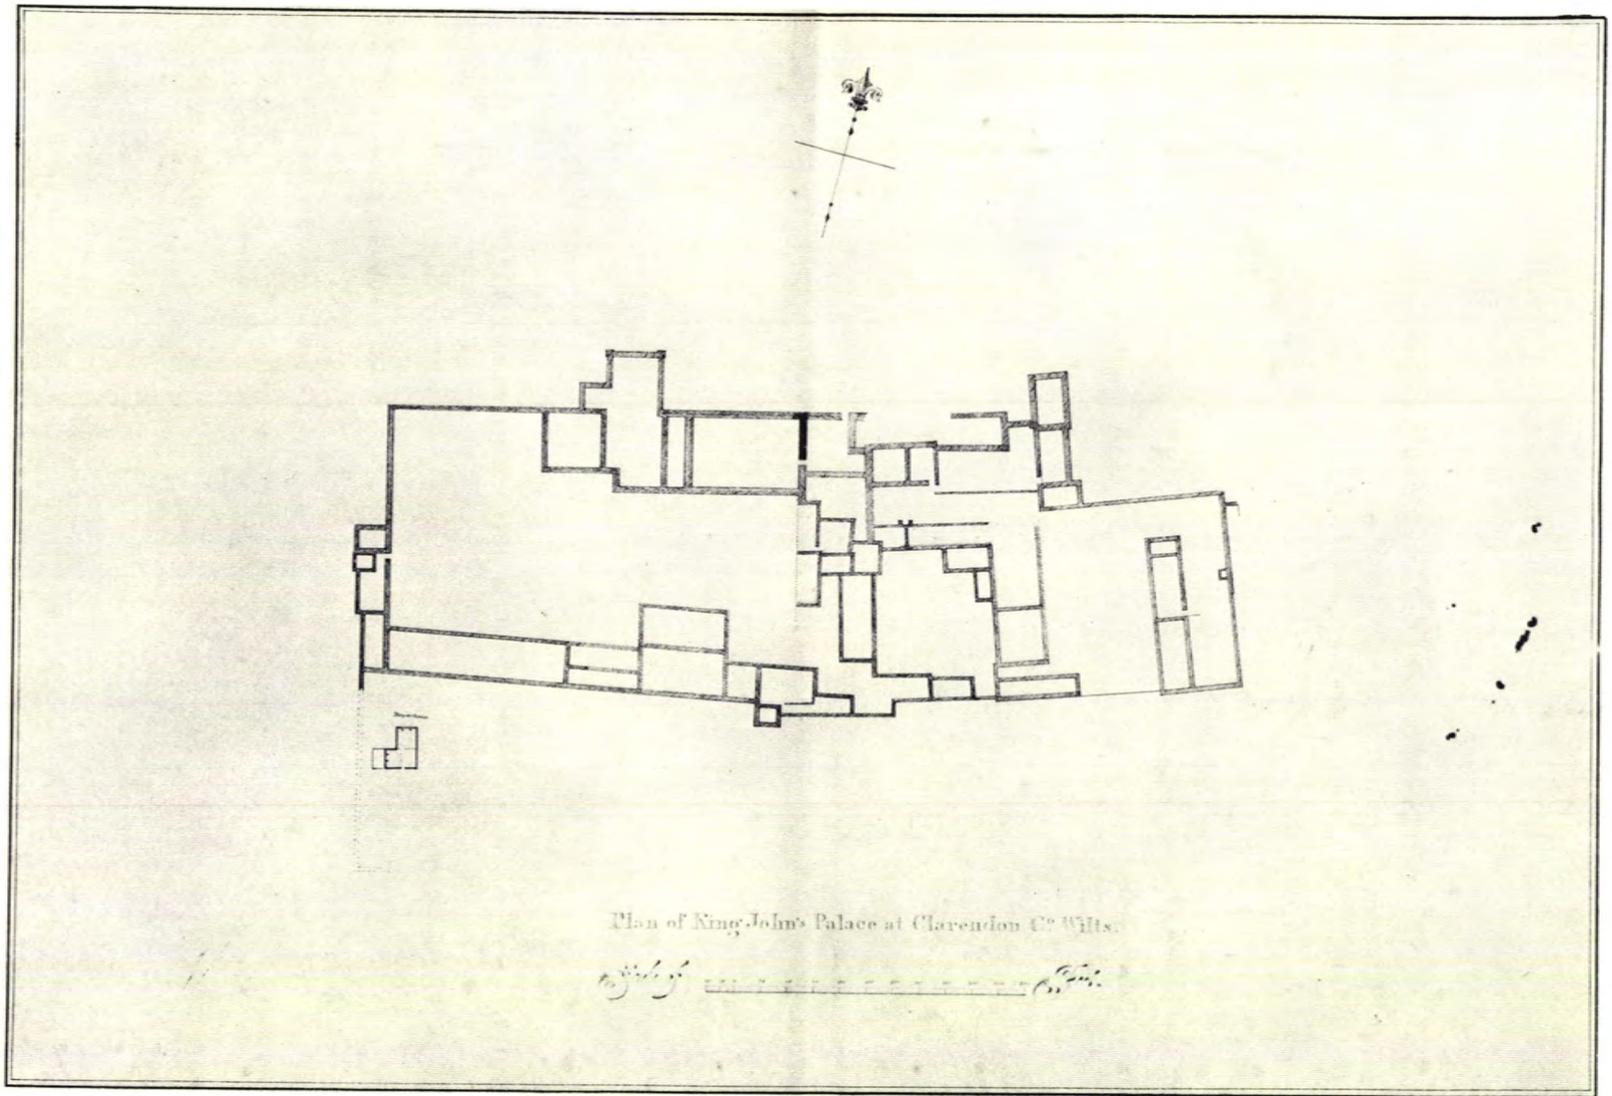
FIG. 3. Plan of Clarendon Palace from Sir Thomas Phillipps's excavations, 1821 (reproduced by permission of the Bodleian Library, Oxford: MS Top. Wilts. a.I)

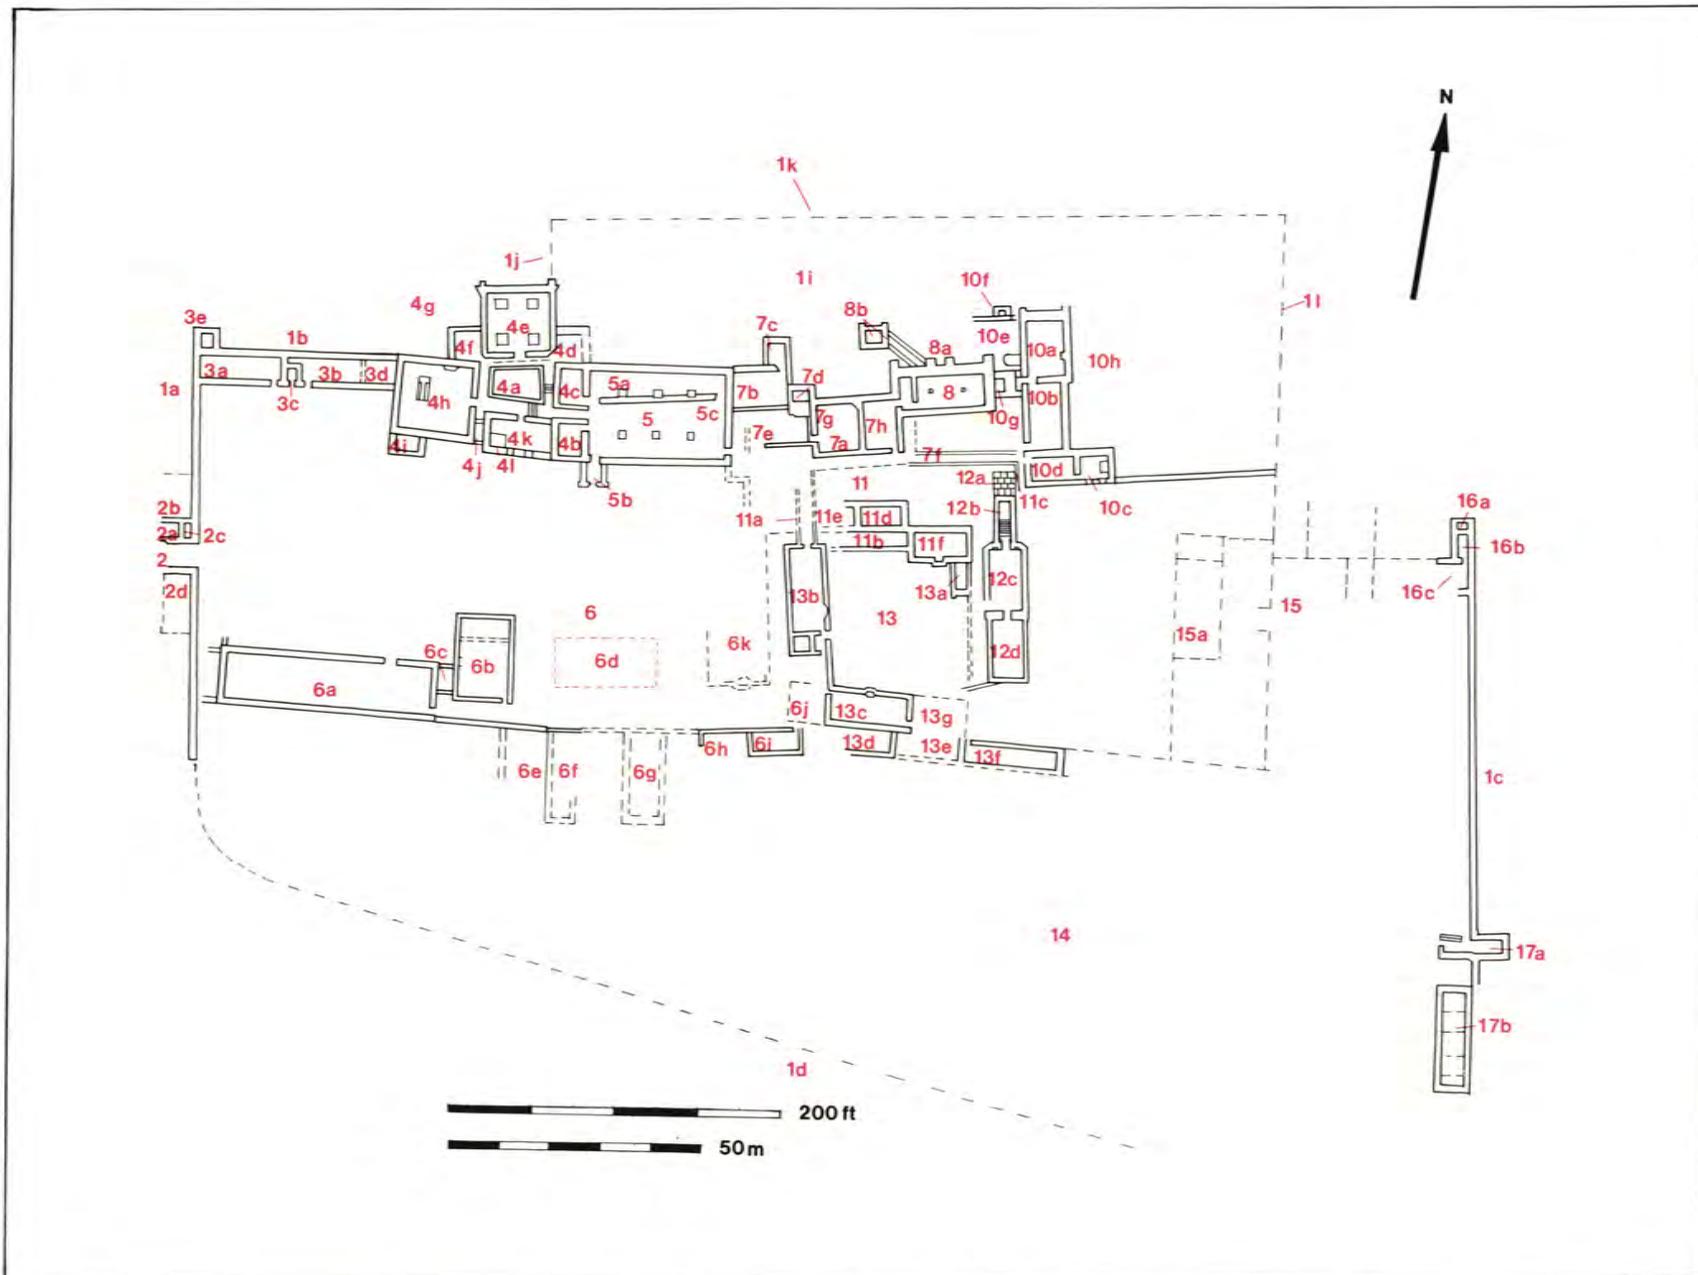
FIG. 5. Composite plan of Clarendon Palace (after Borenius 1943, with additions and amendments); with the structure classification numbers (see pp. 52-5)

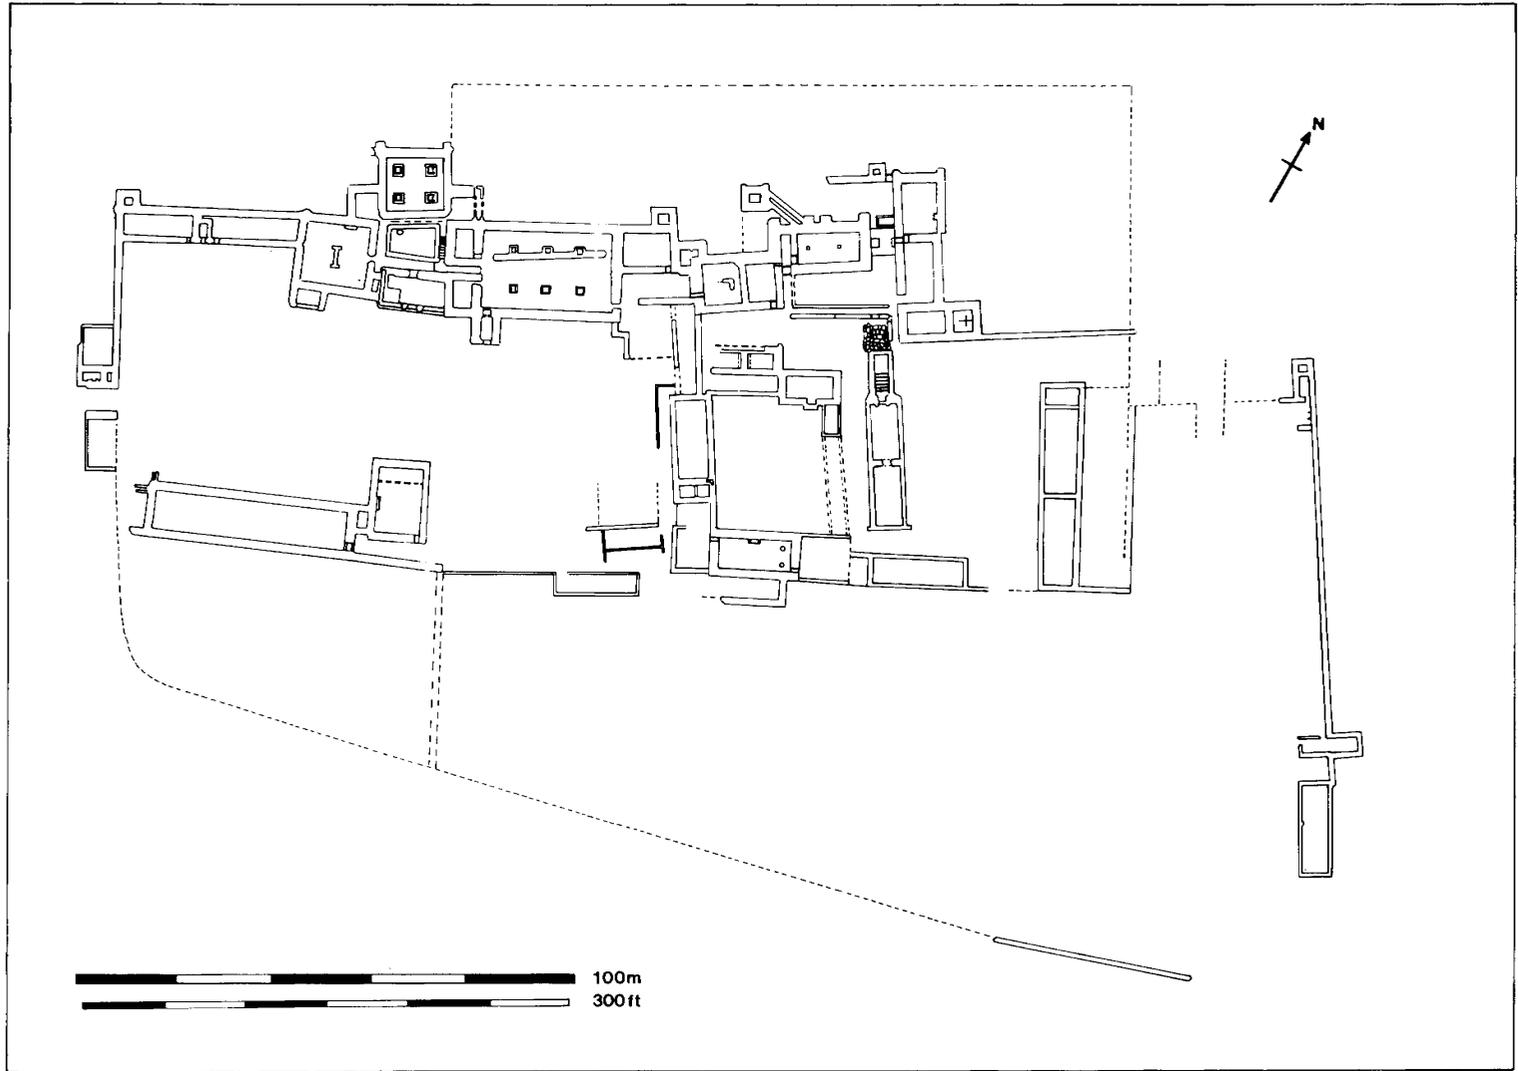
FIG. 11. Previously unpublished plan of Clarendon Palace. Based on Borenius 1943, but including details from unpublished or annotated plans of 1937 and 1943

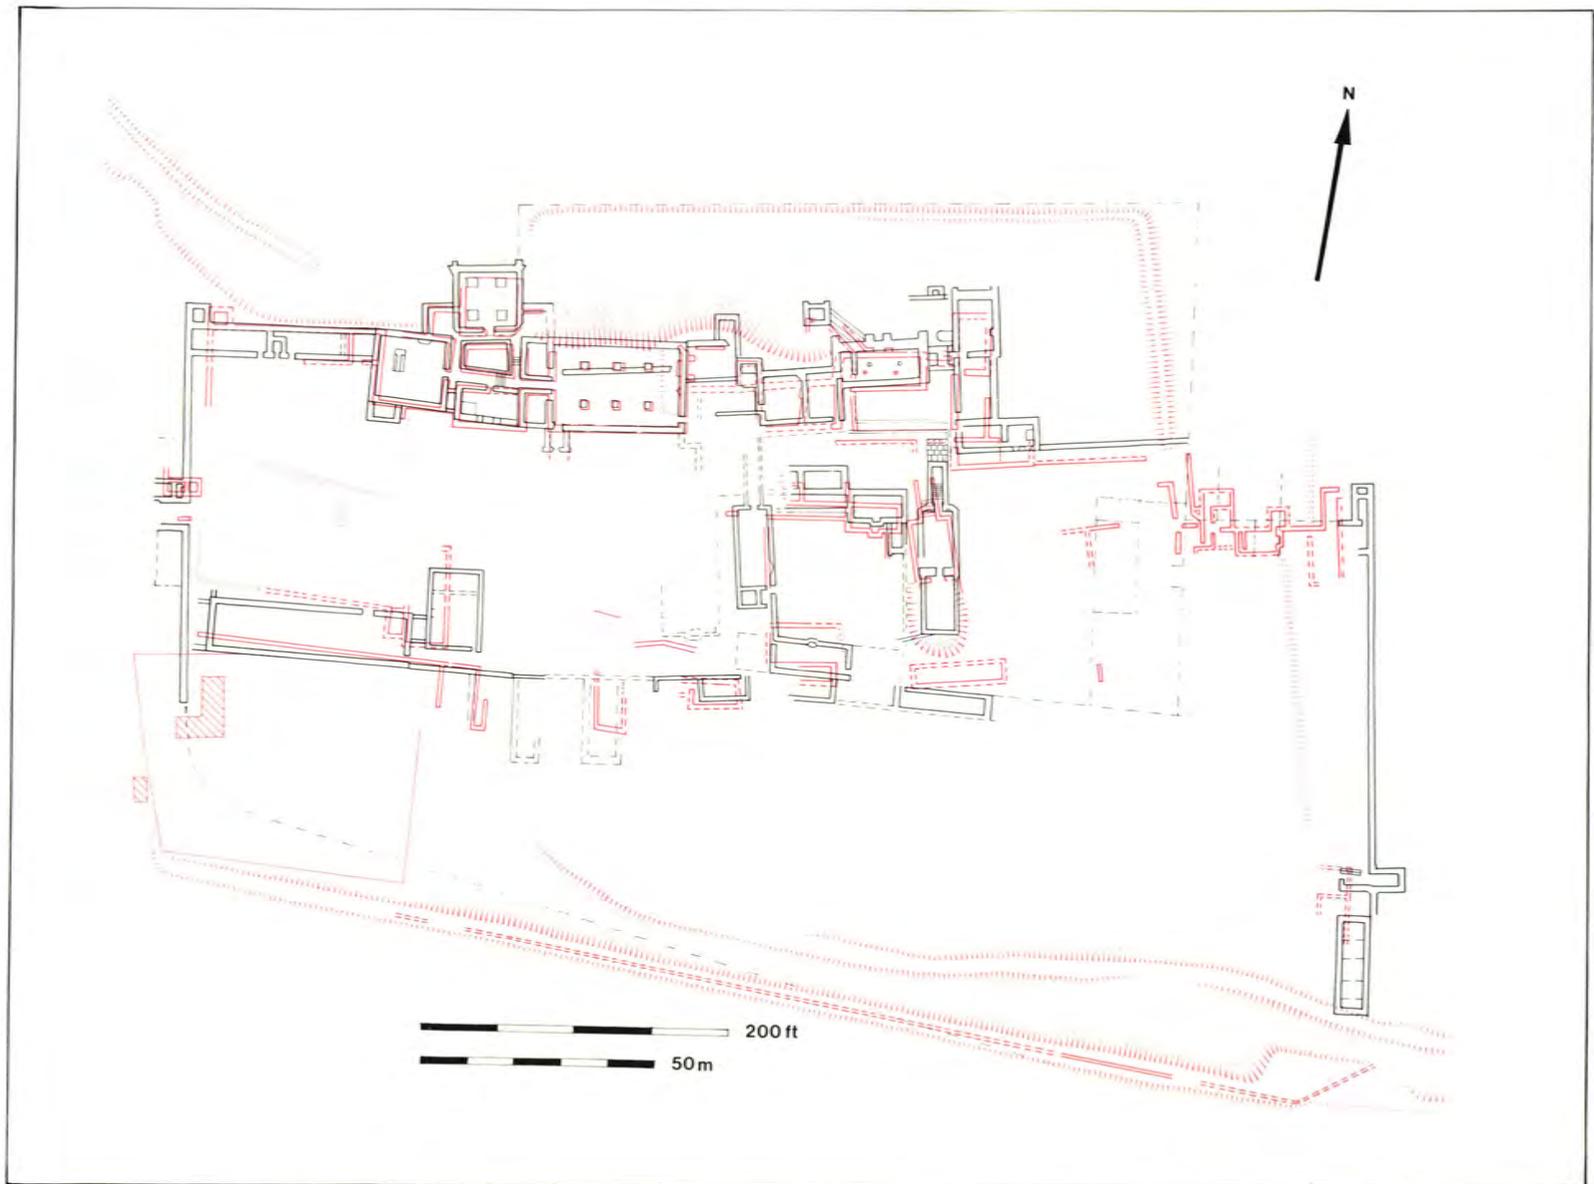
FIG. 13. Plan of Clarendon Palace 1943 and 1980. The outlines in black as recorded in 1943 and in red as recorded in 1980

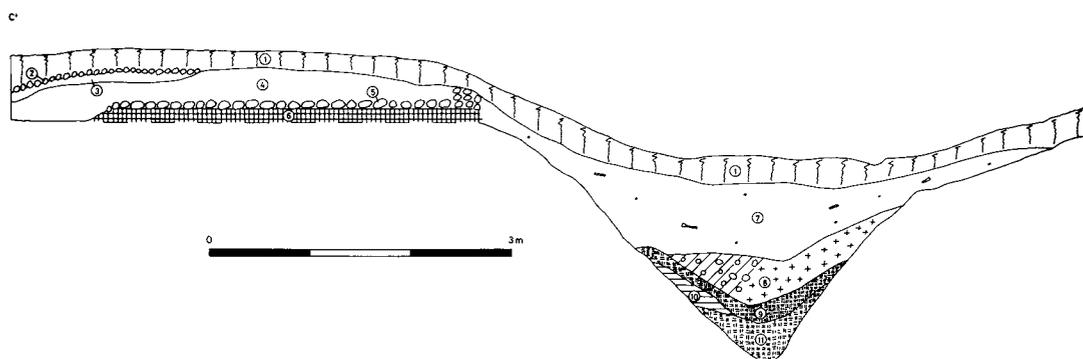
FIG. 17. Section across the bank (**1g**) and ditch (**1h**). Section looking east between C and C1 on fig. 16.

In the south-east corner of the site the perimeter wall and various other associated features were examined in the 1961 excavation programme (fig. 16). Two stretches of the perimeter wall (**1d**) and (**1e**) were picked up. Flat ceramic roof tiles of the type found above the medieval kitchen rubbish deposits were associated with both structures **1d** and **1e**, implying that the walls are not earlier than the late thirteenth century or early fourteenth century, which is the date assigned to the rubbish deposits, and may be later. The dating evidence is not conclusive

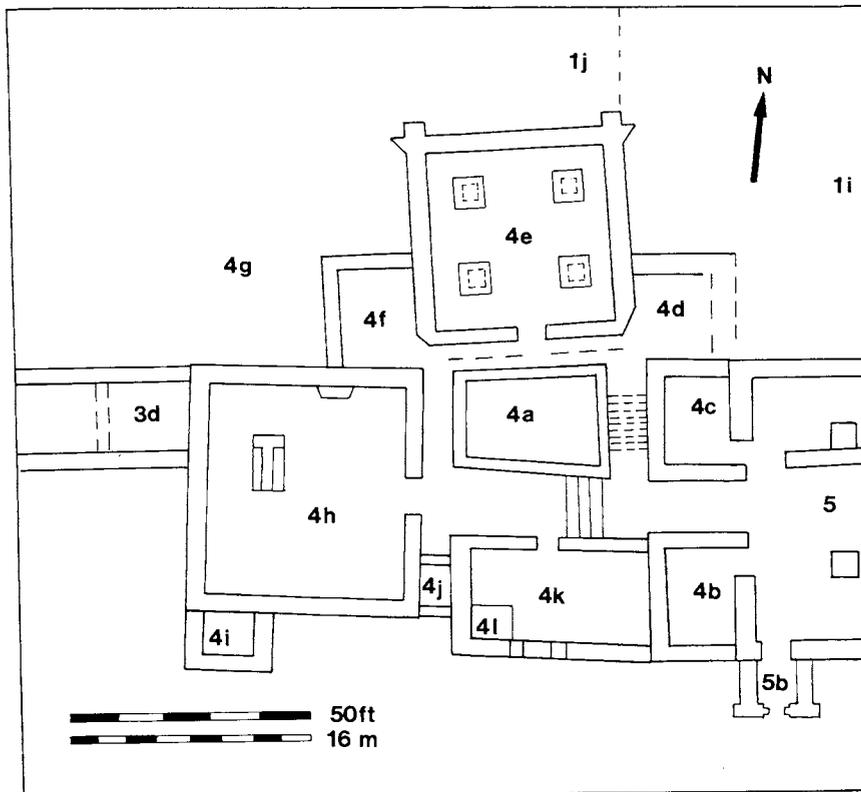
FIG. 22. Composite plan of kitchen area (4) (1:500)

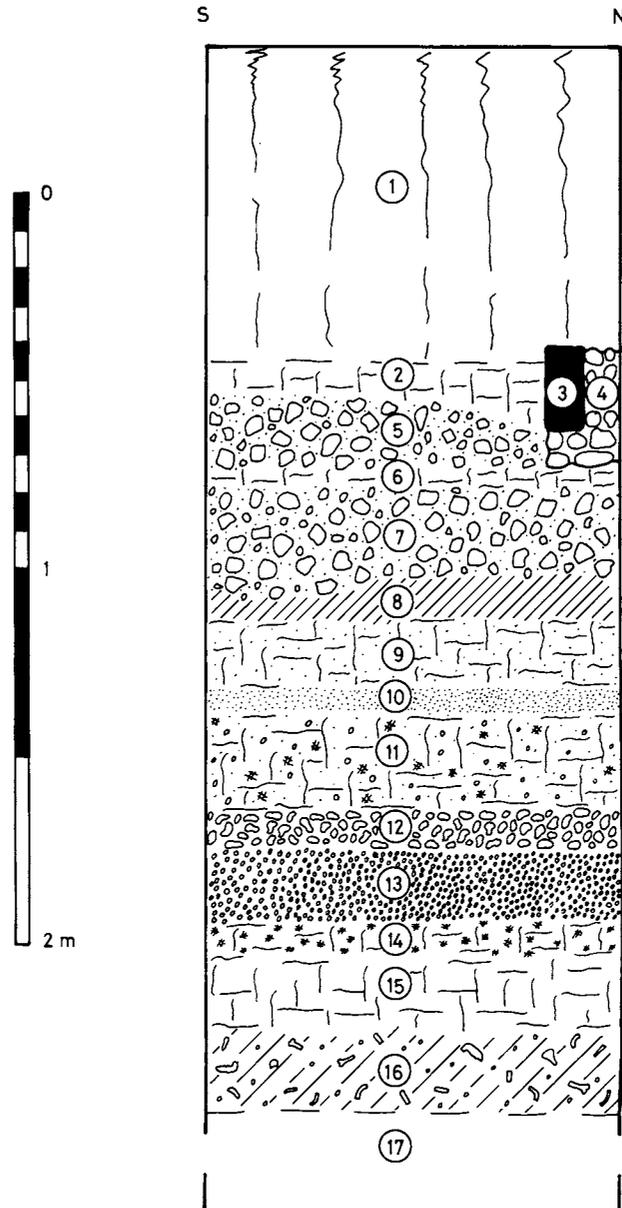
FIG. 24. Section in great hall (5) near the south-east pier base, looking west (Charlton, Notebook, 1933).

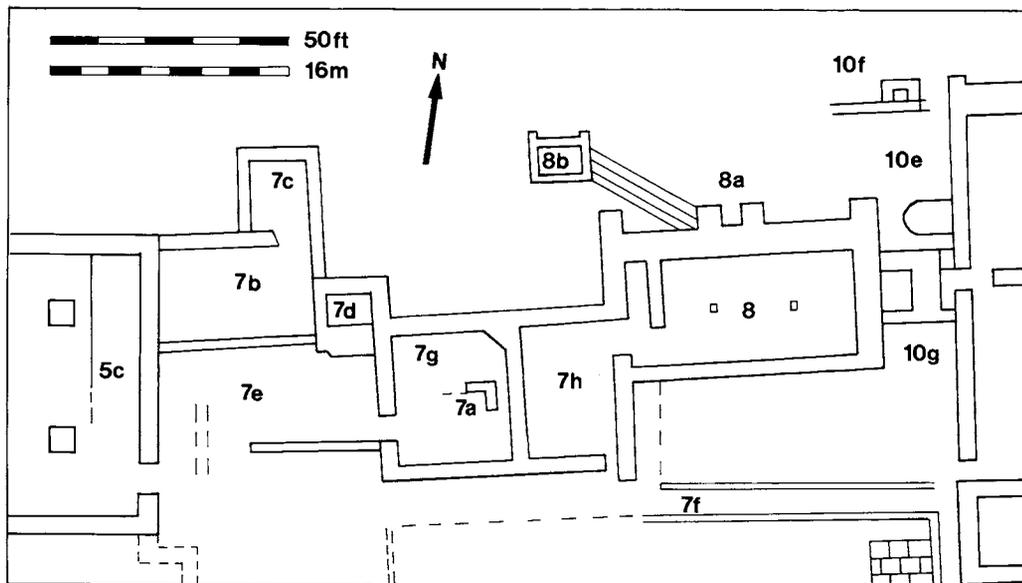
FIG. 25. Composite plan of king's apartments (7 and 8) (1:500)

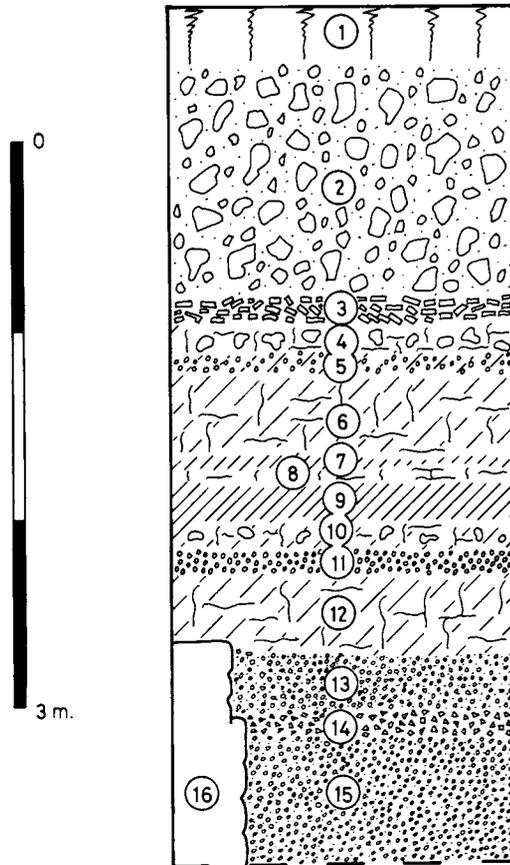
FIG. 26. Section looking east across the west room of the king's chambers (7g) excavated and drawn in the 1930s (undated).

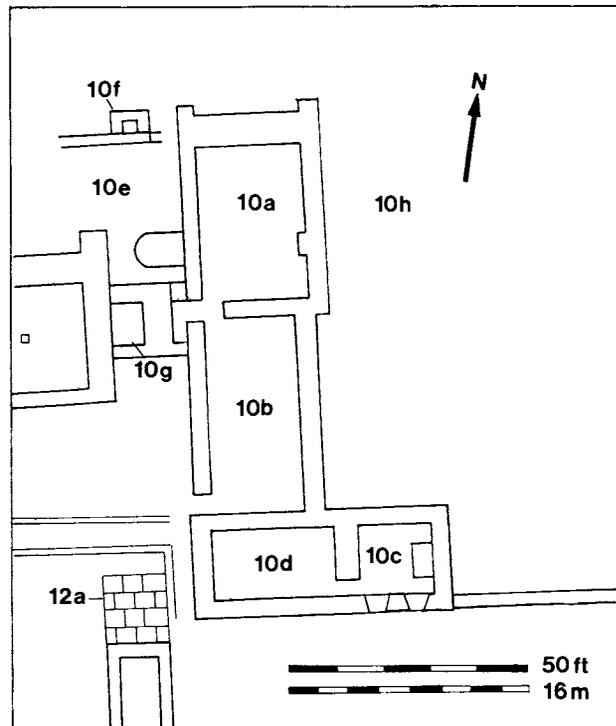
FIG. 27. Composite plan of queen's apartments (10)
(1:500)

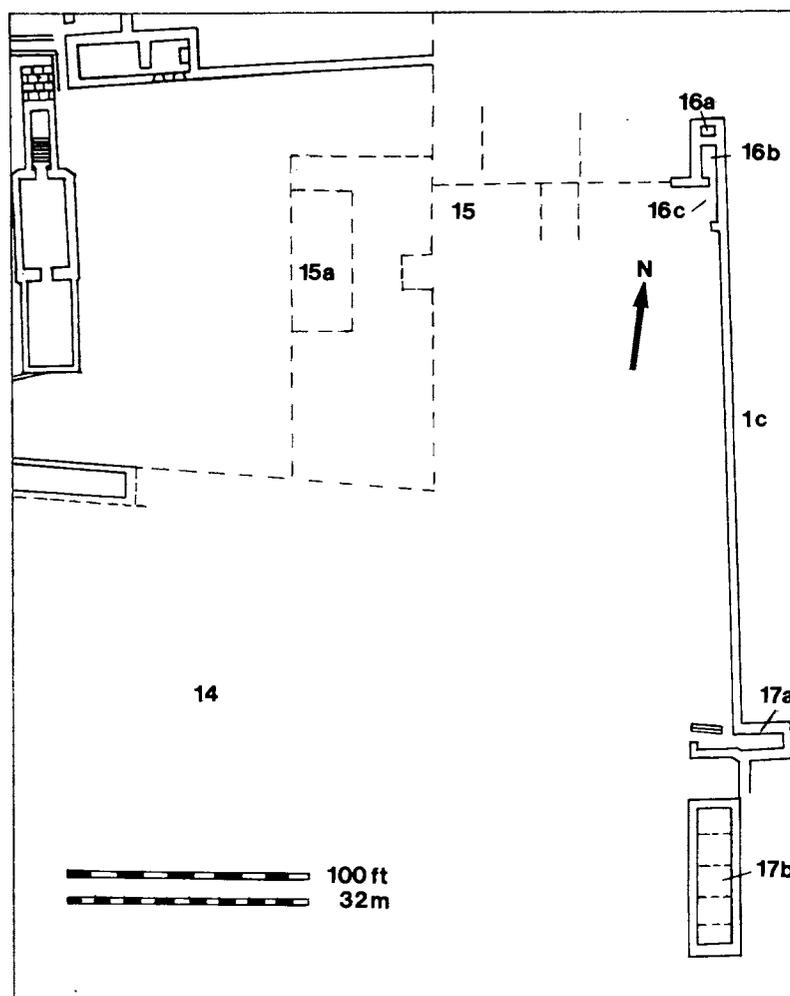
FIG. 31. Composite plan of the south-eastern area of the site (I5, I6, I7)
(1:500)

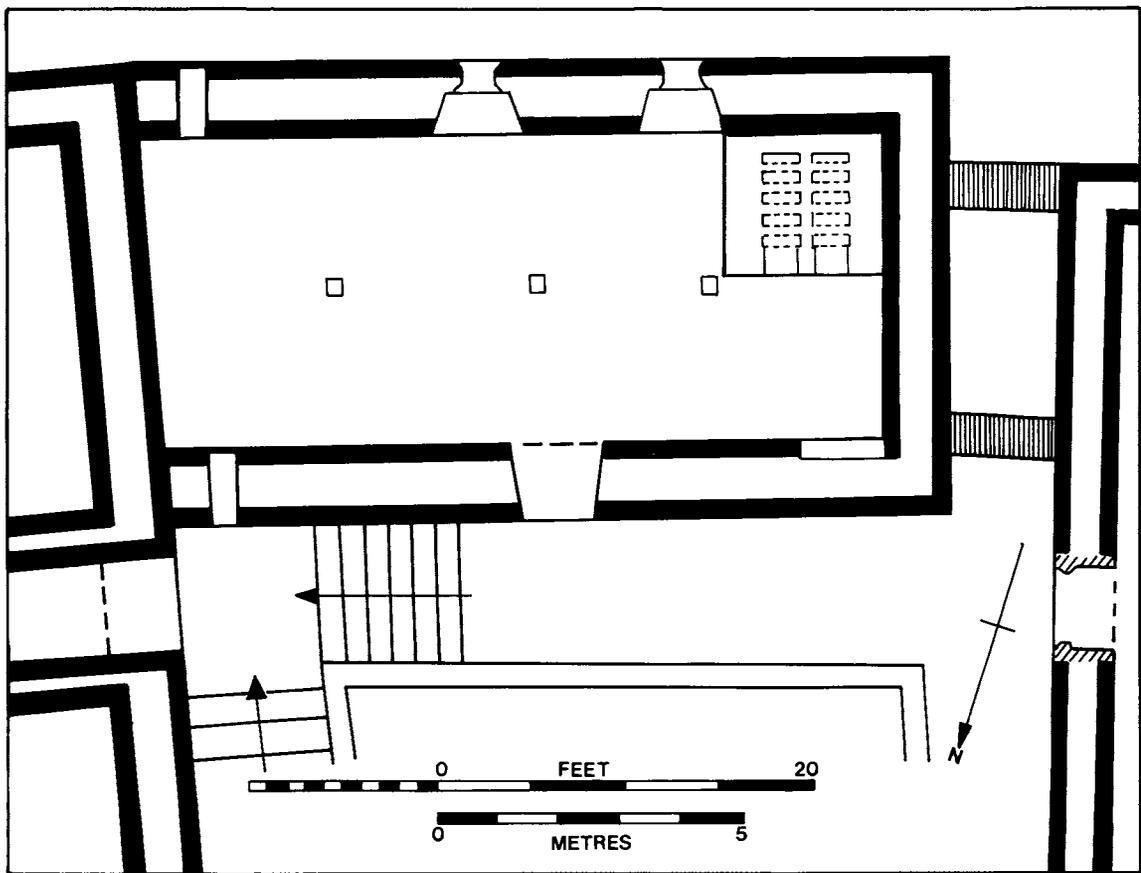
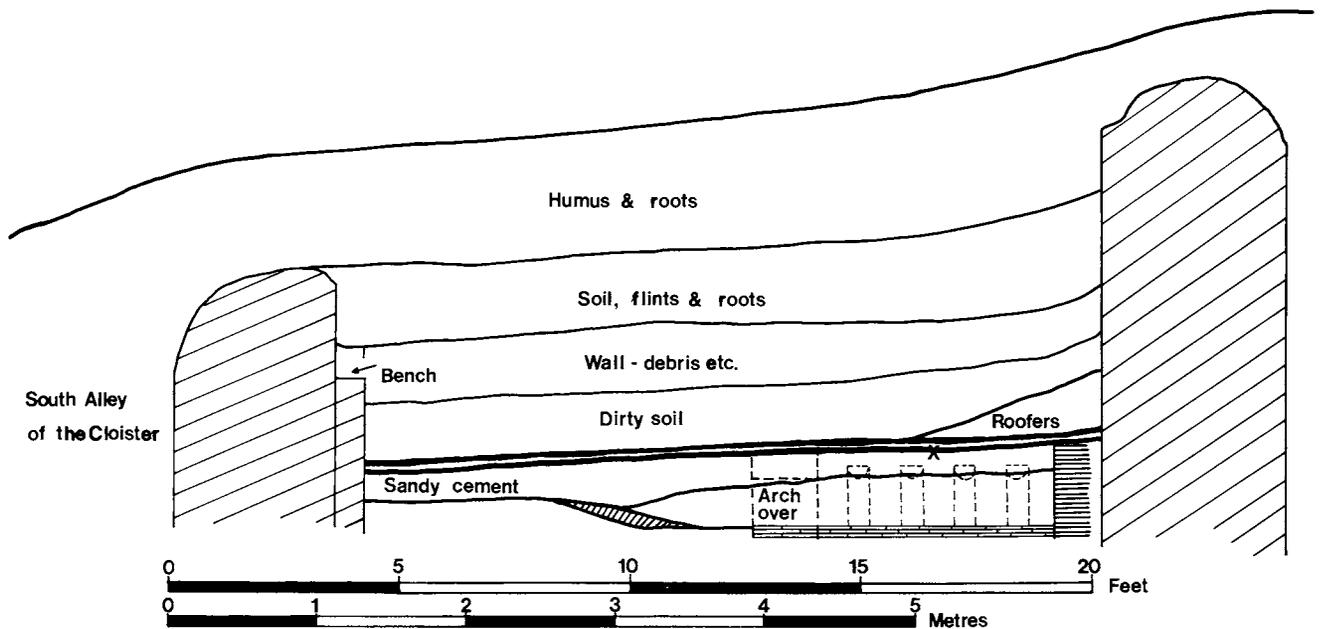
FIG. 32. A. Charlton's plan of the south part of the kitchen court, 1937, showing the position of the tile kiln (4l) under the salsary (4k). The east wall and door of King John's kitchen (4h) are on the right. The heap of waste tiles found in 1934 was at the top right outside the building. The two hatched walls between the salsary and the kitchen blocking the passage between the great court and the kitchen court were much later additions. (1:125). B. Charlton's section through the salsary and tile kiln, 1937. The double black line over the kiln represents the double layers of the salsary floor. The cross marks the findspot of the pot fragment (fig. 62). The great court (6) lay to the right and the kitchen court (4a) to the left. (1:50)

During the excavations of 1934 a heap of waste decorated floor tiles was found in the area of the great court (6) immediately outside the south-west corner of the salsary (4k). The position of the waste tiles was marked by John Charlton on a rough draft plan, here redrawn as fig. 32A. This was south-west of the south-west corner of the salsary in the top right corner. The waste tiles led the excavators to suspect the presence of a kiln in the vicinity and it was found under the floor inside the south-west corner of the salsary in 1937. Its relationship in plan to the building above is shown on Charlton's plan (fig. 32A). Before the salsary was built over the site

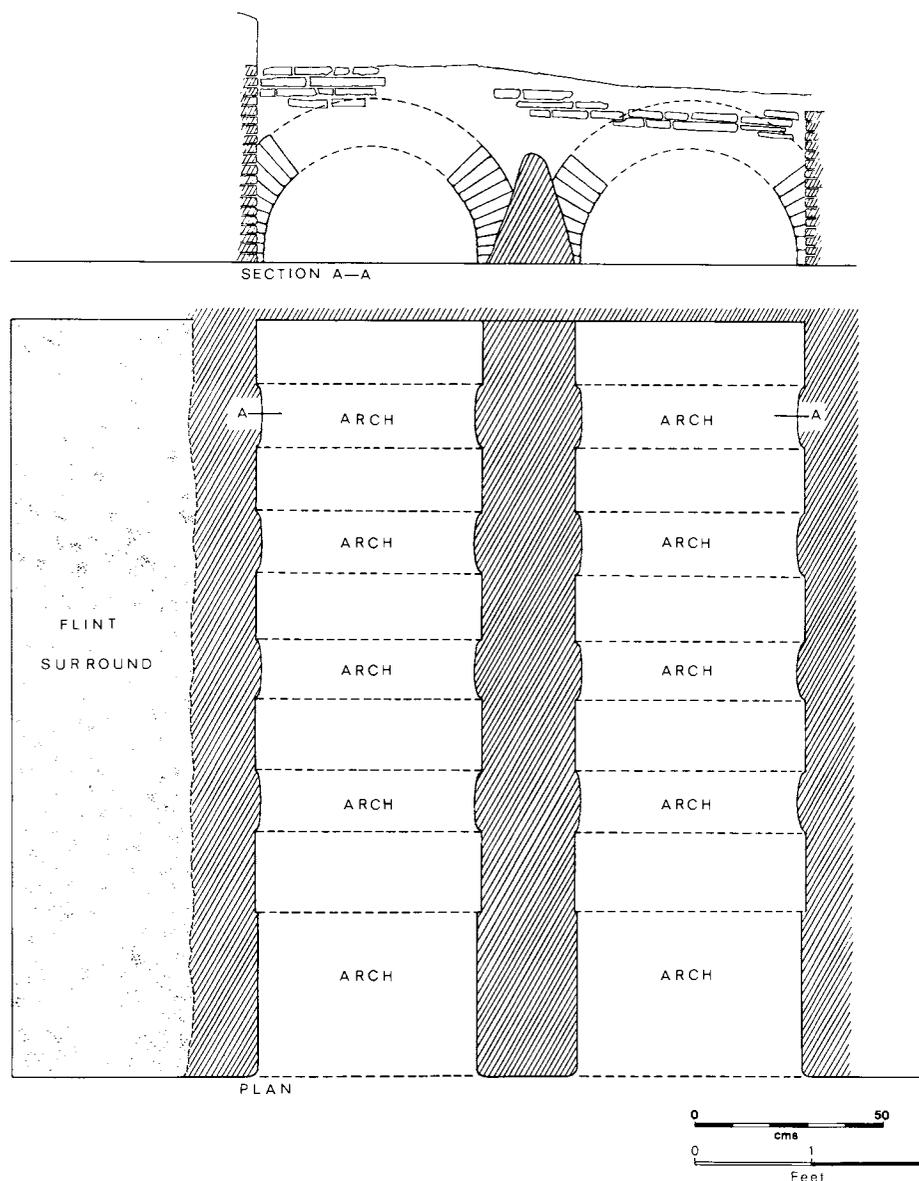
FIG. 33. Charlton's schematic plan and elevation of the tile kiln, 1937 (1:20)

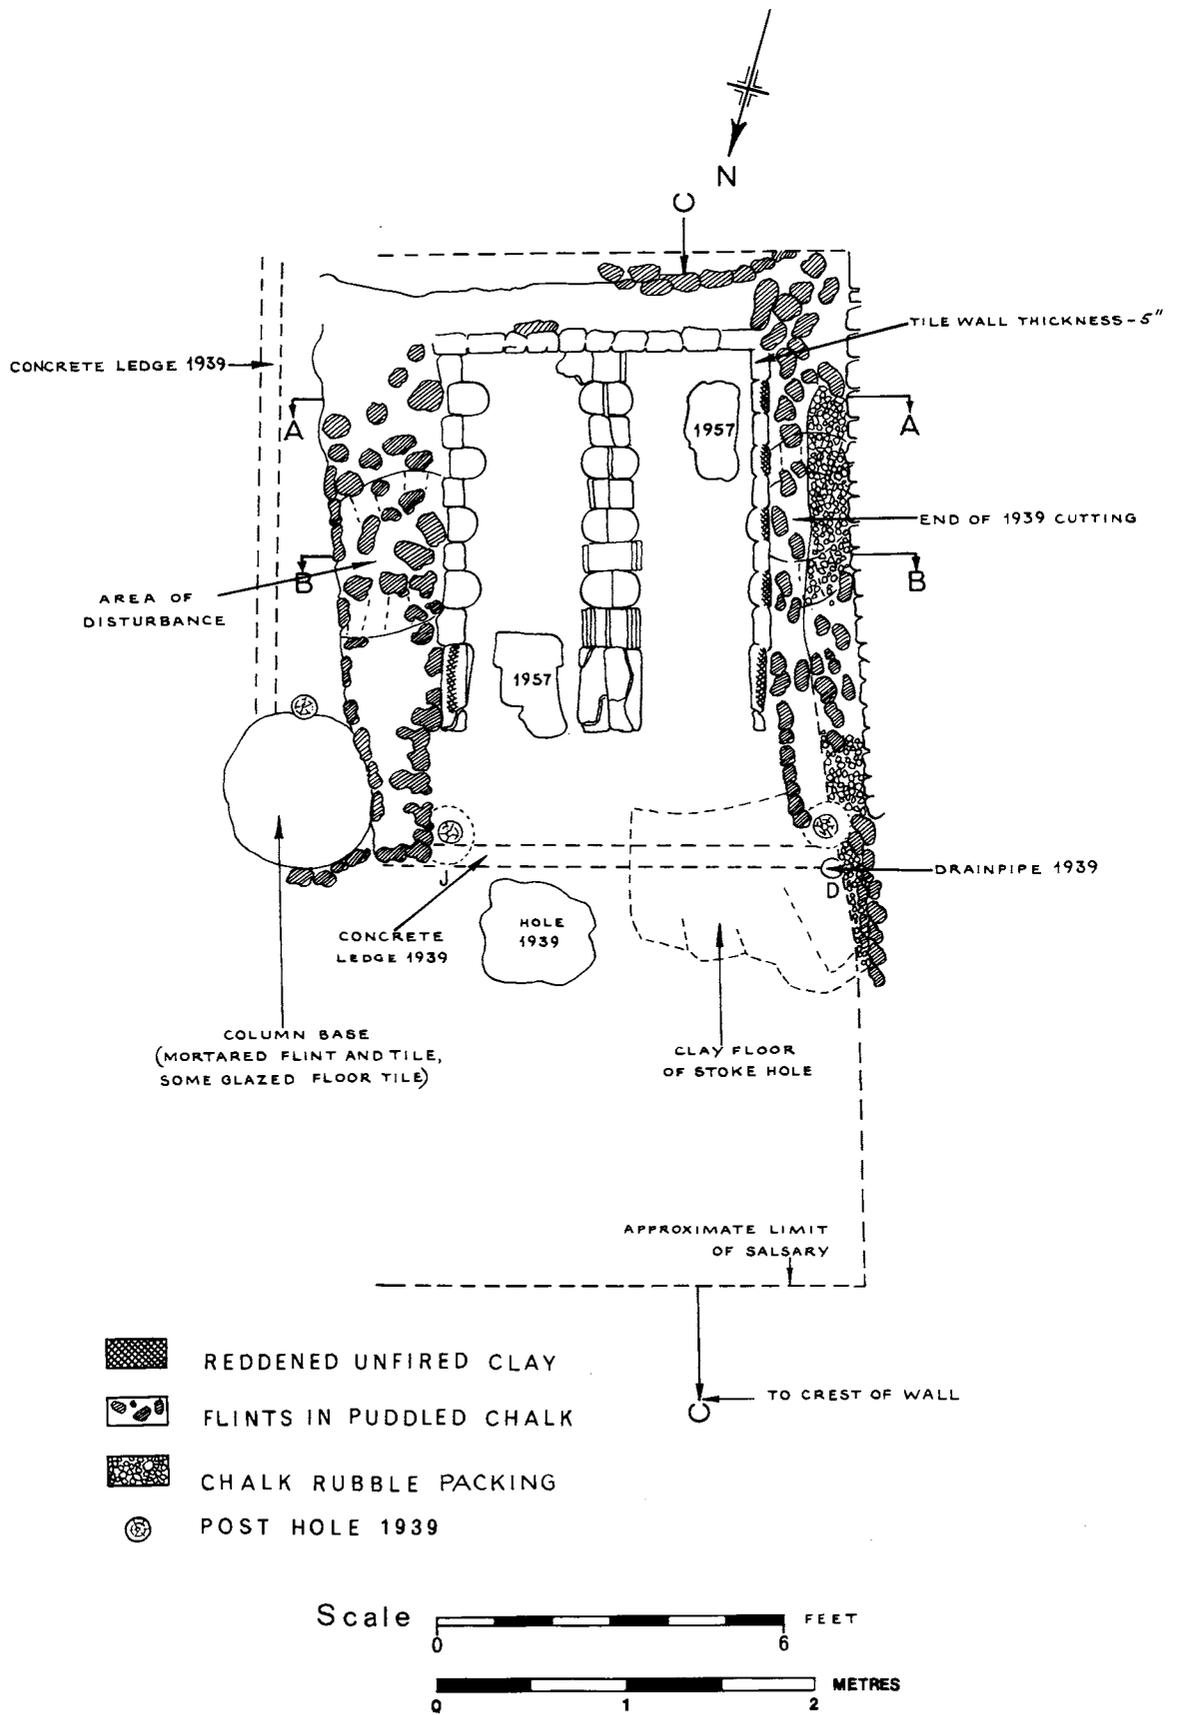
FIG. 34. Measured plan of the kiln drawn by David Algar, 1964 (1:40)
 Copyright: British Museum

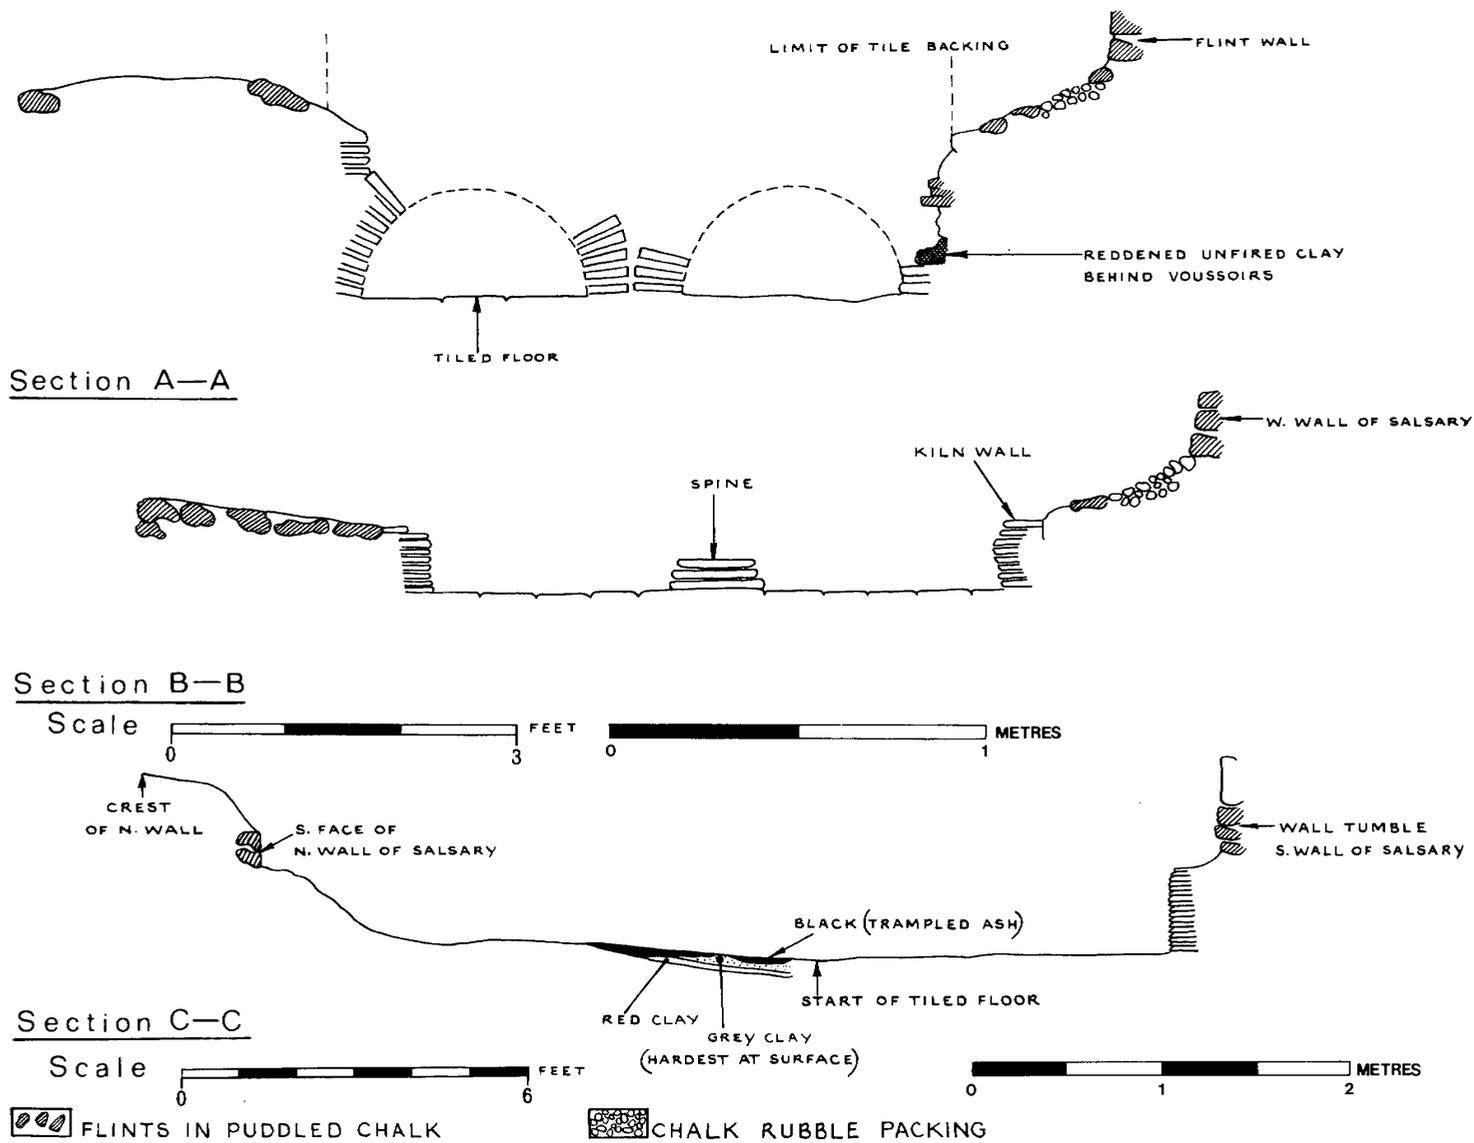
FIG. 35. Measured sections through the kiln drawn by David Algar, 1964: A—A through the fire-boxes; B—B across the furnace chambers; C—C across the width of the salsary through the west furnace chamber and fire-box

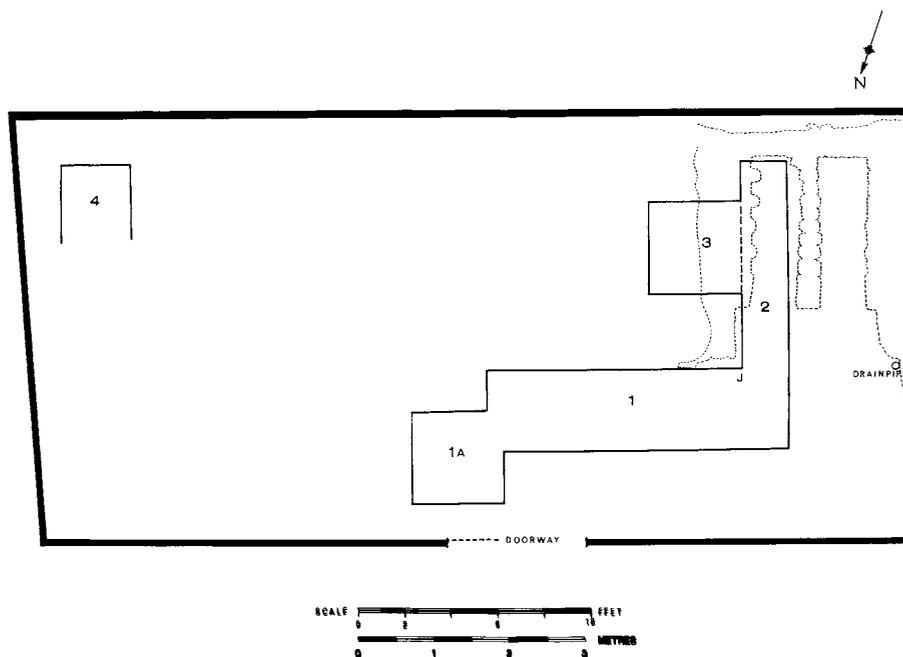
FIG. 37. Plan of the sections excavated in 1965 under the salsary (4k) after the removal of the kiln (4l) (1:100)
