Reports of the Research Committee
of the
Society of Antiquaries of London

Clarendon Palace

The History and Archaeology of a Medieval Palace and
Hunting Lodge near Salisbury, Wiltshire

1988

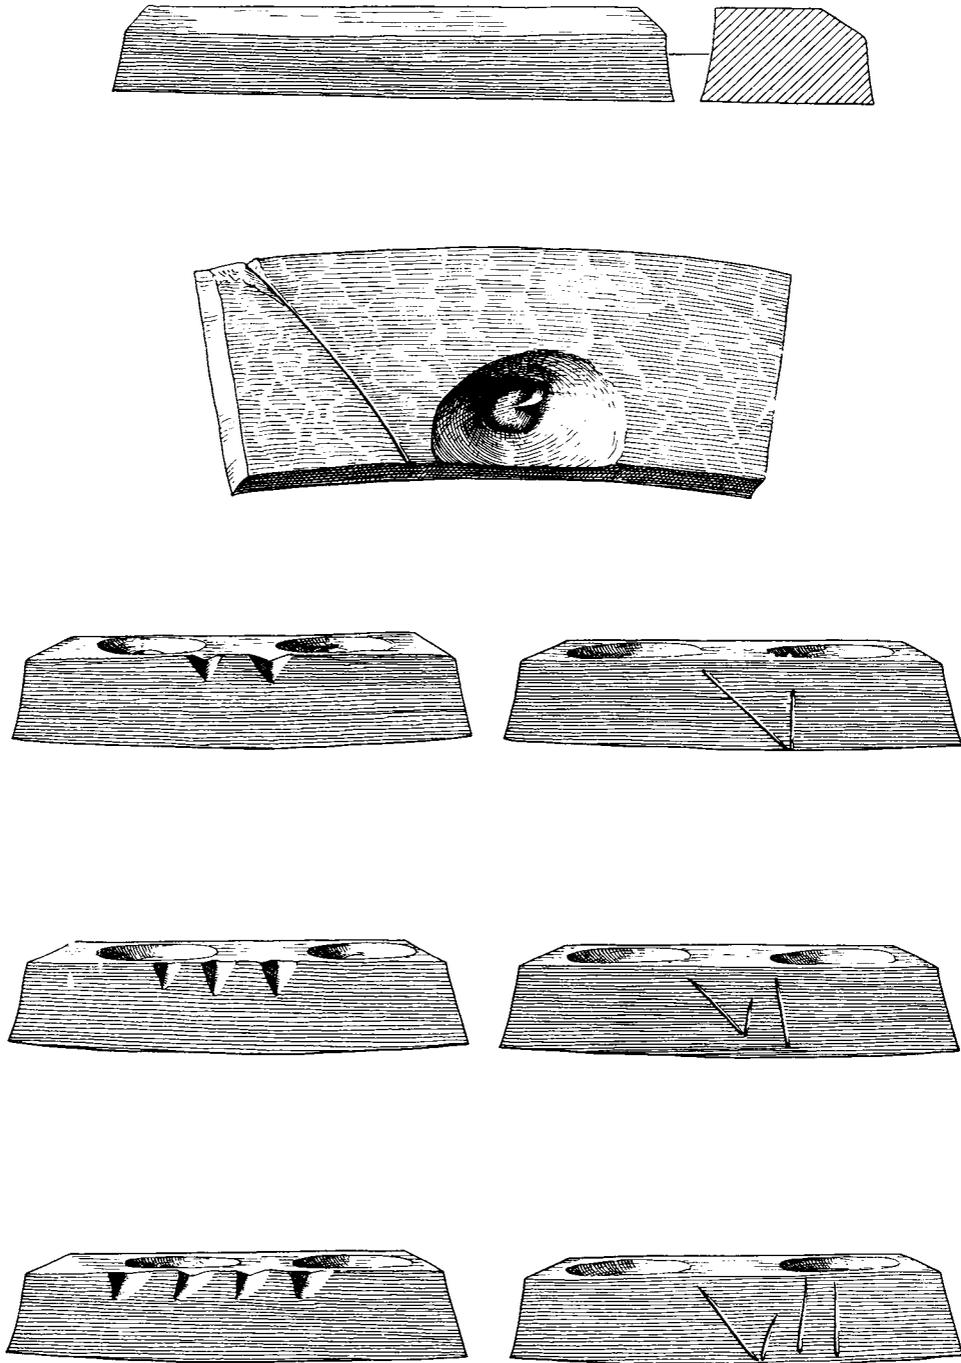
FIG. 40. Assembly marks on the plain tiles from the king's chapel pavement ($\frac{1}{2}$)

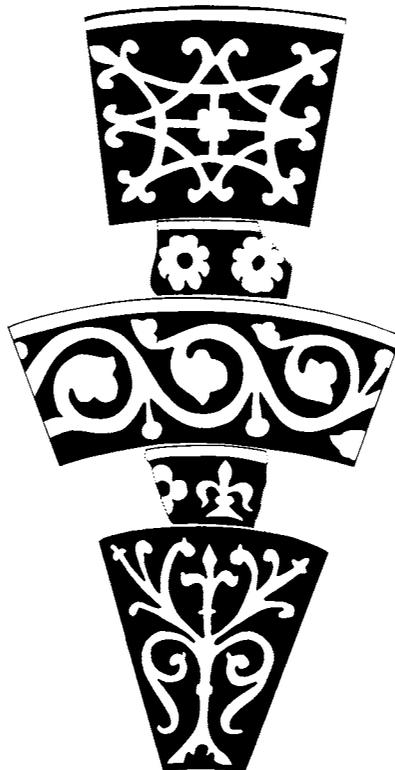
FIG. 42. Possible form of the centre of a second circular pavement at Clarendon, including designs 9 (2nd from bottom) and 10 (4th from bottom) ($\frac{1}{5}$)

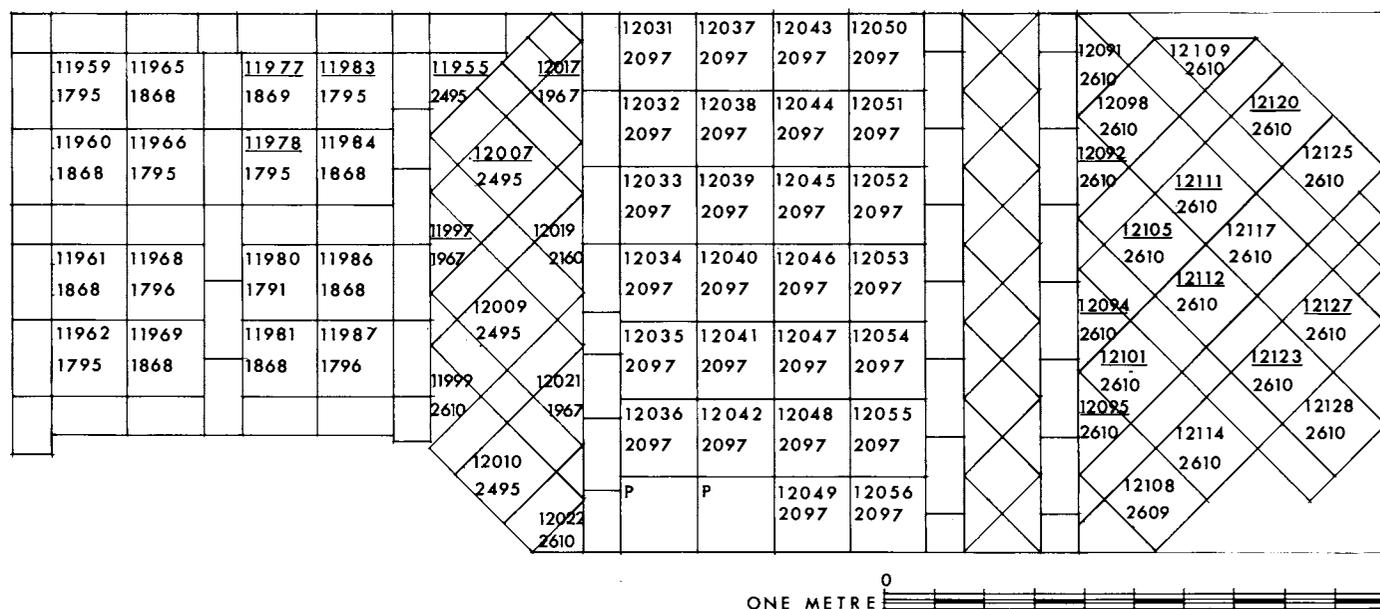
FIG. 43. Plan of the pavement from the queen's chamber (10a), as reassembled in the British Museum (for design numbers, see Eames 1980) (1:15)

No reason was then found for the damage to panel 4, although the foundation beneath the damaged area was severely compressed. The reason for the damage was found in contemporary documentation. The pipe roll for 1275-6 records payment for a new joist to replace one that fell during a fire in the queen's chamber, which is also referred to in the survey of 1273 (Colvin 1963, 916 nn. 11 and 12; Eames 1980, i, 187). It can be assumed that during this fire in the upper floor of the building a great burning joist crashed down end first, hitting the pavement of the room below with tremendous force, shattering the tiles, compressing the foundation under the point of impact and scattering fragments of burning wood over the floor.

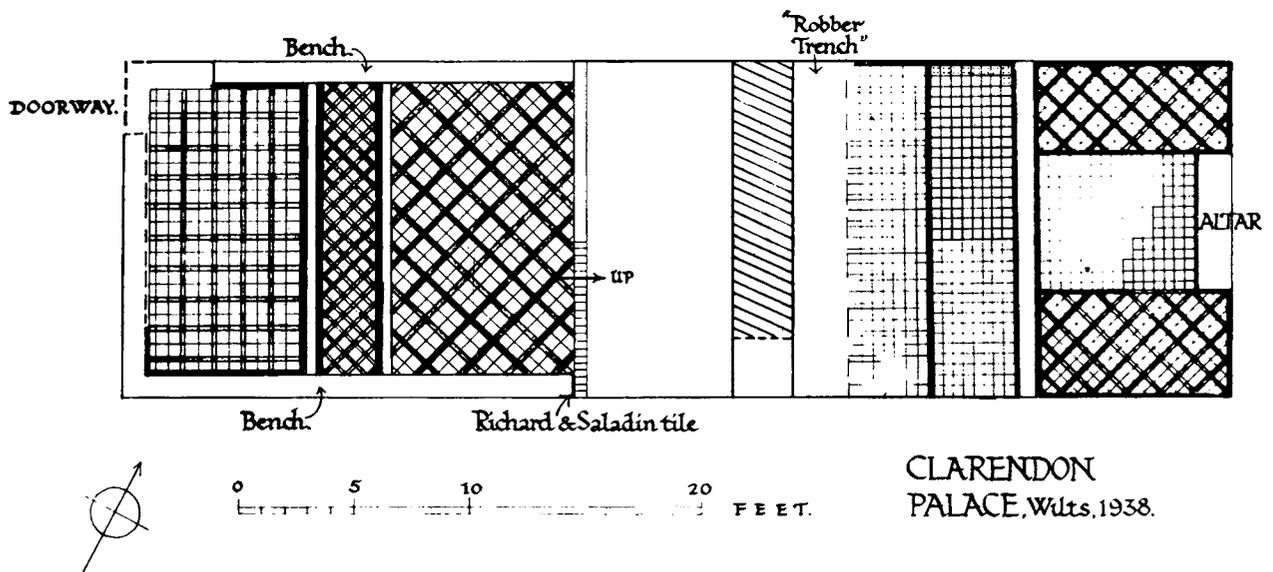
FIG. 44. Charlton's plan of the arrangement of the pavement in the south-western building (10*d*) of the queen's range derived from tile impressions remaining on the mortar bed (1:100)

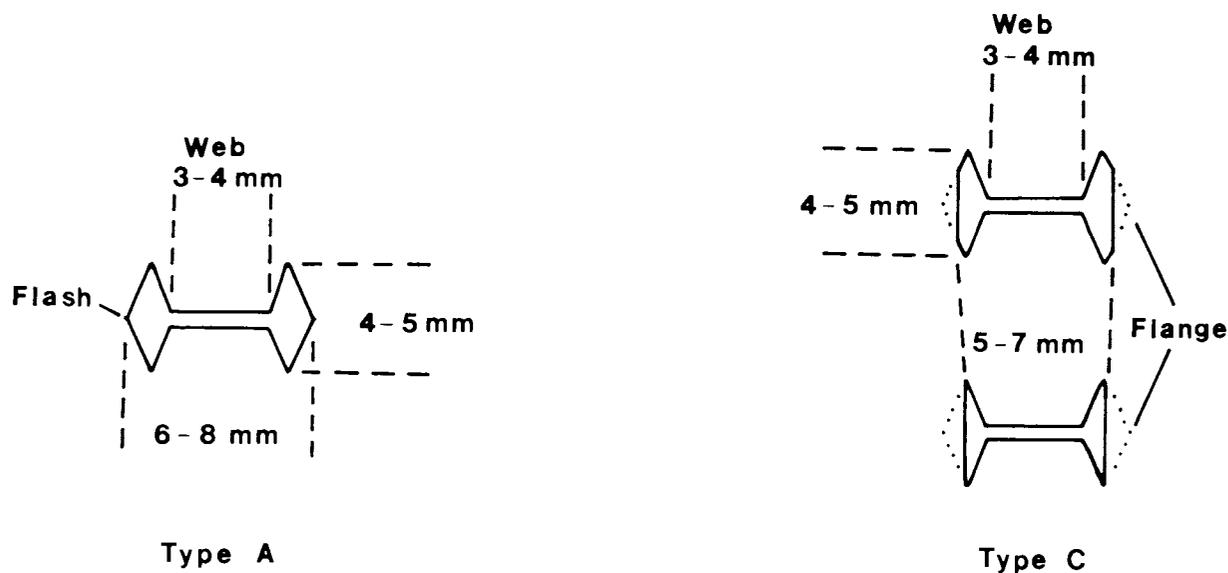
FIG. 84. Came diagram

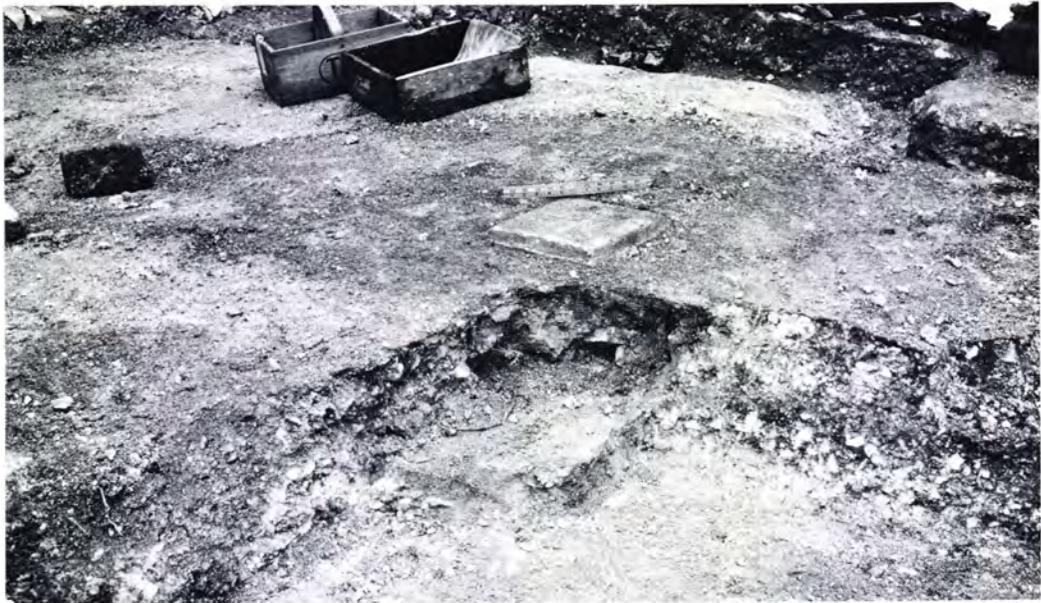
b. The salsary (**4k**): excavating the eastern padstone or pillar base. Note how the section shows how the padstone and its foundation cut through earlier packing of the floor

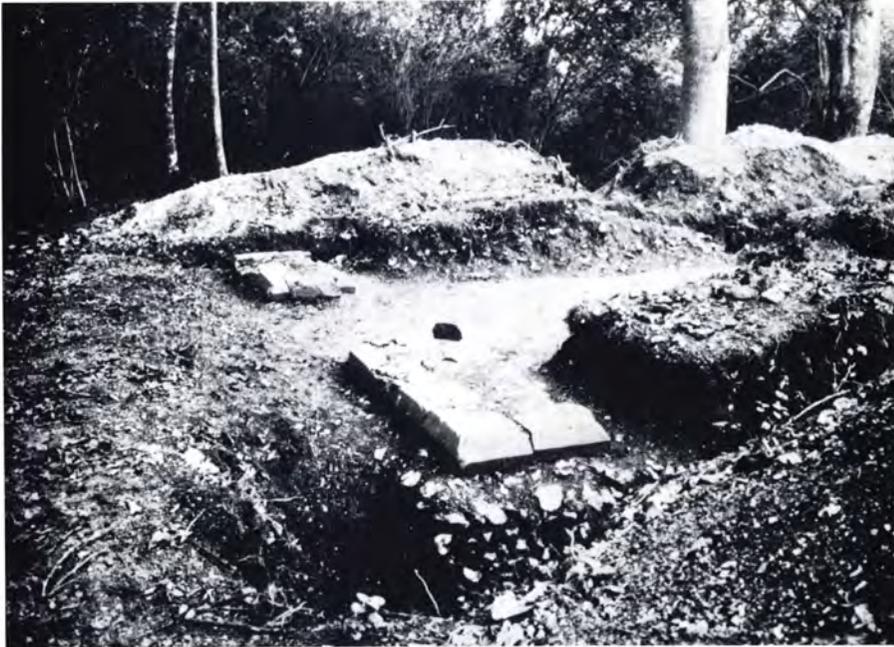
a. The south porch (**5b**) of the great hall (**5**), looking north-west. The broken face of the only stone surviving above the base course is seen in the centre of the picture (cf. below, *b*)

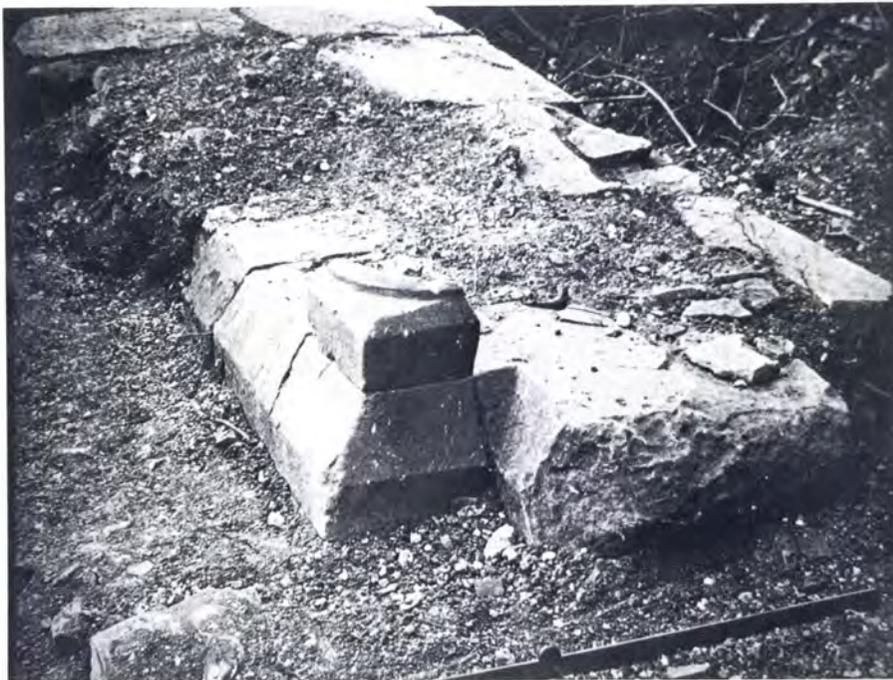
b. The south porch (**5b**), looking south-east from inside, showing the chamfered plinth and column base. The double skin and core filling construction is clearly seen

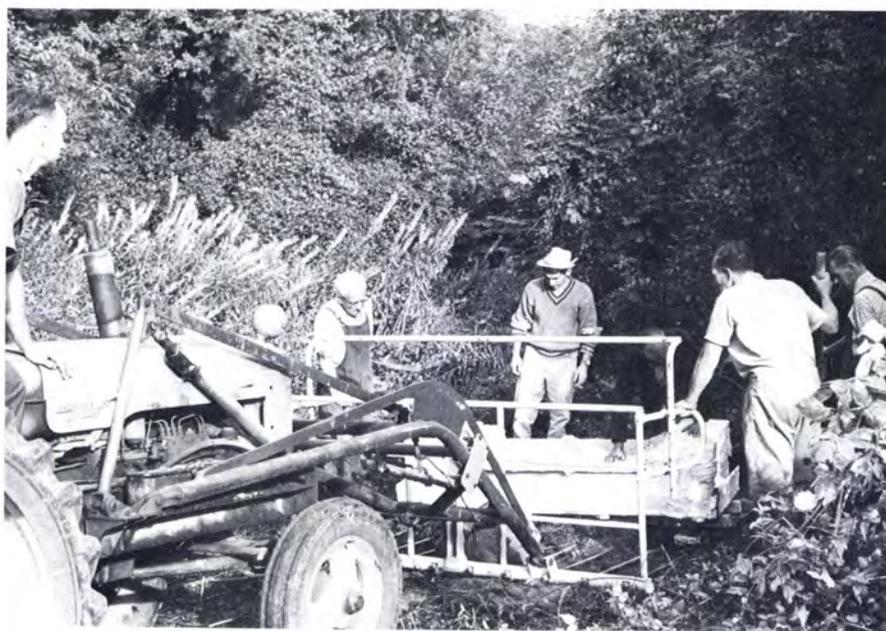
b. The cased rear wall of the tile kiln being fork-lifted out of the site, 1964

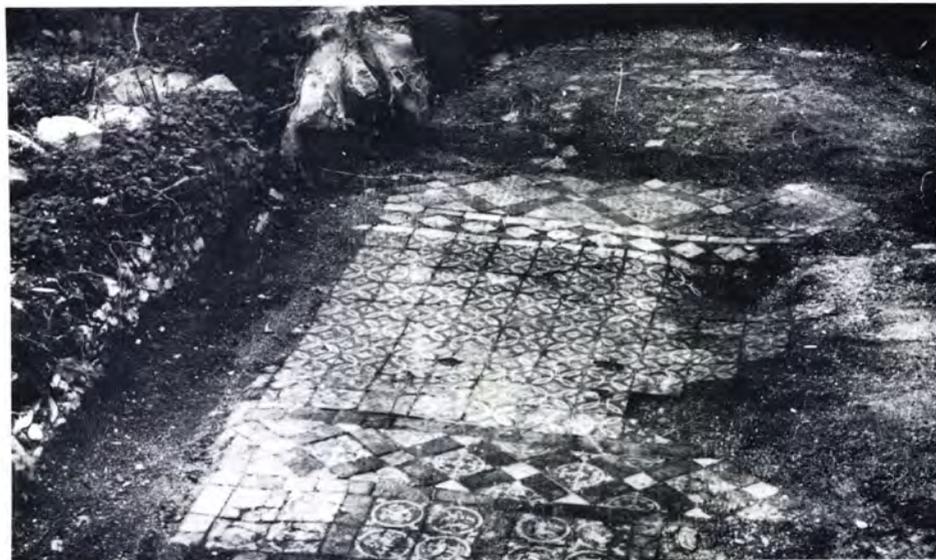
a. The remains of the queen's chamber pavement *in situ*, in **10a**, 1937. The damage caused by a burning joist that presumably fell from the room above is visible near the top right-hand corner
