EXCAVATIONS AT FISHBOURNE

Volume I: The Site

BARRY CUNLIFFE

Excavations at Fishbourne
1961 – 1969

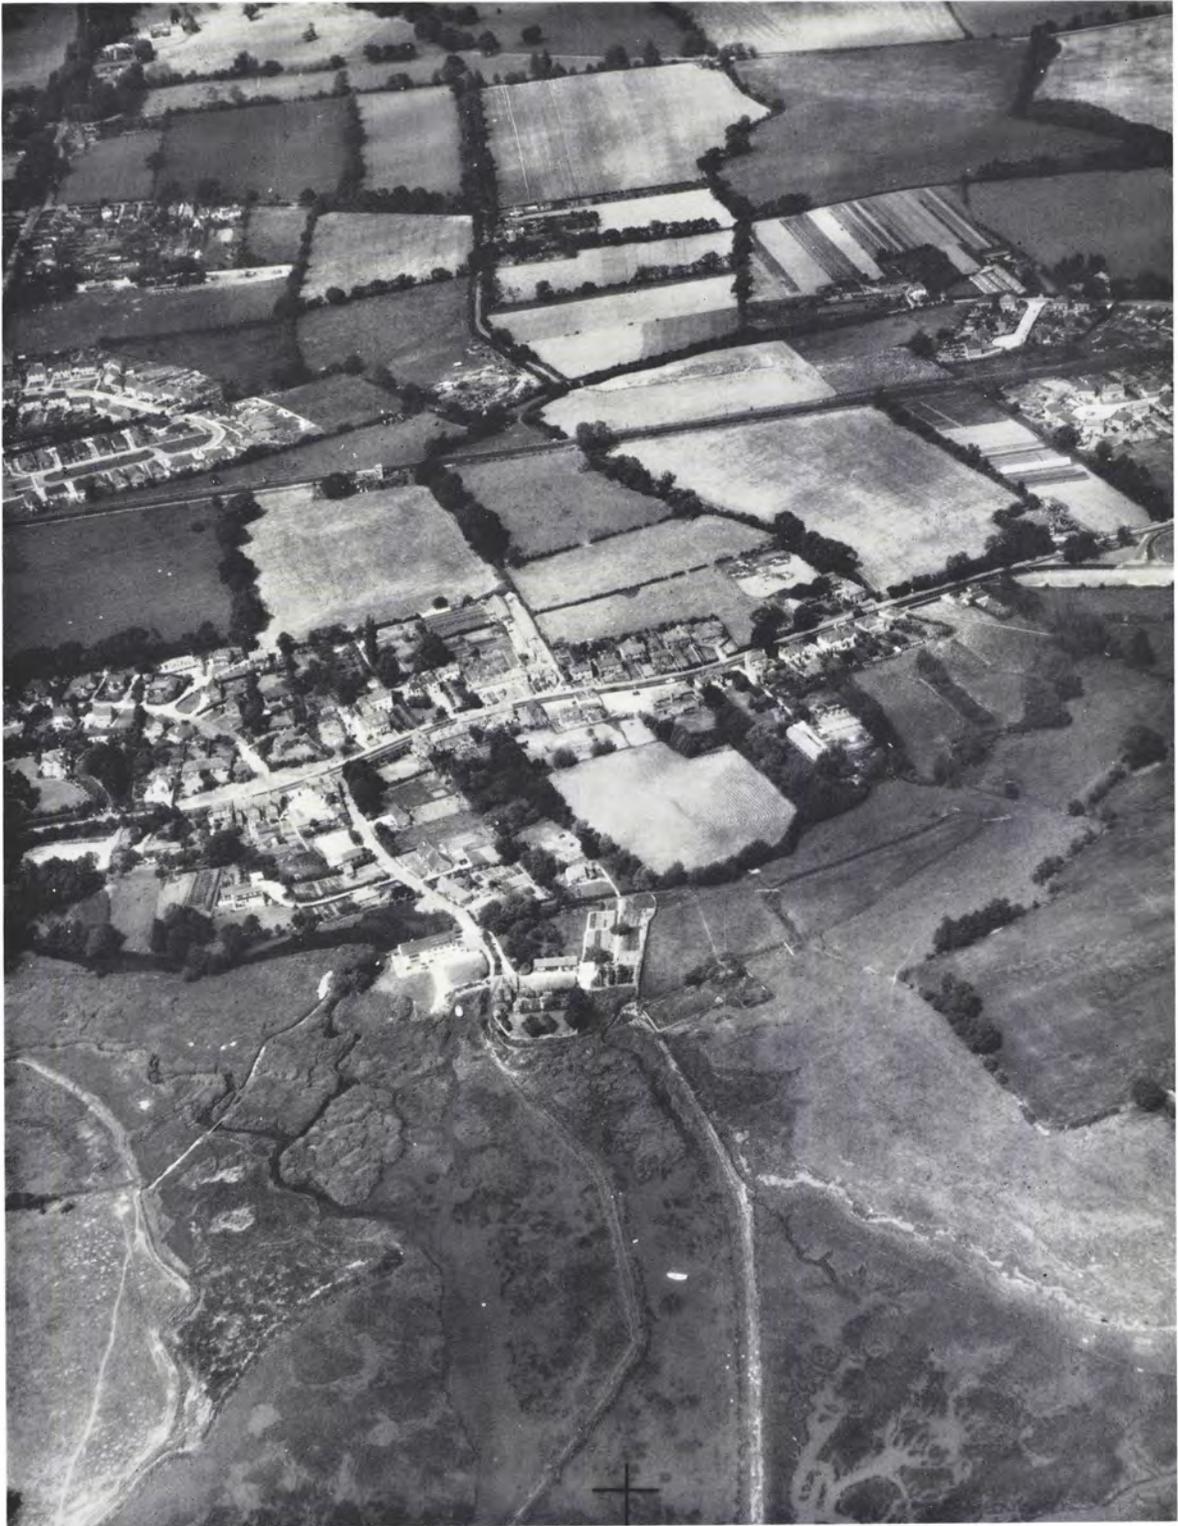
View of Fishbourne looking north from above the creek. The excavation of 1962, over the East Wing, is marked with marginal arrows

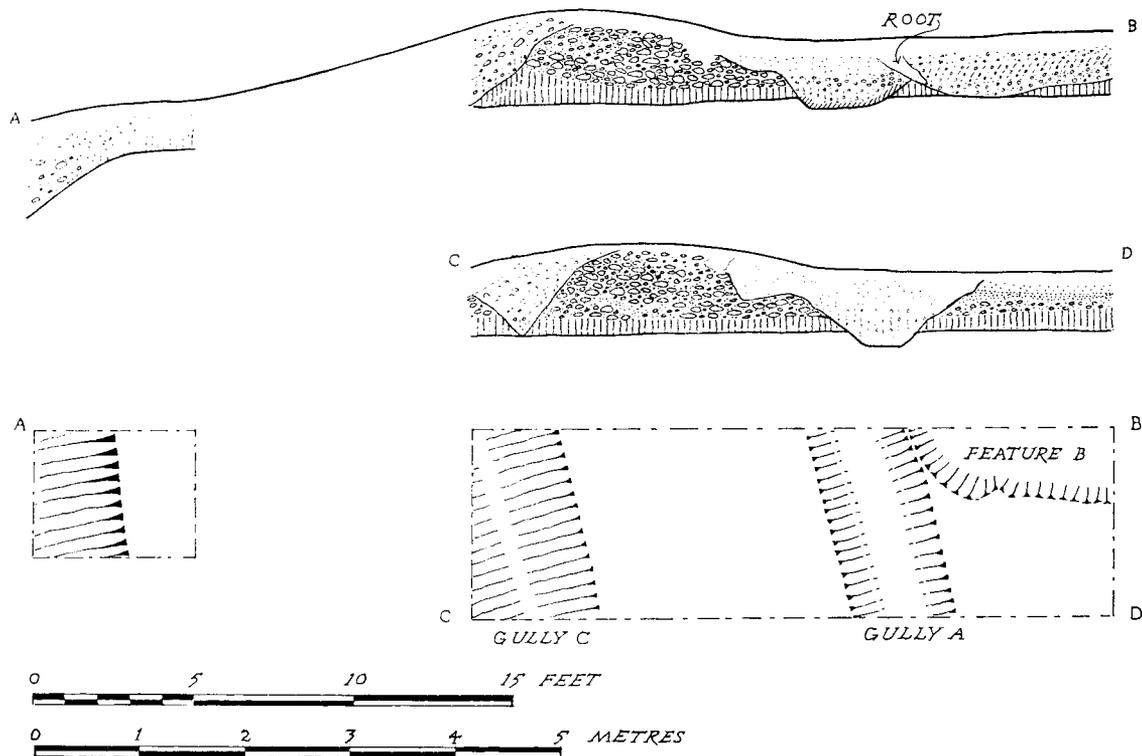
FIG. 7. Section through the Devil's Ditch in Goodwood Park

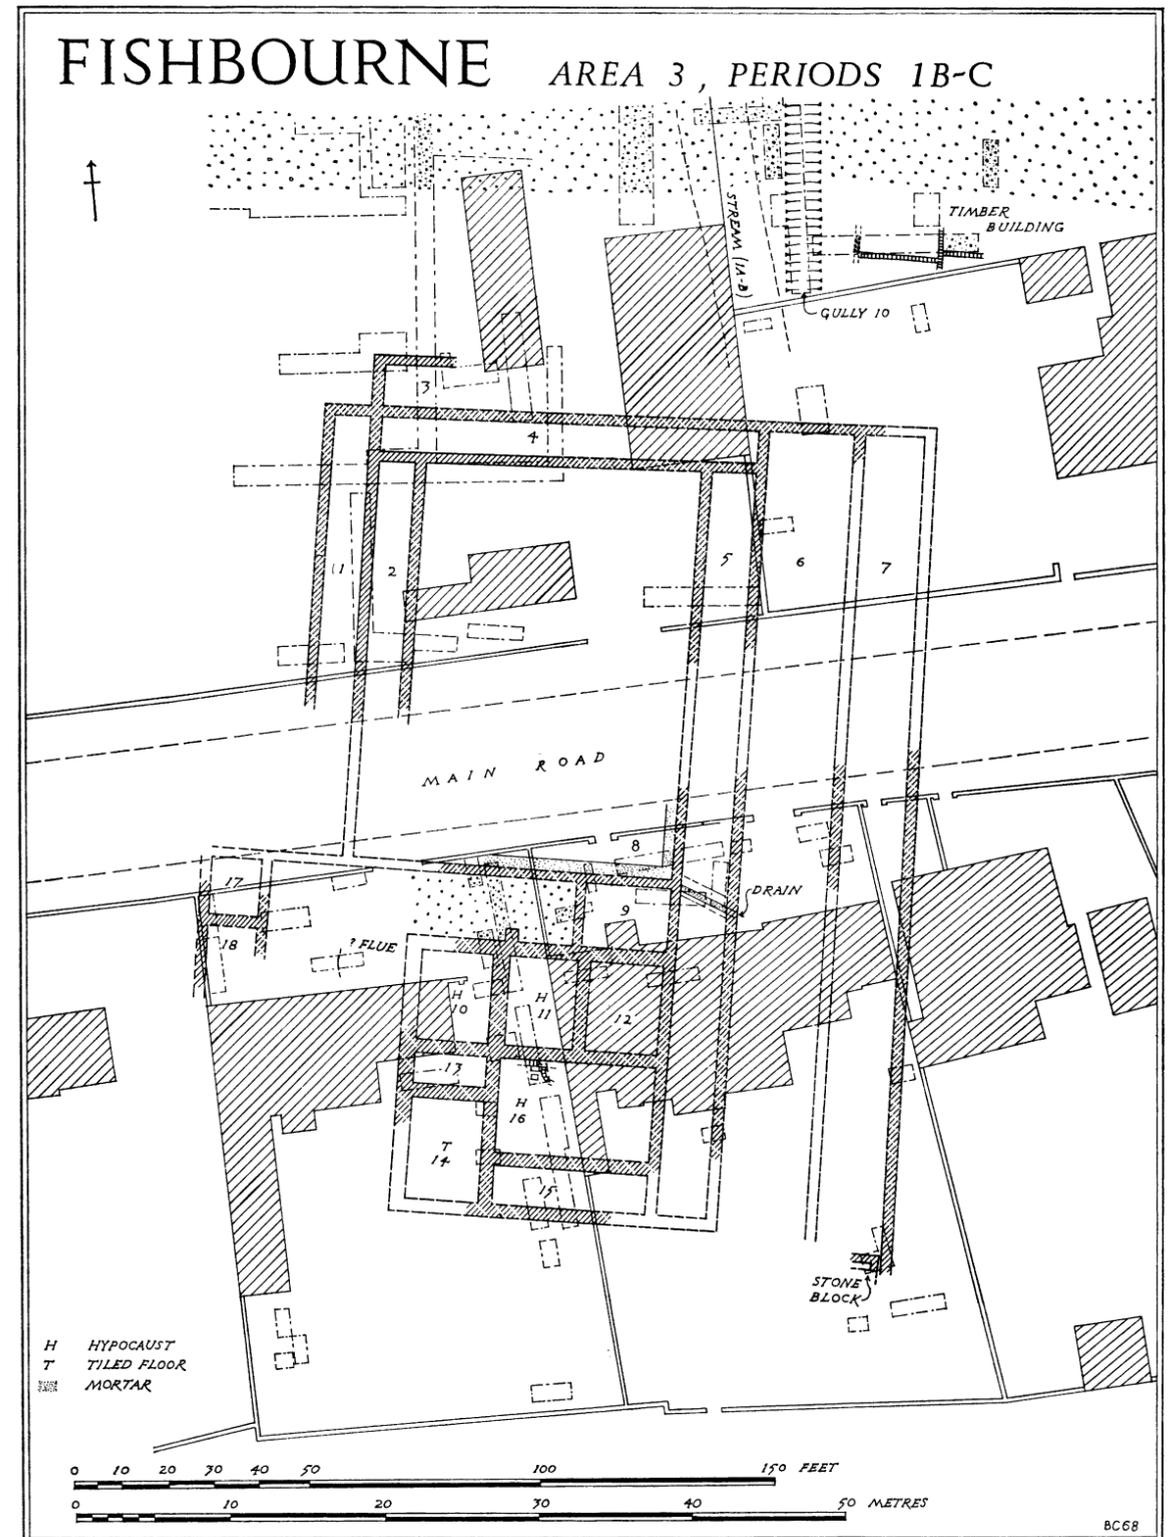
FIG. 18. Plan of the proto-palace

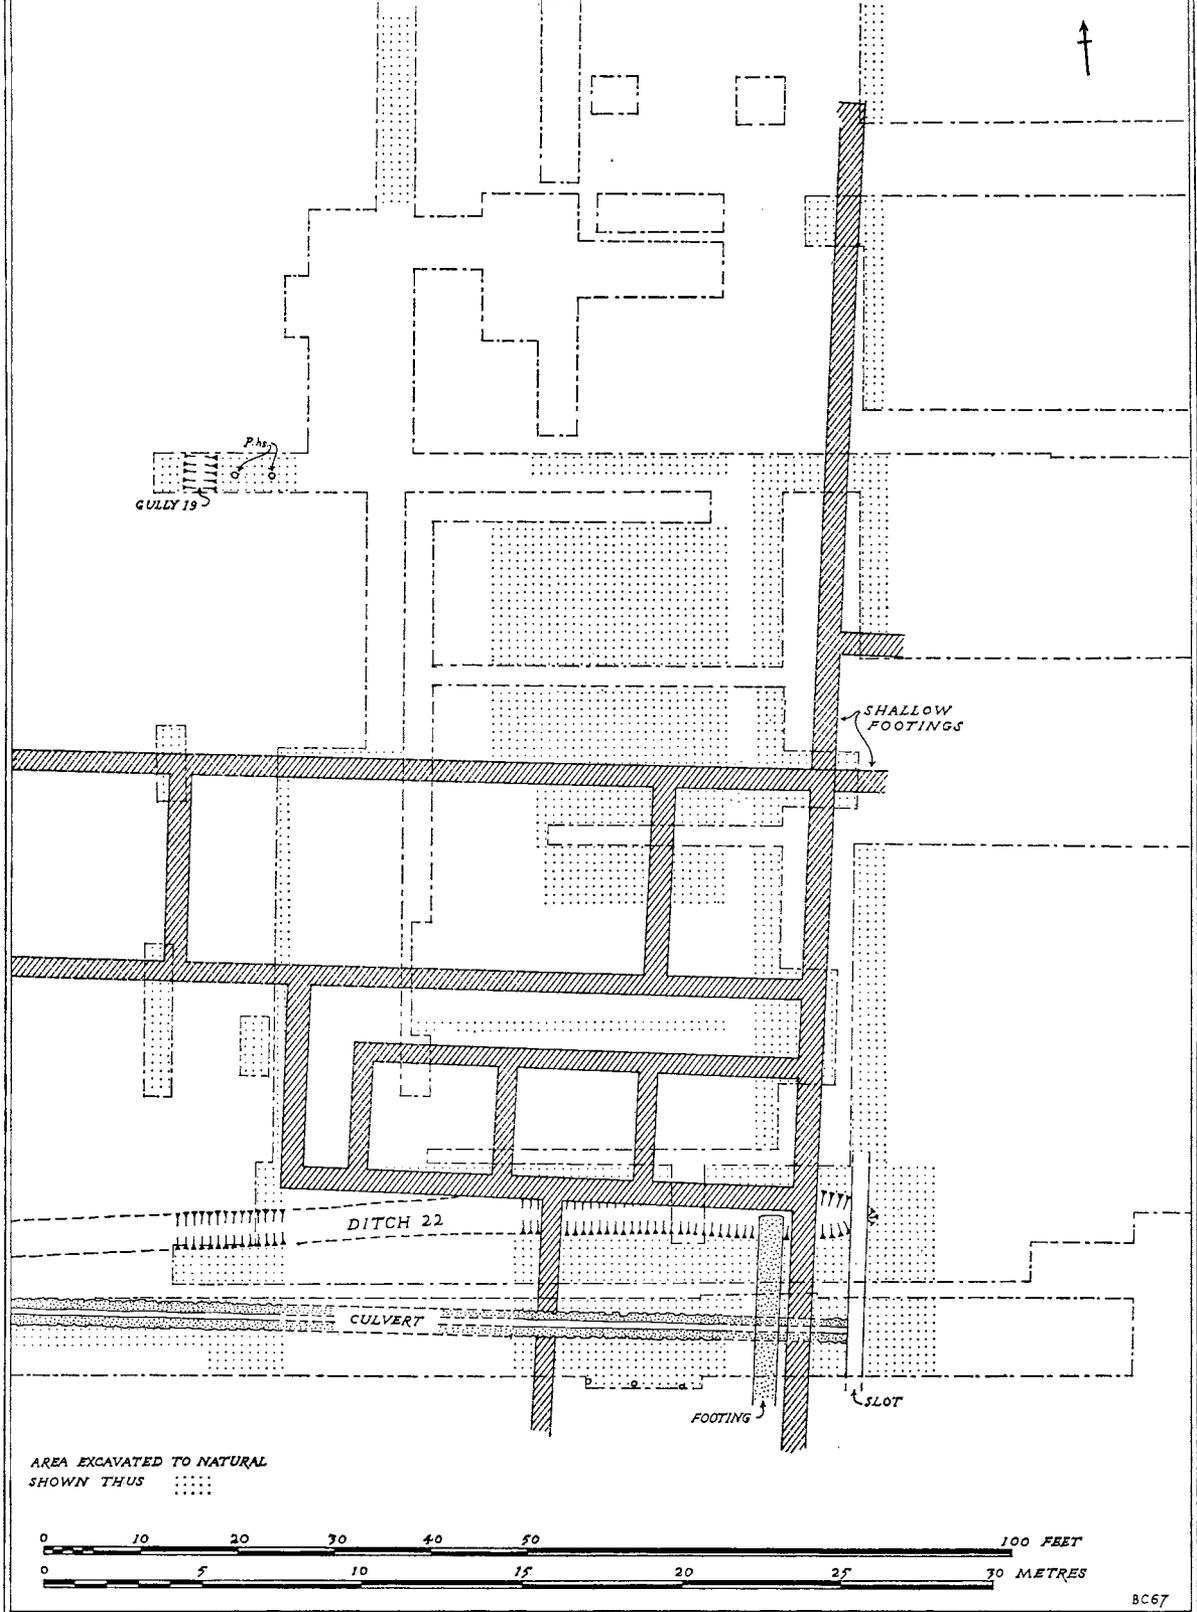
FIG. 19. The second masonry building

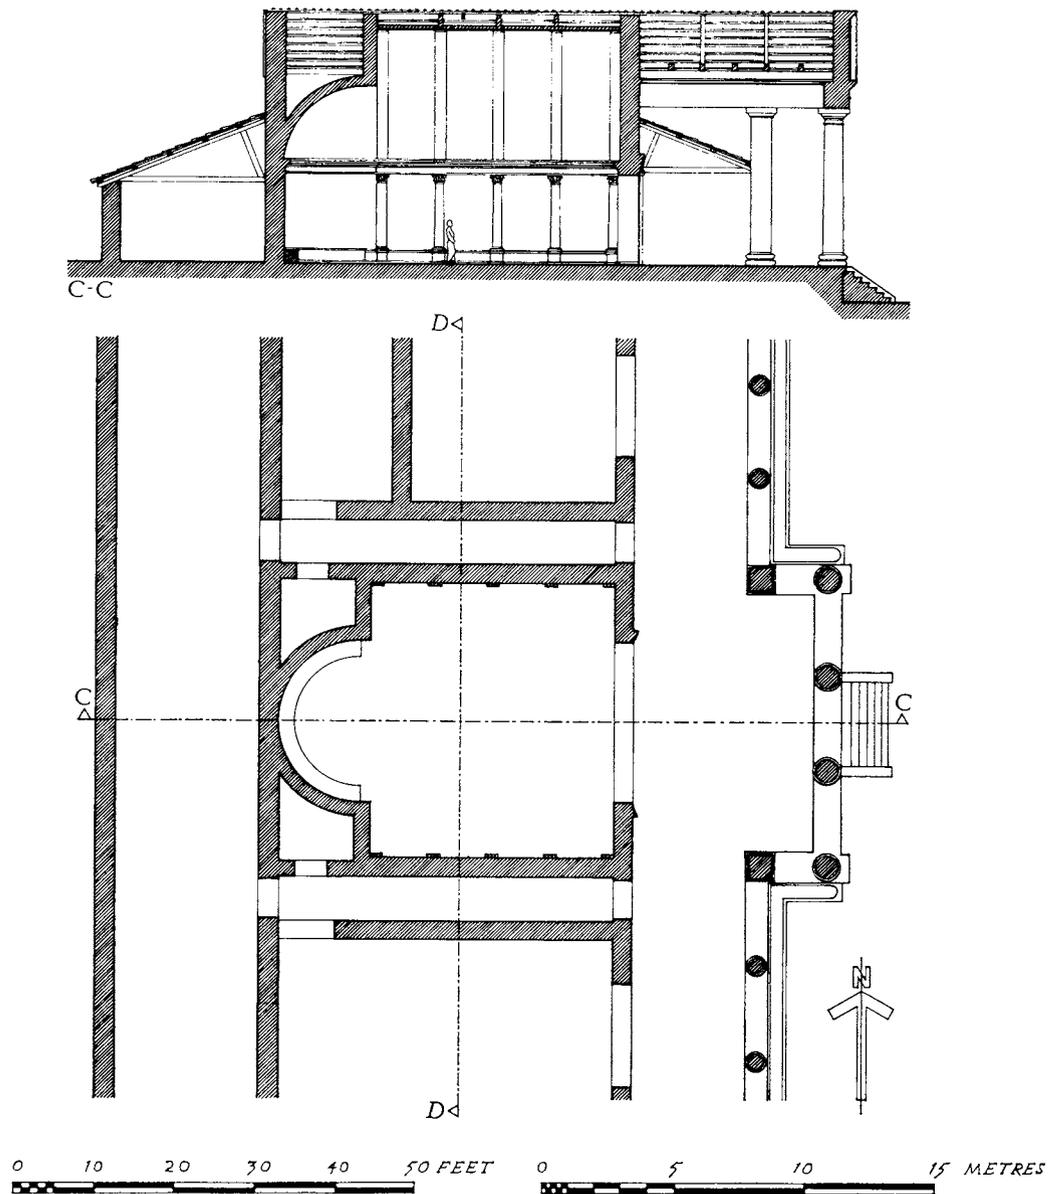
FIG. 23. Reconstruction plan and section of the Audience Chamber
(by N. J. Sunter)

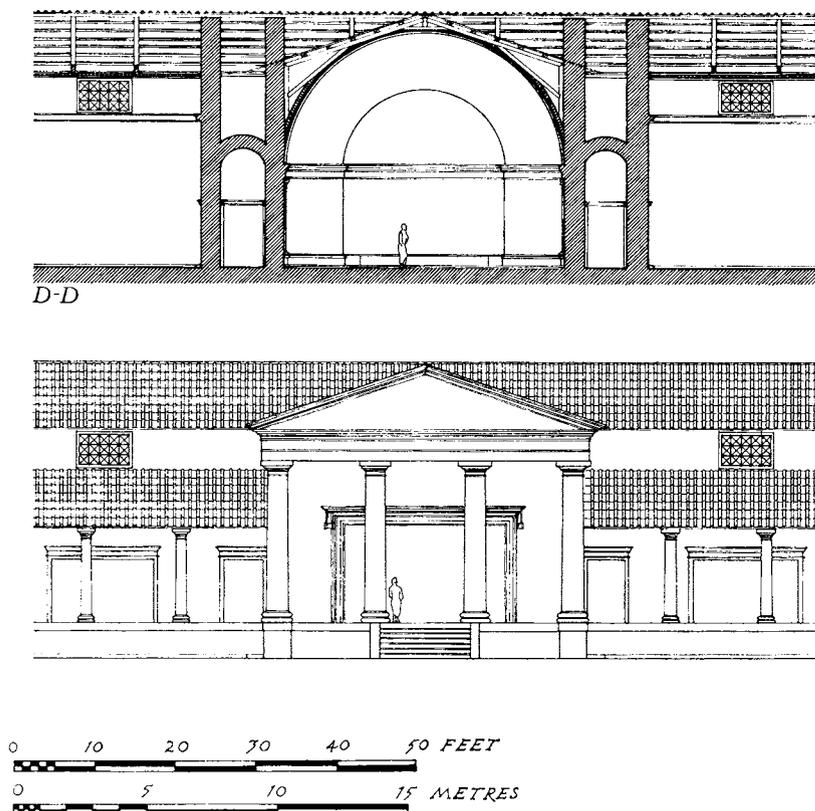
FIG. 24. Reconstruction section and elevation of the Audience Chamber
(by N. J. Sunter)

and spacing (p. 121) it follows that the height of the veranda architrave would have been about 12 ft. (3.66 m.) and therefore, if we allow a sloping veranda roof and provision for clear-story lights into the rooms behind, the eaves would have stood at about 25 ft. (7.62 m.) above floor-level.

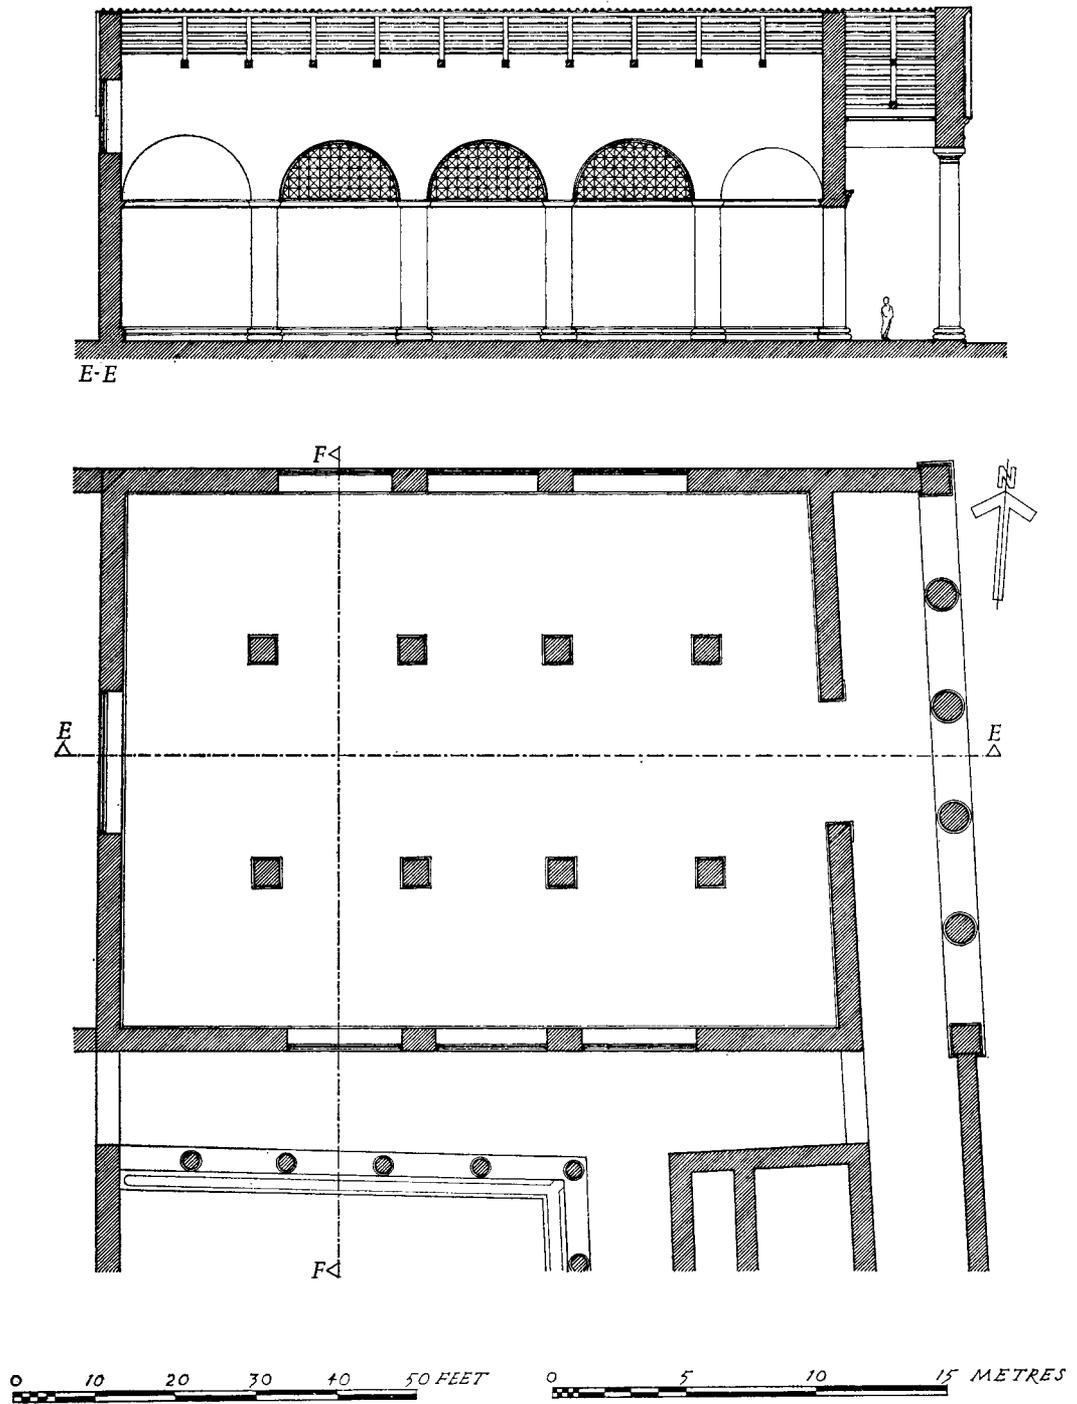
FIG. 29. Reconstruction plan and section of the Aisled Hall
(by N. J. Sunter)

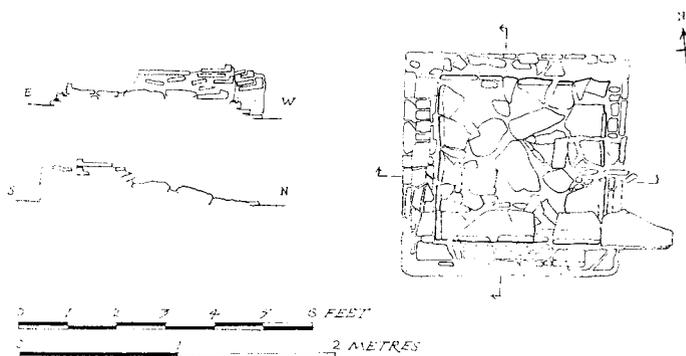
FIG. 36. Base in front of the Audience Chamber

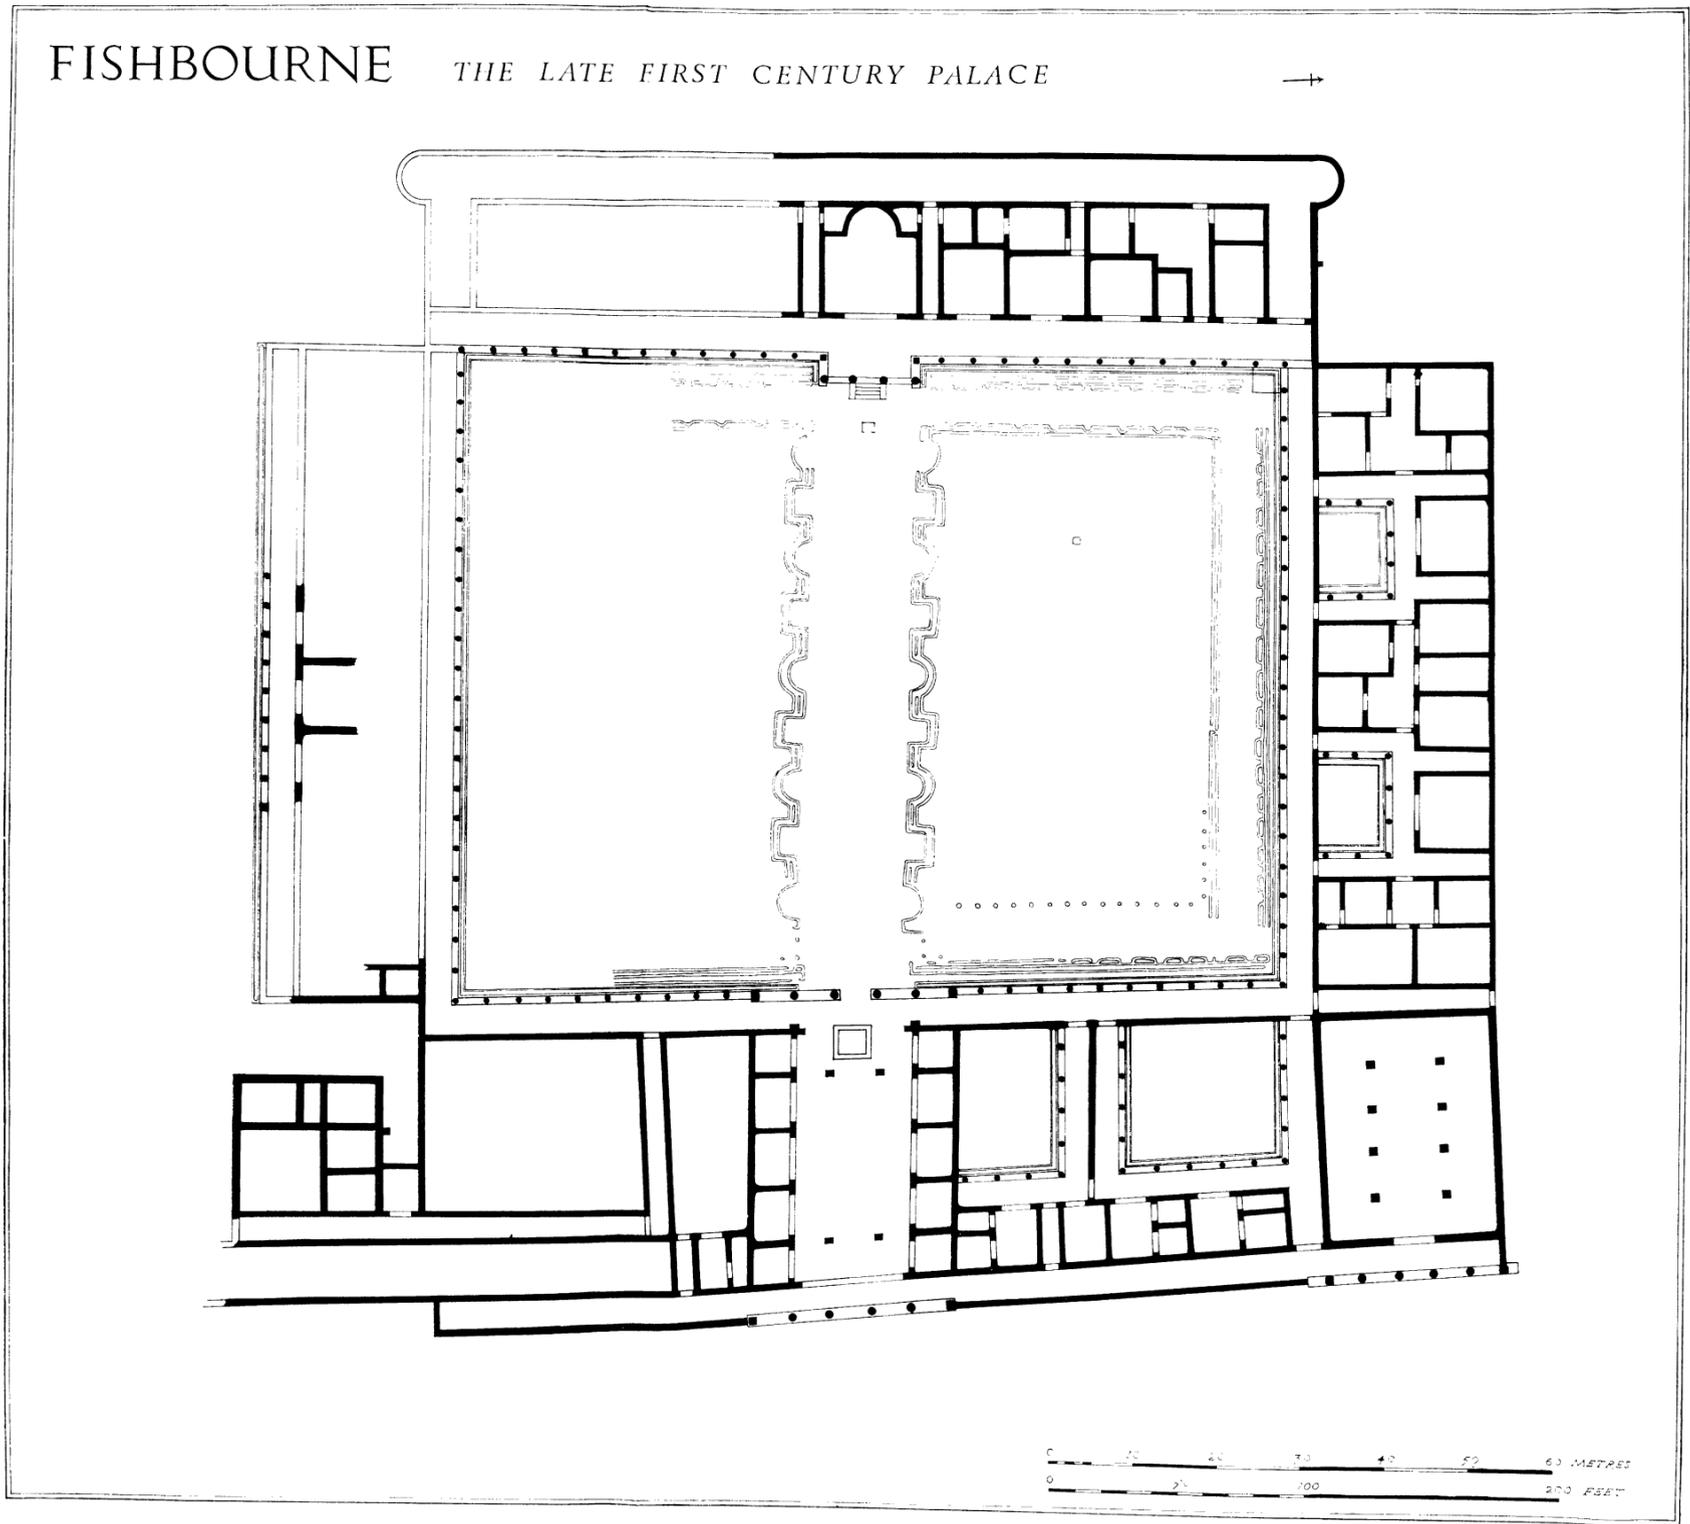
FIG. 42. Simplified general plan of the Palace
(N.B. oriented with west at the top)

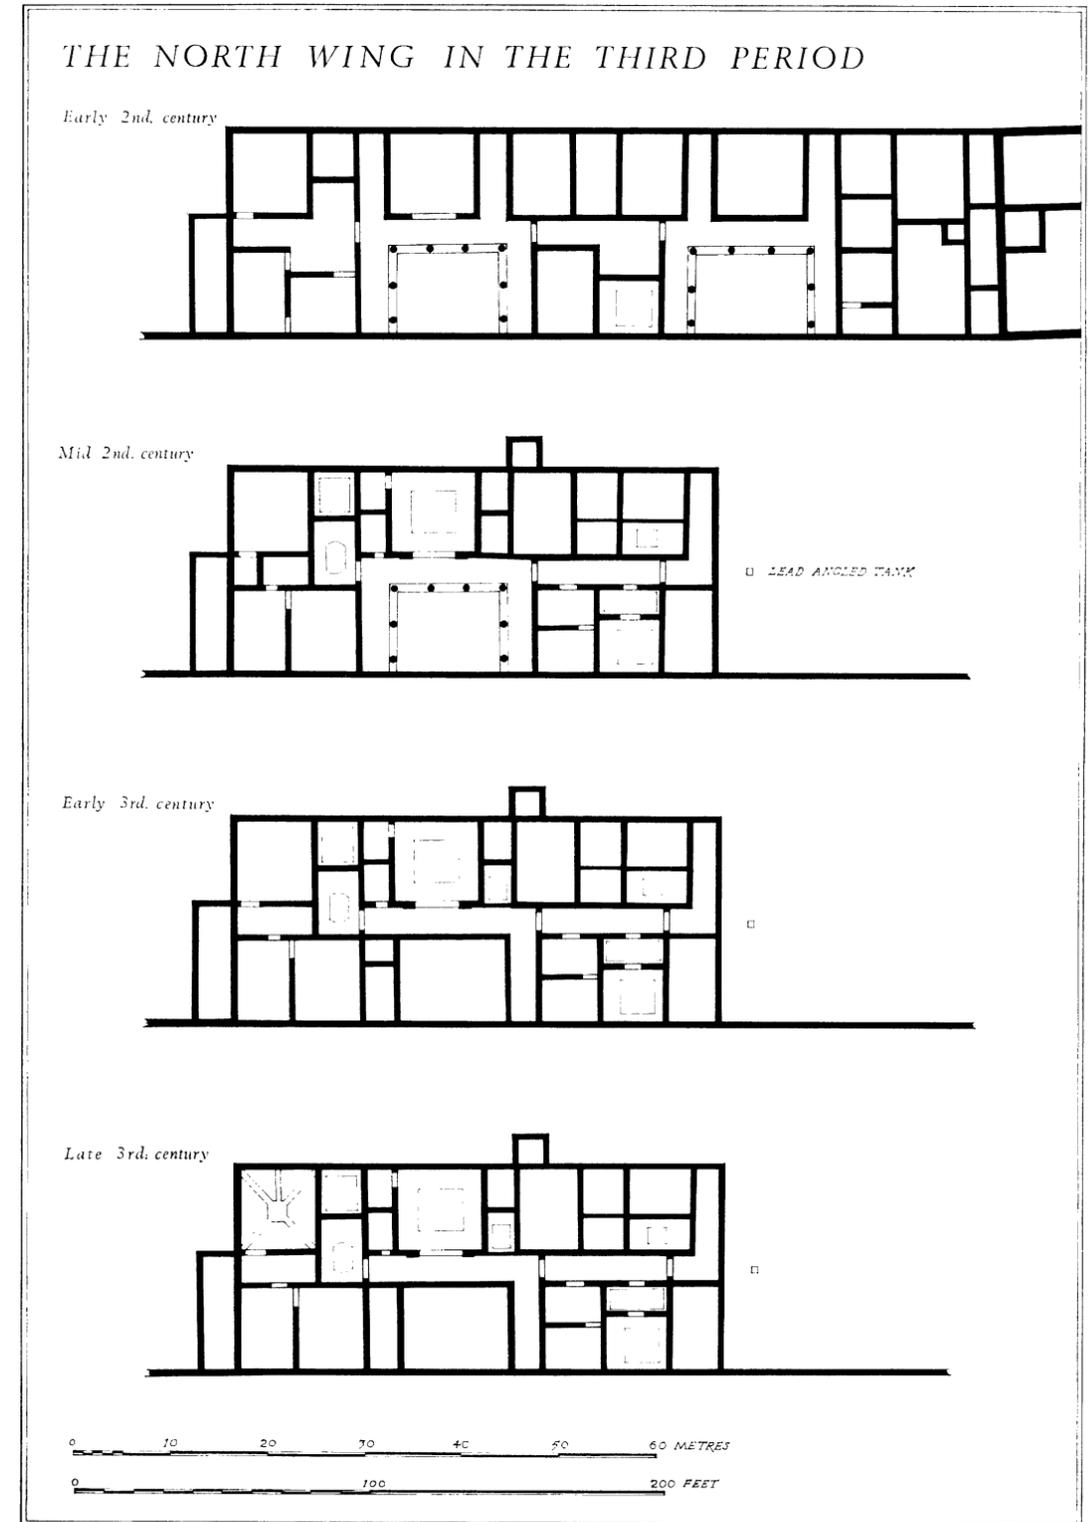
FIG. 45. Summary of the development in the North Wing

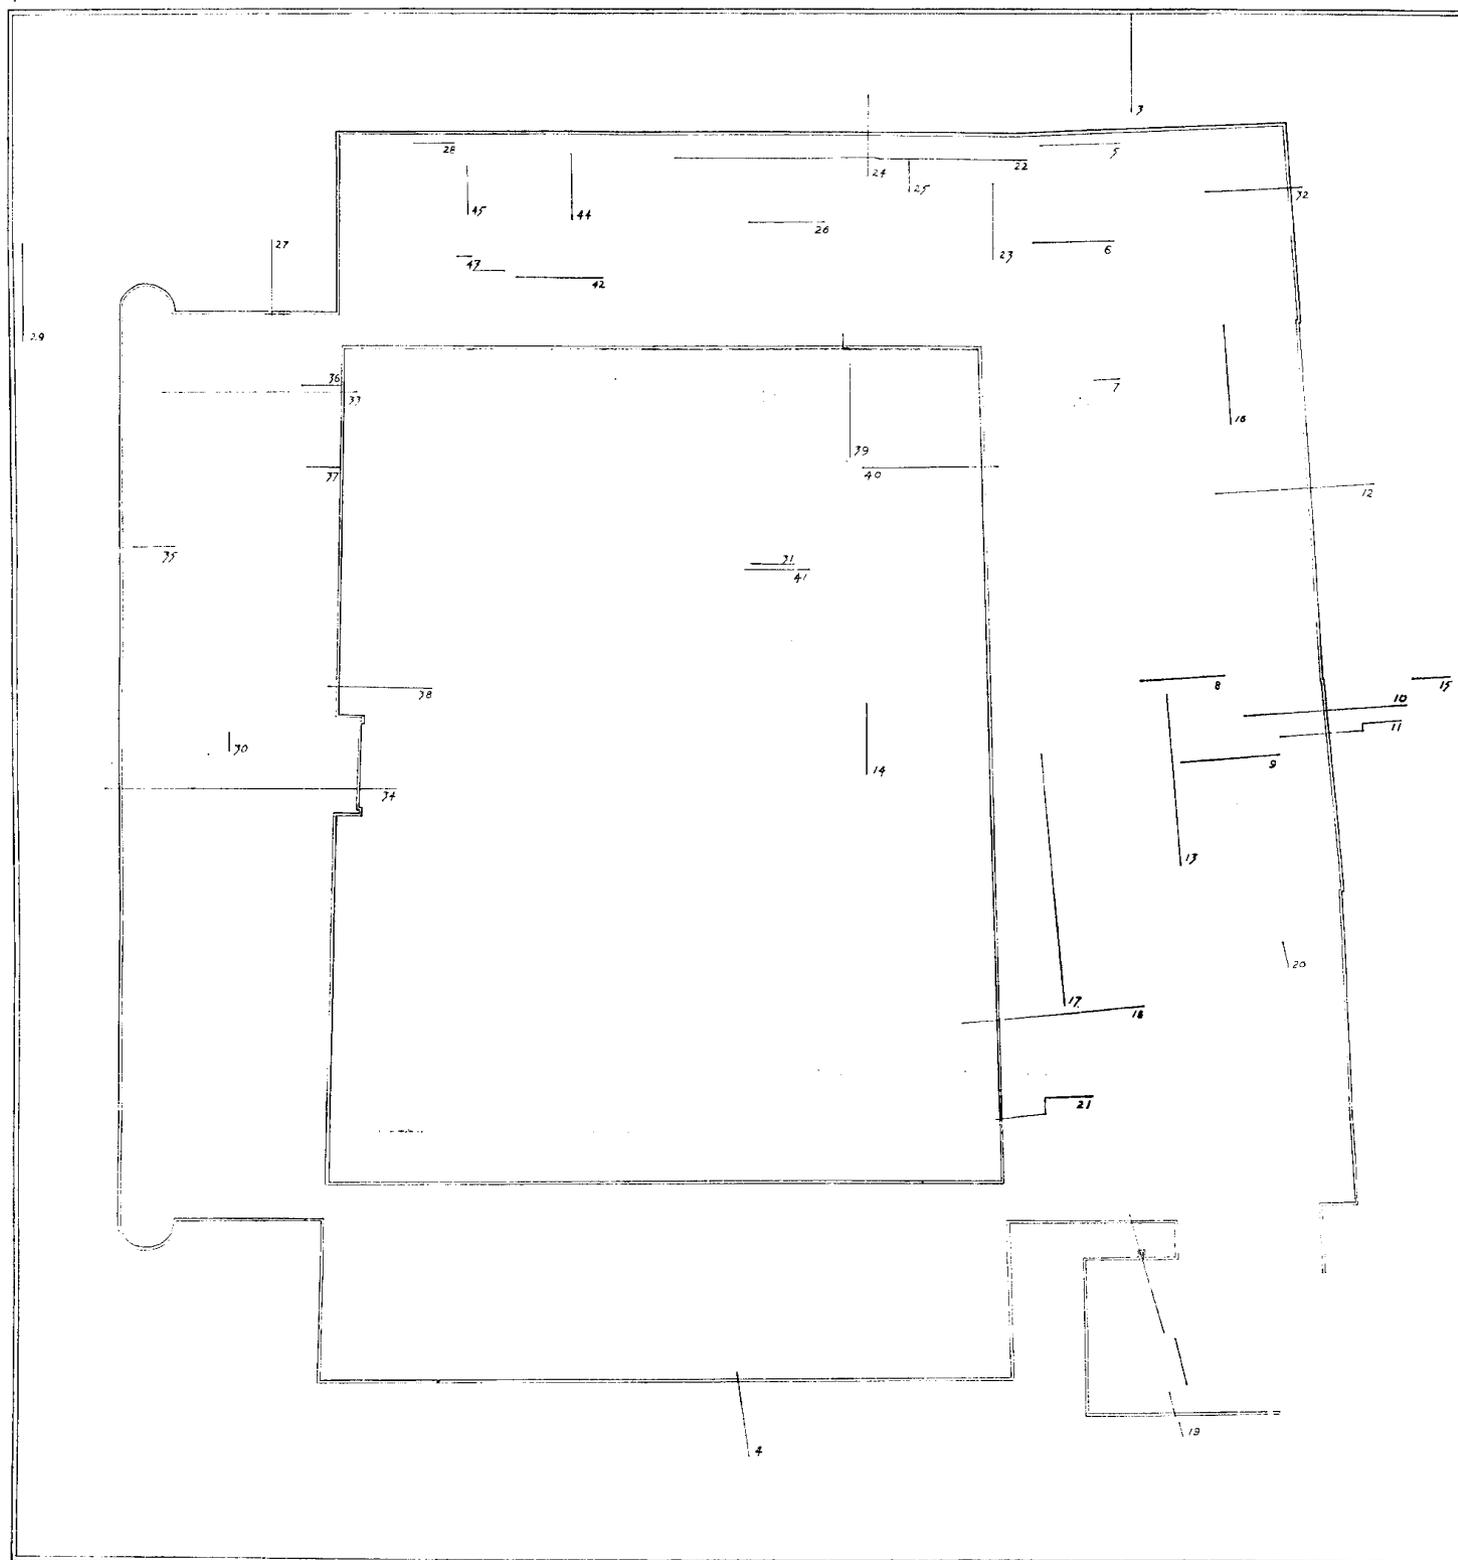
FIG. 60. Outline plan of the Second-Period palace showing the positions of the published sections, figs. 51-9

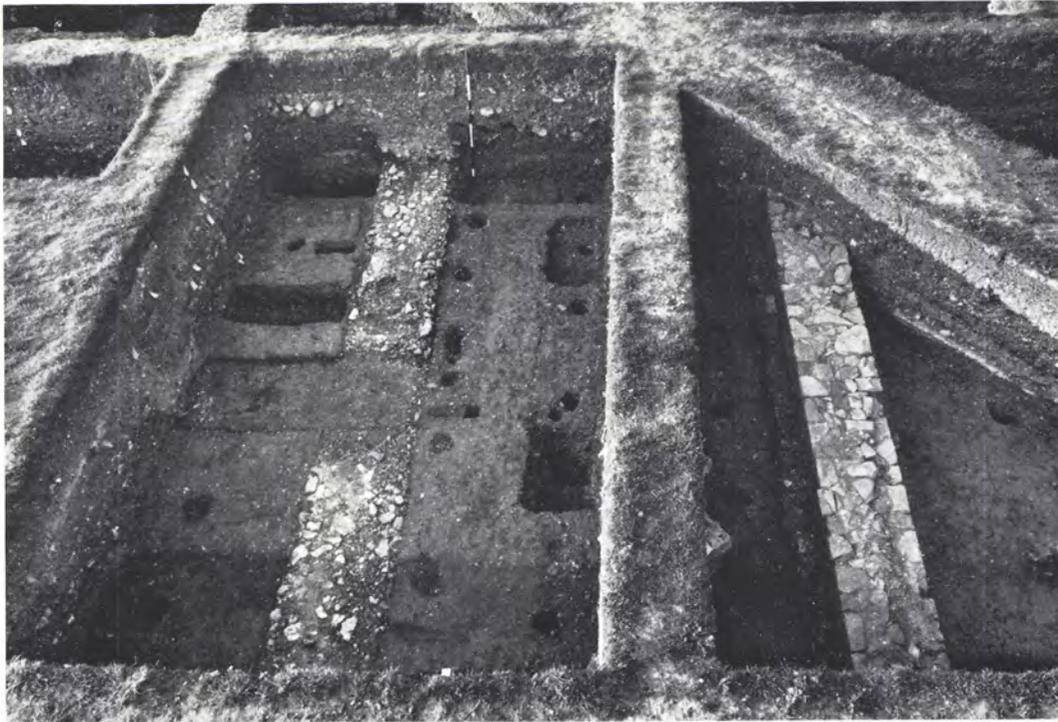
a. General view of Timber Building 1; looking north (p. 39)

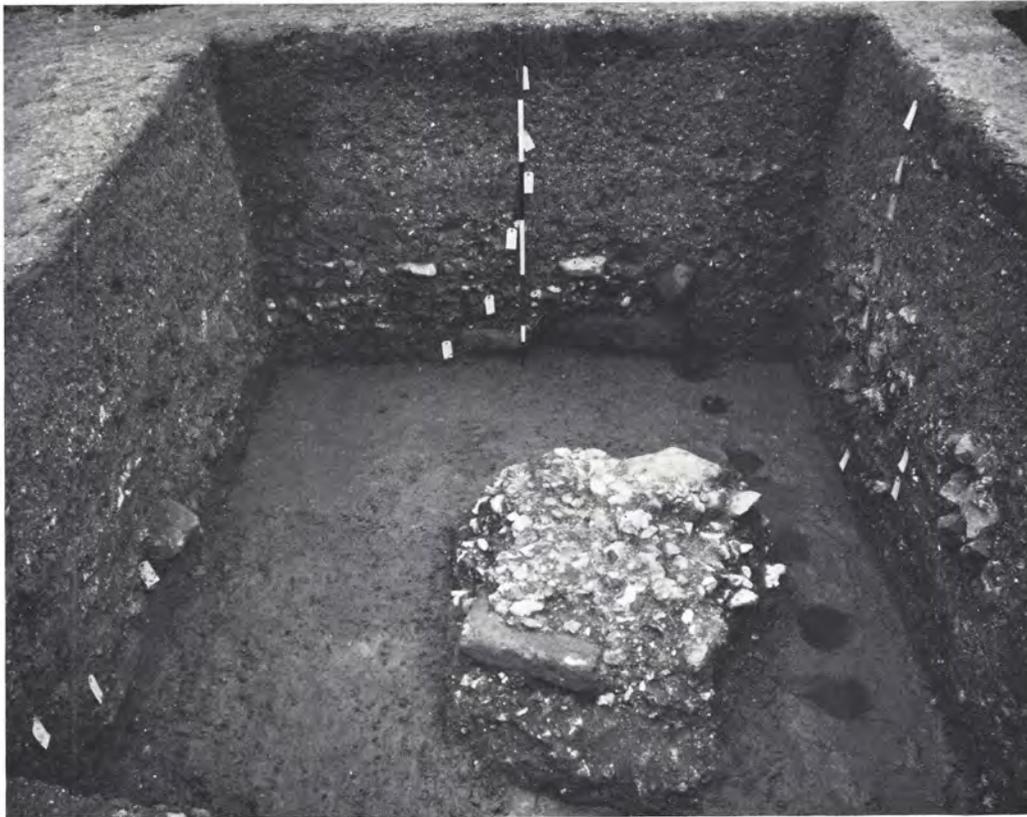
b. Post voids for the west revetment of the Period 1 B bridge. The remaining unexcavated part of the causeway can be seen in the foreground and in the section behind the rod (p. 46)

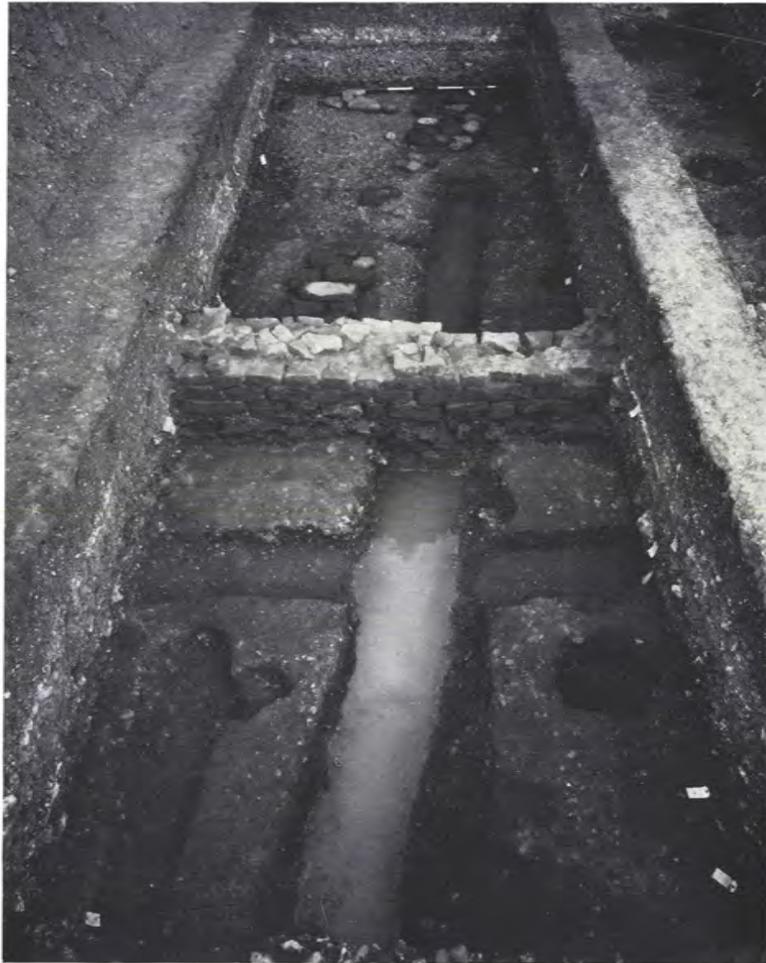
a. Period 1 C gully 11 and 1 B drystone footing behind the second period wall; looking east. The two large post holes on the right-hand side belong to the Period 1 C fence (pp. 57–8)

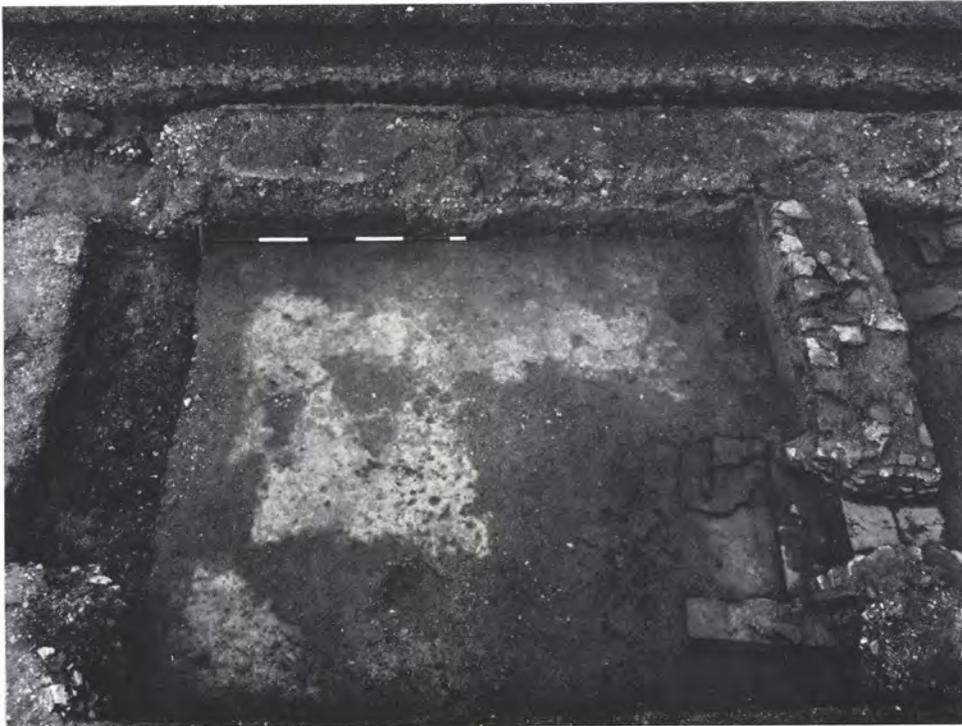
a. Room W 12 showing stoke hole (right) and burnt door sill (left);
looking west (p. 86)

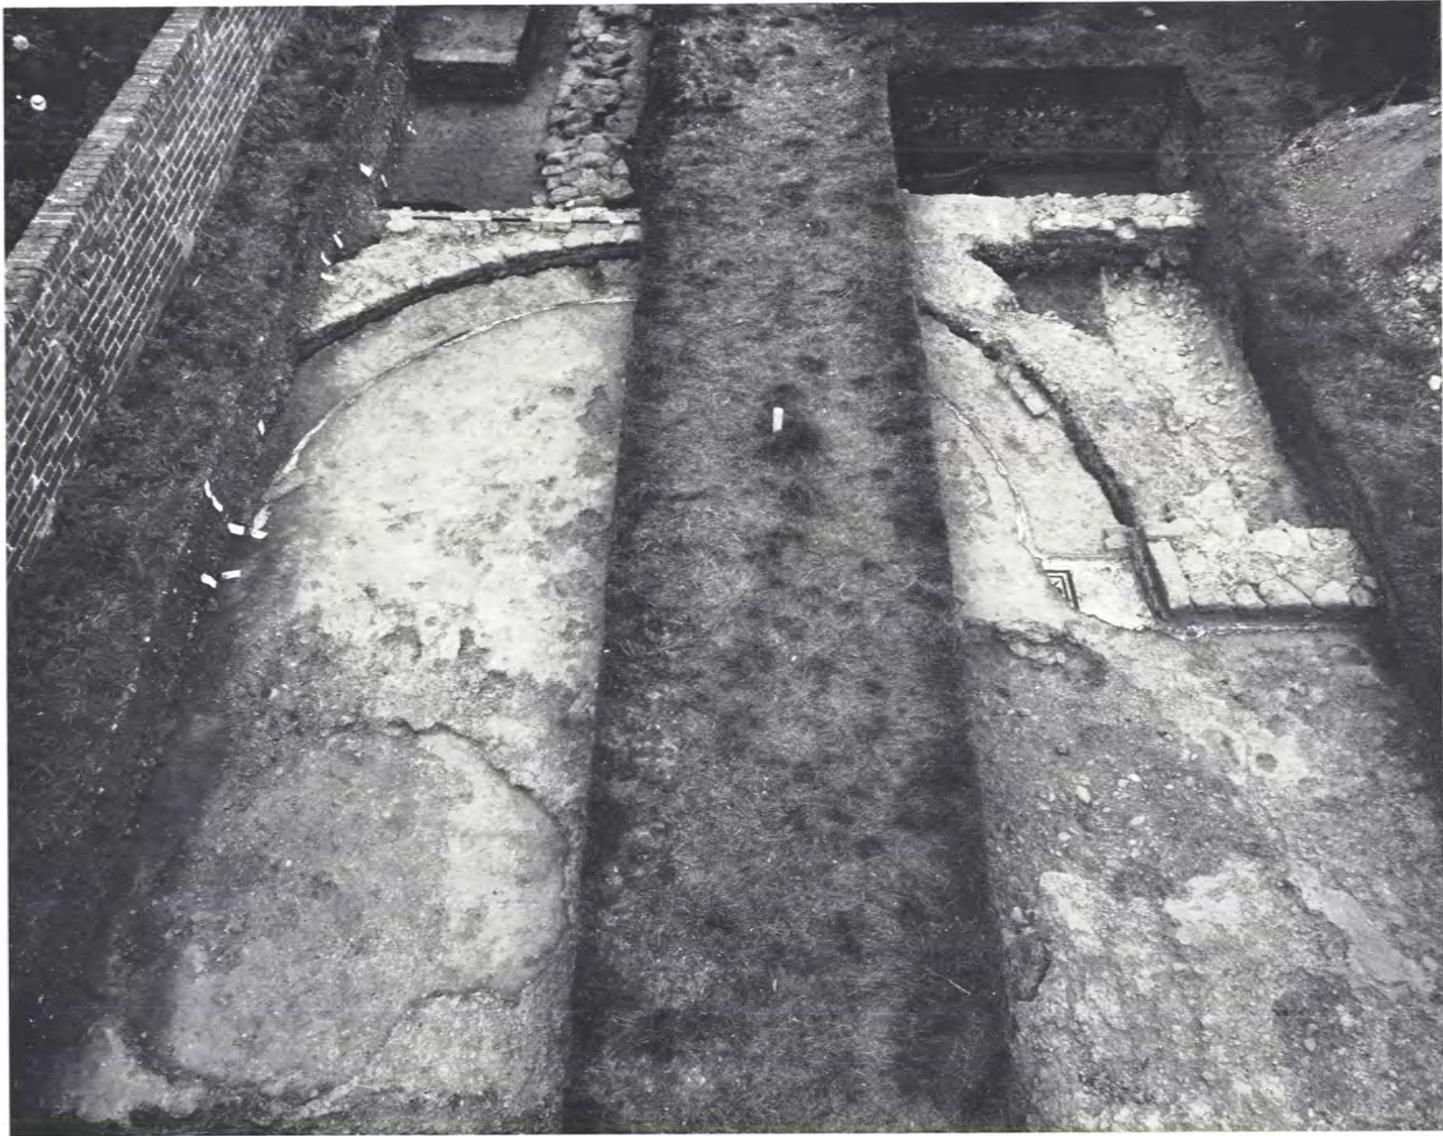
The apse of the Audience Chamber looking west, showing the position of the flanking bench within the apse and the corner of the mosaic still in position (p. 87)

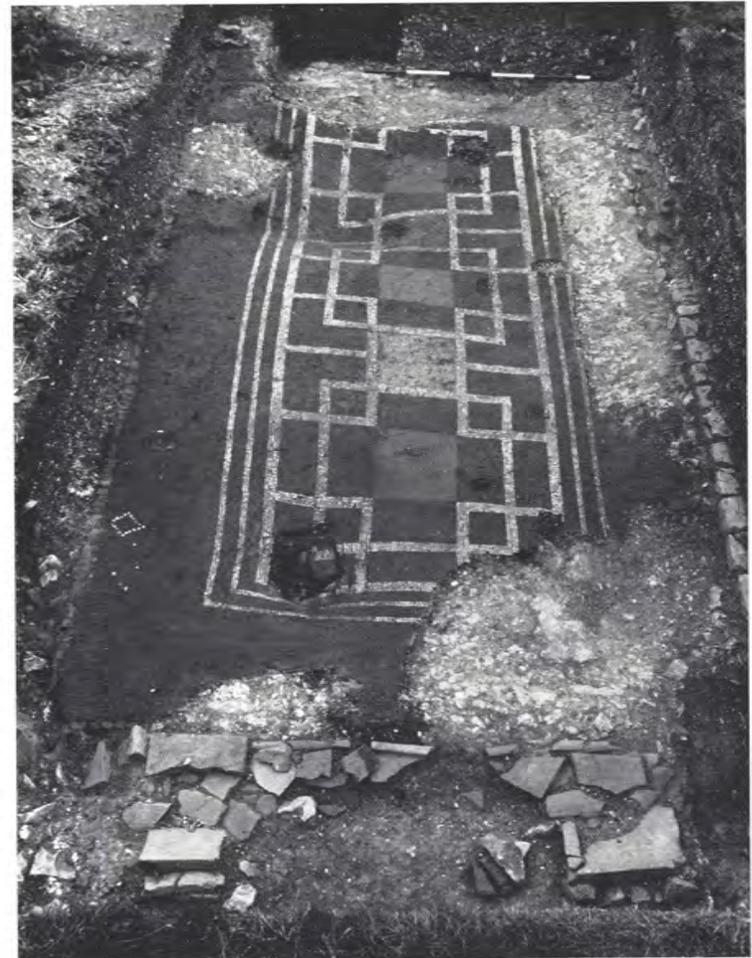
b. Second-Period polychrome mosaic in room N 21, looking west, showing subsidences caused by earlier post holes below, and the tile levelling for a door sill in the foreground (p. 100)
