EXCAVATIONS AT FISHBOURNE

Volume I: The Site

BARRY CUNLIFFE

Excavations at Fishbourne
1961 – 1969

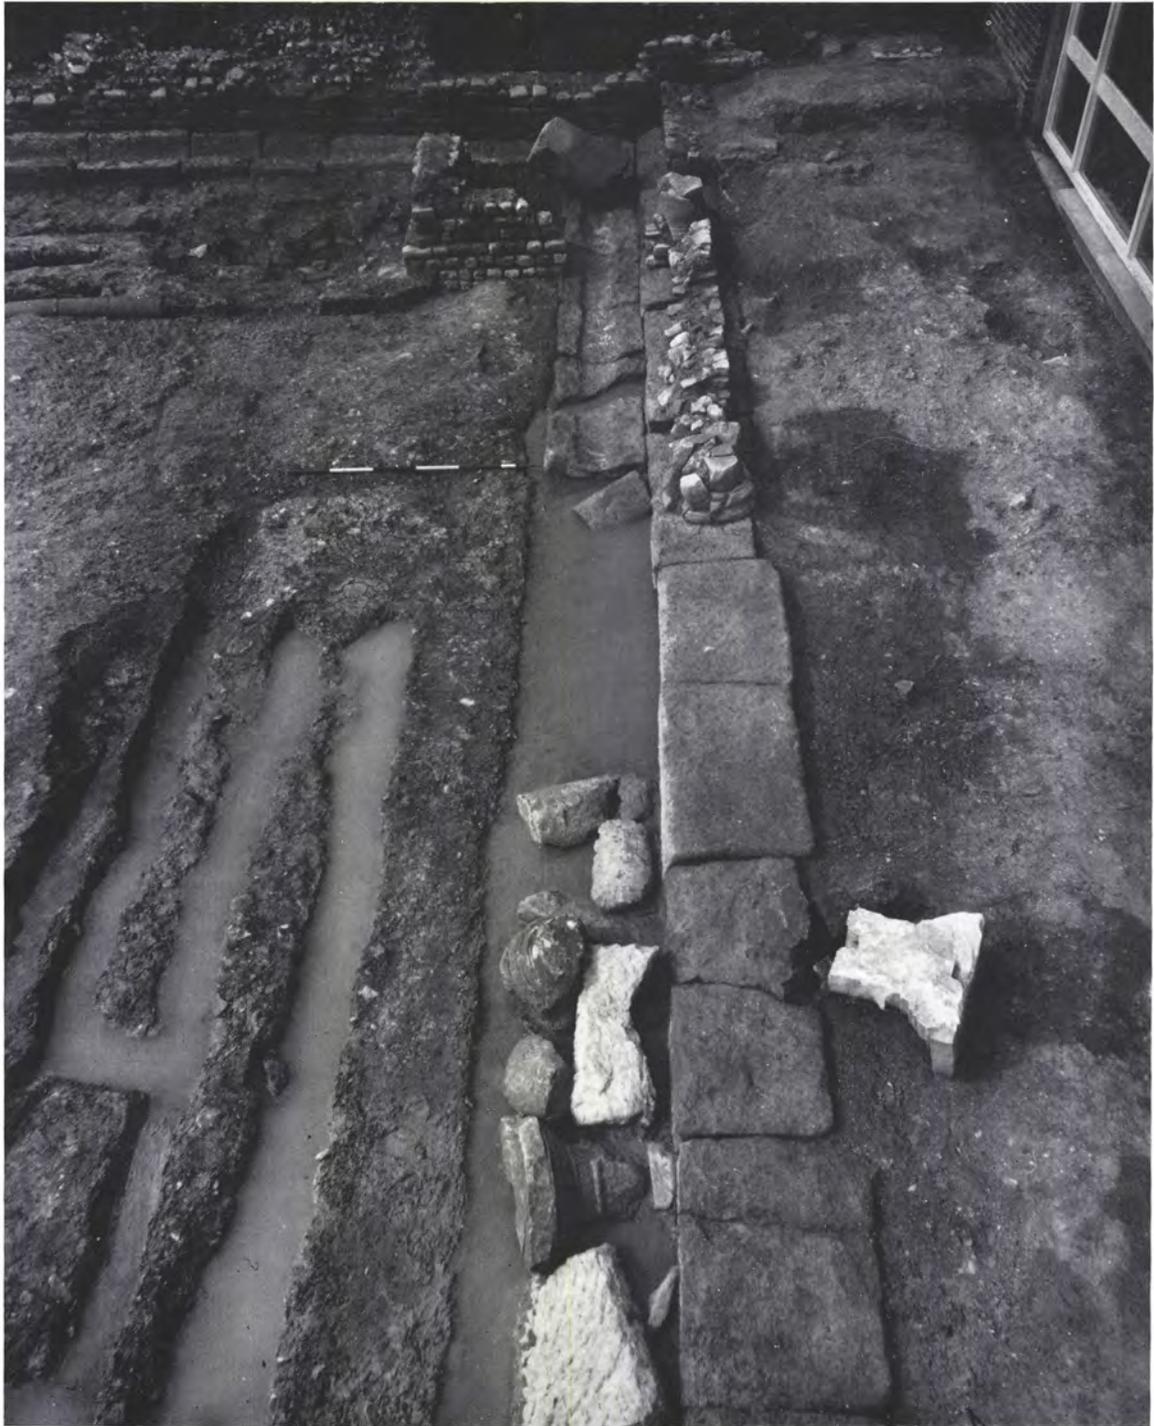
The north-west corner of the formal garden, looking west along the stylobate of the North Wing veranda to the revetting wall in front of the West Wing. Fragments of shattered columns lie in the foreground (p. 121)

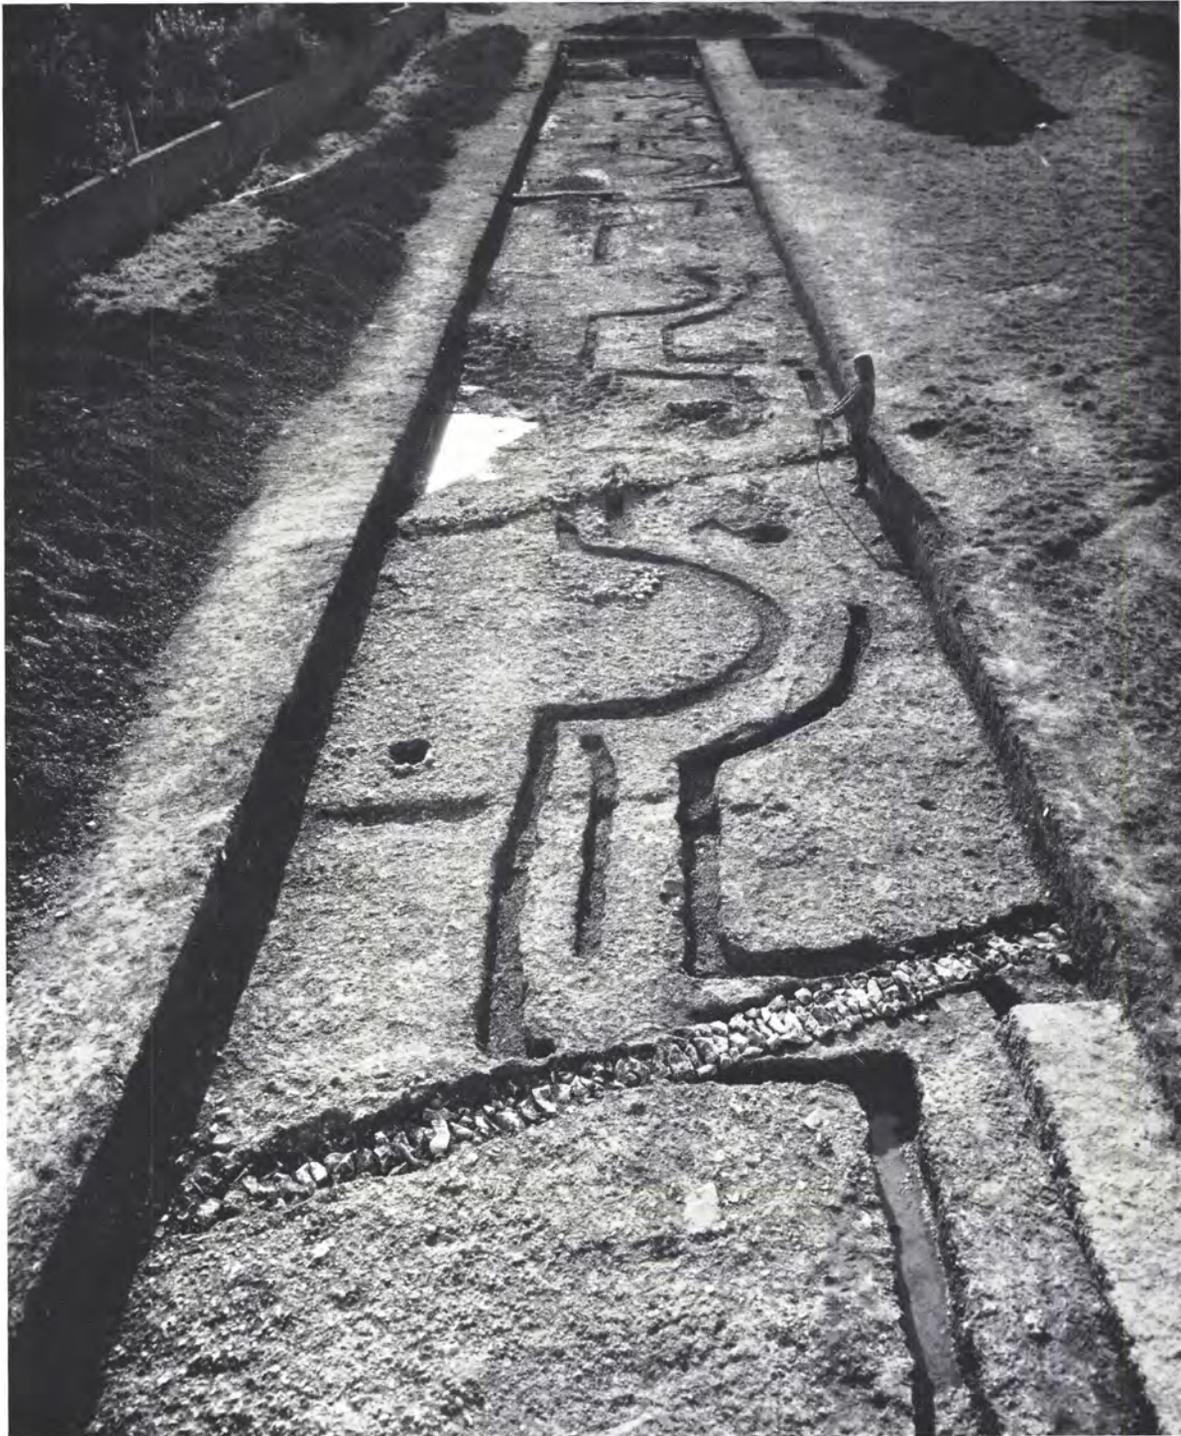
General view across the centre of the formal garden towards the Audience Chamber, showing the bedding trenches for the hedges lining the north side of the central path (p. 124). The diagonal stone-filled trenches are nineteenth-century field drains (p. 195)

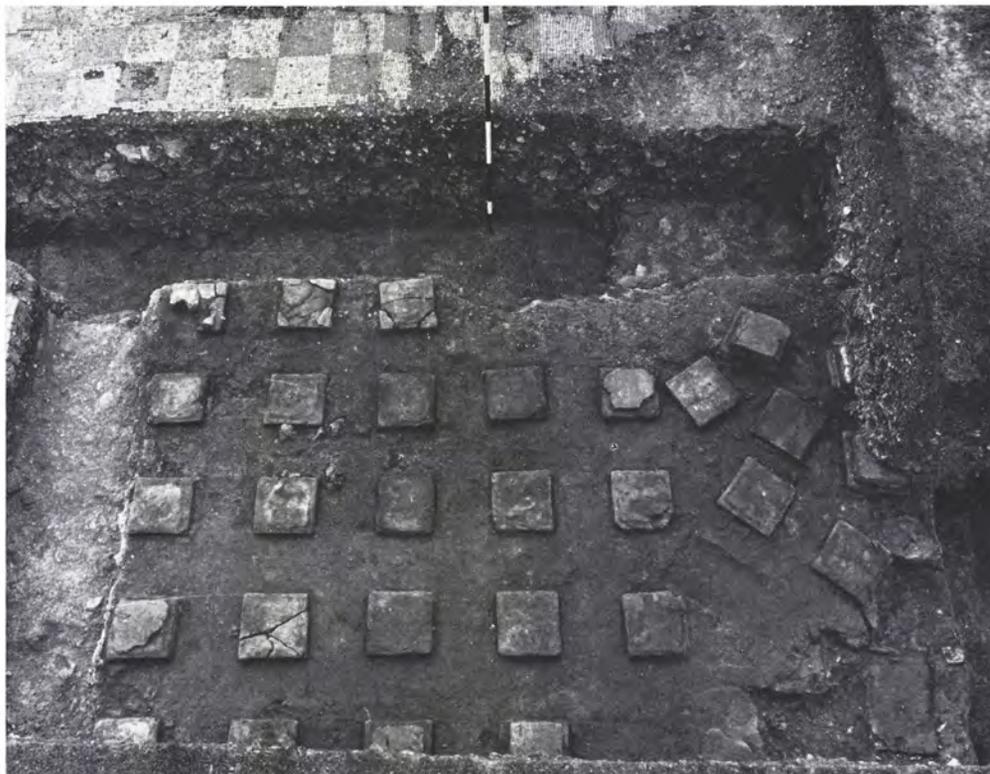
a. Mid second-century hypocaust in room N 8; looking west (p. 165)

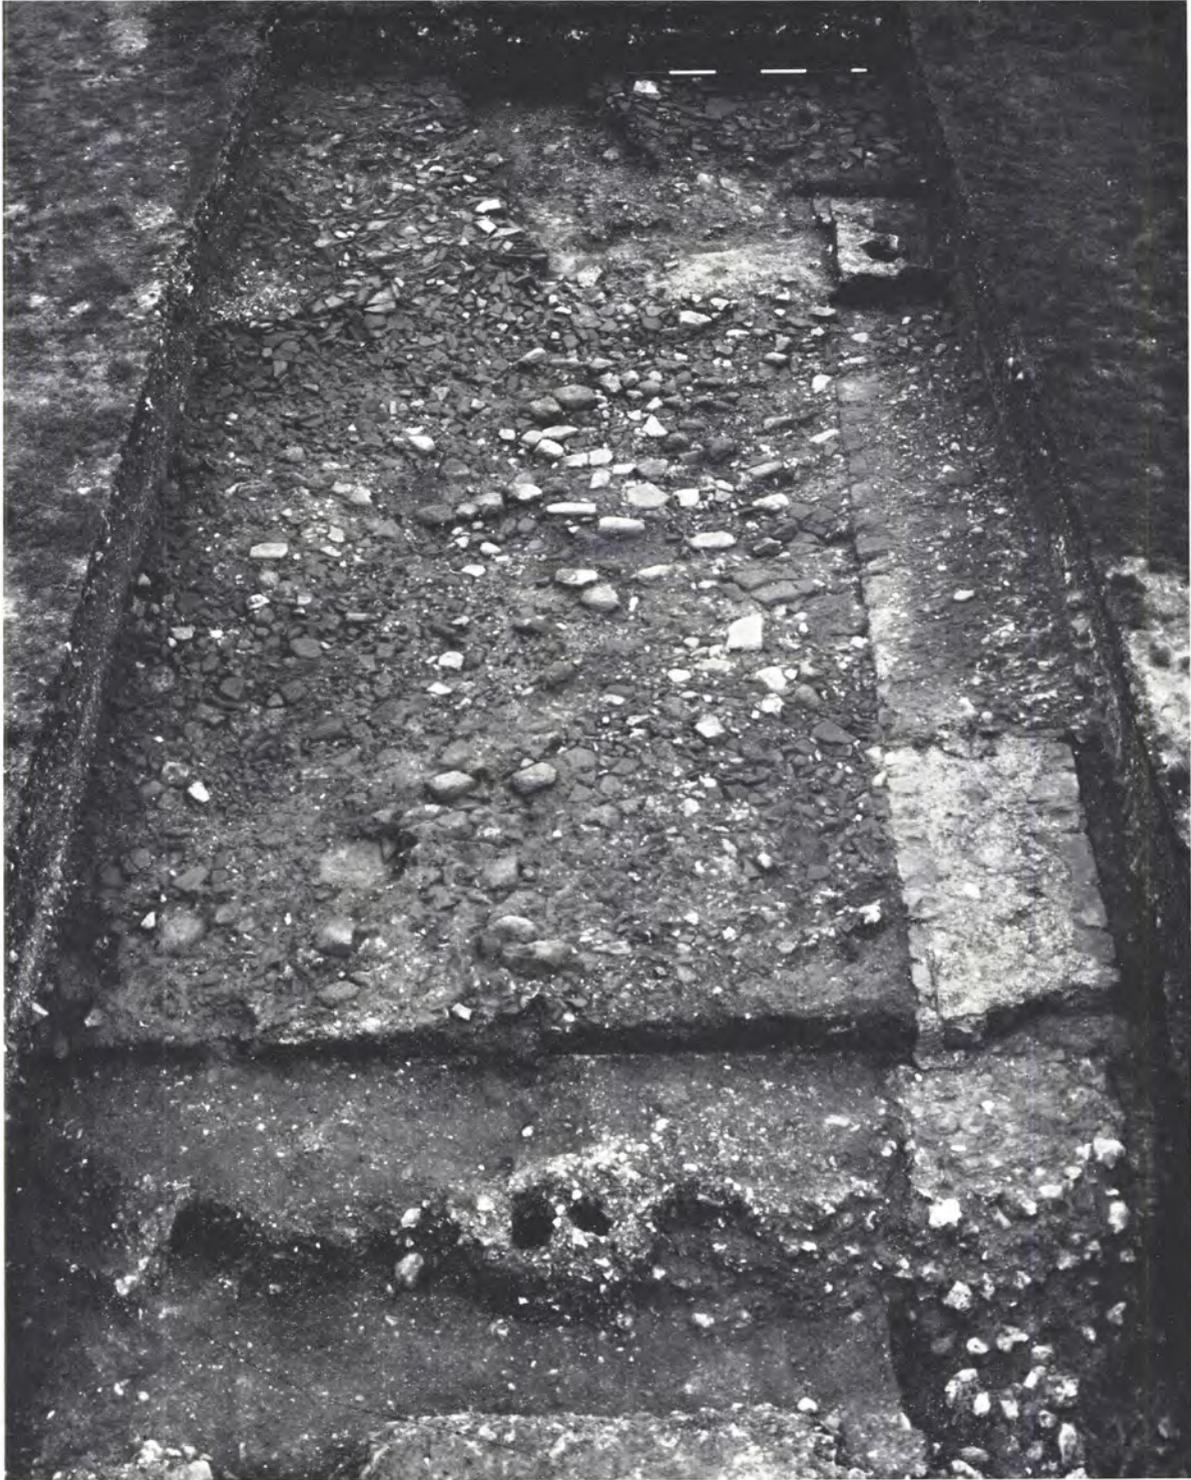
General view of the west end of the Entrance Hall, looking south across the mass of collapsed roof tiles and rubble showing the wear caused by the constant passage of traffic in the third century (p. 182)

- LXVII The Entrance Hall in the East Wing showing collapsed tile roof worn by traffic
- LXVIII *a* Stone anvils in Room N 4
b Burnt door sill leading to Room N 6

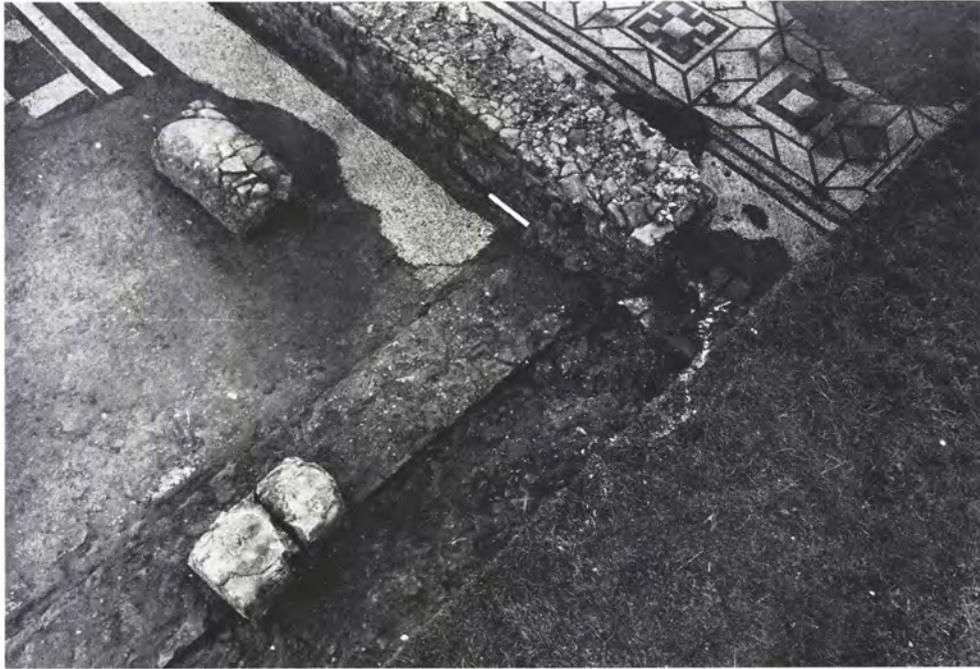
a. The north-west corner of room N 4 showing the two stone anvils still in position; looking south-west (p. 188)

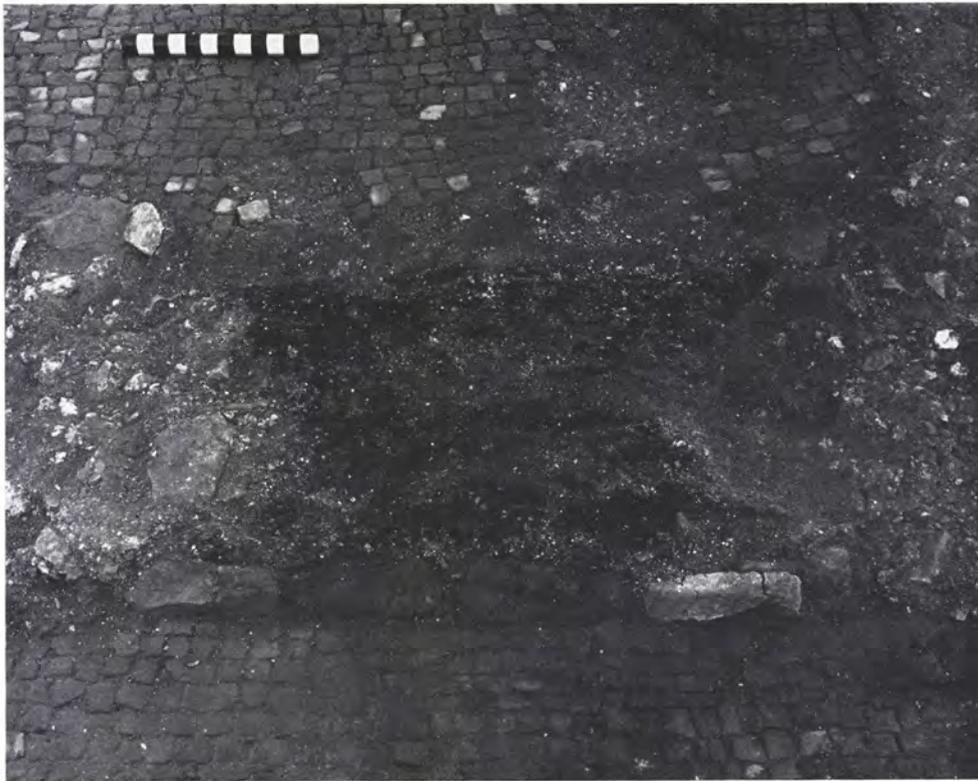
b. Burnt door sill leading into room N 6; looking north (p. 187)

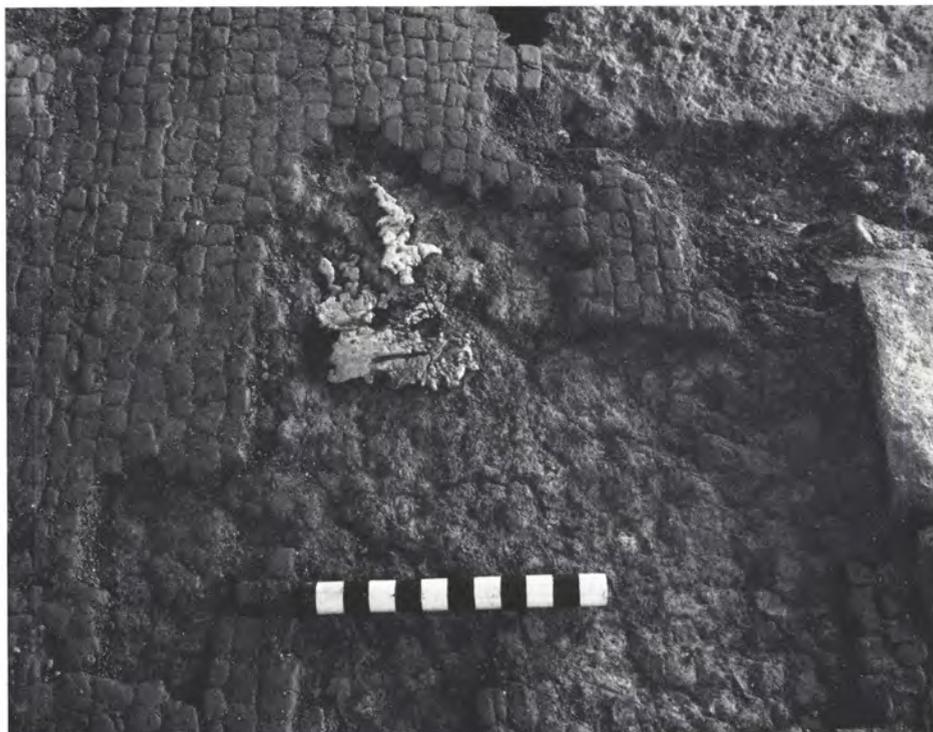
a. Lead puddle formed by the dripping of molten lead on to the already worn tessellated corridor floor in front of room N 7; looking east (p. 187)

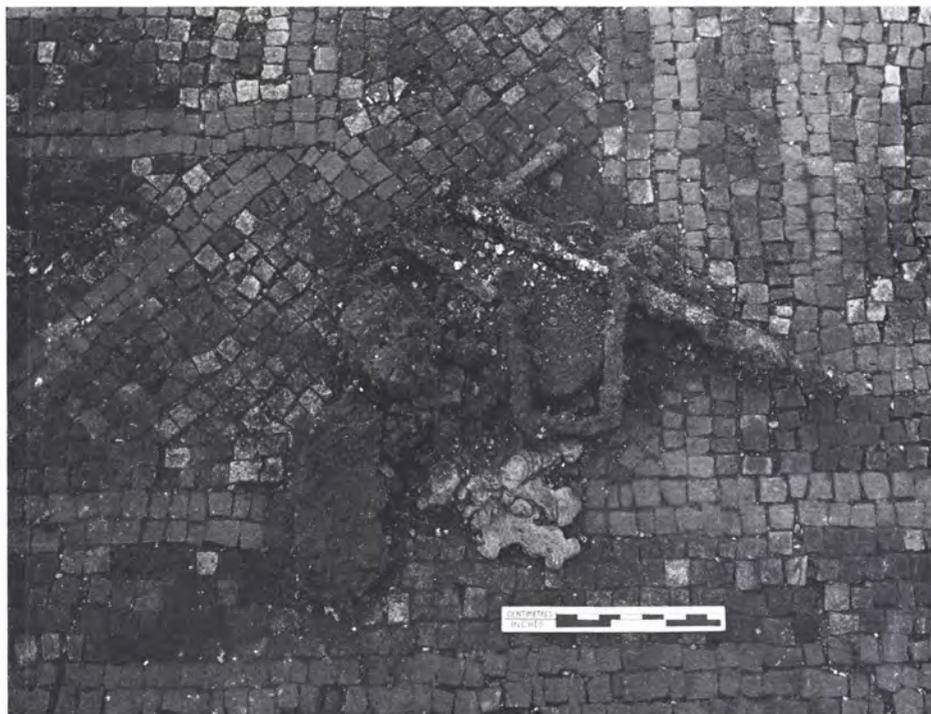
b. Lead puddle and collapsed iron work on the floor of room N 12; looking east (p. 188)
