The impact of vertical greening on local microclimate: preliminary results of field monitoring in Ghent, Belgium

Marie De Groeve¹, Eda Kale¹, Tim De Kock¹, Scott Allan Orr²

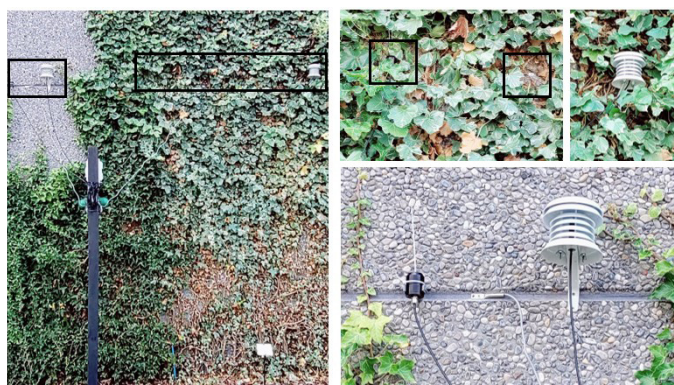
Figure 1. Set-up of monitoring devices on the wall of the case study in Destelbergen with a set-up on the bare wall and a set-up in the vertical greening (*Hedera Helix* 'Glacier').

In order to make a good comparison between the environmental conditions surrounding the bare wall and the green wall, the same monitoring devices are installed on both parts of the wall (Figure 1). The air temperature and relative humidity are measured together with a HOBO S-THC-M002 smart sensor which is covered by a solar radiation shield (HOBO RS3-B) to prevent the measurements from being affected by the solar irradiation. This device is installed at a distance of 10 cm away from the wall surface. The surface temperature is measured with a HOBO TMC6-HE temperature sensor, which is mounted against the wall. The amount of solar irradiation is measured with a silicon pyranometer sensor (HOBO S-LIB-M003) covered by an light sensor level (HOBO MLLA) to receive accurate measurement and is mounted as close as possible against the wall.

The sensors for air temperature, relative humidity and solar irradiation are connected to a HOBO USB Micro station data logger, which collects their data at a frequency of 15 minutes. The surface temperature is connected to a 4-Channel Analog Data Logger, HOBO UX120-006M, and provides measurements at a frequency of 15 minutes.

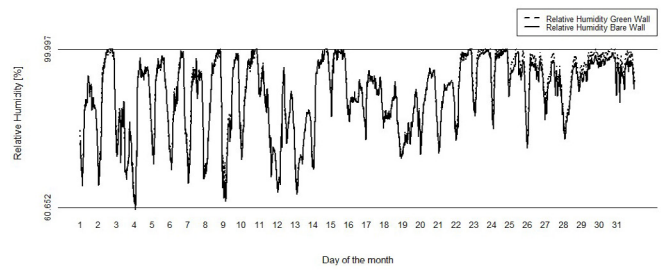
Figure 4. The graph is a subset of the whole measuring period and illustrates the relative humidity of a wall behind the vertical greening and a wall without vertical greening during the month October 2022.

Thirdly, the relative humidity is measured with the same measurement device as the air temperature and is therefore also installed on a distance of 10 cm relative to the wall. By comparing the two walls to each other, there is only a small difference noticeable in the relative humidity due to the implementation of vertical greening. Over the whole monitoring period, the relative humidity of the green wall is on average $+1.07\%$ higher relative to the corresponding bare wall. Due to

the low amount of solar irradiation in the north orientation, it is likely to have a lower amount of evaporation which contributes in rising the relative humidity in front of a green wall.
