# THE MAYA TEMPLE-PALACE OF SANTA ROSA XTAMPAK, MEXICO

DOCUMENTATION AND RECONSTRUCTION OF FORM,  
CONSTRUCTION, AND FUNCTION

HASSO HOHMANN

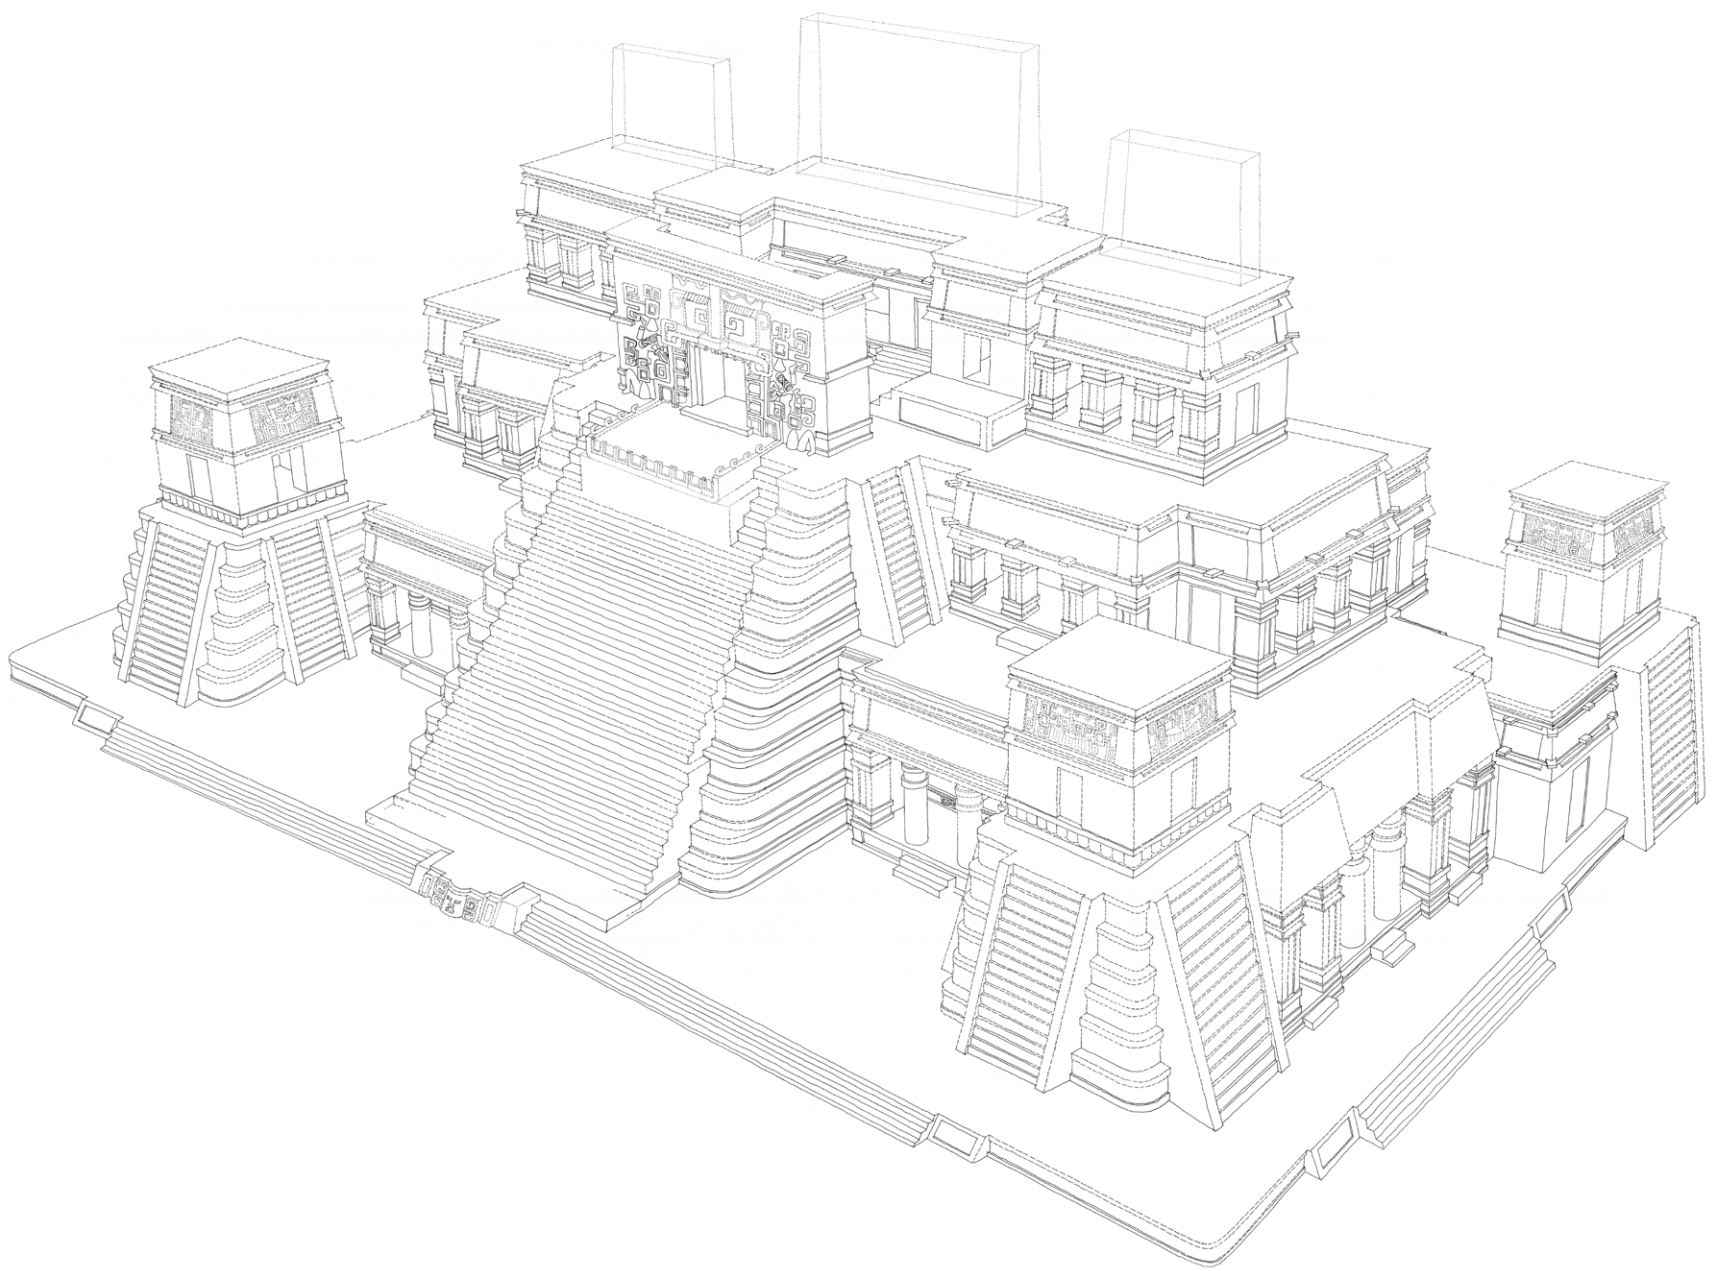
Frontispiece:

Bird's-eye view from the Northeast. This perspective is the main view of the Palace, showing three of the four smaller temple pyramids at the corners of the Palace, the central "Pyramid" with Stairway A and the pseudo Stairway B together with the mega steps and the huge monster mouth passageway in front of the small courtyard on the third floor.

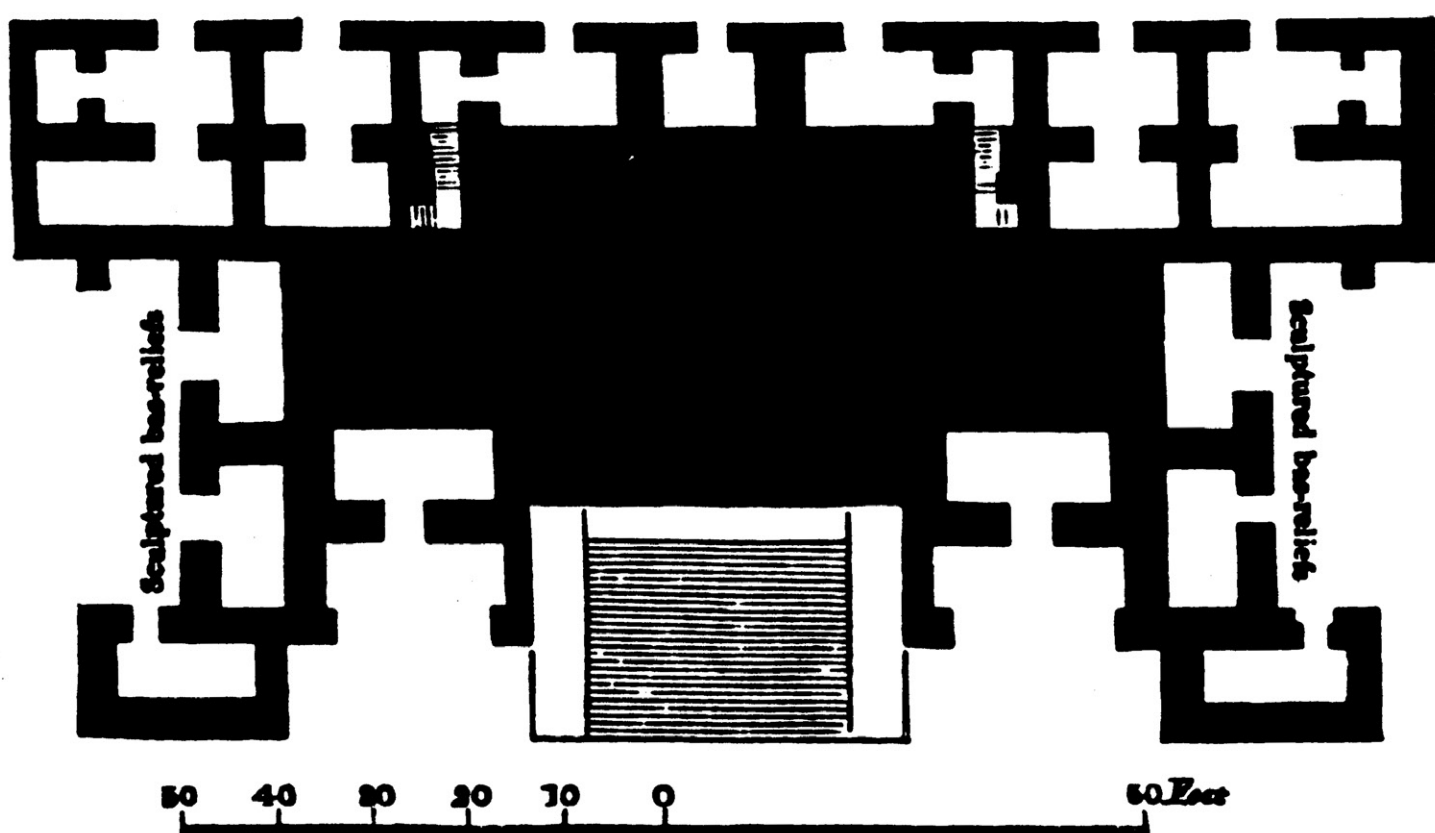
Fig. 3

Catherwood only produced a ground plan of the first floor. He did not discuss the reconstruction of missing supports in Room 1 and in Room 9.

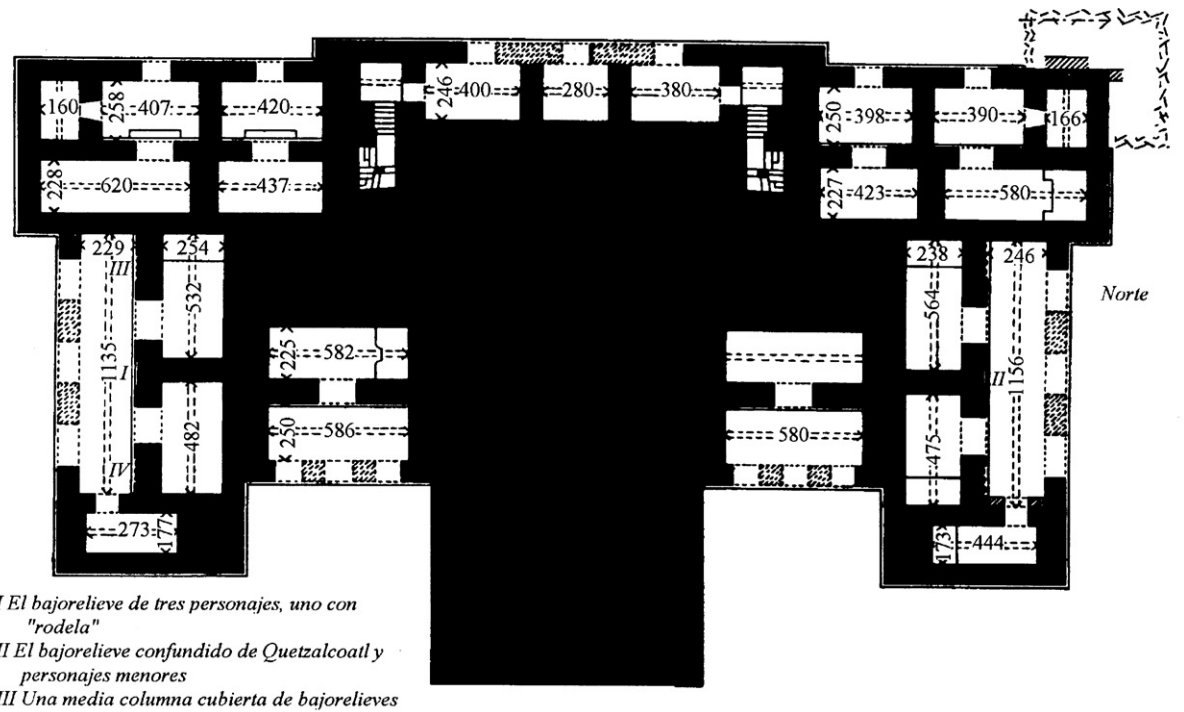
Fig. 4  
 The first floor; Teobert Maler tried to reconstruct missing supports at the Palace. His plans provide measurements and include vaults. The first floor ground plan also shows benches. Along the western façade he introduced a broad central risalit hypothetically, which does not really exist. He was the first to see the extension of the structure at the northwestern corner – the steep pseudo stairways leading up to Room 45, which was excavated by Zapata Peraza more than a hundred years later. Drawing: T. Maler 1891

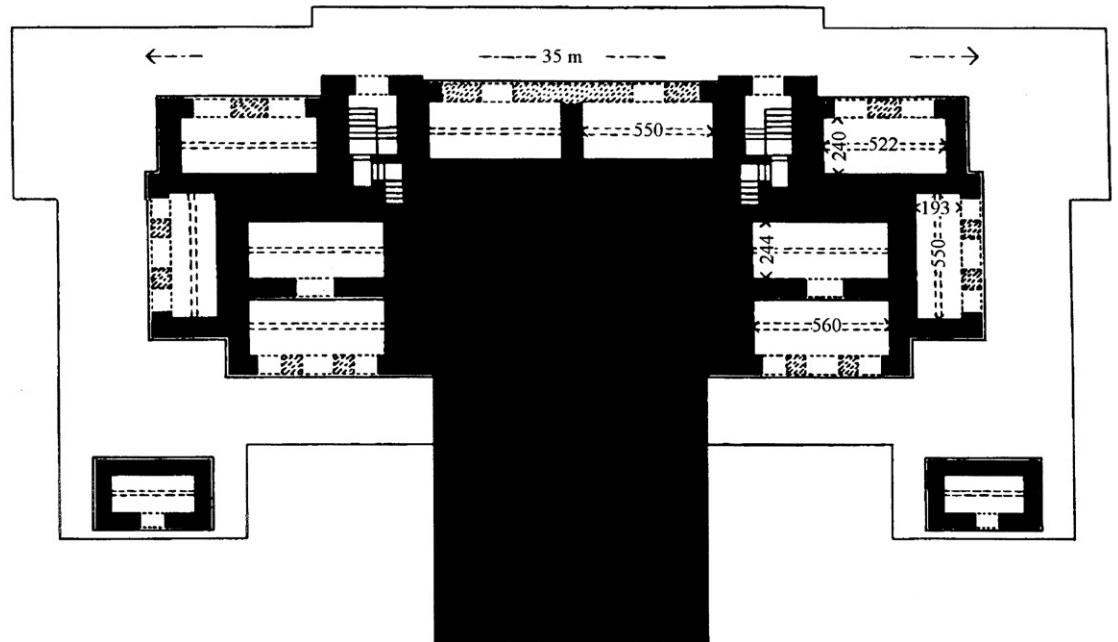
Fig. 5  
 The second floor also shows missing and reconstructed supporting elements. Drawing: T. Maler 1891

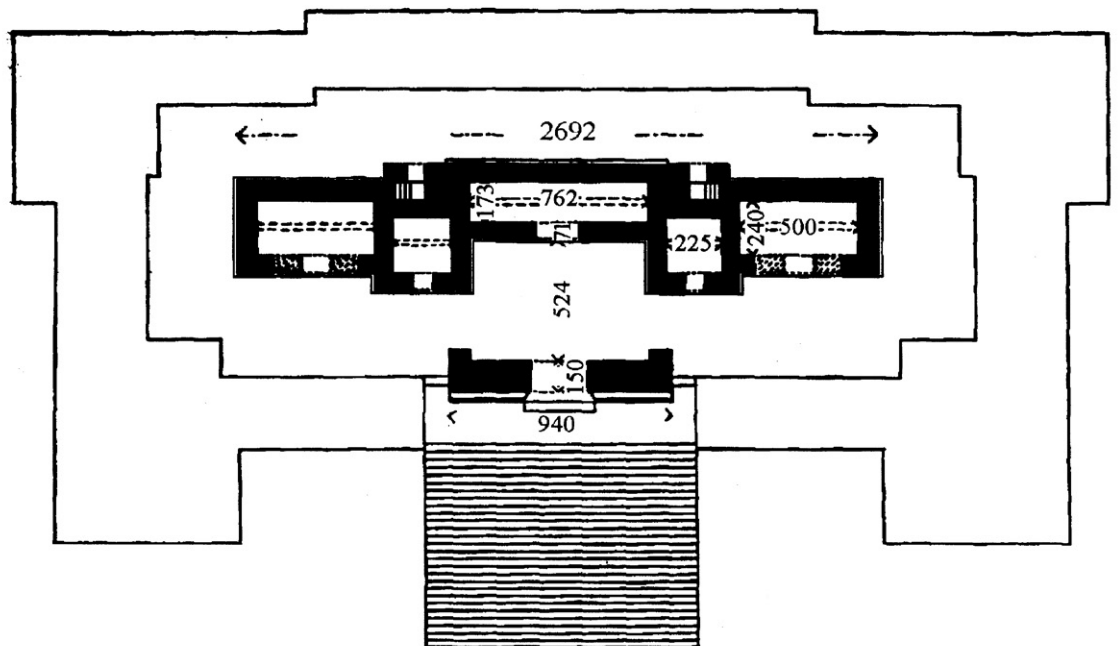
Fig. 6  
 The third floor again shows missing and reconstructed wall sections. Drawing: T. Maler 1891

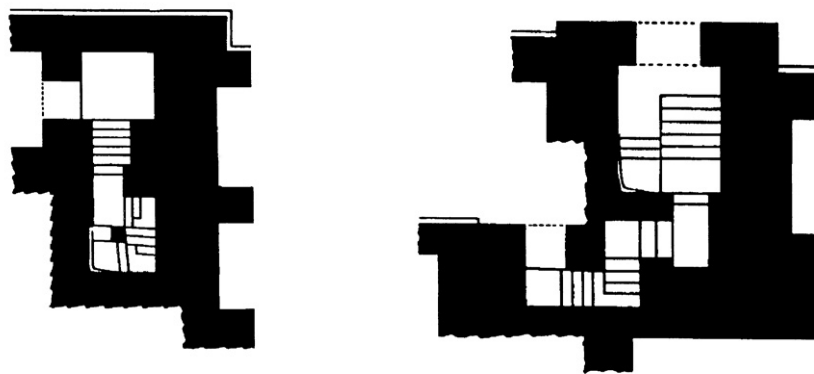
Fig. 7  
Of the two staircases Maler documented the northern one on a larger scale.  
Drawing: T. Maler 1891

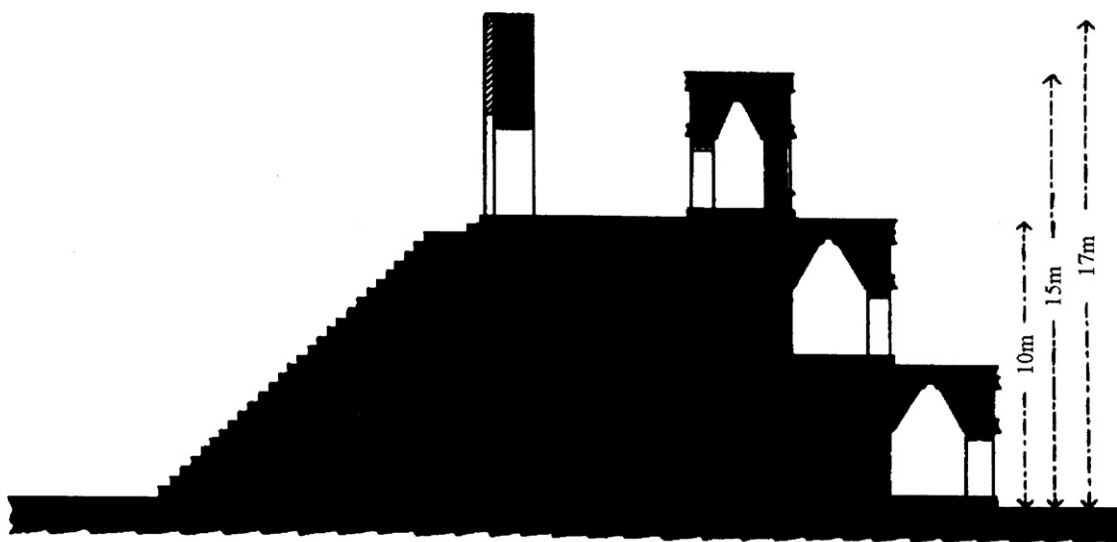
Fig. 8  
Maler even produced a section through the Palace. The reconstructed monster mouth passageway might be too high.  
Drawing: T. Maler 1891

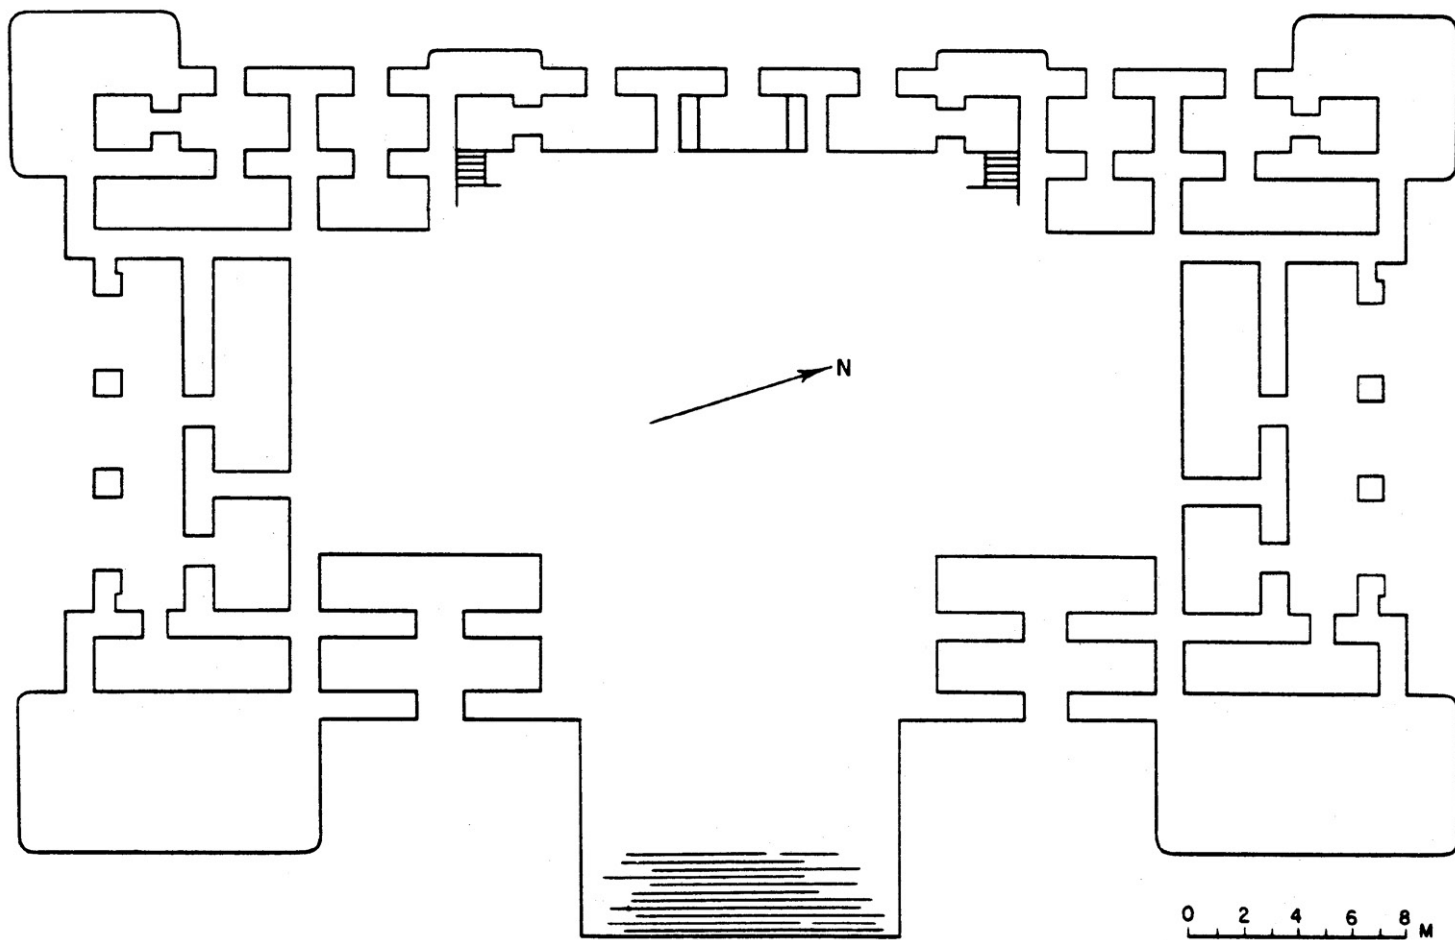
Fig. 9  
 In this first floor ground plan Ruppert reduced Maler's hypothetical wall sections to pillars in the North and in the South. These pillars would not have been sufficient from a static point of view.

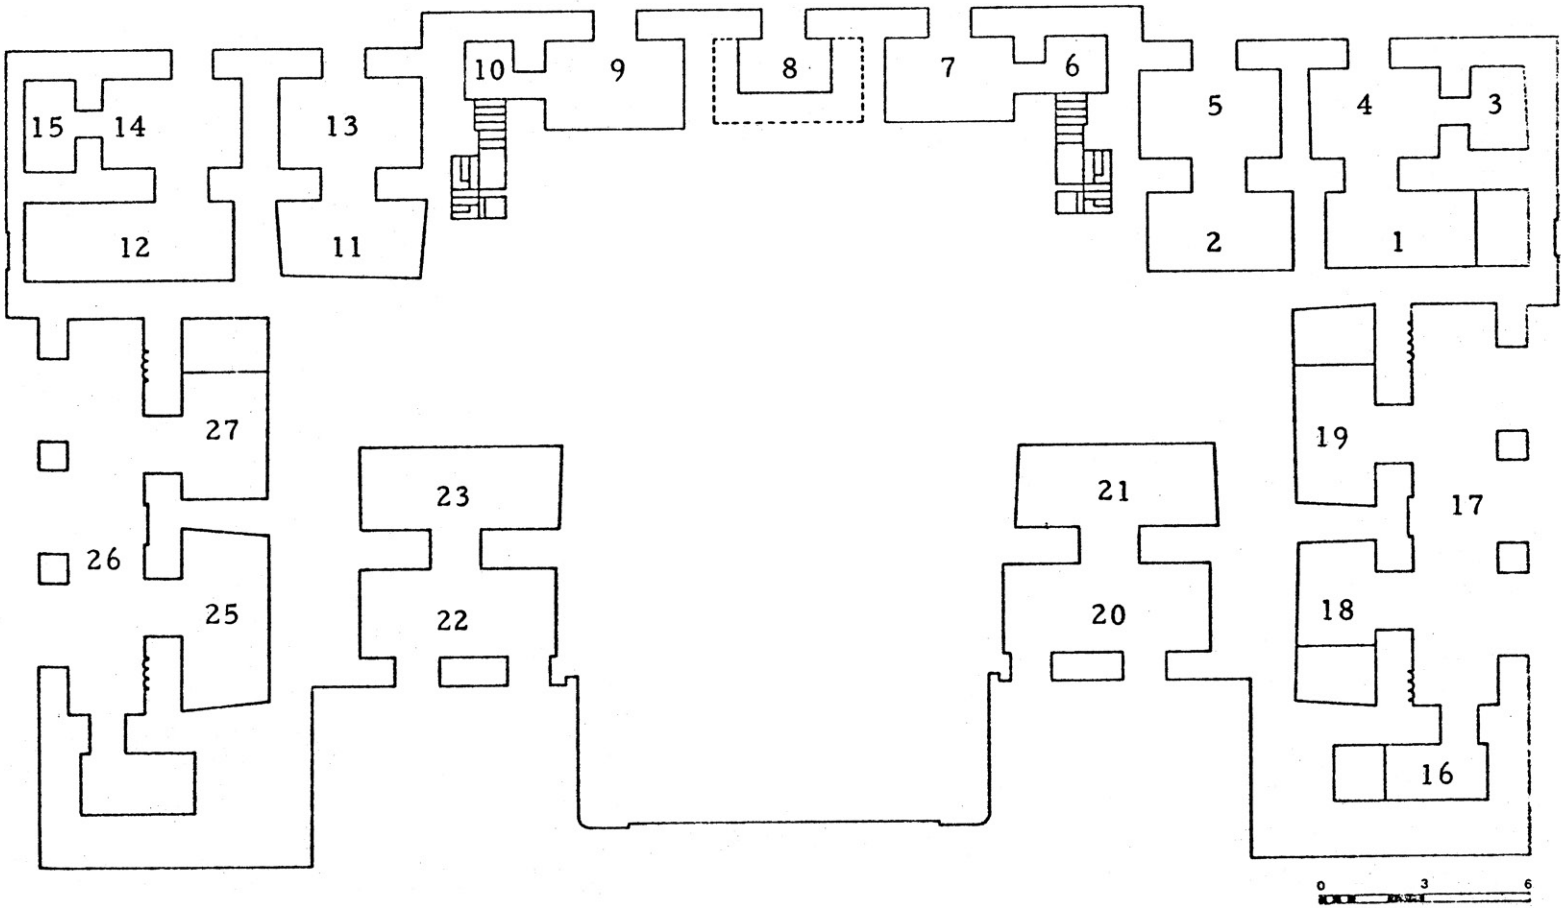
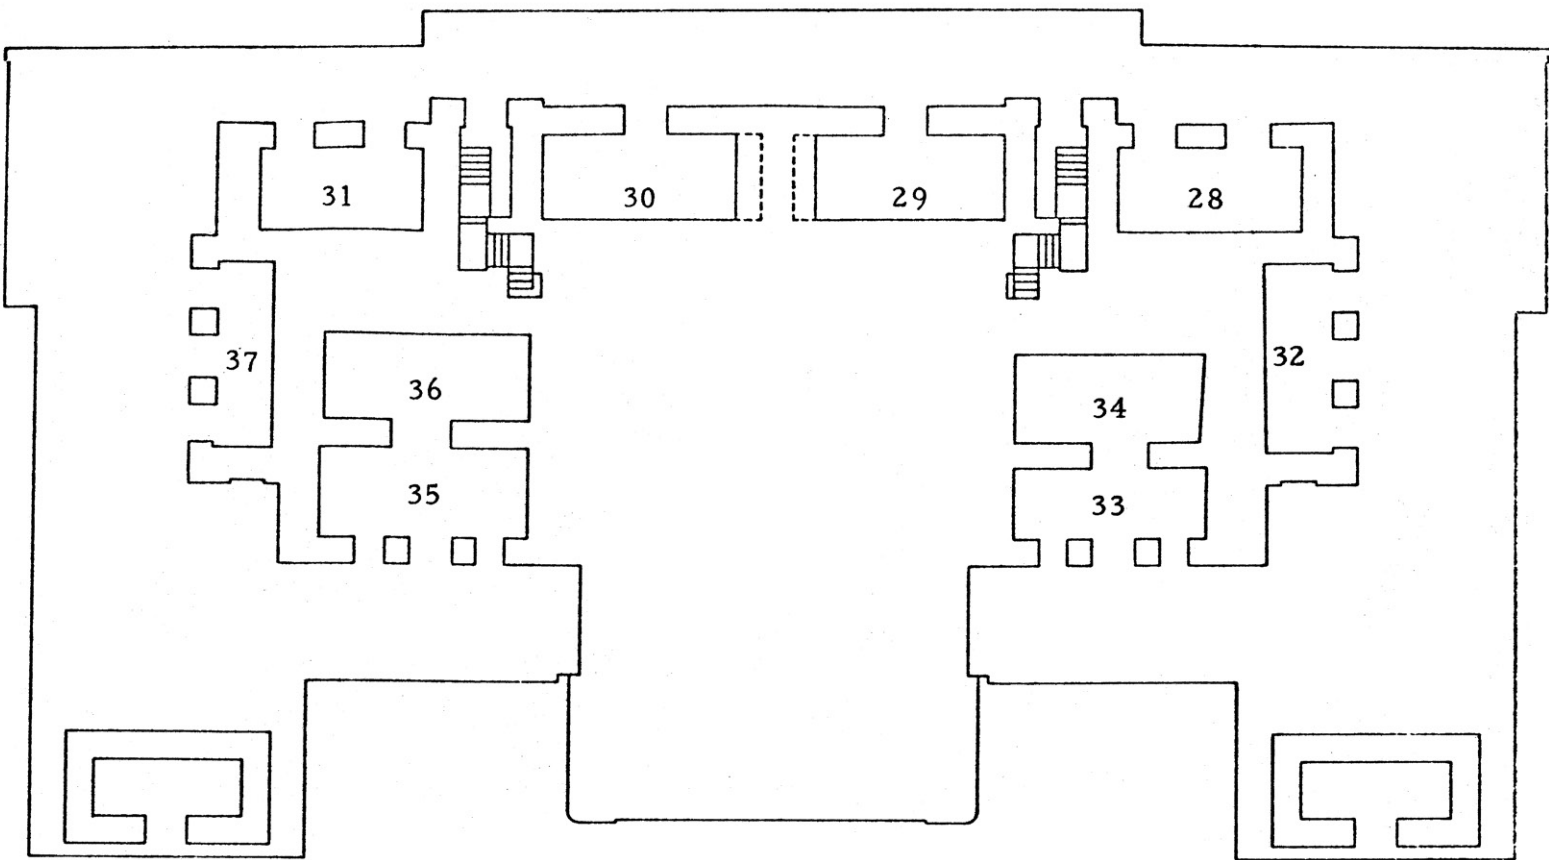
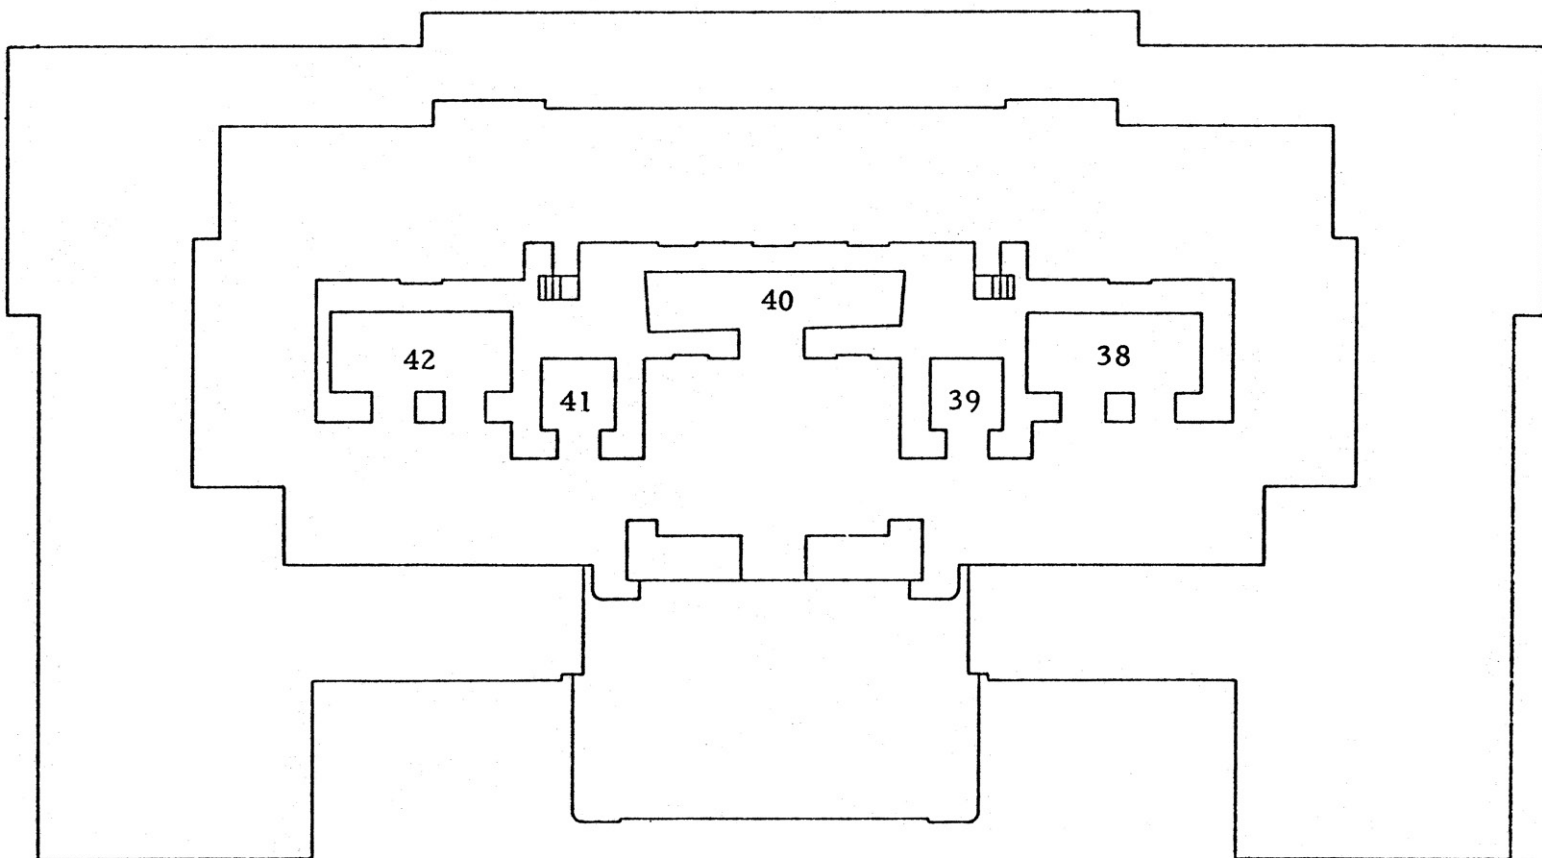
Fig. 10

For the first time Richard Stamps described all the rooms on the three floors using numbers. His first floor ground plan shows walls which deviate from the rectangular wall system of the Palace for the first time. He detected the U-shaped secondary wall in Room 20 (his Room 8). Thus, Stamps then took the non-existing large central risalit from Teobert Maler along the western façade for his ground plan of the first floor and the two pillars for the southern façade and another two for the northern façade from Karl Ruppert. These pillars could never have held the heavy corbelled vaults above.

The ground plan of the second floor is quite correct. On the western façade the entire row of pillars is missing, but they were not excavated at that time. The thin dividing wall between the Rooms 35 and 36 (his Rooms 29 and 30) never existed. On the eastern side Stairways B and C are missing in his plan.

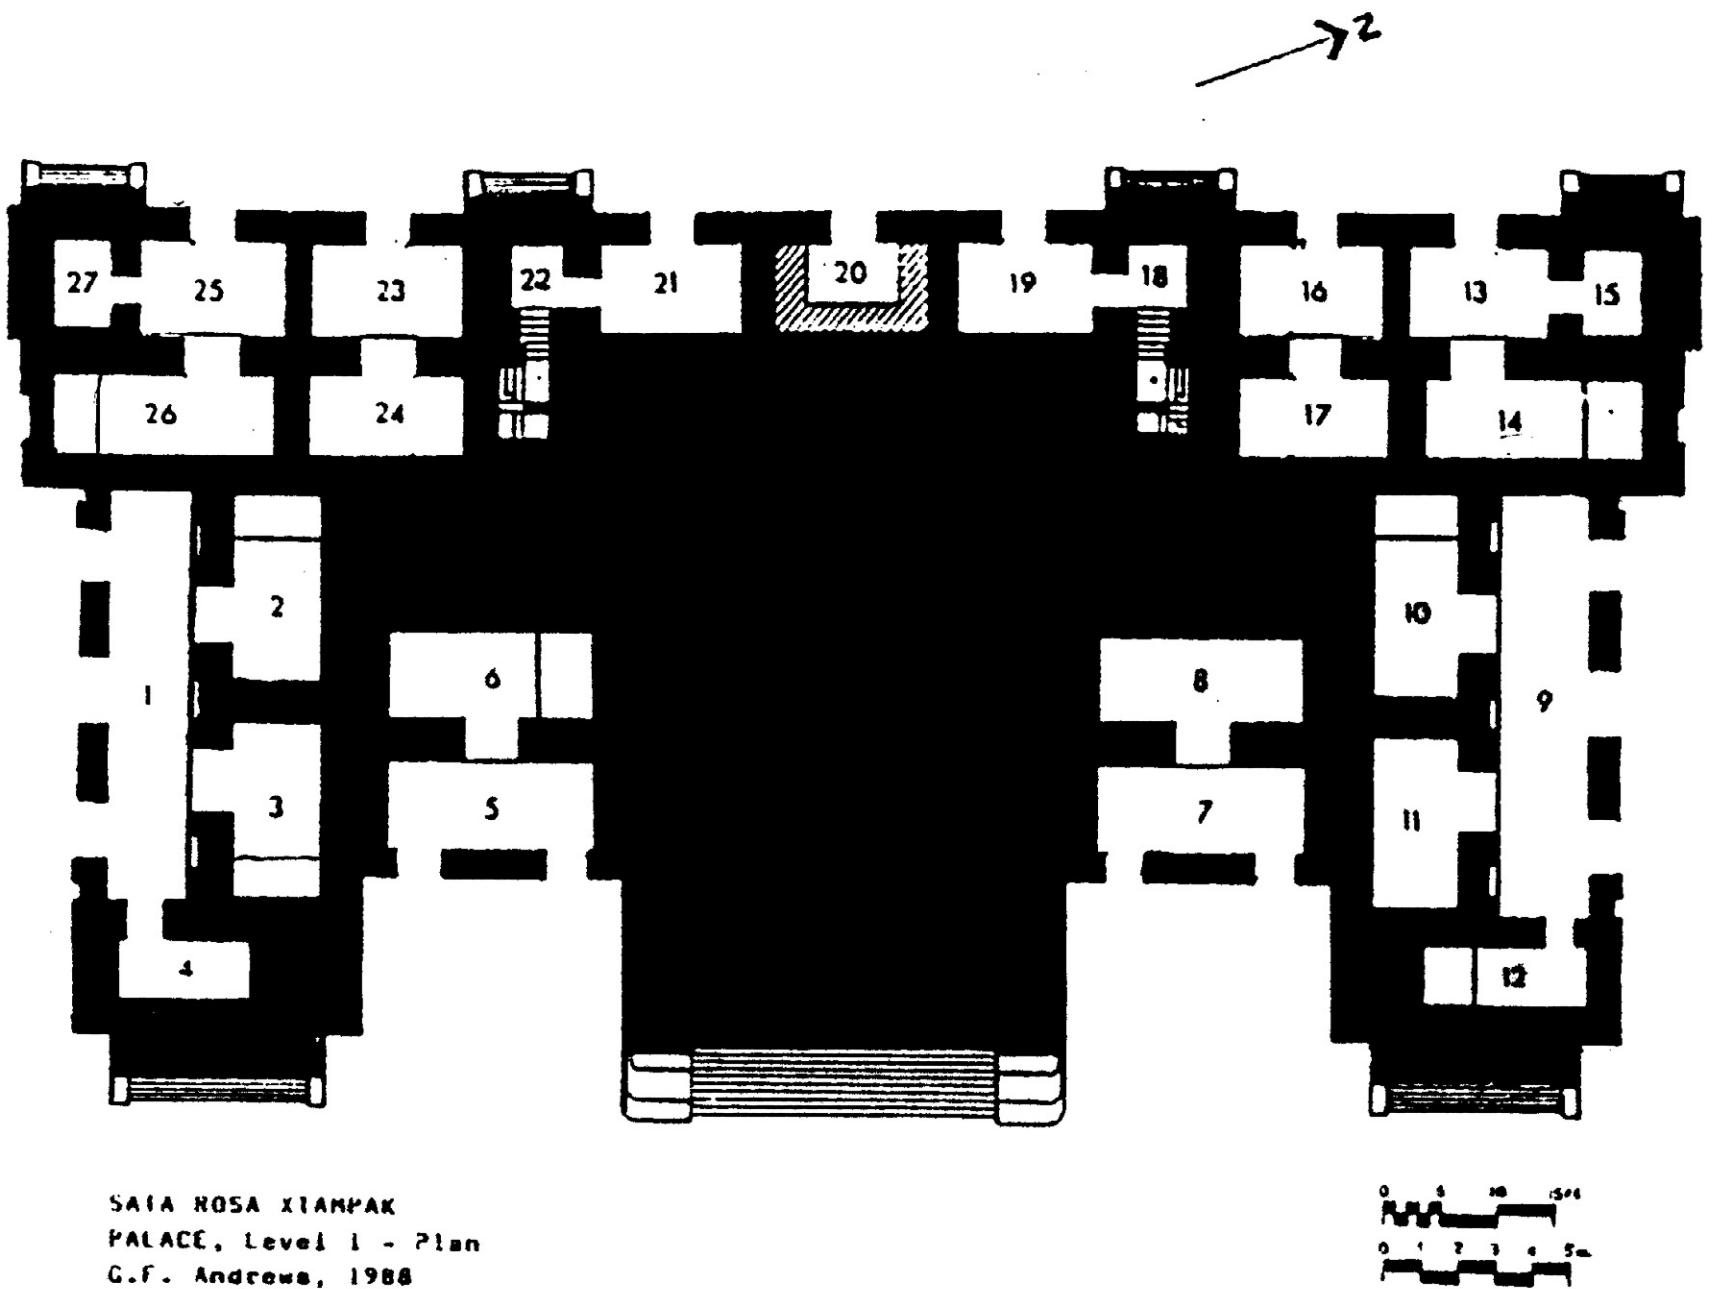
Fig. 13  
 When Andrews realized that the two pillars in Ruppert's and Stamps' reconstruction of the first floor would not have been sufficient, he went back to the two wall sections of Maler for Rooms 1 and 9.  
 Drawing: G. F. Andrews 1988

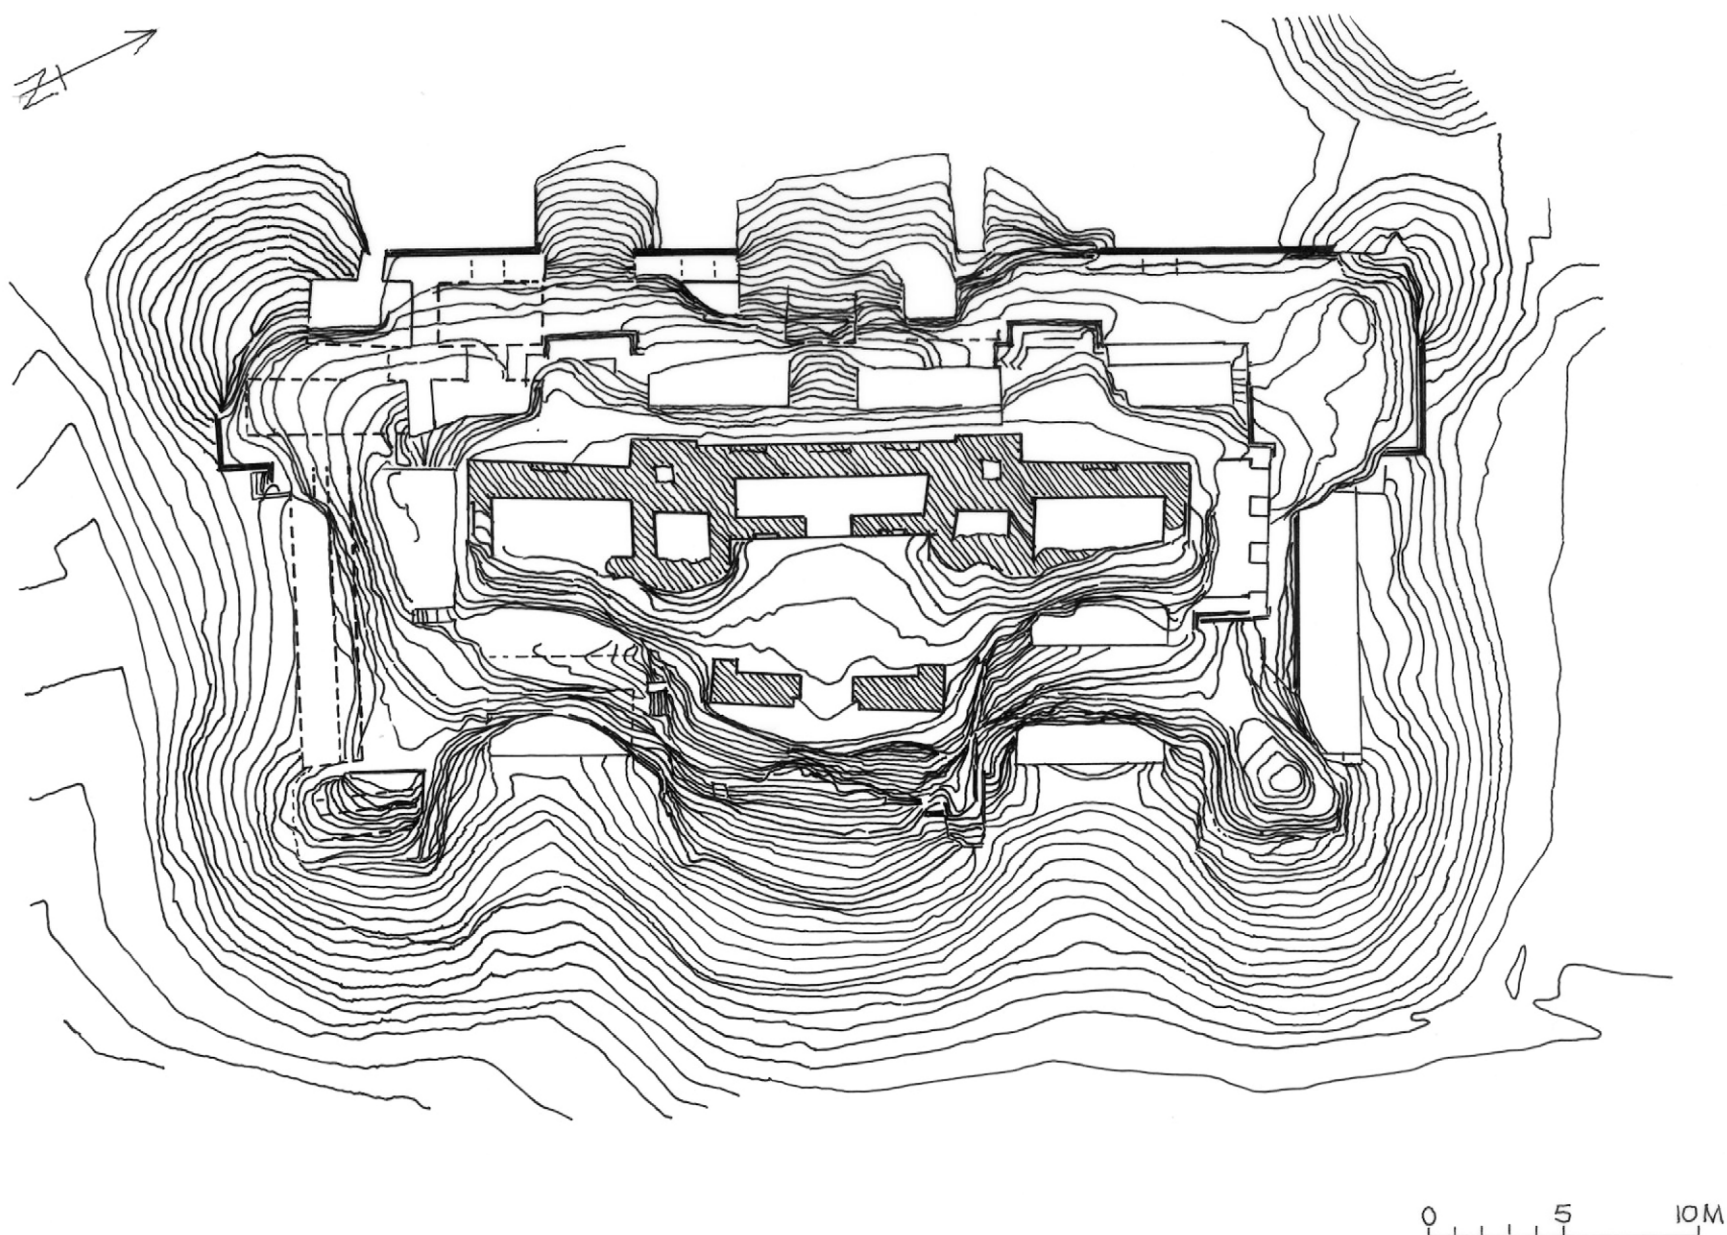
Fig. 15  
 Map with 20 cm equidistant contour lines after Erwin Heine  
 and Andreas Reiter (Heine 1997: Plan 4)  
 Drawing: H. Hohmann 2016

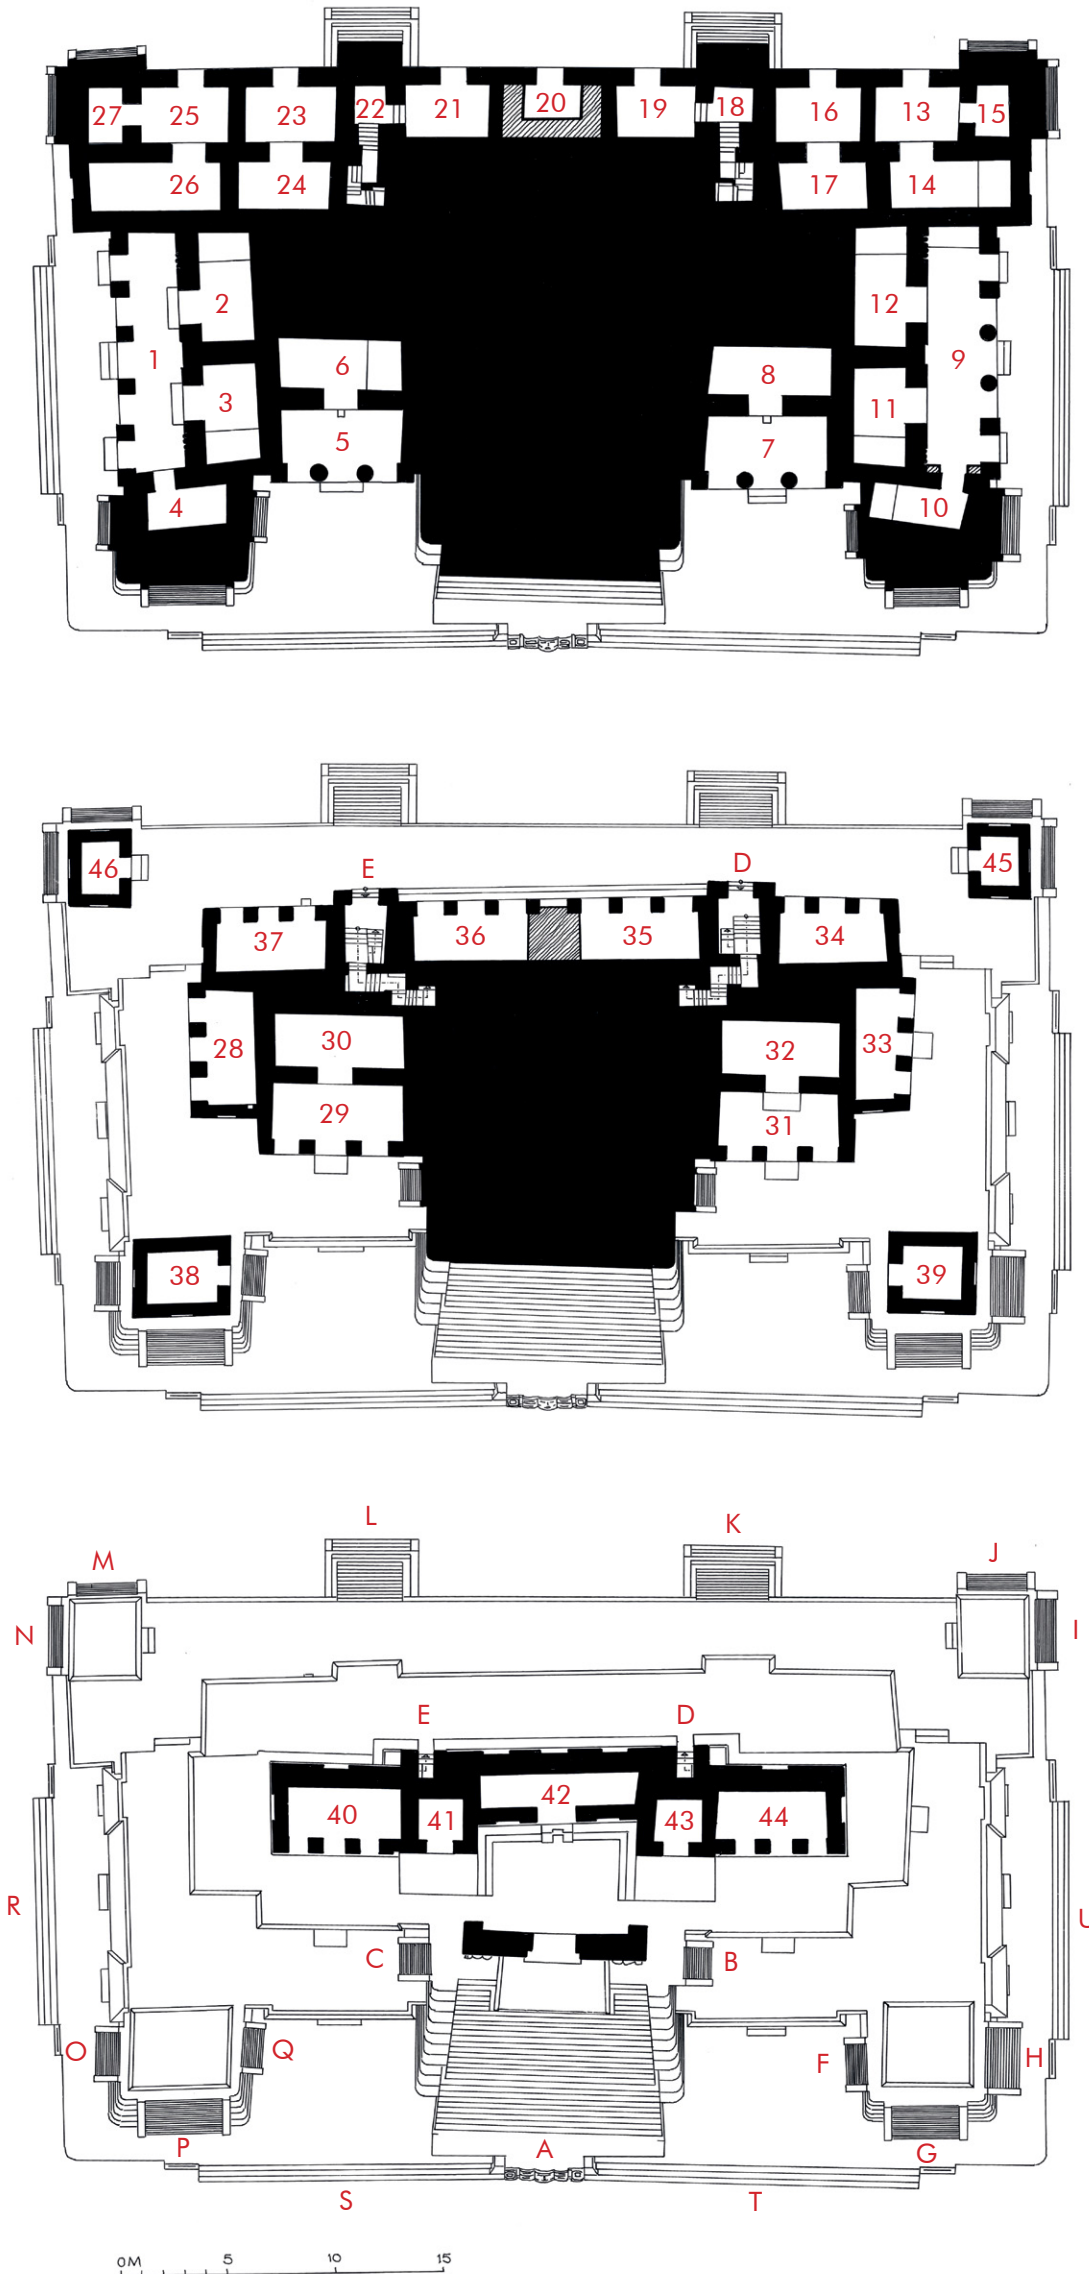
Fig. 17  
 The three ground plans of the three floors of the Palace together with the nomenclature for all rooms and of all stairways and staircases used in this work.  
 Drawings: H. Hohmann 2015

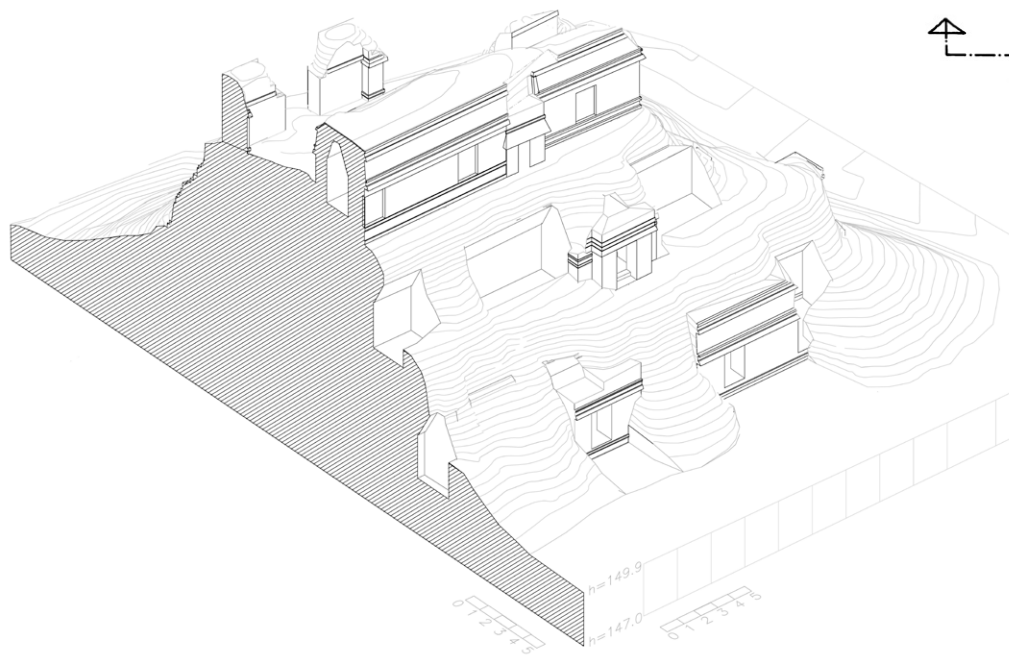
Fig. 20a  
Section through the digital architectural model.  
Drawing: Erwin Heine

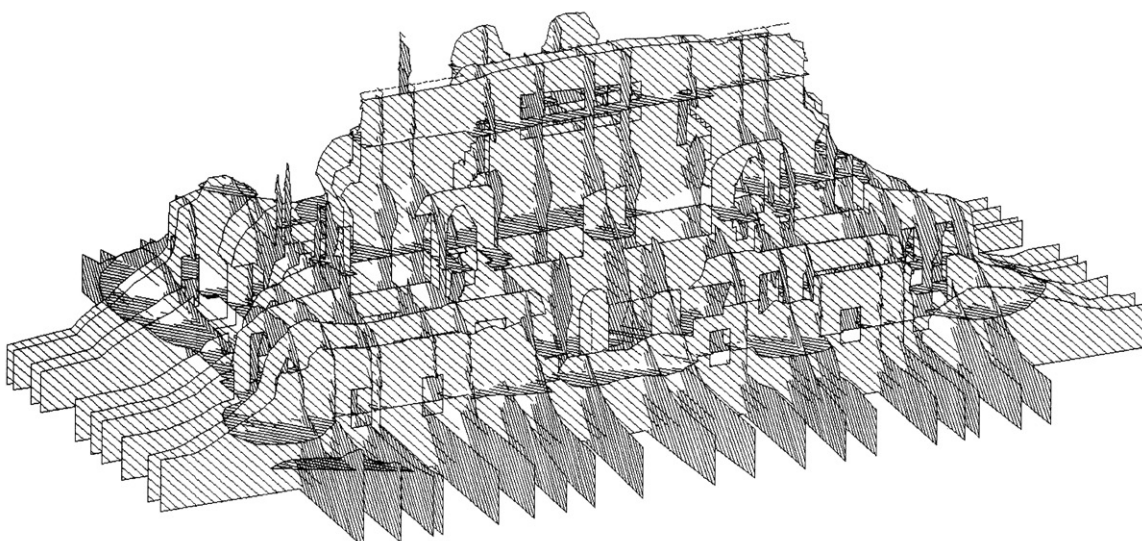
Fig. 20b  
The L and the Q section levels through the Palace  
Drawing: Erwin Heine

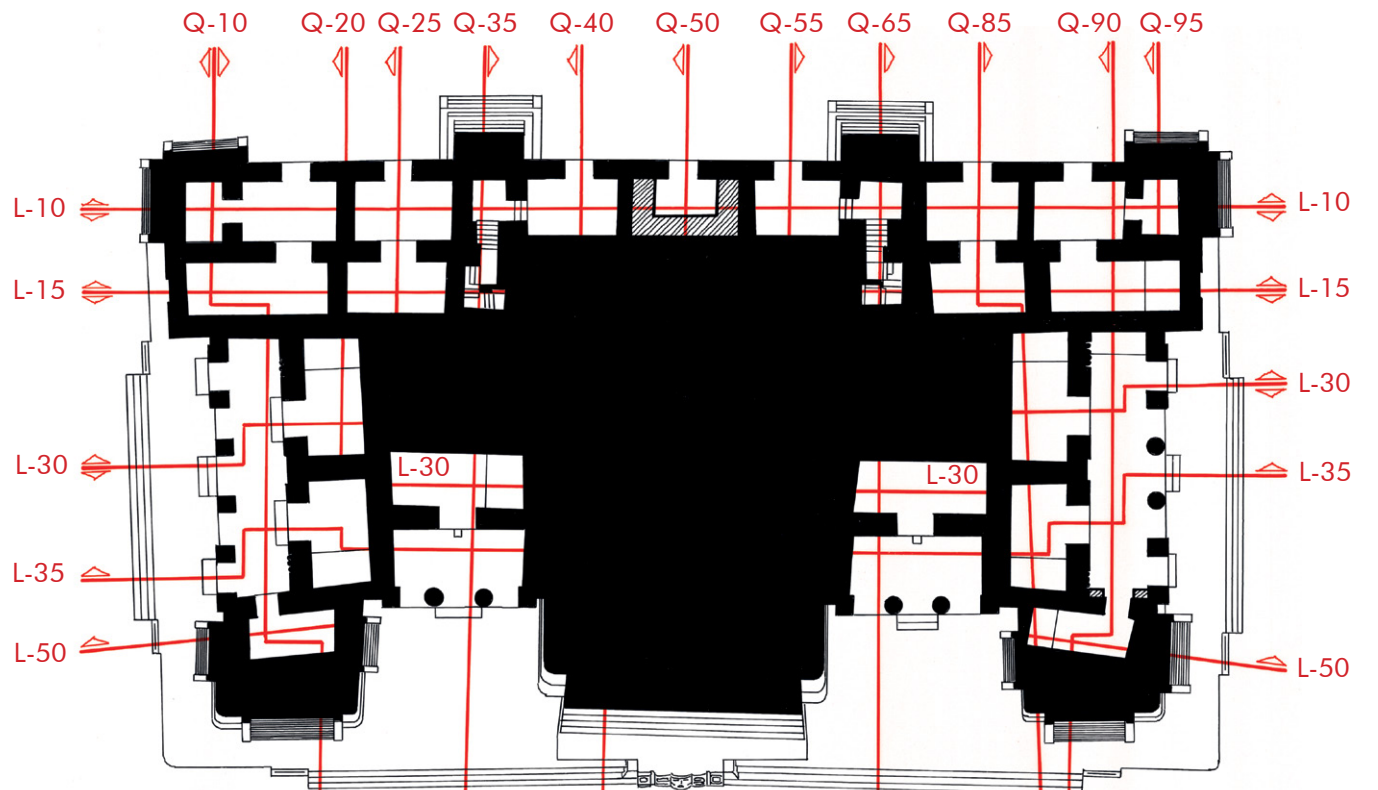
Fig. 21  
The three ground plans of the Palace of Santa Rosa Xtampak with the sections through the structure mentioned below in red.
