# THE MAYA TEMPLE-PALACE OF SANTA ROSA XTAMPAK, MEXICO

DOCUMENTATION AND RECONSTRUCTION OF FORM,  
CONSTRUCTION, AND FUNCTION

HASSO HOHMANN

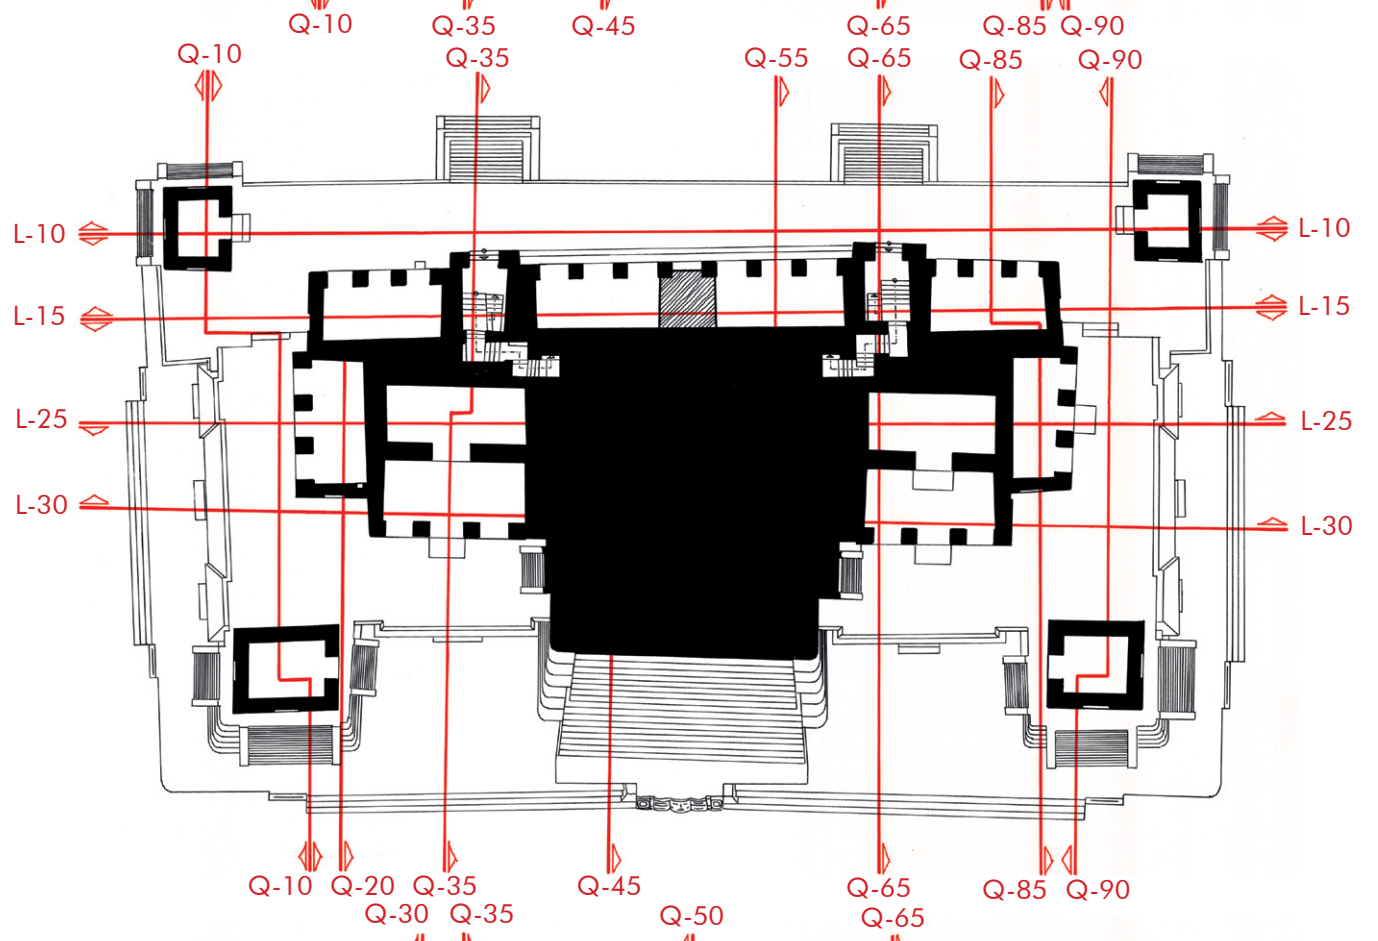
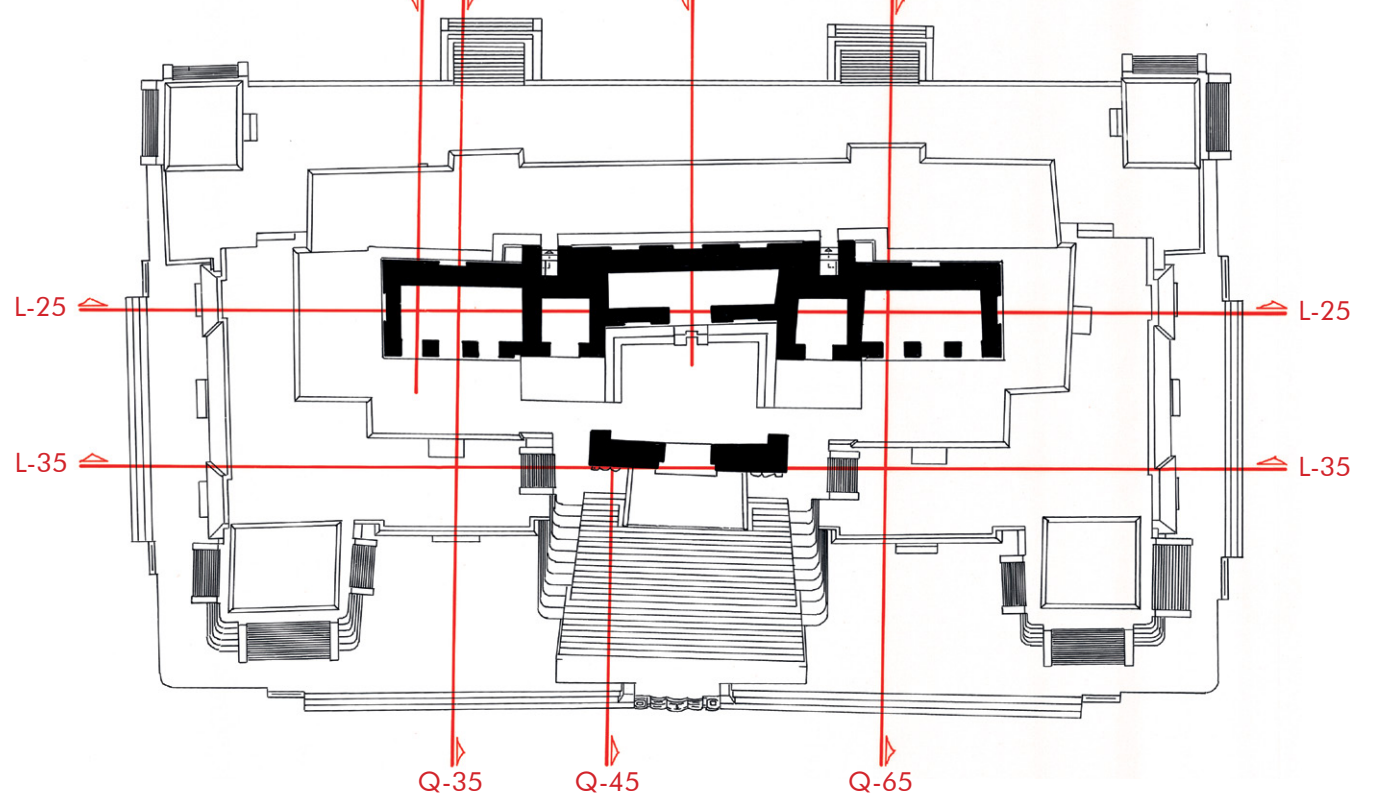
Fig. 21  
The three ground plans of the Palace of Santa Rosa Xtampak with the sections through the structure mentioned below in red.

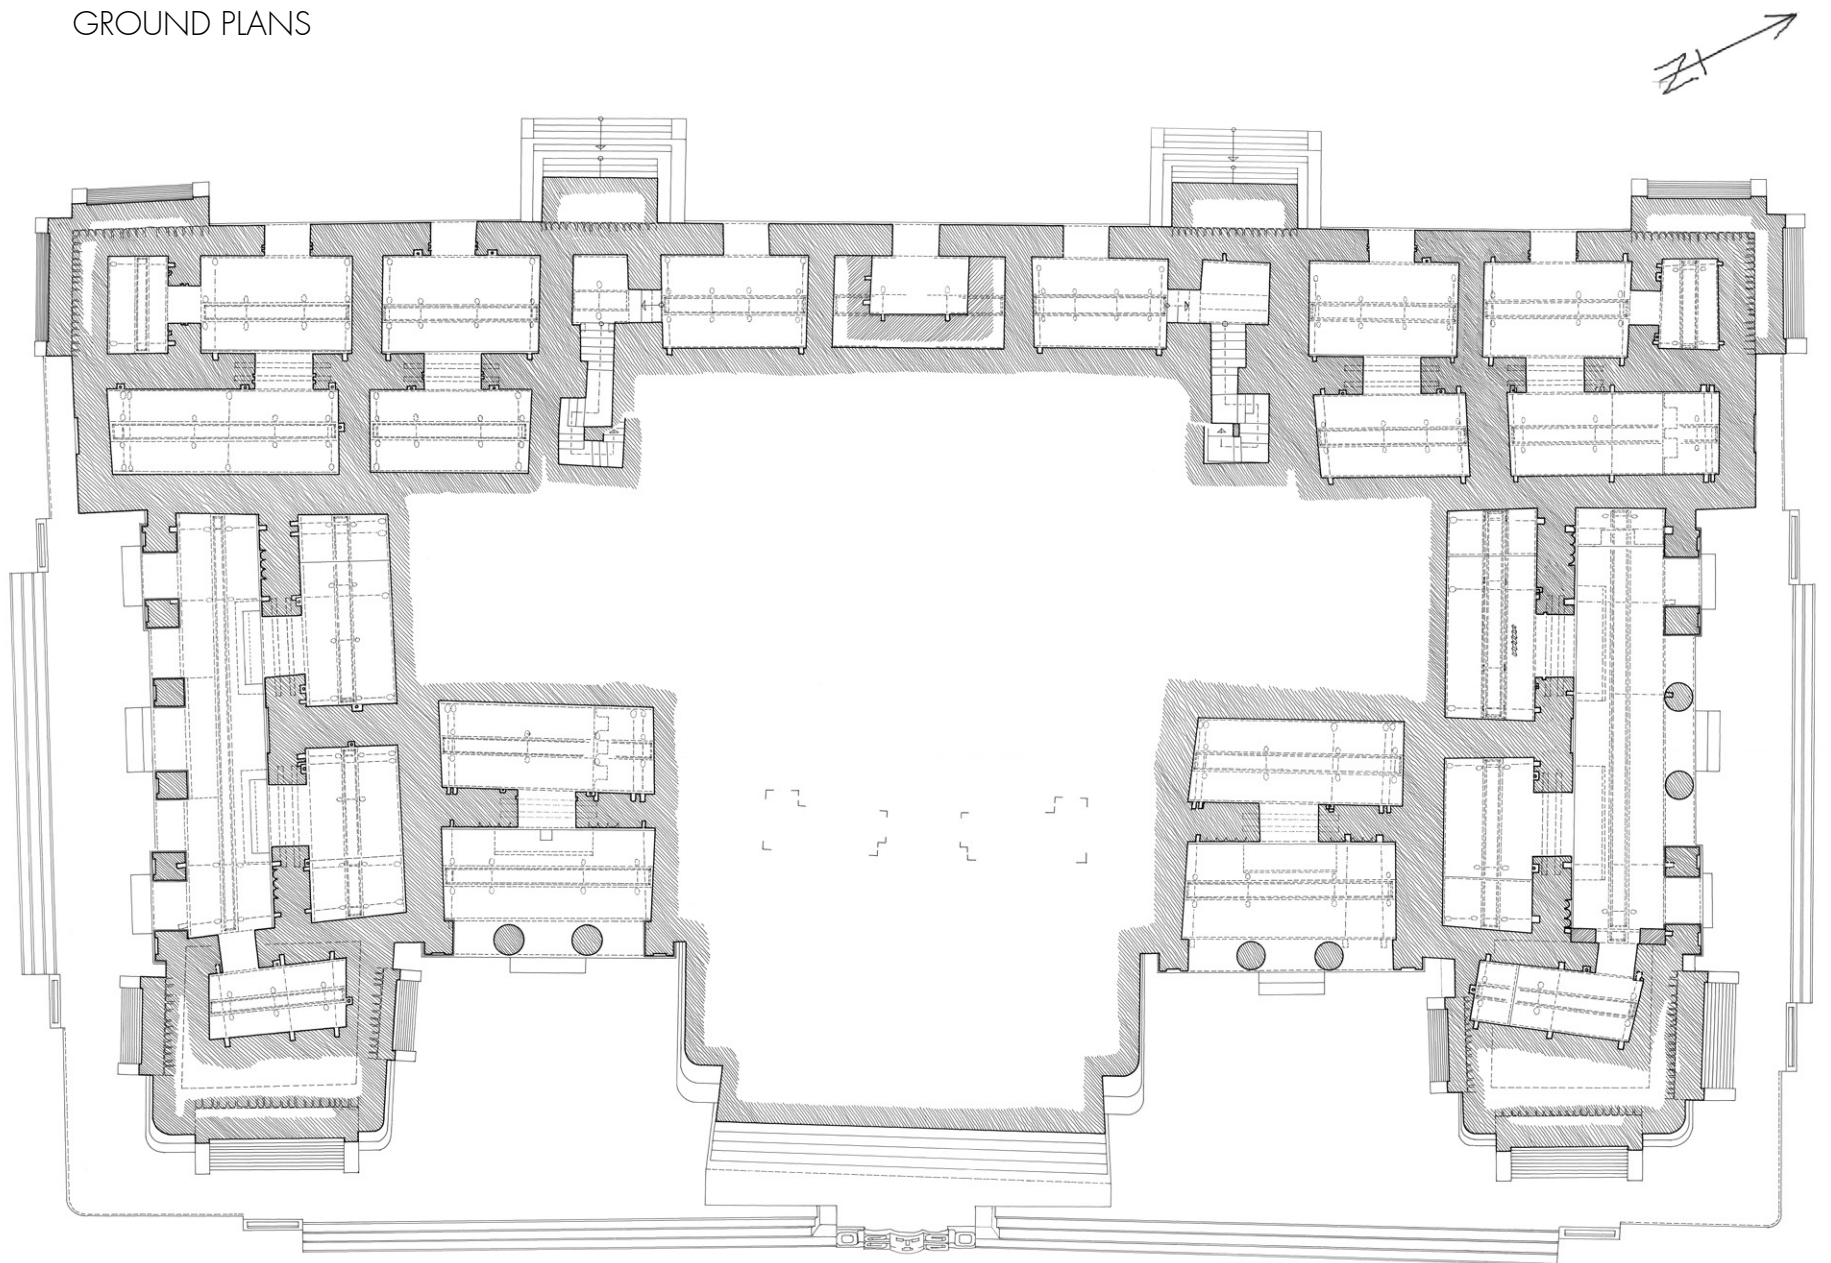
Fig. 22  
GP1.F Ground plan of the first floor

The ground plan is based on the geodetic survey of Erwin Heine and Andreas Reiter (Heine 1997:Plan 34; refer to small drawing).

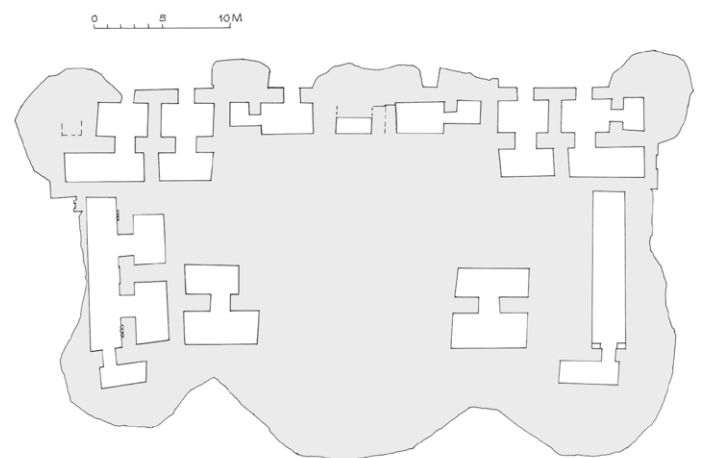
The ground plan of the first floor represents a horizontal section of the Palace approximately 1 m above the main floor level. The plan also shows a projection of the form of the vaults, vault beam holes, the position of the beams, cord holders, rod sockets, and benches. It also shows some of the wooden reinforcements above inner door lintels. Stamps recorded them above the lintels between Rooms 1 and 3 as well as between Rooms 9 and 11. They had a static function and are a reinforcement of the lintel zone. It is quite certain that there are or were more such beams within the core of the massive vault zones above all lintels of the passageways on the first floor and the second floor as well as above all the wide spanned passageways in the Palace. Archaeologists can only check them where lintels have collapsed. Six of them have been drawn from information by Stamps, two from the author's check.

In the case of the two staircases in the Palace the stairs have been continued further on to give a better connection to the ground plan of the second floor. Hatching appears only two times in this ground plan, at the eastern end of Room 9 and in Room 20; in both cases the structure had to be strengthened by supports added at a later date.

The orientations of Room 4 and Room 10 do not fit into the approximately rectangular system of the rest of the Palace. Their axes of symmetry seem to face a certain point under the centre of the lower jaw of the monster mouth passageway on the third floor. The question is the huge space in the core from the first and the second floor. Were there earlier rooms of the first building phase of the Palace here? Were they filled up later? Are there tombs of earlier persons of the Palace, chambers with paintings from an earlier building phase?

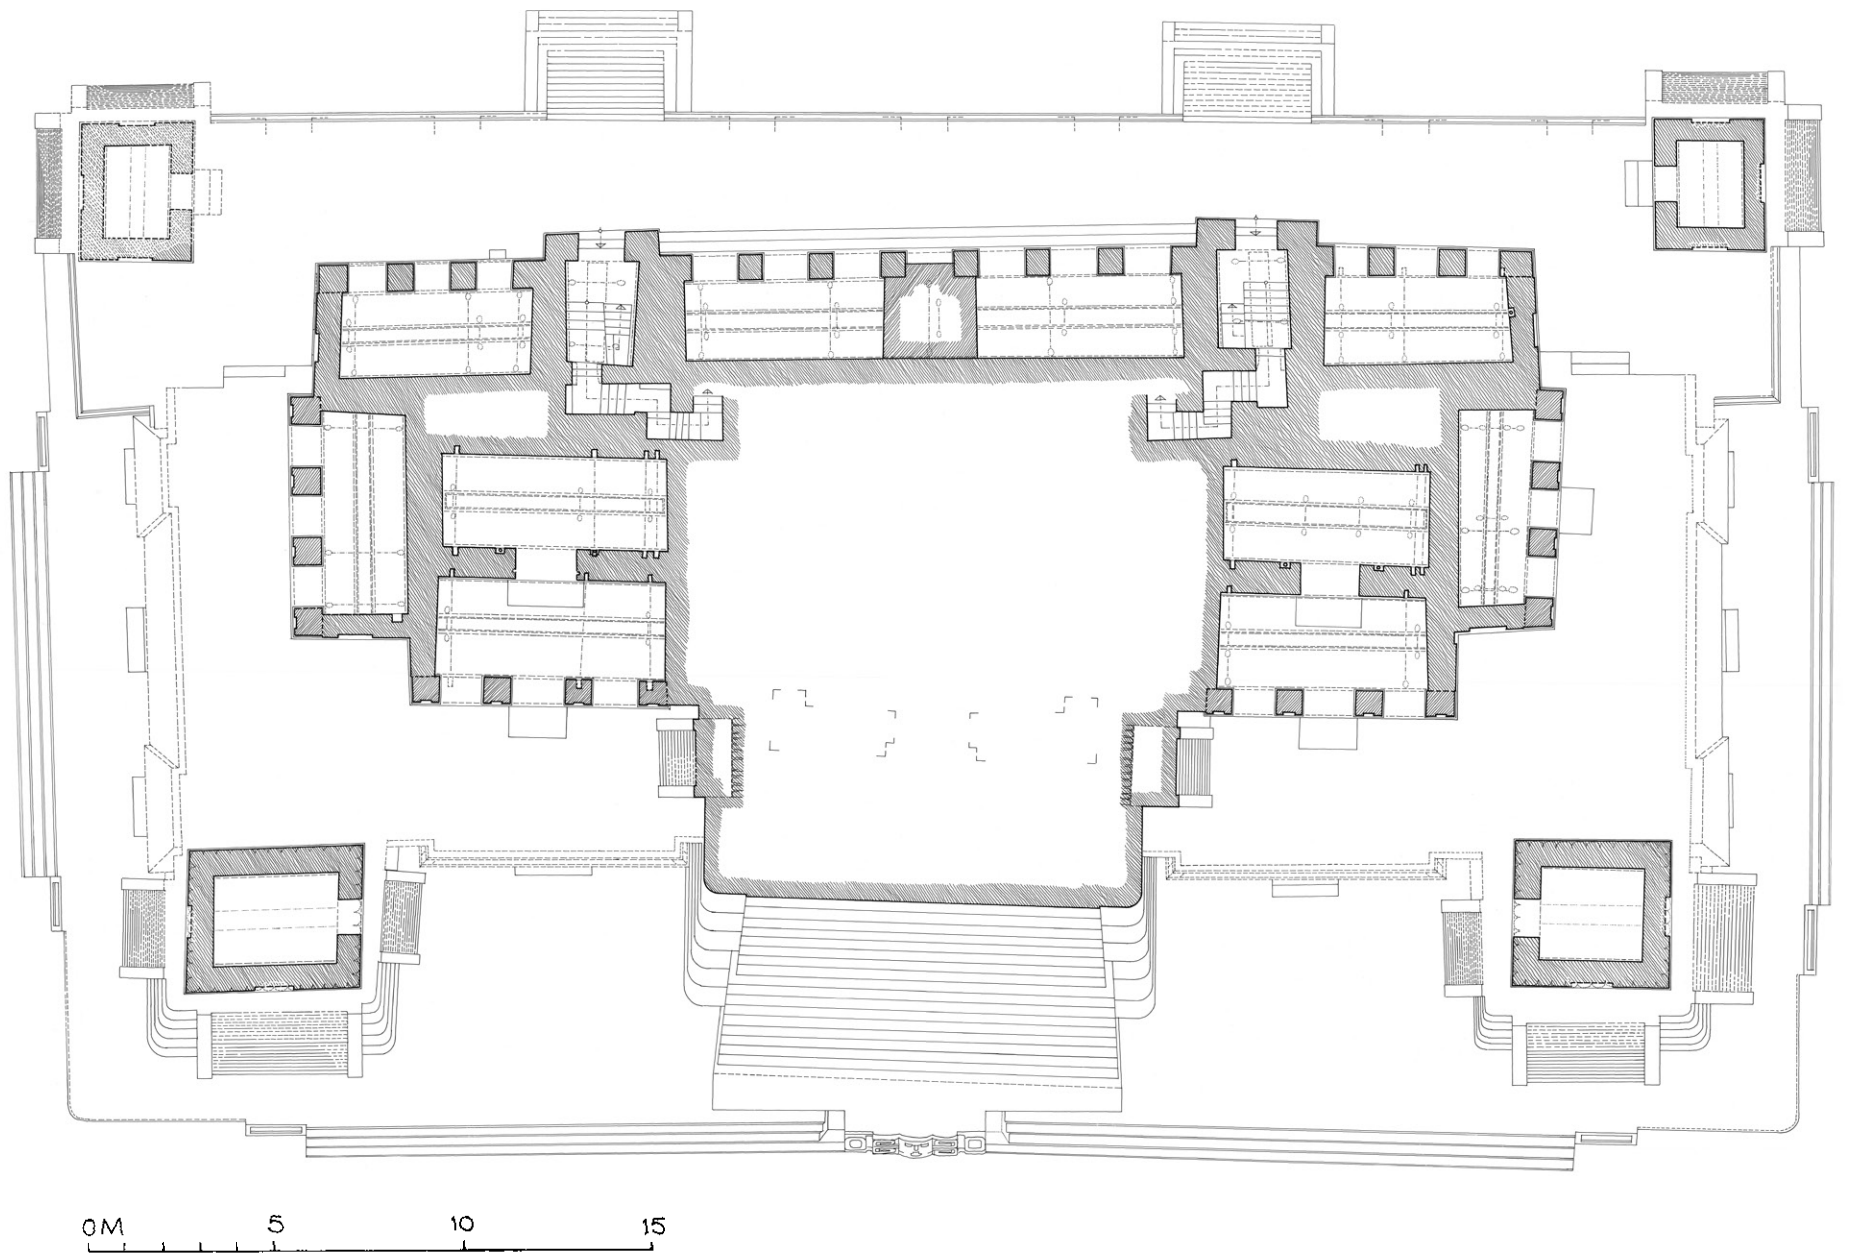
Fig. 23  
GP2.F Ground plan of the second floor

The ground plan is based on the geodetic survey of Erwin Heine and Andreas Reiter (Heine 1997:Plan 35; refer to small drawing).

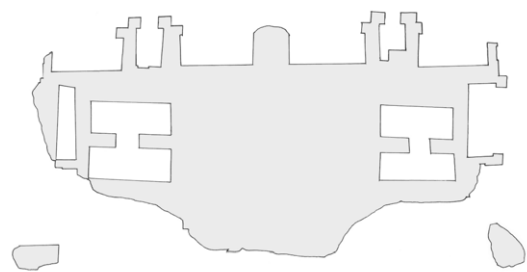
There are 4 stairways leading up to the narrow but large common platform on the first floor. The 15 pseudo stairways around the Palace are not functional. Only the main Stairway A in the center of the eastern façade might sometimes have been functional up to a certain degree. But this stairway is very steep and was presumably only used by specially trained persons for important ceremonies. Therefore the only stairs leading up to the upper floors of the Palace are the two inner staircases. They are quite narrow. They might have been used with a one way system. The former use of the four isolated standing towers or temples on the second level cannot be reconstructed. The entrances of the eastern two temples face each other and are positioned above the steepest of the pseudo stairways. It is a long way around the Palace to get from Temple 38 to Temple 39.

The entrances of the western Temple 45 and Temple 46 also face each other and there is a direct connection from one to the other in front of Rooms 34 to 37. No temple could be reached directly from the first floor.

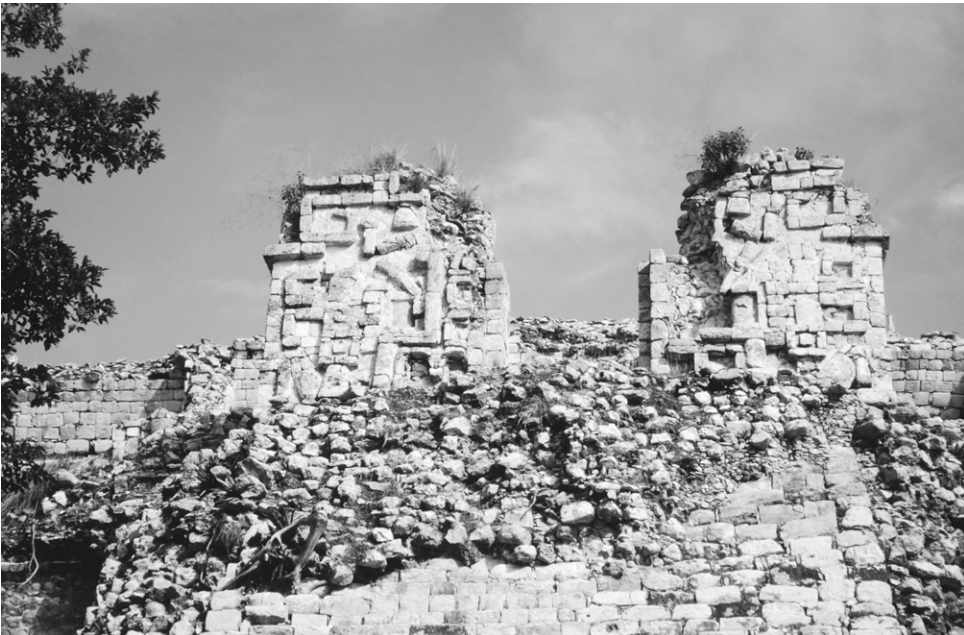
Fig. 26  
The monster mouth passageway and the upper part of Stairway A are visible.  
Photograph: H. Hohmann 2001

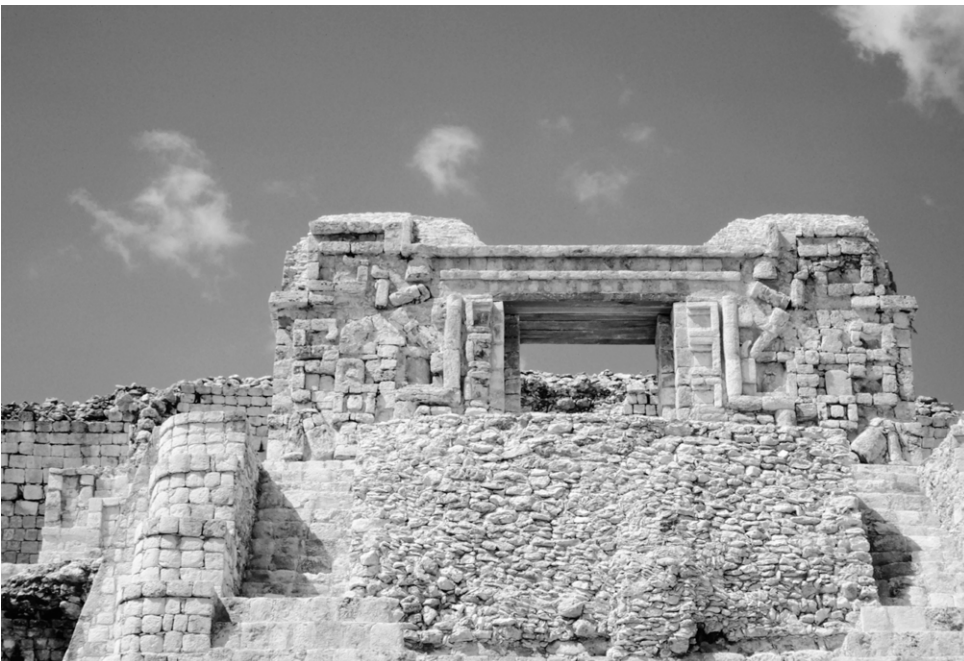
Fig. 27  
The restored version shows a cornice which runs along both sides into the remains of the upper ear rings of the monster. There should at least be a distance between the rings and the cornice.  
Photograph: H. Hohmann 2004

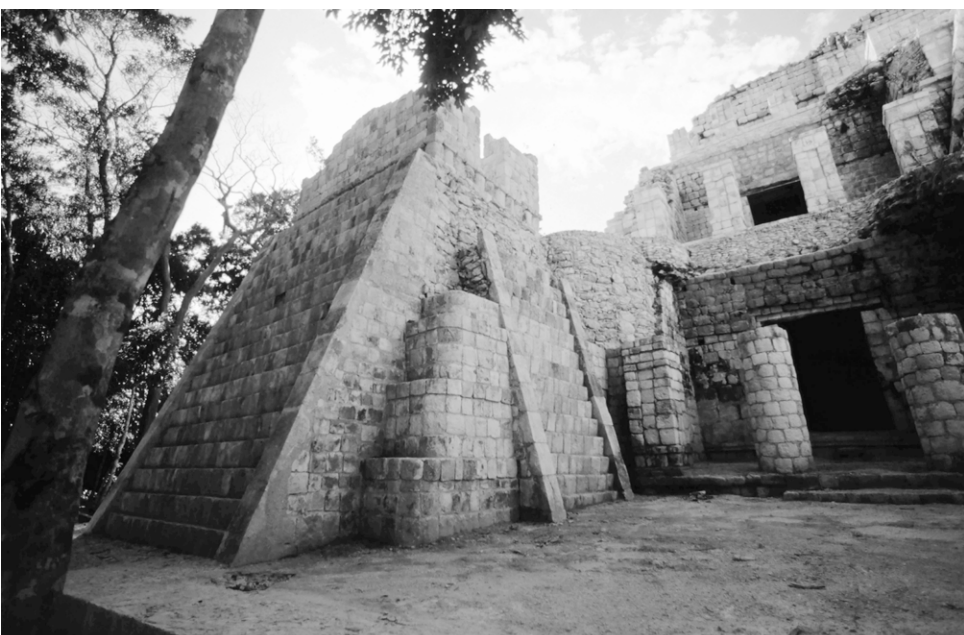
Fig. 28  
This is the north-eastern corner of the south-eastern temple pyramid. The asymmetrical pseudo stairway in the North is flanked by three mega steps to the left. If they are continued they do not fit in with the rest. Change is needed.  
Photograph: H. Hohmann 2004

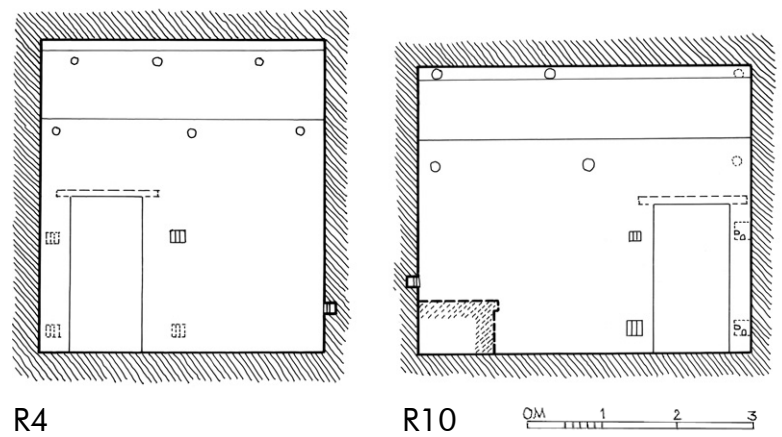
S.L-50 (R4+10)

Section L-50 facing west shows that the two Rooms 4 and 10 are situated under the two small temples, Rooms 38 and 39. Room 10 had a bench, which was measured and documented by Stamps (1970:53). It had already been destroyed by looters. Plaster lines on the wall plaster in Room 10 indicate quite certainly a bench in this room. In Room 4 a wooden bench might have existed. This must have been at a lower level than in Room 10 as otherwise the cord holder would have been covered. The façades of these two rooms consist of three pseudo stairways leading up to the two temples for each room. The use of the two temple pyramids was quite certainly a ceremonial

one; the use of the two rooms behind was certainly for a profane living purpose. Each of these belonged to a compound of four rooms forming a larger living space.

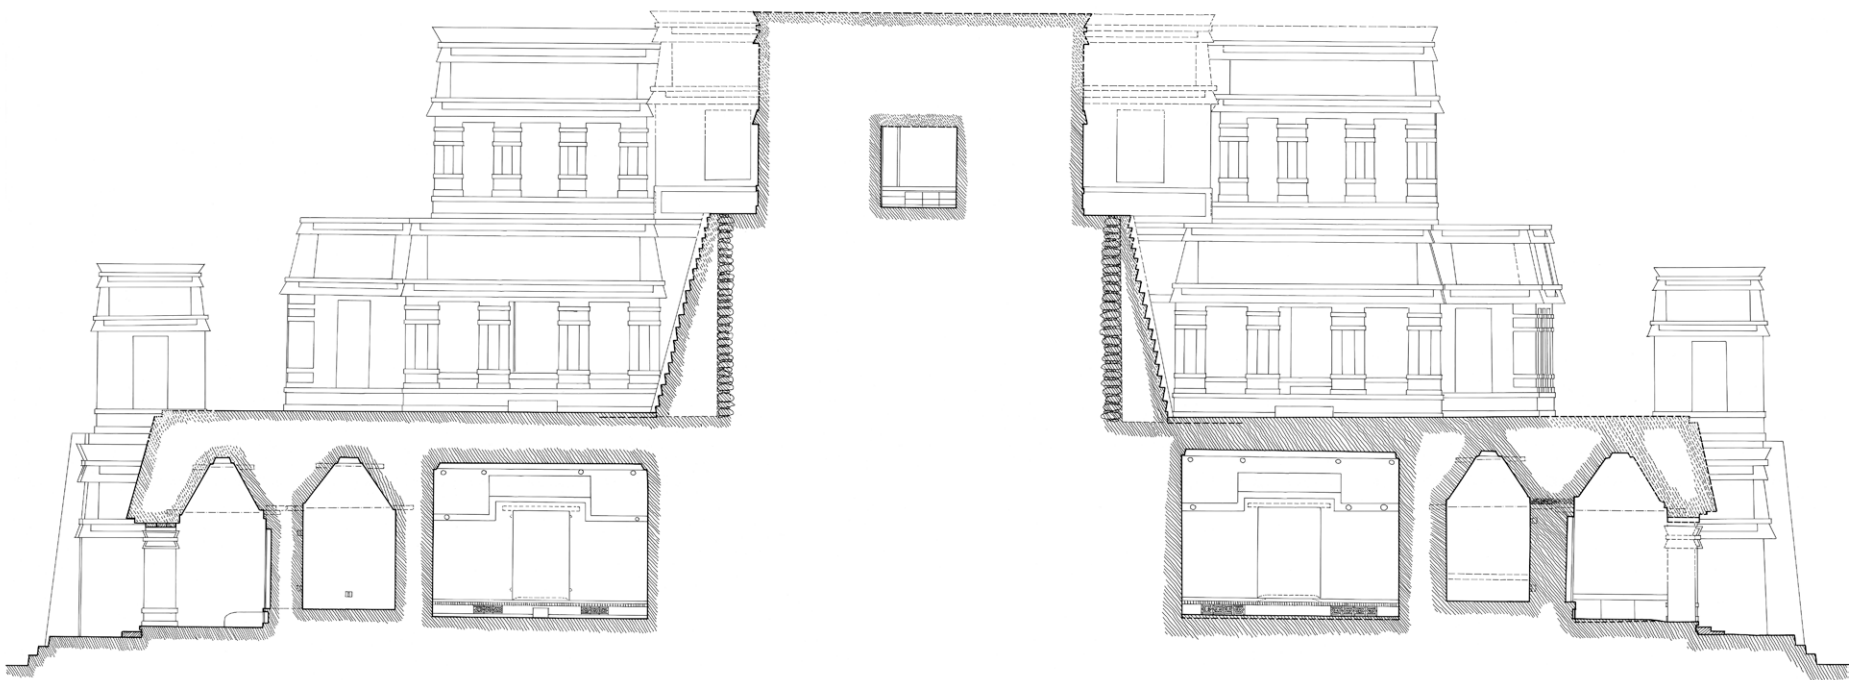
Fig. 30

Above the passageways between Rooms 5 and 6 as well as above the one between Rooms 7 and 8 the vault zone has a special design. It has a similar form to the ones above the passa-

geway in the long Room 1 and to that above the passageway to Room 2 as is shown in the next Section L-30 on the left hand side. This section represents the over-door design above the passageway between Rooms 9 and 12 on the right hand side in profile. This section also shows the deformation of the two basal moldings in Rooms 5 and 7 caused by the high pressure stress of the inner walls.

This section is based on the geodetic survey of Erwin Heine and Andreas Reiter (Heine 1997:Plan 11; refer to small drawing).

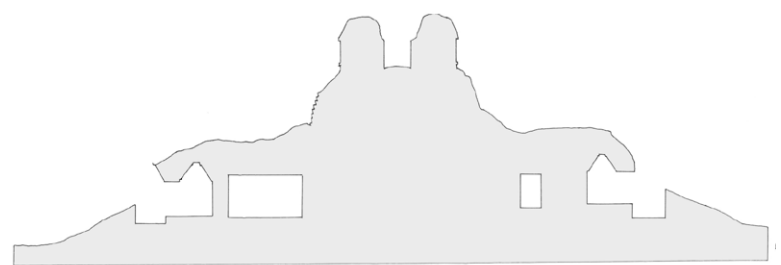
This Section L-35 facing to the West cuts through the two pseudo Stairways B and C and the huge doorway on top of the main Stairway A. The section also shows the entrance halls Rooms 5 and 7 in front of the living spaces Rooms 6 and 8 near Stairway A. Both halls have basal moldings for the next rooms. Both moldings consist of three members. The frieze on the middle, receding part of this three-member molding shows two groups of three small carved colonnettes in Room 5, the upper cornice of the molding is decorated with a border. The basal molding in Room 7 has two groups of four small carved colonnettes. The upper cornice also has a border.

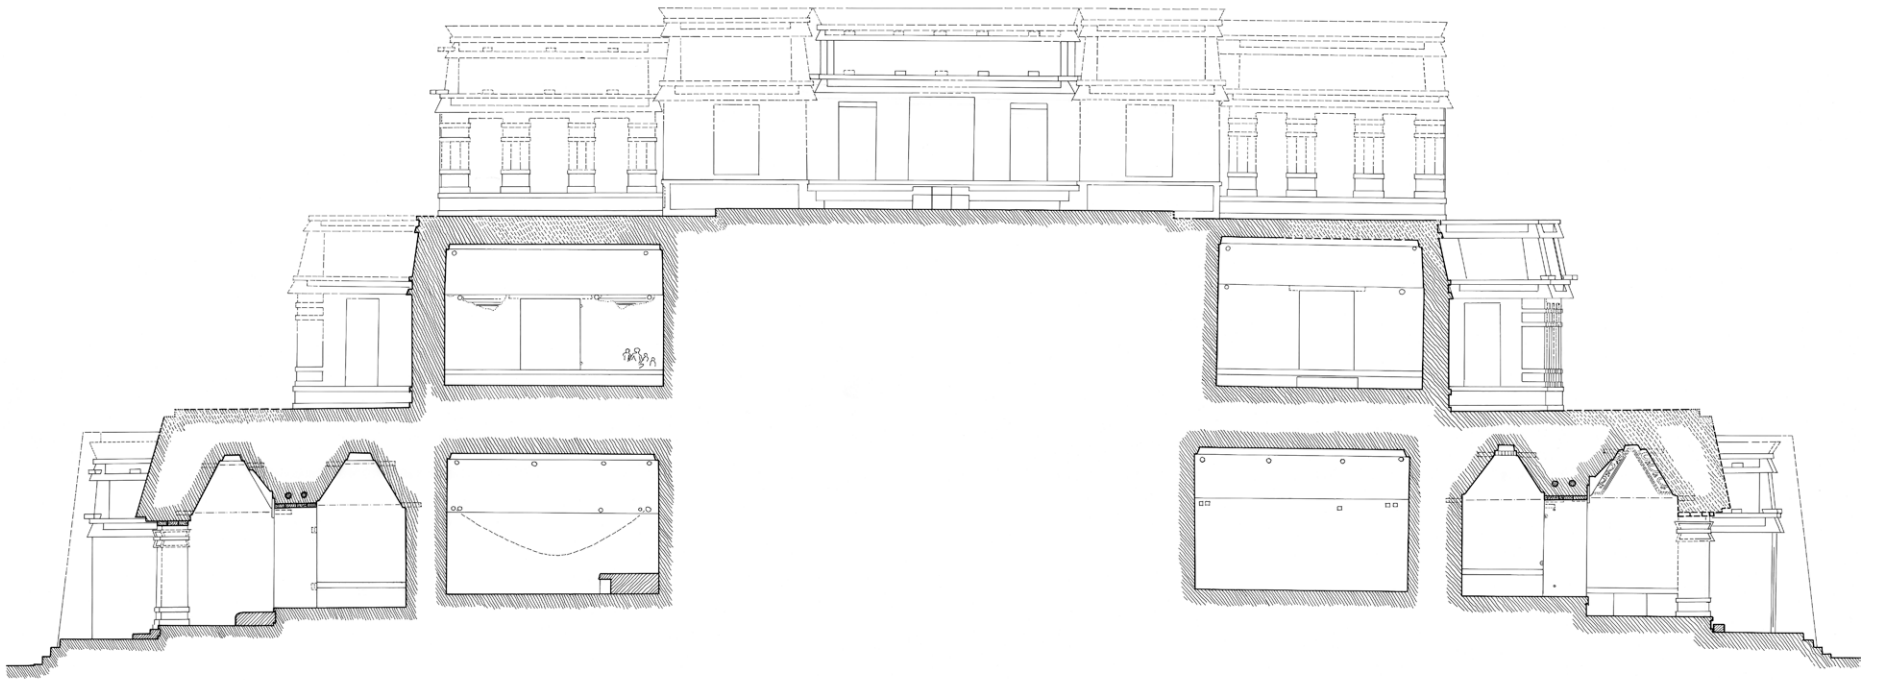
Fig. 31  
S.L-30

This section is based on the geodetic survey of Erwin Heine and Andreas Reiter (Heine 1997:Plan 10; refer to small drawing).

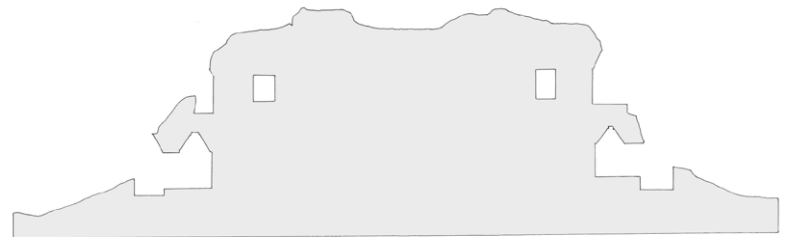
Section L-30 also provides the complete eastern façade of the five third floor rooms of the Palace as the section runs behind the huge monster mouth passageway.

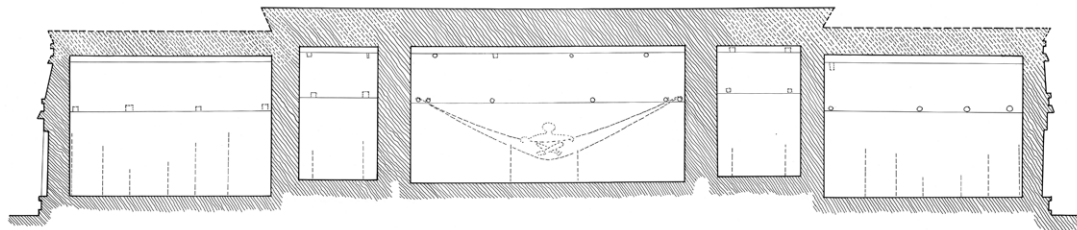
**Fig. 32**  
S.L-25 (Third Floor)

Section L-25 facing west shows only the five third floor Rooms 40 to 44. The upper vault beams cannot be complete as several portions of the five vaults are no longer complete. There are no cord holders, rod sockets or benches on this floor. Beside the two inner Staircases D and E the really steep central Stairway A was the only access to this raised area. Both staircases could be observed easily. It seems that the use of the very steep Stairway A might have been a sacrilege. Therefore this story might have been quite protected. There was possibly no need for cord holders or rod sockets for this reason.

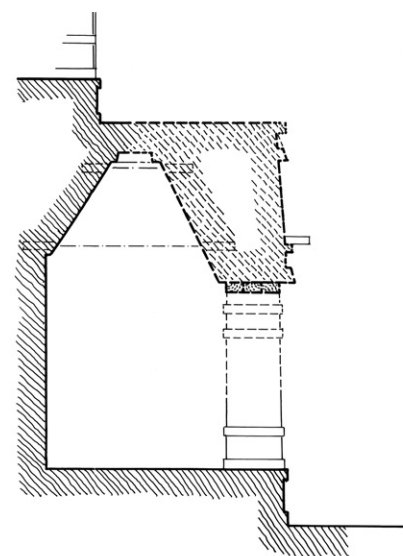
**Fig. 33**  
S.L-25 (R33)

Section L-25 facing west shows the profile of Room 33 in the North of the Palace on the second floor.

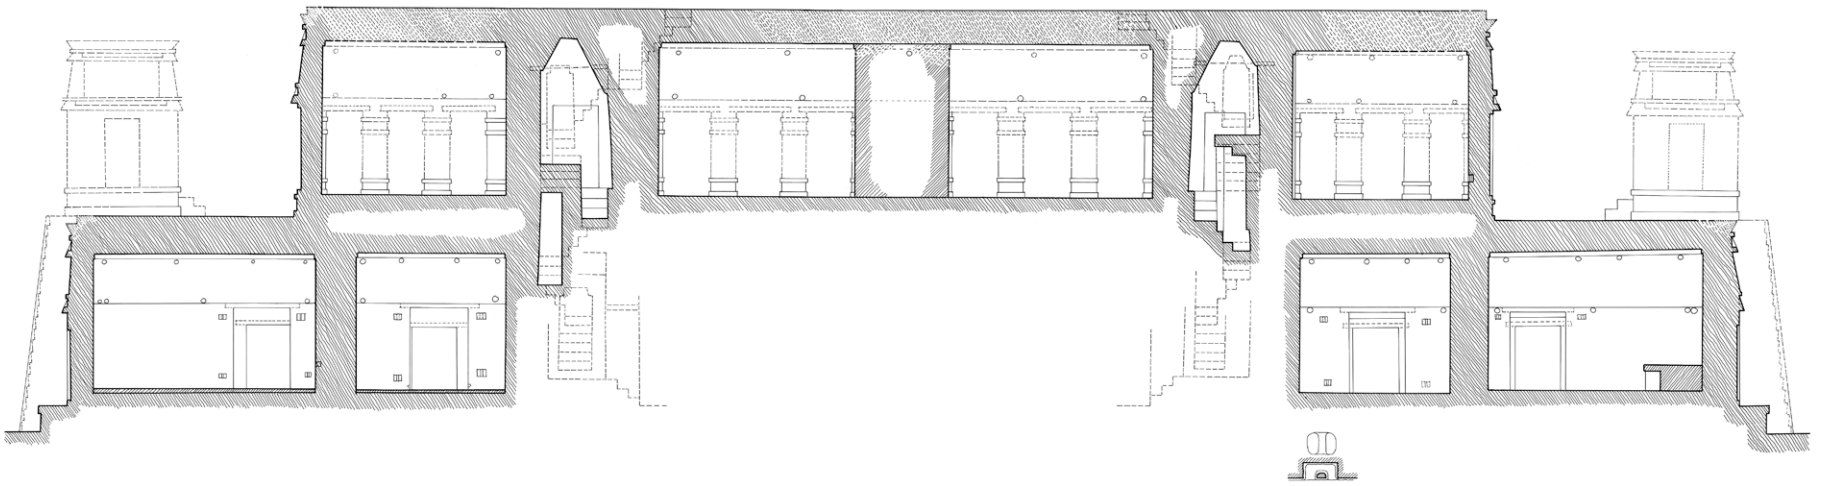
Fig. 34  
S.L-15

Section L-15 facing west shows mainly the two staircases. In the background you can also see the entrances to the staircases. The stairs on the first floor which are not visible in this section are shown by broken lines as well as those stairs up to the third floor, which are behind the observer. In this way you can see both entire staircases and stairs as if they were transparent. This should make the complexity of these two nearly mirror image staircases more visible.

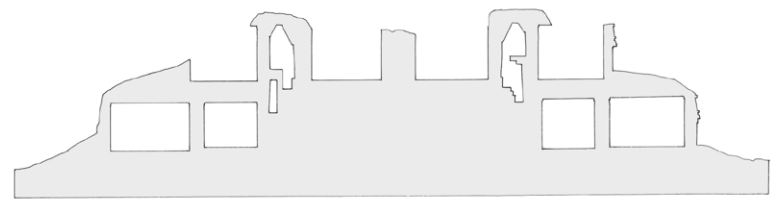
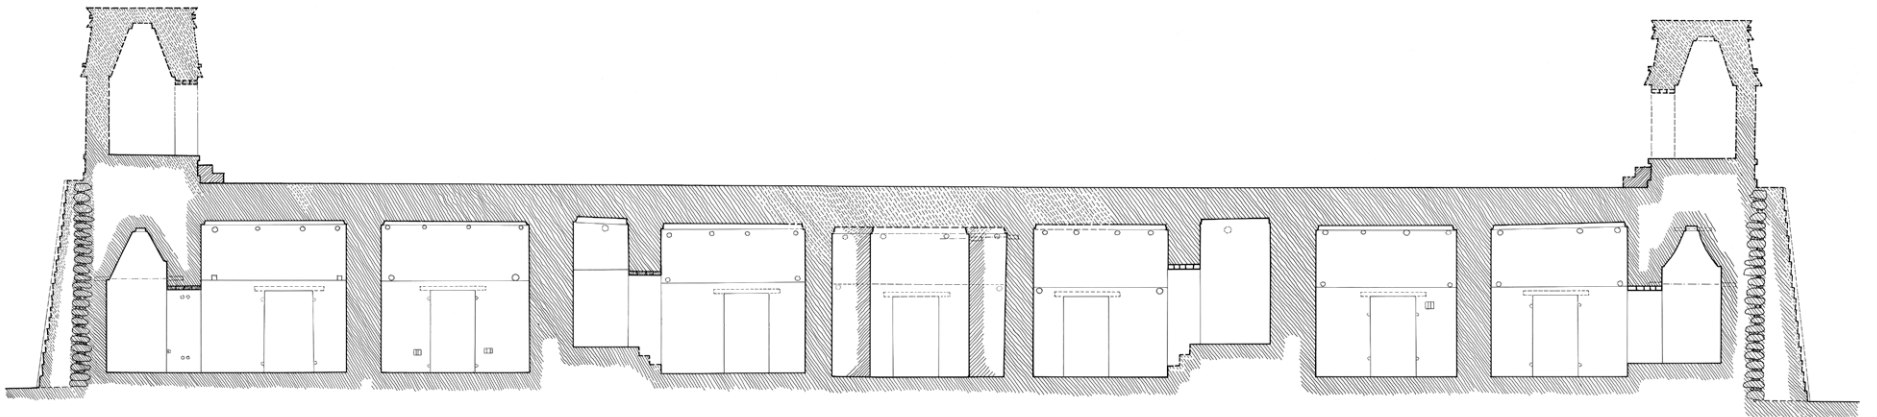
Fig. 35  
S.L-10

The lower vault beams at the southern end of Room 21 and at the northern end of Room 19 might have served to hold a curtain to cover the inner stairways.

This section is based on the geodetic survey of Erwin Heine and Andreas Reiter (Heine 1997:Plan 6; refer to small drawing).

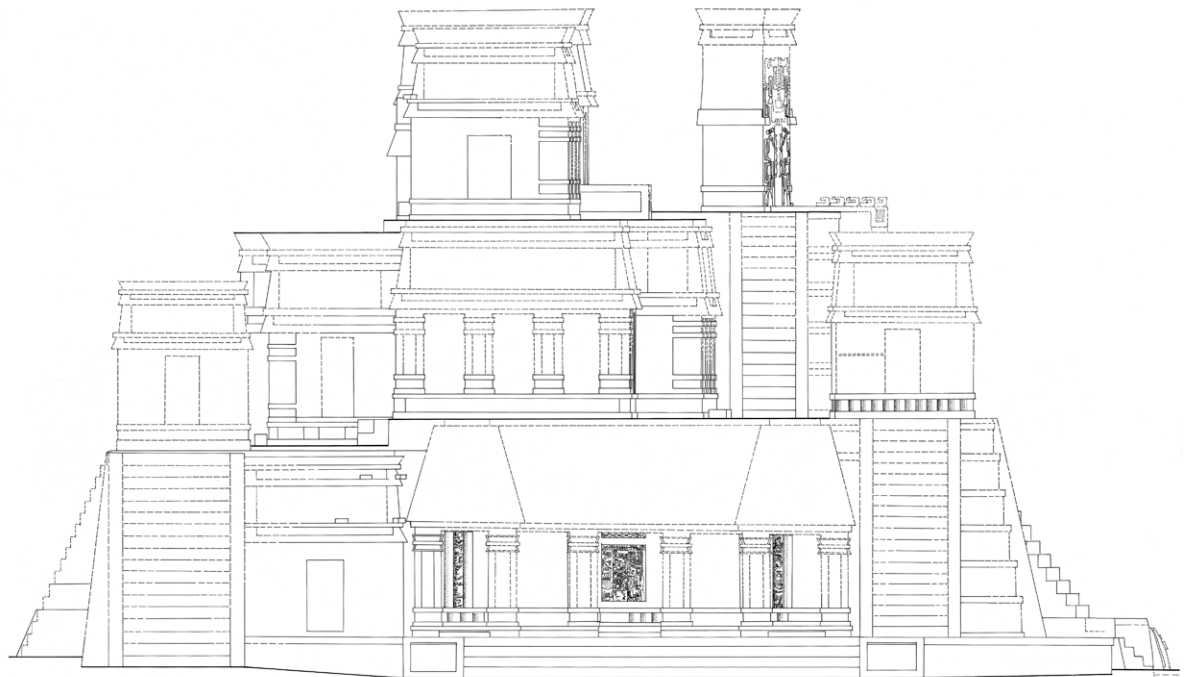
**Fig. 36**  
**SFa Southern Façade**

The southern façade of the Palace shows the two temple pyramids with their pseudo stairways and pseudo entrances at both ends – the eastern one standing on the large platform of the structure to the right, the western one standing directly on the same level as the Plaza del Palacio in the East.

Just behind it on the third floor stands the pseudo monster mouth entrance with the hypothetically added teeth of the lower jaw of the monster. Some of these teeth were found near the Palace! The large massive block at the upper end of the central Stairway A could have been the basis of the lower jaw of the monster mouth. In the west of the free standing entrance on the left hand side we see the small southern side of Room 40 and the ensemble of the five rooms on the third floor. The central Room 42 had a four-member upper molding with a projecting uppermost cornice next to the flat roof. The fourth member was reconstructed from two of the old photos by Teobert Maler with the Palace photographed from the western side. They show at least two large stones of this uppermost projecting cornice of Room 42 (Maler 1997:Fig. 171).

In the reconstruction of the third floor this fourth member is missing. It should be added at least on the façades of Room 42, as here part of it existed until the end of the 19th century. The author believes that the fourth member was also used for all the other Rooms 40, 41, 43, and 44 on the third floor and should also be reconstructed in these four rooms.

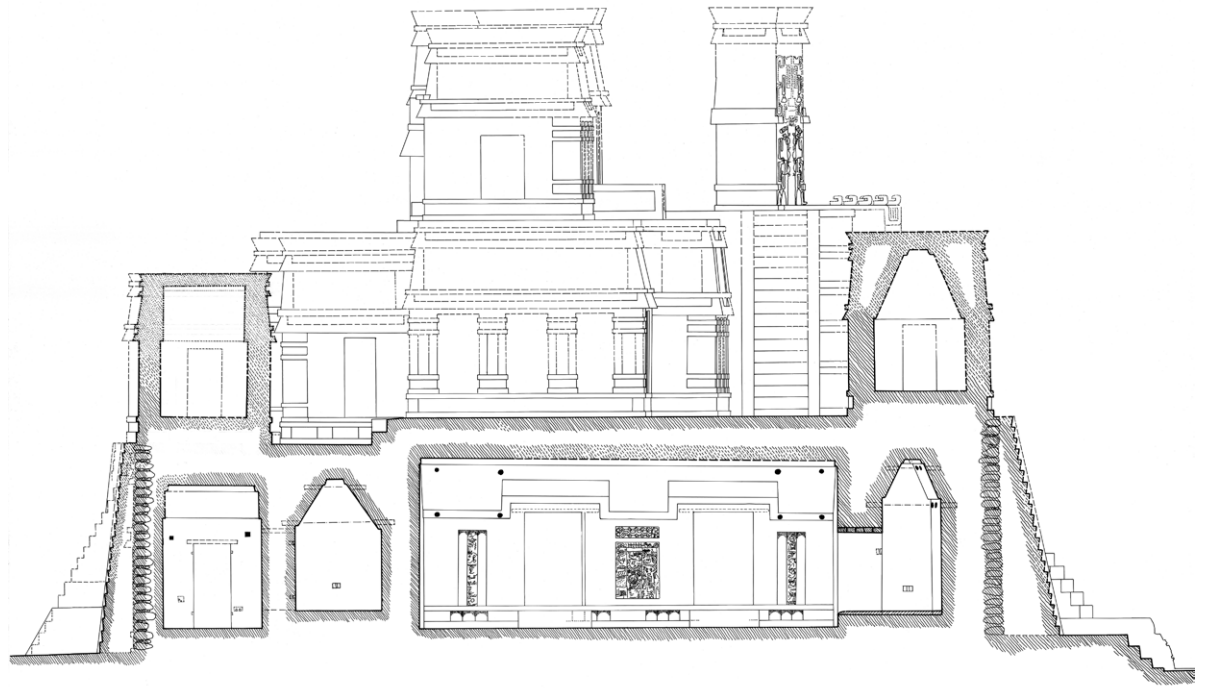
Fig. 37  
SQ-10

This section Q-10 facing north shows the entrance hall in the South (Room 1). The two relief panels in the centre are interesting. They show reused blocks of a larger relief from another earlier building. The relief blocks have obviously been put together in the wrong way. The mistakes must have been intentional. There is another relief in the northern entrance hall, where the blocks are also mixed. It seems to be a special way of showing that such reliefs did not originally belong to the building and its time. On the other hand they shall remind people of their history. It seems to be a special kind of culture of the Maya to remember important structures of the past and their inhabitants.

This section is based on the geodetic survey of Erwin Heine and Andreas Reiter (Heine 1997:Plan 16; refer to small drawing).

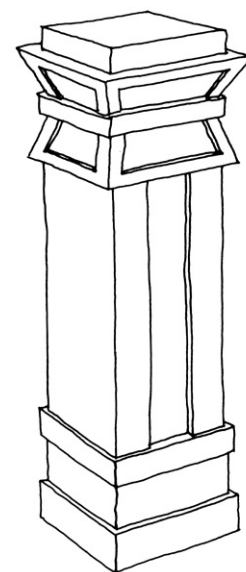
Fig. 38  
P (pillar)  
Perspective of one of the pillars supporting the massive roof of Room 1

The perspective of one of the pillars shows the side, which belongs to the façade, to the right. The pillar has a basis with a

three-member molding all around, a shaft with a vertical recess at the side of the façade and a tethered capital on top.

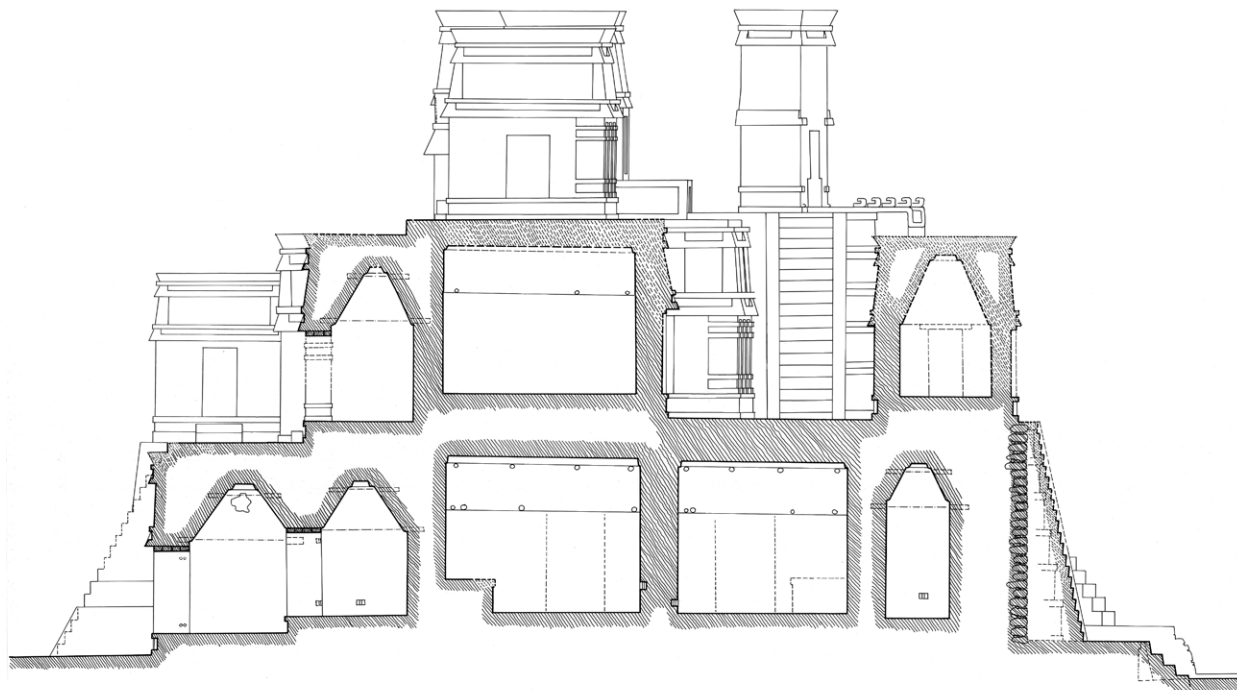
Fig. 39  
SQ-20

This section cuts through Room 25, Room 26, Room 2, Room 3, and Room 4 on the first floor from left to right and through Room 37, Room 28, and Room 38 on the second floor. The plan also shows the southern front views of Room 45 and Room 29 on the second floor and the southern front views of Room 40 as well as of the monster mouth passageway on the third floor. The section through Room 2 shows the bench. The section through Room 3 shows the stucco marks of the former bench on the northern wall, which were recognized by Antonio Benavides Castillo. The bench itself does not exist any longer.

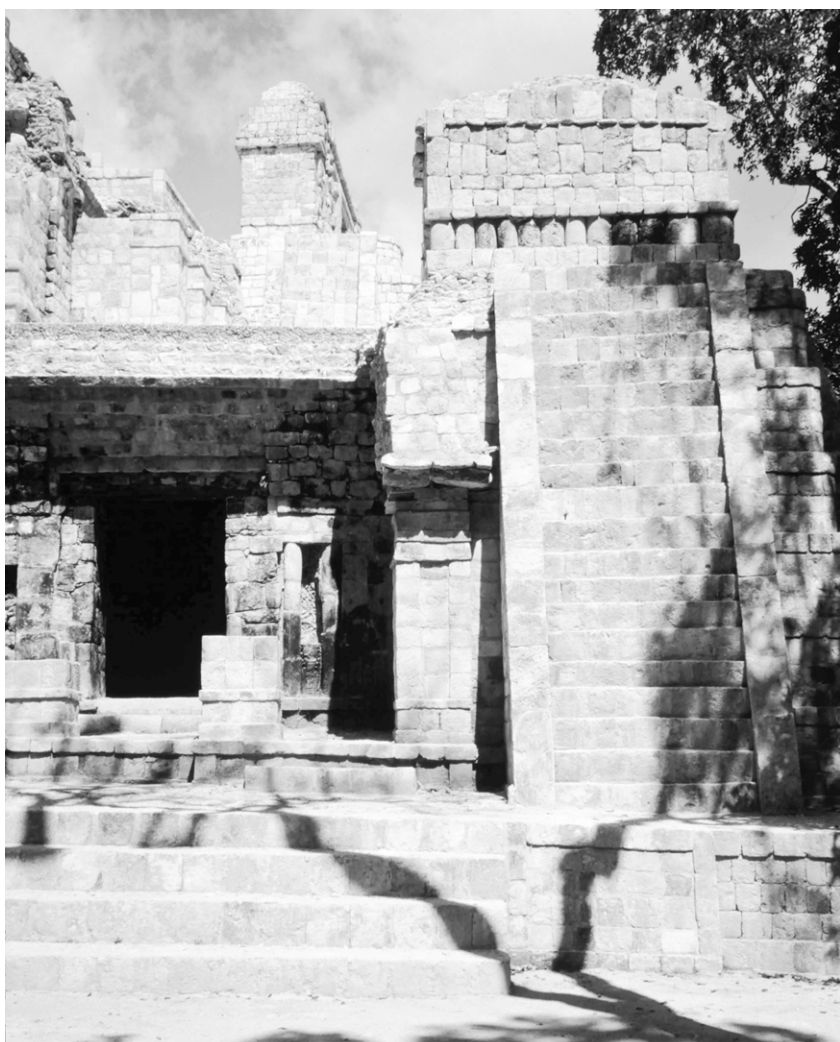
Fig. 40  
This shows the south-eastern temple pyramid, the six mega steps to the right, the asymmetrical pseudo stairway and the southern wall of the temple. The fine horizontal stone line half way up the wall is not understandable, as there was nothing left of this wall. Only the core wall of the structure was still standing.  
Photograph: H. Hohmann 2004

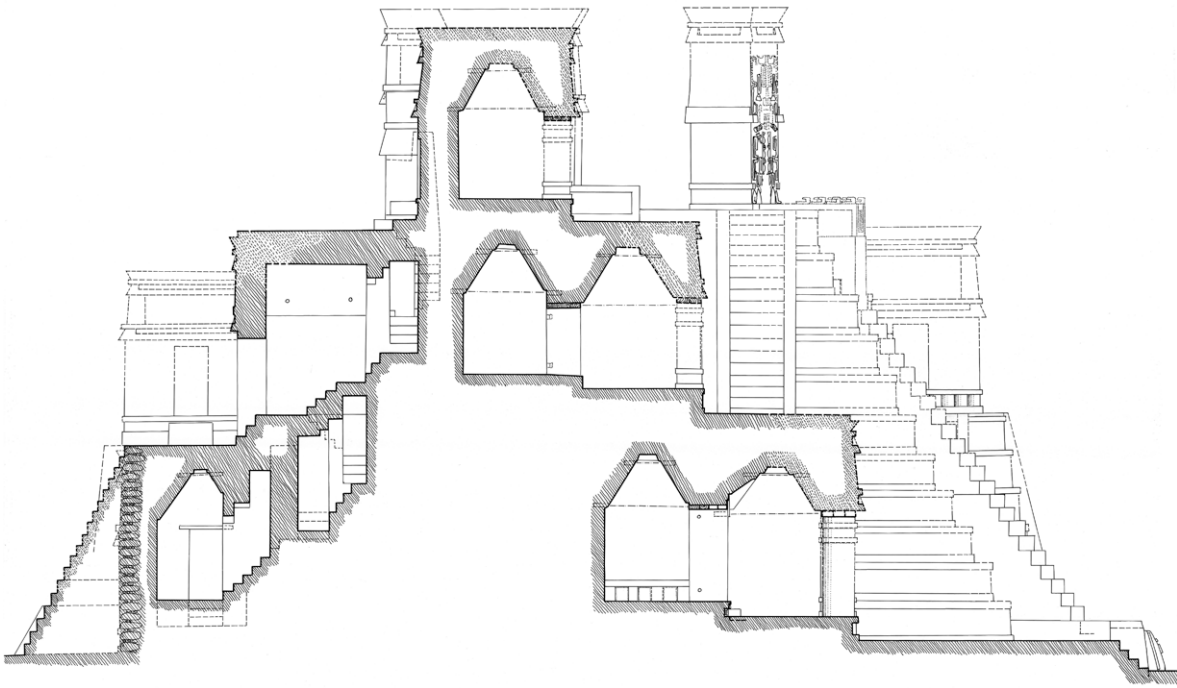
Fig. 42  
S.Q-35

Section 35 facing north shows a different section and projection of the southern staircase and Room 22 as a transit space. Room 48 is also a transit space on the second floor and the entrance from the western terrace; it gives access via this terrace to all the other rooms to the South, the East and the North on this level. All stairs of the southern staircase, even stairs which are not visible and those which are behind the observer are shown in broken lines to produce a complete visualization in combination with the ground plan and the north-south section.
