# THE MAYA TEMPLE-PALACE OF SANTA ROSA XTAMPAK, MEXICO

DOCUMENTATION AND RECONSTRUCTION OF FORM,  
CONSTRUCTION, AND FUNCTION

HASSO HOHMANN

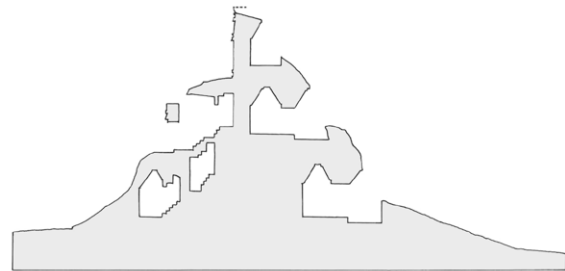
Fig. 42  
S.Q-35

Section 35 facing north shows a different section and projection of the southern staircase and Room 22 as a transit space. Room 48 is also a transit space on the second floor and the entrance from the western terrace; it gives access via this terrace to all the other rooms to the South, the East and the North on this level. All stairs of the southern staircase, even stairs which are not visible and those which are behind the observer are shown in broken lines to produce a complete visualization in combination with the ground plan and the north-south section.

This section is based on the geodetic survey of Erwin Heine and Andreas Reiter (Heine 1997:Plan 21; refer to small drawing).

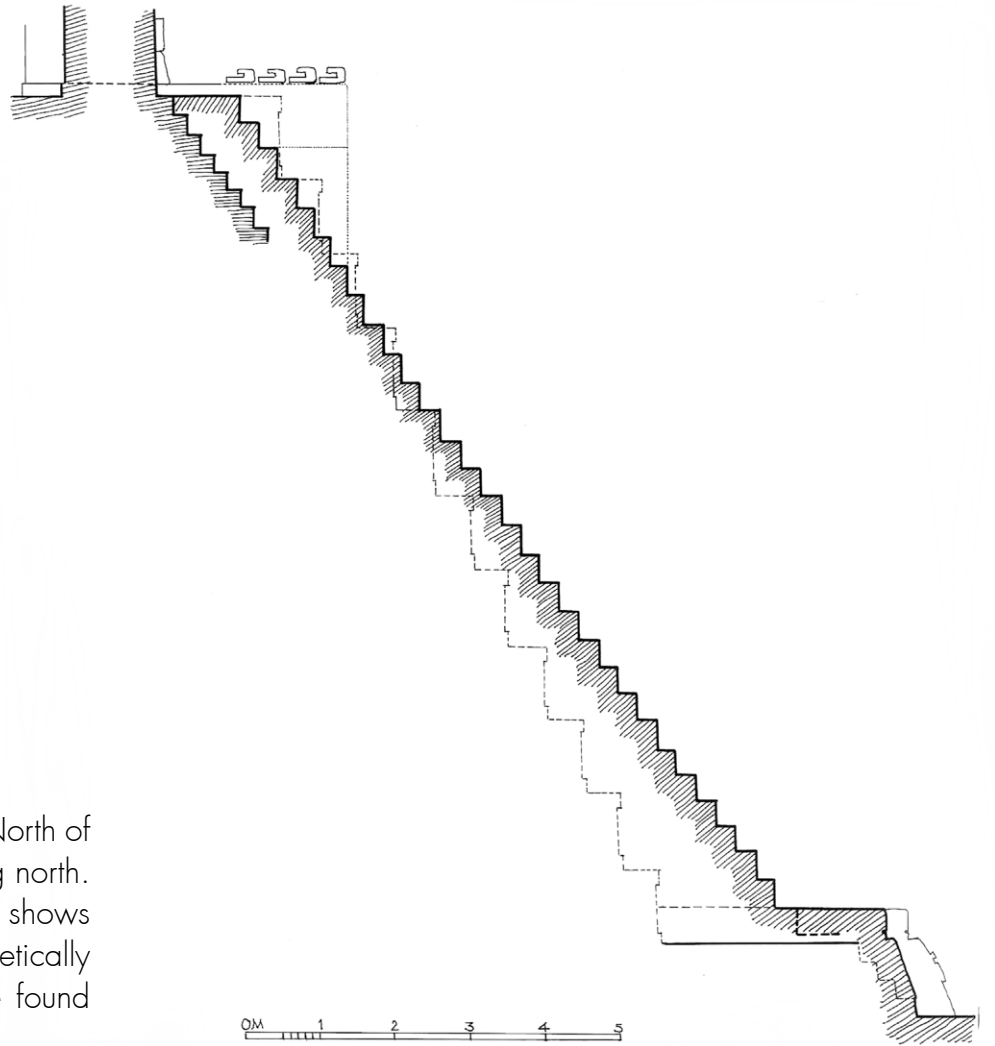
Fig. 43  
S.Q-45 (StA)

Section Q-45\* cuts through the main Stairway A in the North of the lower jaw of the monster mouth passageway looking north. It also provides a section through the earlier stairway, shows the mega steps by thin broken lines and also the hypothetically added lower jaw with some of the teeth, which were found around the Palace.

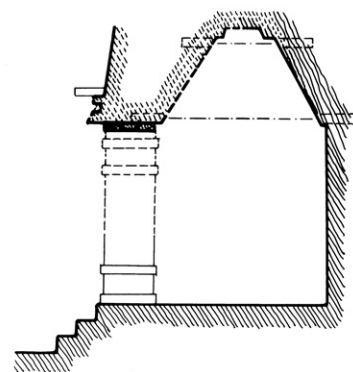
Fig. 45  
S.Q-55 (R19)

Section Q 55 faces to the North and cuts through Room 19, the entrance to the inner Staircase D. The section shows the profile of the room, its base, the corbelled vault and the passageway to Room 18 with the three steps leading up into this room.

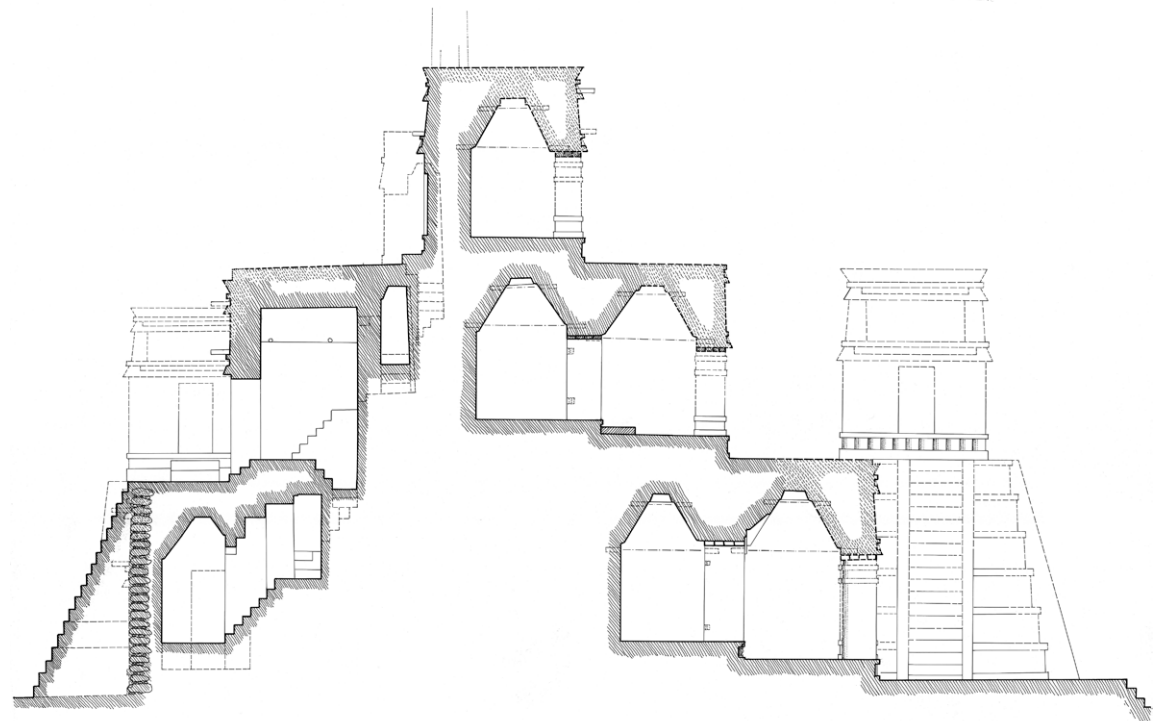
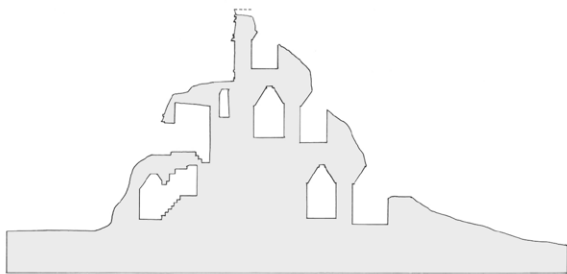
**Fig. 46**  
**S.Q-65**

Section Q 65 facing to the North shows a section through the northern Staircase D. Especially Room 47 with the small platform and the three steps down the western terrace of the first floor are visible. It also includes the invisible parts of the stairway by broken lines. Beside this it shows most of the southern façade of Temple 45 and the complete southern façade of Temple 39.

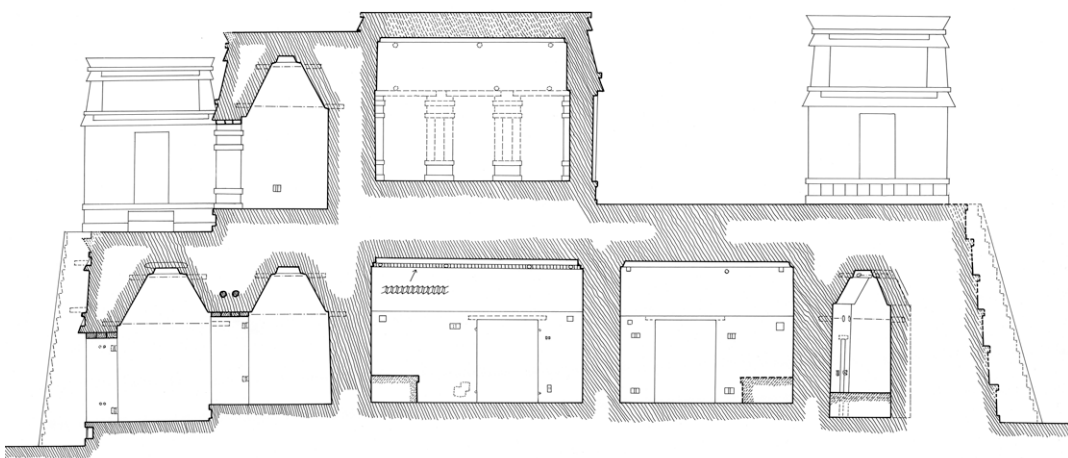
Fig. 47  
S.Q-85

This Section Q-85 facing north cuts through the Rooms 16 and 17, 12, and 11 as well as through Room 10 on the ground floor. On the second level it cuts through Rooms 34 and 33, showing the pillars from inside. The southern façades of the Temples 45 and 39 are nearly complete. The cut through the substructure of Temple 39 just in front of its southern façade shows its six mega steps as well as the sleeping Room 10 underneath in combination.

Between Rooms 16 and 17 the section also shows the two wooden reinforcements above the lintel of the passageway. The upper and lower vault beams as well as the cord holders for both rooms are also visible as are the additional rod sockets at the entrance to this living unit.

We also can see the upper and lower vault beams within the Rooms 12, 11, and 10. The four cord holders to fix the closure at the passageways to Room 9 are complete in Room 11 and one is missing in Room 12. Room 10 has only two such cord holders at the doorway in a position half way up. It is questio-

nable if this was sufficient to fix a closure at this passageway. The three benches in the three Rooms 10, 11, and 12 were all destroyed by looters before 1970, when Richard Stamps could only measure and document the plaster lines of these benches on the wall plaster. Room 12 has a two-member upper molding at the upper end of the vault. Usually there is only one. The lower one of these two members on the level of the upper vault beams is decorated with a tooth line on all four sides. This room has additional rod sockets for a different type of closure at its passageway to Room 9.

This section is based on the geodetic survey of Erwin Heine and Andreas Reiter (Heine 1997:Plan 31; refer to small drawing).

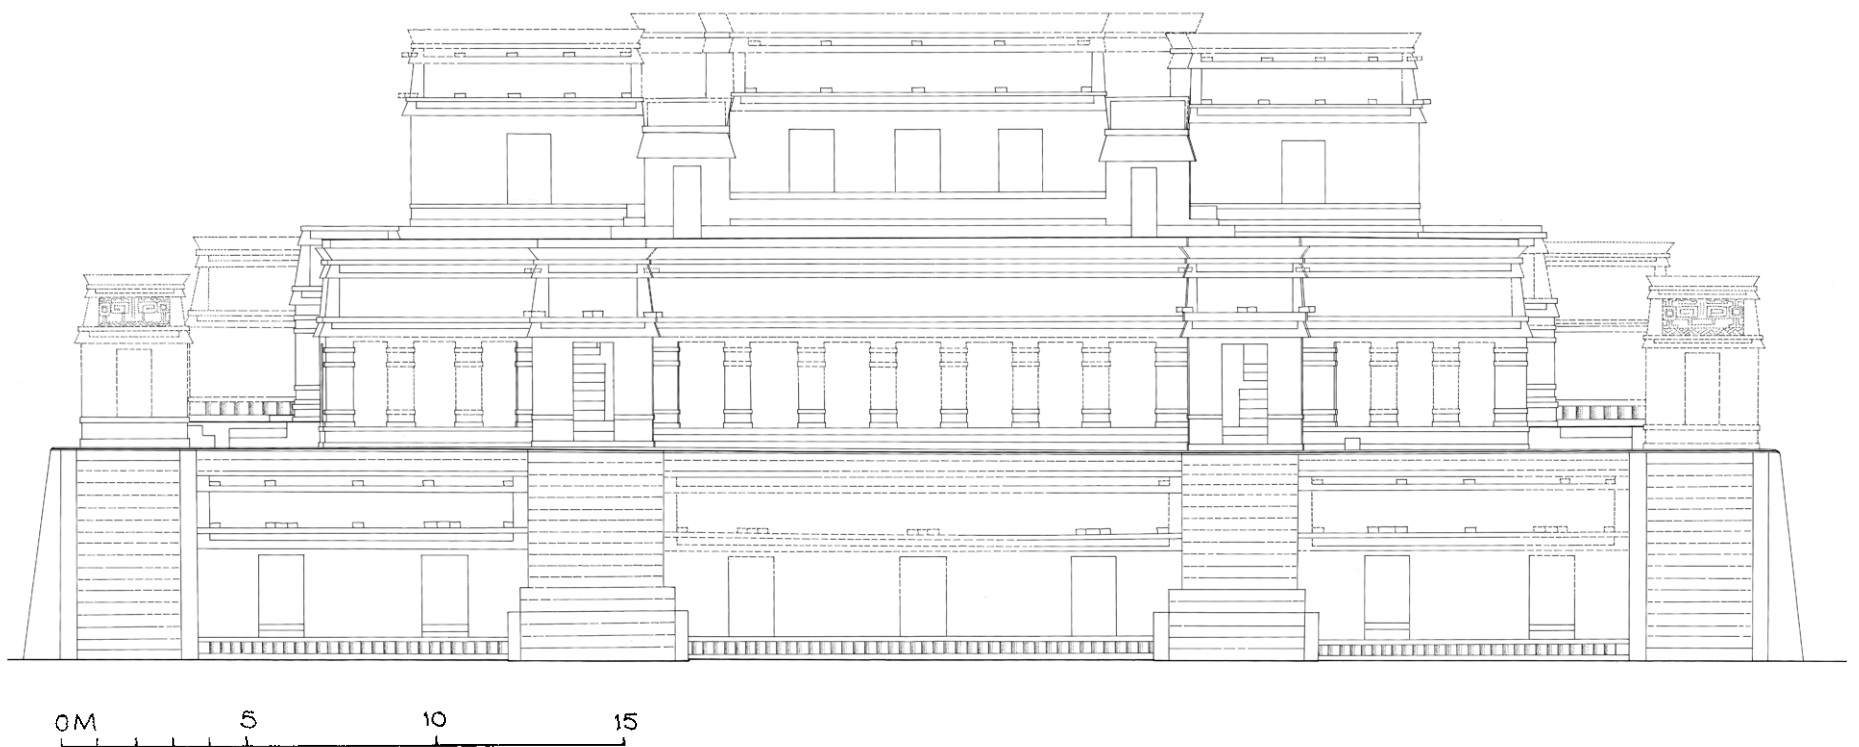
**Fig. 48**  
**WFa Western Façade**

Remains of the two pseudo stairways, framing the central "living unit" on the western façade, had survived and could be reconstructed by drawing. The recently reconstructed version is wrong. The central "living unit" itself, which in reality consisted of the two entrance halls Room 19 and Room 21 for the two inner staircases and the very small central Room 20, were in a quite bad condition. But most parts of the southern entrance of Room 21 had survived.

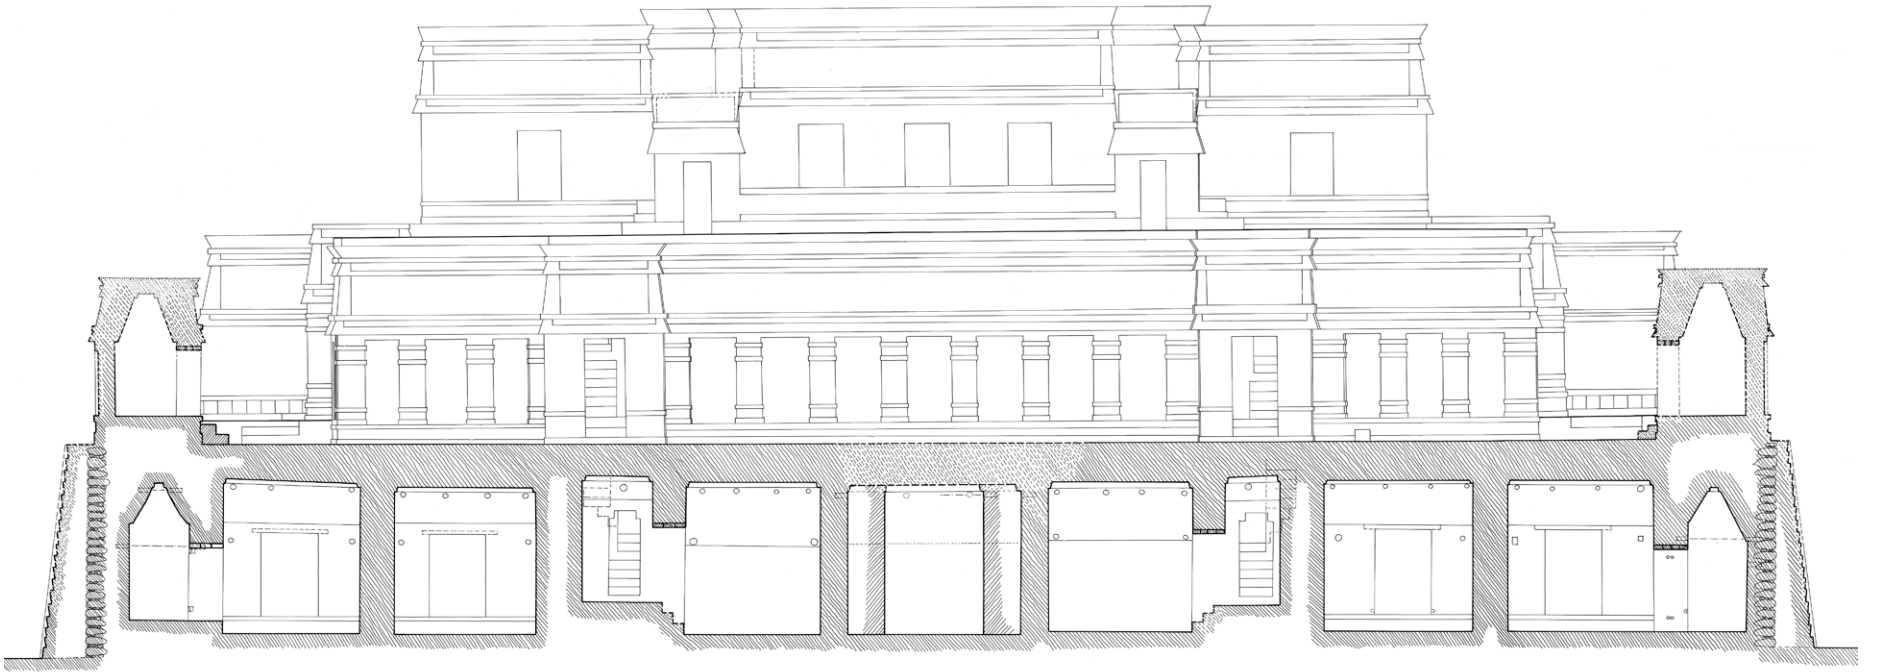
Fig. 50  
S.L-10

Section L-10 focusing to the East cuts the westernmost rooms of the first floor and the two Temples 45 and 46. Room 15 has a raised floor; the floor of Room 14 is also higher than the floor of Room 13. The whole of the very small Room 15 might have functioned as a huge bench. The opposite Room 27 in the South has the same floor level as Room 25. Room 17 is higher than Room 16 and Room 24 is higher than Room 23.

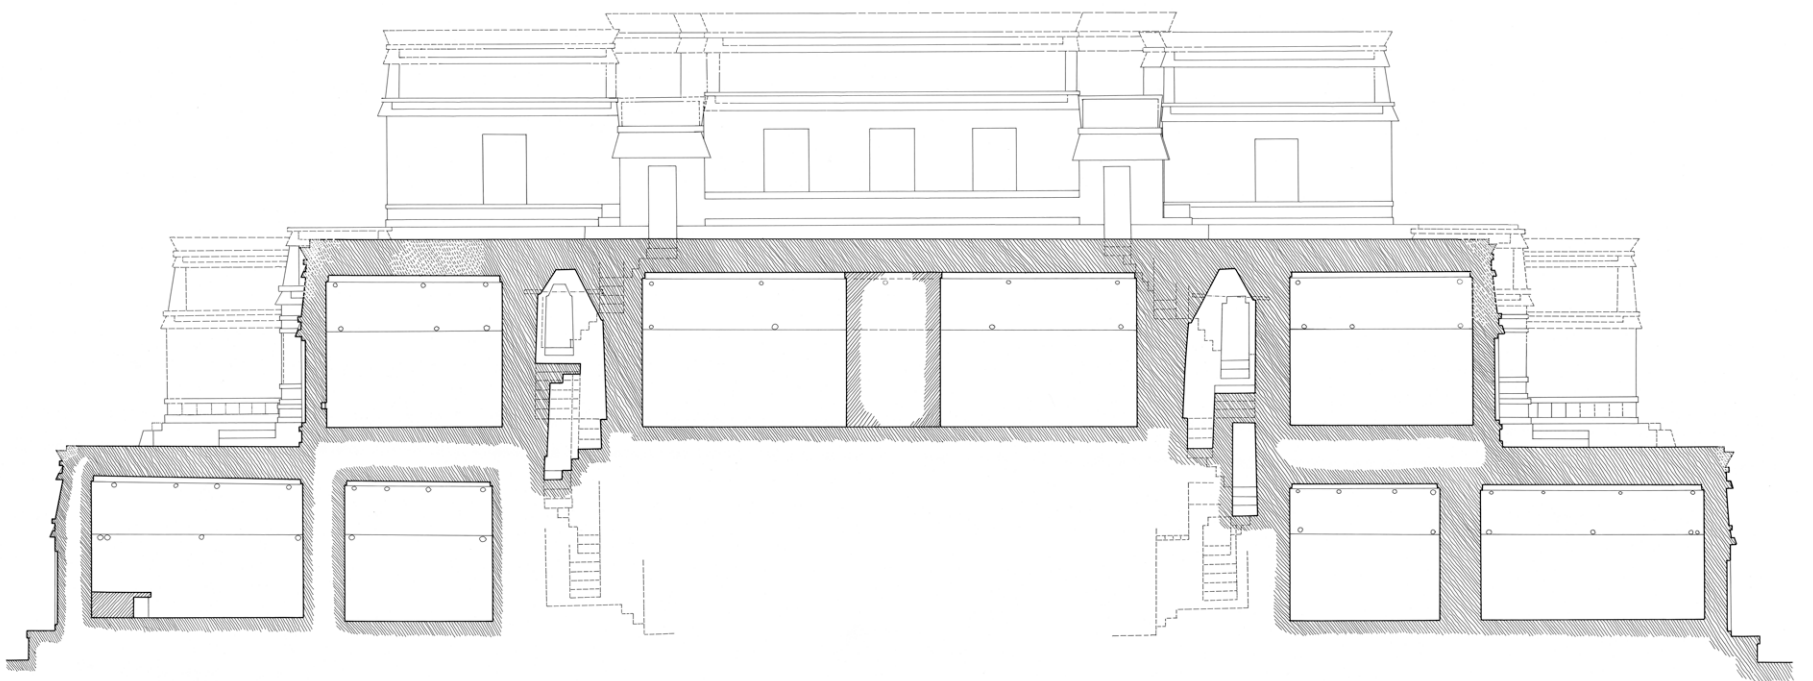
Fig. 51  
S.L-15

Section L-15 facing to the East shows both staircases from the ground floor to the top. Even invisible sections of the staircases behind the viewer and also behind structural elements are represented by broken lines. In this way, in combination with the ground plan, the entire two staircases are completely documented. See also Section L-15 facing to the West and Sections Q-35 and Q-55, both facing to the North, the two cross sections in an east-west direction. Rooms 14, 17, 24, and 26 on the first floor and Rooms 34, 35, 36, and 37 on the second floor are documented. In Room 14 we see the bench, in this and in all other rooms we see the upper and lower vault beams. This section is based on the geodetic survey of Erwin Heine and Andreas Reiter (Heine 1997:Plan 7; refer to small drawing).

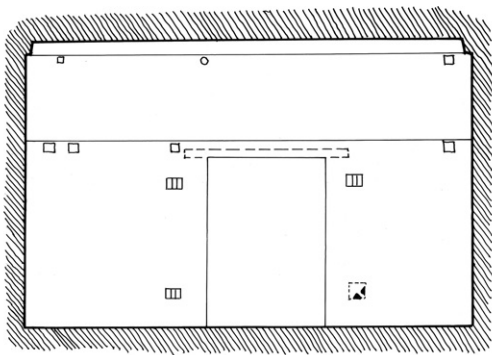
Fig. 52  
S.L-25 (R30)

Section L-25 cuts through Room 30 facing to the East showing four cord holders near the passageway, three upper vault beams and four lower vault beams. A closure could be fastened with the cord holders - the room could be closed. To the North there is a pair of vault beams. Here heavy loads could be hung. Above the northern cord holders is another vault beam. Here a curtain could separate the northern section of the room from the rest. It seems possible that a wooden bench once existed which was used as a sleeping place. The fourth lower vault beam in the very south of the room might have been used to hang up clothes.

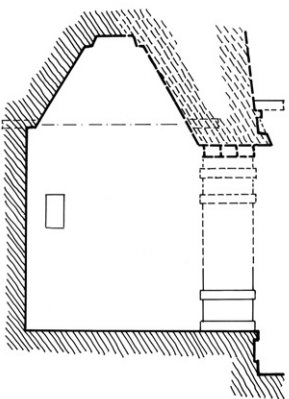
Fig. 53  
S.L-25 (R28)

Section L-25 cuts through Room 28 facing east showing the profile of the room, one of the four pillars to the right and a niche in the eastern wall. The upper vault beams were no longer visible. Only beam holes of the lower vault beams survived in the northern wall.

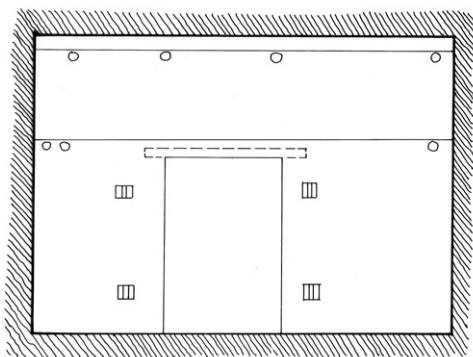
Fig. 54  
S.L-25 (R32)

Section L-25 cuts through Room 32 facing east, showing four cord holders near the passageway to Room 31. Therefore the room could be closed from inside. There are four upper vault beams and three lower ones in the room. Two of the lower vault beams form a pair and could hold heavy loads.

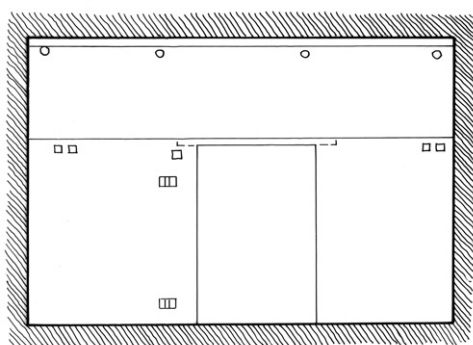
Fig. 55  
S.L-30 (R8)

Section L-30 cuts through Room 8 facing east, showing four upper and five lower vault beams as well as two cord holders north of the passageway to Room 7. Two more cord holders must have once existed south of the passageway to be able to close the room. They possibly disappeared in consolidation work. Otherwise the two northern cord holders would not make sense. The lower vault beams form two pairs of beams – two in the North and two in the South of the room. They might have carried a hammock and the user did not want to risk breaking a beam. We find two more pairs of lower vault beams in Room 6. It seems quite certain that hammocks were used in both cases. Rooms 6 and 8 on the ground floor are symmetrically positioned in the eastern façade of the Palace. The third room with two pairs of lower vault beams is Room 42, the most central room on the third floor. The three rooms form a symmetrical triangle in the façade. It seems that in all three cases important persons of the palace sat and acted in hammocks in the day time.

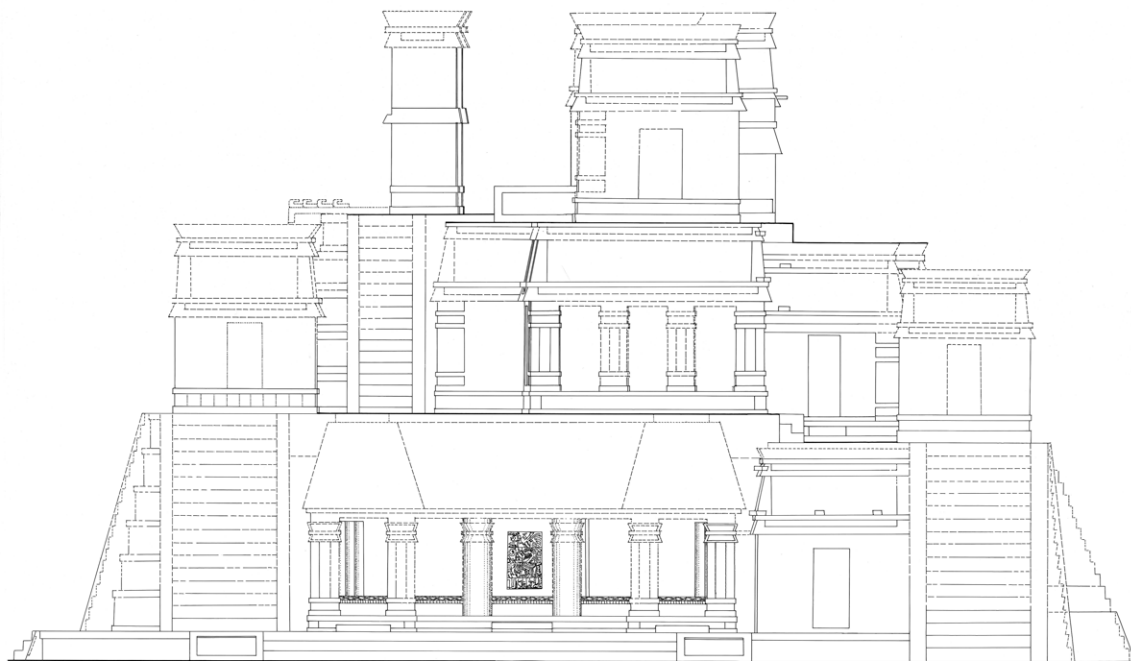
**Fig. 59**  
**NFa Northern Façade**

The northern façade of the Palace shows the two temple pyramids with their pseudo stairways and pseudo entrances at both ends – the eastern one standing on the large platform of the Palace to the left, the western one standing directly on the same level as the Plaza in the East.

The first floor is dominated by the large entrance hall (Room 9) of the Rooms 10, 11, and 12. Its massive looking, steep, undecorated roof is not very usual in Maya architecture. Only two of the altogether 29 roofs at this Palace have or had such a roof - Room 1 in the South and Room 9 in the North. The roof is supported by two columns in the center and these are flanked by two side risalits each having two supporting pillars. The two columns carry the recessing section of this façade. There are three entrances into the long hall marked by steps in front of Room 9.

Each of the four pillars consists of a three-member basis, a profiled shaft and a tethered capital. Each of the two columns consists of a round shaft; in comparison with the pillars a round capital was added hypothetically. Such architectural elements can also be found in Channá in the Río Bec Region (Gendrop 1983:148 and 149) and in El Delfin some 60 km north west of Xpuhil (Merk 2015:39-43). They are also quite common in a smaller size as colonnettes in the roof zone of structures of the Puuc and of the Chenes region. Examples might be the western two corners of Structure 1 in Yakalxiú (Andrews 1995:186, Fig. 18a and 18b) and the wall zone of Structure 1 in Labna, Central Section, southern façade (Andrews 1995:73, Fig. 77).

Just behind it on the third floor stands the pseudo monster mouth entrance with the hypothetically added teeth of the lower jaw of the monster. Some of these teeth were found near the Palace on the Plaza level. The huge massive block at the upper end of the central Stairway A possibly formed the basis of the lower jaw of the monster mouth. West of the free standing passageway the short southern side of the ensemble of five rooms on the third floor is visible. The center of the façade of Room 44 is dominated by a huge pseudo entrance.

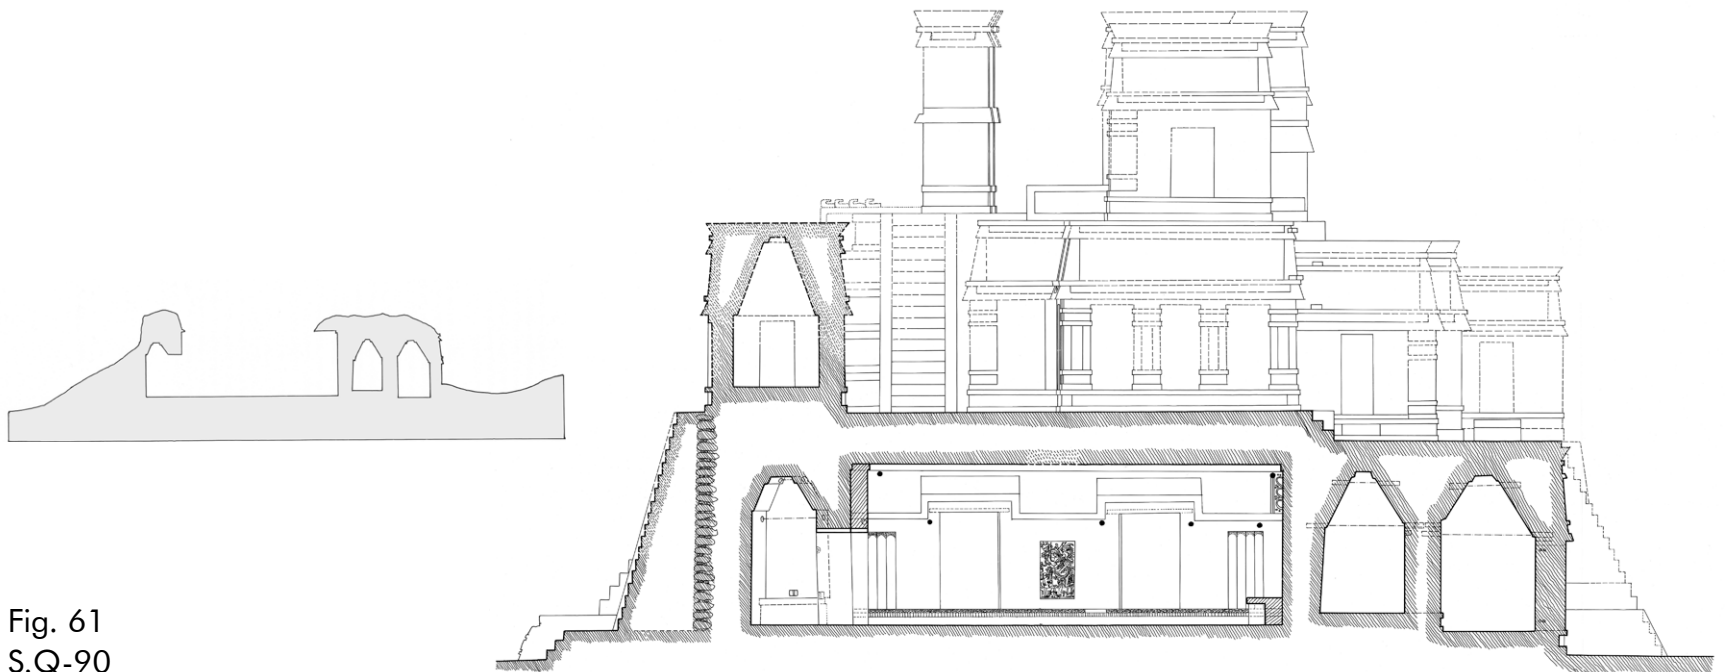
Fig. 61  
S.Q-90

This section is based on the geodetic survey of Erwin Heine and Andreas Reiter (Heine 1997:Plan 32; refer to small drawing).

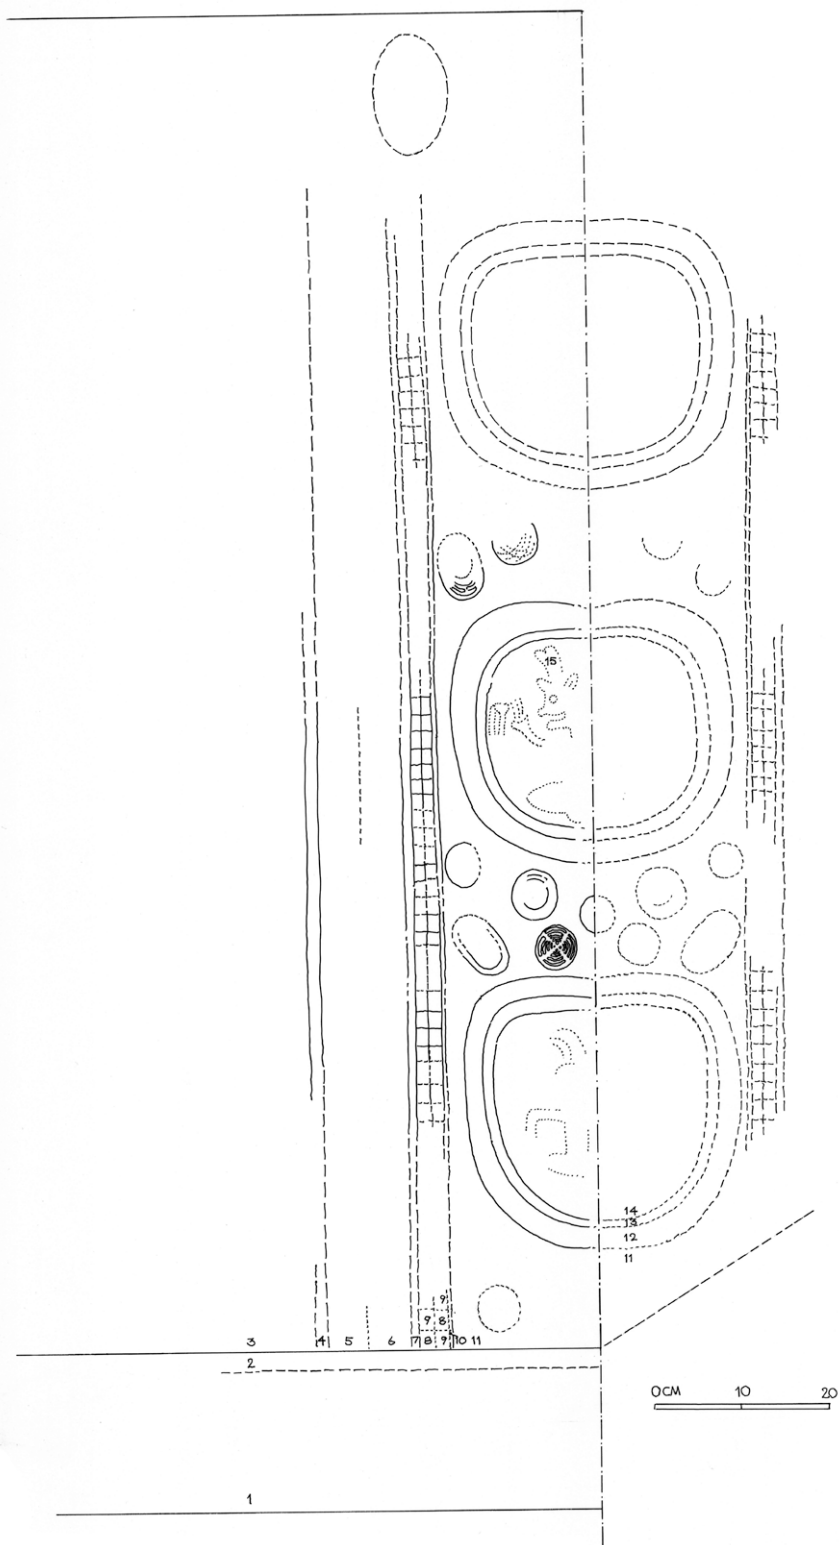
Fig. 62  
Detail S.Q-90\* (R9-Mural Painting)

The remains of the vault painting and wall painting at the western end of Room 9 consist of geometric elements and of other curved oval ones. As already mentioned above, Teobert Maler (1997:214) documented the remains of the painting by drawing and verbal description. Maler already realized that the painting went around the corner from the vault to the western gable wall. The motifs also used to continue down the southern wall. Figures 1 to 15 describe the colors in this new documentation:

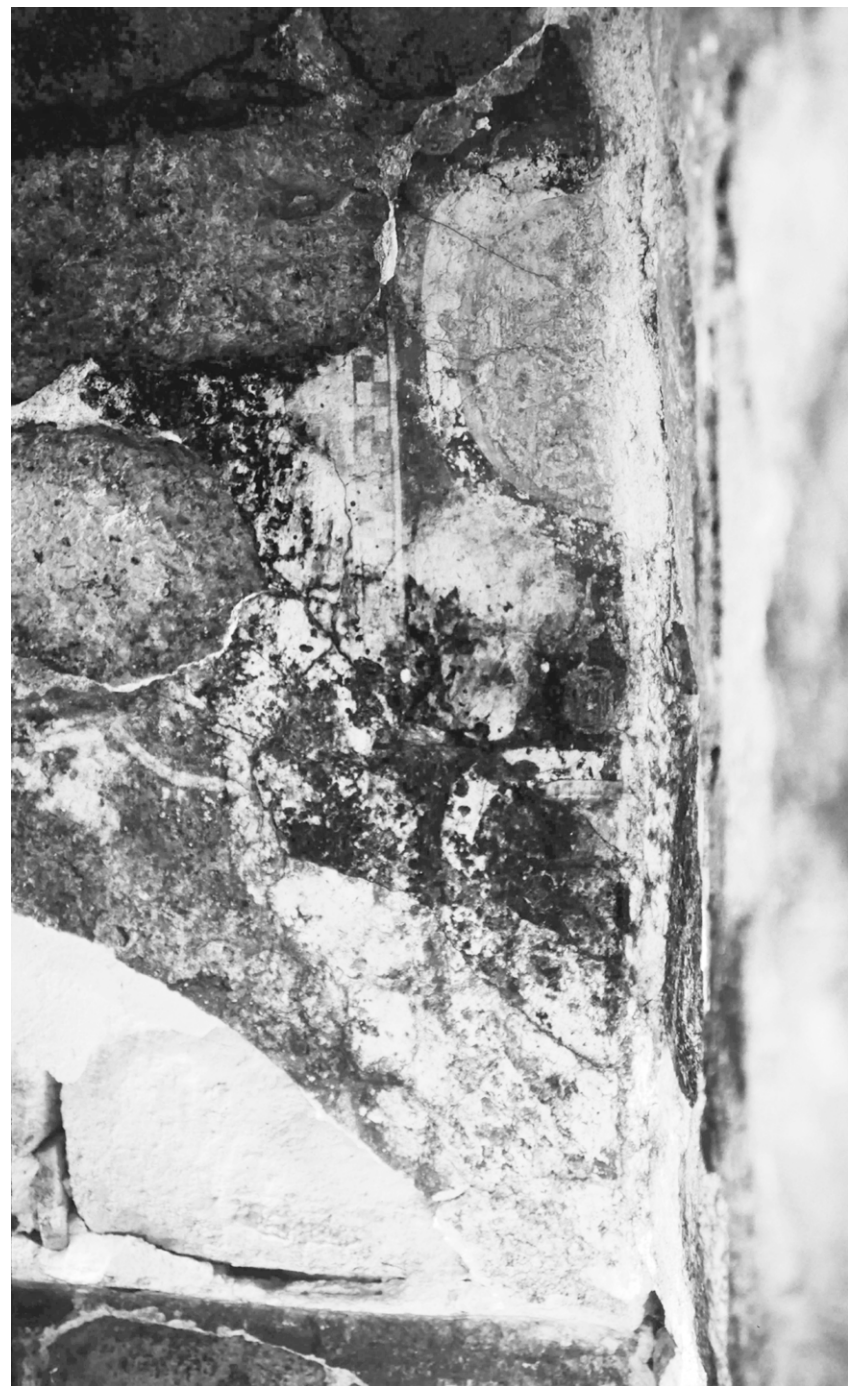
Fig. 63  
The mural above the bench in Room 9.  
Photograph: H. Hohmann 2001

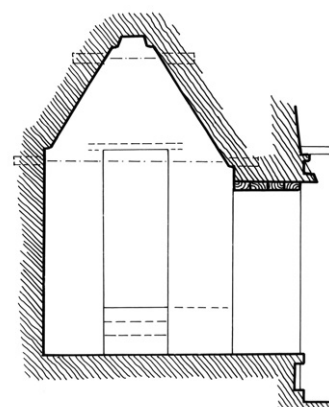
Fig. 66  
S.Q-40 (R21)

Section Q-40 cuts through Room 21 on the first floor on the western side, showing its southern wall, the passageway to Room 22 as well as the three steps leading up to this room and the southern staircase and showing the profile of Room 21 and the entrance from outside. The profile also represents the position of the upper and lower vault beams.

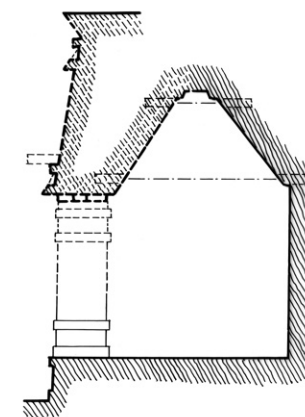
Fig. 67  
S.Q-30 (R40)

Section Q-30 represents the profile of Room 40 on the third floor at the southern end of the Palace. We can see one of the pillars and the position of the upper and lower vault beams. There were no cord holders. It might have been possible to close the room visually by curtains but Room 40 as well as Room 44 could not have been used for living purposes. They might have been used for representational purposes.

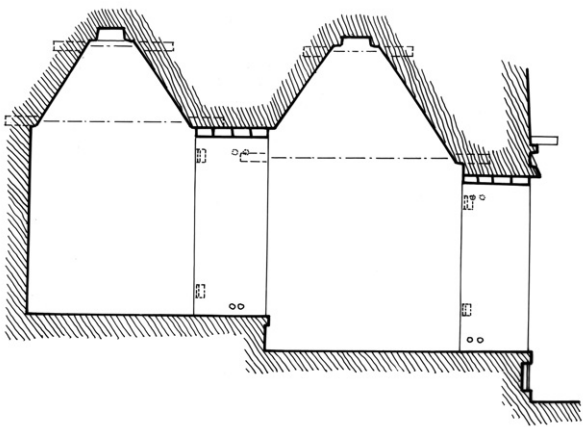
Fig. 68  
S.Q-25 (R23/24)

Section Q-25 shows the profiles of Room 23 and Room 24 including the southern walls of both rooms. Both rooms form a two-room unit. Room 23 is a passage room for Room 24. Both rooms have cord holders and these could be closed from inside; this means that the users of Room 24 had to open both doors to get outside. Only Room 24 provided full privacy. The users of Room 23 always had to be aware that a person from Room 24 wanted to cross their room.

This was possibly the reason for a second closing system at both doors – indicated by rod sockets. It seems quite certain that the closures of these rod sockets could be used from both sides, always to be used from the side from which it was first closed. This means that children could be closed in Room 24 from Room 23 and the users of Room 23 could also close the entrance from inside to have privacy in this room.

Rod sockets could always be installed later! But cord holders usually had to be put into the walls when the Palace was erected if they were to provide maximum security.

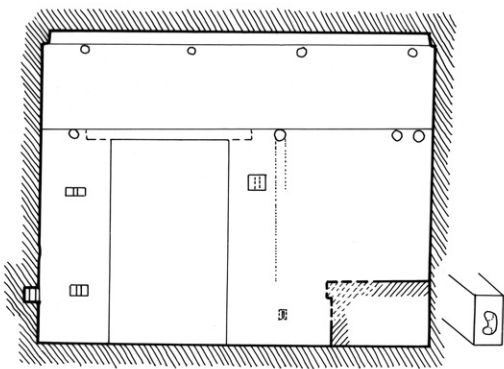
Fig. 69  
S.Q-20 (R2)

Section Q-20 cuts through Room 2 showing its southern wall. The cut shows the four cord holders near the passageway to Room 1 and one more cord holder to the left, possibly to attach a dog. There are four upper and four lower vault beams. The two western lower beams form a pair and could have been used to carry heavy loads. The next one is positioned in front of the sleeping bench and might have held a curtain to hide the person sitting or sleeping on the bench in this room.

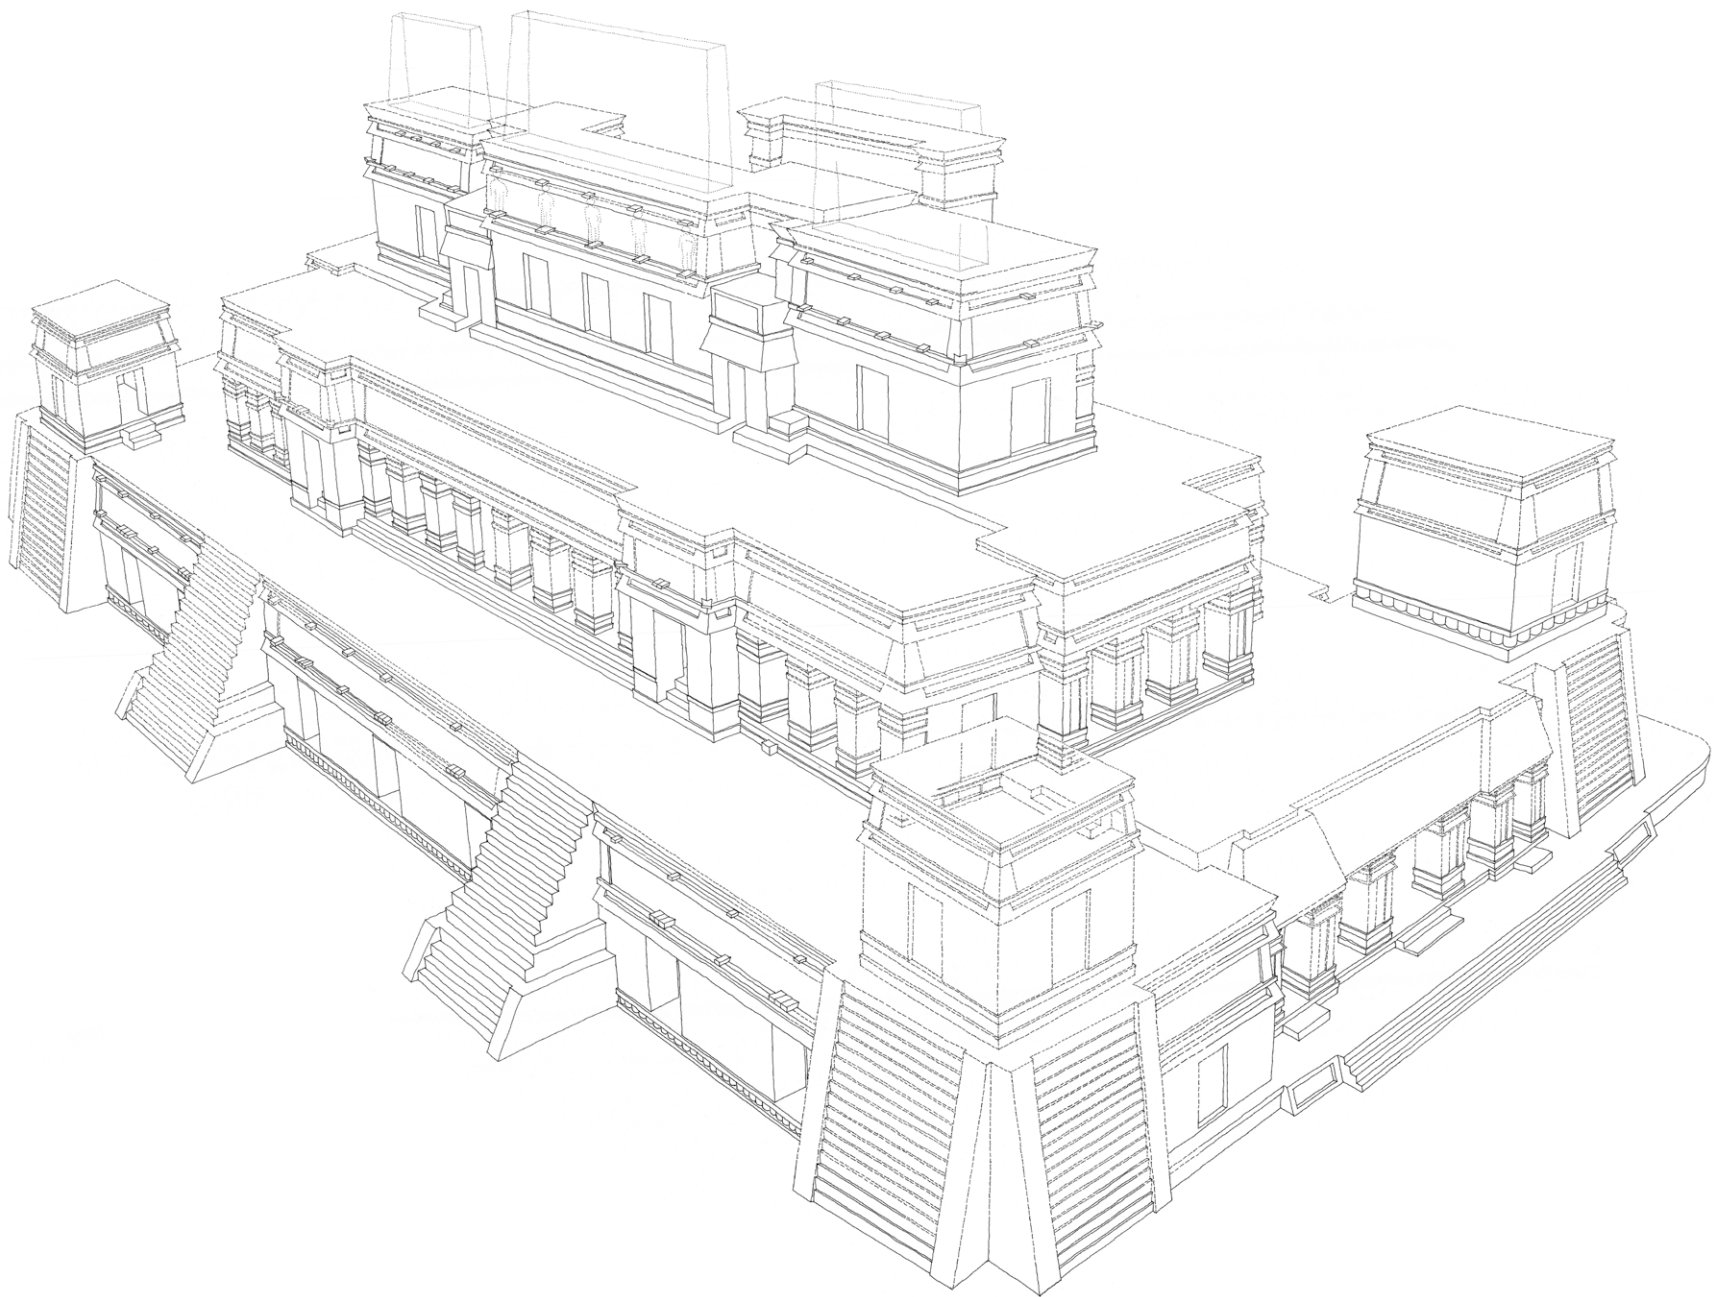
**Fig. 71**  
SWP bird's-eye view from the Southwest

entrances to the staircases are the third and the fifth entrance counted from the corners of the Palace in the western façade. Above the uppermost roofs three roof combs have been hypothetically added in dotted lines. The entire construction of the palace and the breadth of walls under the hypothetical roof combs indicate that the plan once existed to build such combs, but static problems prevented their construction. Behind the third floor rooms the upper section of the rear side of the pseudo monster mouth entrance is visible. Its orientation differs slightly from the other visible parts of the Palace. This perspective is based on the geodetic survey of Erwin Heine and Andreas Reiter of 1992. An unpublished perspective of Heine showed mainly contour lines; one third of it was used for this reconstruction drawing by Hasso Hohmann.

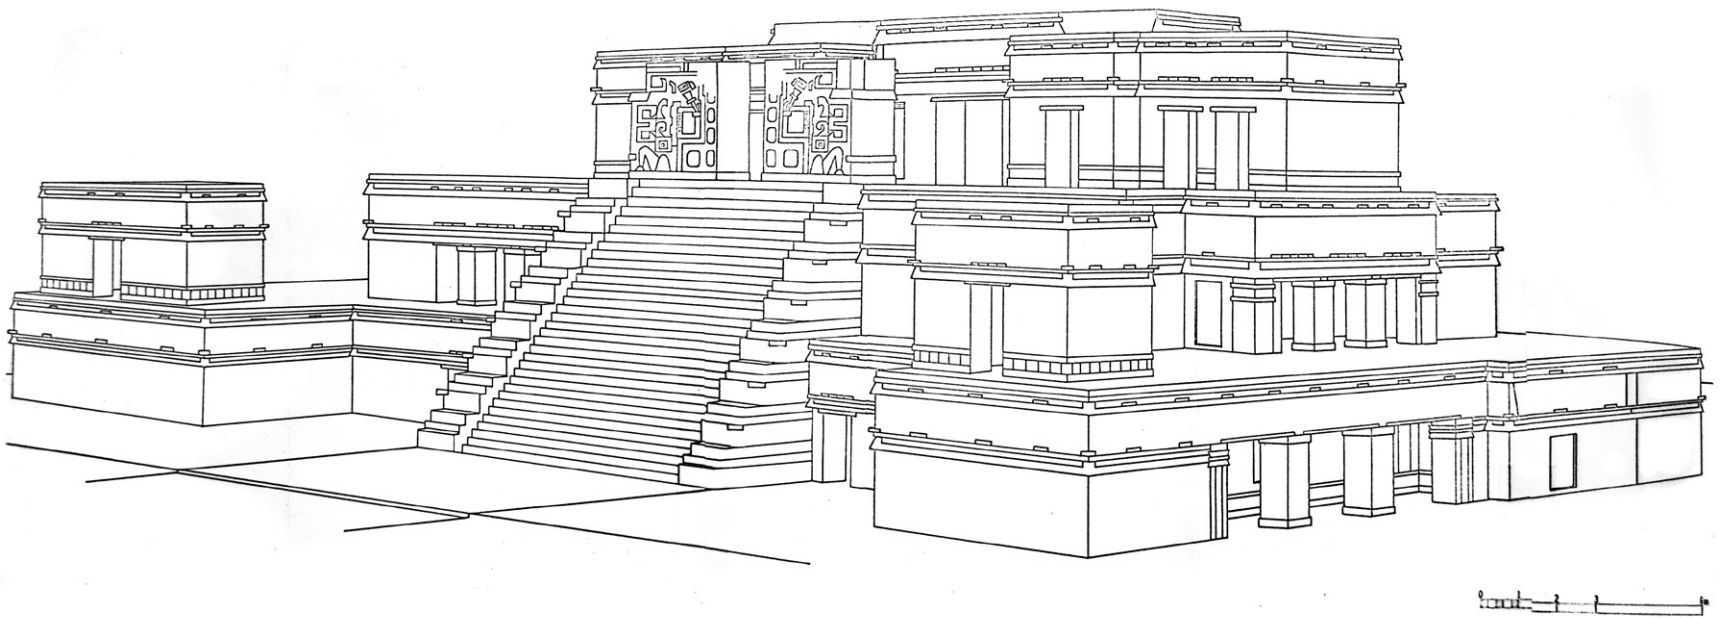
Fig. 73  
Stamps' perspective 1970:39, Fig. 4

At least one of the first or the first perspective of the Palace seen from the Northeast was published in 1970 by Richard Stamps (Stamps 1970:39, Fig. 4). It still shows only two supporting pillars for Room 9 and has no pseudo stairways between the first and the second floor. He did not realize that Stairway C, which was also visible at that time, had a counterpart, here named Stairway B. Nevertheless, with his knowledge – without excavating – the perspective gives a good impression of the Palace.

Richard Stamps (1970:39a; Fig. 4) does not show a roof comb in his "ascetic" perspective of the Palace. The perspective of Alejandro Villalobos (Andrews et al. 1987:73) does not show a roof comb either. Paul Gendrop added roof combs on the two eastern pyramids and on top of the three central third floor structures 41, 42, and 43 in his perspective (Gendrop 1983:75, Fig. 46a).

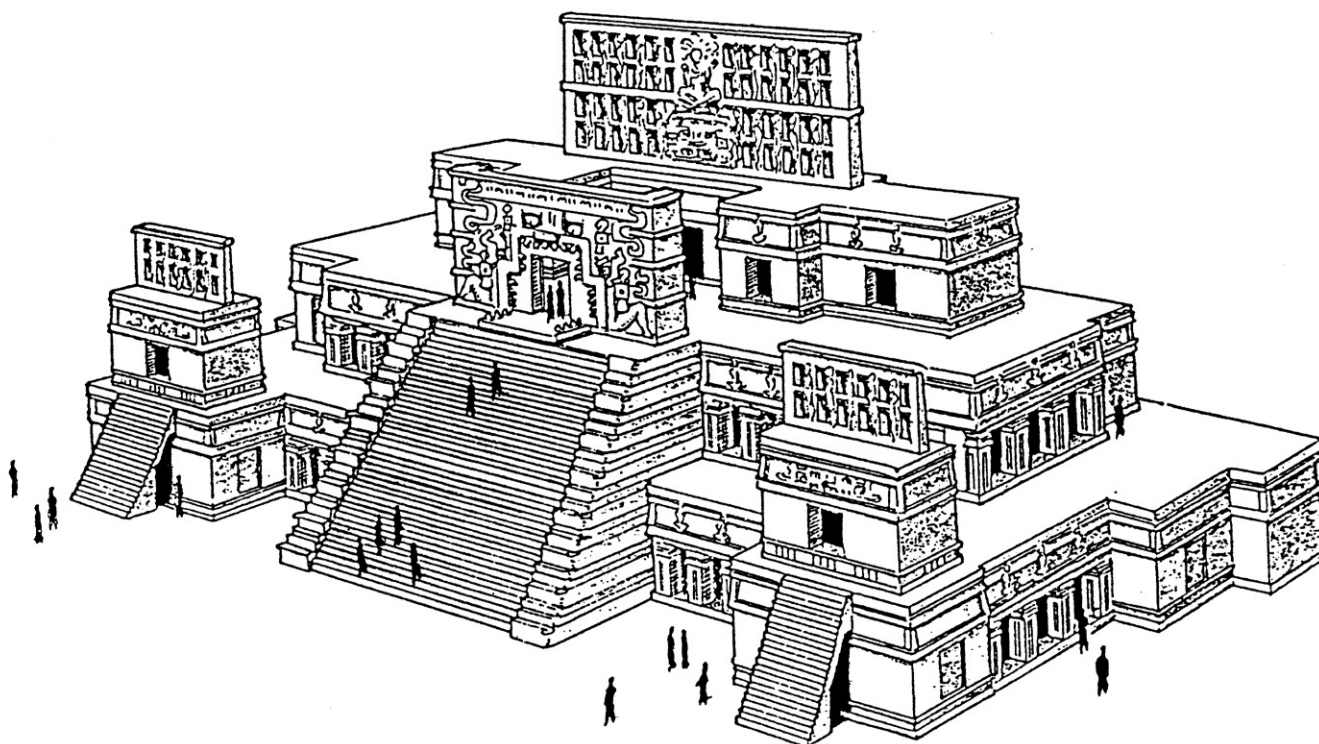
Fig. 74  
Gendrop's perspective 1983:74, Fig. 46a

Paul Gendrop's perspective (Gendrop 1983:74, Fig. 46a) also shows the Palace from the Northeast with a huge roof comb on top of the third floor and stairs leading up to the two eastern temples. They also have roof combs. He uses only two supporting pillars for the northern side of Room 9 and does not show pseudo Stairway B as the counterpart of the pseudo Stairway C, which was also known at that time. His perspective is less ascetic than the one of Stamps, has light and shadow and shows quite a lot of hypothetically added building sculptures.

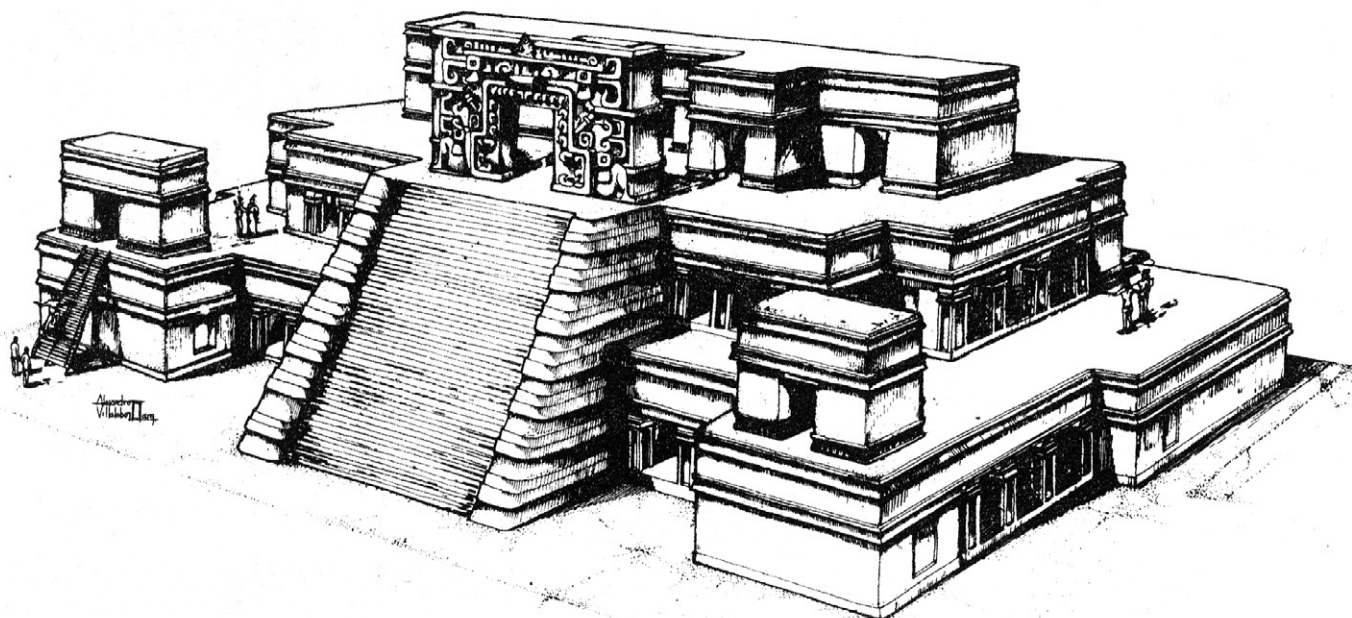
Fig. 75  
Alejandro Villalobos 1986  
Cuadernos No. 10:73, Fig. 48

The perspective of Alejandro Villalobos of 1986 showing the Palace from the Northeast (Andrews 1987:73, Fig. 48) might be based on Gendrop's. Villalobos took the roof combs and even the stairs in front of the eastern temples on the second floor away.
