# THE MAYA TEMPLE-PALACE OF SANTA ROSA XTAMPAK, MEXICO

DOCUMENTATION AND RECONSTRUCTION OF FORM,  
CONSTRUCTION, AND FUNCTION

HASSO HOHMANN

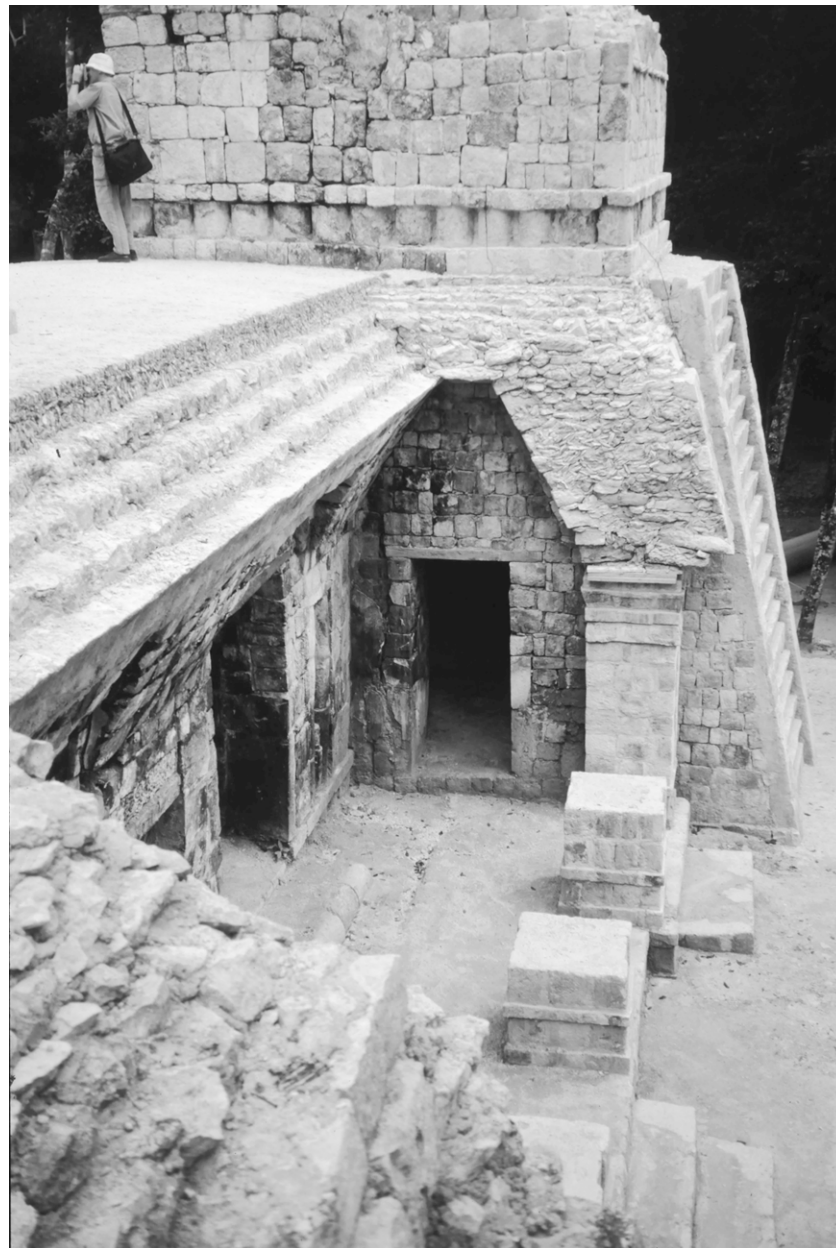
Fig. 76

View from west to east into Room 1. We see the entrances of Room 4 in the centre and Room 3 to the left. The slight risalit along the pillars is visible to the right.

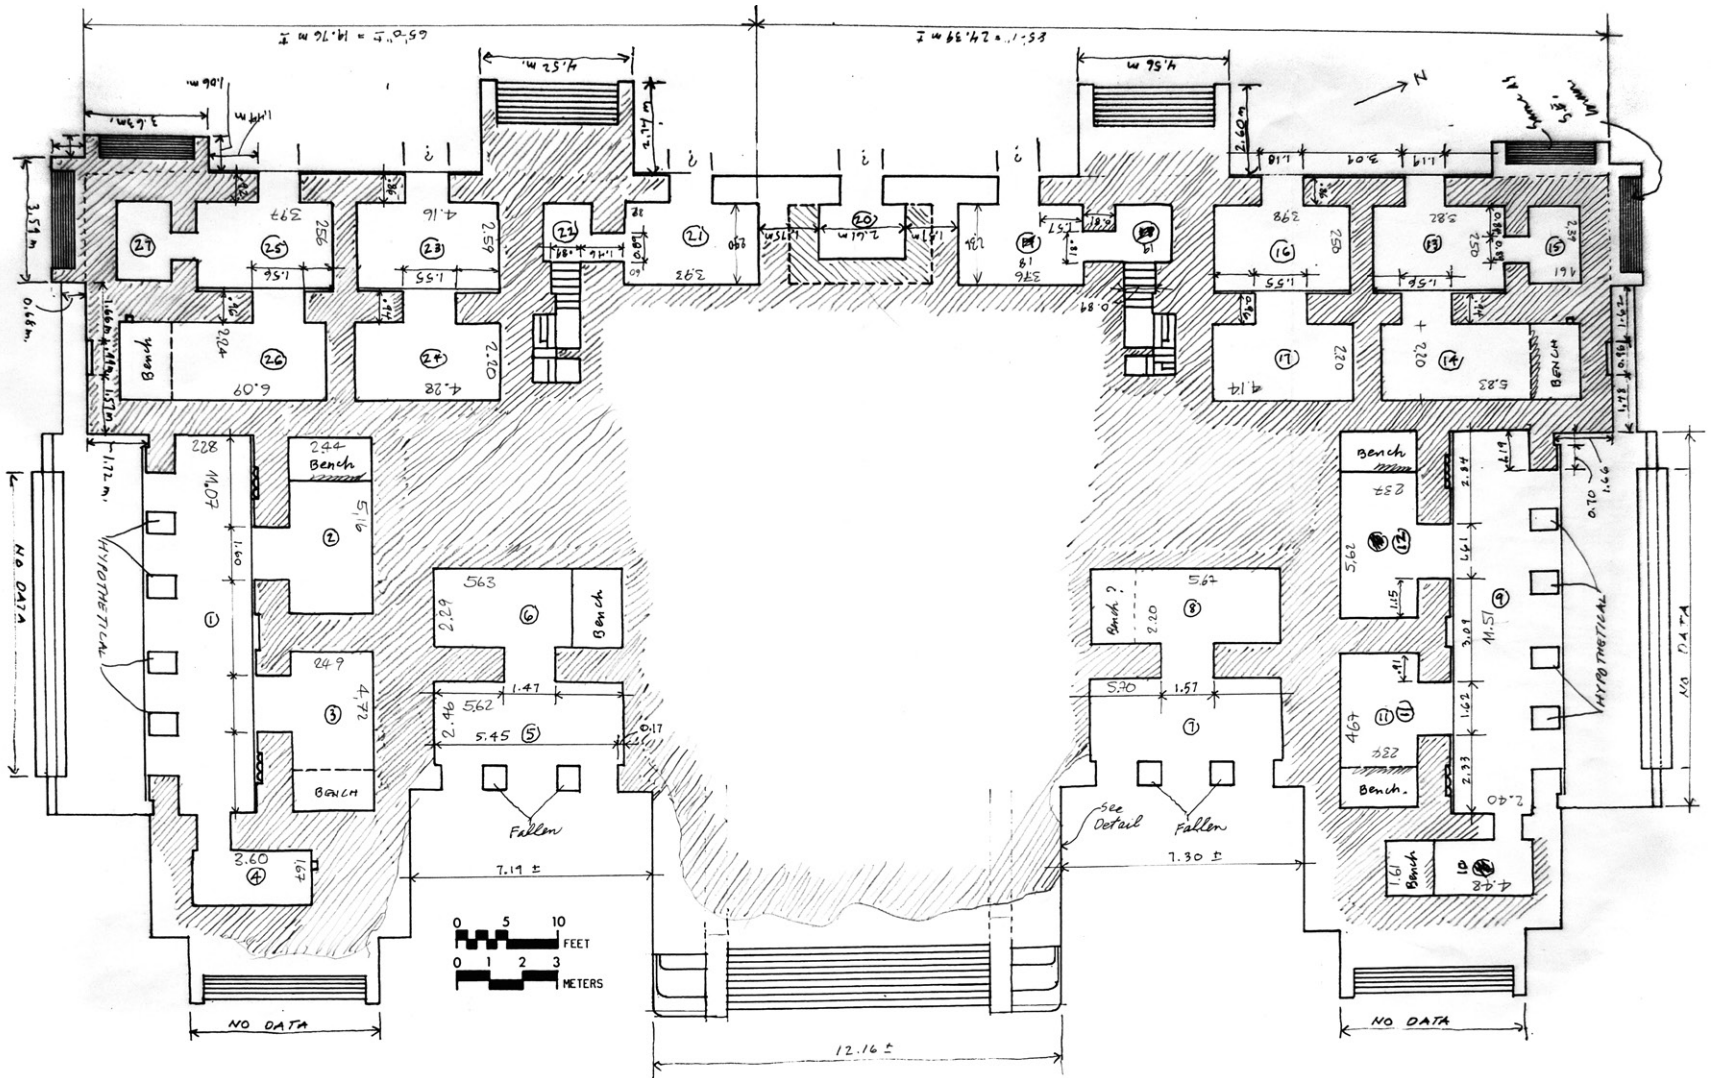
Fig. 77  
 Andrews' plan of the Palace of 1999 with measurements and question marks. The hypothetically added four pillars in Room 1 and in Room 9 are interesting. Andrews was the first to draw a plan with four pillars instead of two wall sections or of just two pillars in Room 1. This plan was very close to reality (Archive of H. Hohmann in Graz). This plan is similar to the plan of 1997 (Andrews 1997:279).

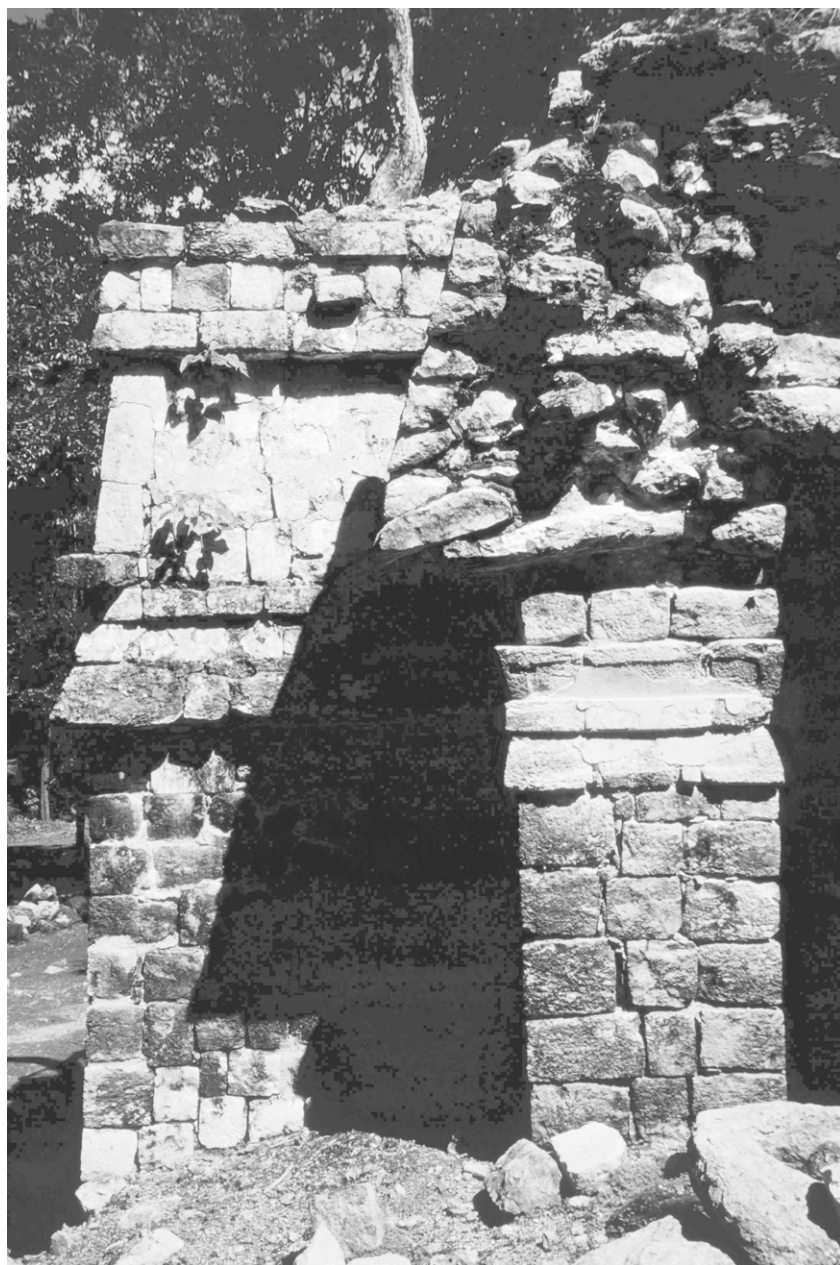
Fig. 78

This is the western end of the row of pillars in Room 1 and the south-eastern corner of Room 26 from the outside. The roof zone shows the medial and the upper three-member moldings. Photograph: H. Hohmann 1999

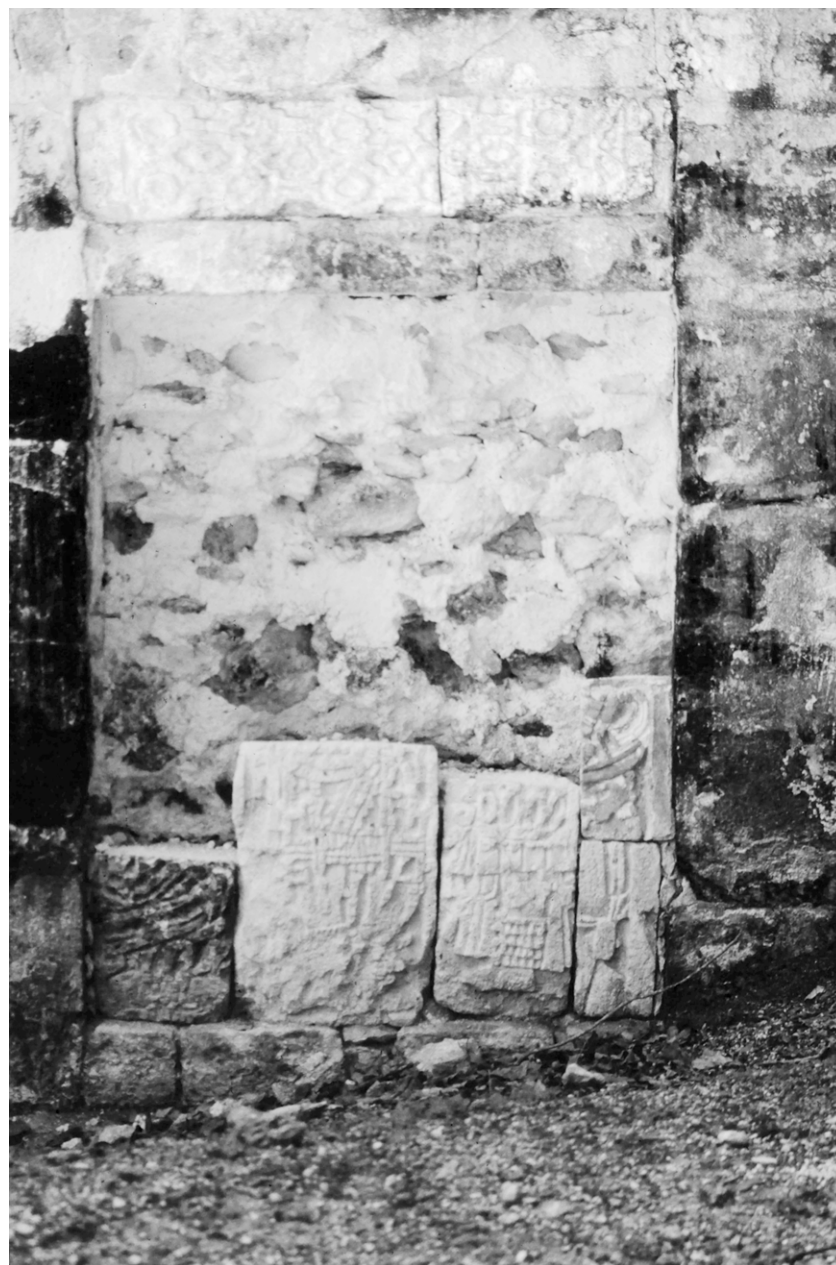
Fig. 79

In 1999 five of the relief elements on the southern central relief still existed in Room 1. Photograph: H. Hohmann 1999

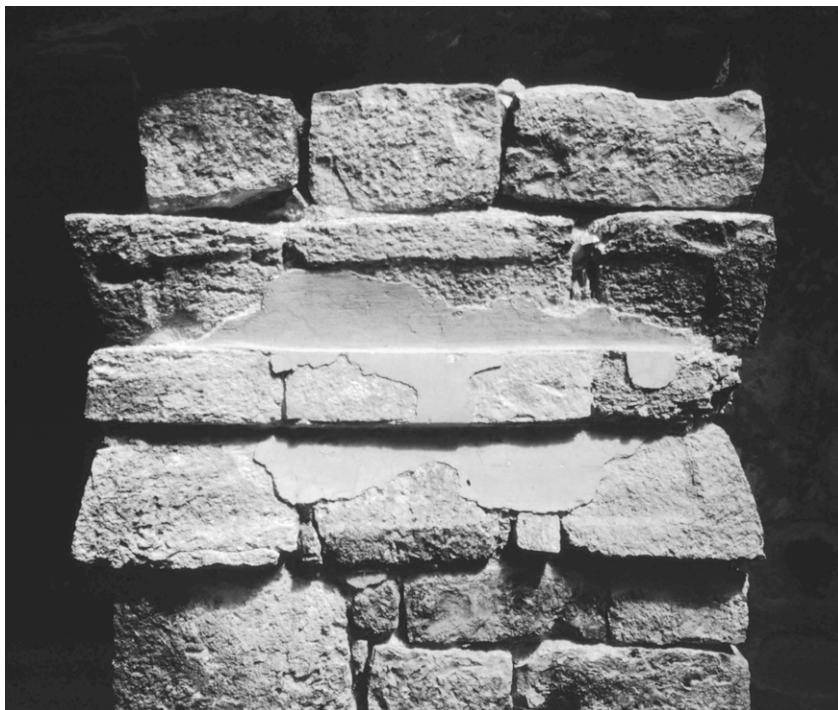
**Fig. 80**

The capital of the most western pillar still shows remains of its very fine elaborated plaster.

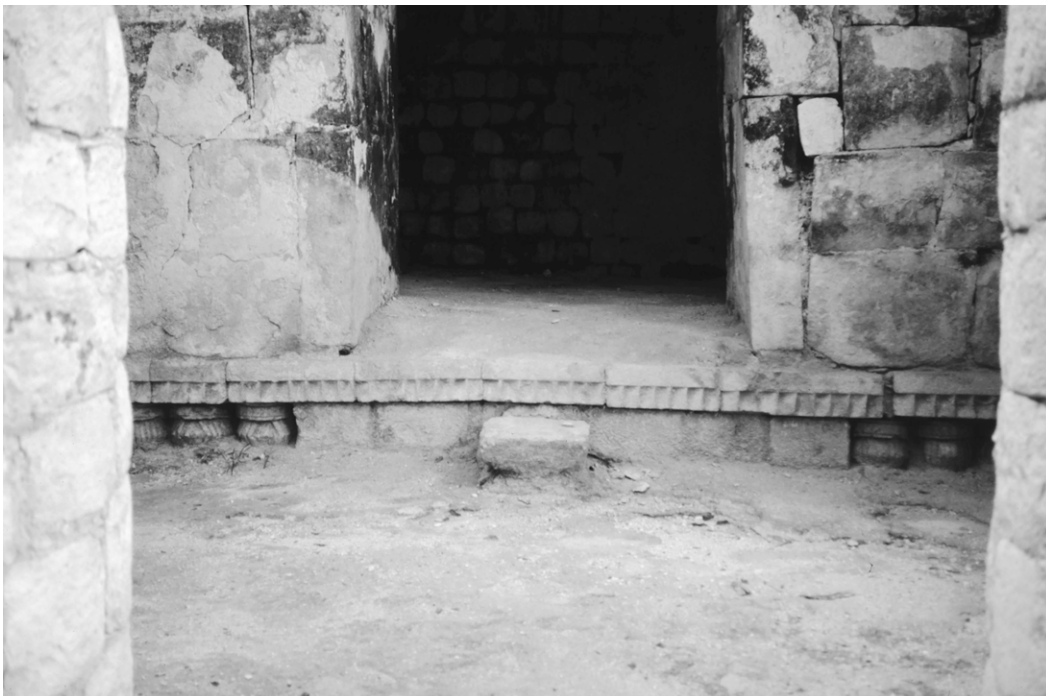
Fig. 81

Base molding of the common wall between Rooms 5 and 6. The molding is pressed into the ground under the wall caused by the great weight of the upper story.

The deformation of the foundation of the Palace can be demonstrated here. Obviously the platform underneath was not solid rock but rubble and earth. This was compressed by the great weight of the upper stories. Therefore the basal molding is not straight and horizontal but pressed several centimeters further into the ground under the wall sections of the middle wall than under the passageway.

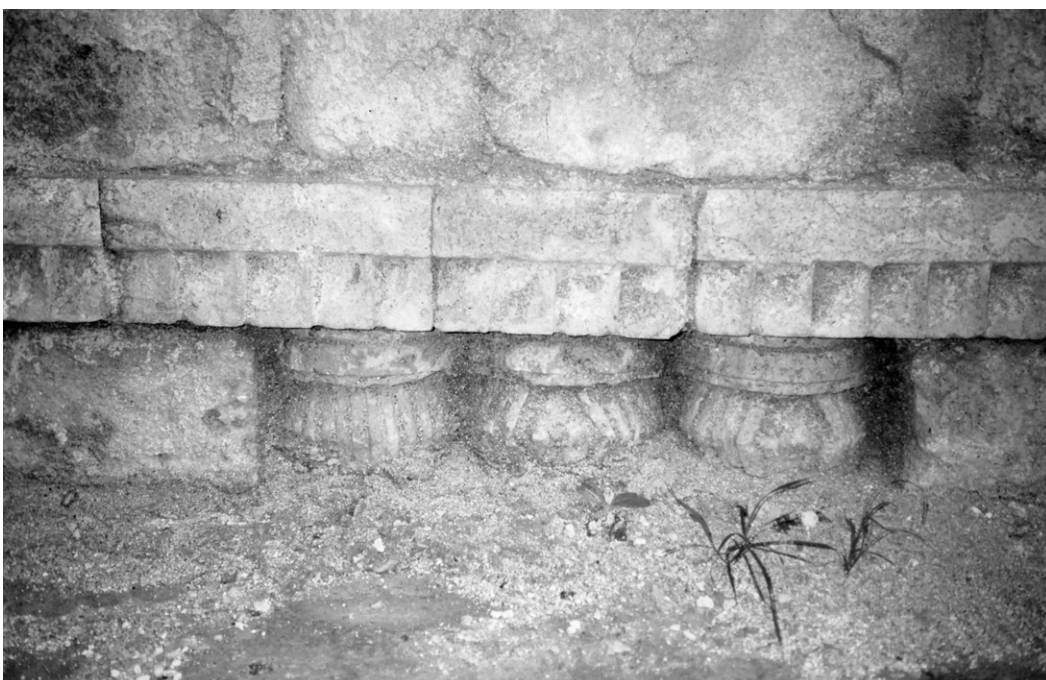
Fig. 82

The three-member base molding in Room 5 has two groups of three profiled and ornamented colonnettes in flat niches on its recessing medial member. The upper member of the three-member base molding shows fringes.

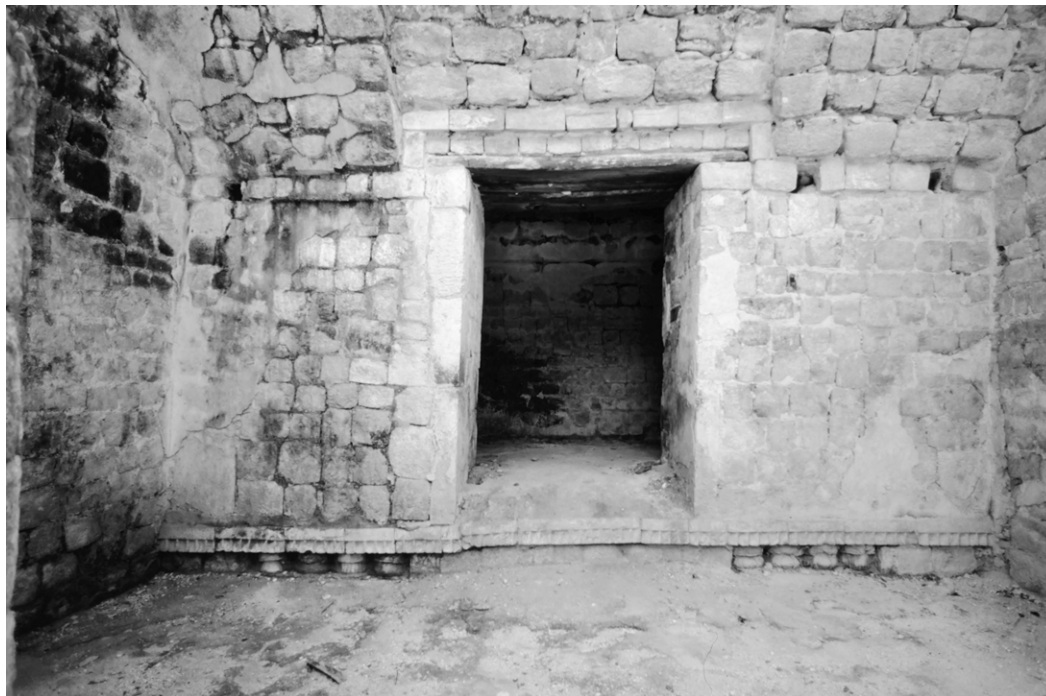
The three-member base molding under the wall between Room 7 and Room 8 is pressed into the floor under the walls on both sides. The base molding has two groups of four ornamented colonnettes. Above the passageway to the back room a recessing field in the corbelled vault can be seen.

Above the passageway a special roof design – similar to the two in Room 1 and 9 – guides into Room 6. Lower vault beams are only at the ends of the room; such beams would have disturbed the room. Four upper vault beams are spread over the length of the room.

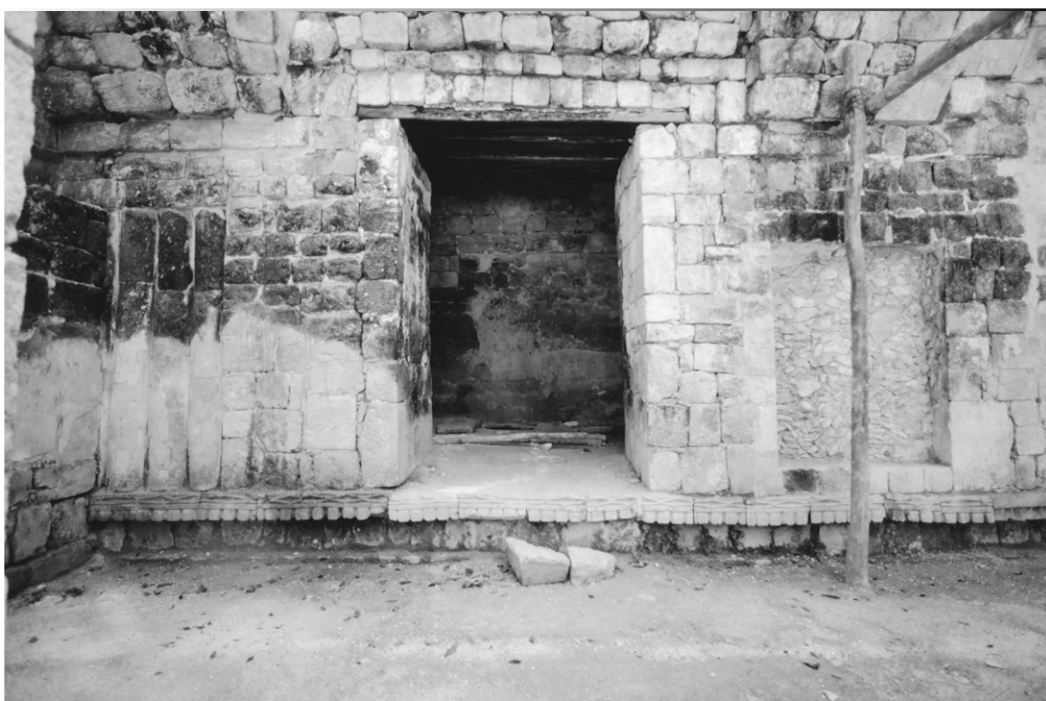
Fig. 84

This photograph shows the eastern part of Room 9 with the three-member base molding, the passageway to Room 11, a group of three half columns to the left, a recessing relief field in the corbelled vault above the passageway and the empty field of the looted central relief to the right.

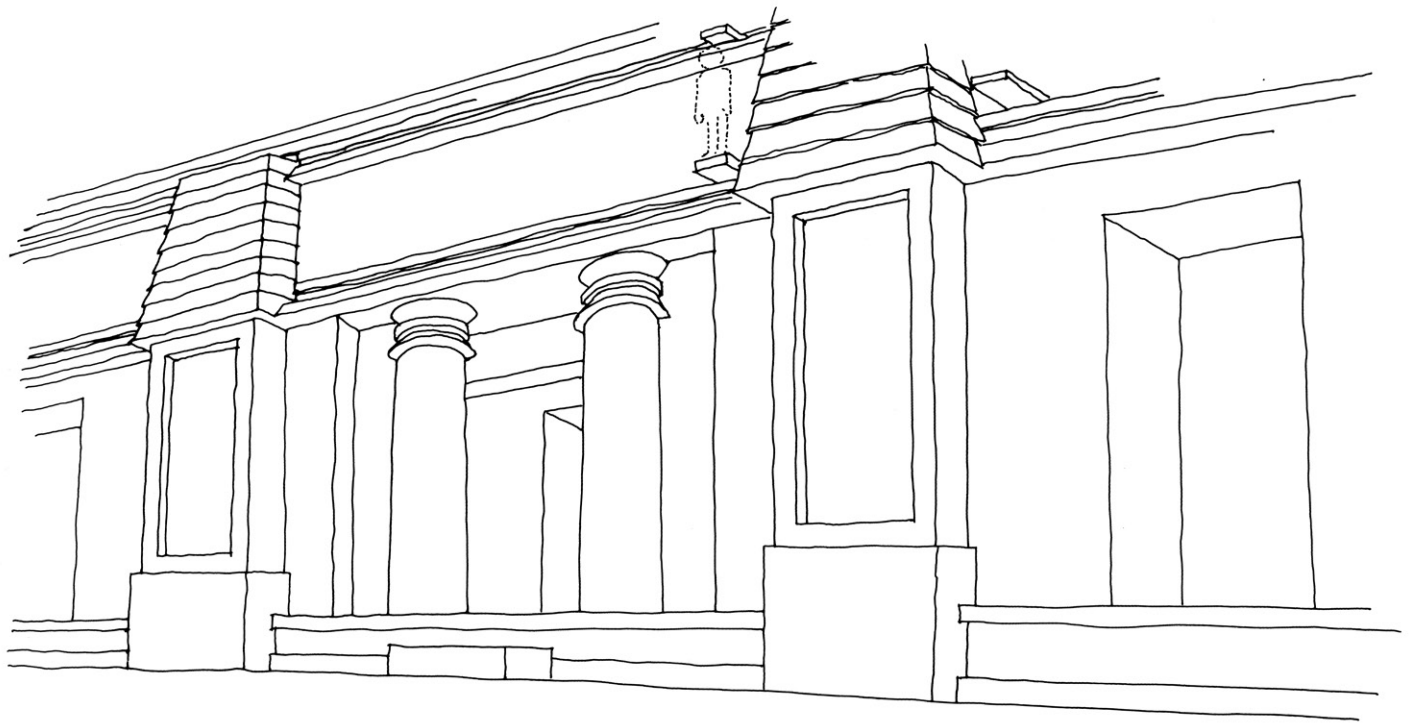
Fig. 85  
 Perspective of Structure 1 at El Delfin with some hypothetical additions. The archaeological site was discovered in 2015 by Stephan Merk.  
 Drawing: H. Hohmann

Gendrop 1983:148 and 149) and in El Delfin in Campeche some 60 km northwest of Xpuhil (Merk 2015:39-43). They are also quite common in a smaller size as colonnettes in roof zones of structures in the entire Puuc region but also in the Chenes region. The western two corners of Structure 1 in Yakalxiú (Andrews 1995:186, Fig. 18a and 18b) or wall zones as façade elements for example in Labna, Structure 1, Central Section, southern façade (Andrews 1995:73, Fig. 77) might serve as examples.

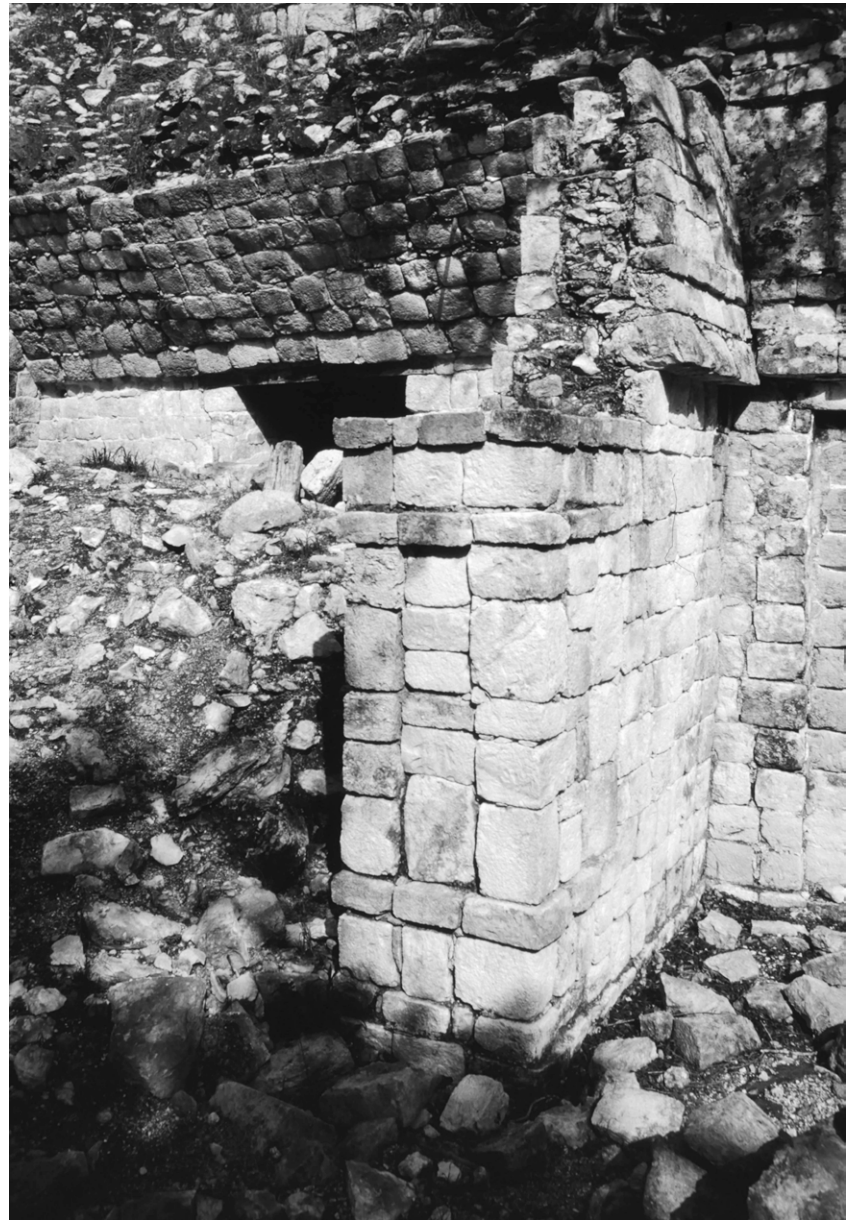
Fig. 88

Room 31 shows the passageway to Room 32 to the left. The northern pillar of Room 31 in the centre, the northern façade of Room 31 and the eastern façade of Room 33 are visible to the right.

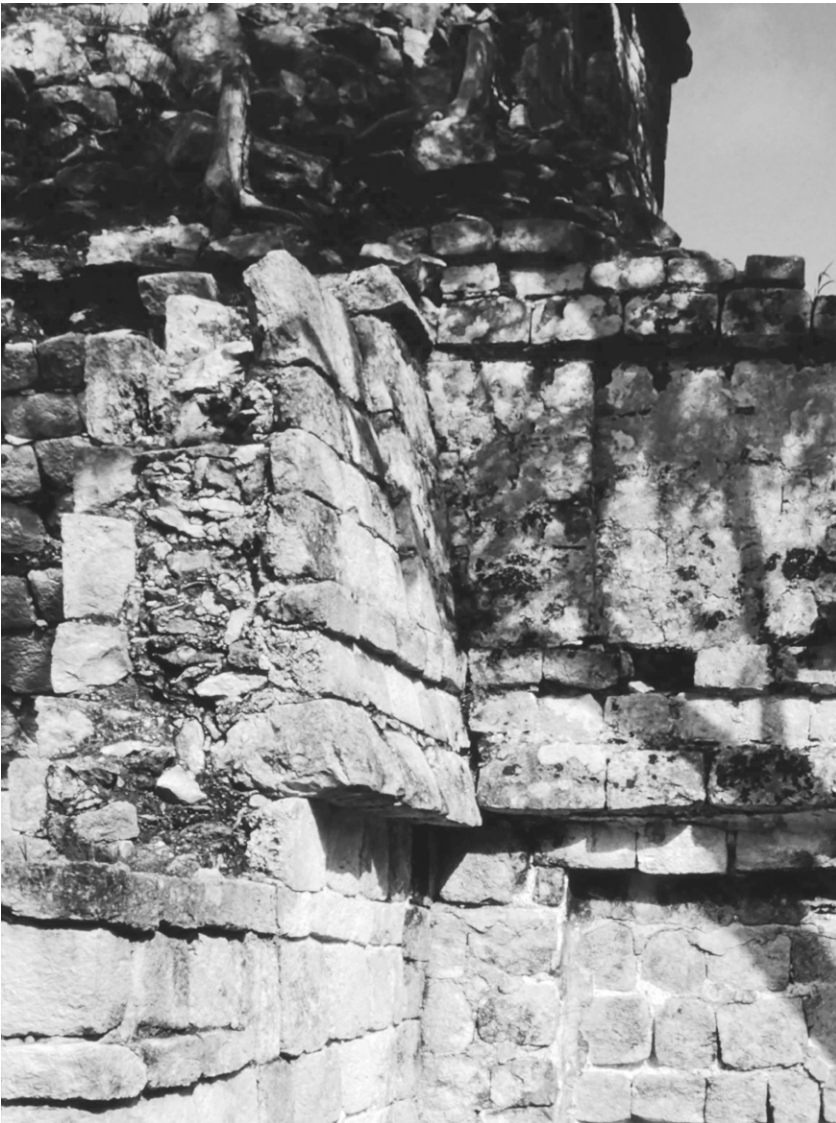
Fig. 89

The eastern façade of Room 33 still shows remains of the three-member base molding, the medial molding and of the upper molding. The large flat niche represents a pseudo side entrance. The eastern pillar to the right shows that it is not a pilaster, as it is separated from the wall.

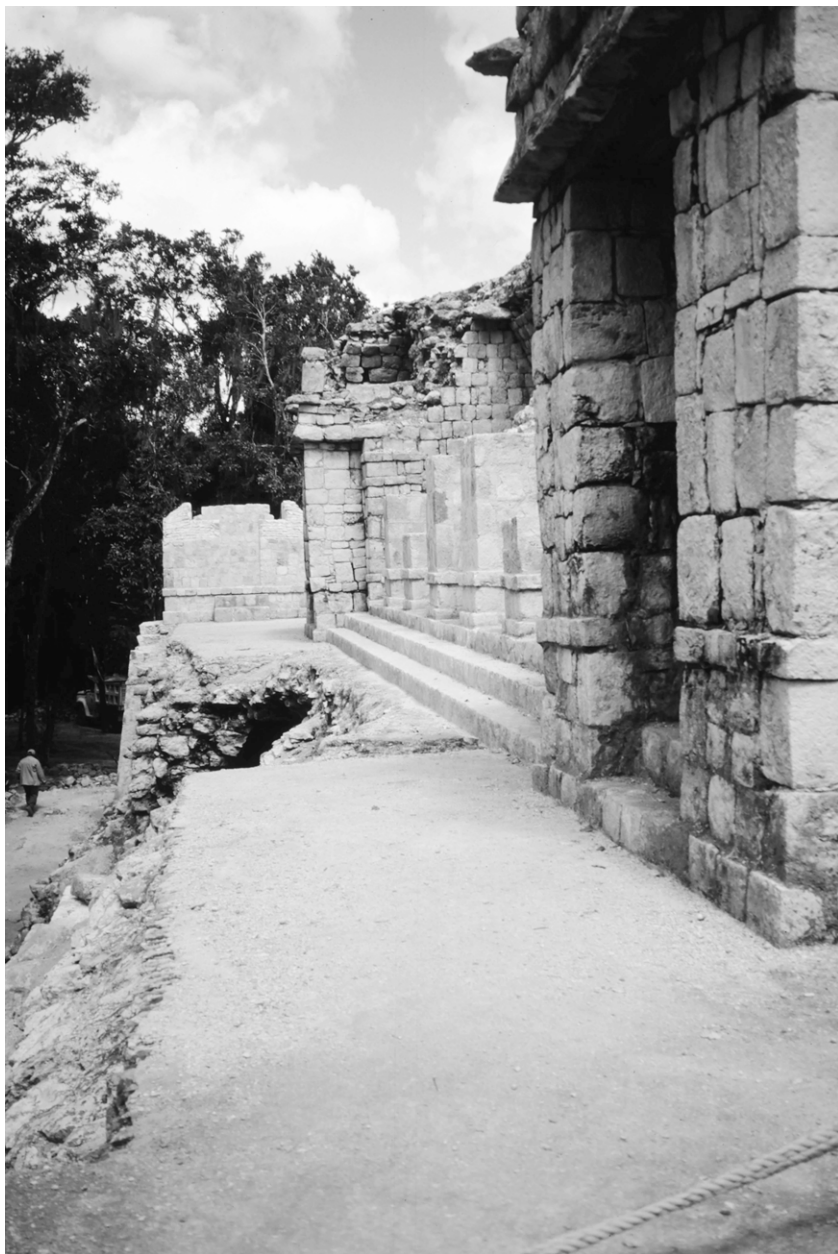
Fig. 92

The two pseudo Temples 48 and 47, the two entrances to the two Staircases E and D, and the Rooms 36 and 35 between, form the centre of the western façade on the second floor. In the background is Temple 45.

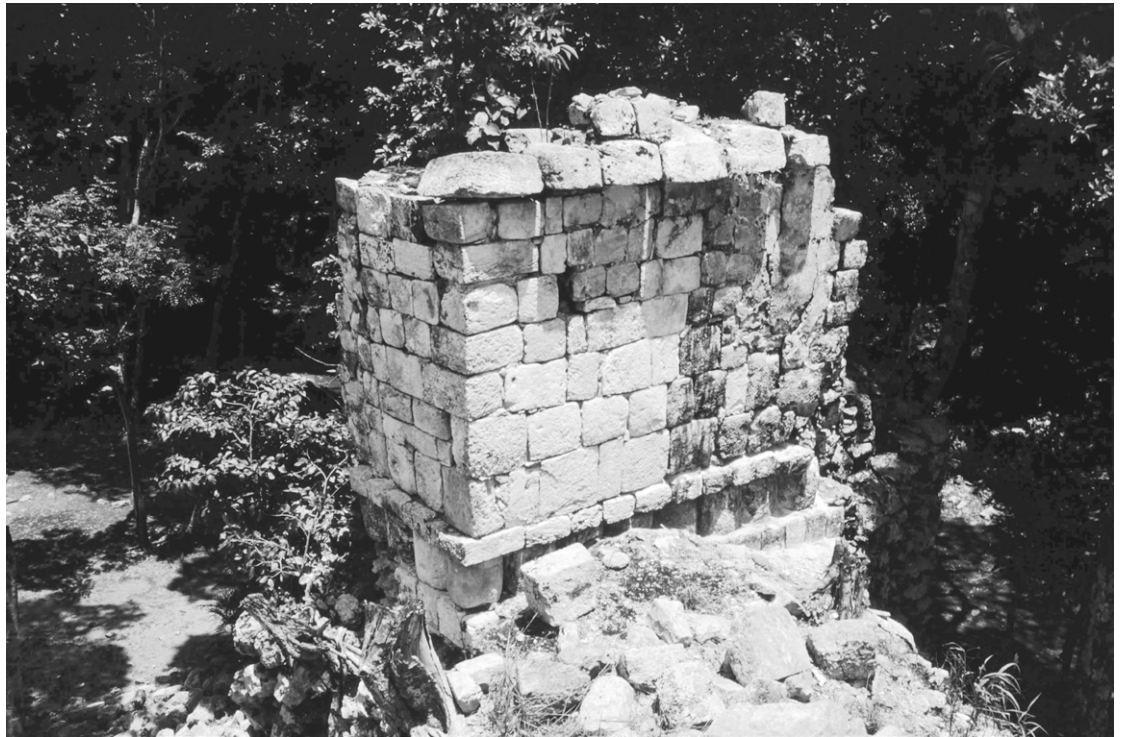
Fig. 94

The western wall only had eight colonnettes and showed the lower member of the three-member medial molding. Photograph: H. Hohmann 1999

cm high upper one and recessing 35 cm high colonnettes in the middle member. In 1989 Heine and Reiter measured 8 of these large colonnettes at the western façade and 4 along the northern one. Including the corner colonnettes the reconstruction shows 12 colonnettes to the South, 13 to the West, 11 to the North, and an unknown number of colonnettes to the East. The northern half of the eastern row shows 7 colonnettes, in the southern part of this side are 3 more colonnettes. The space between seems to be quite straight and without the missing 3 or 4 colonnettes. The southern colonnettes have very different widths. The eastern façade of Room 38 is part of the main façade of

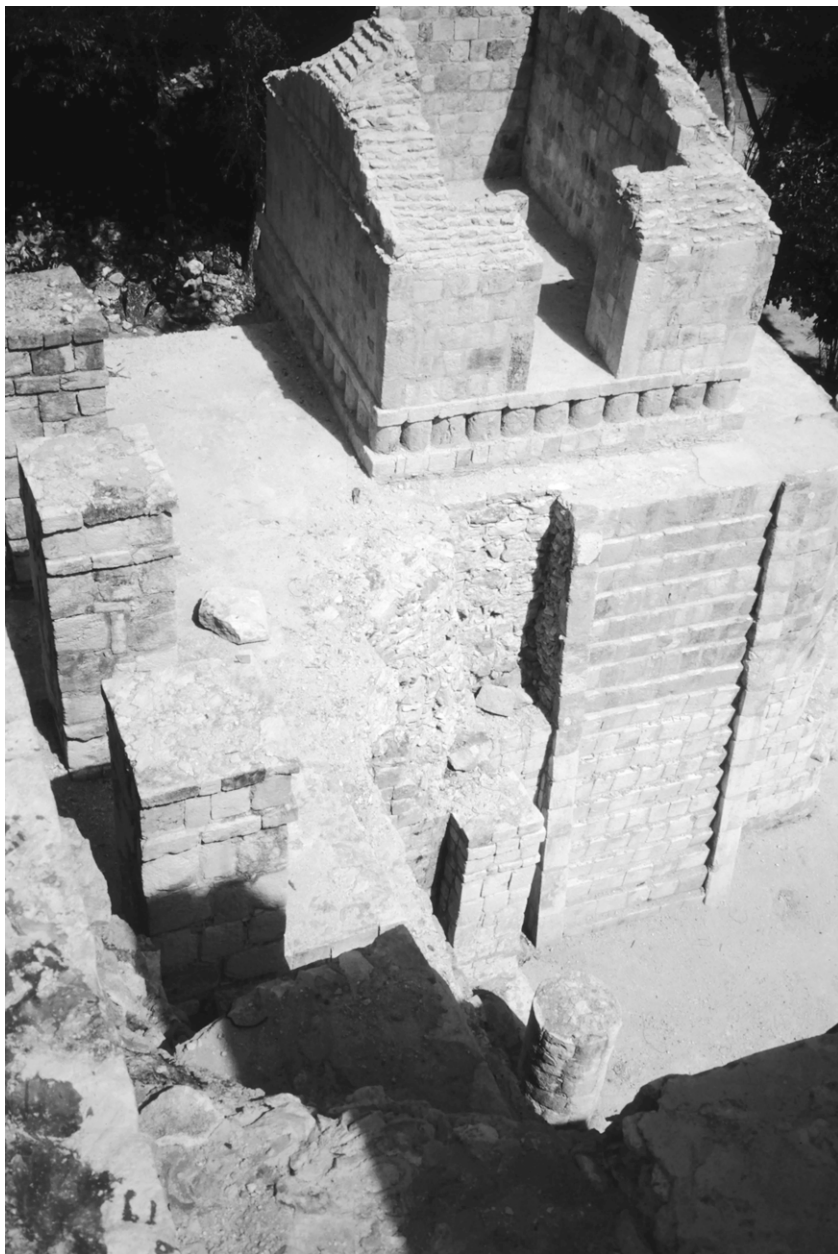
Fig. 95  
 Room 39 and the southern pseudo Stairway F form the north-eastern temple pyramid. The asymmetry of the position of the stairway is visible.  
 Photograph: A. Drexler 2004

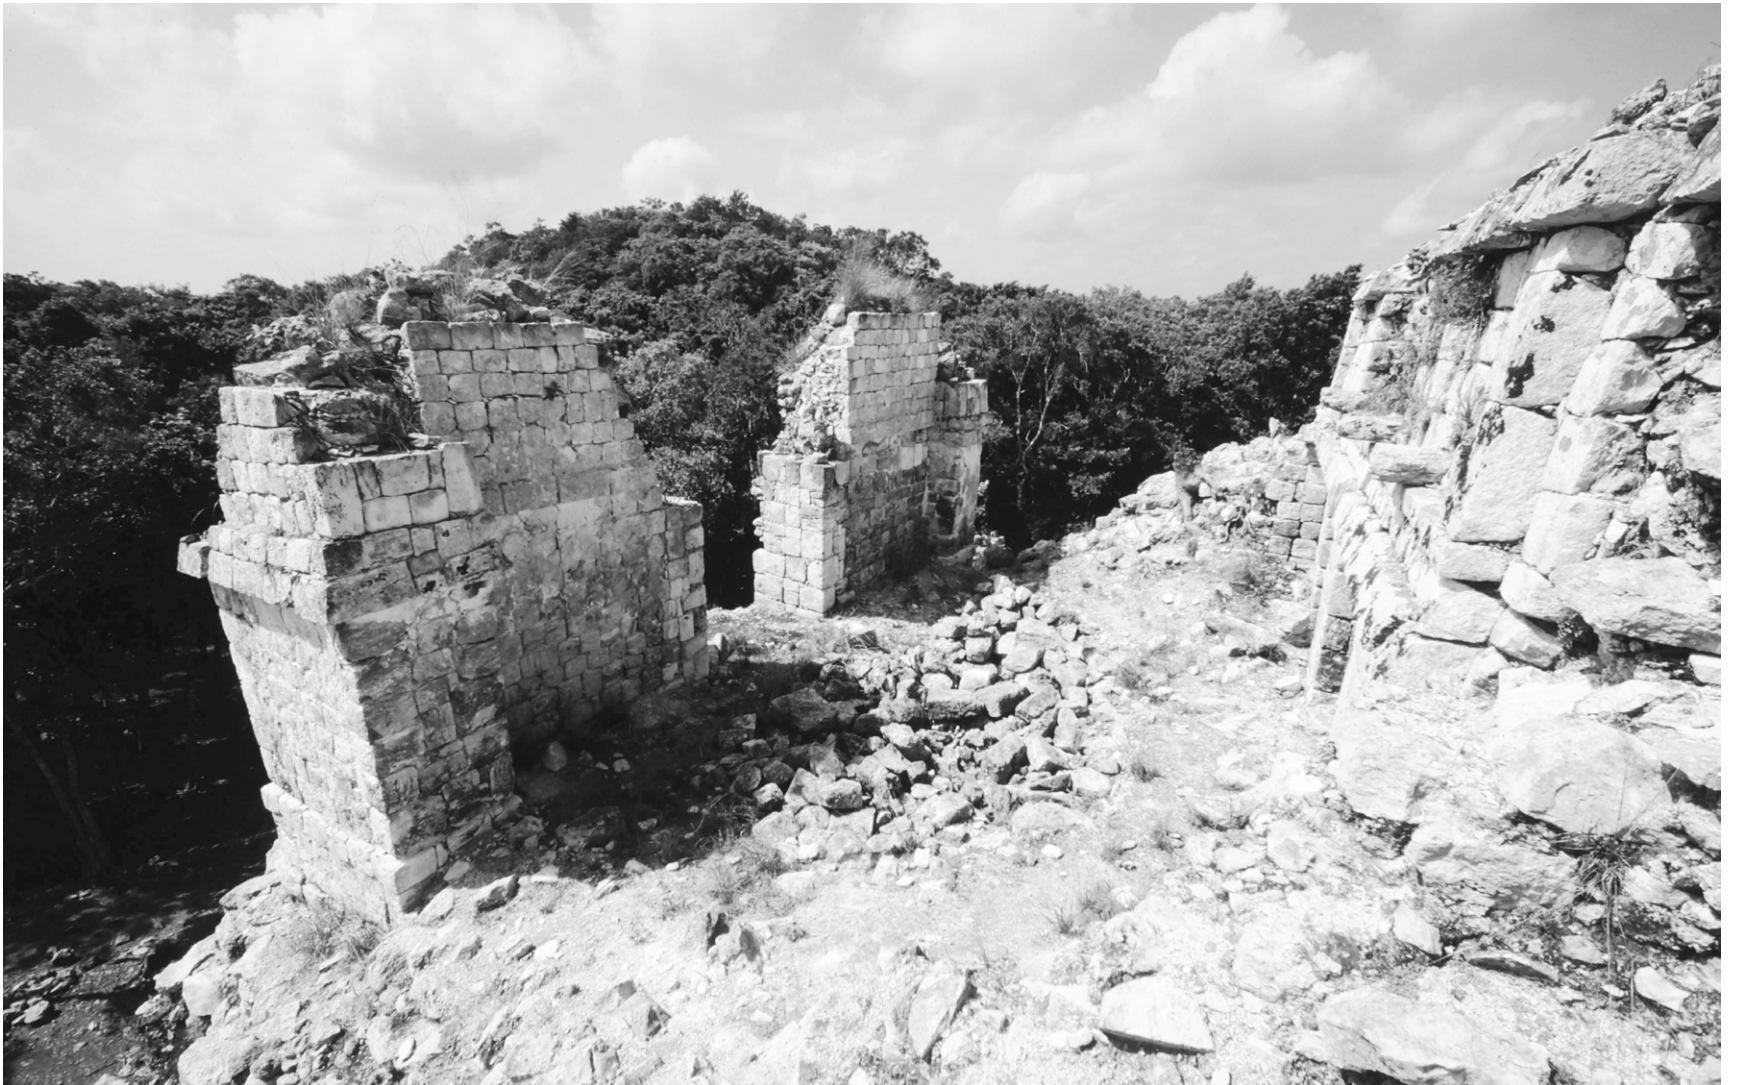
**Fig. 96**

In 2001, the patio behind the monster mouth was still filled with rubble.

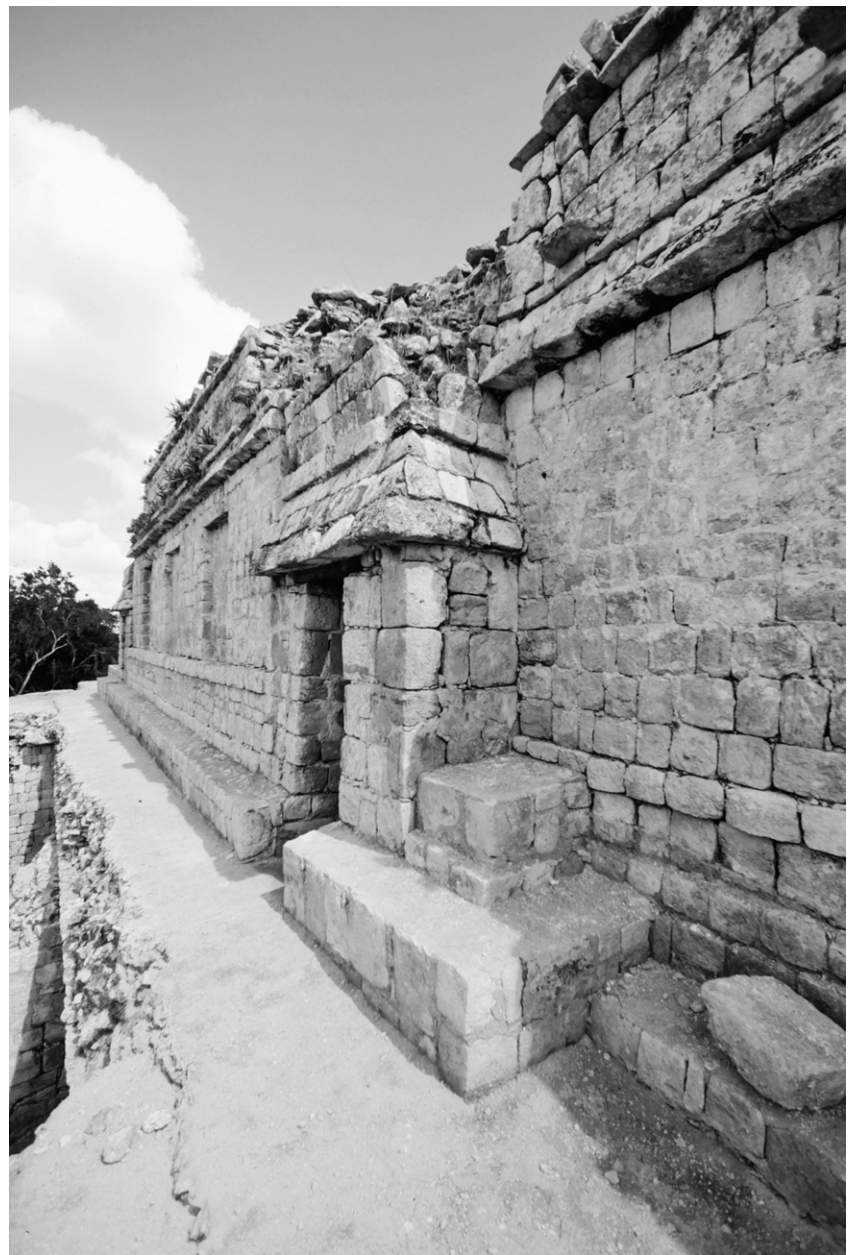
Fig. 101

The third floor entrance of Staircase E also called Room 50 is formed like a small house. The western façade of Room 40 can be seen to the right and the western façade of Room 42 to the left. Both structures show main parts of the three-member base, medial, and upper molding. The coping fourth member of the upper molding is completely missing now.

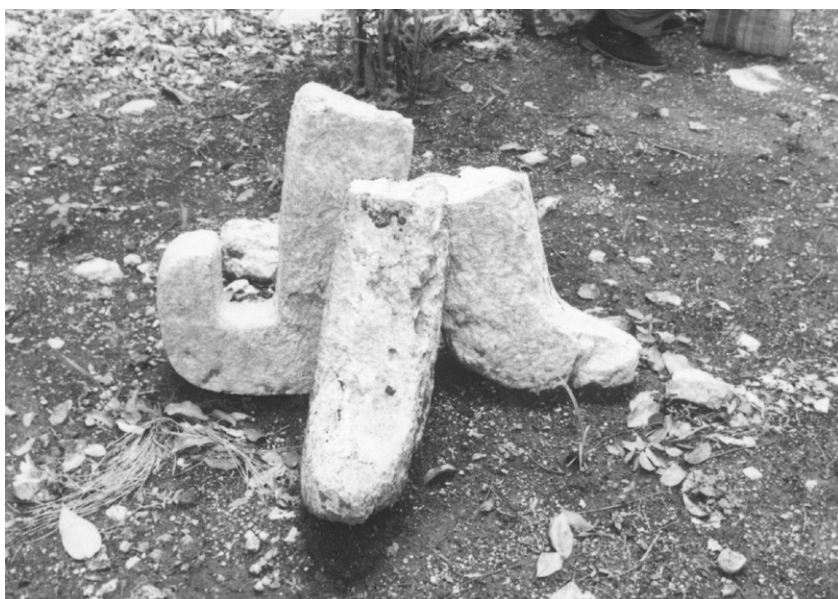
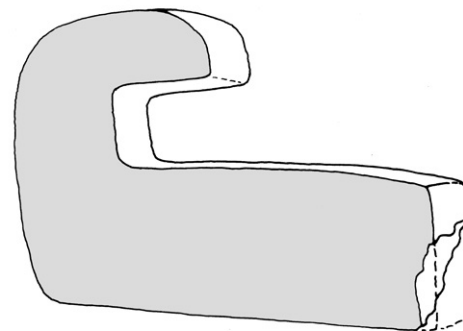
### Fig. 103

One of the teeth around the Palace. The stone element measures approximately 40 cm in length.

Some teeth near the Palace might originate from the lower jaw of the monster mouth passageway.

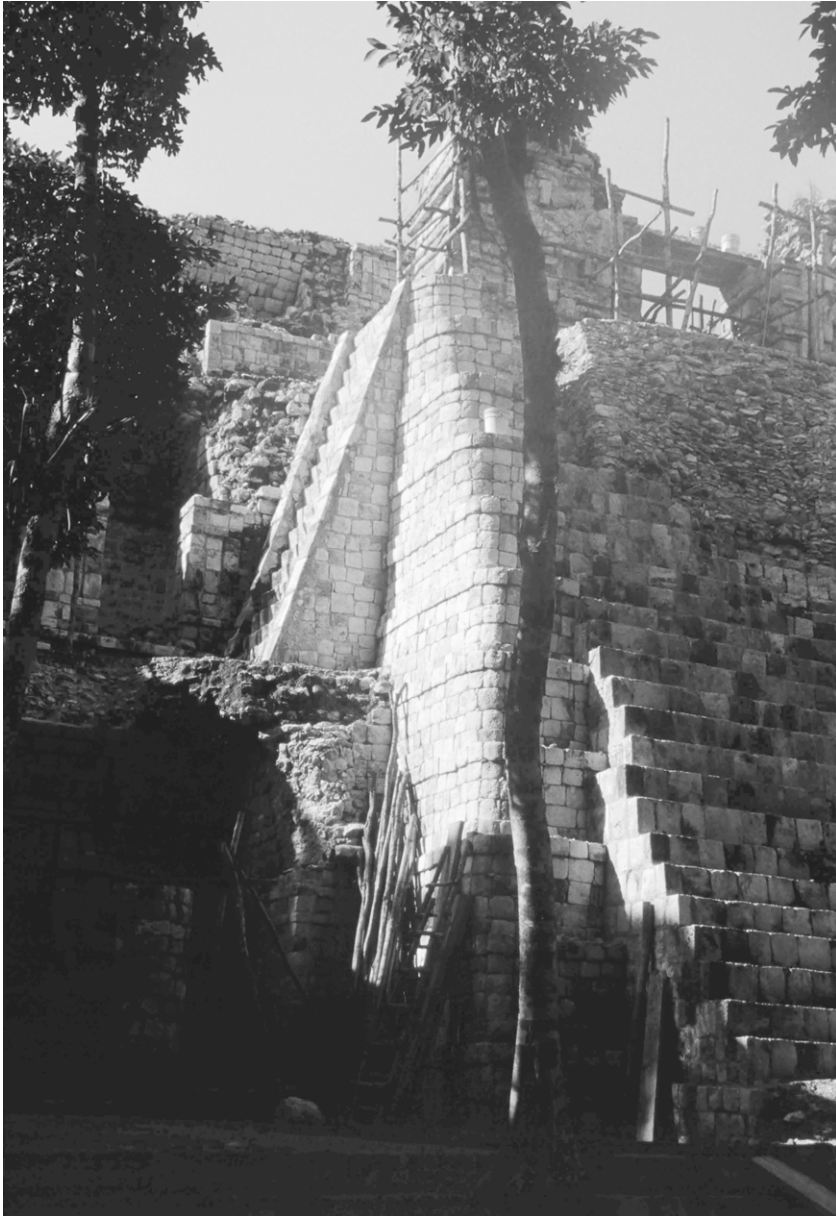
**Fig. 106**  
 Here, too we see the ninth step running around the corner back to the mega steps.  
 Photograph: A. Hohmann-Vogrin 2003

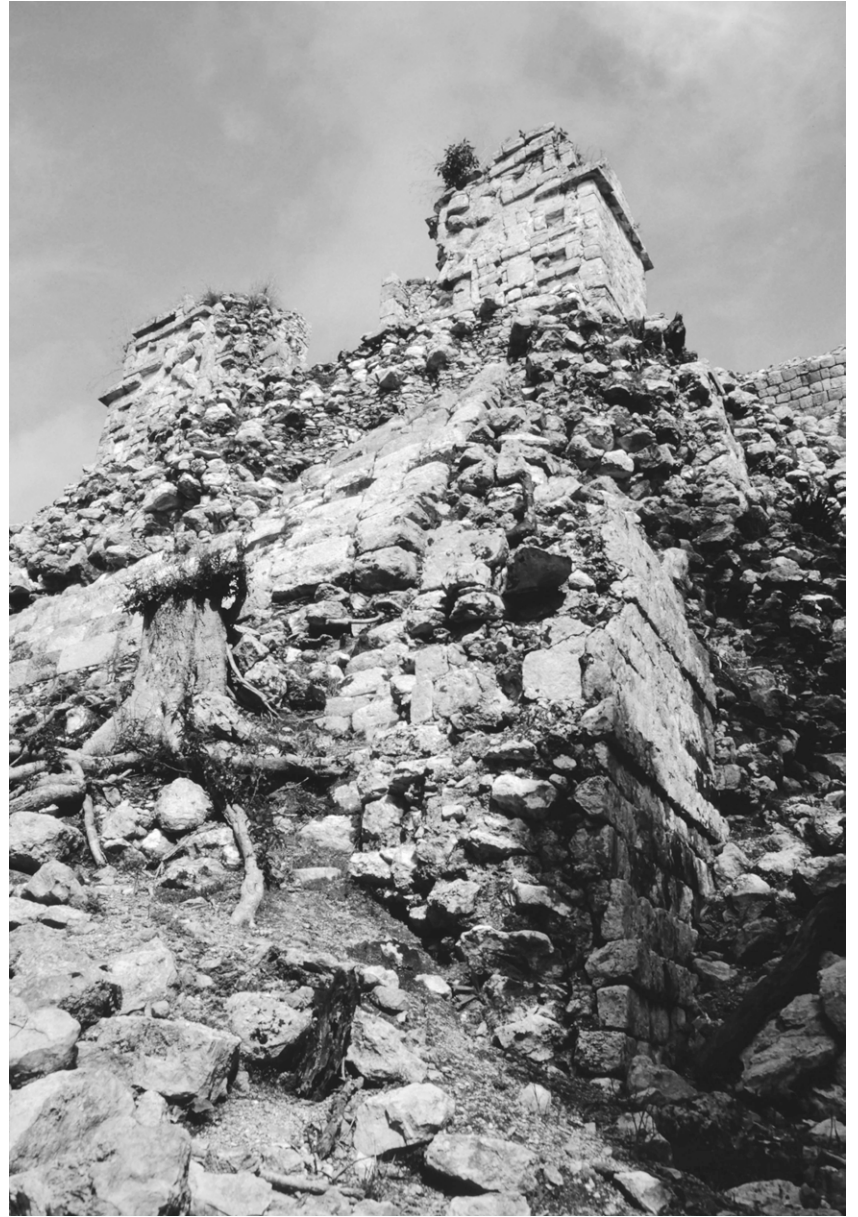
**Fig. 107**  
 The situation in 2001 before reconstruction shows that the mega steps do not reach the breadth of the earlier stairway. There must have been something in-between – possibly a recessing ramp.  
 Photograph: H. Hohmann 2001

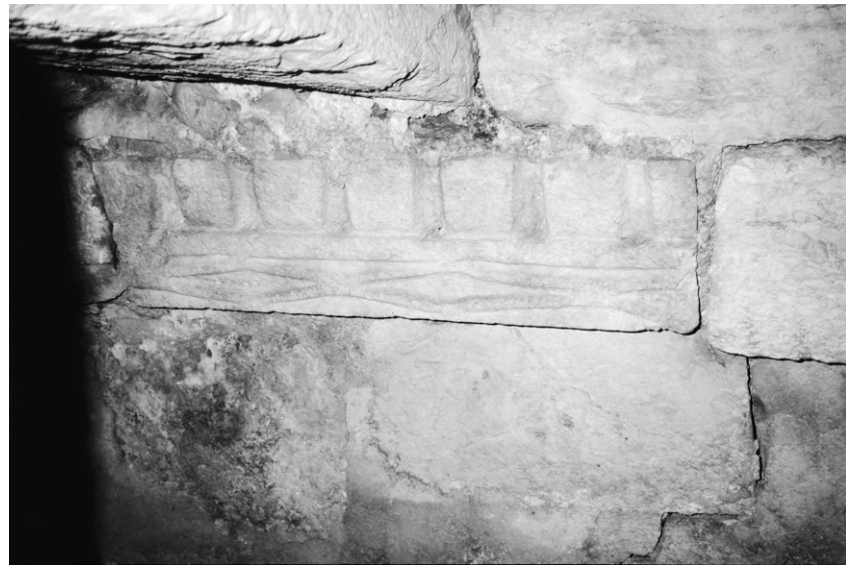
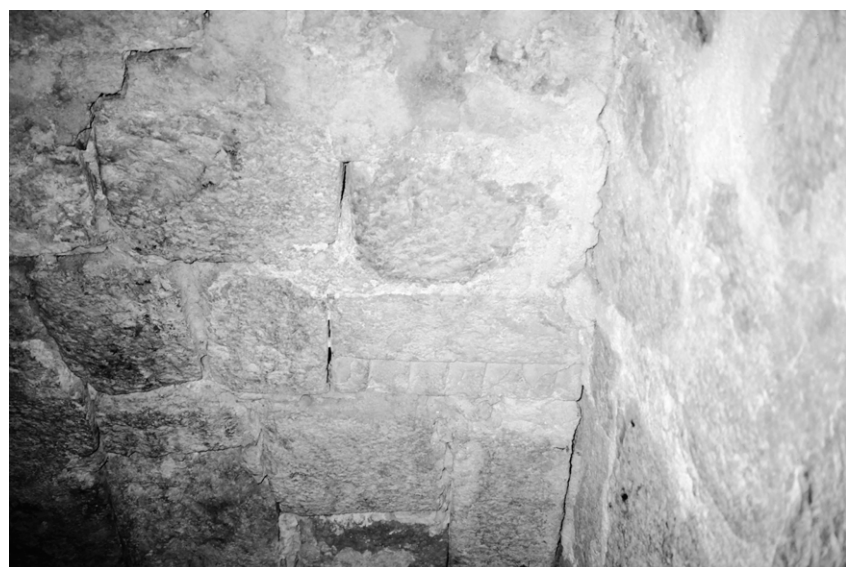
Fig. 108

This spoil in the southern Staircase E was used as a recycled wall stone and plastered over. It is formed like the upper member of the three-member base molding in Room 9.
