# THE MAYA TEMPLE-PALACE OF SANTA ROSA XTAMPAK, MEXICO

DOCUMENTATION AND RECONSTRUCTION OF FORM,  
CONSTRUCTION, AND FUNCTION

HASSO HOHMANN

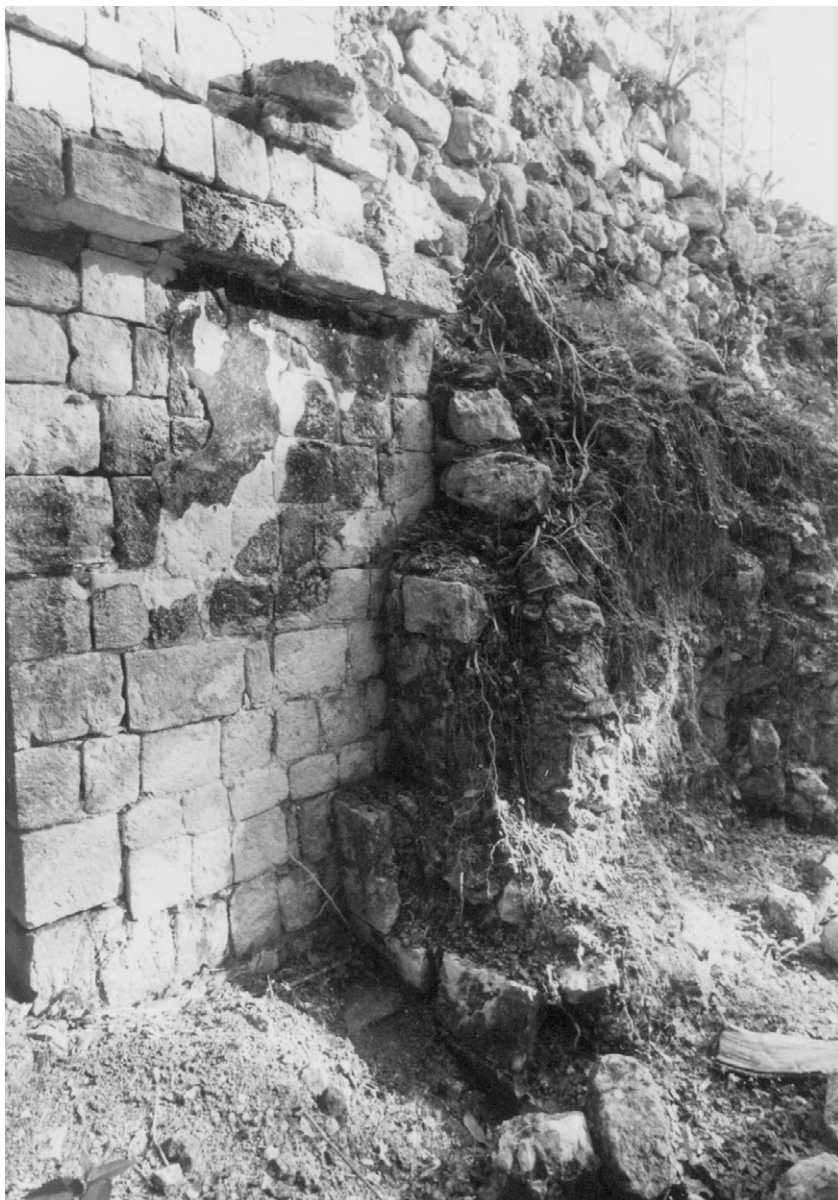
**Fig. 110**

The photo shows the northern side of the mega steps of the northern Stairway K. Above the mega steps the rough construction wall of Stairway K follows.

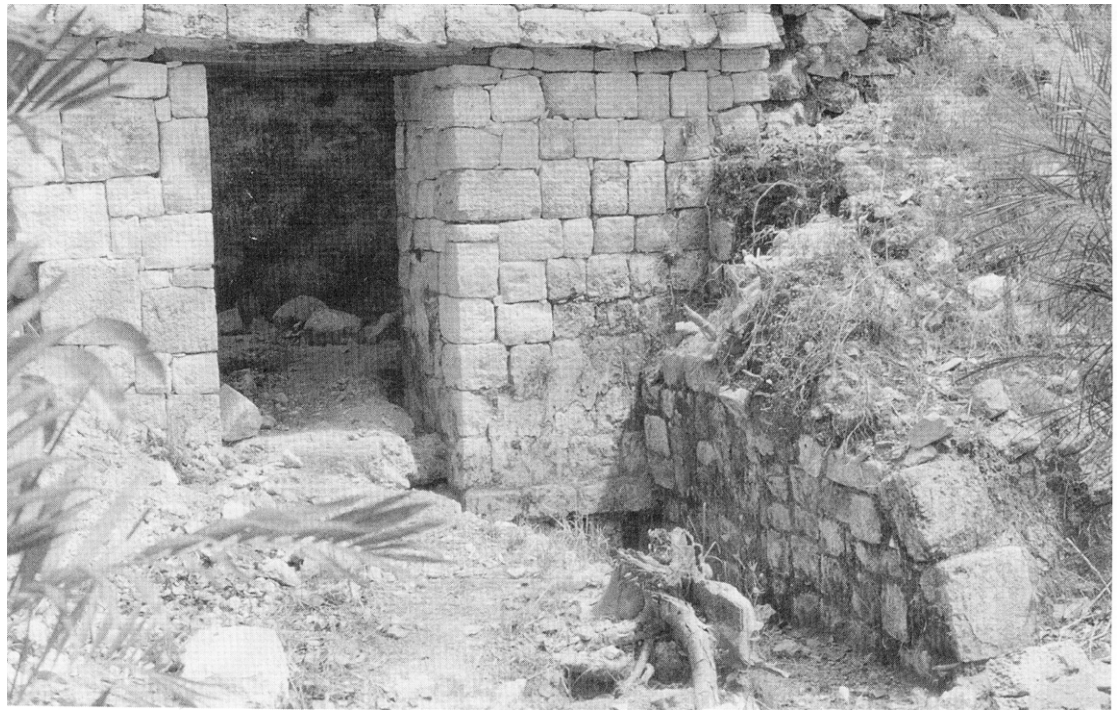
Fig. 112

This shows the western façade of the Palace. On the ground floor in the foreground we see the remains of pseudo Stairway L with remains of the two mega steps in the South.

The western façade is divided into three sections by two more stairways leading from the first floor to the second. The real reconstruction of the two stairways within the western façade cannot be correct. George F. Andrews took photographs and measurements of the remains of these two stairways and the author measured them, too. He documented two less steep and far more differentiated stairways which looked different. Therefore the documented version of these pseudo stairways differs completely from the reconstructed one of the two stairways. The reconstruction should be removed or should be changed following this documentation.

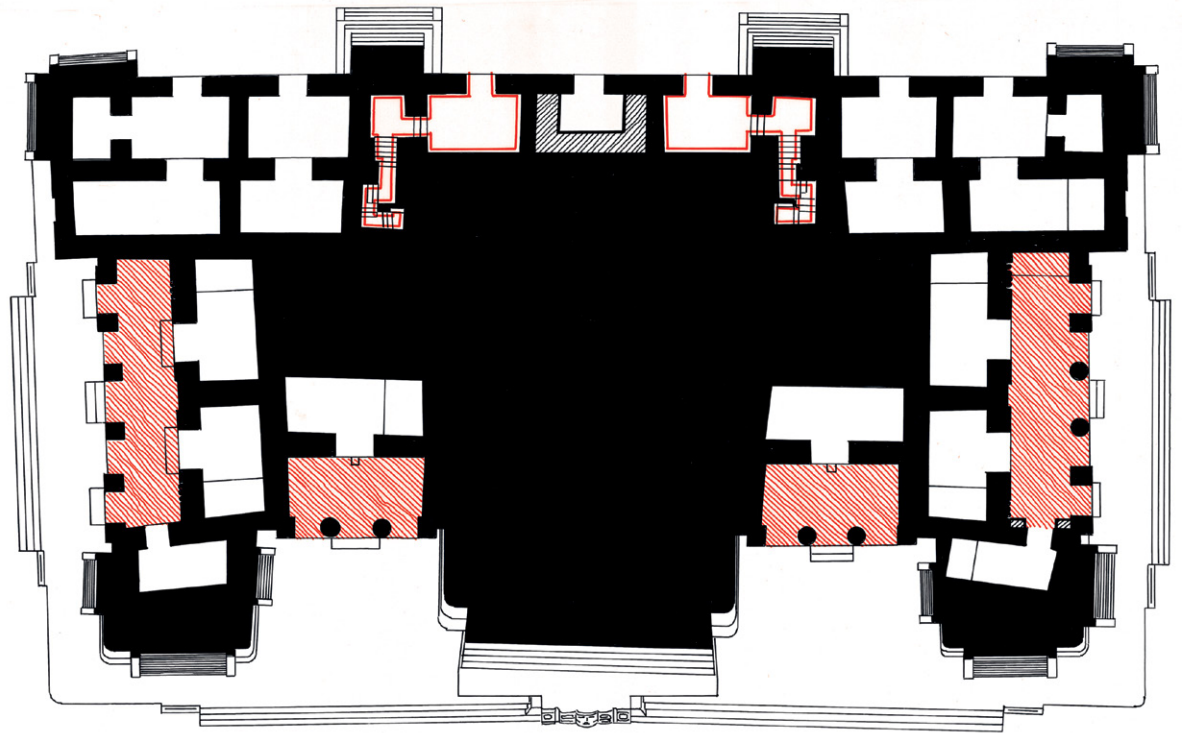
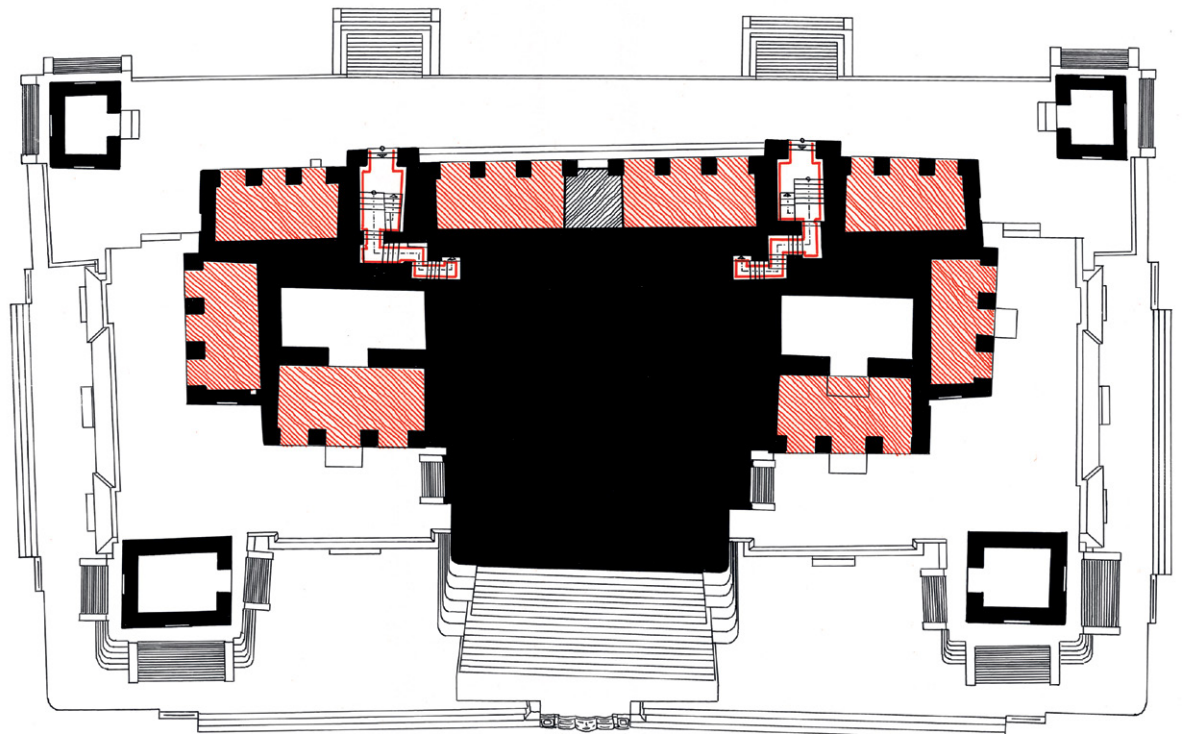
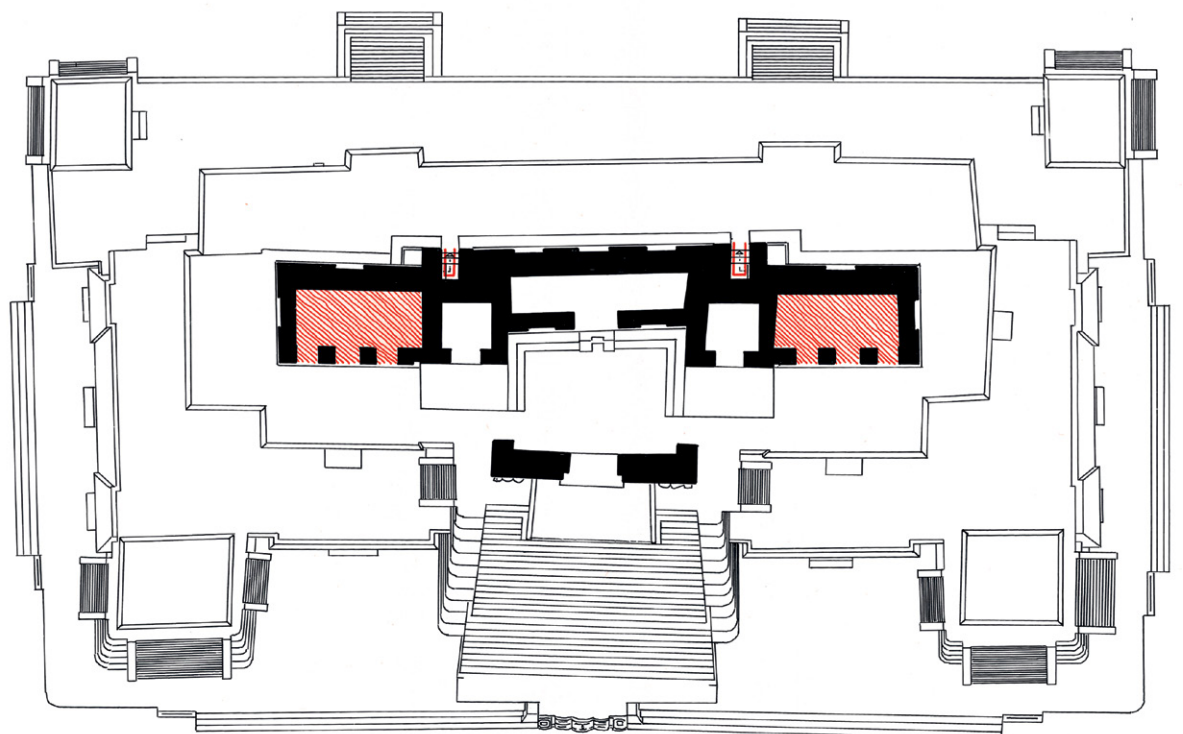
Fig. 113  
Roofed spaces

As far as the domestic spaces are concerned we have to distinguish between roofed open spaces and closable spaces. At the Palace we find plenty of single roofed but open spaces. It seems it was quite complicated to close them or part of them (R28, 33, 34, 35/36, 37, 40, 44). In some cases these open roofed rooms might have been partly closed. For better concealment Rooms 19 and 21 were certainly also used as domestic one-room spaces. Rooms 38, 39, 45, 46 are the temples at the four corners of the Palace and were quite certainly used as sacral spaces. The three Rooms 41, 42, and 43 might be seen as belonging together – Rooms 41 and 43 as sleeping rooms and Room 42 as a living and representational space.

There are two two-room units on the first floor and two more on the second floor with an open space as the first room. Here only one room is closable. The first room might have been used as a representational space (R5+6, 7+8, 29+30, 31+32). The Rooms 16 and 17 as well as Rooms 23 and 24 are real two-room units. The room compounds Rooms 13+14+15 and Rooms 25, 26, 27 are real three-room units. The two four-room compounds Rooms 1+2+3+4 and Rooms 9+10+11+12 are three-room units with an entrance hall.

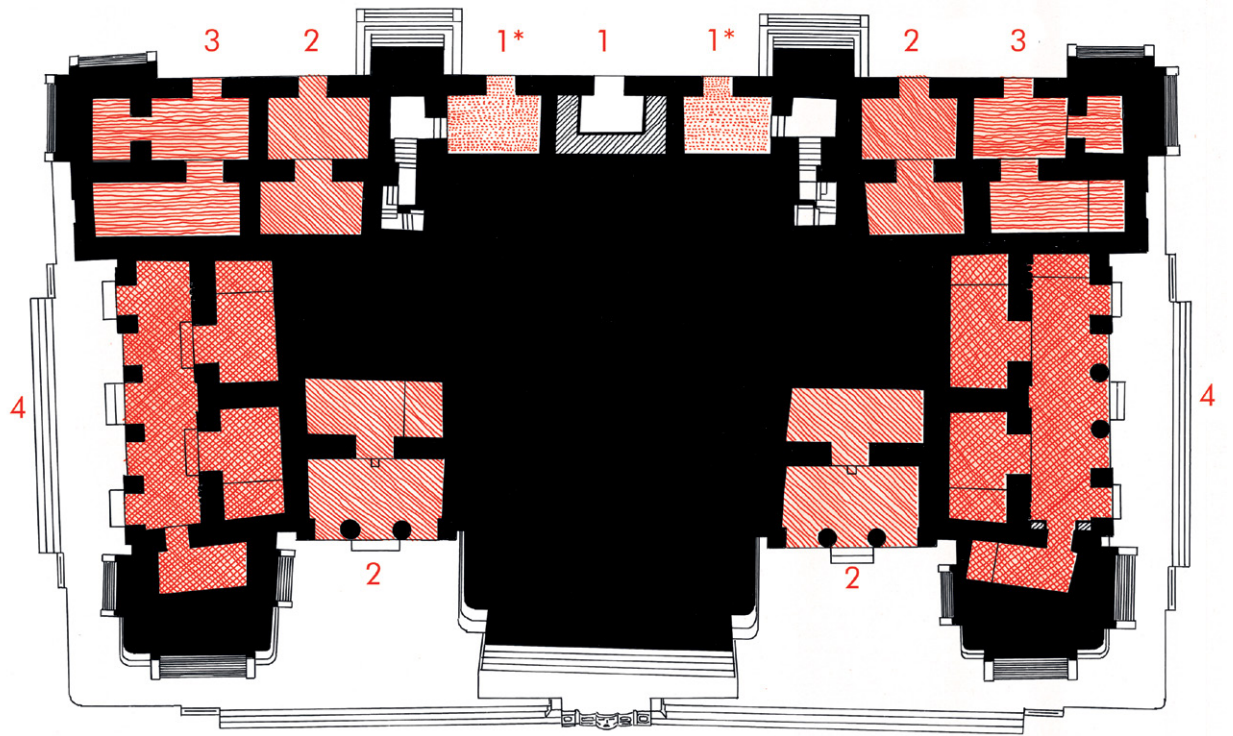
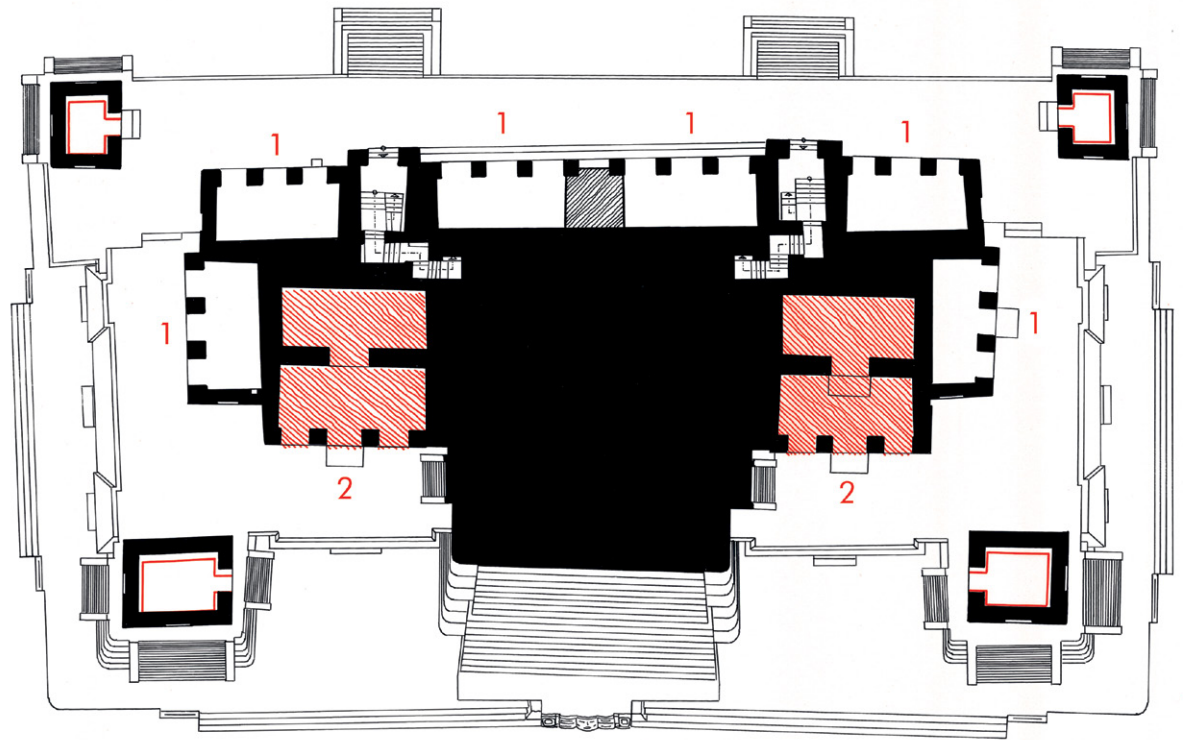
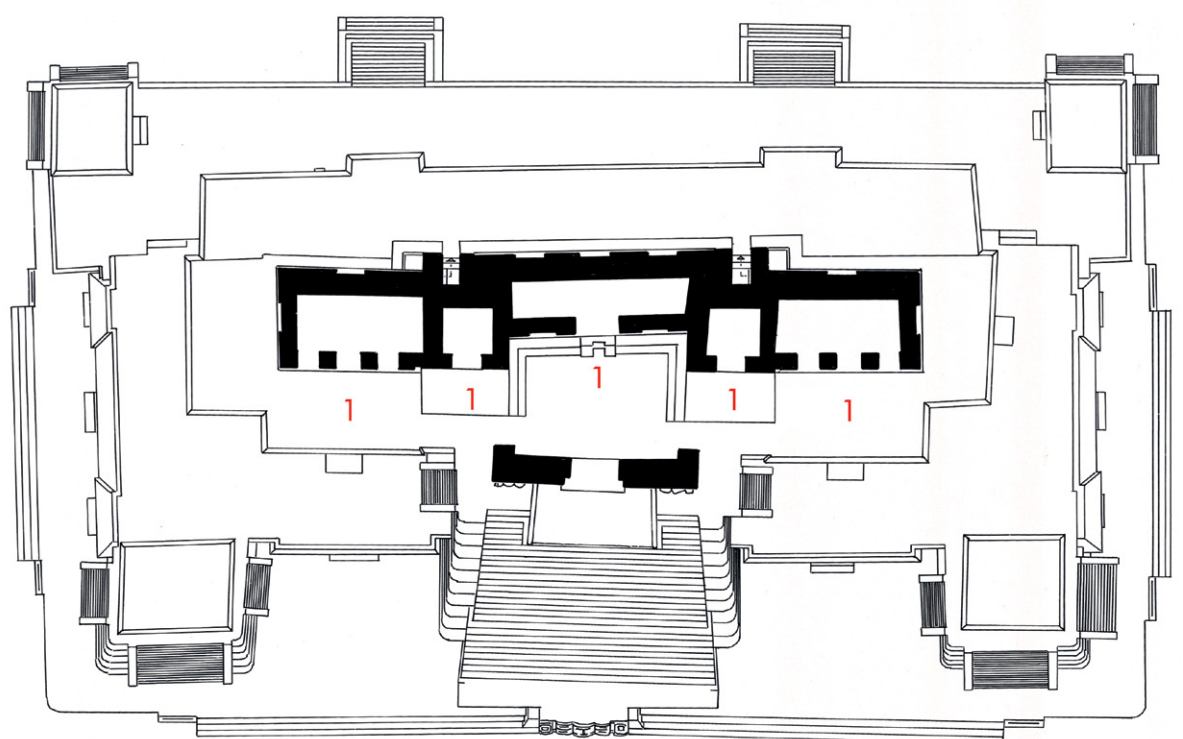
Fig. 114  
Temples and domestic units

- Sacral room
- Domestic room
- ▨ Pseudo room
- ▧ 2 room unit
- ▩ 3 room unit
- 4 room unit

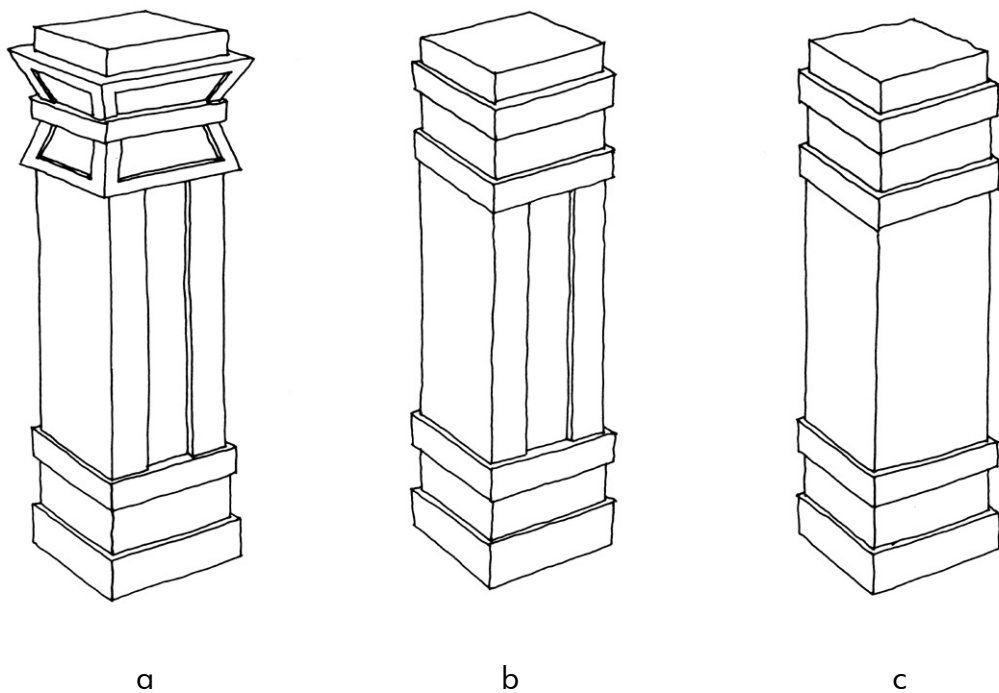
Fig. 116  
Three types of pillars.

c. There are 16 pillars of the third type used on the western façade on the second floor. They have a three-member base molding, a plain rectangular shaft and a three-member capital like the second type.

Some of the pillars show remains of plaster covering the stone and all of the surviving pillars are not really free standing and situated at the building corners. They are bound into the side walls and therefore survived. But, as already stated, the term "pilaster" should not be used for them.

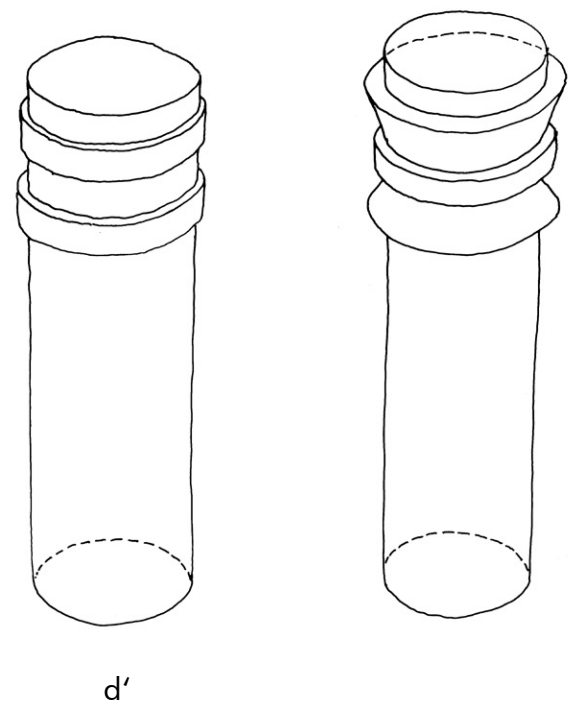
Fig. 117  
Two types of columns.

d. The main entrance of the reception hall for an important room compound is marked and flanked by two free-standing round supports for three rooms on the first floor (Rooms 5, 7, and 9). Neither of them has survived up to the capital - if there was one. Therefore, in this documentation, the capitals of these round supports have to remain hypothetical. The form of the capitals in this reconstruction was taken from the pillars next to them and also compared with other sites. The round supports can only be called columns if they once had capitals.

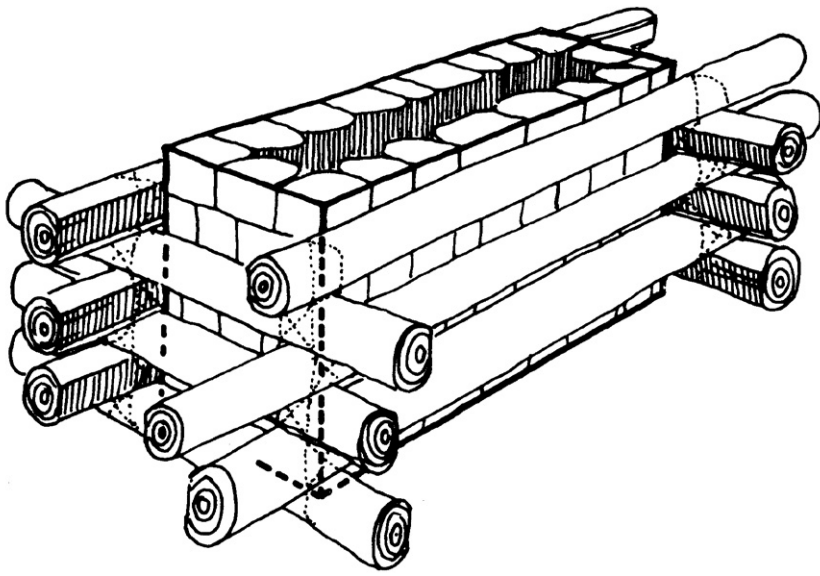
Fig. 118

Veneer stones for the mortar and rubble core of a wall section are held together by intermittent timber paneling (Hohmann 1978:112). The next constructed joining wall element will not interlock with this wall section.

In no instance have masonry corners in the Palace been observed to be bonded. This is a fact one can find throughout the Maya area. For Copan, the author tried to find the reason for this kind of strange construction principle (Hohmann 1978:112). At the Palace of Becan, Structure IV, it was the same (Hohmann 1998:122). Possibly each portion of a straight wall was built in a very specific way so that the Maya could not use such bonded masonry at the corners. It is quite certain that at least in some cases the Maya used an intermittent casing mold to hold the veneer stones in position until the fill, the mixture of mortar and rubble, had hardened. This mold could have been produced by straight beams on all four sides which were tied together with ropes at the ends. In addition, the great weight of the heavy vaults above the walls contributed to keeping them in place.

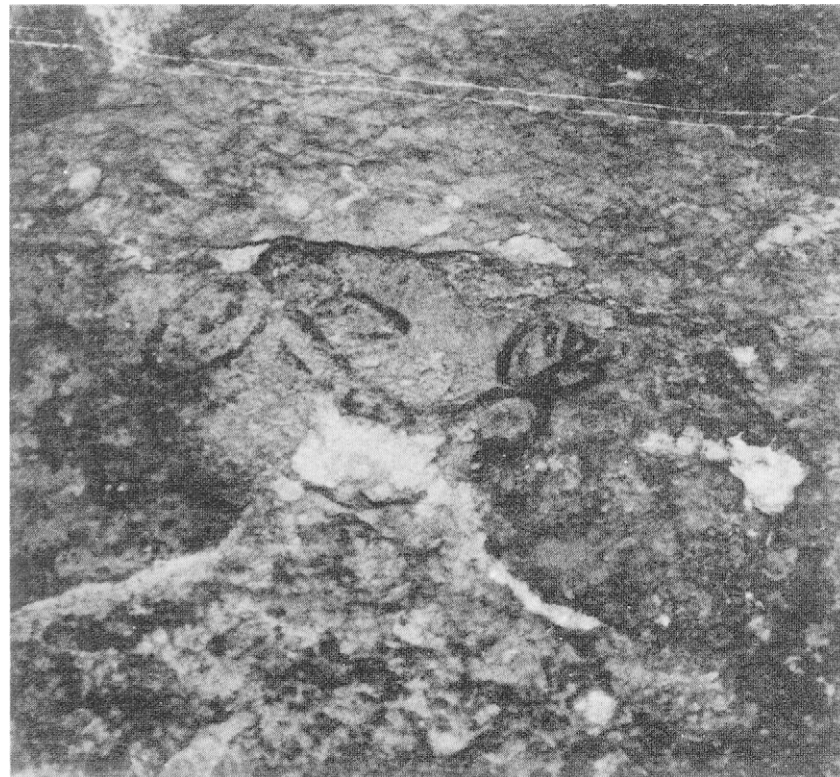
Fig. 119

No one knows what this painting on a molding cornerstone represents.

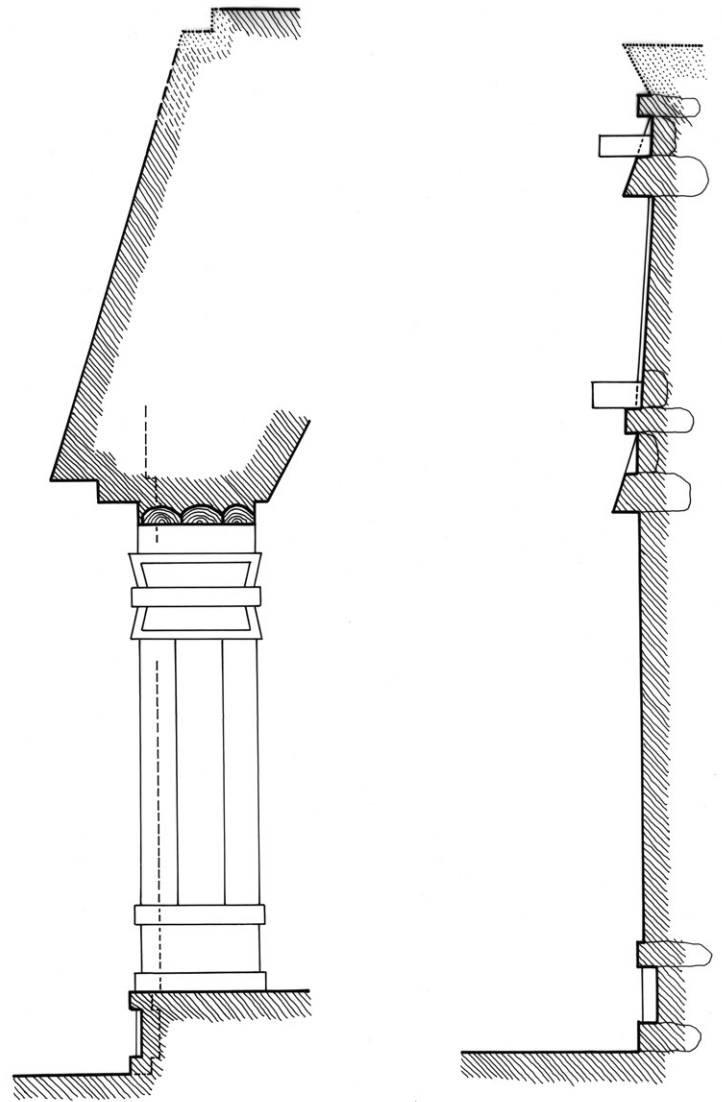
**Fig. 120**  
Profile of the southern façade of Room 1 on the first floor facing west. Such a profile of a roof is quite rare in Maya architecture. It is a little similar to some structures at Naachtun, for example Structure V in Group C (Ruppert and Denison 1943:Fig. 61). The upper step of the roof was added hypothetically in relation to the lower stepped end of the profile.

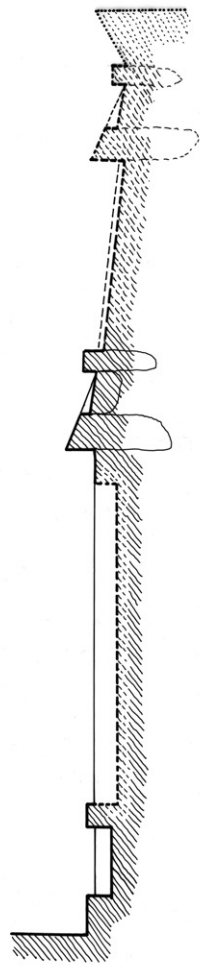
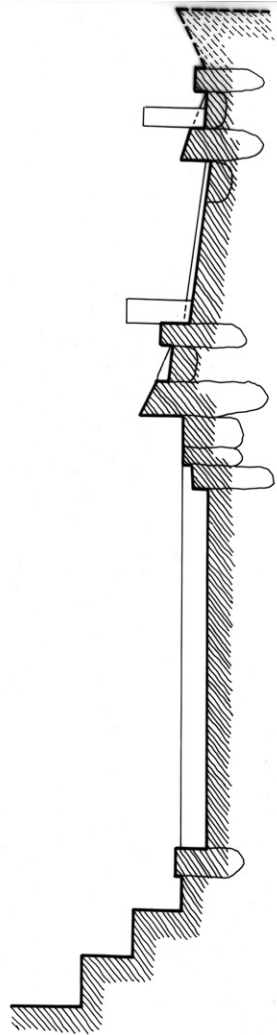
Fig. 122

Profile of the northern façade of Room 34 on the second floor facing east. It cuts through a flat niche representing a pseudo entrance into a building with a higher floor level than the floor in Room 34. The small base above the three-member base molding of Room 34 runs into the lower member of the three-member molding of the pillar at the northwestern corner of the structure.

The same design can be found on the southern façade of Room 37. It seems that the planners of the Palace were playing with façade levels here. We find two different levels in the middle member of the three-member base molding below both rooms on both sides of the axis of symmetry

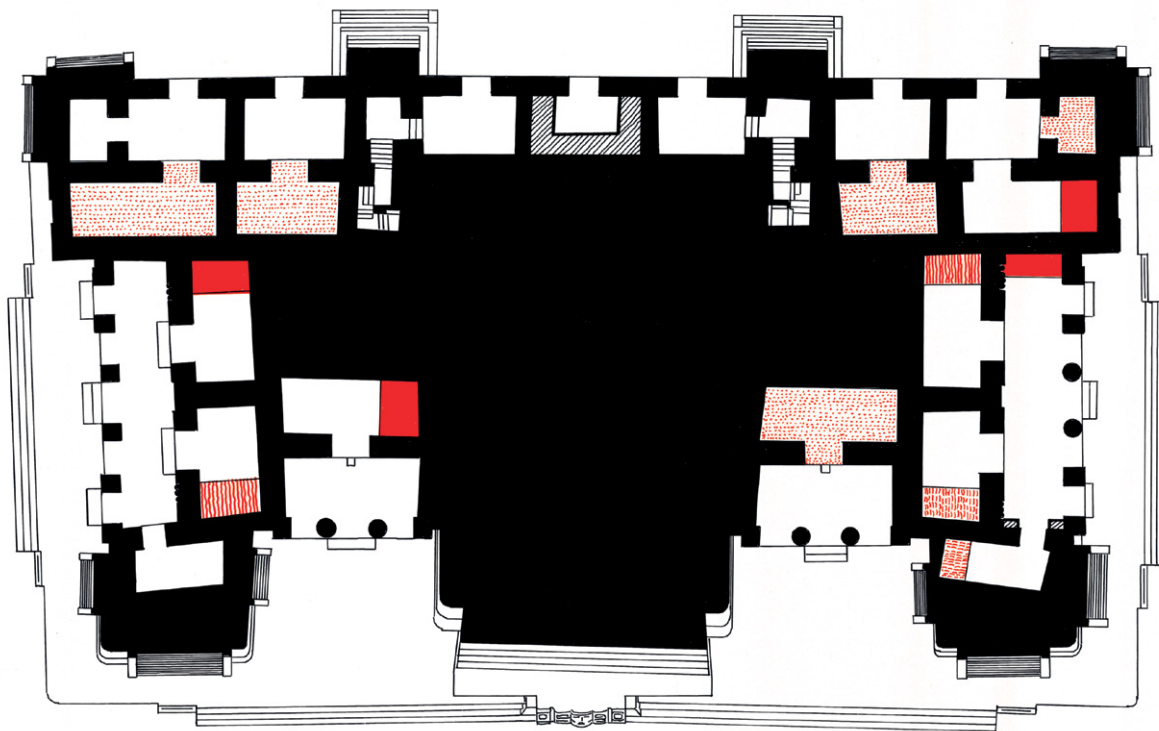
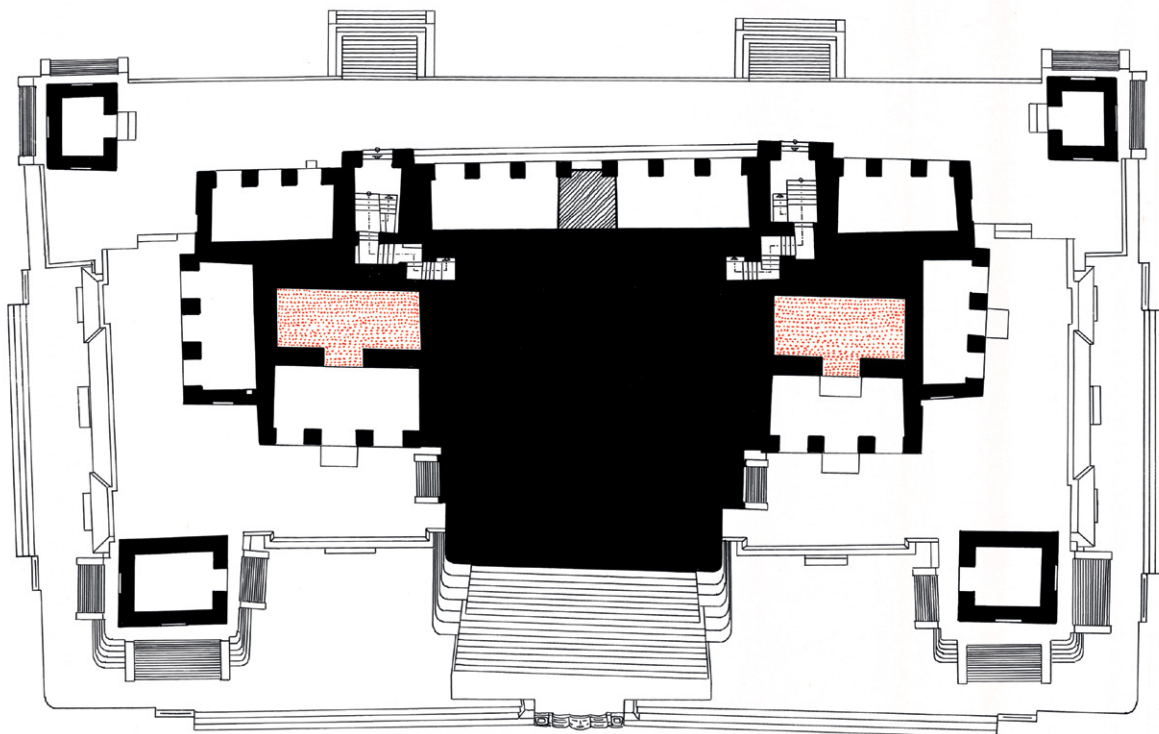
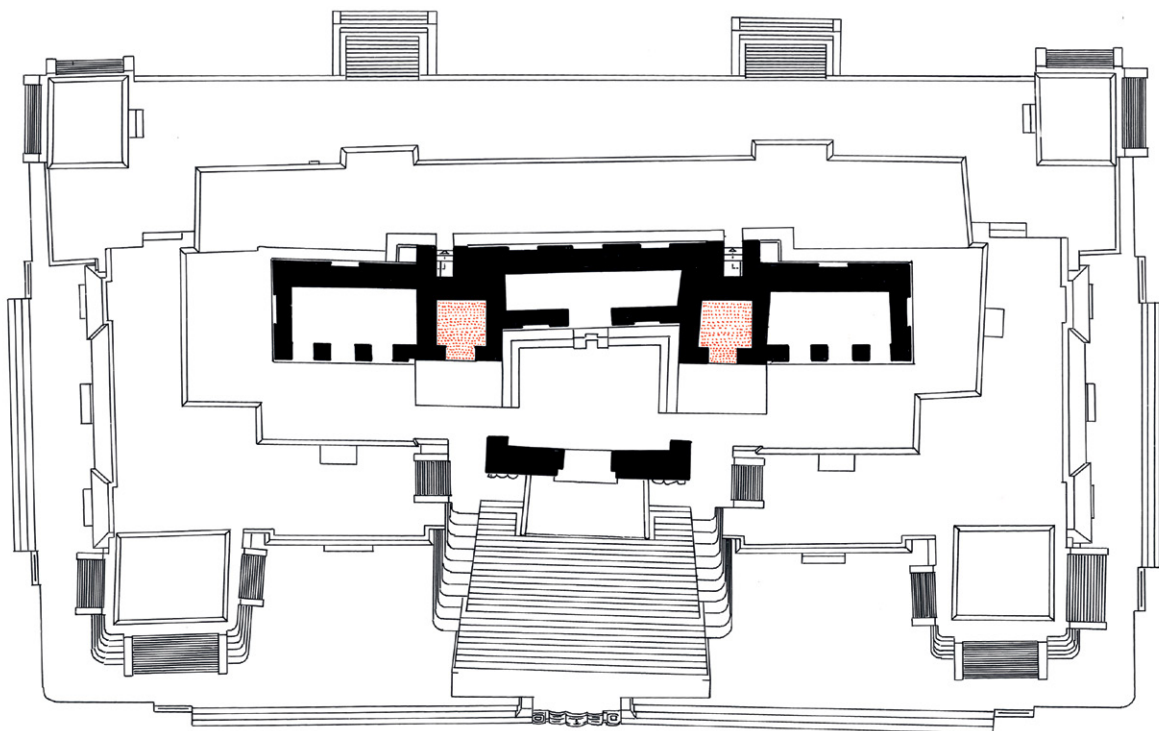
Fig. 125  
Benches

- Existing benches
- ▨ Indications for benches recorded by Antonio Benavides Castillo
- ▩ Indications for benches recorded by Richard B. Stamps
- ▧ Complete room might have been used as a bench

Presently there is no indication for a bench in Room 10. But Richard B. Stamps also measured the outlines of a bench in this room. It had a small simple cornice. Stamps writes about the rubble of the bench, "The back dirt from a treasure hunter's pot hole in this room (under a bench) revealed many human bone fragments and several pieces of broken pottery" (Stamps 1970:52, 53).

In 1969/70 Richard Stamps found good visible indications for benches in Rooms 10, 11, and 12, too. Fortunately Stamps measured them. They were between 65 and 75 cm high. There are clear indications for at least one more bench in Room 3 on the ground floor. In 2014 Antonio Benavides Castillo found stucco marks on the walls of this room marking the sides of a bench in the East of this room. Some more stucco marks which were measured by Benavides in Room 12 fit the measurements of Richard Stamps.

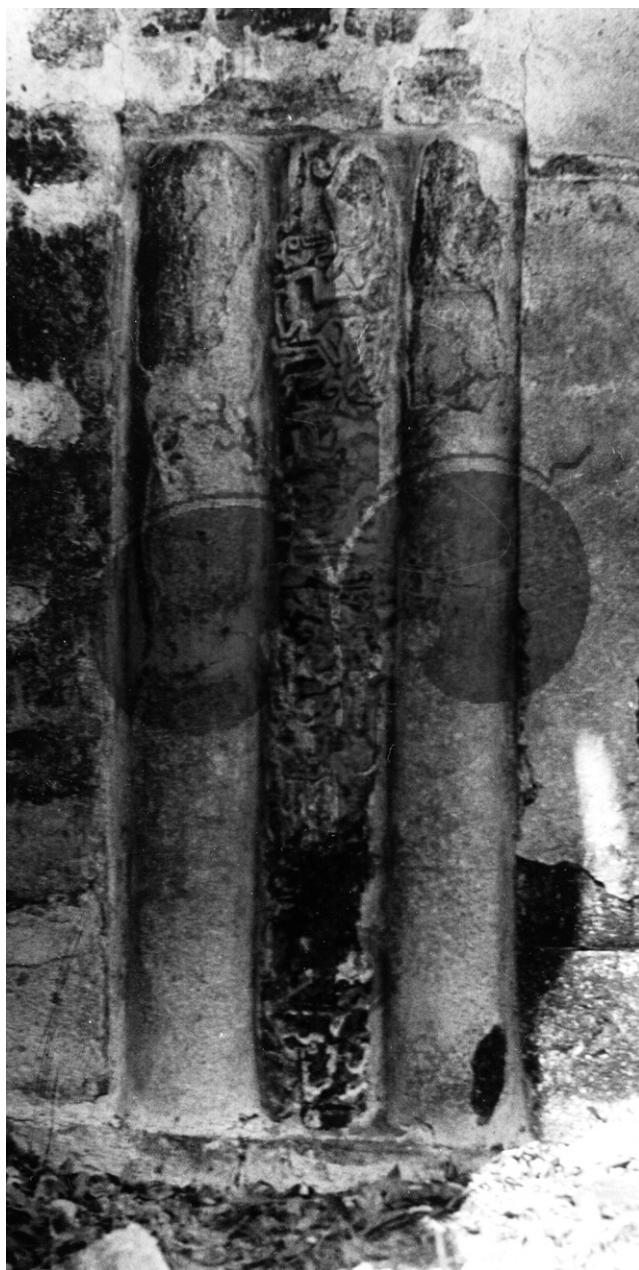
Fig. 126  
The western sculpted half column of Room 1 consisting of different sections (Pollock 1970:55, Fig. 73a). It has been completely looted. One section was later confiscated and is now in the Museo Nacional de Antropología in Mexico DF. With permission of the Peabody Museum, Harvard University by Karl Herbert Mayer; Photographer unknown

The western sculpted half column of those in Room 1 has been completely looted. It was stolen between 1960 and 1986. A short article by Francis Murphy (1961:7) shows the western half column up to the uppermost colonnette in place; a photo by Karl Herbert Mayer taken in 1986 shows the destruction of the looters. This proves the time span of the looting.

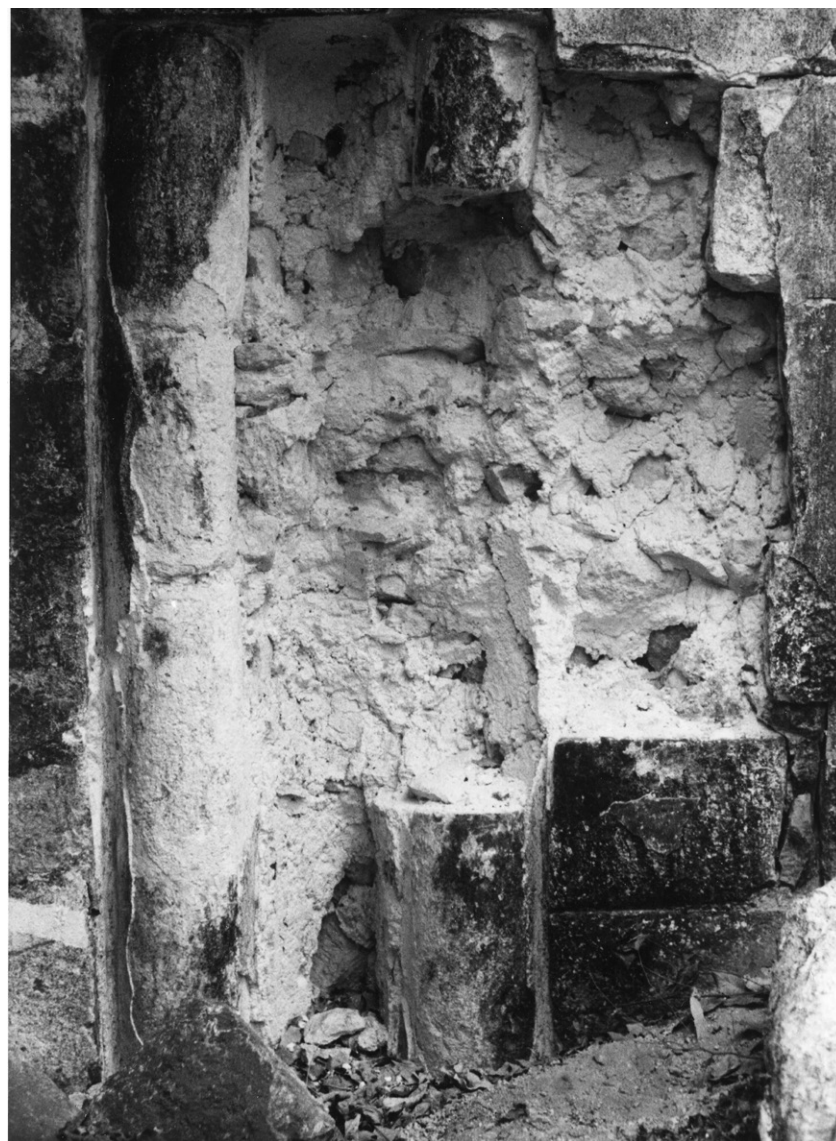
Fig. 127  
The situation after the looting of the western sculpted half column of Room 1 was a serious static problem for the Palace.  
Photograph: K. H. Mayer 1986

But the plane and the sculpted half columns must have been used as veneer stones. This is the reason why some of the looters had problems getting the western column out of the wall. The result was the destruction of the surrounding wall causing static

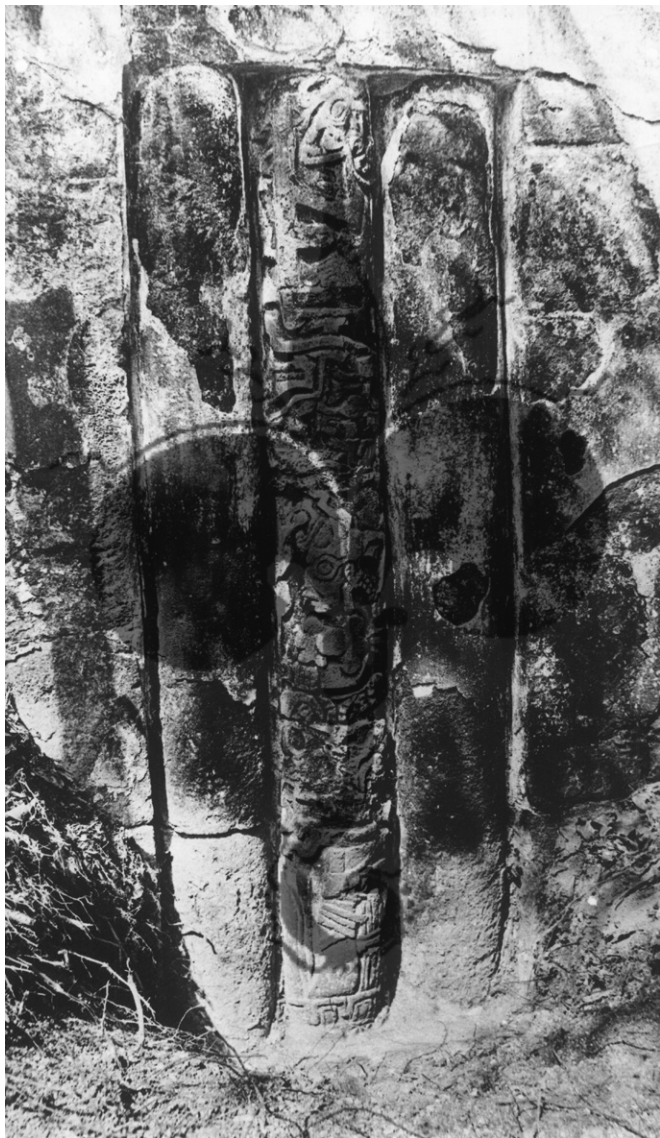
Fig. 128

The eastern sculpted half column in Room 1 consisted of different half cylindrical sculptured stone elements, which do not belong to each other. In 2004 the lowest stone element was still in situ. It represents the leg, foot, and part of the dress of a person and is positioned upside down. In 1985 the next upper element was in Holland. No one knows where the other two looted elements are.

A photo by Erwin Heine, taken in 1992, shows only the lowest section of the eastern sculpted half column in situ. It represents a foot with a sandal and the lower part of the dress of a person – all upside down. This element was even still in situ in 2004.

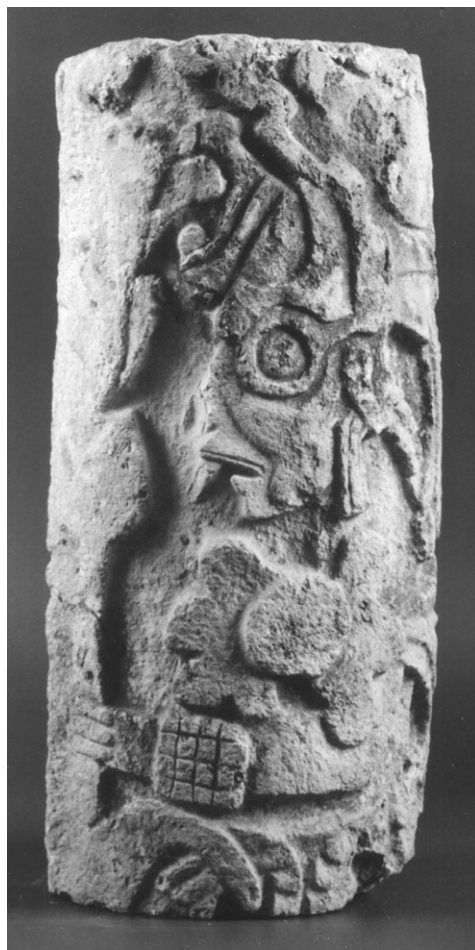
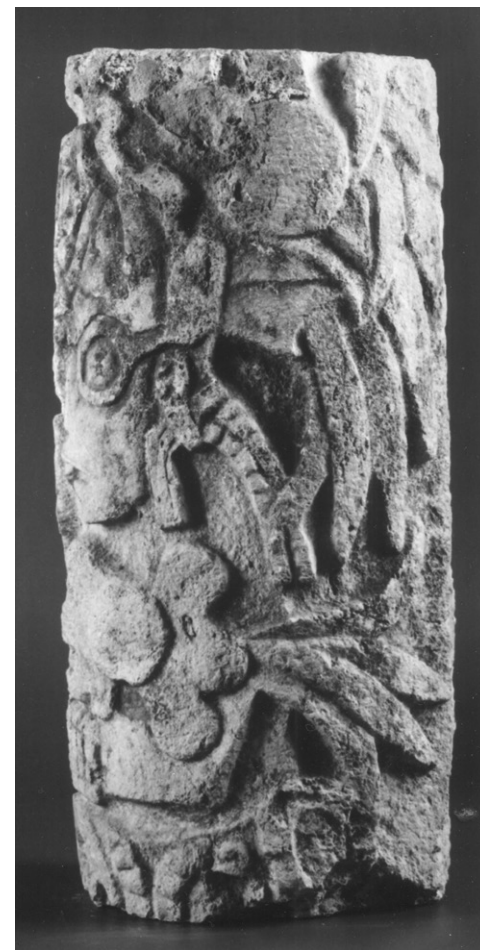
Fig. 129, 130

At the beginning of 1985 this section of the eastern half column belonged to the Theodor P. van Dyck Collection in Tilburg, Holland. Its measurements are: height 48.5 cm, width 21cm.

The following section above this half column was stolen and presently is part of the Theodore P. van Dyck Collection in Tilburg in the Netherlands. Its measurements are given as 48.5 cm high and 21 cm wide. All the rest is also looted but no one knows where the other pieces and those of the western half column are.

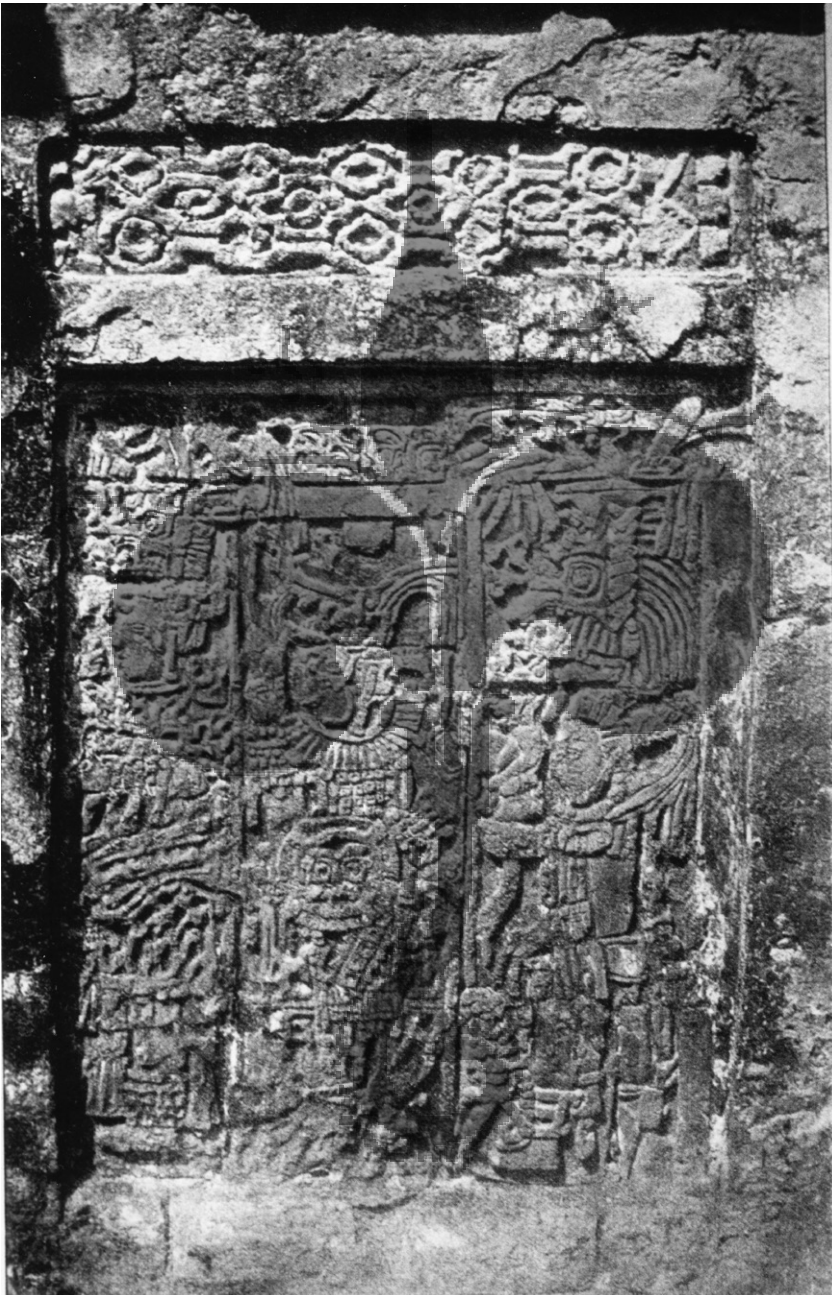
Fig. 131

The two reliefs in the centre of the northern wall of Room 1 in the South of the Palace in 1891 (Maler 1902). Francis S. Murphy also took two photographs of the two reliefs, one in 1960 and one in 1972 (Murphy 1988:26, Plate 28 and 28A). The first photograph shows that the upper relief elements of the lower relief field are still there. The later photograph shows that the upper elements of the lower relief field are missing. This means that they were looted the twelve years between 1960 and 1972. With permission of the Peabody Museum, Harvard University by Karl Herbert Mayer. Photograph: T. Maler before 1891

empty space. They did not change the original size of the relief fields. They just put some stones and mortar into the slits as are visible on both relief panels in the photos by Teobert Maler.

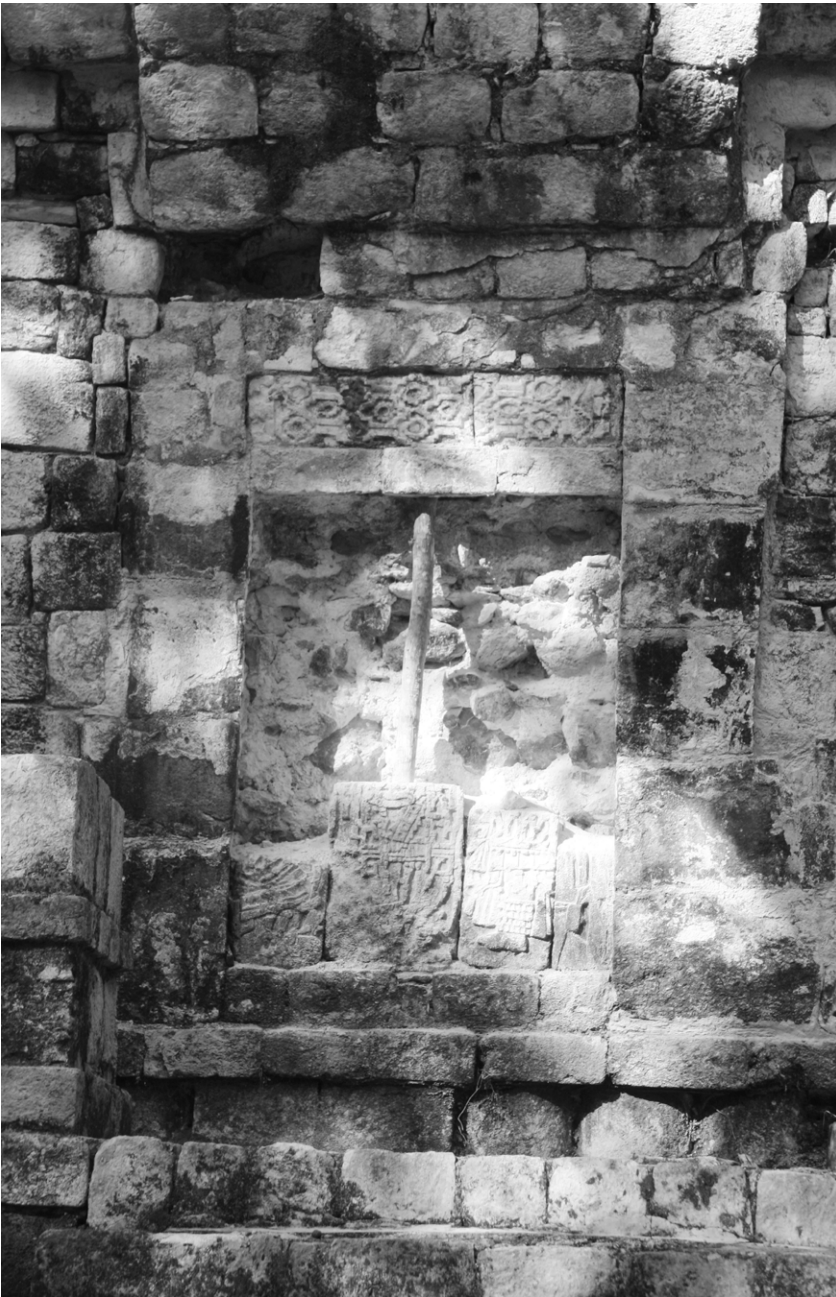
Fig. 132

In 2004 five of the relief elements of the lower relief were still in Room 1. At this time the upper relief was still complete. Photograph: H. Hohmann 2004

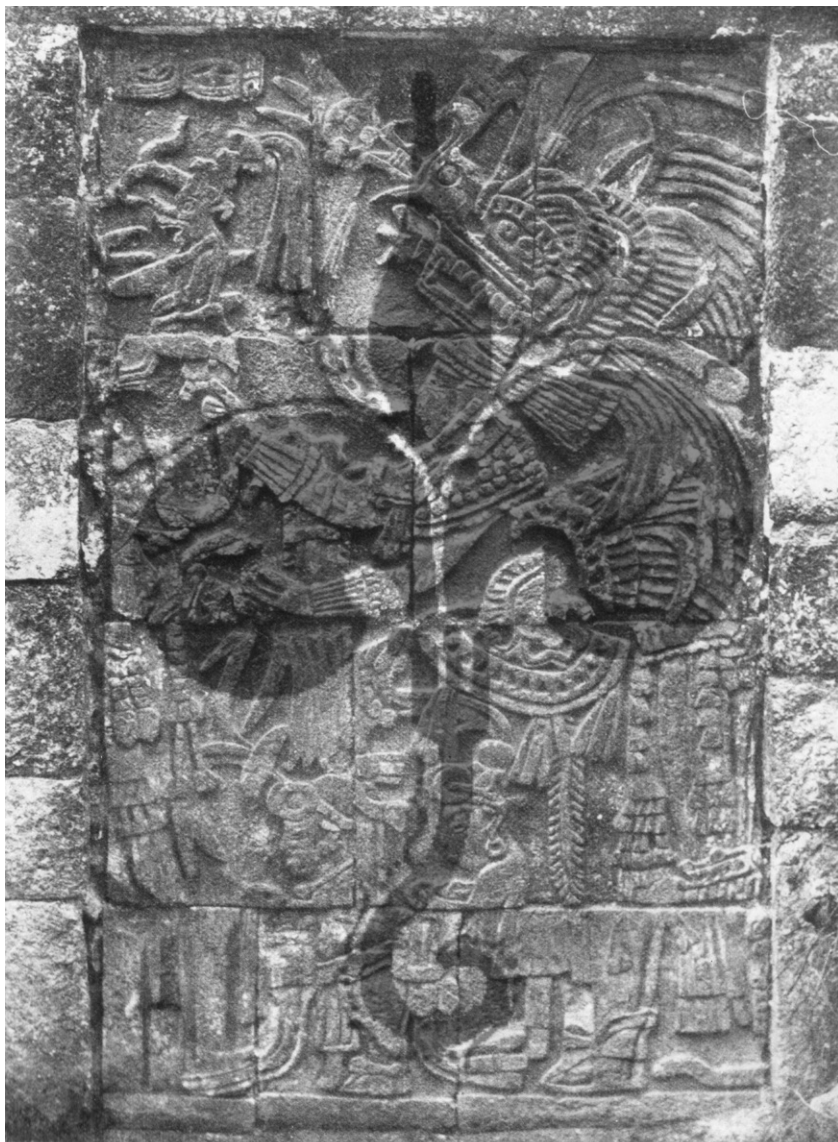
Fig. 135  
The relief in the southern wall of Room 9 in the North of the Palace of Santa Rosa Xtampak (Maler 1902). This relief is also fitted together incorrectly. Only the upper five relief elements form a section which belongs together. Please also refer to the paragraph on: Flat Niches with Reused Reliefs and Other Objects.  
With permission of the Peabody Museum, Harvard University by Karl Herbert Mayer. Photograph: T. Maler 1891
