# THE MAYA TEMPLE-PALACE OF SANTA ROSA XTAMPAK, MEXICO

DOCUMENTATION AND RECONSTRUCTION OF FORM,  
CONSTRUCTION, AND FUNCTION

HASSO HOHMANN

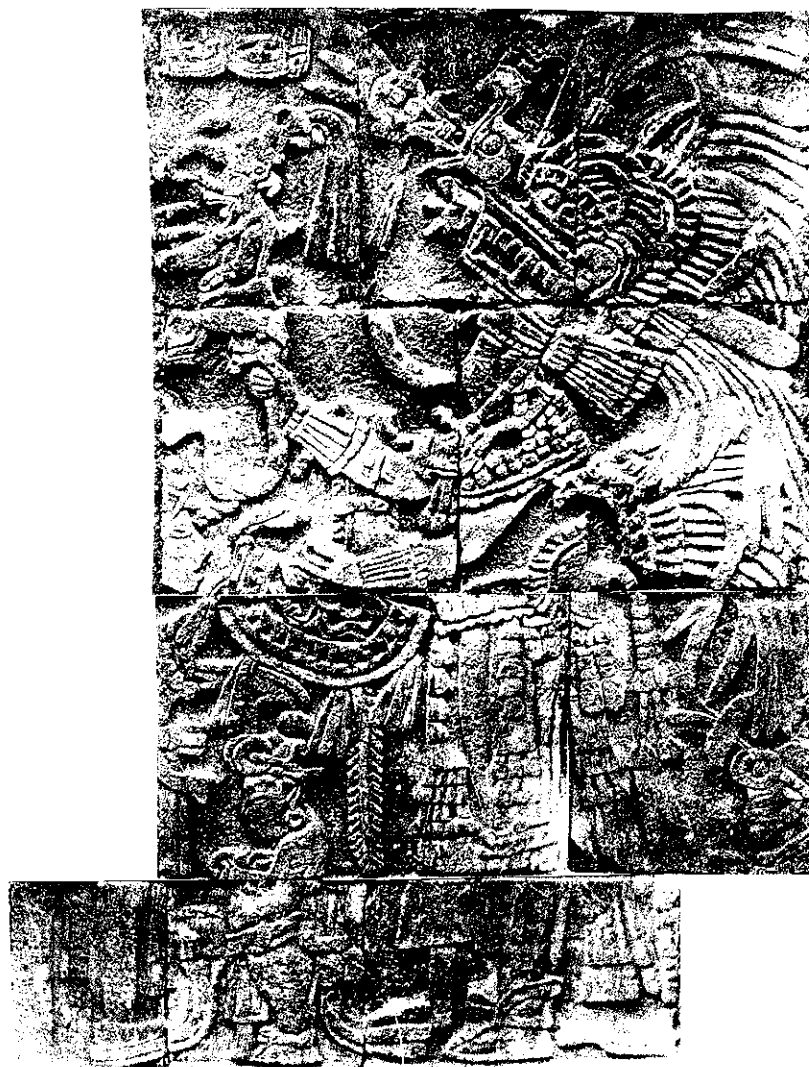
Fig. 136  
Hanns J. Prem's and Teobert Maler's solution of the puzzle.

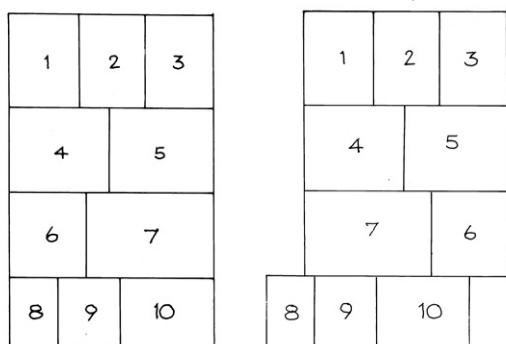
Fig. 137  
Drawing on how to change the fields of the relief in Room 9.  
Drawing: H. Hohmann 2004

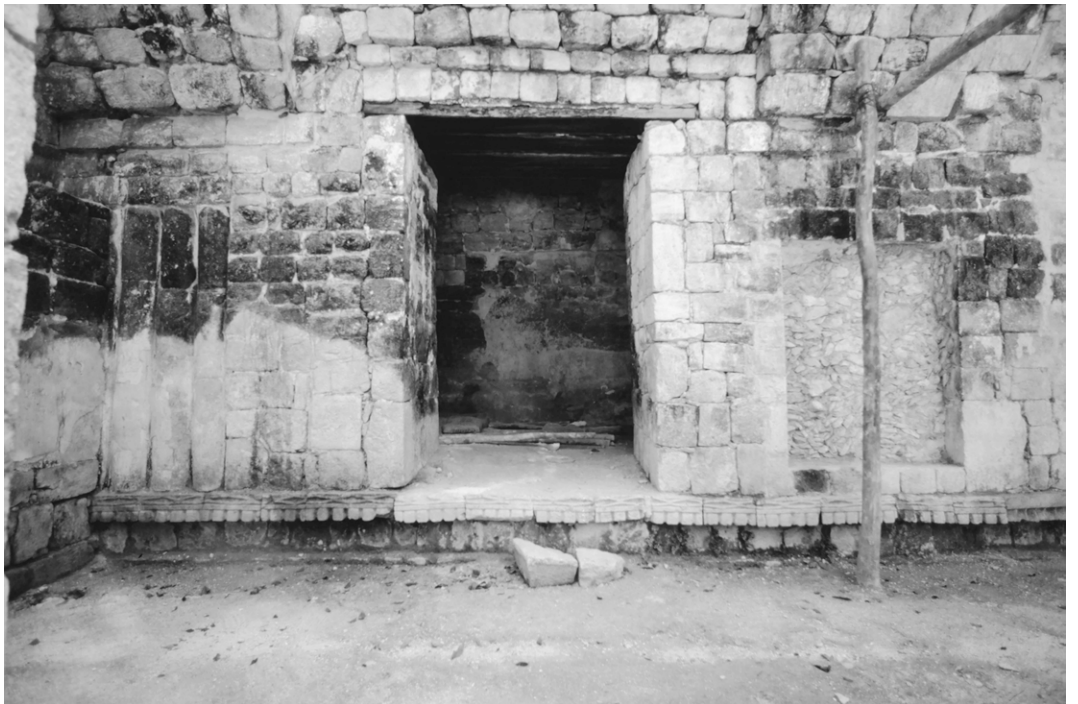
Fig. 138  
The reused cornice elements of the upper member of the three-member base molding in Room 9 under the southern wall.  
Photograph: H. Hohmann 2004

In several rooms, mainly in the walls of the two staircases, we find several reused relief stones from an older structure. There is, for example, a part of a cornice with rhomboid elements and fringes that has also been reused for the cornice of the base molding in Room 9. A more simple relief just with fringes is not far away. Both spoils are visible in walls of the southern staircase. At least one section of a well cut relief representing a standing person, unfortunately without his head, in the format 42 cm x 52 cm (Maler 1997:214) has been lost. Stamps already reported that he could not find this reported relief in 1969 (Stamps 1970:45).

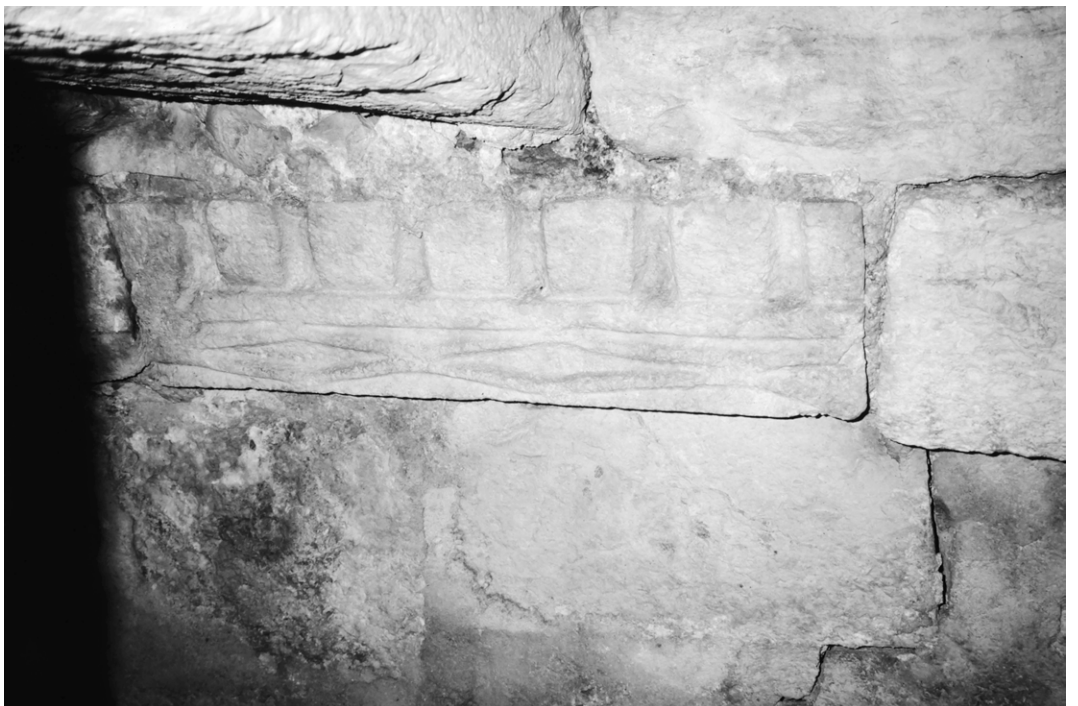
Fig. 139  
A spoil in the southern staircase. It looks like the row of spoils in Room 9 on the upper member of the three-member base molding.  
Photograph: H. Hohmann 1999

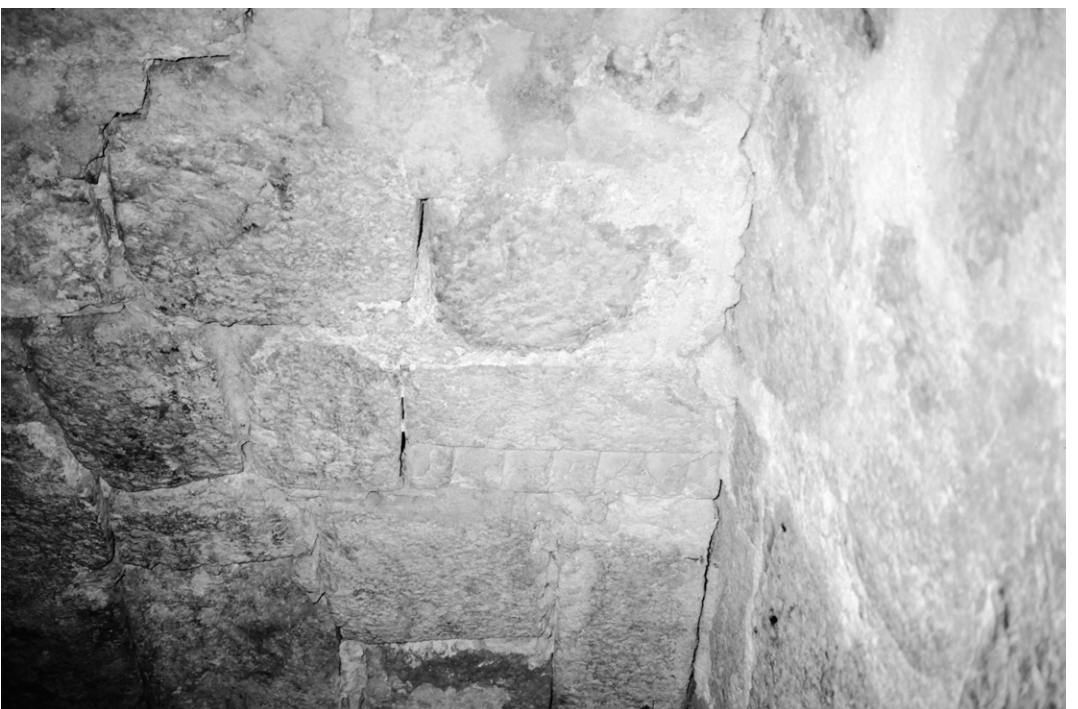
Fig. 140  
A spoil with fringes in the southern staircase.  
Photograph: H. Hohmann 1999

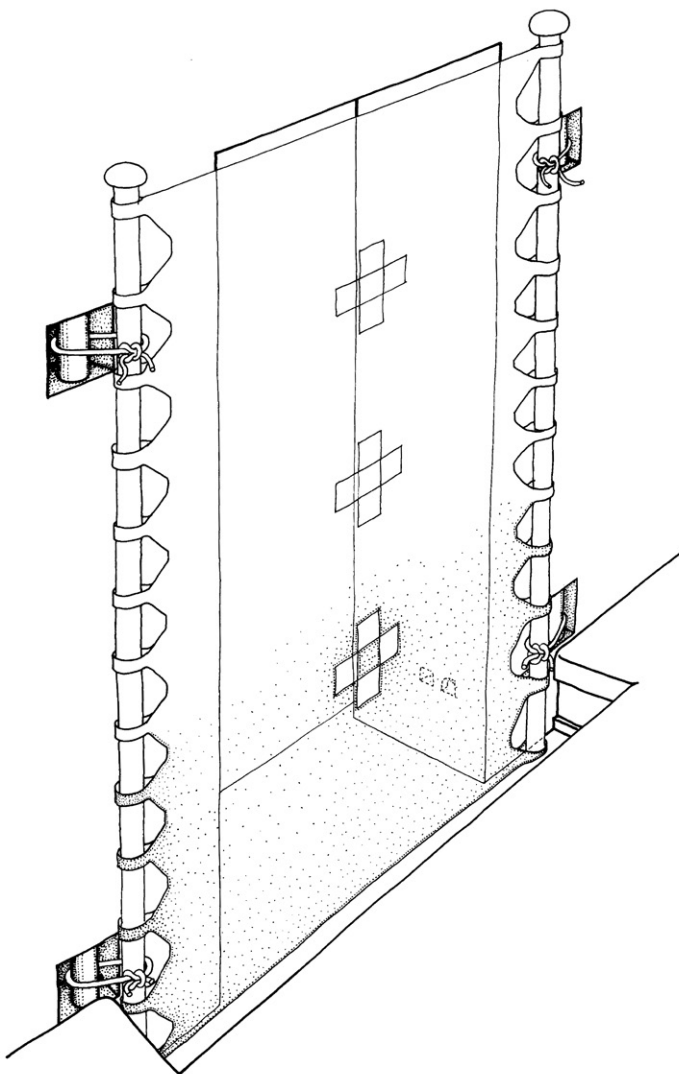
4. The fourth type consists of a wall stone with just one quarter of a half-torus at its edge; it opens with two holes into the room similar to that in Room 10.

5. The fifth type shows two triangular openings with a connecting hole, which can be used to tie a cord through it. We find this type quite often in the Palace as in Room 15.

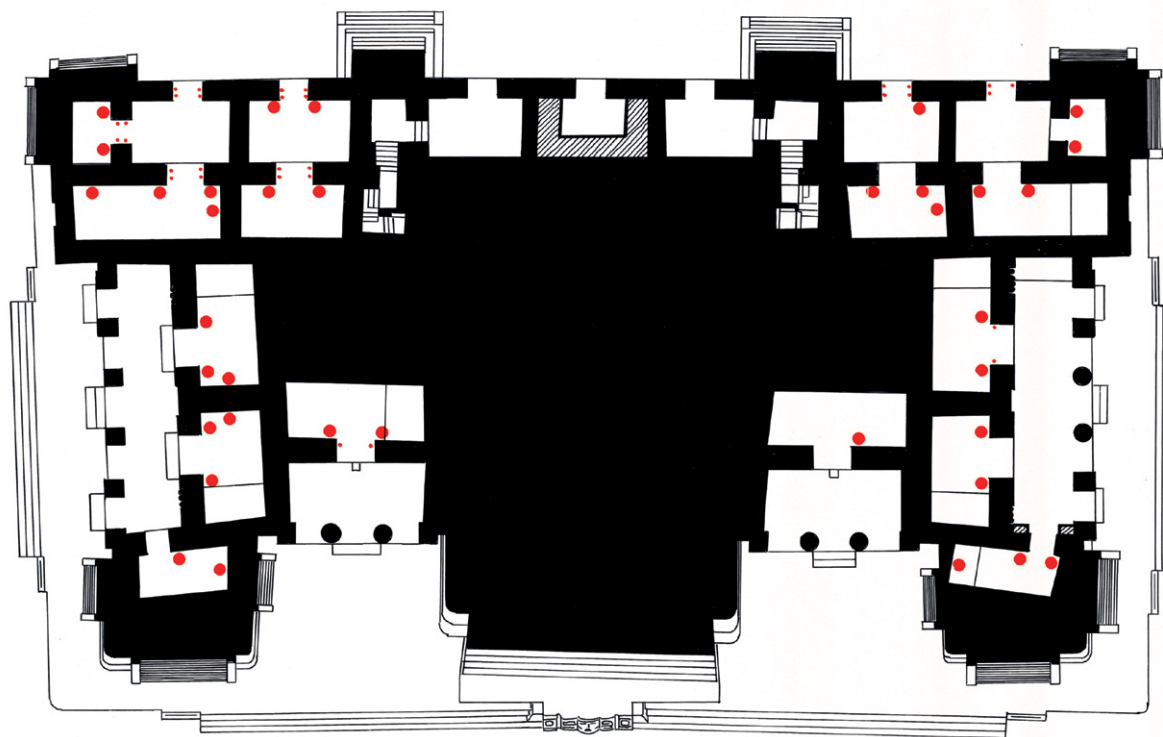
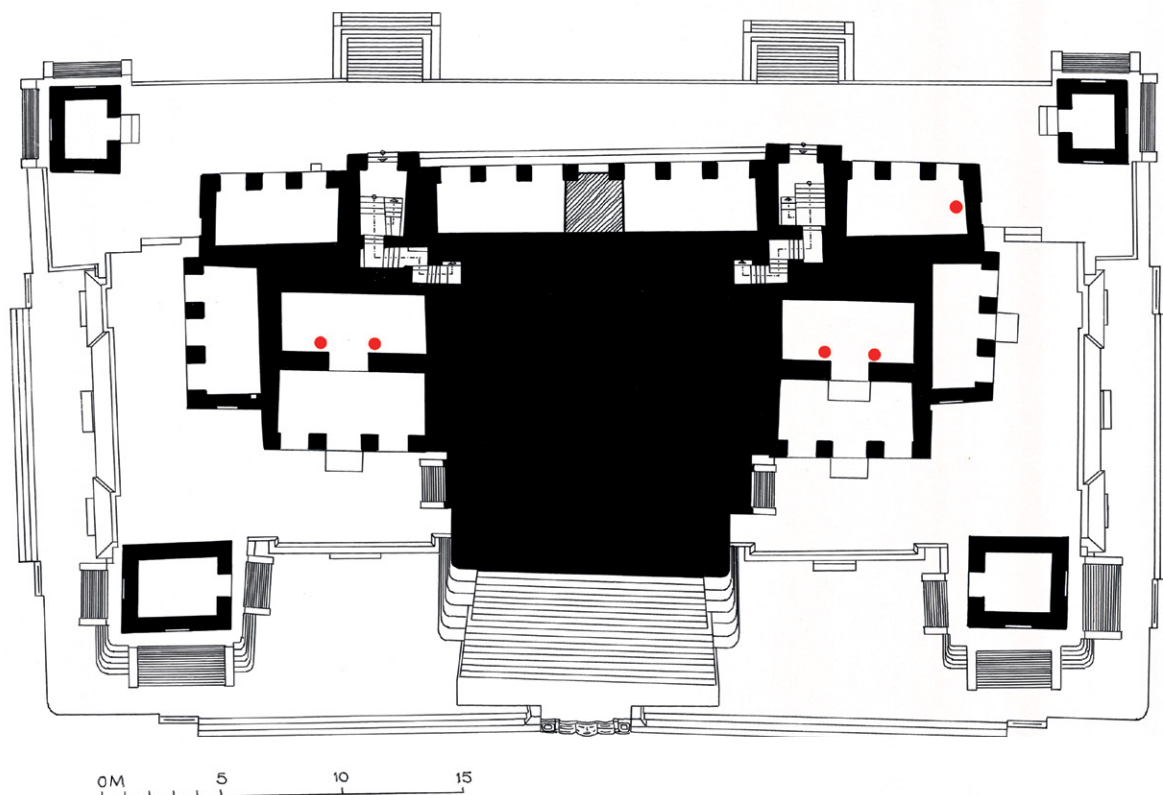
Fig. 142  
Indications for closures

- Cord holders
- Rod sockets

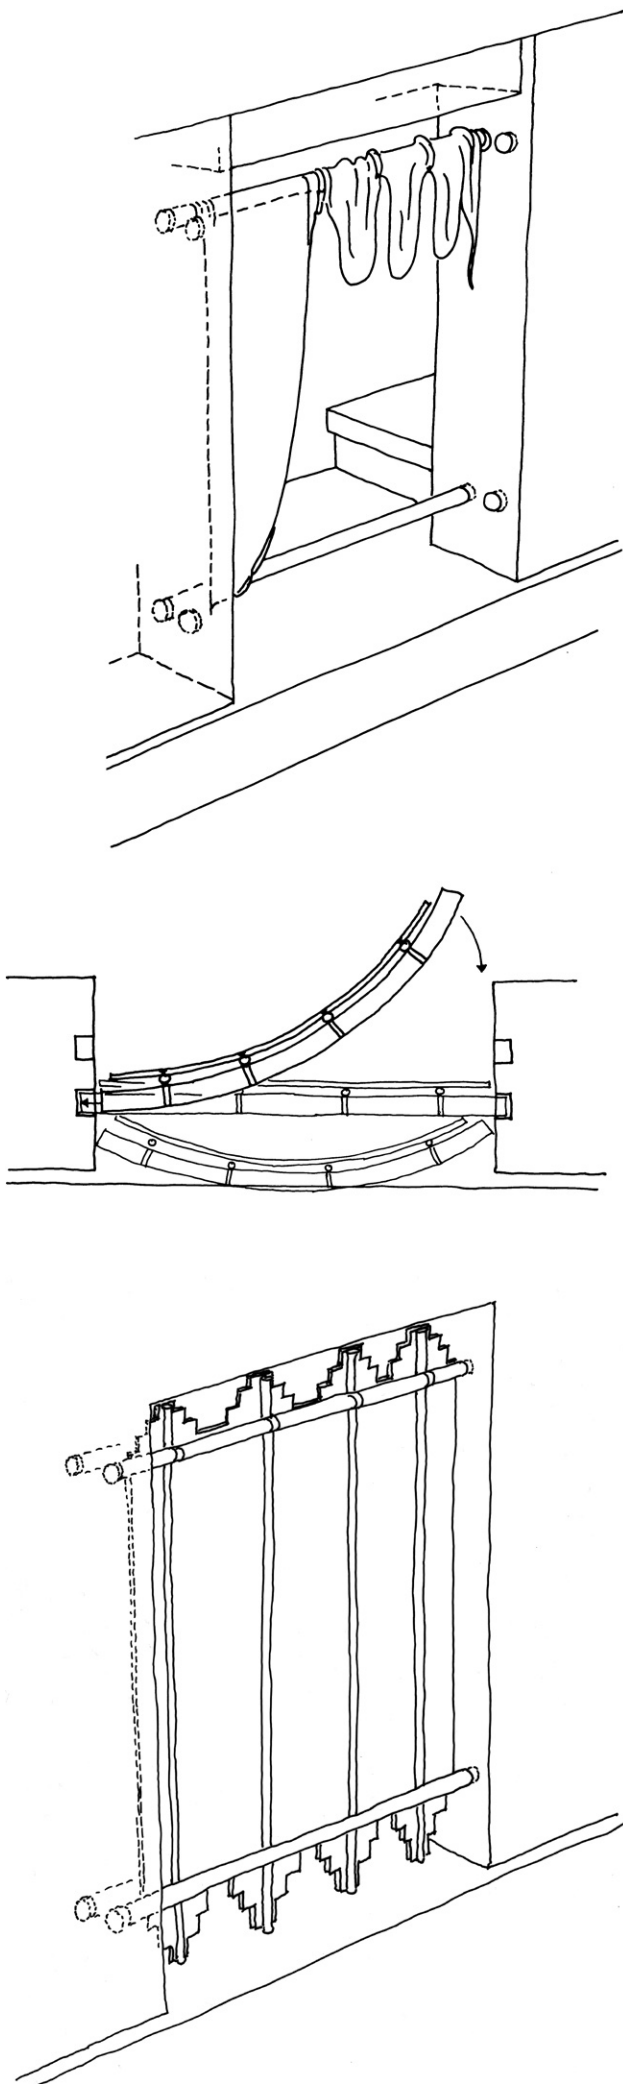
Hypothetically reconstructed closures at rod sockets.

Rod sockets can only be found at entrances and passageways of rooms on the first floor of the Palace. Remains of single rod sockets could be identified at Rooms 6, 12, 13, and 16. Remains of pairs of rod sockets were documented at the passageways of all rooms between Room 23 and Room 27.

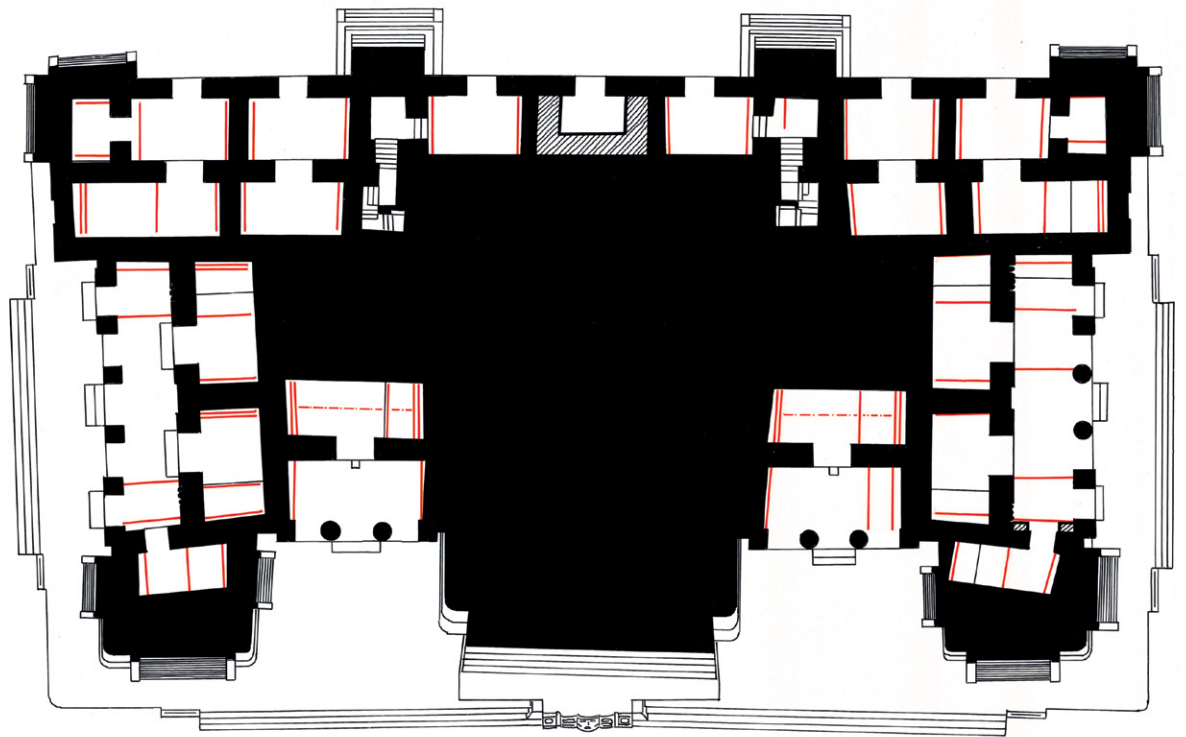
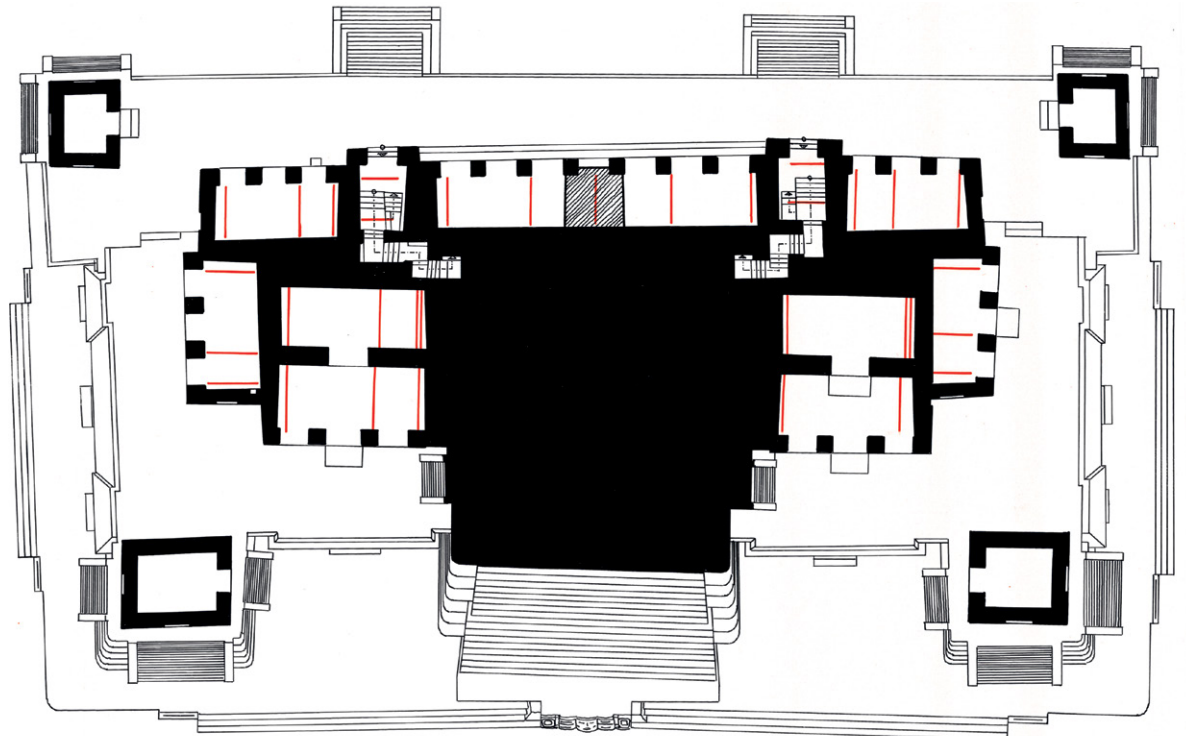
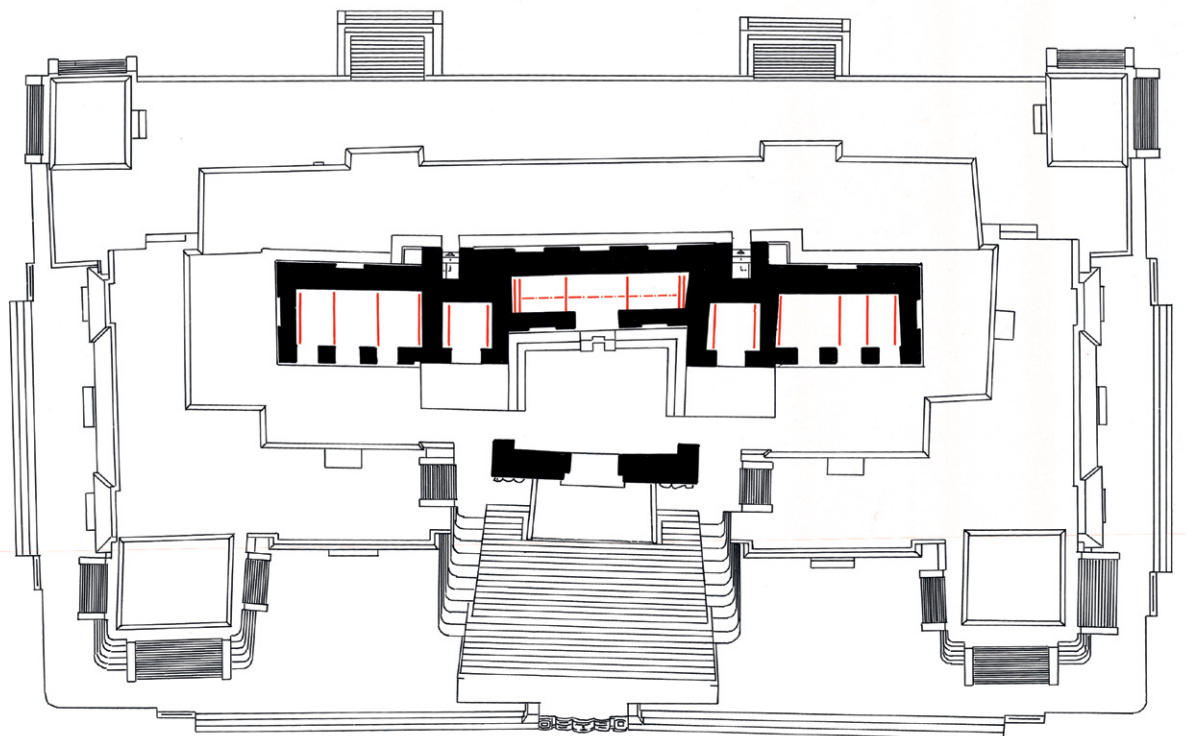
Fig. 147  
 Base maps with the lower vault beams  
 Asymmetrically positioned lower beams are indications of the former use of the room.

- Lower vault beams
- - - Suggested use of hammock

In the Palace of Santa Rosa Xtampak there are a lot of vault beams. They were all measured for this documentation and drawn into the ground plan and are also in at least two of the cross sections. Most of these beams have disappeared due to rot or were used by hunters or *chicleros* to make fire. But in some rooms a few of them have still survived in situ as in Room 8 on the first floor (Hellmuth 1989c:Fig.2 and 3).

Two pairs of vault beams on the short opposite sides of a room are, for the author, a very strong indication of the use of a hammock. The user of a hammock wants to be sure he will not fall down if one of the vault beams breaks - therefore the inhabitants of the Palace used two of them on both sides for reasons of safety. There are some rooms in the Palace with double vault beams at only one end of the room but only one on the opposite side. In some of these cases one of the beams at the other side of the room once broke and since then has not been replaced and the beams were no longer used for hammocks. Two of these rooms are Rooms 30 and 32 on the second floor. They are symmetrically positioned to the main axis of symmetry - just above Room 6 and Room 8 with two pairs of beams - visible from the Plaza del Palacio. The other three rooms with only one double vault beam are Rooms 2, 3 and 26 on the first floor. These are all back rooms of living quarters with more than one room. Here the single pairs of beams had to hold heavy loads near the walls.

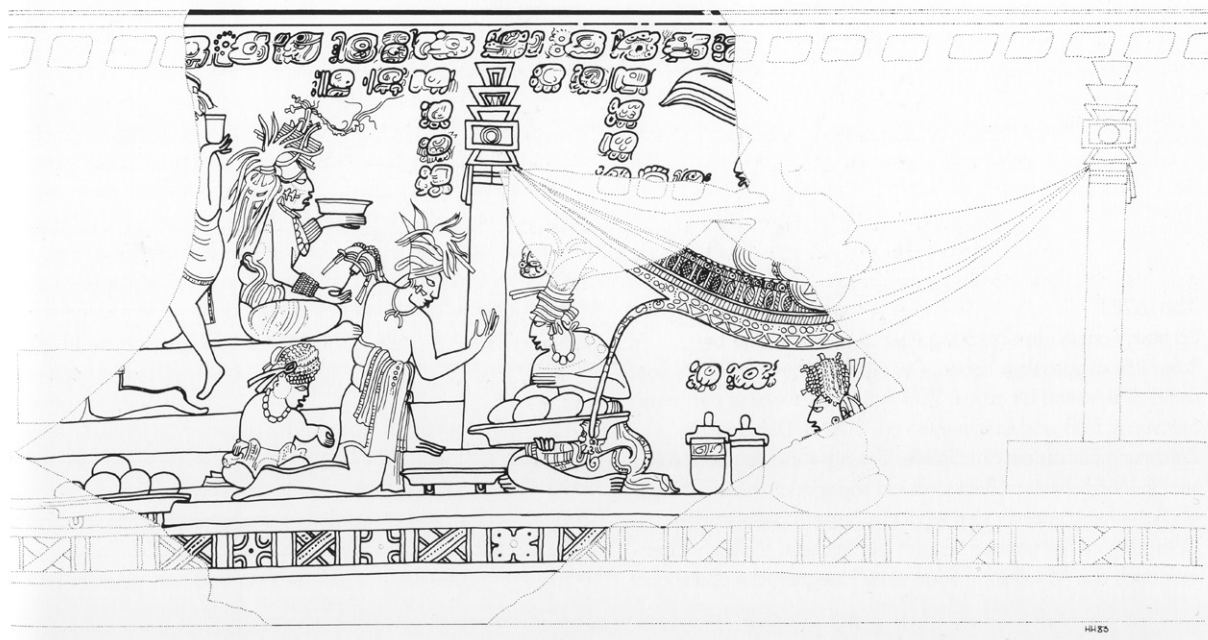
The Maya Classic Period vase of Tabasco, also called "Pellicer Vase of Tabasco" in the Tabasco State Museum in Villa Hermosa is unfortunately incomplete but shows enough to enable us to reconstruct the entire polychrome market scene with a guard sitting in a hammock spanned between two posts (Hohmann 1984:1-5).

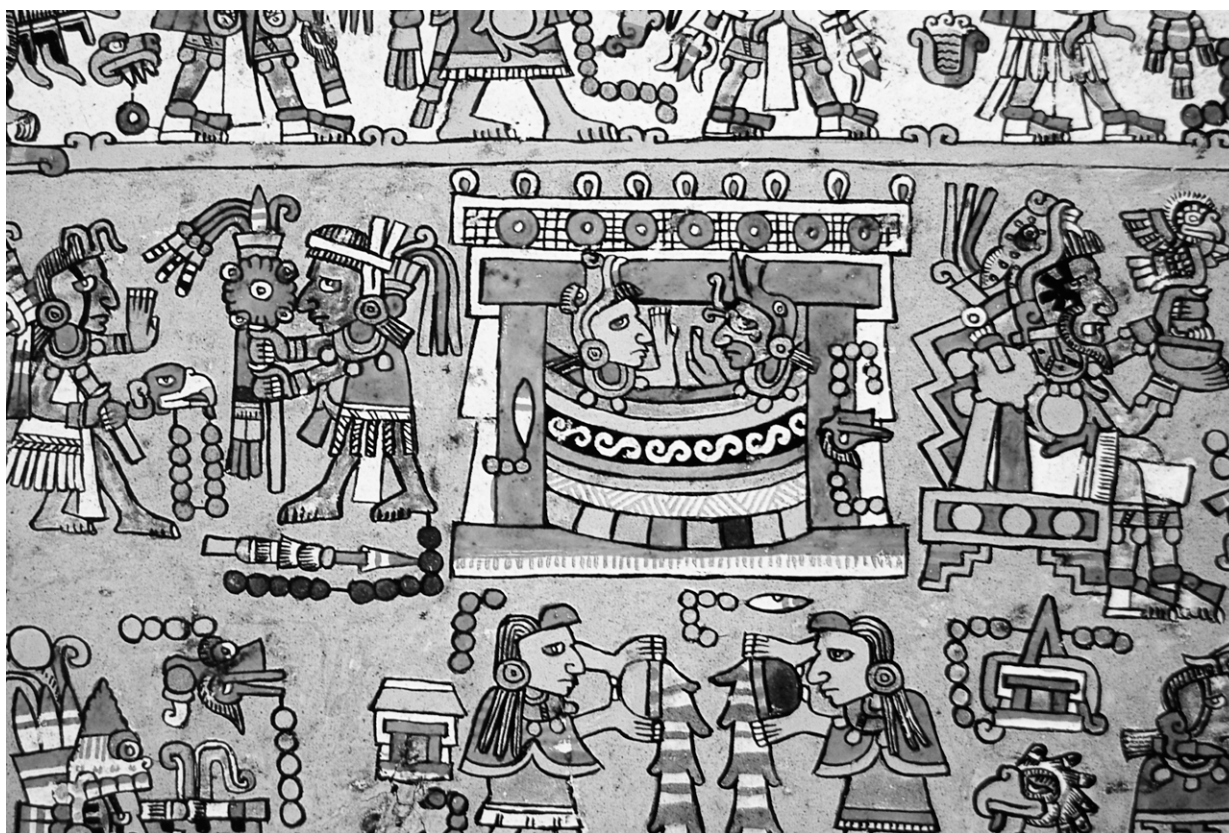
Fig. 149

On page 19 the Mixtec Codex Zouche-Nuttall shows (Codex Zouche-Nuttall 1987:19) the representation of a representative temple or palace with two persons sitting in a hammock in the centre of the room visible through the entrance from outside. It is a different culture and a later century. Thus, it shows the use of hammocks in Pre-Columbian Mesoamerica on the continent.

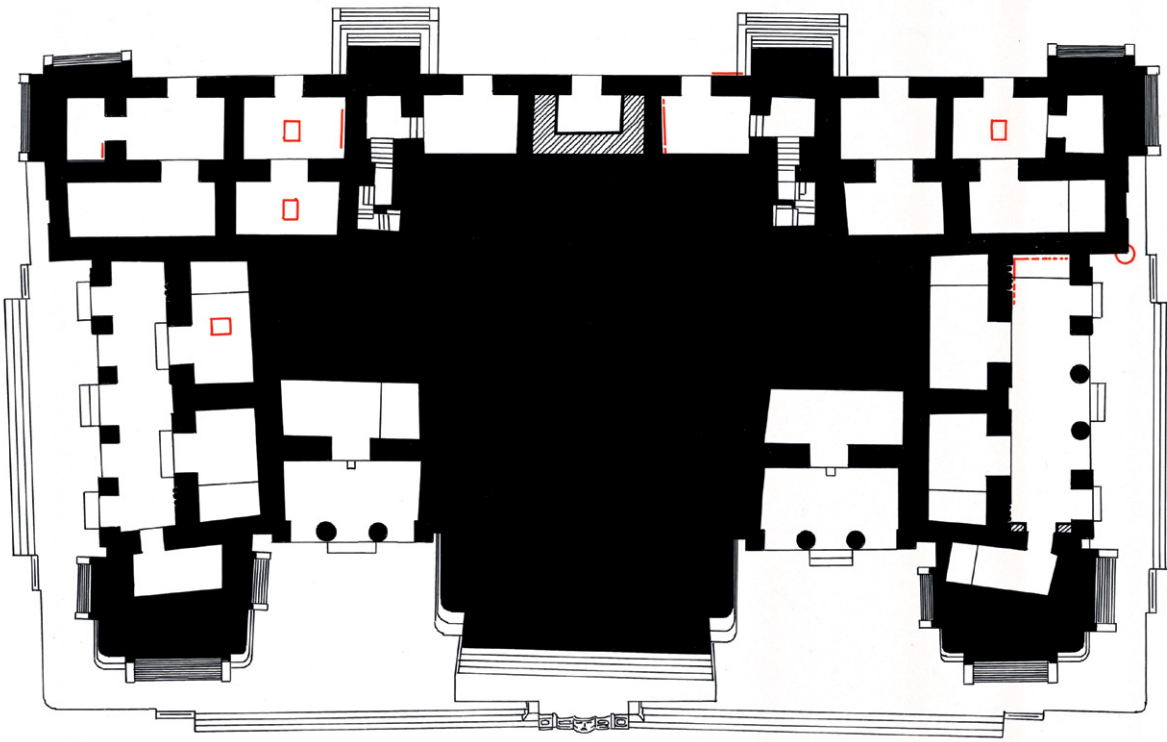
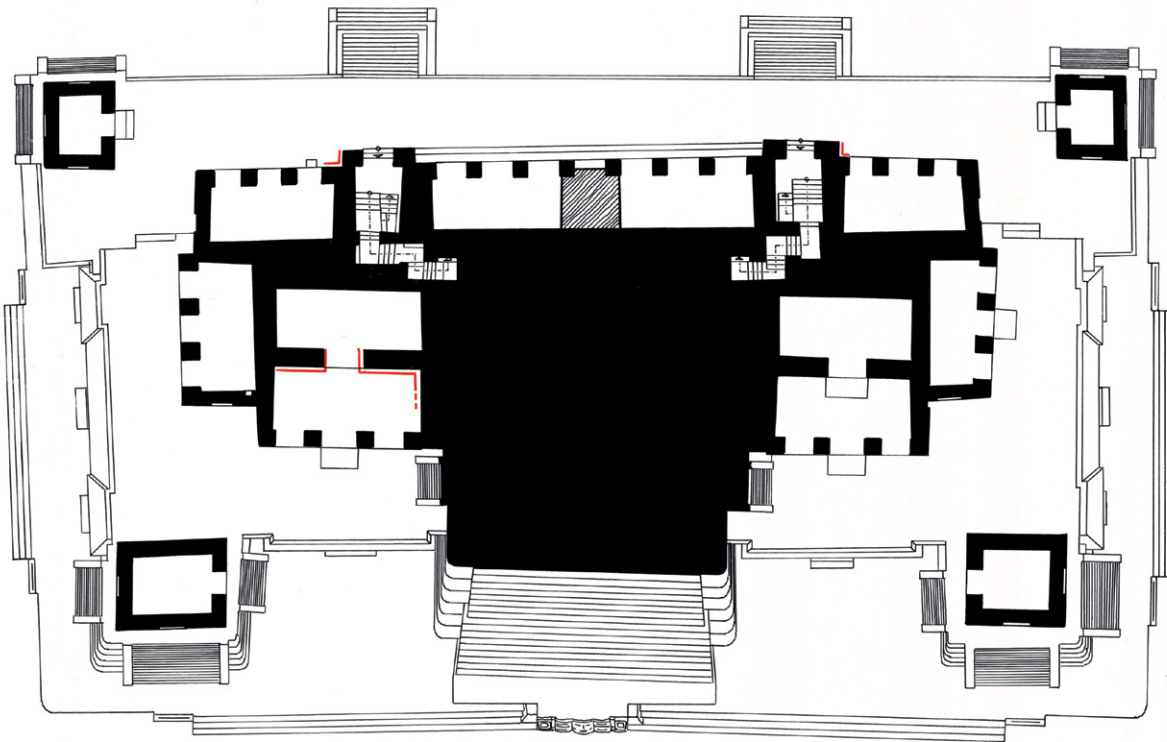
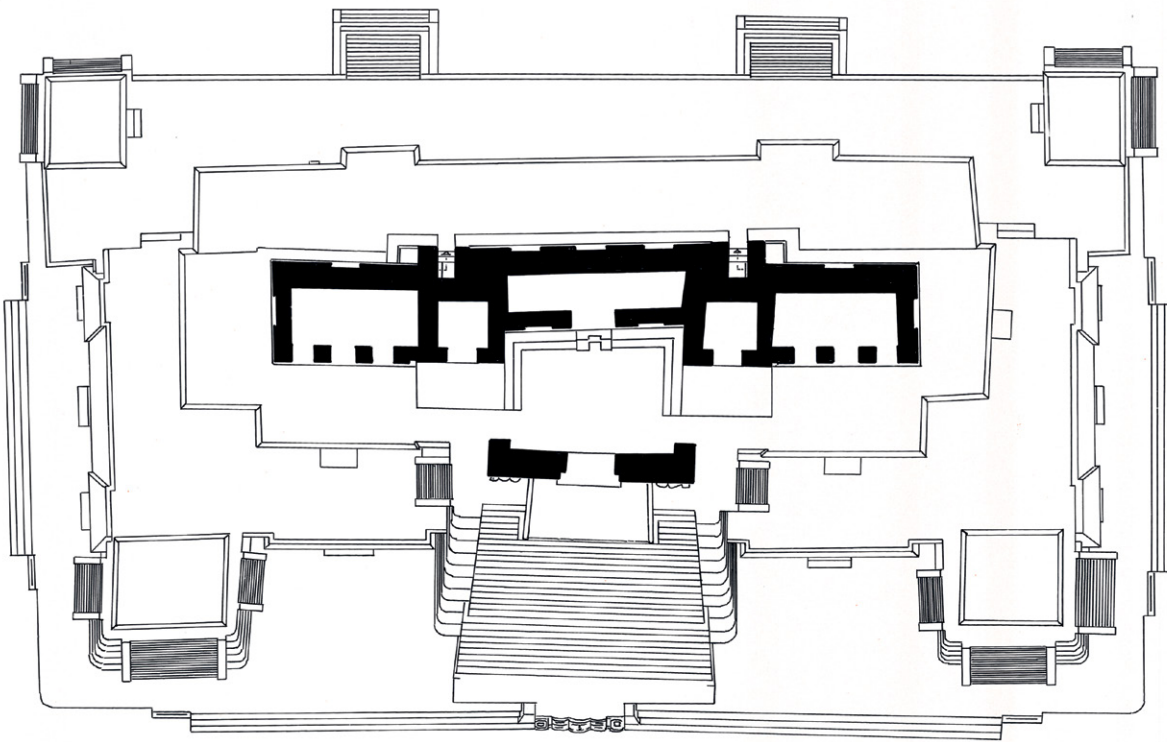
Fig. 150  
Painted decoration

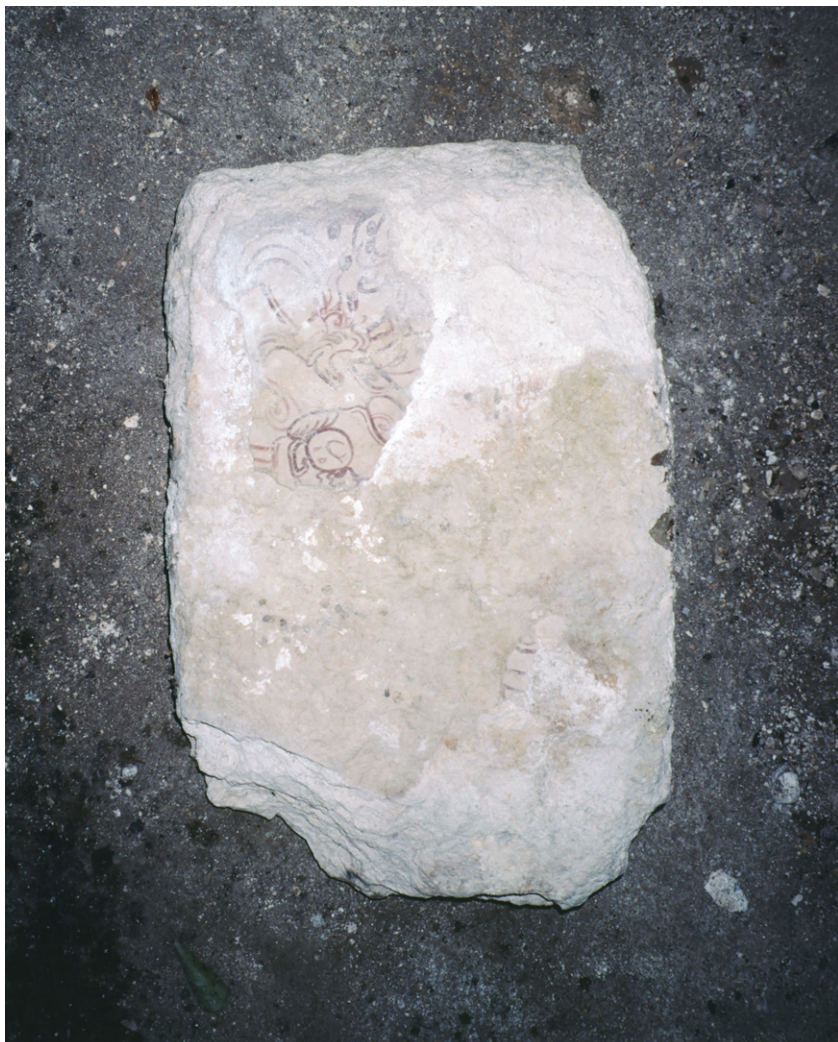
Fig. 152

This capstone was positioned in the South of Room 21 on the floor near the steps up to Room 22. It was called Cst. 8 by Karl-Herbert Mayer (Mayer 1983:40). It still shows some remains of a painting in light and dark red on white plaster. Photograph: H. Hohmann 1999

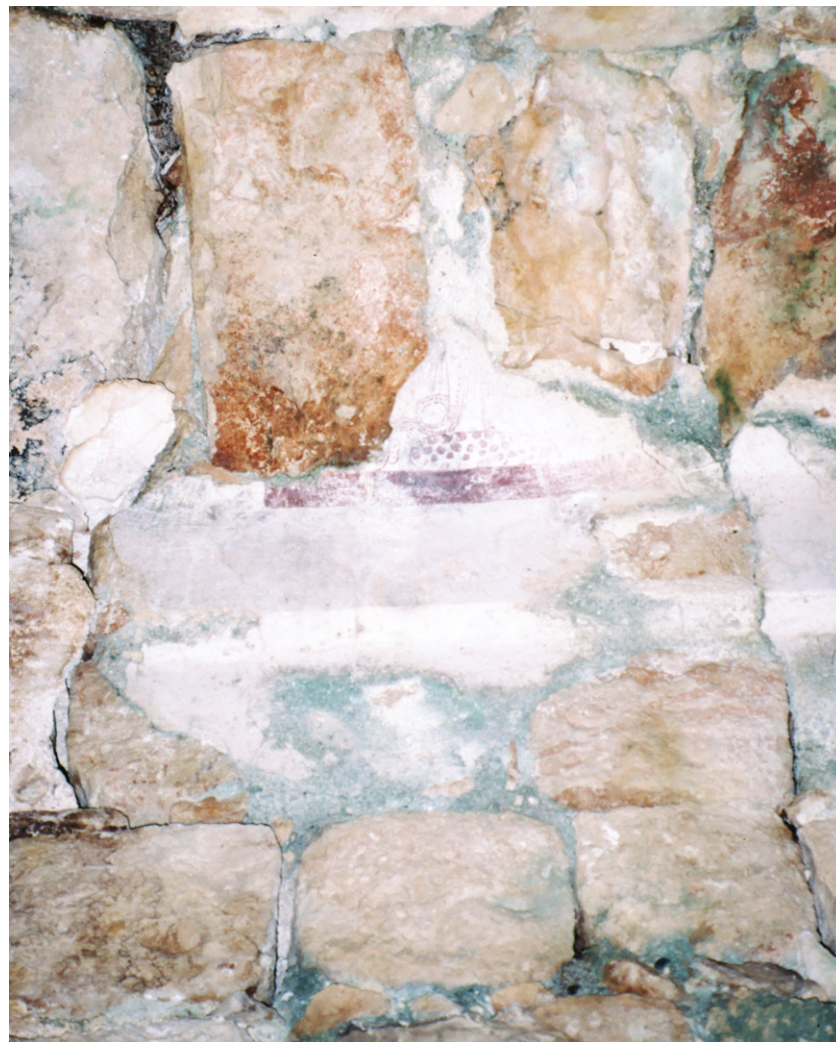
Fig. 153

This shows a section of the corbelled vault in Room 2 with the two most central capstones. Here the capstones were not pre-painted. The plaster covering the capstones was painted at the end of the construction phase. The painting is a mural looking like a painted capstone which was added later. The frame of the painting covered only part of the two capstones behind. Karl-Herbert Mayer called it CST. 5 (Mayer 1983:40).

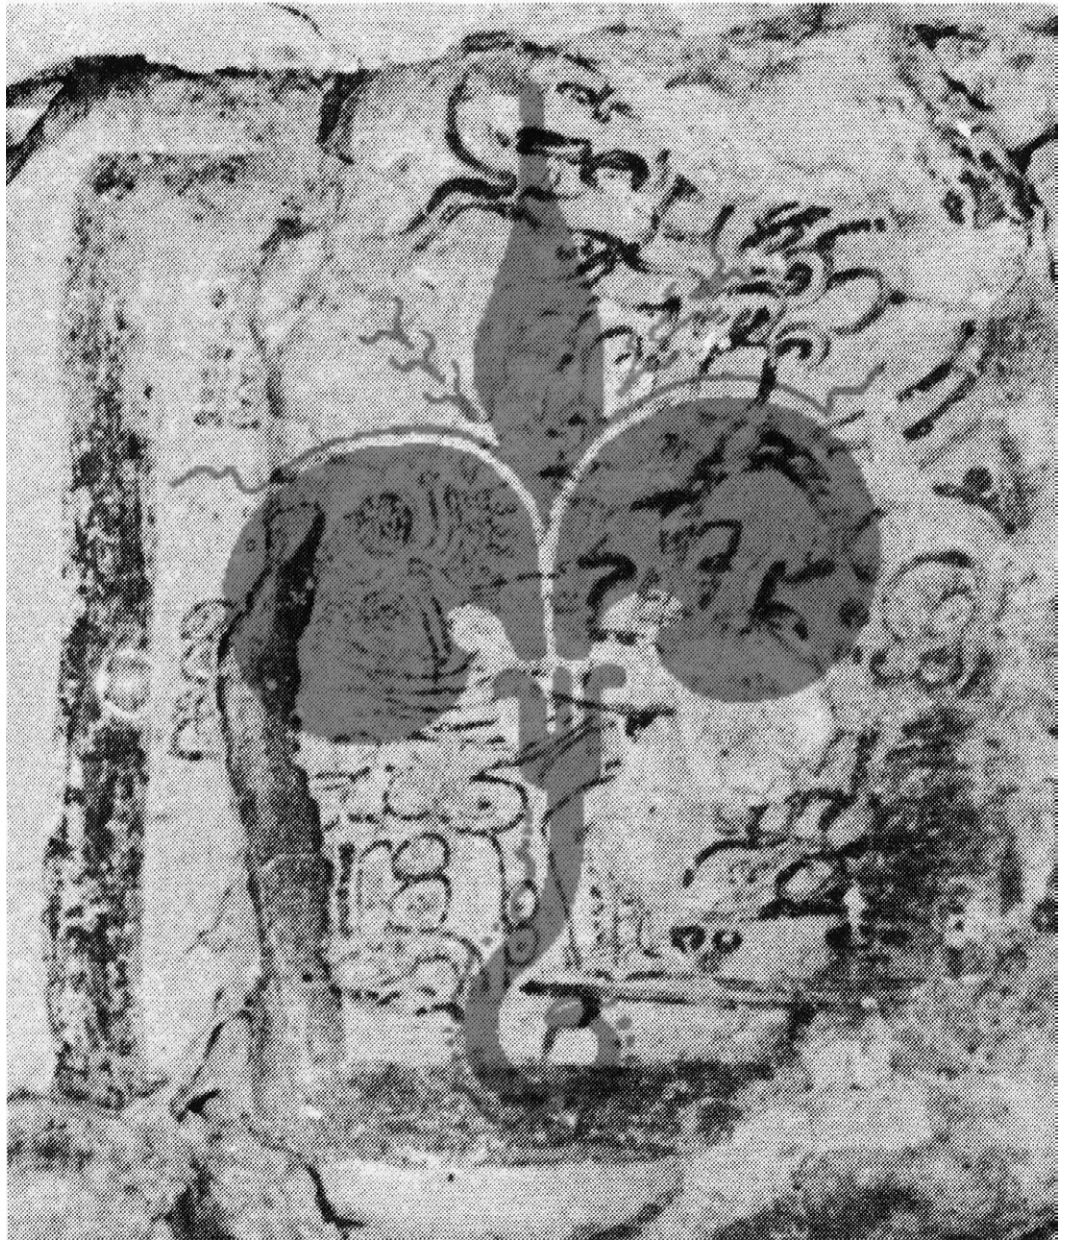
Fig. 154

Capstone Cst. 3 and Cst. 4 in Room 23. They show two layers of plaster with paintings in red lines on a white background, one above the other.

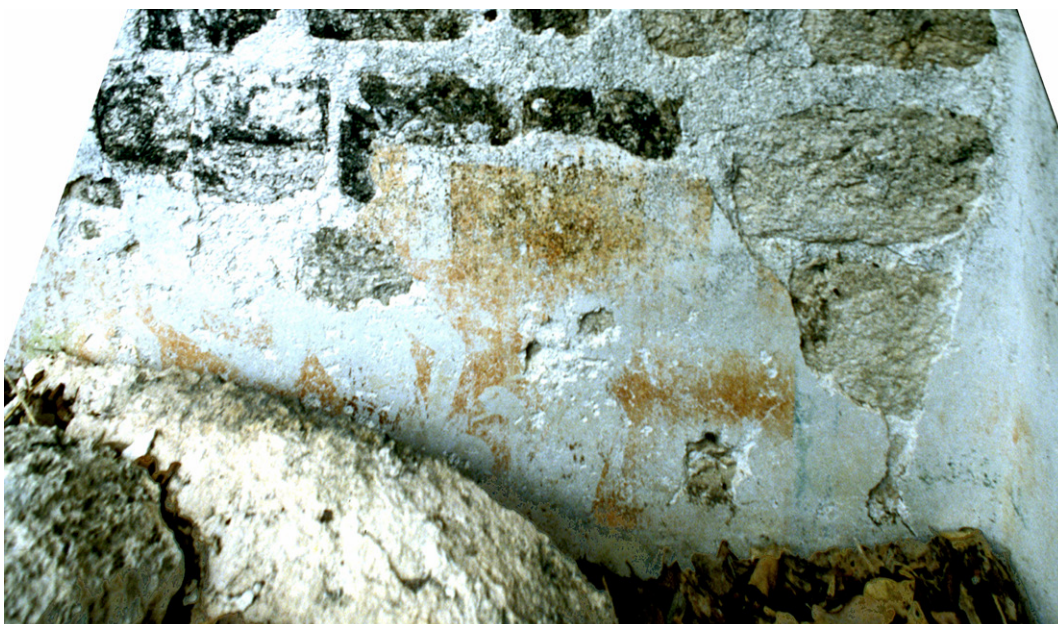
Fig. 158  
Jack Sulak outlined three figures of the mural in Room 29 and the former inscription block above.  
Photograph: J. Sulak 1989

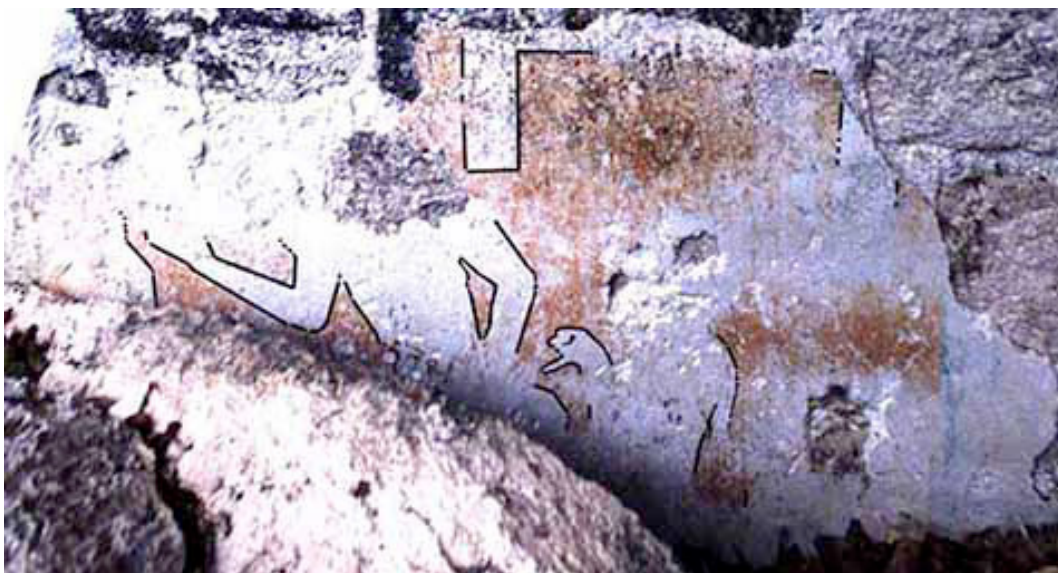
Fig. 159  
This small section of the mural on the western wall of Room 29 north of the passage-way shows three of the four persons. Their heads were destroyed recently.  
Photograph: J. Sulak 1989

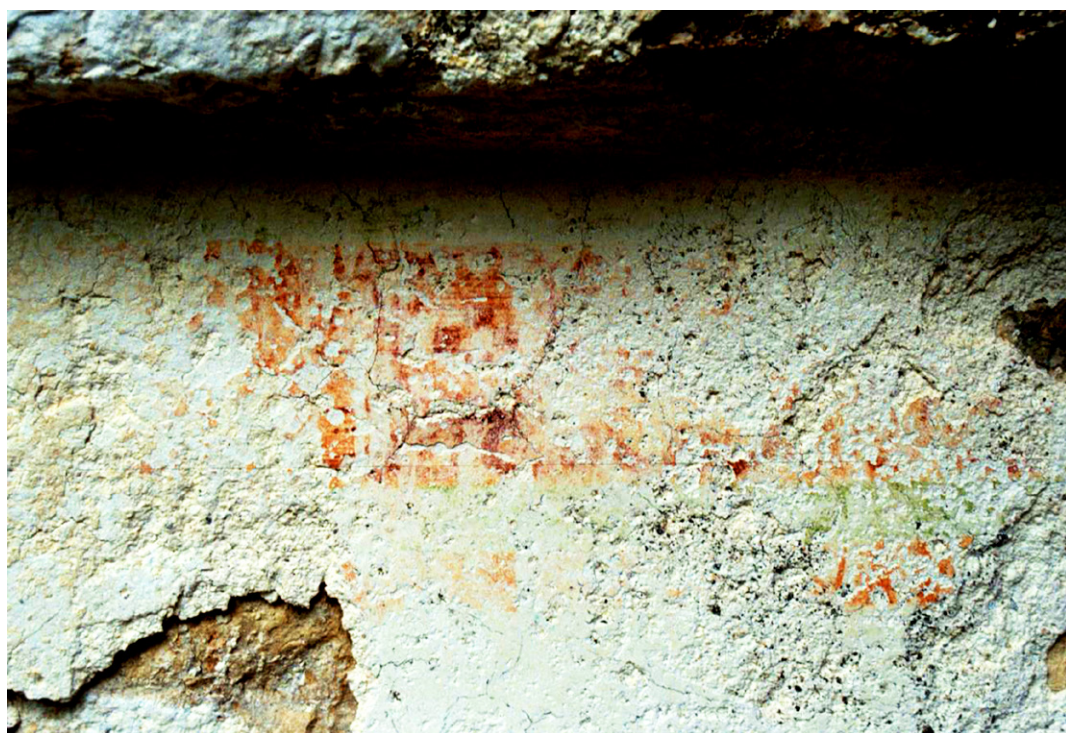
Fig. 161  
 Here we see the last remains of the two  
 bands on the western rear wall under the  
 vault spring of Room 29. The broader  
 band once showed Maya hieroglyphs, as  
 Maler recognized back in 1891 (Pollock  
 1970:57). The color between and above  
 the two bands was green.  
 Photograph: J. Sulak 1989

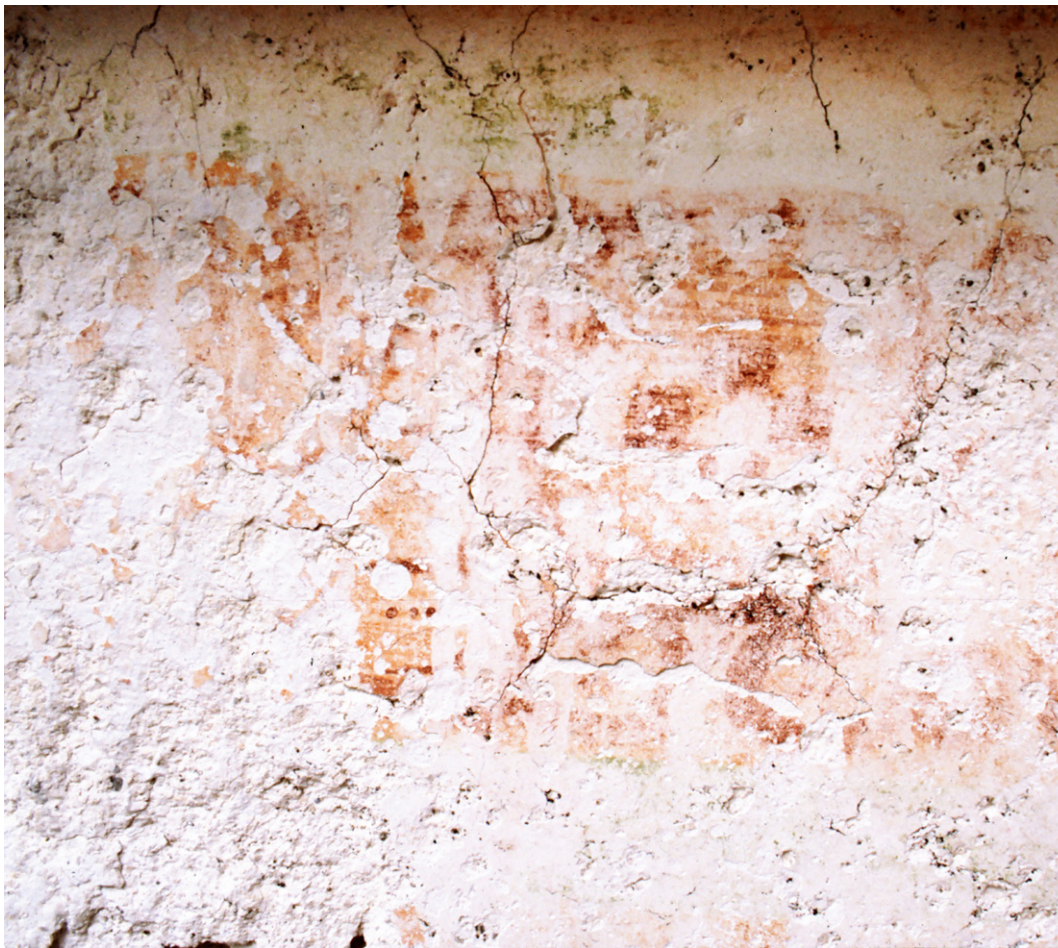
Fig. 163  
The wall north of the passageway shows two bands under the vault spring with remains of Maya hieroglyphs and remains of a mural representing at least four persons above the rubble. Colors: brown, green, and orange.  
Photograph: J. Sulak 1989

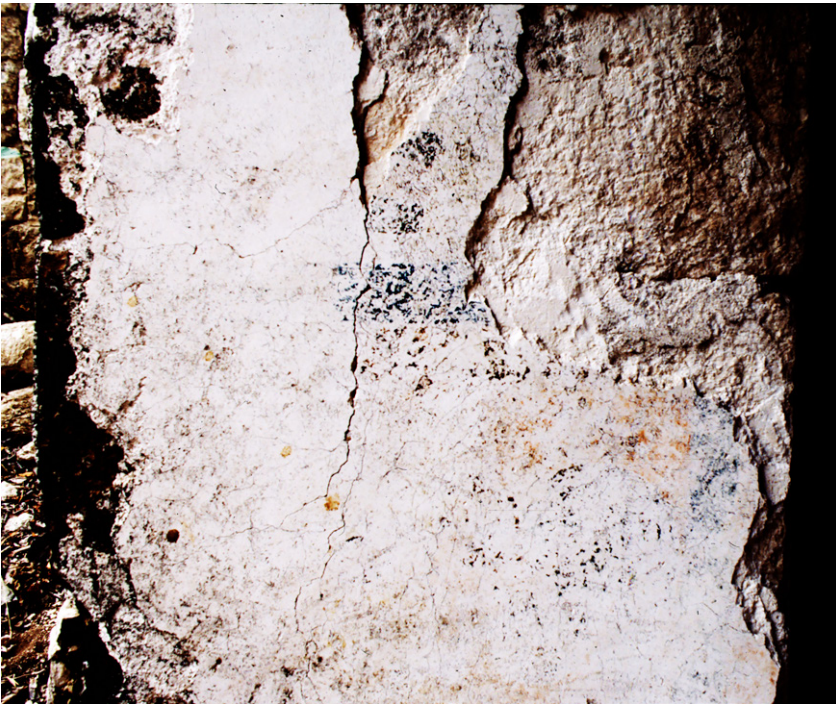
Fig. 164

The southern door jamb shows dark blue, white, yellow, and brown horizontal lines and a light blue vertical line on the right side; a similar painting was on the northern door jamb (Potter 1970:57).
