# THE MAYA TEMPLE-PALACE OF SANTA ROSA XTAMPAK, MEXICO

DOCUMENTATION AND RECONSTRUCTION OF FORM,  
CONSTRUCTION, AND FUNCTION

HASSO HOHMANN

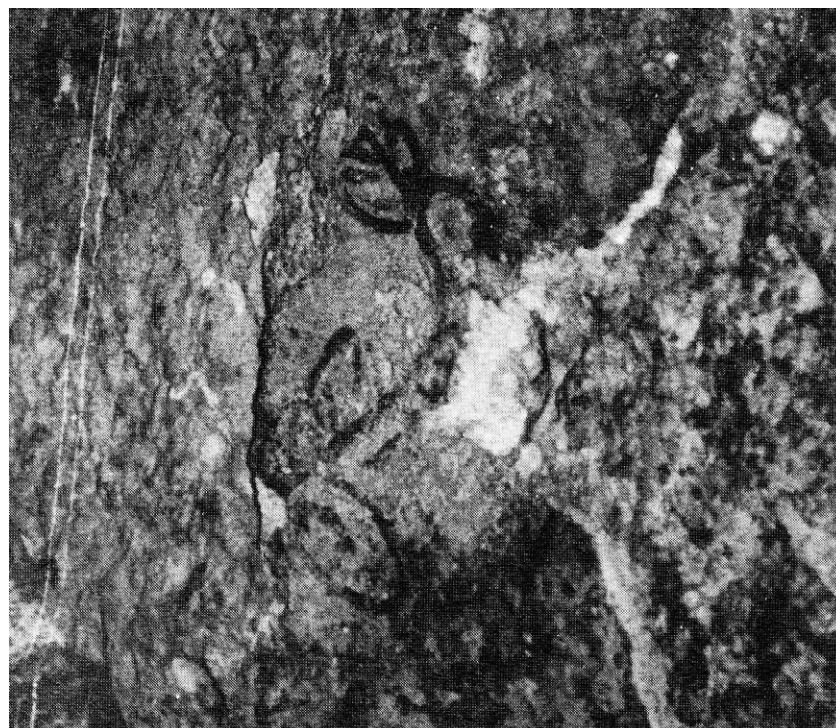
Fig. 165  
The painting on the cornerstone of Room 14.  
Photograph: R. Stamps 1969
