# Collapsing Structures and Public Mismanagement

Wolfgang Seibel

Collapsing Structures  
and Public  
Mismanagement

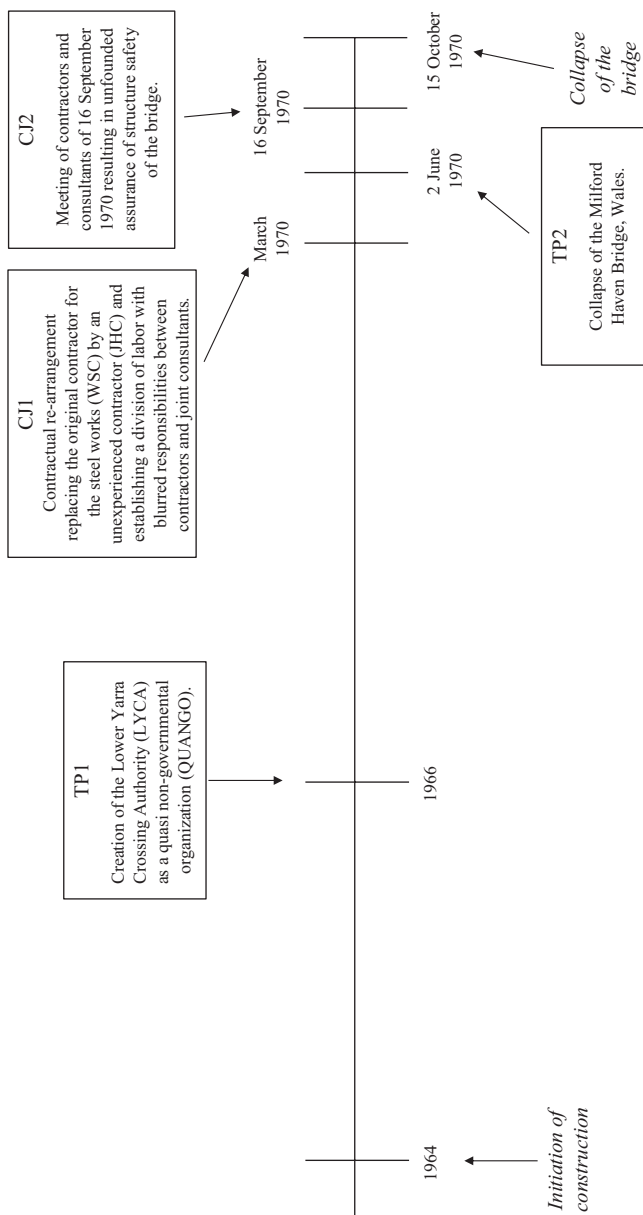
Fig. 2.1 Turning Points (TP) + Critical Junctures (CJ), Collapse of West Gate Bridge

The meeting of 16 September 1970 turned out to be the classic missed opportunity to do what was imperative namely "to put any question of safety beyond reasonable doubt".<sup>107</sup> Instead, appropriate steps to do so fell prey to an organizational and contractual arrangement that systematically generated the type of organized irresponsibility aptly characterized by the Royal Commission (Fig. 2.1):

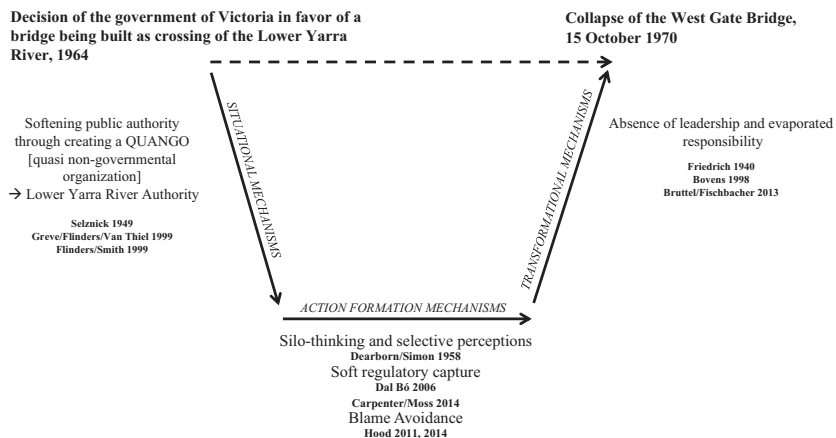
**Fig. 2.2** Causal Mechanisms, Collapse of West Gate Bridge

Still, just as the Royal Commission concluded in its report, the risk-generating consequences of organizational and contractual choices and the risk-increasing impact of resulting behavioral attitudes of key-actors could have been neutralized by mindful and determined management. Accordingly, what can be classified as ultimate trigger factor or transformational mechanism was the absence of appropriate leadership, a sense of responsibility in particular.<sup>118</sup> Both the notion and the reality of responsibility had evaporated. This pertained to awareness in general as well as to conflict management and the managerial and social skills to reintegrate a highly fragmented governance structure. Basically, none of these managerial virtues and attitudes came to bear so that, in the essence, the failure of the West Gate Bridge was, according to the Royal Commission, the consequence of mismanagement and failed leadership (Fig. 2.2).

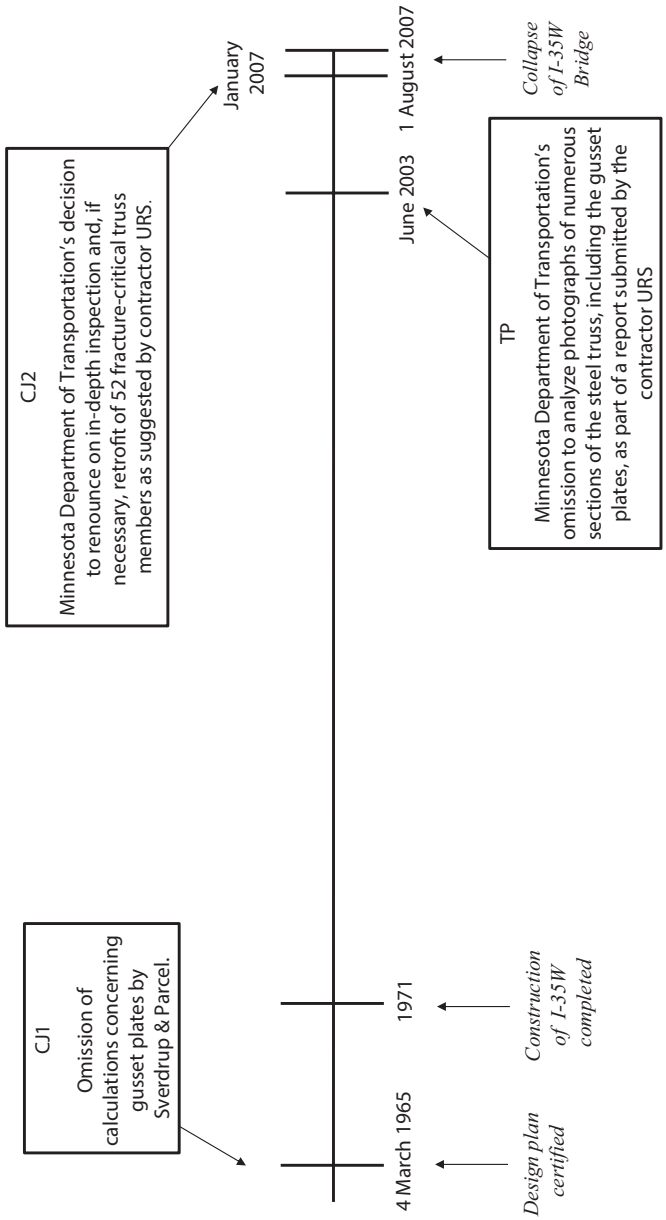
Fig. 3.1 Turning Points + Critical Junctures, collapse of I-35 Bridge

While the decision making process and related meetings stretched over several months starting with URS' first draft report it is safe to say that the critical juncture was reached in January 2007 when it was decided by MnDOT to perform "ultrasonic nondestructive examination of some of the members in the south portion of the deck truss"<sup>92</sup> instead of initiating as soon as possible a comprehensive retrofit of the 52 fracture-critical main truss members, including the gusset plates, as recommended by URS in the first place. That decision was the 'point of no return' beyond which the path to disaster became virtually irreversible (Fig. 3.1).

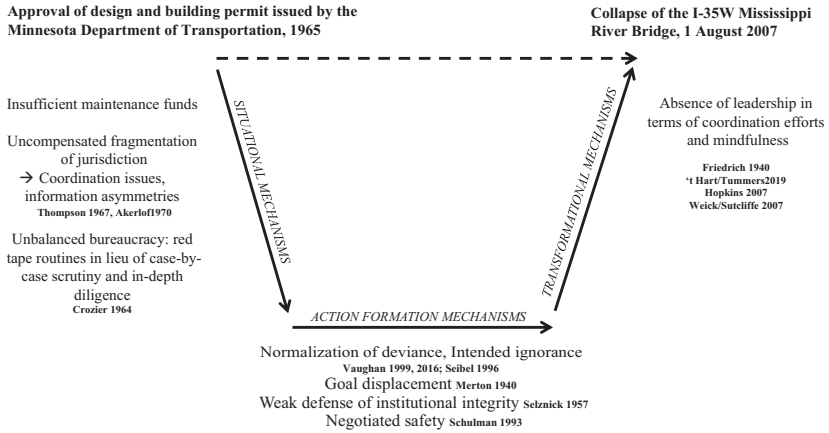
Fig. 3.2 Causal Mechanisms, collapse of I-35 W Bridge

Yet, there was no absolute path dependency. What came to bear on the final stretch of the way to disaster was MnDOT's incapability to re-integrate organizational segments and perspectives. In the essence, it was lack of coordination of an appropriate depth and sophistication.<sup>104</sup> And, to that extent, primarily a lack of mindful leadership.<sup>105</sup> The results of the 2006 inspections, the deliberation between MnDOT and URS during the subsequent months and the planning and preparation of the concrete overlay to be poured on the bridge deck were just not integrated into a comprehensive plan of control and oversight. As a consequence, neither the Office of Bridges and Structures (OBS or Central Bridge) nor URS as the contractor for the non-destructive examination of the steel truss components of the bridge were involved in the preparation and design of the overlay project whose execution finally triggered the collapse of the bridge on 1 August 2007.<sup>106</sup> It was them, however, who had the most intimate and extensive knowledge at their disposal necessary for keeping the load capacity of the bridge in balance. So much for the transformational mechanisms (Fig. 3.2).

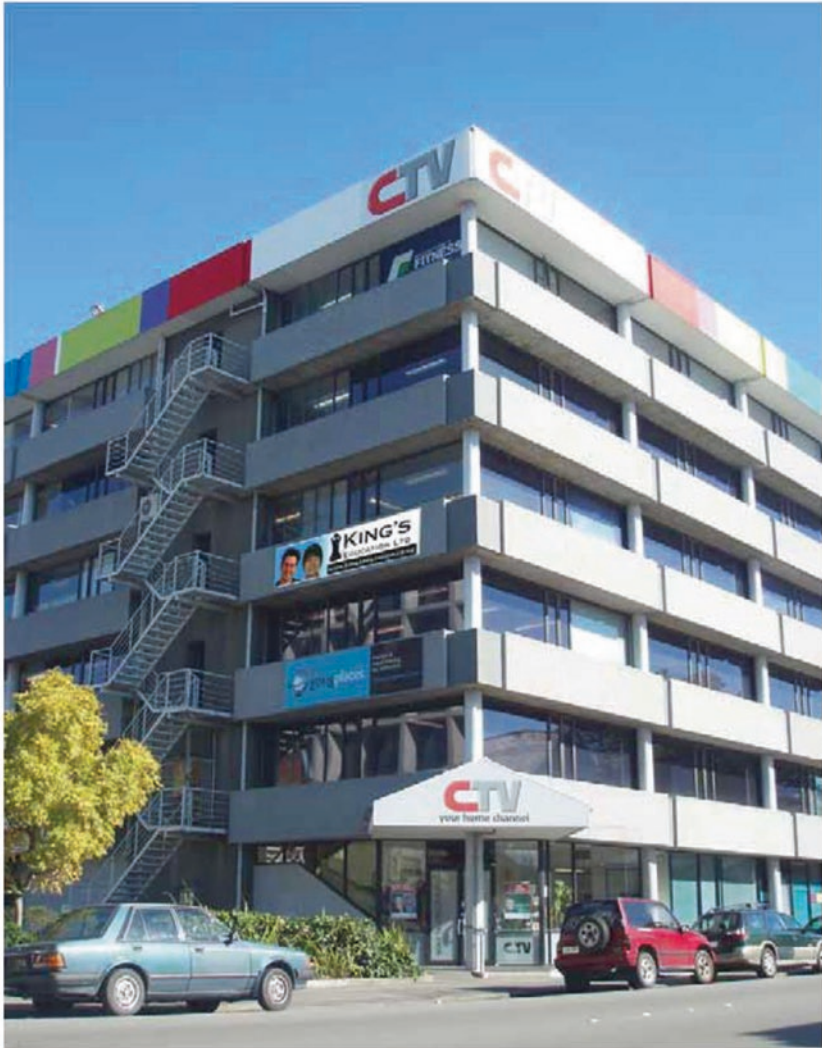
**Illustration 4.1** CTV Building Christchurch prior to its collapse on 22 February 2011. (Source: Royal Commission Vol. 6, p. 3)

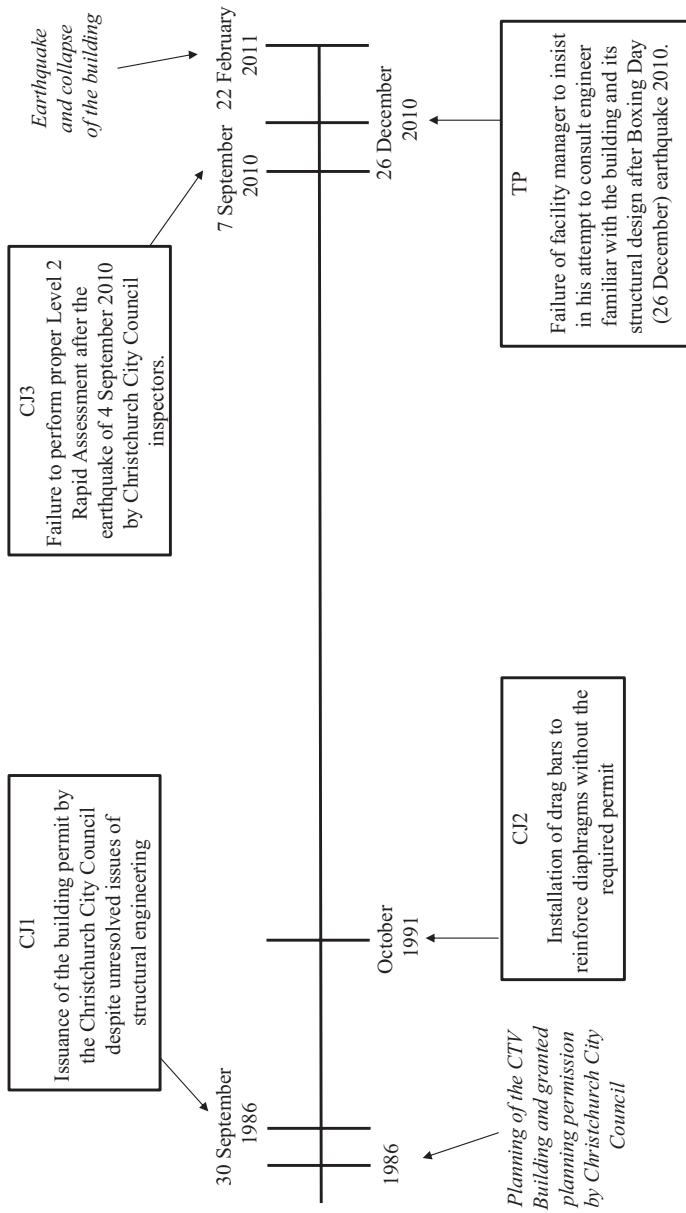
Fig. 4.1 Turning Point (TP) + Critical Junctures (CJ), collapse of CTV building

In sum, Drew's omission to consult Coatsworth, although committed in good faith, one more time followed the pattern of neglect and insufficient risk awareness. Yet, it can be classified a turning point at which an existing path dependency was accentuated rather than generating a new one. Drew initiated repairs whose preparation were still on their way when the CTV building collapsed on 22 February 2011 (Fig. 4.1).

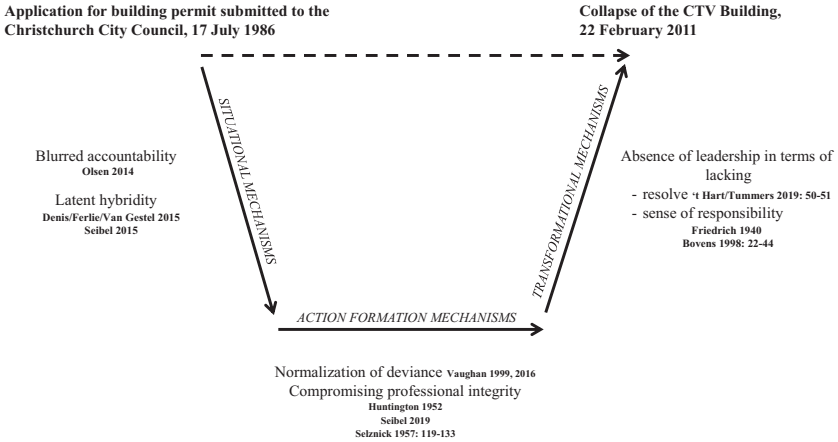
Fig. 4.2 Causal Mechanisms, collapse of CTV building

was the absence of leadership and resolve.<sup>122</sup> Not that at a particular point of a disastrous causal chain a single actor could have intervened and did not do so. It was, rather, a creeping crisis<sup>123</sup> of leadership especially at the helm of the responsible division of the Christchurch City Council that decisively contributed to both the “normalization of deviance” from regular professional standards of structural engineering assessment and the CCC’s inability to address properly the post-earthquake situation of September 2010. Judgment and resolve would have been necessary after the earthquake of 4 September 2010 for the adequate management of building inspections. Instead, it was left to the discretion of private owners whether or not to engage an engineer for a sound structural engineering assessment. Sloppiness in handling structural engineering checking procedures and their documentation could and should have been recognized by the relevant CCC officials in the first place. What is more, however, a sound sense of responsibility beyond formal accountability standards<sup>124</sup> should have ensured that standard operating procedures and routinized attitudes of staff had no detrimental effect on handling sensitive cases of structural engineering assessment in an earthquake prone environment. It was this particular quality of leadership that was tragically missing (Fig. 4.2).

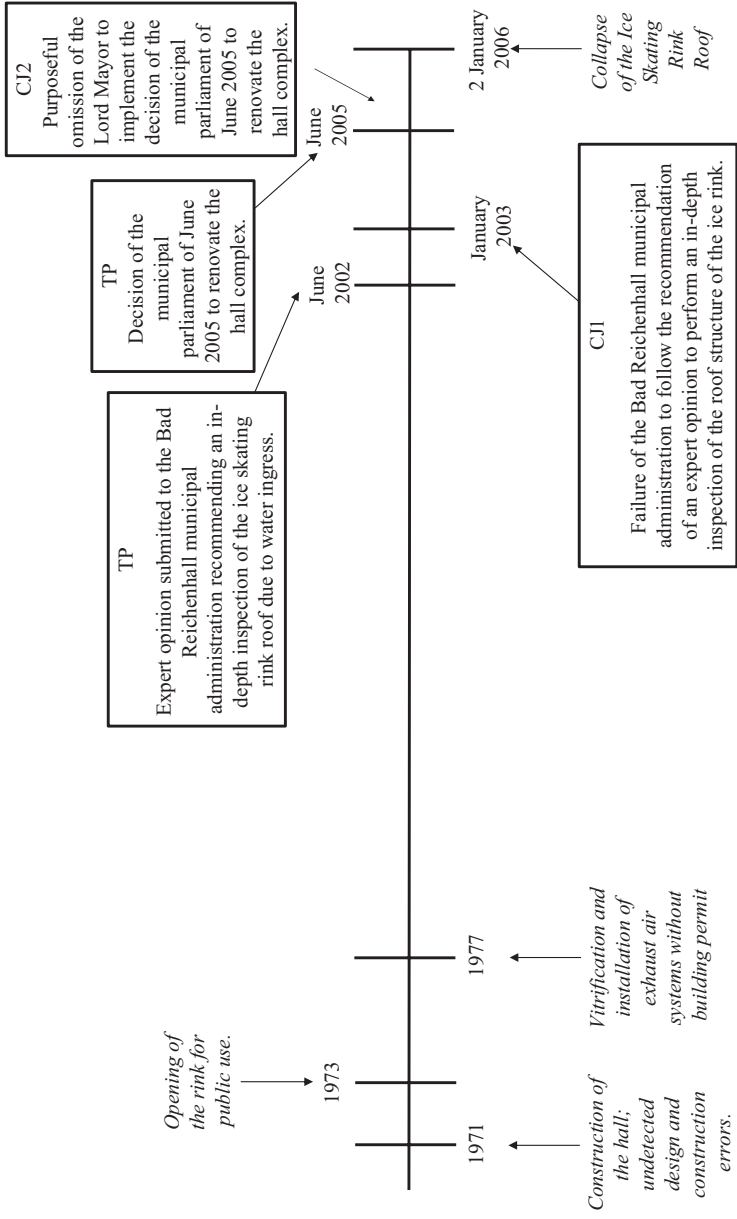
Fig. 5.1 Turning Points (TP) + Critical Junctures (CJ), Collapse of Bad Reichenhall Ice Skating Rink

An antecedent turning point that changed the disposition of the City administration was the turn of the millennium<sup>81</sup> when a new EU Directive for infrastructure standards caused doubts as to whether the hall complex as such could have an economically viable future at all. This provided an incentive for cost reduction in case of any renovation measures. Still, however, it was a serious omission that the Reichenhall City administration did not pay thorough attention to the water ingress and to the advice of the architect consulted in 2002 to conduct an in-depth inspection of the roof construction of the ice rink (Fig. 5.1).

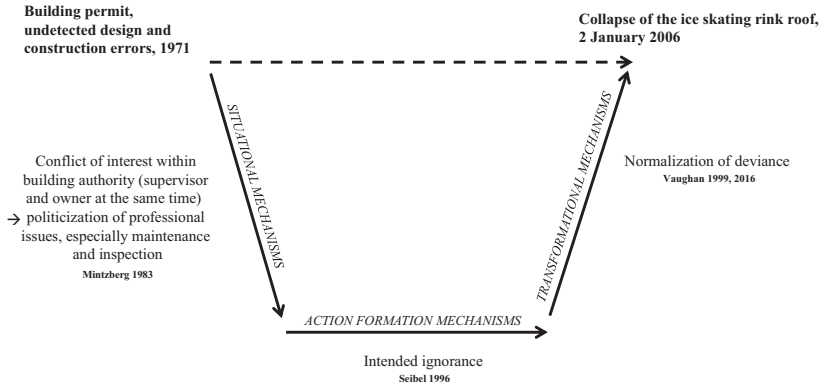
Fig. 5.2 Causal Mechanisms, Collapse of Bad Reichenhall Ice Skating Rink

Nevertheless, the question remains if the collapse of the roof of the ice rink on 2 January 2006 could have been averted at the very last moment. However, it became apparent even on that very day that the lack of risk awareness was deeply engrained so that a timely shut-down and evacuation of the ice rink was not initiated. The facility manager of the ice skating rink, worried about the heavy snow fall, was told by the relevant official of the building authority to wait until 4:00 PM to close the hall. This instruction was issued although the official, according to the Traunstein Regional Court, had not the “slightest idea” of the actual load-carrying capacity of the hall roof (Fig. 5.2).<sup>113</sup>
